## Facility Condition Assessment Summary Report

### Comegys School

School District of Philadelphia  
**S126001;Comegys**  
Final  
**Site Assessment Report**  
January 30, 2017

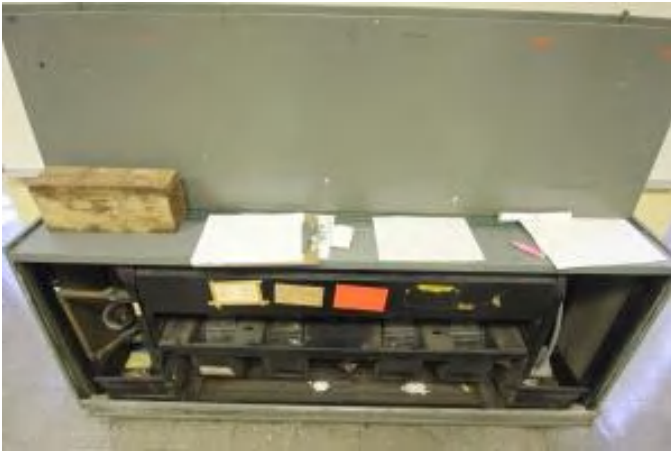
#### System: D3040 - Distribution Systems

**Location:** Classrooms

**Distress:** Beyond Service Life

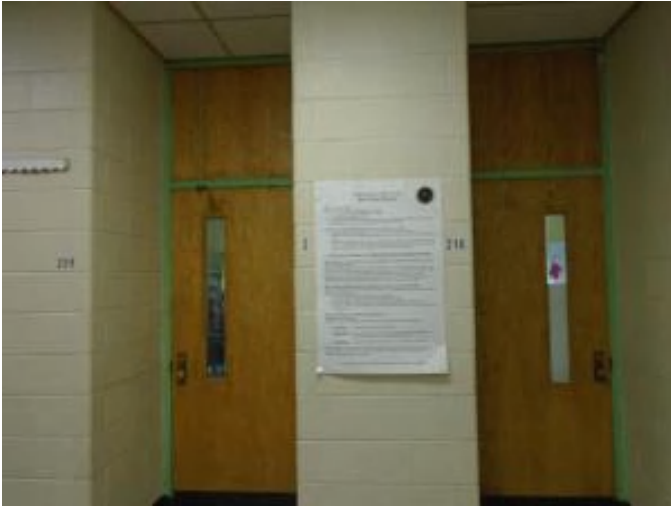
**System: C1020 - Interior Doors**

**Location:** Entire Building

**Distress:** Accessibility

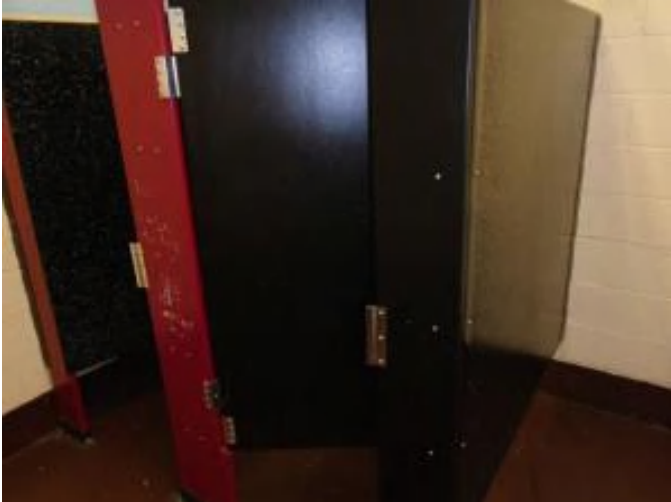
**System: C1030 - Fittings**

**Location:** Throughout

**Distress:** Accessibility

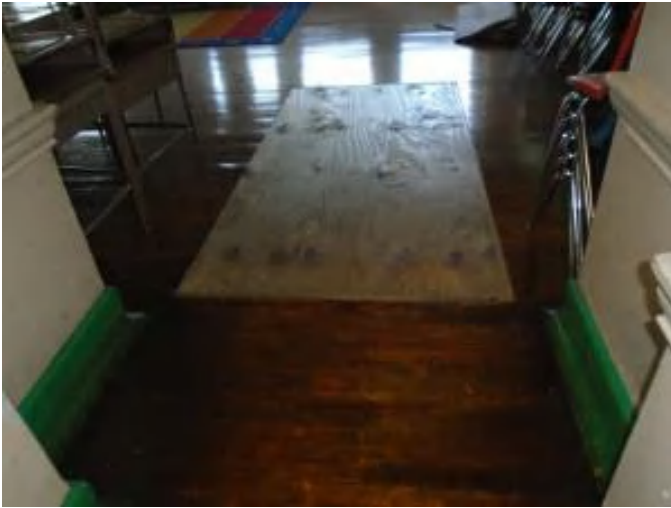
**System: C3020414 - Wood Flooring**

**Location:** Library

**Distress:** Damaged

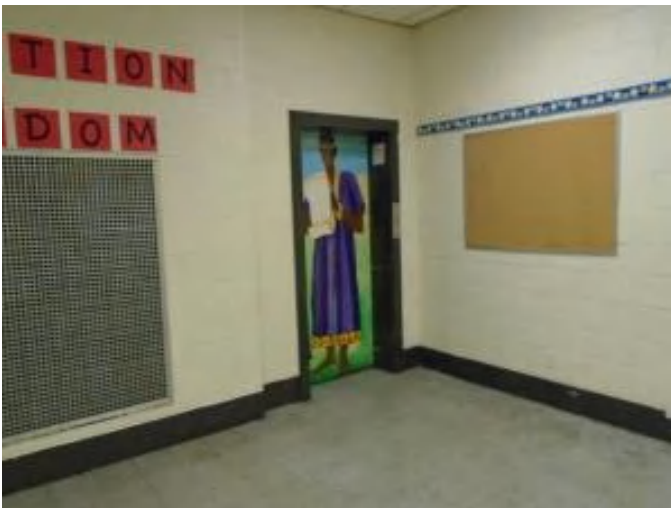
**System: D1010 - Elevators and Lifts**

**Location:** Elevator

**Distress:** Accessibility

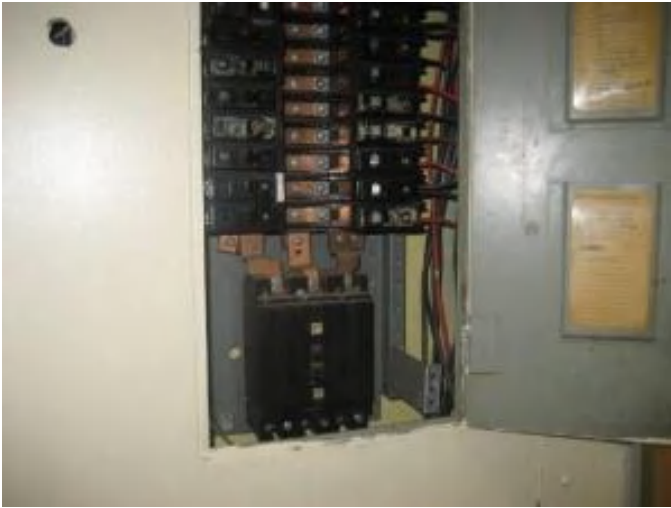
**System: D5010 - Electrical Service/Distribution**

There are 120/208V panel-boards in each floor for lighting and receptacles. These panel-boards and associated wiring were installed in 1996 and have already exceeded their useful service life. The entire distribution system needs to be replaced. Provide new panel-boards.

**Location:** Corridors from the basement to the third floor

**Distress:** Beyond Service Life

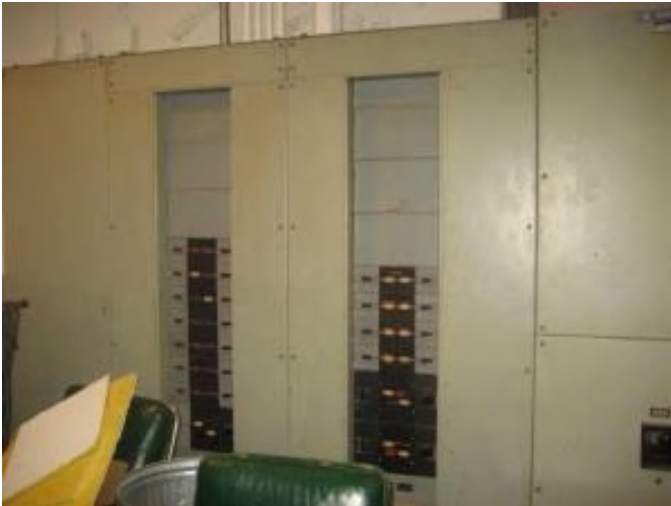
**System: D5010 - Electrical Service/Distribution**

**Location:** Basement electrical room

**Distress:** Beyond Service Life

**Correction:** Replace Switchboard

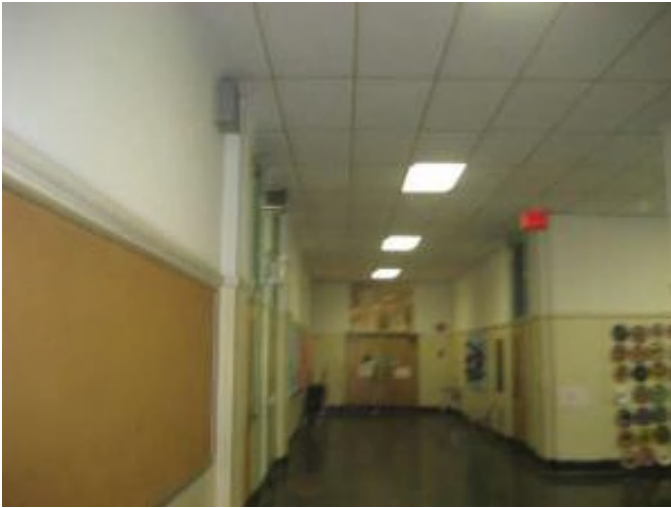
**System: D5020 - Lighting and Branch Wiring**

**Location:** Entire school

**Distress:** Energy Efficiency

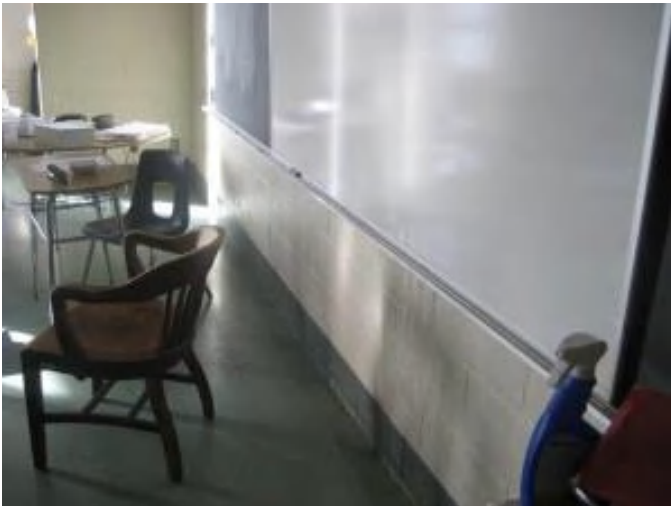
**System: D5020 - Lighting and Branch Wiring**

There number of receptacles in classrooms varies, approximate 30% of the classrooms have been remodeled and provided with the proper amount of receptacles but 70% of them the quantity of receptacles are inadequate. Teachers use extension cords. Provide teacher's whiteboard wall and the opposite of it with double compartment surface raceways, the other two walls with minimum two duplex outlets each, when feasible.

**Location:** classrooms

**Distress:** Inadequate

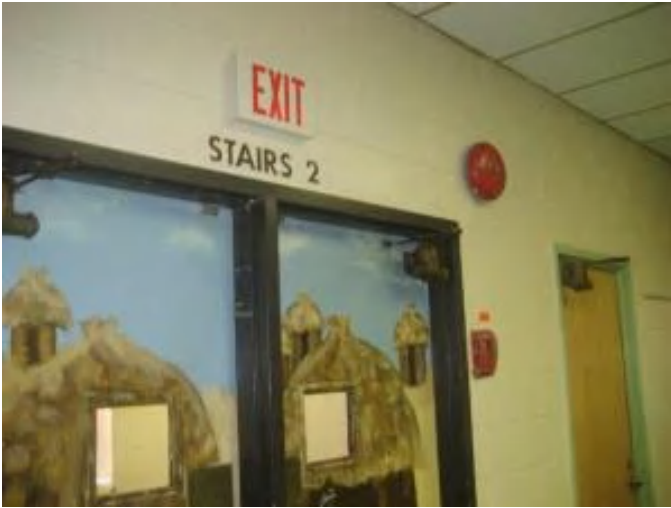
**System: D5020 - Lighting and Branch Wiring**

**Location:** Entire Building  
**Distress:** Building / MEP Codes  
**Category:** 2 - Code Compliance  
**Priority:** 2 - Response Time (2-3 yrs)  
**Correction:** Maintain Lighting Fixtures  
**Qty:** 20.00  
**Unit of Measure:** Ea.  
**Estimate:** \$25,879.39  
**Assessor Name:** System  
**Date Created:** 09/09/2015

**Notes:** Replace exit signs with battery back-up type.

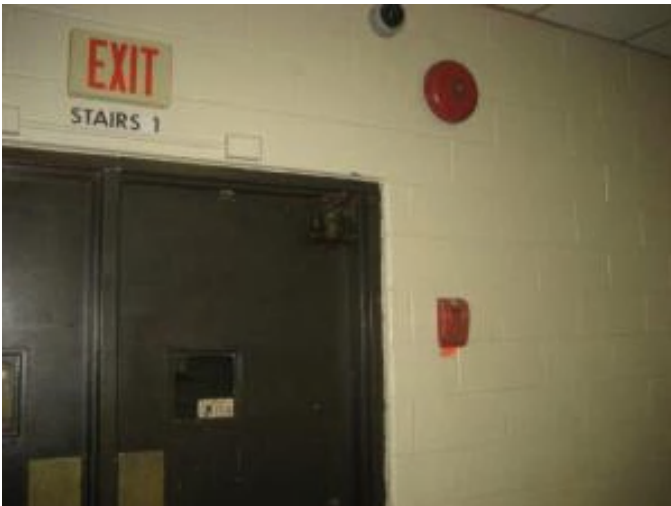
**System: D5030 - Communications and Security**

Fire Alarm System- The FACP system is approximately 30 years old and has exceeded its useful service life. The present Fire Alarm system does not meet current code. Fire alarm system is tested every day in the morning. Replace fire alarm system.

**Location:** Entire building  
**Distress:** Life Safety / NFPA / PFD  
**Category:** 1 - Health & Safety  
**Priority:** 2 - Response Time (2-3 yrs)  
**Correction:** Add fire alarm device  
**Qty:** 95.00  
**Unit of Measure:** Ea.  
**Estimate:** \$178,466.43  
**Assessor Name:** System  
**Date Created:** 08/11/2015

**Notes:** Replace old fire alarm system with addressable type with audio/visual devices in the entire school. Approximate 95 devices.

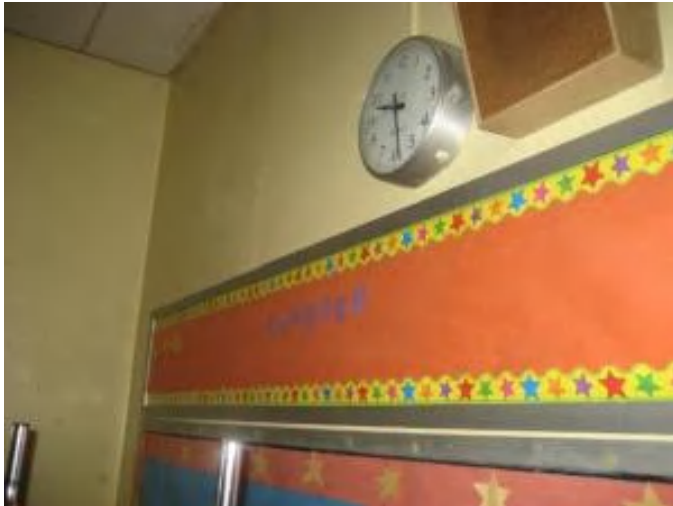
**System: D5030 - Communications and Security**

**Location:** classrooms

**Distress:** Obsolete

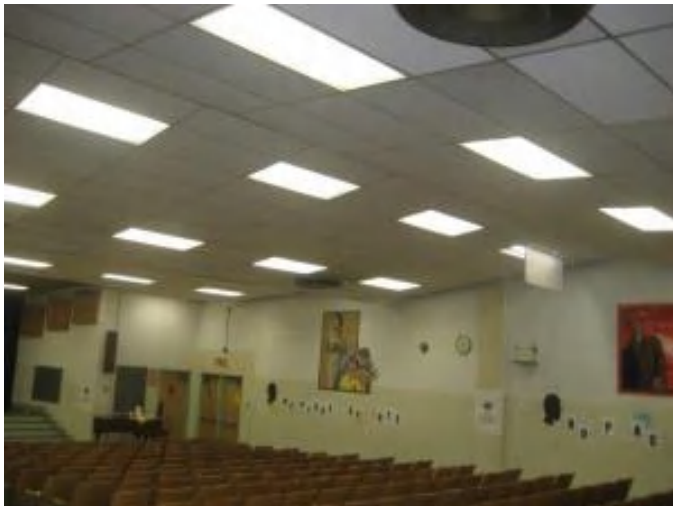
**System: D5030 - Communications and Security**

**Location:** auditorium

**Distress:** Inadequate

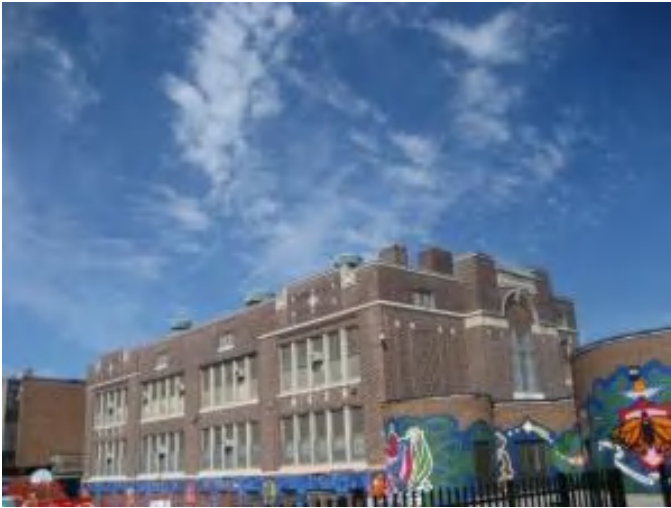
**System: D5090 - Other Electrical Systems**

**Location:** outdoor

**Distress:** Life Safety / NFPA / PFD

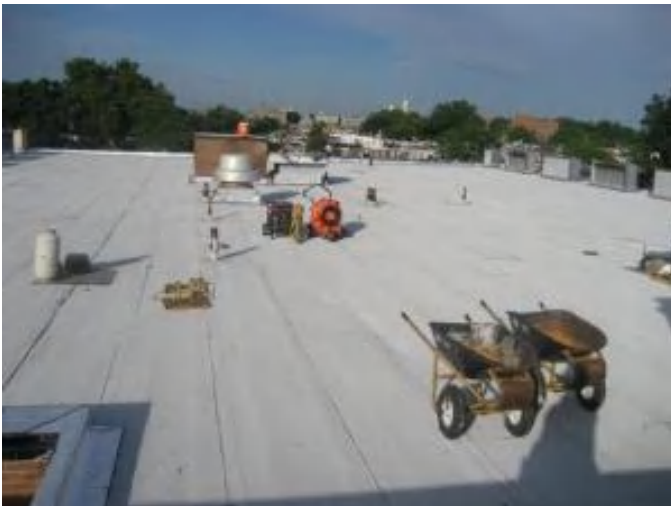
**System: D5090 - Other Electrical Systems**

**Location:** Roof

**Distress:** Building / MEP Codes

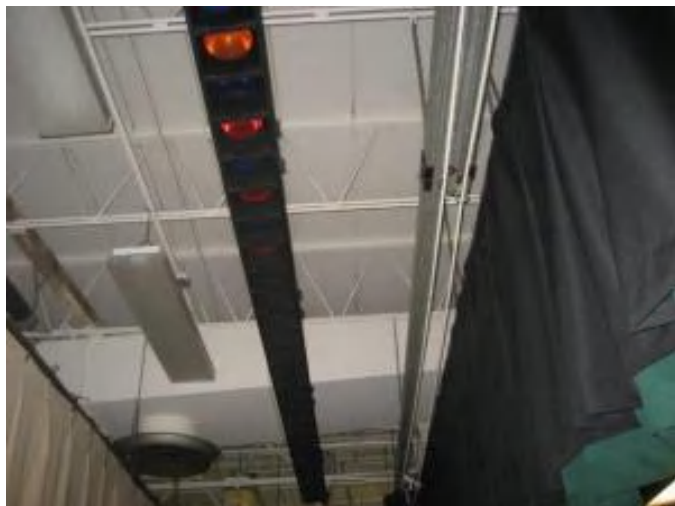
**System: E1020 - Institutional Equipment**

**Location:** auditorium

**Distress:** Inadequate

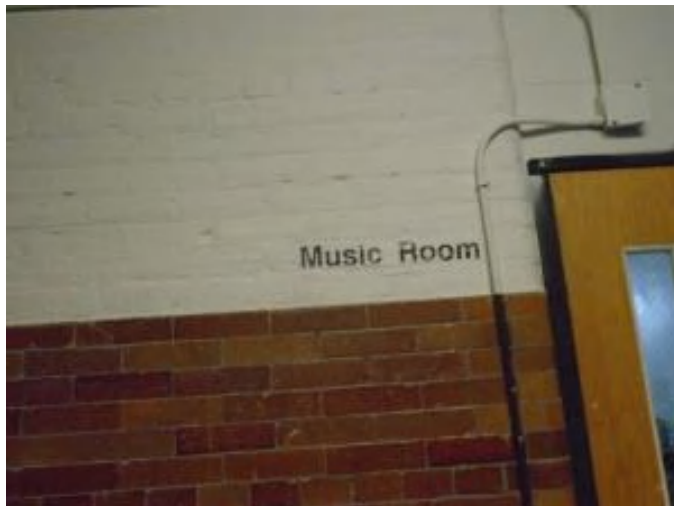
**System: C1030 - Fittings**

**Location:** Throughout

**Distress:** Inadequate

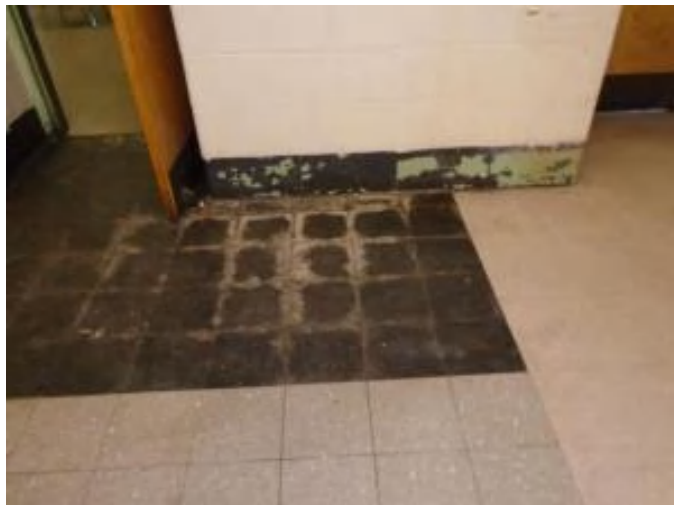
**System: C3020413 - Vinyl Flooring**

**Location:** Various

**Distress:** Damaged

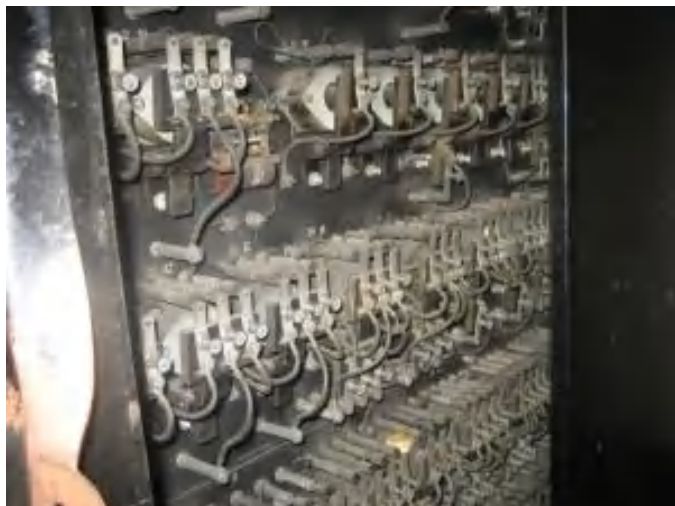
**System: D1010 - Elevators and Lifts**

**Location:** Elevator machine room

**Distress:** Damaged

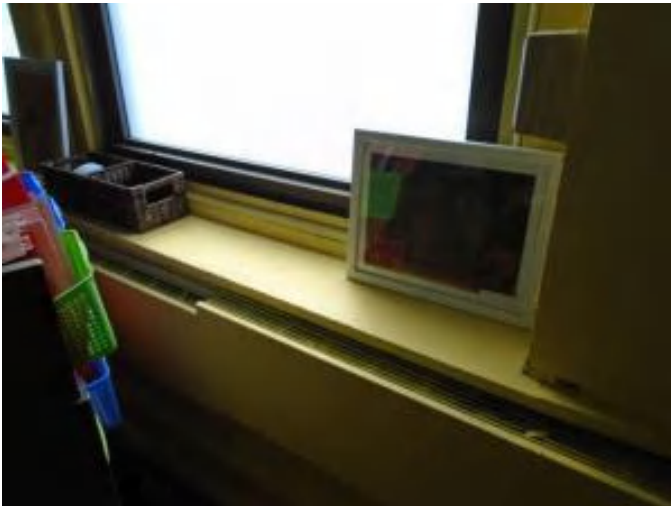
**System: B2020 - Exterior Windows**

**Location:** Entire Building

**Distress:** Energy Efficiency

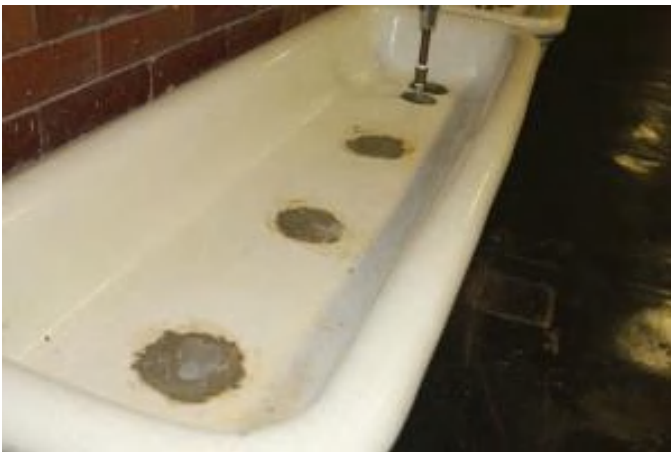
**System: D2010 - Plumbing Fixtures**

Drinking fountains in the corridors are mixture of porcelain, enameled cast iron, and stainless steel, floor standing or wall hung without coolers. They are not accessible and have exceeded their service life and should be replaced.

**Location:** Entire building

**Distress:** Accessibility

**Notes:** Replace aged, non-accessible drinking fountains.

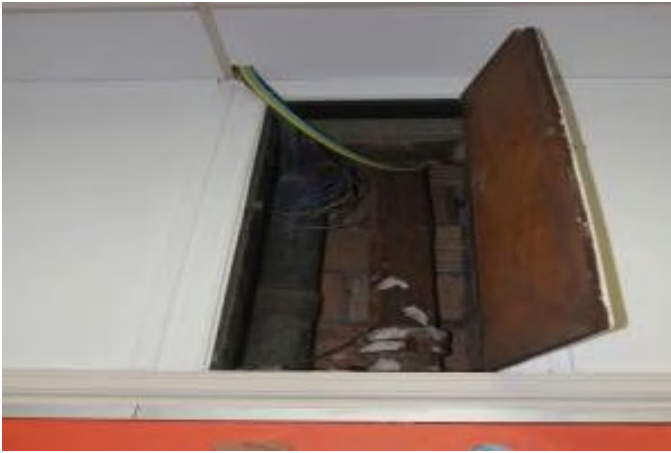
**System: D2030 - Sanitary Waste**

**Location:** Entire building

**Distress:** Beyond Service Life

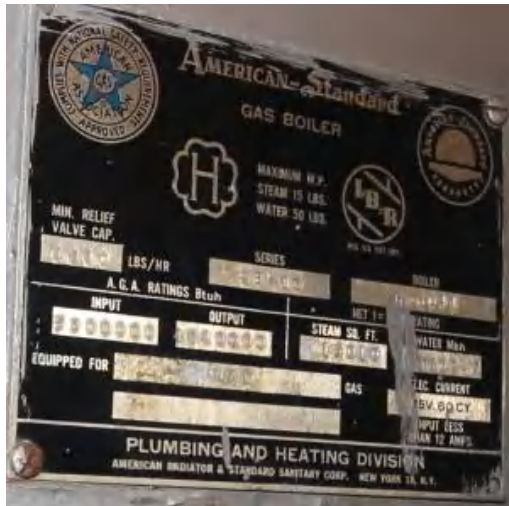
**System: D3020 - Heat Generating Systems**

**Location:** Boiler room

**Distress:** Beyond Service Life

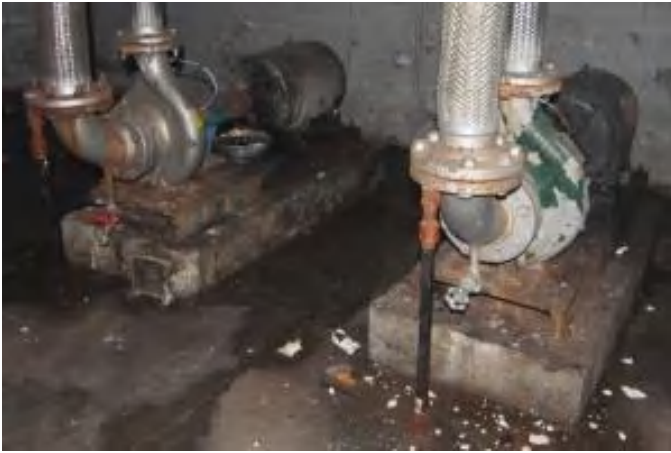
**System: D3020 - Heat Generating Systems**

**Location:** Boiler room

**Distress:** Beyond Service Life

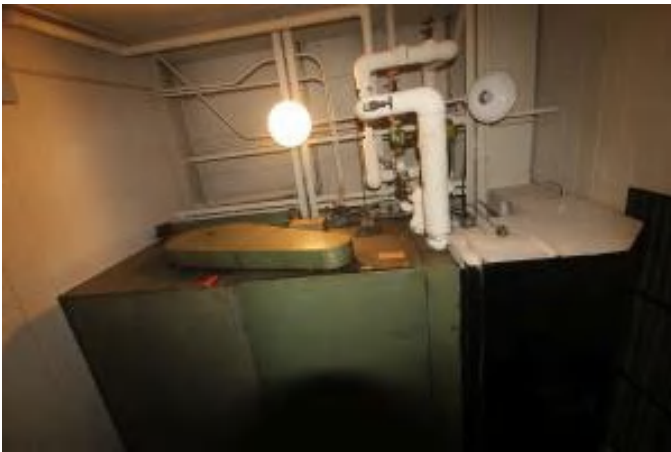
**System: D3040 - Distribution Systems**

The auditorium and gym are ventilated by 4 fan coil units located in those spaces. These units do not have cooling coils. They appear original to the building addition, have pneumatic controls, and have exceeded their lifespan. They should be replaced with new units including cooling coils. Hydronic piping is threaded steel. It should be examined at the time of system upgrades and repaired as needed.

**Location:** Auditorium and gym/cafeteria

**Distress:** Inadequate

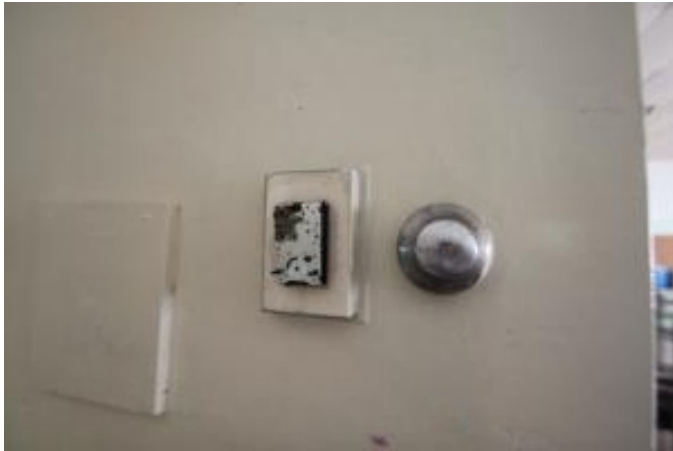
**System: D3060 - Controls & Instrumentation**

Unit vents and fan coils have pneumatic controls. Pneumatic thermostats are in all building areas and many are damaged. The entire system is obsolete. The building control system should be upgraded to modern digital controls, when other components are upgraded.

**Location:** Entire building

**Distress:** Damaged

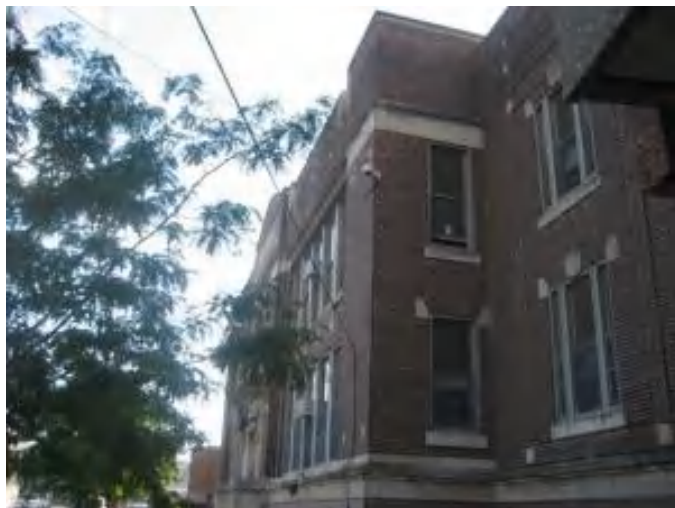
#### System: G4030 - Site Communications & Security

**Location:** Building perimeter

**Distress:** Health Hazard / Risk
