Facility Condition Assessment Summary Report

Elkin School

January 30, 2017

Facility Assessment, August 2015

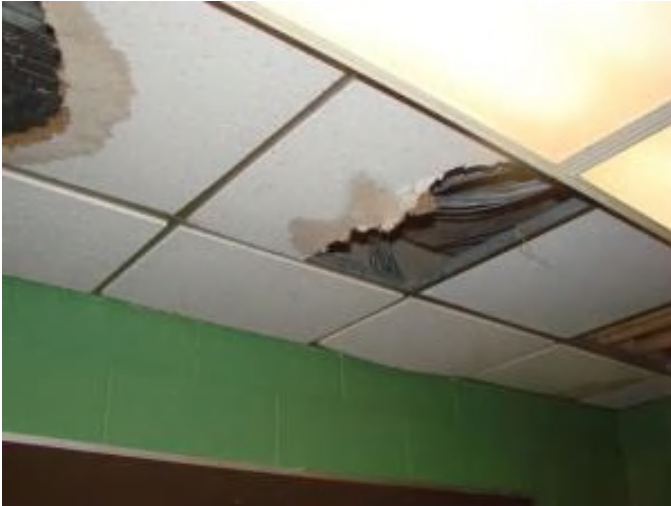
System: C3030 - Ceiling Finishes

Location: Interior

Distress: Beyond Service Life

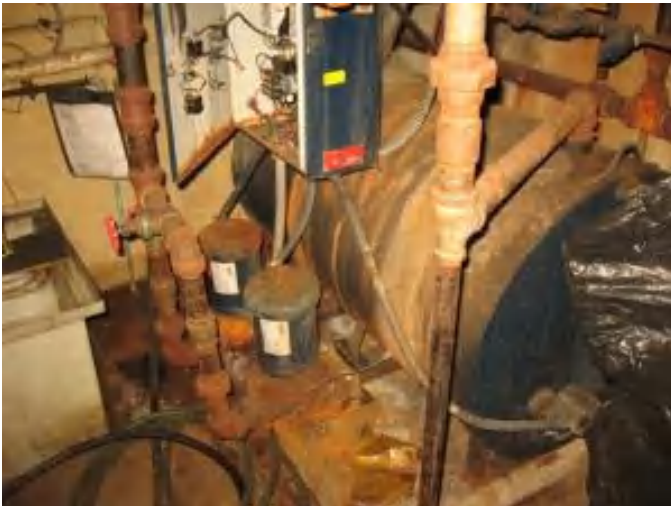
System: D3020 - Heat Generating Systems

Location: Boiler room

Distress: Damaged

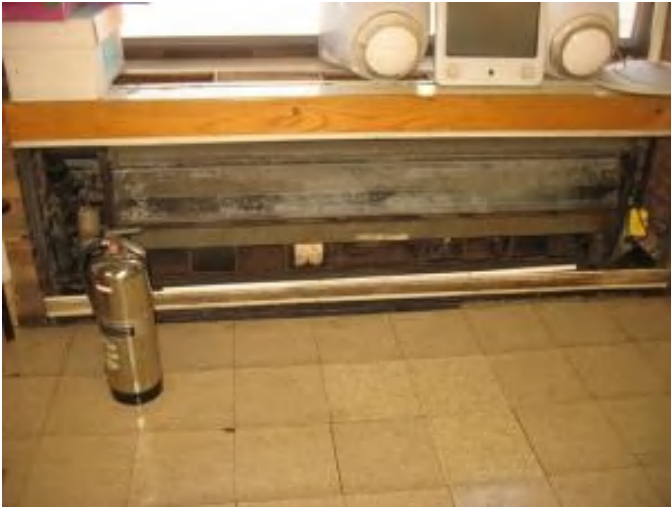
System: D3040 - Distribution Systems

Location: Classrooms
Distress: Beyond Service Life
Category: 3 - Operations / Maint.
Priority: 2 - Response Time (2-3 yrs)
Correction: Replace classroom unit ventilator (htg/clg coils, 5 tons, 2,000 CFM)
Qty: 43.00
Unit of Measure: Ea.
Estimate: \$2,144,782.93
Assessor Name: Craig Anding
Date Created: 09/24/2015

Notes: Replace the existing unit ventilators, which are beyond their service life and in poor condition, with two pipe units that have integral heat exchangers to introduce outdoor air to the building.

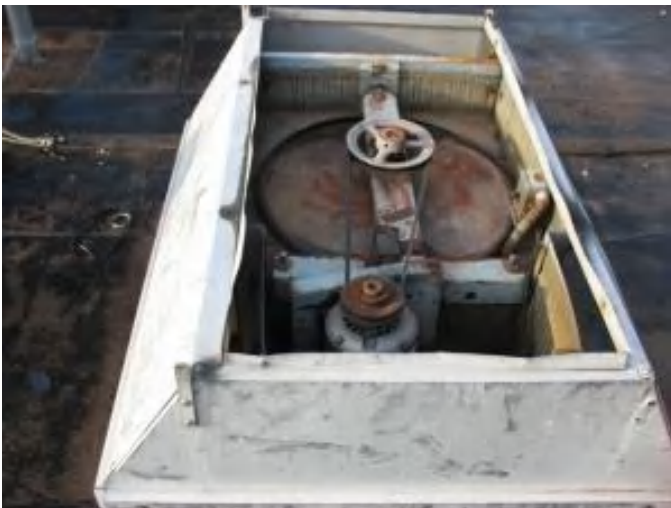
System: D3040 - Distribution Systems

Location: Roof
Distress: Damaged
Category: 3 - Operations / Maint.
Priority: 2 - Response Time (2-3 yrs)
Correction: Replace power roof ventilator (24" dia.)
Qty: 20.00
Unit of Measure: Ea.
Estimate: \$597,896.51
Assessor Name: Craig Anding
Date Created: 09/24/2015

Notes: Replace twenty (20) roof mounted power ventilators which are beyond their service life and damaged to ensure adequate ventilation for the building.

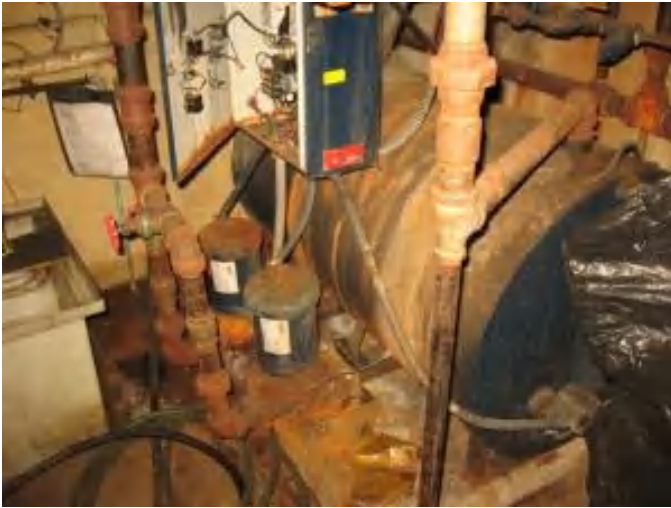
System: D3040 - Distribution Systems

Location: Boiler room

Distress: Damaged

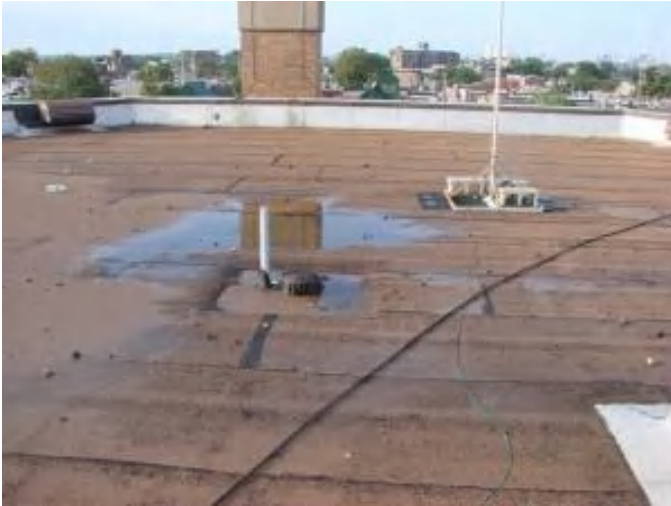
System: B3010105 - Built-Up

Location: Exterior

Distress: Building Envelope Integrity

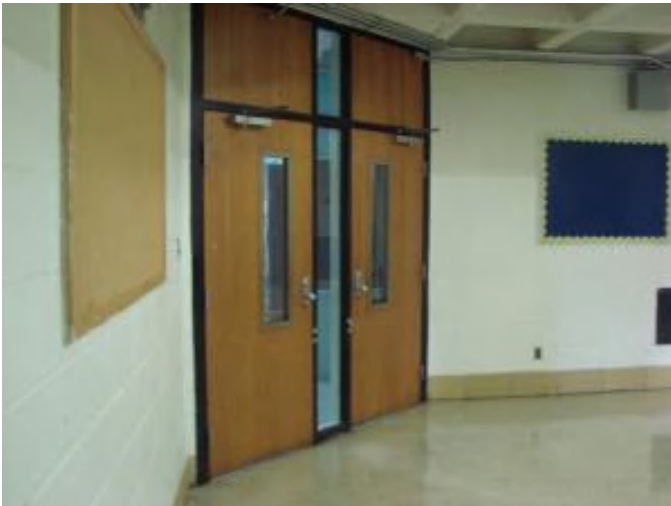
System: C1020 - Interior Doors

Location: Interior

Distress: Accessibility

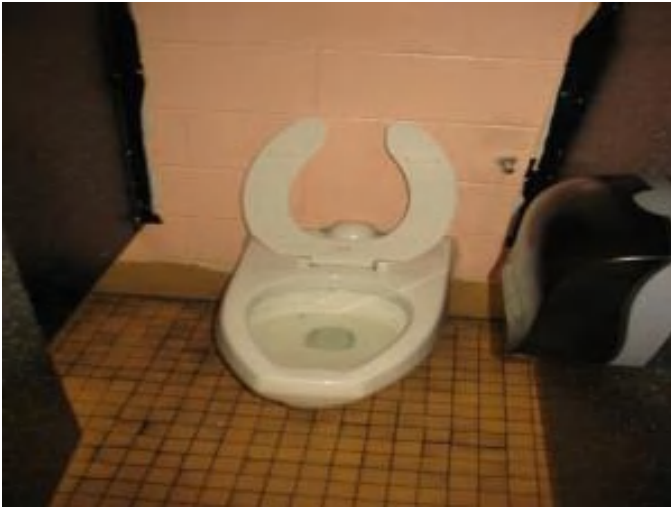
System: D2010 - Plumbing Fixtures

Location: Restrooms
Distress: Beyond Service Life
Category: 3 - Operations / Maint.
Priority: 3 - Response Time (3-4 yrs)
Correction: Remove and replace or replace water closet - quantify additional units
Qty: 20.00
Unit of Measure: Ea.
Estimate: \$149,242.96
Assessor Name: Craig Anding
Date Created: 09/24/2015

Notes: Replace twenty (20) water closets, in use beyond their service life, with new code compliant fixtures.

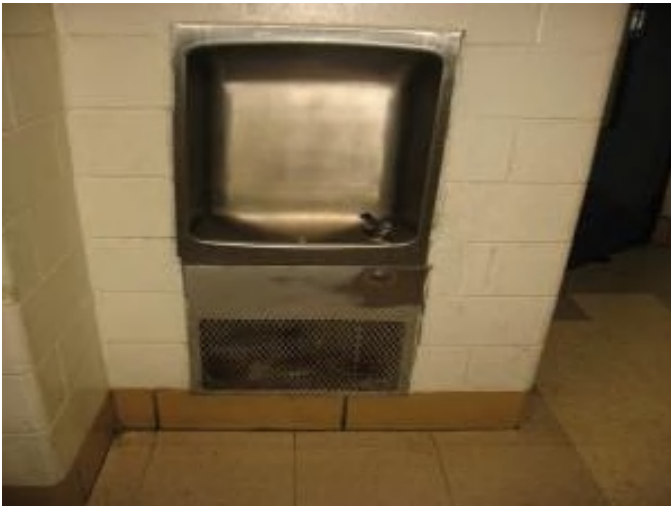
System: D2010 - Plumbing Fixtures

Location: Corridors
Distress: Beyond Service Life
Category: 3 - Operations / Maint.
Priority: 3 - Response Time (3-4 yrs)
Correction: Remove and Replace Water Fountains - without ADA new recessed alcove
Qty: 6.00
Unit of Measure: Ea.
Estimate: \$45,475.14
Assessor Name: Craig Anding
Date Created: 09/24/2015

Notes: Replace the wall hung drinking fountains and integral refrigerated coolers in the corridors and at the restrooms. These units are well beyond their service life and most are NOT accessible type.

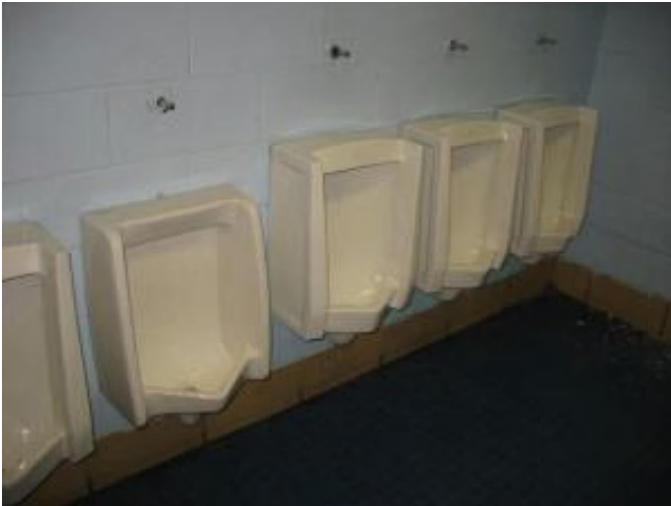
System: D2010 - Plumbing Fixtures

Location: Restrooms

Distress: Beyond Service Life

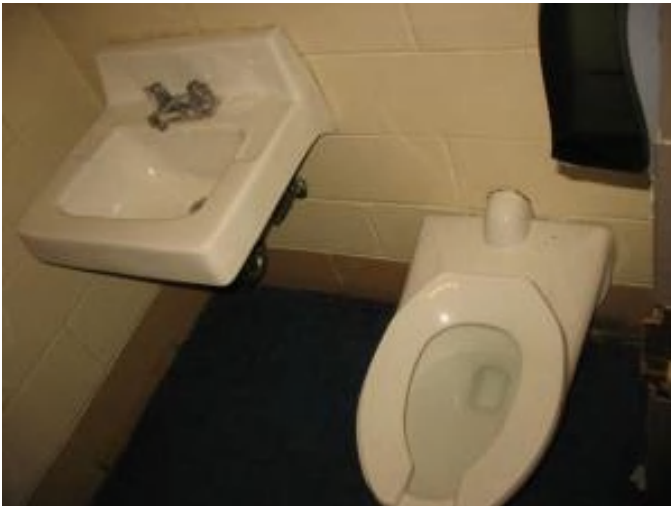
System: D2010 - Plumbing Fixtures

Location: Restrooms

Distress: Beyond Service Life

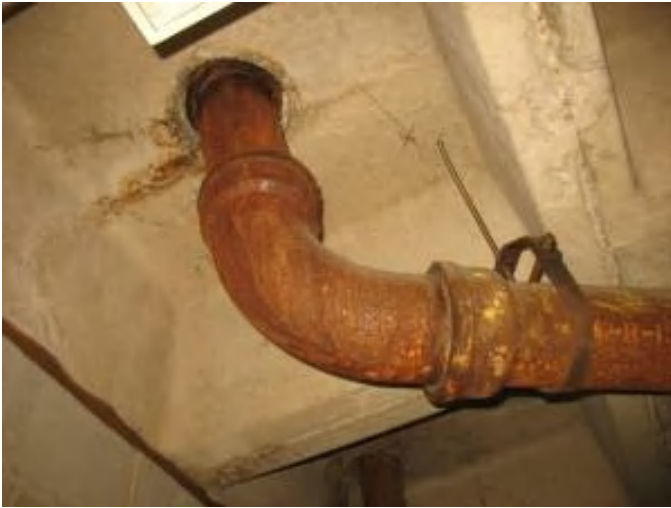
System: D2030 - Sanitary Waste

Location: Throughout building

Distress: Beyond Service Life

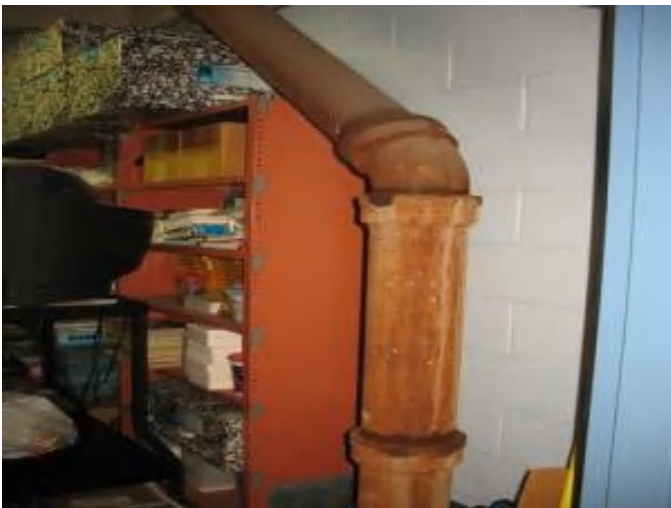
System: D2040 - Rain Water Drainage

Location: Throughout building

Distress: Beyond Service Life

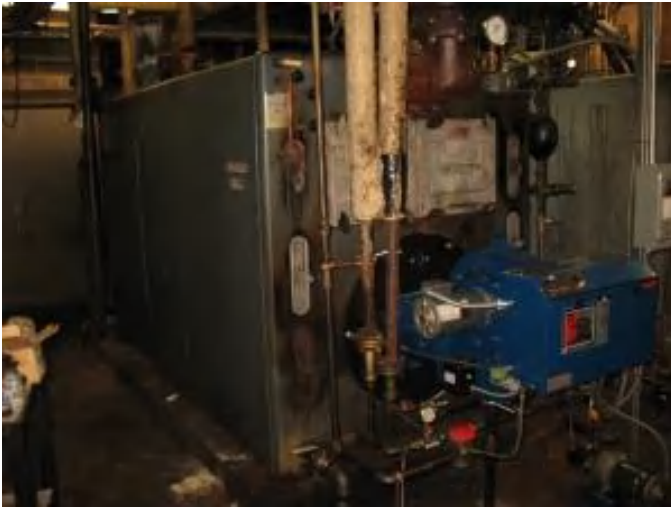
System: D3020 - Heat Generating Systems

Location: Boiler room
Distress: Beyond Service Life
Category: 3 - Operations / Maint.
Priority: 3 - Response Time (3-4 yrs)
Correction: Replace boiler, cast iron sectional (150 HP)
Qty: 2.00
Unit of Measure: Ea.
Estimate: \$1,050,121.66
Assessor Name: Craig Anding
Date Created: 09/24/2015

Notes: Replace the two existing 5,230MBH cast iron boilers, which are beyond their service life, and exhaust ductwork.

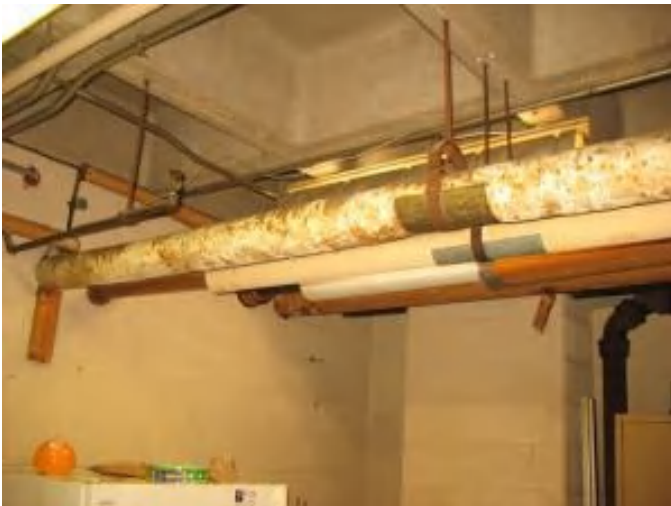
System: D3040 - Distribution Systems

Location: Throughout building
Distress: Beyond Service Life
Category: 3 - Operations / Maint.
Priority: 3 - Response Time (3-4 yrs)
Correction: Perform testing to identify and replace damaged steam and condensate piping.
Qty: 53,200.00
Unit of Measure: S.F.
Estimate: \$503,291.92
Assessor Name: Craig Anding
Date Created: 09/24/2015

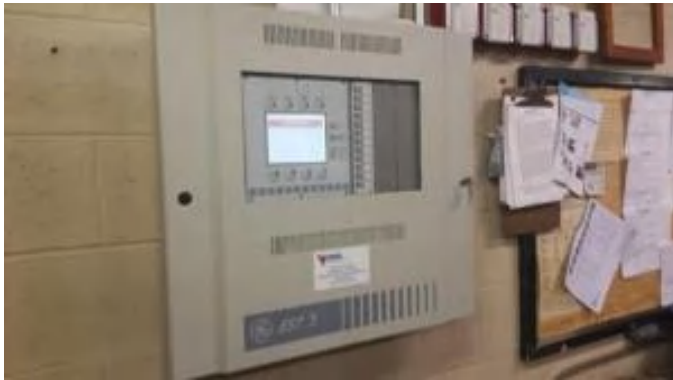
System: D5030 - Communications and Security

Location: throughout the building
Distress: Building / MEP Codes
Category: 2 - Code Compliance
Priority: 3 - Response Time (3-4 yrs)
Correction: Replace fire alarm system
Qty: 1.00
Unit of Measure: S.F.
Estimate: \$183,271.13
Assessor Name: Craig Anding
Date Created: 09/28/2015

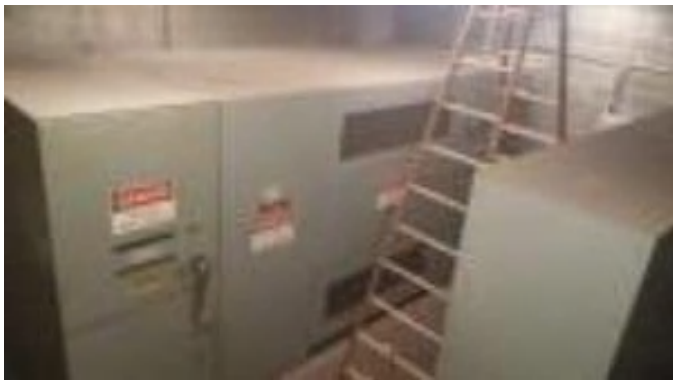
System: D5090 - Other Electrical Systems

Location: electrical room
Distress: Building / MEP Codes
Category: 2 - Code Compliance
Priority: 3 - Response Time (3-4 yrs)
Correction: Replace standby generator system
Qty: 1.00
Unit of Measure: Ea.
Estimate: \$207,273.92
Assessor Name: Craig Anding
Date Created: 09/29/2015

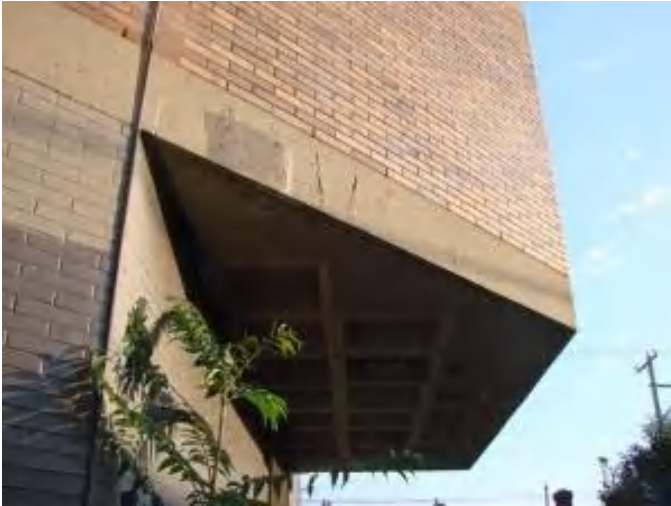
System: B2010 - Exterior Walls

Location: Exterior

Distress: Damaged

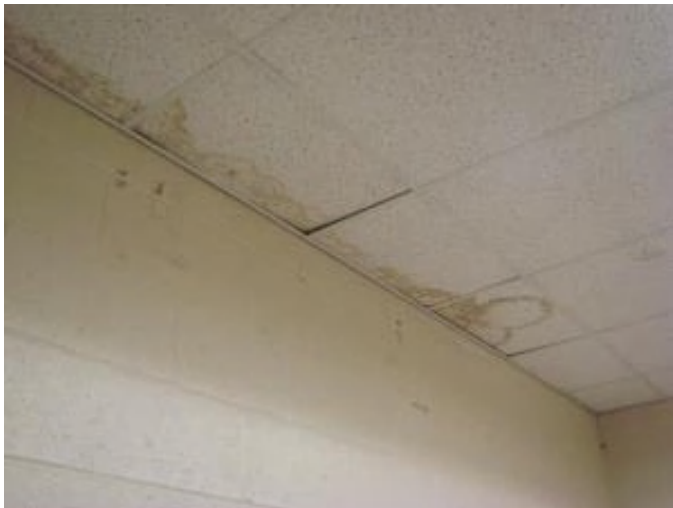
System: C3030 - Ceiling Finishes

Location: Interior
Distress: Beyond Service Life
Category: 3 - Operations / Maint.
Priority: 4 - Response Time (4-5 yrs)
Correction: Remove and replace suspended acoustic ceilings - lighting not included
Qty: 3,600.00
Unit of Measure: S.F.
Estimate: \$54,296.75
Assessor Name: Craig Anding
Date Created: 11/17/2015

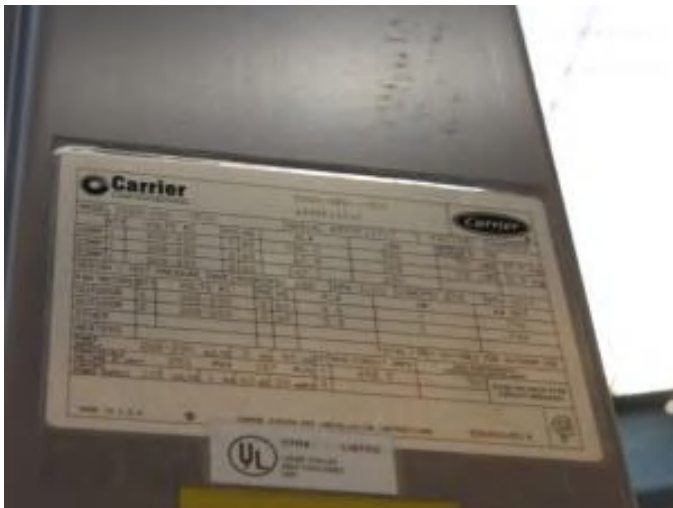
System: D3030 - Cooling Generating Systems

Location: Mechanical yard
Distress: Beyond Service Life
Category: 3 - Operations / Maint.
Priority: 4 - Response Time (4-5 yrs)
Correction: Replace chiller, air-cooled (130 tons)
Qty: 1.00
Unit of Measure: Ea.
Estimate: \$379,478.83
Assessor Name: Craig Anding
Date Created: 09/16/2015
