Facility Condition Assessment Summary Report

Emlen School

School District of Philadelphia
S622001;Emlen
Final
Site Assessment Report
January 31, 2017

Site Assessment Report

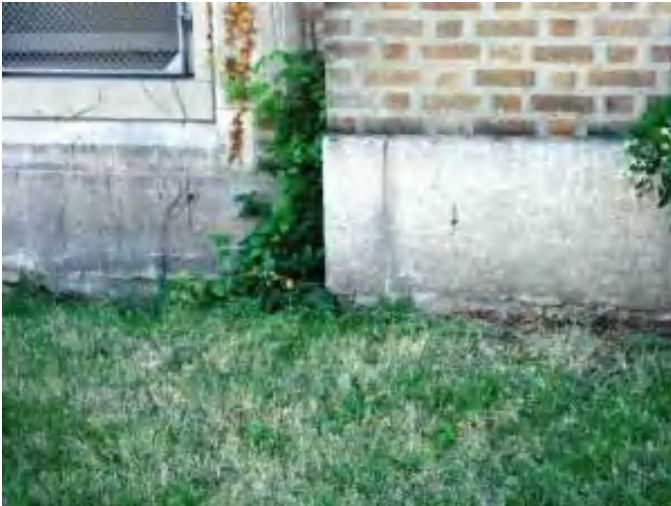
Location: Exterior Elevation

There is evidence of water infiltration through the basement foundations wall facing the East Upsal street exterior. To improve the integrity of the basement wall excavation and waterproofing system upgrades are recommended. Improve the slope of the grade away from the foundation prior to restoring the landscaping system.

System: A1010 - Standard Foundations

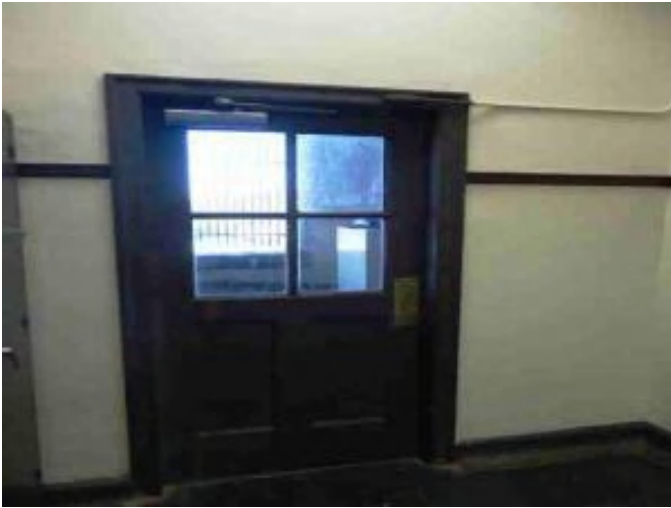
Location: Fire Escape and Corridor Stairs

System: C1010 - Partitions

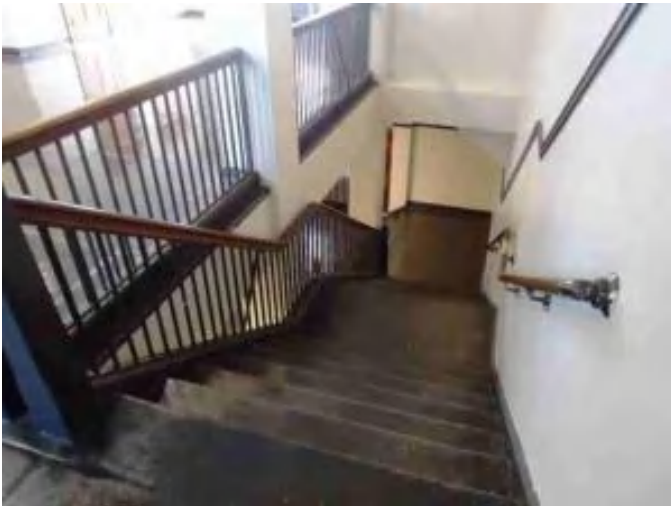
Location: Auditorium Lobby

The present floor plan arrangement has the lobby to the Auditorium opening up into the existing hall corridor. This opening into a corridor and stair access to the second floor does not have fire doors or barriers designed to support modern code. The lobby should be completely separate from the corridor with rated partitions and fire door installations. This Auditorium lobby needs to have at least one means of egress and contain smoke detectors. This deficiency recommends the construction of fire resistant barrier with automatically closing fire doors to be installed between the existing corridor access to the Auditorium and the corridors to provide the required separation and protection.

System: C1010 - Partitions

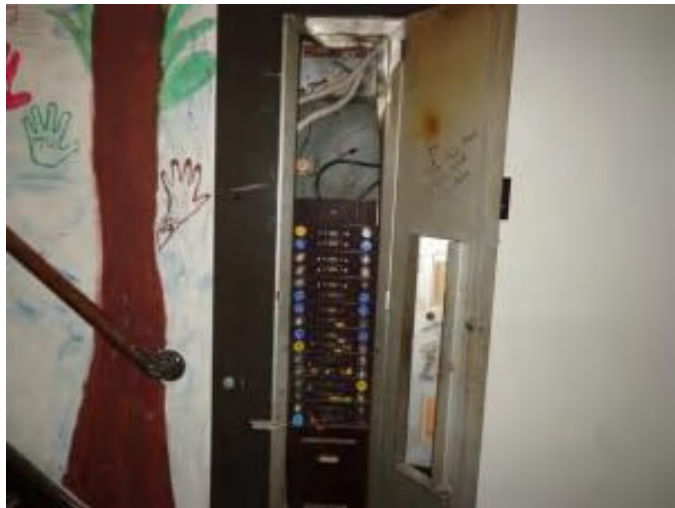
Location: Panelboards

System: D5010 - Electrical Service/Distribution

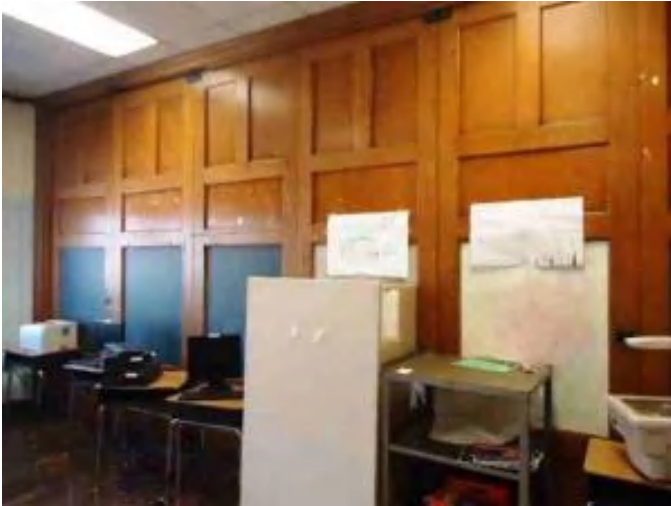
Location: Classrooms

There are several movable partitions that remain in classrooms. These wall systems are no longer used and in most cases cannot be used due to damage or wall modifications to support classroom needs. This deficiency provides a budgetary consideration to remove and replace the wall systems with universal removal of the existing movable partitions and upgrades to a permeate wall systems.

System: C1010 - Partitions

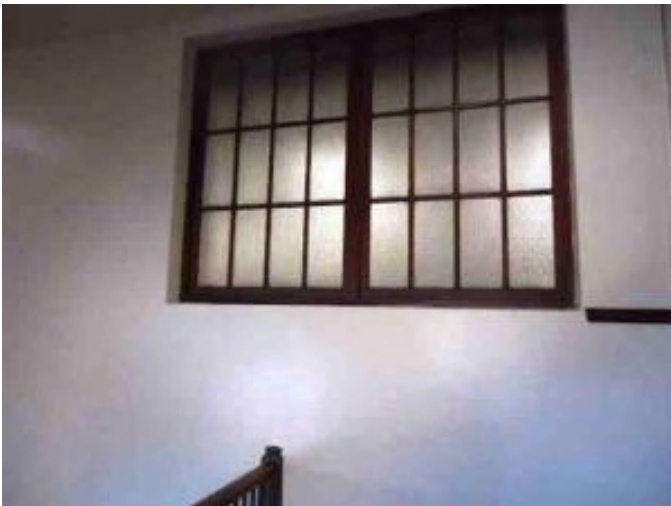
Location: Hallways

There are several transom lites and sidelights constructed into hallway wall systems. It is recommended that the lites and sidelights be removed and replaced with a fire rated wall construction. The deficiency provides a budgetary consideration to correct the hallway, transoms, lites and sidelights.

System: C1010 - Partitions

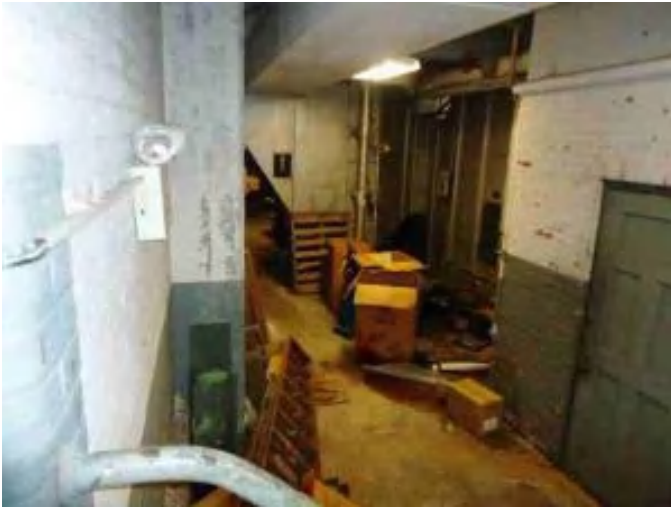
Location: Mechanical Room

System: C1010 - Partitions

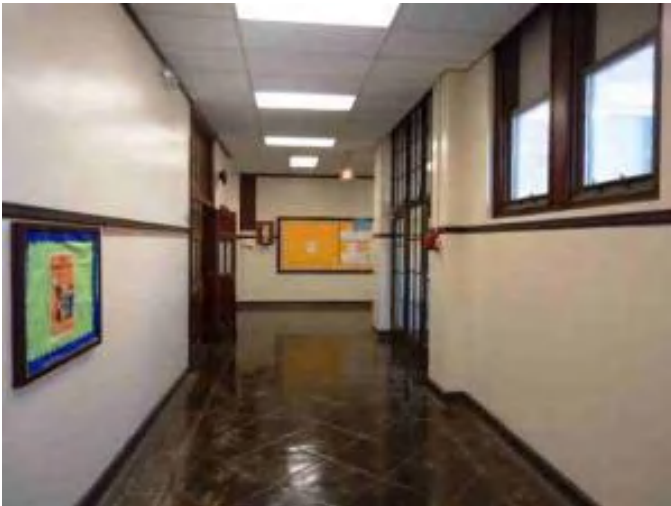
Location: Building Wide

There are several minor areas of wall damage that ranges from serious to minor. Although the school is on a cyclical program of renewal and each painted surface is renewed at years end this system is at the point in which repairs are necessary. Remove damaged wall finishes and repair areas then apply primer and paint finish.

System: C3010230 - Paint & Covering

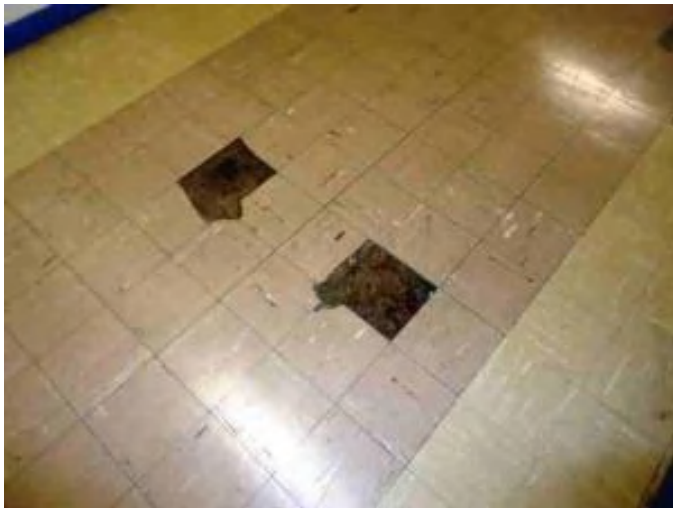
Location: Building Wide

The floor finish for this school is a combination of marble, polished stone and terrazzo, tile in the kitchen and service line areas, wood classrooms with concrete hallways and stairs finishes and a vinyl tile finish. The vinyl tile finish is a 9 x 9 application and is suspect to contain asbestos. This finish is recommended for upgrade to a new 12 x 12 vinyl tile application. Suspected asbestos containing materials (ACM) are believed to be limited to the original vinyl floor tile and mastic. While currently sound and manageable in place, future renovation efforts should include provision to test and abate any and all ACM.

System: C3020413 - Vinyl Flooring

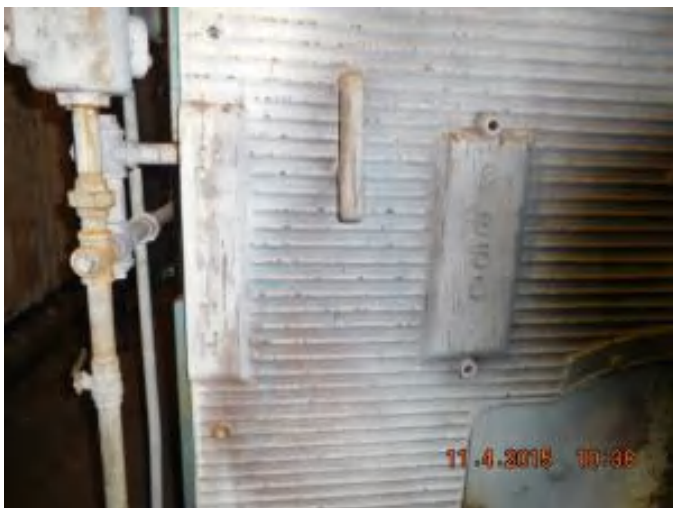
Location: mechanical room

System: D3020 - Heat Generating Systems

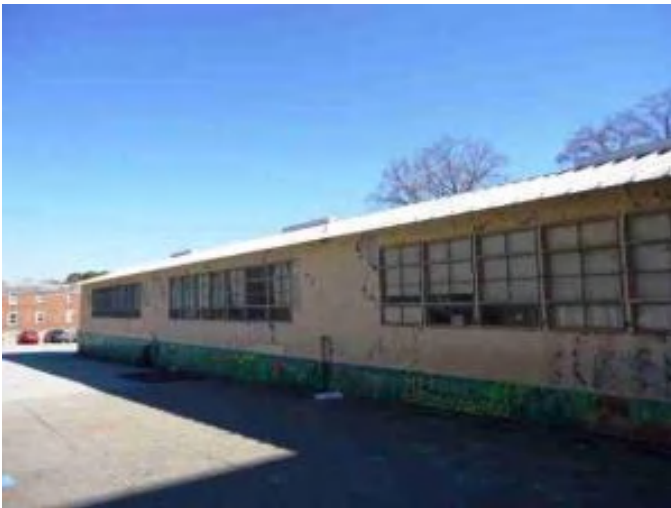
Most of the exterior windows have been upgraded from the original applications. As indicated in the photos several of the windows appear to be original. A majority of the window system is estimated to have been installed in the 1990's with the exception of the 1970 addition. The Addition windows are original. Overall, the windows are in fair condition based on the year of installation or last renovation. The entire exterior window system is recommended to be replaced with units that retain their dimensions and profiles, but that incorporate updated energy-efficient features.

System: B2020 - Exterior Windows

Location: Exterior Elevation
Distress: Damaged
Category: 3 - Operations / Maint.
Priority: 3 - Response Time (3-4 yrs)
Correction: Remove and replace aluminum windows - pick the appropriate size and style and insert the number of units
Qty: 240.00
Unit of Measure: Ea.
Estimate: \$1,319,857.98
Assessor Name: System
Date Created: 02/01/2016

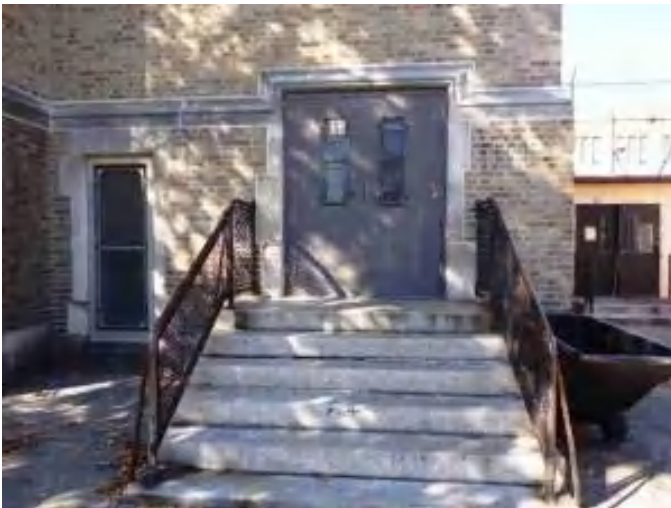
The exterior doors are metal applications with metal frames. The exterior door system for this school is a very high traffic system. The doors are in fair condition but are aging at a faster rate than expected based on traffic and condition. The exterior door system and service doors are recommended for upgrade. The new doors are expected to retain their dimensions and profiles, but that incorporate updated energy-efficient features.

System: B2030 - Exterior Doors

Location: Exterior Elevation
Distress: Damaged
Category: 3 - Operations / Maint.
Priority: 3 - Response Time (3-4 yrs)
Correction: Remove and replace exterior doors - per leaf
Qty: 20.00
Unit of Measure: Ea.
Estimate: \$182,146.42
Assessor Name: System
Date Created: 02/01/2016

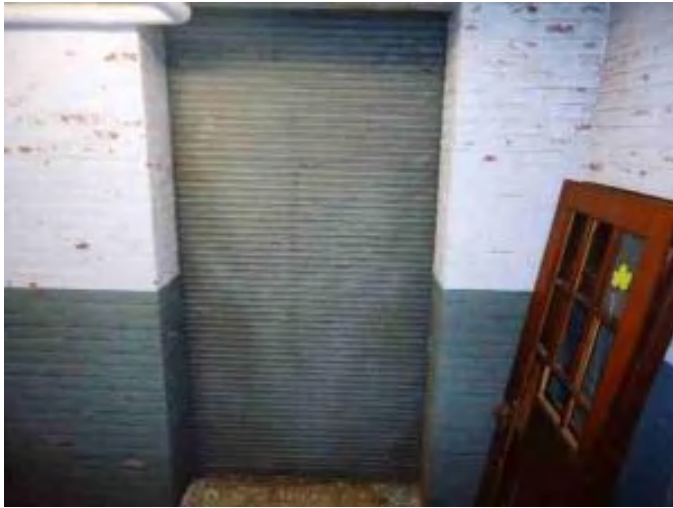
Location: Mechanical Access Door

The mechanical room roll up door is an original metal application. The safety equipment for this door is no longer functional and the door was reported to be limited in operation. This door system is recommended to be removed and replaced with a modern overhead door system with safety and security considerations.

System: B2030 - Exterior Doors

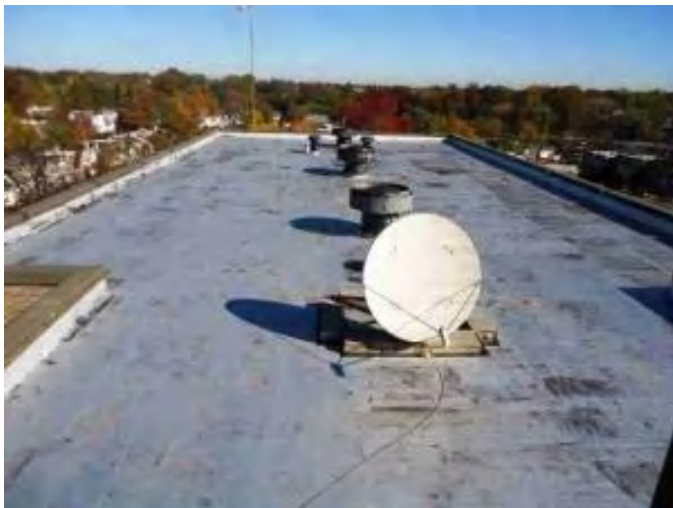
Location: Roof

extend the life of the roof the condition of the insulation and some of the seams have become an issue. Considering the age and condition of the roofing systems, universal upgrades are recommended.

System: B3010105 - Built-Up

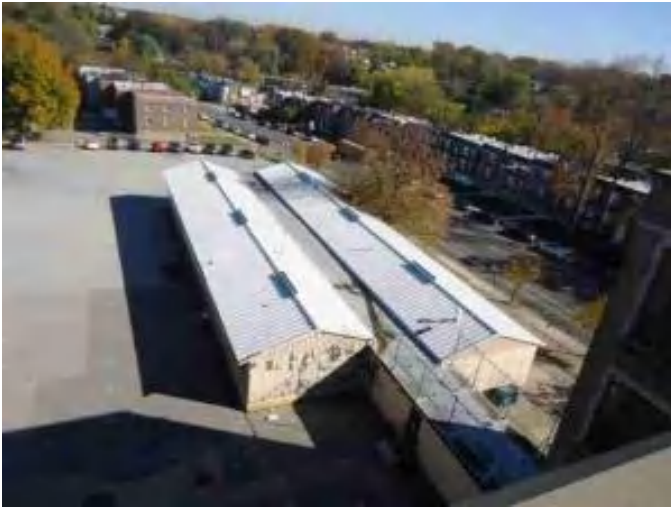
This 1970 building addition has a metal roof over the footprint and small areas of flat roofing atop the center section extending the length of the addition. During the time of the inspection several issues were reported related to minor leaks and that repairs have become the standard. Experience indicates that repairs on a metal roof application of this age creates a diminishing returns. It is recommended that this roof be added in the capital renewal funding process for universal upgrade.

System: B3010130 - Preformed Metal Roofing

Location: Addition Roof
Distress: Damaged
Category: 3 - Operations / Maint.
Priority: 3 - Response Time (3-4 yrs)
Correction: Remove and replace preformed metal roofing
Qty: 8,000.00
Unit of Measure: S.F.
Estimate: \$464,788.66
Assessor Name: System
Date Created: 02/01/2016

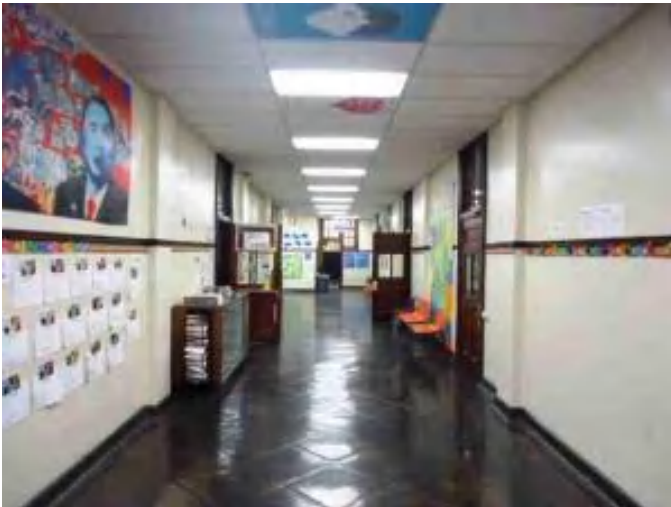
Interior doors are typically wood in wood frames with transom lites, sidelights, wired glass glazing. Other interior doors include wooden glass pane doors with original wooden pane frames. Doors are generally in fair condition considering the age of the application. Doors swing in the direction of exit and do not obstruct hallways. . Universal upgrades are required for the interior door systems it is recommended that the interior doors system be removed and replaced with a new modern metal framed hollow metal door system with consideration for ADA compliance.

System: C1020 - Interior Doors

Location: Classrooms
Distress: Damaged
Category: 3 - Operations / Maint.
Priority: 3 - Response Time (3-4 yrs)
Correction: Remove and replace interior doors - wood doors with hollow metal frames - per leaf
Qty: 200.00
Unit of Measure: Ea.
Estimate: \$954,117.42
Assessor Name: System
Date Created: 02/01/2016

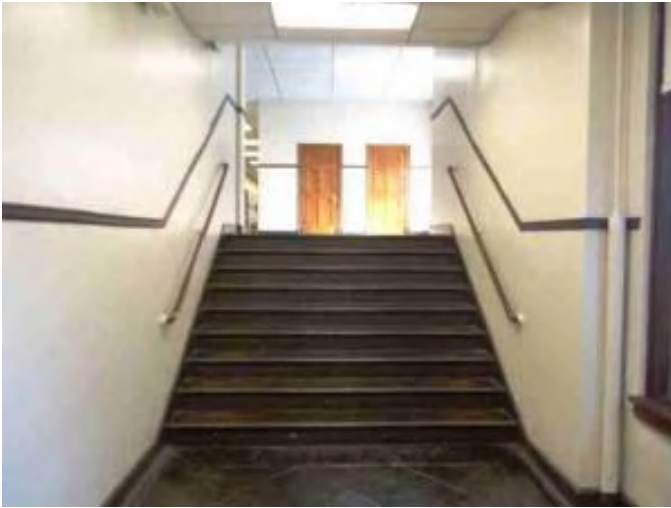
enforced at the time of construction until a major renovation occurs, they are deficient in handrail and guardrail design relative to current standards. Future efforts should include comprehensive stair railing removal and replacement upgrades.

System: C2010 - Stair Construction

Location: Stairs
Distress: Life Safety / NFPA / PFD
Category: 1 - Health & Safety
Priority: 3 - Response Time (3-4 yrs)
Correction: Replace inadequate or install proper stair railing - select appropriate material
Qty: 1,500.00
Unit of Measure: L.F.
Estimate: \$23,354.19
Assessor Name: System
Date Created: 02/01/2016

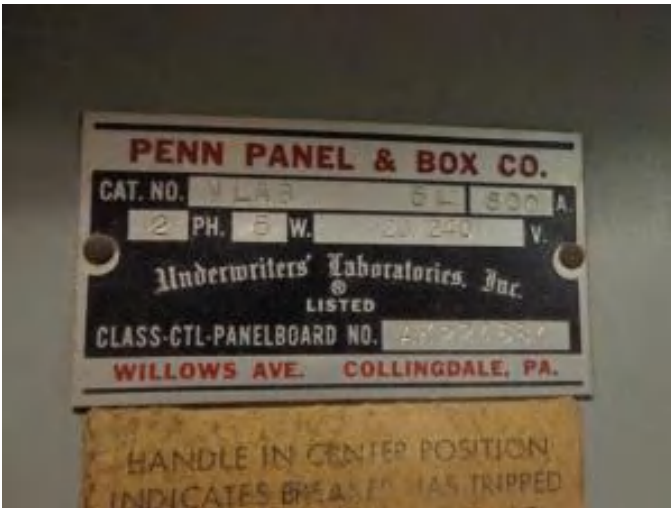
System: D5010 - Electrical Service/Distribution

Location: Mechanical Rom 007
Distress: Beyond Service Life
Category: 3 - Operations / Maint.
Priority: 3 - Response Time (3-4 yrs)
Correction: Replace Electrical Distribution System (U)
Qty: 1.00
Unit of Measure: Ea.
Estimate: \$653,254.26
Assessor Name: System
Date Created: 01/11/2016

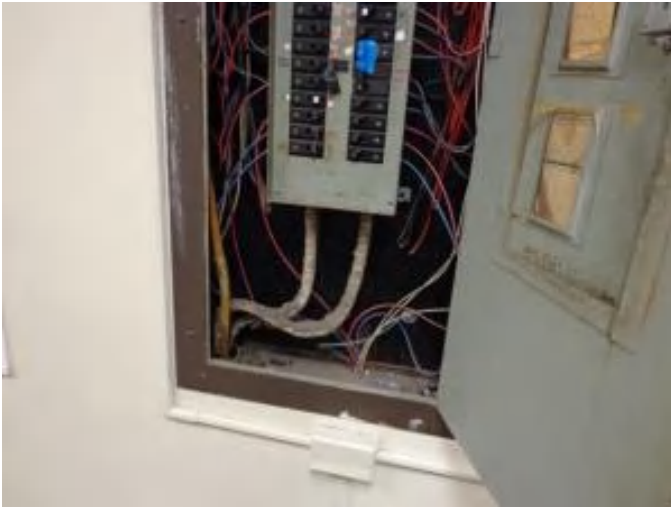
System: D5010 - Electrical Service/Distribution

Location: Building wide
Distress: Beyond Service Life
Category: 3 - Operations / Maint.
Priority: 3 - Response Time (3-4 yrs)
Correction: Replace Panelboard
Qty: 17.00
Unit of Measure: Ea.
Estimate: \$393,772.34
Assessor Name: System
Date Created: 01/11/2016

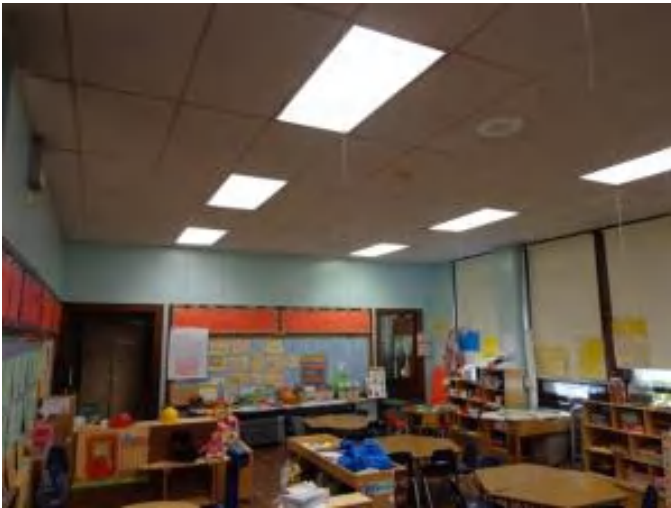
System: D5020 - Lighting and Branch Wiring

Location: Building wide
Distress: Beyond Service Life
Category: 3 - Operations / Maint.
Priority: 3 - Response Time (3-4 yrs)
Correction: Replace Lighting Fixtures (SF)
Qty: 48,350.00
Unit of Measure: S.F.
Estimate: \$885,919.16
Assessor Name: System
Date Created: 01/11/2016

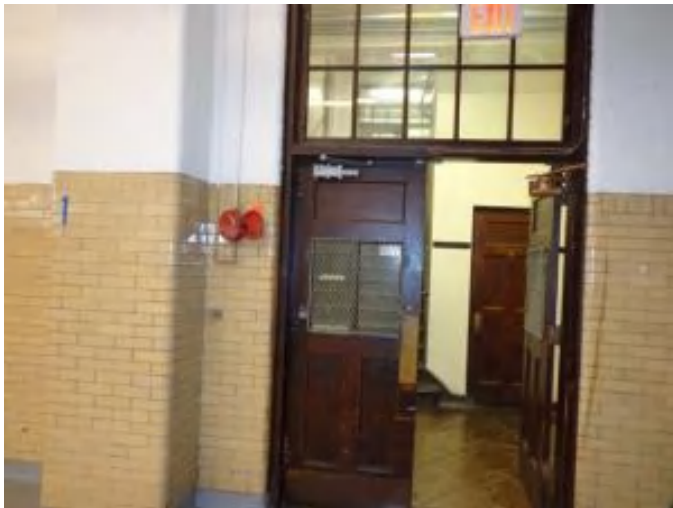
System: D5030 - Communications and Security

Location: Building wide
Distress: Life Safety / NFPA / PFD
Category: 1 - Health & Safety
Priority: 3 - Response Time (3-4 yrs)
Correction: Replace fire alarm system
Qty: 74,500.00
Unit of Measure: S.F.
Estimate: \$353,260.90
Assessor Name: System
Date Created: 01/11/2016

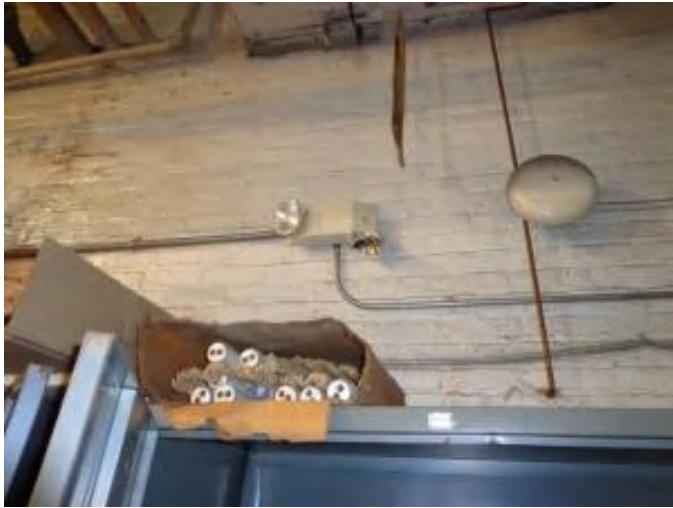
System: D5090 - Other Electrical Systems

Location: Building wide
Distress: Life Safety / NFPA / PFD
Category: 1 - Health & Safety
Priority: 3 - Response Time (3-4 yrs)
Correction: Replace Emergency/Exit Lighting
Qty: 41.00
Unit of Measure: Ea.
Estimate: \$41,999.92
Assessor Name: System
Date Created: 01/11/2016

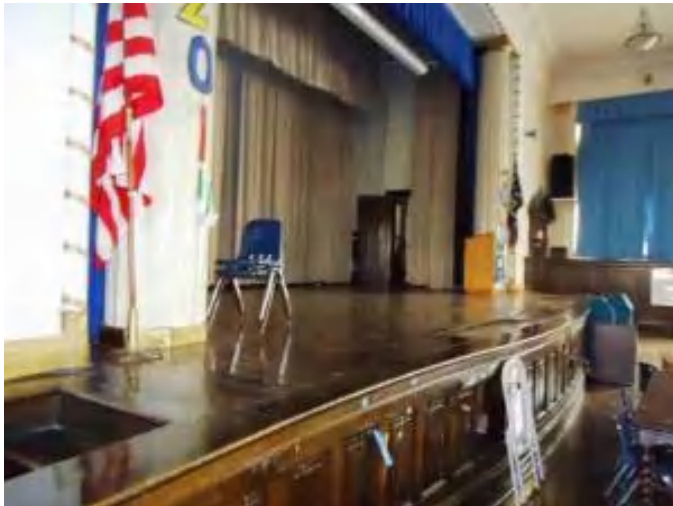
The school stage has a stage curtain assembly that appears to be from the original construction. Modern applications are typically fire-proof applications with adjustable tracks and electric support for operation. The curtains are torn in a few section and the track is not functioning properly, overall the system is in poor condition. It is recommended that the curtain and track system be upgraded to a new system. Special care should be considered in regards to modern fire proofing for the new installation.

System: E2010 - Fixed Furnishings

Location: Stage
Distress: Life Safety / NFPA / PFD
Category: 1 - Health & Safety
Priority: 3 - Response Time (3-4 yrs)
Correction: Remove and replace stage curtain - insert the LF of track and SF of curtain
Qty: 1.00
Unit of Measure: Ea.
Estimate: \$13,831.55
Assessor Name: System
Date Created: 02/01/2016

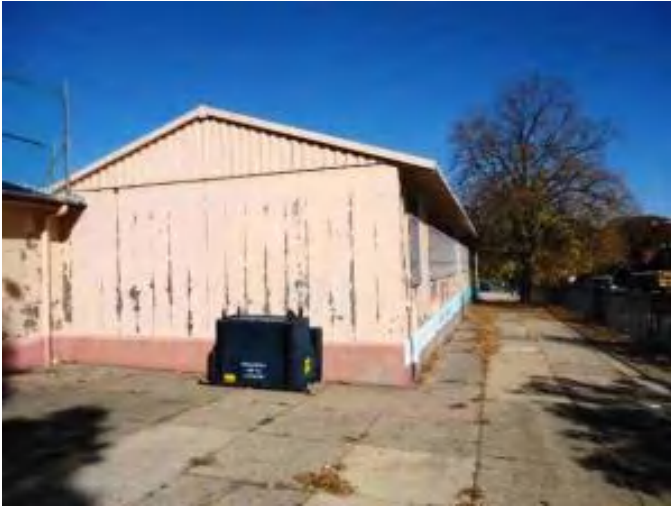
Location: Exterior Elevation

The exterior brick surfaces are generally in fair to good condition for their age. In some locations, bricks have cracked or spalled and should be replaced. The repointing of deteriorated mortar joints is also recommended, using mortar of a similar color and consistency as the original. Following the detailed examination of the brick and repair of mortar construction joints, the entire building should be pressure washed to remove stains and embedded pollutants. If moisture is found to be penetrating the masonry facade, the application of a spray sealant to the suspected exterior masonry surface is recommended.

System: B2010 - Exterior Walls

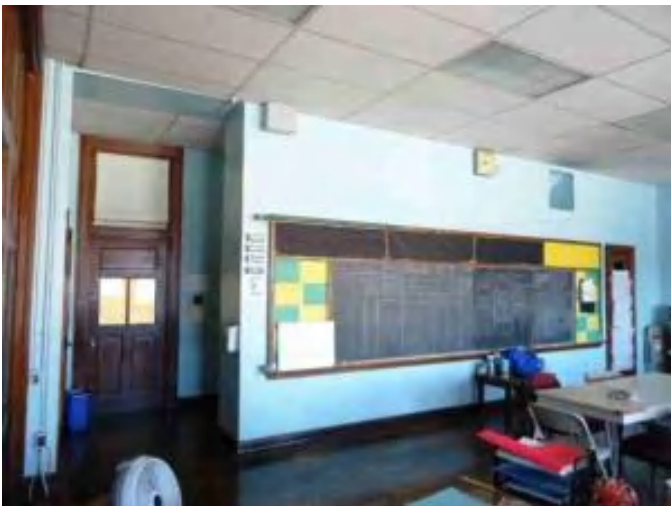
Location: Classroom

Some of the classroom chalk boards are original to the buildings construction. This system is damaged and beyond its expected life, universal upgrades are warranted. Remove and upgrade damaged chalk boards to new marker board systems.

System: C1030 - Fittings

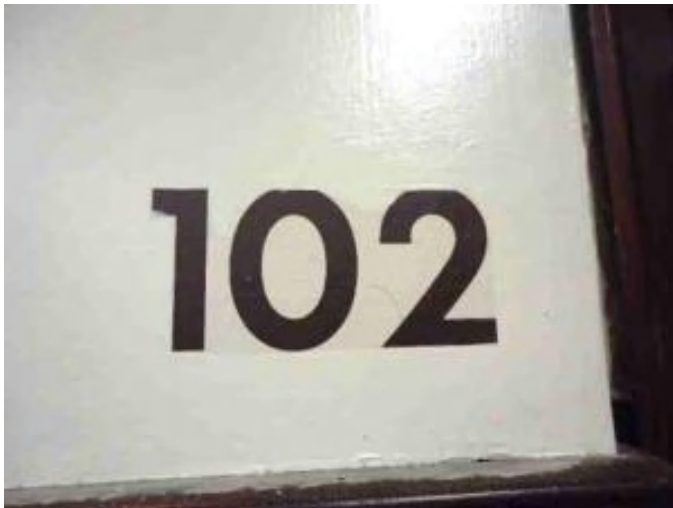
There is no directional signage and room signage is a custom design in places and scarce or painted with no consistency in others. Accessibility signage criteria have been established for the physically challenged. These include mounting heights, contrast and finish, raised and Braille characters and pictograms, and character proportions and heights. It is recommended that compliant signage be installed throughout the building.

System: C1030 - Fittings

Location: Building Wide
Distress: Damaged
Category: 3 - Operations / Maint.
Priority: 4 - Response Time (4-5 yrs)
Correction: Replace missing or damaged signage - insert the number of rooms
Qty: 150.00
Unit of Measure: Ea.
Estimate: \$40,636.87
Assessor Name: System
Date Created: 02/01/2016

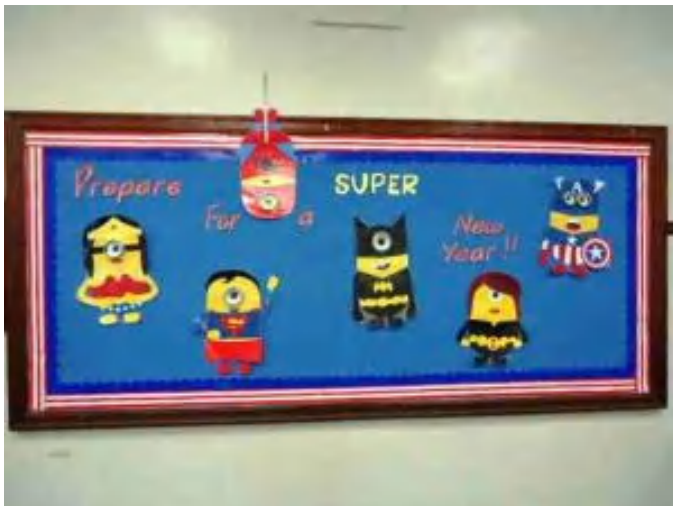
There are several tack boards in the hallways for student displays. The systems are damaged and beyond the expected service life for this application. Remove and replace tack boards is recommended.

System: C1030 - Fittings

Location: Hallways
Distress: Damaged
Category: 3 - Operations / Maint.
Priority: 4 - Response Time (4-5 yrs)
Correction: Remove and replace tackboards - select size
Qty: 10.00
Unit of Measure: Ea.
Estimate: \$7,927.26
Assessor Name: System
Date Created: 02/01/2016

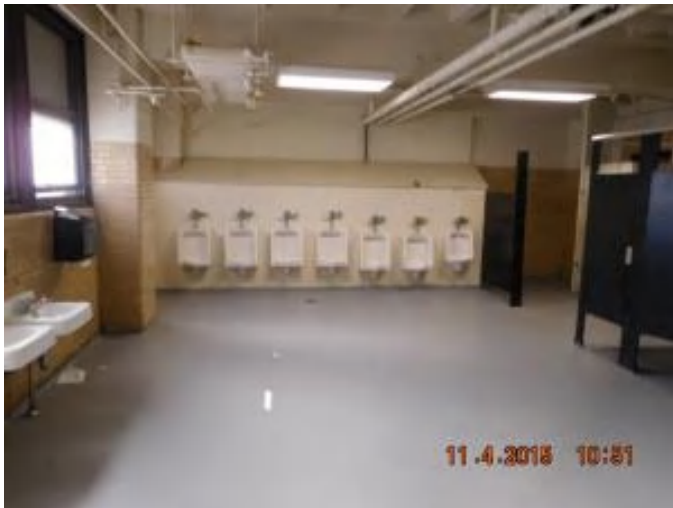
System: D2020 - Domestic Water Distribution

Location: entire building
Distress: Beyond Service Life
Category: 3 - Operations / Maint.
Priority: 4 - Response Time (4-5 yrs)
Correction: Replace domestic water piping (75 KSF)
Qty: 74,500.00
Unit of Measure: S.F.
Estimate: \$377,517.98
Assessor Name: System
Date Created: 01/30/2016

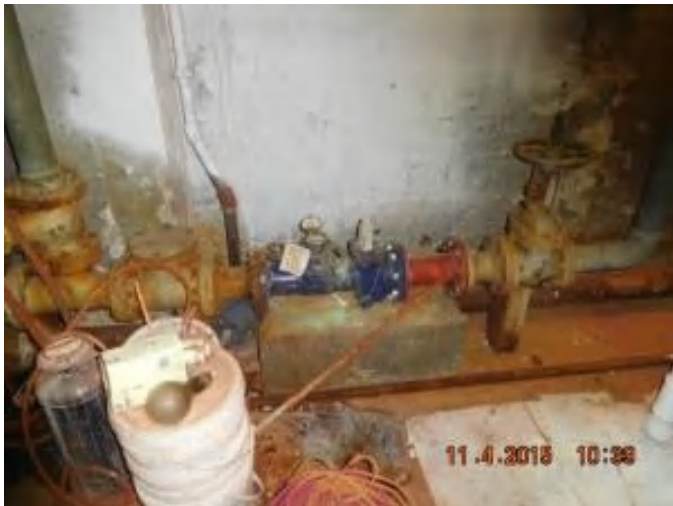
System: D2020 - Domestic Water Distribution

Location: mechanical room
Distress: Building / MEP Codes
Category: 2 - Code Compliance
Priority: 4 - Response Time (4-5 yrs)
Correction: Provide 4" reduced pressure back flow preventer
Qty: 1.00
Unit of Measure: Ea.
Estimate: \$51,112.25
Assessor Name: System
Date Created: 01/30/2016

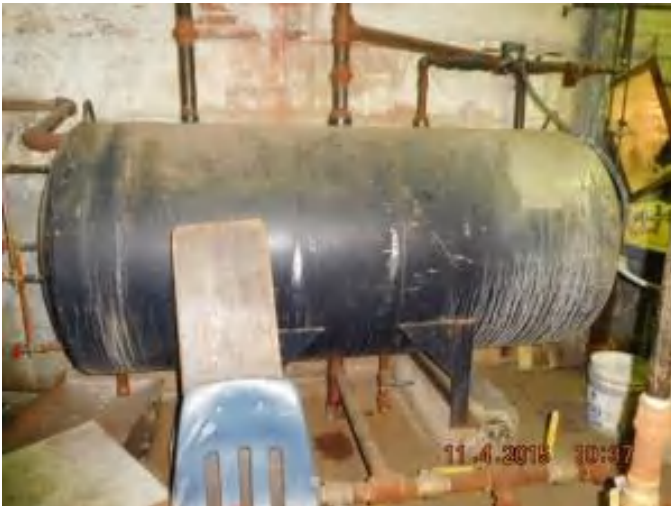
Location: mechanical room

System: D3020 - Heat Generating Systems

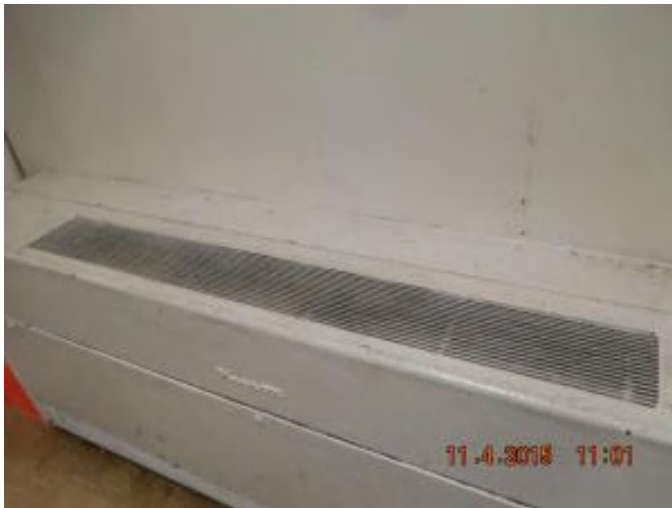
Location: classrooms

System: D3040 - Distribution Systems

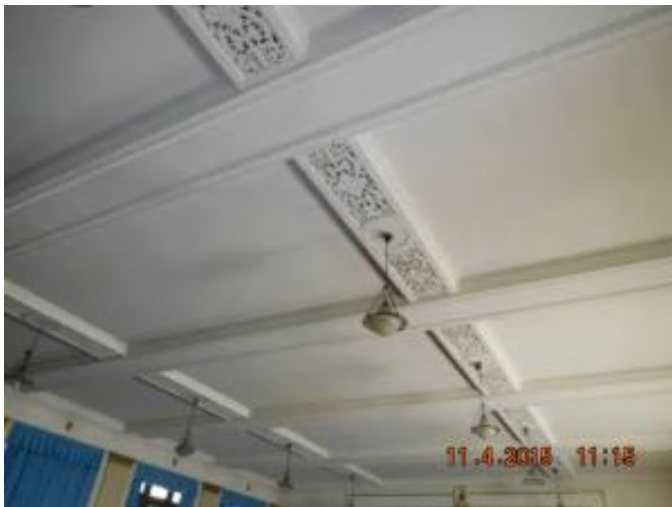
Location: auditorium

System: D3040 - Distribution Systems

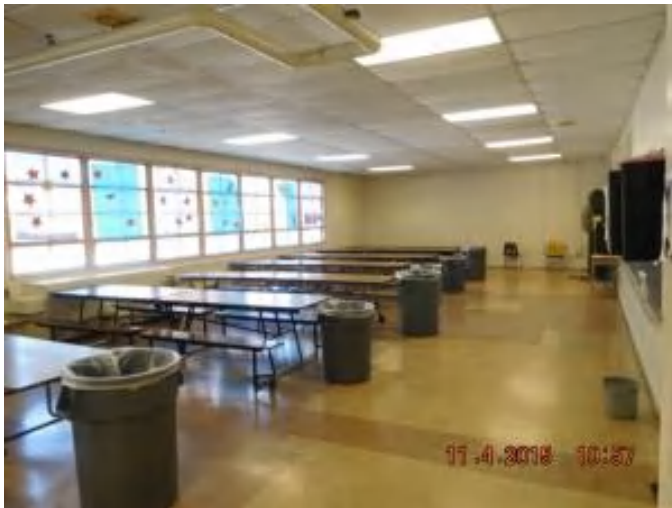
System: D3040 - Distribution Systems

Location: cafeteria
Distress: Building / MEP Codes
Category: 2 - Code Compliance
Priority: 4 - Response Time (4-5 yrs)
Correction: Install HVAC unit for Cafeteria (850 students).
Qty: 735.00
Unit of Measure: Student
Estimate: \$376,109.93
Assessor Name: System
Date Created: 01/30/2016

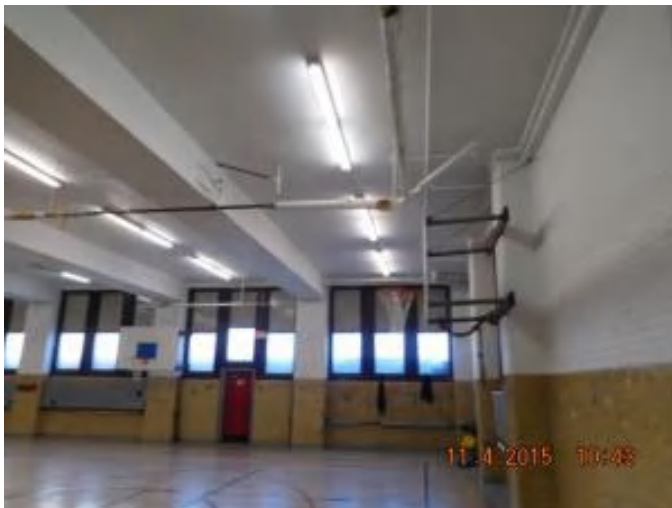
System: D3040 - Distribution Systems

Location: gymnasium
Distress: Building / MEP Codes
Category: 2 - Code Compliance
Priority: 4 - Response Time (4-5 yrs)
Correction: Install HVAC unit for Gymnasium (single station).
Qty: 6,000.00
Unit of Measure: S.F.
Estimate: \$344,860.27
Assessor Name: System
Date Created: 01/30/2016

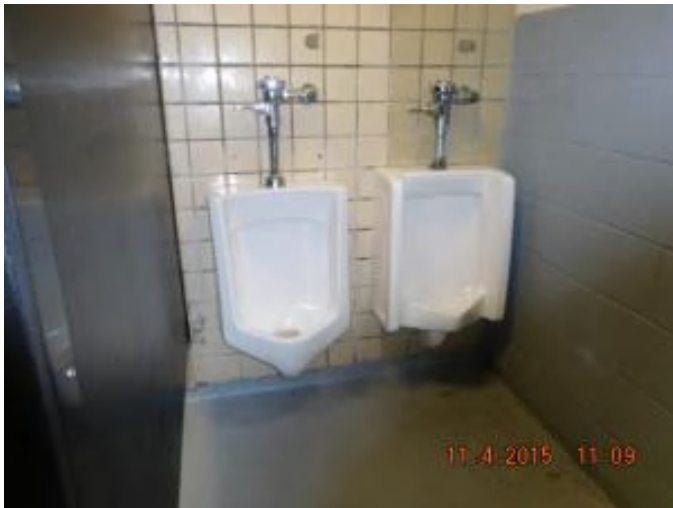
System: D3040 - Distribution Systems

Location: toilet rooms
Distress: Building / MEP Codes
Category: 2 - Code Compliance
Priority: 4 - Response Time (4-5 yrs)
Correction: Provide inline centrifugal fan and wall outlet louver for restroom exhaust (4 plbg fixtures)
Qty: 10.00
Unit of Measure: Ea.
Estimate: \$172,070.42
Assessor Name: System
Date Created: 01/30/2016

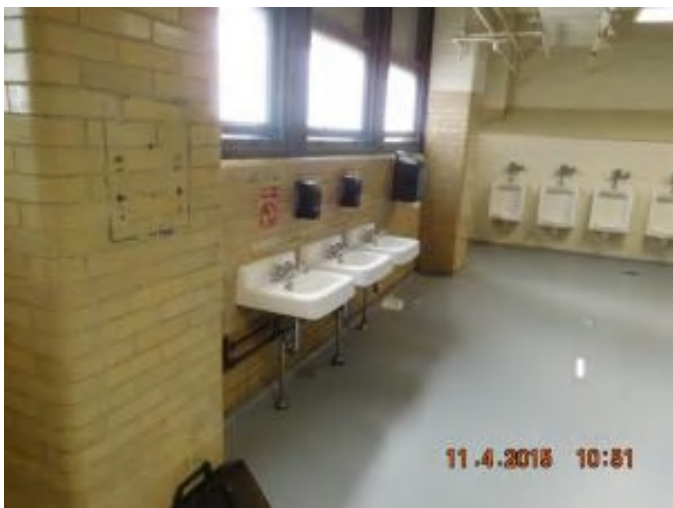
System: D3040 - Distribution Systems

Location: toilet rooms
Distress: Building / MEP Codes
Category: 2 - Code Compliance
Priority: 4 - Response Time (4-5 yrs)
Correction: Provide inline centrifugal fan and wall outlet louver for restroom exhaust (8 plbg fixtures)
Qty: 2.00
Unit of Measure: Ea.
Estimate: \$53,942.64
Assessor Name: System
Date Created: 01/30/2016

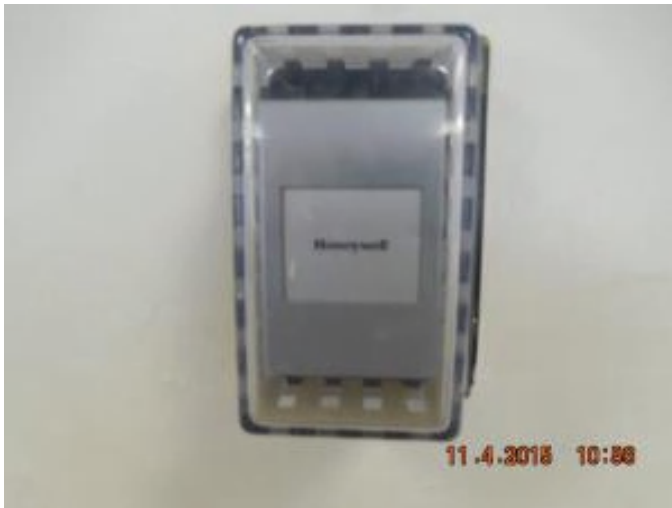
System: D3060 - Controls & Instrumentation

Location: entire building
Distress: Inadequate
Category: 4 - Capital Improvement
Priority: 4 - Response Time (4-5 yrs)
Correction: Replace pneumatic controls with DDC (75KSF)
Qty: 74,500.00
Unit of Measure: S.F.
Estimate: \$1,598,178.27
Assessor Name: System
Date Created: 01/30/2016

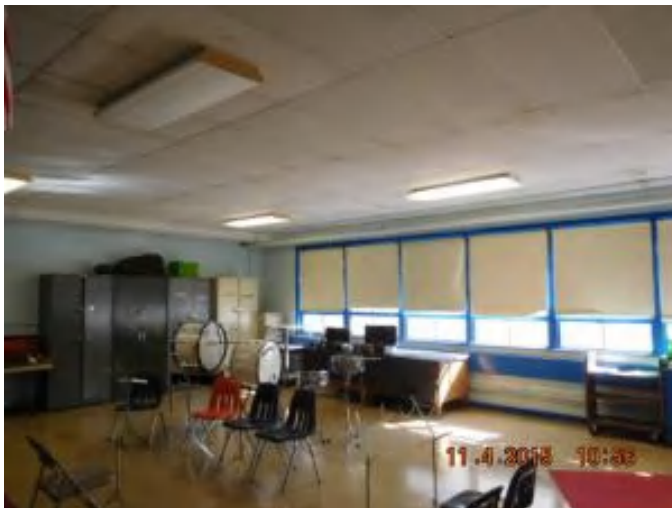
System: D4010 - Sprinklers

Location: entire building
Distress: Life Safety / NFPA / PFD
Category: 1 - Health & Safety
Priority: 4 - Response Time (4-5 yrs)
Correction: Install a fire protection sprinkler system
Qty: 74,500.00
Unit of Measure: S.F.
Estimate: \$1,065,757.17
Assessor Name: System
Date Created: 01/30/2016

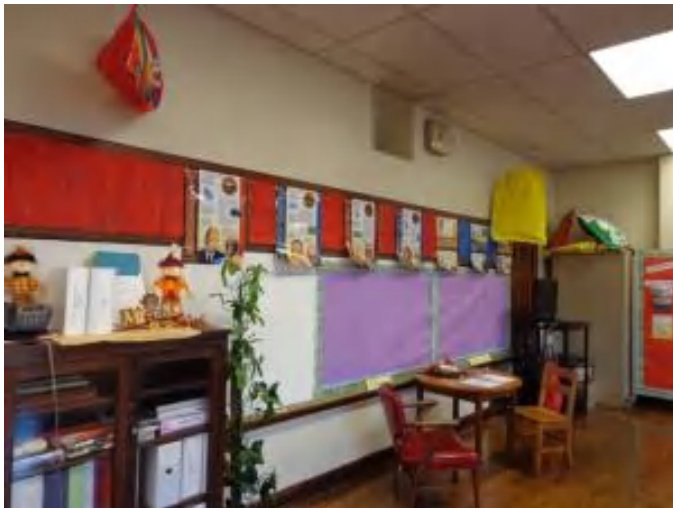
Location: Classrooms and Building wide

System: D5020 - Lighting and Branch Wiring

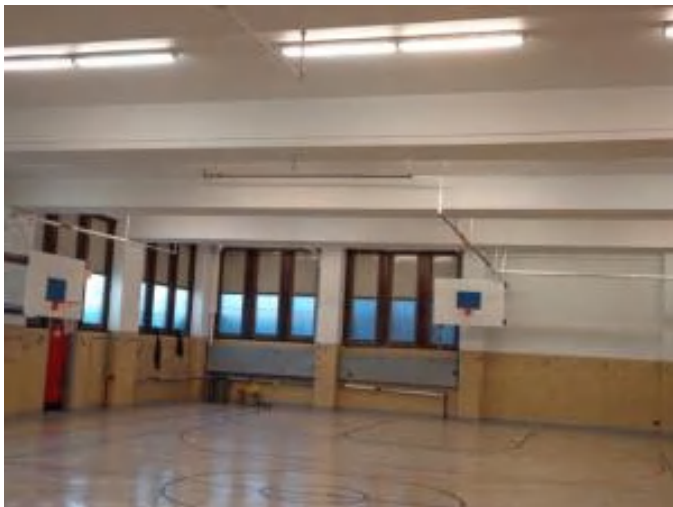
Location: Cafeteria/Gymnasium

System: D5020 - Lighting and Branch Wiring

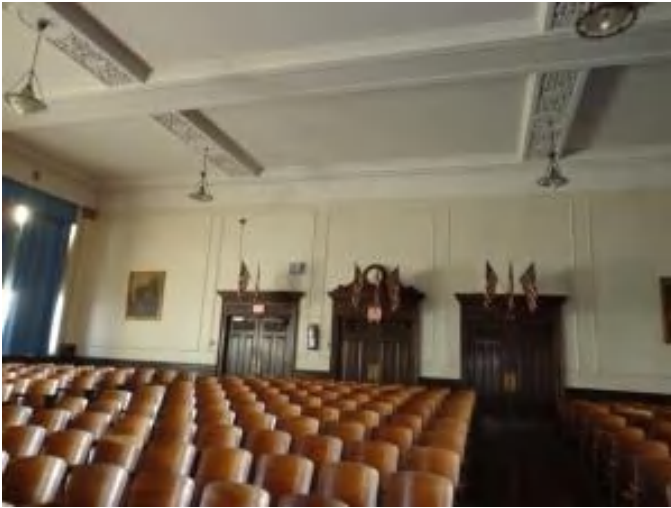
System: D5020 - Lighting and Branch Wiring

Location: Auditorium
Distress: Damaged
Category: 3 - Operations / Maint.
Priority: 4 - Response Time (4-5 yrs)
Correction: Maintain Lighting Fixtures
Qty: 10.00
Unit of Measure: Ea.
Estimate: \$9,417.59
Assessor Name: System
Date Created: 01/11/2016

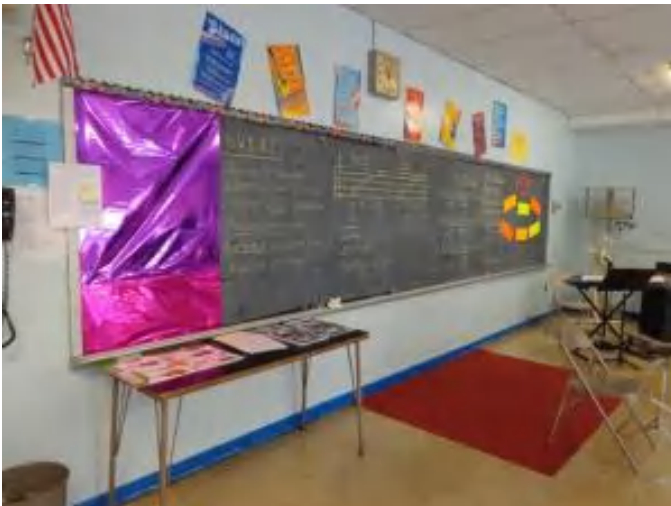
System: D5030 - Communications and Security

Location: Building wide
Distress: Damaged
Category: 3 - Operations / Maint.
Priority: 4 - Response Time (4-5 yrs)
Correction: Provide wireless GPS clock system
Qty: 1.00
Unit of Measure: LS
Estimate: \$34,908.12
Assessor Name: System
Date Created: 01/11/2016

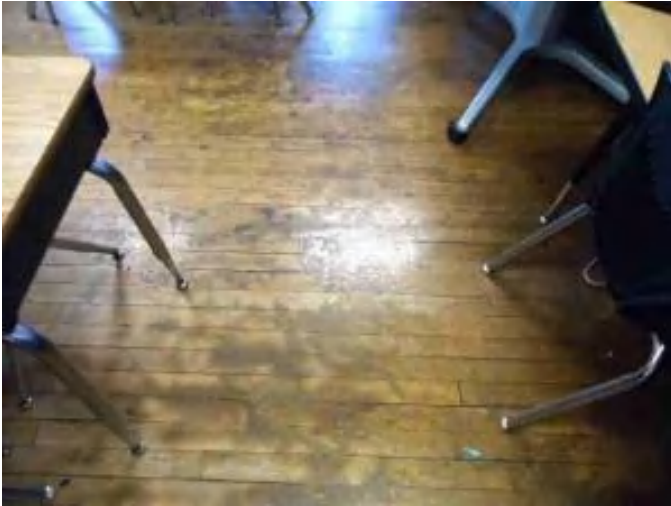
Location: Classrooms

The wooden floor finish in the classrooms has served this school from the first day of school. The systems maintenance has been a priority each year as part of a cyclical program to either, sand, clean and resurface or wax as needed. Considering the age and current condition of the classroom wooden floor finish, removal and replacement is recommended.

System: C3020414 - Wood Flooring

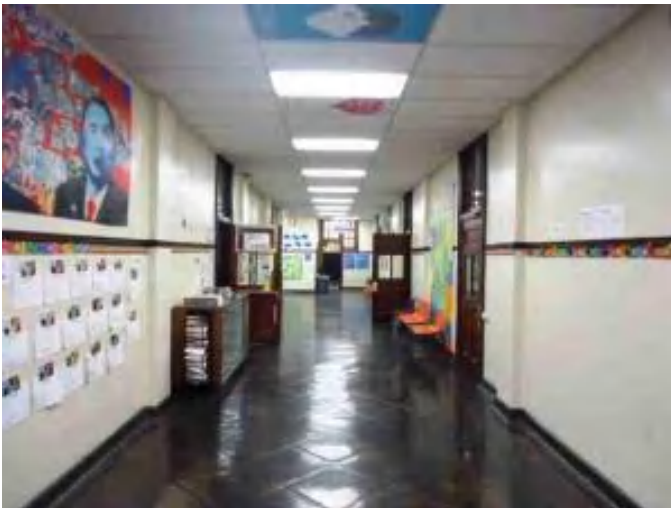
Location: Building Wide

The ceiling finish is a mix of 12 x 12 ceiling grid, painted and 2 x 4 Acoustical tile finish. Ceilings have been repaired in several areas and is in good condition considering the age of the application and the current condition of the school. The ceiling finish is expected to require upgrades to support the recommended efforts in this report prior to re-opening. This deficiency provides a budgetary consideration for removal and replacement of the current ceiling finish to a new acoustical tile finish. Considering the recommended mechanical and electrical upgrades this effort should be completed as part of an overall renewal program for the school. No work should be considered until after the recommended exterior efforts are complete.

System: C3030 - Ceiling Finishes

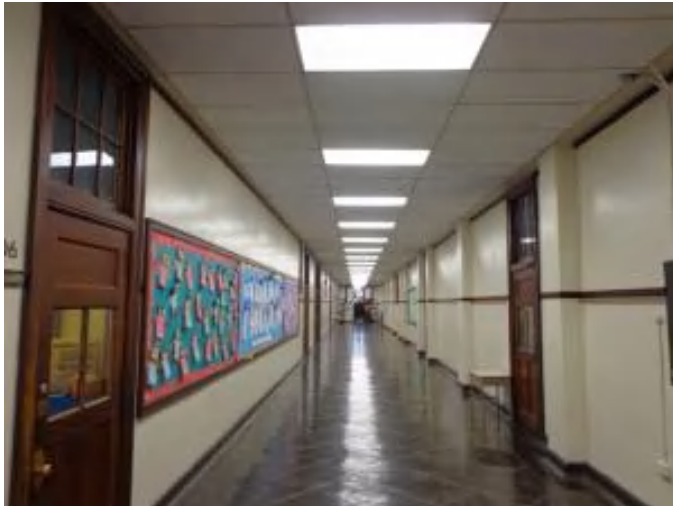
Location: Corridors - Floors 1, 2 and 3

System: D5030 - Communications and Security

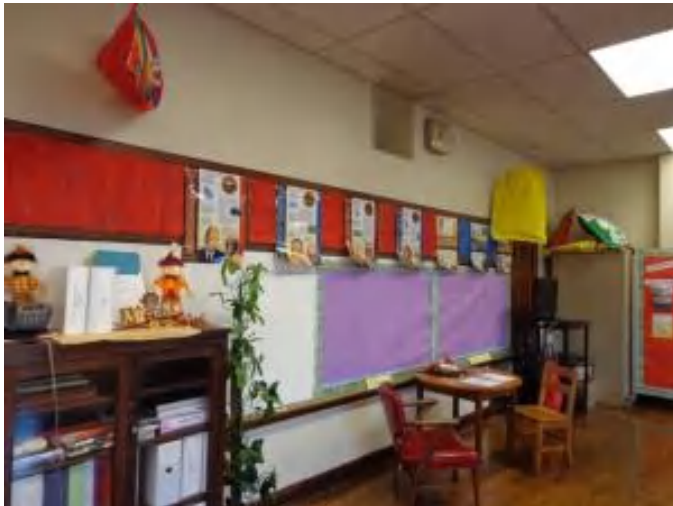
Location: Classrooms

System: D5030 - Communications and Security

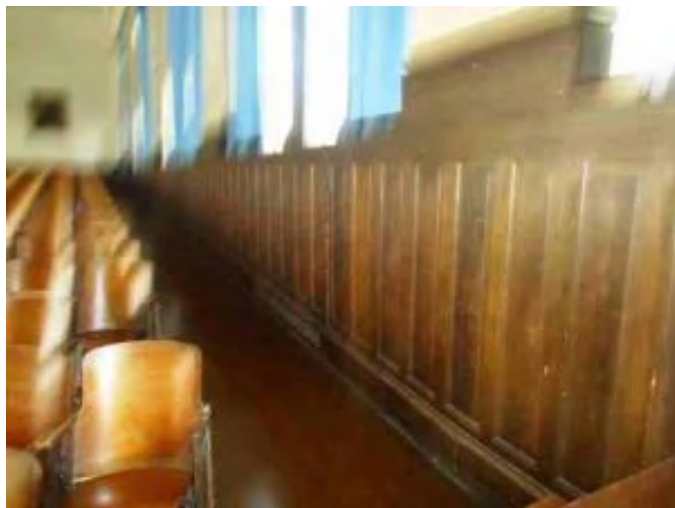
Location: Auditorium

System: E2010 - Fixed Furnishings

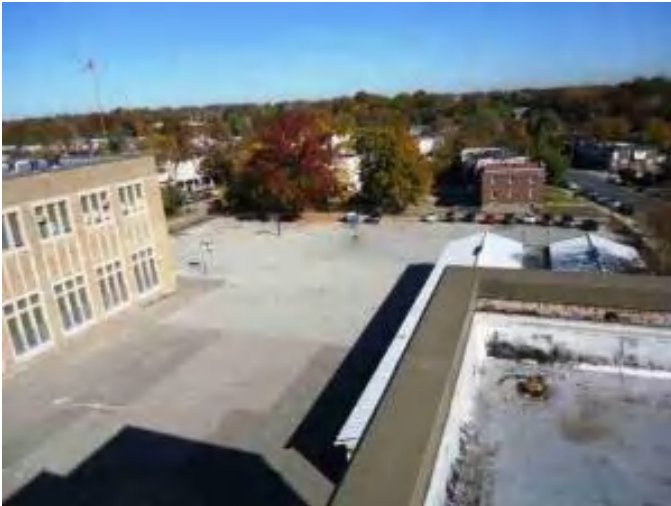
Location: Sidewalks

System: G2030 - Pedestrian Paving
