### AMY at (Martin, James) School

# **S543001;Martin, James**

## **Site Assessment Report**

February 2, 2017

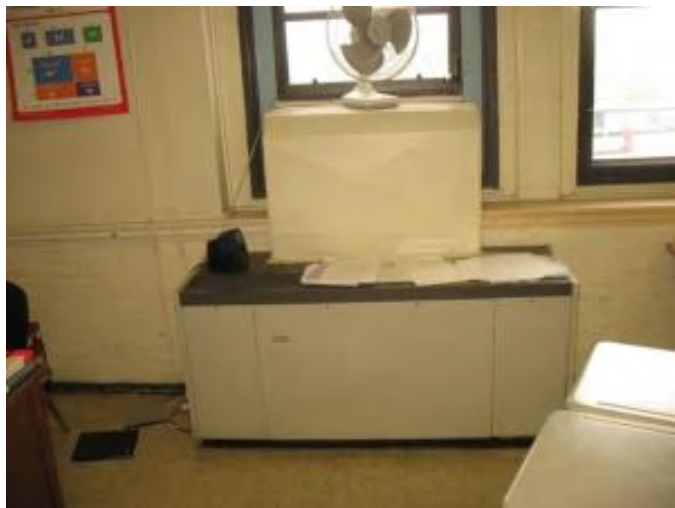
#### System: D3040 - Distribution Systems

**Location:** Classrooms

**Distress:** Inadequate

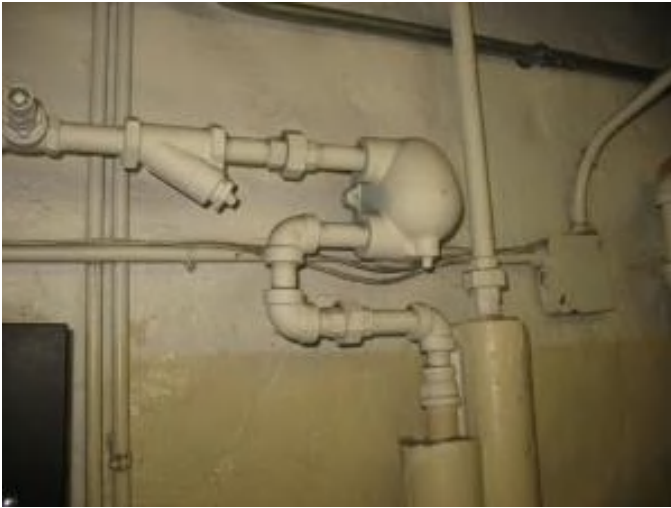
**System: D3040 - Distribution Systems**

**Location:** Throughout building

**Distress:** Failing

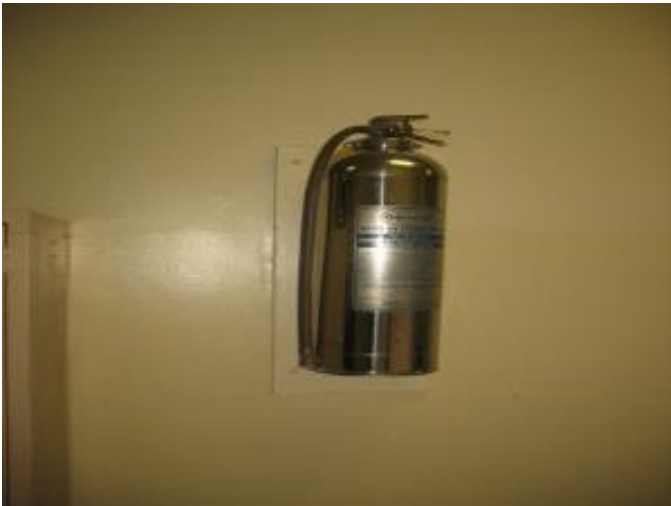
**System: D4010 - Sprinklers**

**Location:** Throughout building

**Distress:** Life Safety / NFPA / PFD

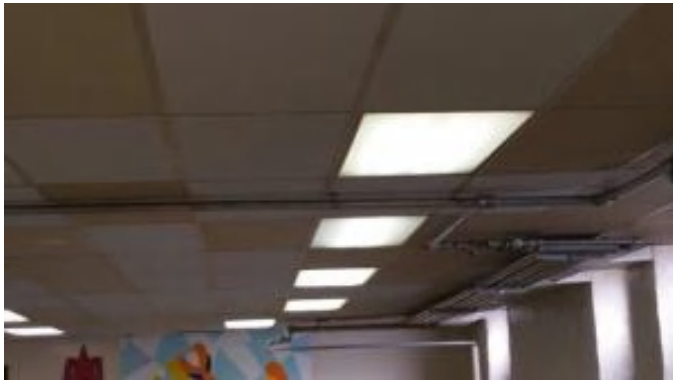
**System: D5020 - Lighting and Branch Wiring**

**Location:** throughout the building

**Distress:** Beyond Service Life

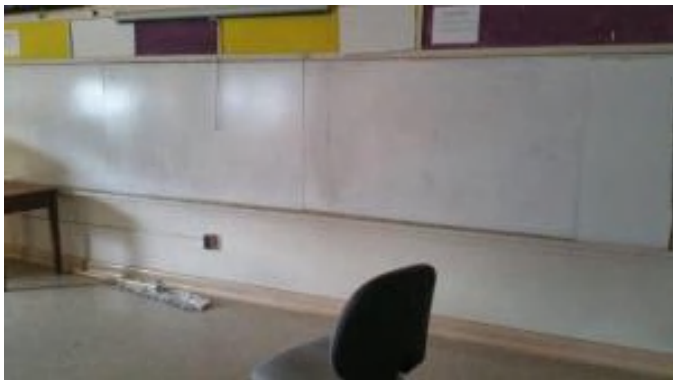
**System: D5020 - Lighting and Branch Wiring**

**Location:** Throughout the building

**Distress:** Beyond Service Life

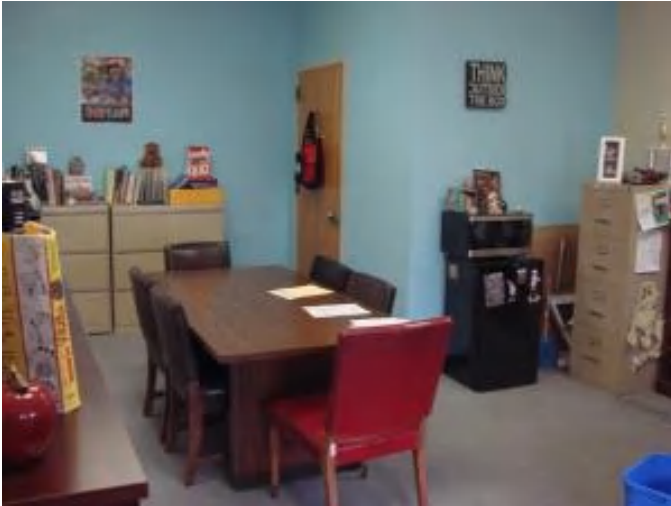
**System: C3020411 - Carpet**

**Location:** Interior

**Distress:** Beyond Service Life

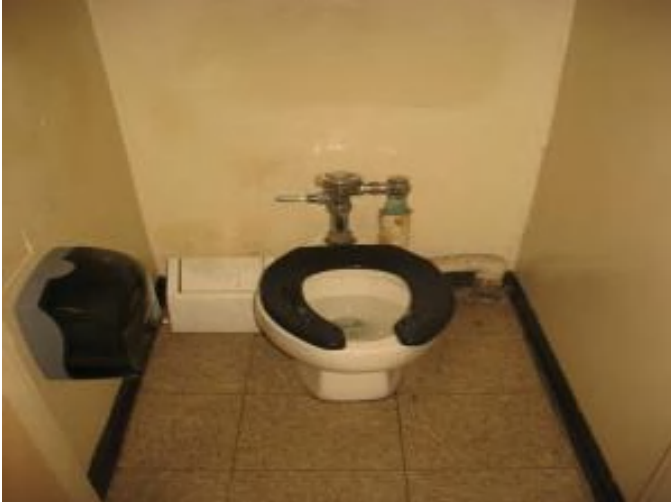
**System: D2010 - Plumbing Fixtures**

**Location:** Restrooms

**Distress:** Beyond Service Life

**Notes:** Replace twenty (20) floor mounted water closets in the restrooms, which are well beyond their service lives, with new code compliant fixtures.

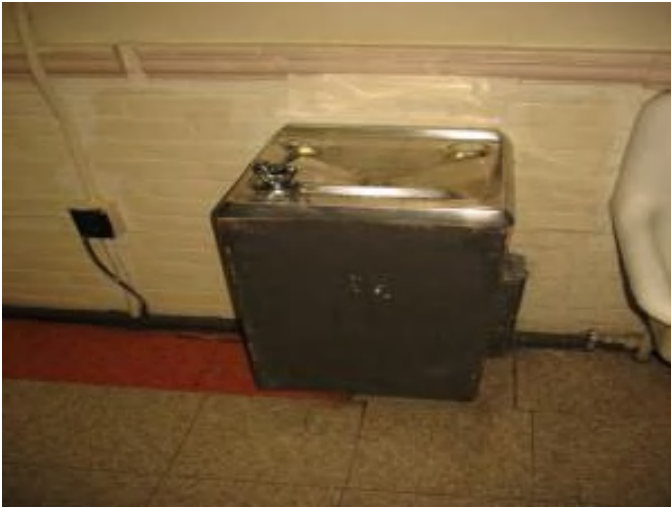
**System: D2010 - Plumbing Fixtures**

**Location:** Corridors

**Distress:** Beyond Service Life

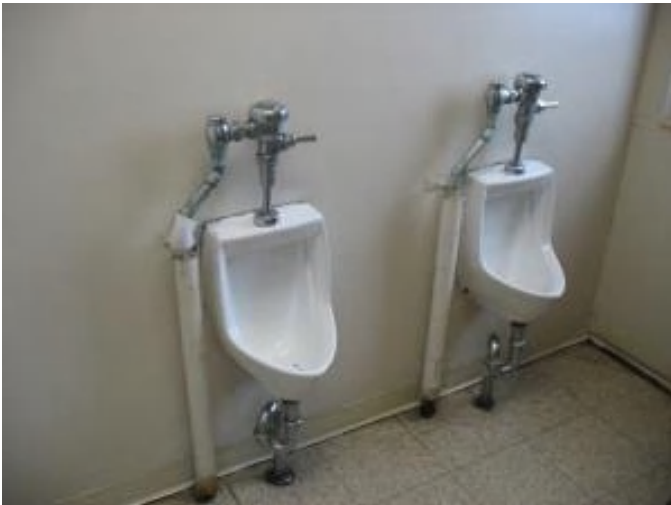
**System: D2010 - Plumbing Fixtures**

**Location:** Restrooms

**Distress:** Beyond Service Life

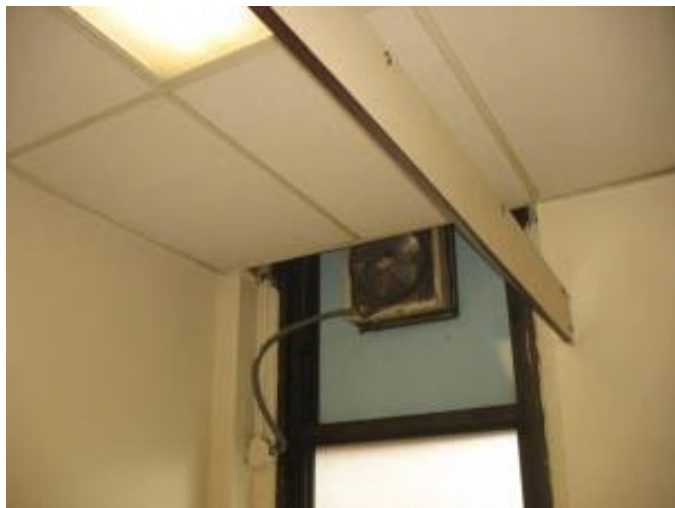
**System: D3040 - Distribution Systems**

**Location:** Restrooms

**Distress:** Building / MEP Codes

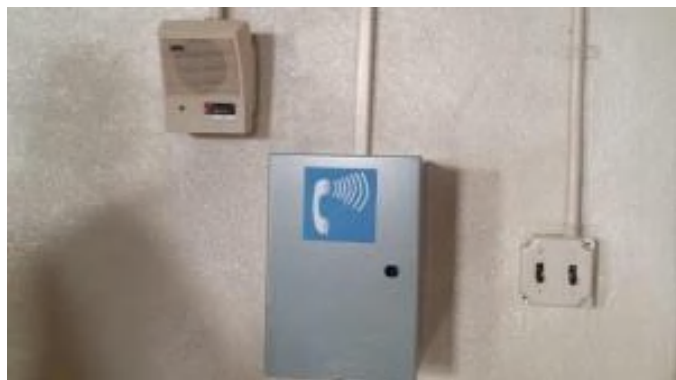
**System: D5030 - Communications and Security**

**Location:** Throughout the building

**Distress:** Beyond Service Life

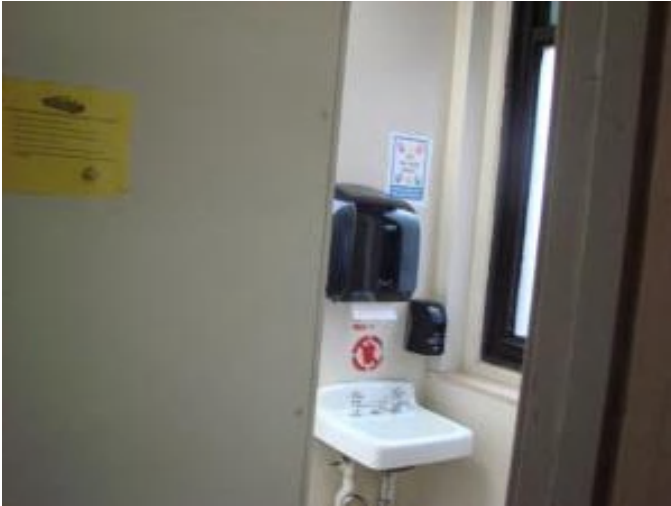
**System: C1030 - Fittings**

**Location:** Interior

**Distress:** Building / MEP Codes

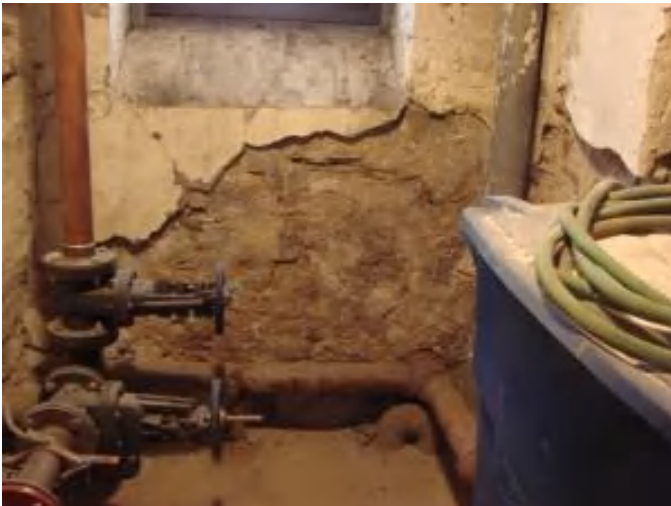
**System: C3010230 - Paint & Covering**

**Location:** Interior

**Distress:** Beyond Service Life

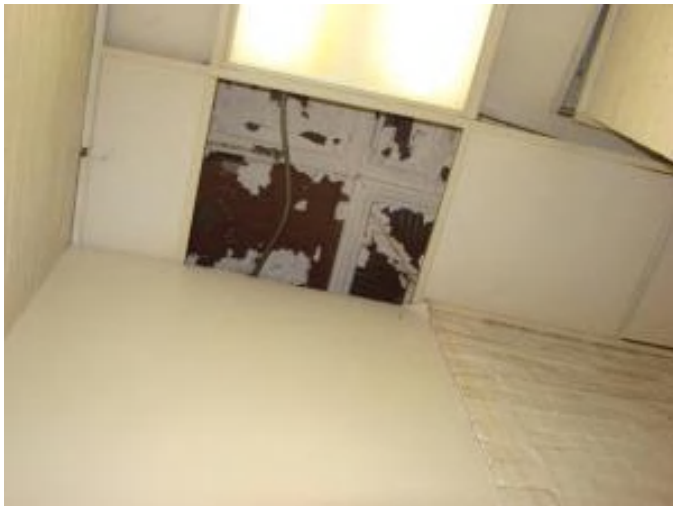
**System: C3030 - Ceiling Finishes**

**Location:** Interior

**Distress:** Beyond Service Life

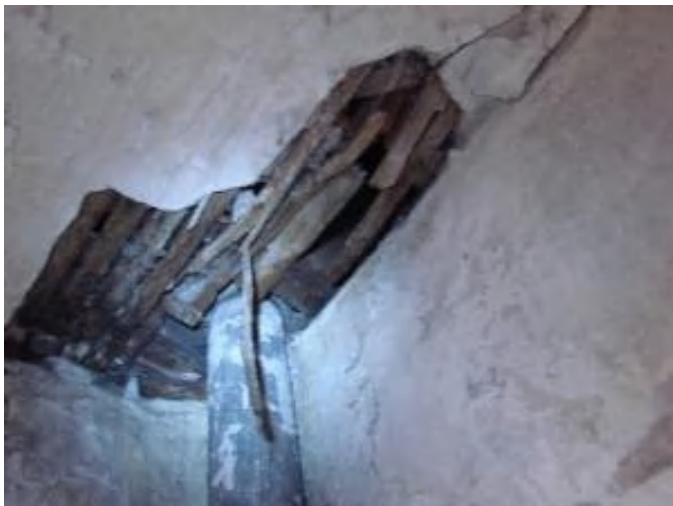
**System: C3030 - Ceiling Finishes**

**Location:** Interior

**Distress:** Damaged

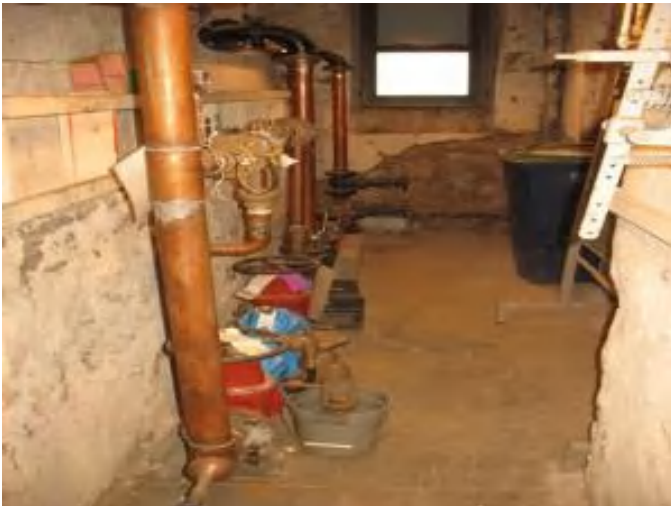
**System: D2020 - Domestic Water Distribution**

**Location:** Throughout building

**Distress:** Beyond Service Life

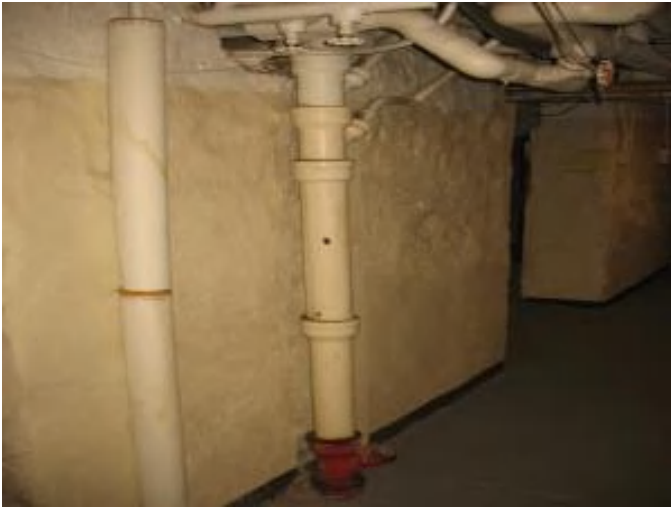
**System: D2030 - Sanitary Waste**

**Location:** Throughout building

**Distress:** Beyond Service Life

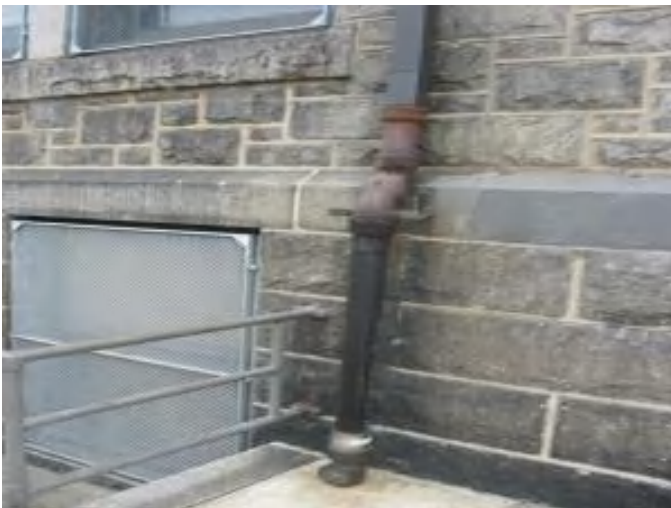
**System: D2040 - Rain Water Drainage**

**Location:** Exterior

**Distress:** Beyond Service Life

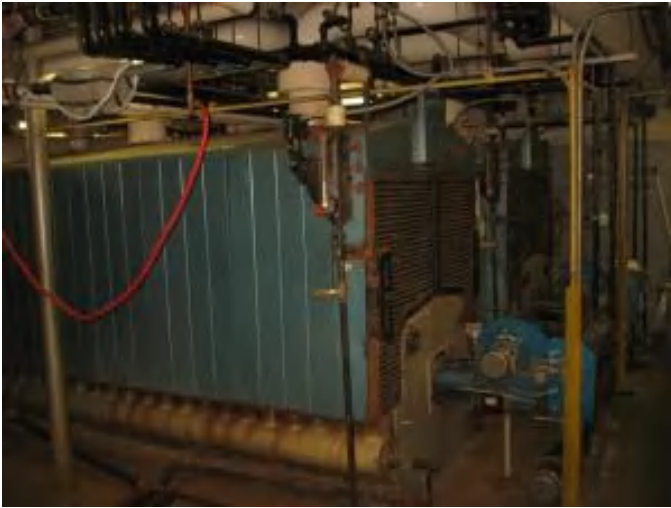
**System: D3020 - Heat Generating Systems**

**Location:** Boiler room

**Distress:** Beyond Service Life

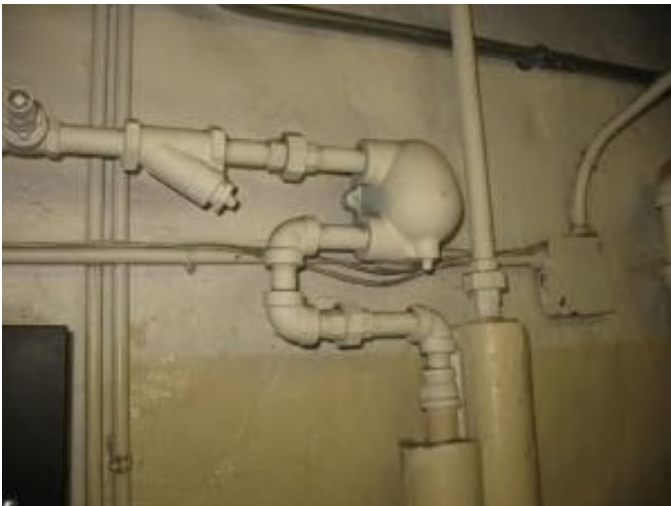
**System: D3040 - Distribution Systems**

**Location:** Throughout building

**Distress:** Beyond Service Life

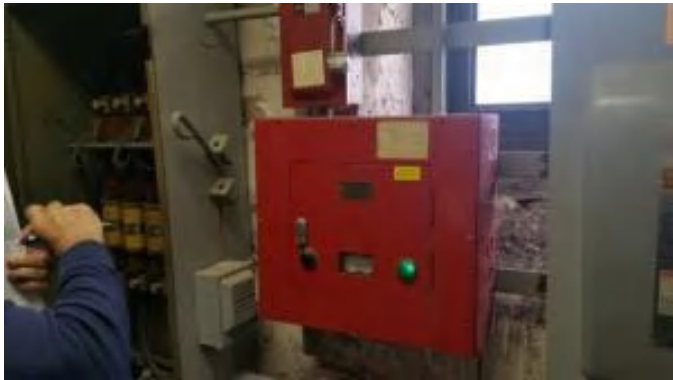
**System: D5030 - Communications and Security**

**Location:** Throughout the building

**Distress:** Beyond Service Life

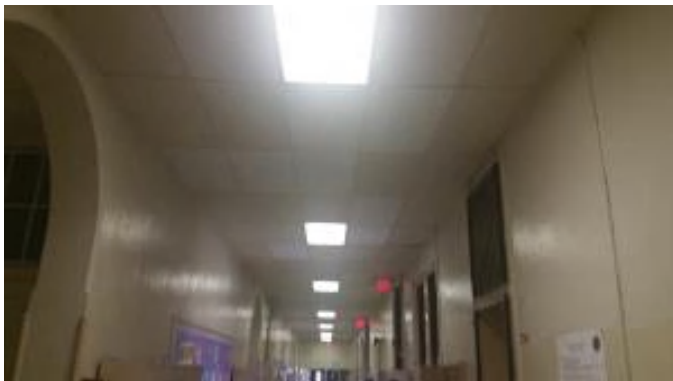
**System: D5090 - Other Electrical Systems**

**Location:** throughout the building

**Distress:** Health Hazard / Risk

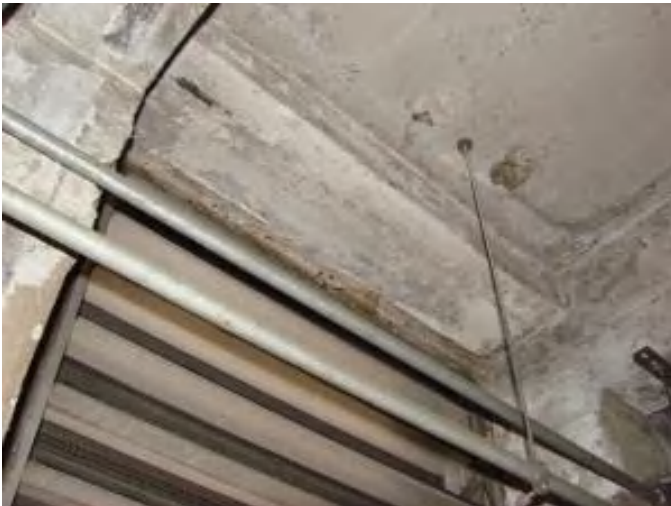
**System: B1010 - Floor Construction**

**Location:** Interior/exterior

**Distress:** Damaged

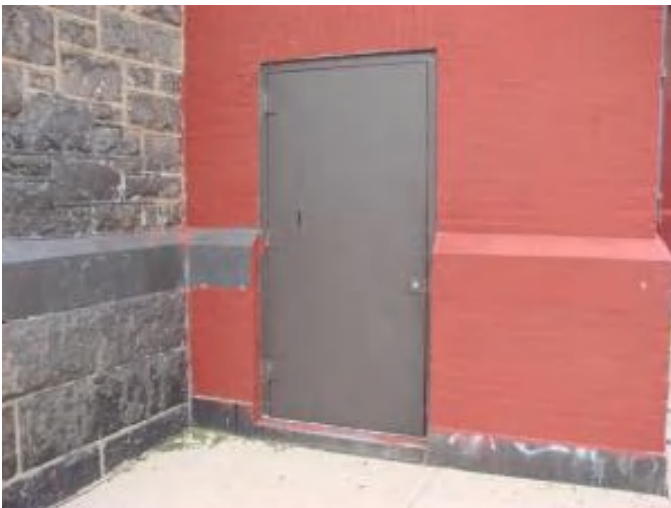
**System: B2030 - Exterior Doors**

**Location:** Exterior

**Distress:** Beyond Service Life

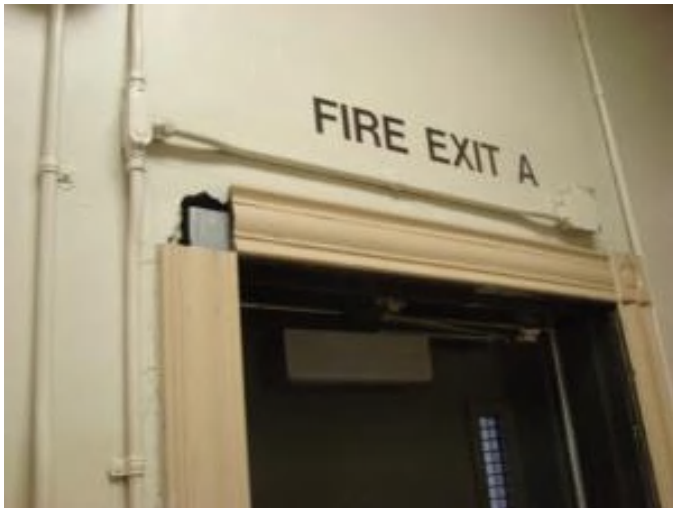
**System: C1020 - Interior Doors**

**Location:** Interior

**Distress:** Damaged

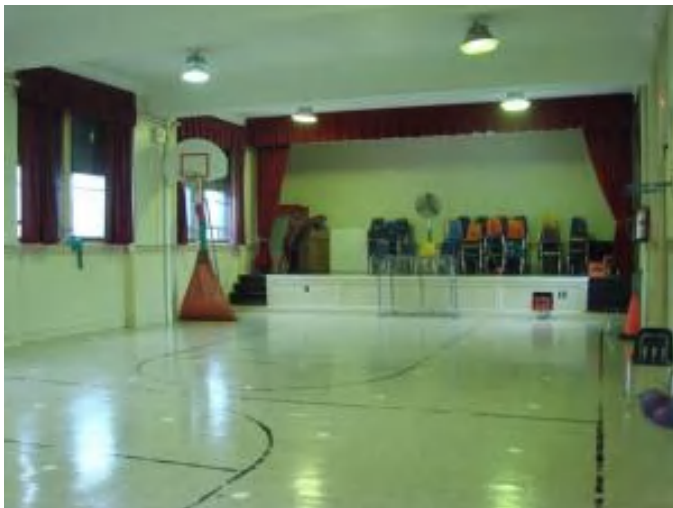
**System: C3020413 - Vinyl Flooring**

**Location:** Interior

**Distress:** Beyond Service Life

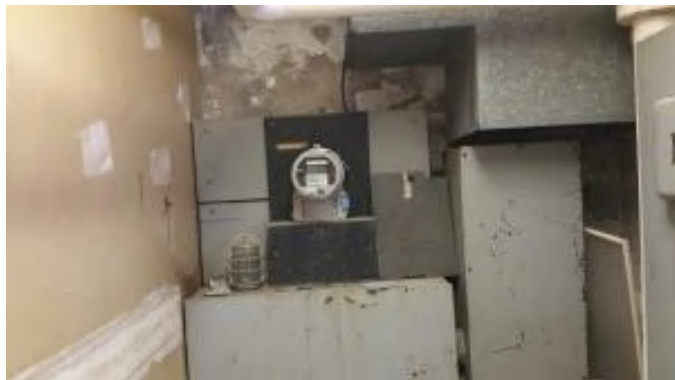
**System: D5010 - Electrical Service/Distribution**

**Location:** Electrical room

**Distress:** Beyond Service Life

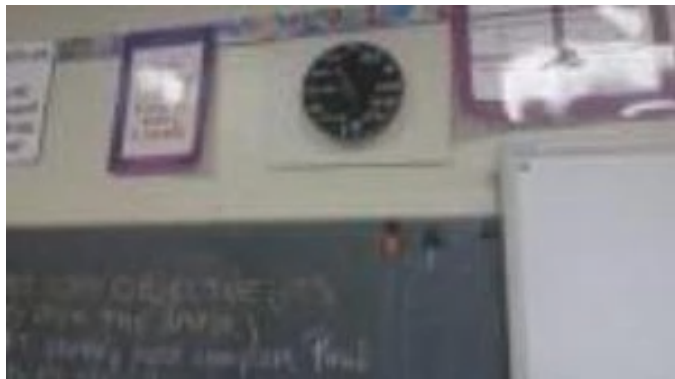
**System: D5030 - Communications and Security**

**Location:** Throughout the building

**Distress:** Beyond Service Life

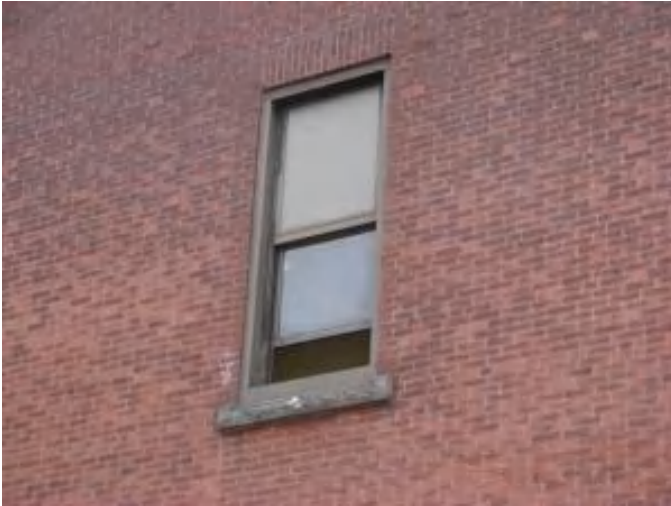
**System: B2010 - Exterior Walls**

**Location:** Exterior

**Distress:** Building Envelope Integrity

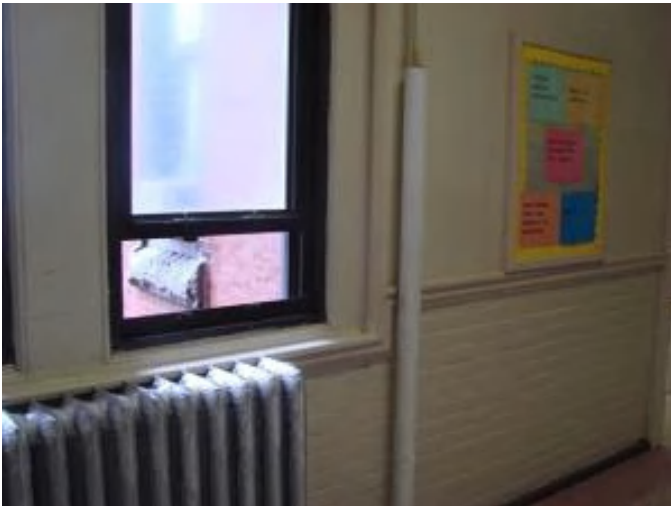
**System: B2020 - Exterior Windows**

**Location:** Exterior

**Distress:** Energy Efficiency

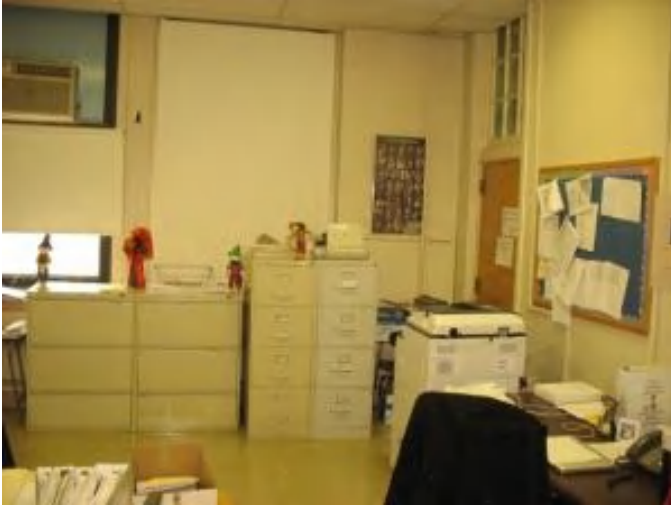
**System: D3030 - Cooling Generating Systems**

**Location:** Throughout building

**Distress:** Inadequate

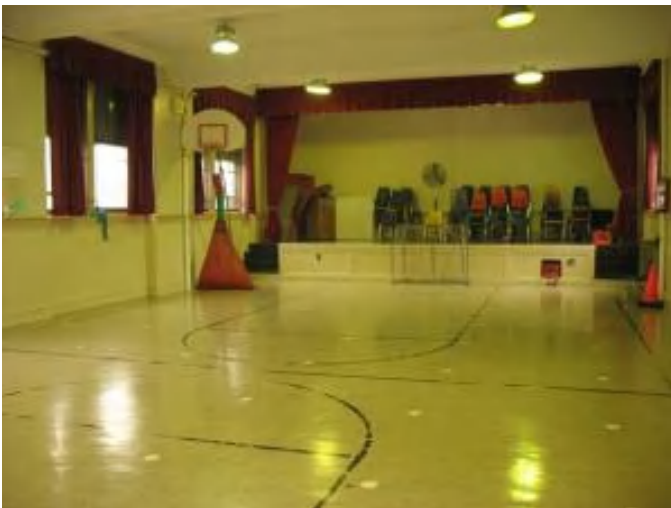
**System: D3040 - Distribution Systems**

**Location:** Gymnasium

**Distress:** Building / MEP Codes

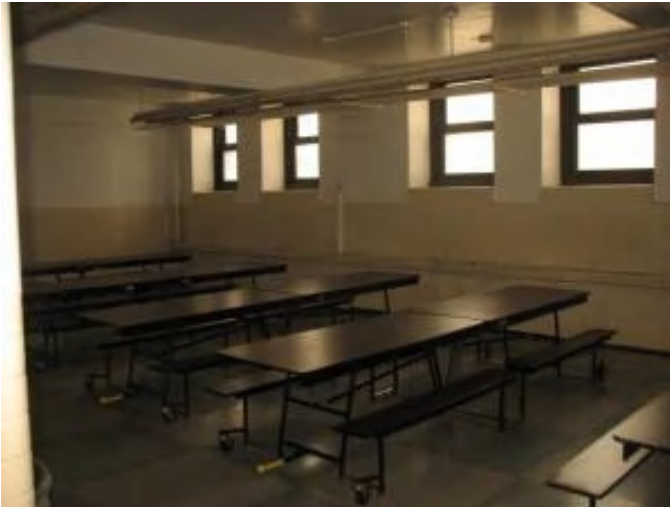
**System: D3040 - Distribution Systems**

**Location:** Cafeteria

**Distress:** Building / MEP Codes

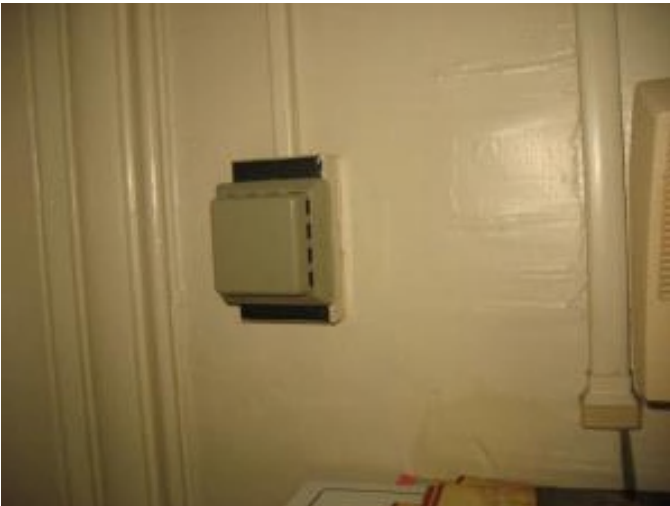
**System: D3060 - Controls & Instrumentation**

**Location:** Throughout building

**Distress:** Inadequate

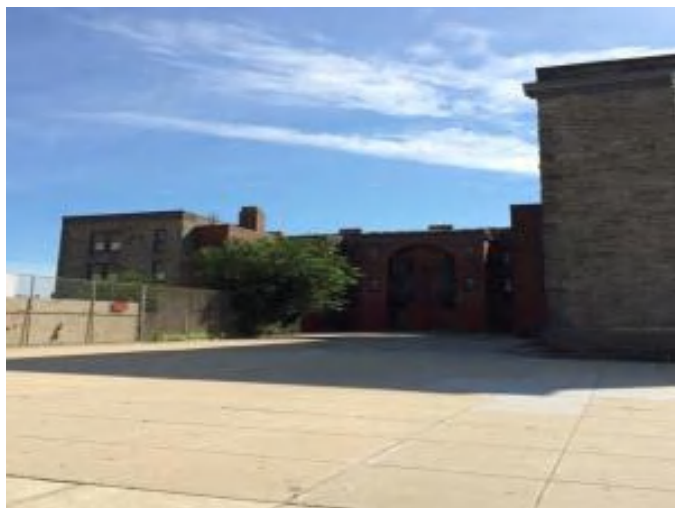
**System: G2030 - Pedestrian Paving**

**Location:** Grounds

**Distress:** Beyond Service Life
