## Facility Condition Assessment Summary Report

### AMY at Levering School

School District of Philadelphia  
**S629001; Levering**  
Final  
**Site Assessment Report**  
February 2, 2017

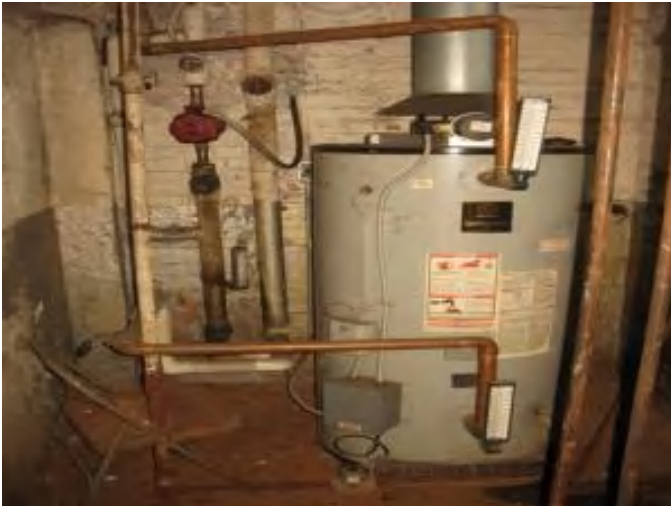
#### System: D2020 - Domestic Water Distribution

**Location:** Boiler room

**Distress:** Beyond Service Life

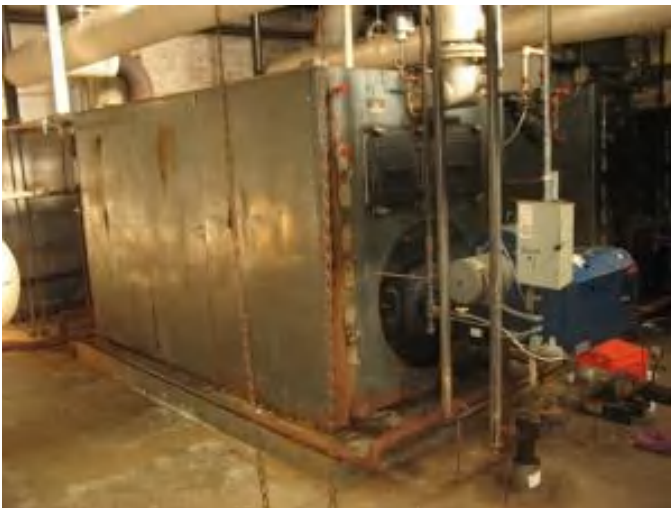
#### System: D3020 - Heat Generating Systems

**Location:** Boiler room

**Distress:** Failing

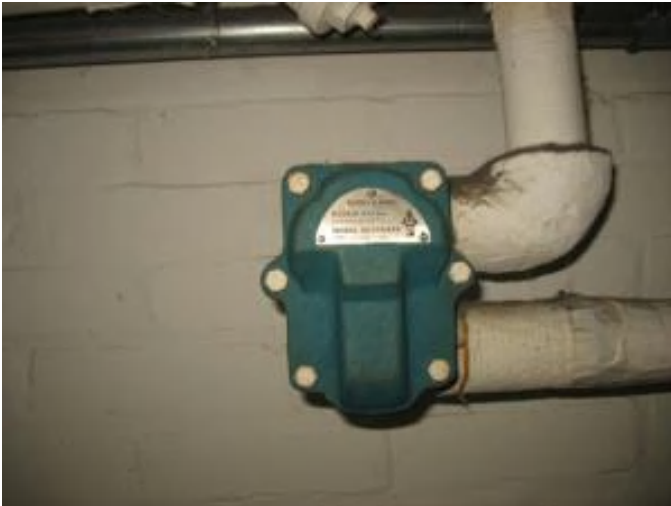
**System: D3040 - Distribution Systems**

**Location:** Throughout building

**Distress:** Failing

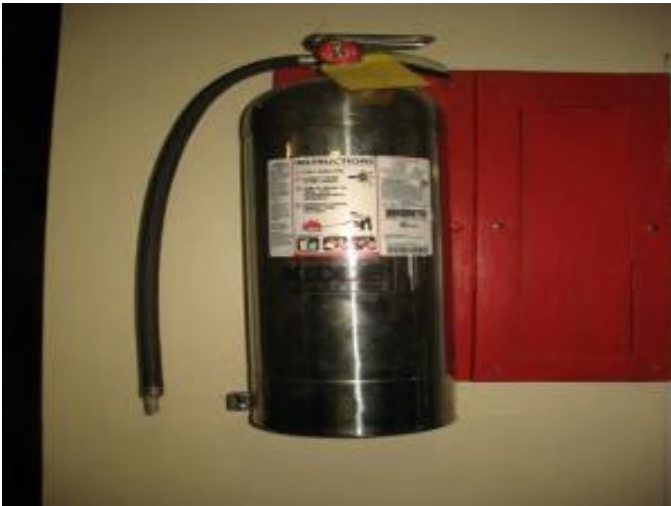
**System: D4010 - Sprinklers**

**Location:** Throughout building

**Distress:** Life Safety / NFPA / PFD

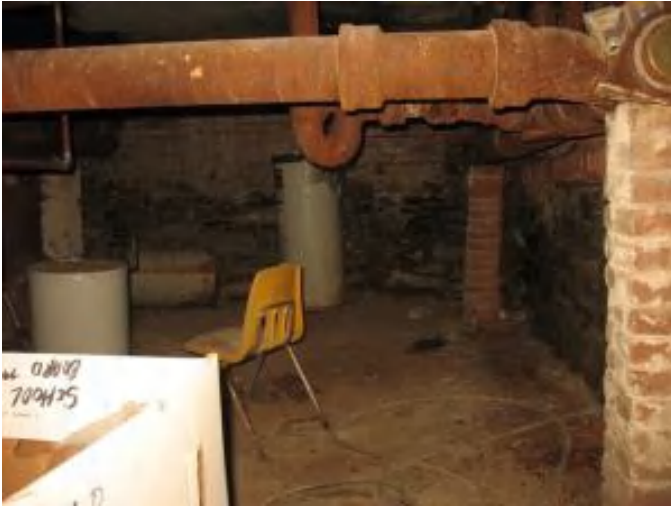
**System: D2030 - Sanitary Waste**

**Location:** Throughout building

**Distress:** Beyond Service Life

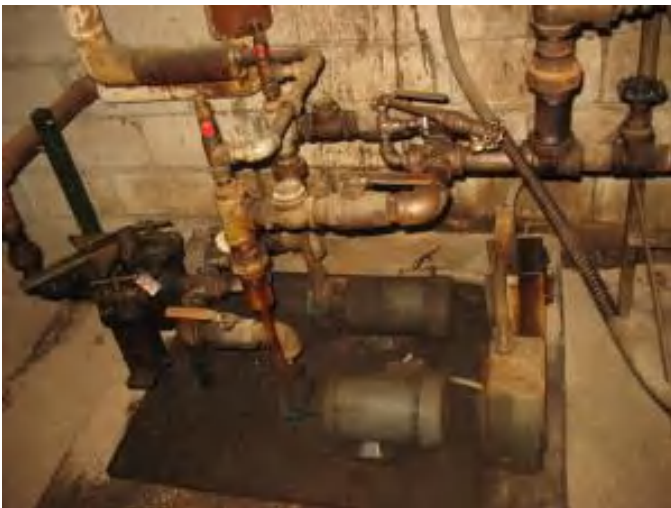
**System: D3020 - Heat Generating Systems**

**Location:** Boiler room

**Distress:** Beyond Service Life

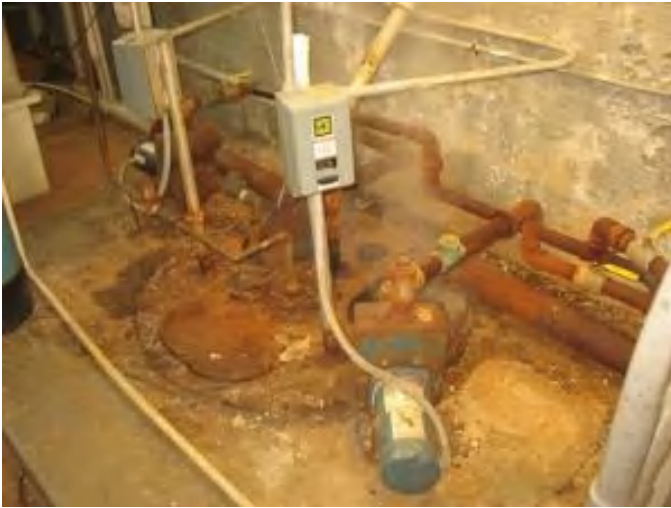
**System: D3040 - Distribution Systems**

**Location:** Boiler room

**Distress:** Damaged

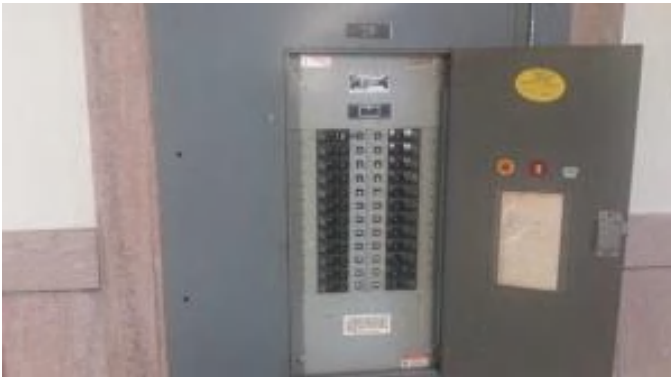
**System: D5010 - Electrical Service/Distribution**

**Location:** throughout the building

**Distress:** Beyond Service Life

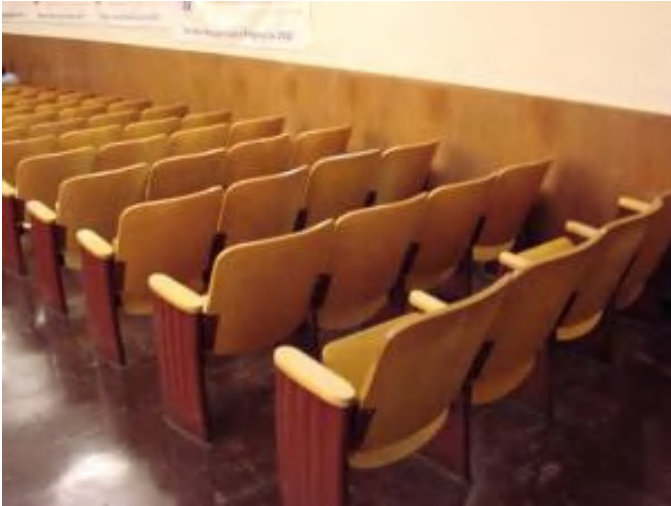
**System: C3020413 - Vinyl Flooring**

Flooring in main entryway is marble, in corridors sealed concrete, in offices and gym VCT in fair condition. The IMC is carpeted in fair condition with a few stained areas. Flooring in restrooms is typically ceramic tile installed in approximately 2000. Auditorium floor is VAT and needs to be replaced with VCT.

**Location:** Auditorium

**Distress:** Health Hazard / Risk

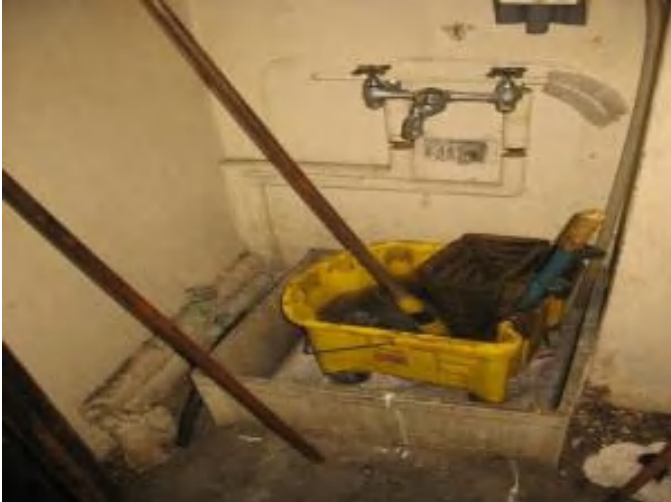
**System: D2010 - Plumbing Fixtures**

**Location:** Corridors

**Distress:** Beyond Service Life

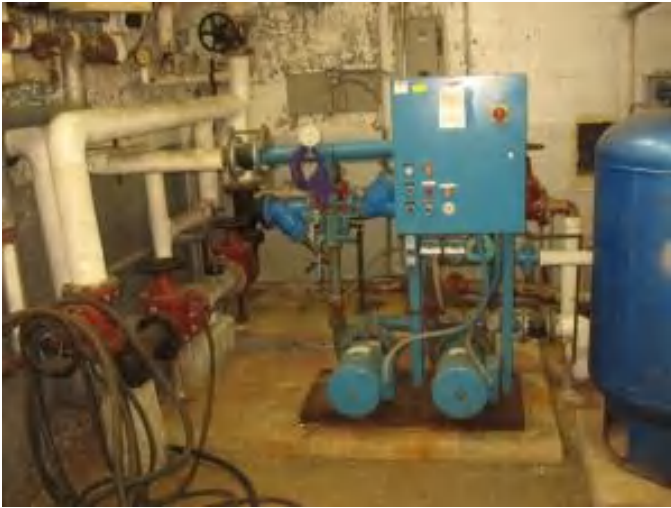
**System: D2020 - Domestic Water Distribution**

**Location:** Throughout building

**Distress:** Beyond Service Life

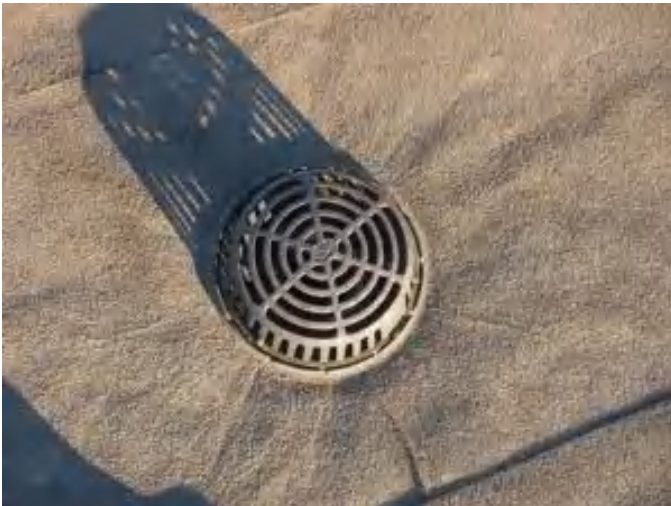
**System: D2040 - Rain Water Drainage**

**Location:** Throughout building

**Distress:** Beyond Service Life

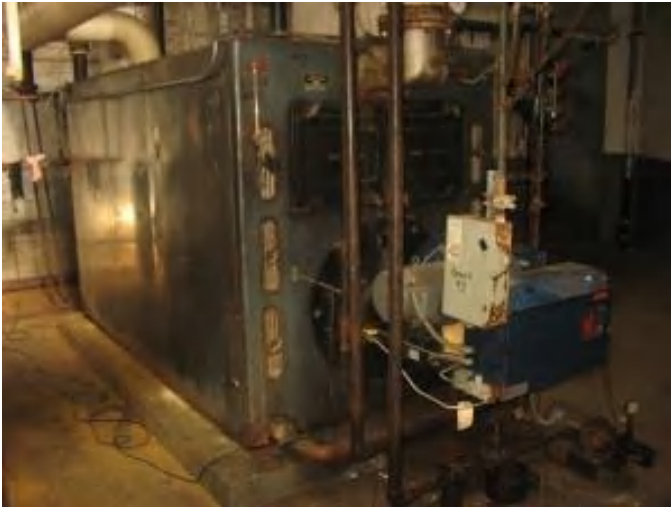
**System: D3020 - Heat Generating Systems**

**Location:** Boiler room  
**Distress:** Beyond Service Life  
**Category:** 3 - Operations / Maint.  
**Priority:** 3 - Response Time (3-4 yrs)  
**Correction:** Replace boiler, cast iron sectional (150 HP)  
**Qty:** 1.00  
**Unit of Measure:** Ea.  
**Estimate:** \$506,102.63  
**Assessor Name:** System  
**Date Created:** 01/27/2016

**Notes:** Replace the one (1) operational existing 5,320MBH cast iron boiler (B2), which is approaching the end of its service life, within the next 3-5 years.

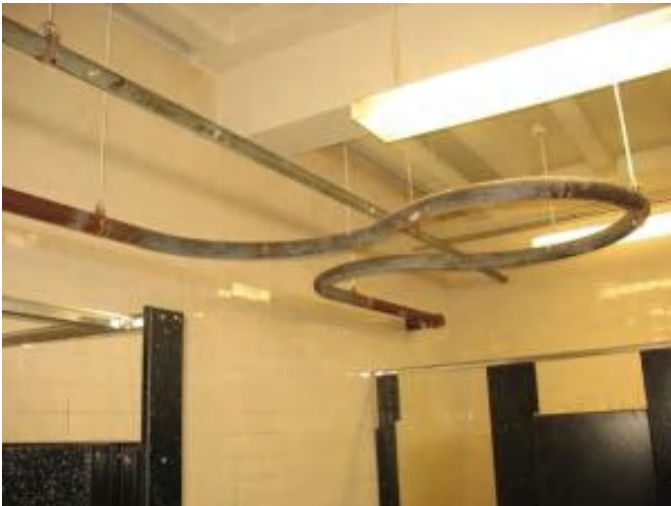
**System: D3040 - Distribution Systems**

**Location:** Throughout building  
**Distress:** Beyond Service Life  
**Category:** 3 - Operations / Maint.  
**Priority:** 3 - Response Time (3-4 yrs)  
**Correction:** Perform testing to identify and replace damaged steam and condensate piping.  
**Qty:** 69,475.00  
**Unit of Measure:** S.F.  
**Estimate:** \$657,259.49  
**Assessor Name:** System  
**Date Created:** 01/27/2016

**Notes:** Hire a qualified contractor to examine the steam piping, in service for 85 years, and perform additional testing to locate and replace any damaged piping and to further quantify the extent of potential failures.

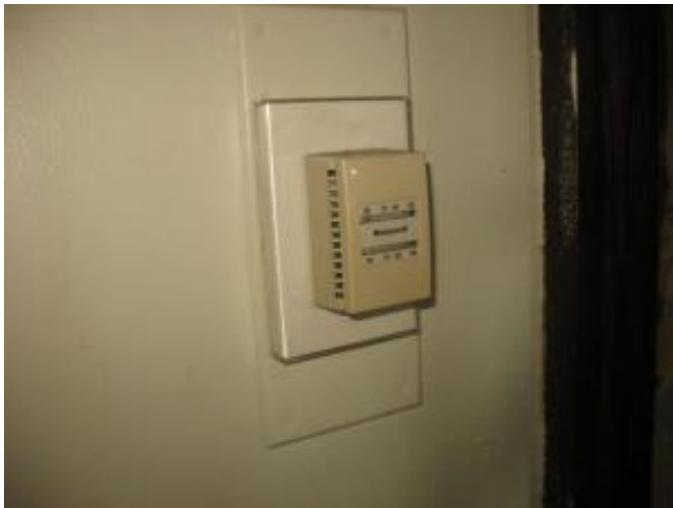
**System: D3060 - Controls & Instrumentation**

**Location:** Throughout building  
**Distress:** Failing  
**Category:** 3 - Operations / Maint.  
**Priority:** 3 - Response Time (3-4 yrs)  
**Correction:** Replace pneumatic controls with DDC (75KSF)  
**Qty:** 69,475.00  
**Unit of Measure:** S.F.  
**Estimate:** \$1,490,381.60  
**Assessor Name:** System  
**Date Created:** 01/27/2016

**Notes:** Replace the pneumatic controls for the HVAC systems with modern DDC modules, valves and actuators to improve reliability and energy efficiency. Provide a new building automation system (BAS) with communication interface to the preferred system in use throughout the District.

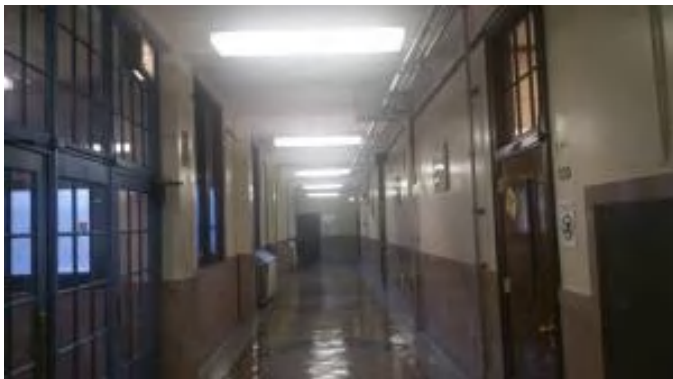
**System: D5020 - Lighting and Branch Wiring**

**Location:** throughout the building  
**Distress:** Beyond Service Life  
**Category:** 3 - Operations / Maint.  
**Priority:** 3 - Response Time (3-4 yrs)  
**Correction:** Replace Lighting Fixtures (SF)  
**Qty:** 0.00  
**Unit of Measure:** S.F.  
**Estimate:** \$437,774.04  
**Assessor Name:** System  
**Date Created:** 02/05/2016

**Notes:** Install new lighting system for 70% of the building  
 $69,475 \text{ SF} \times 70\% = 48,633 \text{ SF}$

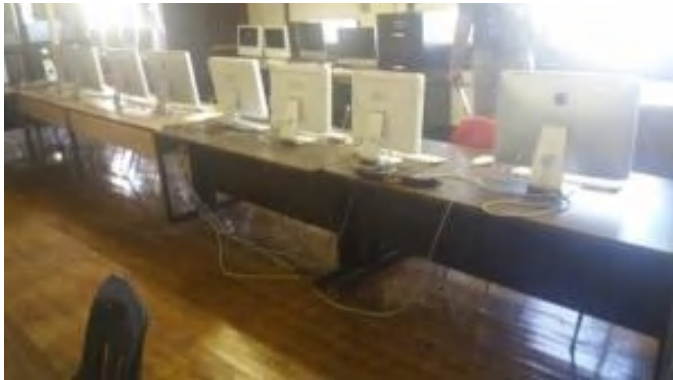
**System: D5020 - Lighting and Branch Wiring**

**Location:** throughout the building

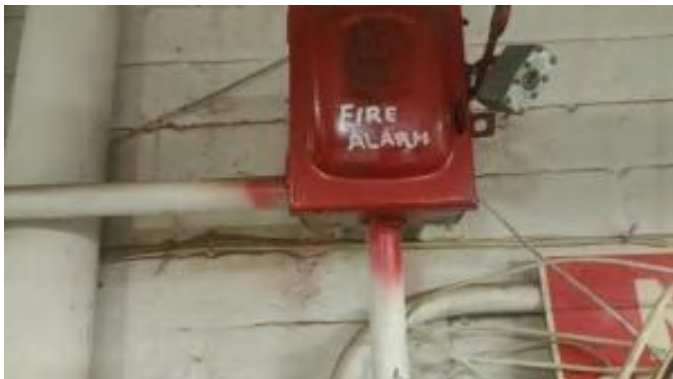
**System: D5030 - Communications and Security**

**Location:** throughout the building

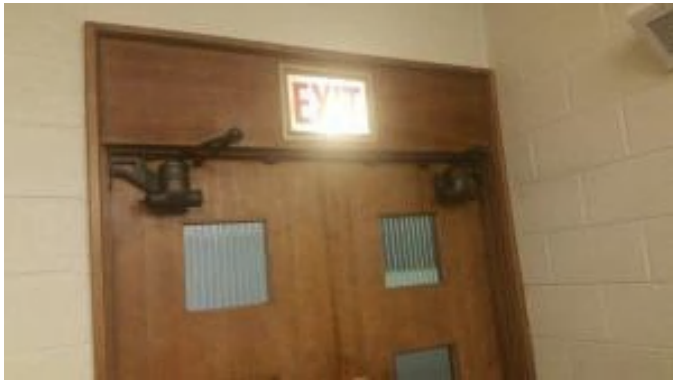
**System: D5090 - Other Electrical Systems**

**Location:** throughout the building

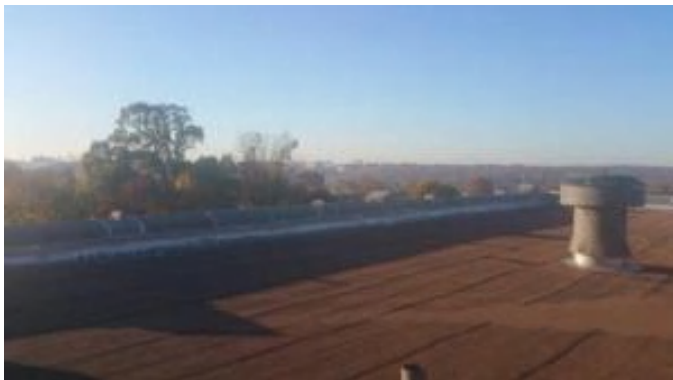
**System: D5090 - Other Electrical Systems**

**Location:** roof

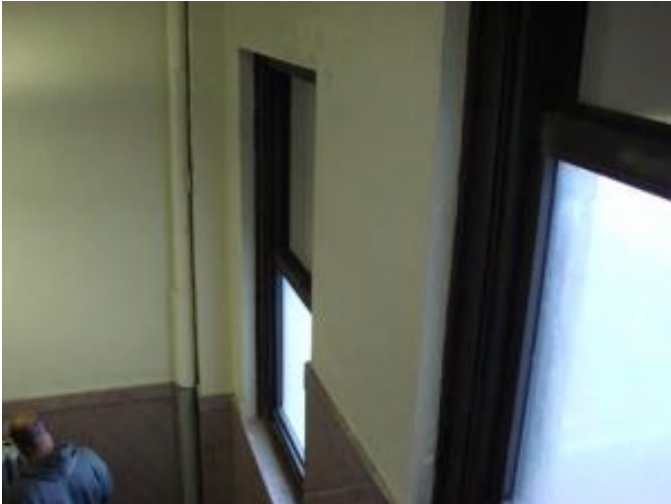
**System: B2020 - Exterior Windows**

**Location:** Exterior all elevations

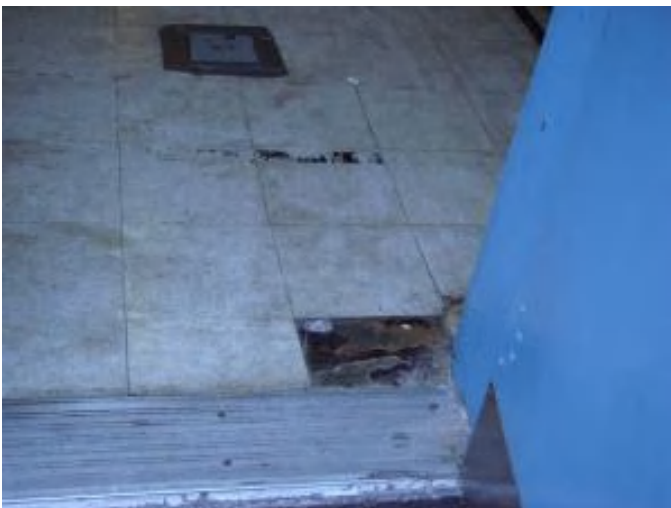
**System: B2030 - Exterior Doors**

**Location:** Building elevations

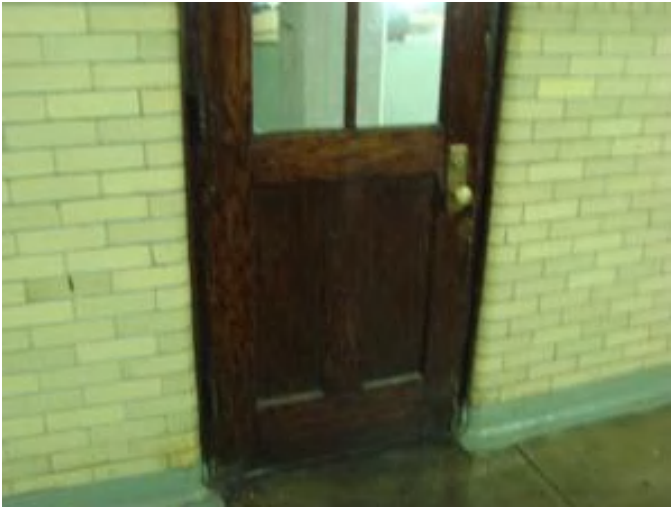
**System: C1020 - Interior Doors**

**Location:** Interior doors; corridors, classrooms, restrooms

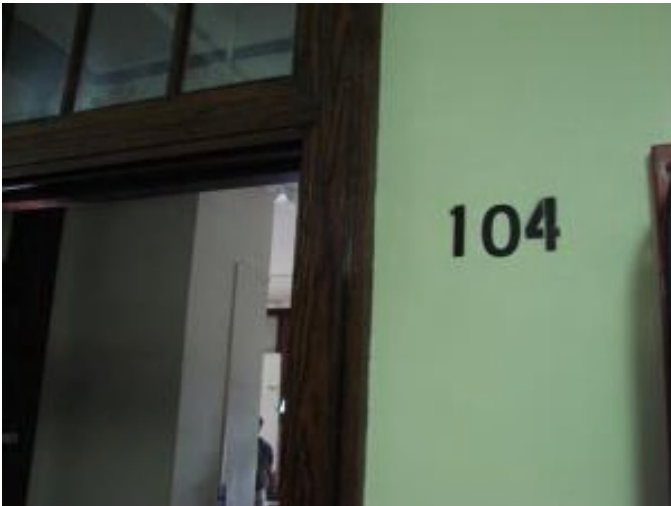
**System: C1030 - Fittings**

**Location:** Throughout building

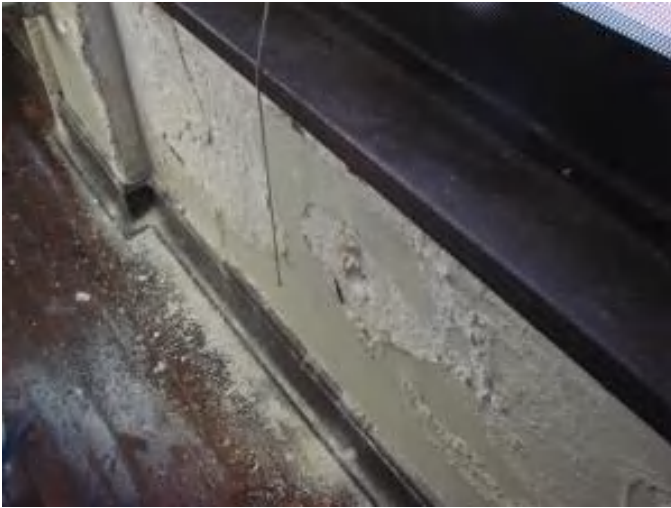
**System: C3010230 - Paint & Covering**

**Location:** Corridor and stairwell walls

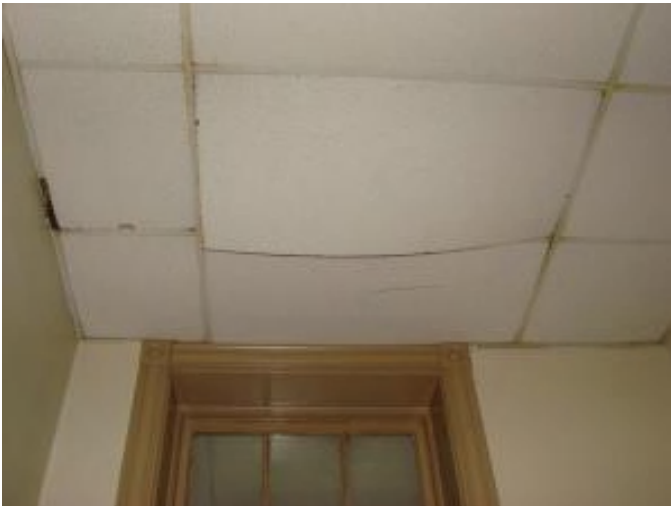
**System: C3030 - Ceiling Finishes**

**Location:** Throughout building

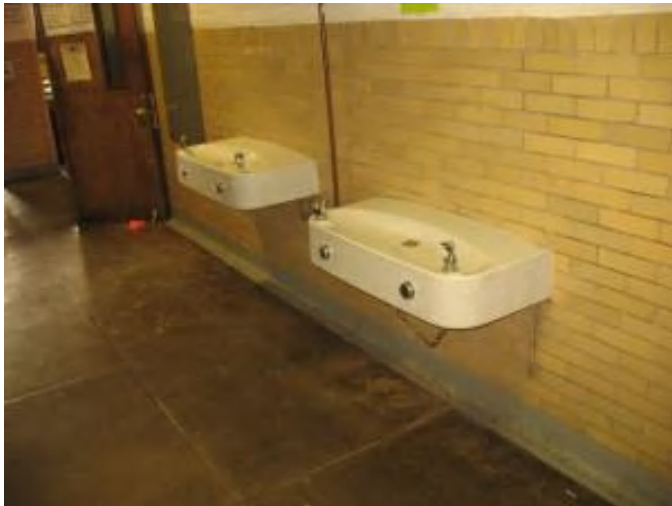
**System: D2010 - Plumbing Fixtures**

**Location:** Corridors

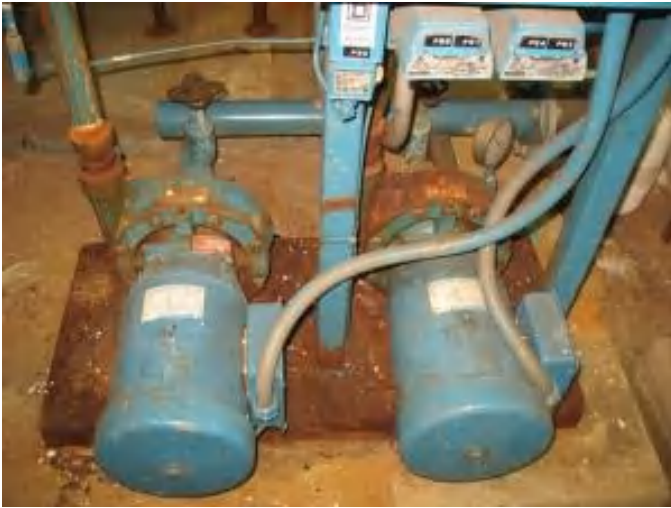
**System: D2020 - Domestic Water Distribution**

**Location:** Boiler room  
**Distress:** Damaged  
**Category:** 3 - Operations / Maint.  
**Priority:** 4 - Response Time (4-5 yrs)  
**Correction:** Replace duplex domestic booster pump set (5 HP)  
**Qty:** 1.00  
**Unit of Measure:** Ea.  
**Estimate:** \$48,381.44  
**Assessor Name:** System  
**Date Created:** 01/27/2016

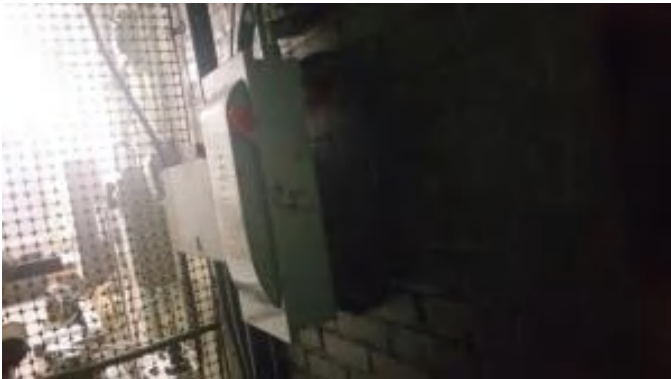
**System: D5010 - Electrical Service/Distribution**

**Location:** electrical room  
**Distress:** Beyond Service Life  
**Category:** 3 - Operations / Maint.  
**Priority:** 4 - Response Time (4-5 yrs)  
**Correction:** Replace Service Transformer, Add Switchboard  
**Qty:** 0.00  
**Unit of Measure:** Ea.  
**Estimate:** \$324,192.58  
**Assessor Name:** System  
**Date Created:** 02/05/2016

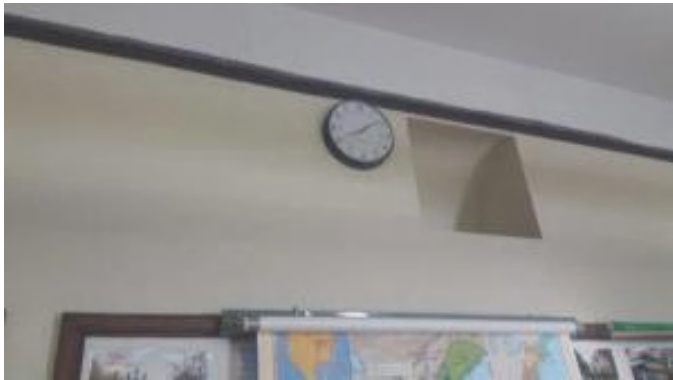
**System: D5030 - Communications and Security**

**Location:** throughout the building

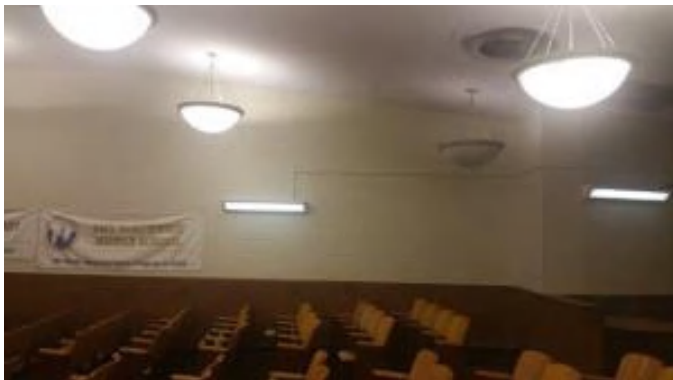
**System: D5030 - Communications and Security**

**Location:** auditorium

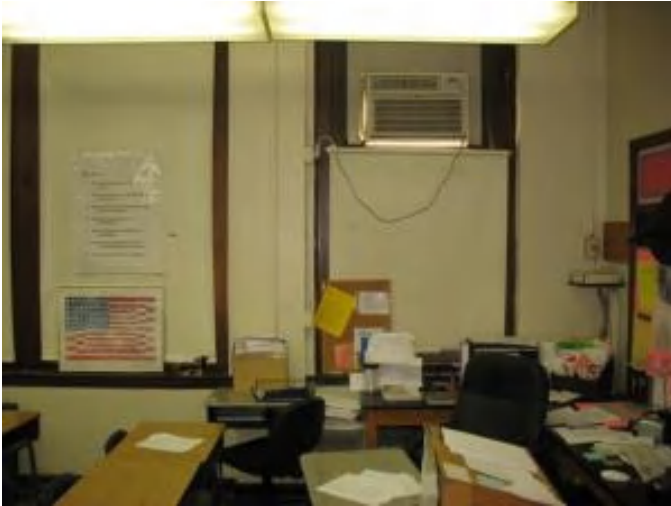
**System: D3030 - Cooling Generating Systems**

**Location:** Throughout building

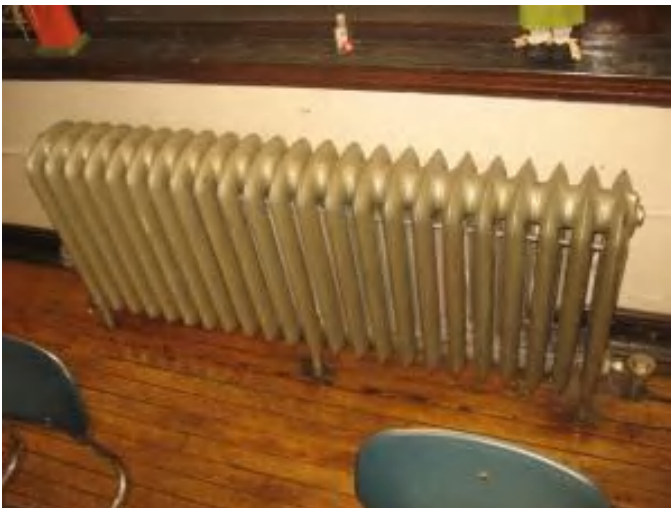
**System: D3040 - Distribution Systems**

**Location:** Throughout building

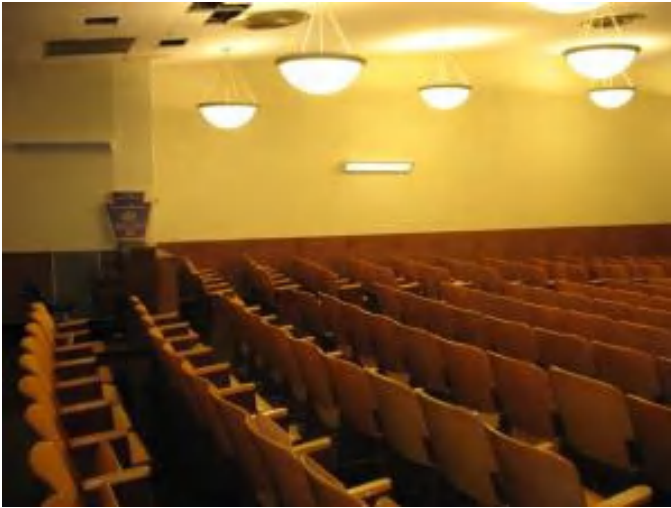
**System: D3040 - Distribution Systems**

**Location:** Auditorium

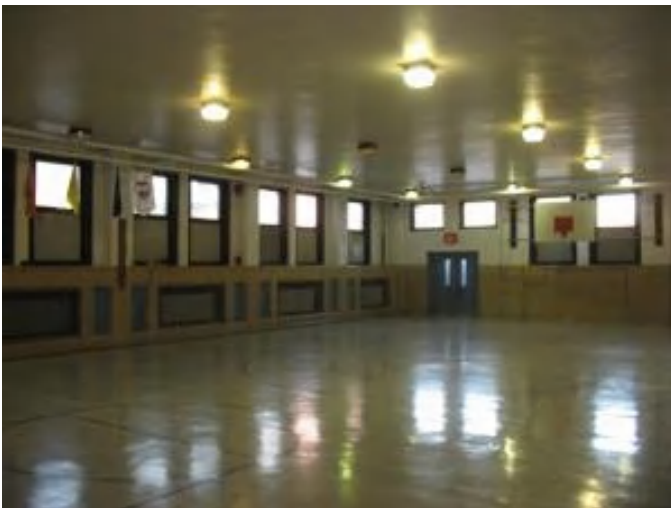
**System: D3040 - Distribution Systems**

**Location:** Gymnasium

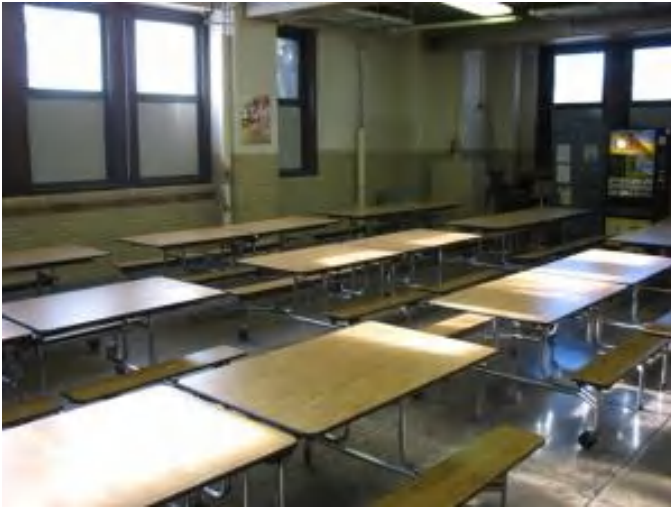
**System: D3040 - Distribution Systems**

**Location:** Cafeteria

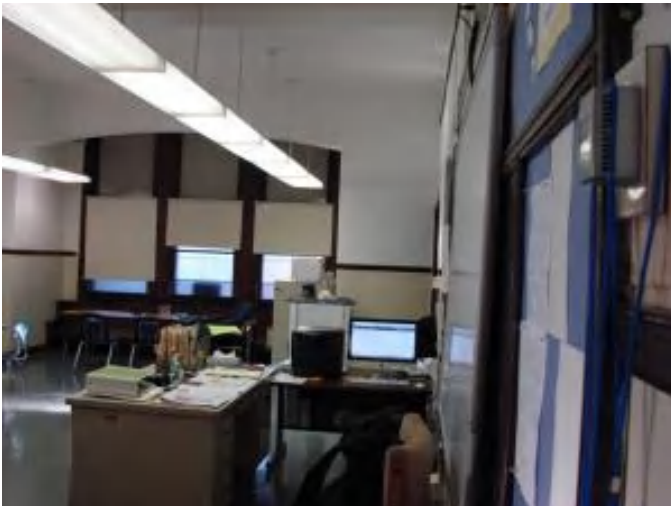
**System: D3040 - Distribution Systems**

**Location:** Administration offices

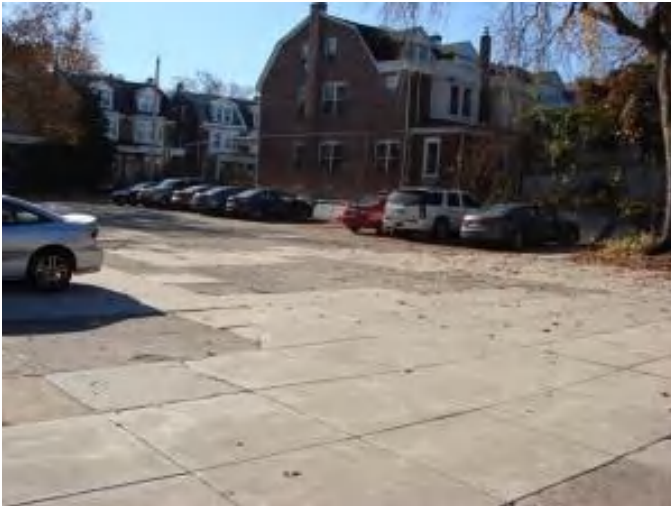
#### System: G2020 - Parking Lots

**Location:** Parking area west side of site

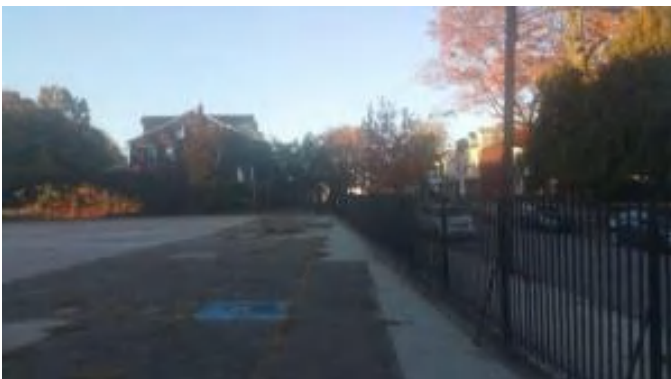
#### System: G4020 - Site Lighting

**Location:** grounds

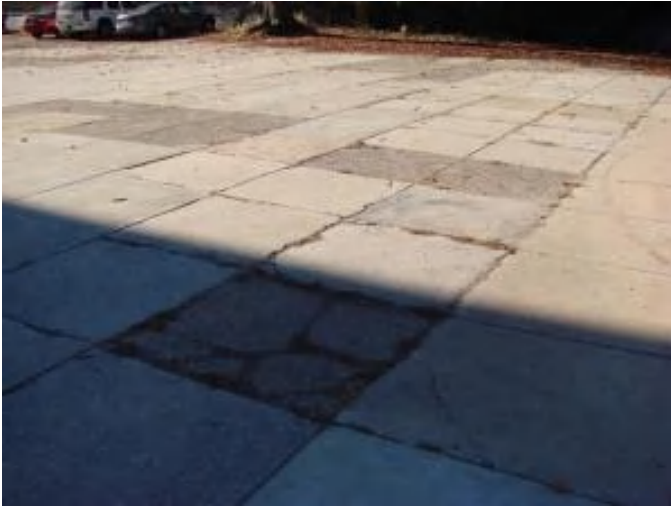
**System: G2020 - Parking Lots**

**Location:** Parking area west side of site

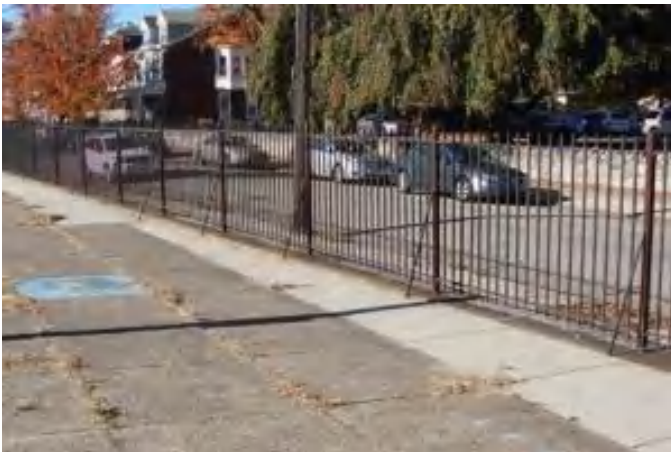
**System: G2040 - Site Development**

**Location:** Picket fence along site perimeter

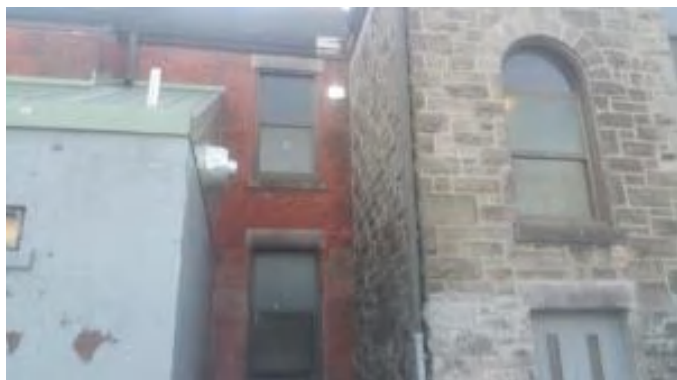
**System: G4030 - Site Communications & Security**

**Location:** grounds
