Facility Condition Assessment Summary Report

Adaire School

S520001;Adaire

Site Assessment Report

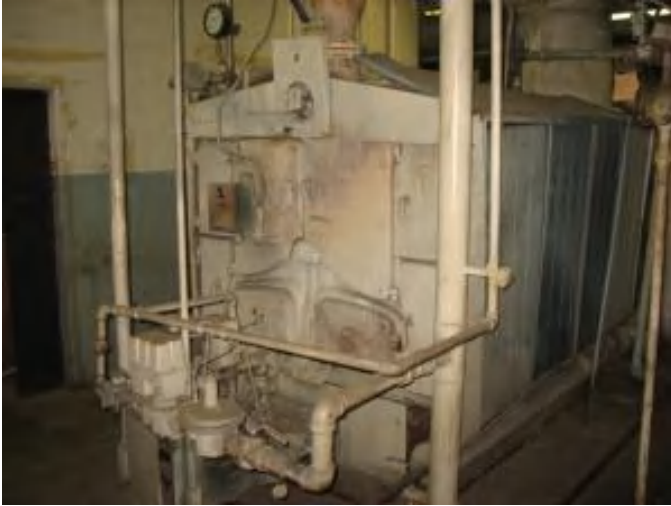
System: D3020 - Heat Generating Systems

Heat Generating Systems - Building heating hot water is generated by two HB Smith Series 44 cast iron sectional boilers. There are three boilers, but one is defunct. The boilers are original to the building and are almost 60 years old. One boiler is required to hold the building load in normal winter weather conditions. Each boiler is equipped with an Auburn burner designed to operate on natural gas and is well beyond its useful service life. The gas train serving the boilers does appear to have code required venting of the regulators and dual solenoid valves with venting of the chamber between. Cast iron sectional boilers have an anticipated service life of 35 years or more; these units have been in service for almost 60 years and need to be replaced.

Location: Boiler room

Distress: Failing

Notes: Replace the three existing cast iron boilers which are well beyond their service life.

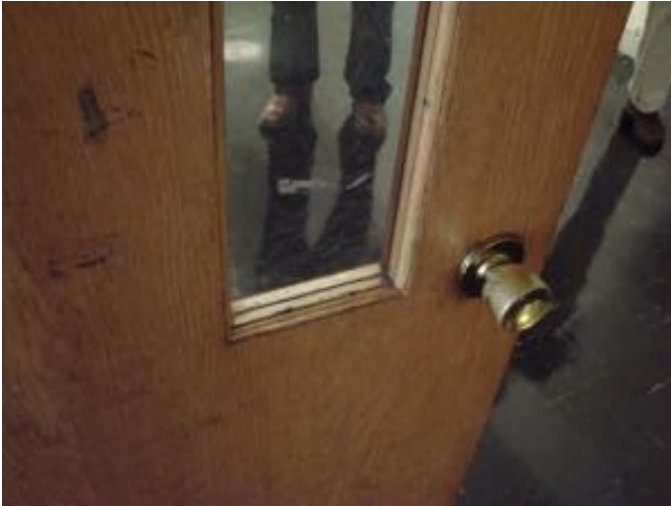
System: C1020 - Interior Doors

Interior doors are generally solid core wood doors, some glazed, with hollow metal frames, in fair to poor condition, some doors have damaged finish (40%). Doors generally do not have accessible hardware. The doors leading to exit stairways are hollow metal doors and frames in good condition.

Location: Interior

Distress: Building / MEP Codes

Notes: Replace interior doors hardware for ADA accessibility

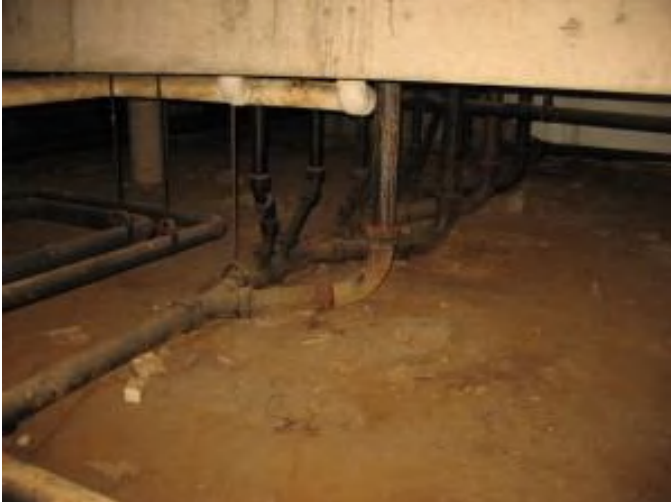
System: D2030 - Sanitary Waste

The maintenance staff reported mostly minor problems with the sanitary waste piping systems. However, the sewer piping has been in service for six decades and will require more frequent attention from the maintenance staff as time passes. The District should hire a qualified contractor to examine the sanitary waste piping using video cameras to locate and replace any damaged piping and to further quantify the extent of potential failures.

Location: Throughout building

Distress: Health Hazard / Risk

Notes: Hire a qualified contractor to perform a detailed examination of the sanitary waste piping using visual inspection and video cameras to locate and replace any damaged piping and to further quantify the extent of potential failures.

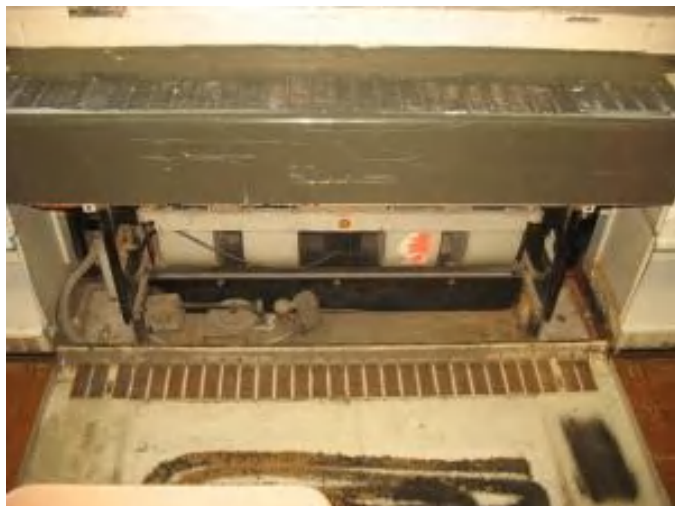
System: D3040 - Distribution Systems

Location: Throughout building

Distress: Beyond Service Life

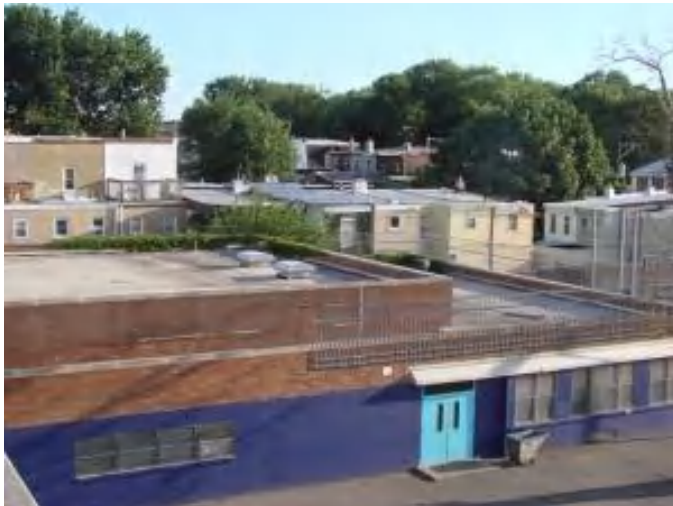
System: B3010105 - Built-Up

Roofing system is a ballasted built-up system, very old and in poor condition; all roofing and flashing is typically in poor condition with some counter flashing separated from parapet walls; leaks have not been reported. The roof hatch is old and damaged.

Location: Exterior

Distress: Building Envelope Integrity

Notes: Install all new roofing system including insulation within next 5 to 10 years; tear-down existing roofing; install flashing, and counter flashing

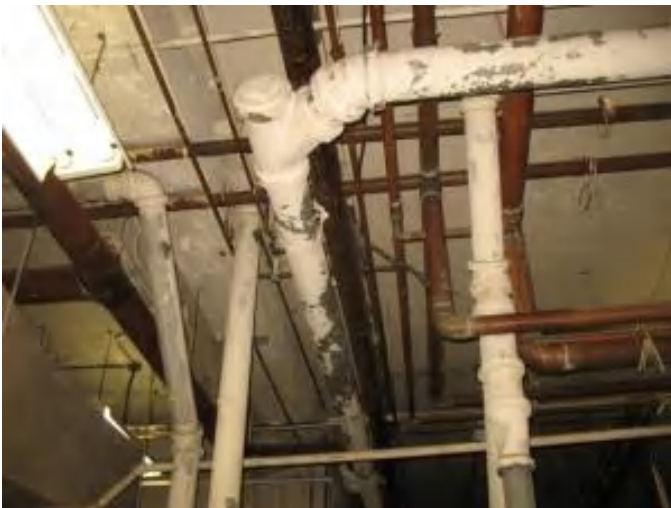
System: D2020 - Domestic Water Distribution

Location: Throughout building

Distress: Beyond Service Life

Notes: Hire a qualified contractor to perform a detailed inspection of the domestic water piping, in use for almost twenty years, and replace any damaged piping.

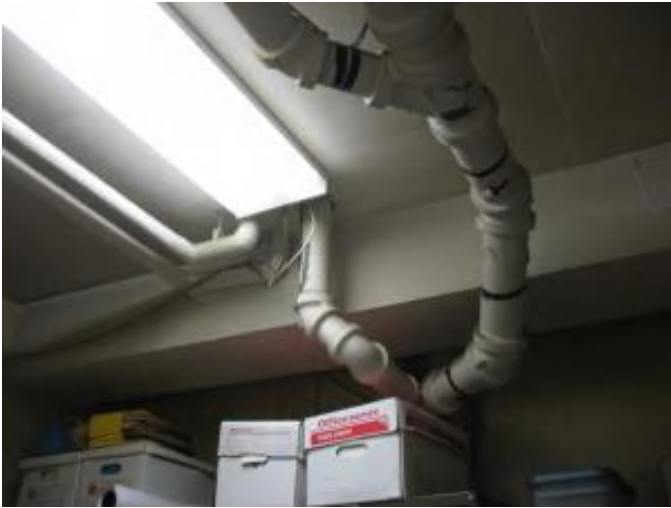
System: D2040 - Rain Water Drainage

Rain Water Drainage - Rain water from the roof is routed down through pipe chases in the interior of the building by both cast iron hub and spigot piping and threaded galvanized piping. The drain piping should be inspected by a qualified contractor and repaired as necessary.

Location: Throughout building

Distress: Beyond Service Life

Notes: Hire a qualified contractor to perform a detailed examination of the rain water drainage piping using visual inspection and video cameras to locate and replace any damaged piping and to further quantify the extent of potential failures.

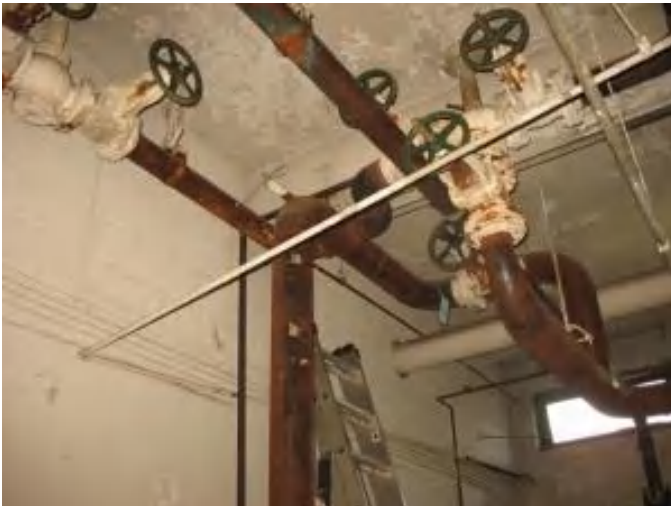
System: D3040 - Distribution Systems

Distribution Systems - Hot water distribution piping is black steel (ASTM A53) with welded fittings coming off the boilers; none of the piping off the boilers was insulated. The main building heating distribution piping is Schedule 80 black steel with threaded fittings. The piping mains from the basement level run up through the building to the unit ventilators on both floors. The distribution piping has been in use well beyond its service life and will require more frequent attention from the maintenance staff to address pipe/valve failures as time passes. The District should hire a qualified contractor to examine the hot water distribution piping and perform

Location: Throughout building

Distress: Beyond Service Life

Notes: Hire a qualified contractor to examine the hot water distribution piping and perform additional testing to locate and replace any damaged piping and to further quantify the extent of potential failures.

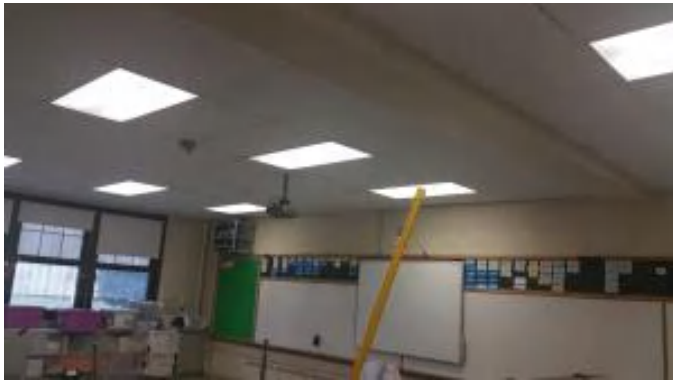
System: D5020 - Lighting and Branch Wiring

Location: Throughout the building

Distress: Beyond Service Life

Notes: Install new lighting fixtures for all the class rooms, and other rooms. New fluorescent lighting (T-5) will be adequate, however, using the state-of-the-art LED lighting will improve the energy usage.

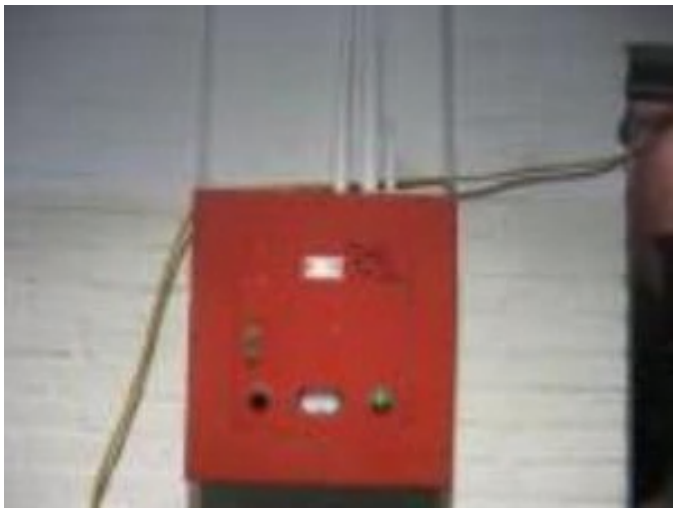
System: D5030 - Communications and Security

Fire Alarm System – The present Fire Alarm system is inadequate and is not addressable. A new Automated Fire Alarm System is needed.

Location: Throughout the building

Distress: Building / MEP Codes

Notes: Install a new Automated Fire Alarm System to be located in the new Electrical Room.

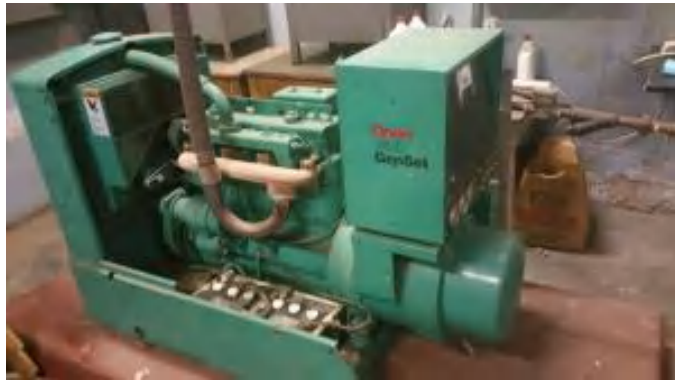
System: D5090 - Other Electrical Systems

Location: Electrical room in the basement

Distress: Building / MEP Codes

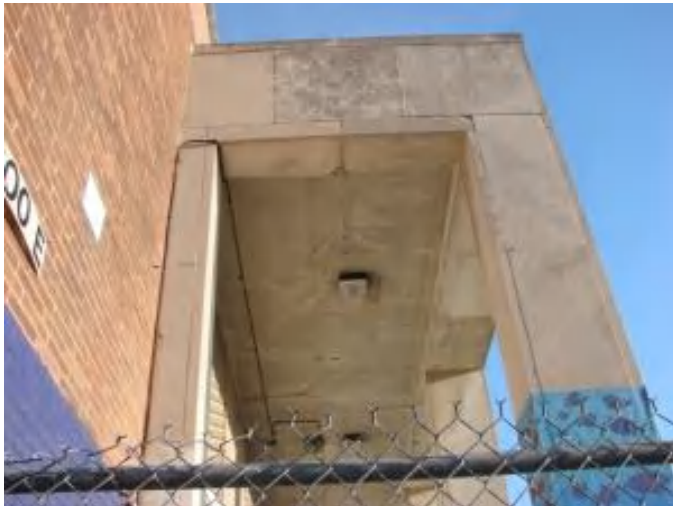
System: B2010 - Exterior Walls

The building envelope is typically face brick masonry with CMU backup. Some brick parapet walls were rebuilt in mid 2000's. In general, masonry is in fair to good condition. The Auditorium wing has a stone clad 2 story portico with some missing mortar. Water penetration through walls has been reported.

Location: Exterior

Distress: Maintenance Required

Notes: Tuck-point stone clad portico at Auditorium entrance

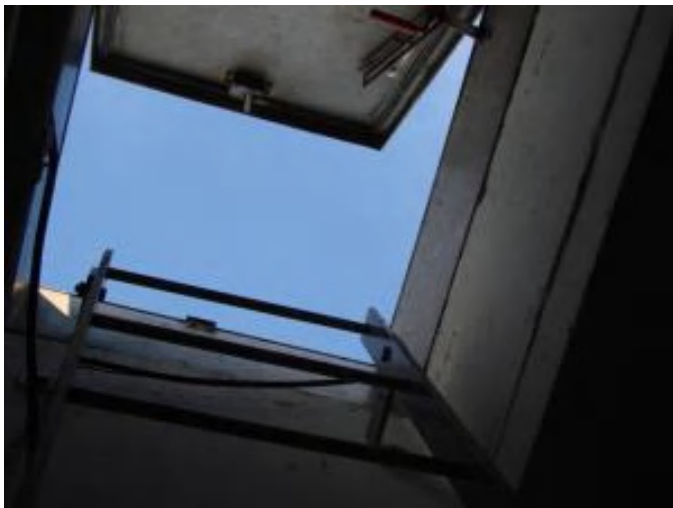
System: B3020 - Roof Openings

Location: Exterior

Distress: Beyond Service Life

Notes: Replace roof access hatch

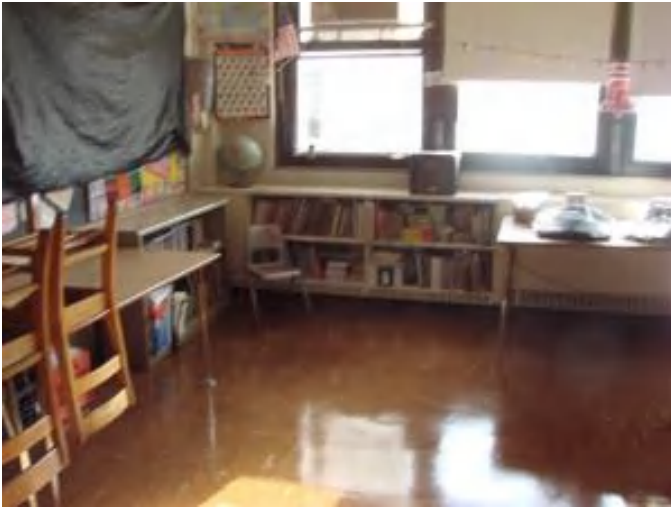
System: C3020413 - Vinyl Flooring

Flooring in classrooms and auditorium is VAT (approximately 70% of floor area); the balance of the floor is VCT in portion of Kindergarten installed in 2000's; and painted concrete and terrazzo in toilets. Most flooring is in fair to good condition; however, the VAT tile flooring will need to be replaced at the end of its useful life.

Location: Interior

Distress: Health Hazard / Risk

Notes: Replace all VAT flooring including cove base within 5 years

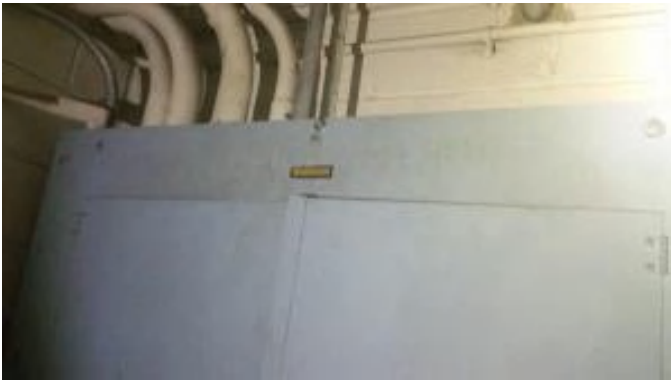
System: D5010 - Electrical Service/Distribution

Location: Electrical room in the basement.

Distress: Beyond Service Life

Notes: Upgrade the existing electrical service with a new 1000 KVA dry-type Transformer, 13.2KV to 480V/277V, 3Ph. Install a new 1200A, 480V, 3 Ph. Switchboard. The new Main switchboard shall be sized to handle the existing loads plus any new HVAC loads. Install a new step down transformer from 480V to 120V/208V, and a new 600 Amp main 120V/208V Panel Board for all the lighting/receptacle loads.

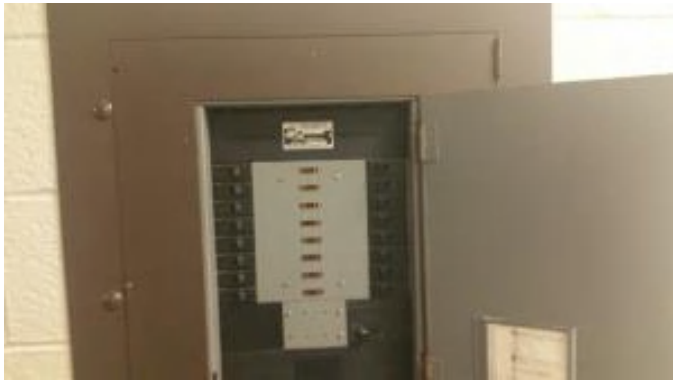
System: D5010 - Electrical Service/Distribution

Location: Throughout the building

Distress: Beyond Service Life

Notes: Install two 120V/208V panels in each floor to replace the existing panels. Also replace the power feeders, conduit wire to the four panels from the new 120V/208V three phase main Panel Board.

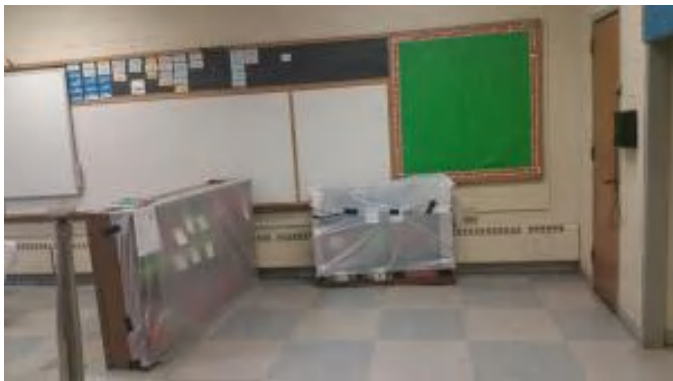
System: D5020 - Lighting and Branch Wiring

Receptacles - There is inadequate receptacles in classrooms, multi-purpose room, computer room, etc. We recommend two receptacles in each wall of class rooms and other purpose rooms. Also, it is recommended adding a wire-mold system with receptacles on every 3' in the computer room.

Location: Throughout the building

Distress: Beyond Service Life

Notes: Install two receptacles in all of class rooms and other purpose rooms. Add a wire-mold system with receptacles on every 3' for the computer room.

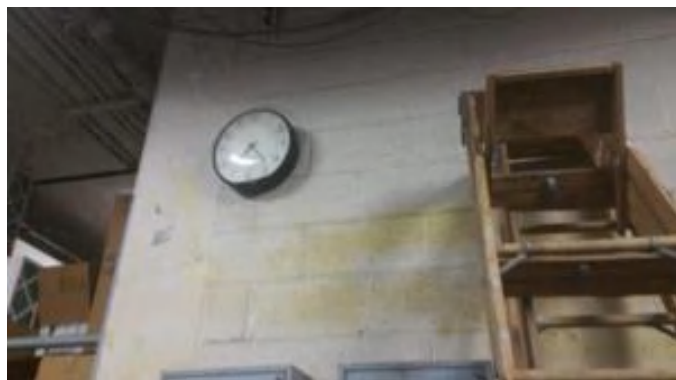
System: D5030 - Communications and Security

Location: Throughout the building

Distress: Beyond Service Life

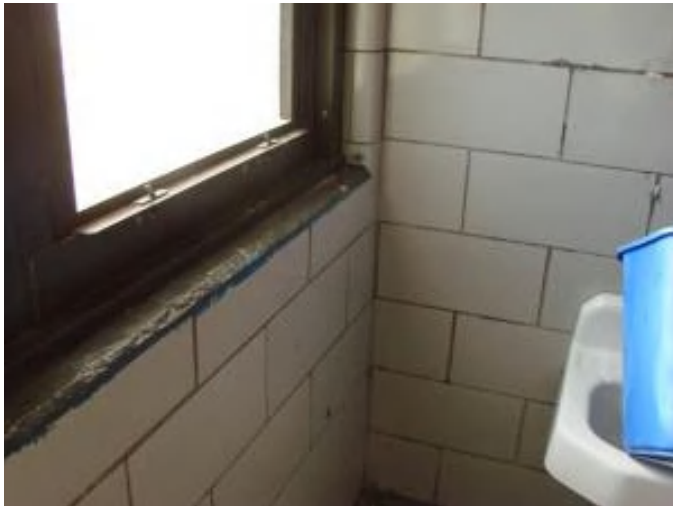
System: B2020 - Exterior Windows

The original building windows were replaced in 1990's with extruded aluminum double hung windows single, acrylic glazed. All windows are generally in poor condition with some of the windows inoperable; at the end of service life. First and second floor windows have security screens in fair condition. The leaks around the windows perimeters have not been reported.

Location: Exterior

Distress: Beyond Service Life

Notes: Replace all windows within next 4 to 5 years

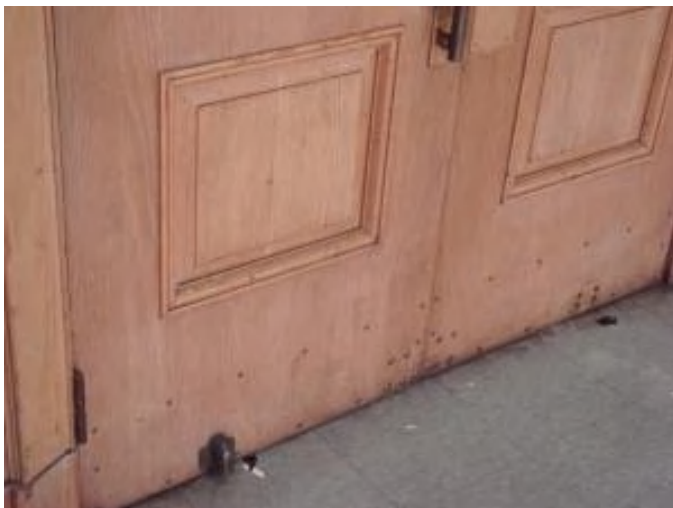
System: C1020 - Interior Doors

Location: Interior

Distress: Damaged

Notes: Refinish damaged doors

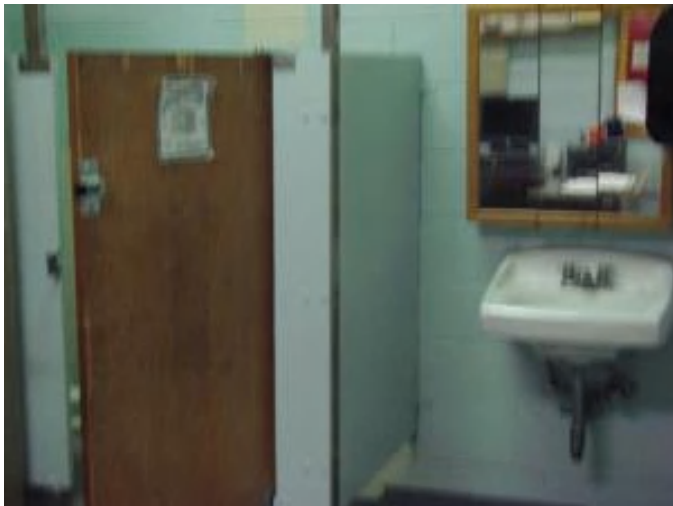
System: C1030 - Fittings

Fittings include toilet accessories and toilet partitions, generally in poor condition, some toilet accessories are missing, no accessible compartments; chalkboards in good condition. Handrails and ornamental metals are generally in good condition. Built-in cabinets are steel and wood in poor condition. Interior identifying signage is typically directly painted on wall or door surfaces generally in poor condition; some signage is missing.

Location: Interior

Distress: Damaged

Notes: Provide new toilet accessories including grab bars

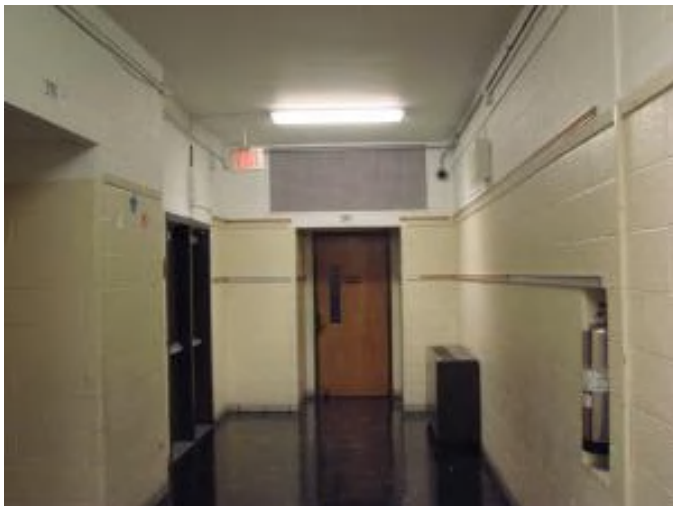
System: C1030 - Fittings

Location: Interior

Distress: Inadequate

Notes: Replace signage throughout the building

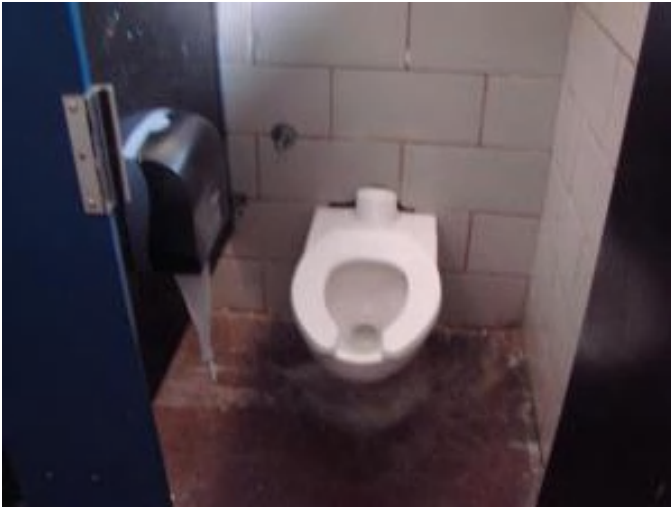
System: C3010232 - Wall Tile

The building partition wall types include painted CMU; Toilets have structural glazed facing tile (SGFT) wainscot. Partitions are generally in good condition; however, some grout is missing in SGFT in toilets.

Location: Interior/ toilets

Distress: Damaged

Notes: Re-grout wainscot in toilets

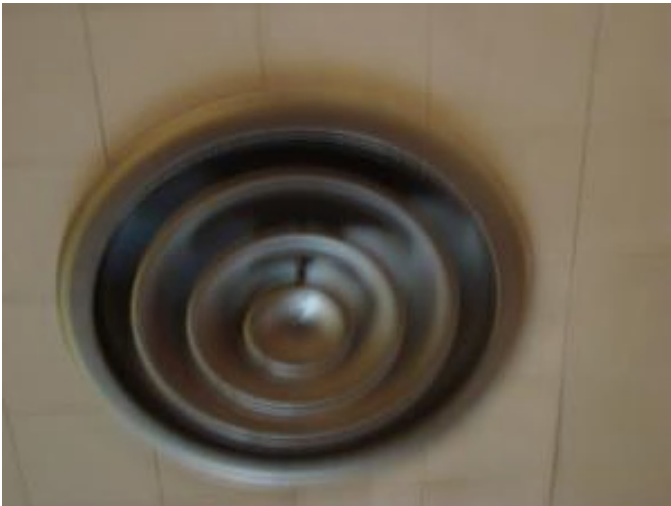
System: C3030 - Ceiling Finishes

Location: Interior

Distress: Beyond Service Life

Notes: Replace all suspended acoustical ceilings

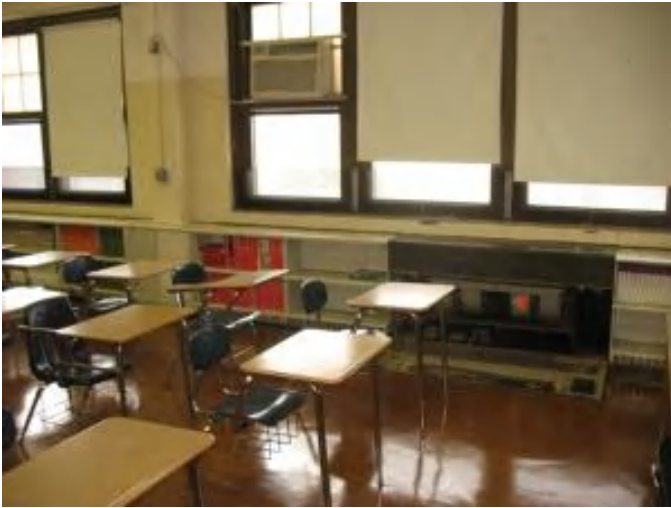
System: D3030 - Cooling Generating Systems

Terminal & Package Units - Several of the classrooms in the school building have window air conditioning units that have an anticipated service life of only 10 years. Installing a 125 ton air-cooled chiller with pumps located in a mechanical room and chilled water distribution piping would supply more reliable air conditioning for the building with a much longer service life.

Location: Throughout building

Distress: Inadequate

Notes: Remove the window air conditioning units and install a 125 ton air-cooled chiller with chilled water distribution piping and pumps located in a mechanical room to supply more reliable air conditioning for the building with a much longer service life.

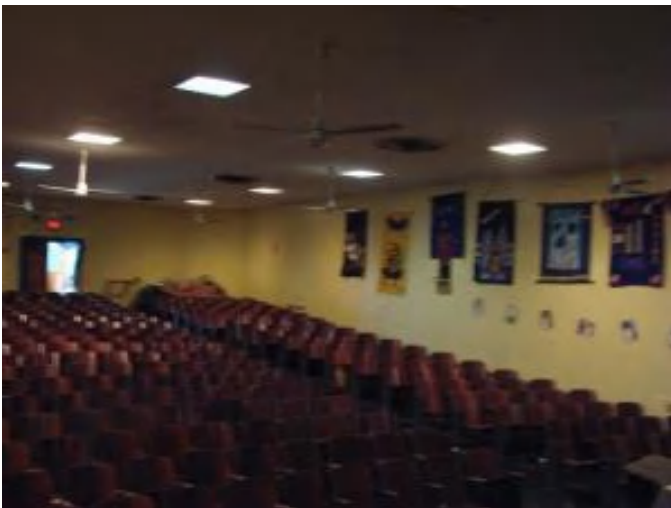
System: D3040 - Distribution Systems

Location: Auditorium

Distress: Building / MEP Codes

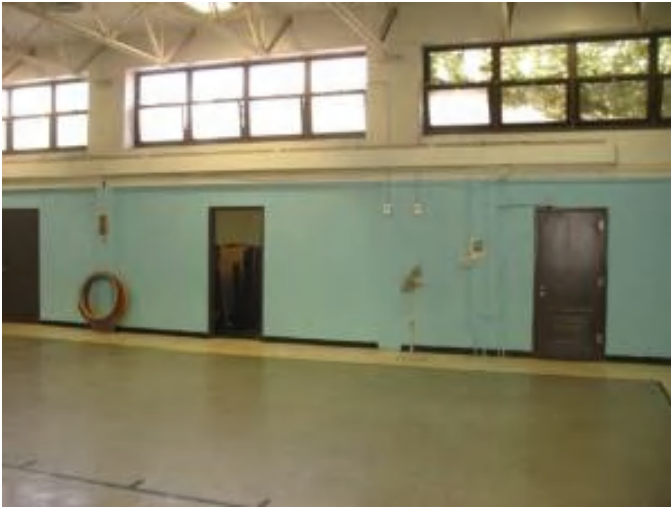
System: D3040 - Distribution Systems

Location: Gymnasium

Distress: Building / MEP Codes

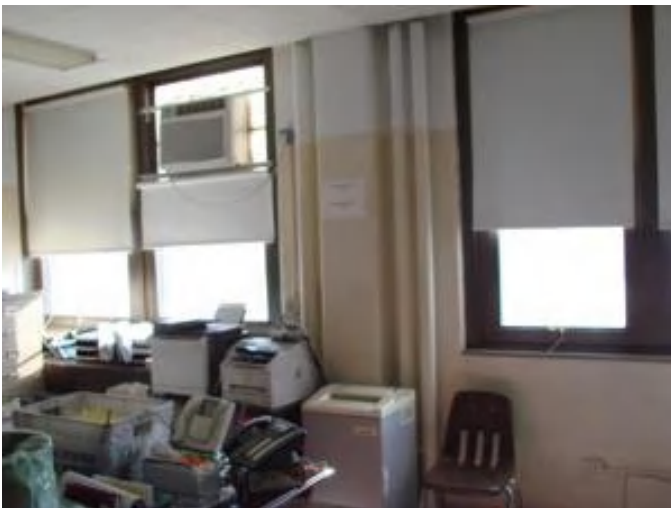
System: D3040 - Distribution Systems

Location: Administration

Distress: Building / MEP Codes

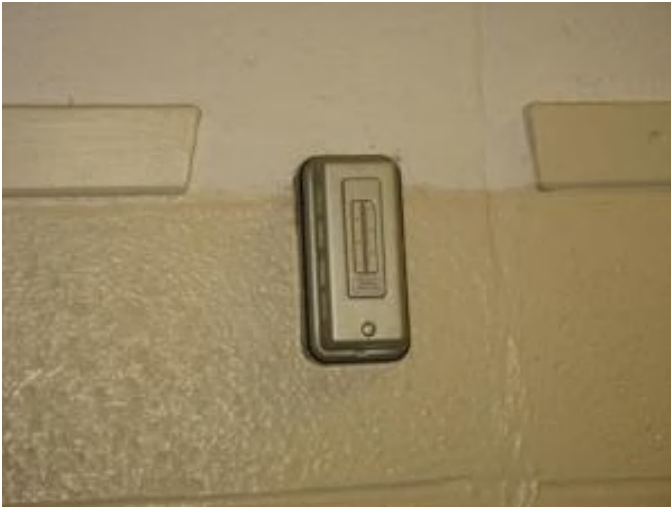
System: D3060 - Controls & Instrumentation

Controls & Instrumentation - The original pneumatic systems still provide basic control functions. Pneumatic room thermostats are intended to control the steam radiator control valves. In reality the radiator control valves are wide open and heating control is achieved via the boilers. Pneumatic control air is supplied from a Champion compressor and Hankison air dryer located in the boiler room. The maintenance staff reports no problems with oil, moisture, or dirt in the pneumatic copper tubing. The pneumatic systems are beyond their service life and require too much attention from the maintenance staff. The original control valves and pneumatic actuators are beyond their service life and should be rebuilt or replaced. These controls should be converted to DDC.

Location: Throughout building

Distress: Inadequate

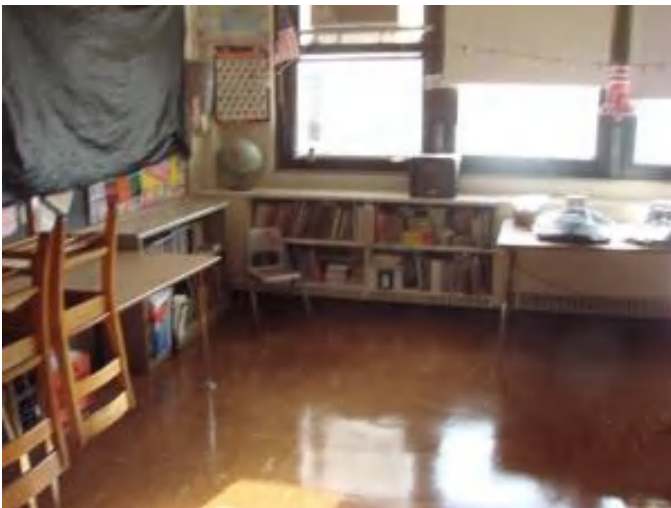
System: E2010 - Fixed Furnishings

Furnishings include fixed casework in classrooms, corridors and library, generally in poor condition; window shades/blinds, generally in good condition; fixed auditorium seating is original, generally in poor condition; some seats are damaged or missing.

Location: Interior

Distress: Beyond Service Life

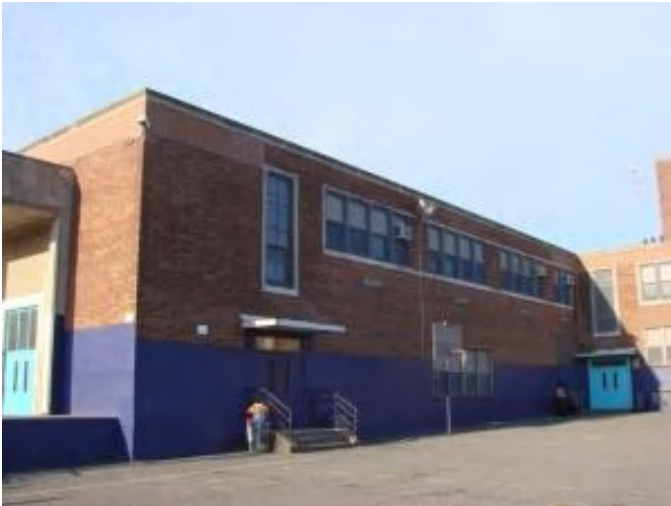
System: G4020 - Site Lighting

Location: Grounds

Distress: Beyond Service Life

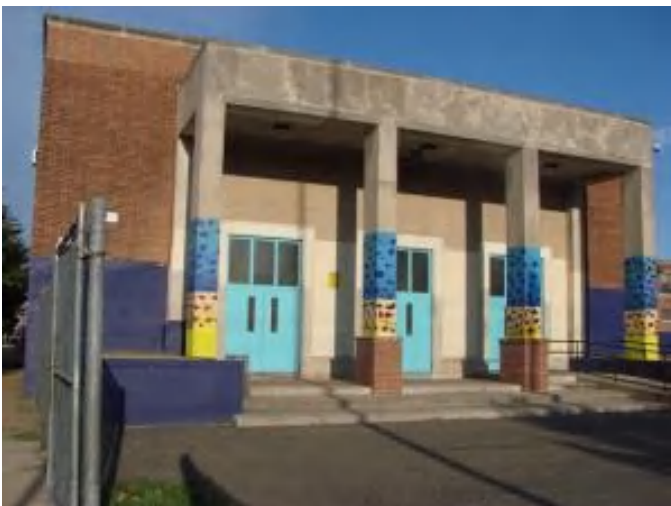
System: G4030 - Site Communications & Security

Location: Grounds

Distress: Security Issue

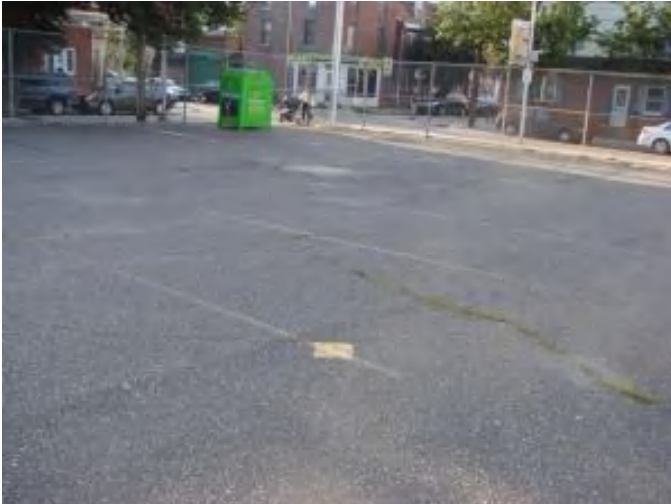
System: G2020 - Parking Lots

Location: Grounds/ site

Distress: Beyond Service Life

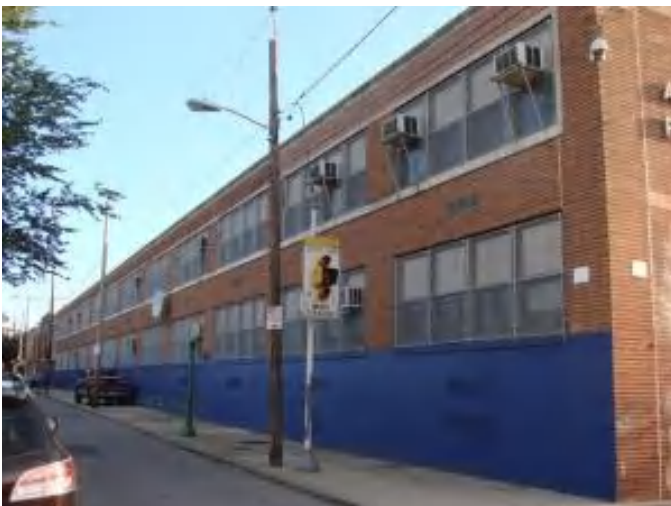
System: G4030 - Site Communications & Security

Location: Grounds

Distress: Security Issue
