## Facility Condition Assessment Summary Report

### Alcorn School

School District of Philadelphia  
**S220001;Alcorn**  
Final  
**Site Assessment Report**

February 1, 2017

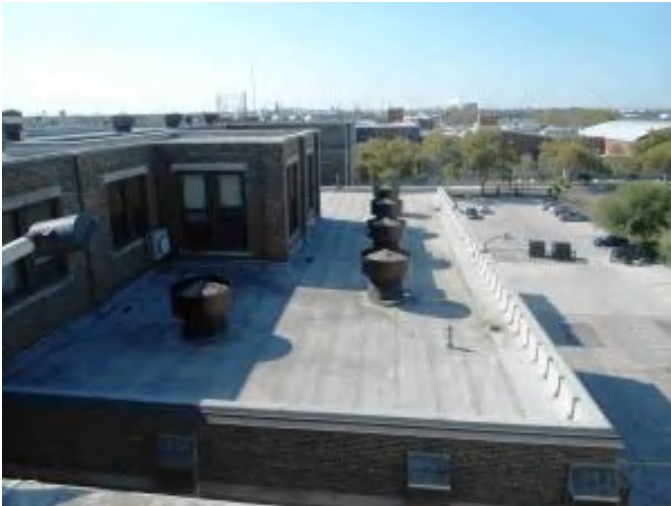
#### **System: B3010105 - Built-Up**

The built up roof was installed within the past ten years as reported by the school. The roof is in very good condition with few exceptions. Currently there is an active leak over the western most roof section that if not repaired soon will start to deteriorate the insulation and the integrity of the classroom finishes. This deficiency provides a budgetary consideration for built up roof repair for this section.

**Location:** Roof

**Distress:** Damaged

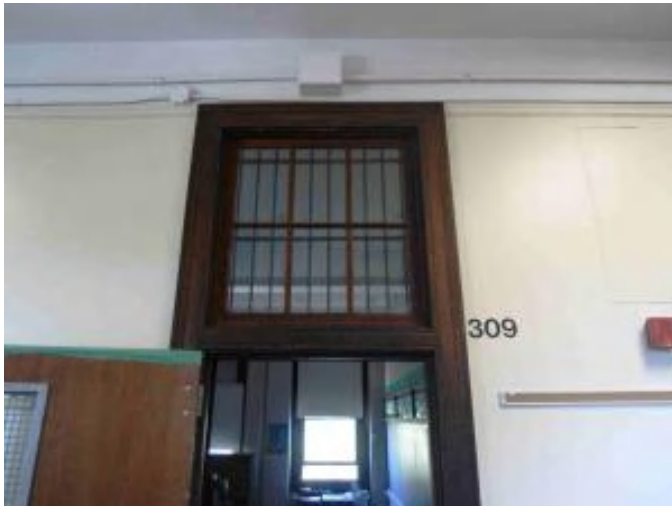
**System: C1010 - Partitions**

**Location:** Building Wide

**Distress:** Life Safety / NFPA / PFD

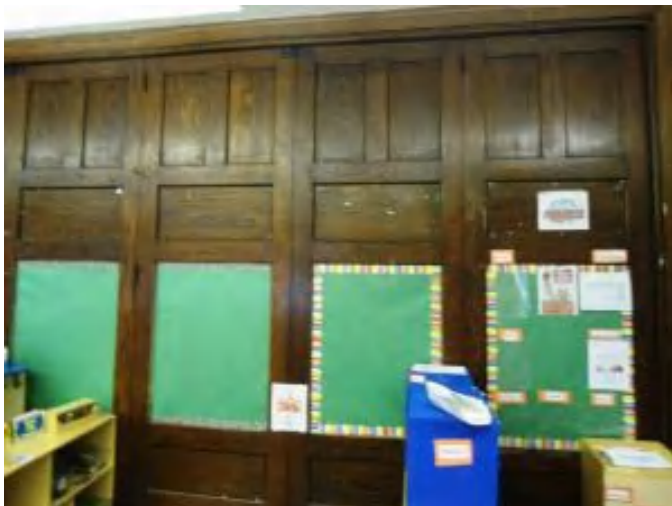
**System: C1010 - Partitions**

**Location:** Classrooms

**Distress:** Life Safety / NFPA / PFD

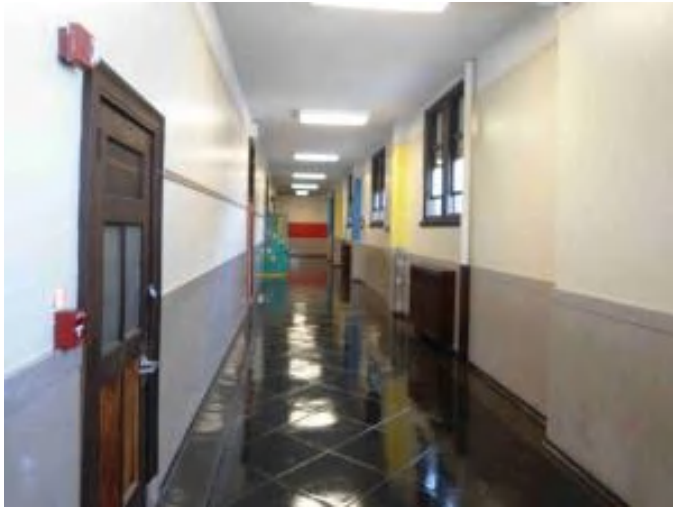
**System: D1010 - Elevators and Lifts**

**Location:** Building Wide

**Distress:** Inadequate

available to all persons. To assist those that may be physically challenged and to meet current accessibility legislation to provide wheelchair access to the upper floors of this facility, the installation of a new hydraulic elevator has been recommended on the exterior elevation of the building or at another suitable location. The new installation should blend as much as possible with the overall appearance of this historic structure and include all required ADA features, such as audible jewels and gongs, an accessible control panel, etc.

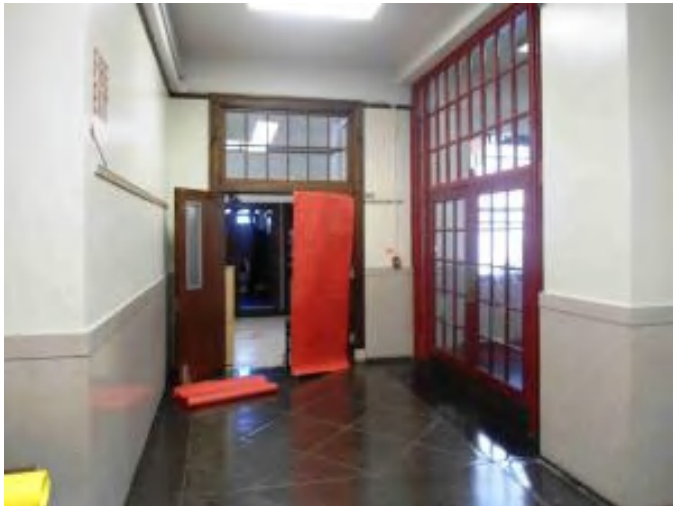
**System: C1010 - Partitions**

**Location:** Stairs

**Distress:** Life Safety / NFPA / PFD

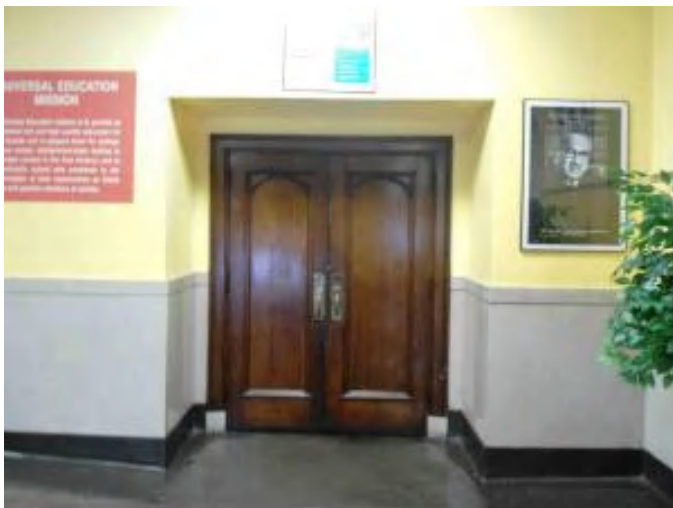
**System: C1020 - Interior Doors**

**Location:** Classrooms

**Distress:** Damaged

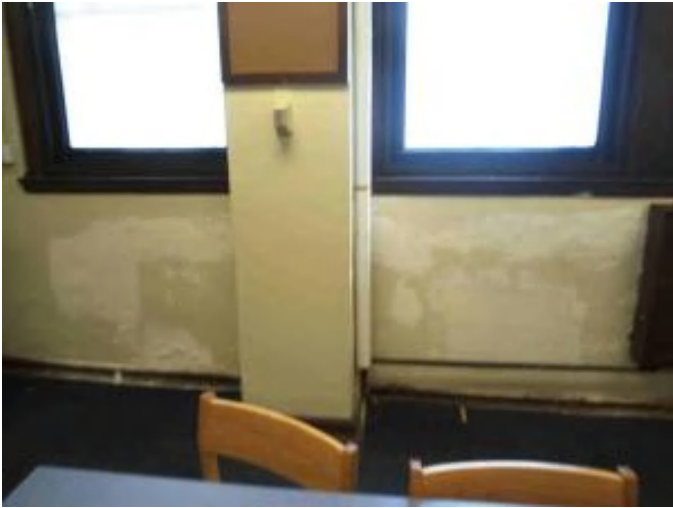
**System: C3010230 - Paint & Covering**

**Location:** Building Wide  
**Distress:** Damaged  
**Category:** 3 - Operations / Maint.  
**Priority:** 3 - Response Time (3-4 yrs)  
**Correction:** Repair and repaint all interior walls - SF of wall surface  
**Qty:** 3,000.00  
**Unit of Measure:** S.F.  
**Estimate:** \$20,321.63  
**Assessor Name:** System  
**Date Created:** 11/19/2015

**Notes:** There are several minor areas of wall damage that ranges from serious to minor. Although the school is on a cyclical program of renewal and each painted surface is renewed at years end this system is at the point in which repairs are necessary. Remove damaged wall finishes and repair areas then apply primer and paint finish.

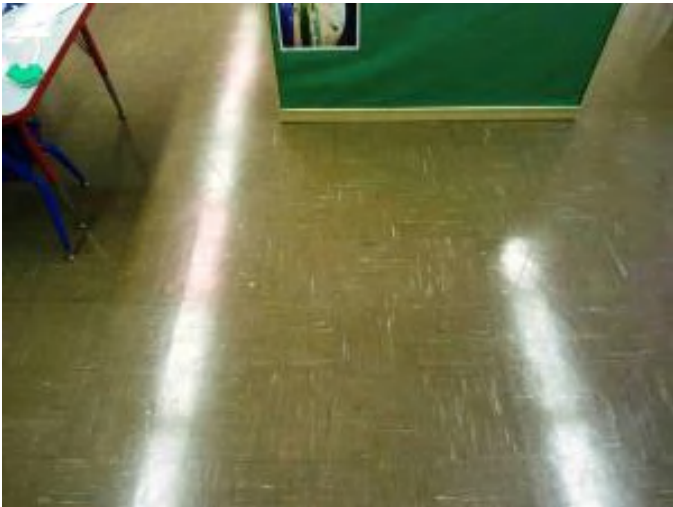
**System: C3020413 - Vinyl Flooring**

**Location:** Classrooms  
**Distress:** Health Hazard / Risk  
**Category:** 1 - Health & Safety  
**Priority:** 3 - Response Time (3-4 yrs)  
**Correction:** Remove VAT and replace with VCT - SF of area  
**Qty:** 5,000.00  
**Unit of Measure:** S.F.  
**Estimate:** \$75,833.34  
**Assessor Name:** System  
**Date Created:** 11/19/2015

**Notes:** The floor finish for this school is a combination of carpet in the library area, tile in the kitchen and service line areas, wooden classrooms with concrete hallways and stairs finishes and a vinyl tile finish. The vinyl tile finish is a 9 x 9 application and is suspect to contain asbestos. Suspected asbestos containing materials (ACM) are believed to be limited to the original vinyl floor tile and mastic. While currently sound and manageable in place, future renovation efforts should include provision to test and abate any and all ACM.

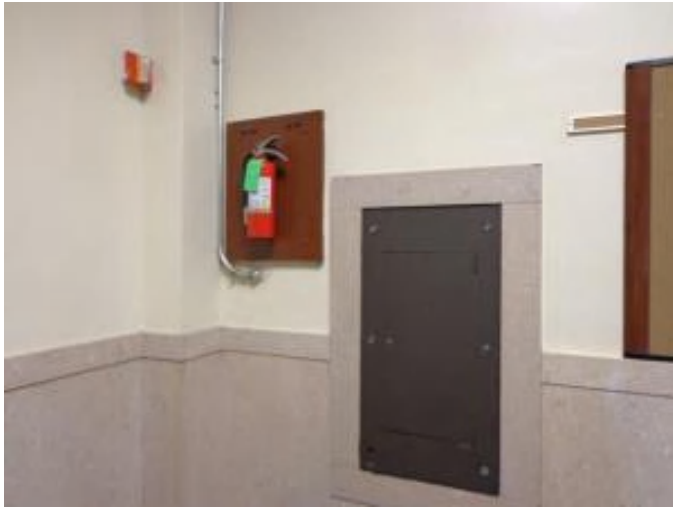
**System: D5010 - Electrical Service/Distribution**

**Location:** Boiler Room and Corridors on all floors

**Distress:** Beyond Service Life

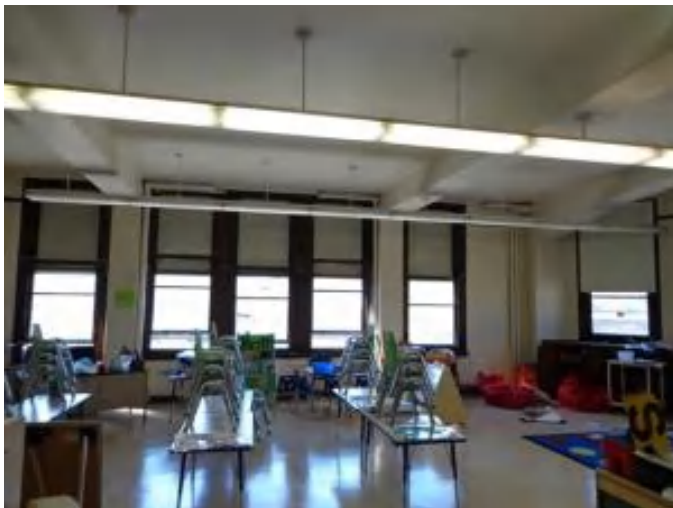
**System: D5020 - Lighting and Branch Wiring**

**Location:** Classrooms

**Distress:** Beyond Service Life

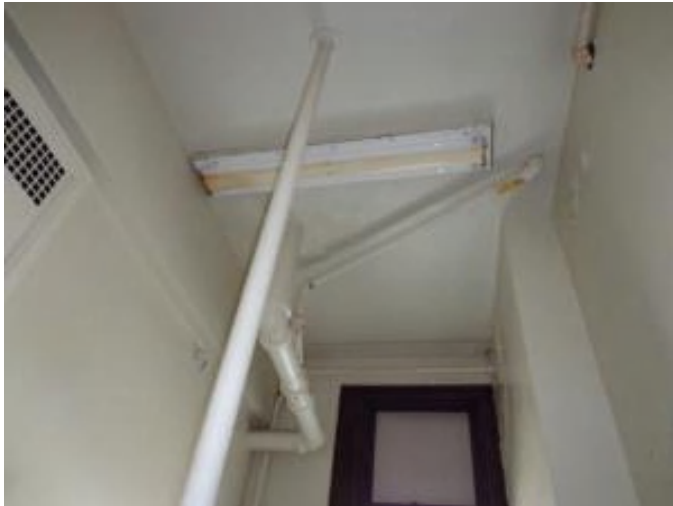
**System: D5020 - Lighting and Branch Wiring**

**Location:** Various rooms

**Distress:** Beyond Service Life

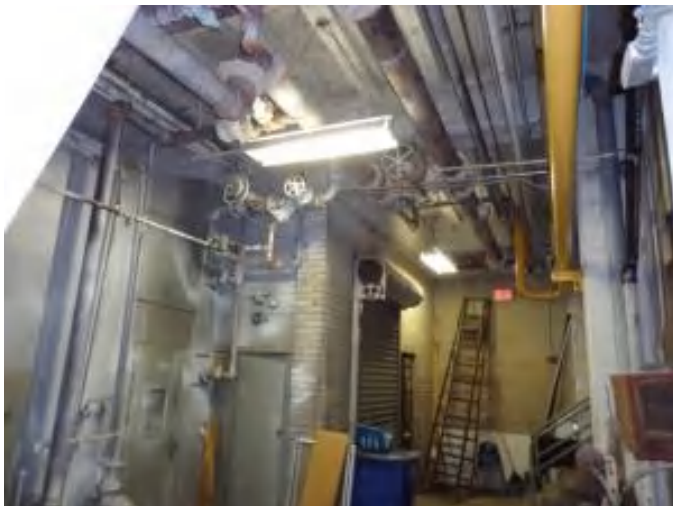
**System: D5020 - Lighting and Branch Wiring**

**Location:** Boiler Room

**Distress:** Beyond Service Life

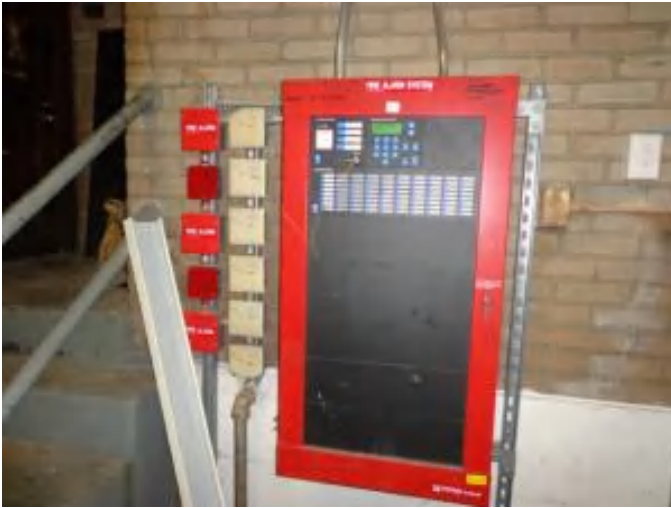
**System: D5030 - Communications and Security**

**Location:** Building wide  
**Distress:** Beyond Service Life  
**Category:** 3 - Operations / Maint.  
**Priority:** 3 - Response Time (3-4 yrs)  
**Correction:** Replace fire alarm system  
**Qty:** 1.00  
**Unit of Measure:** S.F.  
**Estimate:** \$267,822.81  
**Assessor Name:** System  
**Date Created:** 10/23/2015

**Notes:** Replace fire alarm system with an addressable type system, including pull stations, smoke and heat detectors, and audible and visual notification appliances.

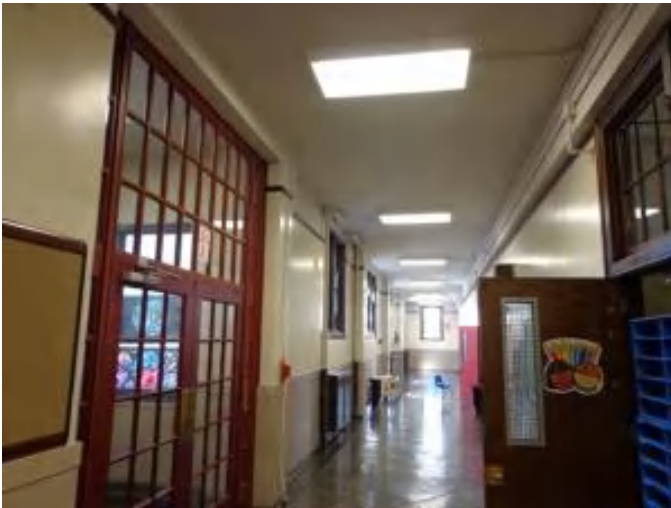
**System: D5030 - Communications and Security**

**Location:** Building interior  
**Distress:** Inadequate  
**Category:** 4 - Capital Improvement  
**Priority:** 3 - Response Time (3-4 yrs)  
**Correction:** Add/Replace Video Surveillance System  
**Qty:** 17.00  
**Unit of Measure:** Ea.  
**Estimate:** \$115,522.80  
**Assessor Name:** System  
**Date Created:** 10/23/2015

**Notes:** Add (17) interior video surveillance cameras, equipment rack, DVR's, monitors and associated equipment.

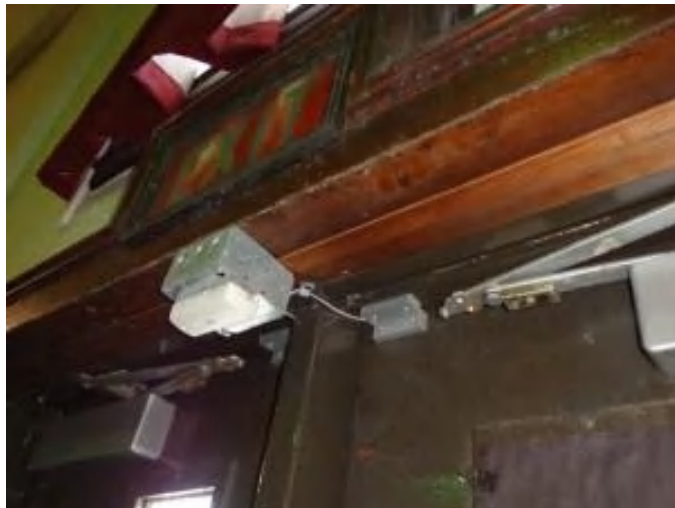
**System: D5090 - Other Electrical Systems**

**Location:** Auditorium and gymnasium

**Distress:** Failing

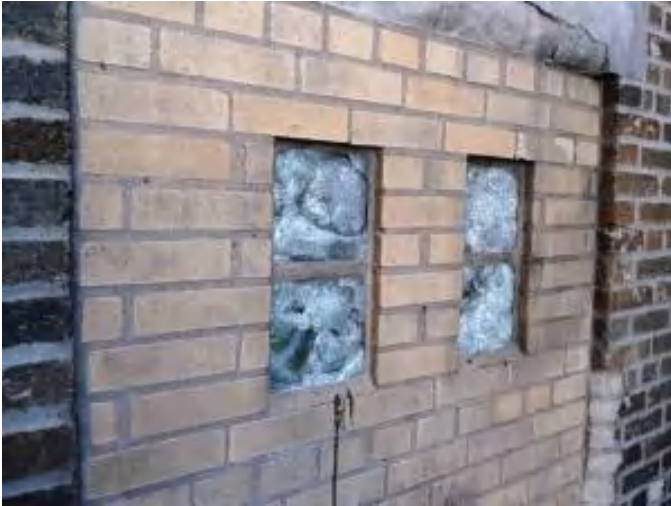
**System: B2010 - Exterior Walls**

The exterior brick and stone surfaces are generally in fair to good condition for their age. In some locations, bricks have cracked or spalled and should be replaced. The repointing of deteriorated mortar joints is also recommended, using mortar of a similar color and consistency as the original. Following the detailed examination of the brick and repair of mortar construction joints, the entire building should be pressure washed to remove stains and embedded pollutants. If moisture is found to be penetrating the masonry facade, the application of a spray sealant to the suspected exterior masonry surface is recommended.

**Location:** Exterior Elevation

**Distress:** Damaged

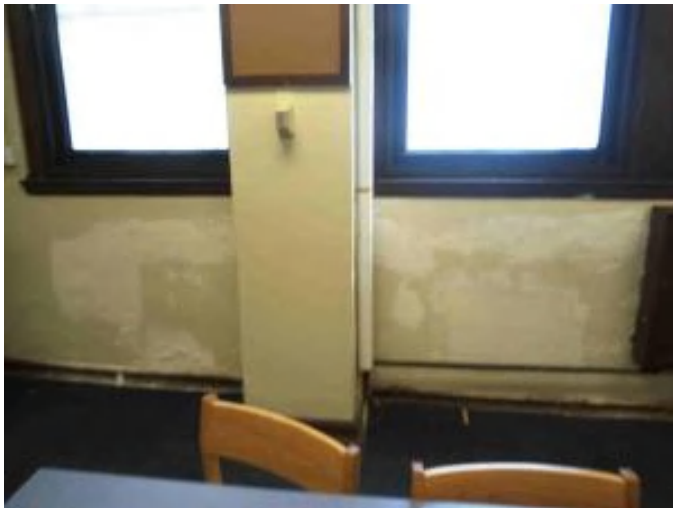
**System: B2020 - Exterior Windows**

The wood and metal-framed, double hung windows with standard single pane glass have been replaced in the last twenty years. Several of the windows are leaking into the interior finishes as indicated in the photos and others do not operate correctly. It is recommended that the exterior window systems be replaced with units that retain their dimensions and profiles, but that incorporate updated energy-efficient features.

**Location:** Exterior Elevation

**Distress:** Damaged

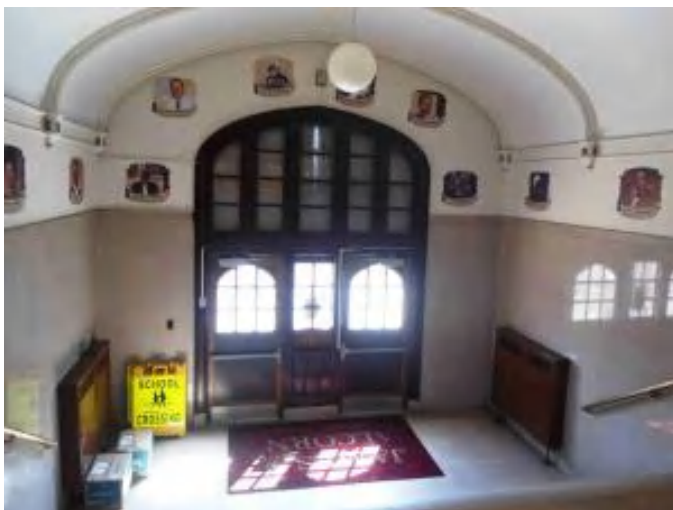
**System: B2030 - Exterior Doors**

The exterior doors are metal applications with metal frames. The exterior door system for this school is a very high traffic system. The doors are in fair condition but are aging at a faster rate than expected based on traffic and condition. The exterior door system, store front and service doors are recommended for upgrade.

**Location:** Exterior Elevation

**Distress:** Damaged

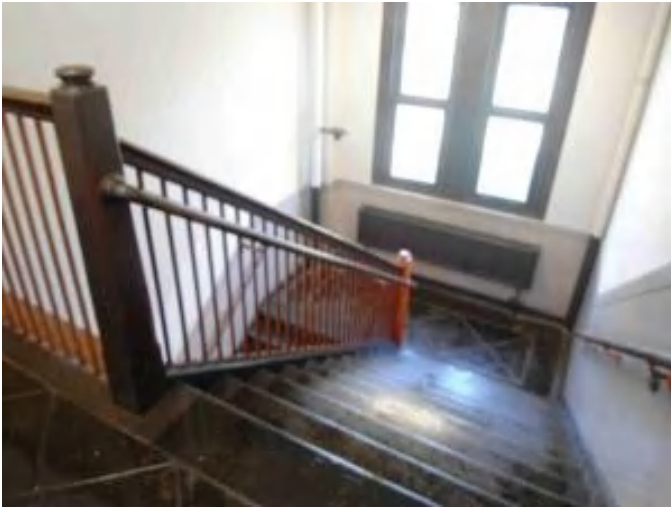
**System: C2010 - Stair Construction**

**Location:** Stairs

**Distress:** Life Safety / NFPA / PFD

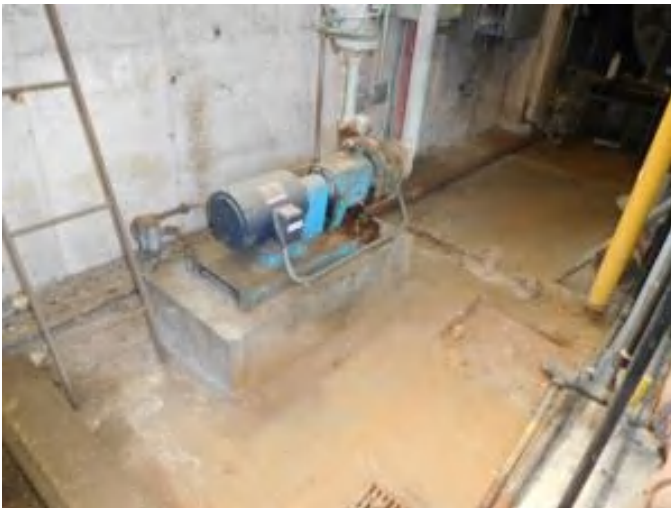
**System: D2020 - Domestic Water Distribution**

**Location:** mechanical room

**Distress:** Inadequate

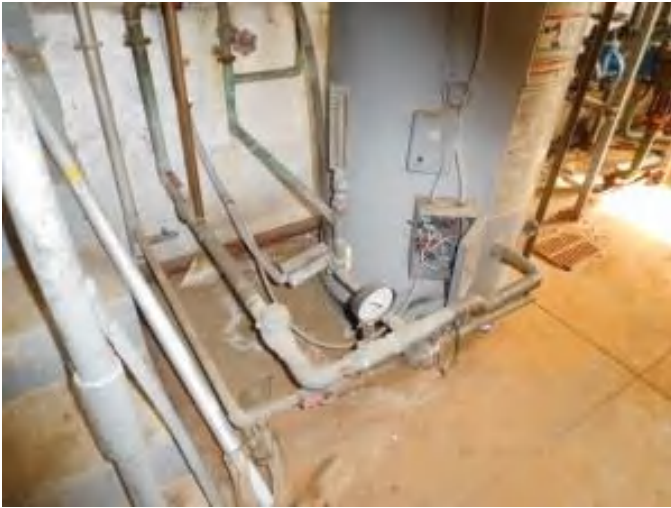
**System: D2020 - Domestic Water Distribution**

**Location:** entire building

**Distress:** Beyond Service Life

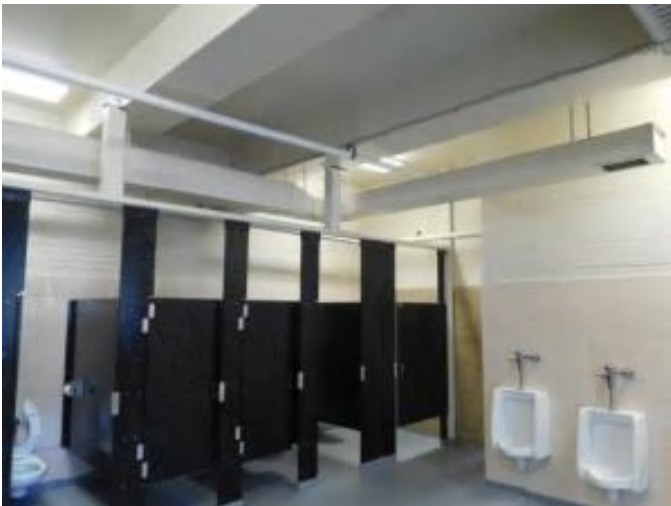
**System: D2030 - Sanitary Waste**

**Location:** entire building

**Distress:** Beyond Service Life

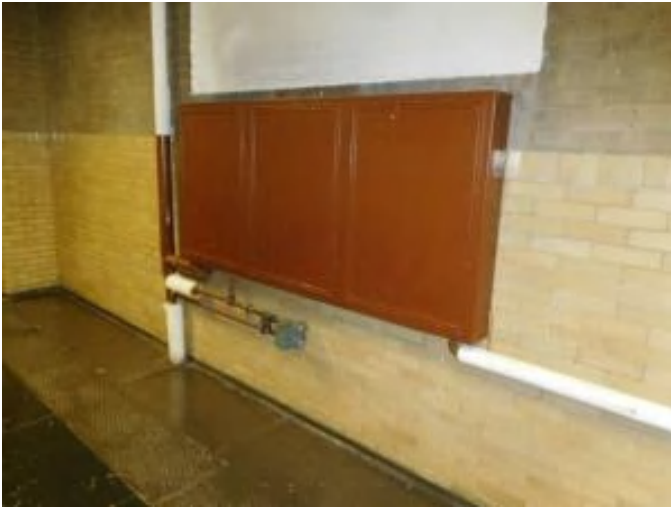
**System: D3040 - Distribution Systems**

**Location:** entire building

**Distress:** Building / MEP Codes

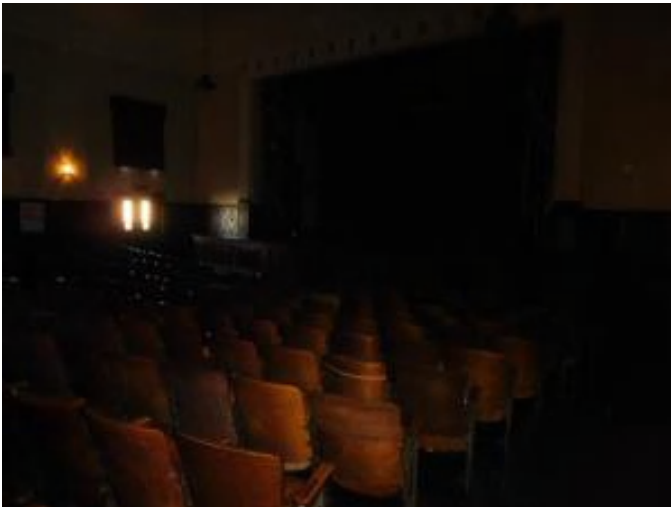
**System: D3040 - Distribution Systems**

**Location:** auditorium

**Distress:** Building / MEP Codes

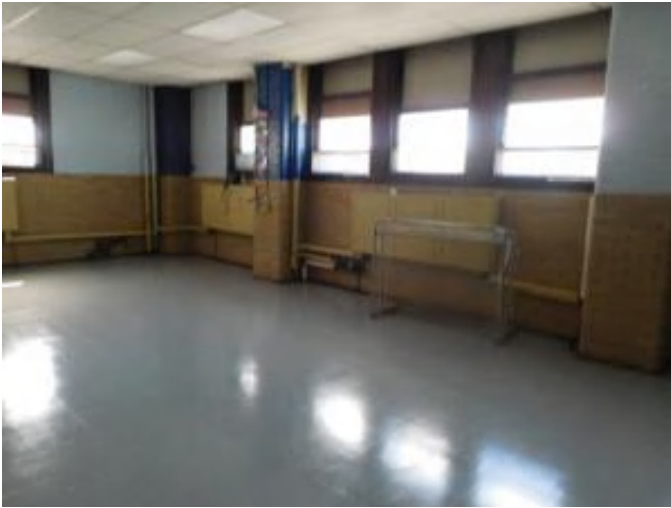
**System: D3040 - Distribution Systems**

**Location:** cafeteria/gymnasium  
**Distress:** Building / MEP Codes  
**Category:** 2 - Code Compliance  
**Priority:** 4 - Response Time (4-5 yrs)  
**Correction:** Install HVAC unit for Cafeteria (850 students).  
**Qty:** 775.00  
**Unit of Measure:** Pr.  
**Estimate:** \$362,347.66  
**Assessor Name:** System  
**Date Created:** 10/24/2015

**Notes:** Provide a new central station air handling unit for the cafeteria/gymnasium with hot and chilled water coils, filters, outside and return air dampers, hydronic valves and controls, blower and motor. Connect to hot and chilled water systems.

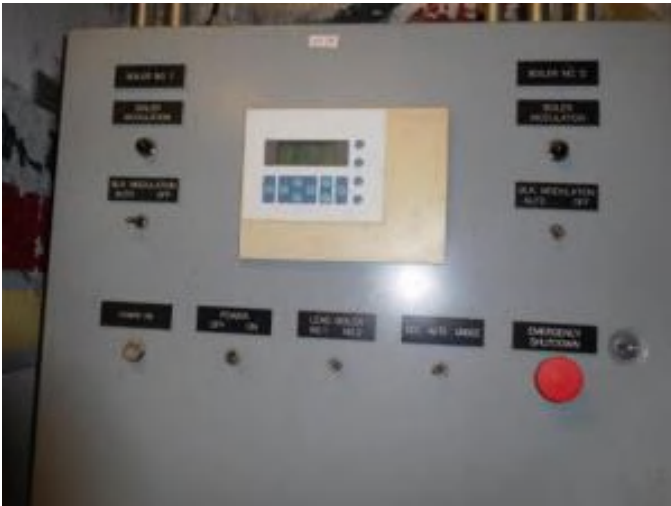
**System: D3060 - Controls & Instrumentation**

**Location:** entire building  
**Distress:** Inadequate  
**Category:** 4 - Capital Improvement  
**Priority:** 4 - Response Time (4-5 yrs)  
**Correction:** Replace pneumatic controls with DDC (75KSF)  
**Qty:** 63,000.00  
**Unit of Measure:** S.F.  
**Estimate:** \$1,351,481.76  
**Assessor Name:** System  
**Date Created:** 10/24/2015

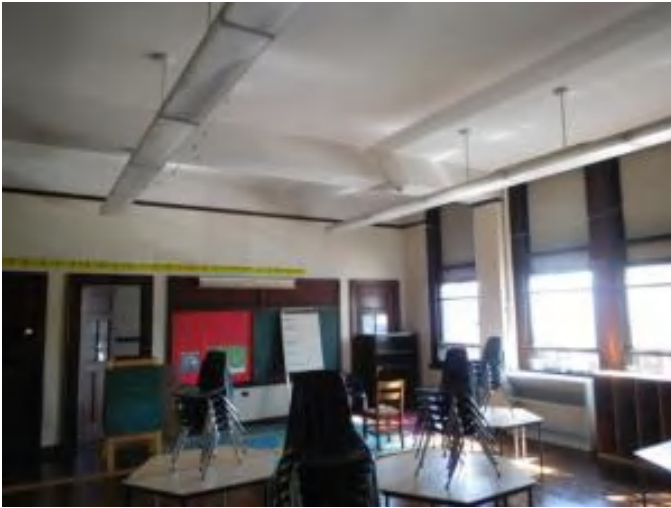
**System: D4010 - Sprinklers**

**Location:** entire building

**Distress:** Life Safety / NFPA / PFD

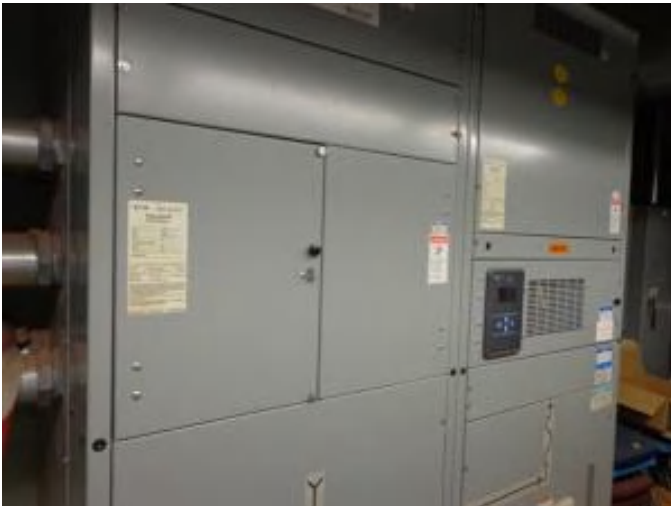
**System: D5010 - Electrical Service/Distribution**

**Location:** Main Electrical Room

**Distress:** Inadequate

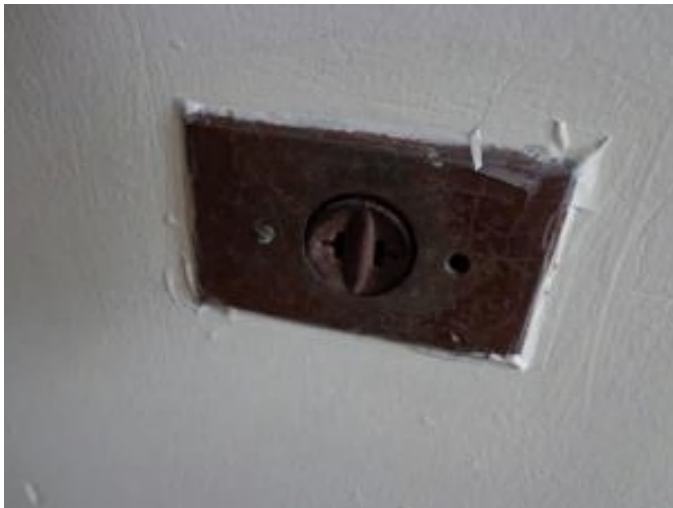
**System: D5020 - Lighting and Branch Wiring**

**Location:** Classrooms  
**Distress:** Inadequate  
**Category:** 4 - Capital Improvement  
**Priority:** 4 - Response Time (4-5 yrs)  
**Correction:** Provide surface raceway system and wiring devices  
**Qty:** 720.00  
**Unit of Measure:** L.F.  
**Estimate:** \$100,563.74  
**Assessor Name:** System  
**Date Created:** 10/23/2015

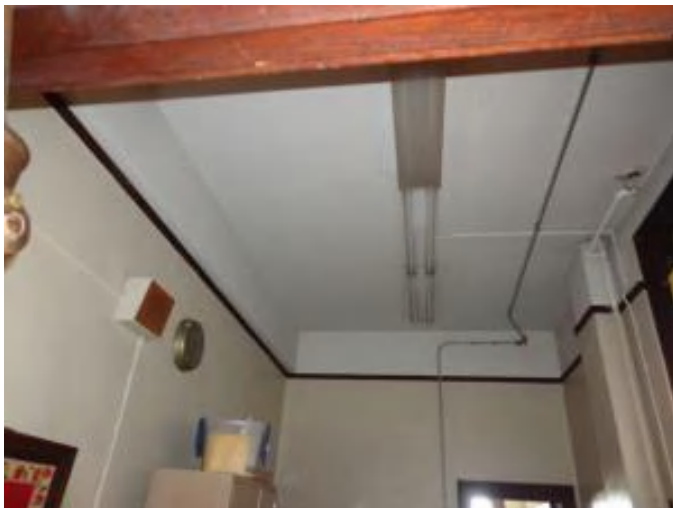
**System: D5030 - Communications and Security**

**Location:** Building wide  
**Distress:** Damaged  
**Category:** 3 - Operations / Maint.  
**Priority:** 4 - Response Time (4-5 yrs)  
**Correction:** Add/Replace Clock System or Components  
**Qty:** 48.00  
**Unit of Measure:** Ea.  
**Estimate:** \$30,539.22  
**Assessor Name:** System  
**Date Created:** 10/23/2015

**Notes:** Replace clock system with a wireless GPS system.

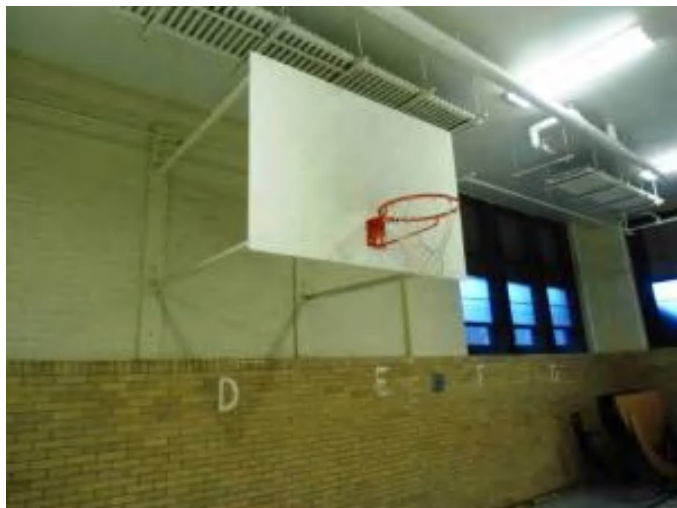
**System: E1020 - Institutional Equipment**

**Location:** Gym

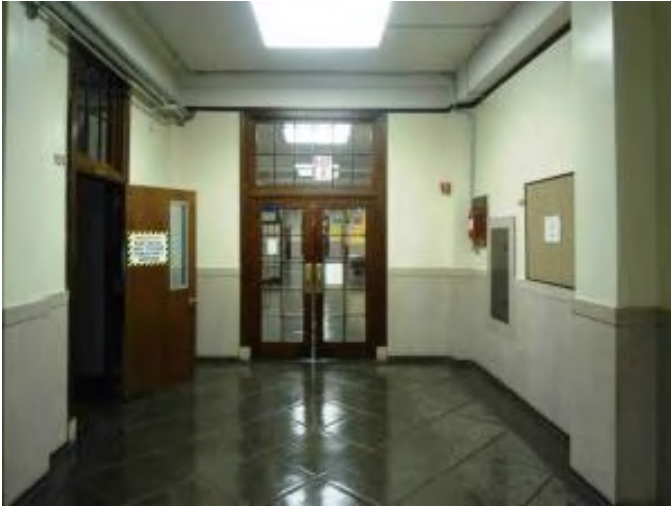
**System: C1030 - Fittings**

**Location:** Building Wide

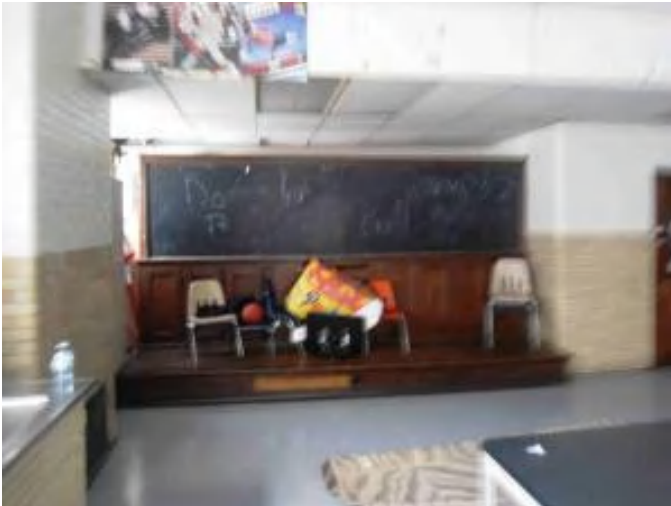
**System: C1030 - Fittings**

The classroom chalk boards are original to the buildings construction. This system is damaged and beyond its expected life, universal upgrades are warranted. Remove and upgrade chalk boards to new marker board systems.

**Location:** Classrooms

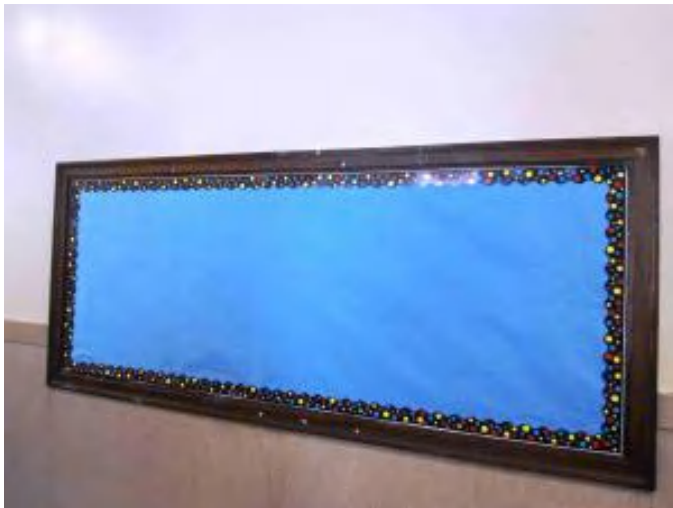
**System: C1030 - Fittings**

**Location:** Building Wide

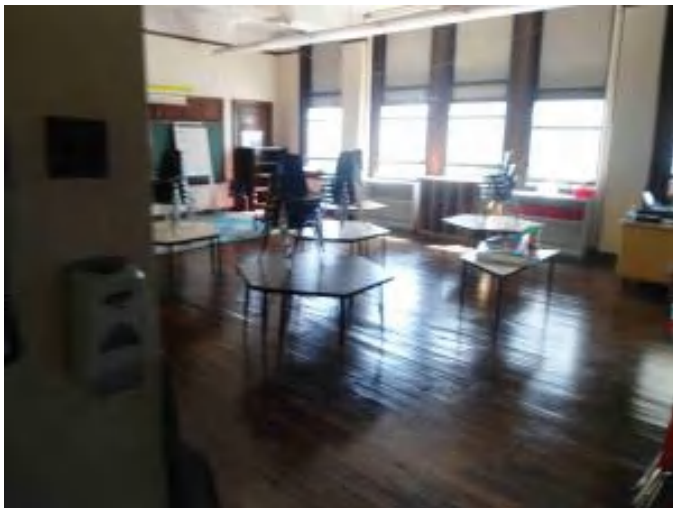
**System: C3020414 - Wood Flooring**

The classrooms and auditorium in this school have a wooden floor finish that appears to be from original construction. The system is showing signs of age such as the effects of sanding and refinishing with yearly cleaning and waxing with some repairs. The floor finish is in fair condition however, the finish is beyond its expected life cycle. It is recommended that the wooden floor finish be removed and replaced with an in kind finish.

**Location:** Building Wide

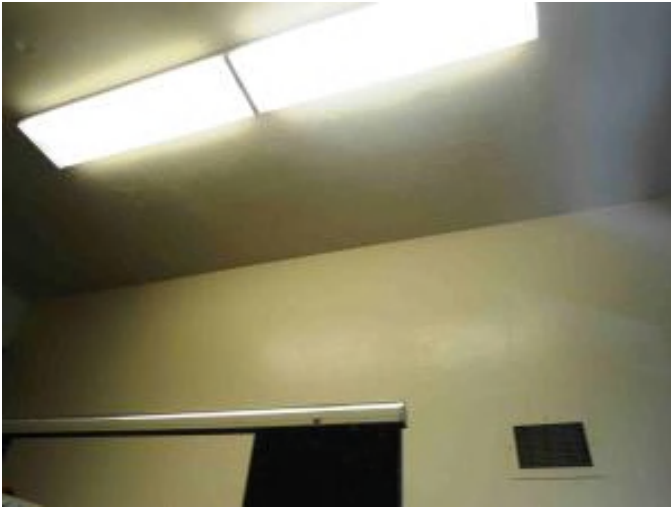
**System: C3030 - Ceiling Finishes**

The ceiling finish is a mix of painted and 2 x 4 acoustical tile finish. Ceilings have been repaired in several areas and is in good condition considering the age of the application and the current condition of the school. The ceiling finish is expected to require upgrades to support the recommended efforts in this report prior to re-opening. This deficiency provides a budgetary consideration for removal and replacement of the current ceiling finish to a new acoustical tile finish. Considering the recommended mechanical and electrical upgrades this effort should be completed as part of an overall renewal program for the school. No work should be considered until after the recommended exterior efforts are complete.

**Location:** Building Wide

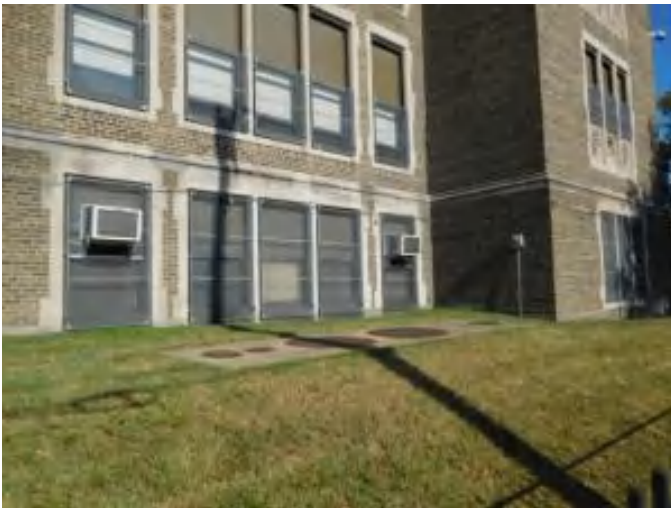
**System: D3030 - Cooling Generating Systems**

**Location:** roof, mechanical room

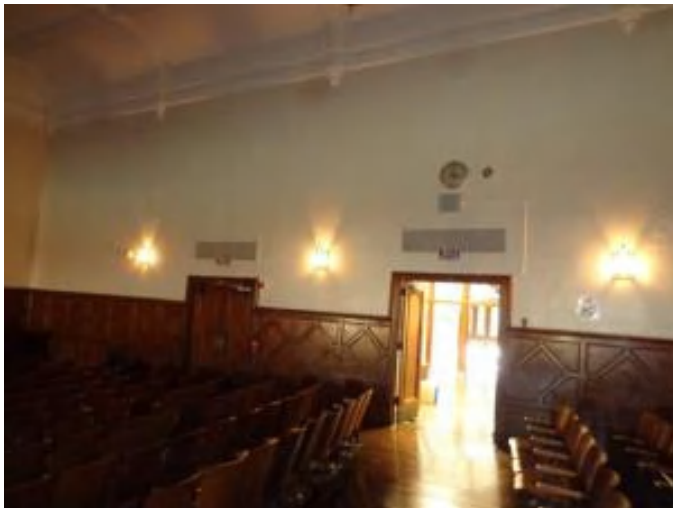
**System: D5020 - Lighting and Branch Wiring**

**Location:** Auditorium  
**Distress:** Energy Efficiency  
**Category:** 4 - Capital Improvement  
**Priority:** 5 - Response Time (> 5 yrs)  
**Correction:** Maintain Lighting Fixtures  
**Qty:** 20.00  
**Unit of Measure:** Ea.  
**Estimate:** \$15,425.13  
**Assessor Name:** System  
**Date Created:** 10/23/2015

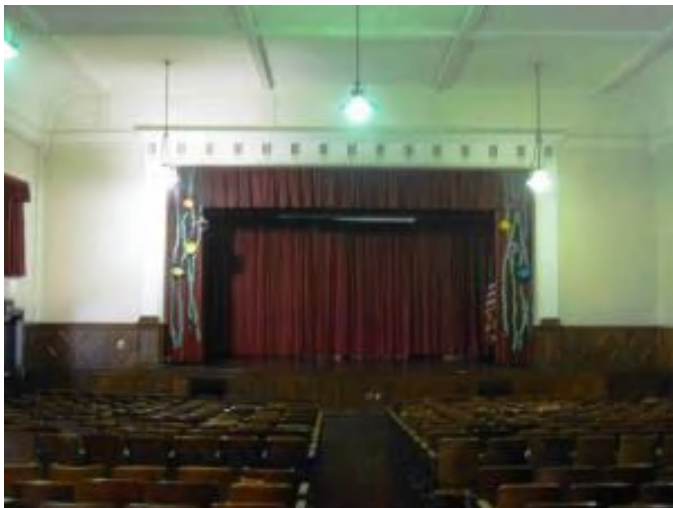
**System: E2010 - Fixed Furnishings**

The fixed seating for this school is from the original construction. The systems are in fair condition considering the age and usage. This project provides a budgetary consideration for universal upgrades for the fixed seating and furnishing of this school. Ensure that ADA requirements are followed with the new seating layout.

**Location:** Auditorium  
**Distress:** Damaged  
**Category:** 3 - Operations / Maint.  
**Priority:** 5 - Response Time (> 5 yrs)  
**Correction:** Replace auditorium seating - add tablet arms if required. Veneer seating is an option.  
**Qty:** 300.00  
**Unit of Measure:** Ea.  
**Estimate:** \$270,571.65  
**Assessor Name:** System  
**Date Created:** 11/19/2015

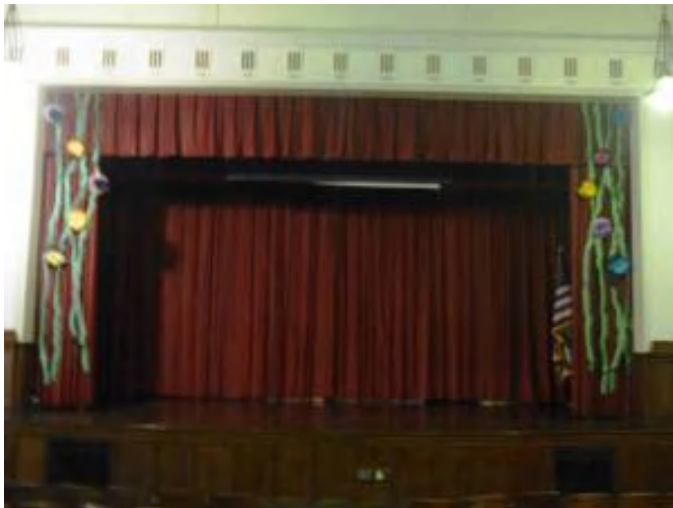
**System: E2010 - Fixed Furnishings**

The school stage has a stage curtain assembly that appears to be from the original construction. Modern applications are typically fire-proof applications with adjustable tracks and electric support for operation. The curtains are torn in a few section and the track is not functioning properly, overall the system is in poor condition. It is recommended that the curtain and track system be upgraded to a new system. Special care should be considered in regards to modern fire proofing for the new installation.

**Location:** Stage

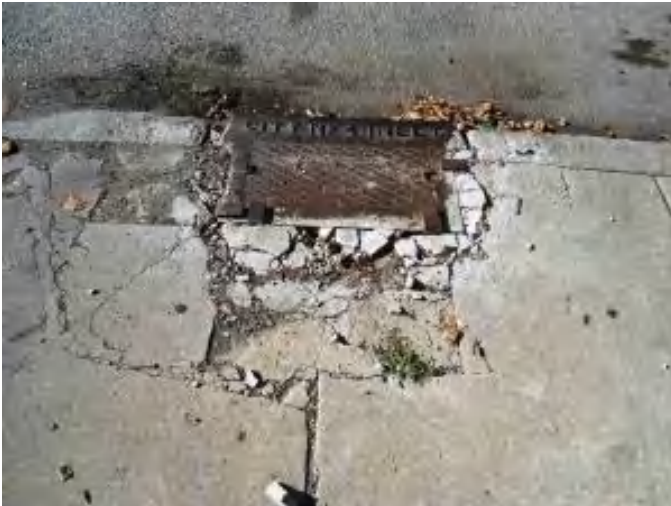
#### System: G2030 - Pedestrian Paving

**Location:** Site

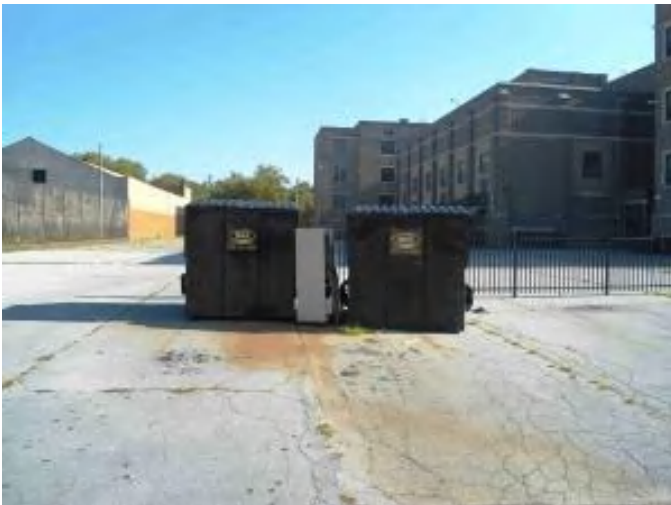
#### System: G2040 - Site Development

**Location:** Site

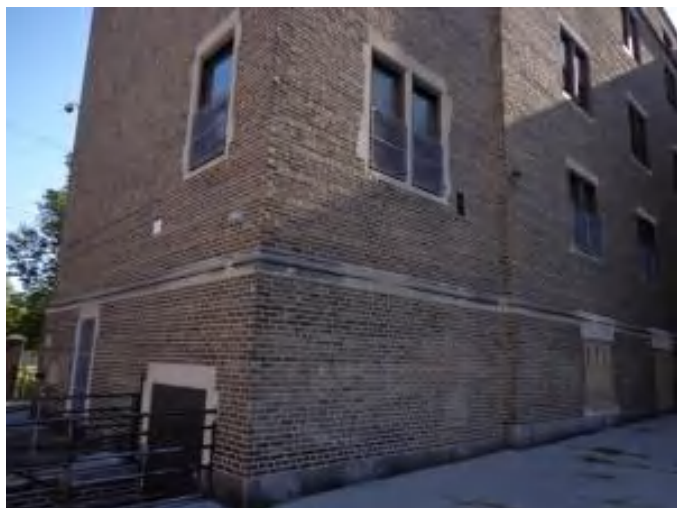
**System: G4030 - Site Communications & Security**

**Location:** Building exterior

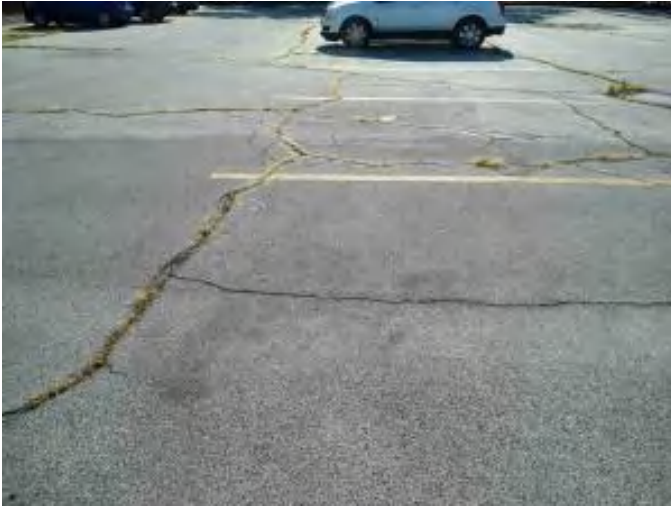
**System: G2020 - Parking Lots**

**Location:** Site

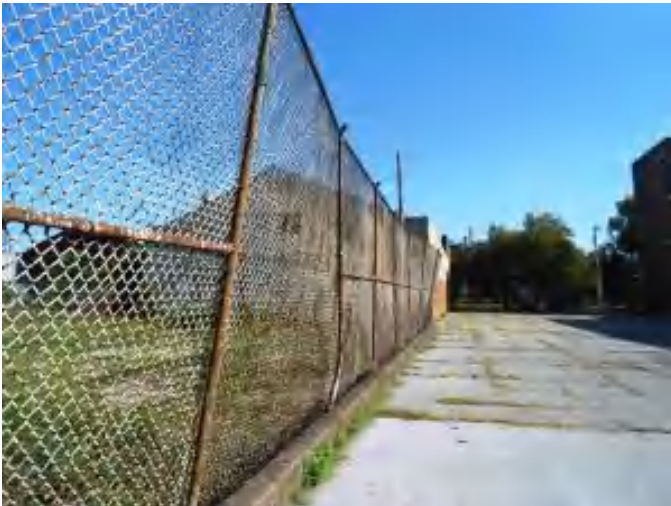
**System: G2040 - Site Development**

**Location:** Site
