Facility Condition Assessment Summary Report

Allen, Ethan School

S820001;Allen, Ethan

Site Assessment Report

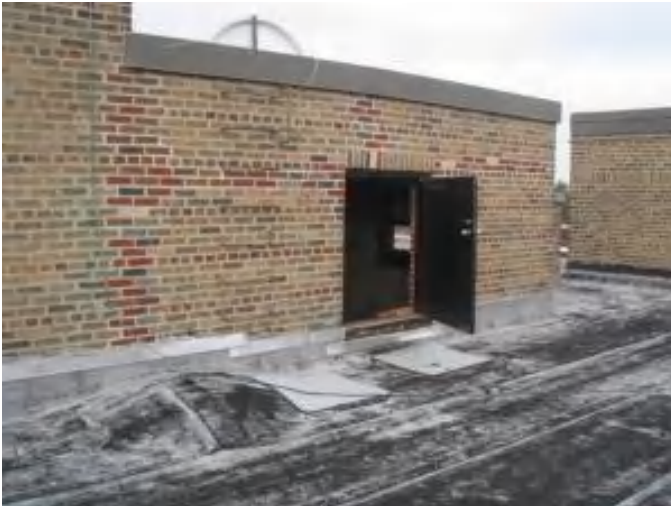
System: B3010105 - Built-Up

Location: roof covering

Distress: Beyond Service Life

Notes: Remove and replace existing flat roof and insulation; 7 levels (14,100sf)

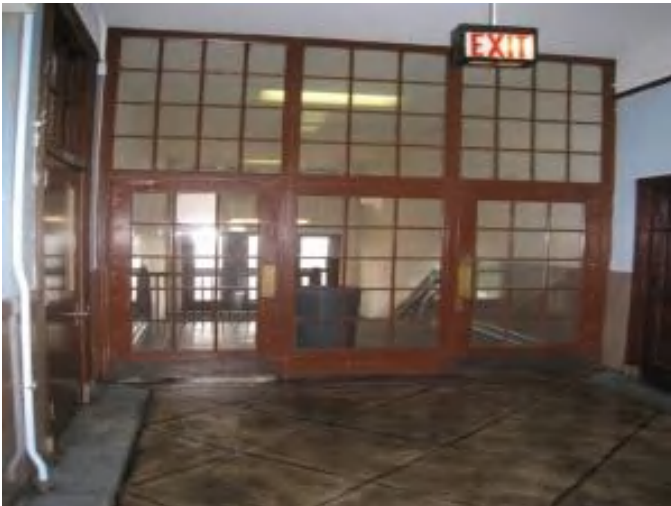
System: C1010 - Partitions

Location: stairways

Distress: Life Safety / NFPA / PFD

Notes: Remove and replace stairway enclosure corridor walls, including (20)3x7 doors

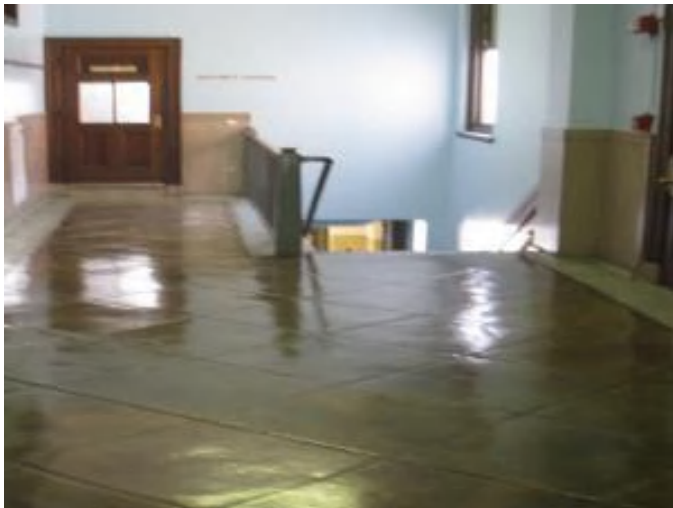
System: C1010 - Partitions

Location: stair enclosure at 1st floor

Distress: Life Safety / NFPA / PFD

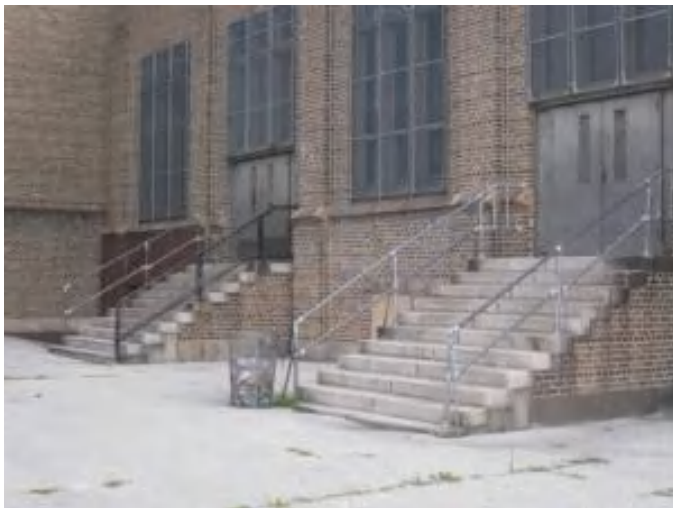
System: C2010 - Stair Construction

Location: exterior stairs

Distress: Failing

Notes: New handrails for exterior stairs (600 lf)

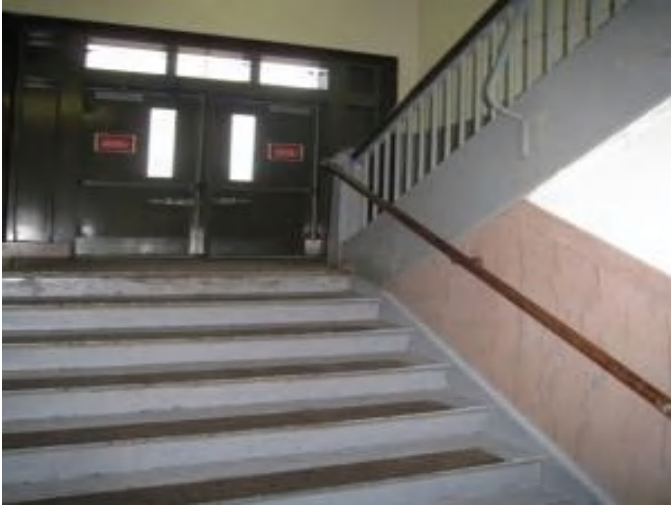
System: C2010 - Stair Construction

Location: stairways

Distress: Building / MEP Codes

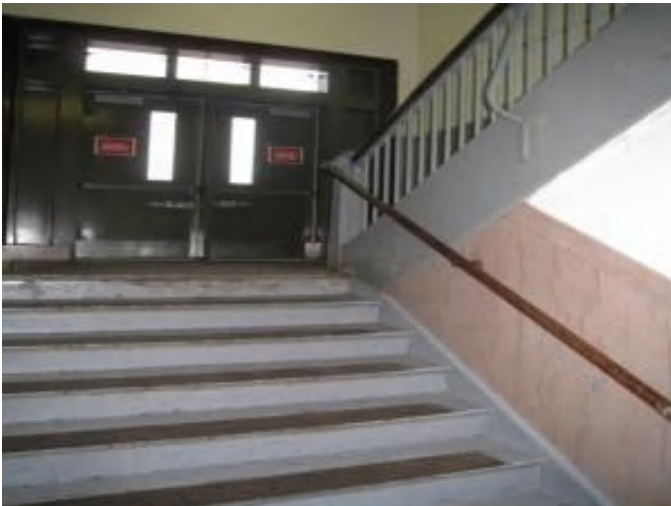
System: C2010 - Stair Construction

Location: stairways

Distress: Building / MEP Codes

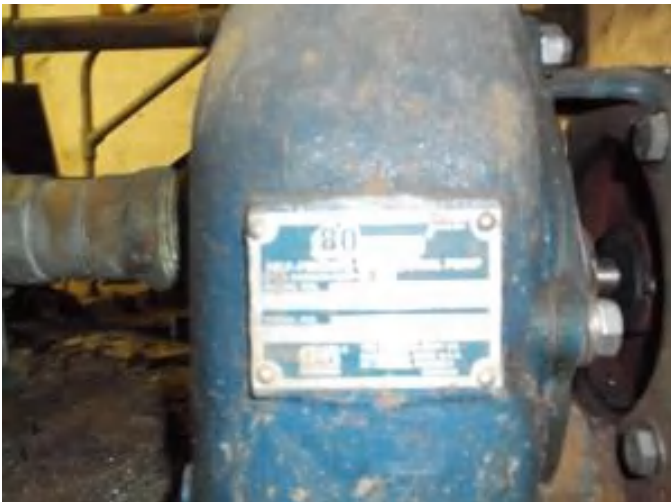
System: D3040 - Distribution Systems

Location: Throughout the building

Distress: Beyond Service Life

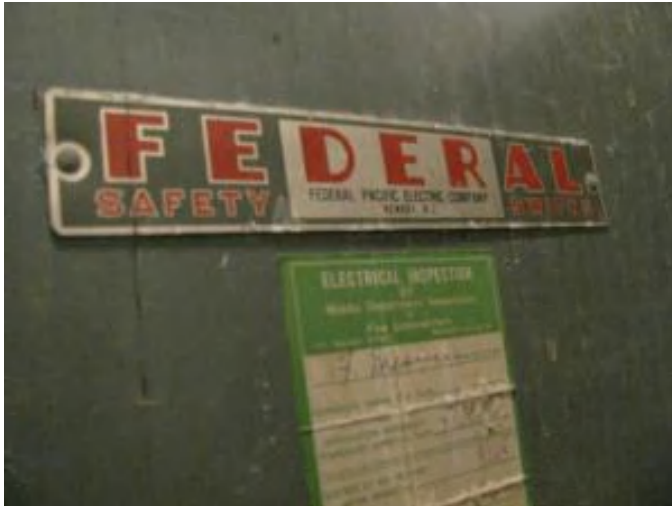
System: D5010 - Electrical Service/Distribution

Location: BUilding Engineer

Distress: Beyond Service Life

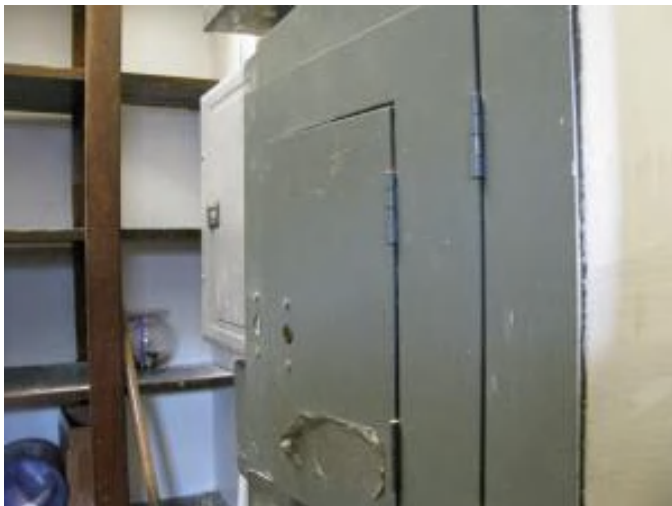
System: D5010 - Electrical Service/Distribution

Location: Entire Building

Distress: Beyond Service Life

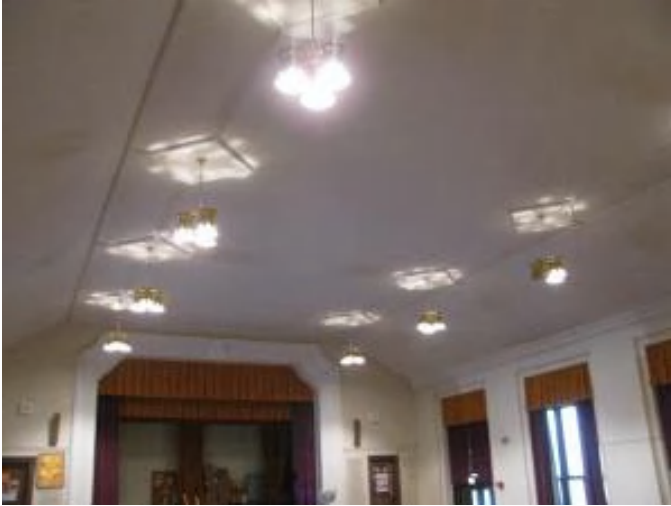
System: D5020 - Lighting and Branch Wiring

Location: Entire Building

Distress: Beyond Service Life

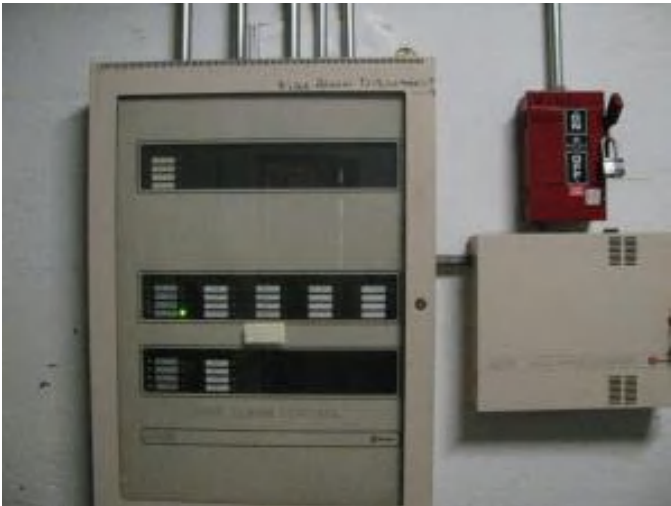
System: D5030 - Communications and Security

Location: Entire Building

Distress: Beyond Service Life

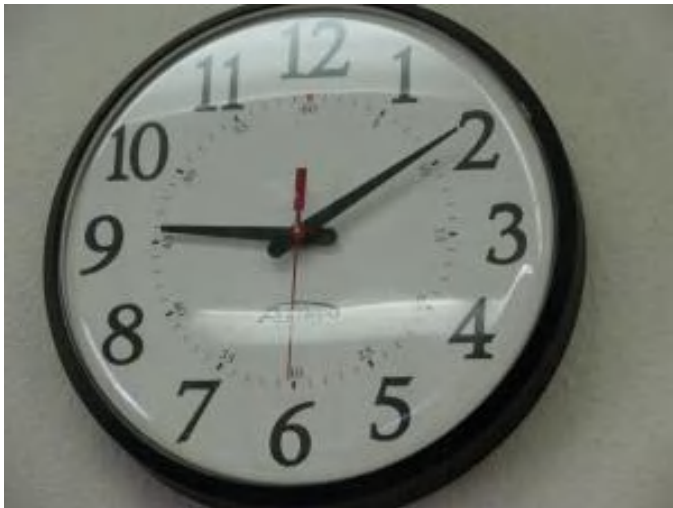
System: D5030 - Communications and Security

Location: Entire Building

Distress: Damaged

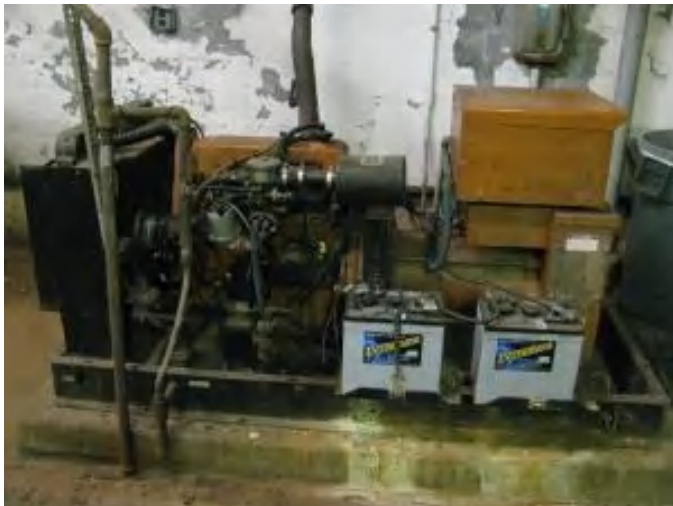
System: D5090 - Other Electrical Systems

Emergency Power System is provided in the school. A 15KW, 240/120V, 1PH, 3W diesel generator manufactured by "Billows Electric Inc" is installed in the boiler room. This generator is old and has exceeded its useful life and should be replaced.

Location: Boiler Room

Distress: Beyond Service Life

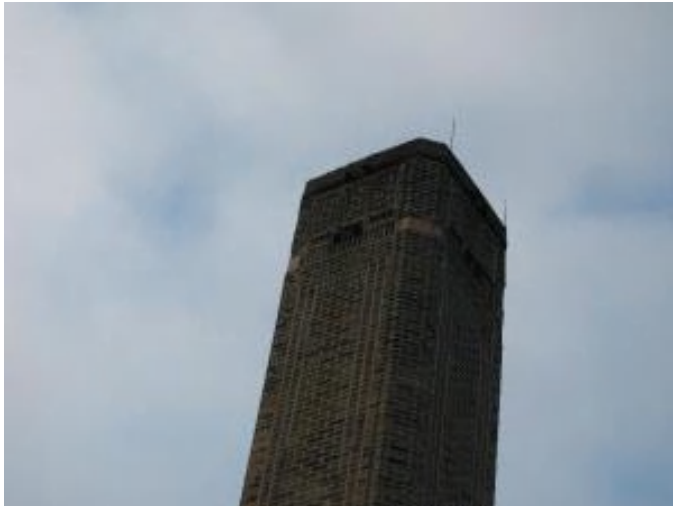
System: D5090 - Other Electrical Systems

Location: Roof

Distress: Life Safety / NFPA / PFD

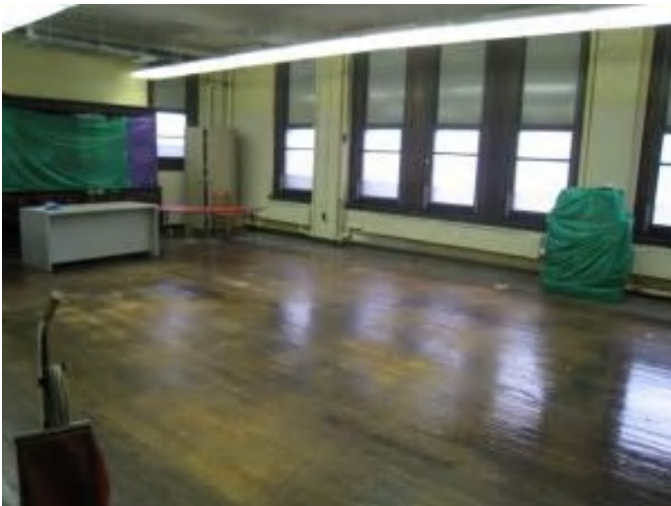
System: B2020 - Exterior Windows

Exterior windows were replaced in the 1990's with bronze anodized aluminum frame operable single hung units with single thickness clear plexiglass acrylic vision panel glazing. Windows are in poor condition with oxidized frames and severely scratched single-pane plexiglass vision panels. Operable units are difficult to operate up and down or do not stay open due to broken internal counterbalance weights, accidentally slamming closed in some cases – a potential safety hazard. Single pane plexiglass units do not meet today's energy code requirements and are large sources of heat loss. Basement level windows are at grade when viewed from the outside; galvanized steel security screens attached to basement windows, the lower section of 1st floor windows, and the auditorium window gratings are in good condition.

Location: exterior walls

Distress: Beyond Service Life

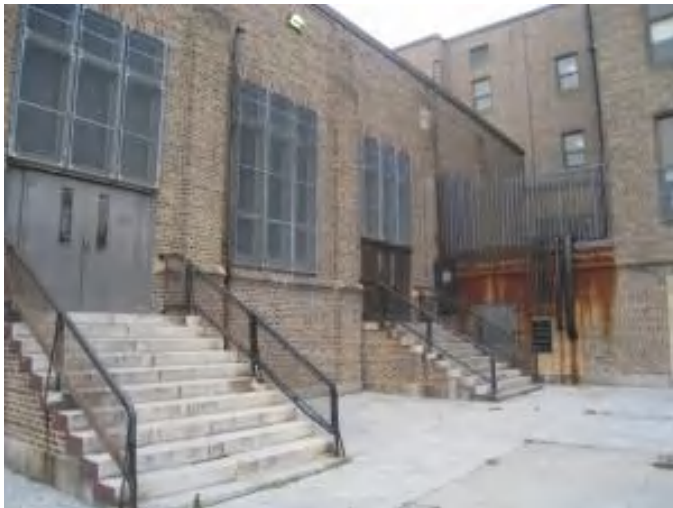
System: B2030 - Exterior Doors

Exterior doors are painted steel framed flush hollow metal units with steel frames. The main entrance and secondary main entrance on Battersby Street have decorative Romanesque-style tile arches around door openings. They can be cleaned to highlight their style and artistic technique. Some doors have small glazing vision panels. Doors are in generally poor condition, have broken or non-functioning panic hardware, rusted dented panels and frames, and are not ADA compliant. There are no handicap entrances, no accessible ramps and no elevators. All exterior steel doors, frames, and hardware systems need to be replaced.

Location: exterior doors

Distress: Damaged

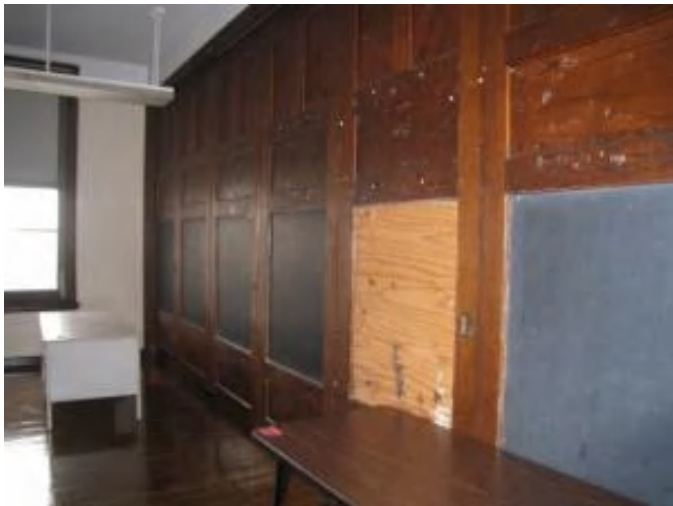
System: C1010 - Partitions

Location: walls between classrooms

Distress: Damaged

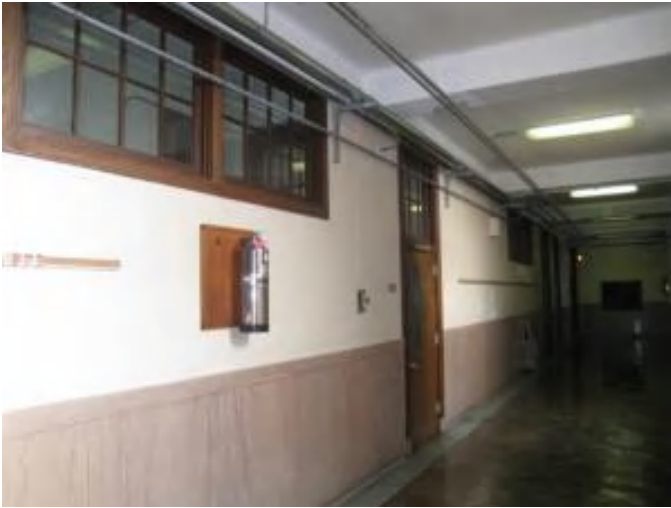
System: C1010 - Partitions

Location: corridor walls along classrooms

Distress: Life Safety / NFPA / PFD

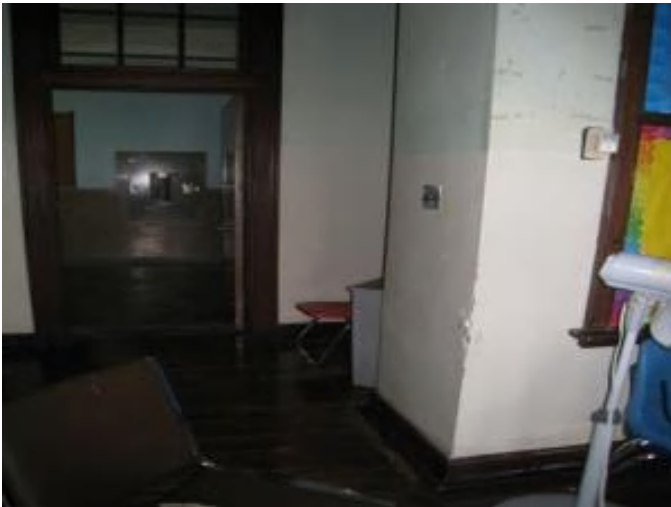
System: C1020 - Interior Doors

Location: classroom and office doors

Distress: Building / MEP Codes

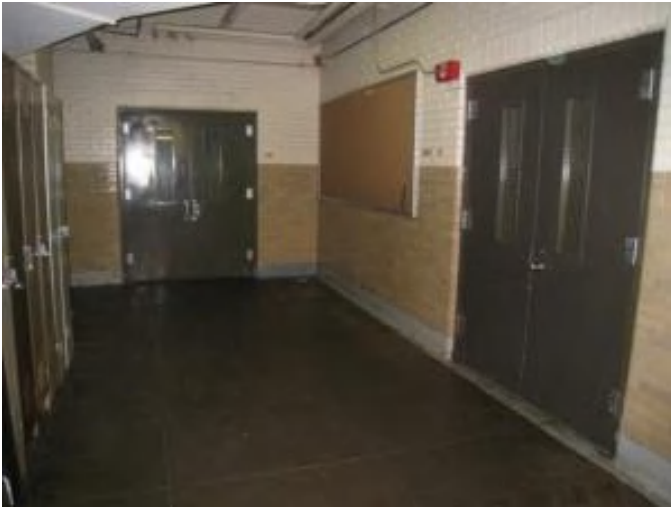
System: C1020 - Interior Doors

Location: basement doors

Distress: Beyond Service Life

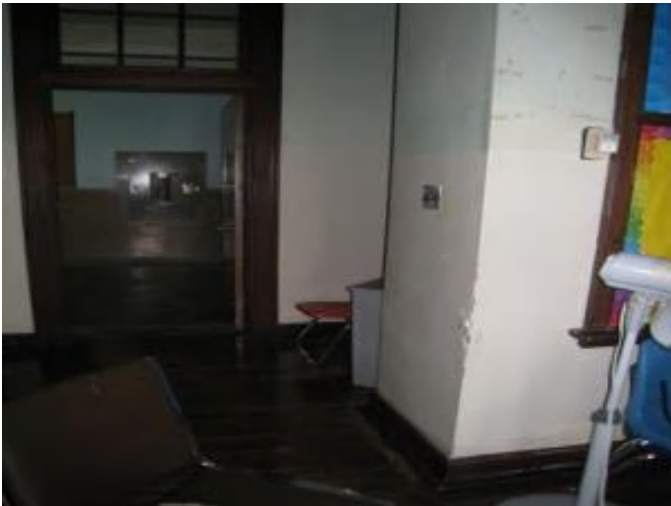
System: C1020 - Interior Doors

Location: classroom, cafeteria, and office doors

Distress: Life Safety / NFPA / PFD

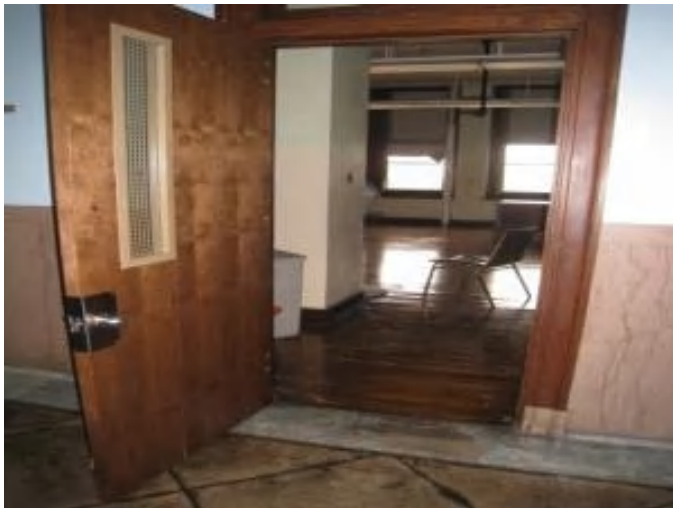
System: C1020 - Interior Doors

Location: 3rd floor doors

Distress: Appearance

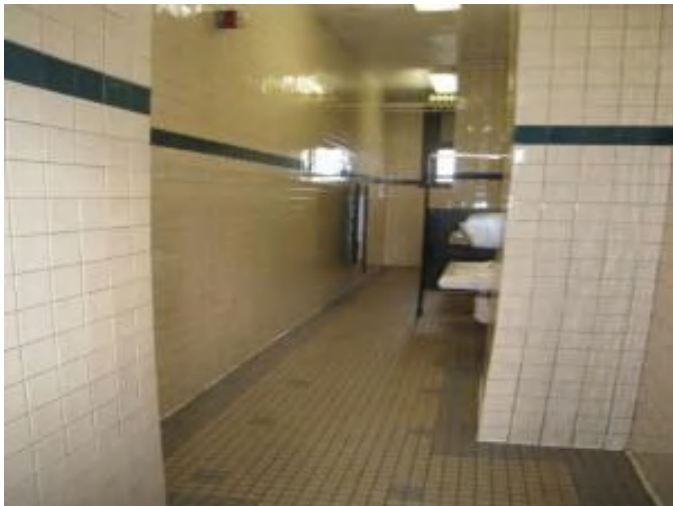
System: C1030 - Fittings

Location: toilet rooms

Distress: Damaged

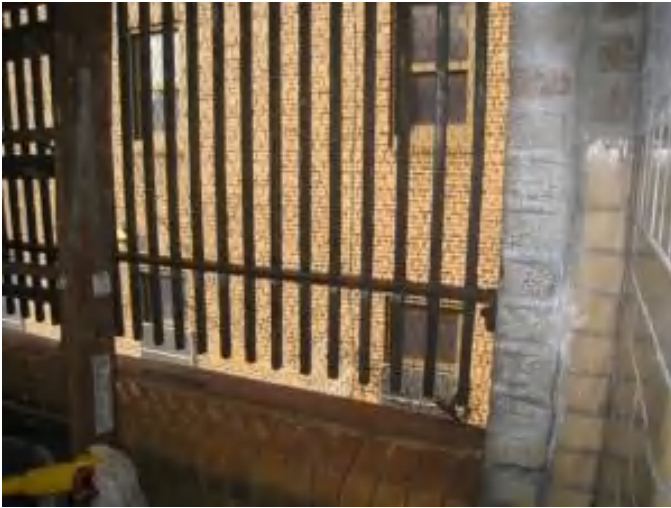
System: C2010 - Stair Construction

Location: exterior fire stair balconies

Distress: Failing

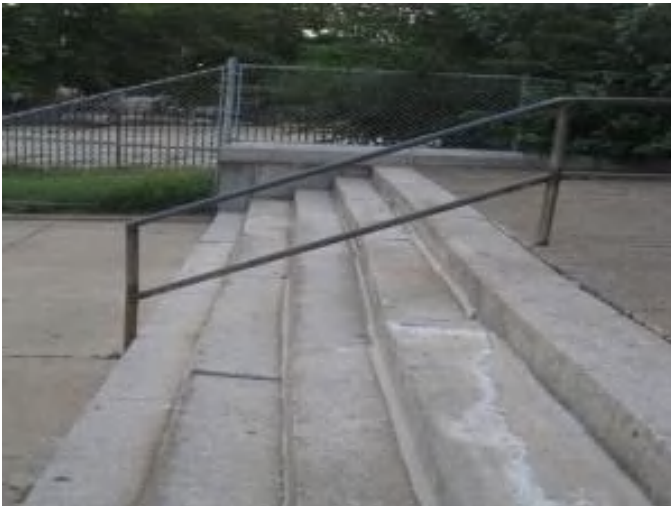
System: C2010 - Stair Construction

Location: exterior stairs

Distress: Failing

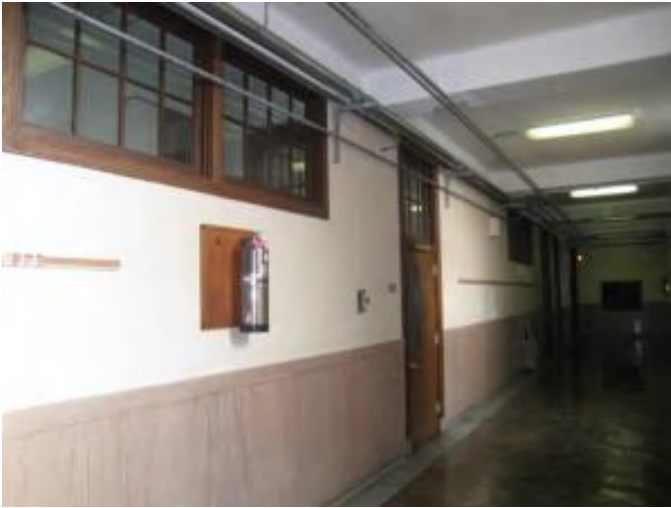
System: C3010230 - Paint & Covering

Location: interior walls

Distress: Appearance

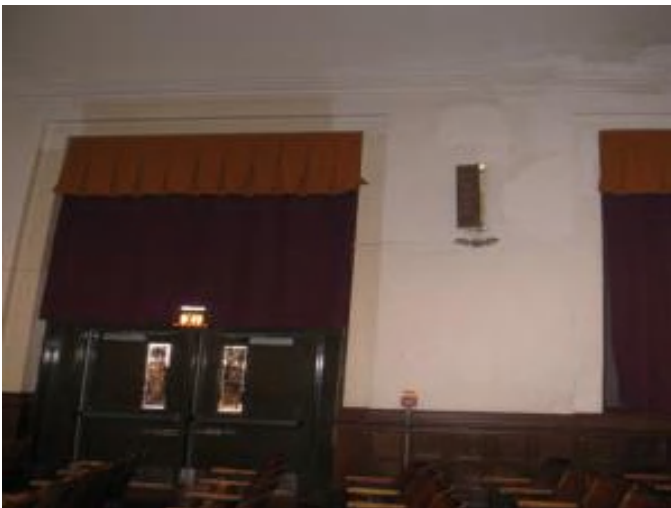
System: C3010230 - Paint & Covering

Location: auditorium walls

Distress: Appearance

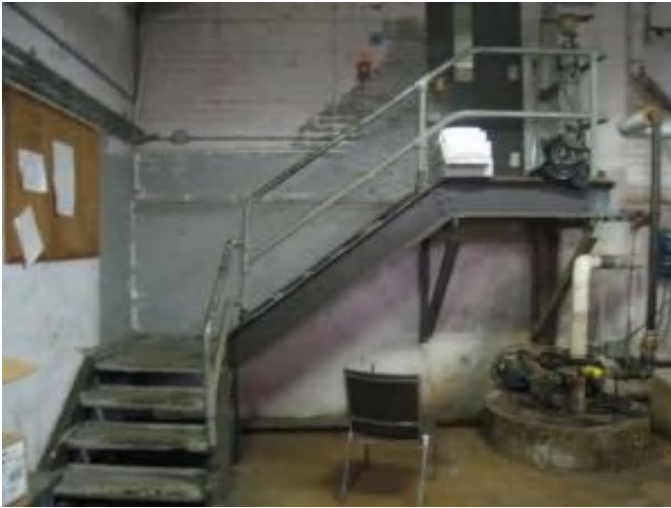
System: C3010230 - Paint & Covering

Location: mechanical rooms

Distress: Appearance

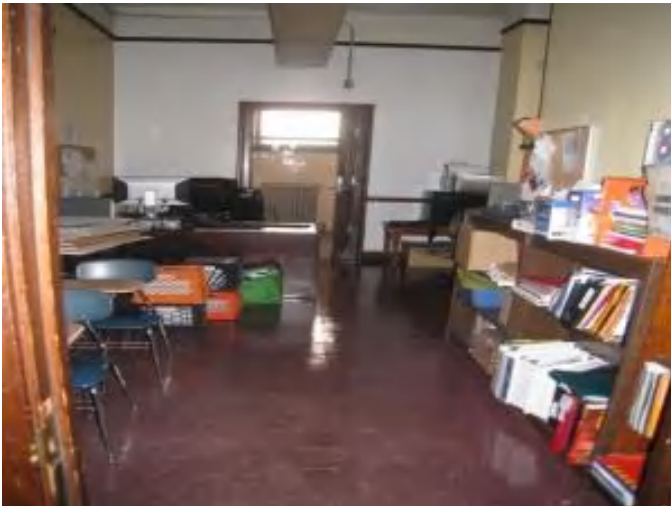
System: C3020413 - Vinyl Flooring

Location: gym and offices

Distress: Beyond Service Life

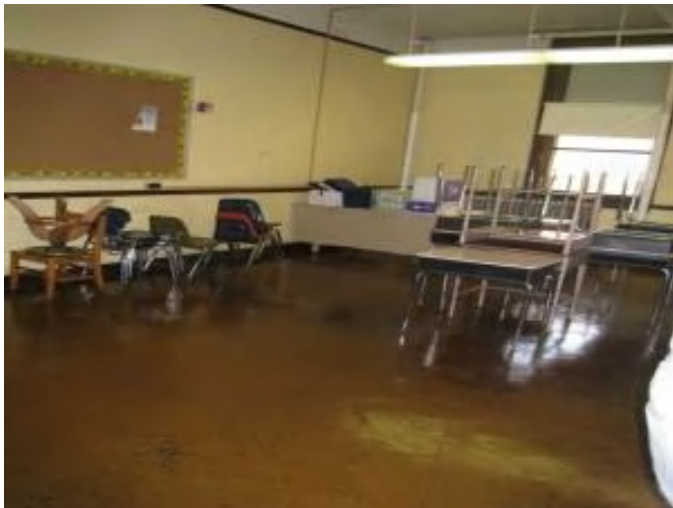
System: C3020413 - Vinyl Flooring

Location: offices

Distress: Beyond Service Life

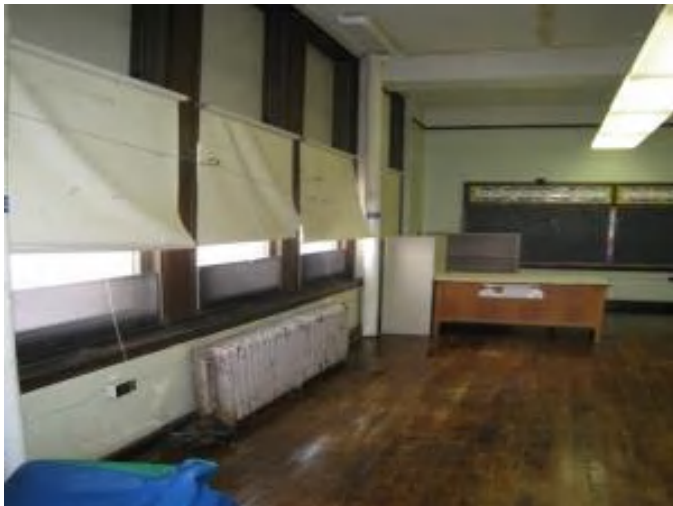
System: C3020414 - Wood Flooring

Location: classrooms

Distress: Appearance

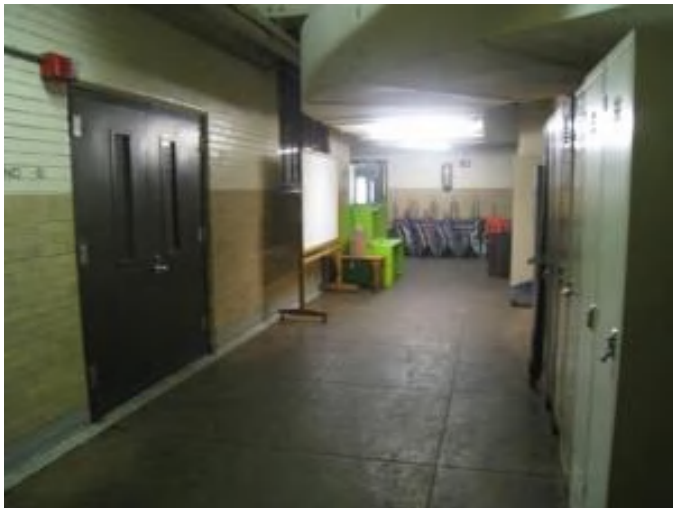
System: C3020415 - Concrete Floor Finishes

Location: basement mech rooms and all stairs

Distress: Appearance

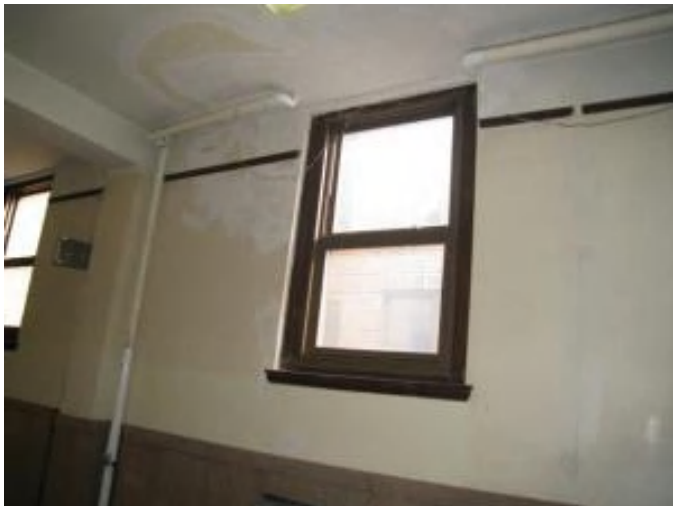
System: C3030 - Ceiling Finishes

Ceiling finishes are mostly exposed plaster throughout the original building with suspended fluorescent lighting fixtures; minor cracking is evident throughout the building.

Location: ceilings

Distress: Damaged

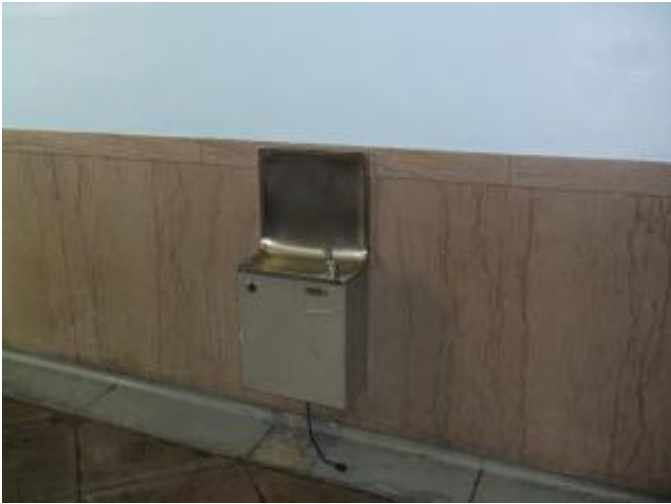
System: D2010 - Plumbing Fixtures

Location: Throughout the building

Distress: Beyond Service Life

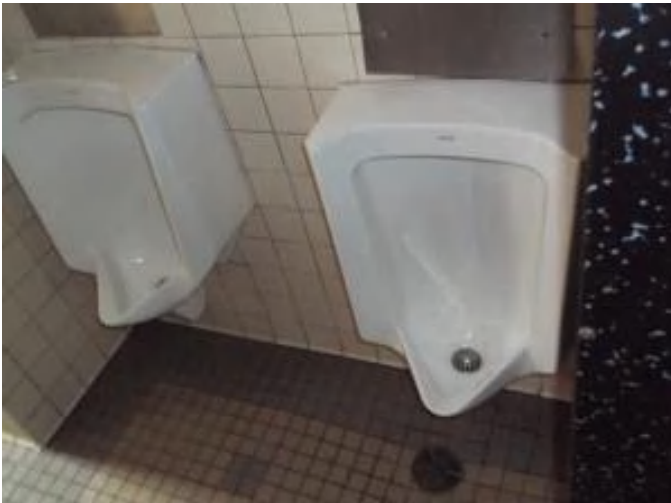
System: D2010 - Plumbing Fixtures

Location: Throughout the building

Distress: Beyond Service Life

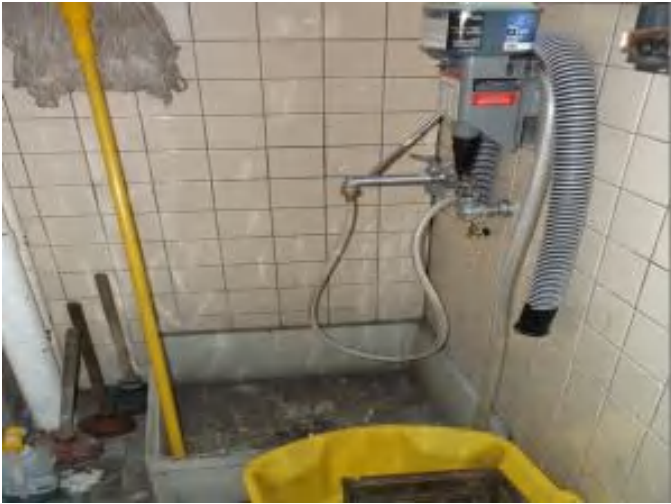
System: D2010 - Plumbing Fixtures

Location: Throughout the building

Distress: Beyond Service Life

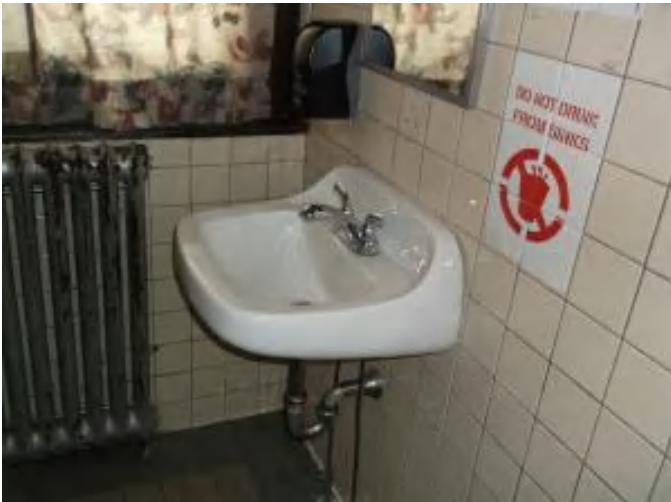
System: D2010 - Plumbing Fixtures

Location: Throughout the building

Distress: Beyond Service Life

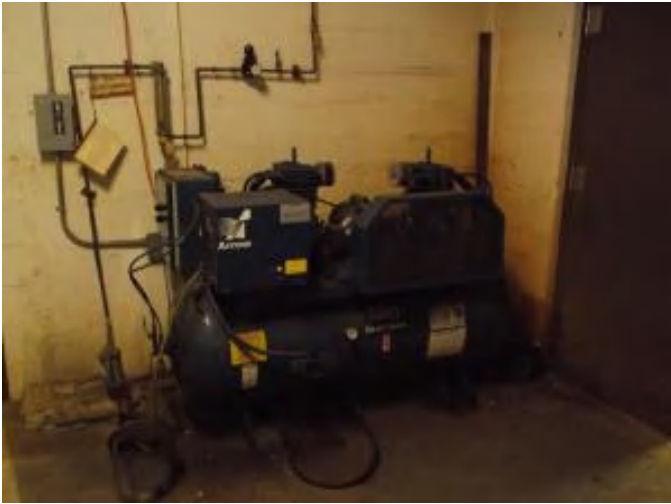
System: D3060 - Controls & Instrumentation

Location: Throughout the building

Distress: Beyond Service Life

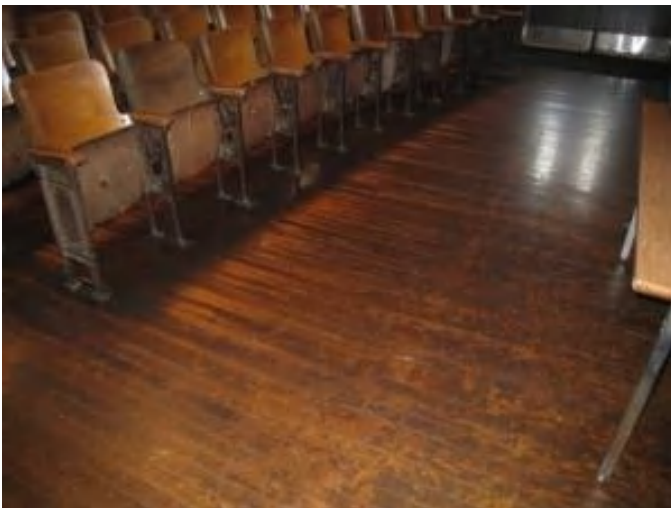
System: E2010 - Fixed Furnishings

Furnishings include the original folding wood seating in the auditorium is still in use. Some seats need to be repaired to operate properly and many are scratched; at approximately 25% need repairs and refinishing. Casework and storage cabinets in the classrooms and the office is damaged, worn and should be repainted.

Location: auditorium

Distress: Appearance

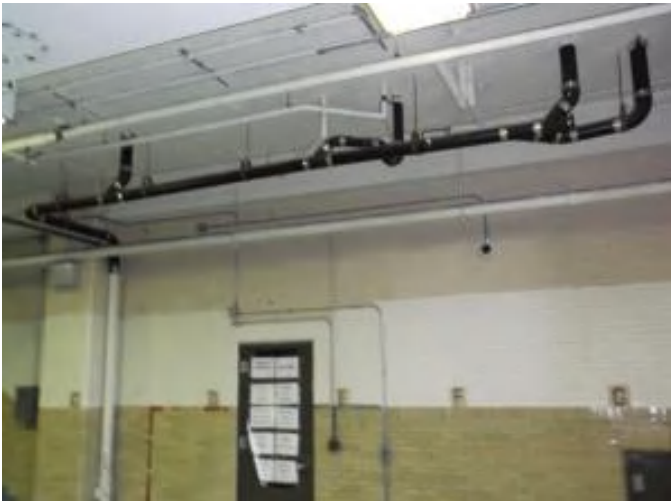
System: D2030 - Sanitary Waste

Location: Throughout the building

Distress: Beyond Service Life

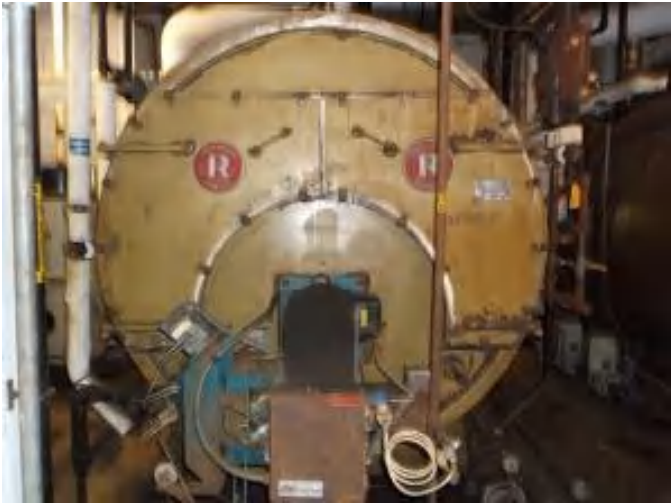
System: D3020 - Heat Generating Systems

Location: Boiler Mechanical Equipment Room

Distress: Beyond Service Life

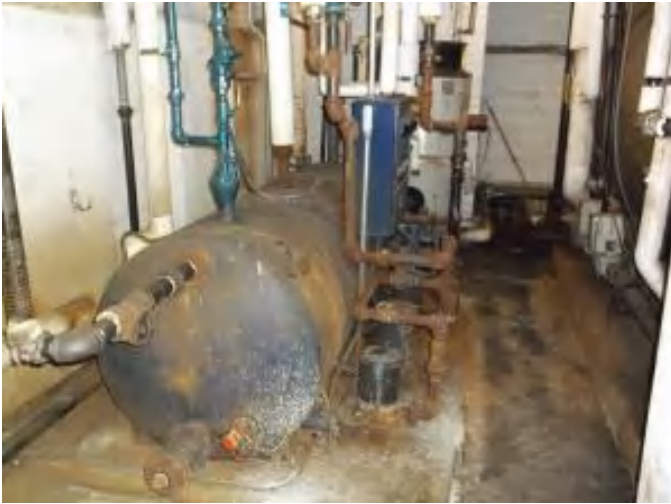
System: D3040 - Distribution Systems

Location: Throughout the building

Distress: Beyond Service Life

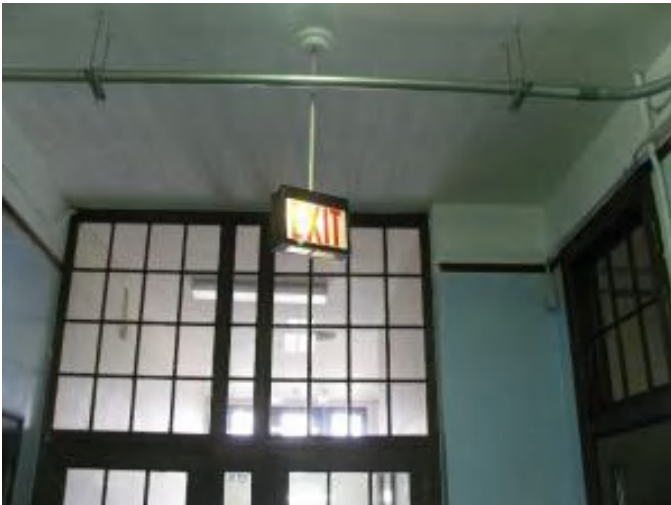
System: D5020 - Lighting and Branch Wiring

Location: Entire building

Distress: Life Safety / NFPA / PFD

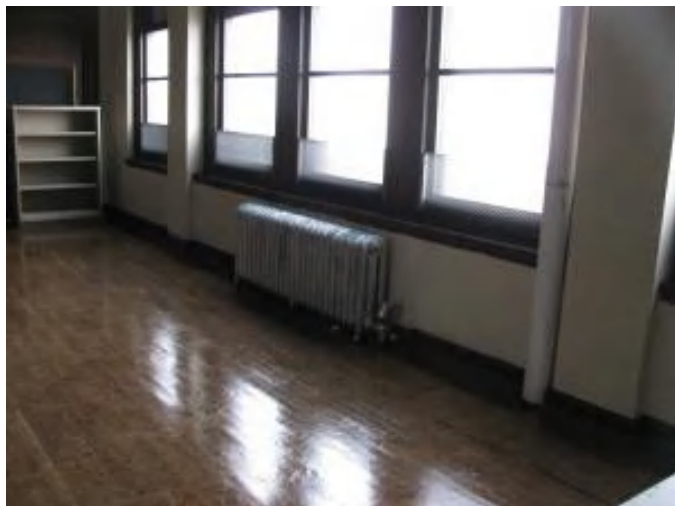
System: D5020 - Lighting and Branch Wiring

Location: Entire Building

Distress: Inadequate

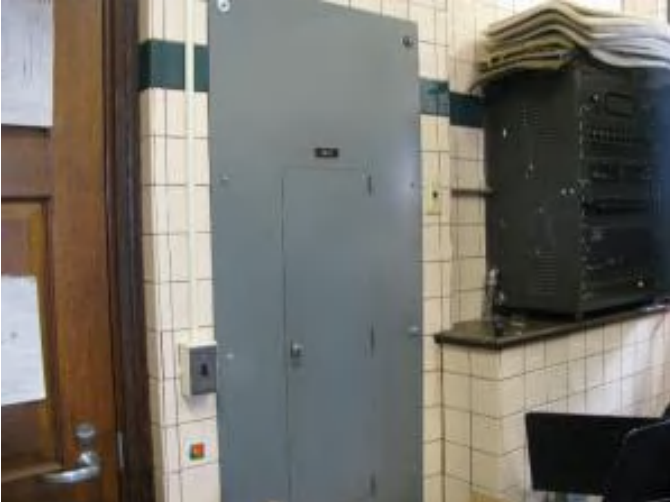
System: D5030 - Communications and Security

Location: Auditorium

Distress: Inadequate

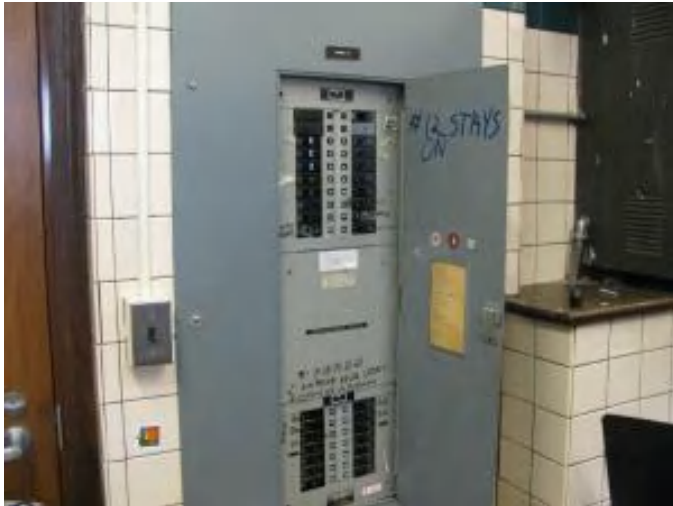
System: E1020 - Institutional Equipment

Location: Entire Building

Distress: Inadequate

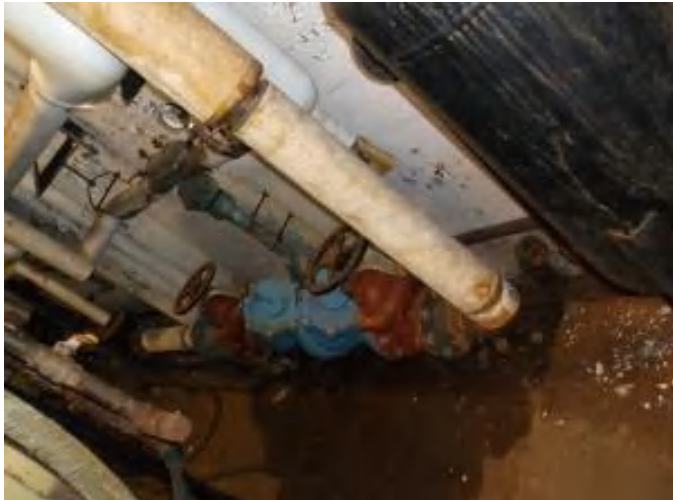
System: D2020 - Domestic Water Distribution

Location: Throughout the building

Distress: Beyond Service Life

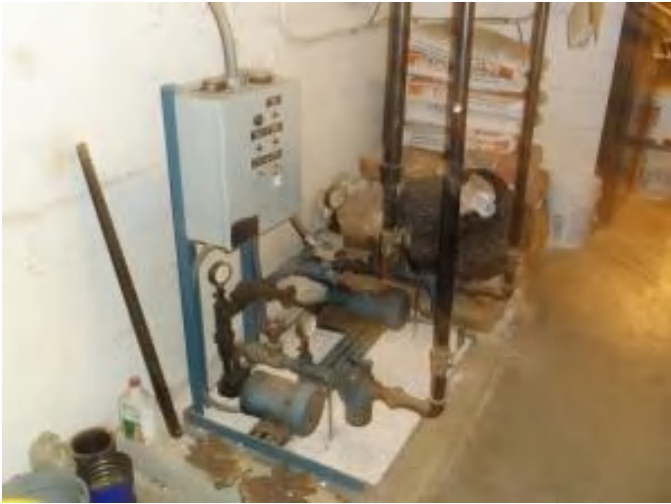
System: D3020 - Heat Generating Systems

Location: Boiler Mechanical Equipment Room

Distress: Beyond Service Life

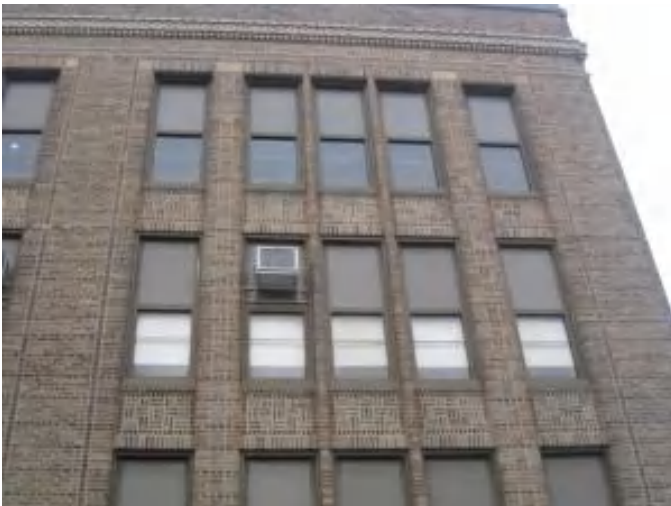
System: D3030 - Cooling Generating Systems

Location: Adjacent to building

Distress: Inadequate

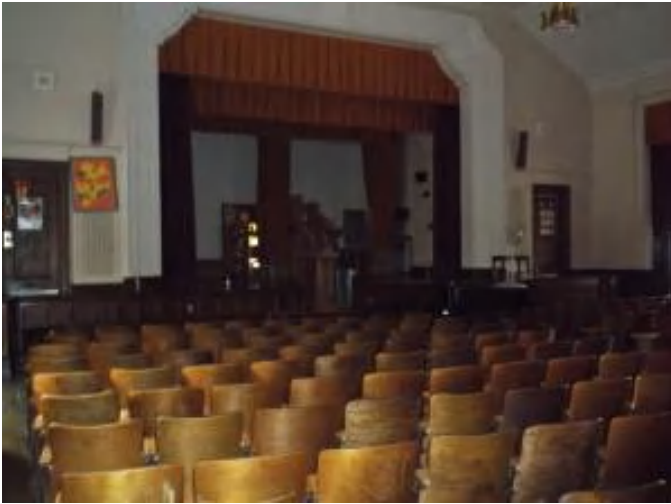
System: D3040 - Distribution Systems

Location: Auditorium

Distress: Beyond Service Life

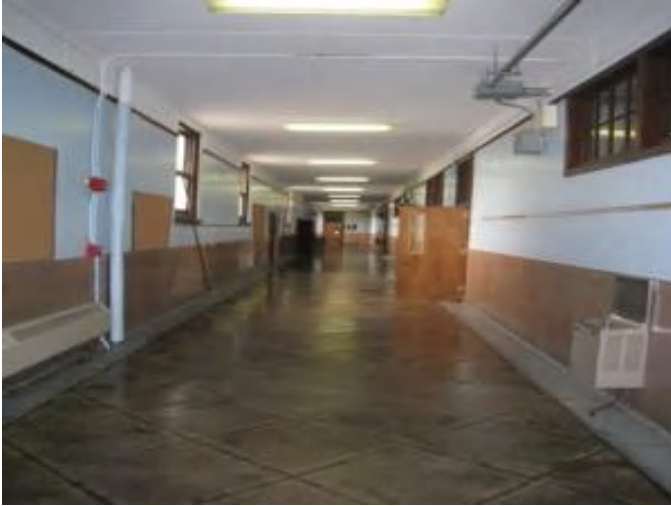
System: D4010 - Sprinklers

Location: Throughout the building

Distress: Life Safety / NFPA / PFD

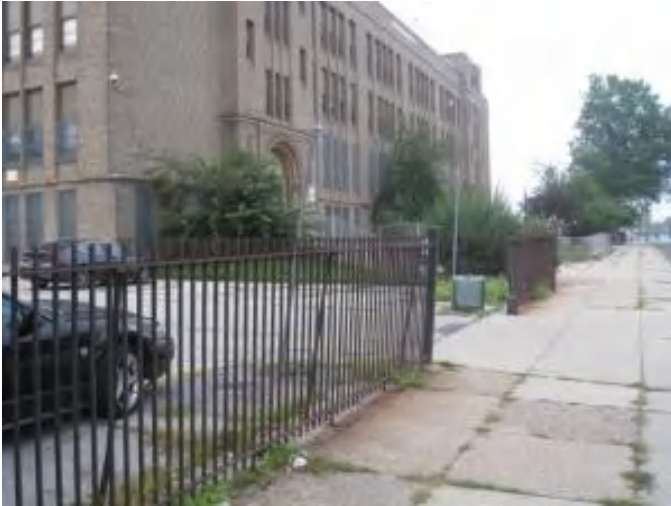
System: G2030 - Pedestrian Paving

Location: front sidewalk

Distress: Failing

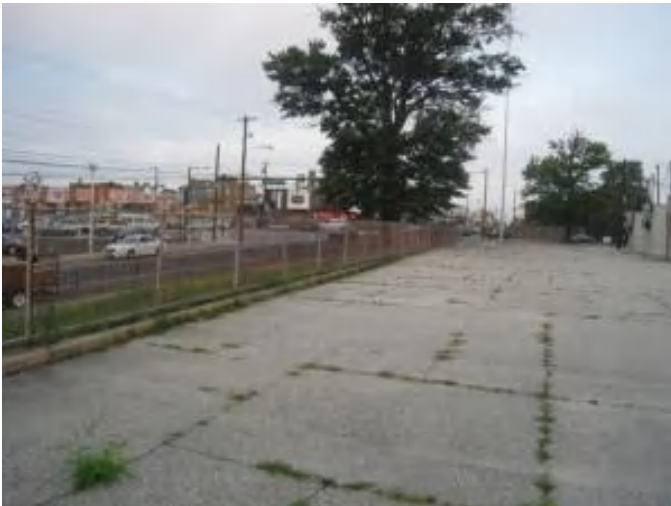
System: G2040 - Site Development

Location: site fence

Distress: Failing

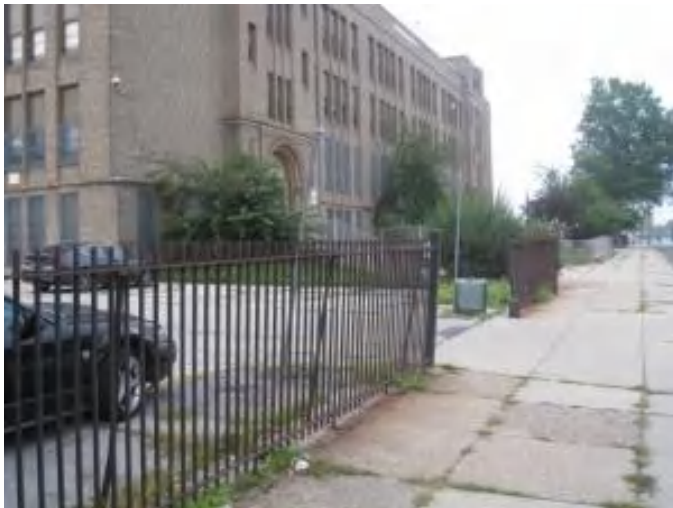
System: G2040 - Site Development

Location: site fence

Distress: Failing

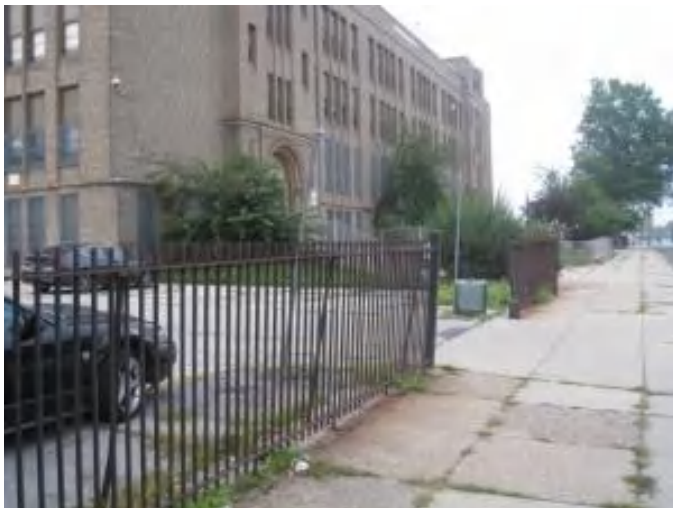
System: G2040 - Site Development

Location: gate at parking lot entrance

Distress: Failing

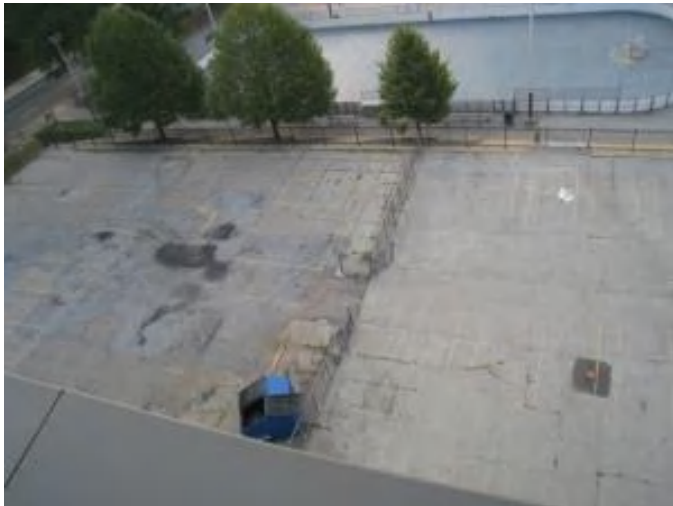
System: G2020 - Parking Lots

Location: parking lot and play area

Distress: Failing
