Facility Condition Assessment Summary Report

Allen, Ethel School

School District of Philadelphia
S444001;Allen, Ethel
Final
Site Assessment Report
February 1, 2017

Facility Assessment
November 2015

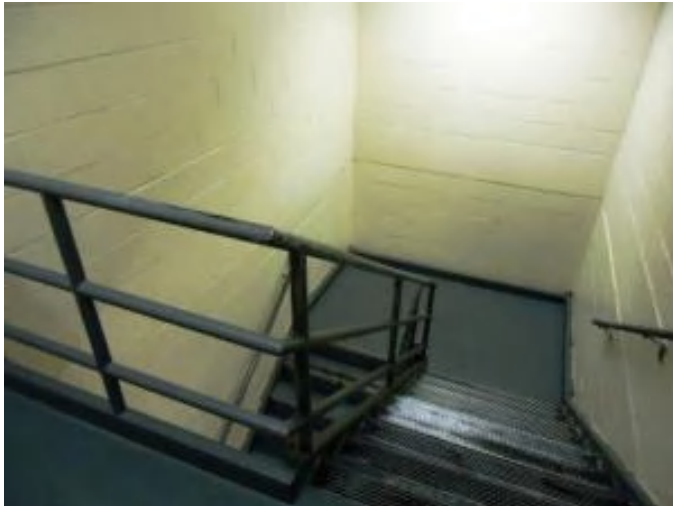
System: C2010 - Stair Construction

Current requirements for stairs indicate that they have graspable handrails on both sides, that the rails have a specific end geometry, and that the handrails continue horizontally at the landings. In addition, guardrails must prevent the passage of a 4 inch diameter sphere (6 inches in the triangle formed by the lower rail and tread/riser angle). Although the stairs are compliant with the code enforced at the time of construction until a major renovation occurs, they are deficient in handrail and guardrail design relative to current standards. Future efforts should include comprehensive stair railing removal and replacement upgrades.

Location: Stairs

Distress: Life Safety / NFPA / PFD

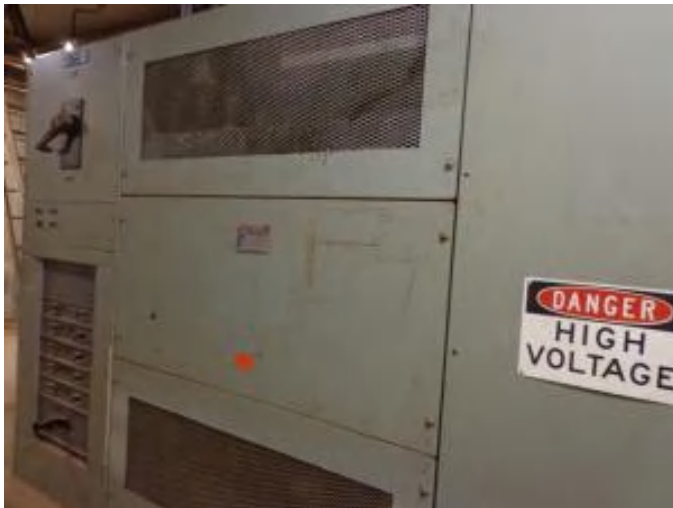
System: D5010 - Electrical Service/Distribution

Location: Electrical Room 001B
Distress: Building / MEP Codes
Category: 3 - Operations / Maint.
Priority: 3 - Response Time (3-4 yrs)
Correction: Replace unit substation
Qty: 1.00
Unit of Measure: Ea.
Estimate: \$483,499.01
Assessor Name: Hayden Collins
Date Created: 01/18/2016

Notes: Replace the 500 kVA, 1600A, 208/120V, 3 phase, 4 wire substation.

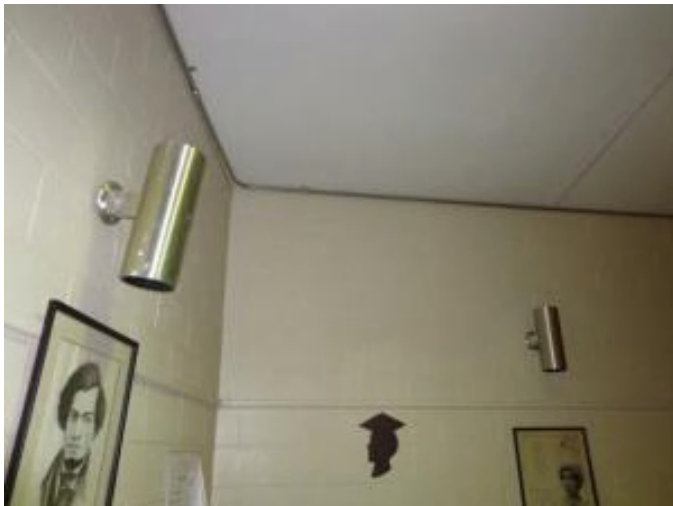
System: D5020 - Lighting and Branch Wiring

The auditorium is illuminated with (22) 250W recessed mercury vapor downlights. Replacement with LED fixtures is recommended for improved energy efficiency and reduced maintenance cost. There are also eight (8) incandescent wall mounted cylinders with up and down lighting that should have lamps replaced with LED type.

Location: Auditorium
Distress: Beyond Service Life
Category: 3 - Operations / Maint.
Priority: 3 - Response Time (3-4 yrs)
Correction: Replace lighting fixtures
Qty: 22.00
Unit of Measure: Ea.
Estimate: \$34,438.48
Assessor Name: Hayden Collins
Date Created: 01/18/2016

Notes: Replace (22) 250W recessed mercury vapor downlights in the auditorium with LED downlights. Replace lamps in eight (8) incandescent wall mounted cylinders with up and down lighting with LED lamps.

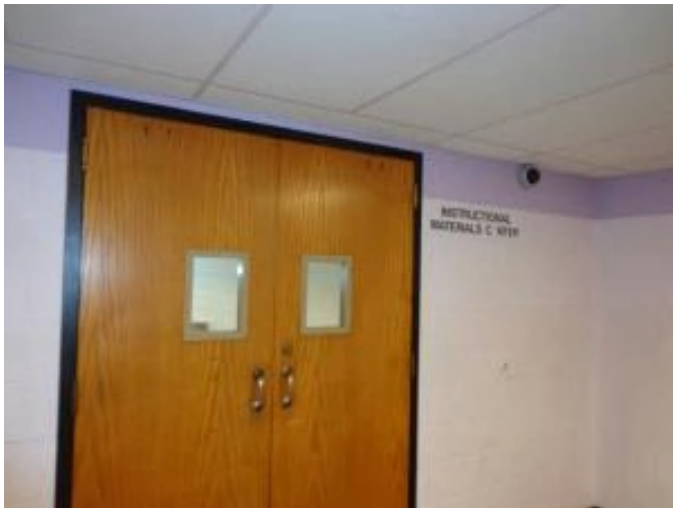
System: D5030 - Communications and Security

Video Surveillance and Security Systems-- Interior video surveillance cameras provide coverage of entrances and corridors. There are a total of 16 cameras, including two (2) exterior cameras. The system includes two monitors and a digital video recorder (DVR). The cameras and equipment are reported to be more than 10 years old and are near end of life and should be replaced.

Location: Building wide
Distress: Beyond Service Life
Category: 3 - Operations / Maint.
Priority: 3 - Response Time (3-4 yrs)
Correction: Add/Replace Video Surveillance System
Qty: 18.00
Unit of Measure: Ea.
Estimate: \$62,274.24
Assessor Name: Hayden Collins
Date Created: 01/18/2016

Notes: Replace video surveillance system equipment, including 14 interior cameras, two (2) monitors and one (1) digital video recorder (DVR). Add a second DVR.

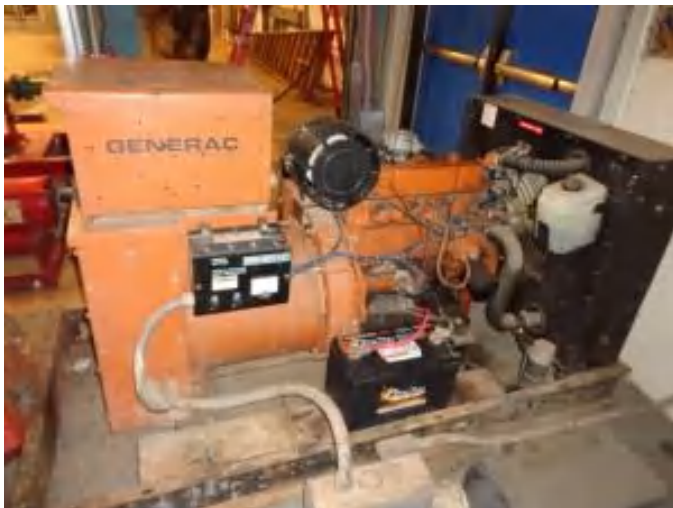
System: D5090 - Other Electrical Systems

Location: Boiler Room
Distress: Beyond Service Life
Category: 3 - Operations / Maint.
Priority: 3 - Response Time (3-4 yrs)
Correction: Replace standby generator system
Qty: 1.00
Unit of Measure: Ea.
Estimate: \$88,010.44
Assessor Name: Hayden Collins
Date Created: 01/18/2016

Notes: Replace 15 kW standby generator, automatic transfer switch (ATS) and emergency lighting panelboard. Increase generator size to 50 kW minimum to supply the hydraulic elevator.

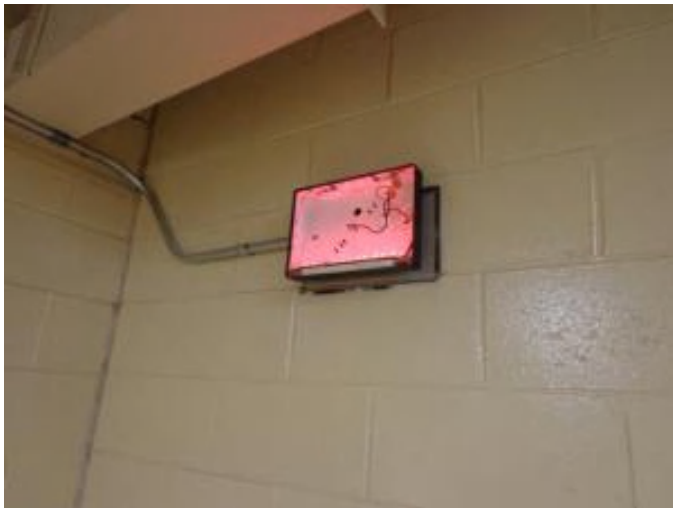
System: D5090 - Other Electrical Systems

Emergency Lighting System / Exit Lighting-- Emergency egress lighting fixtures and exit signs are connected to emergency power and fed from the emergency lighting panelboard. Some of the exit signs are not properly supported from the ceiling or have been damaged and need to be maintained or replaced.

Location: Corridors
Distress: Damaged
Category: 3 - Operations / Maint.
Priority: 3 - Response Time (3-4 yrs)
Correction: Replace Emergency/Exit Lighting
Qty: 10.00
Unit of Measure: Ea.
Estimate: \$8,478.19
Assessor Name: Hayden Collins
Date Created: 01/18/2016

Notes: Repair/replace exit signs that are not properly supported from the ceiling or are damaged (estimate 10 exit signs).

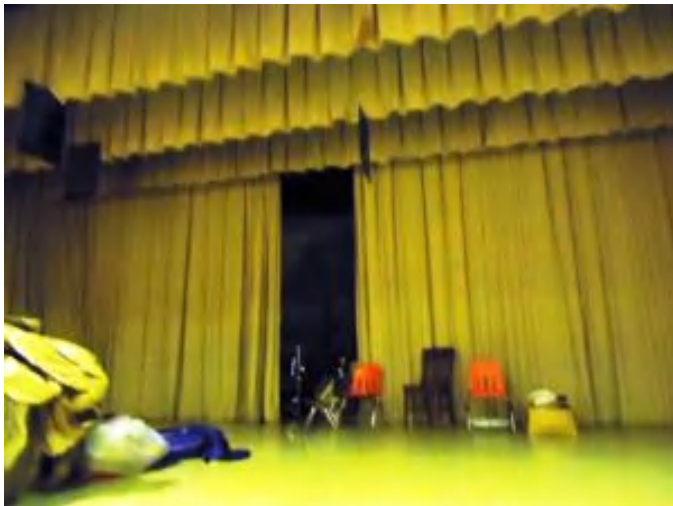
System: E2010 - Fixed Furnishings

-proof applications with adjustable tracks and electric support for operation. The curtains are torn in a few section and the track is not functioning properly, overall the system is in poor condition. It is recommended that the curtain and track system be upgraded to a new system. Special care should be considered in regards to modern fire proofing for the new installation.

Location: Stage
Distress: Life Safety / NFPA / PFD
Category: 1 - Health & Safety
Priority: 3 - Response Time (3-4 yrs)
Correction: Remove and replace stage curtain - insert the LF of track and SF of curtain
Qty: 1.00
Unit of Measure: Ea.
Estimate: \$13,831.55
Assessor Name: Hayden Collins
Date Created: 02/02/2016

Notes: The school stage has a stage curtain assembly that appears to be from the original construction. Modern applications are typically fire-proof applications with adjustable tracks and electric support for operation. The curtains are torn in a few section and the track is not functioning properly, overall the system is in poor condition. It is recommended that the curtain and track system be upgraded to a new system. Special care should be considered in regards to modern fire proofing for the new installation

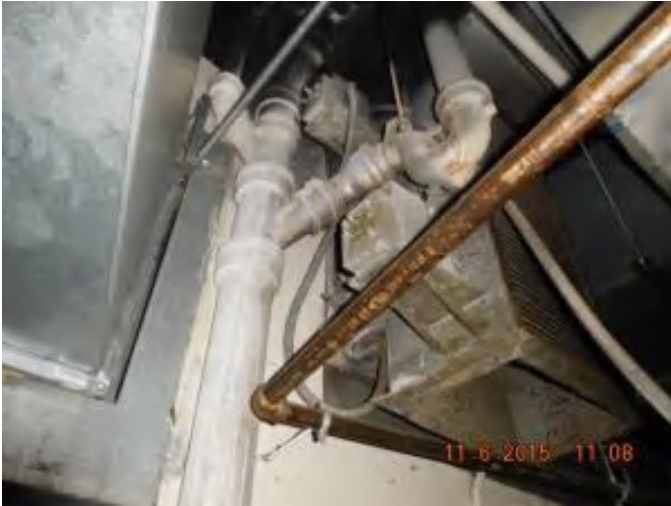
System: D2030 - Sanitary Waste

The plumbing system was renovated in 2006 including fixtures, water heaters and supply piping. Sanitary, waste and vent piping is from 1971 installation. Fixtures should have remaining service life of twenty five years. Water heater and piping should be serviceable fifteen more years. Cast iron piping should be inspected for damage and replaced or repaired as required.

Location: entire building

Distress: Beyond Service Life

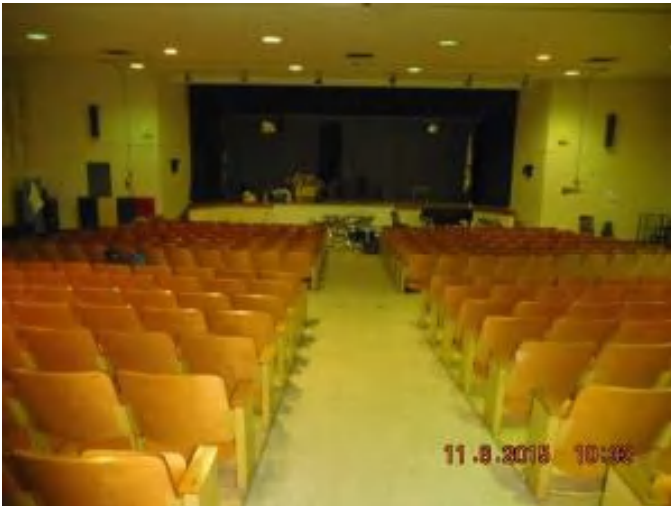
System: D4010 - Sprinklers

Location: entire building

Distress: Life Safety / NFPA / PFD

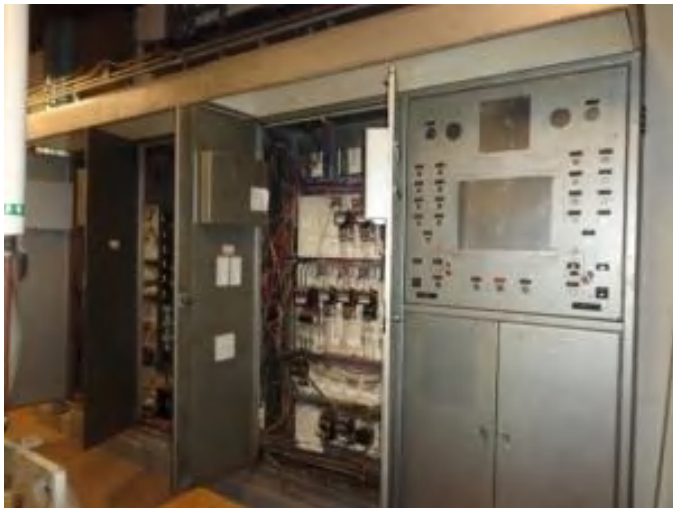
System: D5010 - Electrical Service/Distribution

Location: Building wide
Distress: Beyond Service Life
Category: 3 - Operations / Maint.
Priority: 4 - Response Time (4-5 yrs)
Correction: Replace Panelboard
Qty: 10.00
Unit of Measure: Ea.
Estimate: \$582,063.82
Assessor Name: Hayden Collins
Date Created: 01/18/2016

Notes: Replace the 800A, 208/120V, 3 phase, three section motor control center located in the chiller room and nine (9) panelboards located throughout the building.

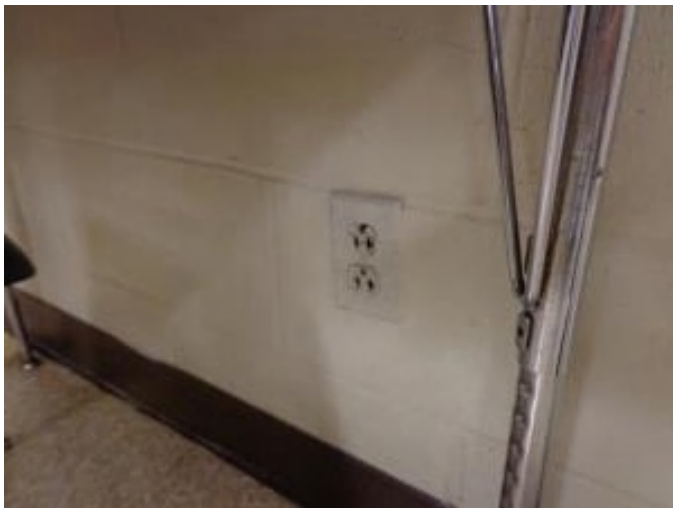
System: D5020 - Lighting and Branch Wiring

Receptacles-- All rooms are typically provided with an adequate number of receptacles, except for classrooms. It is recommended that 4 to 6 additional duplex receptacles be provided in 31 classrooms using a metal surface raceway system. A budgetary allowance is also included in this report for 20 duplex receptacles to be replaced because of their age/condition.

Location: Classrooms
Distress: Inadequate
Category: 4 - Capital Improvement
Priority: 4 - Response Time (4-5 yrs)
Correction: Provide surface raceway system and wiring devices
Qty: 930.00
Unit of Measure: L.F.
Estimate: \$124,999.02
Assessor Name: Hayden Collins
Date Created: 01/18/2016

Notes: Provide surface metal raceway system with 4 to 6 duplex receptacles in each of 31 classrooms. This deficiency includes a budgetary allowance for replacement 20 duplex receptacles because of their age/condition.

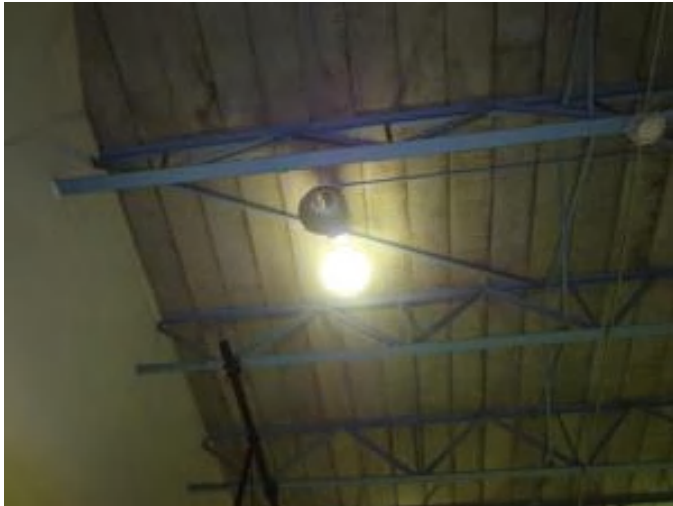
System: D5020 - Lighting and Branch Wiring

The gymnasium is illuminated with (16) 400W mercury vapor industrial fixtures and four (4) incandescent industrial fixtures used for emergency lighting. The fixtures have reached the end of their useful life. Replacement with LED fixtures is recommended for improved energy efficiency and reduced maintenance cost.

Location: Gymnasium
Distress: Beyond Service Life
Category: 3 - Operations / Maint.
Priority: 4 - Response Time (4-5 yrs)
Correction: Replace lighting fixtures
Qty: 16.00
Unit of Measure: Ea.
Estimate: \$55,966.52
Assessor Name: Hayden Collins
Date Created: 01/18/2016

Notes: Replace (16) mercury vapor lighting fixtures in the gymnasium with LED industrial fixtures.

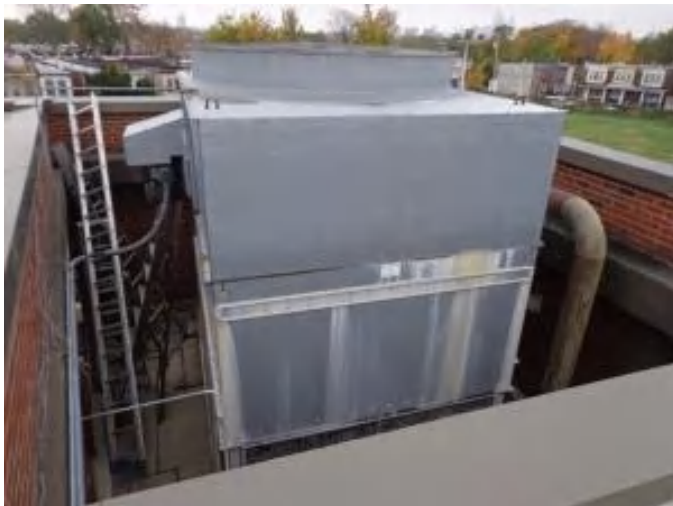
System: D5020 - Lighting and Branch Wiring

Location: Roof
Distress: Inadequate
Category: 4 - Capital Improvement
Priority: 4 - Response Time (4-5 yrs)
Correction: Add Exterior Lighting
Qty: 1.00
Unit of Measure: Ea.
Estimate: \$20,323.41
Assessor Name: Hayden Collins
Date Created: 01/18/2016

Notes: Provide budgetary allowance add lighting on the roof at the access door and at HVAC equipment for personnel safety and to service/maintain equipment.

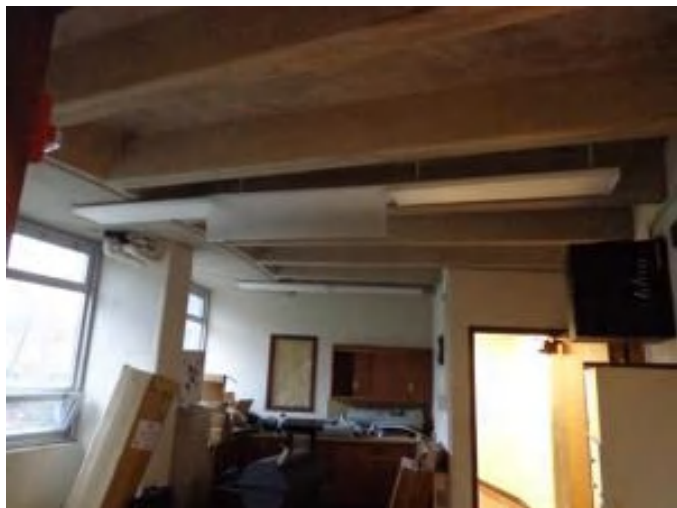
System: D5020 - Lighting and Branch Wiring

Location: Various locations

Distress: Beyond Service Life

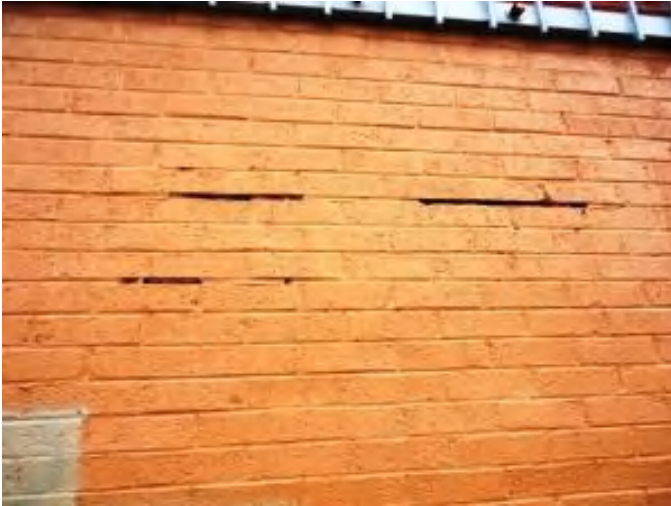
System: B2010 - Exterior Walls

The exterior brick surfaces are generally in good condition for their age. In a few locations, bricks have cracked or spalled and should be replaced. The repointing of deteriorated mortar joints is also recommended, using mortar of a similar color and consistency as the original. Following the detailed examination of the brick and repair of mortar construction joints, the entire building should be pressure washed to remove stains and embedded pollutants. If moisture is found to be penetrating the masonry facade, the application of a spray sealant to the suspected exterior masonry surface is recommended.

Location: Exterior Elevation

Distress: Damaged

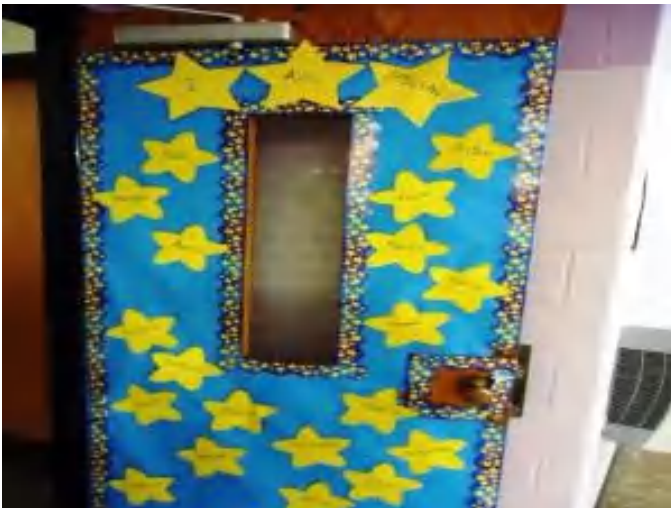
System: C1020 - Interior Doors

Location: Building Wide
Distress: Damaged
Category: 3 - Operations / Maint.
Priority: 5 - Response Time (> 5 yrs)
Correction: Remove and replace interior doors - wood doors with hollow metal frames - per leaf
Qty: 20.00
Unit of Measure: Ea.
Estimate: \$95,411.74
Assessor Name: Hayden Collins
Date Created: 02/02/2016

Notes: Interior doors are typically wood in wood frames with wooden transom and wired glass glazing. Other interior doors include hollow metal in hollow metal frames at the stairwells and exit ways and access doors. Doors are generally in fair condition and is a mix of ADA compliant and non-complaint doors with both non-rated and fire rated. Several of the classroom doors are aging at a faster than normal rate for this application. Numerous repairs to locksets and door hardware have advanced the deterioration of the doors. This deficiency provides a budgetary consideration to replace a portion of the interior doors and frames with consideration for the physically challenged.

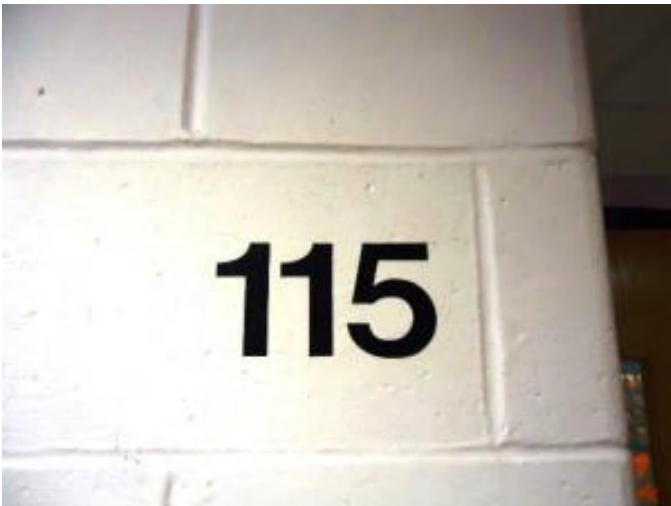
System: C1030 - Fittings

There is no directional signage and room signage is a custom design in places and scarce or painted with no consistency in others. Accessibility signage criteria have been established for the physically challenged. These include mounting heights, contrast and finish, raised and Braille characters and pictograms, and character proportions and heights. It is recommended that compliant signage be installed throughout the building.

Location: Building Wide
Distress: Damaged
Category: 3 - Operations / Maint.
Priority: 5 - Response Time (> 5 yrs)
Correction: Replace missing or damaged signage - insert the number of rooms
Qty: 100.00
Unit of Measure: Ea.
Estimate: \$27,091.25
Assessor Name: Hayden Collins
Date Created: 02/02/2016

Notes: There is no directional signage and room signage is a custom design in places and scarce or painted with no consistency in others. Accessibility signage criteria have been established for the physically challenged. These include mounting heights, contrast and finish, raised and Braille characters and pictograms, and character proportions and heights. It is recommended that compliant signage be installed throughout the building.

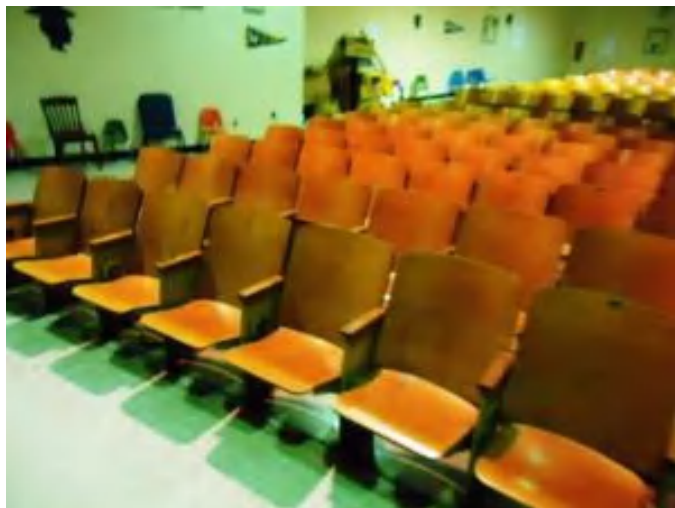
System: E2010 - Fixed Furnishings

The fixed seating for this school is from the original construction. The systems are in fair condition considering the age and usage. This project provides a budgetary consideration for universal upgrades for the fixed seating and furnishing of this school. Ensure that ADA requirements are followed with the new seating layout.

Location: Auditorium

Distress: Damaged

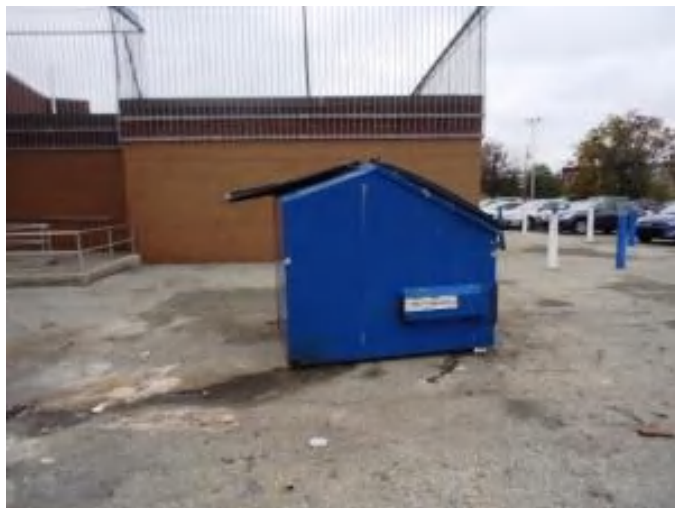
System: G2040 - Site Development

The trash dumpster is located in the parking lot open to the students and to the public. The exterior services are not protected. Upgrades to protect the exterior services and trash area is necessary for the safety of the students and the general public. Construction of a secure lockable dumpster area is recommended.

Location: Site

Distress: Health Hazard / Risk

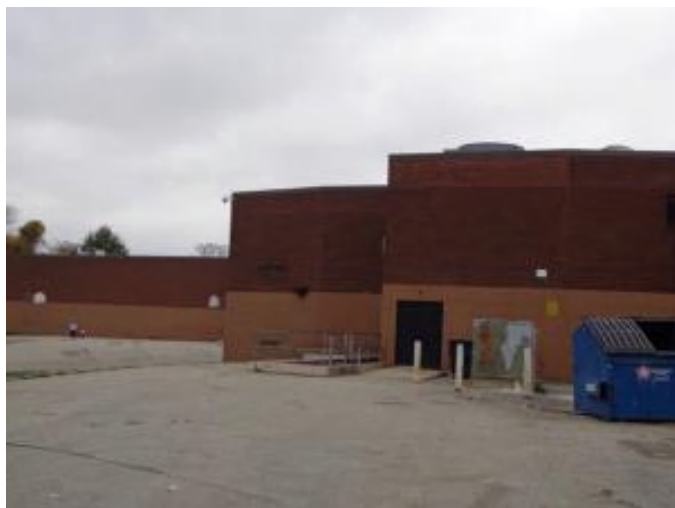
System: G4030 - Site Communications & Security

Location: Site

Distress: Beyond Service Life

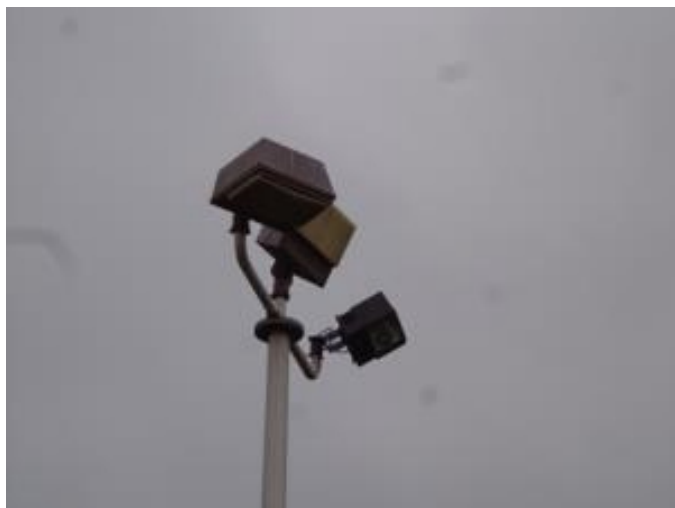
System: G4020 - Site Lighting

Location: Site

Distress: Failing

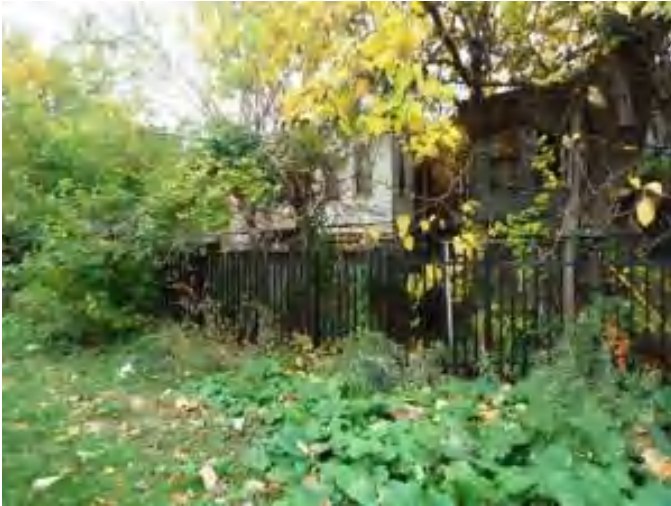
System: G2050 - Landscaping & Irrigation

The landscaping is in good condition and well maintained but with no irrigation system. The landscaping is generally located near the parking / play area of the site with limited turf sections around the general exterior of the school. This deficiency provides a budgetary consideration for the installation of an irrigation system for this site.

Location: Site

Distress: Damaged
