## Facility Condition Assessment Summary Report

### Arthur School

School District of Philadelphia  
**S248001;Arthur**  
Final  
**Site Assessment Report**

January 30, 2017

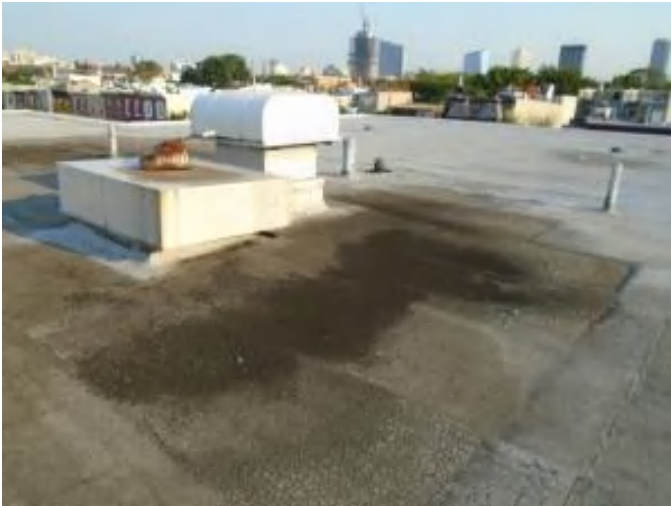
#### System: B3010105 - Built-Up

**Location:** Roof

**Distress:** Failing

- Replace roof - beyond service life and failing
- Replace interior door handles with lever type handles and latch sets
- Replace carpet - worn and beyond service life

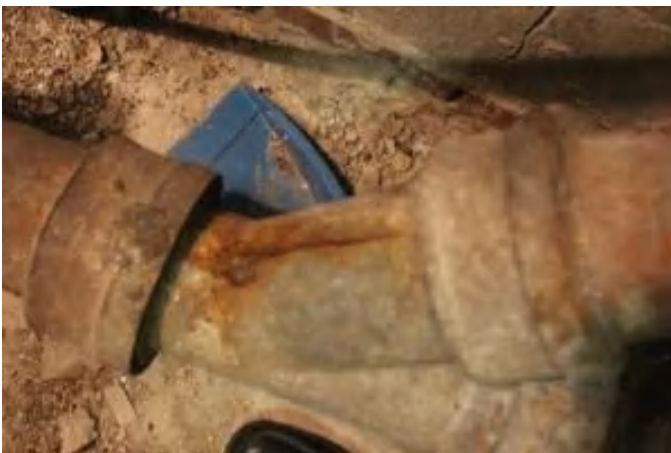
#### System: D2030 - Sanitary Waste

The sanitary sewer piping is hub and spigot cast iron pipe with lead and oakum connections. Visible areas of sanitary piping show internal rust reaching the outer surface. The entire sanitary drain piping system should be replaced. The building has a sewage ejector with two pumps.

**Location:** Entire building

**Distress:** Health Hazard / Risk

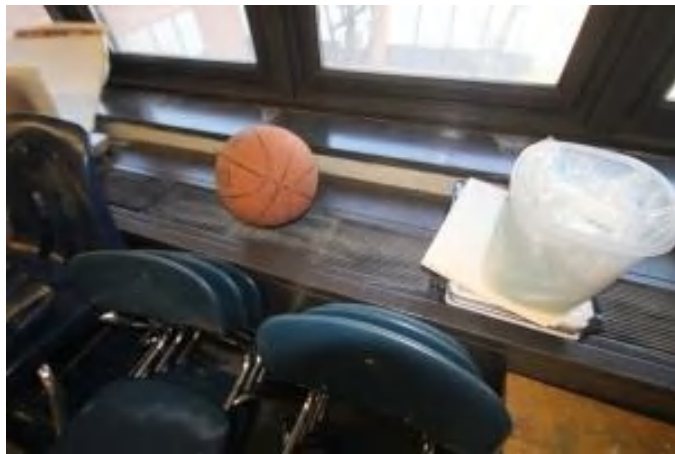
**System: D3040 - Distribution Systems**

Classroom heating and ventilation is provided by original unit ventilators and natural draft finned tube steam heaters. The unit vents have exceeded their lifespan, some are physically damaged, and their controls are obsolete, so they should be replaced. Hallways, bathrooms, and other areas are heated by natural draft steam finned tube convectors, which despite their age can be expected to serve another 10-15 years. Classroom cooling is provided by window unit air conditioners. Some classrooms do not have air conditioners, some units are inoperable, and all of them are beyond their expected service life. Where operable, these units provide adequate cooling. Air conditioners should be added to rooms lacking them and replaced where they have failed.

**Location:** Classrooms

**Distress:** Beyond Service Life

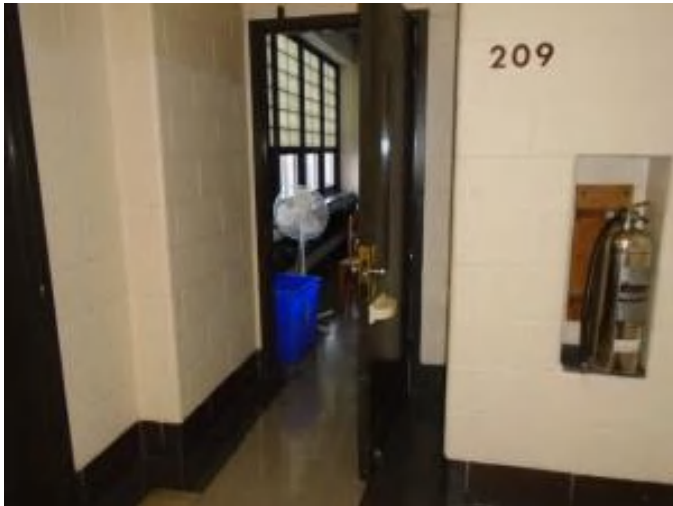
**System: C1020 - Interior Doors**

**Location:** Throughout

**Distress:** Accessibility

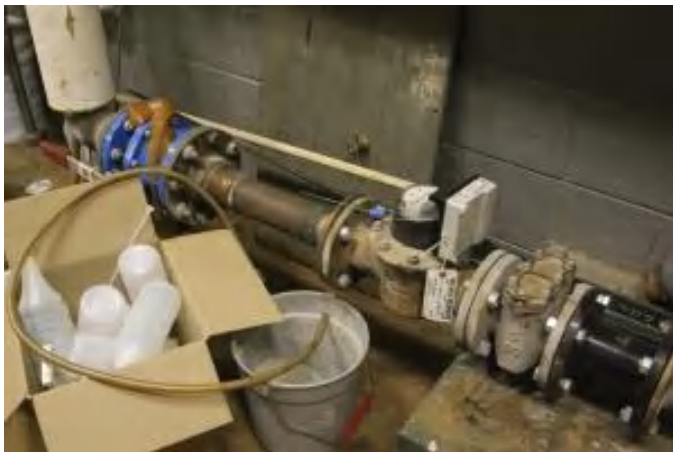
**System: D2020 - Domestic Water Distribution**

**Location:** Meter room

**Distress:** Building / MEP Codes

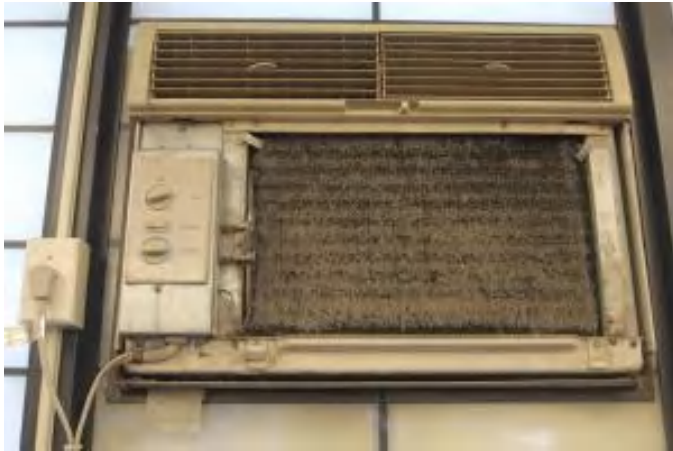
**System: D3050 - Terminal & Package Units**

**Location:** Classrooms

**Distress:** Failing

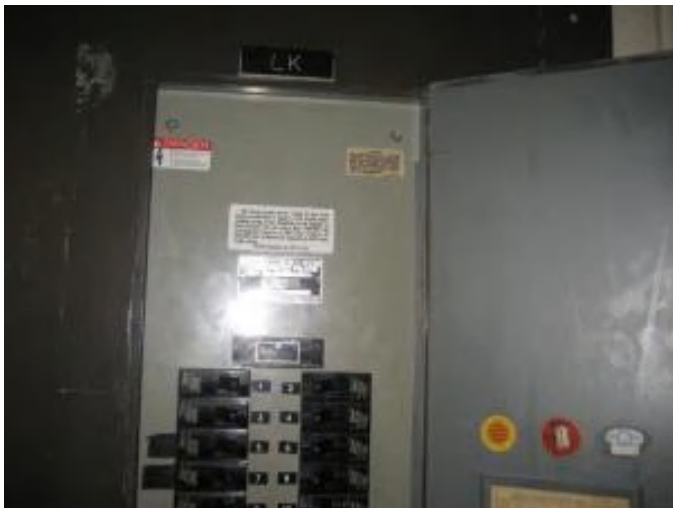
**System: D5010 - Electrical Service/Distribution**

**Location:** Entire Building

**Distress:** Inadequate

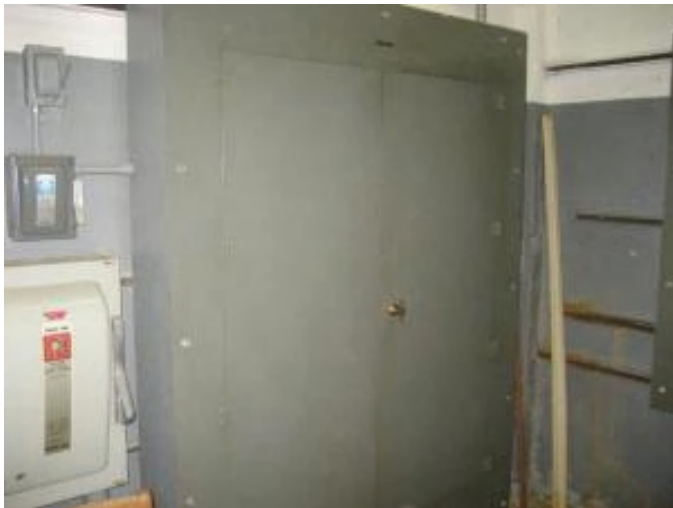
**System: D5010 - Electrical Service/Distribution**

**Location:** Basement  
**Distress:** Inadequate  
**Category:** 4 - Capital Improvement  
**Priority:** 2 - Response Time (2-3 yrs)  
**Correction:** Replace Switchboard  
**Qty:** 1.00  
**Unit of Measure:** Ea.  
**Estimate:** \$309,635.06  
**Assessor Name:** System  
**Date Created:** 10/16/2015

**Notes:** Provide a new electrical service 480V/277V, 3 phase power, approximate 800 Amperes and will be located in the vicinity of the existing electrical service.

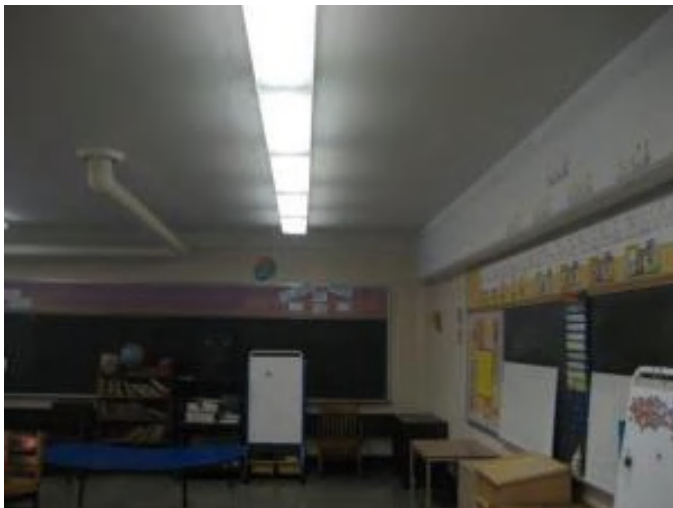
**System: D5020 - Lighting and Branch Wiring**

Classrooms, corridors, stairways, equipment rooms are illuminated with surface mounted fluorescent fixtures, with T-12 lamps. The IMC room is illuminated with pendant mounted, up/down, modern fluorescent fixtures with T-8 lamps. The auditorium is illuminated with pendant mounted architectural fixture with most probably compact fluorescent lamps. The Gymnasium is illuminated with High Intensity Discharge (HID), surface mounted fixtures. Approximately 90% of the fluorescent fixtures need to be replaced.

**Location:** Entire Building  
**Distress:** Energy Efficiency  
**Category:** 4 - Capital Improvement  
**Priority:** 2 - Response Time (2-3 yrs)  
**Correction:** Add Lighting Fixtures  
**Qty:** 552.00  
**Unit of Measure:** Ea.  
**Estimate:** \$490,337.14  
**Assessor Name:** System  
**Date Created:** 10/16/2015

**Notes:** Replace 90% of the existing fluorescent lighting fixtures with up/down, recessed fluorescent fixtures with T8 lamps in classroom/offices and corridors. Approximate 552.

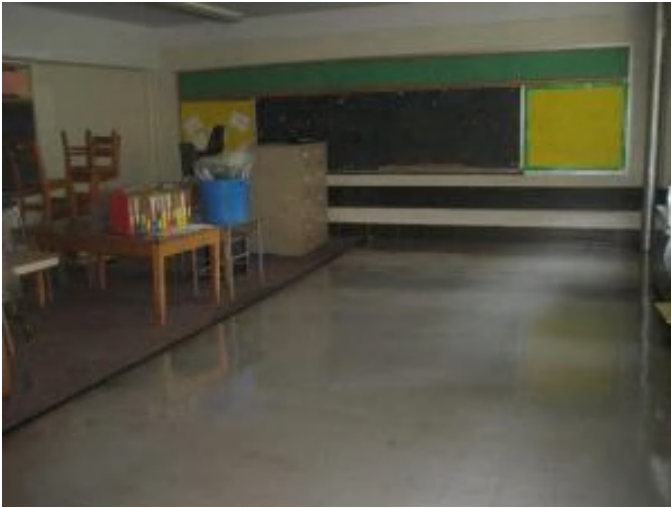
**System: D5020 - Lighting and Branch Wiring**

There numbers of receptacles in classrooms are inadequate. Teachers use extension cords. The teacher's whiteboard wall and the opposite of it need to be provided with double compartment surface raceways, the other two walls with minimum two duplex outlets each, when feasible.

**Location:** Classrooms  
**Distress:** Inadequate  
**Category:** 4 - Capital Improvement  
**Priority:** 2 - Response Time (2-3 yrs)  
**Correction:** Add wiring device  
**Qty:** 352.00  
**Unit of Measure:** Ea.  
**Estimate:** \$129,314.59  
**Assessor Name:** System  
**Date Created:** 10/16/2015

**Notes:** Provide (2)25FT of surface raceways with 24" receptacles on center and two-duplex wall mount receptacles. Approximate 352 receptacles

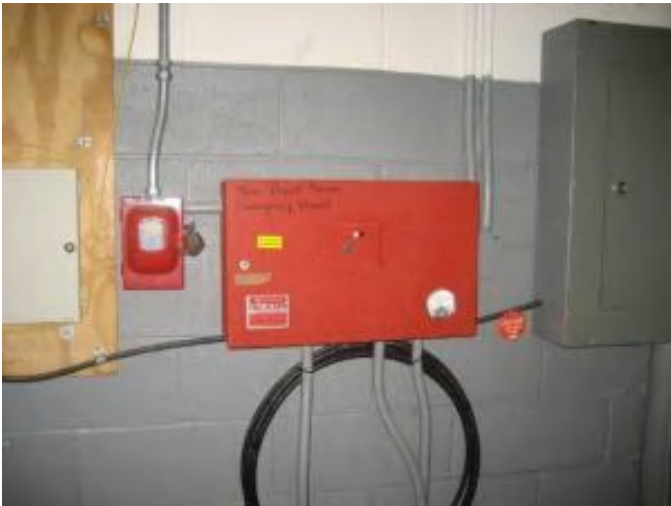
**System: D5030 - Communications and Security**

The Fire Alarm system is manufactured by Edwards. The system is approximately 30 years old. The present Fire Alarm system does not meet current code and needs to be replaced. Fire alarm system is tested every day in the morning.

**Location:** Entire Building  
**Distress:** Building / MEP Codes  
**Category:** 2 - Code Compliance  
**Priority:** 2 - Response Time (2-3 yrs)  
**Correction:** Replace fire alarm system  
**Qty:** 1.00  
**Unit of Measure:** S.F.  
**Estimate:** \$115,483.95  
**Assessor Name:** System  
**Date Created:** 10/16/2015

**Notes:** Replace old fire alarm system with addressable type with audio/visual devices at corridors and classrooms.

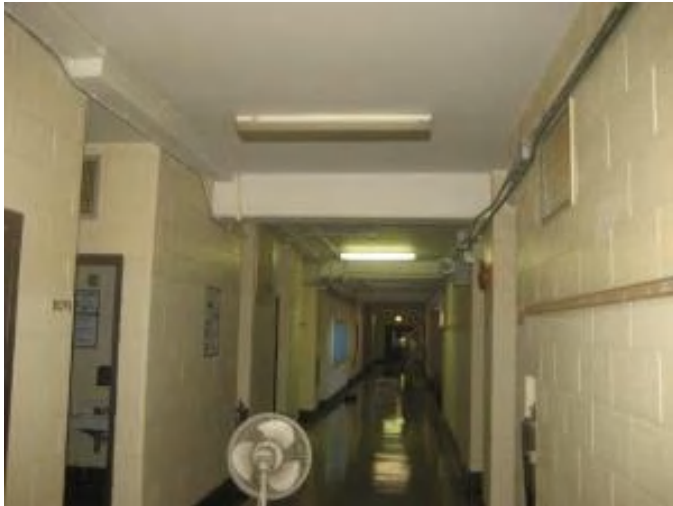
**System: D5030 - Communications and Security**

The security system consists of CCTV cameras at corridors and building exterior. There are missing CCTV cameras at the gym, south stairway the auditorium. Provide additional CCTV cameras.

**Location:** Entire Building  
**Distress:** Security Issue  
**Category:** 1 - Health & Safety  
**Priority:** 2 - Response Time (2-3 yrs)  
**Correction:** Add/Replace Video Surveillance System  
**Qty:** 22.00  
**Unit of Measure:** Ea.  
**Estimate:** \$99,013.77  
**Assessor Name:** System  
**Date Created:** 10/16/2015

**Notes:** Add CCTV cameras to provide a full coverage of the building interior. Approximate 22 CCTV cameras

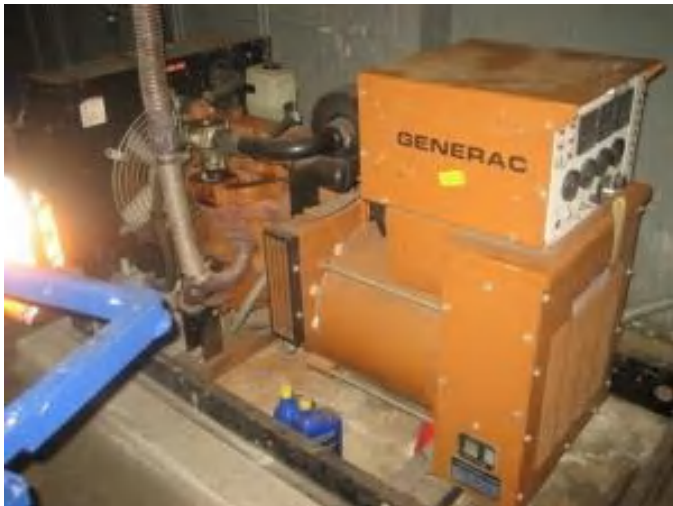
**System: D5090 - Other Electrical Systems**

**Location:** Outdoor  
**Distress:** Beyond Service Life  
**Category:** 3 - Operations / Maint.  
**Priority:** 2 - Response Time (2-3 yrs)  
**Correction:** Add Standby Generator System  
**Qty:** 1.00  
**Unit of Measure:** Ea.  
**Estimate:** \$102,936.23  
**Assessor Name:** System  
**Date Created:** 10/16/2015

**Notes:** Provide 50KW, outdoor, diesel powered generator

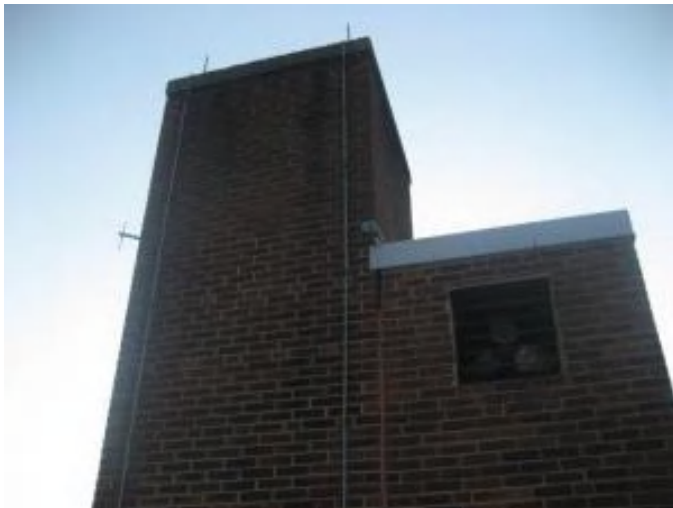
**System: D5090 - Other Electrical Systems**

**Location:** Roof  
**Distress:** Building / MEP Codes  
**Category:** 2 - Code Compliance  
**Priority:** 2 - Response Time (2-3 yrs)  
**Correction:** Provide Lightning Protection System  
**Qty:** 1.00  
**Unit of Measure:** LS  
**Estimate:** \$21,472.30  
**Assessor Name:** System  
**Date Created:** 10/19/2015

**Notes:** Prepare a study to determine if the existing lightning system provide the proper protection to the school building.

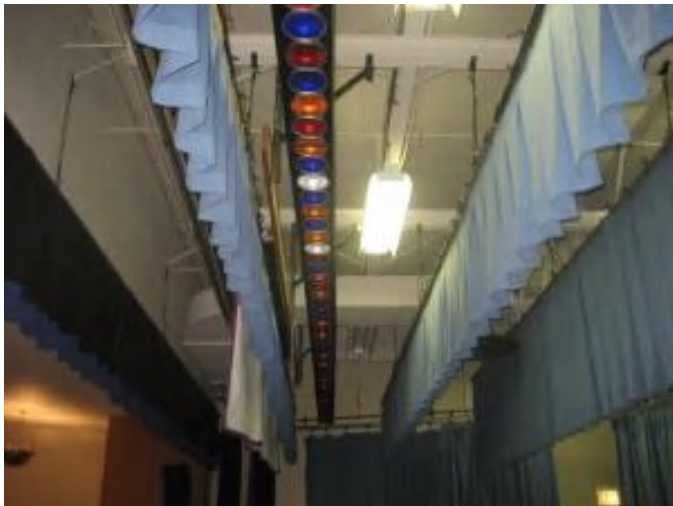
**System: E1020 - Institutional Equipment**

**Location:** Auditorium  
**Distress:** Inadequate  
**Category:** 4 - Capital Improvement  
**Priority:** 2 - Response Time (2-3 yrs)  
**Correction:** Add/Replace Stage Theatrical Lighting System  
**Qty:** 1.00  
**Unit of Measure:** Ea.  
**Estimate:** \$323,055.06  
**Assessor Name:** System  
**Date Created:** 10/19/2015

**Notes:** Provide a dimming system and additional theatrical lighting.

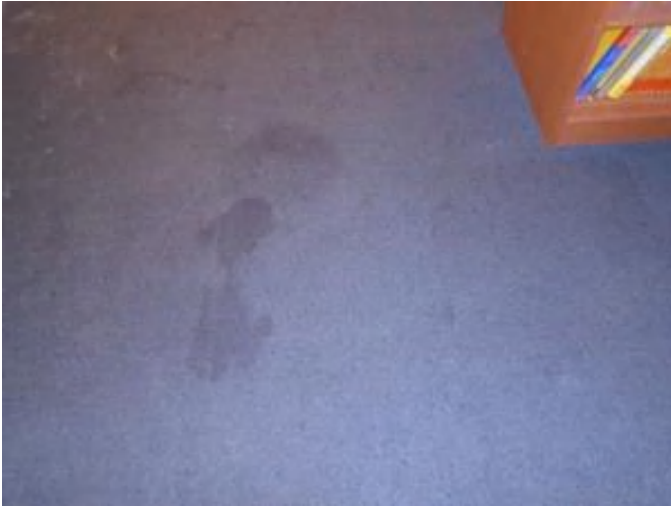
**System: C3020411 - Carpet**

**Location:** Various

**Distress:** Appearance

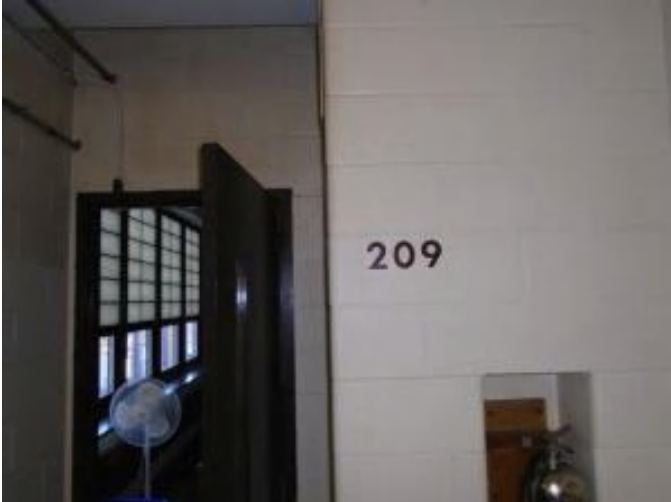
**System: C3030 - Ceiling Finishes**

**Location:** Corridors

**Distress:** Inadequate

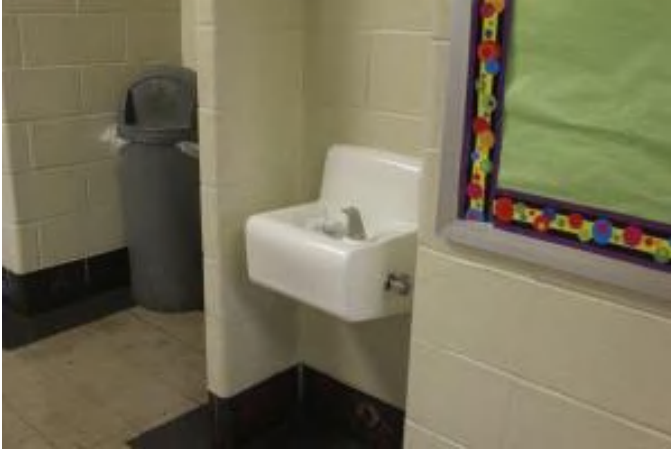
**System: D2010 - Plumbing Fixtures**

Drinking fountains in the corridors are mixture of porcelain and stainless steel, wall hung without coolers. They are not accessible and have exceeded their service life and should be replaced.

**Location:** Entire building  
**Distress:** Accessibility  
**Category:** 2 - Code Compliance  
**Priority:** 3 - Response Time (3-4 yrs)  
**Correction:** Remove and Replace Water Fountains - without ADA new recessed alcove  
**Qty:** 10.00  
**Unit of Measure:** Ea.  
**Estimate:** \$75,791.90  
**Assessor Name:** System  
**Date Created:** 09/03/2015

**Notes:** Replace aged, non-accessible drinking fountains.

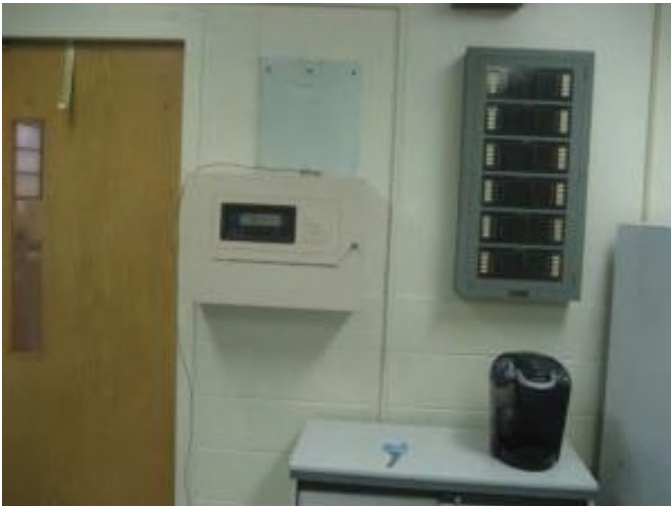
**System: D5030 - Communications and Security**

The present clocks are old and difficult to find parts and repair. Replace clock system with wireless, battery operated, clock system.

**Location:** Entire Building  
**Distress:** Obsolete  
**Category:** 3 - Operations / Maint.  
**Priority:** 3 - Response Time (3-4 yrs)  
**Correction:** Add/Replace Clock System or Components  
**Qty:** 39.00  
**Unit of Measure:** Ea.  
**Estimate:** \$112,560.22  
**Assessor Name:** System  
**Date Created:** 10/19/2015

**Notes:** Replace clock and bell system with wireless, battery operated, clock system. Approximate 39 clocks

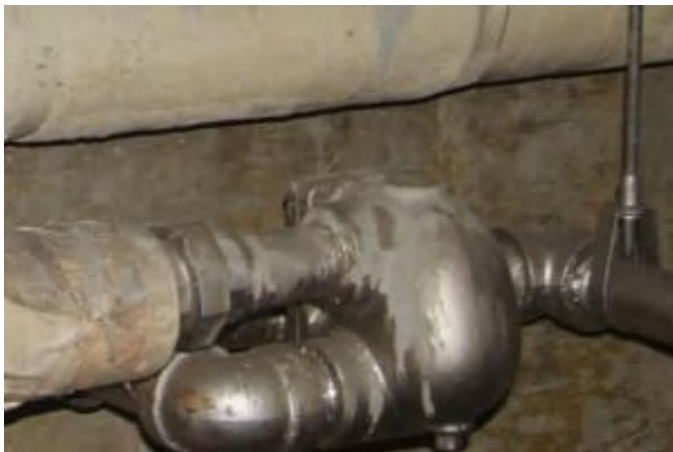
**System: D3040 - Distribution Systems**

Steam piping is threaded steel. There is no history of steam trap replacement, and they should be surveyed based on age. The building engineer stated he did not need large amounts of makeup water for the steam system. There is presently no hydronic piping or pumps.

**Location:** Entire building.

**Distress:** Maintenance Required

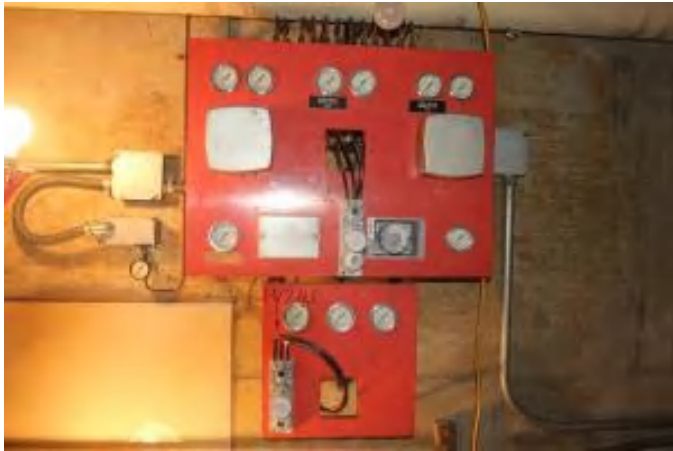
**System: D3060 - Controls & Instrumentation**

**Location:** Entire building

**Distress:** Energy Efficiency

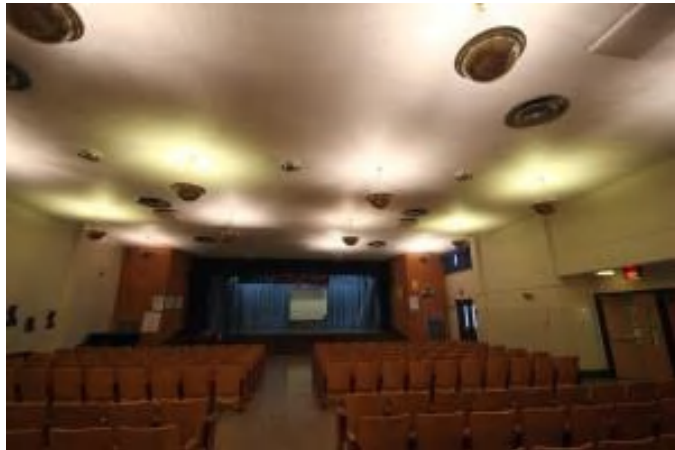
**System: D3030 - Cooling Generating Systems**

**Location:** Auditorium and gym

**Distress:** Inadequate

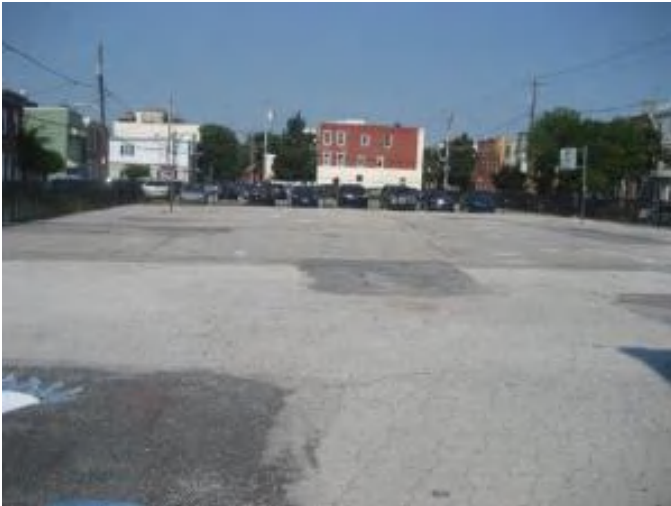
#### System: G4020 - Site Lighting

**Location:** Outdoor

**Distress:** Security Issue

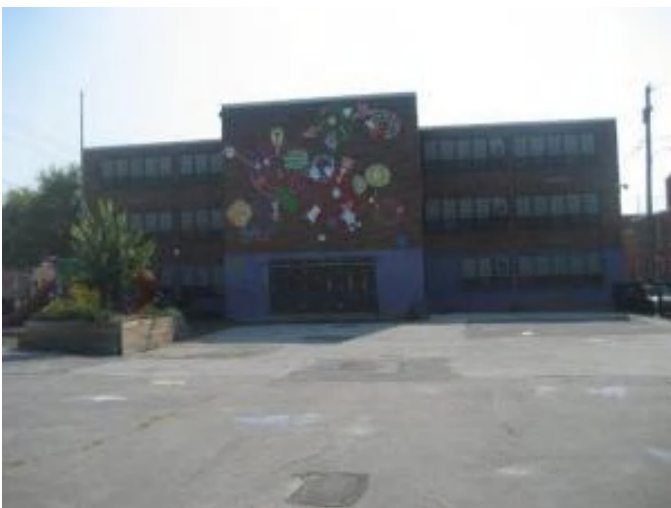
#### System: G4030 - Site Communications & Security

**Location:** Outdoor

**Distress:** Inadequate

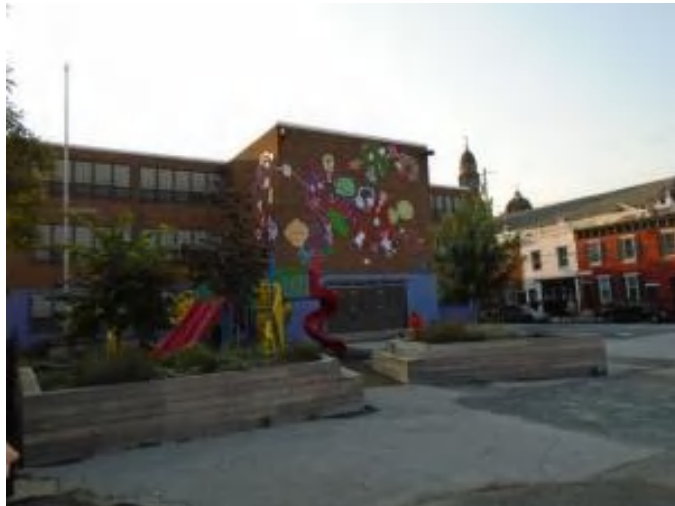
**System: G2020 - Parking Lots**

The site surrounds the building on all four sides which is set back from the street. Yard area on the west side is asphalt paving in poor condition with multiple patches and in need of resurfacing. Parking for staff vehicles is on the far west side and is accessible via Webster St. Metal fence surrounding and separating yard and parking area is in good condition. Fencing and gates at courtyards are also in good condition. Play structure and fall protection surface is in good condition. Landscaping is limited to courtyards on north and south sides of building with mature trees in need of trimming at south student entrance.

**Location:** Yard

**Distress:** Failing
