## Facility Condition Assessment Summary Report

### Arts and Sciences (Edmunds, HR) School

**S725001;Edmunds, H**

**Site Assessment Report**

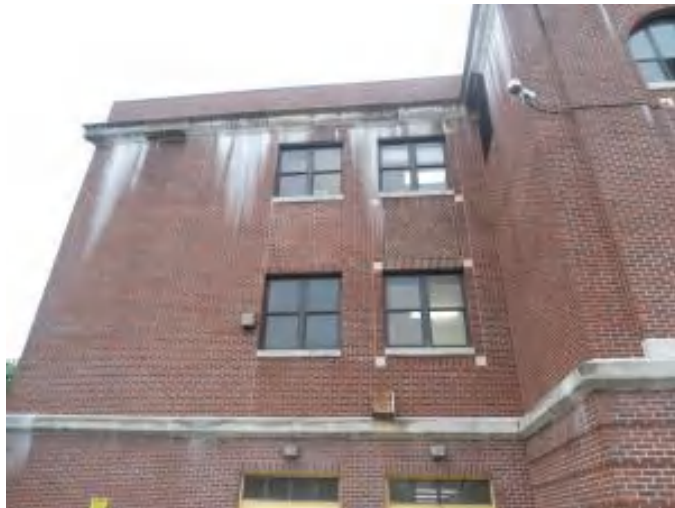
#### System: B2010 - Exterior Walls

**Location:** Exterior Elevation

**Distress:** Failing

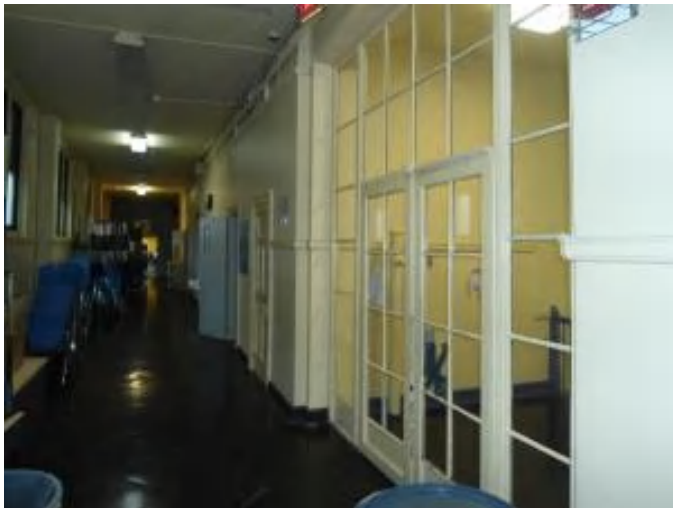
**System: C1010 - Partitions**

**Location:** Building Wide

**Distress:** Life Safety / NFPA / PFD

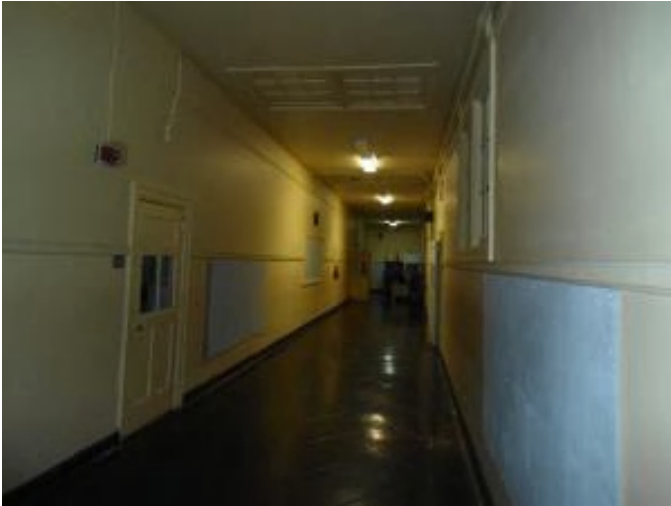
**System: C1030 - Fittings**

**Location:** Building Wide

**Distress:** Beyond Service Life

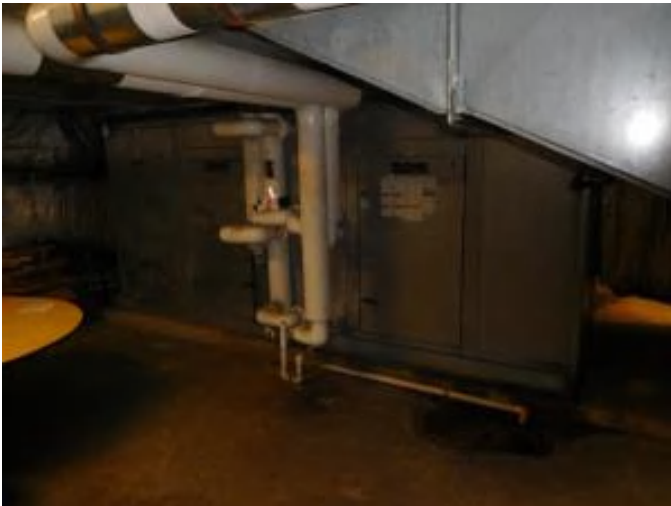
**System: D3060 - Controls & Instrumentation**

**Location:** entire building

**Distress:** Inadequate

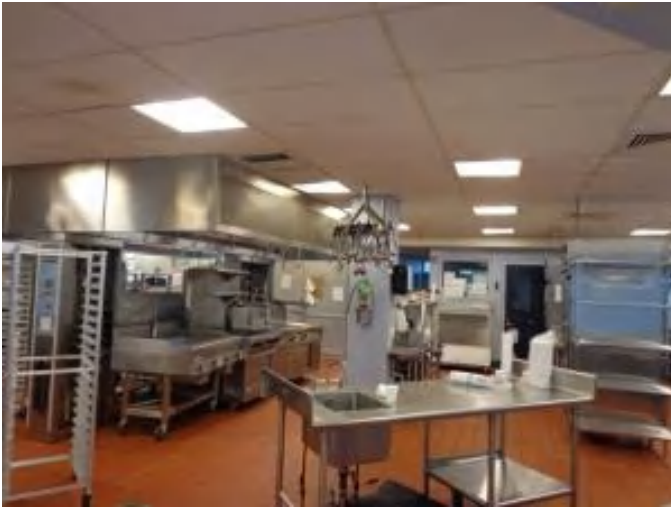
**System: D5020 - Lighting and Branch Wiring**

**Location:** Kitchen

**Distress:** Life Safety / NFPA / PFD

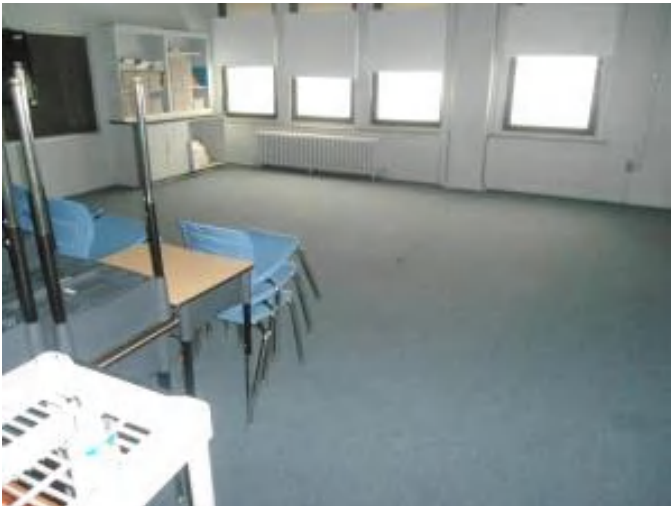
**System: E2010 - Fixed Furnishings**

**Location:** Building Wide

**Distress:** Beyond Service Life

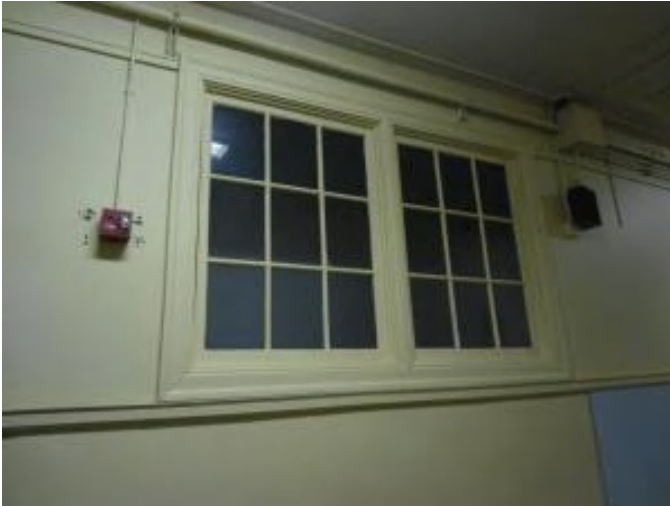
**System: C1010 - Partitions**

**Location:** Building Wide

**Distress:** Life Safety / NFPA / PFD

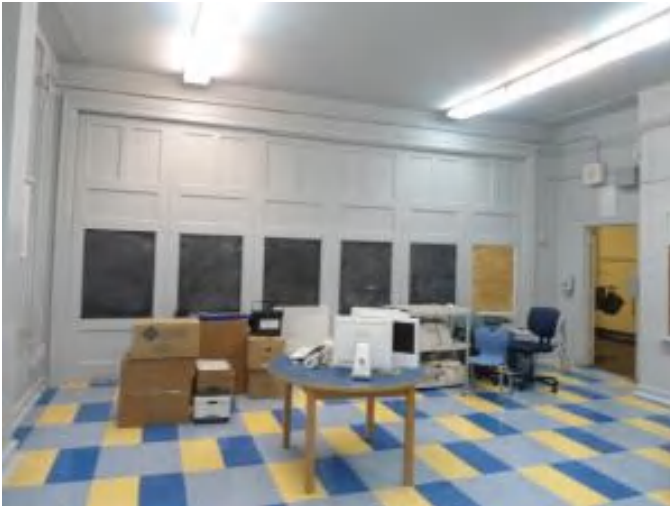
**System: C1010 - Partitions**

**Location:** Building Wide

**Distress:** Building / MEP Codes

**Notes:** The movable partition that has been modified and no longer functions as originally designed in room 300 and is a good example for a universal correction. This wall has been modified to suite the classroom needs however does not reflect the most recent code requirements. This deficiency recommends universal removal of the existing movable partitions and upgrades to a permeate wall systems.

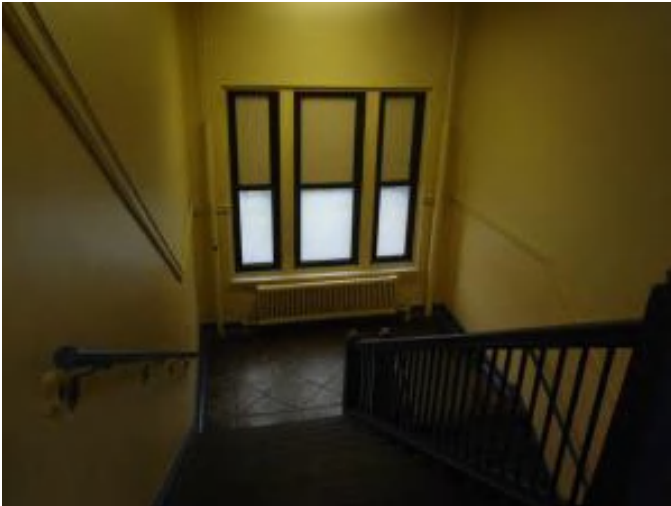
**System: C2010 - Stair Construction**

**Location:** Stairs

**Distress:** Building / MEP Codes

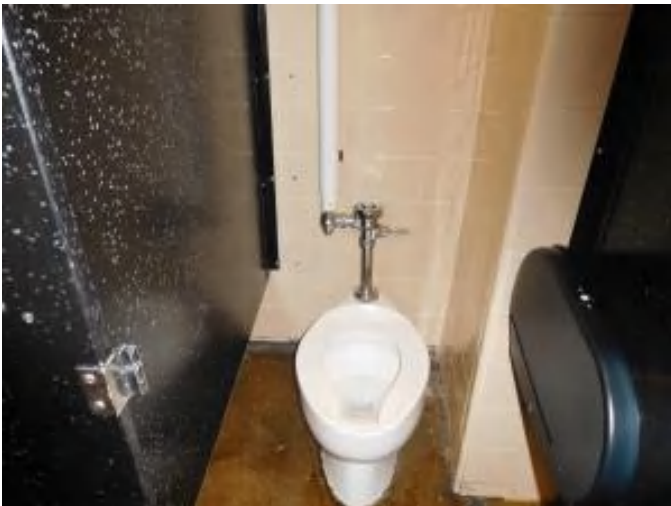
**System: D2010 - Plumbing Fixtures**

**Location:** toilet rooms

**Distress:** Beyond Service Life

**Notes:** Replace older plumbing fixtures, including water closets, lavatories, urinals, service sinks, and water coolers. Include fittings and trim.

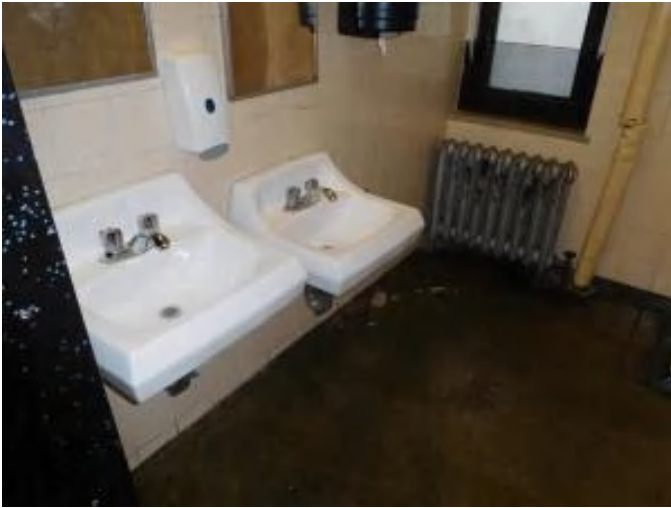
**System: D2010 - Plumbing Fixtures**

**Location:** toilet rooms

**Distress:** Beyond Service Life

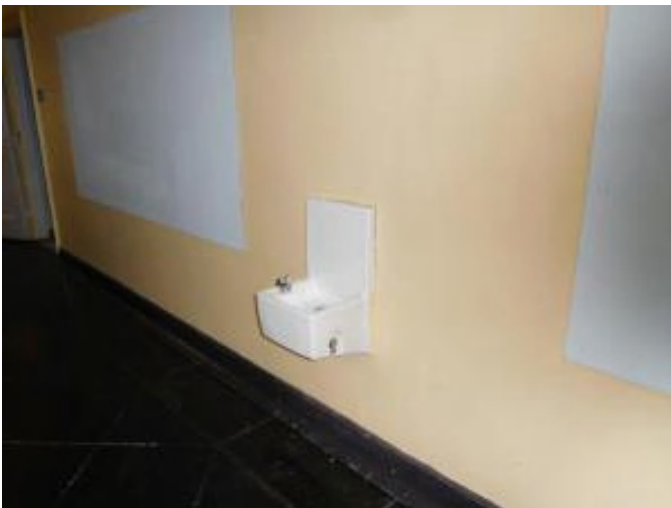
**System: D2010 - Plumbing Fixtures**

**Location:** corridors

**Distress:** Beyond Service Life

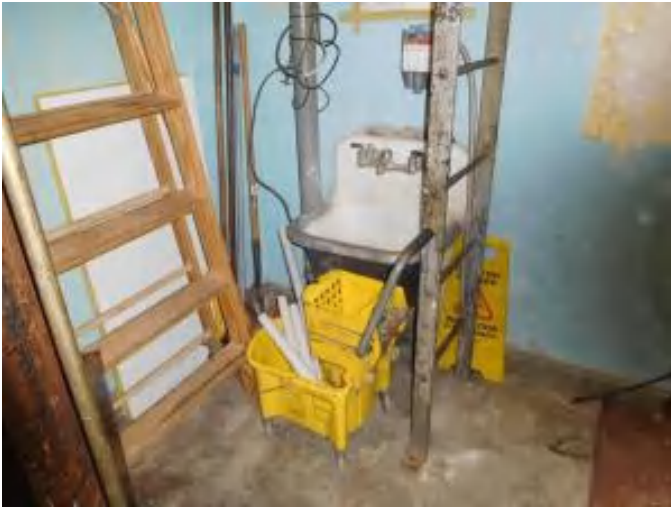
**System: D2030 - Sanitary Waste**

**Location:** entire building

**Distress:** Beyond Service Life

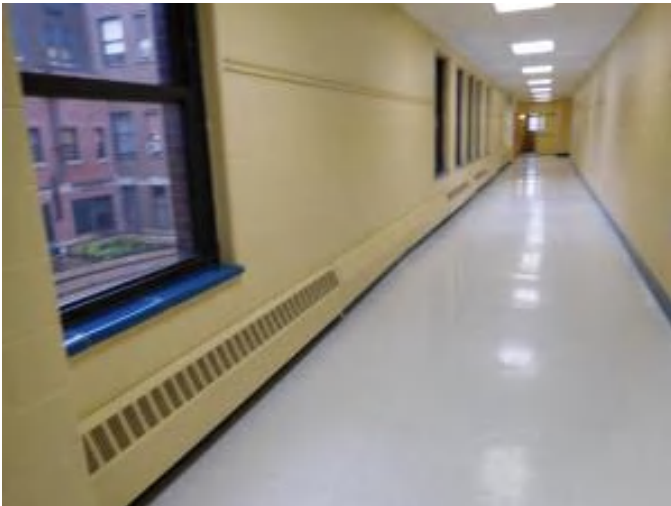
**System: D3040 - Distribution Systems**

**Location:** original building

**Distress:** Inadequate

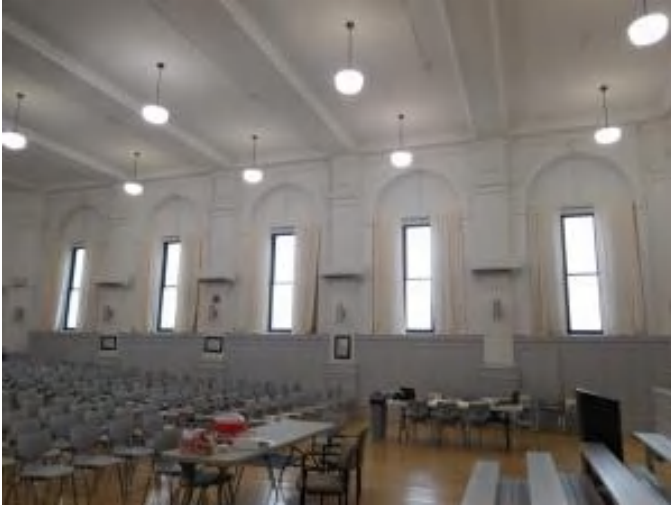
**System: D3040 - Distribution Systems**

**Location:** auditorium

**Distress:** Building / MEP Codes

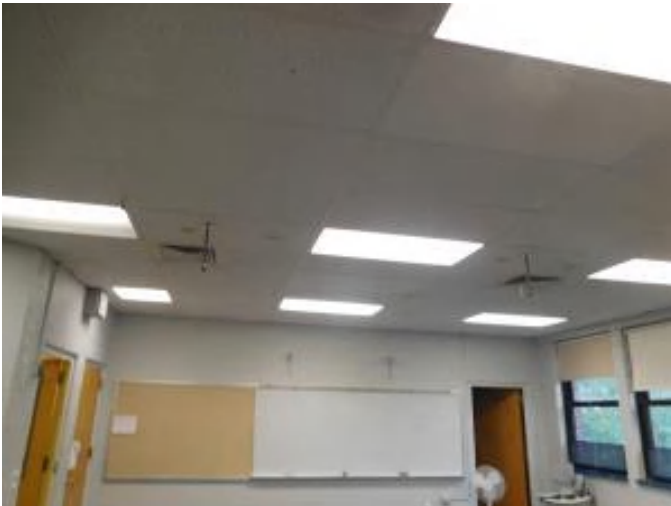
**System: D4010 - Sprinklers**

**Location:** entire building

**Distress:** Life Safety / NFPA / PFD

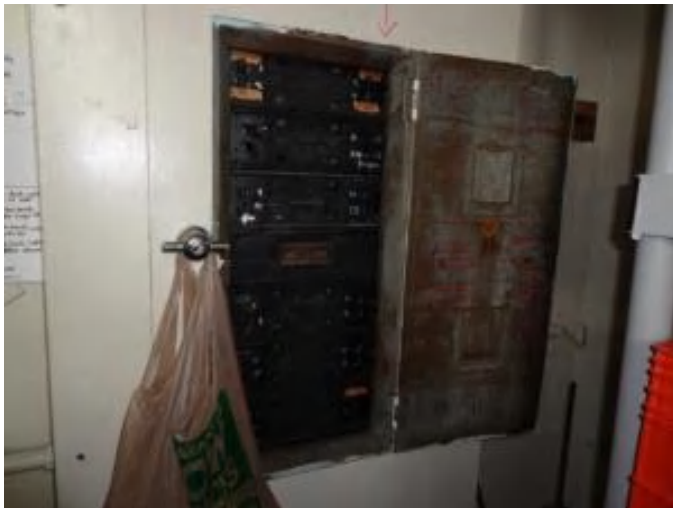
**System: D5010 - Electrical Service/Distribution**

**Location:** Auditorium platform

**Distress:** Beyond Service Life

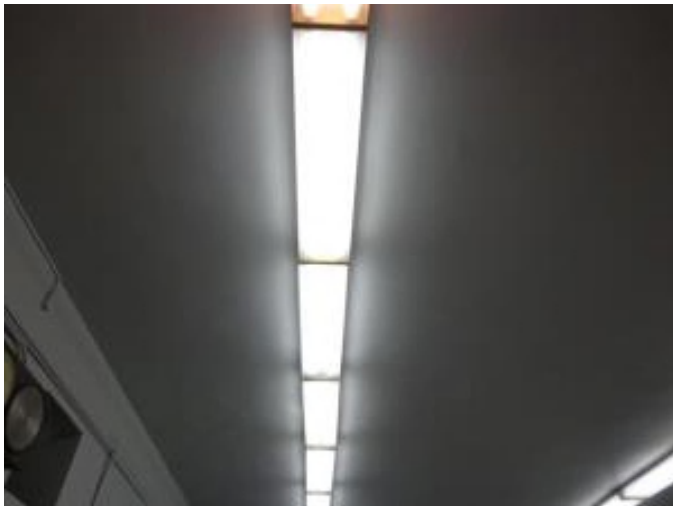
**System: D5020 - Lighting and Branch Wiring**

**Location:** 1924 Building

**Distress:** Beyond Service Life

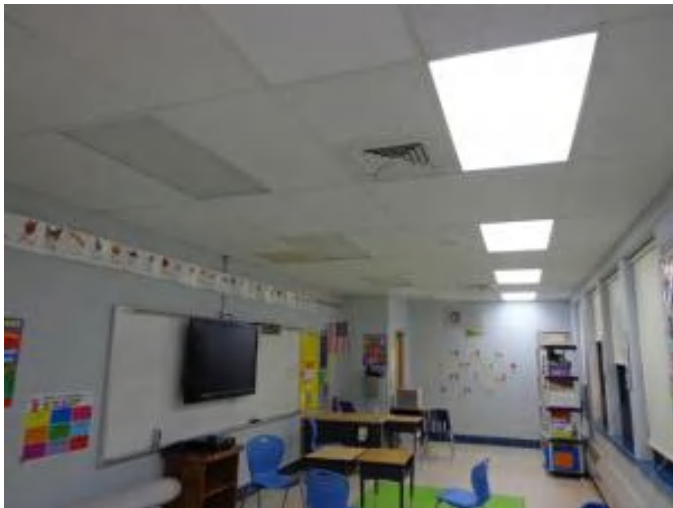
**System: D5030 - Communications and Security**

**Location:** Classrooms

**Distress:** Life Safety / NFPA / PFD

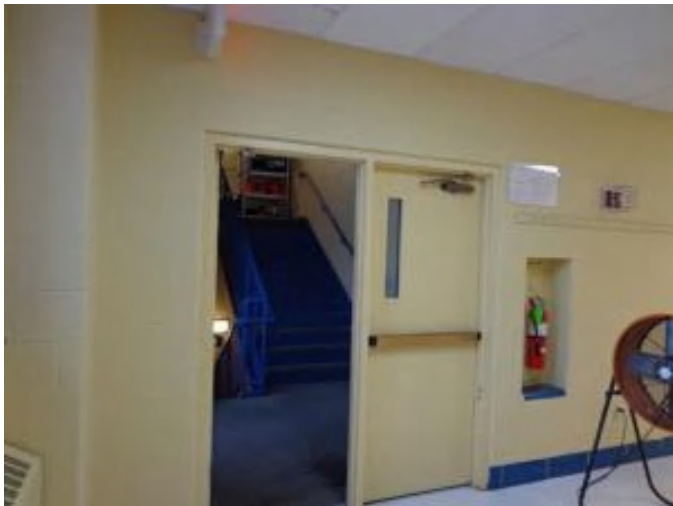
**System: D5030 - Communications and Security**

**Location:** Entire building

**Distress:** Life Safety / NFPA / PFD

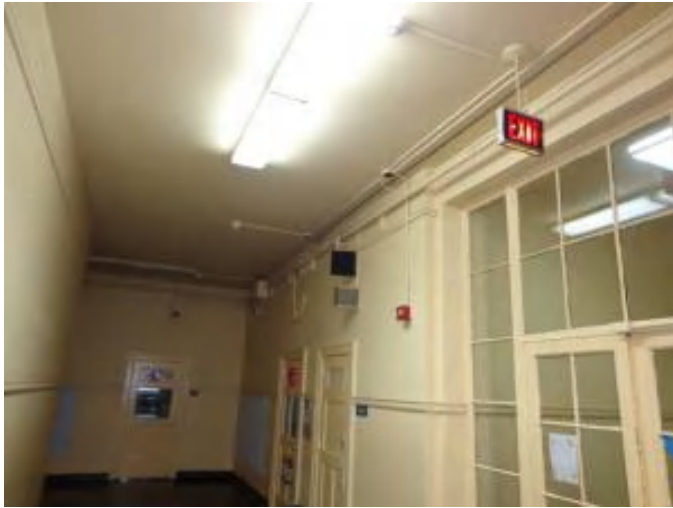
**System: D5090 - Other Electrical Systems**

**Location:** 1924 Building

**Distress:** Beyond Service Life

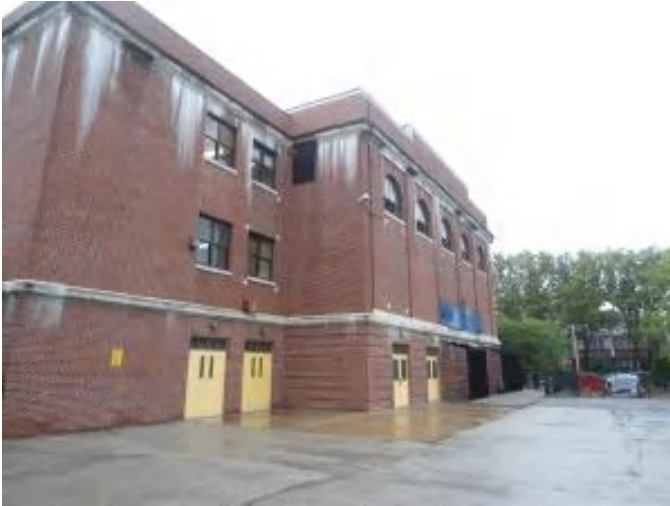
### System: B2010 - Exterior Walls

**Location:** Exterior Elevation

**Distress:** Beyond Service Life

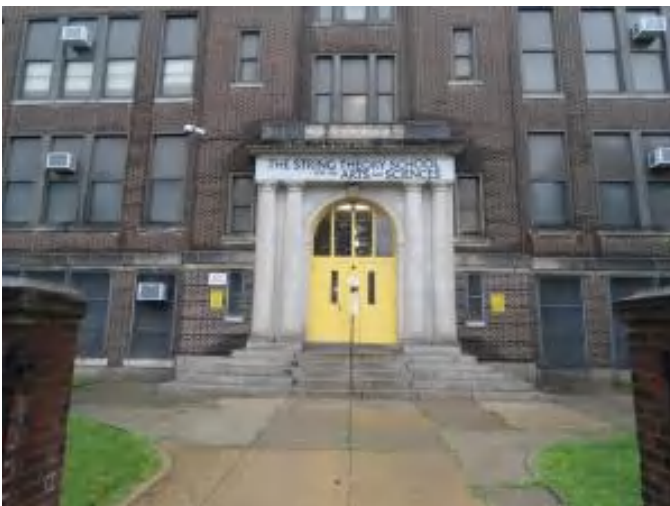
### System: B2030 - Exterior Doors

**Location:** Exterior Elevation

**Distress:** Damaged

**Notes:** The exterior doors are metal applications with metal frames. The exterior door system for this school is a very high traffic system. The doors are in fair condition but are aging at a faster rate than expected based on traffic and condition. The exterior door system, store front and service doors are recommended for upgrade.

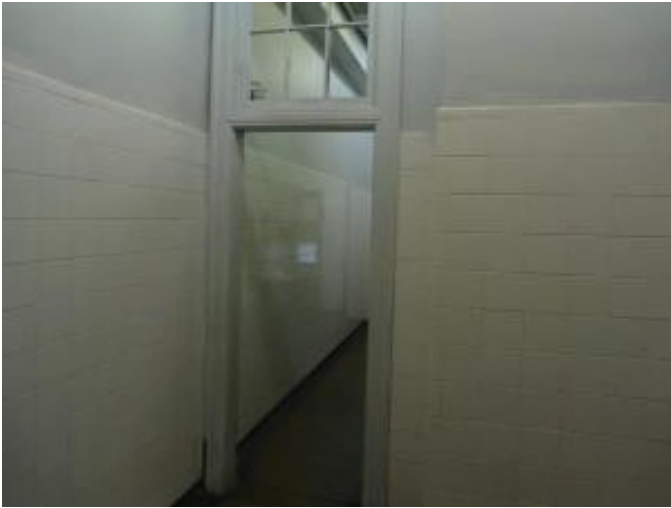
**System: C1020 - Interior Doors**

**Location:** Building Wide

**Distress:** Life Safety / NFPA / PFD

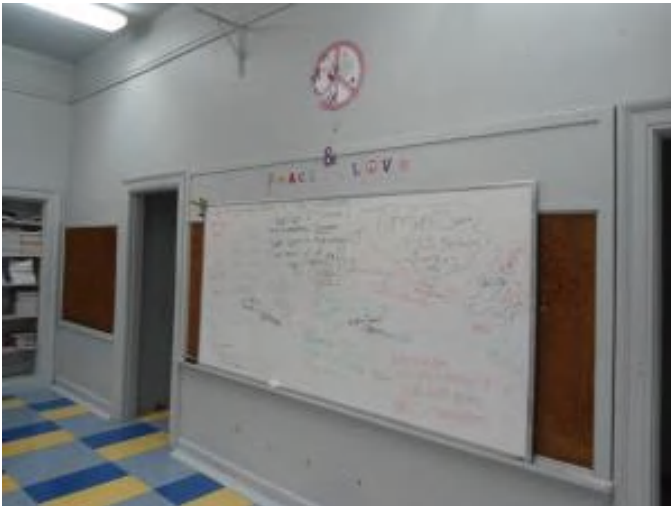
**System: C1030 - Fittings**

**Location:** Building Wide

**Distress:** Beyond Service Life

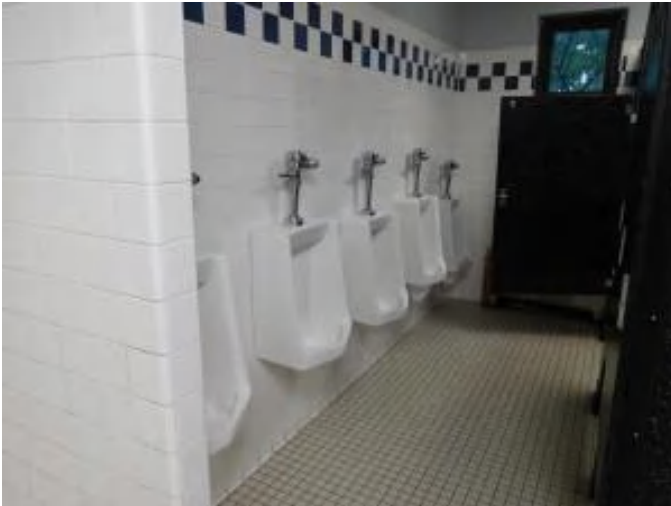
**System: D2010 - Plumbing Fixtures**

**Location:** toilet rooms

**Distress:** Beyond Service Life

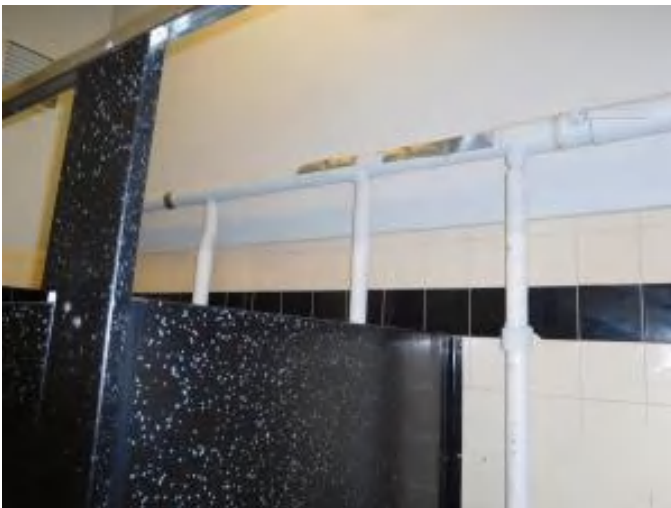
**System: D2020 - Domestic Water Distribution**

**Location:** entire building

**Distress:** Beyond Service Life

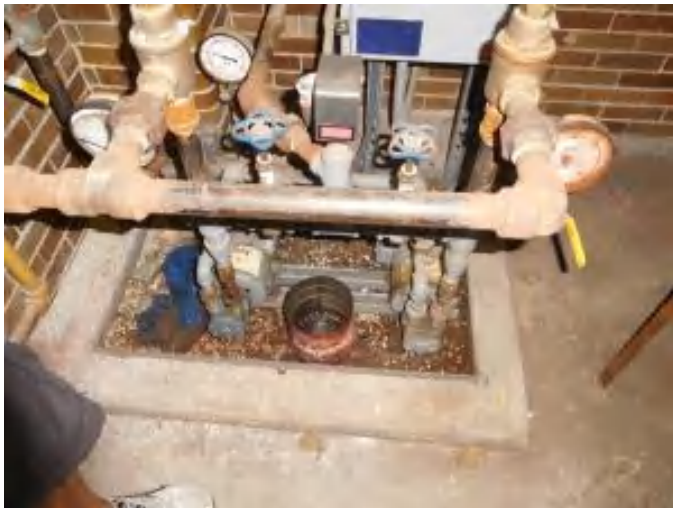
**System: D3020 - Heat Generating Systems**

**Location:** ballet mechanical room

**Distress:** Failing

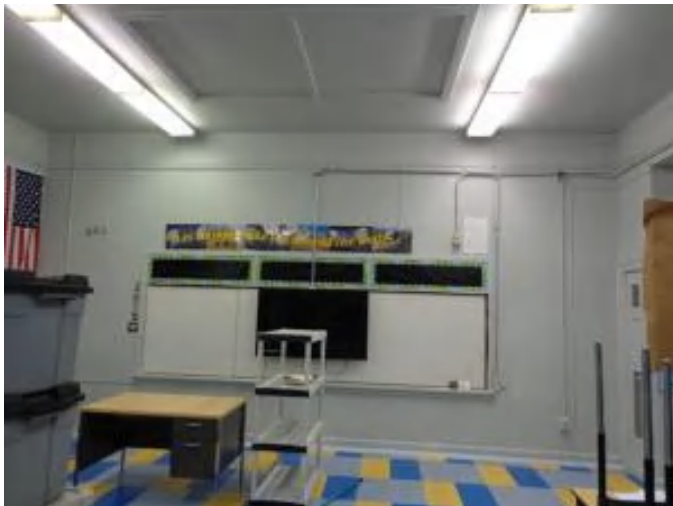
**System: D5020 - Lighting and Branch Wiring**

**Location:** Classrooms

**Distress:** Inadequate

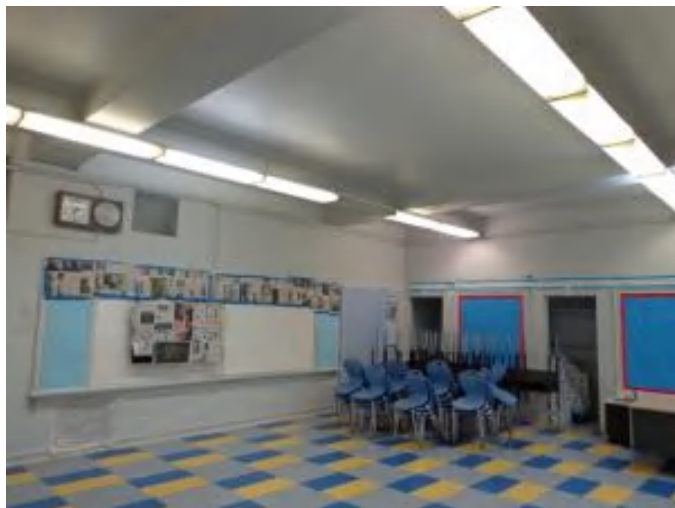
**System: D5030 - Communications and Security**

**Location:** Classrooms, offices

**Distress:** Beyond Service Life

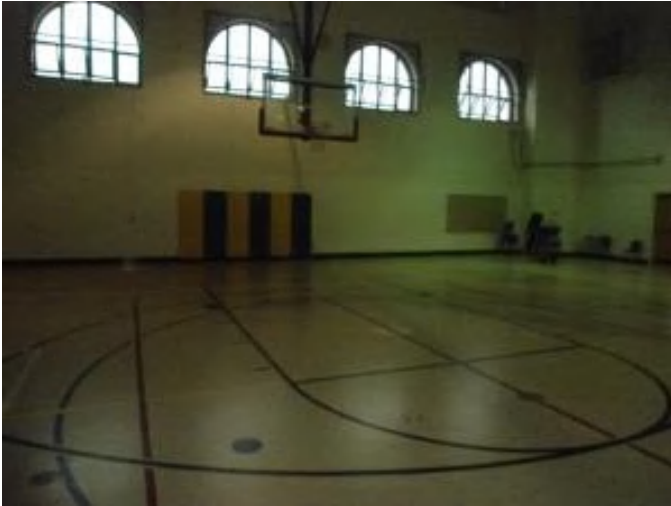
**System: B2020 - Exterior Windows**

**Location:** Exterior Elevation

**Distress:** Beyond Service Life

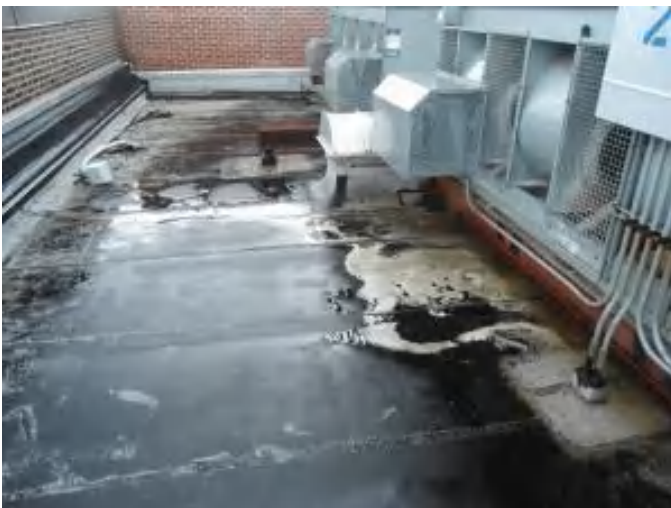
**System: B3010105 - Built-Up**

**Location:** Roof

**Distress:** Beyond Service Life

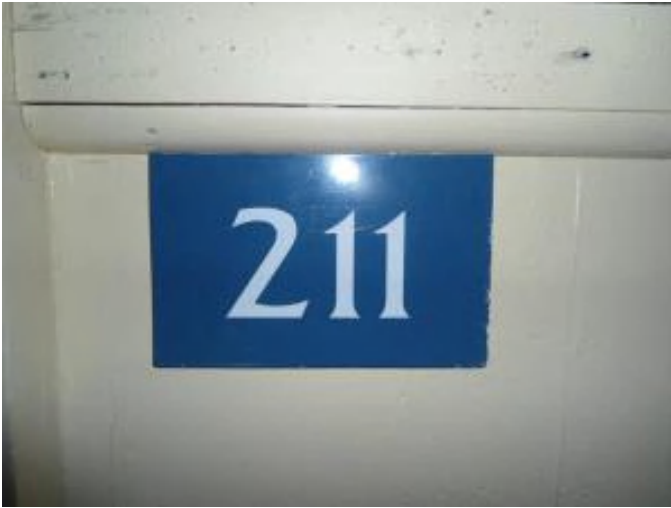
**System: C1030 - Fittings**

**Location:** Building Wide Signage

**Distress:** Beyond Service Life

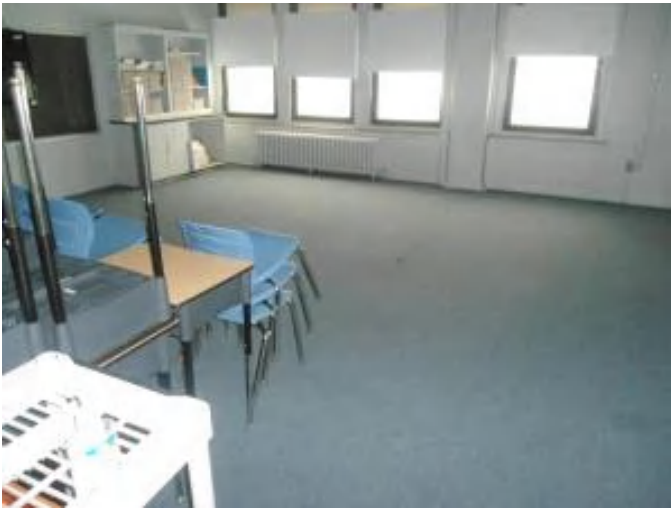
**System: C3020411 - Carpet**

**Location:** Admin and Library

**Distress:** Beyond Service Life

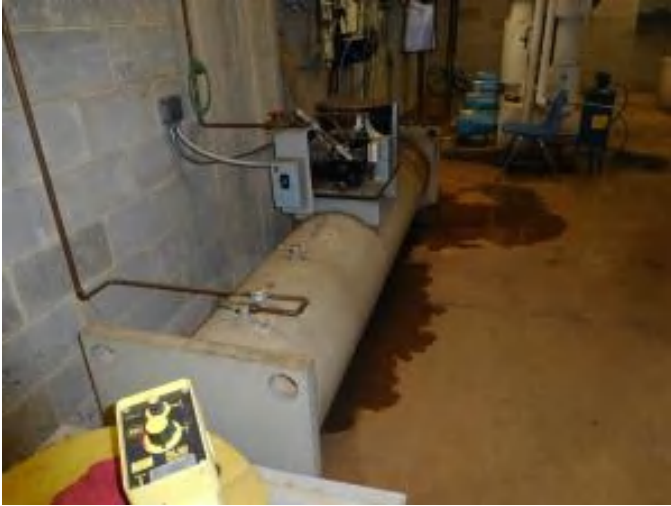
**System: D3030 - Cooling Generating Systems**

**Location:** roof, mechanical room

**Distress:** Inadequate

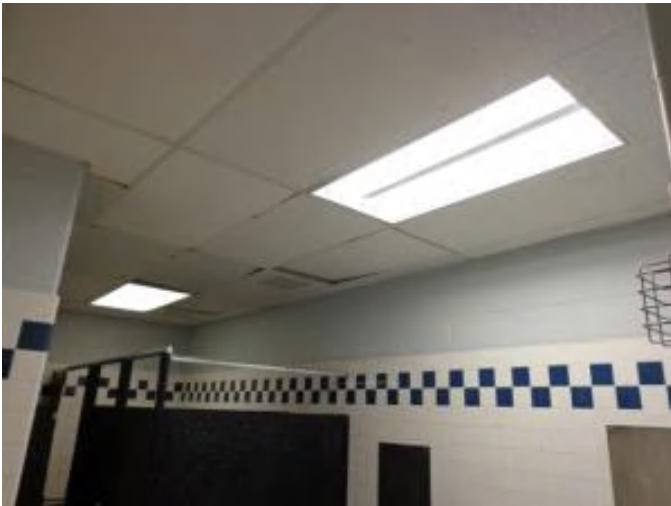
**System: D5020 - Lighting and Branch Wiring**

**Location:** 1998 Addition

**Distress:** Damaged

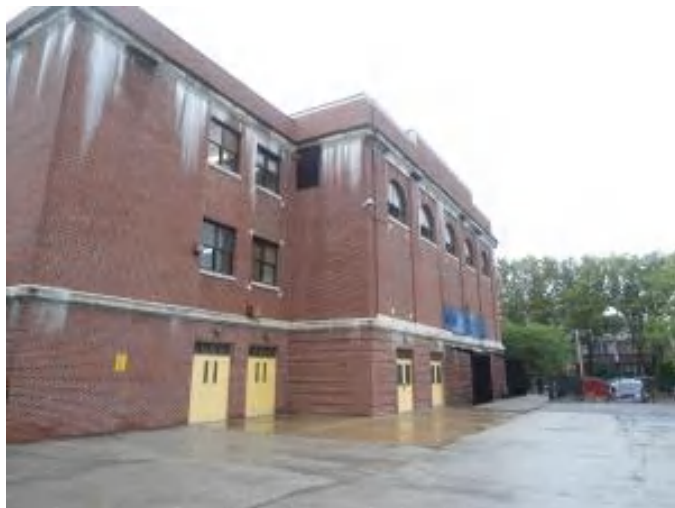
**System: E1090 - Other Equipment**

**Location:** Loading Dock

**Distress:** Beyond Service Life

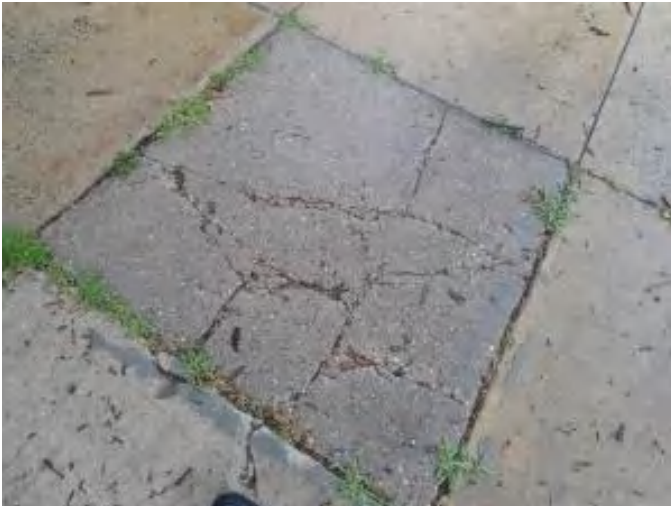
#### **System: G2030 - Pedestrian Paving**

**Location:** Exterior Elevation

**Distress:** Damaged

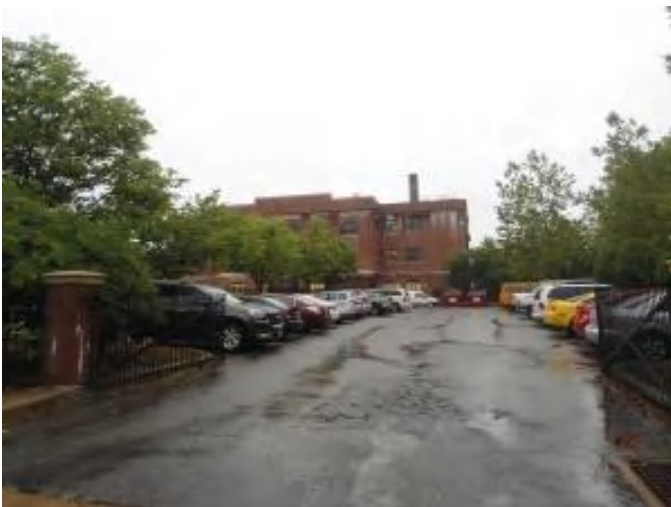
#### **System: G2040 - Site Development**

**Location:** Parking Lot

**Distress:** Health Hazard / Risk

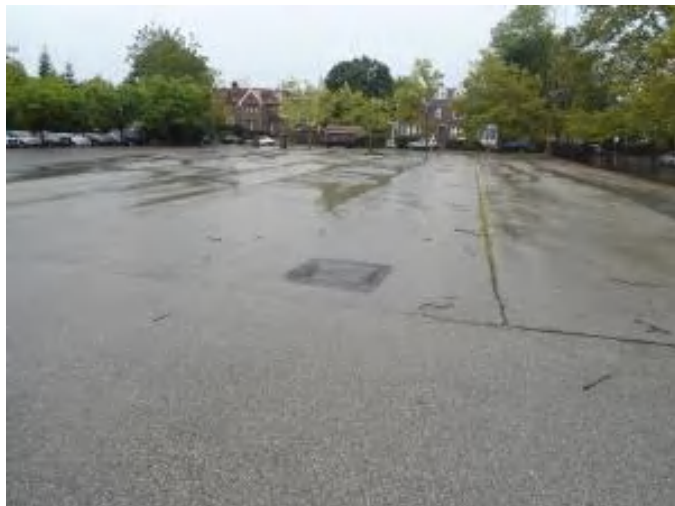
**System: G2020 - Parking Lots**

**Location:** Play Area

**Distress:** Beyond Service Life

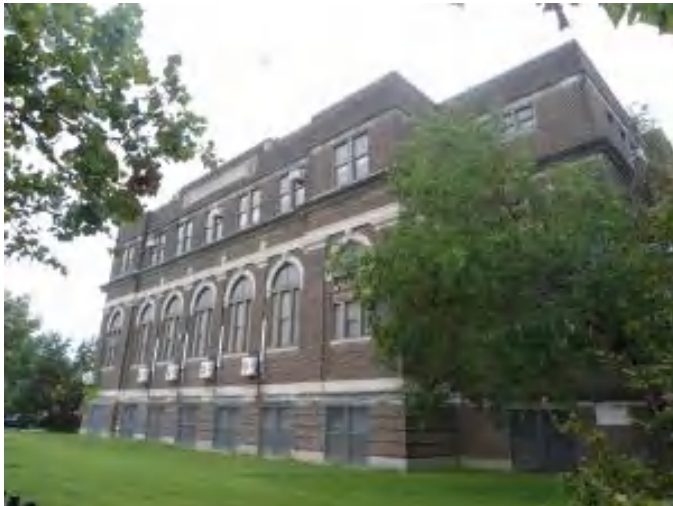
**System: G2050 - Landscaping & Irrigation**

**Location:** Site

**Distress:** Inadequate
