## Facility Condition Assessment Summary Report

### Audenried high School

School District of Philadelphia  
**S280001; Audenried**  
Final  
**Site Assessment Report**  
February 1, 2017

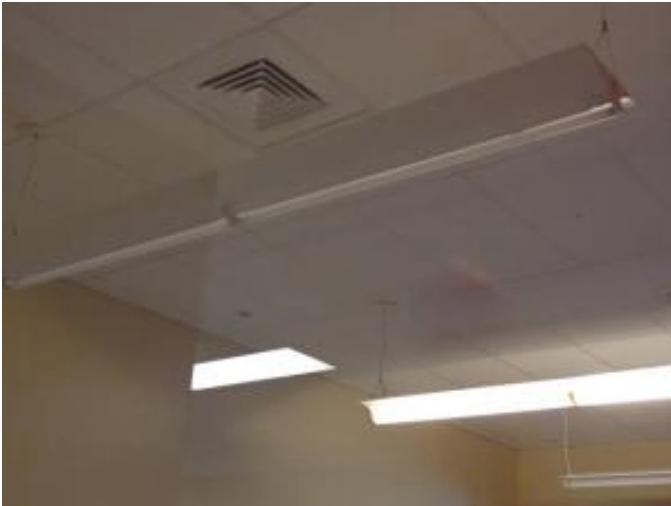
**Location:** Weight Room E120

Cable suspended direct/indirect fluorescent fixtures with T8 lamps are located in the cafeteria, clerical areas, vocal and instrumental music rooms, weight room and IMC. There are approximately 10 lighting fixtures in Weight Room E120 that have damaged fixture diffusers or housings and need to be replaced.

**Distress:** Damaged

**Correction:** Replace lighting fixtures

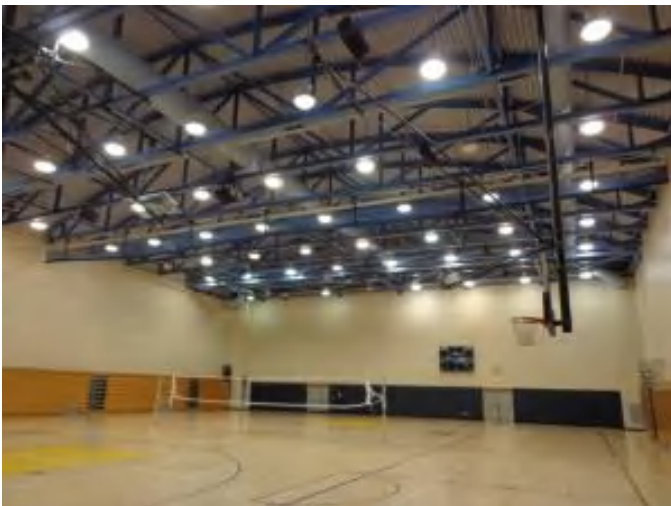
**Location:** Gymnasium E100

The two gymnasiums and diesel academy are provided with low-bay industrial metal halide fixtures with prismatic lenses. There are seven (7) lighting fixtures in Gymnasium E100 that are not working and need to be re-lamped or repaired. Lighting is controlled by key switches. Industrial fluorescent fixtures are used in mechanical and electrical rooms and similar spaces.

**Distress:** Maintenance Required

**Notes:** Re-lamp or repair seven (7) lighting fixtures in Gymnasium E100 that are not working.

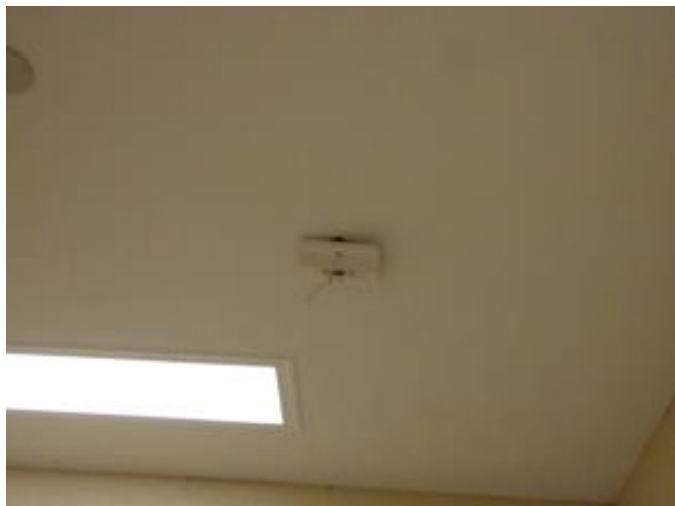
**Location:** Food Lab D215 and Locker Rooms

**Distress:** Damaged

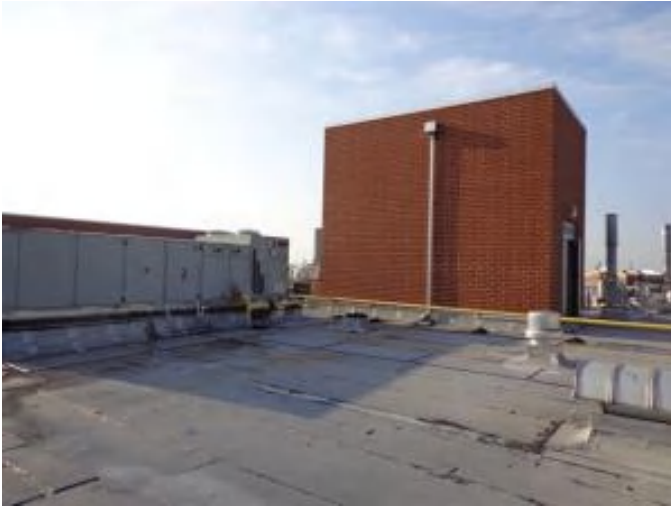
**Location:** Roof

There are lighting fixtures on the exterior of the building above the access doors to each roof, but no additional lighting at rooftop equipment. It is recommended for service and safety considerations that at least four (4) floodlighting fixtures with light switches be provided on the lower roof and two (2) floodlighting fixtures with light switch be provided on the higher roof.

**Distress:** Inadequate

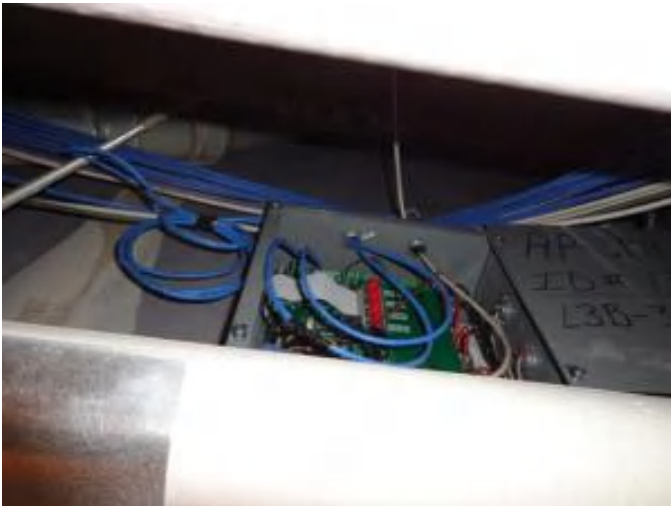
**Location:** Lighting Control System

There is a Leviton Z-Max lighting control system for controlling lighting in classrooms and corridors. Wall mounted lighting control stations are provided in all classrooms. The Building Engineer reports there are approximately 12 low voltage lighting control stations in classrooms and corridors that are not functional and require manual switching at the relay packs to operate the system. An allowance is included in this report for testing each lighting control station for proper operation and for repairing and/or replacing up to 12 defective control stations and/or relays.

**Distress:** Damaged

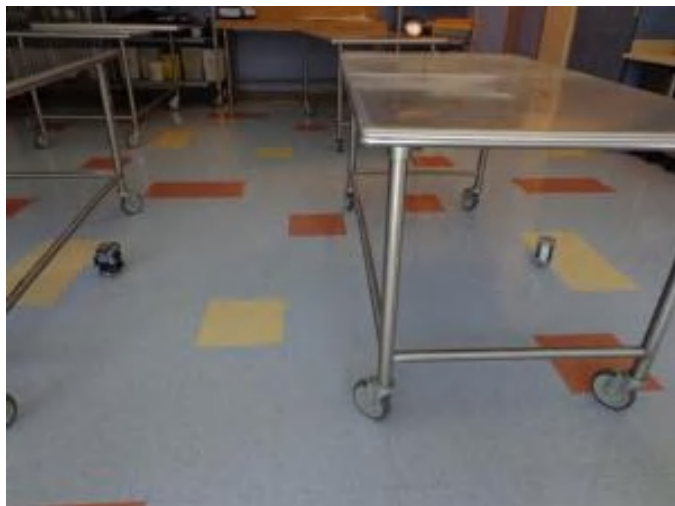
**Location:** Kitchen D120

**Receptacles**-- Classrooms are supplied with an adequate quantity of receptacles, including isolated ground receptacles. Some classrooms are provided with surface metal raceway with duplex receptacles; some other classrooms and computer labs have floor boxes with receptacles to serve workstations that are not located along a wall. All receptacles located within 6 feet of wet locations are ground-fault circuit-interrupting (GFCI) type. There are approximately ten (10) duplex receptacles in the kitchen that need to be replaced with GFCI type, as required by NFPA 70, National Electrical Code (NEC) Article 210.8 (B).

**Distress:** Life Safety / NFPA / PFD

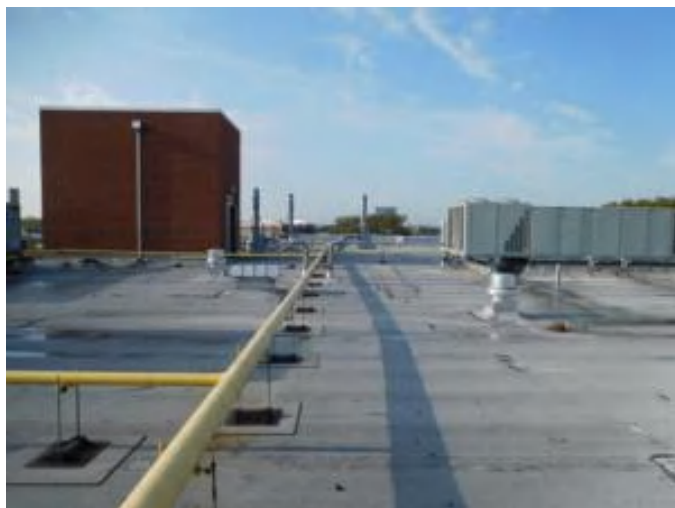
**Location:** roof

**Distress:** Inadequate

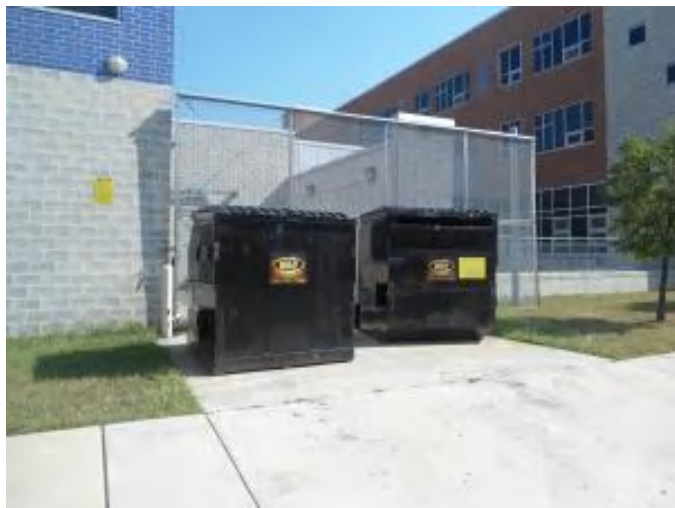
**Location:** Site

The trash dumpster is located near the southern exterior on concrete pads is open to the students and to the public. The exterior services are not protected. Upgrades to protect the exterior services and trash area is necessary for the safety of the students and the general public. Construction of a secure lockable dumpster area is recommended.

**Distress:** Health Hazard / Risk
