Facility Condition Assessment Summary Report

Bache-Martin School

Martin (Bache-Martin) School

January 31, 2017

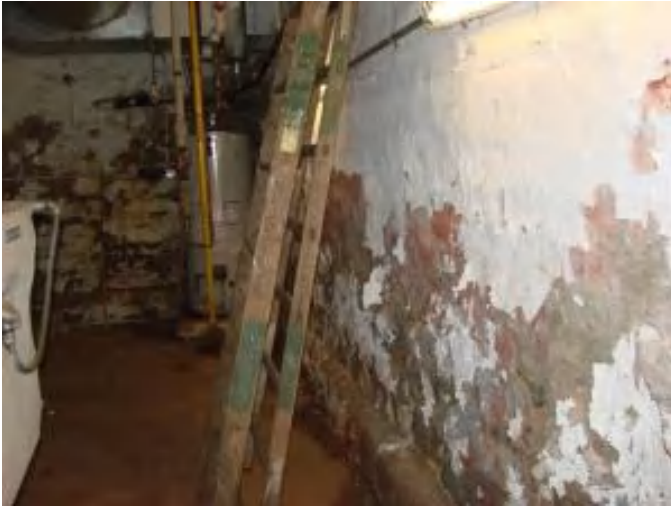
System: A1010 - Standard Foundations

Location: Exterior

Distress: Building Envelope Integrity

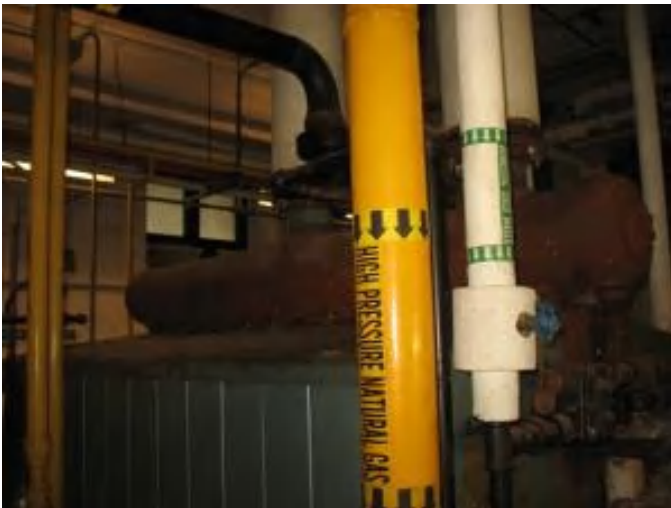
System: D3040 - Distribution Systems

Location: Throughout buliding

Distress: Beyond Service Life

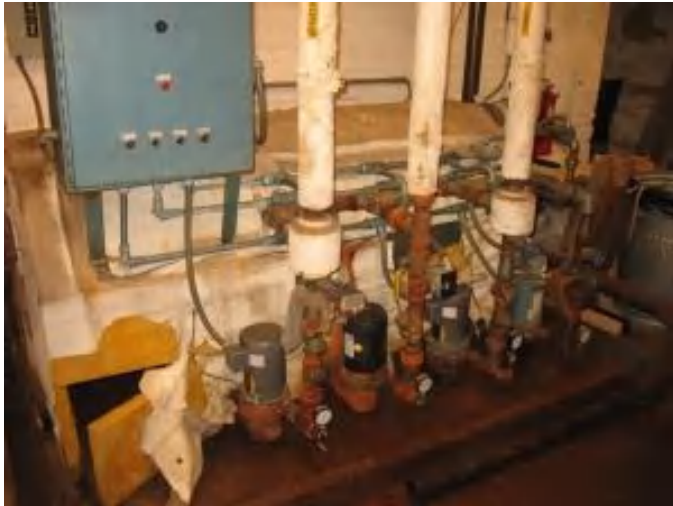
System: D3040 - Distribution Systems

Location: Throughout building

Distress: Failing

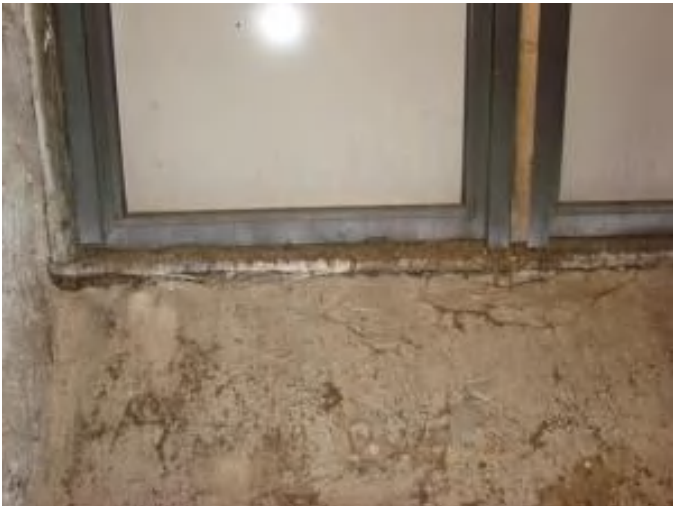
System: B2020 - Exterior Windows

Location: Exterior

Distress: Beyond Service Life

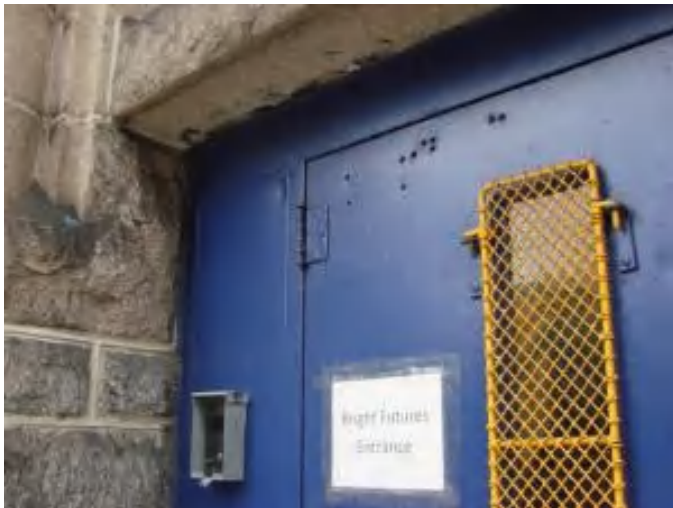
System: B2030 - Exterior Doors

Location: Exterior

Distress: Building Envelope Integrity

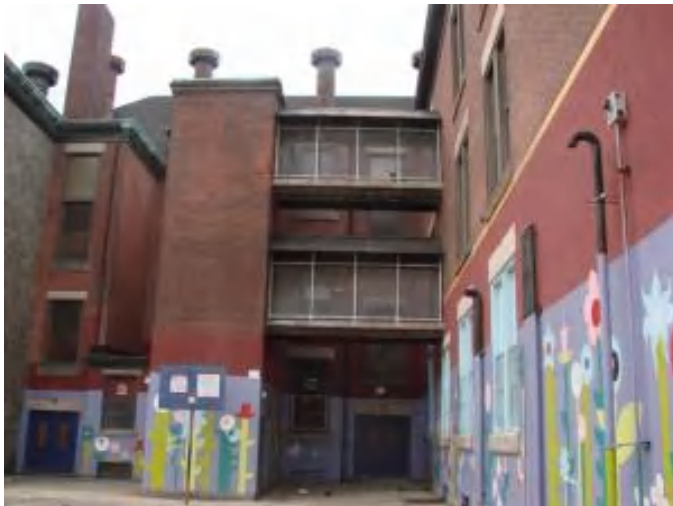
System: B3010105 - Built-Up

Location: Exterior

Distress: Building Envelope Integrity

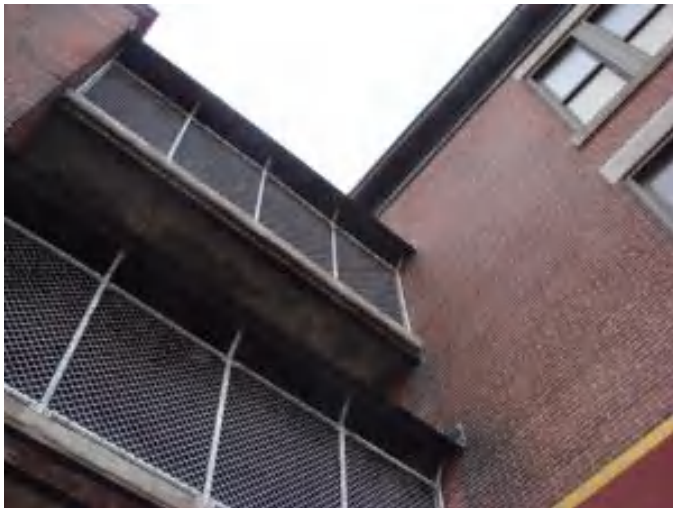
System: B3010130 - Preformed Metal Roofing

Location: Exterior

Distress: Beyond Service Life

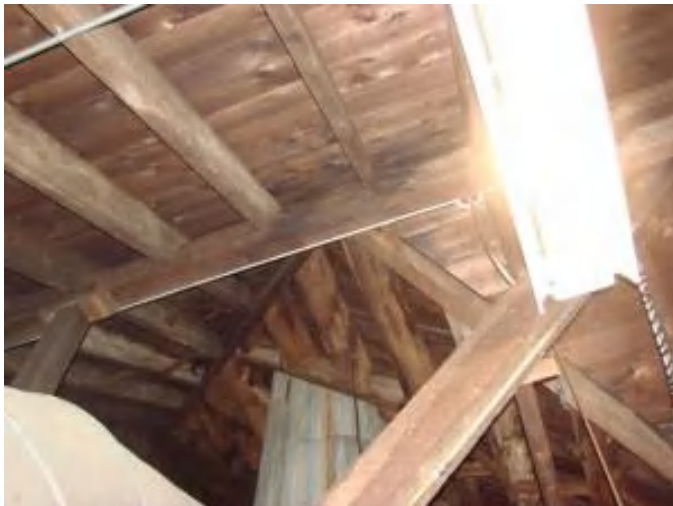
System: B3010140 - Shingle & Tile

Location: Exterior/ roof

Distress: Beyond Service Life

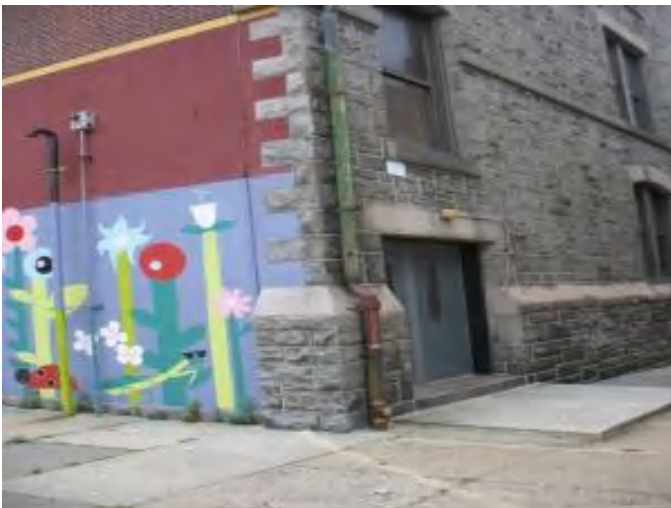
System: D2040 - Rain Water Drainage

Location: Throughout building

Distress: Beyond Service Life

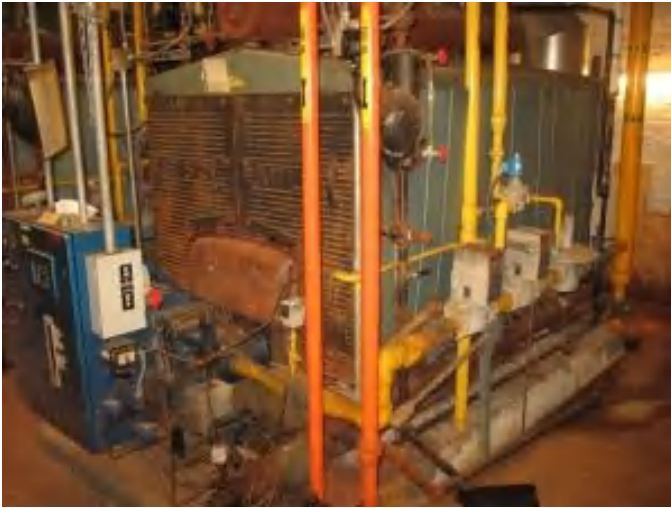
System: D3020 - Heat Generating Systems

Location: Boiler room

Distress: Beyond Service Life

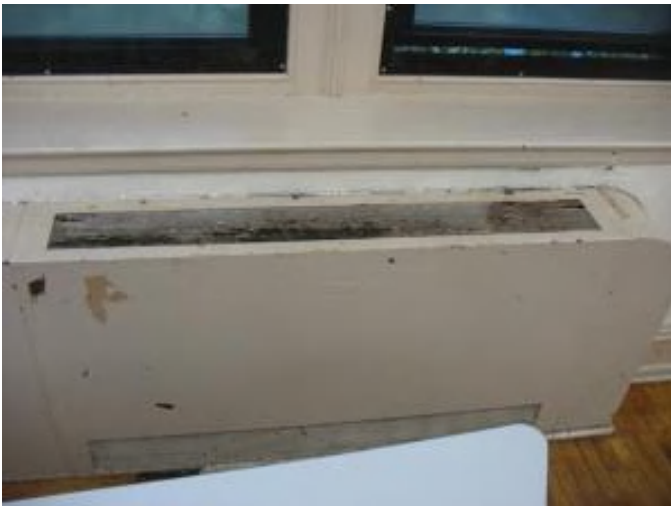
System: D3040 - Distribution Systems

Location: Throughout building

Distress: Beyond Service Life

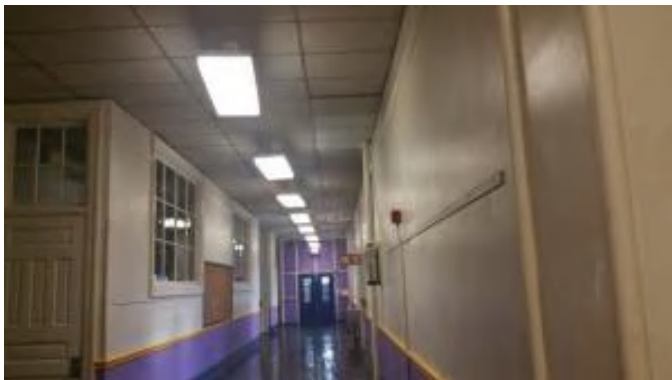
System: D5020 - Lighting and Branch Wiring

Location: Throughout the building

Distress: Beyond Service Life

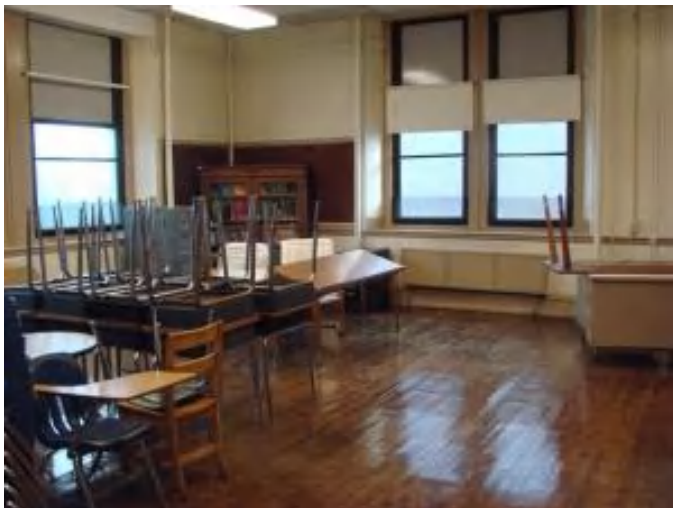
System: C3020414 - Wood Flooring

Location: Interior

Distress: Maintenance Required

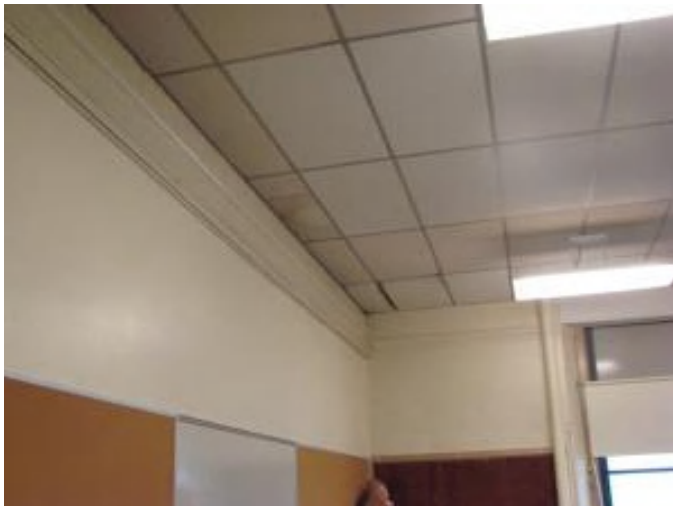
System: C3030 - Ceiling Finishes

Location: Interior

Distress: Beyond Service Life

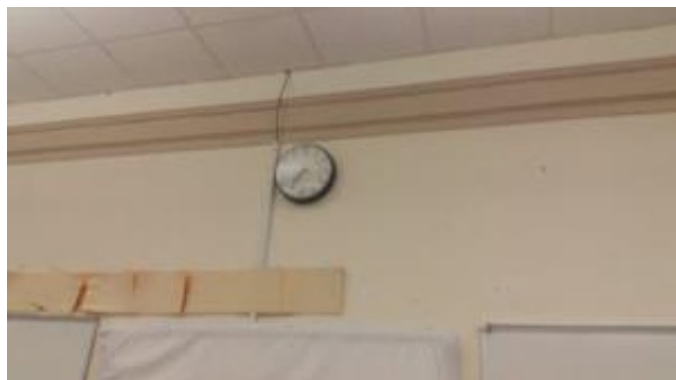
System: D5030 - Communications and Security

Location: Throughout the building

Distress: Beyond Service Life

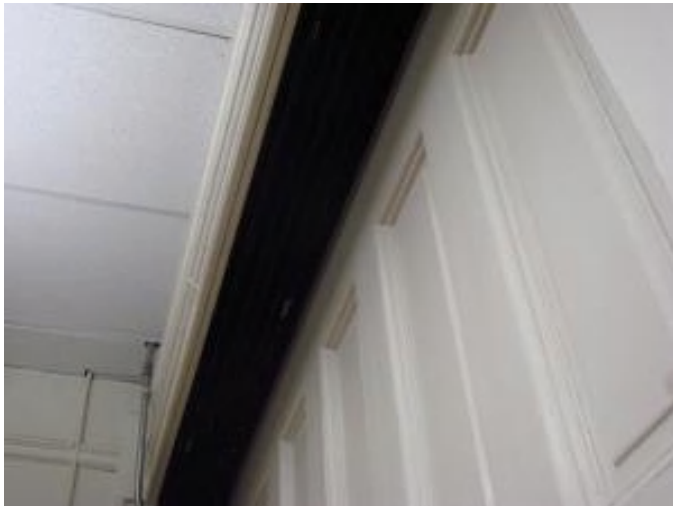
System: C1010 - Partitions

Location: Interior

Distress: Inadequate

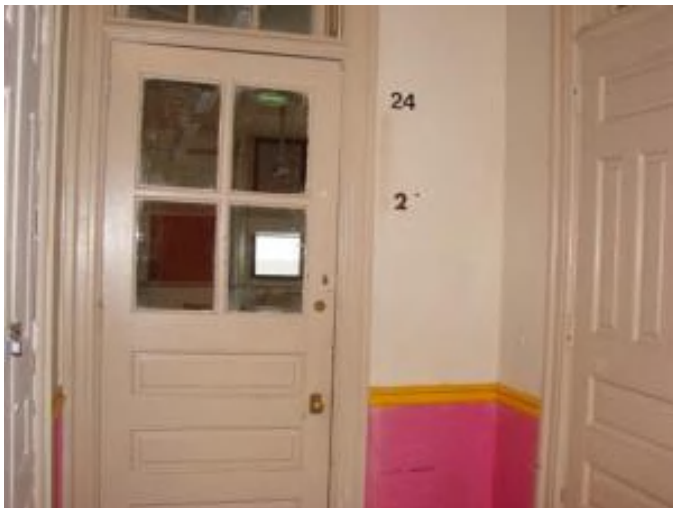
System: C1020 - Interior Doors

Location: Interior

Distress: Beyond Service Life

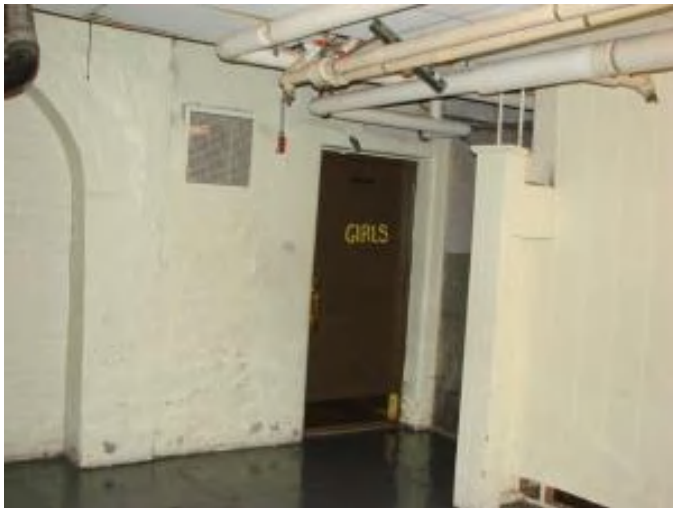
System: C1030 - Fittings

Location: Interior

Distress: Building / MEP Codes

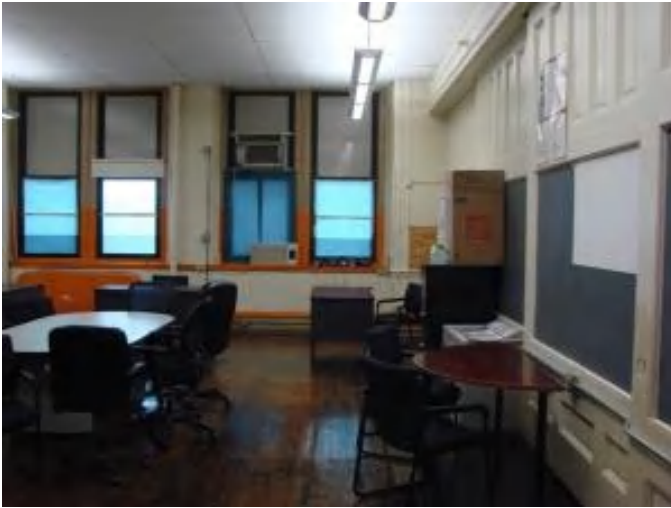
System: D3030 - Cooling Generating Systems

Location: Throughout building

Distress: Inadequate

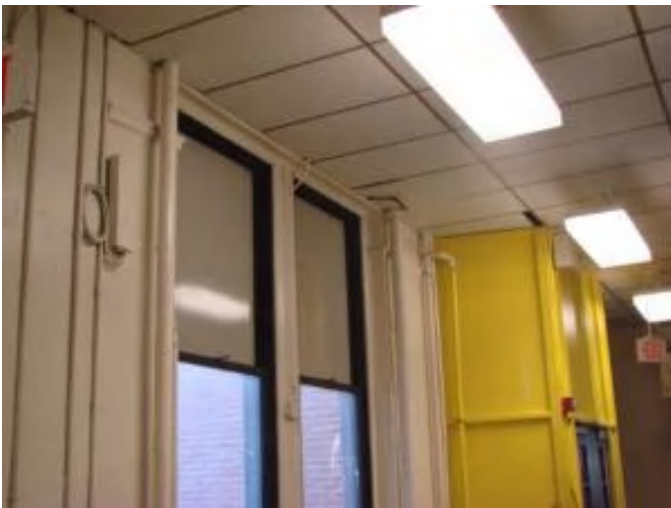
System: D3040 - Distribution Systems

Location: Administration

Distress: Building / MEP Codes

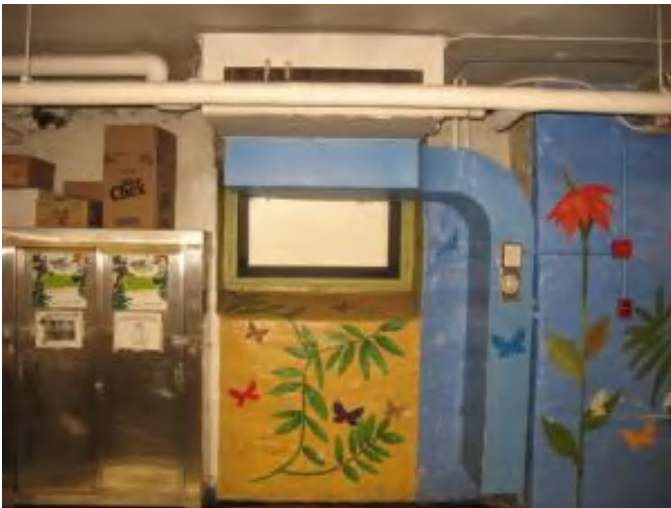
System: D3060 - Controls & Instrumentation

Location: Throughout building

Distress: Inadequate

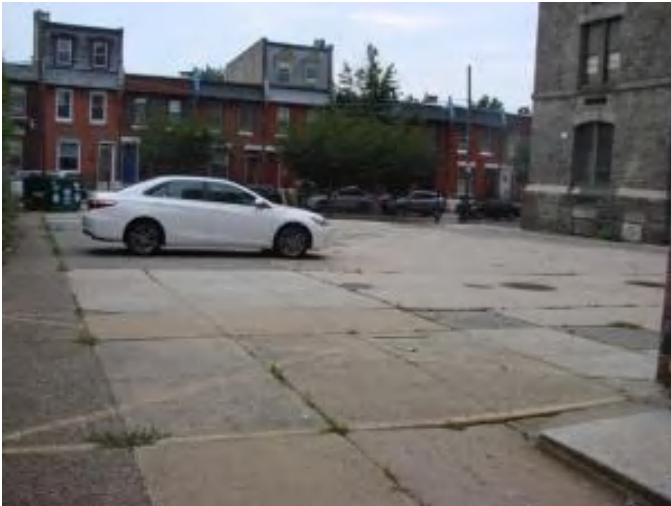
System: G2020 - Parking Lots

Location: grounds/site

Distress: Damaged

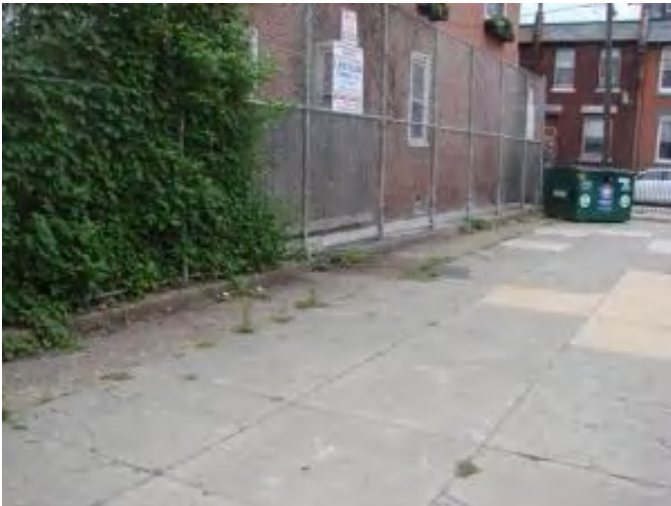
System: G2040 - Site Development

Location: Grounds/ site

Distress: Beyond Service Life

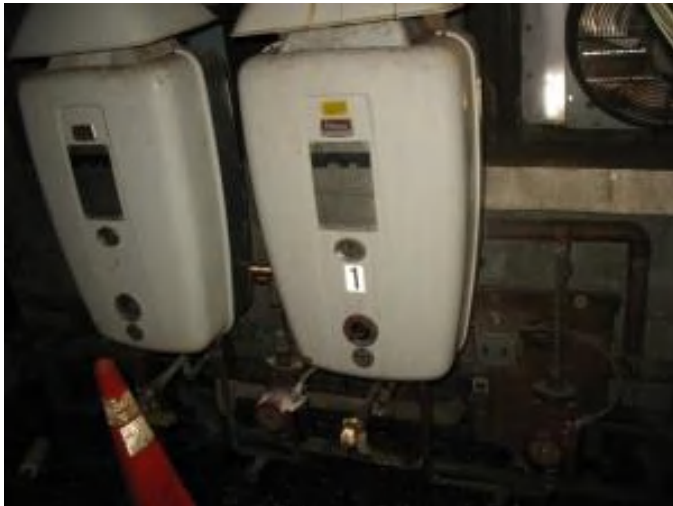
System: D2020 - Domestic Water Distribution

Location: Mechanical room

Distress: Failing
