Facility Condition Assessment Summary Report

Barry School

School District of Philadelphia
S120001;Barry
Final
Site Assessment Report

February 1, 2017

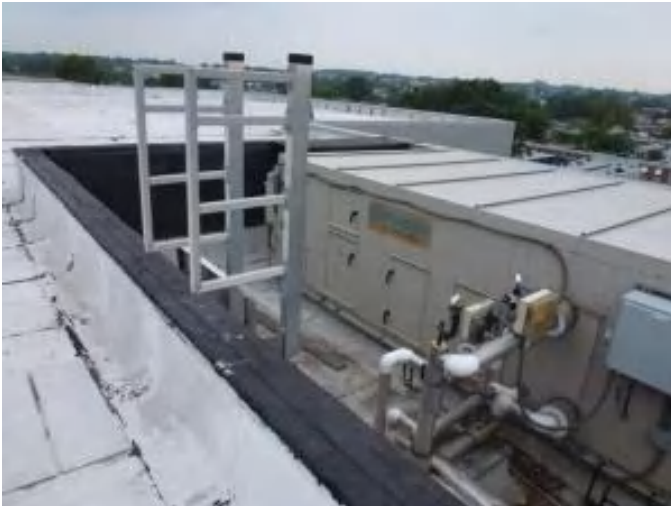
Location: Roof

System: D5020 - Lighting and Branch Wiring

Distress: Inadequate

Correction: Replace lighting fixtures

Notes: Install new wall mounted 70 watt high pressure sodium lighting fixtures on roof where AHU1 and AHU2 are installed. Estimated 2 fixtures.

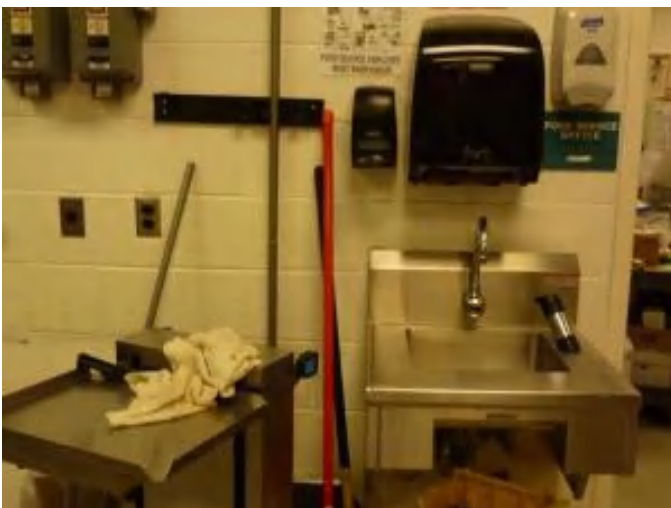
Location: Kitchen

Receptacle- There is sufficient number of receptacles installed in classrooms, officer, corridors and other areas throughout the building. No major deficiency observed except in kitchen area which general receptacle was installed close to the sink without Ground Fault Current Interrupter device (GFCI).

System: D5020 - Lighting and Branch Wiring

Distress: Building / MEP Codes

Notes: Replace existing general receptacle adjacent to the sink in the kitchen with GFCI receptacle
