Facility Condition Assessment Summary Report

Barton School

School District of Philadelphia
S720001; Barton
Final
Site Assessment Report

January 31, 2017

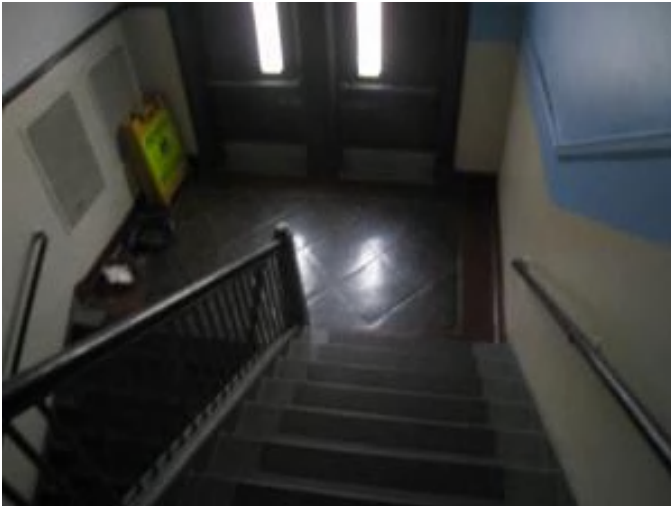
System: C2010 - Stair Construction

Location: stairways

Distress: Building / MEP Codes

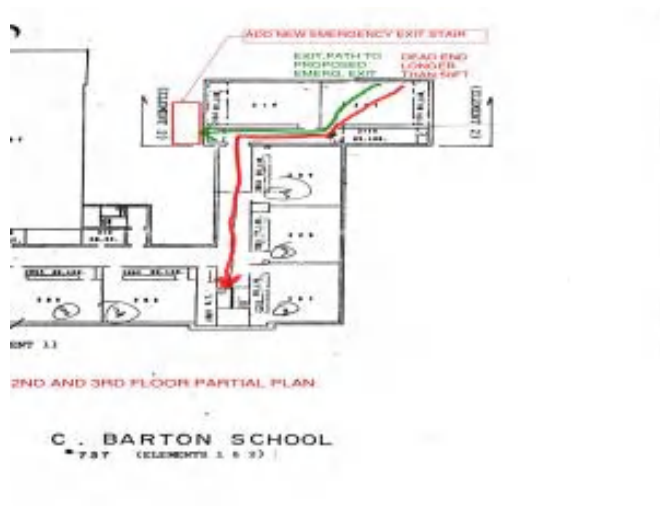
System: C2010 - Stair Construction

Location: corridor

Distress: Building / MEP Codes

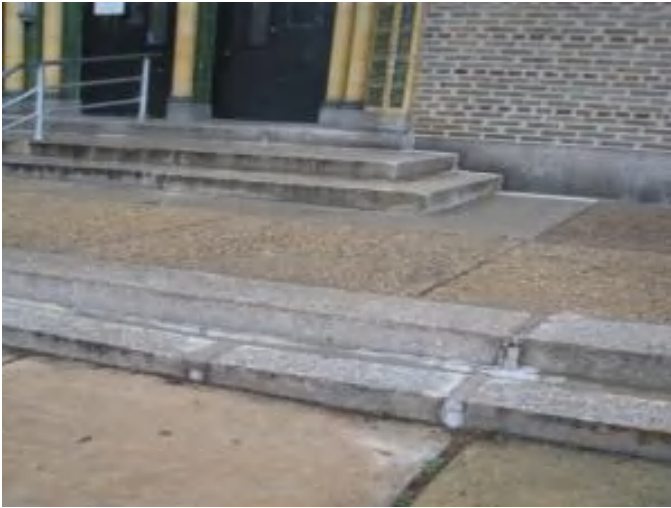
System: C2010 - Stair Construction

Location: exterior stairs
Distress: Failing
Category: 3 - Operations / Maint.
Priority: 1 - Response Time (< 2 yr)
Correction: Repair exterior stairs
Qty: 50.00
Unit of Measure: Riser
Estimate: \$20,520.12
Assessor Name: System
Date Created: 07/30/2015

Notes: RegROUT all joints between limestone block tread/risers at exterior stairs

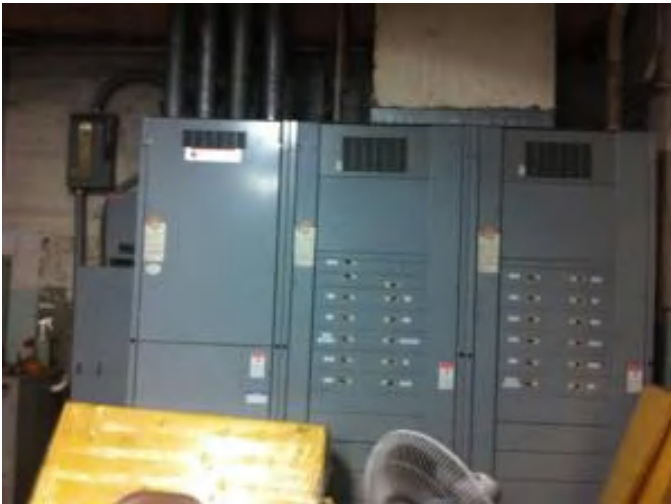
System: D5010 - Electrical Service/Distribution

Location: Boiler Room
Distress: Inadequate
Category: 4 - Capital Improvement
Priority: 1 - Response Time (< 2 yr)
Correction: Add service entrance switchboard
Qty: 1.00
Unit of Measure: Ea.
Estimate: \$441,955.99
Assessor Name: System
Date Created: 09/17/2015

Notes: Upgrade the existing electrical service with a new 2000A service. Provide connection between existing switchboard with the new service switchboard.

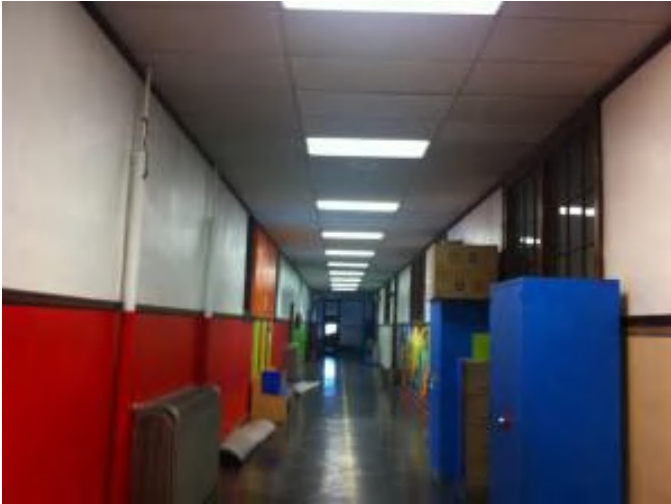
System: D5020 - Lighting and Branch Wiring

Location: corridors and exitways
Distress: Building / MEP Codes
Category: 2 - Code Compliance
Priority: 1 - Response Time (< 2 yr)
Correction: Add wiring device
Qty: 1.00
Unit of Measure: Ea.
Estimate: \$59,888.97
Assessor Name: System
Date Created: 07/29/2015

Notes: Provide emergency power to sufficient number of lighting fixtures in corridors, hallways, stairways and other egress ways to get minimum 1fc at egress ways per code.

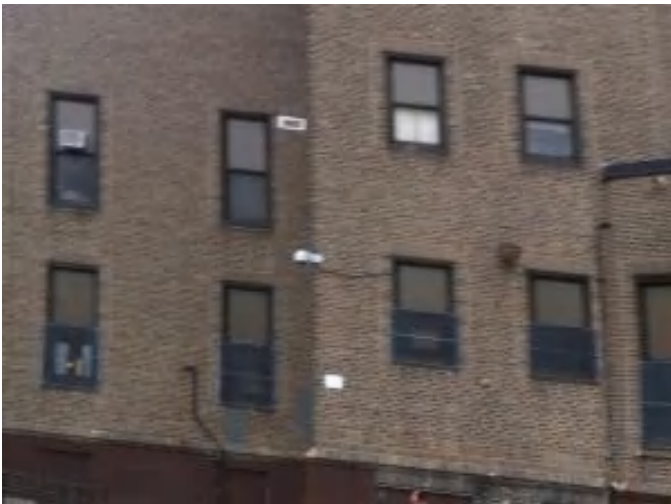
System: D5020 - Lighting and Branch Wiring

Location: Exterior Building
Distress: Damaged
Category: 3 - Operations / Maint.
Priority: 1 - Response Time (< 2 yr)
Correction: Replace lighting fixtures
Qty: 1.00
Unit of Measure: Ea.
Estimate: \$11,108.93
Assessor Name: System
Date Created: 08/05/2015

Notes: Replace existing lighting fixtures that are not functioning. Estimated 30each

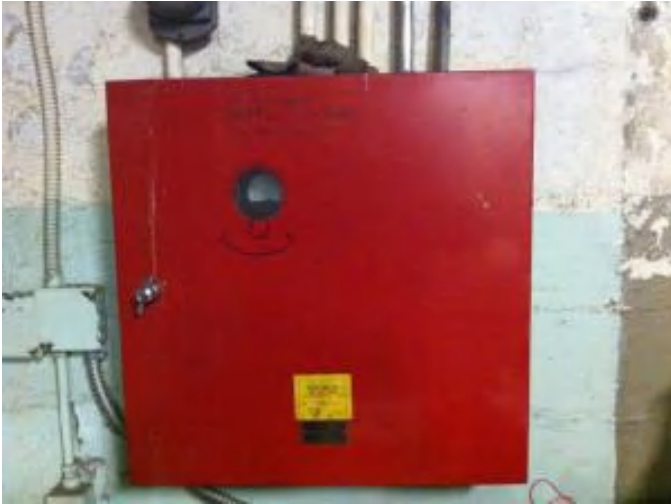
System: D5030 - Communications and Security

Location: Entire Building
Distress: Beyond Service Life
Category: 3 - Operations / Maint.
Priority: 1 - Response Time (< 2 yr)
Correction: Replace fire alarm system
Qty: 1.00
Unit of Measure: S.F.
Estimate: \$433,023.03
Assessor Name: System
Date Created: 07/29/2015

Notes: Replace existing fire alarm system with a new automatic Fire Alarm System including control panel, initiated devices in corridors, air ducts, electrical and LAN rooms, library, and computer rooms. Provide notification devices in class rooms, offices, auditorium, corridors, other area recommended by codes.

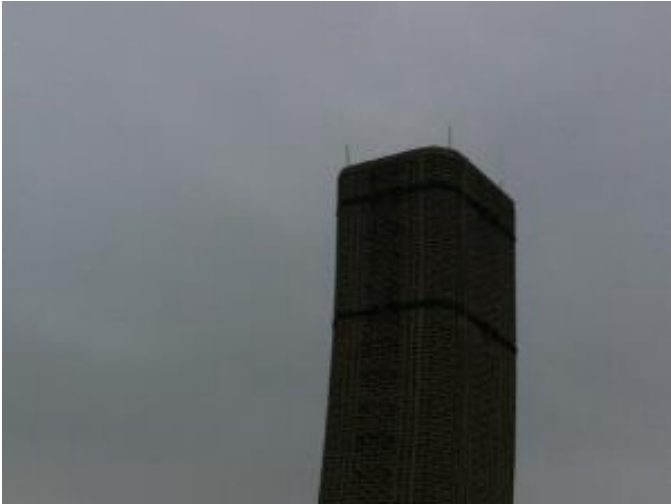
System: D5090 - Other Electrical Systems

Location: Roof

Distress: Life Safety / NFPA / PFD

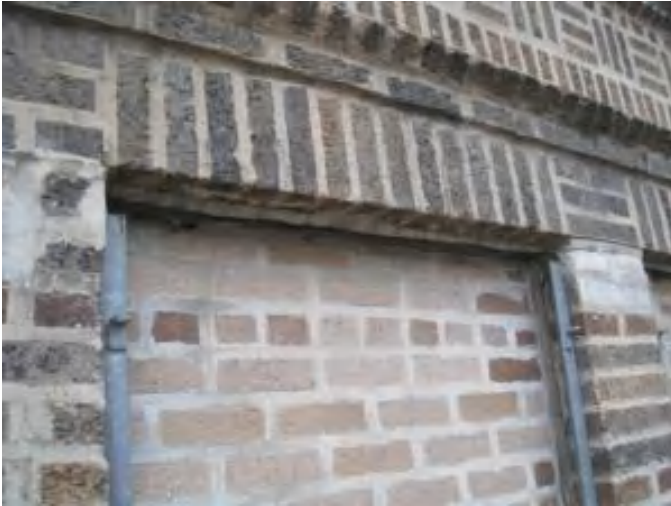
System: B2010 - Exterior Walls

Location: exterior walls

Distress: Failing

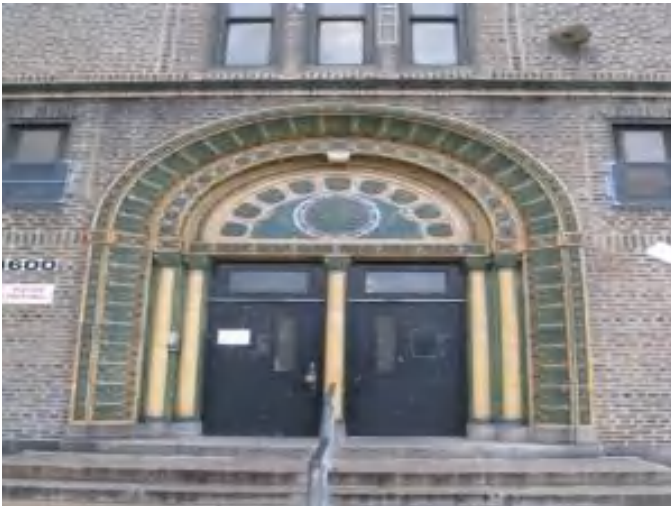
System: B2030 - Exterior Doors

Location: exterior doors

Distress: Damaged

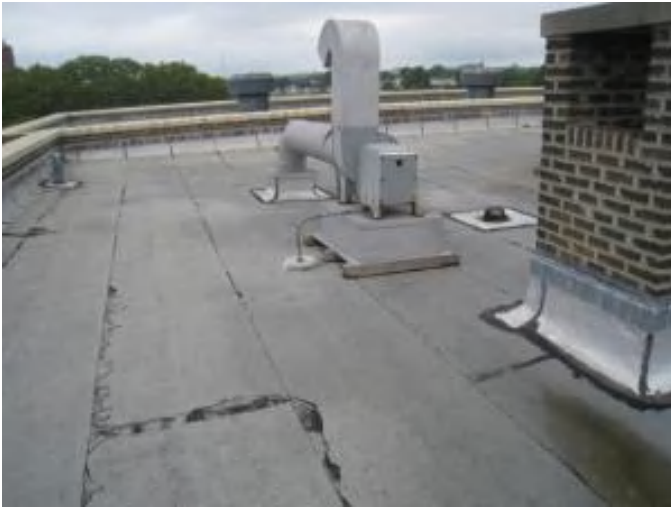
System: B3010105 - Built-Up

Location: roof
Distress: Beyond Service Life
Category: 3 - Operations / Maint.
Priority: 2 - Response Time (2-3 yrs)
Correction: Remove and Replace Built Up Roof
Qty: 18,500.00
Unit of Measure: S.F.
Estimate: \$626,817.22
Assessor Name: System
Date Created: 07/30/2015

Notes: Remove and replace existing flat roof and insulation;

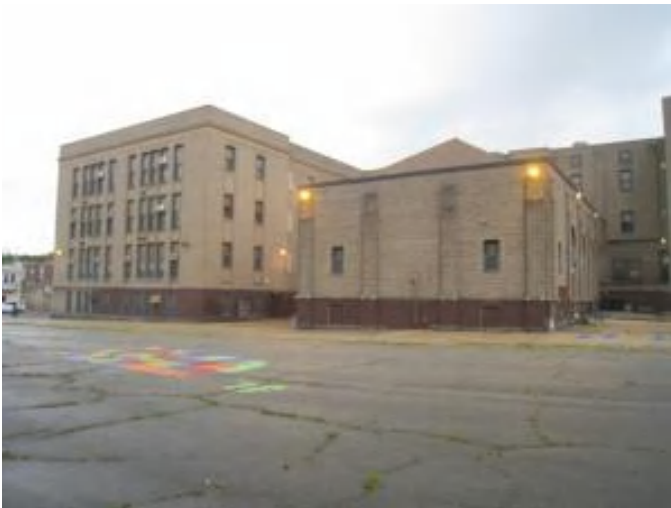
System: B3010140 - Shingle & Tile

Location: asphalt roof (auditorium)
Distress: Beyond Service Life
Category: 3 - Operations / Maint.
Priority: 2 - Response Time (2-3 yrs)
Correction: Remove and replace asphalt shingle roof - partial area
Qty: 6,000.00
Unit of Measure: S.F.
Estimate: \$205,810.25
Assessor Name: System
Date Created: 07/30/2015

Notes: Remove and replace existing sloped asphalt shingle roof on auditorium

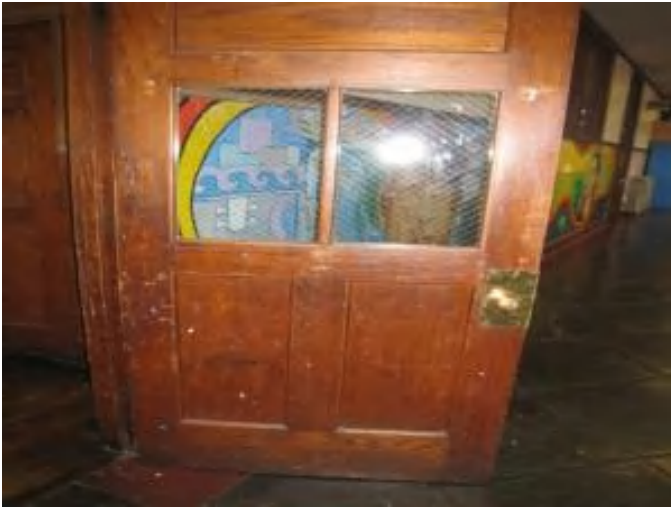
System: C1020 - Interior Doors

Location: interior doors
Distress: Building / MEP Codes
Category: 2 - Code Compliance
Priority: 2 - Response Time (2-3 yrs)
Correction: Remove and replace interior doors - wood doors with wood frame - per leaf
Qty: 100.00
Unit of Measure: Ea.
Estimate: \$465,433.90
Assessor Name: System
Date Created: 07/30/2015

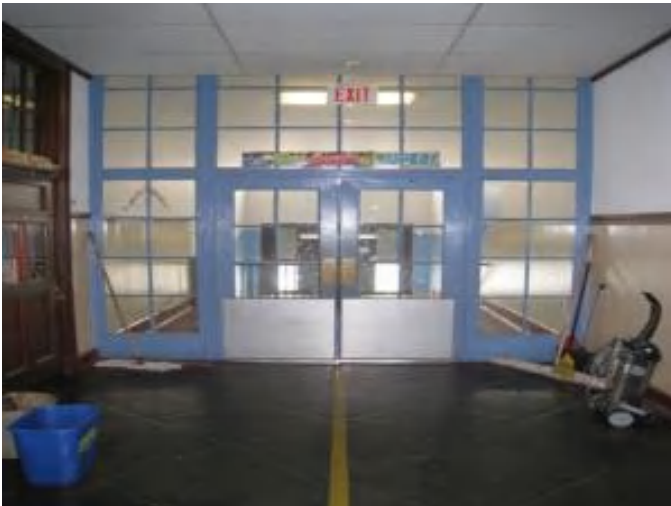
System: C1020 - Interior Doors

Location: interior rooms
Distress: Damaged
Category: 3 - Operations / Maint.
Priority: 2 - Response Time (2-3 yrs)
Correction: Remove and replace hollow metal frames and doors
Qty: 60.00
Unit of Measure: Ea.
Estimate: \$304,679.23
Assessor Name: System
Date Created: 07/30/2015

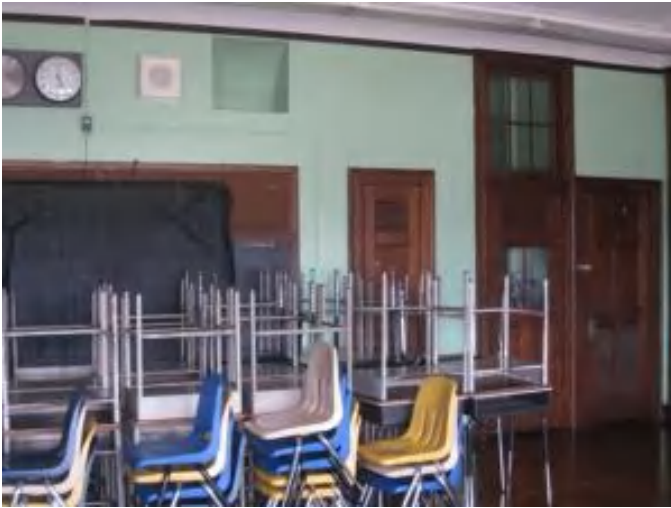
System: C1020 - Interior Doors

Location: interior of rooms

Distress: Beyond Service Life

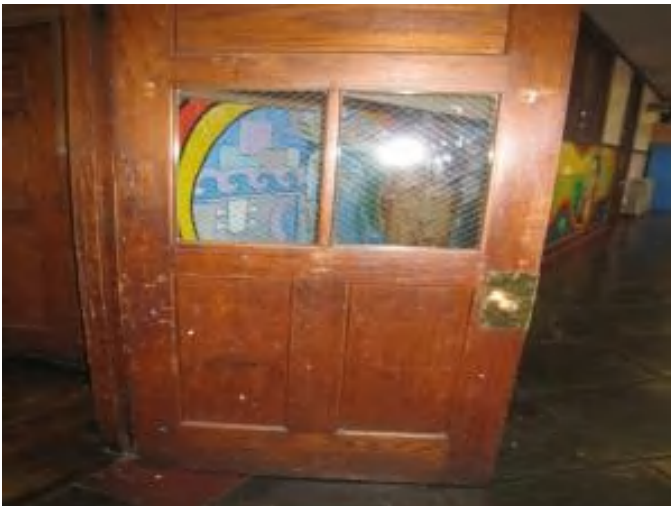
System: C1020 - Interior Doors

Location: interior doors

Distress: Building / MEP Codes

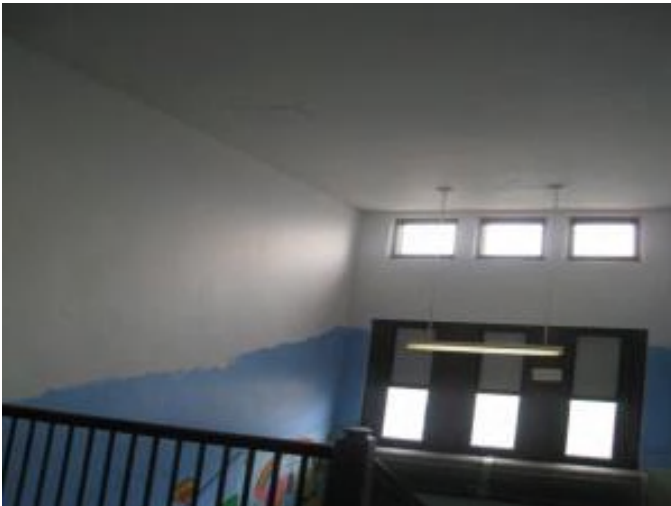
System: C3010230 - Paint & Covering

Location: interior walls

Distress: Appearance

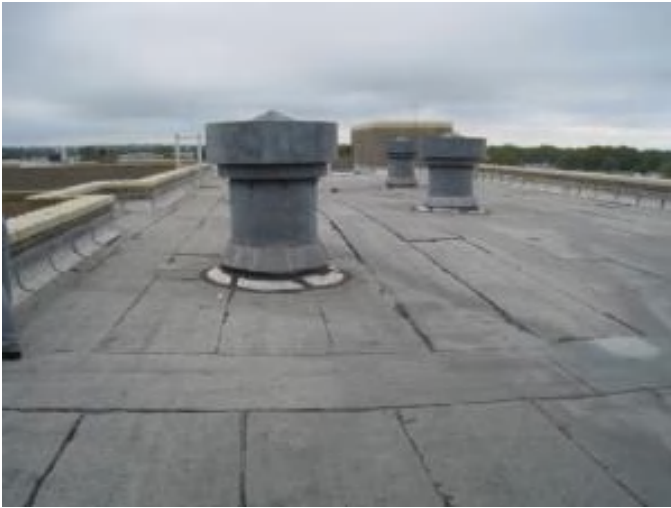
System: D2040 - Rain Water Drainage

Location: roof
Distress: Building / MEP Codes
Category: 2 - Code Compliance
Priority: 2 - Response Time (2-3 yrs)
Correction: Create new overflow scupper through a parapet with up to 100' downspout
Qty: 5.00
Unit of Measure: Ea.
Estimate: \$52,339.33
Assessor Name: System
Date Created: 10/23/2015

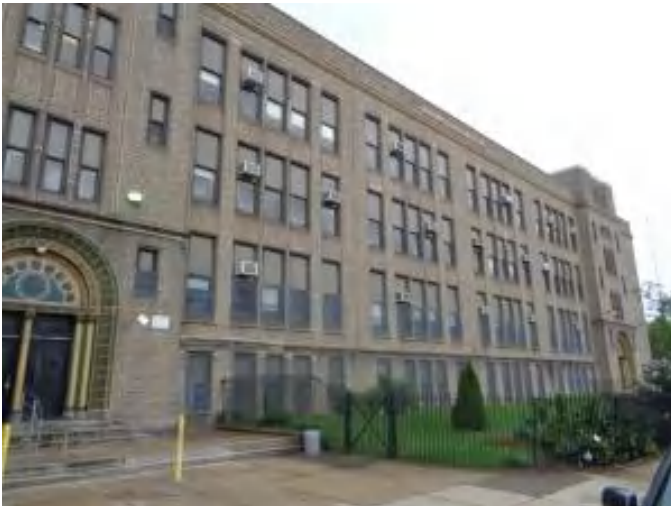
System: D3040 - Distribution Systems

Location: classrooms
Distress: Inadequate
Category: 4 - Capital Improvement
Priority: 2 - Response Time (2-3 yrs)
Correction: Replace the existing unit ventilators with new units designed to provide adequate ventilation per ASHRAE Std 62 - insert the SF of bldg. in the qty.
Qty: 72,200.00
Unit of Measure: S.F.
Estimate: \$3,482,873.16
Assessor Name: System
Date Created: 08/04/2015

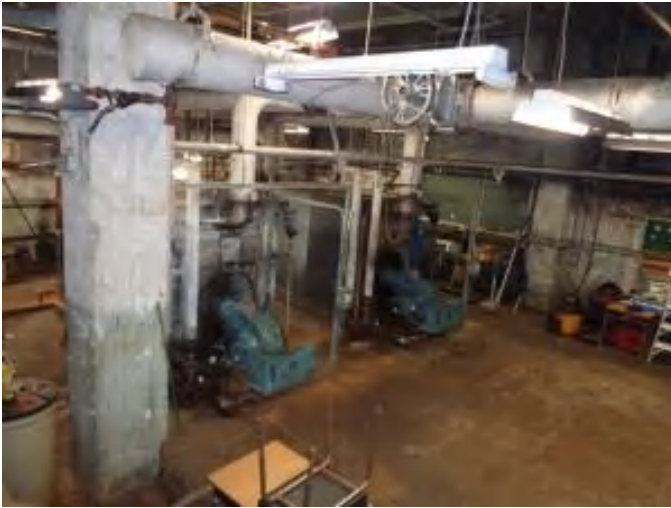
System: D3040 - Distribution Systems

Location: Throughout Building
Distress: Beyond Service Life
Category: 3 - Operations / Maint.
Priority: 3 - Response Time (3-4 yrs)
Correction: Perform testing to identify and replace damaged steam and condensate piping.
Qty: 60,000.00
Unit of Measure: S.F.
Estimate: \$567,622.35
Assessor Name: System
Date Created: 08/04/2015

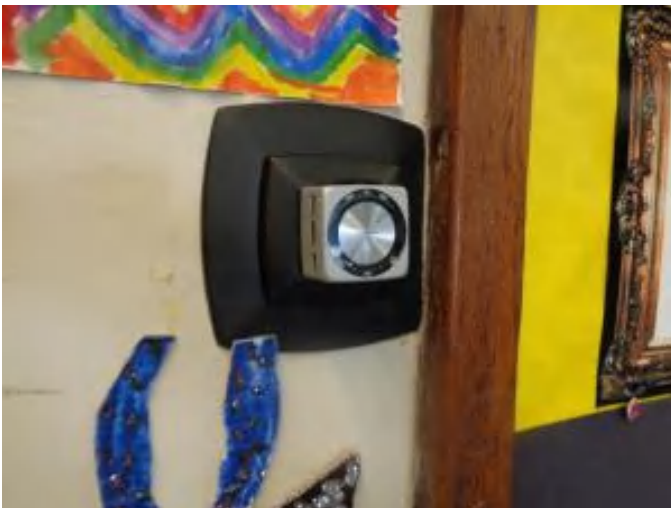
System: D3060 - Controls & Instrumentation

Location: entire building
Distress: Obsolete
Category: 3 - Operations / Maint.
Priority: 3 - Response Time (3-4 yrs)
Correction: Replace pneumatic controls with DDC (150KSF)
Qty: 72,200.00
Unit of Measure: S.F.
Estimate: \$1,293,202.91
Assessor Name: System
Date Created: 08/04/2015

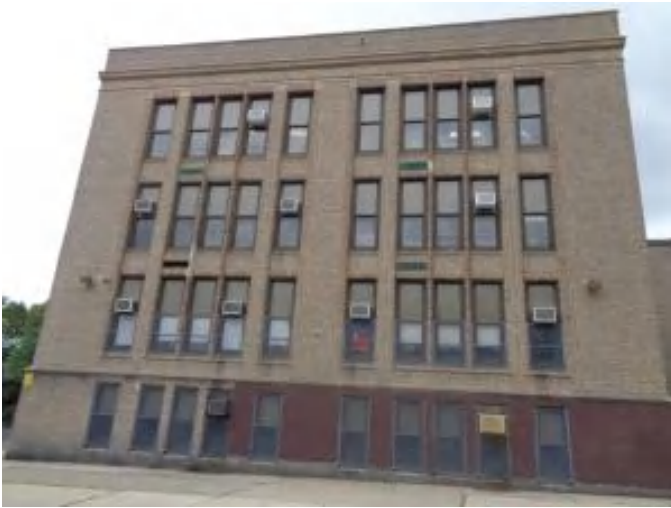
System: D3030 - Cooling Generating Systems

Location: entire building
Distress: Inadequate
Category: 4 - Capital Improvement
Priority: 5 - Response Time (> 5 yrs)
Correction: Install chilled water system with distribution piping and pumps. (+150KSF)
Qty: 72,200.00
Unit of Measure: S.F.
Estimate: \$1,200,803.61
Assessor Name: System
Date Created: 08/04/2015

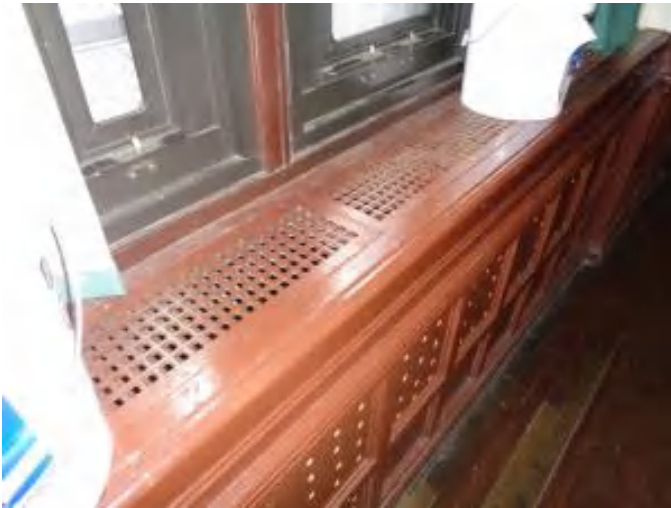
System: D3040 - Distribution Systems

Location: auditorium
Distress: Inadequate
Category: 4 - Capital Improvement
Priority: 5 - Response Time (> 5 yrs)
Correction: Install HVAC unit for Auditorium (200 seat).
Qty: 400.00
Unit of Measure: Seat
Estimate: \$570,170.82
Assessor Name: System
Date Created: 08/04/2015
