School District of Philadelphia

# **S101001; Bartram and Tilden**

## **Site Assessment Report**

January 30, 2017

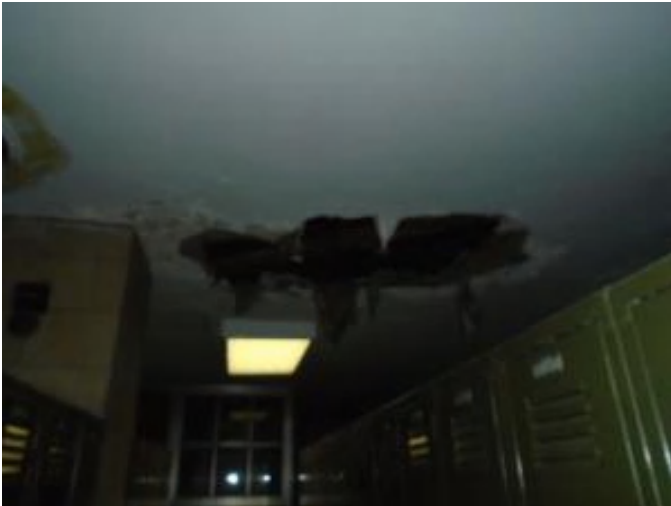
#### System: C3030 - Ceiling Finishes

**Location:** Locker rooms, auditorium

**Distress:** Damaged

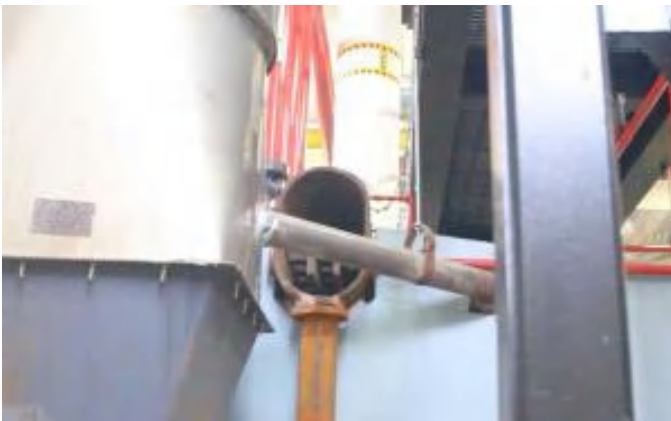
#### System: D3020 - Heat Generating Systems

**Location:** Boiler room

**Distress:** Damaged

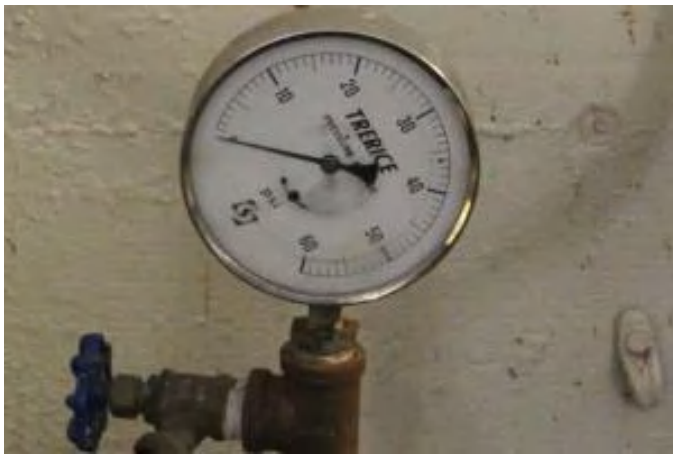
**System: D3060 - Controls & Instrumentation**

**Location:** Boiler room

**Distress:** Damaged

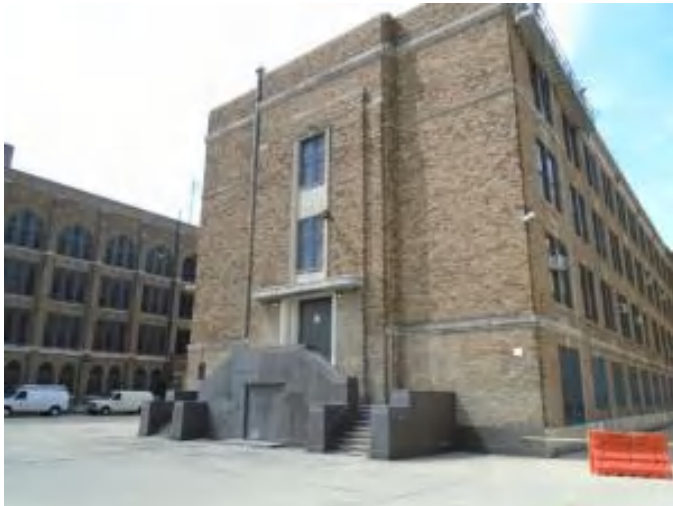
**System: B2030 - Exterior Doors**

**Location:** Entrance

**Distress:** Accessibility

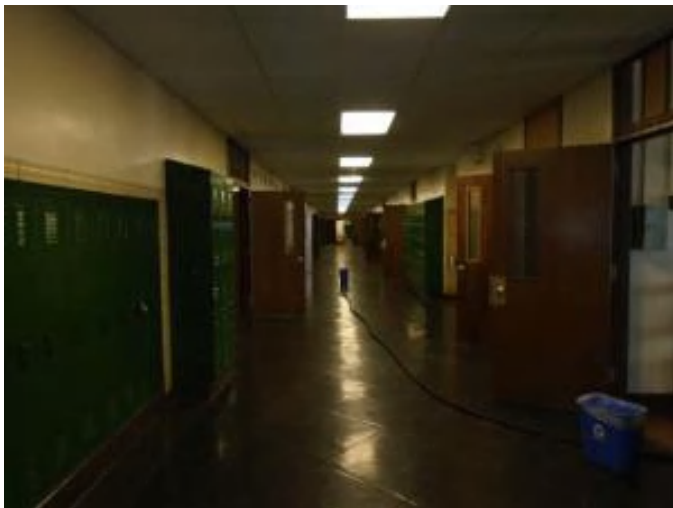
**System: C1020 - Interior Doors**

**Location:** Throughout

**Distress:** Accessibility

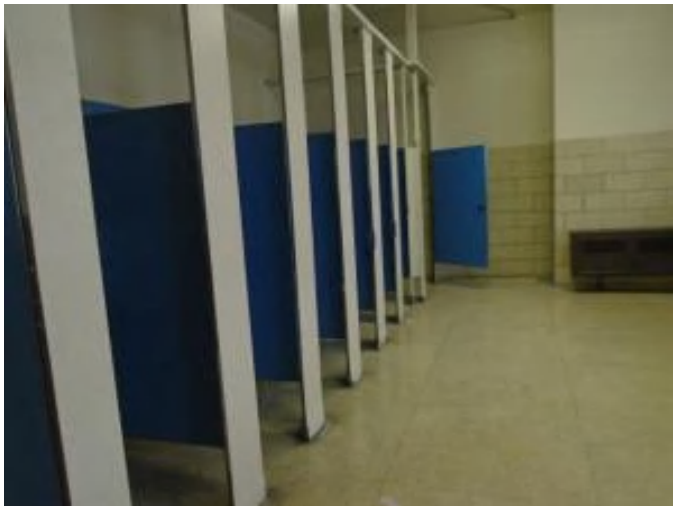
**System: C1030 - Fittings**

**Location:** Toilets

**Distress:** Beyond Service Life

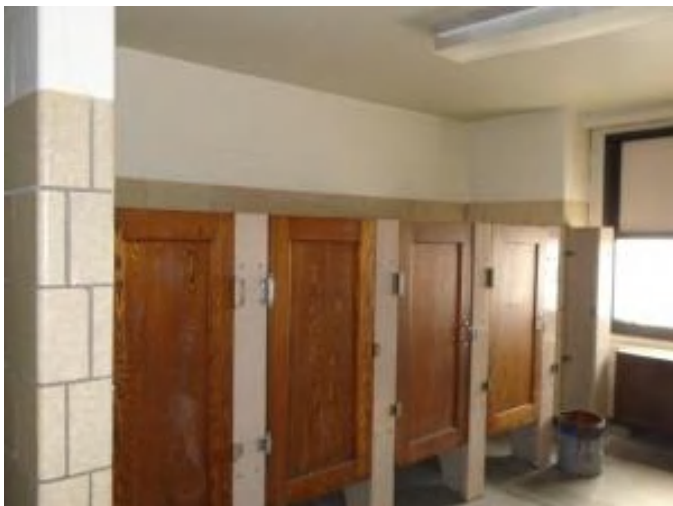
**System: C1030 - Fittings**

**Location:** Toilets

**Distress:** Accessibility

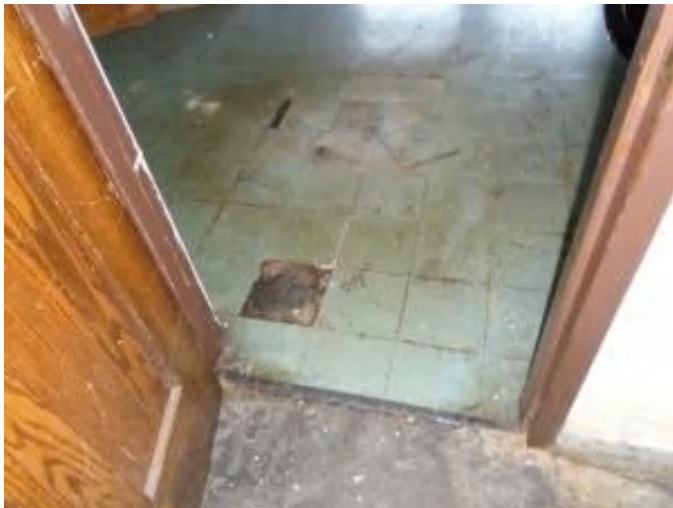
**System: C3020413 - Vinyl Flooring**

**Location:** Various

**Distress:** Damaged

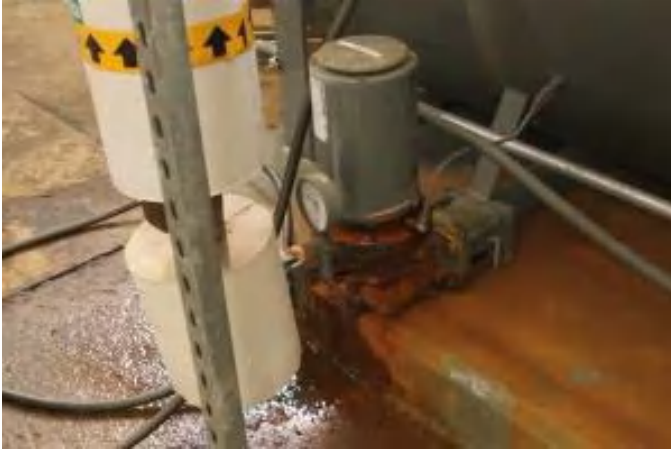
**System: D3020 - Heat Generating Systems**

**Location:** Boiler room

**Distress:** Failing

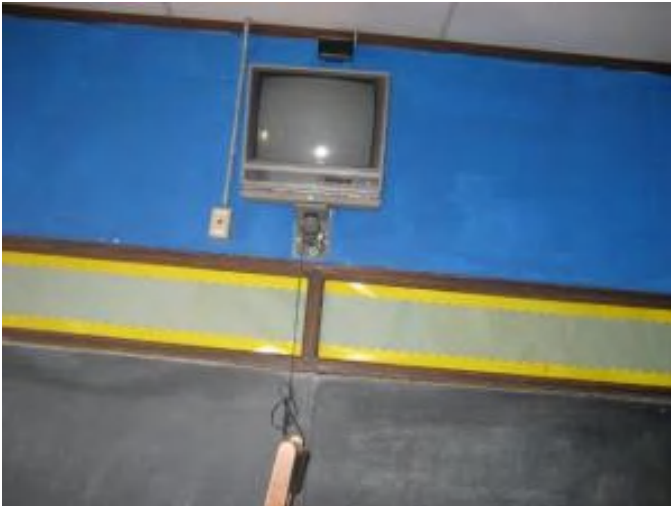
**System: D5020 - Lighting and Branch Wiring**

**Location:** Classrooms

**Distress:** Inadequate

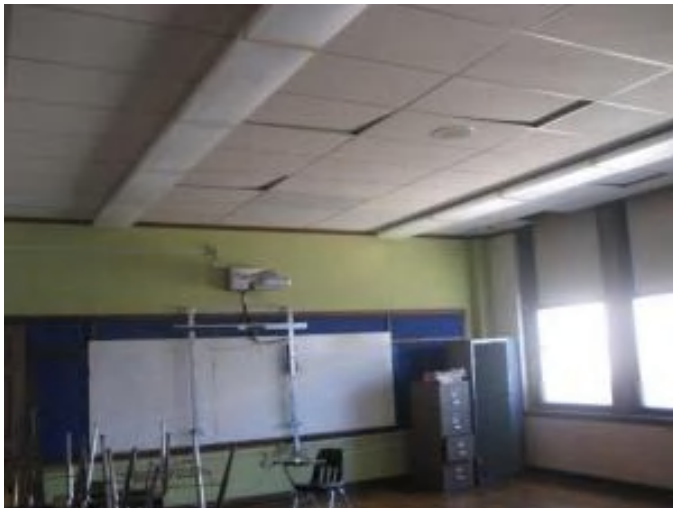
**System: D5030 - Communications and Security**

**Location:** Entire Building

**Distress:** Life Safety / NFPA / PFD

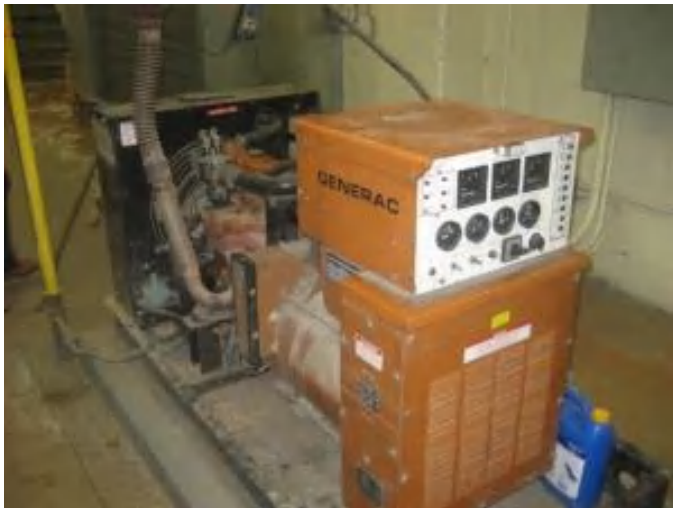
**System: D5090 - Other Electrical Systems**

**Location:** Basement

**Distress:** Beyond Service Life

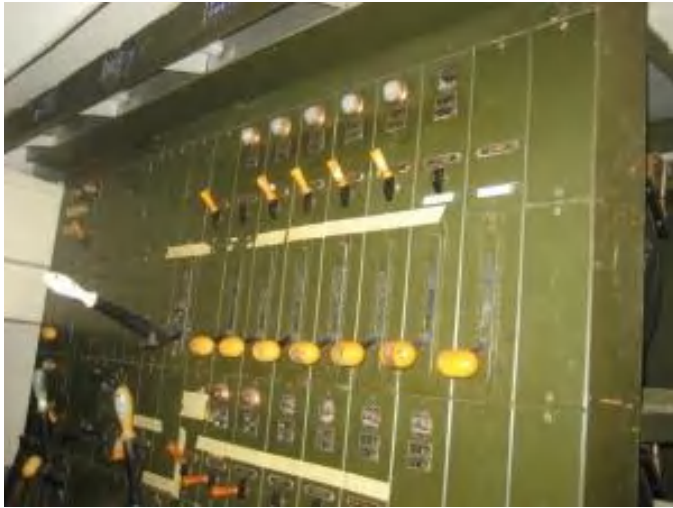
**System: E1020 - Institutional Equipment**

**Location:** Auditorium

**Distress:** Beyond Service Life

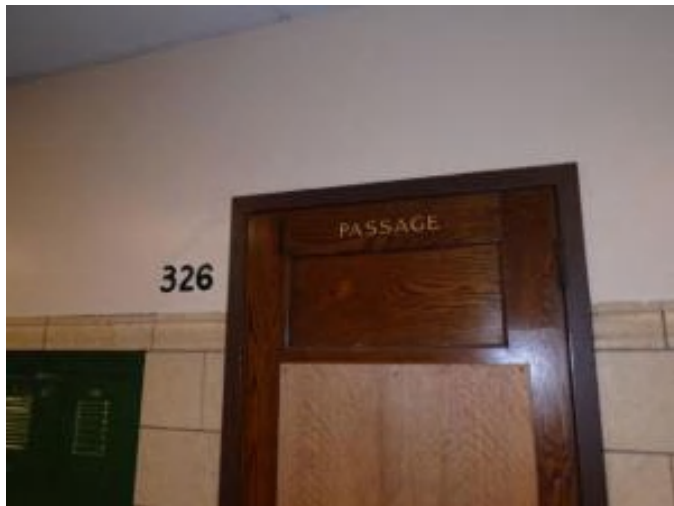
**System: C1020 - Interior Doors**

**Location:** Throughout

**Distress:** Damaged

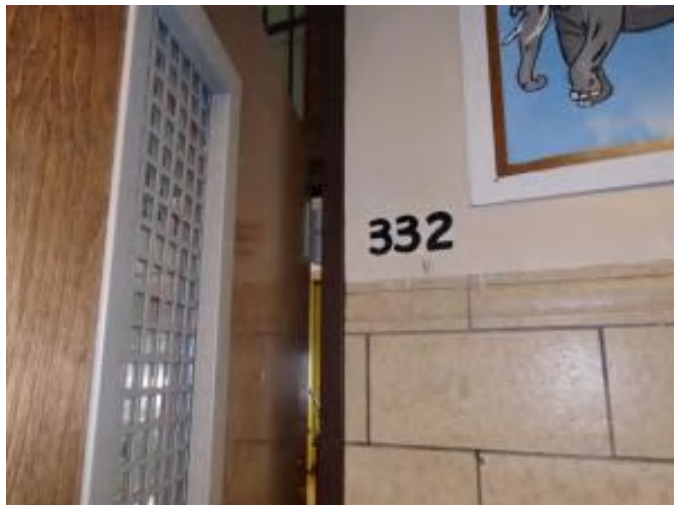
**System: C1030 - Fittings**

**Location:** Throughout

**Distress:** Inadequate

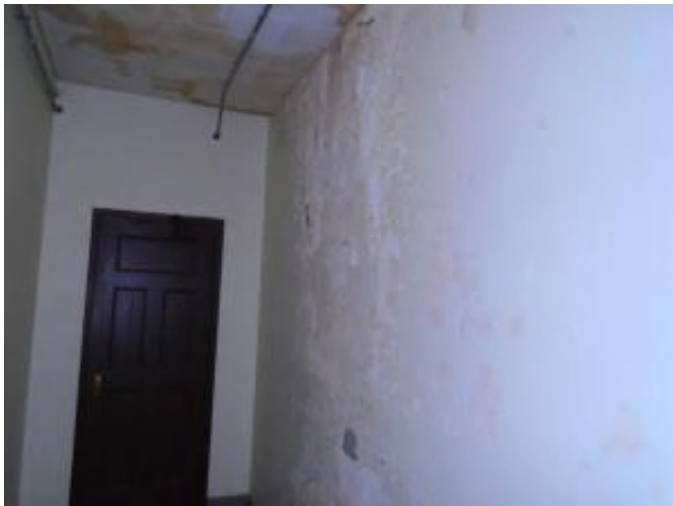
**System: C3010230 - Paint & Covering**

**Location:** Throughout

**Distress:** Damaged

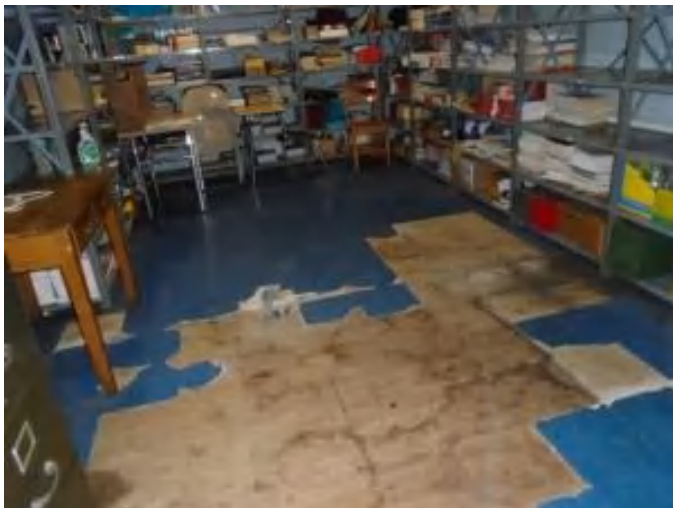
**System: C3020413 - Vinyl Flooring**

**Location:** Various

**Distress:** Damaged

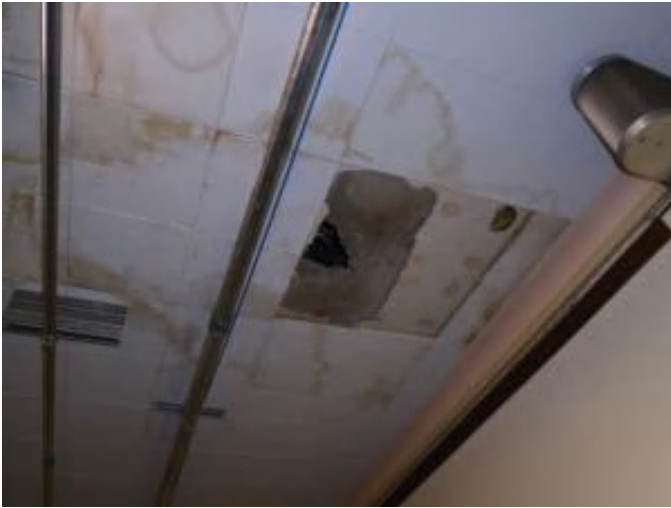
**System: C3030 - Ceiling Finishes**

**Location:** corridors, weight room

**Distress:** Failing

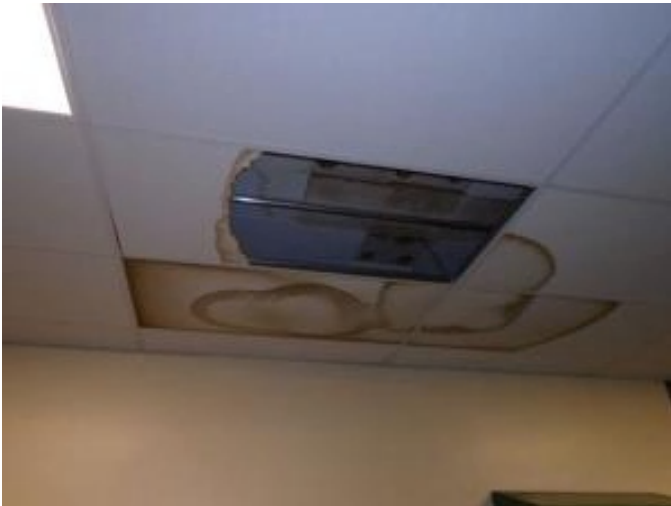
**System: C3030 - Ceiling Finishes**

**Location:** Throughout

**Distress:** Damaged

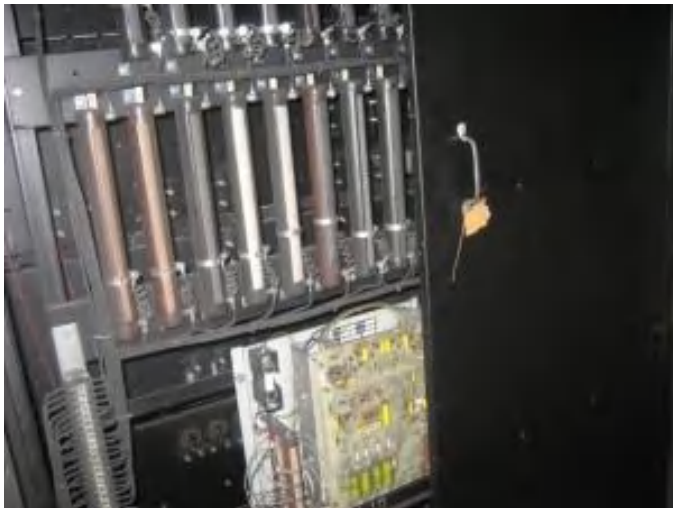
**System: D1010 - Elevators and Lifts**

**Location:** Elevator Machine room

**Distress:** Beyond Service Life

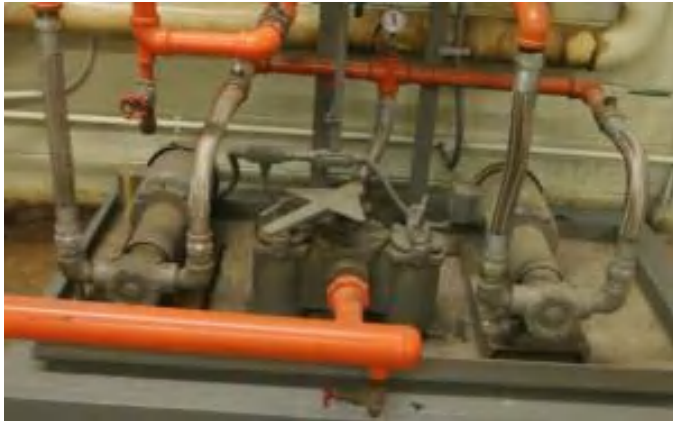
**System: D3020 - Heat Generating Systems**

**Location:** Boiler room

**Distress:** Failing

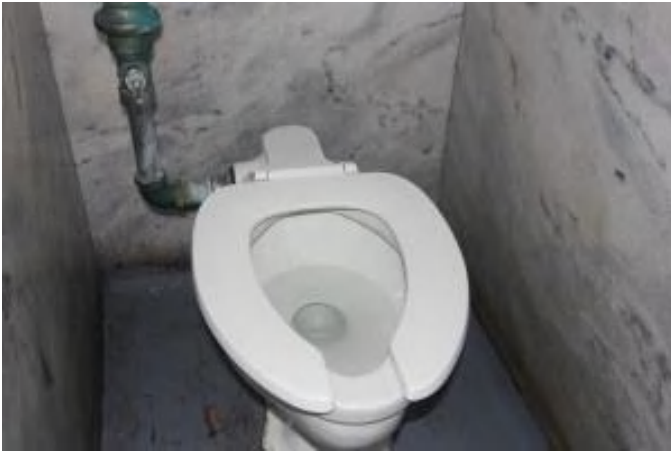
#### System: D2010 - Plumbing Fixtures

**Location:** Toilet rooms and classrooms

**Distress:** Failing

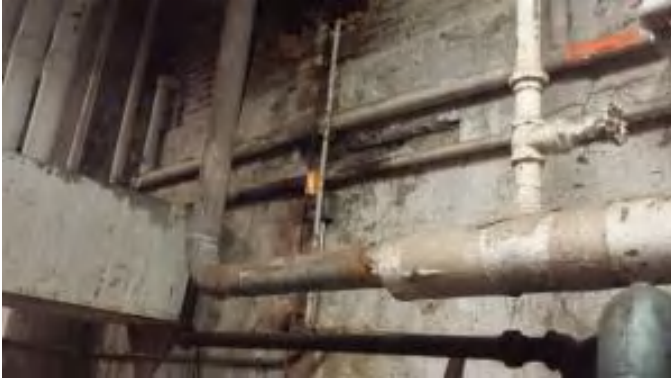
**System: A2020 - Basement Walls**

**Location:** Basement

**Distress:** Damaged

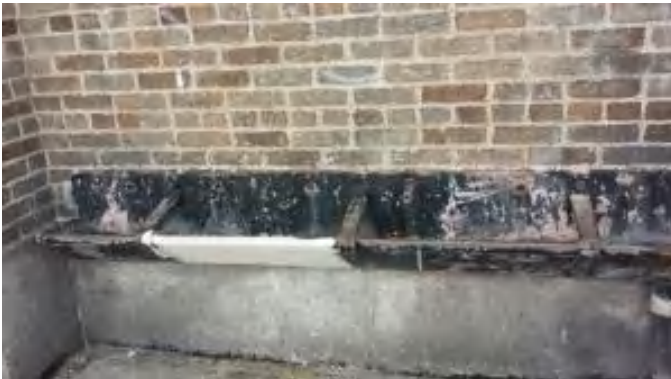
**System: B2010 - Exterior Walls**

**Location:** Ground level

**Distress:** Failing

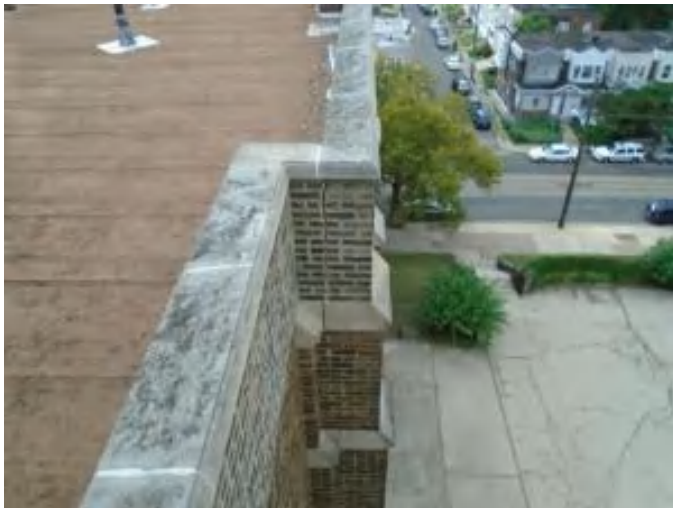
**System: B2010 - Exterior Walls**

**Location:** South wall

**Distress:** Building Envelope Integrity

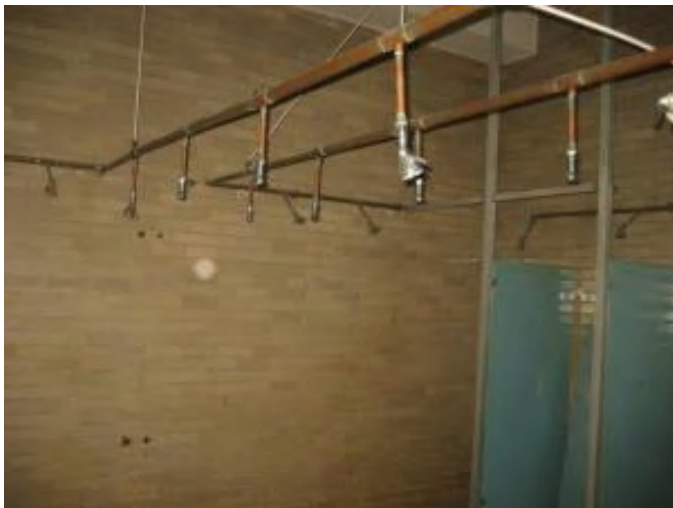
**System: C1010 - Partitions**

**Location:** Shower rooms

**Distress:** Inadequate

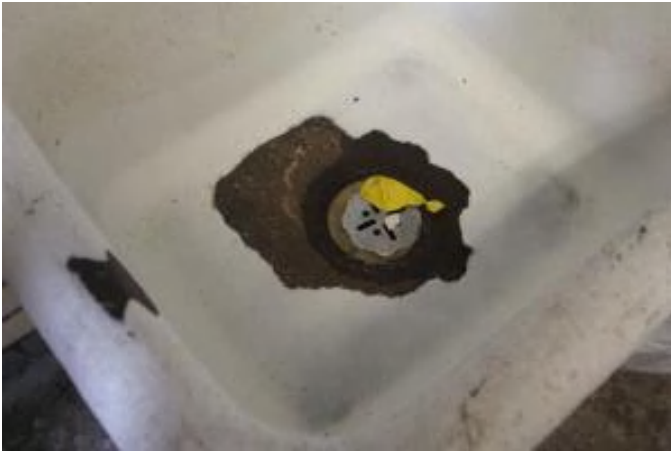
**System: D2010 - Plumbing Fixtures**

**Location:** Janitor closets

**Distress:** Failing

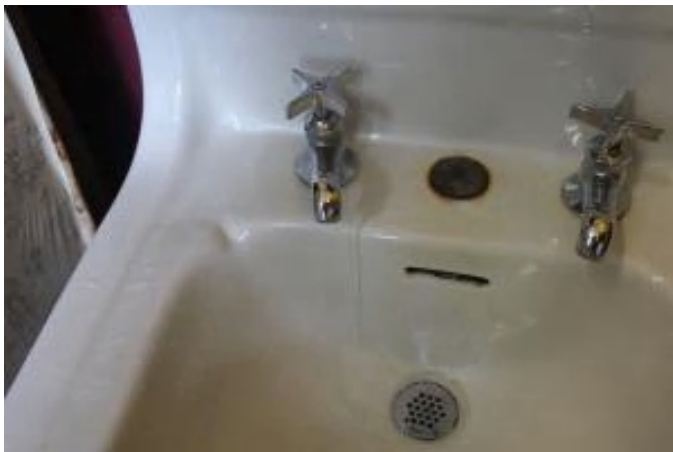
**System: D2010 - Plumbing Fixtures**

**Location:** Toilet rooms and classrooms

**Distress:** Failing

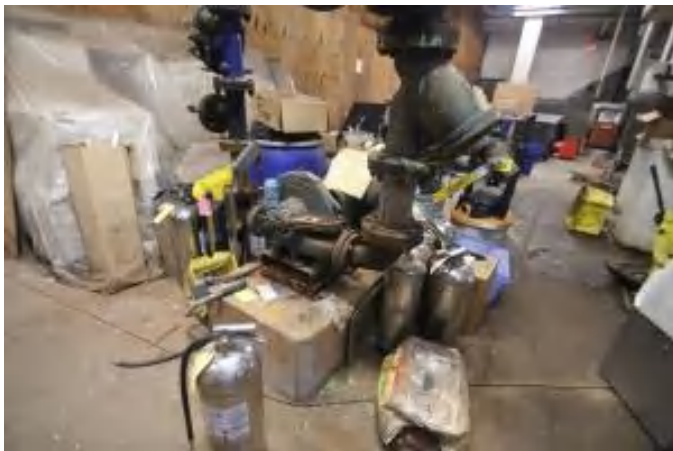
**System: D2020 - Domestic Water Distribution**

**Location:** Basement

**Distress:** Failing

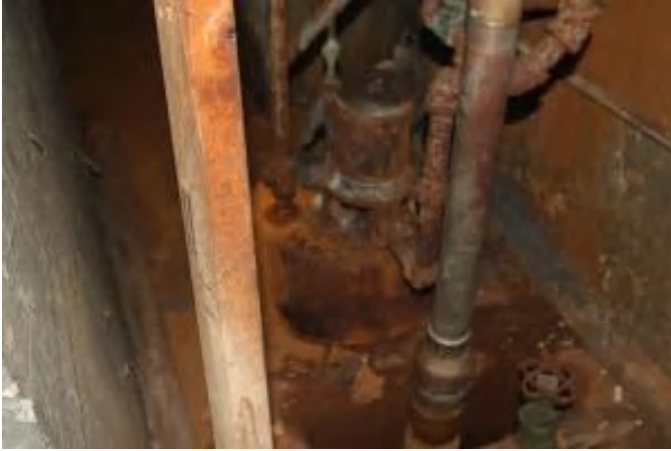
**System: D2030 - Sanitary Waste**

**Location:** Basement

**Distress:** Failing

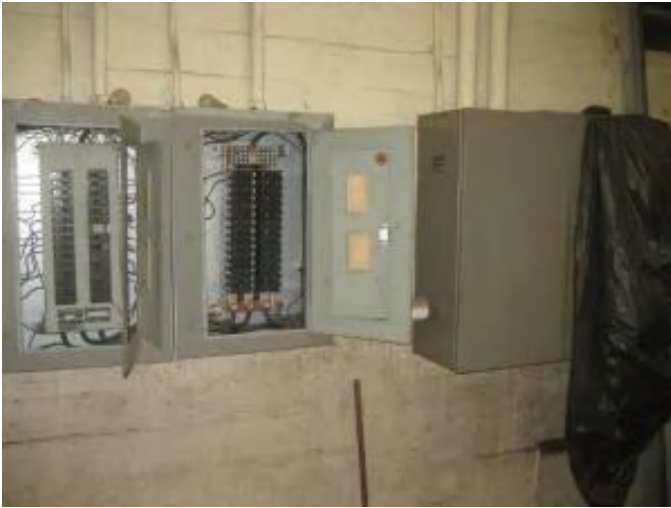
**System: D5010 - Electrical Service/Distribution**

**Location:** Entire Building

**Distress:** Inadequate

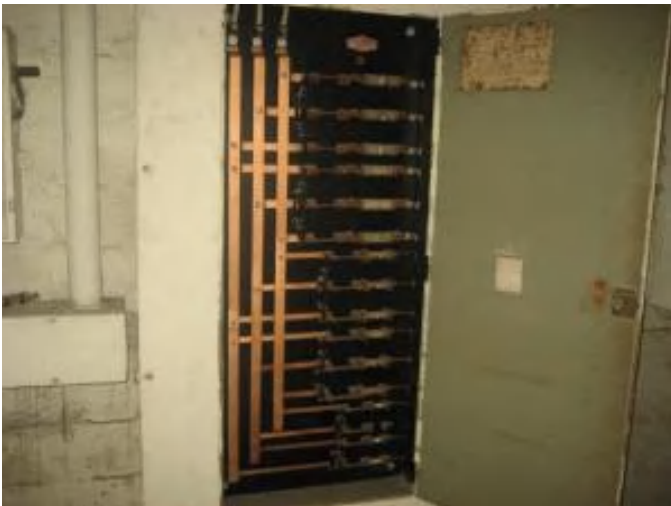
**System: D5010 - Electrical Service/Distribution**

**Location:** Basement

**Distress:** Inadequate

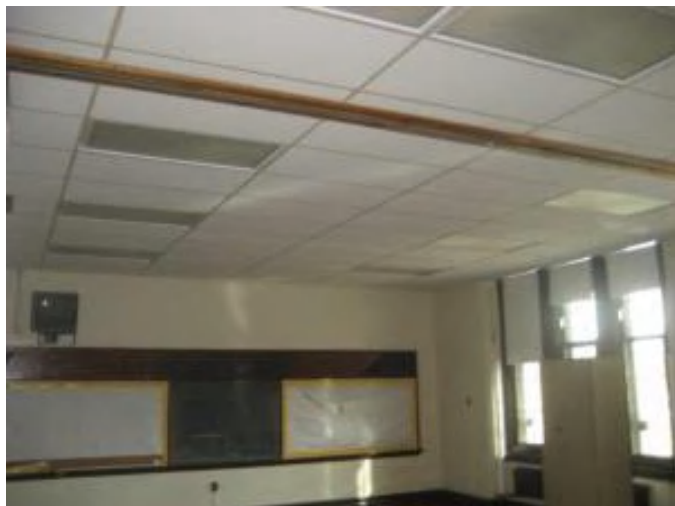
**System: D5020 - Lighting and Branch Wiring**

**Location:** Classrooms

**Distress:** Inadequate

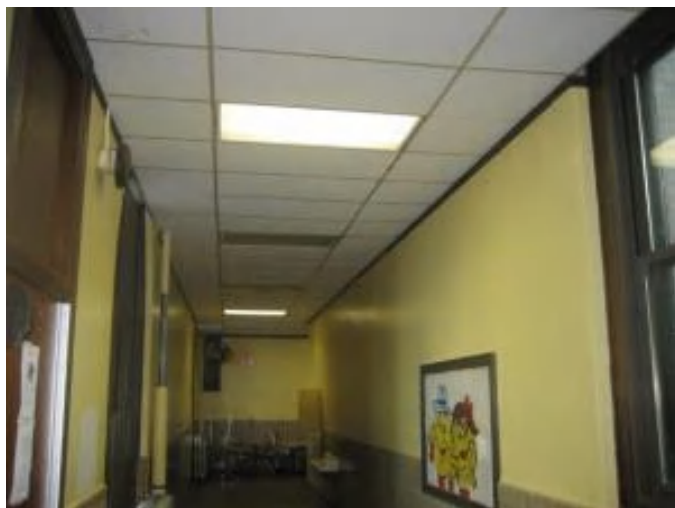
**System: D5030 - Communications and Security**

**Location:** Entire Building

**Distress:** Security Issue

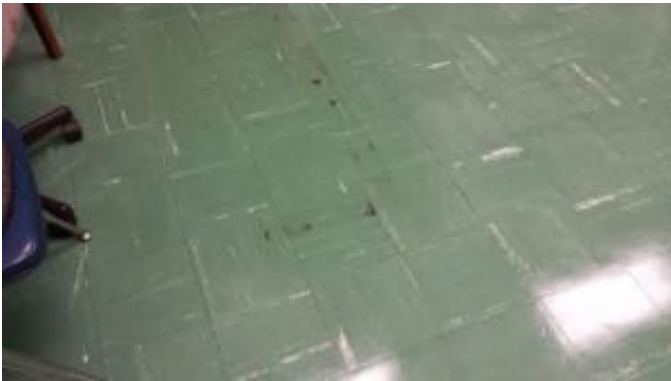
**System: C3020413 - Vinyl Flooring**

**Location:** Various

**Distress:** Damaged

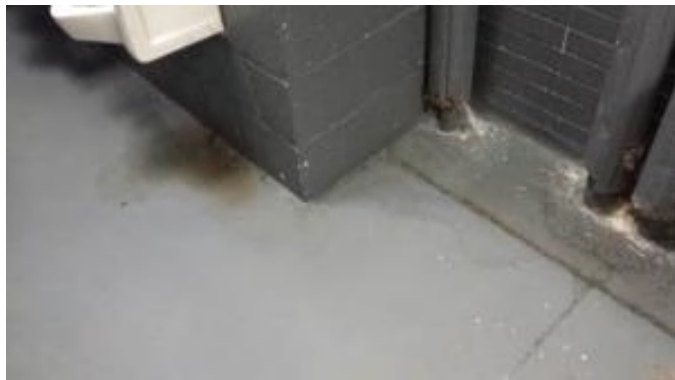
**System: C3020415 - Concrete Floor Finishes**

**Location:** Toilets

**Distress:** Health Hazard / Risk

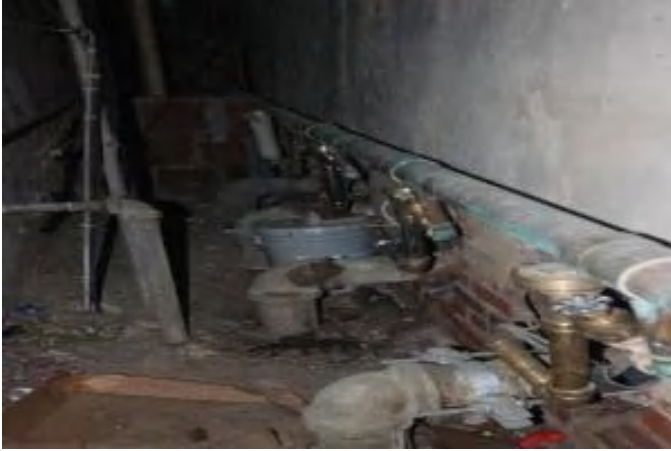
**System: D2030 - Sanitary Waste**

**Location:** Entire building

**Distress:** Failing

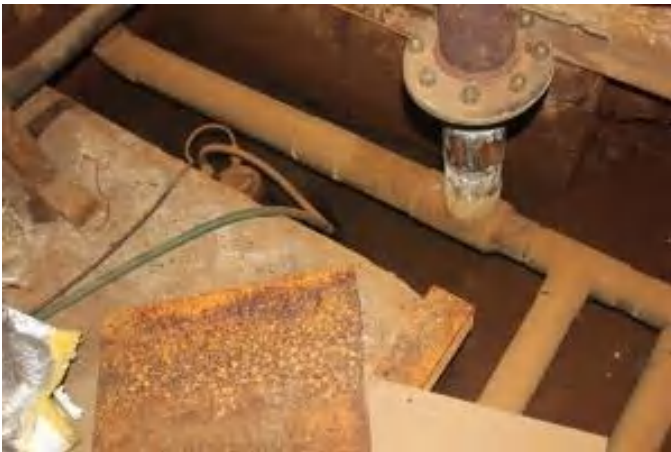
**System: D3040 - Distribution Systems**

**Location:** Entire building

**Distress:** Damaged

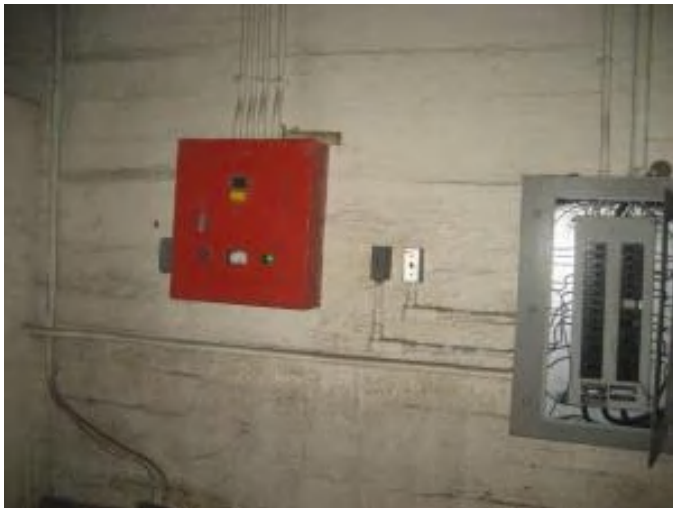
**System: D5030 - Communications and Security**

**Location:** Entire Building

**Distress:** Building / MEP Codes

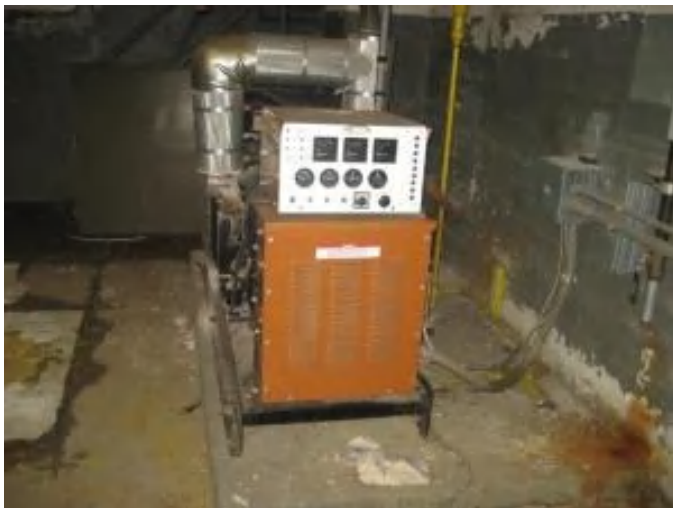
**System: D5090 - Other Electrical Systems**

**Location:** Roof

**Distress:** Inadequate

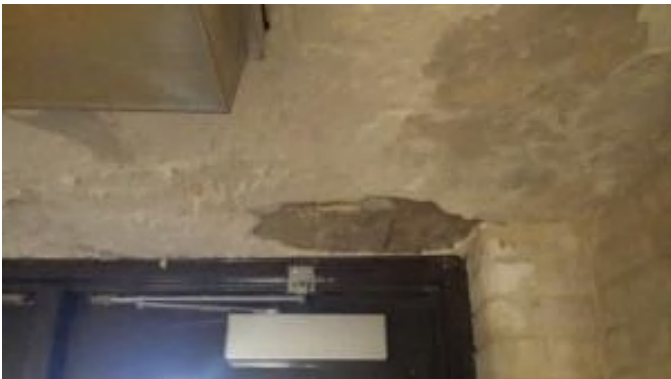
**System: C3010230 - Paint & Covering**

**Location:** Various

**Distress:** Damaged

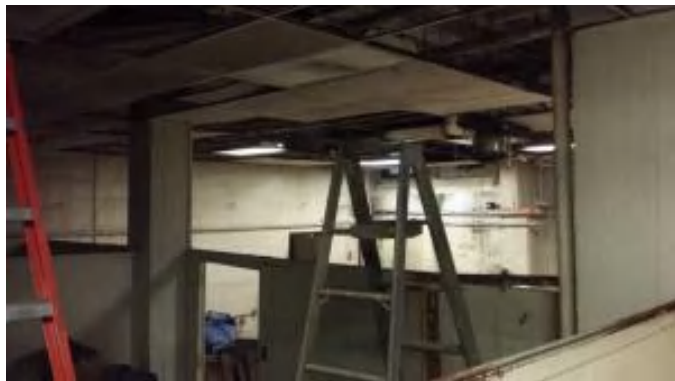
**System: C3030 - Ceiling Finishes**

**Location:** Basement

**Distress:** Failing

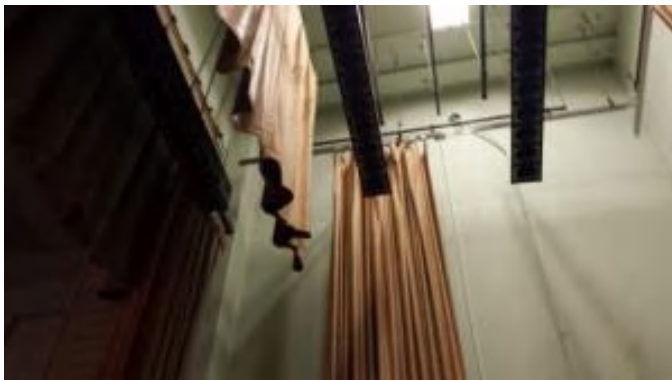
**System: E1020 - Institutional Equipment**

**Location:** Stage

**Distress:** Damaged

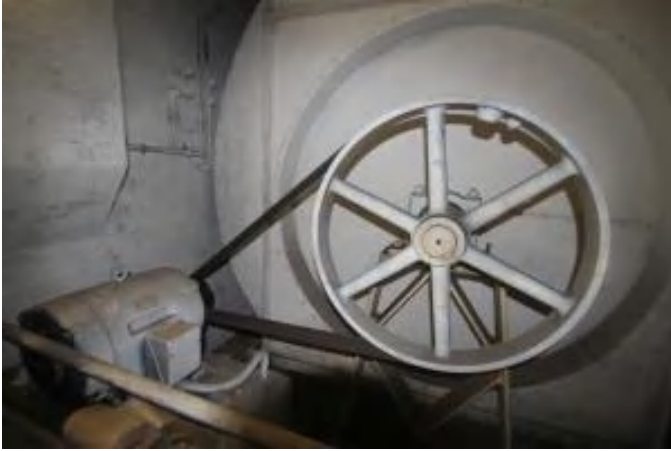
**System: D3040 - Distribution Systems**

**Location:** Basement fan rooms

**Distress:** Beyond Service Life

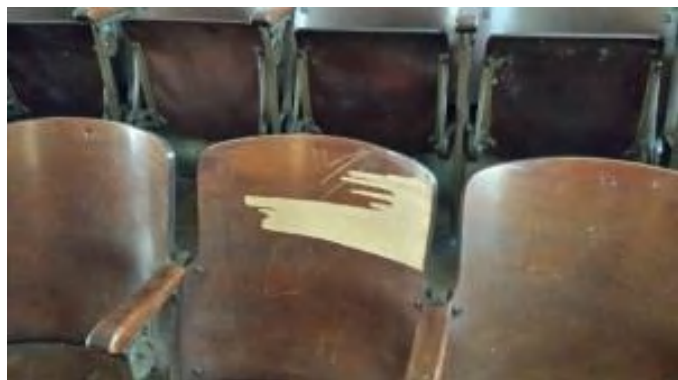
**System: E2010 - Fixed Furnishings**

**Location:** Auditorium / balcony

**Distress:** Failing

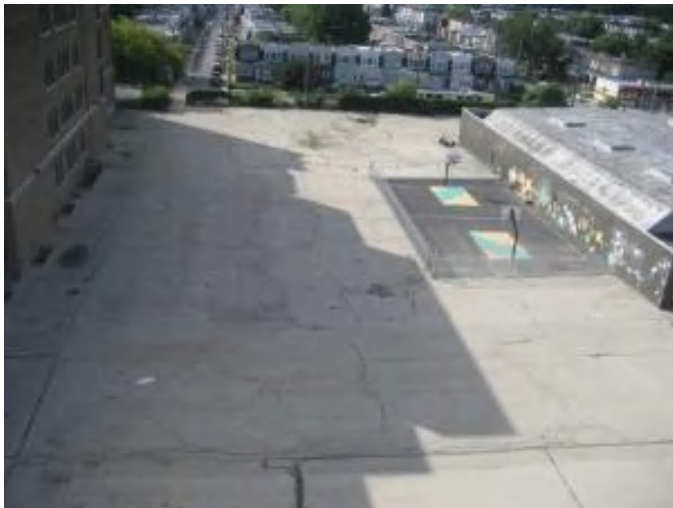
**System: G4020 - Site Lighting**

**Location:** Parkinglot/playground

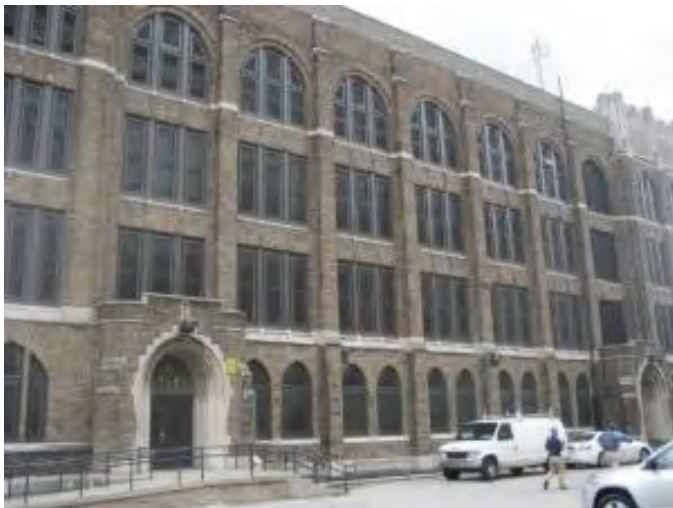
**System: G4030 - Site Communications & Security**

**Location:** Tilden- Building Perimeter

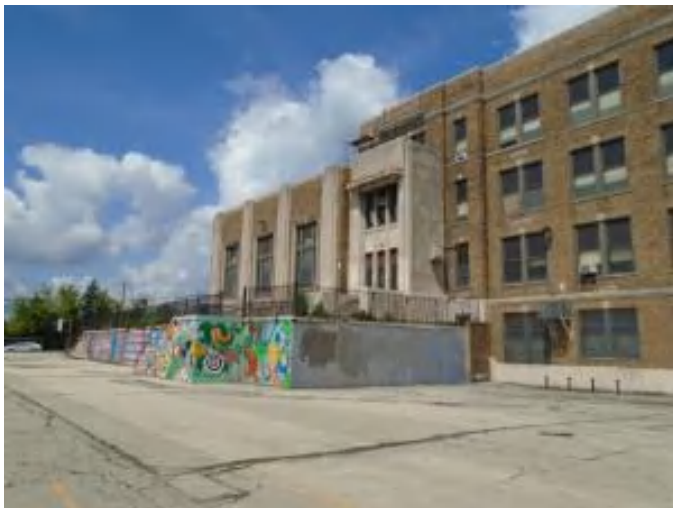
**System: G2040 - Site Development**

**Location:** Site
