## Facility Condition Assessment Summary Report

### Beeber Middle School

School District of Philadelphia  
**S410001;Beeber**  
Final  
**Site Assessment Report**

January 30, 2017

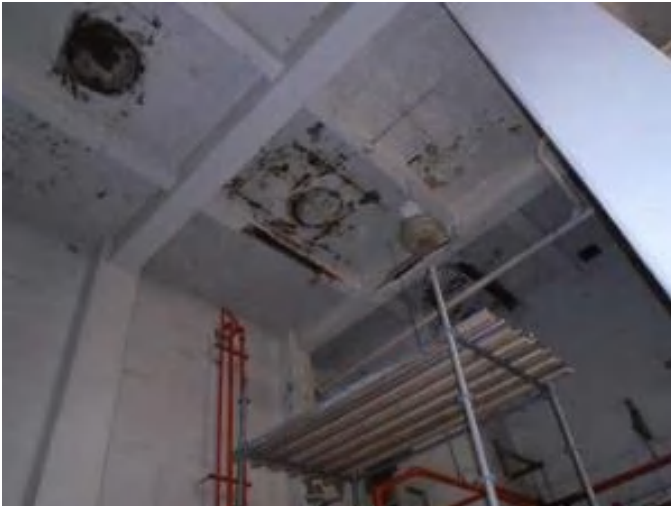
#### System: A2020 - Basement Walls

**Location:** Basement

**Distress:** Health Hazard / Risk

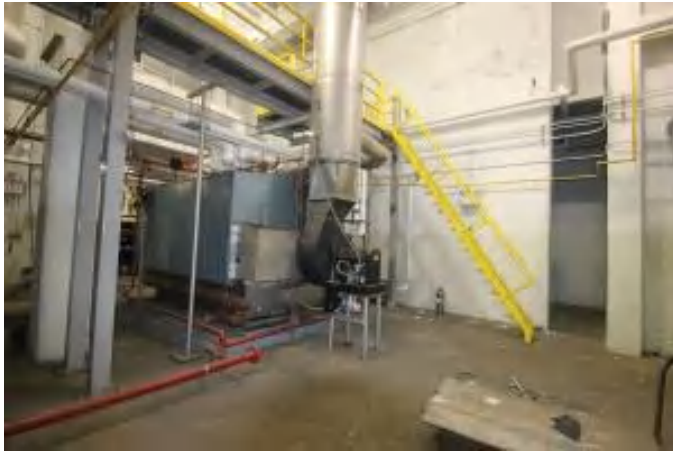
**System: D3020 - Heat Generating Systems**

**Location:** Boiler room  
**Distress:** Failing  
**Category:** 3 - Operations / Maint.  
**Priority:** 1 - Response Time (< 2 yr)  
**Correction:** Replace boiler, cast iron sectional (150 HP)  
**Qty:** 3.00  
**Unit of Measure:** Ea.  
**Estimate:** \$1,685,560.49  
**Assessor Name:** System  
**Date Created:** 01/11/2016

**Notes:** Replace boilers due to age and chronic repair needs

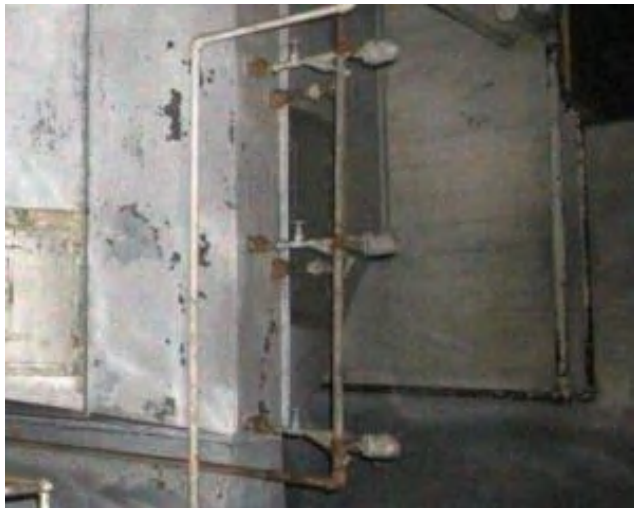
**System: D3040 - Distribution Systems**

**Location:** Entire building  
**Distress:** Failing  
**Category:** 3 - Operations / Maint.  
**Priority:** 1 - Response Time (< 2 yr)  
**Correction:** Conduct a steam trap survey and replace failed units.  
**Qty:** 139,000.00  
**Unit of Measure:** S.F.  
**Estimate:** \$456,074.20  
**Assessor Name:** System  
**Date Created:** 01/08/2016

**Notes:** Survey and repair steam traps

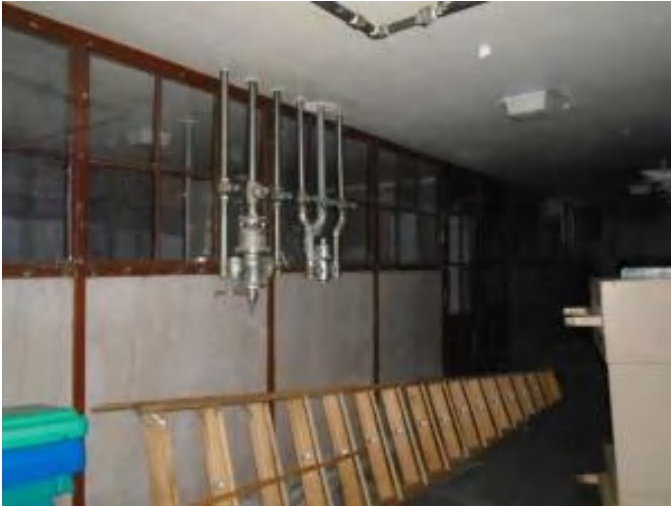
**System: B1010 - Floor Construction**

**Location:** Locker rooms

**Distress:** Beyond Service Life

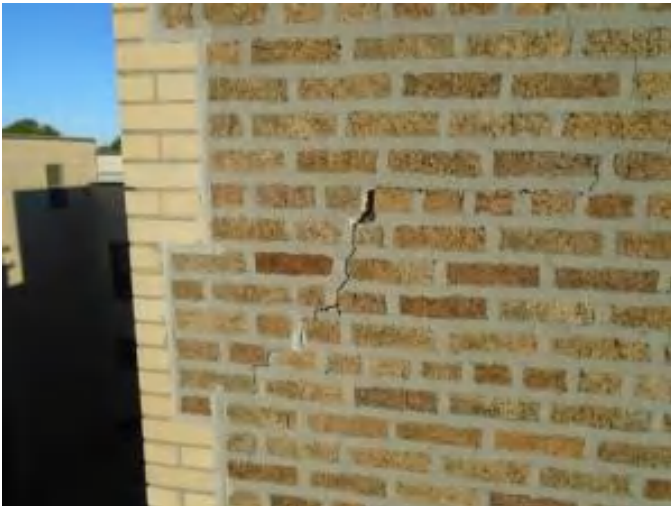
**System: B2010 - Exterior Walls**

**Location:** Ext. walls

**Distress:** Building Envelope Integrity

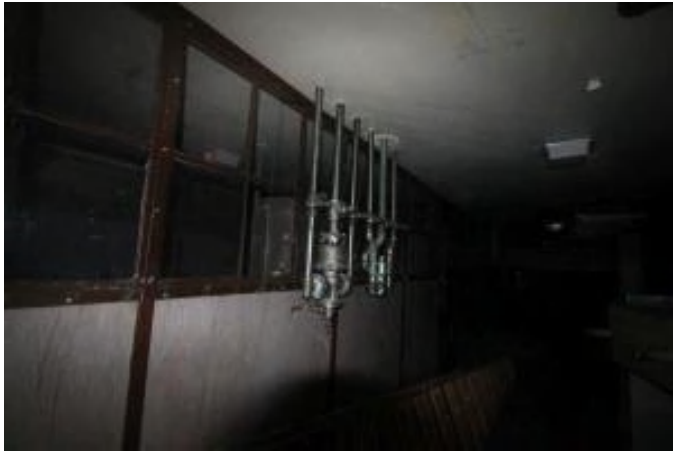
**System: C1010 - Partitions**

**Location:** Locker rooms

**Distress:** Obsolete

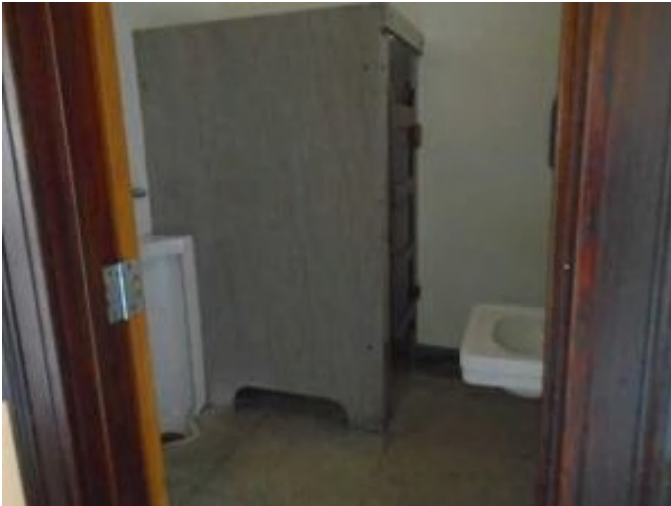
**System: C1030 - Fittings**

**Location:** Toilets

**Distress:** Accessibility

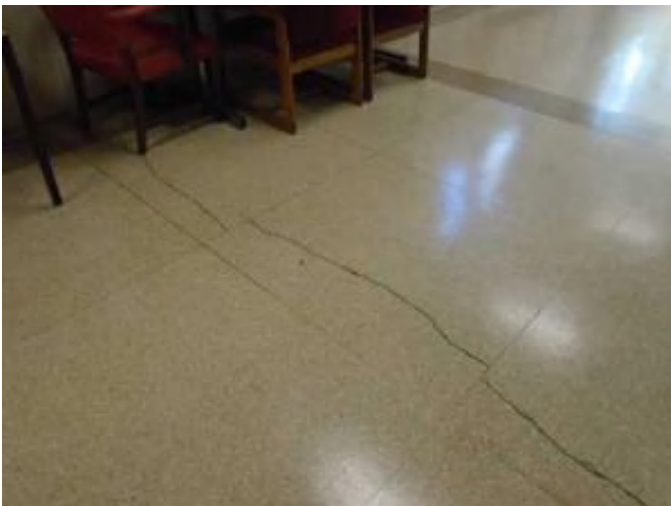
**System: C3020412 - Terrazzo & Tile**

**Location:** Various

**Distress:** Damaged

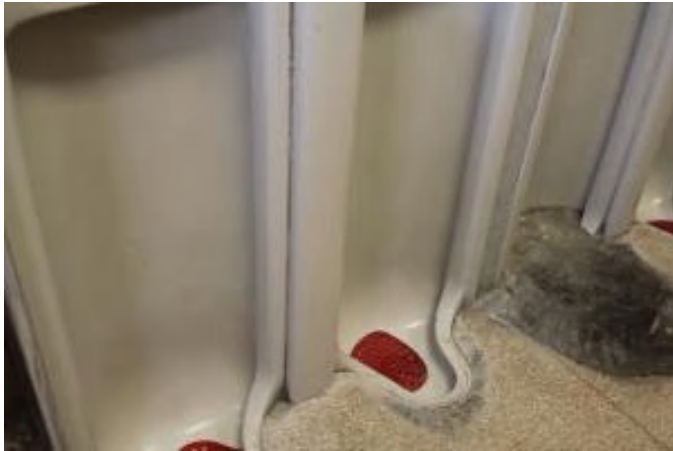
**System: D2010 - Plumbing Fixtures**

**Location:** Boys' toilets  
**Distress:** Obsolete  
**Category:** 3 - Operations / Maint.  
**Priority:** 2 - Response Time (2-3 yrs)  
**Correction:** Remove and replace or replace wall hung urinals  
**Qty:** 38.00  
**Unit of Measure:** Ea.  
**Estimate:** \$137,554.98  
**Assessor Name:** System  
**Date Created:** 01/08/2016

**Notes:** Replace all floor standing urinals

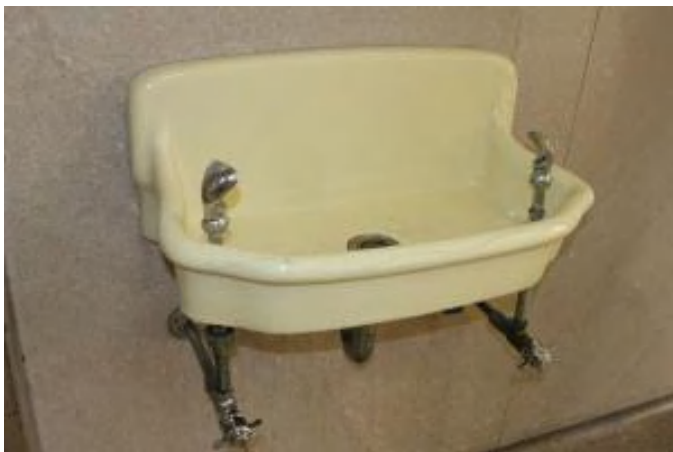
**System: D2010 - Plumbing Fixtures**

**Location:** Corridors  
**Distress:** Accessibility  
**Category:** 2 - Code Compliance  
**Priority:** 2 - Response Time (2-3 yrs)  
**Correction:** Remove and replace water fountains to meet ADA - includes high and low fountains and new recessed alcove  
**Qty:** 4.00  
**Unit of Measure:** Ea.  
**Estimate:** \$62,771.59  
**Assessor Name:** System  
**Date Created:** 01/08/2016

**Notes:** Install accessible fountains with integral chillers on each floor

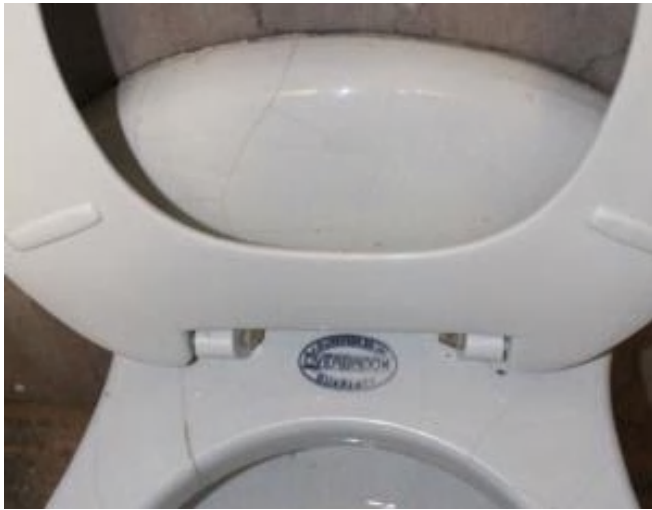
**System: D2010 - Plumbing Fixtures**

**Location:** Toilet rooms  
**Distress:** Beyond Service Life  
**Category:** 3 - Operations / Maint.  
**Priority:** 2 - Response Time (2-3 yrs)  
**Correction:** Remove and replace or replace wall hung urinals  
**Qty:** 15.00  
**Unit of Measure:** Ea.  
**Estimate:** \$56,920.18  
**Assessor Name:** System  
**Date Created:** 01/08/2016

**Notes:** Replace 25% water closets

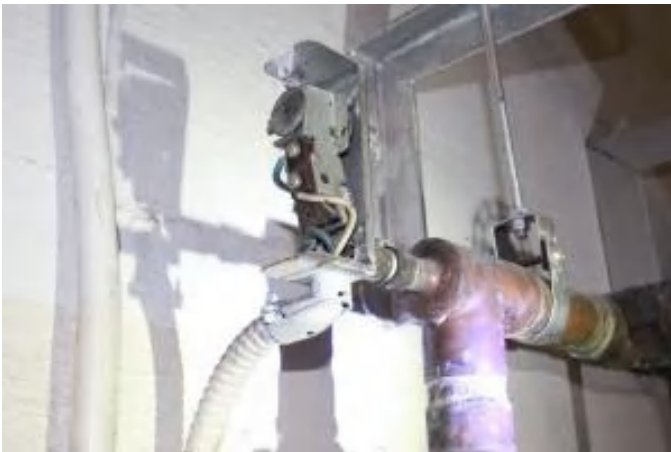
**System: D2020 - Domestic Water Distribution**

**Location:** Boiler room  
**Distress:** Failing  
**Category:** 3 - Operations / Maint.  
**Priority:** 2 - Response Time (2-3 yrs)  
**Correction:** Replace domestic water circulation pump (to 1 HP)  
**Qty:** 1.00  
**Unit of Measure:** Ea.  
**Estimate:** \$22,015.51  
**Assessor Name:** System  
**Date Created:** 01/07/2016

**Notes:** Repair or replace inoperative hot water circulation pump

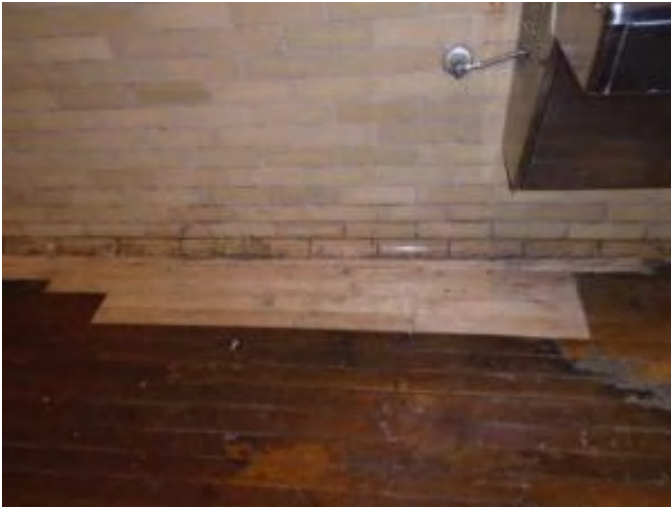
**System: C3020414 - Wood Flooring**

**Location:** Various  
**Distress:** Maintenance Required  
**Category:** 3 - Operations / Maint.  
**Priority:** 3 - Response Time (3-4 yrs)  
**Correction:** Refinish wood floors  
**Qty:** 15,300.00  
**Unit of Measure:** S.F.  
**Estimate:** \$164,734.18  
**Assessor Name:** System  
**Date Created:** 11/04/2015

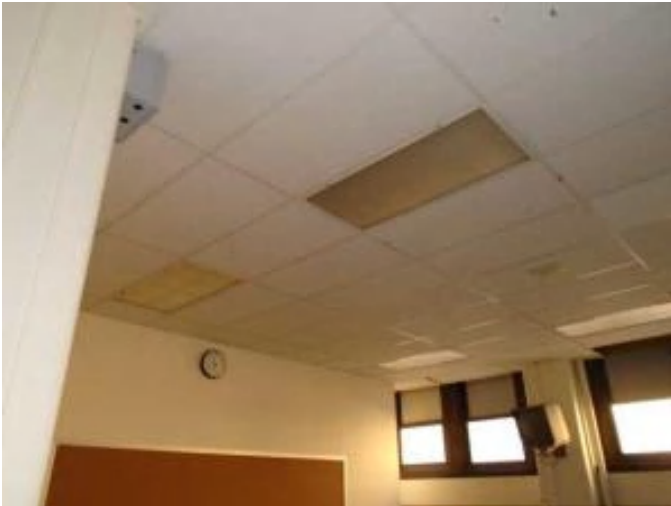
**System: C3030 - Ceiling Finishes**

**Location:** Throughout  
**Distress:** Beyond Service Life  
**Category:** 3 - Operations / Maint.  
**Priority:** 3 - Response Time (3-4 yrs)  
**Correction:** Remove and replace suspended acoustic ceilings - lighting not included  
**Qty:** 18,000.00  
**Unit of Measure:** S.F.  
**Estimate:** \$271,483.74  
**Assessor Name:** System  
**Date Created:** 11/04/2015

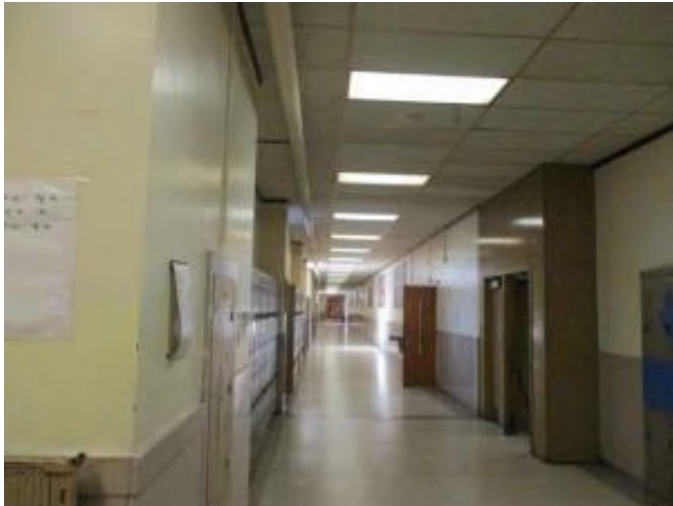
**System: D5090 - Other Electrical Systems**

**Location:** Entire Building  
**Distress:** Health Hazard / Risk  
**Category:** 1 - Health & Safety  
**Priority:** 3 - Response Time (3-4 yrs)  
**Correction:** Add Emergency/Exit Lighting  
**Qty:** 20.00  
**Unit of Measure:** Ea.  
**Estimate:** \$35,900.77  
**Assessor Name:** System  
**Date Created:** 12/29/2015

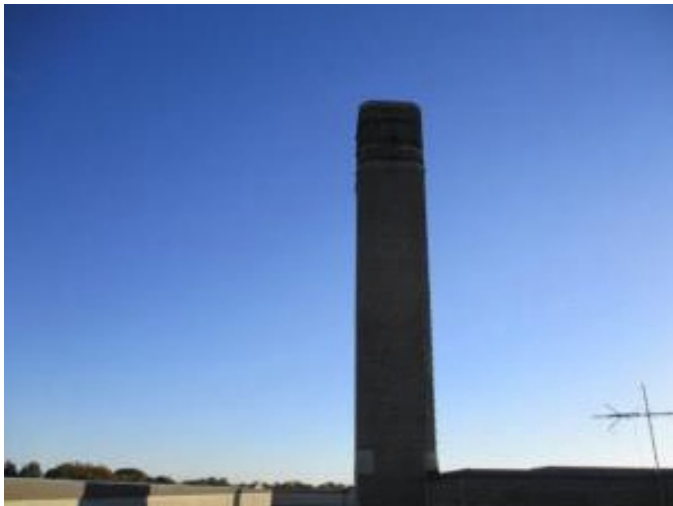
**System: D5090 - Other Electrical Systems**

**Location:** Roof  
**Distress:** Building / MEP Codes  
**Category:** 2 - Code Compliance  
**Priority:** 3 - Response Time (3-4 yrs)  
**Correction:** Repair Lightning Protection System  
**Qty:** 1.00  
**Unit of Measure:** Job  
**Estimate:** \$24,249.82  
**Assessor Name:** System  
**Date Created:** 12/29/2015

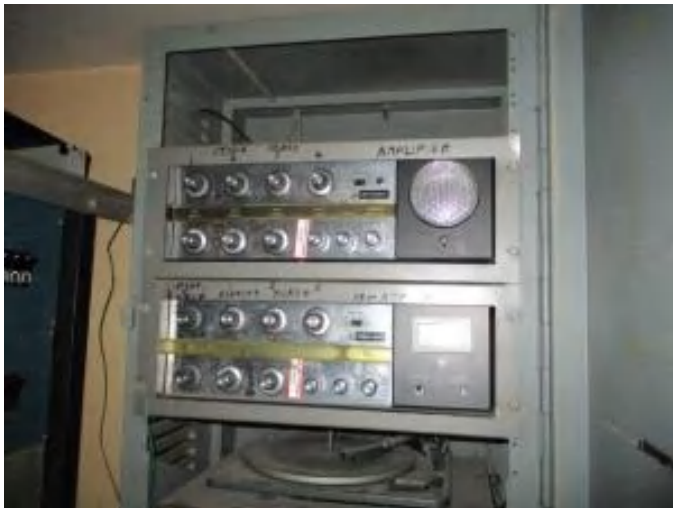
**System: D5030 - Communications and Security**

**Location:** Auditorium  
**Distress:** Beyond Service Life  
**Category:** 3 - Operations / Maint.  
**Priority:** 4 - Response Time (4-5 yrs)  
**Correction:** Add/Replace Sound System  
**Qty:** 1.00  
**Unit of Measure:** LS  
**Estimate:** \$25,352.33  
**Assessor Name:** System  
**Date Created:** 12/29/2015

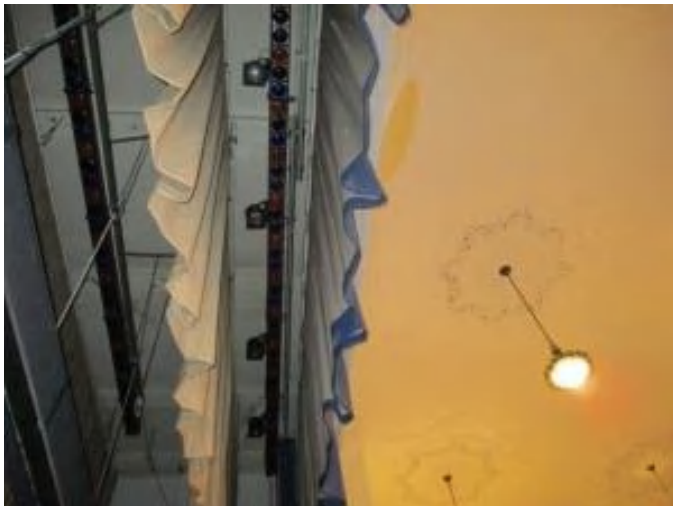
**System: E1020 - Institutional Equipment**

**Location:** Auditorium  
**Distress:** Obsolete  
**Category:** 3 - Operations / Maint.  
**Priority:** 4 - Response Time (4-5 yrs)  
**Correction:** Add/Replace Stage Theatrical Lighting System  
**Qty:** 1.00  
**Unit of Measure:** Ea.  
**Estimate:** \$293,594.70  
**Assessor Name:** System  
**Date Created:** 12/29/2015

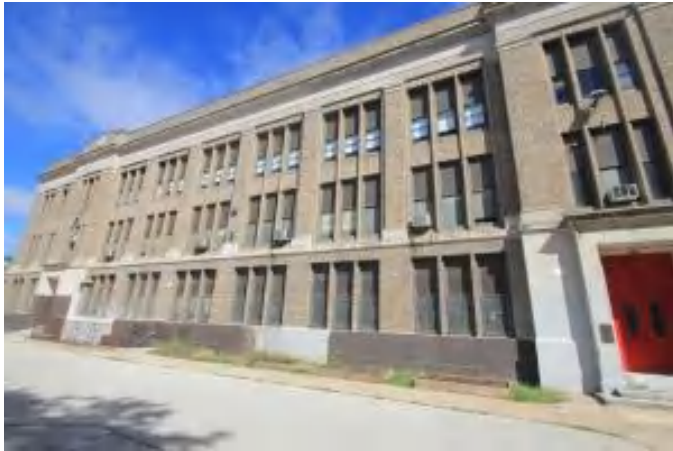
**System: D3030 - Cooling Generating Systems**

**Location:** Entire building  
**Distress:** Inadequate  
**Category:** 4 - Capital Improvement  
**Priority:** 5 - Response Time (> 5 yrs)  
**Correction:** Install chilled water system with distribution piping and pumps. (+150KSF)  
**Qty:** 105,000.00  
**Unit of Measure:** S.F.  
**Estimate:** \$1,746,308.01  
**Assessor Name:** System  
**Date Created:** 01/08/2016

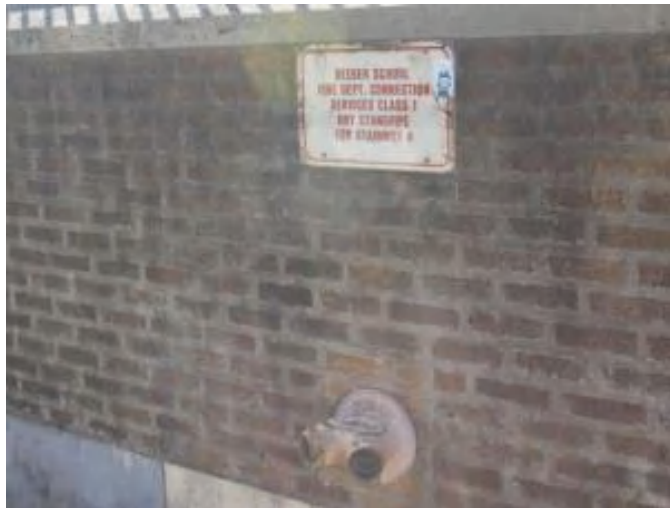
**System: D4010 - Sprinklers**

**Location:** Entire building  
**Distress:** Life Safety / NFPA / PFD  
**Category:** 1 - Health & Safety  
**Priority:** 5 - Response Time (> 5 yrs)  
**Correction:** Install a fire protection sprinkler system  
**Qty:** 139,000.00  
**Unit of Measure:** S.F.  
**Estimate:** \$1,988,458.48  
**Assessor Name:** System  
**Date Created:** 01/07/2016

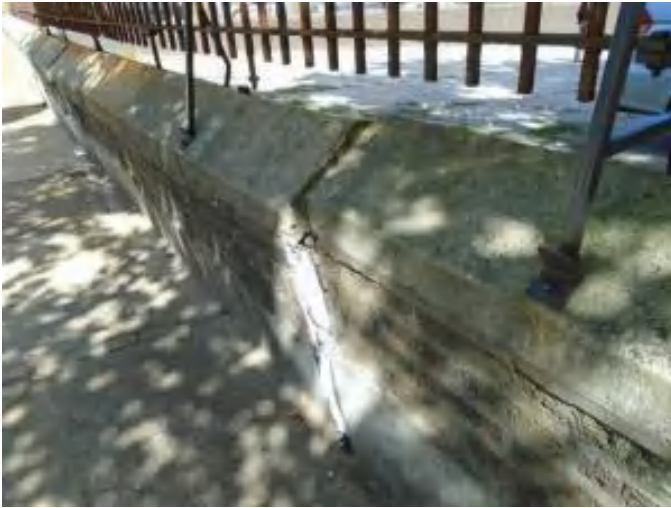
**System: G2040 - Site Development**

**Location:** Site  
**Distress:** Damaged  
**Category:** 3 - Operations / Maint.  
**Priority:** 3 - Response Time (3-4 yrs)  
**Correction:** Repair and regrout stone retaining wall - LF of wall - up to 4' tall  
**Qty:** 50.00  
**Unit of Measure:** L.F.  
**Estimate:** \$23,322.39  
**Assessor Name:** Eduardo Zambrano  
**Date Created:** 11/04/2015

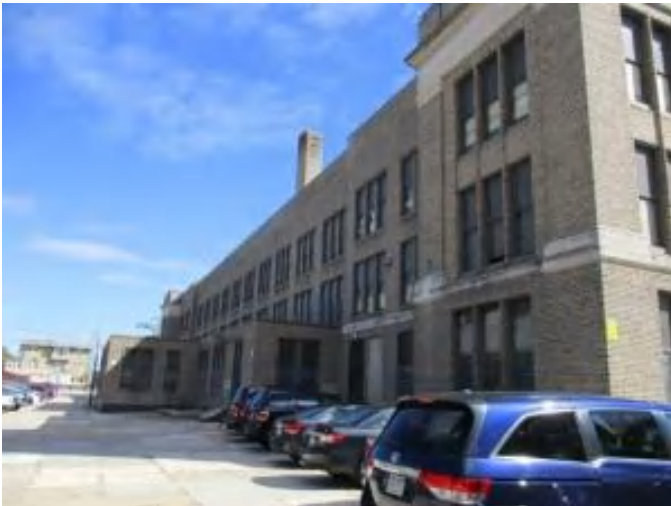
**System: G4030 - Site Communications & Security**

**Location:** Building Perimeter  
**Distress:** Security Issue  
**Category:** 1 - Health & Safety  
**Priority:** 3 - Response Time (3-4 yrs)  
**Correction:** Add Video Surveillance System  
**Qty:** 15.00  
**Unit of Measure:** Ea.  
**Estimate:** \$276,566.19  
**Assessor Name:** Eduardo Zambrano  
**Date Created:** 12/29/2015
