Facility Condition Assessment Summary Report

Belmont School

School District of Philadelphia
S121001;Belmont
Final
Site Assessment Report
February 1, 2017

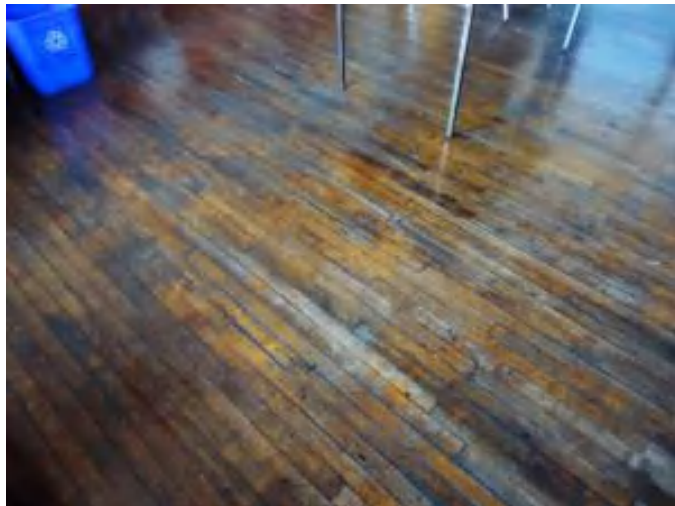
System: C3020414 - Wood Flooring

The wooden floor finish in the classrooms has served this school from the first day of school. The systems maintenance has been a priority each year as part of a cyclical program to either, sand, clean and resurface or wax as needed. Considering the age and current condition of the classroom wooden floor finish, removal and replacement is recommended.

Location: Classrooms

Distress: Damaged

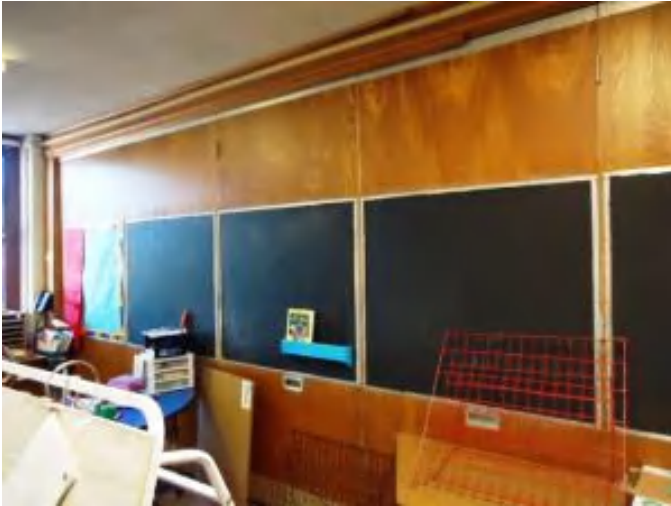
System: C1010 - Partitions

Location: Classrooms

Distress: Damaged

Notes: There are several movable partitions that remain in classrooms. These wall systems are no longer used and in most cases cannot be used due to damage or wall modifications to support classroom needs. This deficiency provides a budgetary consideration to remove and replace the wall systems with universal removal of the existing movable partitions and upgrades to a permeate wall systems.

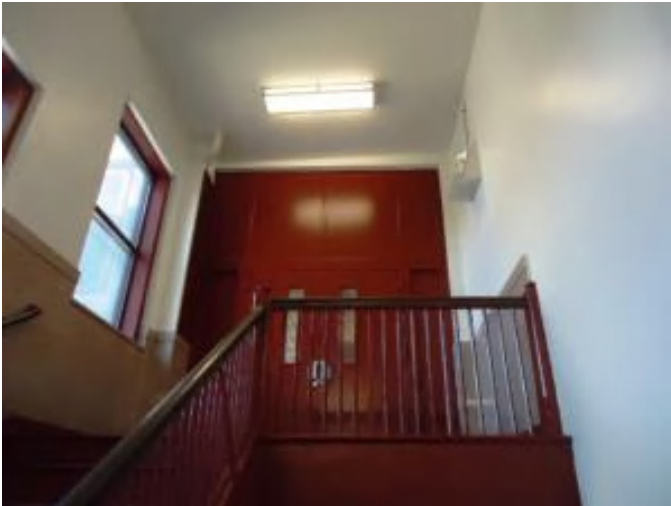
System: C1010 - Partitions

Location: Building Wide

Distress: Damaged

Notes: A large portion of the interior corridor, exit stair doors are not code compliant. Several doors are typically metal in metal frames with transom lites or sidelights, glass glazing. Although the doors appear to be fire rated several of the tags have either been removed or painted over. The older doors are generally in good condition considering the age of the application. To restore the door finishes, universal upgrades are required for the older door applications. Remove and replace original door systems with new code compliant fire rated door system.

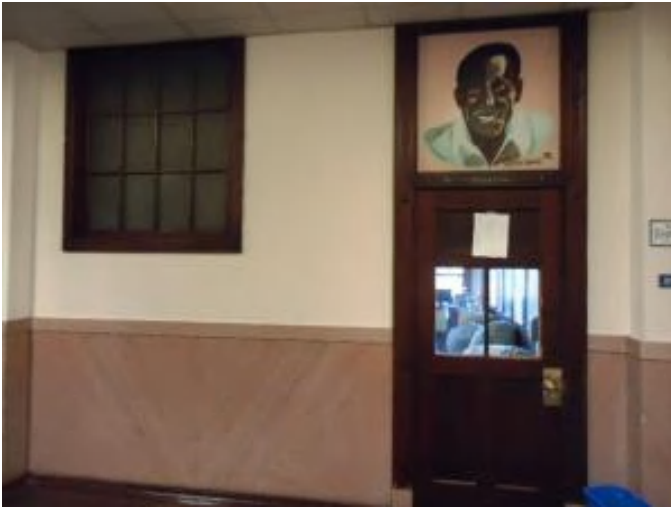
System: C1010 - Partitions

Location: Hallways

Distress: Damaged

Notes: There are several transom lites and sidelights constructed into hallway wall systems. It is recommended that the lites and sidelights be removed and replaced with a fire rated wall construction. The deficiency provides a budgetary consideration to correct the hallway, transoms, lites and sidelights.

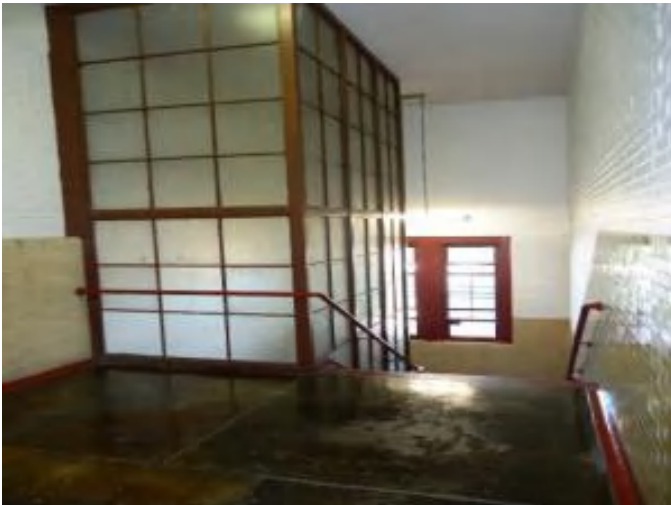
System: C2010 - Stair Construction

Location: Stairs

Distress: Life Safety / NFPA / PFD

Notes: Current requirements for stairs indicate that they have graspable handrails on both sides, that the rails have a specific end geometry, and that the handrails continue horizontally at the landings. In addition, guardrails must prevent the passage of a 4 inch diameter sphere (6 inches in the triangle formed by the lower rail and tread/riser angle). Although the stairs are compliant with the code enforced at the time of construction until a major renovation occurs, they are deficient in handrail and guardrail design relative to current standards. Future efforts should include comprehensive stair railing removal and replacement upgrades.

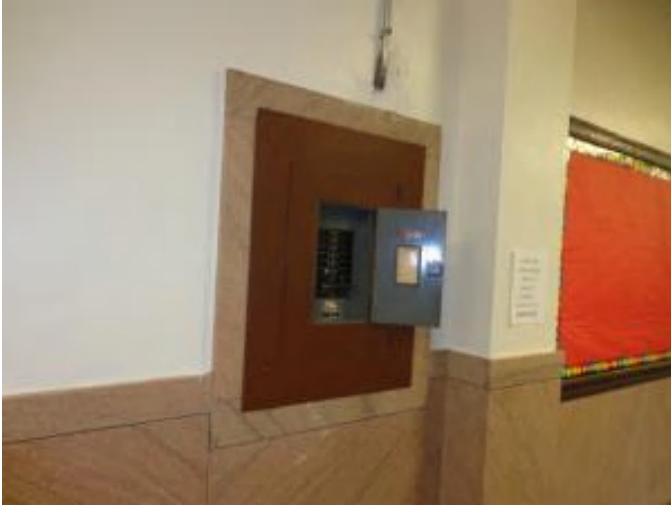
System: D5010 - Electrical Service/Distribution

Location: Building wide

Distress: Beyond Service Life

Notes: Replace all 120/240V, 1 phase panelboards in the building and the 400A, 120/240V, 2 phase, 5 wire Panelboard in the Boiler Room. Total of (17) panelboards. Also, replace the 25 kVA, 240V, 3 phase transformer.

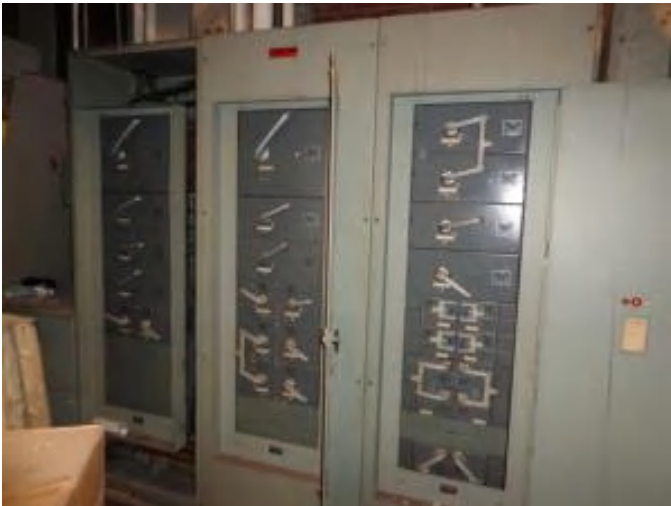
System: D5010 - Electrical Service/Distribution

Location: Main Electrical Room

Distress: Beyond Service Life

Notes: Replace 800A, 120/240V, 2 phase, 5 wire switchboard with a 3000A, 208/120V, 3 phase, 4 wire service distribution switchboard with associated feeder circuit breakers and feeders to serve the exiting building and added central air conditioning equipment, an elevator addition, and a fire pump (if required).

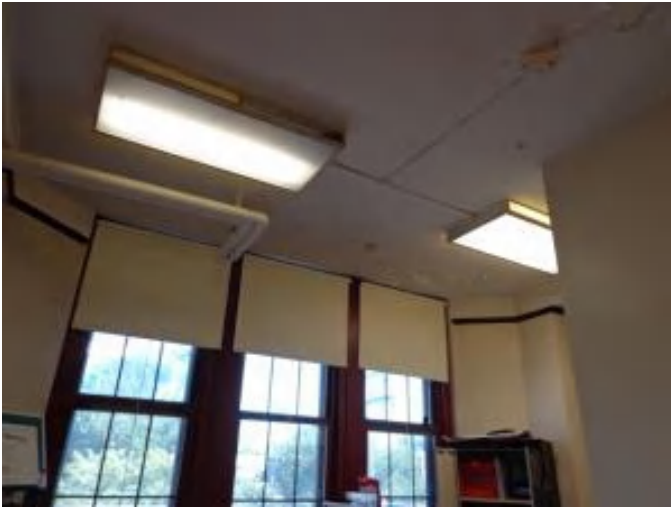
System: D5020 - Lighting and Branch Wiring

Location: Classrooms, gym, auditorium, support areas

Distress: Beyond Service Life

Notes: Replace fluorescent lighting fixtures in classrooms, gymnasium/cafeteria, auditorium and support areas throughout the building (Approximately 73,000 SF).

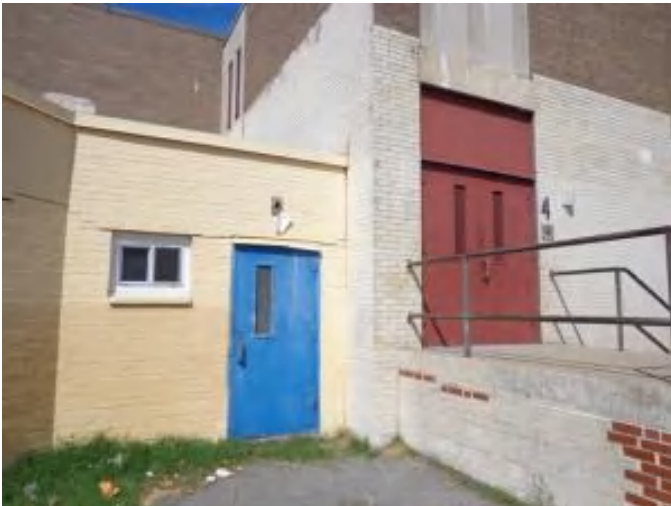
System: D5020 - Lighting and Branch Wiring

Location: Building Exterior

Distress: Beyond Service Life

Notes: Replace exterior wall mounted lighting fixtures at exit discharges to grade (Total of 8).

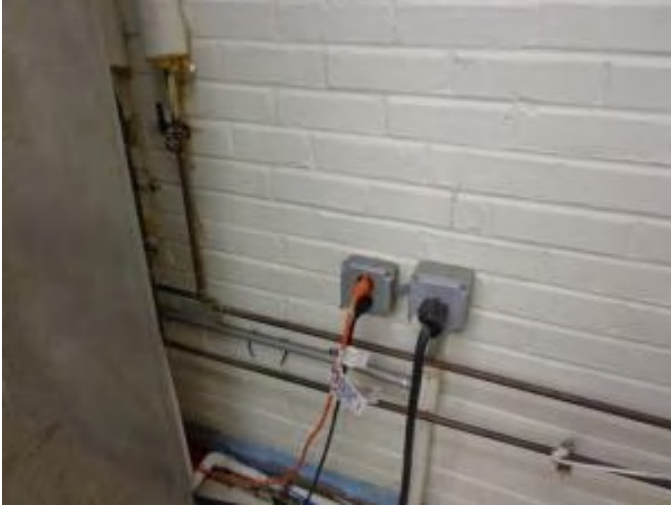
System: D5020 - Lighting and Branch Wiring

Location: Kitchen, Computer Room 308

Distress: Life Safety / NFPA / PFD

Notes: Replace total of (5) duplex receptacles in the kitchen and Computer Room 308 with ground-fault circuit-interrupting (GFCI) type to provide personnel protection, as required by NFPA 70, Article 210.8.

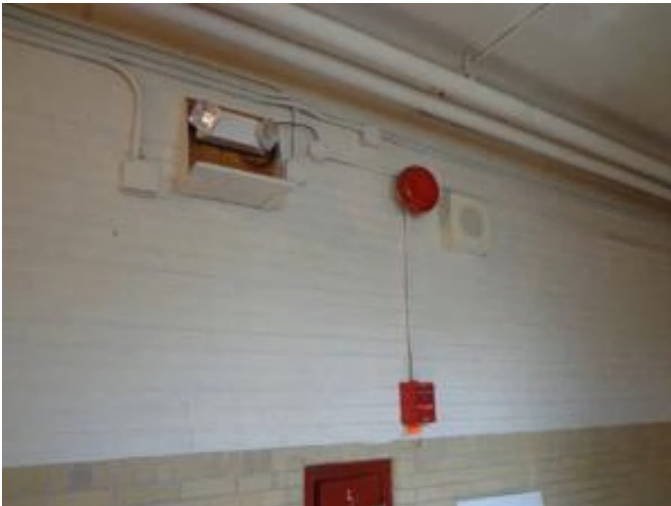
System: D5030 - Communications and Security

Location: Building wide

Distress: Beyond Service Life

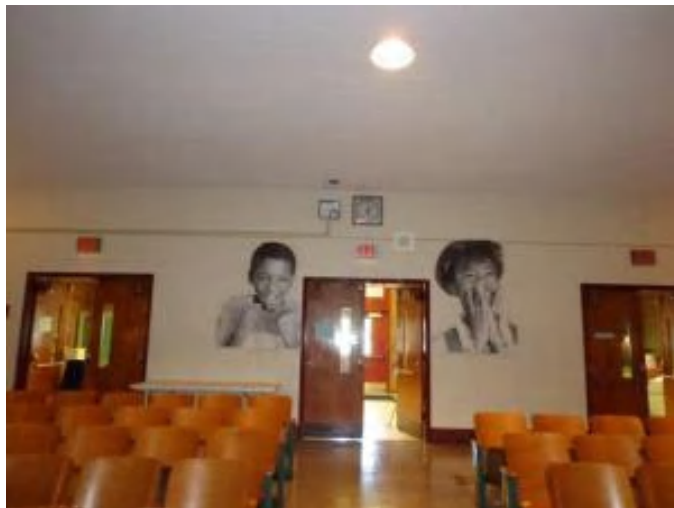
System: D5090 - Other Electrical Systems

Location: Building wide

Distress: Life Safety / NFPA / PFD

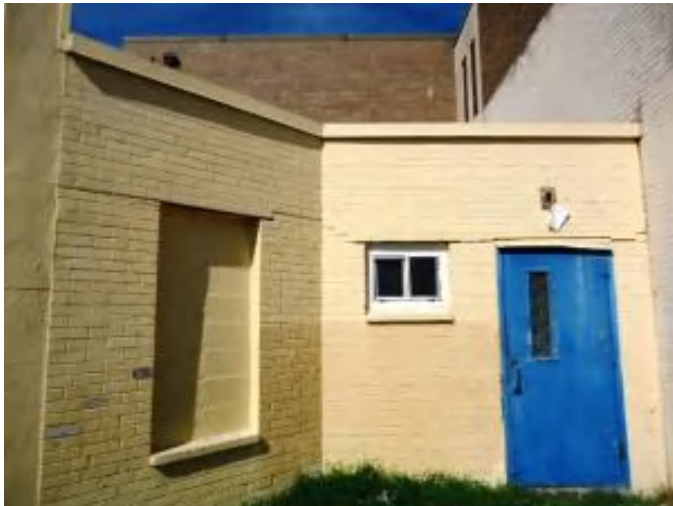
System: B2010 - Exterior Walls

The exterior brick surfaces are generally in fair to good condition for their age. In some locations, bricks have cracked or spalled and should be replaced. The repointing of deteriorated mortar joints is also recommended, using mortar of a similar color and consistency as the original. Following the detailed examination of the brick and repair of mortar construction joints, the entire building should be pressure washed to remove stains and embedded pollutants. If moisture is found to be penetrating the masonry facade, the application of a spray sealant to the suspected exterior masonry surface is recommended.

Location: Exterior Elevation

Distress: Damaged

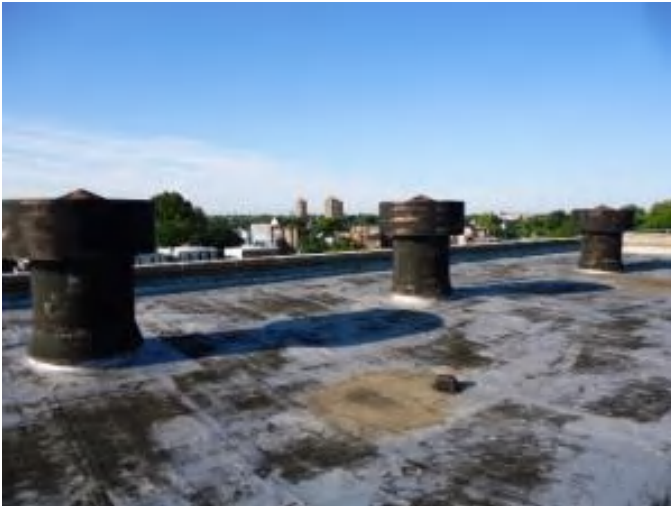
System: B3010105 - Built-Up

There are a number of roof sections and different roof elevations ranging from the main roof to the mechanical roof. Parapet heights, coping materials, and the height of the flashing also varies in different sections. The main roof is a built up application that was installed in the early 1990'S. The other built up roofs have not conclusive installation dates and have been seal coated several times to extend the life cycle of the application. Considering the age and condition of the roofing systems, universal upgrades are recommended. Remove and replace all roof sections.

Location: Roof

Distress: Damaged

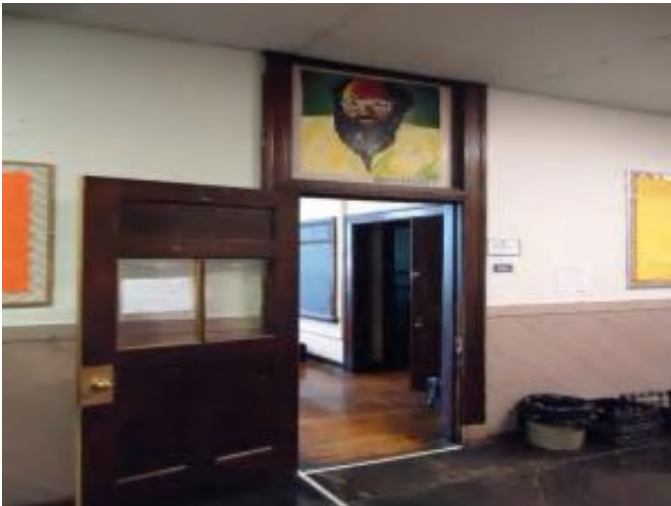
System: C1020 - Interior Doors

Interior doors are typically wood in wood frames with glass glazing. Other interior doors include wooden glass pane doors with original wooden pane frames, hollow metal in hollow metal frames. Doors are generally in good condition considering the age of the application. Universal upgrades are required for the interior door systems, it is recommended that the interior doors system be removed and replaced with a new modern metal framed wooden door system with consideration for ADA compliance.

Location: Classrooms

Distress: Damaged

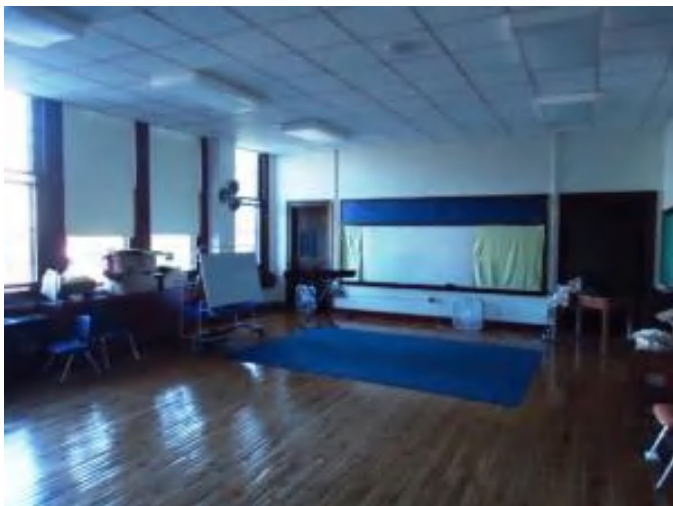
System: C1030 - Fittings

The classroom chalk boards are original to the buildings construction. This system is damaged and beyond its expected life, universal upgrades are warranted. Remove and upgrade chalk boards to new marker board systems.

Location: Classrooms

Distress: Damaged

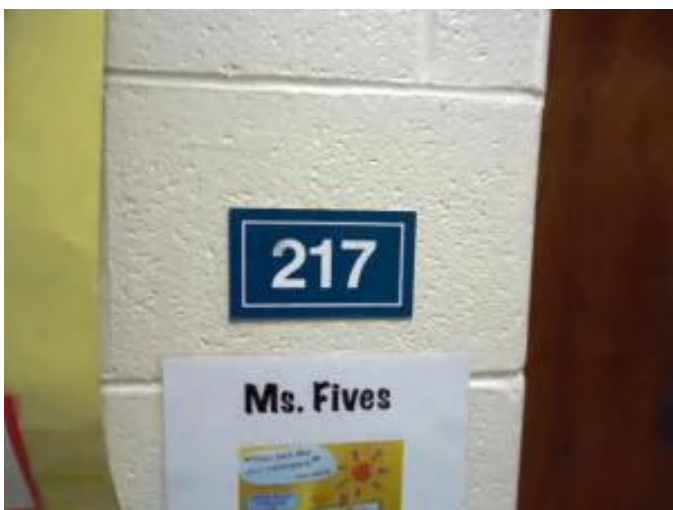
System: C1030 - Fittings

Location: Building Wide

Distress: Damaged

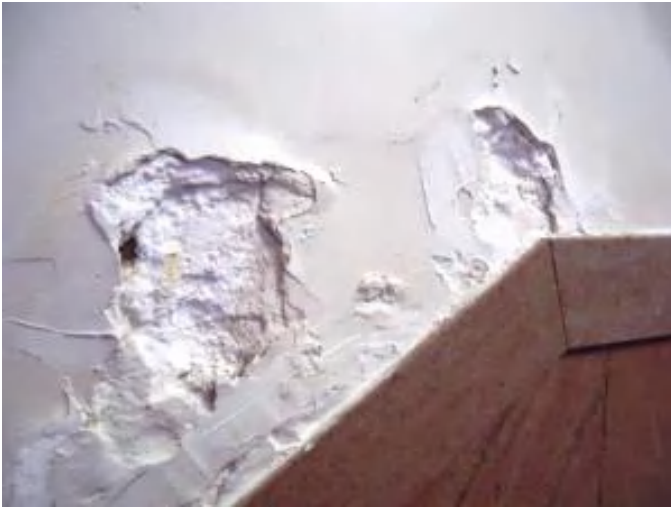
System: C3010230 - Paint & Covering

Interior wall finishes are typically marble, plaster, CMU or Brick finishes. Other wall finishes include: ceramic tile at restrooms. Wall finishes are generally in fair condition. There are several minor areas of wall damage that ranges from serious to minor. Although the school is on a cyclical program of renewal and each painted surface is renewed at years end this system is at the point in which repairs are necessary. Remove damaged wall finishes and repair areas then apply primer and paint finish.

Location: Building Wide

Distress: Damaged

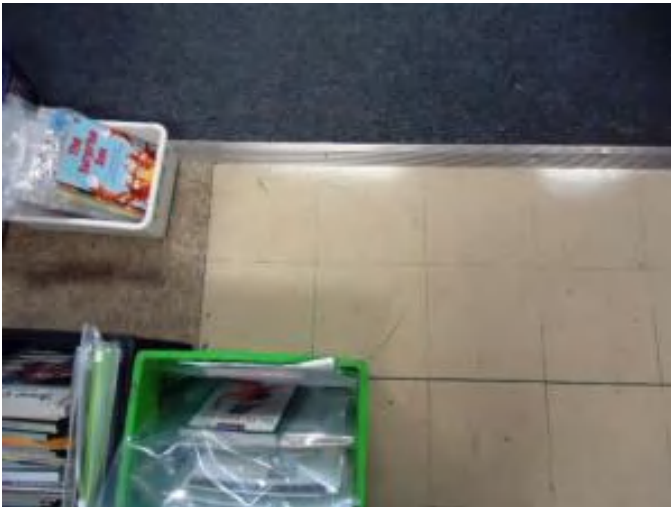
System: C3020411 - Carpet

The interior carpet finish was installed approximately in 2000 and is in fair condition considering the age and high traffic conditions. This finish will exceeded its expected life within the next five years and is recommended for removal and replacement.

Location: Administrative Area

Distress: Damaged

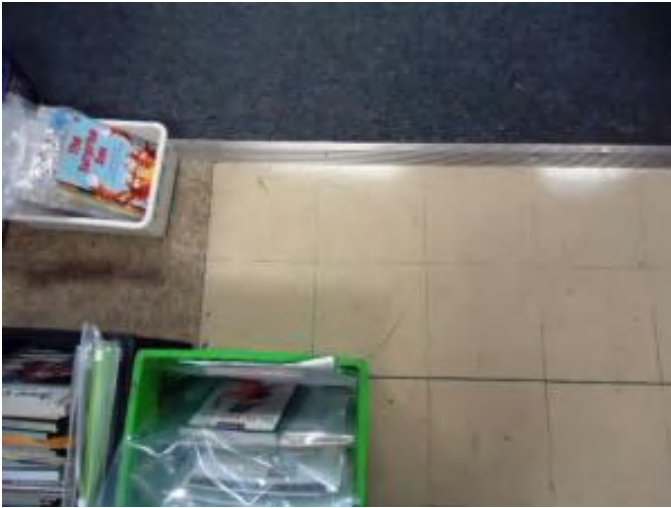
System: C3020413 - Vinyl Flooring

The floor finish for this school is a combination of carpet, marble, terrazzo, clay tile with concrete hallways and stirs finishes. The vinyl tile finish is a mix of 12 x 12 and 9 x 9 tile application. The 9x9 finish is suspect to contain asbestos. This finish is recommended for upgrade to a new 12 x 12 vinyl tile application.

Location: Classrooms

Distress: Health Hazard / Risk

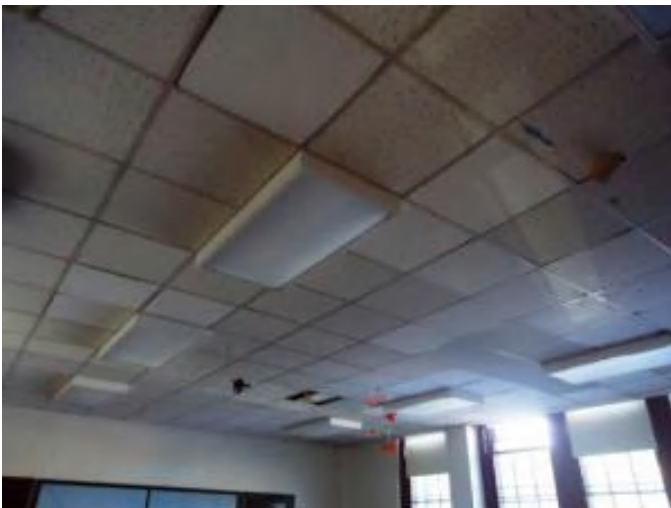
System: C3030 - Ceiling Finishes

The ceiling finish is a mix of 12 x 12 ceiling grid, painted and 2 x 4 Acoustical tile finish. Ceilings have been repaired in several areas and is in good condition considering the age of the application and the current condition of the school. The ceiling finish is expected to require upgrades to support the recommended efforts in this report prior to re-opening. This deficiency provides a budgetary consideration for removal and replacement of the current ceiling finish to a new acoustical tile finish. Considering the recommended mechanical and electrical upgrades this effort should be completed as part of an overall renewal program for the school. No work should be considered until after the recommended exterior efforts are complete.

Location: Building Wide

Distress: Damaged

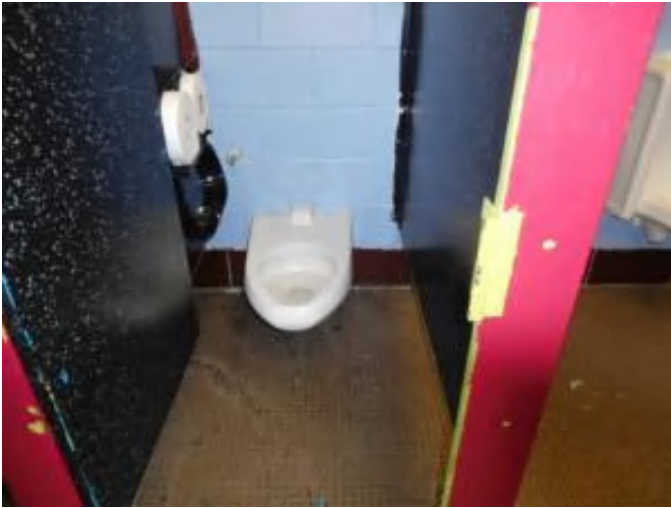
System: D2010 - Plumbing Fixtures

Location: toilet rooms

Distress: Beyond Service Life

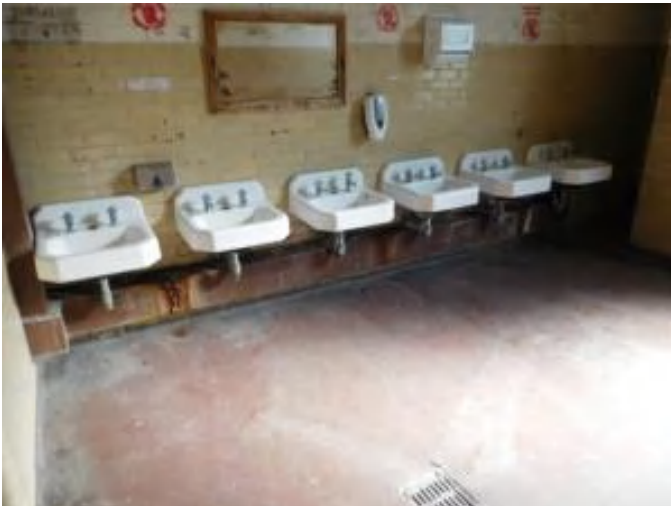
System: D2010 - Plumbing Fixtures

Location: toilet rooms

Distress: Beyond Service Life

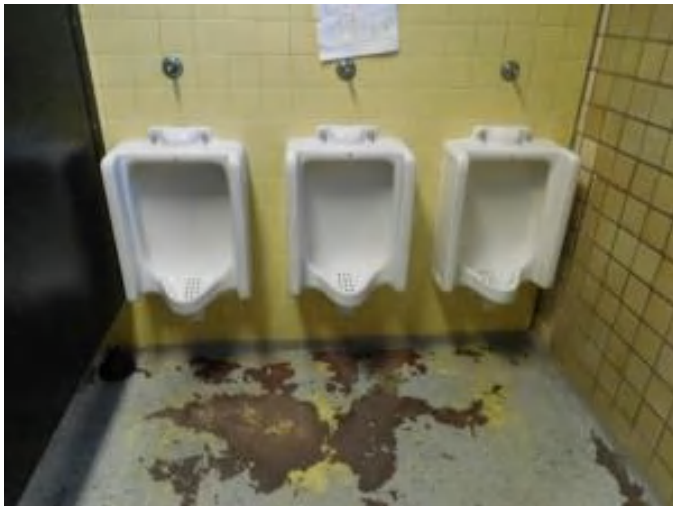
System: D2010 - Plumbing Fixtures

Location: toilet rooms

Distress: Beyond Service Life

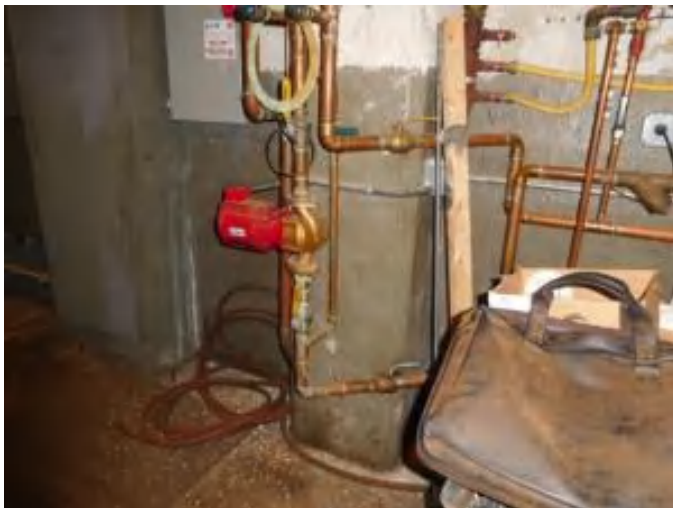
System: D2020 - Domestic Water Distribution

Location: entire building

Distress: Beyond Service Life

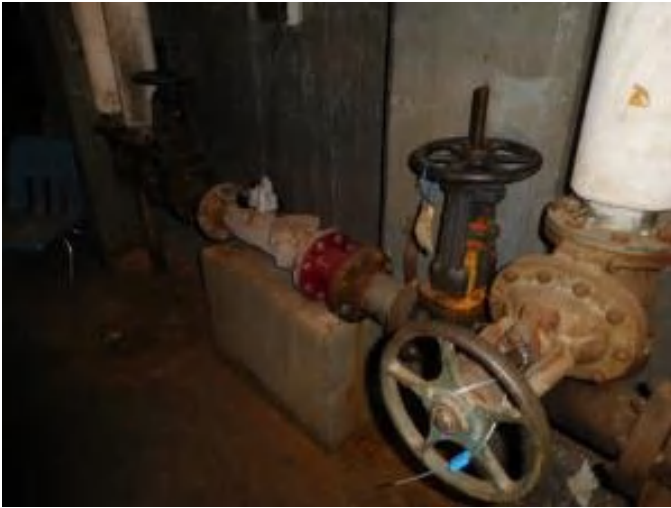
System: D2020 - Domestic Water Distribution

Location: mechanical room

Distress: Building / MEP Codes

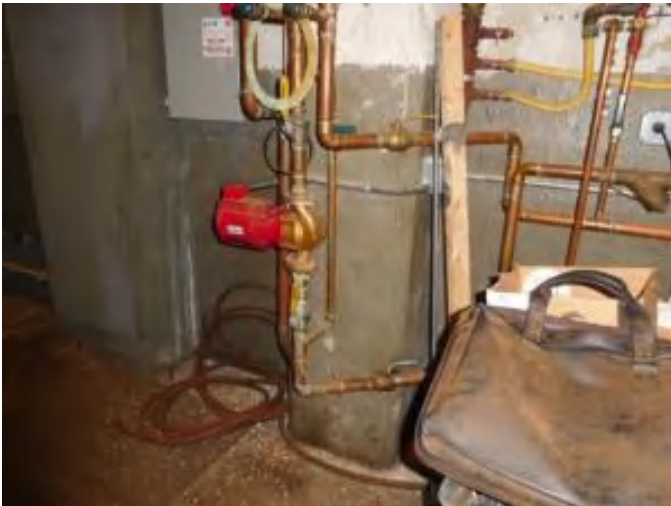
System: D2020 - Domestic Water Distribution

Location: mechanical room

Distress: Beyond Service Life

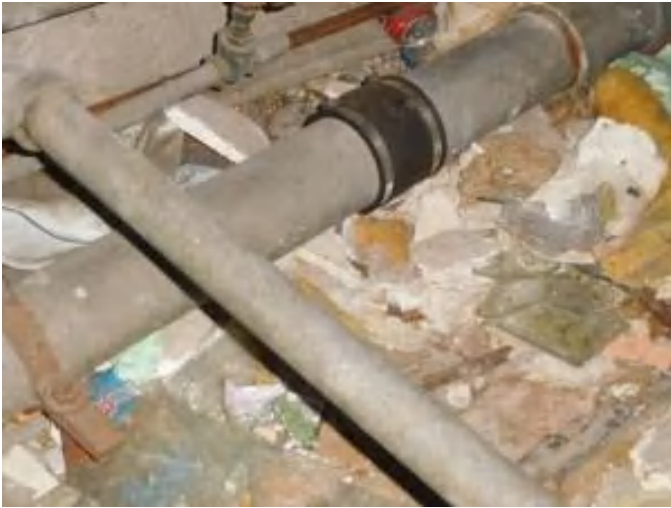
System: D2030 - Sanitary Waste

Location: entire building

Distress: Beyond Service Life

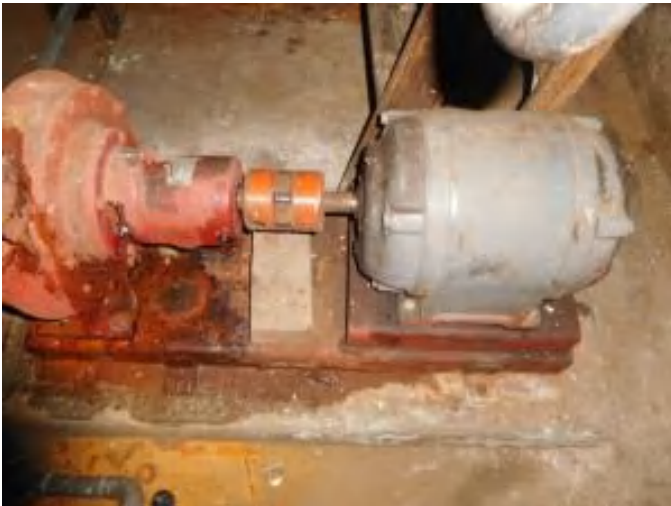
System: D3020 - Heat Generating Systems

Location: mechanical room

Distress: Beyond Service Life

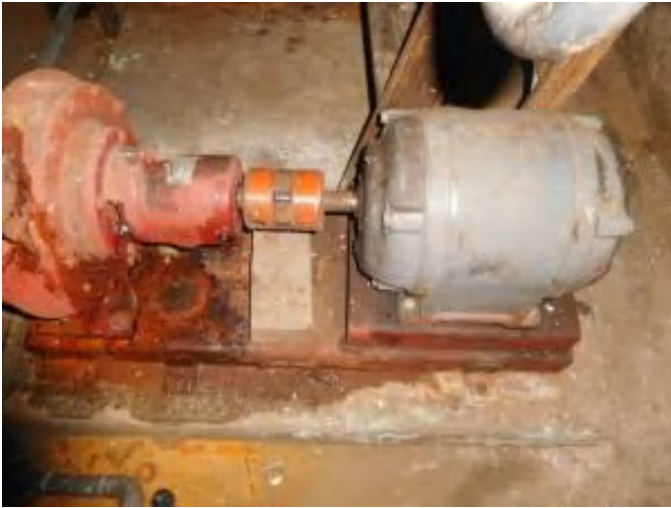
System: D3020 - Heat Generating Systems

Location: mechanical room

Distress: Beyond Service Life

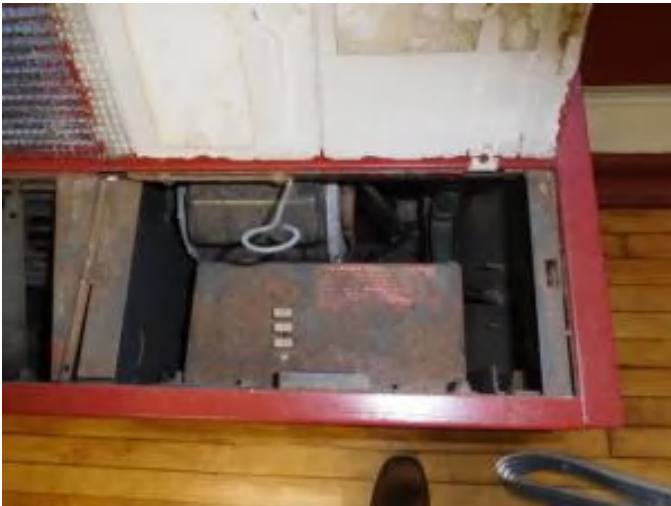
System: D3040 - Distribution Systems

Location: entire building

Distress: Beyond Service Life

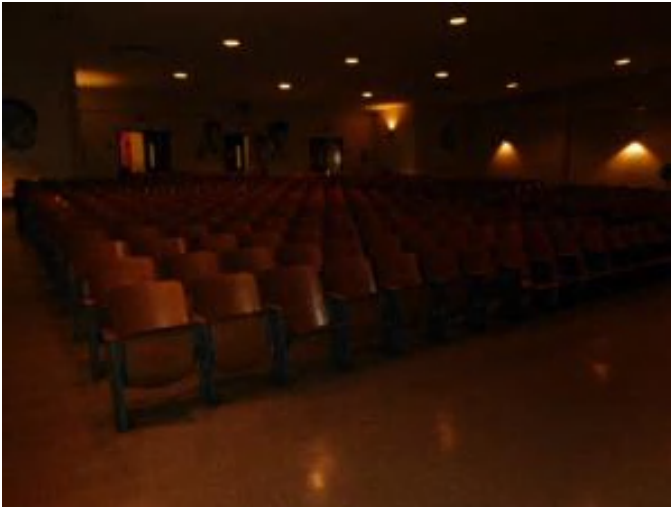
System: D3040 - Distribution Systems

Location: auditorium

Distress: Building / MEP Codes

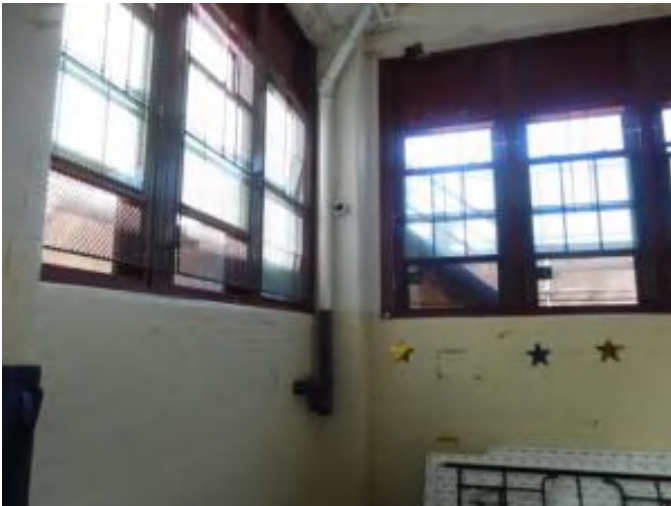
System: D3040 - Distribution Systems

Location: cafeteria/gymnasium

Distress: Building / MEP Codes

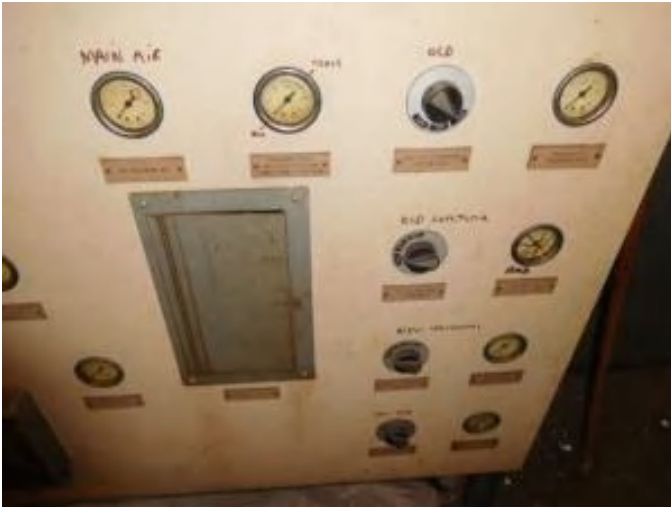
System: D3060 - Controls & Instrumentation

Location: entire building

Distress: Inadequate

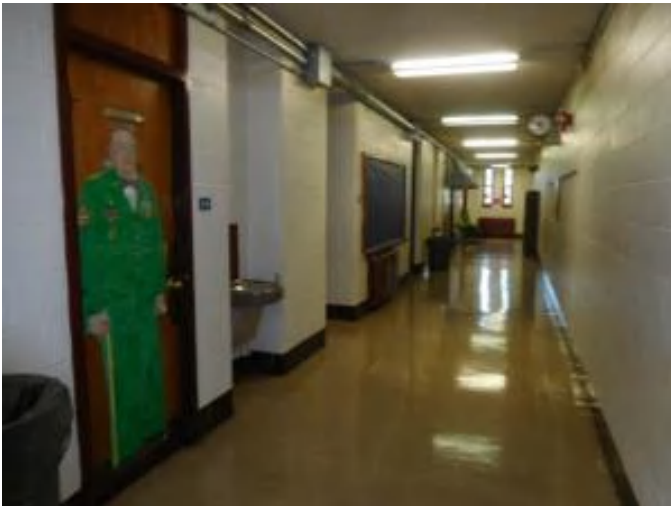
System: D4010 - Sprinklers

Location: entire building

Distress: Life Safety / NFPA / PFD

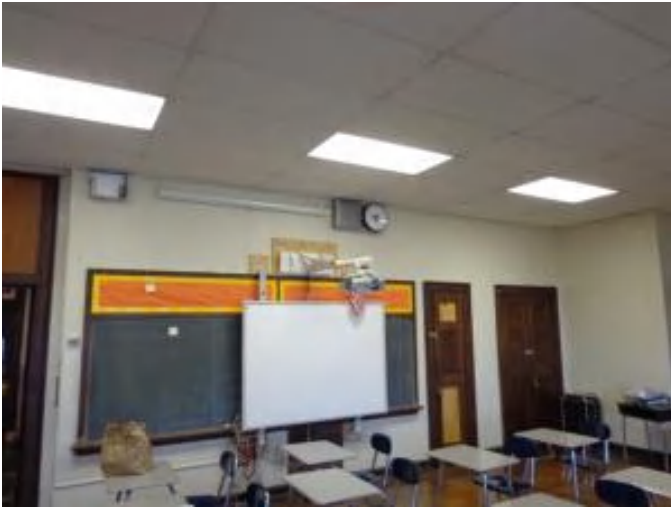
System: D5020 - Lighting and Branch Wiring

Location: Classrooms

Distress: Inadequate

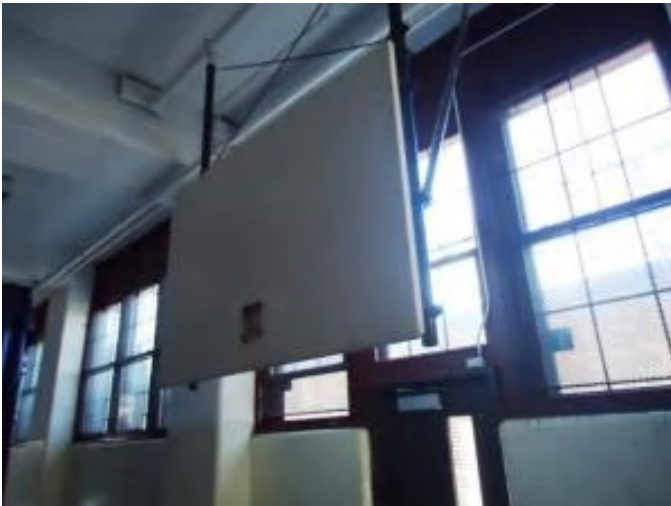
System: E1020 - Institutional Equipment

Institutional equipment includes: library equipment; stage equipment; instrumental equipment; A/V equipment; and laboratory equipment; gym equipment – basketball backstops, scoreboards, etc. Other equipment includes kitchen equipment. The Gyms are still used as either a student common area or practice court. The interior backboards and support equipment is beyond its service life. Damaged boards are recommended for removal and replacement.

Location: Gym

Distress: Damaged

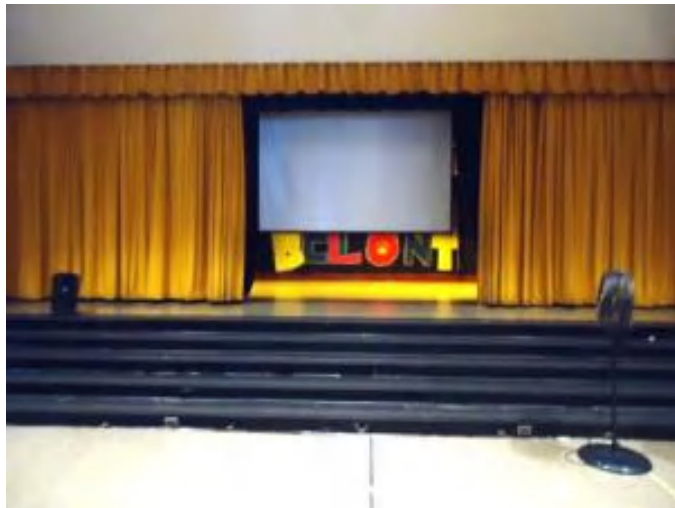
System: E2010 - Fixed Furnishings

The school stage has a stage curtain assembly that appears to be from the original construction. Modern applications are typically fire -proof applications with adjustable tracks and electric support for operation. The curtains are torn in a few section and the track is not functioning properly, overall the system is in poor condition. It is recommended that the curtain and track system be upgraded to a new system. Special care should be considered in regards to modern fire proofing for the new installation.

Location: Stage

Distress: Life Safety / NFPA / PFD

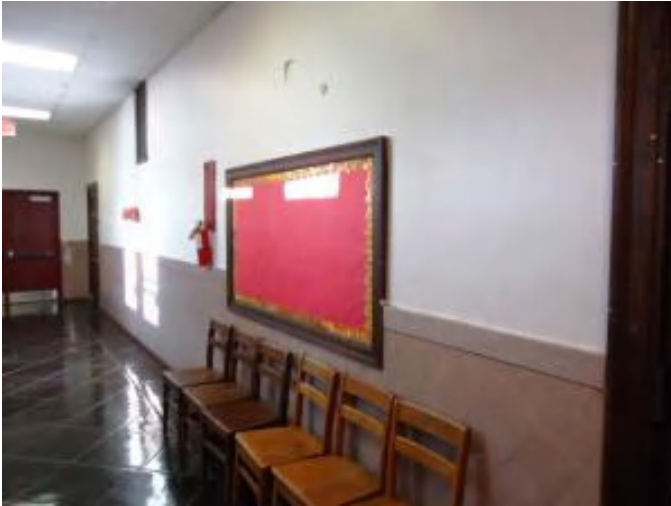
System: C1030 - Fittings

Fittings include: chalkboards; marker boards; tack boards; interior signage; metal lockers; toilet accessories and wood/metal/marble toilet partitions; fixed storage shelving. There are several tack boards in the hallways for student displays. The systems are damaged and beyond the expected service life for this application. Remove and replace tack boards is recommended.

Location: Hallways

Distress: Damaged

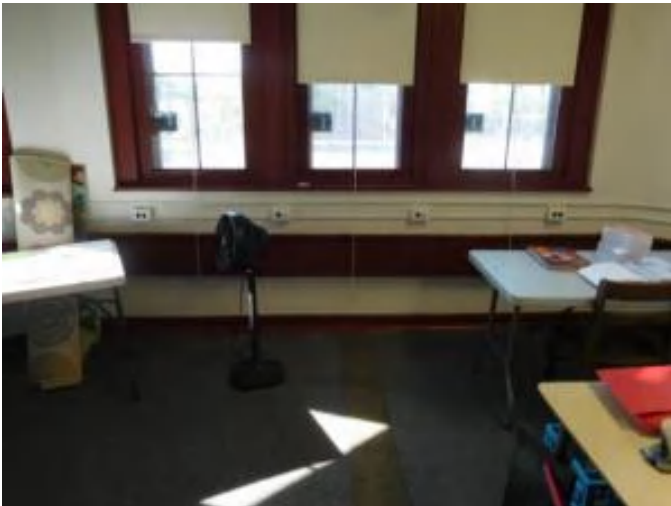
System: D3030 - Cooling Generating Systems

Location: roof, mechanical room

Distress: Inadequate

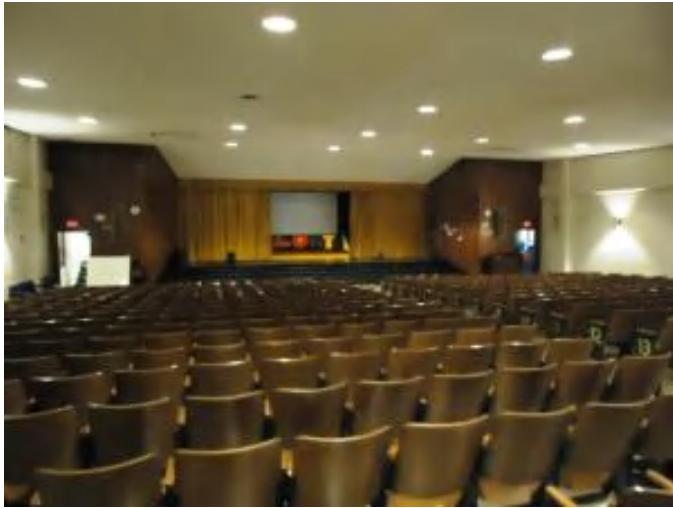
System: E2010 - Fixed Furnishings

The fixed seating for this school is from the original construction. The systems are in fair condition considering the age and usage. This project provides a budgetary consideration for universal upgrades for the fixed seating and furnishing of this school. Ensure that ADA requirements are followed with the new seating layout.

Location: Auditorium

Distress: Damaged

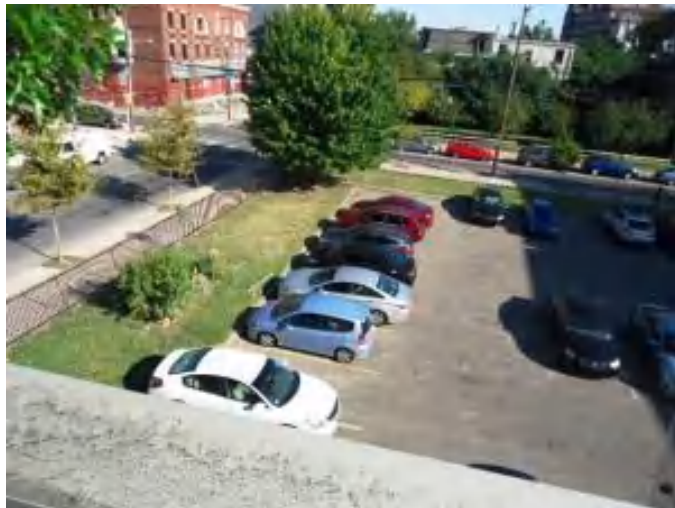
System: G2020 - Parking Lots

Location: Site

Distress: Accessibility

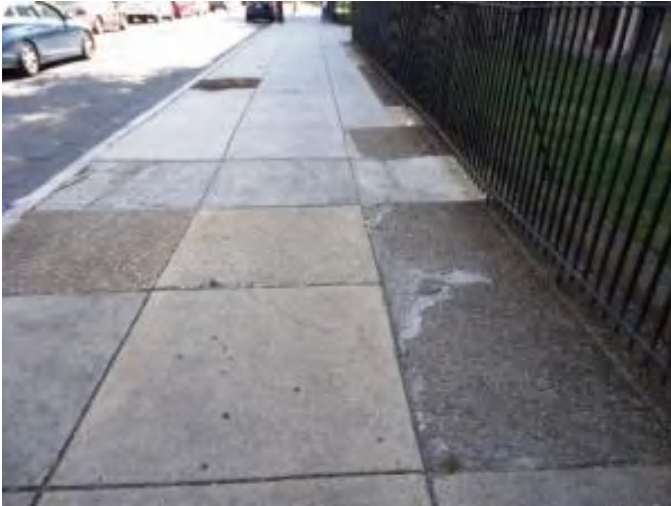
System: G2030 - Pedestrian Paving

Location: Site

Distress: Damaged
