Facility Condition Assessment Summary Report

Birney School

School District of Philadelphia
S721001;Birney
Final
Site Assessment Report

February 1, 2017

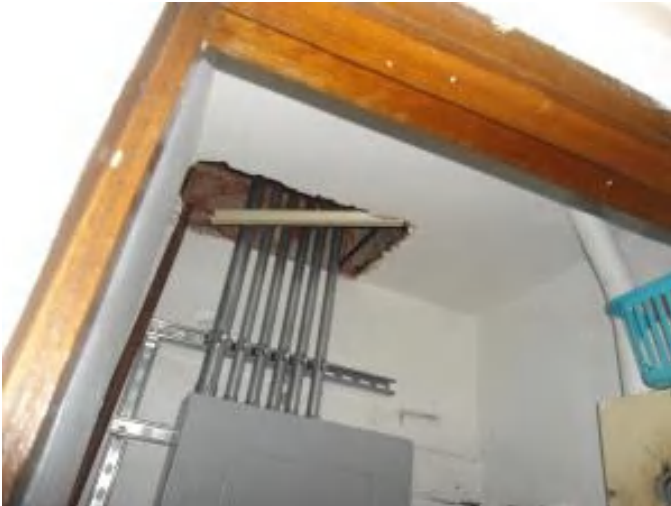
System: C1010 - Partitions

The mechanical room has several penetrations and as indicted in the photos an industrial window that has been compromised with several holes for equipment. Also, note the electrical modifications recently completed at this school has left several closet penetrations open. This deficiency provides a budgetary consideration to properly enclose the areas and to meet the current fire life safety requirements for mechanical and electrical spaces.

Location: Mechanical Electrical Spaces

Distress: Building / MEP Codes

Notes: The mechanical room has several penetrations and as indicted in the photos an industrial window that has been compromised with several holes for equipment. Also, note the electrical modifications recently completed at this school has left several closet penetrations open. This deficiency provides a budgetary consideration to properly enclose the areas and to meet the current fire life safety requirements for mechanical and electical spaces.

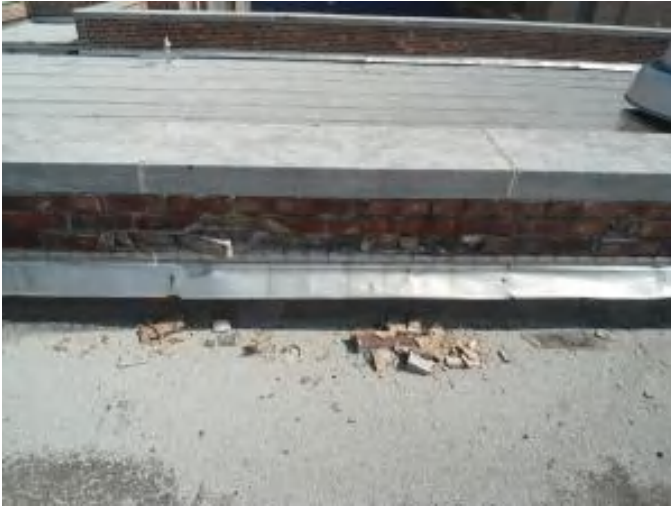
System: B2010 - Exterior Walls

The exterior brick surfaces are generally in fair to good condition for their age. In some locations, bricks have cracked or spalled and should be replaced. The repointing of deteriorated mortar joints is also recommended, using mortar of a similar color and consistency as the original. Following the detailed examination of the brick and repair of mortar construction joints, the entire building should be pressure washed to remove stains and embedded pollutants. If moisture is found to be penetrating the masonry facade, the application of a spray sealant to the suspected exterior masonry surface is recommended.

Location: Exterior Elevation

Distress: Damaged

Notes: The exterior brick surfaces are generally in fair to good condition for their age. In some locations, bricks have cracked or spalled and should be replaced. The repointing of deteriorated mortar joints is also recommended, using mortar of a similar color and consistency as the original. Following the detailed examination of the brick and repair of mortar construction joints, the entire building should be pressure washed to remove stains and embedded pollutants. If moisture is found to be penetrating the masonry façade, the application of a spray sealant to the suspected exterior masonry surface is recommended.

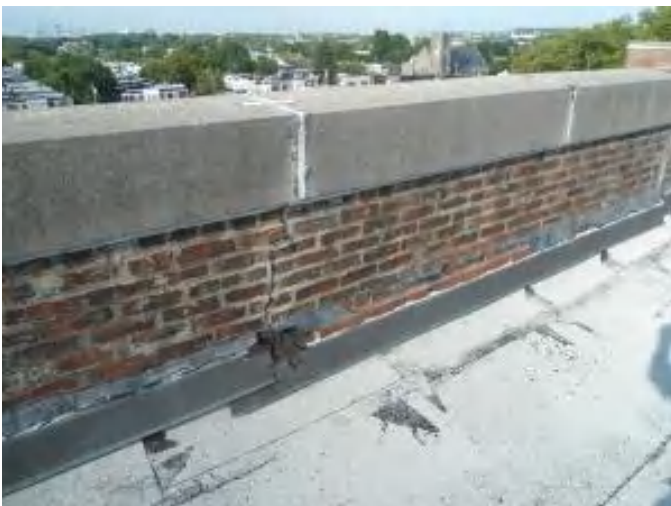
System: B2010 - Exterior Walls

The exterior building wall on the western exterior of the building is showing signs of age and deterioration associated with weather conditions such as freezing and thawing. As indicated in the photo this issue starts at the roof and the obvious crack extends down the exterior wall to the next floor. This wall is in very poor condition and upgrades are recommended. The wall is recommended for point and tuck work as well as joint recovery and cleaning.

Location: Exterior Elevation

Distress: Damaged

Notes: The exterior building wall on the western exterior of the building is showing signs of age and deterioration associated with weather conditions such as freezing and thawing. As indicated in the photo this issue starts at the roof and the obvious crack extends down the exterior wall to the next floor. This wall is in very poor condition and upgrades are recommended. The wall is recommended for point and tuck work as well as joint recovery and cleaning.

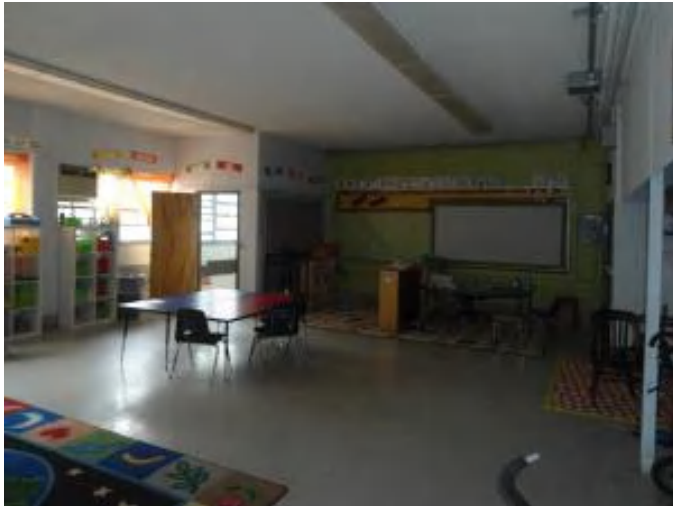
System: D1010 - Elevators and Lifts

There is no elevator that services this school. Goods, services, and amenities offered in public buildings are generally required to be available to all persons. To assist those that may be physically challenged and to meet current accessibility legislation to provide wheelchair access to the upper floors of this facility, the installation of a new hydraulic elevator has been recommended on the southern elevation of the building or at another suitable location. The new installation should blend as much as possible with the overall appearance of this historic structure and include all required ADA features, such as audible jewels and gongs, an accessible control panel, etc.

Location: Building Wide

Distress: Accessibility

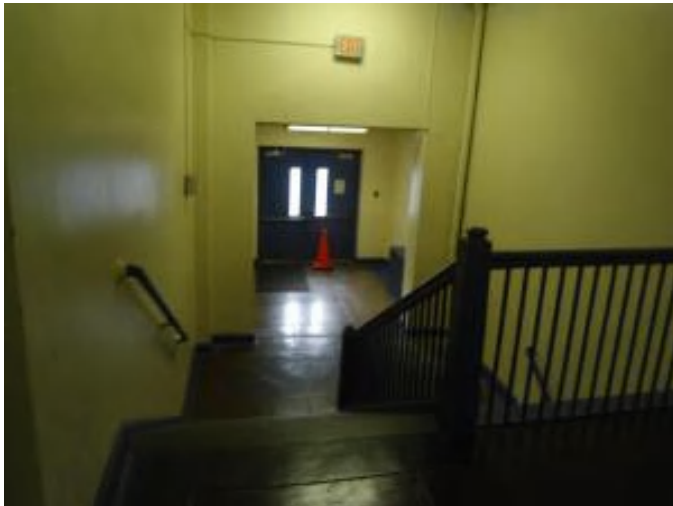
System: C1010 - Partitions

Location: Stair Fire Doors

Distress: Building / MEP Codes

Notes: A large portion of the interior corridor, exit stair doors are not code compliant. Several doors are typically wood in wood frames with transom lites or sidelights, glass glazing. The entrance doors to the lobby from the main entrance and the stair entrance to the common area are good examples of the interior system needs. The older doors are generally in good condition considering the age of the application. To restore the door finishes, universal upgrades are required for the older door applications. Remove and replace original door systems with new code compliant fire rated door system.

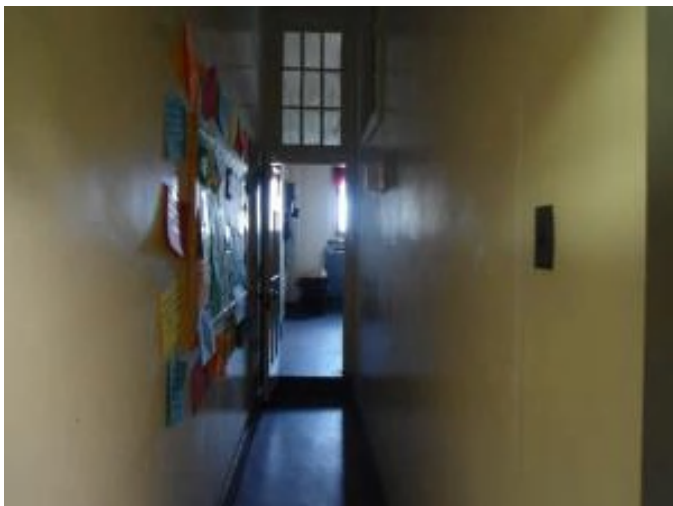
System: C1010 - Partitions

There are several transom lites and sidelights constructed into hallway wall systems. It is recommended that the lites and sidelights be removed and replaced with a fire rated wall construction. The deficiency provides a budgetary consideration to correct the hallway, transoms, lites and sidelights.

Location: Hallways

Distress: Life Safety / NFPA / PFD

Notes: There are several transom lites and sidelights constructed into hallway wall systems. It is recommended that the lites and sidelights be removed and replaced with a fire rated wall construction. The deficiency provides a budgetary consideration to correct the hallway, transoms, lites and sidelights.

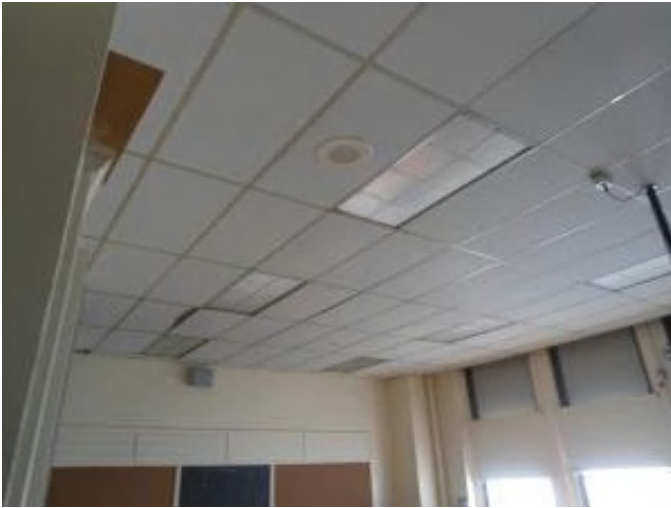
System: C1010 - Partitions

Location: Classrooms

Distress: Inadequate

Notes: There are several movable partitions that remain in classrooms. These wall systems are no longer used and in most cases cannot be used due to damage or wall modifications to support classroom needs. This deficiency provides a budgetary consideration to remove and replace the wall systems with universal removal of the existing movable partitions and upgrades to a permeate wall systems.

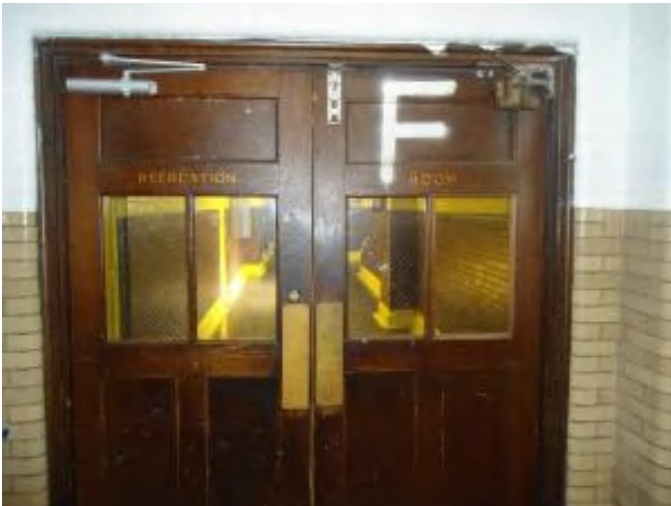
System: C1020 - Interior Doors

Interior doors are typically wood in wood frames with glass glazing. Other interior doors include wooden glass pane doors with original wooden pane frames, hollow metal in hollow metal frames. Doors are generally in good condition considering the age of the application. Universal upgrades are required for the interior door systems, it is recommended that the interior doors system be removed and replaced with a new modern metal framed hollow metal door system with consideration for ADA compliance.

Location: Interior Classroom Doors

Distress: Building / MEP Codes

Notes: Interior doors are typically wood in wood frames with glass glazing. Other interior doors include wooden glass pane doors with original wooden pane frames, hollow metal in hollow metal frames. Doors are generally in good condition considering the age of the application. Universal upgrades are required for the interior door systems, it is recommended that the interior doors system be removed and replaced with a new modern metal framed hollow metal door system with consideration for ADA compliance.

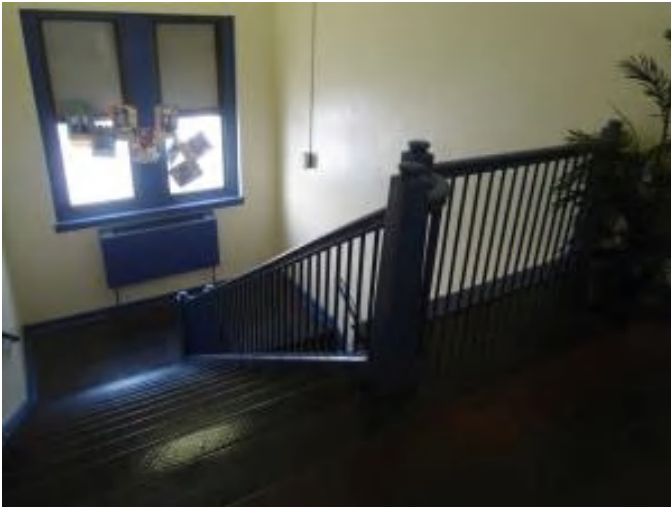
System: C2010 - Stair Construction

Current requirements for stairs indicate that they have graspable handrails on both sides, that the rails have a specific end geometry, and that the handrails continue horizontally at the landings. In addition, guardrails must prevent the passage of a 4 inch diameter sphere (6 inches in the triangle formed by the lower rail and tread/riser angle). Although the stairs are compliant with the code enforced at the time of construction until a major renovation occurs, they are deficient in handrail and guardrail design relative to current standards. Future efforts should include comprehensive stair railing removal and replacement upgrades.

Location: Stairs

Distress: Building / MEP Codes

Notes: Current requirements for stairs indicate that they have graspable handrails on both sides, that the rails have a specific end geometry, and that the handrails continue horizontally at the landings. In addition, guardrails must prevent the passage of a 4 inch diameter sphere (6 inches in the triangle formed by the lower rail and tread/riser angle). Although the stairs are compliant with the code enforced at the time of construction until a major renovation occurs, they are deficient in handrail and guardrail design relative to current standards. Future efforts should include comprehensive stair railing removal and replacement upgrades.

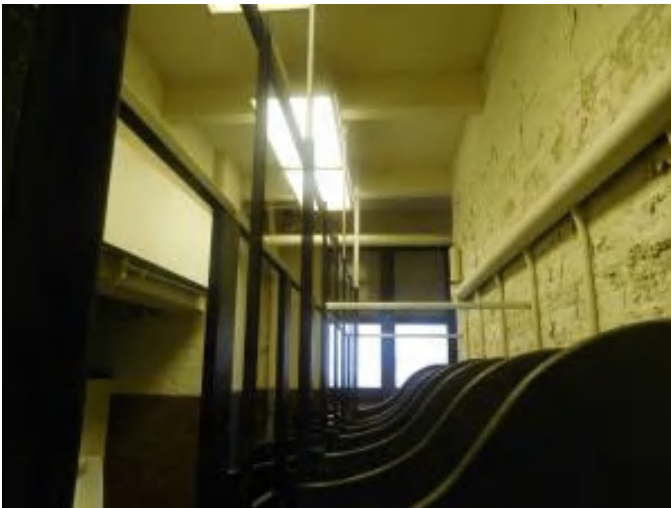
System: D2020 - Domestic Water Distribution

Location: entire building

Distress: Beyond Service Life

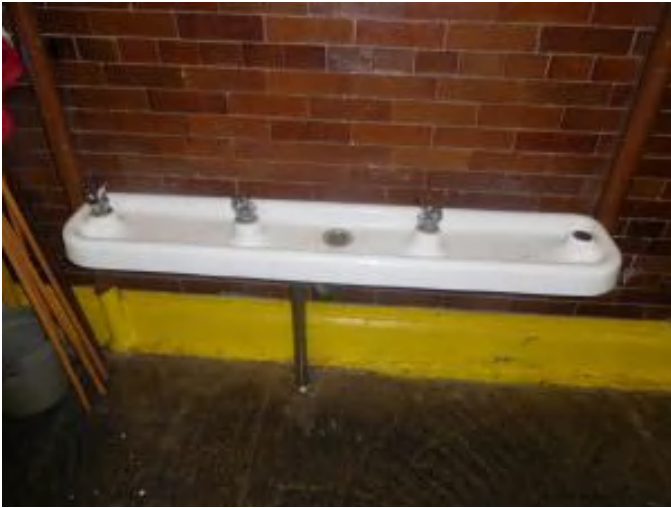
System: D2030 - Sanitary Waste

Location: entire building

Distress: Beyond Service Life

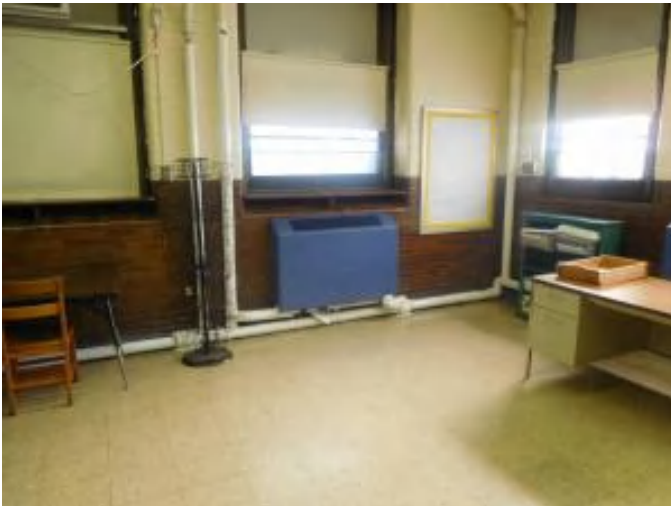
System: D3040 - Distribution Systems

Location: classrooms

Distress: Building / MEP Codes

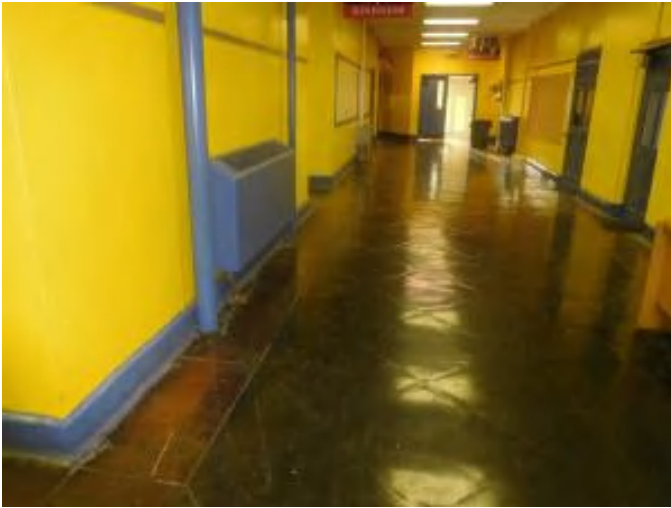
System: D4010 - Sprinklers

Location: entire building

Distress: Life Safety / NFPA / PFD

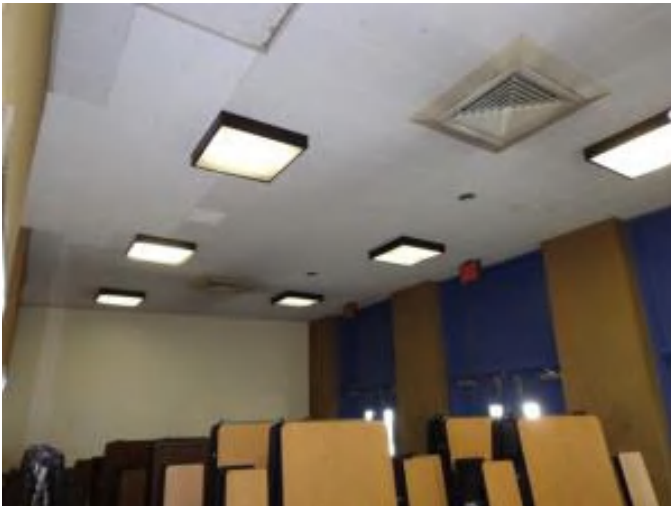
System: D5020 - Lighting and Branch Wiring

Location: Entire Building

Distress: Beyond Service Life

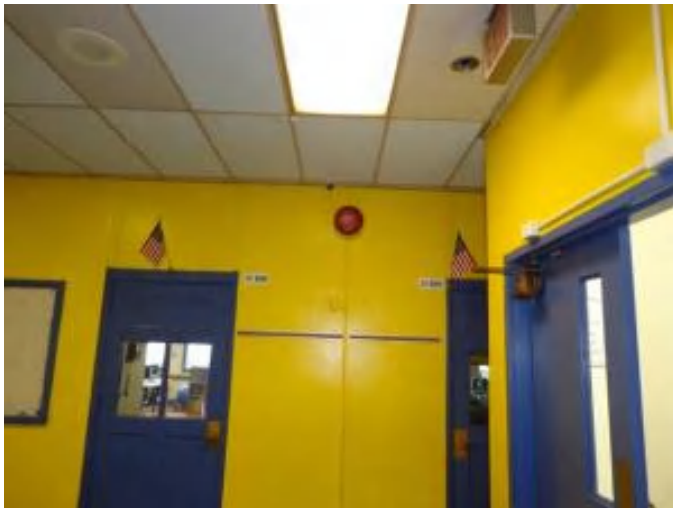
System: D5030 - Communications and Security

Location: Entire Building

Distress: Building / MEP Codes

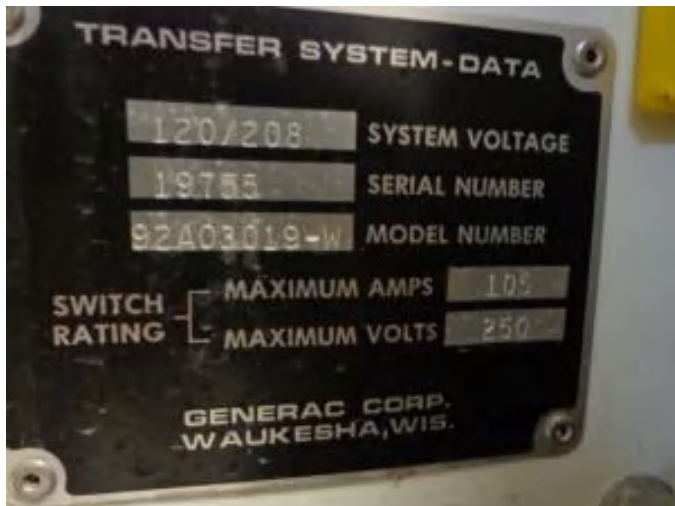
System: D5090 - Other Electrical Systems

Location: Mechanical Room

Distress: Beyond Service Life

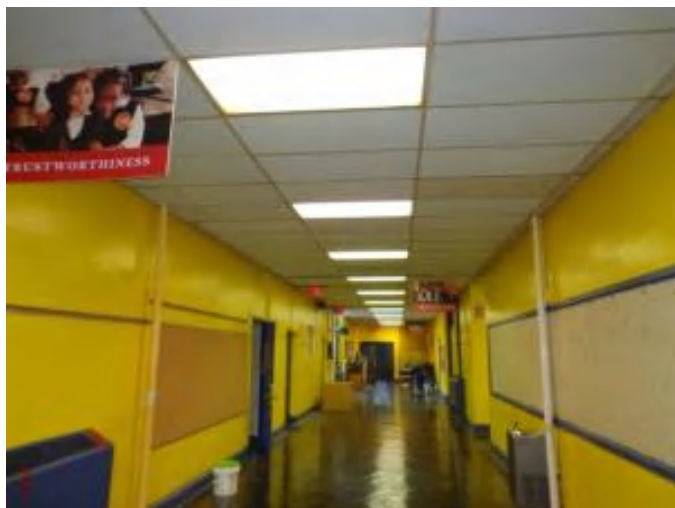
System: D5090 - Other Electrical Systems

Location: Entire Building

Distress: Beyond Service Life

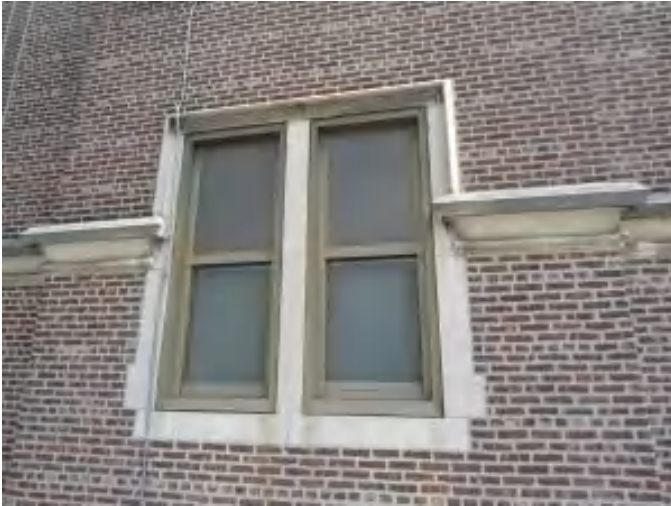
System: B2020 - Exterior Windows

Location: Exterior Elevation

Distress: Beyond Service Life

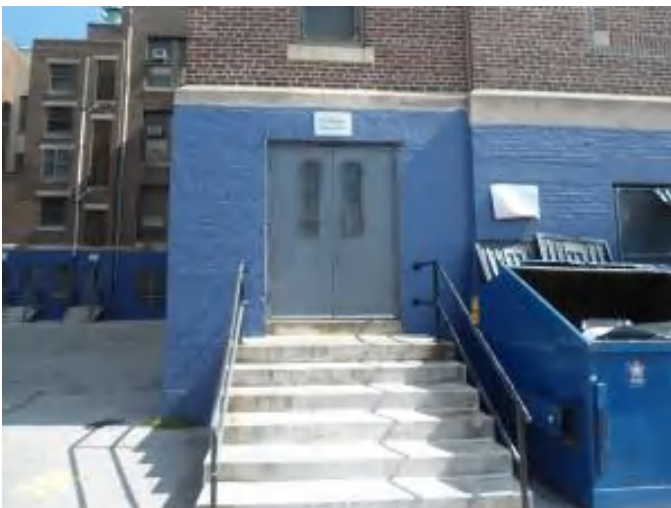
System: B2030 - Exterior Doors

The exterior doors are metal applications with metal frames. The exterior door system for this school is a very high traffic system. The doors are in fair condition but are aging at a faster rate than expected based on traffic and condition. The exterior door system, store front and service doors are recommended for upgrade.

Location: Exterior Elevation

Distress: Damaged

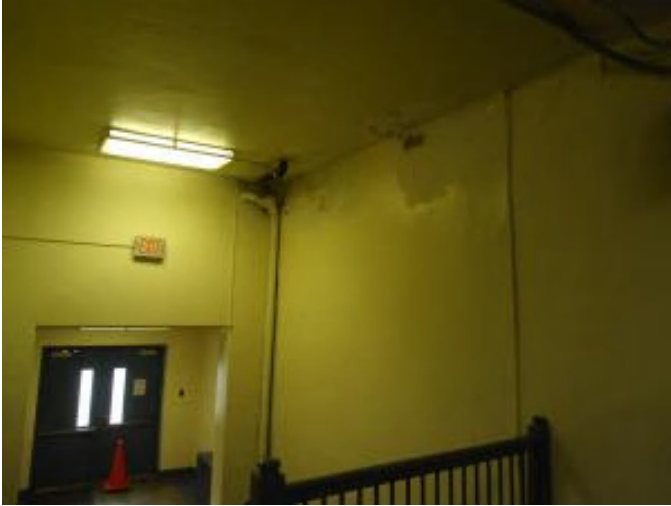
System: C3010230 - Paint & Covering

There are several minor areas of wall damage that ranges from serious to minor. Although the school is on a cyclical program of renewal and each painted surface is renewed at years end this system is at the point in which repairs are necessary. Remove damaged wall finishes and repair areas then apply primer and paint finish.

Location: Interior Walls

Distress: Damaged

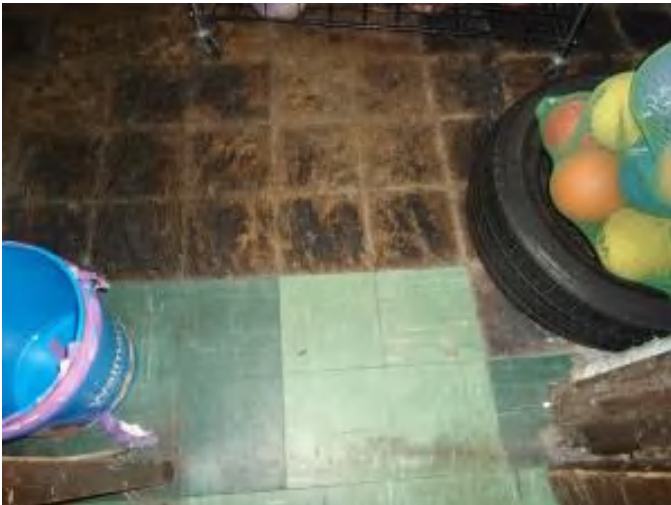
System: C3020413 - Vinyl Flooring

The floor finish for this school is a combination of carpet in the administrative area, tile in the kitchen and service line areas, wooden classrooms with concrete hallways and stairs finishes and a vinyl tile finish. The vinyl tile finish is a 9 x 9 application and is suspect to contain asbestos. This finish is recommended for upgrade to a new 12 x 12 vinyl tile application.

Location: Building Wide

Distress: Beyond Service Life

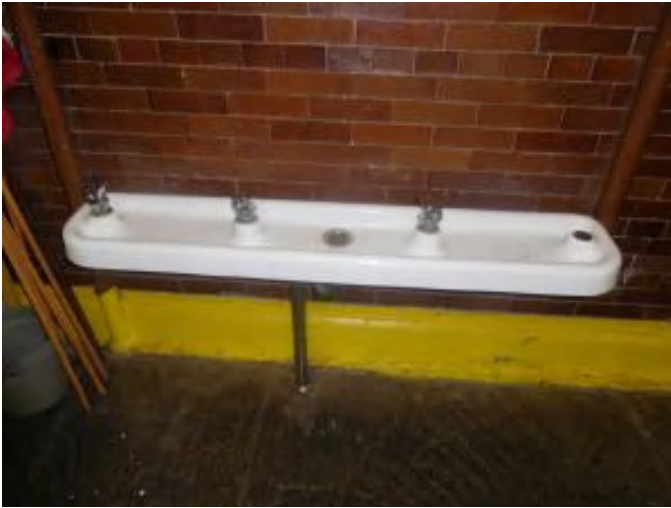
System: D2010 - Plumbing Fixtures

Location: corridors

Distress: Beyond Service Life

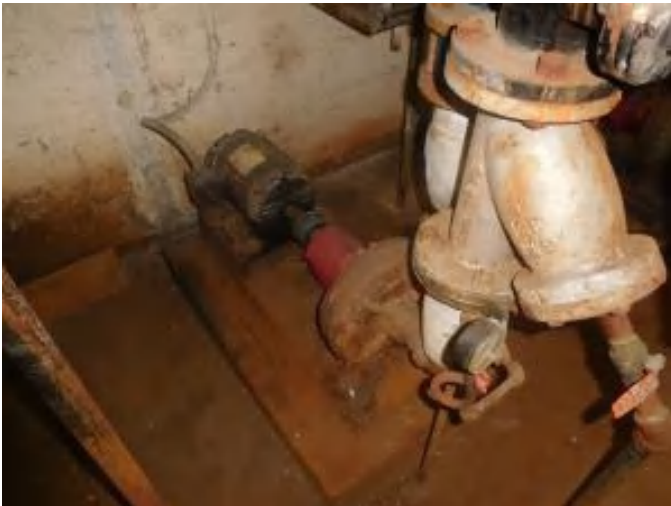
System: D3020 - Heat Generating Systems

Location: mechanical room

Distress: Beyond Service Life

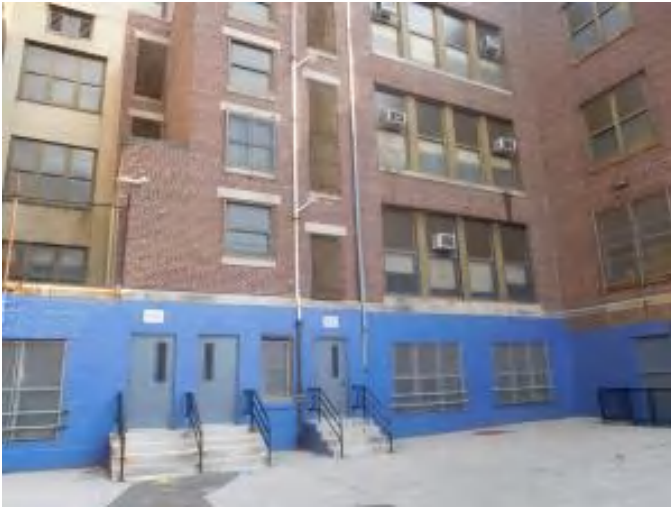
System: D3030 - Cooling Generating Systems

Location: roof, mechanical room

Distress: Inadequate

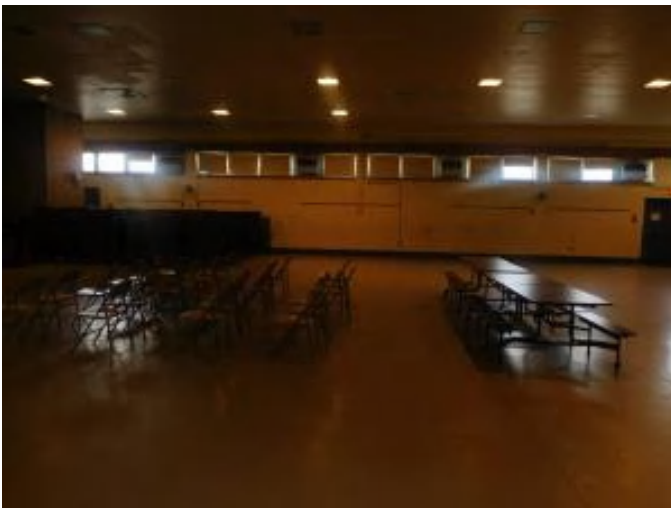
System: D3040 - Distribution Systems

Location: cafetorium

Distress: Building / MEP Codes

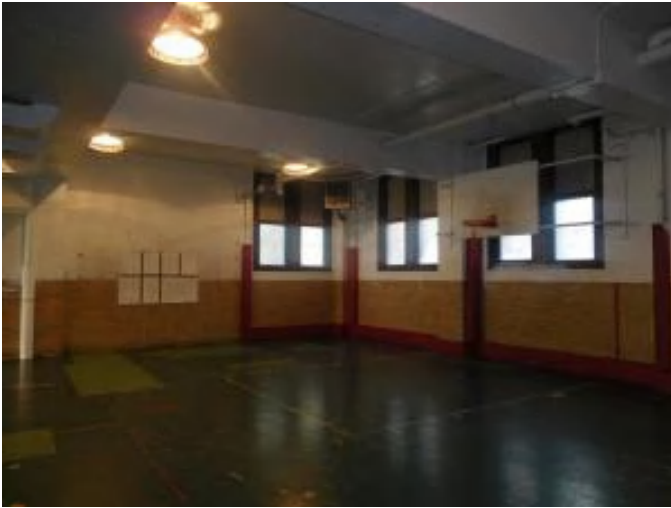
System: D3040 - Distribution Systems

Location: gymnasium

Distress: Building / MEP Codes

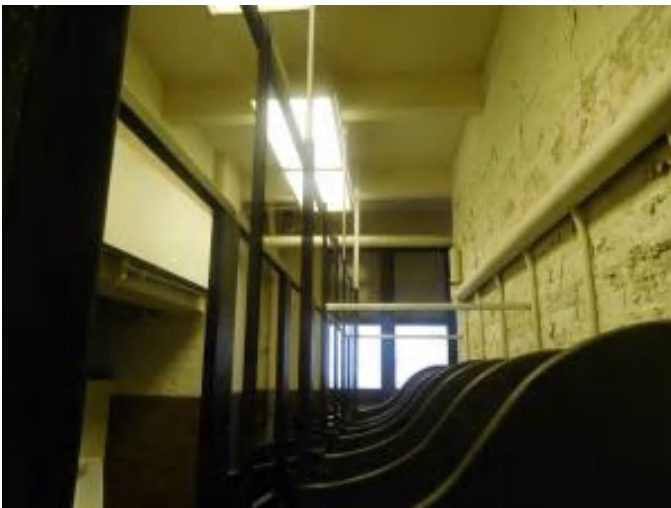
System: D3040 - Distribution Systems

Location: toilet rooms

Distress: Building / MEP Codes

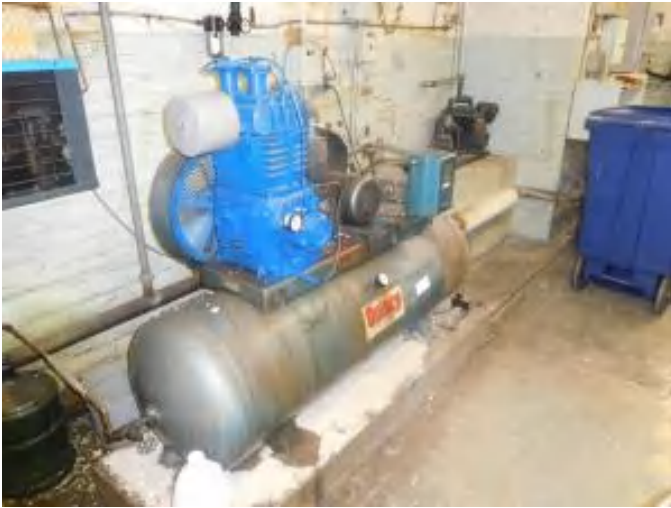
System: D3060 - Controls & Instrumentation

Location: entire building

Distress: Inadequate

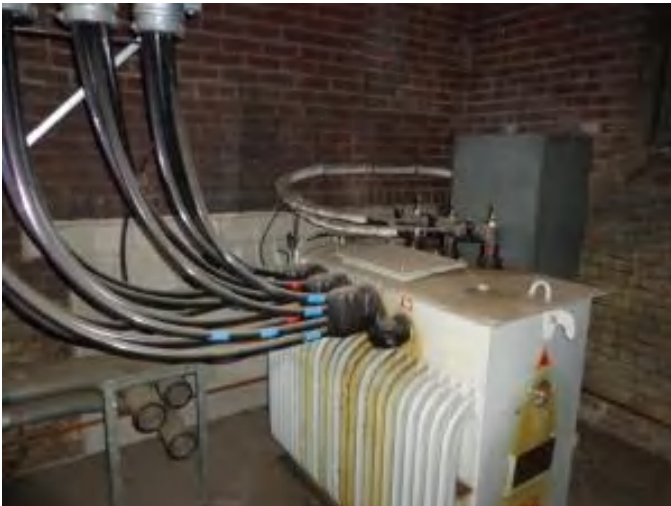
System: D5010 - Electrical Service/Distribution

Location: Main Electrical Room

Distress: Inadequate

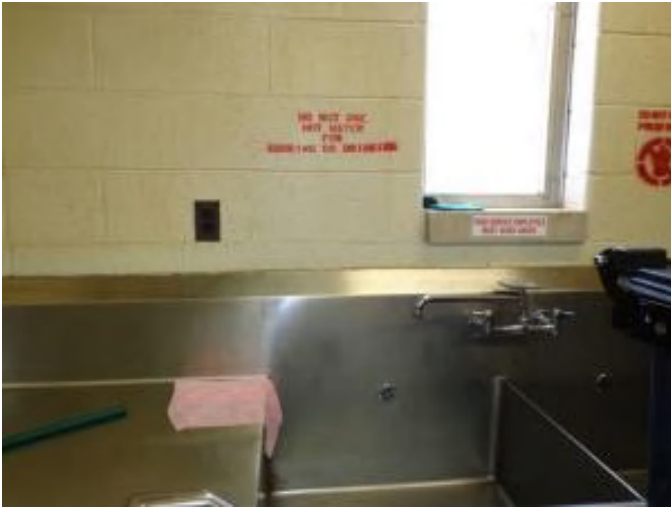
System: D5020 - Lighting and Branch Wiring

Location: Kitchen

Distress: Failing

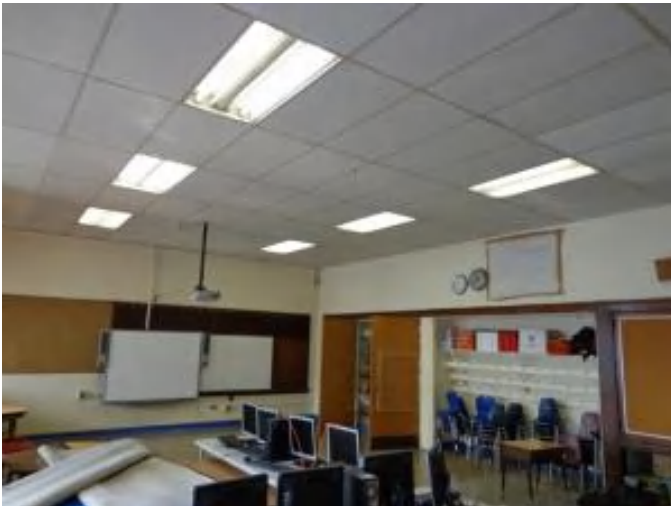
System: D5020 - Lighting and Branch Wiring

Location: Classrooms

Distress: Inadequate

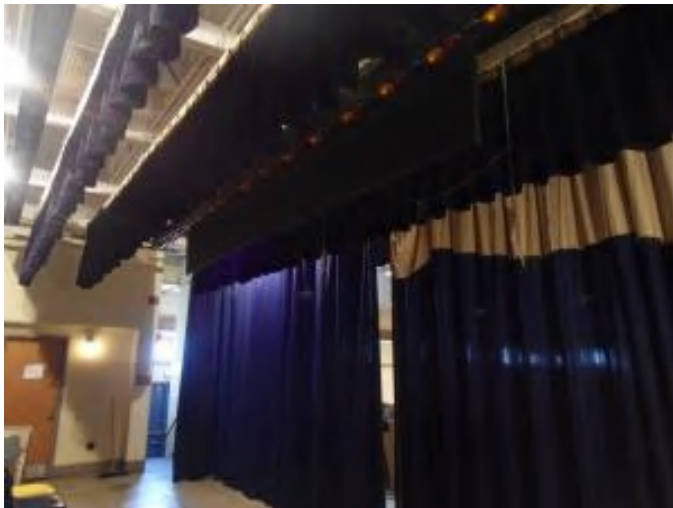
System: E2010 - Fixed Furnishings

The school stage has a stage curtain assembly that appears to be from the original construction. Modern applications are typically fire-proof applications with adjustable tracks and electric support for operation. The curtains are torn in a few section and the track is not functioning properly, overall the system is in poor condition. It is recommended that the curtain and track system be upgraded to a new system. Special care should be considered in regards to modern fire proofing for the new installation.

Location: Stage

Distress: Damaged

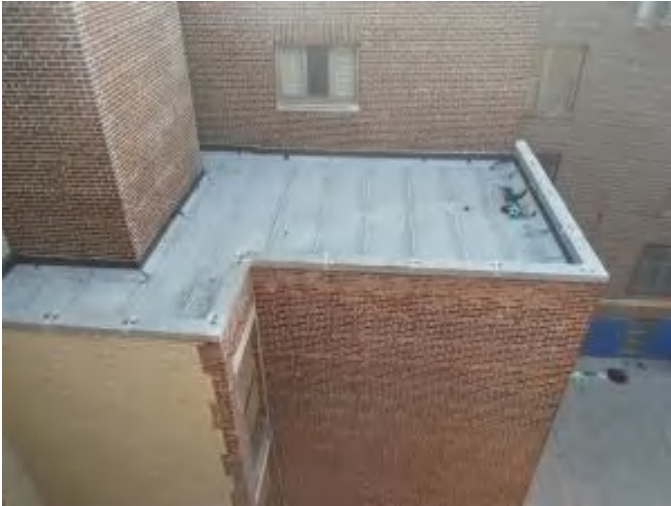
System: B3010105 - Built-Up

The existing built up roofing system has clear signs of ponding and there reportedly has been an increase of roofing maintenance on this single ply roofing system. It is recommended that a new built-up roofing system be installed within the next ten years.

Location: Roof

Distress: Beyond Service Life

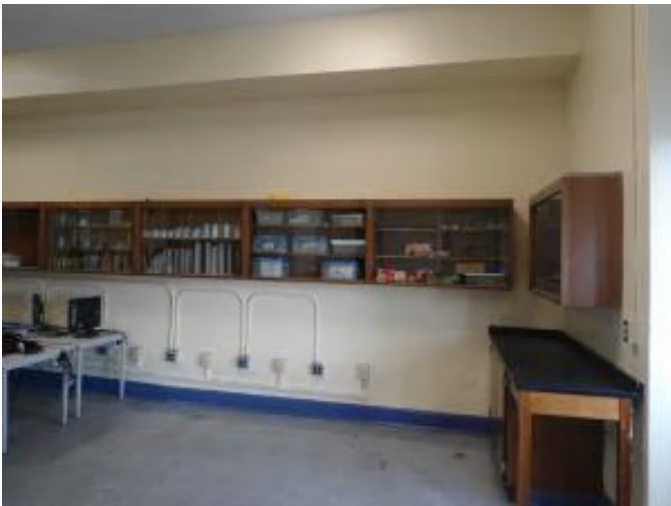
System: C1010 - Partitions

Lab casework and countertops are located in the science classrooms on the second floor of this school. They vary in design, age, and degree of deterioration. Selective replacement of both base cabinets and countertops should be anticipated within ten years. The new cabinetry should be designed in accordance with current MAC requirements and include utility upgrades.

Location: Science Labs

Distress: Beyond Service Life

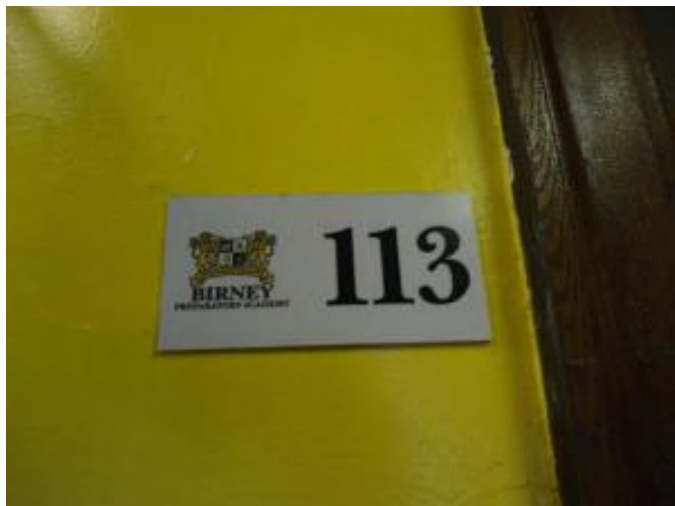
System: C1030 - Fittings

Location: Building Wide

Distress: Damaged

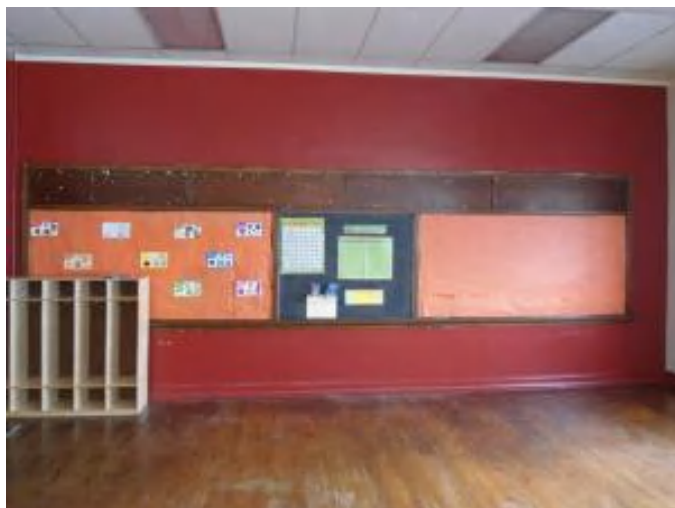
System: C1030 - Fittings

There are several tack boards in the hallways for student displays. The systems are beyond the expected service life for this application. Remove and replace tack boards is recommended.

Location: Building Wide

Distress: Beyond Service Life

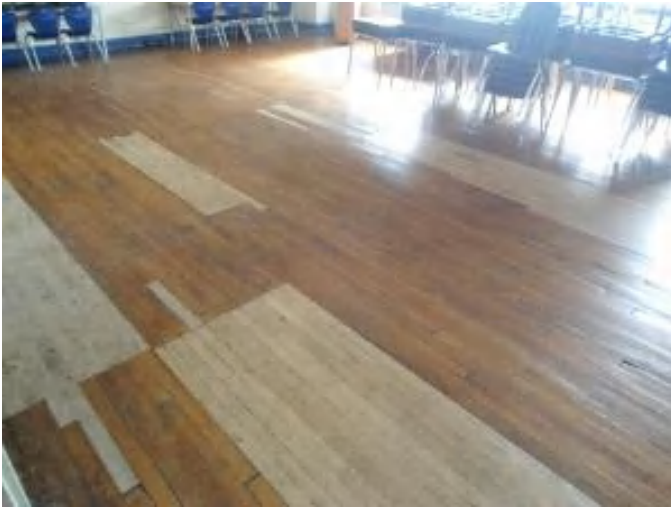
System: C3020414 - Wood Flooring

The classrooms in this school have a wooden floor finish that appears to be from original construction. The system is showing signs of age such as the effects of sanding and refinishing with yearly cleaning and waxing with some repairs. The floor finish is in fair condition however, the finish is beyond its expected life cycle. It is recommended that the wooden floor finish be removed and replaced with an in kind finish.

Location: Classrooms

Distress: Damaged

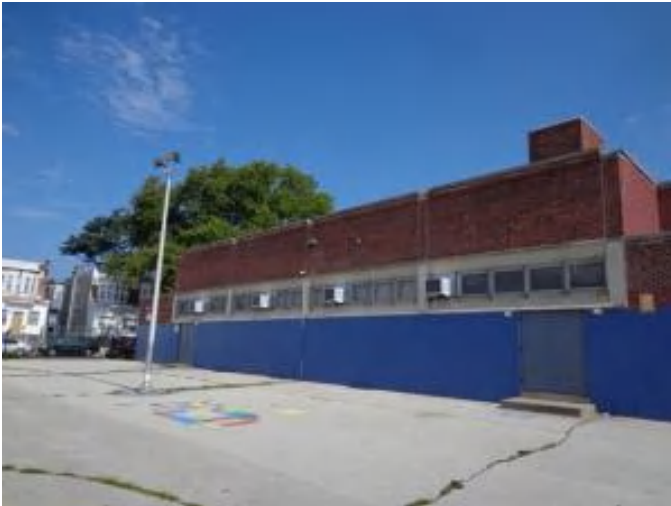
System: G4020 - Site Lighting

Location: Site Lighting

Distress: Maintenance Required

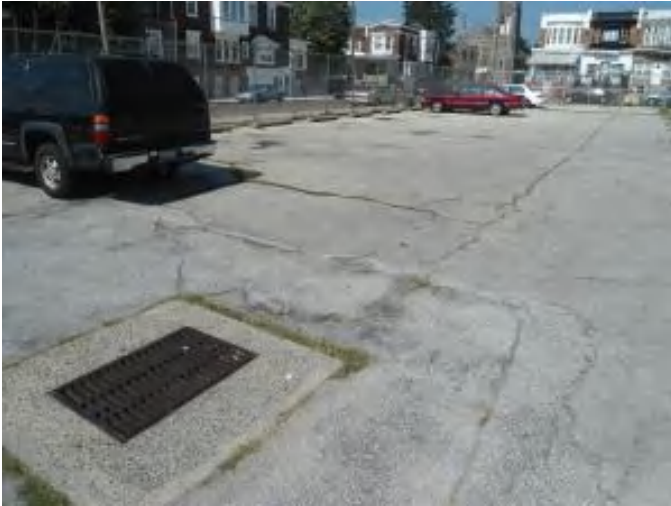
System: G2020 - Parking Lots

Location: Parking Lot

Distress: Failing

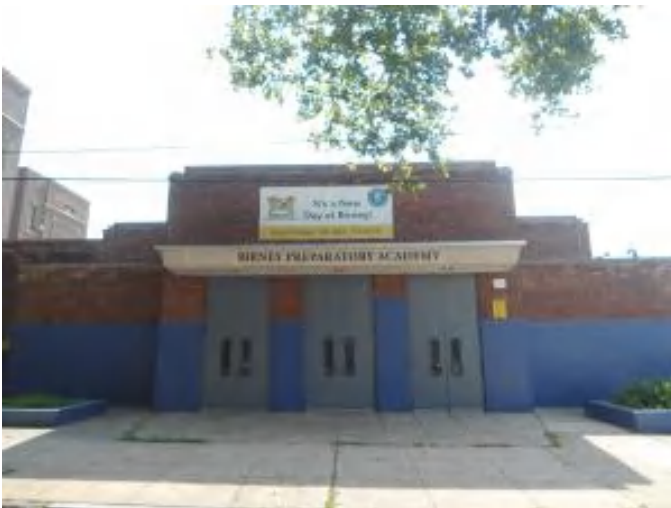
System: G2030 - Pedestrian Paving

Location: Site

Distress: Damaged

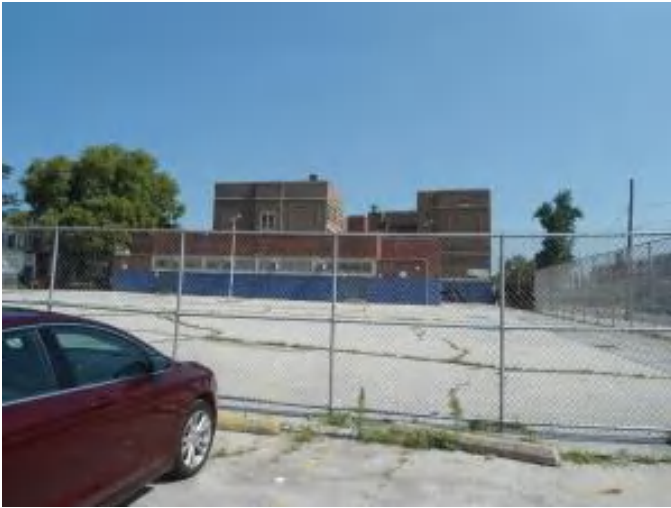
System: G2040 - Site Development

Location: Site

Distress: Damaged

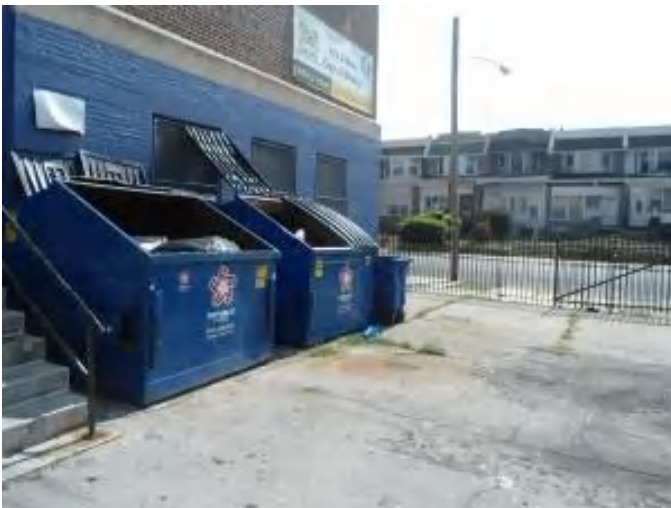
System: G2040 - Site Development

Location: South Entrance

Distress: Health Hazard / Risk
