## Facility Condition Assessment Summary Report

### Blankenburg School

School District of Philadelphia  
**S149001;Blankenburg**  
Final  
**Site Assessment Report**  
January 30, 2017

Facility Assessment  
October 1st, 2015

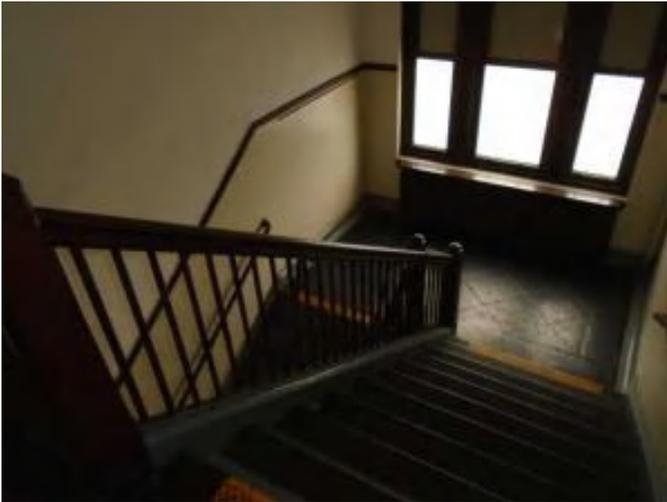
#### System: C2010 - Stair Construction

**Location:** Stairs

**Distress:** Building / MEP Codes

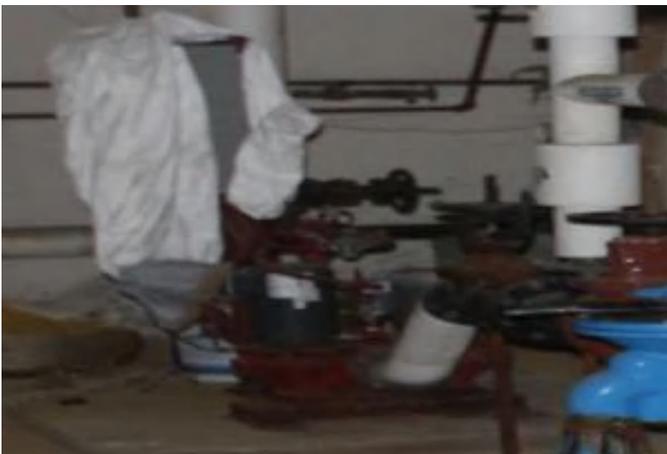
#### System: D2020 - Domestic Water Distribution

**Location:** Boiler room

**Distress:** Maintenance Required

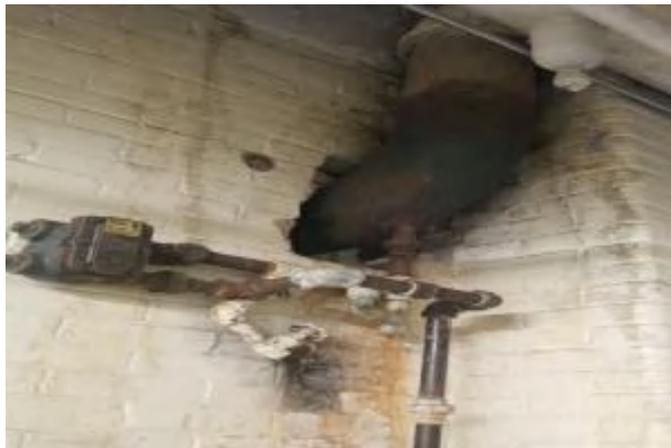
**System: D3040 - Distribution Systems**

**Location:** Entire building

**Distress:** Failing

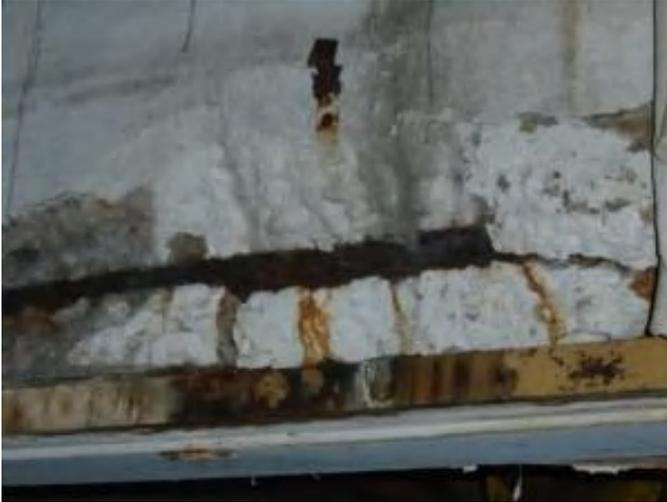
**System: A2020 - Basement Walls**

**Location:** Basement

**Distress:** Damaged

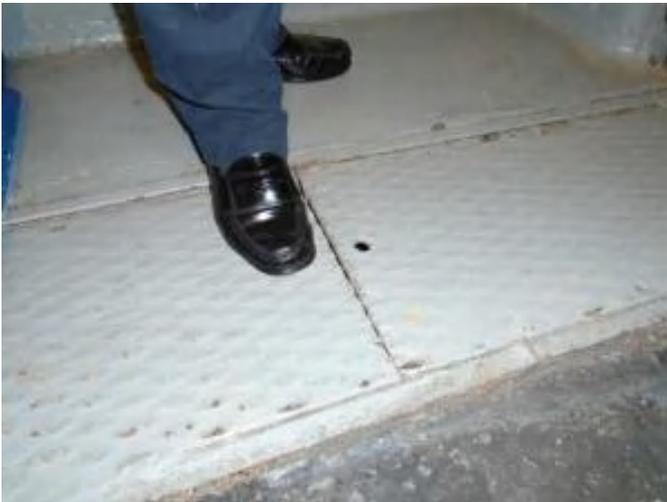
**System: B1010 - Floor Construction**

**Location:** Basement

**Distress:** Failing

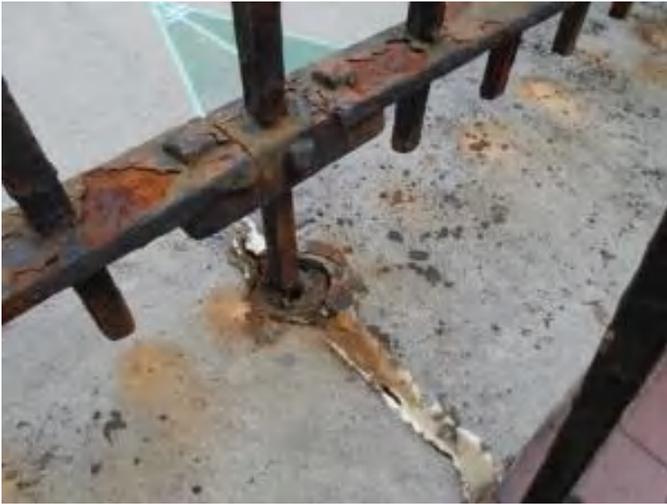
**System: B2010 - Exterior Walls**

**Location:** Courtyard wall

**Distress:** Failing

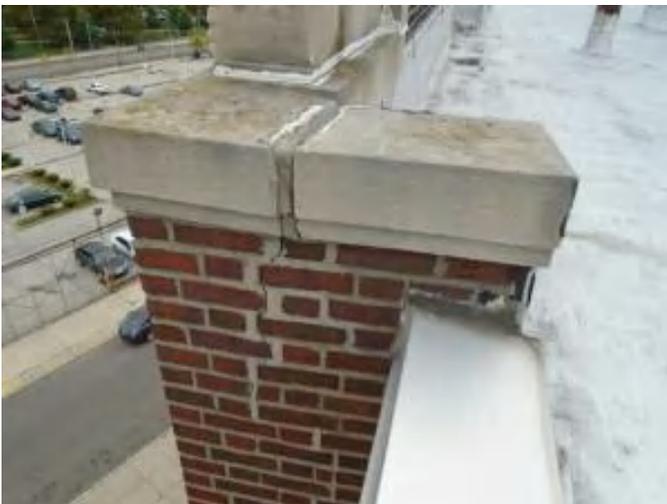
**System: B2010 - Exterior Walls**

**Location:** Chimney/parapet wall

**Distress:** Damaged

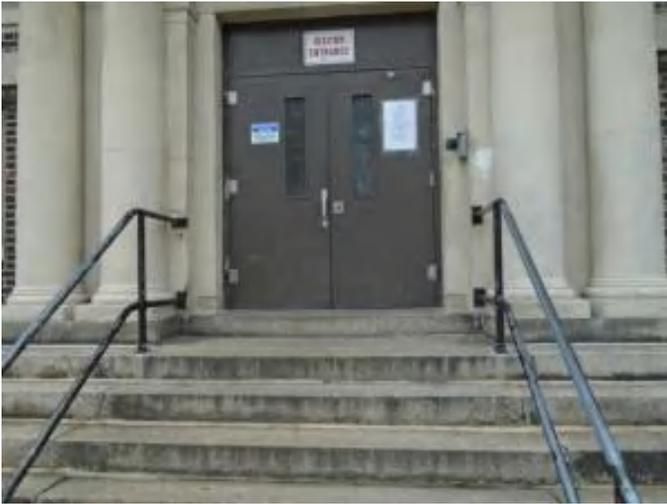
**System: B2030 - Exterior Doors**

**Location:** Entrance

**Distress:** Accessibility

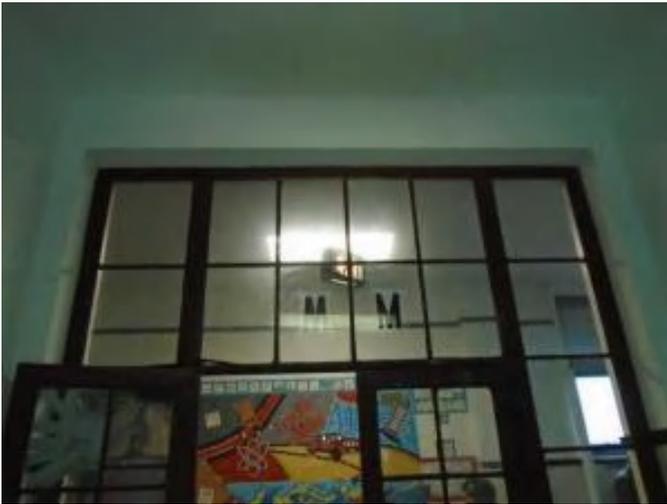
**System: C1020 - Interior Doors**

**Location:** Exit stairways

**Distress:** Beyond Service Life

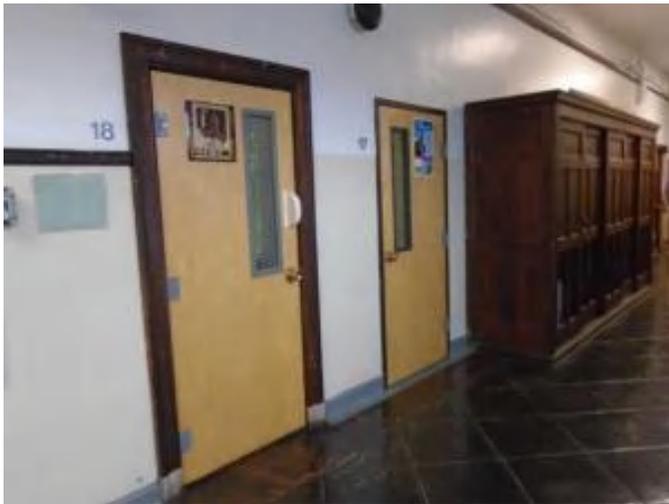
**System: C1020 - Interior Doors**

**Location:** Throughout  
**Distress:** Accessibility  
**Category:** 2 - Code Compliance  
**Priority:** 2 - Response Time (2-3 yrs)  
**Correction:** Replace door knobs with compliant lever type  
**Qty:** 63.00  
**Unit of Measure:** Ea.  
**Estimate:** \$35,063.88  
**Assessor Name:** System  
**Date Created:** 10/30/2015

**Notes:** Replace interior door handles with lever type handles and latch sets

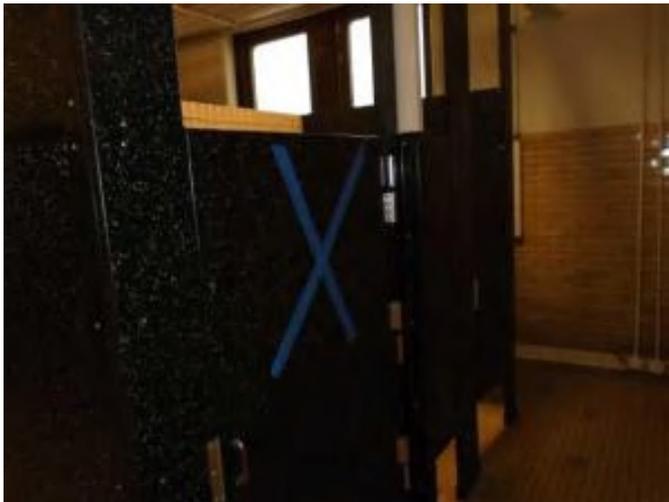
**System: C1030 - Fittings**

**Location:** Toilets  
**Distress:** Failing  
**Category:** 3 - Operations / Maint.  
**Priority:** 2 - Response Time (2-3 yrs)  
**Correction:** Remove and replace damaged toilet partitions - handicap units  
**Qty:** 33.00  
**Unit of Measure:** Ea.  
**Estimate:** \$32,269.22  
**Assessor Name:** System  
**Date Created:** 10/30/2015

**Notes:** Replace toilet partitions to fit and operate properly

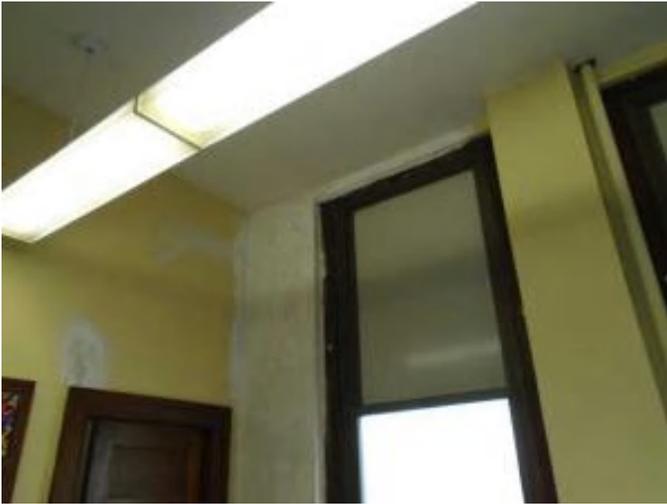
**System: C3010230 - Paint & Covering**

**Location:** Throughout

**Distress:** Damaged

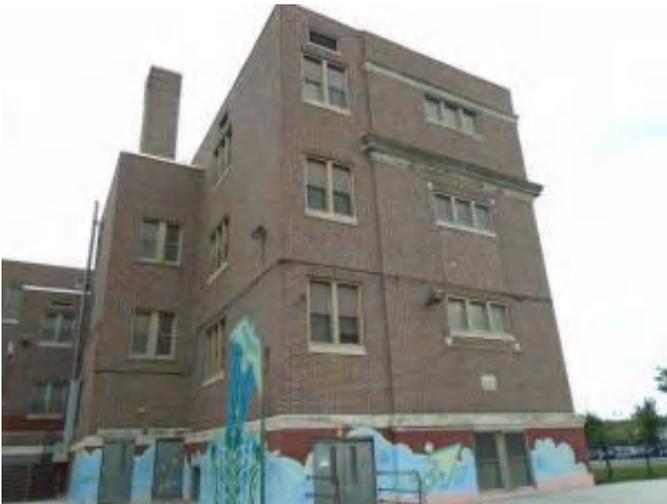
**System: D1010 - Elevators and Lifts**

**Location:** TBD

**Distress:** Accessibility

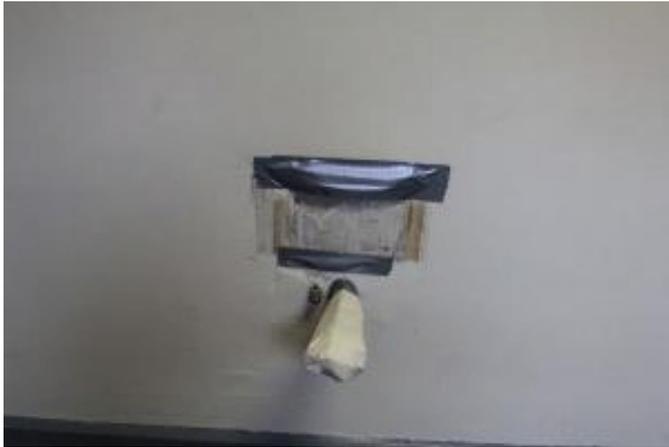
**System: D2010 - Plumbing Fixtures**

**Location:** Corridors

**Distress:** Beyond Service Life

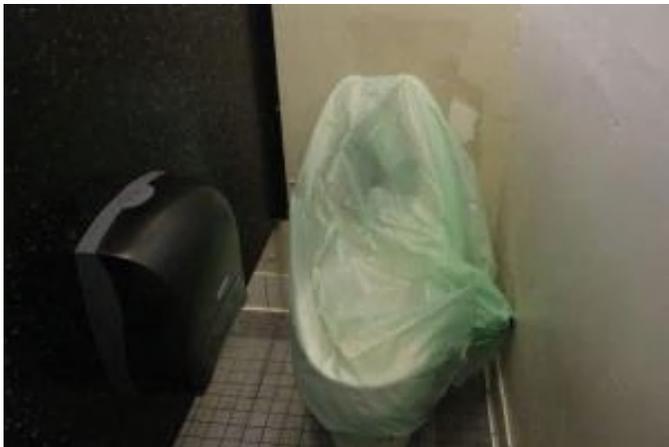
**System: D2010 - Plumbing Fixtures**

**Location:** Toilet rooms

**Distress:** Maintenance Required

**Notes:** Replace two water closets

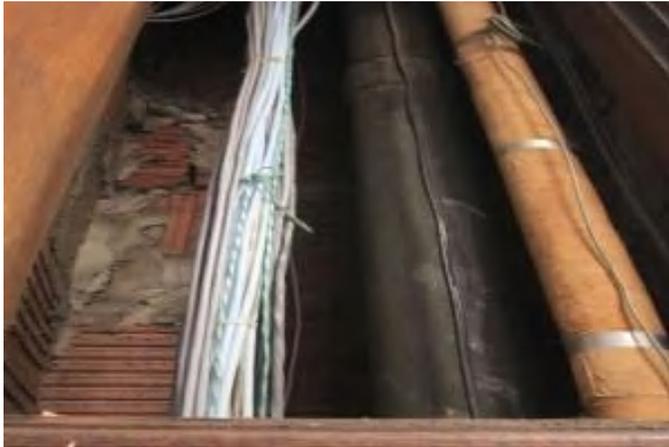
**System: D2030 - Sanitary Waste**

**Location:** Basement

**Distress:** Failing

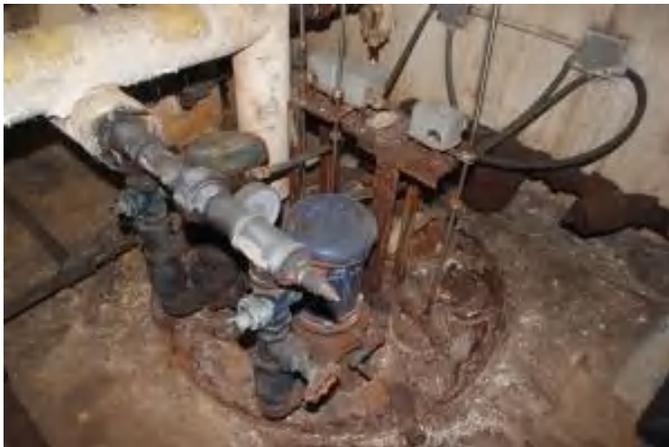
**System: D3020 - Heat Generating Systems**

**Location:** Boiler room

**Distress:** Failing

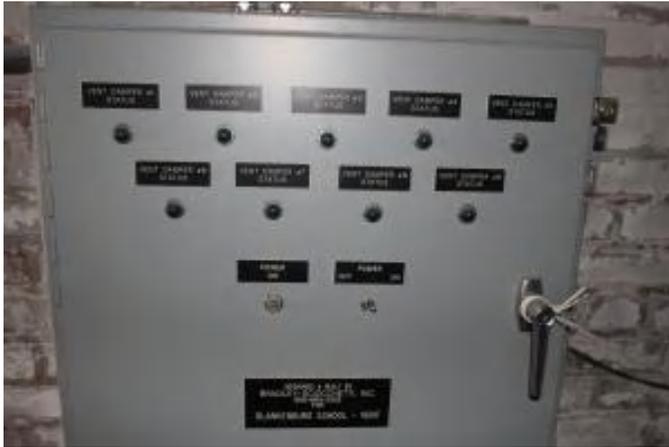
**System: D3060 - Controls & Instrumentation**

**Location:** Entire building  
**Distress:** Energy Efficiency  
**Category:** 4 - Capital Improvement  
**Priority:** 2 - Response Time (2-3 yrs)  
**Correction:** Replace pneumatic controls with DDC (75KSF)  
**Qty:** 64,000.00  
**Unit of Measure:** S.F.  
**Estimate:** \$1,372,931.33  
**Assessor Name:** System  
**Date Created:** 12/30/2015

**Notes:** Upgrade HVAC controls to modern digital system for entire building

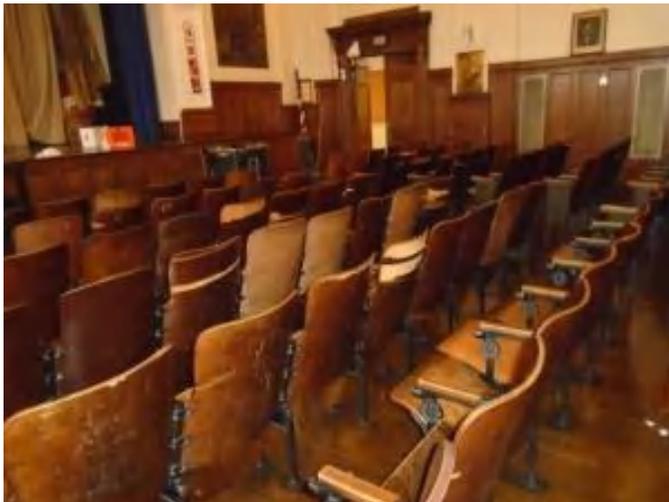
**System: E2010 - Fixed Furnishings**

**Location:** Auditorium  
**Distress:** Beyond Service Life  
**Category:** 3 - Operations / Maint.  
**Priority:** 2 - Response Time (2-3 yrs)  
**Correction:** Replace auditorium seating - add tablet arms if required. Veneer seating is an option.  
**Qty:** 441.00  
**Unit of Measure:** Ea.  
**Estimate:** \$359,472.75  
**Assessor Name:** System  
**Date Created:** 10/30/2015

**Notes:** Replace auditorium seats – damaged and beyond service life

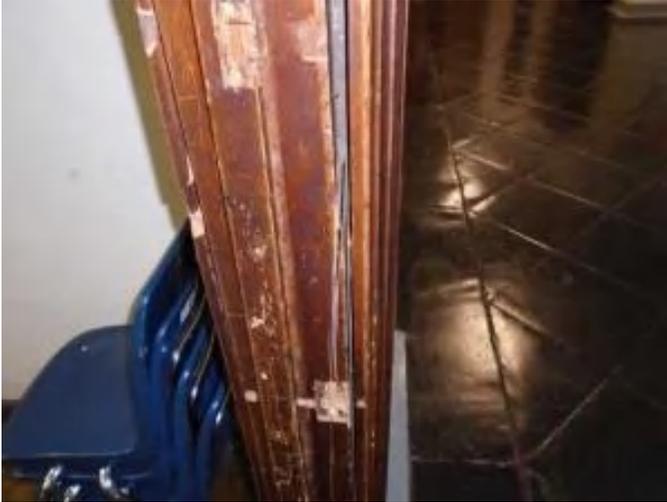
**System: C1020 - Interior Doors**

**Location:** Throughout

**Distress:** Beyond Service Life

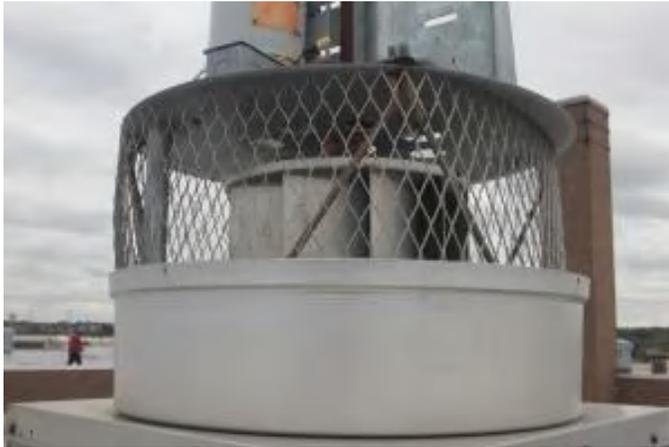
**System: D3040 - Distribution Systems**

**Location:** Roof  
**Distress:** Failing  
**Category:** 3 - Operations / Maint.  
**Priority:** 3 - Response Time (3-4 yrs)  
**Correction:** Replace power roof ventilator (24" dia.)  
**Qty:** 2.00  
**Unit of Measure:** Ea.  
**Estimate:** \$47,165.63  
**Assessor Name:** System  
**Date Created:** 12/30/2015

**Notes:** Replace 2 inoperable rooftop power ventilators for toilet rooms

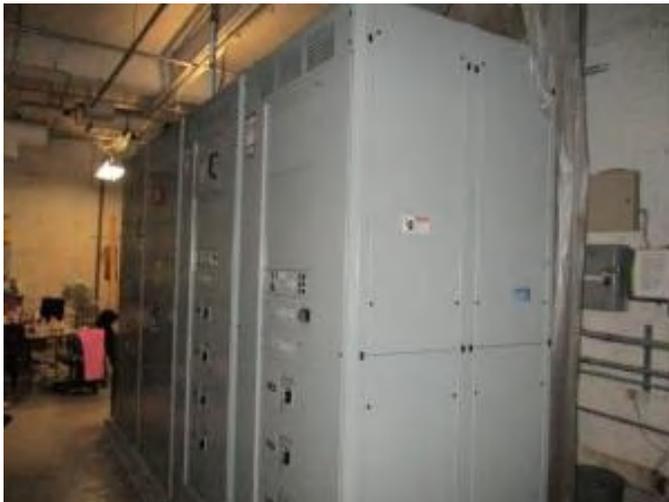
**System: D5010 - Electrical Service/Distribution**

**Location:** Basement Electrical Room  
**Distress:** Inadequate  
**Category:** 4 - Capital Improvement  
**Priority:** 3 - Response Time (3-4 yrs)  
**Correction:** Replace Switchboard  
**Qty:** 1.00  
**Unit of Measure:** Ea.  
**Estimate:** \$164,820.82  
**Assessor Name:** System  
**Date Created:** 12/21/2015

**Notes:** Provide a new electrical service 480V/277V, 3 phase power, approximate 800 Amperes and will be located in the vicinity of the existing electrical service.

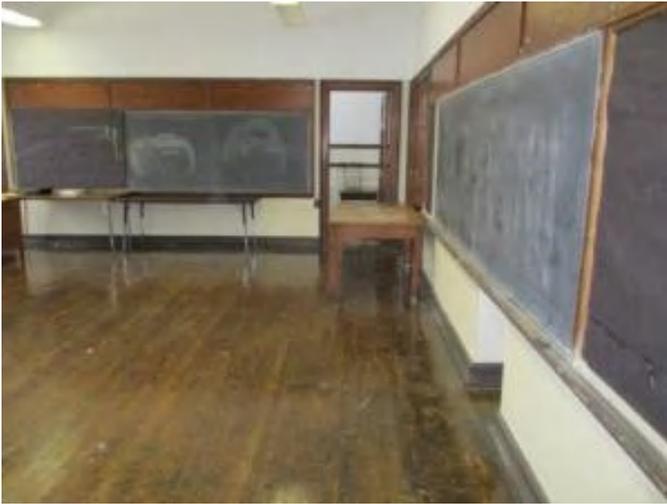
**System: D5020 - Lighting and Branch Wiring**

**Location:** Entire Building  
**Distress:** Inadequate  
**Category:** 4 - Capital Improvement  
**Priority:** 3 - Response Time (3-4 yrs)  
**Correction:** Add wiring device  
**Qty:** 380.00  
**Unit of Measure:** Ea.  
**Estimate:** \$140,752.95  
**Assessor Name:** System  
**Date Created:** 12/21/2015

**Notes:** Provide (2)25FT of surface raceways with 24" receptacles on center and two-duplex wall mount receptacles. Approximate 380

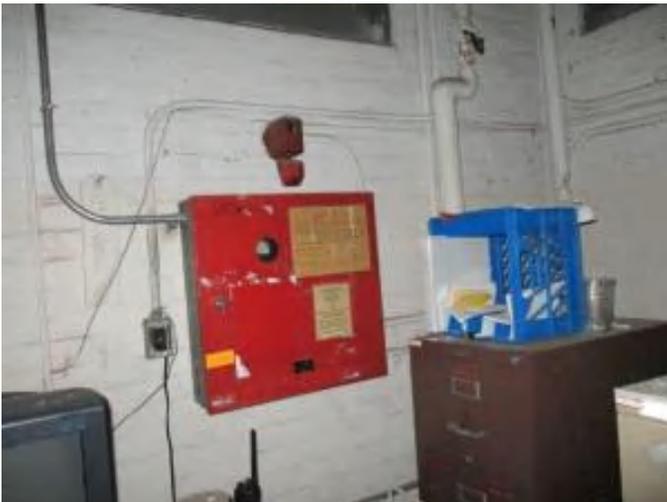
**System: D5030 - Communications and Security**

**Location:** Entire Building  
**Distress:** Health Hazard / Risk  
**Category:** 1 - Health & Safety  
**Priority:** 3 - Response Time (3-4 yrs)  
**Correction:** Replace fire alarm system  
**Qty:** 1.00  
**Unit of Measure:** S.F.  
**Estimate:** \$162,415.22  
**Assessor Name:** System  
**Date Created:** 12/21/2015

**Notes:** Replace old fire alarm system with addressable type with audio/visual devices at corridors and classrooms. Approximate 90 devices

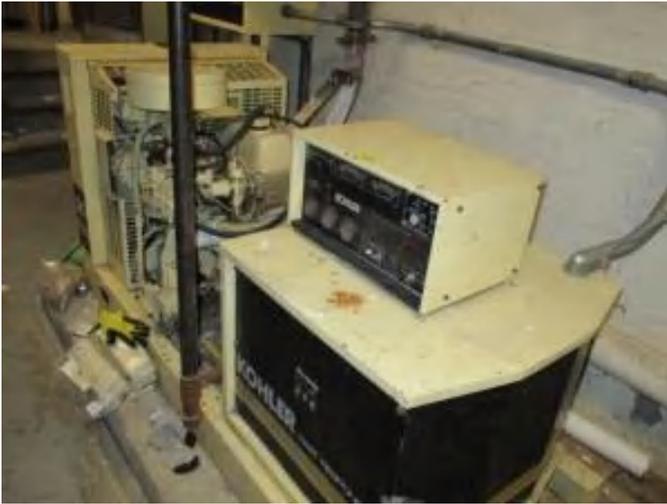
**System: D5090 - Other Electrical Systems**

**Location:** Outdoor  
**Distress:** Inadequate  
**Category:** 4 - Capital Improvement  
**Priority:** 3 - Response Time (3-4 yrs)  
**Correction:** Add Standby Generator System  
**Qty:** 1.00  
**Unit of Measure:** Ea.  
**Estimate:** \$130,796.46  
**Assessor Name:** System  
**Date Created:** 12/21/2015

**Notes:** Provide 70KW, outdoor, diesel powered generator

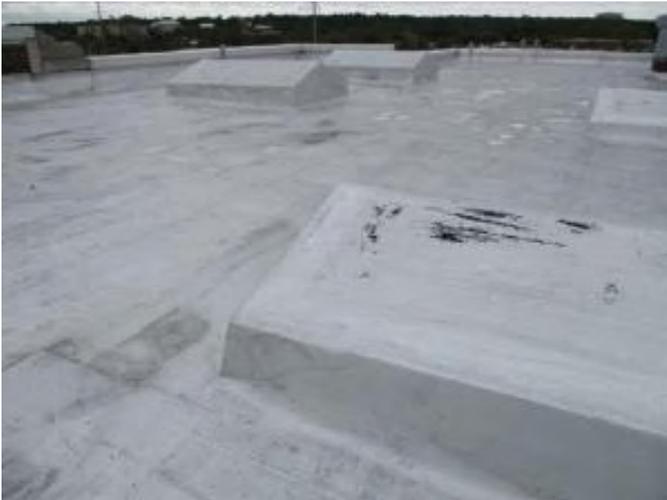
**System: D5090 - Other Electrical Systems**

**Location:** Roof  
**Distress:** Building / MEP Codes  
**Category:** 2 - Code Compliance  
**Priority:** 3 - Response Time (3-4 yrs)  
**Correction:** Repair Lightning Protection System  
**Qty:** 1.00  
**Unit of Measure:** Job  
**Estimate:** \$24,249.82  
**Assessor Name:** System  
**Date Created:** 12/21/2015

**Notes:** Prepare a study to determine if the school building requires lightning protection system.

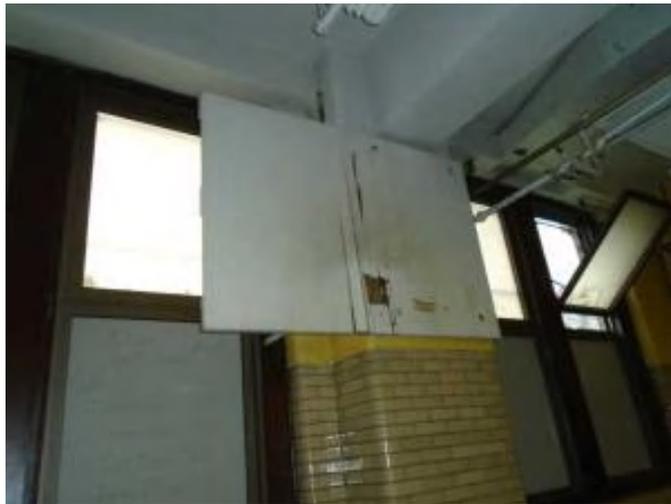
**System: E1020 - Institutional Equipment**

**Location:** Gym

**Distress:** Failing

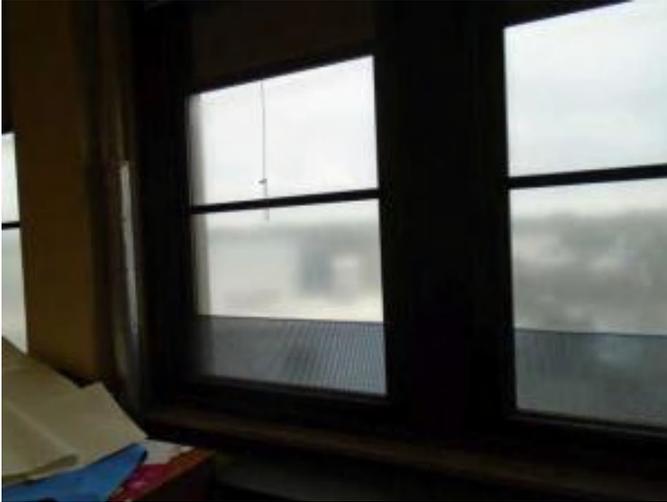
**System: B2020 - Exterior Windows**

**Location:** Throughout

**Distress:** Energy Efficiency

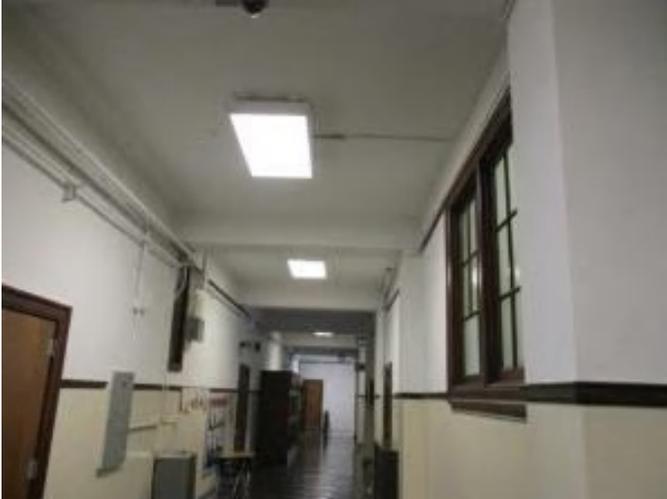
**System: D5020 - Lighting and Branch Wiring**

**Location:** Entire Building

**Distress:** Obsolete

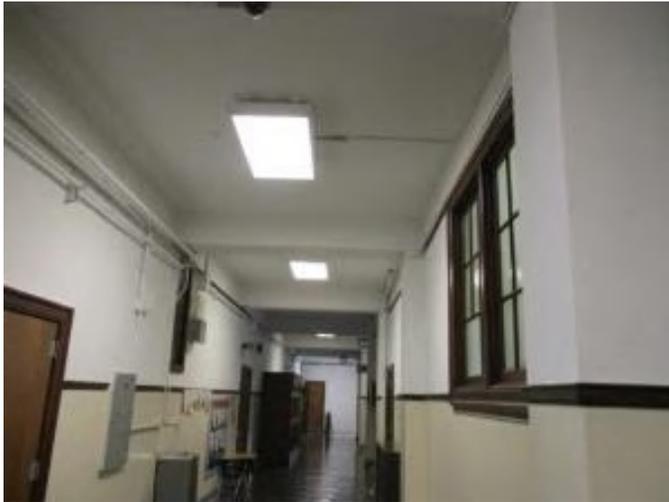
**System: D5030 - Communications and Security**

**Location:** Entire Building

**Distress:** Security Issue

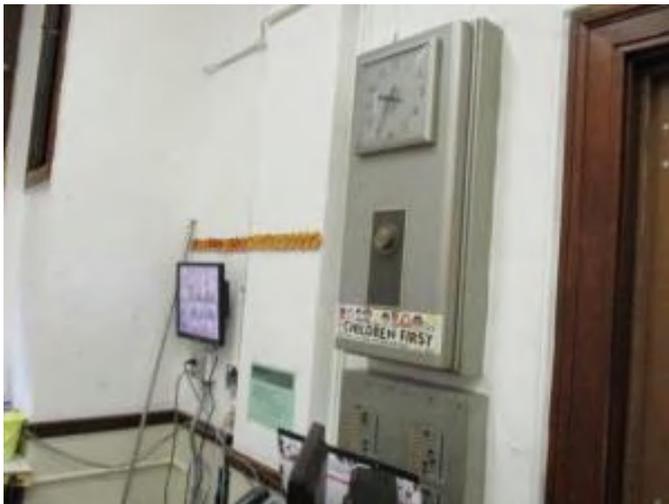
**System: D5030 - Communications and Security**

**Location:** Entire building

**Distress:** Obsolete

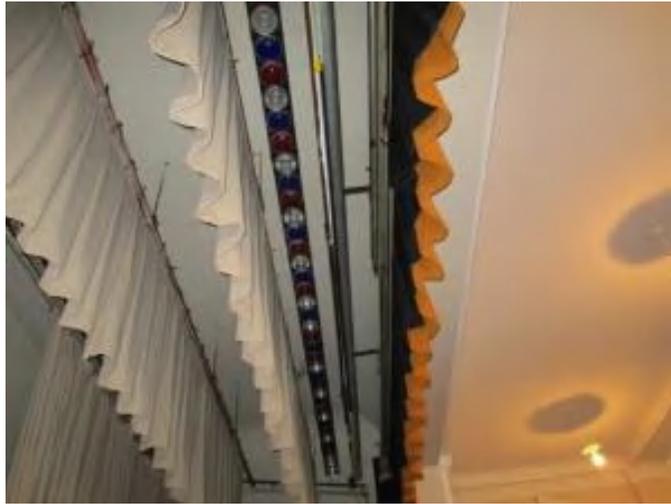
**System: E1020 - Institutional Equipment**

**Location:** Auditorium

**Distress:** Obsolete

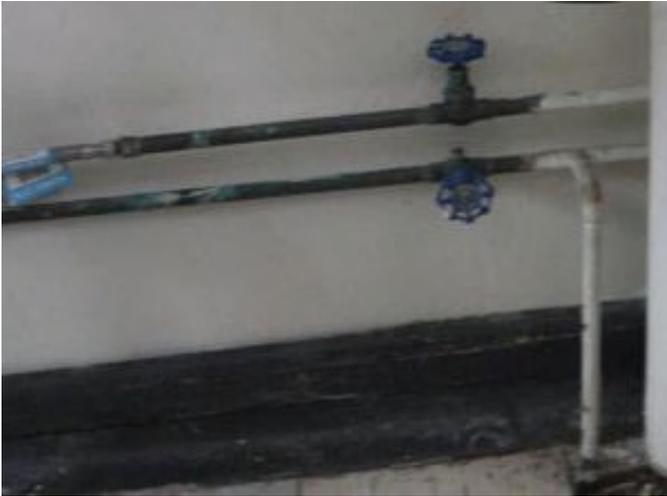
**System: D2020 - Domestic Water Distribution**

**Location:** Entire building

**Distress:** Beyond Service Life

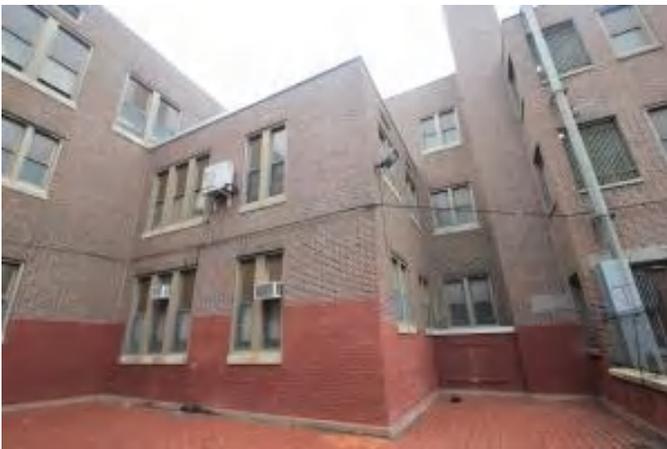
**System: D3030 - Cooling Generating Systems**

**Location:** Entire building

**Distress:** Inadequate

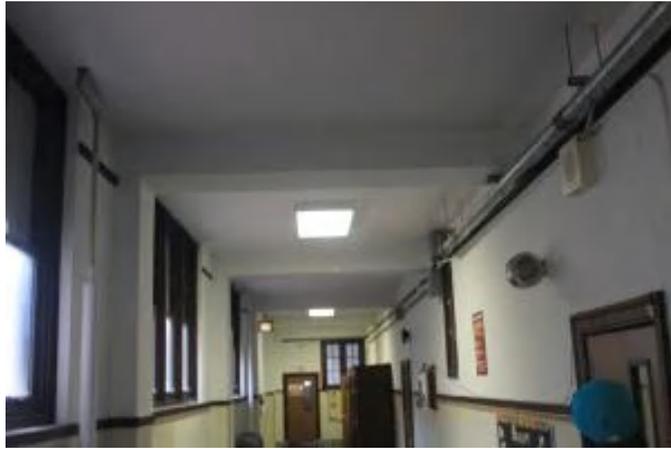
**System: D4010 - Sprinklers**

**Location:** Entire building

**Distress:** Life Safety / NFPA / PFD

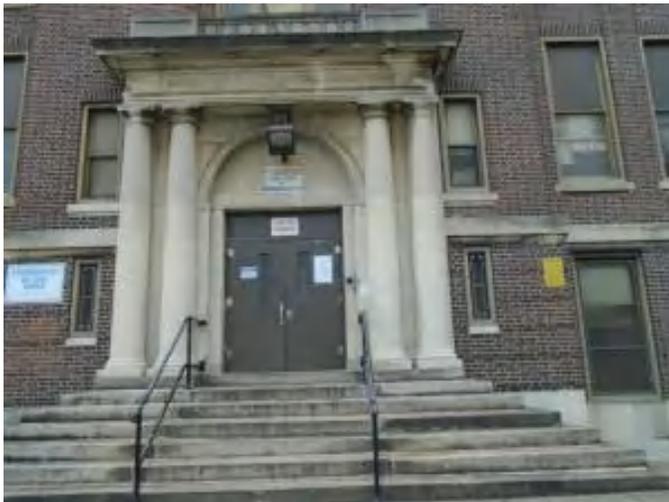
#### System: G2030 - Pedestrian Paving

**Location:** Entrance

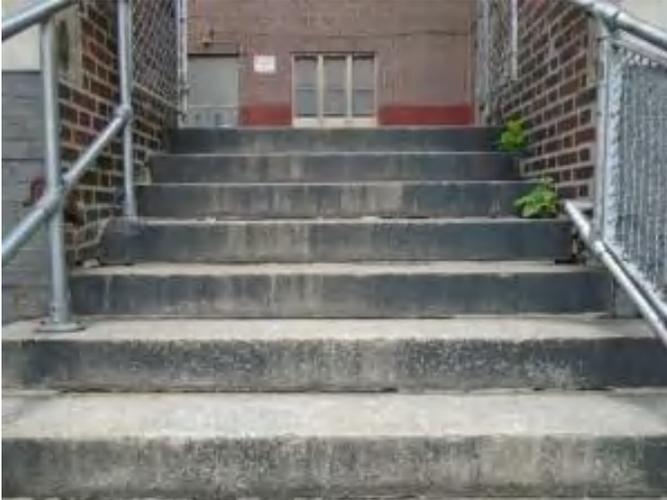
**System: G2030 - Pedestrian Paving**

**Location:** Ext. steps

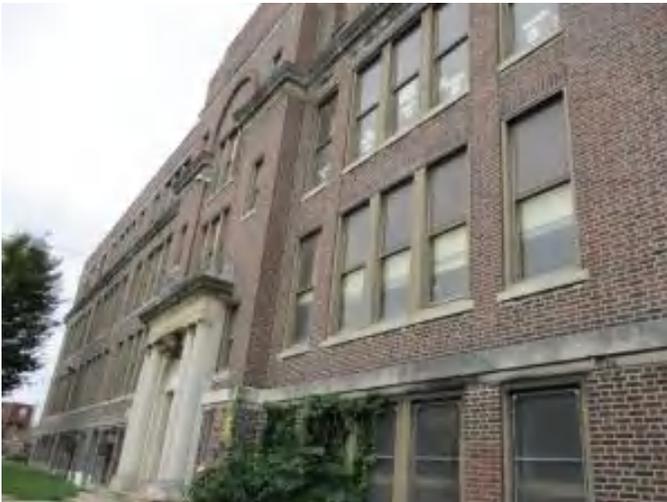
**System: G4030 - Site Communications & Security**

**Location:** Building Perimeter

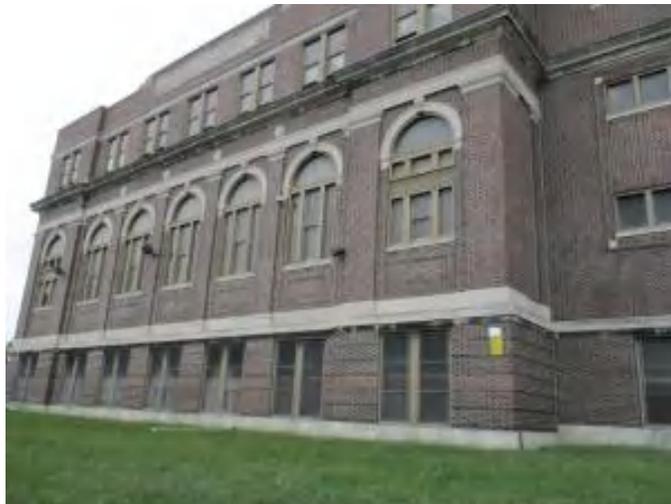
**System: G4020 - Site Lighting**

**Location:** Exit Doors
