Facility Condition Assessment Summary Report

Blaine School

School District of Philadelphia
S422001;Blaine
Final
Site Assessment Report

January 30, 2017

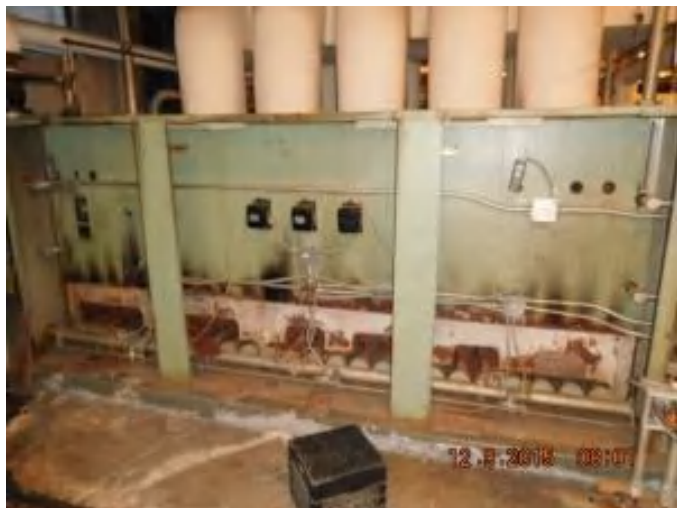
System: D3020 - Heat Generating Systems

Location: mechanical room

Distress: Beyond Service Life

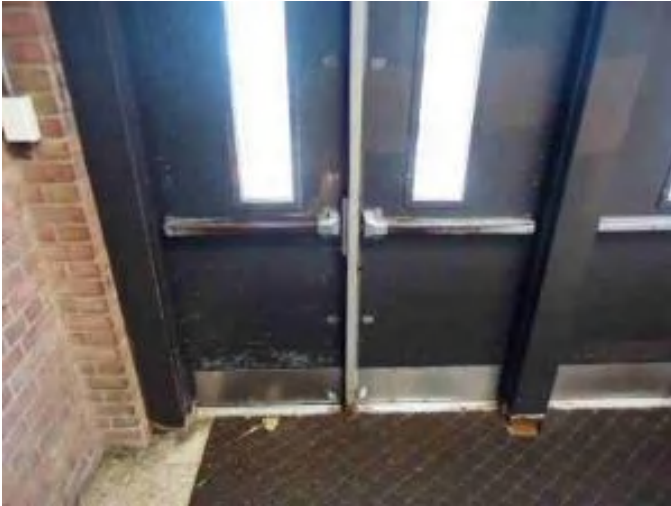
System: B2030 - Exterior Doors

Location: Exterior Elevation

Distress: Damaged

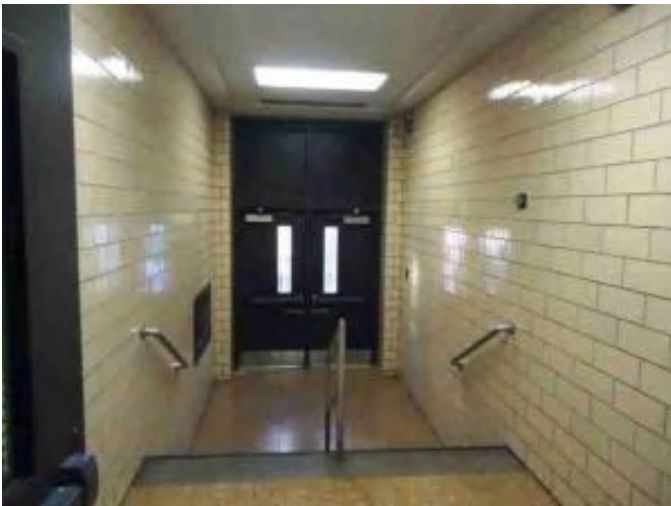
System: C2010 - Stair Construction

Location: Stairs

Distress: Life Safety / NFPA / PFD

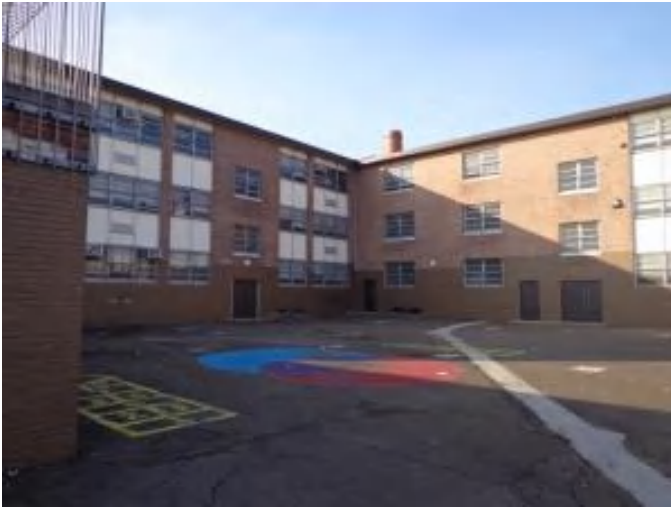
System: D5020 - Lighting and Branch Wiring

Location: Exit discharges
Distress: Life Safety / NFPA / PFD
Category: 1 - Health & Safety
Priority: 2 - Response Time (2-3 yrs)
Correction: Add Exterior Lighting
Qty: 7.00
Unit of Measure: Ea.
Estimate: \$20,596.90
Assessor Name: System
Date Created: 02/04/2016

Notes: Provide LED wall mounted fixtures at seven (7) exit discharges on the north side of the building.

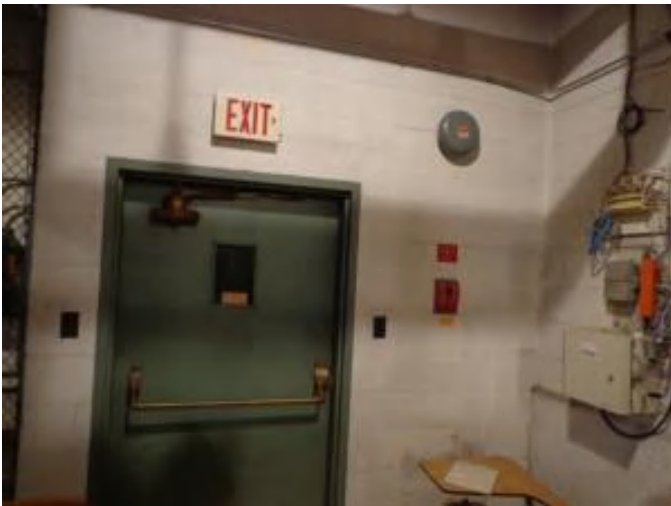
System: D5030 - Communications and Security

Location: Building wide
Distress: Life Safety / NFPA / PFD
Category: 1 - Health & Safety
Priority: 2 - Response Time (2-3 yrs)
Correction: Replace fire alarm system
Qty: 88,317.00
Unit of Measure: S.F.
Estimate: \$427,124.94
Assessor Name: System
Date Created: 02/04/2016

Notes: Replace fire alarm system with an addressable type system meeting current NFPA Codes and ADA requirements.

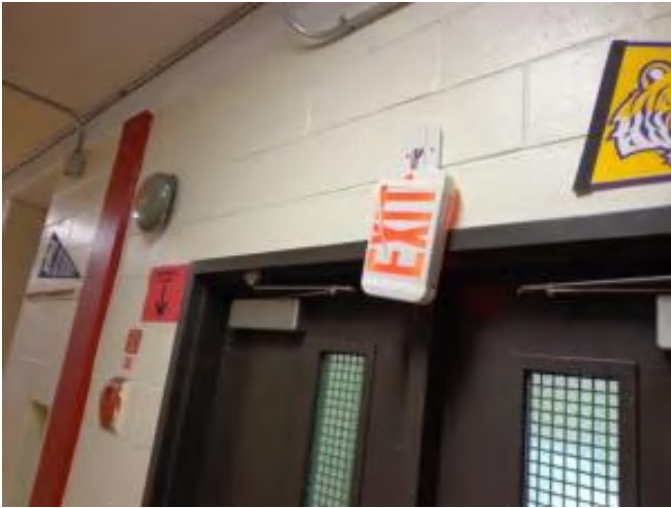
System: D5090 - Other Electrical Systems

Location: Building wide
Distress: Beyond Service Life
Category: 3 - Operations / Maint.
Priority: 2 - Response Time (2-3 yrs)
Correction: Replace Emergency/Exit Lighting
Qty: 35.00
Unit of Measure: Ea.
Estimate: \$29,673.67
Assessor Name: System
Date Created: 02/04/2016

Notes: Replace all exit signs with LED type (estimate 35 exit signs).

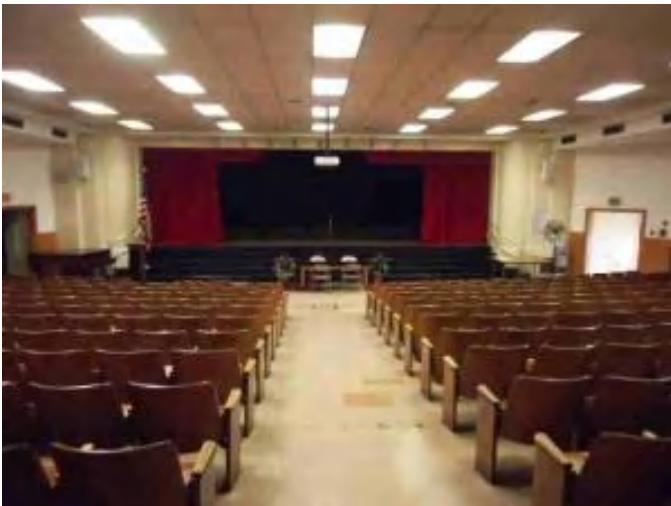
System: E2010 - Fixed Furnishings

Location: Stage
Distress: Life Safety / NFPA / PFD
Category: 1 - Health & Safety
Priority: 2 - Response Time (2-3 yrs)
Correction: Remove and replace stage curtain - insert the LF of track and SF of curtain
Qty: 1.00
Unit of Measure: Ea.
Estimate: \$13,831.55
Assessor Name: System
Date Created: 02/05/2016

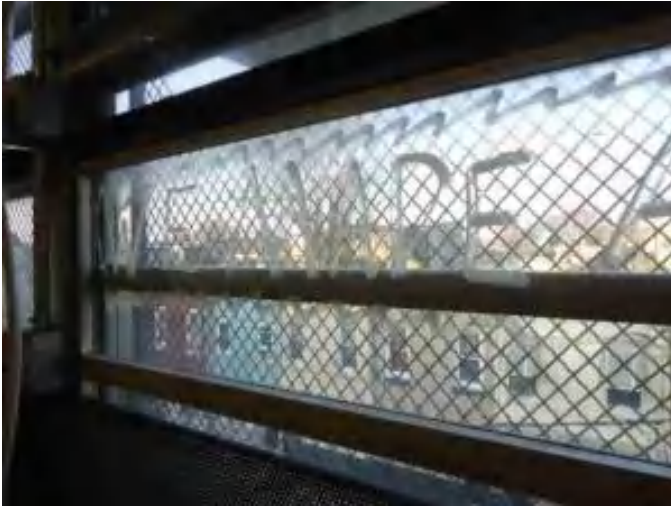
System: B2020 - Exterior Windows

Location: Exterior Elevation

Distress: Damaged

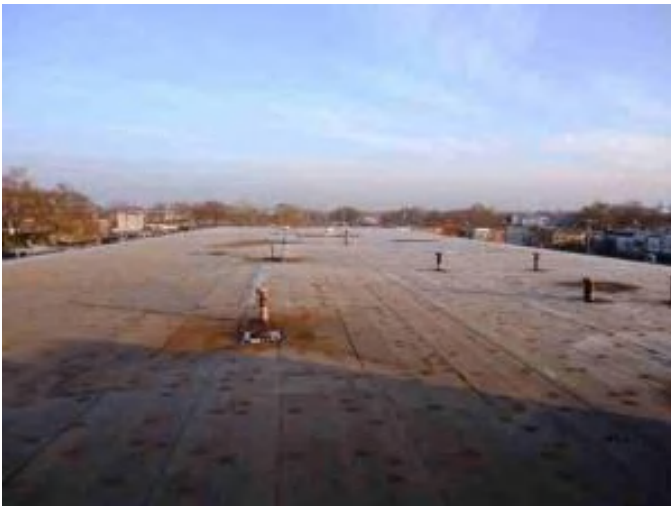
System: B3010105 - Built-Up

Location: Roof

Distress: Damaged

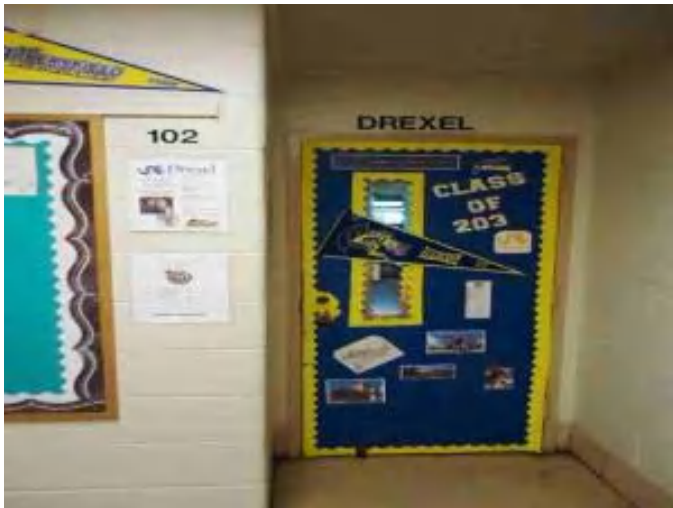
System: C1020 - Interior Doors

Location: Building Wide

Distress: Damaged

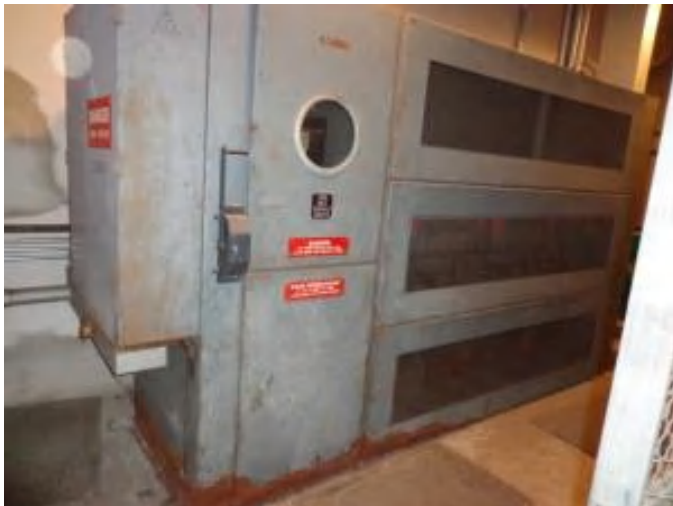
System: D5010 - Electrical Service/Distribution

Location: Boiler Room 001

Distress: Beyond Service Life

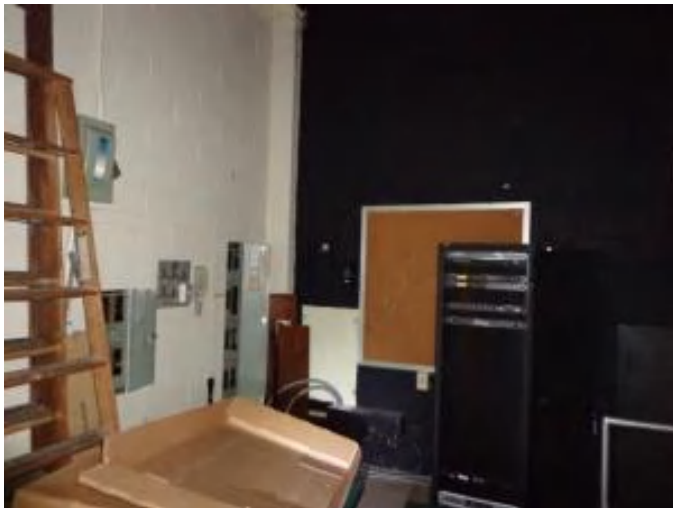
System: D5010 - Electrical Service/Distribution

Location: Building wide
Distress: Beyond Service Life
Category: 3 - Operations / Maint.
Priority: 3 - Response Time (3-4 yrs)
Correction: Replace Panelboard
Qty: 14.00
Unit of Measure: Ea.
Estimate: \$442,677.86
Assessor Name: System
Date Created: 02/03/2016

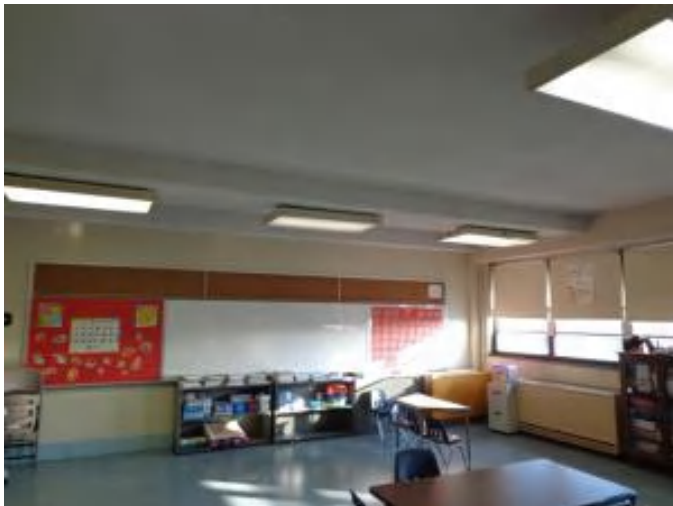
System: D5020 - Lighting and Branch Wiring

Location: Building wide
Distress: Beyond Service Life
Category: 3 - Operations / Maint.
Priority: 3 - Response Time (3-4 yrs)
Correction: Replace Lighting Fixtures (SF)
Qty: 50,580.00
Unit of Measure: S.F.
Estimate: \$900,443.16
Assessor Name: System
Date Created: 02/03/2016

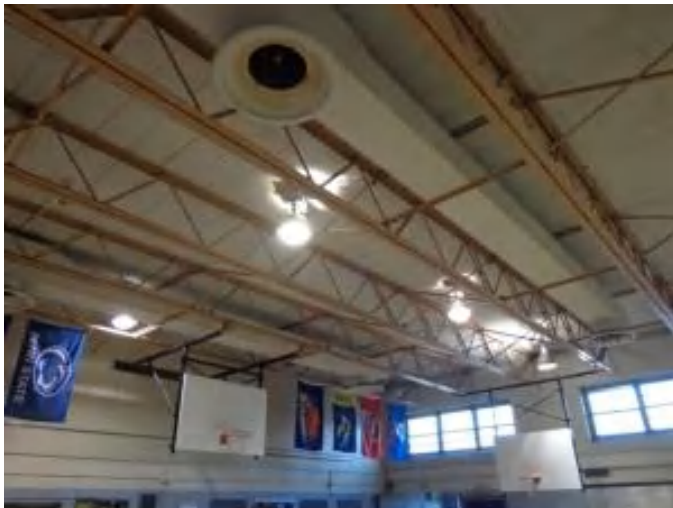
System: D5020 - Lighting and Branch Wiring

Location: Cafeteria/gymnasium
Distress: Beyond Service Life
Category: 3 - Operations / Maint.
Priority: 3 - Response Time (3-4 yrs)
Correction: Replace lighting fixtures
Qty: 20.00
Unit of Measure: Ea.
Estimate: \$71,797.27
Assessor Name: System
Date Created: 02/04/2016

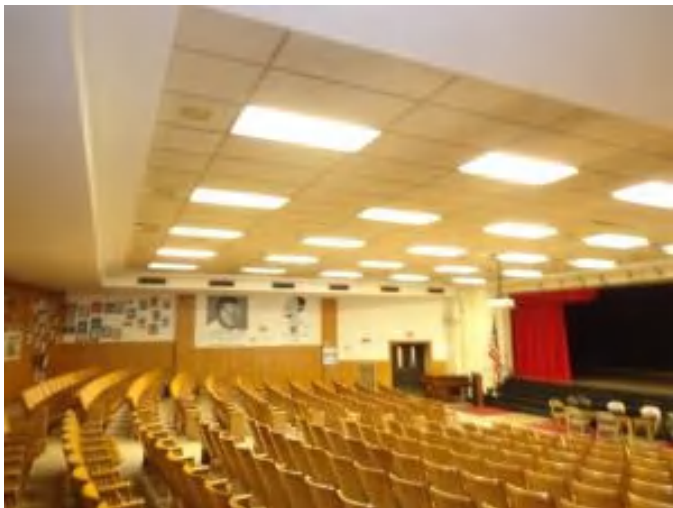
System: D5020 - Lighting and Branch Wiring

Location: Auditorium
Distress: Beyond Service Life
Category: 3 - Operations / Maint.
Priority: 3 - Response Time (3-4 yrs)
Correction: Replace lighting fixtures
Qty: 25.00
Unit of Measure: Ea.
Estimate: \$17,971.05
Assessor Name: System
Date Created: 02/04/2016

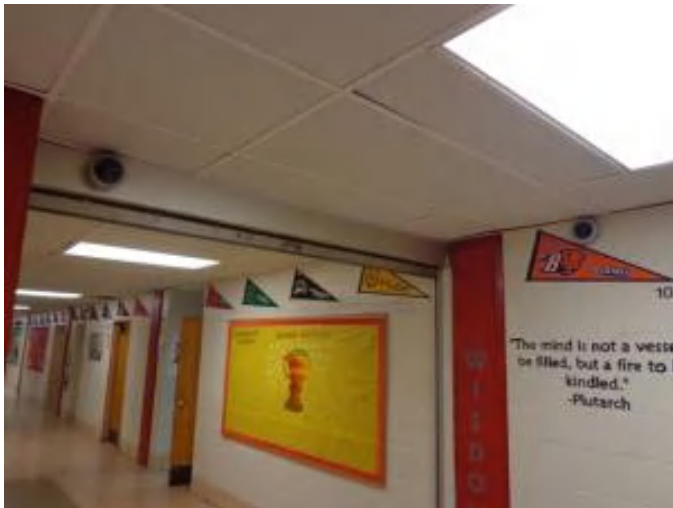
System: D5030 - Communications and Security

Location: Building wide
Distress: Beyond Service Life
Category: 3 - Operations / Maint.
Priority: 3 - Response Time (3-4 yrs)
Correction: Add/Replace Video Surveillance System
Qty: 14.00
Unit of Measure: Ea.
Estimate: \$59,536.05
Assessor Name: System
Date Created: 02/04/2016

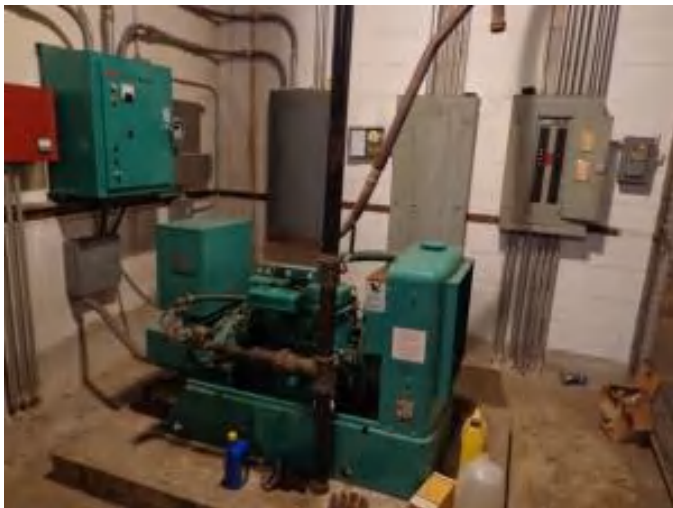
System: D5090 - Other Electrical Systems

Location: Boiler Room 001
Distress: Beyond Service Life
Category: 3 - Operations / Maint.
Priority: 3 - Response Time (3-4 yrs)
Correction: Replace standby generator system
Qty: 1.00
Unit of Measure: Ea.
Estimate: \$119,206.47
Assessor Name: System
Date Created: 02/04/2016

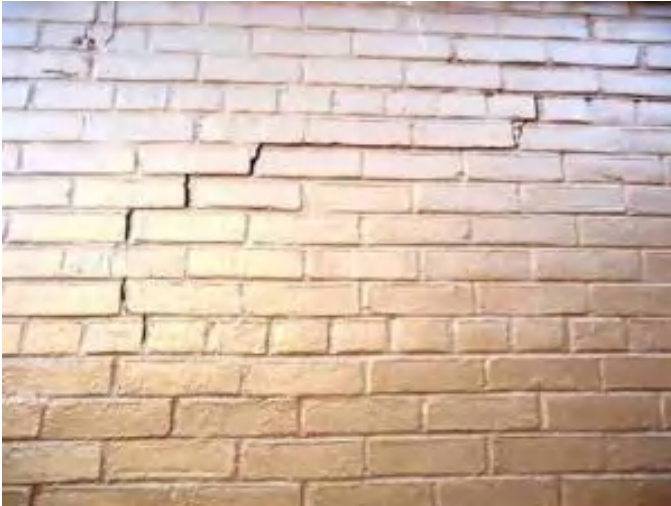
System: B2010 - Exterior Walls

Location: Exterior Elevation

Distress: Damaged

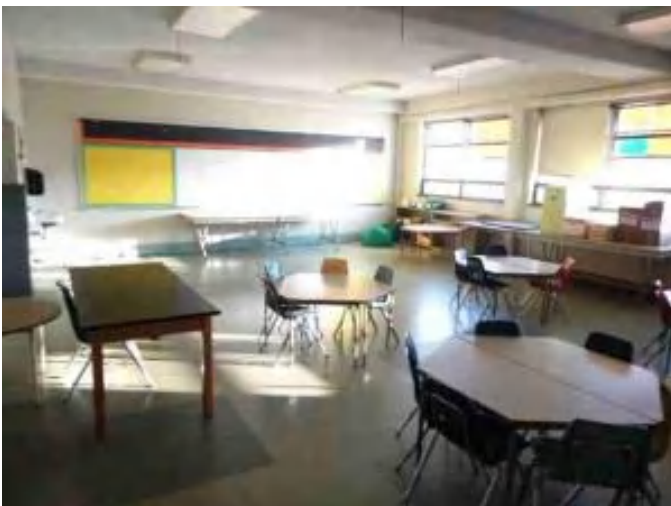
System: C1030 - Fittings

Location: Classrooms

Distress: Damaged

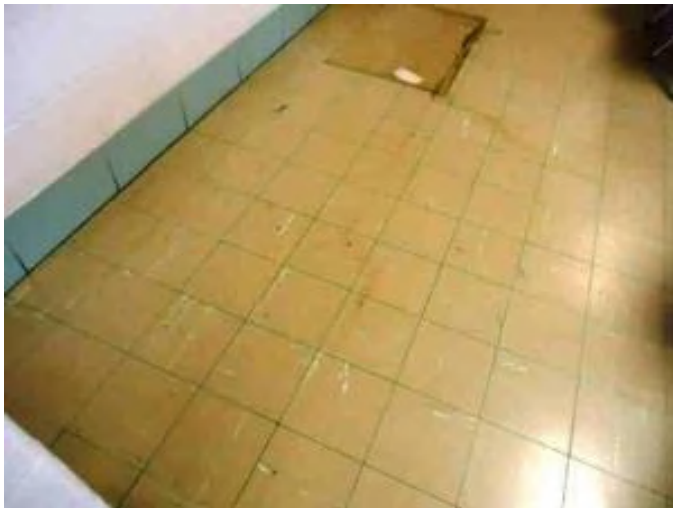
System: C3020413 - Vinyl Flooring

Location: Building Wide
Distress: Health Hazard / Risk
Category: 1 - Health & Safety
Priority: 4 - Response Time (4-5 yrs)
Correction: Remove VAT and replace with VCT - SF of area
Qty: 50,000.00
Unit of Measure: S.F.
Estimate: \$758,333.40
Assessor Name: System
Date Created: 02/05/2016

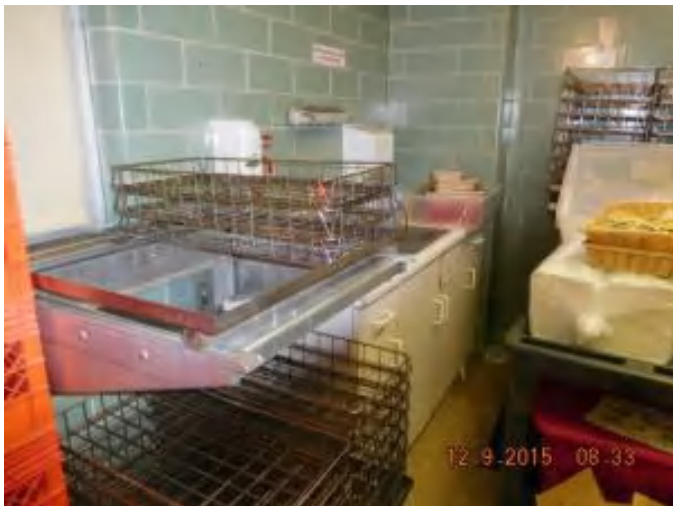
System: D2010 - Plumbing Fixtures

Location: kitchen
Distress: Building / MEP Codes
Category: 2 - Code Compliance
Priority: 4 - Response Time (4-5 yrs)
Correction: Replace 3 compartment sink with sanitizing basin.
Qty: 1.00
Unit of Measure: Ea.
Estimate: \$43,808.66
Assessor Name: System
Date Created: 02/12/2016

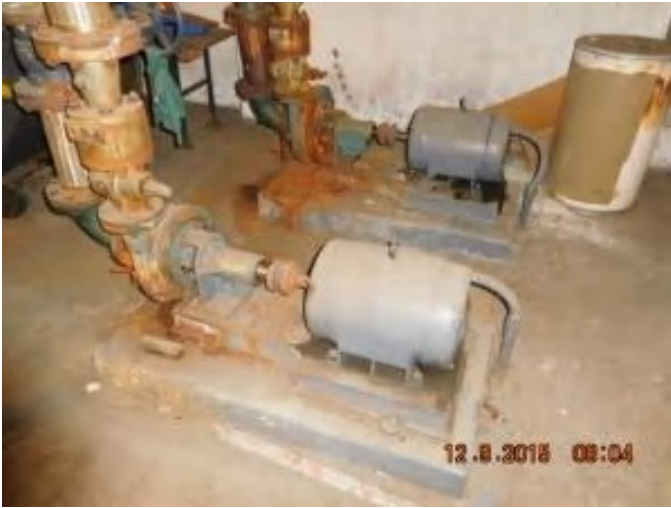
System: D2020 - Domestic Water Distribution

Location: mechanical room
Distress: Beyond Service Life
Category: 3 - Operations / Maint.
Priority: 4 - Response Time (4-5 yrs)
Correction: Replace duplex domestic booster pump set (5 HP)
Qty: 1.00
Unit of Measure: Ea.
Estimate: \$50,533.86
Assessor Name: System
Date Created: 02/12/2016

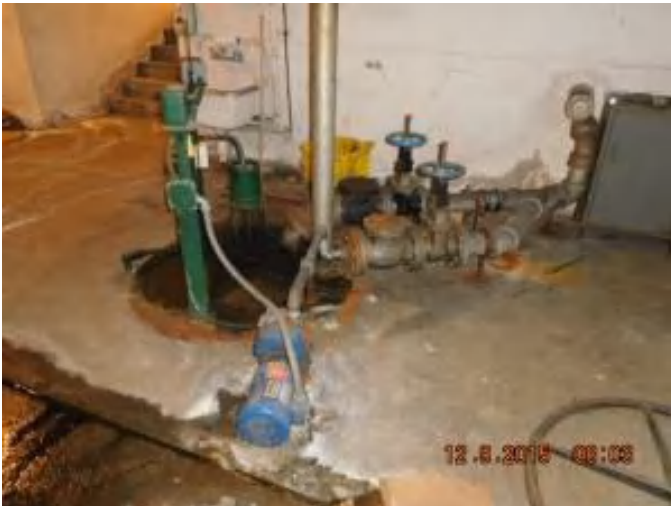
System: D2030 - Sanitary Waste

Location: entire building
Distress: Beyond Service Life
Category: 3 - Operations / Maint.
Priority: 4 - Response Time (4-5 yrs)
Correction: Inspect sanitary waste piping and replace damaged sections. (+100KSF)
Qty: 88,317.00
Unit of Measure: S.F.
Estimate: \$375,047.65
Assessor Name: System
Date Created: 02/12/2016

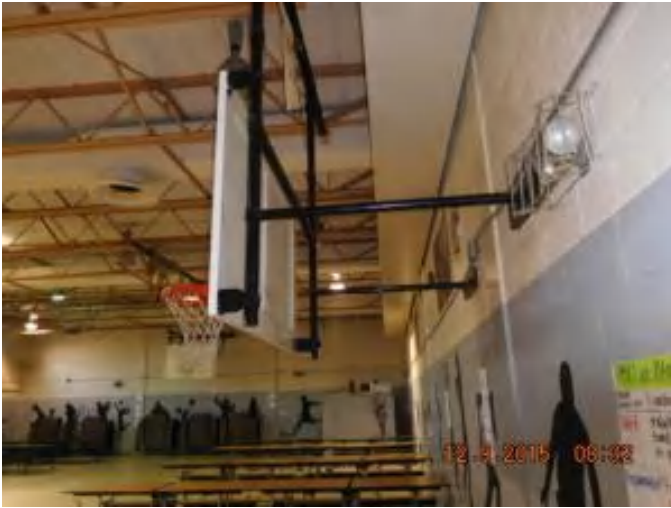
System: D3040 - Distribution Systems

Location: cafeteria/ gymnasium
Distress: Building / MEP Codes
Category: 2 - Code Compliance
Priority: 4 - Response Time (4-5 yrs)
Correction: Install HVAC unit for Gymnasium (single station).
Qty: 3,725.00
Unit of Measure: S.F.
Estimate: \$214,098.20
Assessor Name: System
Date Created: 02/12/2016

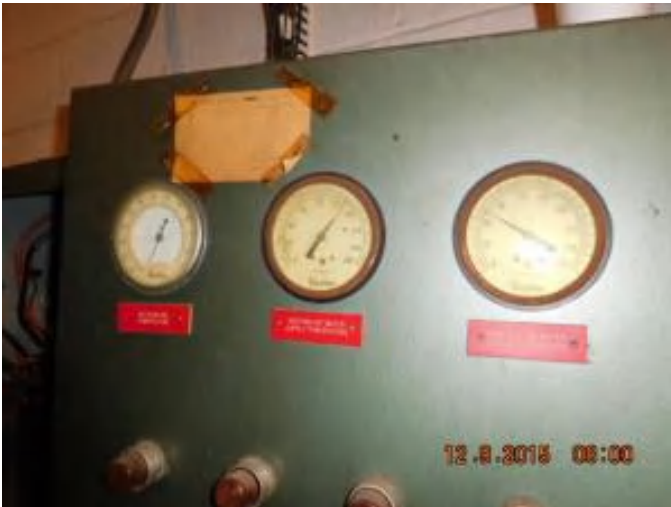
System: D3060 - Controls & Instrumentation

Location: entire building
Distress: Inadequate
Category: 4 - Capital Improvement
Priority: 4 - Response Time (4-5 yrs)
Correction: Replace pneumatic controls with DDC (75KSF)
Qty: 88,317.00
Unit of Measure: S.F.
Estimate: \$1,894,586.20
Assessor Name: System
Date Created: 02/12/2016

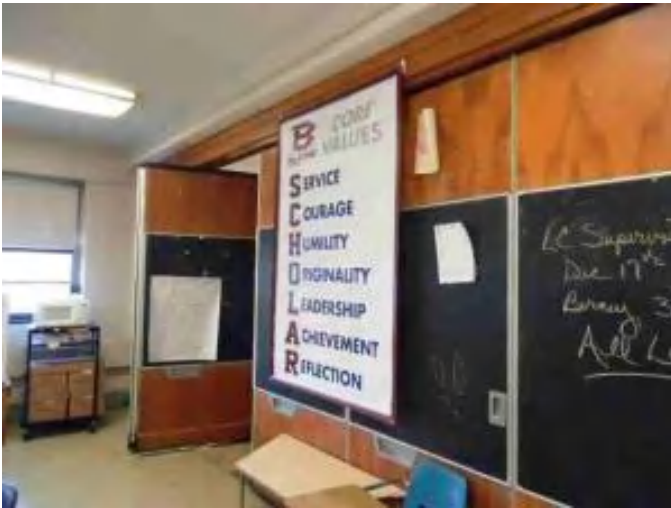
System: C1010 - Partitions

Location: Classrooms
Distress: Damaged
Category: 3 - Operations / Maint.
Priority: 5 - Response Time (> 5 yrs)
Correction: Remove folding wood partitions; replace with metal studs and gypsum board painted
Qty: 5,000.00
Unit of Measure: S.F.
Estimate: \$111,397.49
Assessor Name: System
Date Created: 02/05/2016

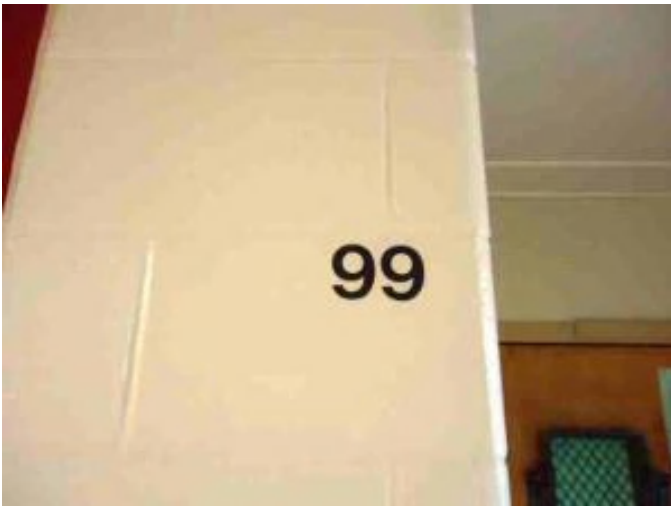
System: C1030 - Fittings

Location: Building Wide
Distress: Damaged
Category: 3 - Operations / Maint.
Priority: 5 - Response Time (> 5 yrs)
Correction: Replace missing or damaged signage - insert the number of rooms
Qty: 200.00
Unit of Measure: Ea.
Estimate: \$54,182.50
Assessor Name: System
Date Created: 02/05/2016

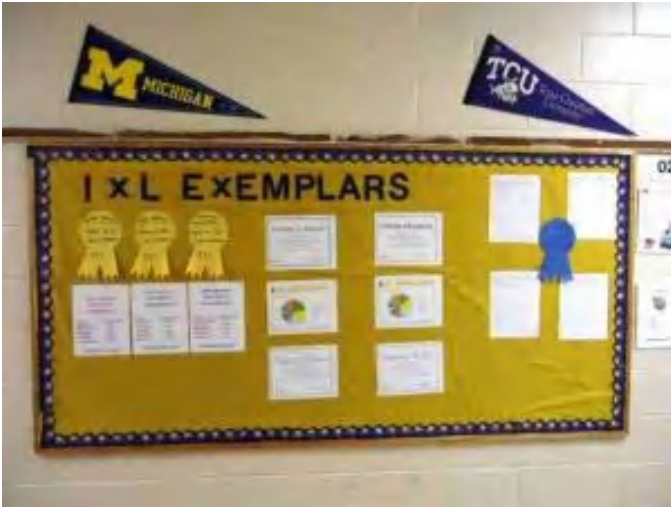
System: C1030 - Fittings

Location: Classrooms
Distress: Damaged
Category: 3 - Operations / Maint.
Priority: 5 - Response Time (> 5 yrs)
Correction: Remove and replace tackboards - select size
Qty: 10.00
Unit of Measure: Ea.
Estimate: \$7,927.26
Assessor Name: System
Date Created: 02/05/2016
