## Facility Condition Assessment Summary Report

### Bluford School

School District of Philadelphia  
**S429001;Bluford**  
Final  
**Site Assessment Report**  
February 1, 2017

## Site Assessment Report

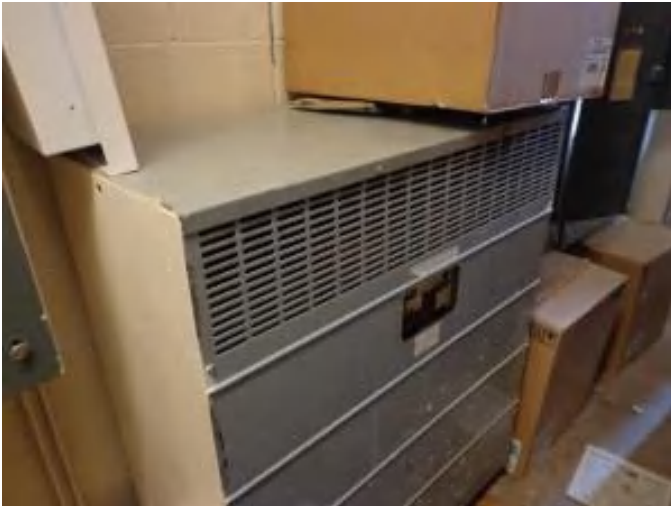
**Location:** Electrical Room 203B

The electrical room for the original 1974 building is Room 203B, which houses a General Electric 800A, 480/277V Distribution Panelboard DPA, and Federal Pacific Electric 225A, 480/277V Panelboard PP1, FPE 225 kVA step-down transformer, a 200A Distribution Panelboard with 6 circuit breakers and 100A Panelboard RP-3. Panelboards PP1, RP-3, the 200A Distribution Panelboard and the 225 kVA transformer have reached the end of their useful life and need to be replaced within the next 3 to 4 years.

#### **System: D5010 - Electrical Service/Distribution**

**Distress:** Beyond Service Life

**Correction:** Replace Electrical Distribution System (U)

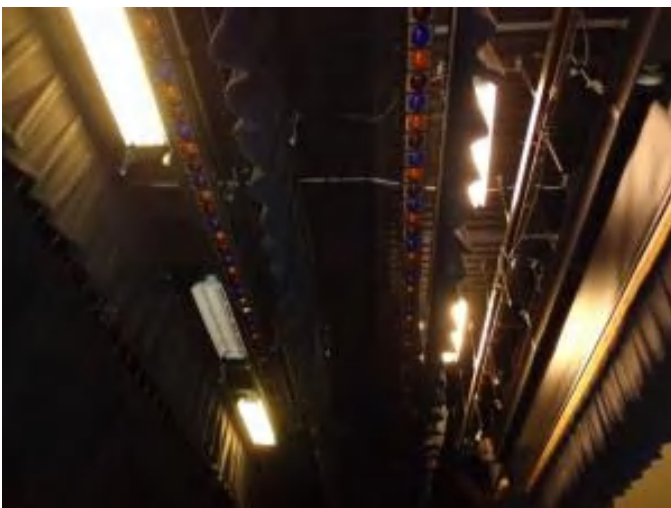
**Location:** Auditorium Platform

#### **System: D5020 - Lighting and Branch Wiring**

**Distress:** Beyond Service Life

**Correction:** Replace lighting fixtures

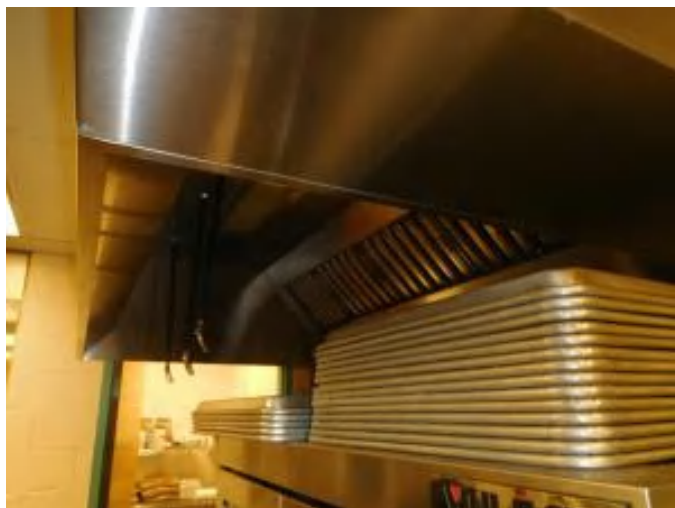
**Location:** kitchen storage

**System: D3040 - Distribution Systems**

**Distress:** Inadequate

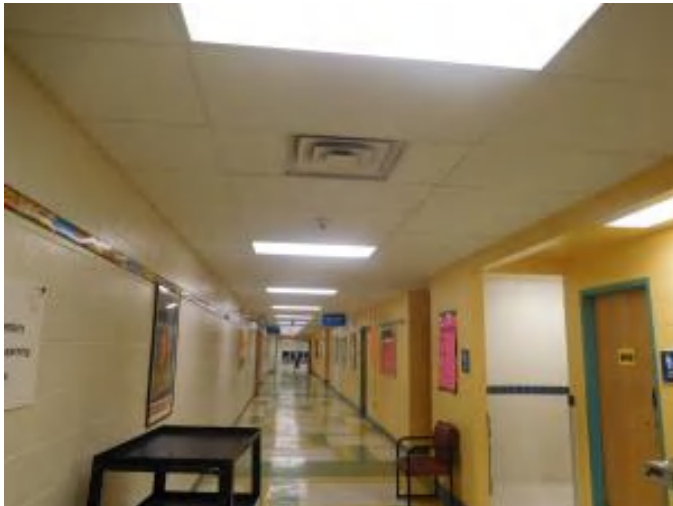
**Location:** original building

**System: D4010 - Sprinklers**

**Distress:** Life Safety / NFPA / PFD

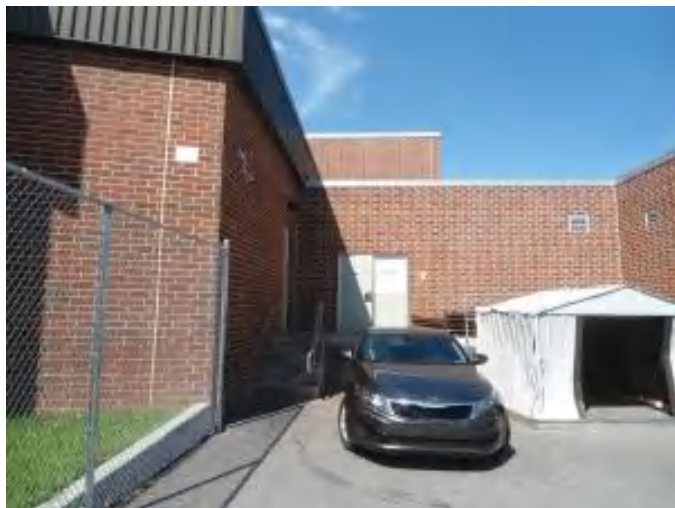
**Location:** Parking Lot

The loading dock is located just off the parking area between the dumpsters and the access point for students entering the school. The existing recommendation to enclose and move the dumpsters to a new location is related to this effort. After the dumpster correction is complete it is recommended that the loading dock area be clearly marked and safety barriers be placed to protect pedestrian traffic and mitigate possible issues related to loading and unloading materials and supplies.

#### System: G2040 - Site Development

**Distress:** Inadequate

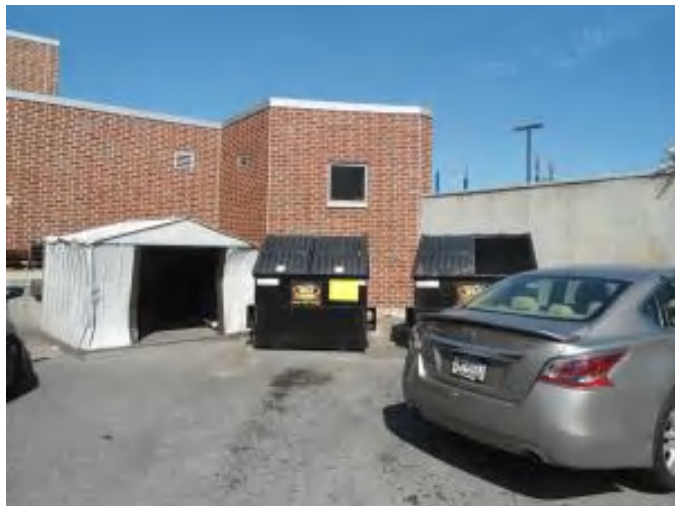
**Location:** Parking Lot

The trash dumpster is located in the parking lot open to the students and to the public. The exterior services are not protected. Upgrades to protect the exterior services and trash area are necessary for the safety of the students and the general public. Construction of a secure lockable dumpster area is recommended.

**System: G2040 - Site Development**

**Distress:** Health Hazard / Risk
