## Facility Condition Assessment Summary Report

### Bregy School

School District of Philadelphia  
**S224001;Bregy**  
Final  
**Site Assessment Report**

January 30, 2017

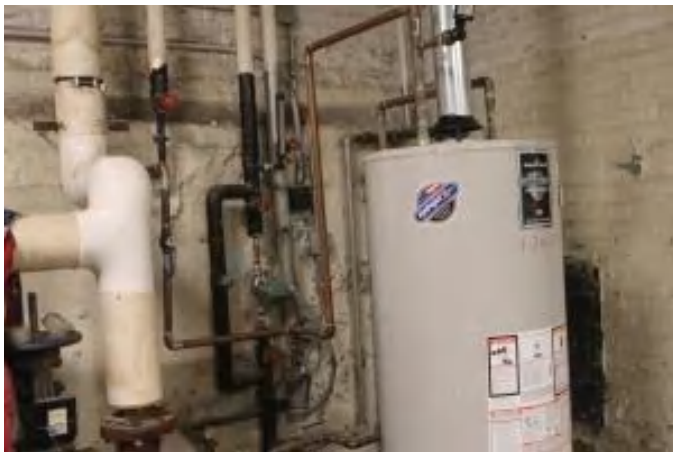
#### System: D2020 - Domestic Water Distribution

**Location:** Entire building

**Distress:** Inadequate

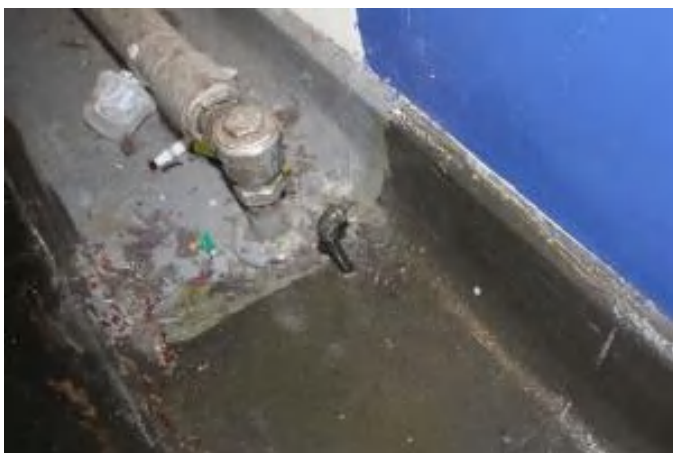
#### System: D3040 - Distribution Systems

**Location:** Entire building

**Distress:** Maintenance Required

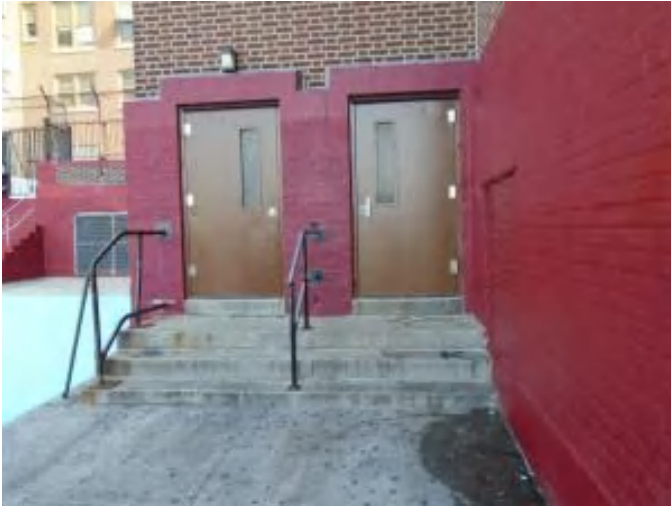
**System: B2030 - Exterior Doors**

**Location:** Entrance

**Distress:** Accessibility

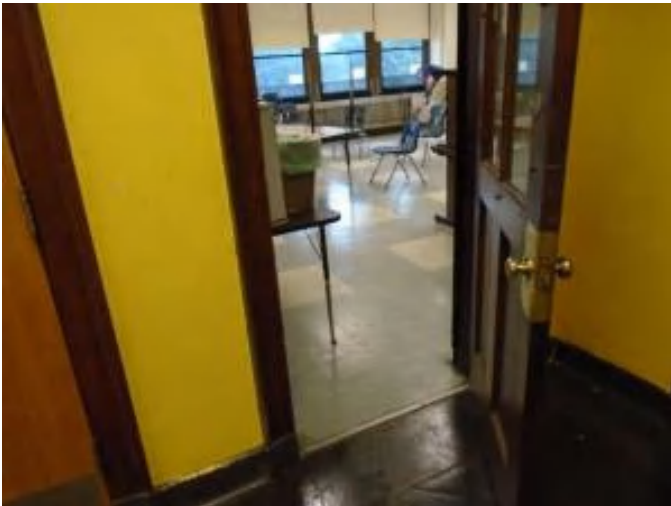
**System: C1020 - Interior Doors**

**Location:** Throughout

**Distress:** Accessibility

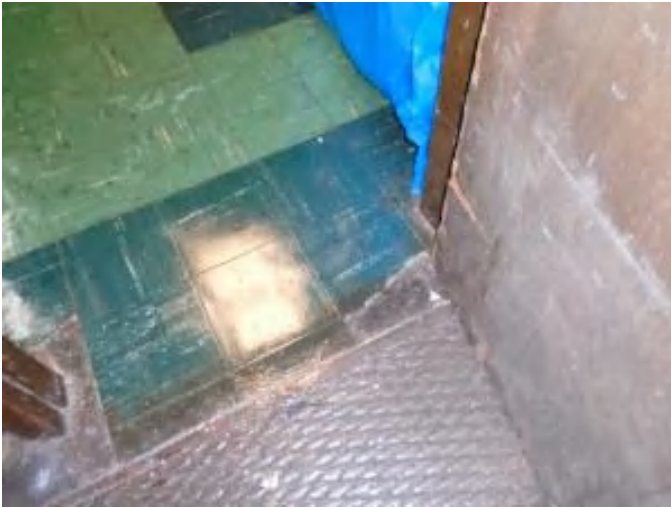
**System: C3020413 - Vinyl Flooring**

**Location:** Various

**Distress:** Damaged

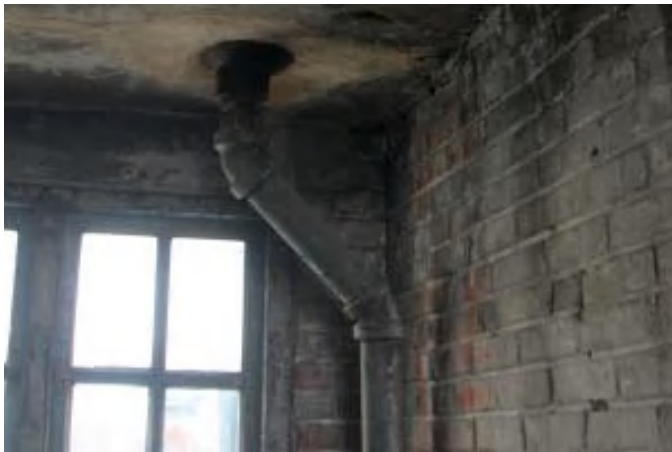
**System: D2040 - Rain Water Drainage**

**Location:** Entire building

**Distress:** Beyond Service Life

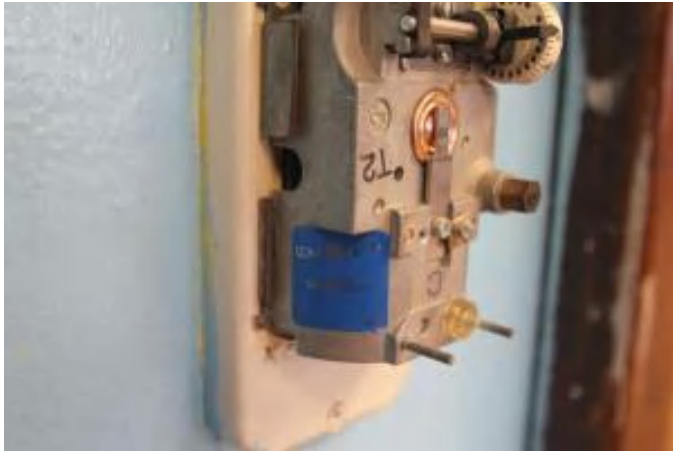
**System: D3060 - Controls & Instrumentation**

**Location:** Entire building  
**Distress:** Obsolete  
**Category:** 3 - Operations / Maint.  
**Priority:** 2 - Response Time (2-3 yrs)  
**Correction:** Replace pneumatic controls with DDC (75KSF)  
**Qty:** 66,000.00  
**Unit of Measure:** S.F.  
**Estimate:** \$1,415,838.01  
**Assessor Name:** System  
**Date Created:** 10/14/2015

**Notes:** Upgrade obsolete pneumatic control system to digital.

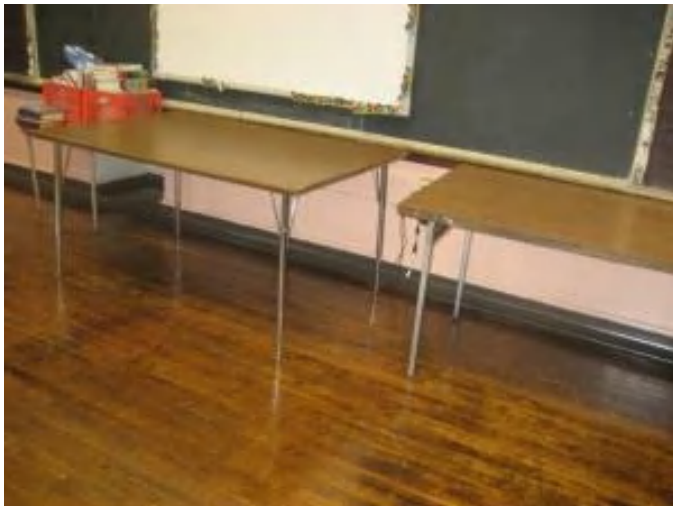
**System: D5020 - Lighting and Branch Wiring**

**Location:** Classrooms  
**Distress:** Inadequate  
**Category:** 4 - Capital Improvement  
**Priority:** 2 - Response Time (2-3 yrs)  
**Correction:** Add wiring device  
**Qty:** 48.00  
**Unit of Measure:** Ea.  
**Estimate:** \$17,633.81  
**Assessor Name:** System  
**Date Created:** 10/19/2015

**Notes:** Provide receptacles outlets at 10% of the classrooms. Provide (2)25FT of surface raceways with 24" receptacles on center and two-duplex wall mount receptacles. Approximate 48

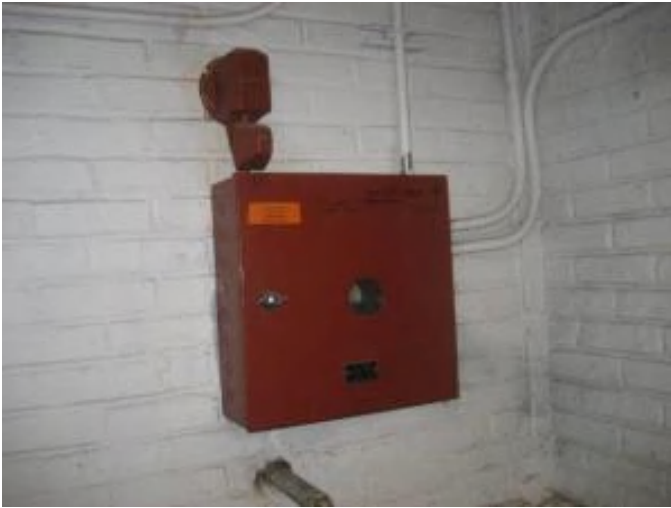
**System: D5030 - Communications and Security**

**Location:** Entire Building  
**Distress:** Building / MEP Codes  
**Category:** 2 - Code Compliance  
**Priority:** 2 - Response Time (2-3 yrs)  
**Correction:** Replace fire alarm system  
**Qty:** 1.00  
**Unit of Measure:** S.F.  
**Estimate:** \$168,222.79  
**Assessor Name:** System  
**Date Created:** 10/19/2015

**Notes:** Provide new fire alarm system. Approximate 88 devices.

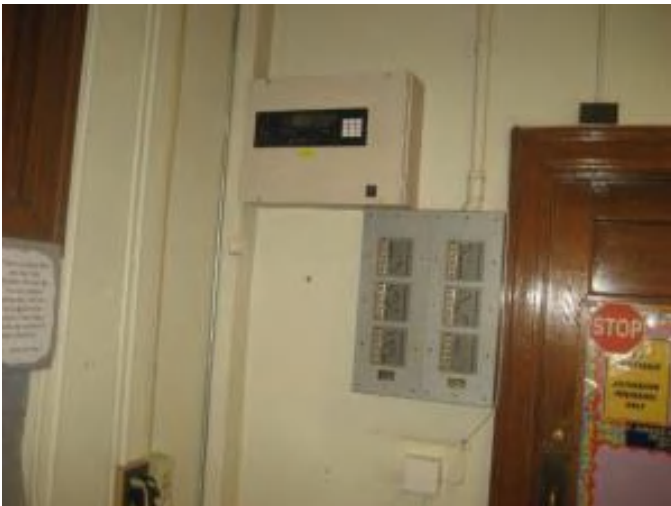
**System: D5030 - Communications and Security**

**Location:** Entire Building  
**Distress:** Obsolete  
**Category:** 3 - Operations / Maint.  
**Priority:** 2 - Response Time (2-3 yrs)  
**Correction:** Add/Replace Clock System or Components  
**Qty:** 50.00  
**Unit of Measure:** Ea.  
**Estimate:** \$112,560.22  
**Assessor Name:** System  
**Date Created:** 10/19/2015

**Notes:** Provide a new clock system, wireless battery operated. Approximate 50 clocks

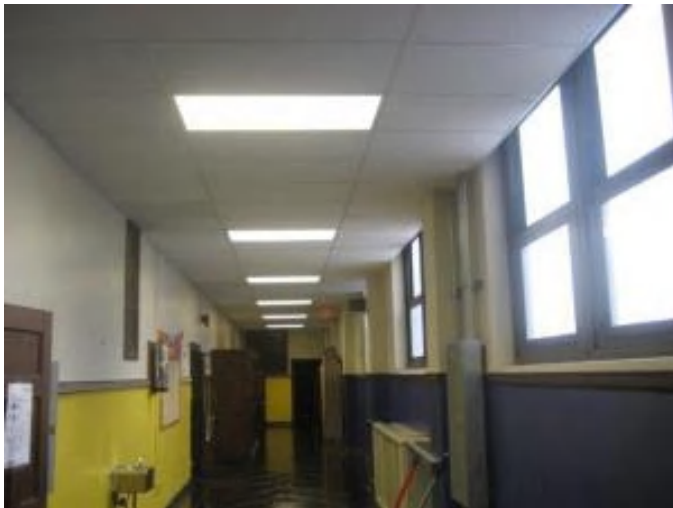
**System: D5030 - Communications and Security**

**Location:** Entire School  
**Distress:** Security Issue  
**Category:** 1 - Health & Safety  
**Priority:** 2 - Response Time (2-3 yrs)  
**Correction:** Add/Replace Video Surveillance System  
**Qty:** 30.00  
**Unit of Measure:** Ea.  
**Estimate:** \$109,264.11  
**Assessor Name:** System  
**Date Created:** 10/19/2015

**Notes:** Provide CCTV cameras to provide complete interior coverage. Approximate 30 cameras

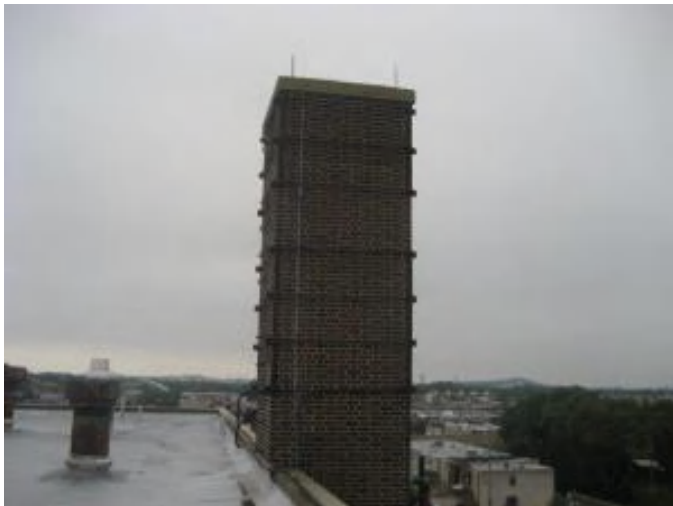
**System: D5090 - Other Electrical Systems**

**Location:** Roof  
**Distress:** Building / MEP Codes  
**Category:** 2 - Code Compliance  
**Priority:** 2 - Response Time (2-3 yrs)  
**Correction:** Provide Lightning Protection System  
**Qty:** 1.00  
**Unit of Measure:** LS  
**Estimate:** \$21,472.30  
**Assessor Name:** System  
**Date Created:** 10/19/2015

**Notes:** Prepare a study to determine if the existing lightning system provide the proper protection to the school building.

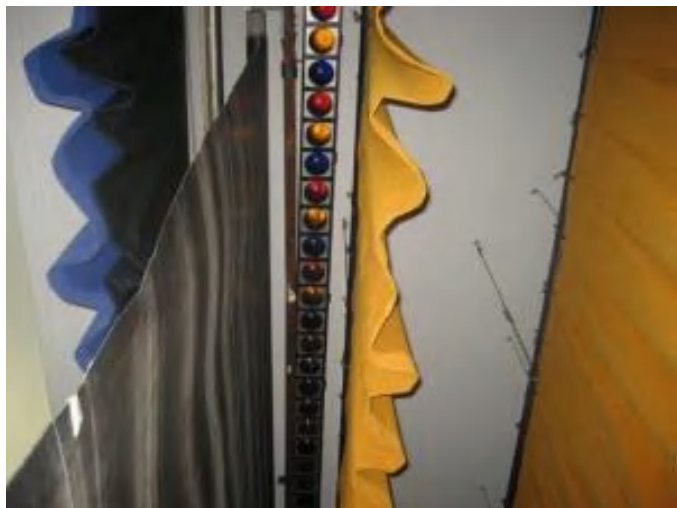
**System: E1020 - Institutional Equipment**

**Location:** Auditorium

**Distress:** Inadequate

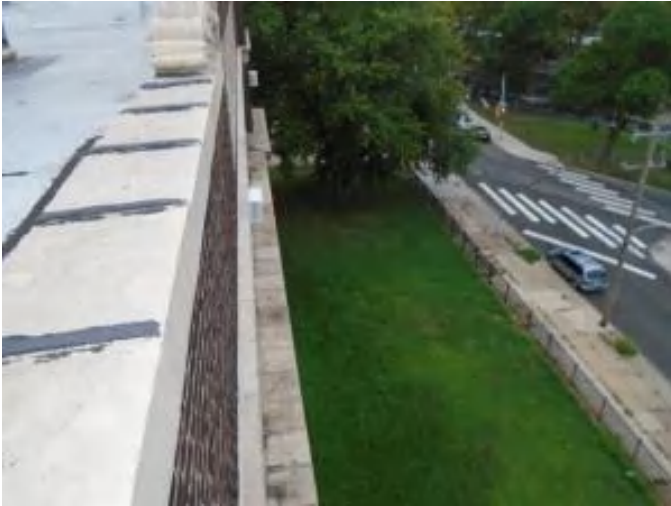
**System: B2010 - Exterior Walls**

**Location:** Parapet wall

**Distress:** Maintenance Required

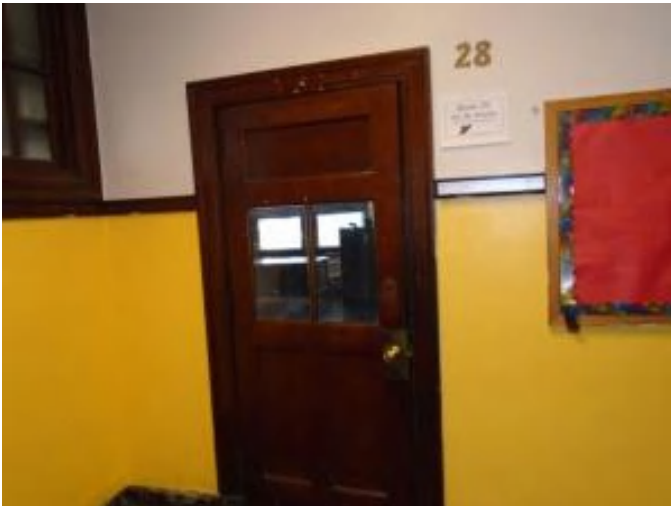
**System: C1020 - Interior Doors**

**Location:** Throughout

**Distress:** Beyond Service Life

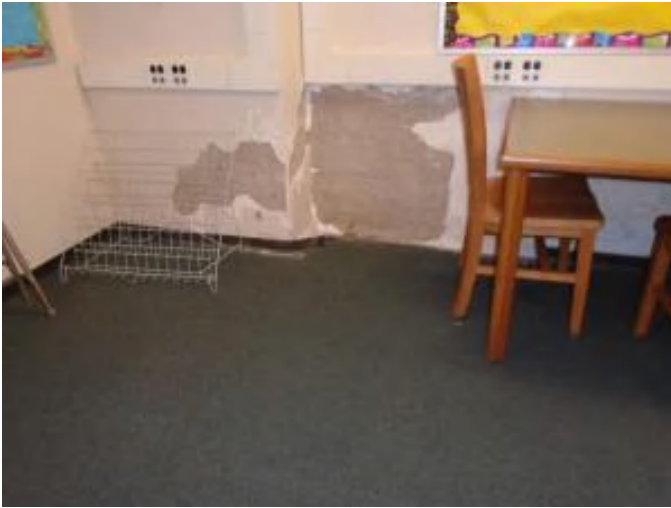
**System: C3010230 - Paint & Covering**

**Location:** Throughout  
**Distress:** Damaged  
**Category:** 3 - Operations / Maint.  
**Priority:** 3 - Response Time (3-4 yrs)  
**Correction:** Repair substrate and repaint interior walls - SF of wall surface  
**Qty:** 11,600.00  
**Unit of Measure:** S.F.  
**Estimate:** \$99,378.08  
**Assessor Name:** System  
**Date Created:** 09/16/2015

**Notes:** Repair and paint interior plaster walls – damaged (10% of plaster area)

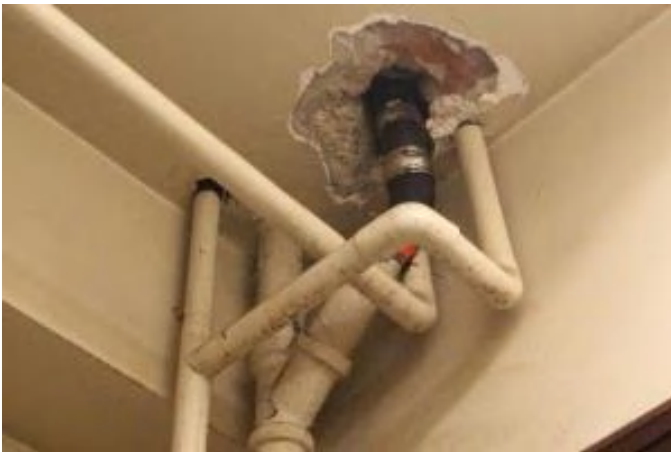
**System: D2030 - Sanitary Waste**

**Location:** Entire building  
**Distress:** Beyond Service Life  
**Category:** 3 - Operations / Maint.  
**Priority:** 3 - Response Time (3-4 yrs)  
**Correction:** Inspect sanitary waste piping and replace damaged sections. (+50KSF)  
**Qty:** 66,000.00  
**Unit of Measure:** S.F.  
**Estimate:** \$323,779.55  
**Assessor Name:** System  
**Date Created:** 10/14/2015

**Notes:** Inspect and repair sanitary drain piping due to age.

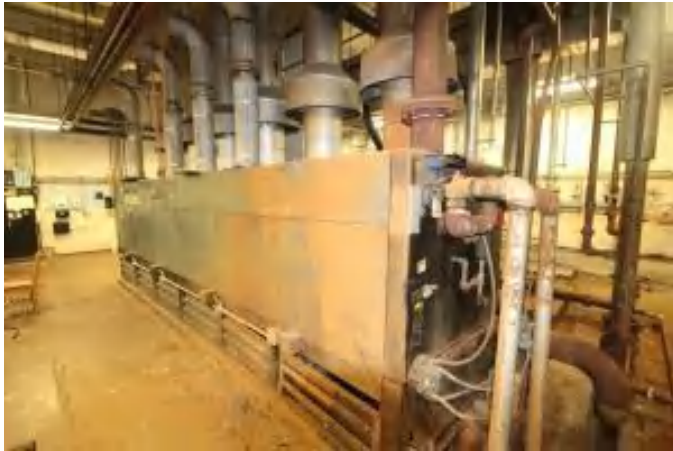
**System: D3020 - Heat Generating Systems**

**Location:** Boiler Room  
**Distress:** Beyond Service Life  
**Category:** 3 - Operations / Maint.  
**Priority:** 3 - Response Time (3-4 yrs)  
**Correction:** Replace boiler, cast iron sectional (100 HP)  
**Qty:** 1.00  
**Unit of Measure:** Ea.  
**Estimate:** \$327,898.44  
**Assessor Name:** System  
**Date Created:** 01/19/2016

**Notes:** Boiler #2 is a Weil McLain cast iron boiler installed in 1968. It has exceeded its expected lifespan and should be replaced. It is gas fired only.

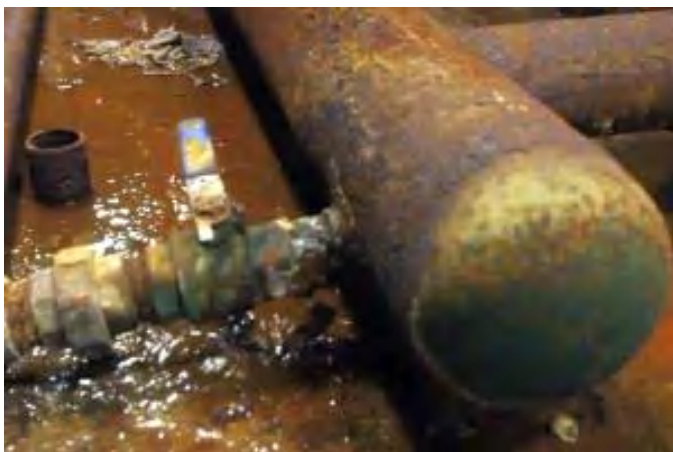
**System: D3040 - Distribution Systems**

**Location:** Entire building  
**Distress:** Failing  
**Category:** 3 - Operations / Maint.  
**Priority:** 3 - Response Time (3-4 yrs)  
**Correction:** Perform testing to identify and replace damaged steam and condensate piping.  
**Qty:** 66,000.00  
**Unit of Measure:** S.F.  
**Estimate:** \$624,384.59  
**Assessor Name:** System  
**Date Created:** 10/14/2015

**Notes:** Inspect and repair steam and condensate lines including boiler feed water piping including crossover block valve replacement.

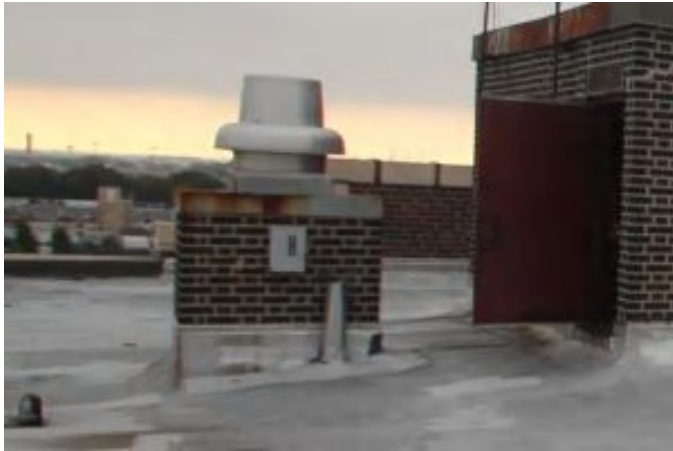
**System: D3040 - Distribution Systems**

**Location:** Roof top  
**Distress:** Inadequate  
**Category:** 4 - Capital Improvement  
**Priority:** 3 - Response Time (3-4 yrs)  
**Correction:** Replace power roof ventilator (24" dia.)  
**Qty:** 4.00  
**Unit of Measure:** Ea.  
**Estimate:** \$88,222.06  
**Assessor Name:** System  
**Date Created:** 10/14/2015

**Notes:** Replace aged and insufficient roof top toilet room exhaust fans with more powerful ones.

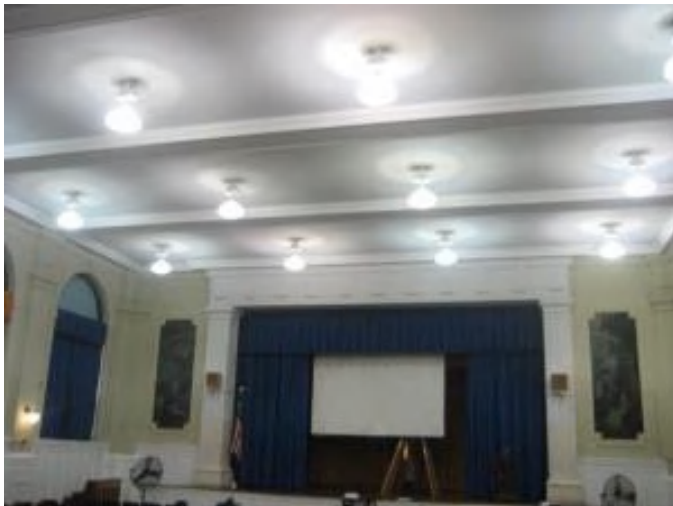
**System: D5030 - Communications and Security**

**Location:** Auditorium  
**Distress:** Inadequate  
**Category:** 4 - Capital Improvement  
**Priority:** 3 - Response Time (3-4 yrs)  
**Correction:** Add/Replace Sound System  
**Qty:** 1.00  
**Unit of Measure:** LS  
**Estimate:** \$34,585.89  
**Assessor Name:** System  
**Date Created:** 10/19/2015

**Notes:** Provide the auditorium with a sound system.

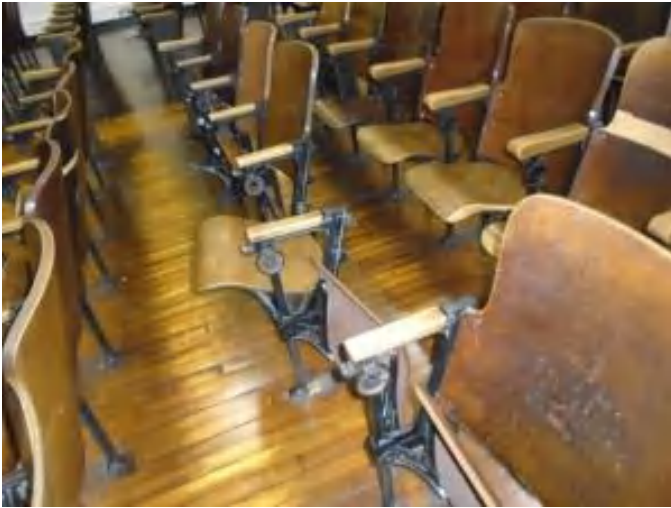
**System: E2010 - Fixed Furnishings**

**Location:** Auditorium

**Distress:** Failing

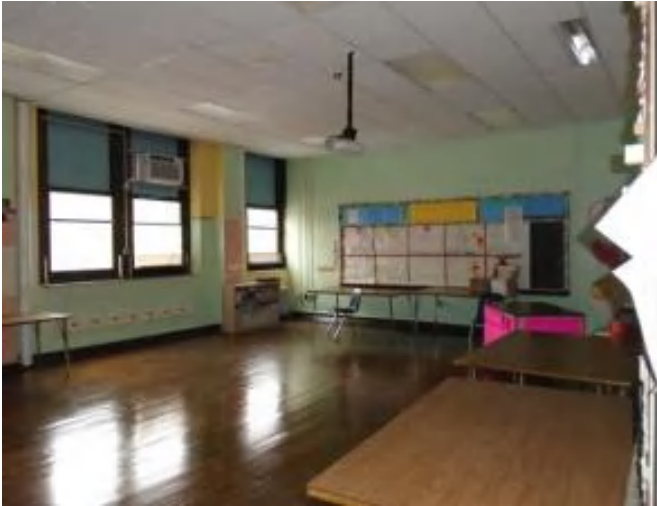
**System: B2020 - Exterior Windows**

**Location:** Windows

**Distress:** Energy Efficiency

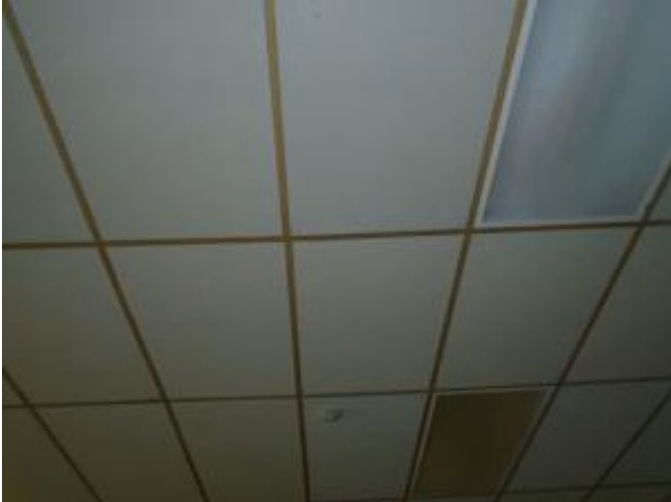
**System: C3030 - Ceiling Finishes**

**Location:** Various

**Distress:** Beyond Service Life

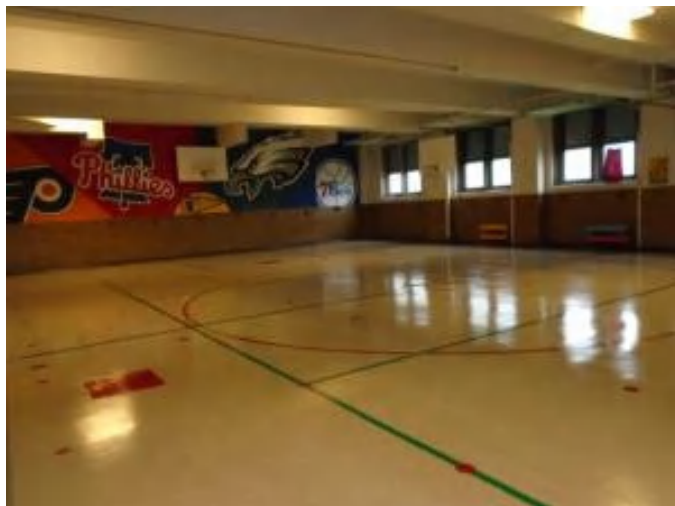
**System: C3030 - Ceiling Finishes**

**Location:** Gym

**Distress:** Inadequate

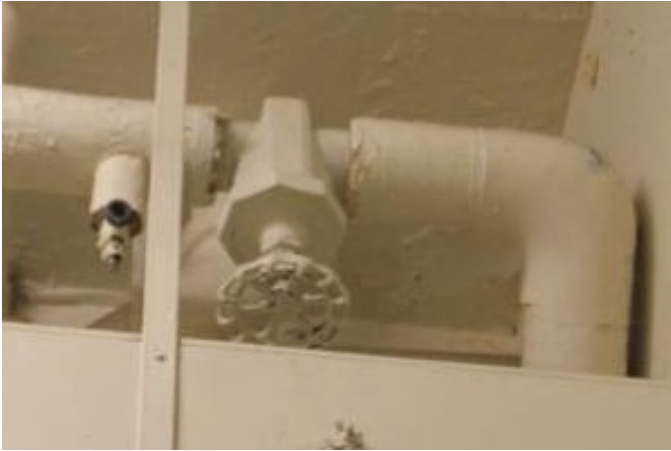
**System: D2020 - Domestic Water Distribution**

**Location:** Entire building

**Distress:** Beyond Service Life

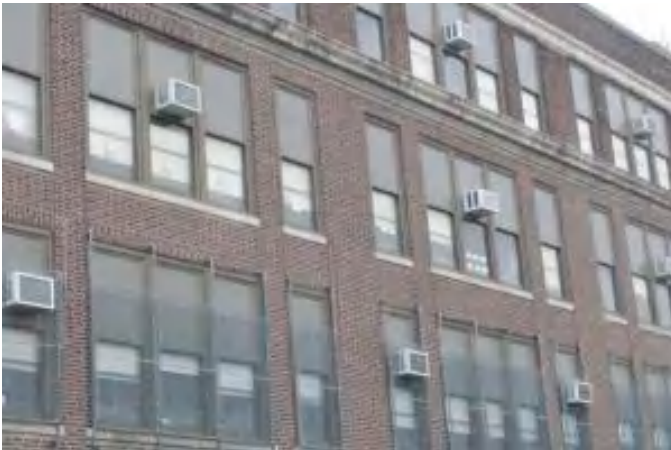
**System: D3030 - Cooling Generating Systems**

**Location:** Roof top

**Distress:** Inadequate

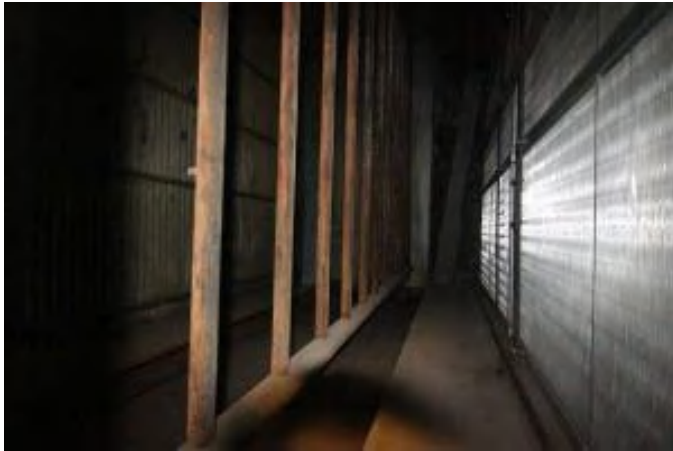
**System: D3040 - Distribution Systems**

**Location:** Basement mechanical room

**Distress:** Beyond Service Life

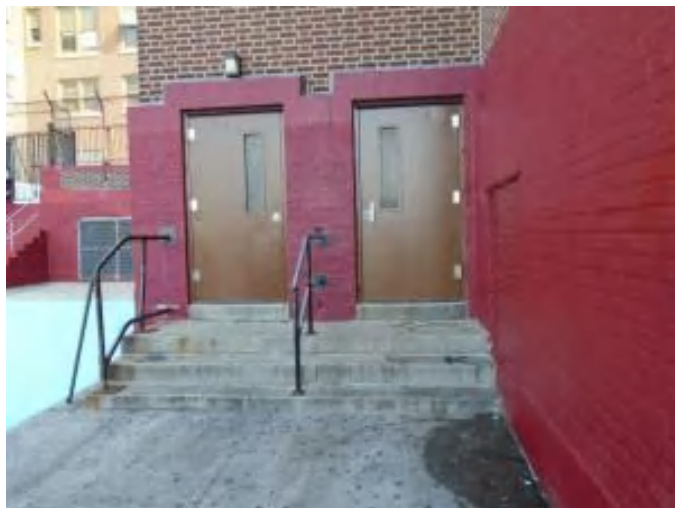
#### System: G2030 - Pedestrian Paving

**Location:** Entrance

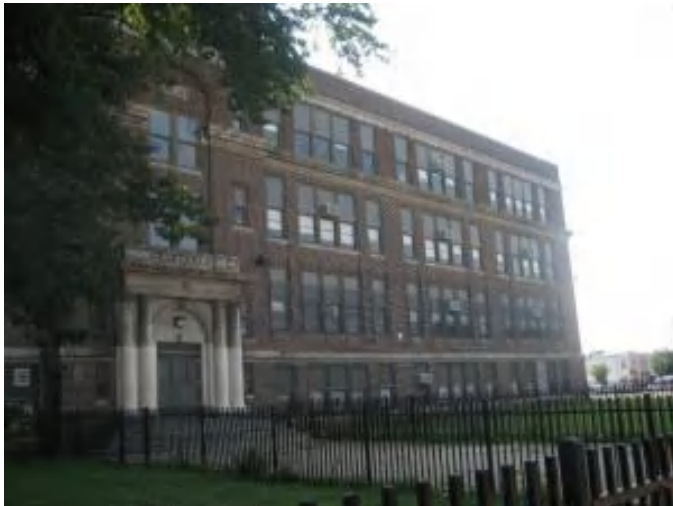
**System: G4020 - Site Lighting**

**Location:** Outdoor  
**Distress:** Security Issue  
**Category:** 1 - Health & Safety  
**Priority:** 2 - Response Time (2-3 yrs)  
**Correction:** Add site lighting fixtures  
**Qty:** 6.00  
**Unit of Measure:** Ea.  
**Estimate:** \$29,390.84  
**Assessor Name:** Ben Nixon  
**Date Created:** 10/19/2015

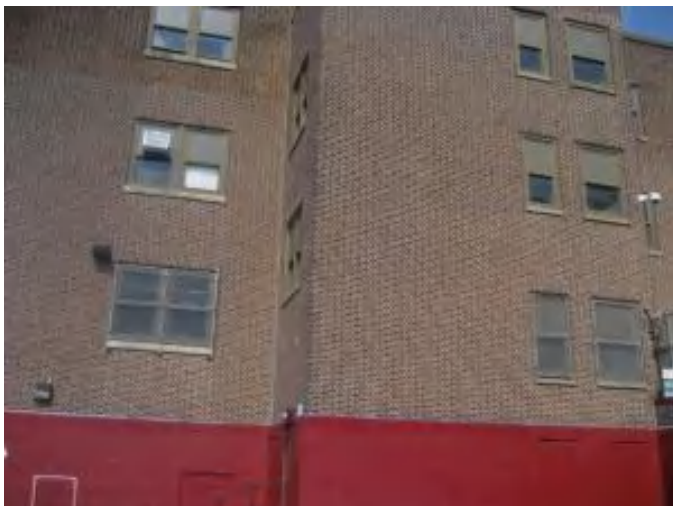
**System: G4030 - Site Communications & Security**

**Location:** Outdoor  
**Distress:** Security Issue  
**Category:** 1 - Health & Safety  
**Priority:** 2 - Response Time (2-3 yrs)  
**Correction:** Add Video Surveillance System  
**Qty:** 2.00  
**Unit of Measure:** Ea.  
**Estimate:** \$26,961.00  
**Assessor Name:** Ben Nixon  
**Date Created:** 10/19/2015

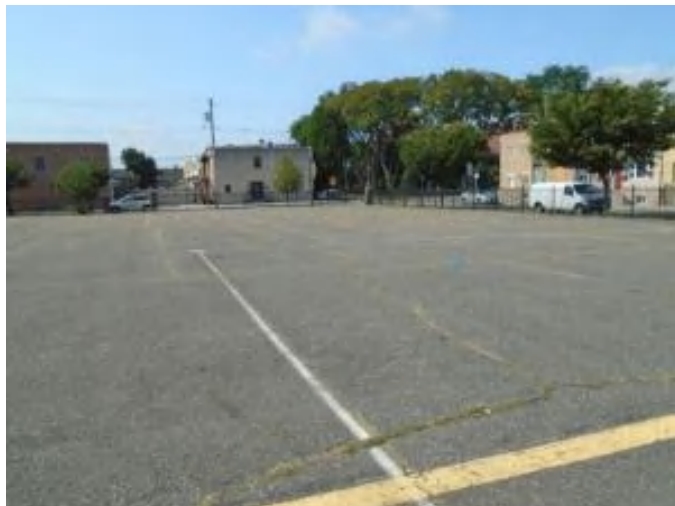
**System: G2020 - Parking Lots**

**Location:** Yard/Parking
