Facility Condition Assessment Summary Report

Bridesburg School

School District of Philadelphia
S747001;Bridesburg
Final
Site Assessment Report
January 31, 2017

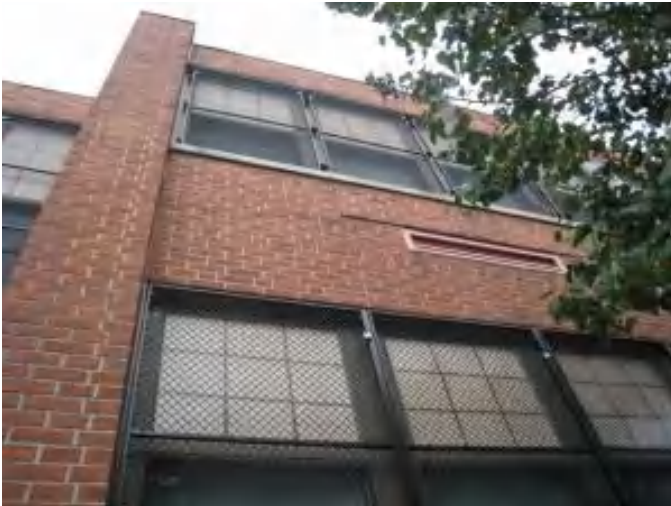
Location: walls

Distress: Failing

Notes: Repair vertical crack in brick masonry at corner of Element 2 building and around uninvent louvers in at least 2 locations

- Repair vertical crack in brick masonry at corner of Element 2 building and around univent louvers in at least 2 locations (150sf)
- Recaulk top of limestone panels at window heads in Element 1 and Element 2 (150lf)

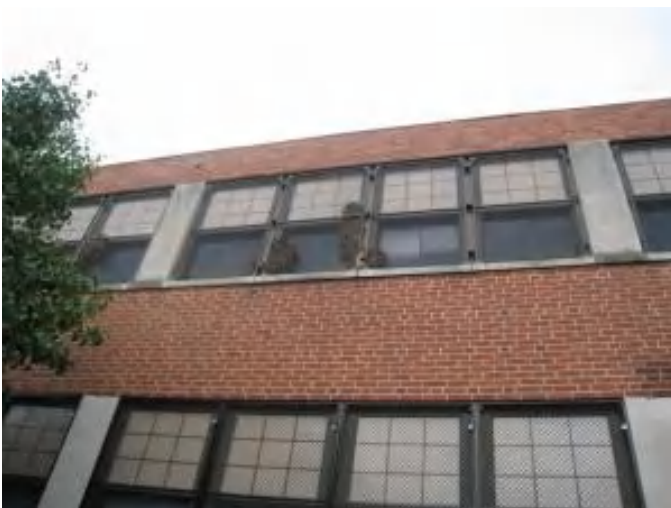
Location: walls - old building

Distress: Failing

Notes: Recaulk top of limestone panels at window heads in Element 1 and Element 2

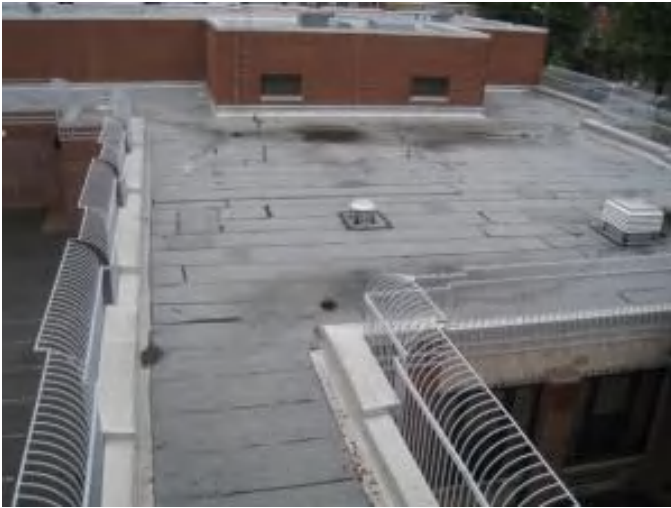
Location: roof

Distress: Failing

Notes: Repair existing flat roof areas where water is ponding – Element 1 and Element 2 roofs

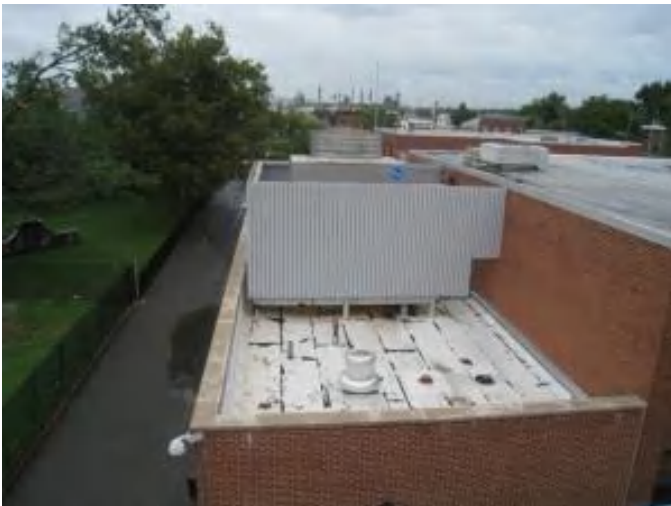
Location: roof

Distress: Failing

Notes: Recaulk top of reglet set into brick penthouses – Element 3 and Element 2

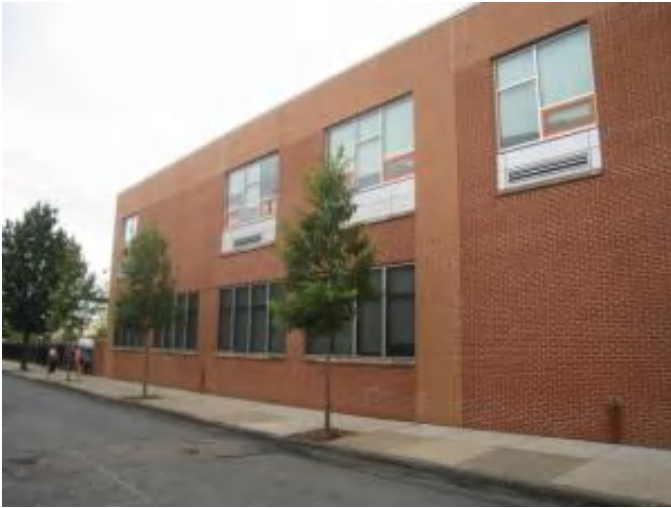
Location: roof

Distress: Failing

Notes: Improve drainage to roof drains in Element 3 and Element 2 - roof drains are not draining properly causing water to go thru overflows and show on building exterior wall

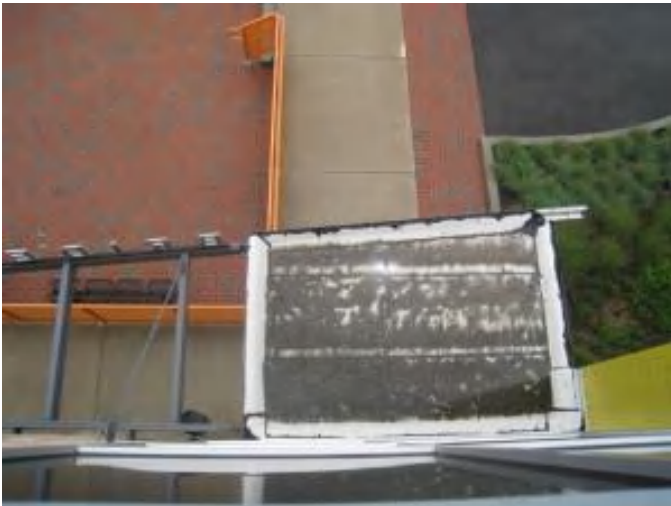
Location: roof over entrance

Distress: Failing

Notes: Repair roof over new building entrance – provide better drainage - Element 3

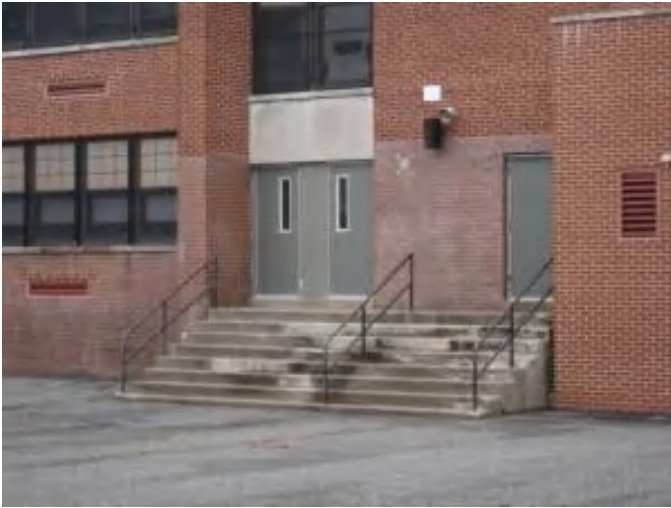
Location: exterior stairs
Distress: Failing
Category: 3 - Operations / Maint.
Priority: 1 - Response Time (< 2 yr)
Correction: Repair exterior stairs
Qty: 8.00
Unit of Measure: Riser
Estimate: \$15,436.23
Assessor Name: Steven Litman
Date Created: 08/07/2015

Notes: Repair cast in place treads/risers at exterior stairs – Element 1

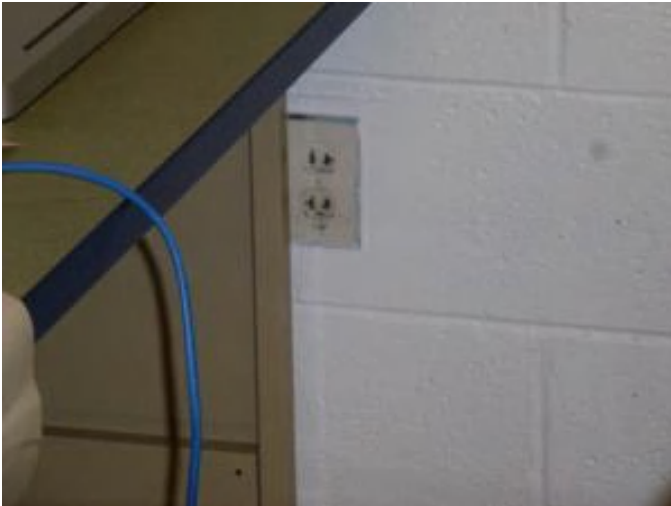
Location: walls
Distress: Beyond Service Life
Category: 3 - Operations / Maint.
Priority: 1 - Response Time (< 2 yr)
Correction: Replace Wiring Device
Qty: 30.00
Unit of Measure: Ea.
Estimate: \$4,622.04
Assessor Name: Steven Litman
Date Created: 07/30/2015

Notes: Replace non-grounding type receptacles with grounding type receptacles

There is sufficient number of receptacles installed in classrooms, offices, corridors and other areas throughout the building. No major deficiencies were observed with the exception that in a few classrooms there are general-type receptacles without ground contacts, still in service. These receptacles are obsolete and should be replaced with ground-type receptacles.

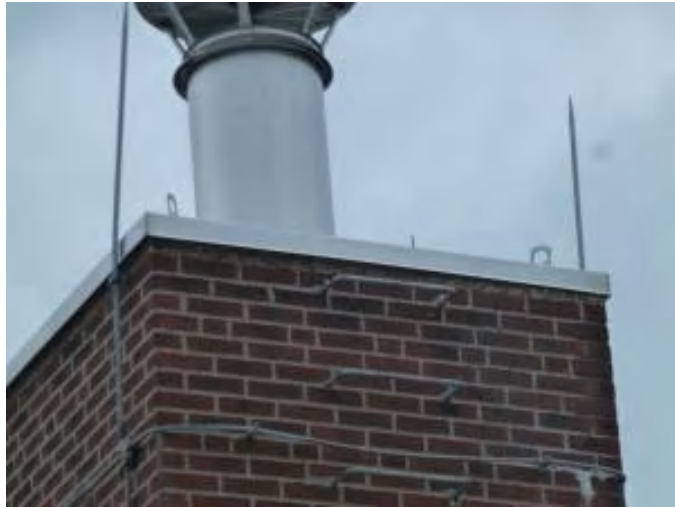
Location: roof / chimney

Distress: Life Safety / NFPA / PFD

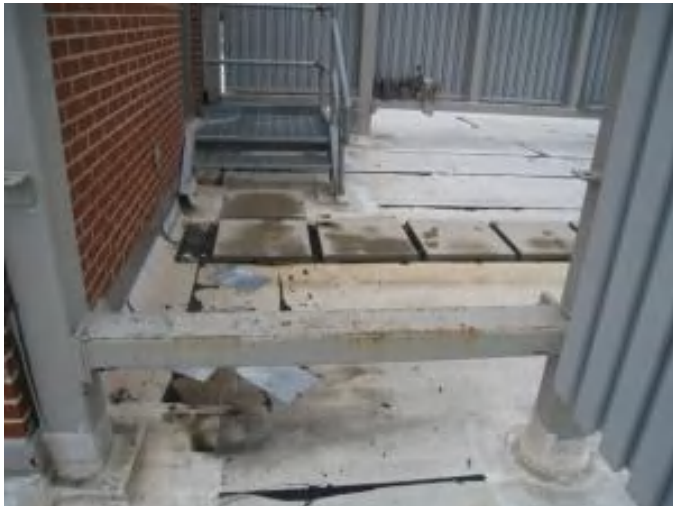
Location: roof - penthouse enclosure

Distress: Failing

Notes: Repaint steel supporting the rooftop mechanical area enclosure – Element 3

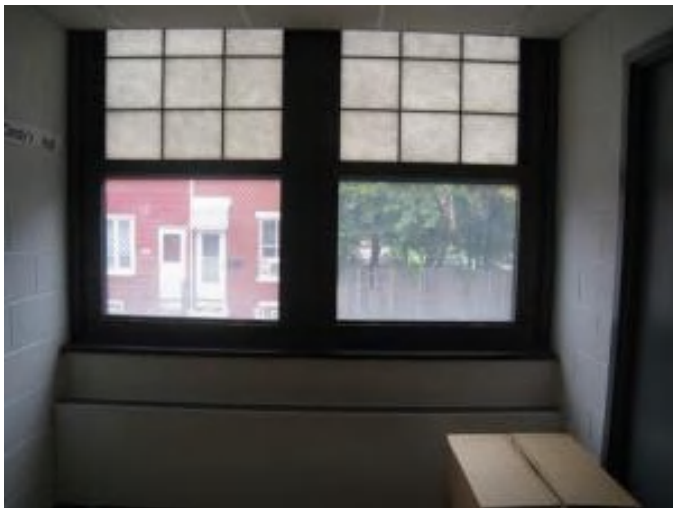
Location: windows - old building

Distress: Beyond Service Life

Notes: Replace all exterior windows in Element 1 with insulated single hung units

Exterior windows in Element 1 were not replaced when the new addition was constructed. They are made of bronze anodized aluminum frames with operable single hung units and single thickness clear plexiglass vision panel glazing. These windows are in poor condition with oxidized frames and severely scratched single-pane plexiglass vision panels. Operable units are difficult to operate up and down, due to broken internal counterbalance weights. Single pane plexiglass units do not meet today's energy code requirements and are large sources of heat loss. Element 1 windows facing play areas on both have external steel security screens. Steel lintels over these windows are in good condition. Element 2 windows are similar to the Element 1 original building windows – single glazed plexiglass panels in anodized aluminum frames. Element 3 new addition windows are more modern double glazed glass windows in clear anodized aluminum frames. Each window unit grouping has at least one operable "hopper" window that can be opened to allow for natural ventilation when appropriate. First floor windows have external steel security screens for protection of glazing. Element 3 windows appear to be in good condition.

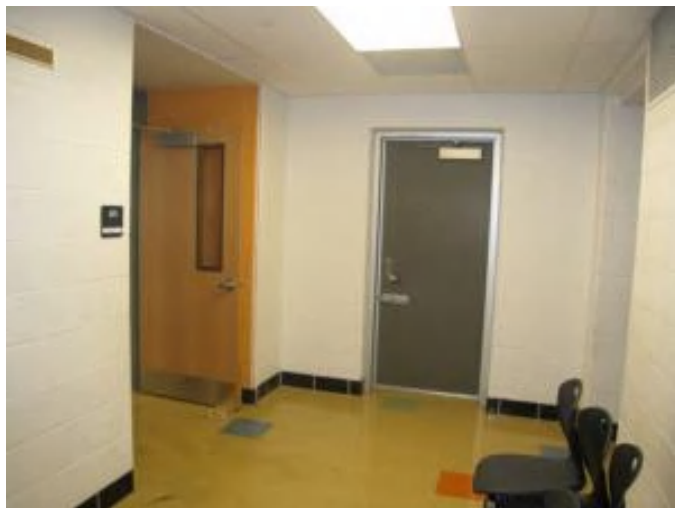
Location: classrooms and offices - old building

Distress: Security Issue

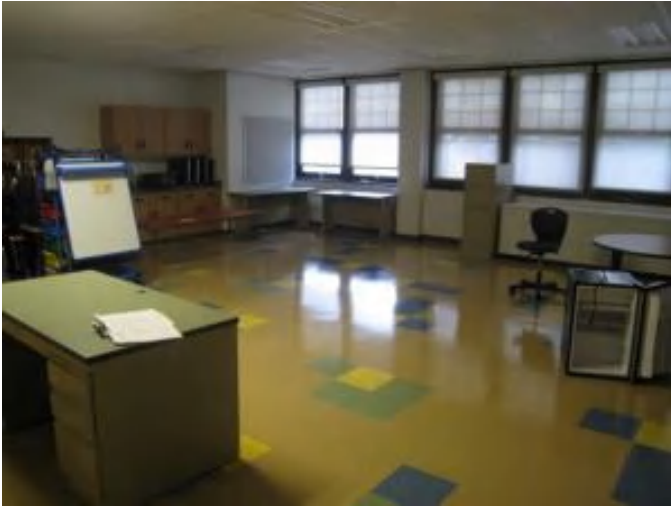
Location: interior wall / floor joint

Distress: Appearance

Notes: Re-apply sealant to cover gap in Element 1 between floor slab and exterior wall

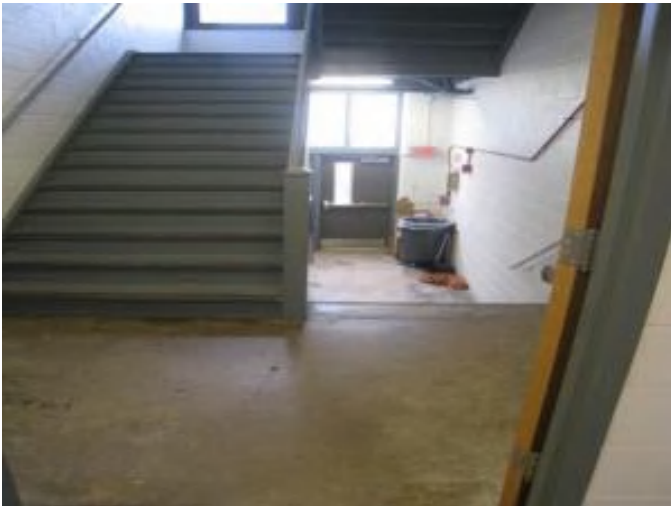
Location: stairways - old building

Distress: Building / MEP Codes

Notes: Remove and replace stairway handrails and guards with code compliant systems – Element 1 (2) 2 story; wall mounted handrails and center mounted railings and balustrade

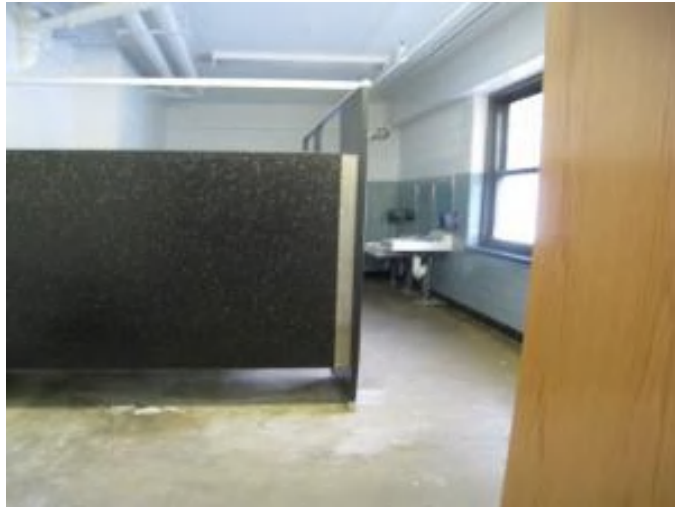
Location: stairs and toilet rooms - old building

Distress: Appearance

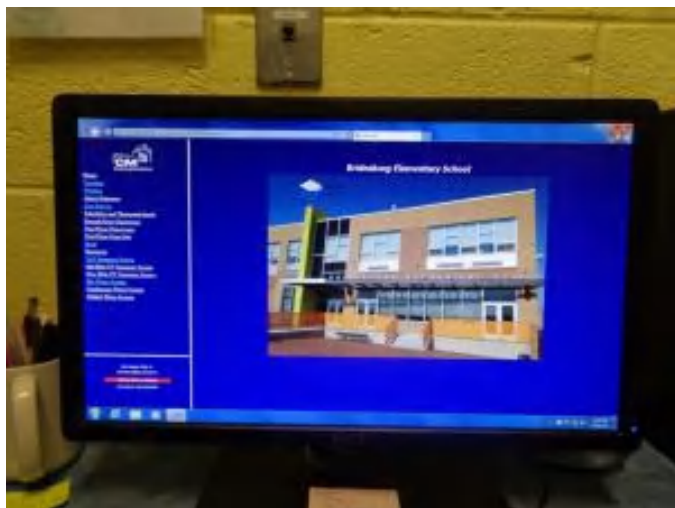
Location: entire building

Distress: Maintenance Required

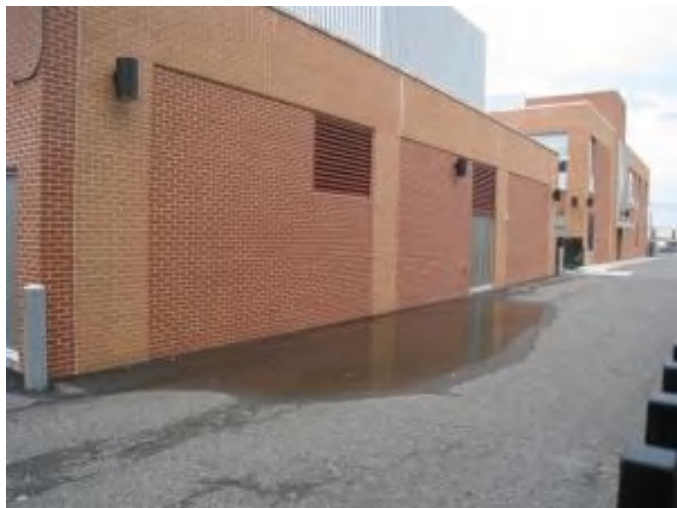
Location: G747001;Grounds

Distress: Failing

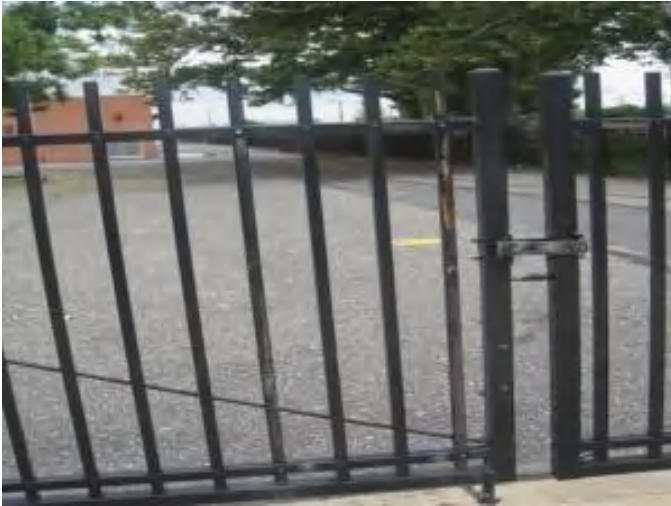
Location: G747001;Grounds

Distress: Damaged

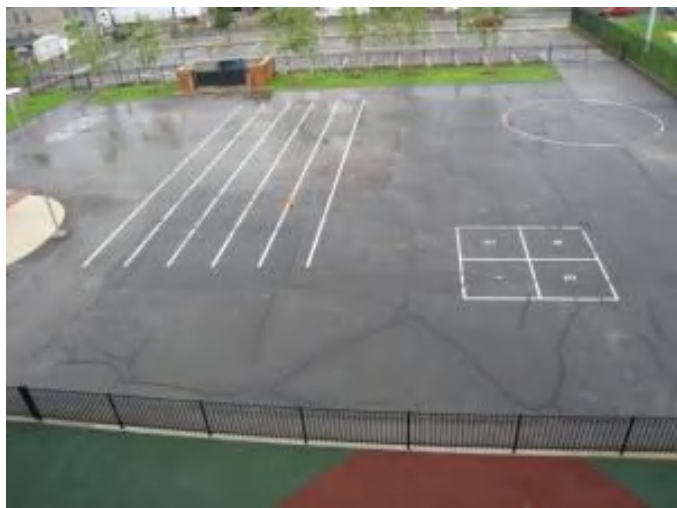
Location: G747001;Grounds

Distress: Failing
