Facility Condition Assessment Summary Report

Brown, H A School

School District of Philadelphia
S521001;Brown, H A
Final
Site Assessment Report
January 31, 2017

Site Assessment Report

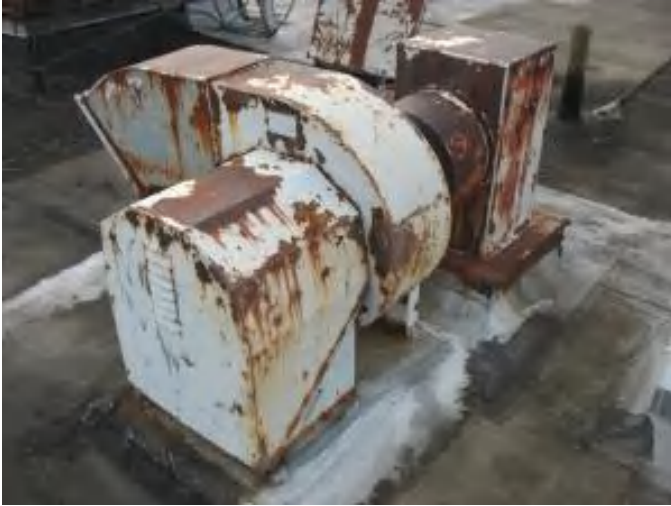
System: D3040 - Distribution Systems

The original building has two roof mounted exhaust fans. One fan serves the first through third floor boys and girls restrooms; the second fan serves the teachers' lounge and staff restroom. Both fans are defunct and need to be replaced.

Location: Roof - original building

Distress: Failing

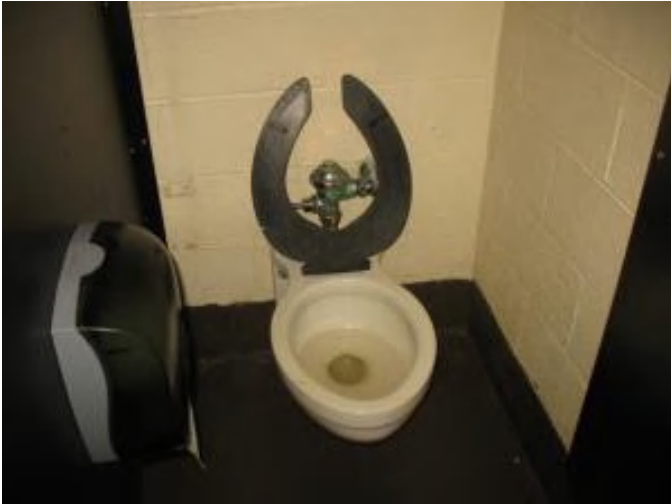
System: D2010 - Plumbing Fixtures

Plumbing Fixtures - In the original building many of the original plumbing fixtures remain in service. Fixtures in the restrooms on each of the three floors consist of wall mounted flush valve water closets, wall hung urinals and lavatories with wheel handle faucets. A few of the fixtures were not in service during the site visit. These older units should be replaced as they are beyond their service life.

Location: Restrooms - original building

Distress: Beyond Service Life

Notes: Replace twenty (20) water closets in the restrooms of the original building with new code compliant fixtures.

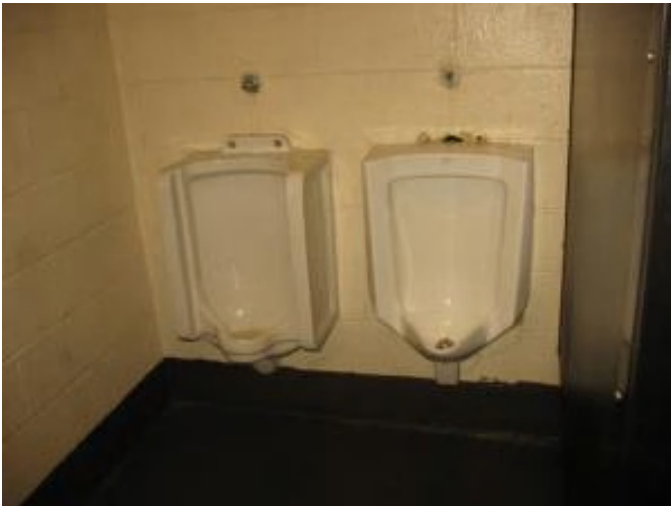
System: D2010 - Plumbing Fixtures

Location: Restrooms - original building

Distress: Beyond Service Life

Notes: Replace ten (10) urinals in the restrooms of the original building with new code compliant fixtures.

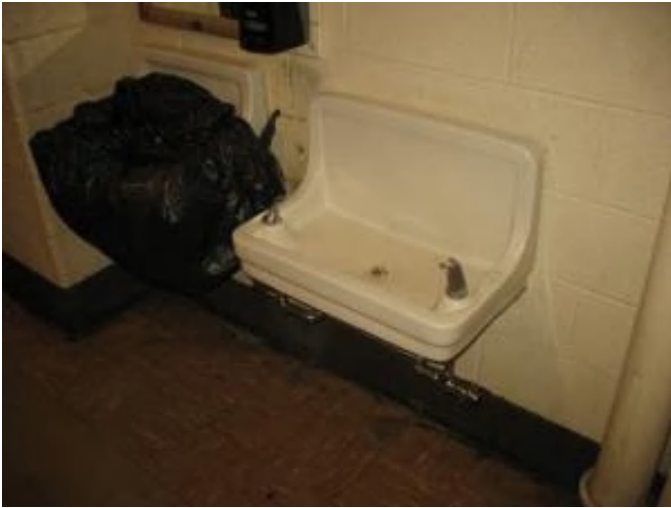
System: D2010 - Plumbing Fixtures

In the original building drinking fountains in the corridors are wall hung porcelain fixtures. They are well beyond their service life and should be replaced; most are NOT accessible type.

Location: Corridors

Distress: Beyond Service Life

Notes: Replace three (3) porcelain wall hung drinking fountains in the corridors with units that have integral refrigerated coolers. These units are beyond their service life and most are NOT accessible type.

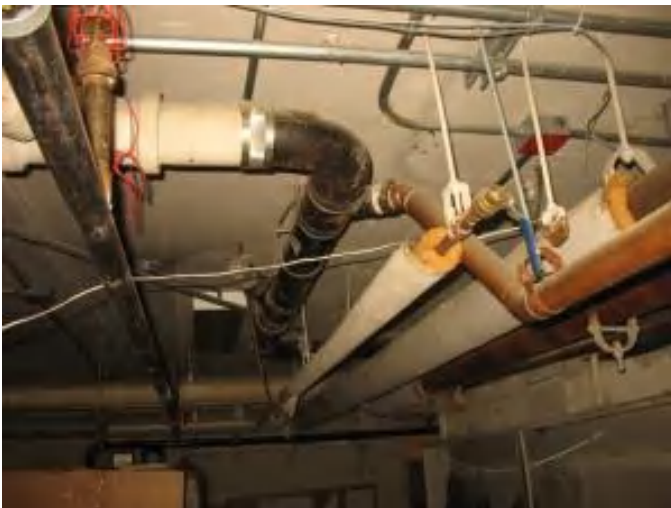
System: D2030 - Sanitary Waste

Sanitary Waste - In the original building the original sanitary sewer piping remains and is galvanized piping with threaded fittings. Sections of the original piping have been replaced with steel piping with no-hub couplings. The Principal reported that when it rains sewage from a first floor bathroom backs up into the building. A backflow preventer should be installed on the main sanitary line to prevent this health hazard from occurring.

Location: Basement

Distress: Health Hazard / Risk

Notes: Install a backwater valve on the outgoing sewage line in the original building to prevent sewage from backing up into the building when it rains.

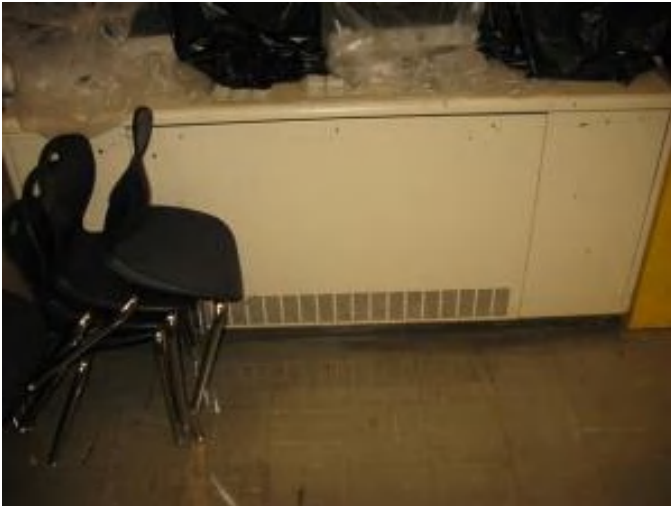
System: D3040 - Distribution Systems

Location: Throughout - original building

Distress: Beyond Service Life

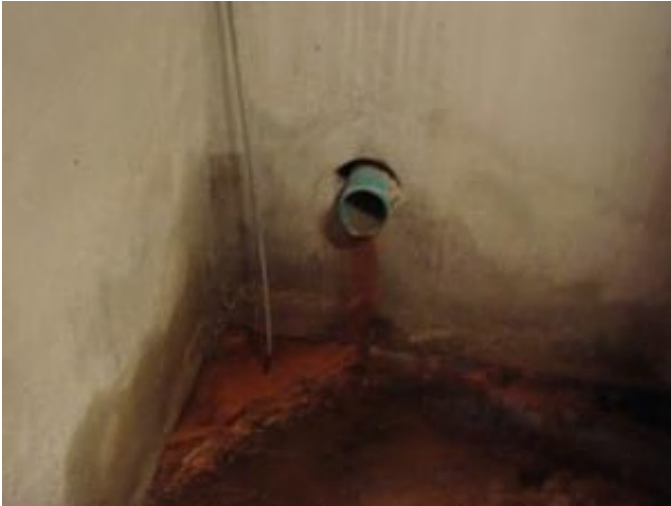
System: A2020 - Basement Walls

The original building typically rests on concrete foundations and bearing walls that are not showing signs of settlement. However, there is constant water seepage through basement walls especially in the boiler room and mechanical closet of unknown origin. There is no mold build-up. The addition rests on spread and strip footings and foundation walls; it has no basement.

Location: Interior/ Exterior

Distress: Failing

Notes: Install membrane waterproofing on foundation wall adjacent to boiler room and mechanical closet

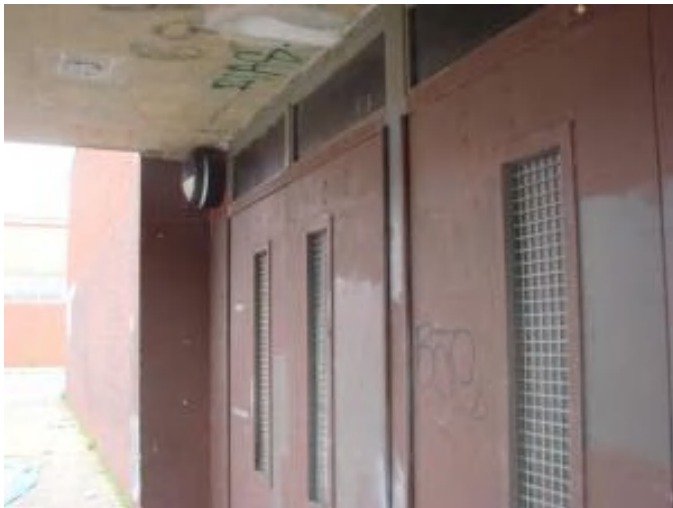
System: B2030 - Exterior Doors

The original building's exterior doors are typically hollow metal doors and frames, painted. The doors are generally in poor condition; no weather-stripping is installed; some doors have vision glazing with security screens. The new addition has fully glazed hollow metal doors in aluminum, store front type frames for people access and hollow metal doors and frames leading to support spaces, in good condition.

Location: Exterior
Distress: Beyond Service Life
Category: 3 - Operations / Maint.
Priority: 3 - Response Time (3-4 yrs)
Correction: Remove and replace exterior doors - per leaf
Qty: 13.00
Unit of Measure: Ea.
Estimate: \$118,395.17
Assessor Name: Craig Anding
Date Created: 11/09/2015

Notes: Replace exterior service and egress doors including hardware in the original building

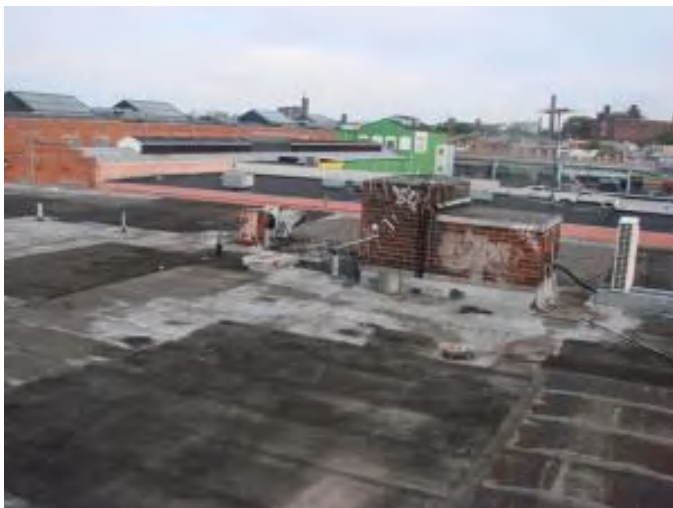
System: B3010105 - Built-Up

Roofing system on the original building is built-up, and in fair condition; however, it is beyond service life. All roofing and flashing is typically in fair condition with some deterioration of the built-up system; leaks have not been reported. There is no access from original main roof to original roof over auditorium and gym. Roofing over the new addition is in very good condition.

Location: Exterior
Distress: Beyond Service Life
Category: 3 - Operations / Maint.
Priority: 3 - Response Time (3-4 yrs)
Correction: Remove and Replace Built Up Roof
Qty: 18,600.00
Unit of Measure: S.F.
Estimate: \$630,205.40
Assessor Name: Craig Anding
Date Created: 11/09/2015

Notes: Install all new roofing system including insulation within next 3 to 4 years over the original building; tear-down existing roofing; install flashing, counter flashing and reglets

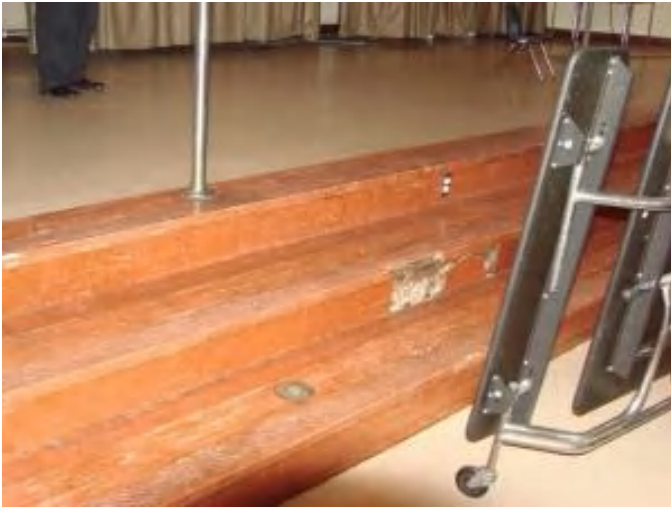
System: C3020413 - Vinyl Flooring

Flooring in classrooms and corridors is generally VCT, and ceramic tile in toilets. Corridors and some classrooms, gym and auditorium in the original building are mostly VAT. Most flooring is in good condition, however, the VAT tile is in poor condition; the main office and cafeteria/gym has VCT tile, generally in good condition. Library and principal's office has carpet in good condition.

Location: Interior

Distress: Health Hazard / Risk

Notes: Replace all VAT flooring including cove base

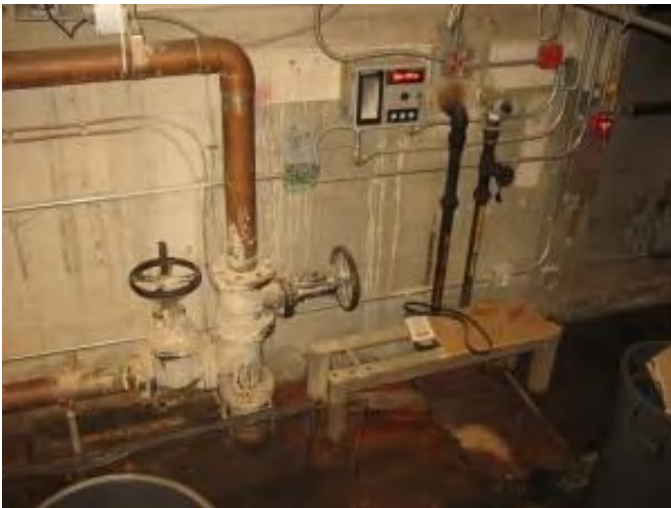
System: D2020 - Domestic Water Distribution

Location: Throughout - original building

Distress: Beyond Service Life

Notes: Hire a qualified contractor to perform a detailed inspection of the domestic water piping in the original building, in use for almost 60 years, and replace any damaged piping.

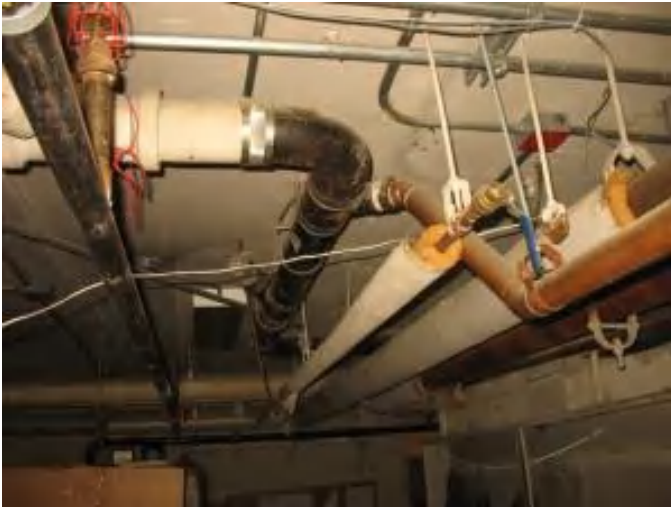
System: D2030 - Sanitary Waste

The maintenance staff reported problems with the sanitary waste piping system in the original building. The sewer piping has been in service for six decades and will require more frequent attention from the maintenance staff as time passes. The District should hire a qualified contractor to examine the sanitary waste piping using video cameras to locate and replace any damaged piping and to further quantify the extent of potential failures.

Location: Throughout - original building

Distress: Beyond Service Life

Notes: Hire a qualified contractor to perform a detailed examination of the sanitary waste piping using visual inspection and video cameras to locate and replace any damaged piping and to further quantify the extent of potential failures.

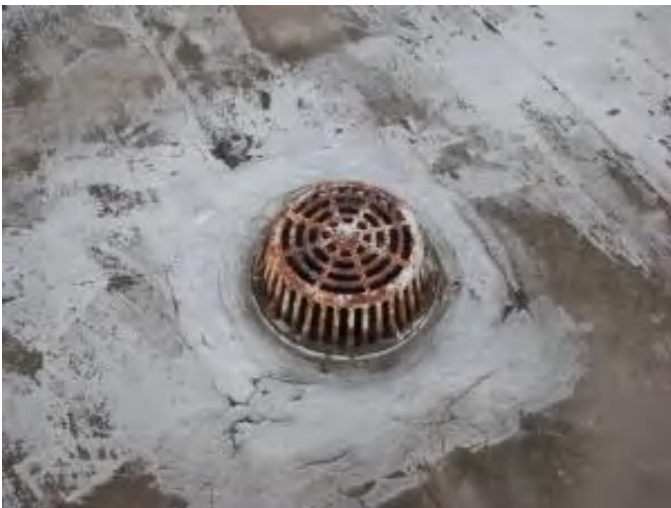
System: D2040 - Rain Water Drainage

Rain Water Drainage - In the original building rain water from the roof is routed down through pipe chases in the interior of the building by threaded galvanized piping. Some repairs have been made with HDPE piping with no-hub fittings. The drain piping should

Location: Throughout - original building

Distress: Beyond Service Life

Notes: Hire a qualified contractor to perform a detailed examination of the rain water drainage piping using visual inspection and video cameras to locate and replace any damaged piping and to further quantify the extent of potential failures.

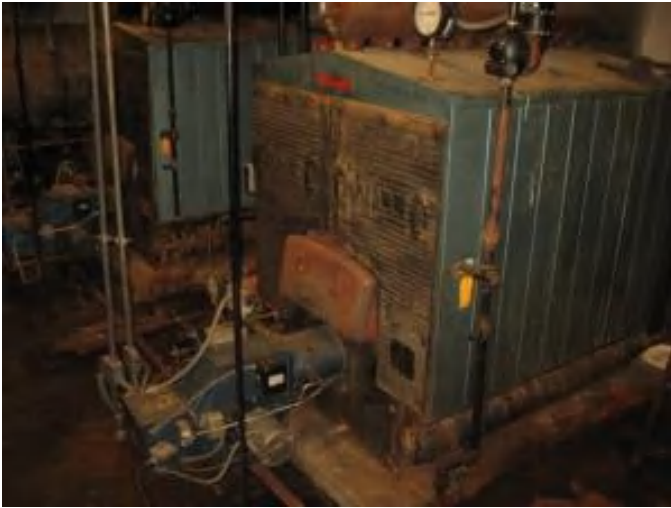
System: D3020 - Heat Generating Systems

Heat Generating Systems - Building heating hot water is generated by two (2) 42HP HB Smith 350 Mills cast iron sectional boilers. The boilers appear to be original to the building and are almost 60 years old. The two boilers serve the original building as well as the addition. Both boilers are required to hold the building load in normal winter weather conditions. Each boiler is equipped with a Power Flame burner designed to operate on natural gas or fuel oil. The burners appeared well beyond their useful service life. The gas train serving the boilers does appear to have code required venting of the regulators and dual solenoid valves with venting of the chamber between. Cast iron sectional boilers have an anticipated service life of 35 years or more; these units have been in service for almost 60 years and need to be replaced.

Location: Boiler room

Distress: Beyond Service Life

Notes: Replace the two existing 1,405 MBH cast iron boilers, which are well beyond their service life, with new more efficient boilers.

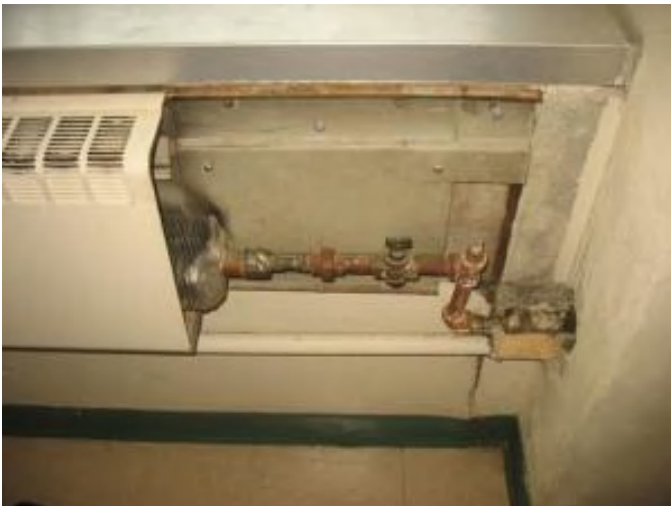
System: D3040 - Distribution Systems

In the original building hot water distribution piping is black steel with welded fittings coming off the boilers. The main building heating distribution piping is black steel with threaded fittings. The piping mains from the basement level run up through the building to the unit ventilators and fin tube radiators on all three floors. The distribution piping has been in use well beyond its service life and will require more frequent attention from the maintenance staff to address pipe/valve failures as time passes. The District should hire a qualified contractor to examine the hot water distribution piping and perform additional testing to locate and replace any damaged piping and to further quantify the extent of potential failures. The District should budget for replacing this piping over the next 10 years.

Location: Throughout - original building

Distress: Beyond Service Life

Notes: Hire a qualified contractor to examine the hot water distribution piping in the original building, in service for almost 60 years, and replace any damaged piping and to further quantify the extent of potential failures

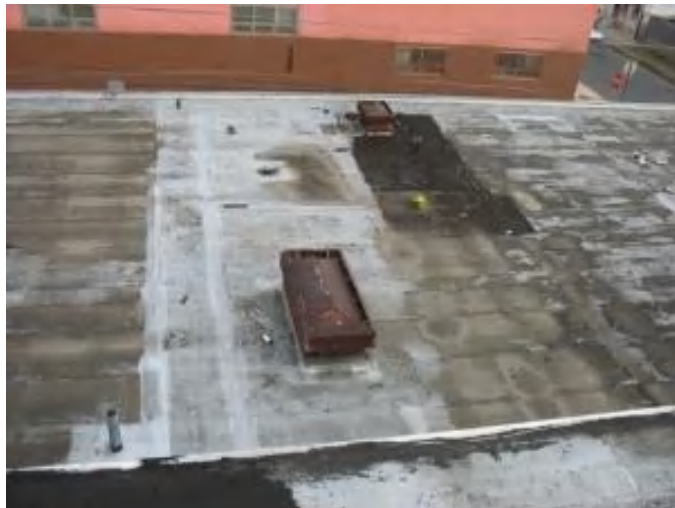
System: D3040 - Distribution Systems

Location: Roof - original building

Distress: Failing

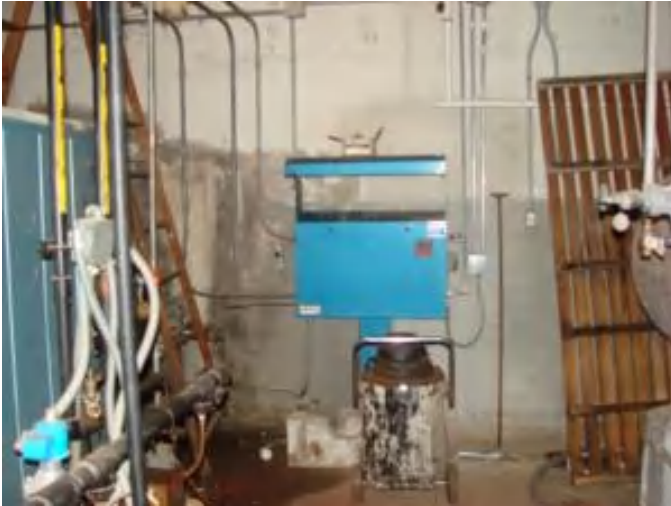
System: C3010230 - Paint & Covering

The interior wall finishes in the original building are generally painted CMU or drywall. Generally, paint is in good condition throughout the original building and the addition. Boiler room and other mechanical and electrical spaces show substantial finish deterioration with paint peeling from walls and ductwork.

Location: Interior

Distress: Beyond Service Life

Notes: Repaint walls in basement

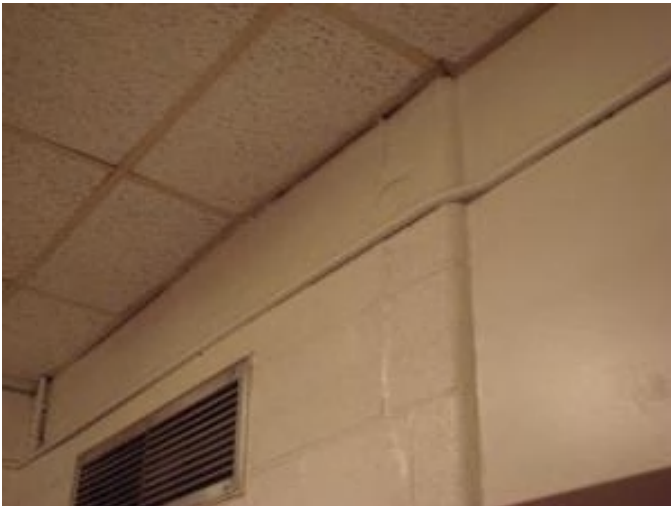
System: C3030 - Ceiling Finishes

Most ceilings in the original building are 2x4 suspended acoustical panels or 1x1 tiles directly adhered to underside of floor slab; generally in fair to poor condition. Ceilings in the basement are exposed, painted, in poor condition. The acoustical tiles in the original building are old; at the end of their service life.

Location: Interior

Distress: Beyond Service Life

Notes: Replace all suspended acoustical ceilings in original building

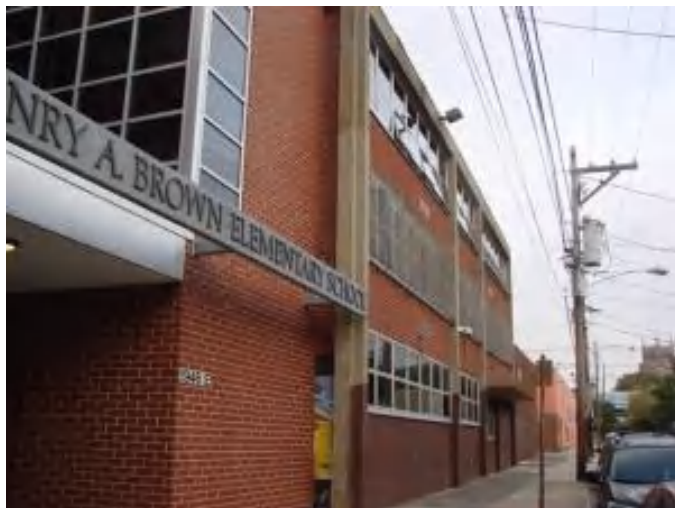
System: D5030 - Communications and Security

Location: throughout the building

Distress: Appearance

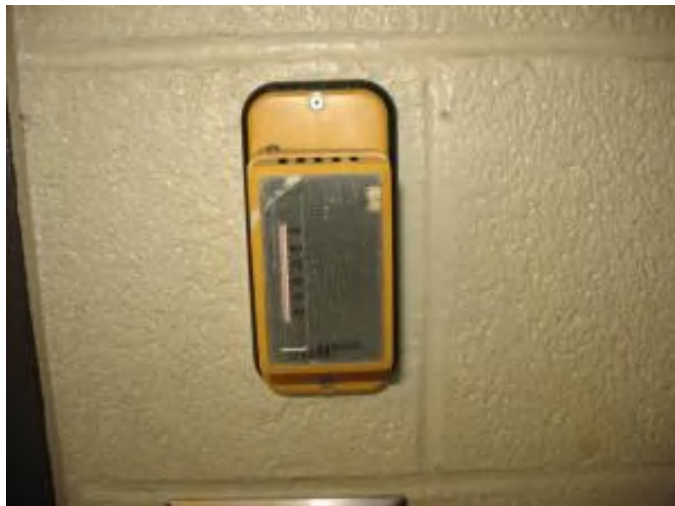
System: D3060 - Controls & Instrumentation

Controls & Instrumentation - The original pneumatic systems still provide basic control functions. Pneumatic room thermostats are intended to control the unit ventilator control valves. In reality the unit ventilator control valves are wide open and heating control is achieved via the boilers. Pneumatic control air is supplied from a duplex Quincy compressor and Hankison air dryer located in the boiler room. The maintenance staff reports no problems with oil, moisture, or dirt in the pneumatic copper tubing. The pneumatic systems are beyond their service life and require too much attention from the maintenance staff. The original control valves and pneumatic actuators are beyond their service life and should be rebuilt or replaced. These controls should be converted to DDC.

Location: Throughout building

Distress: Inadequate

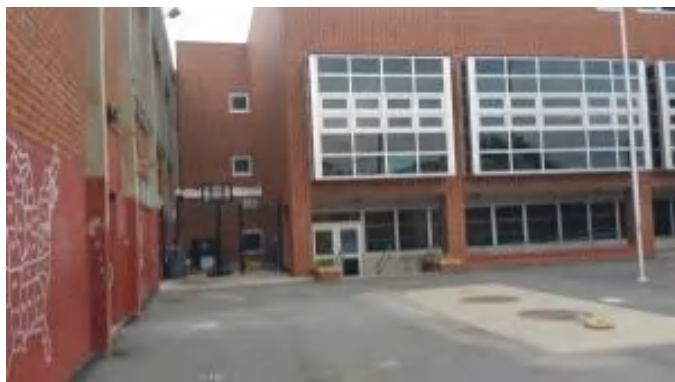
System: G4030 - Site Communications & Security

Location: Grounds

Distress: Security Issue
