Facility Condition Assessment Summary Report

Brown, JH School

School District of Philadelphia
S821001;Brown, J H
Final
Site Assessment Report
January 31, 2017

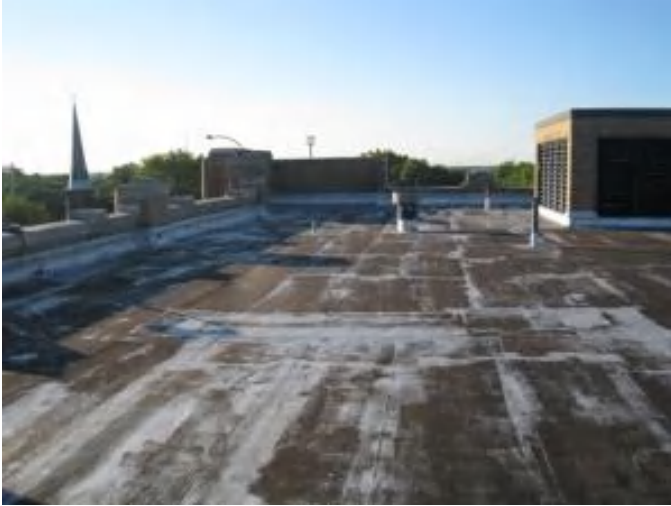
System: B3010105 - Built-Up

Location: roofs

Distress: Failing

Notes: Remove and replace existing flat roof and insulation; 6 levels (17,500sf)

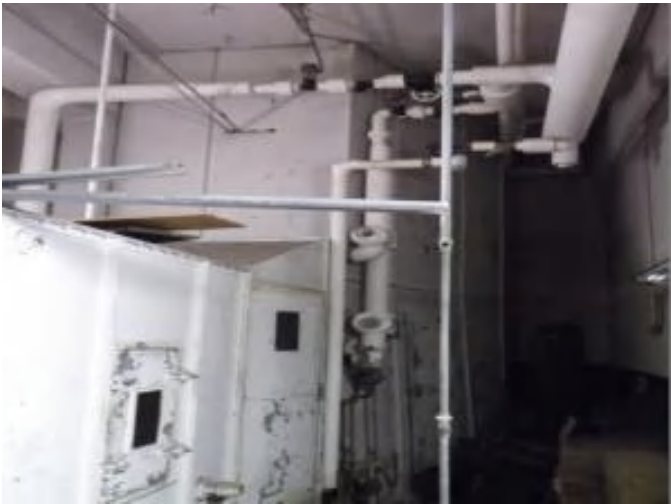
System: D3040 - Distribution Systems

Location: Throughout the building

Distress: Beyond Service Life

Notes: Conduct a steam trap survey to identify and replace failed traps passing live steam into the condensate piping system

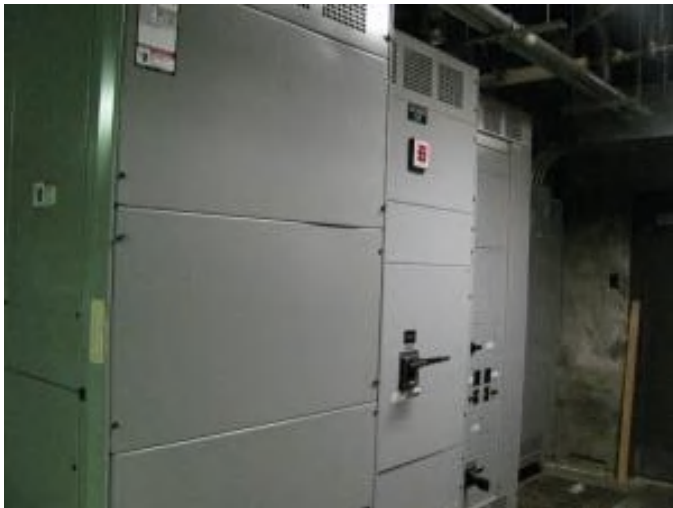
System: D5010 - Electrical Service/Distribution

Location: Basement

Distress: Inadequate

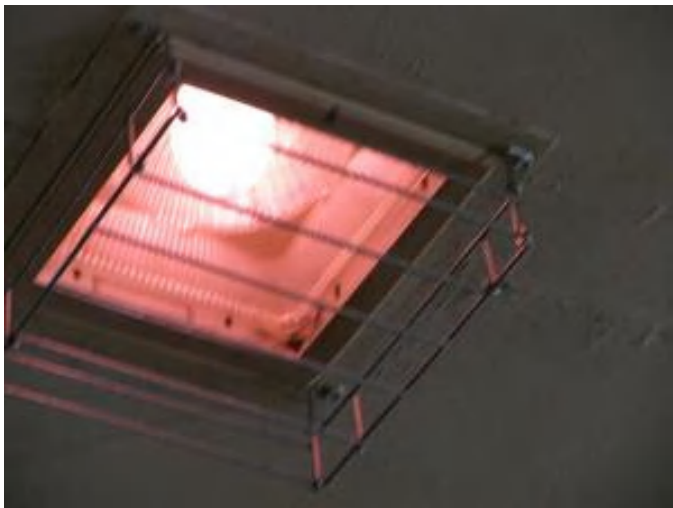
System: D5020 - Lighting and Branch Wiring

Location: Entire Building

Distress: Beyond Service Life

Notes: Replace all lighting fixtures with new fluorescent lighting fixtures with T-5 lamp throughout all buildings.

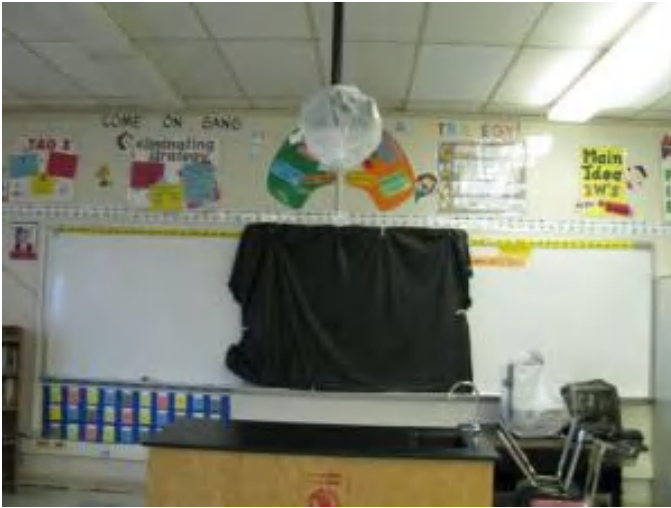
System: D5020 - Lighting and Branch Wiring

Location: Classrooms

Distress: Inadequate

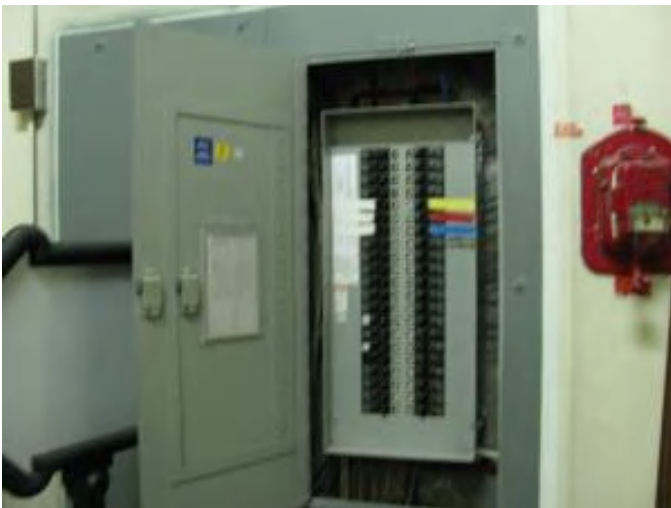
System: D5030 - Communications and Security

Location: Entire Building

Distress: Beyond Service Life

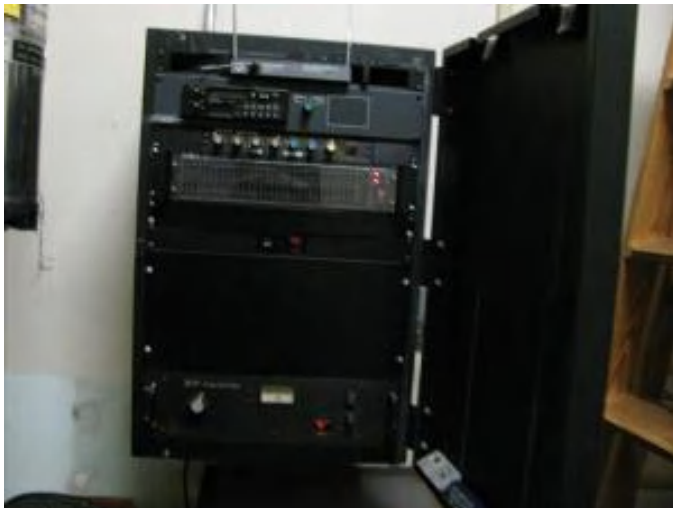
System: D5030 - Communications and Security

Location: Auditorium

Distress: Inadequate

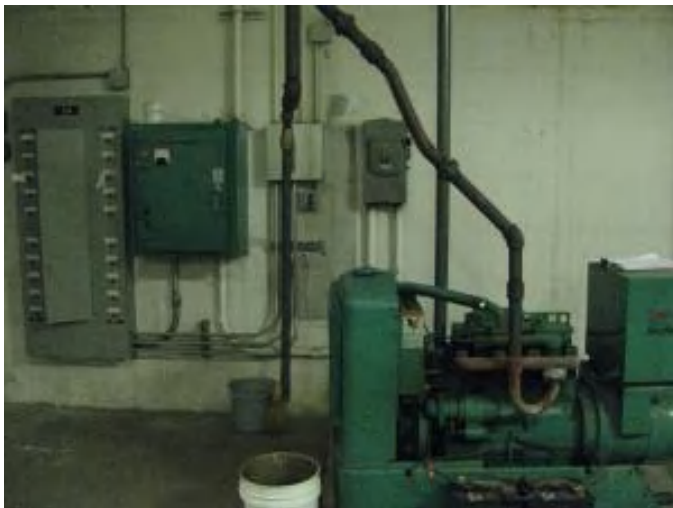
System: D5090 - Other Electrical Systems

Location: Basement

Distress: Inadequate

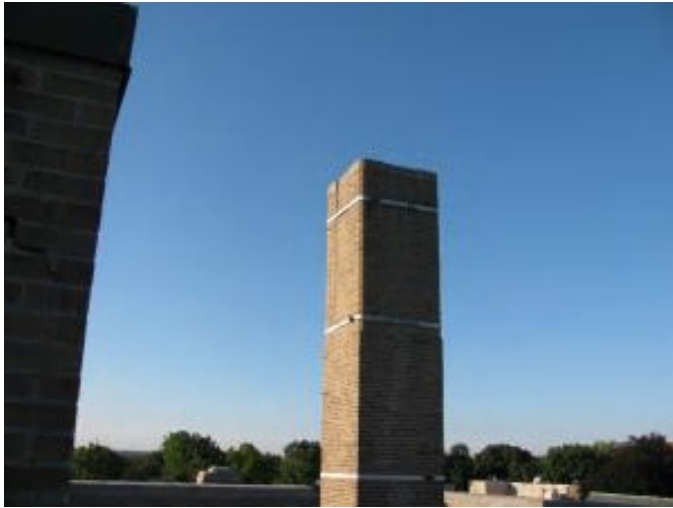
System: D5090 - Other Electrical Systems

Location: Roof

Distress: Life Safety / NFPA / PFD

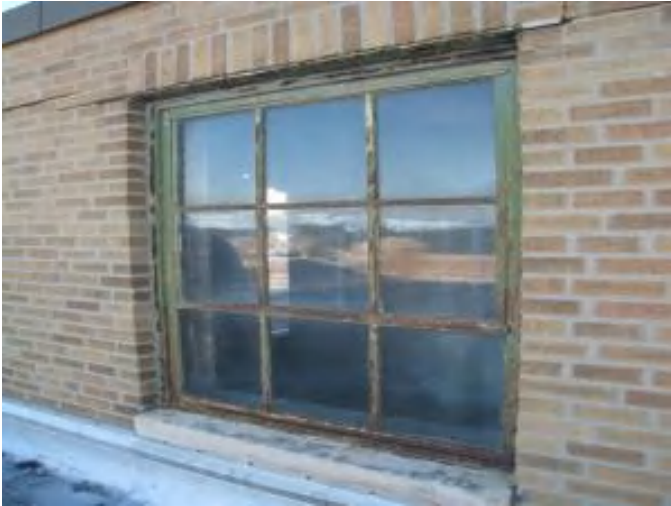
System: B2010 - Exterior Walls

Location: rooftop structures

Distress: Failing

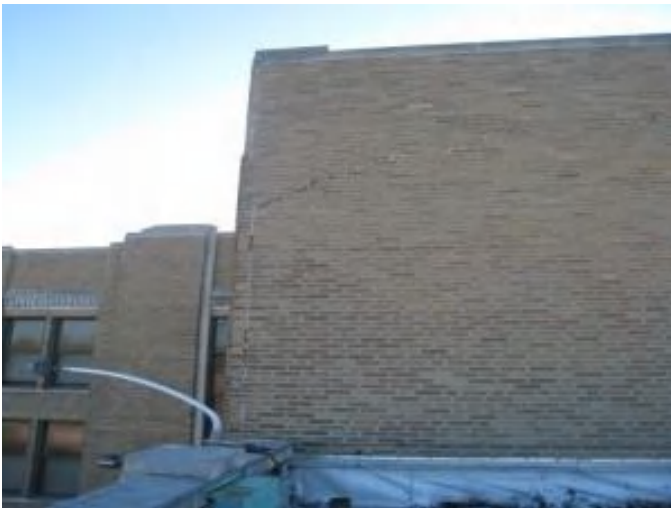
System: B2010 - Exterior Walls

Location: exterior walls

Distress: Failing

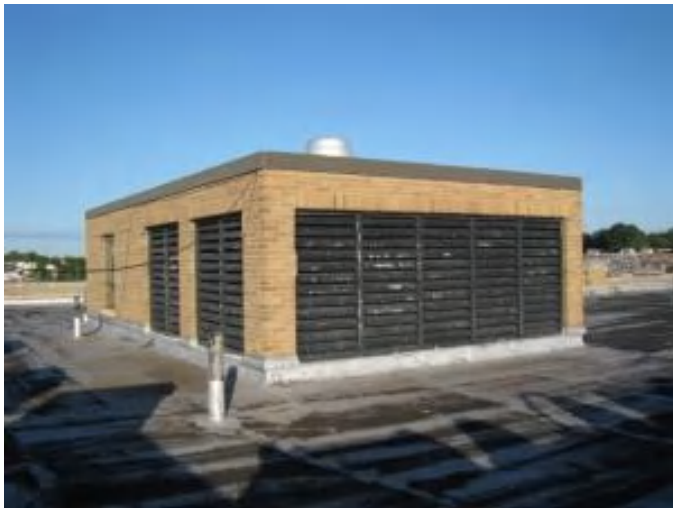
System: B2010 - Exterior Walls

Location: rooftop structures

Distress: Damaged

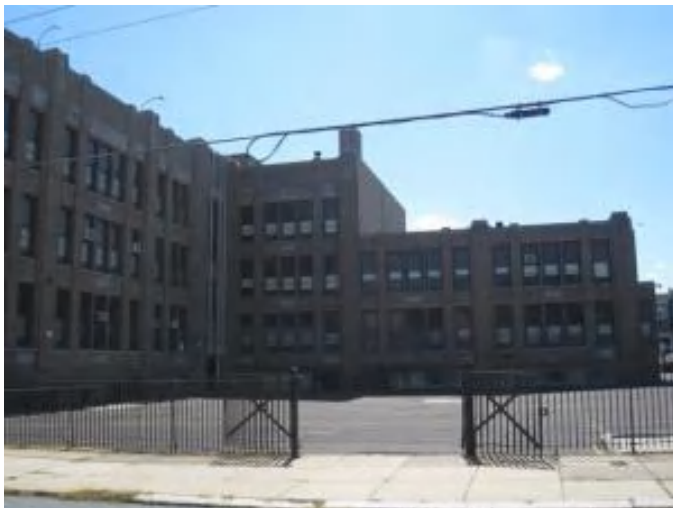
System: B2010 - Exterior Walls

Location: rear walls facing playground

Distress: Damaged

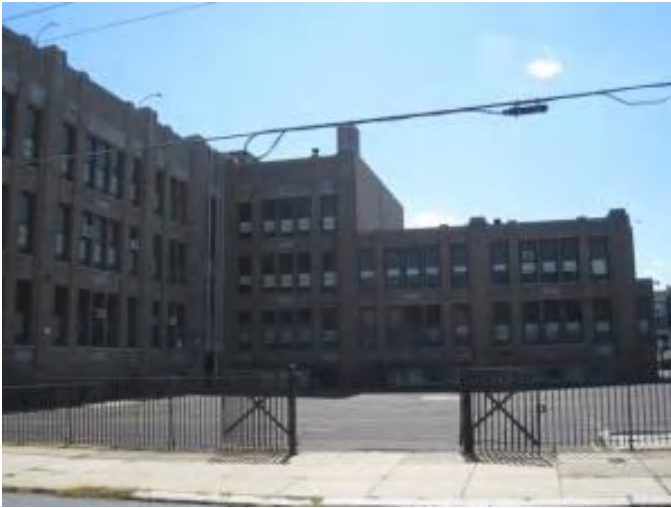
System: B2020 - Exterior Windows

Location: windows

Distress: Beyond Service Life

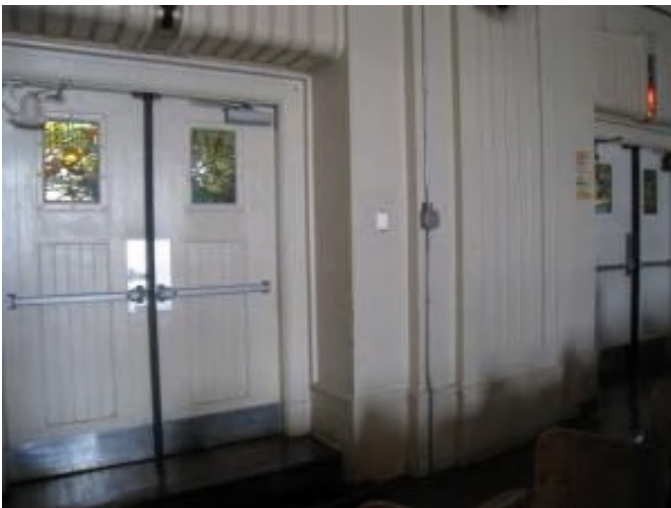
System: B2030 - Exterior Doors

Location: exterior doors

Distress: Failing

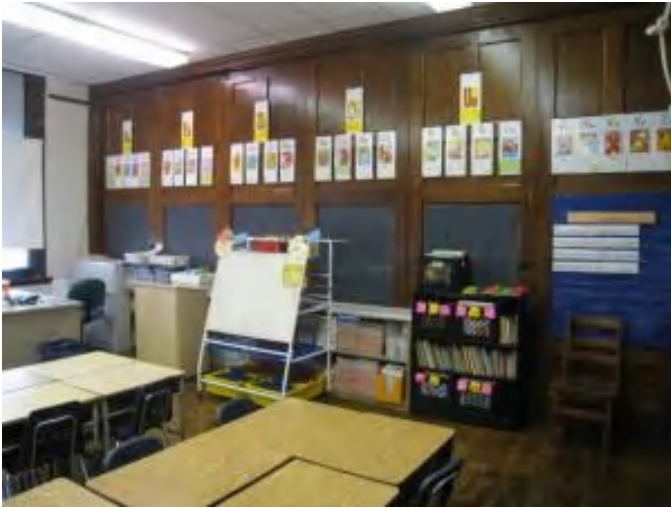
System: C1010 - Partitions

Location: classrooms

Distress: Failing

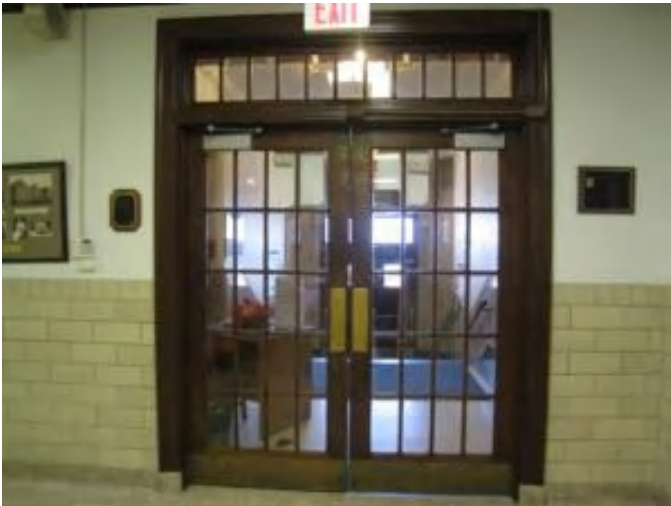
System: C1010 - Partitions

Location: corridors, above doors

Distress: Building / MEP Codes

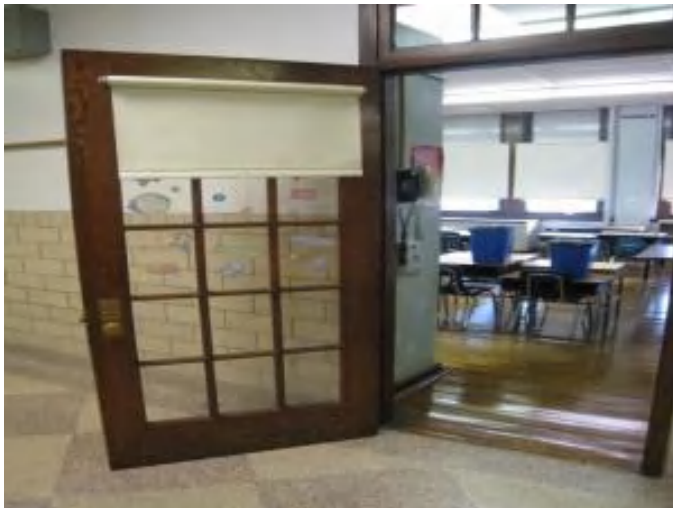
System: C1020 - Interior Doors

Location: classroom doors in corridors

Distress: Building / MEP Codes

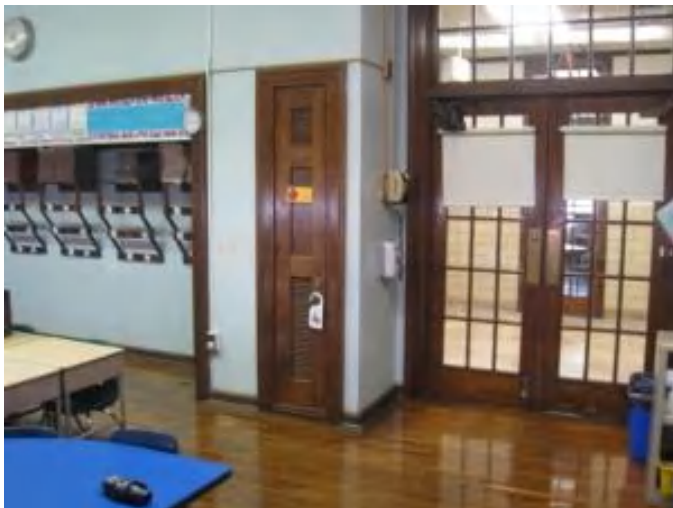
System: C1020 - Interior Doors

Location: closet and storage area doors in classrooms

Distress: Appearance

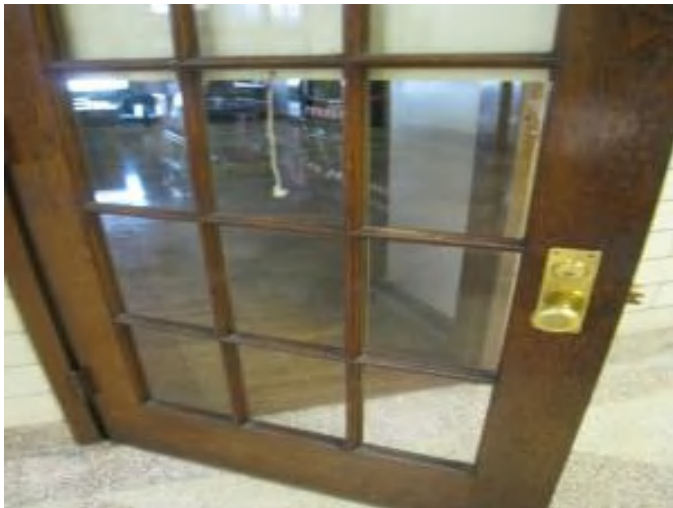
System: C1020 - Interior Doors

Location: classroom and office doors

Distress: Security Issue

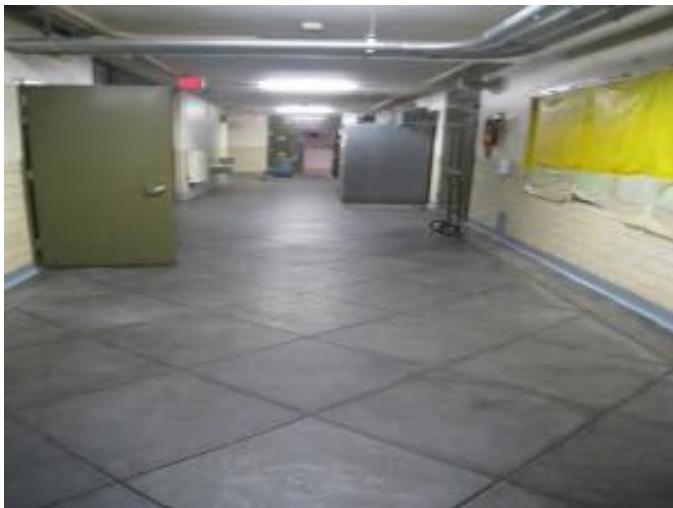
System: C1020 - Interior Doors

Location: mechanical rooms

Distress: Appearance

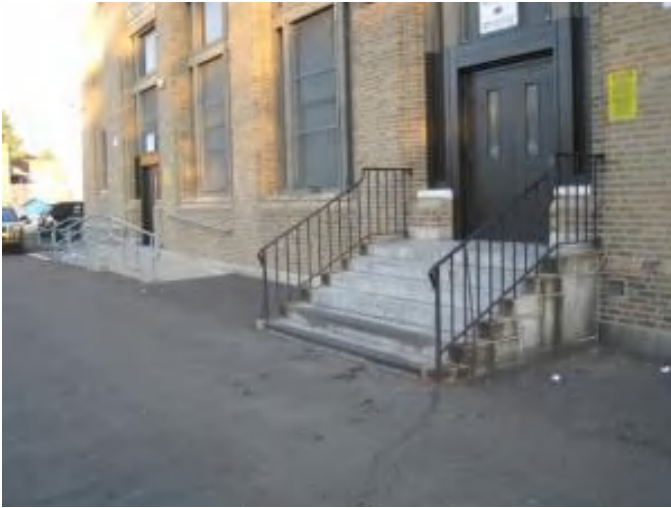
System: C2010 - Stair Construction

Location: exterior stairs

Distress: Damaged

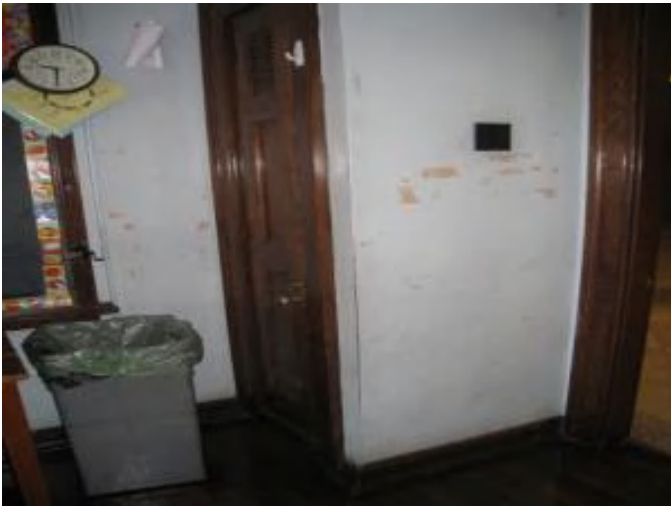
System: C3010230 - Paint & Covering

Location: stairway, classrooms, corridor walls

Distress: Damaged

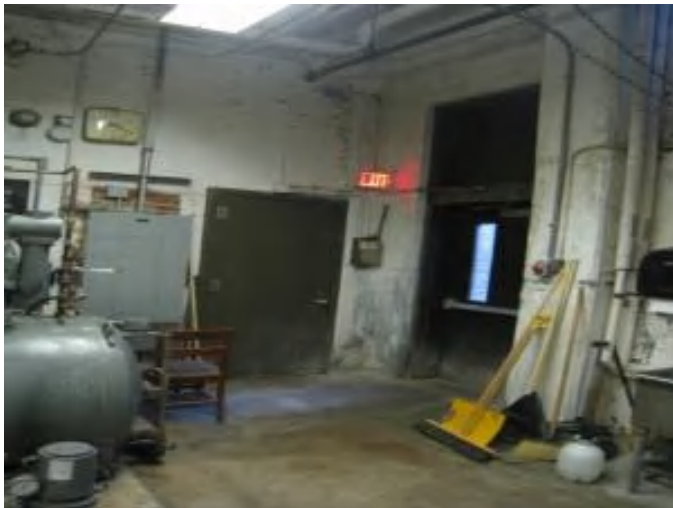
System: C3010230 - Paint & Covering

Location: mechanical rooms

Distress: Appearance

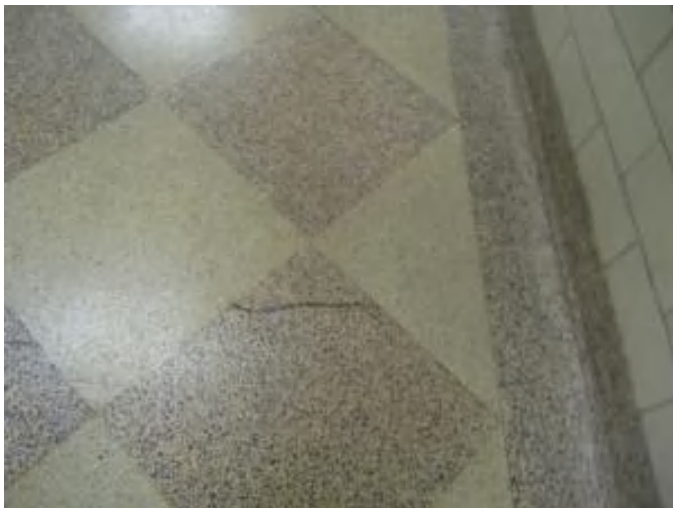
System: C3020412 - Terrazzo & Tile

Location: stairways and corridors

Distress: Damaged

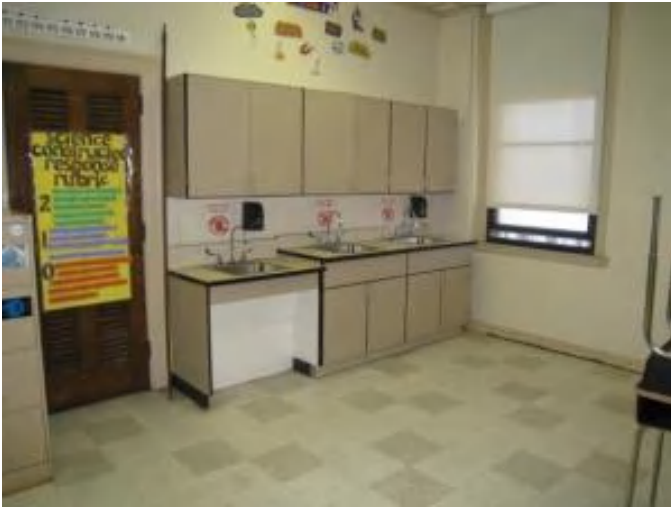
System: C3020413 - Vinyl Flooring

Location: offices and classroom

Distress: Appearance

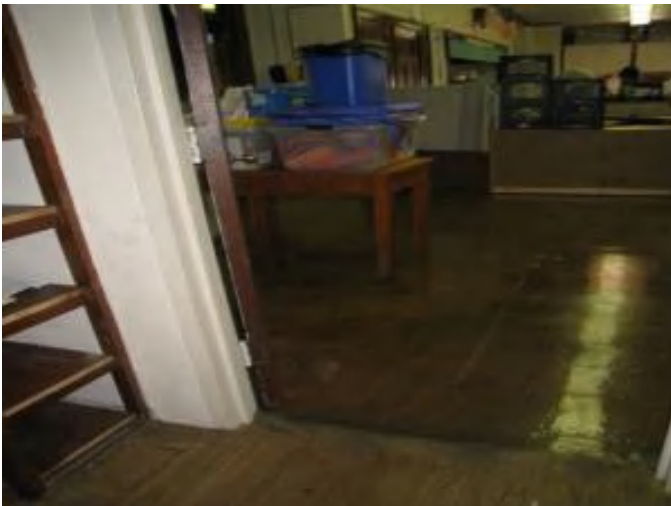
System: C3020413 - Vinyl Flooring

Location: classroom

Distress: Health Hazard / Risk

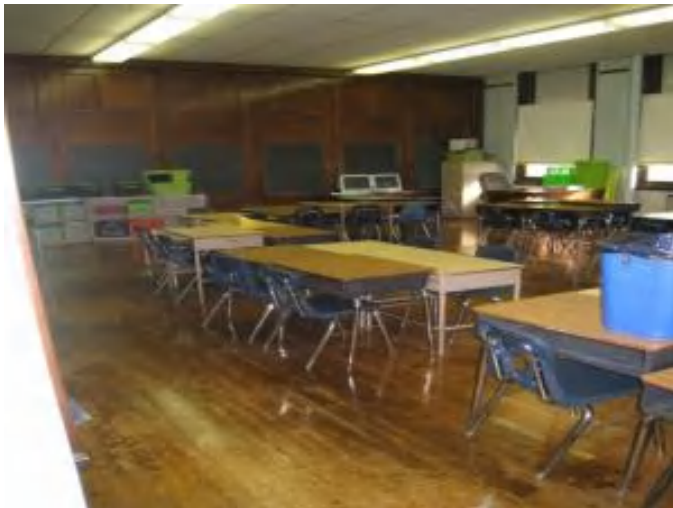
System: C3020414 - Wood Flooring

Location: classrooms, gym, and auditorium

Distress: Appearance

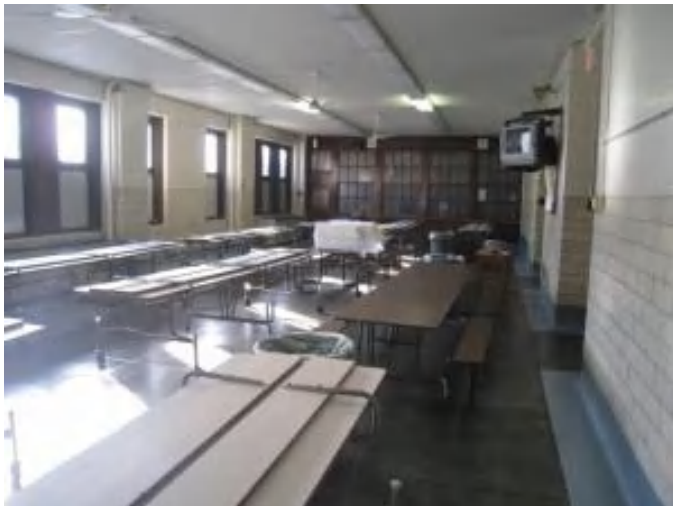
System: C3020415 - Concrete Floor Finishes

Location: mechanical rooms and cafeteria

Distress: Appearance

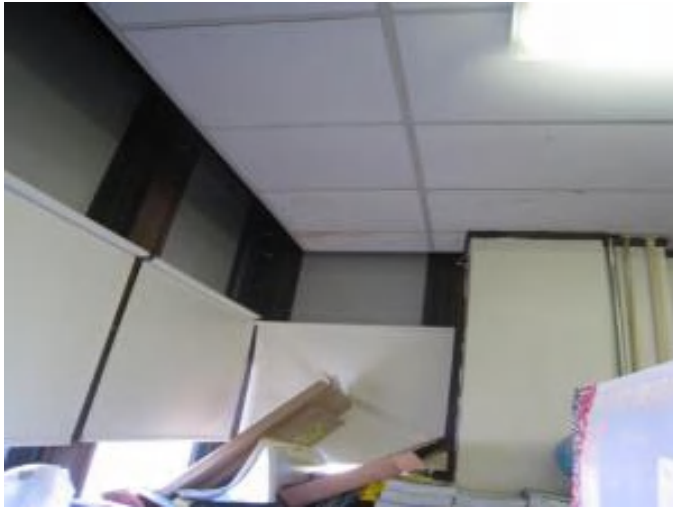
System: C3030 - Ceiling Finishes

Location: kindergarten

Distress: Damaged

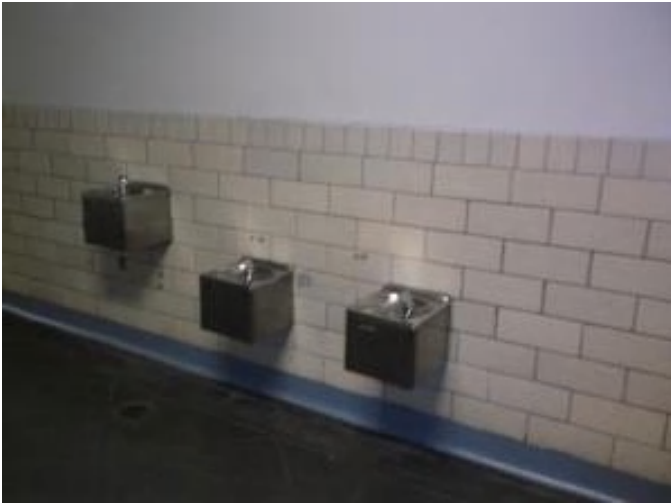
System: D2010 - Plumbing Fixtures

Location: Throughout the building

Distress: Beyond Service Life

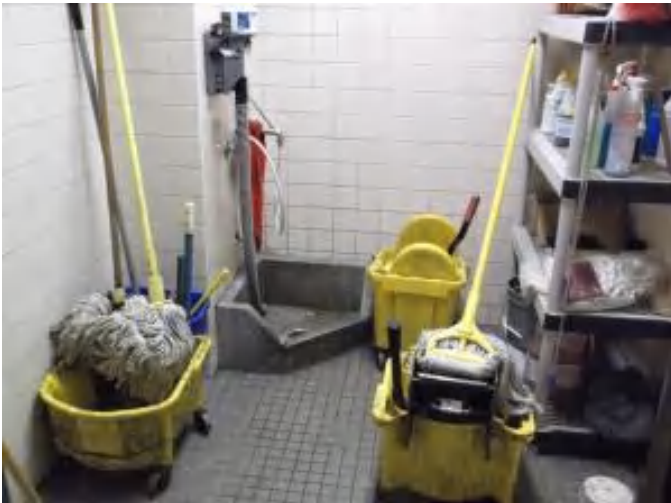
System: D2010 - Plumbing Fixtures

Location: Throughout the building

Distress: Beyond Service Life

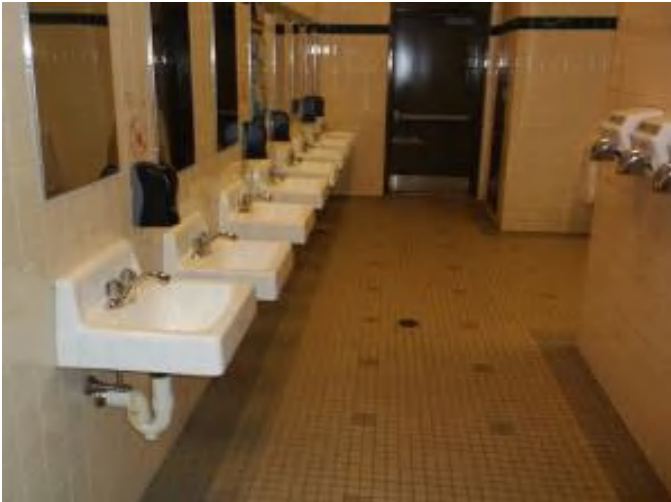
System: D2010 - Plumbing Fixtures

Location: Throughout the building

Distress: Beyond Service Life

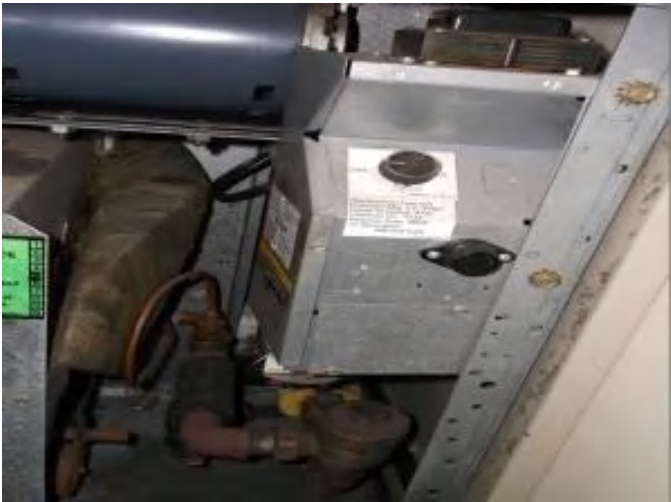
System: D3060 - Controls & Instrumentation

Location: Throughout the building

Distress: Beyond Service Life

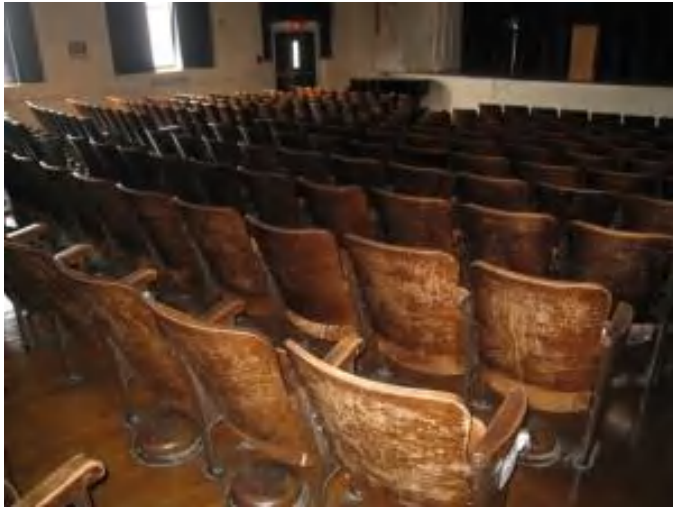
System: E2010 - Fixed Furnishings

Location: auditorium seating

Distress: Appearance

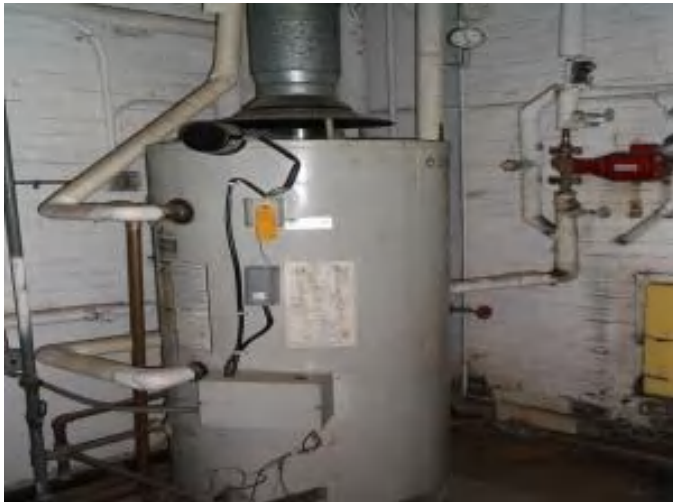
System: D2020 - Domestic Water Distribution

Location: Boiler Mechanical Equipment Room

Distress: Beyond Service Life

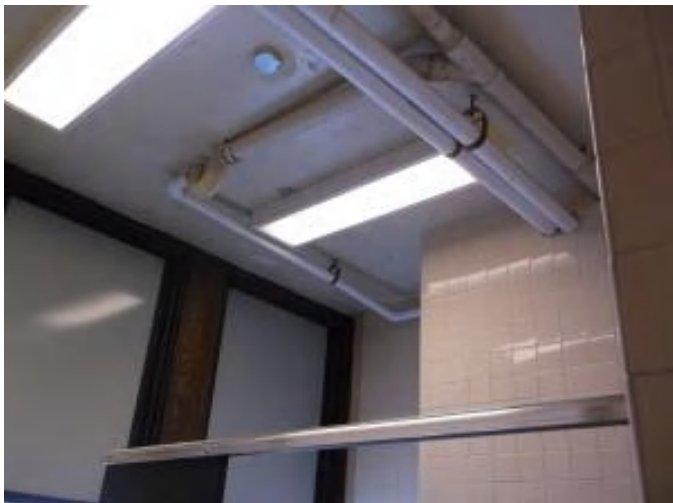
System: D2030 - Sanitary Waste

Location: Throughout the building

Distress: Beyond Service Life

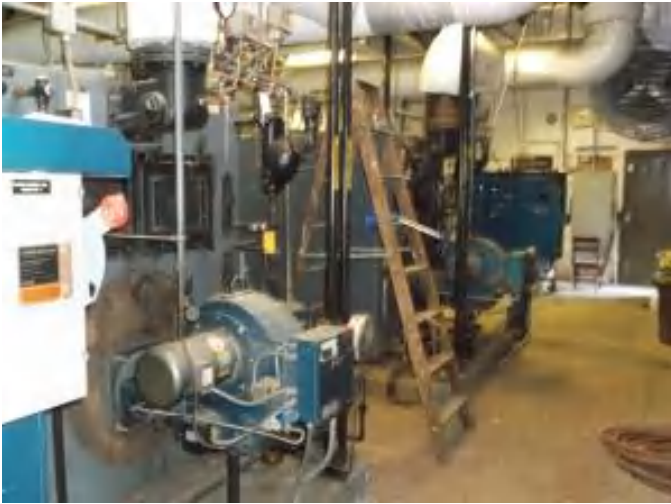
System: D3020 - Heat Generating Systems

Location: Boiler Mechanical Equipment Room

Distress: Beyond Service Life

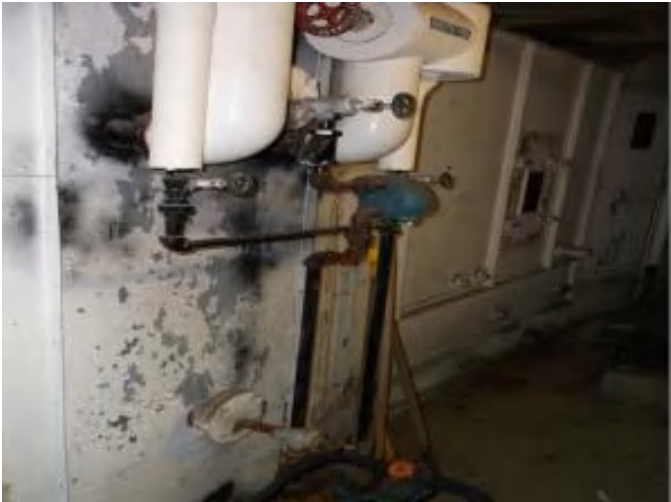
System: D3040 - Distribution Systems

Location: Throughout the building

Distress: Beyond Service Life

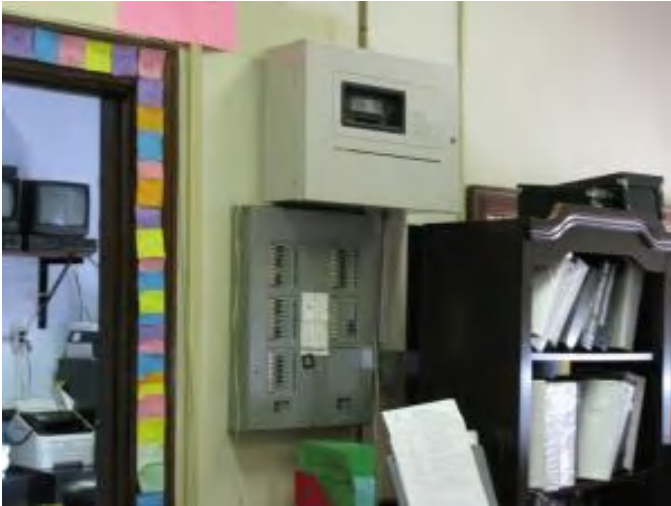
System: D5030 - Communications and Security

Location: Entire Buiding

Distress: Inadequate

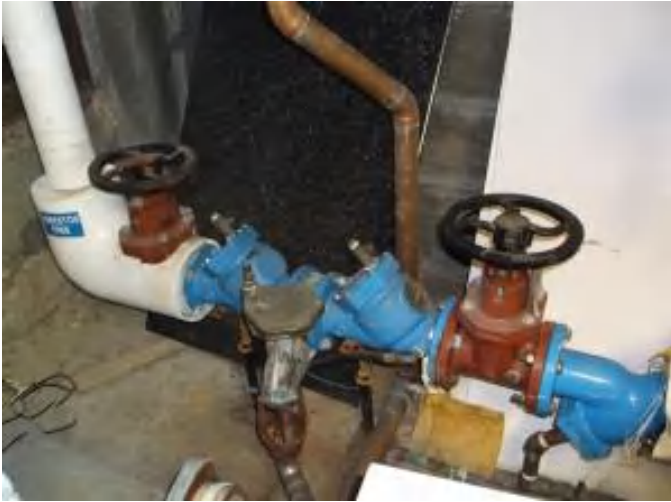
System: D2020 - Domestic Water Distribution

Location: Throughout the building

Distress: Beyond Service Life

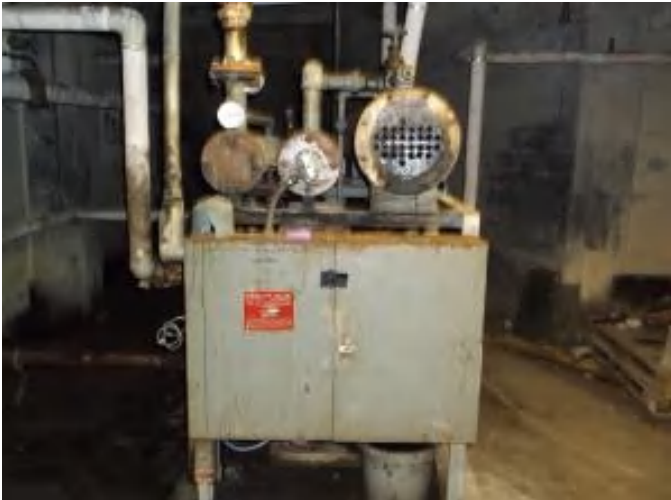
System: D3020 - Heat Generating Systems

Location: Boiler Mechanical Equipment Room

Distress: Beyond Service Life

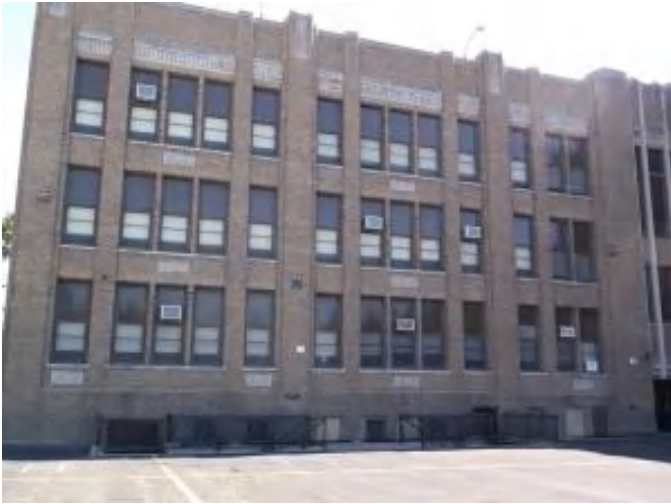
System: D3030 - Cooling Generating Systems

Location: Adjacent to building

Distress: Inadequate

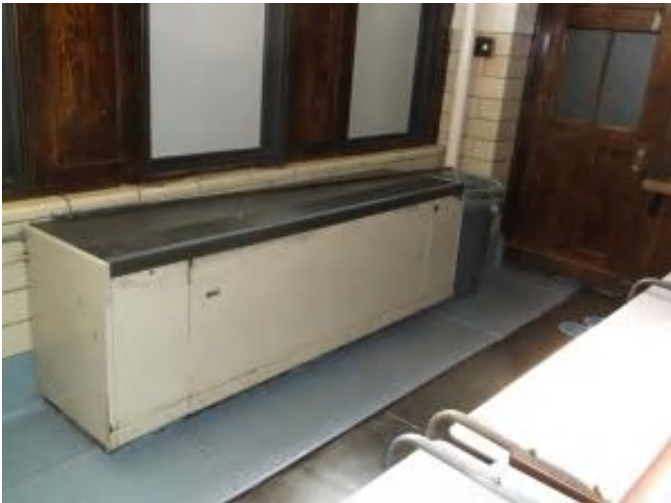
System: D3040 - Distribution Systems

Location: Throughout the building

Distress: Beyond Service Life

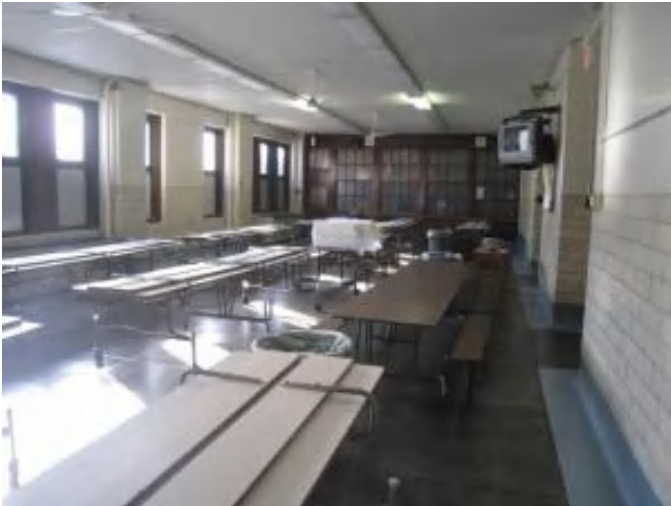
System: D3040 - Distribution Systems

Location: Cafeteria

Distress: Beyond Service Life

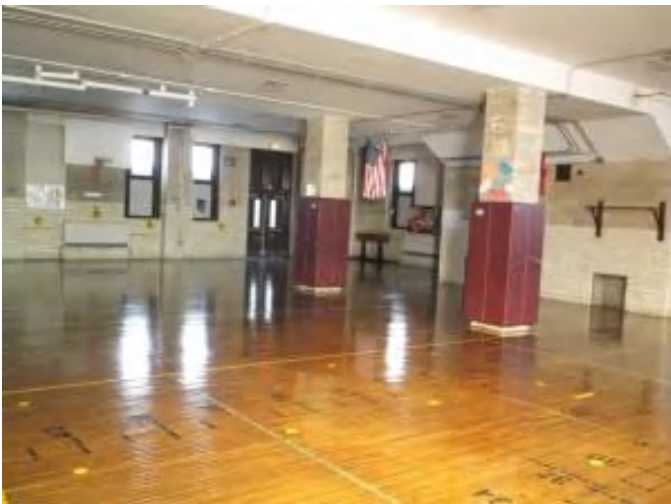
System: D3040 - Distribution Systems

Location: Gym

Distress: Beyond Service Life

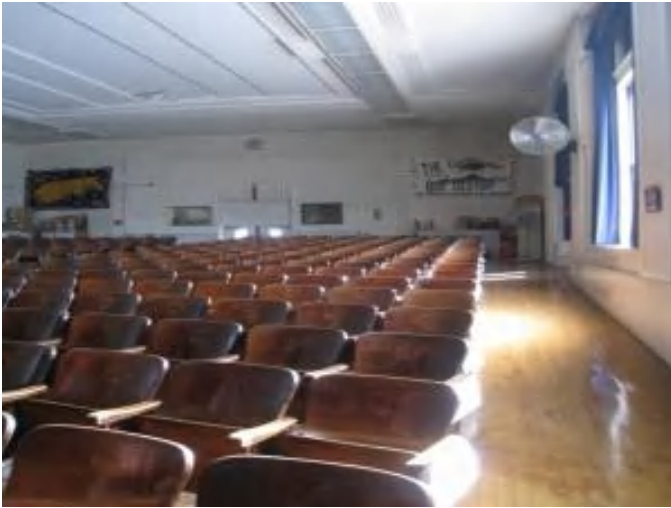
System: D3040 - Distribution Systems

Location: Auditorium

Distress: Beyond Service Life

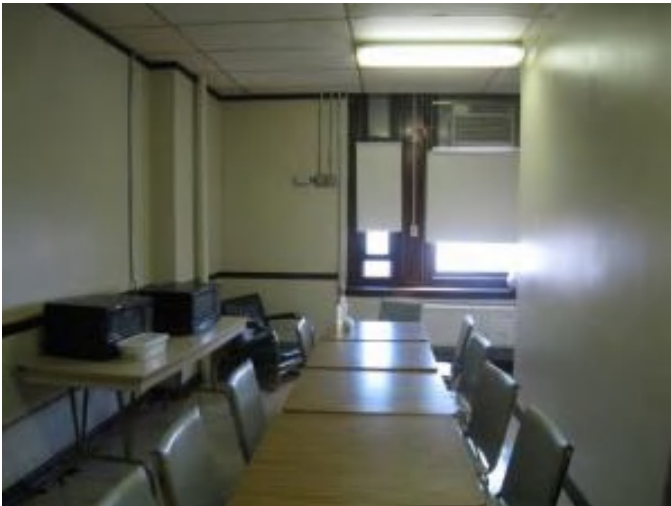
System: D4010 - Sprinklers

Location: Throughout the building

Distress: Life Safety / NFPA / PFD

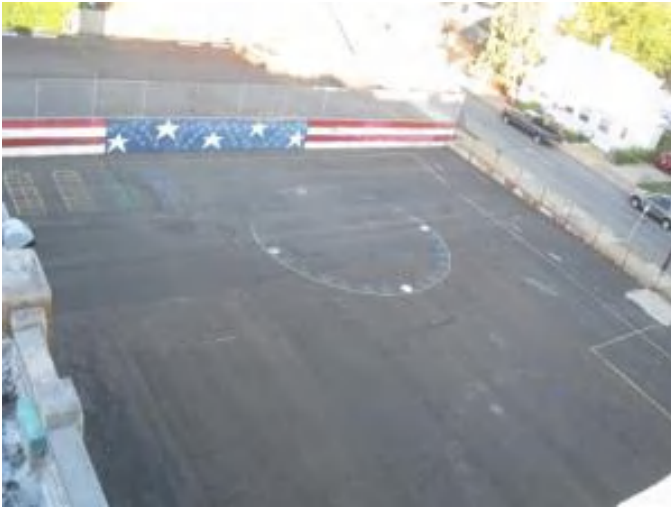
System: G2020 - Parking Lots

Location: parking lots / play areas

Distress: Failing

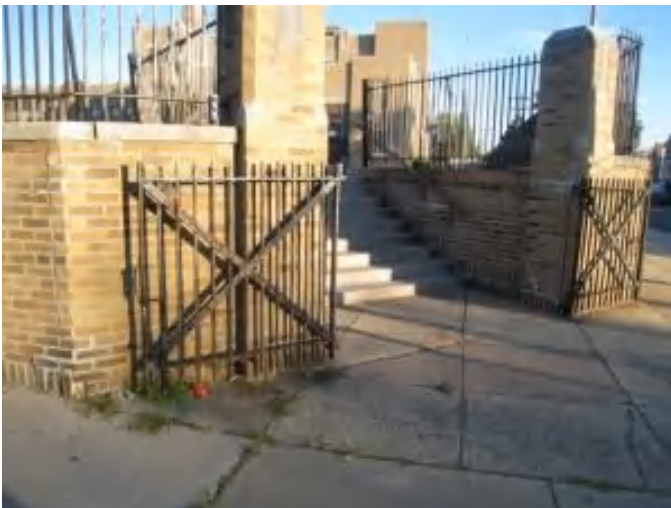
System: G2040 - Site Development

Location: Retaining wall - Frankford Ave

Distress: Failing

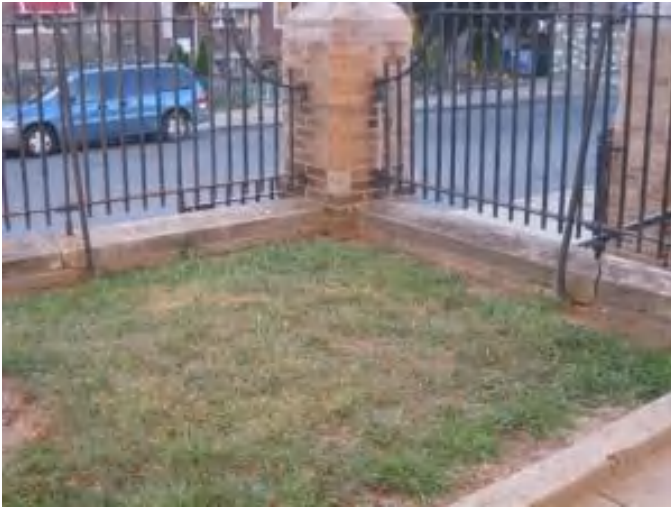
System: G2040 - Site Development

Location: wrought iron site fence

Distress: Failing

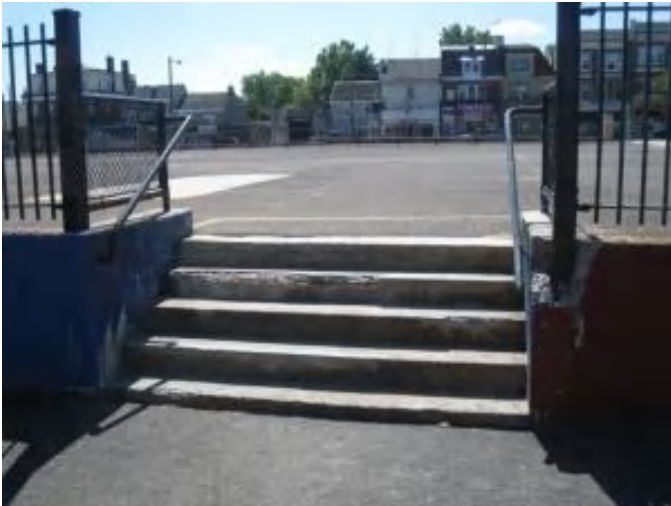
System: G2040 - Site Development

Location: between high and low parking areas

Distress: Failing

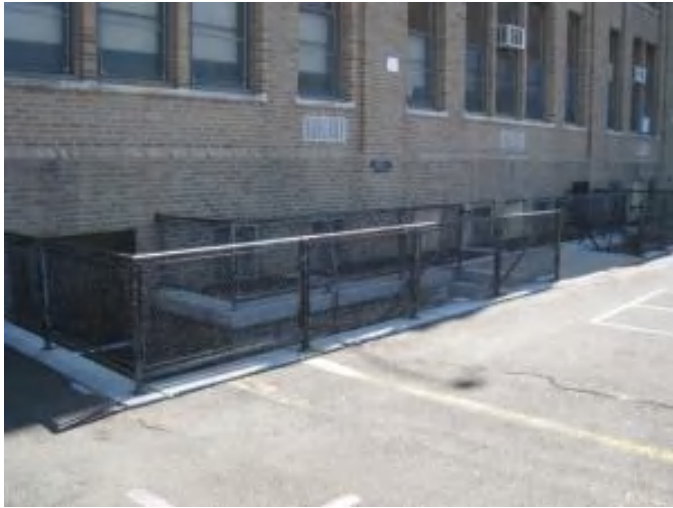
System: G2040 - Site Development

Location: window wells and exit wells

Distress: Damaged

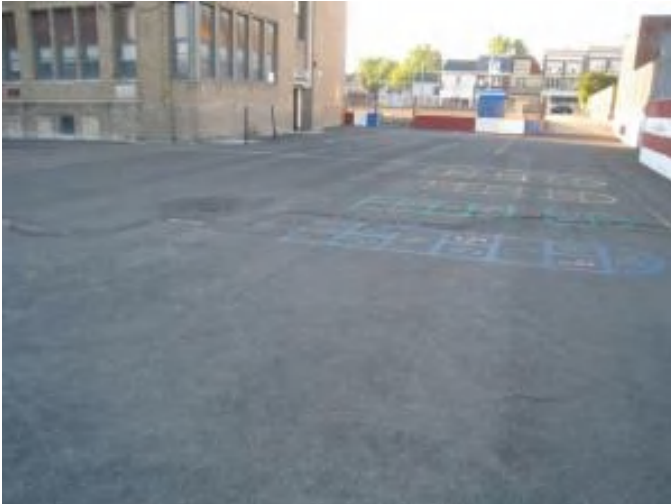
System: G2020 - Parking Lots

Location: asphalt play area

Distress: Failing
