Facility Condition Assessment Summary Report

Building 21 (Ferguson) School

School District of Philadelphia
S529001;Ferguson
Final
Site Assessment Report
February 2, 2017

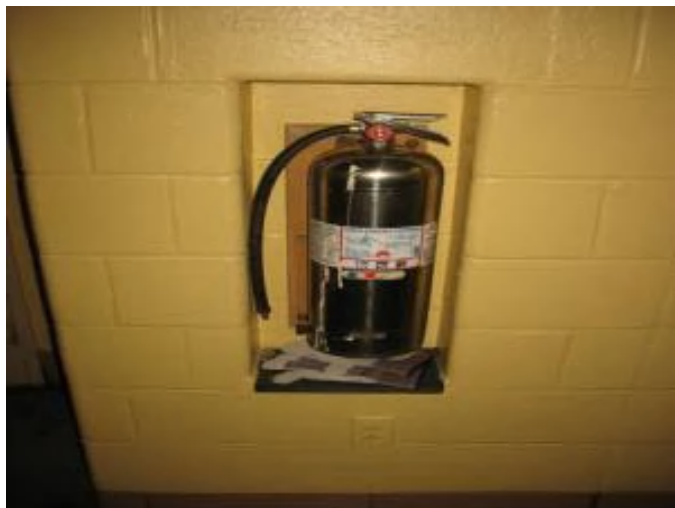
System: D4010 - Sprinklers

Location: Throughout building

Distress: Life Safety / NFPA / PFD

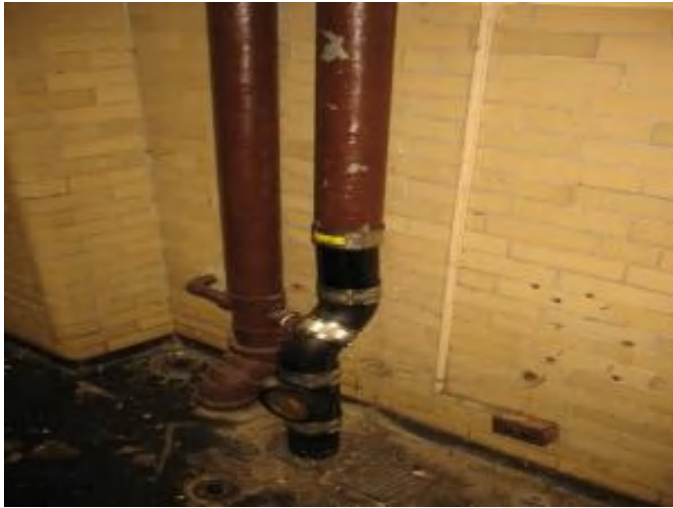
System: D2030 - Sanitary Waste

The maintenance staff reported mostly minor problems with the sanitary waste piping systems. However, the sewer piping has been in service for decades and will require more frequent attention from the maintenance staff as time passes. The District should hire a qualified contractor to examine the sanitary waste piping using video cameras to locate and replace any damaged piping and to further quantify the extent of potential failures.

Location: Throughout building

Distress: Beyond Service Life

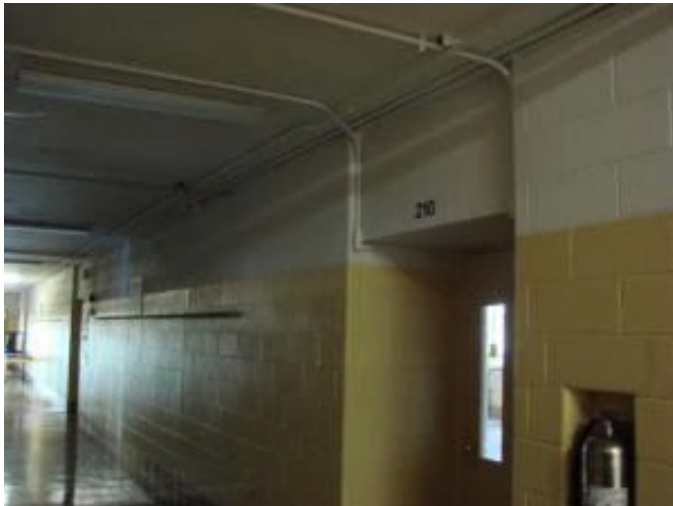
System: C1020 - Interior Doors

Location: Interior

Distress: Accessibility

Notes: Provide wheelchair lifts on 3 floors between original building and added wing

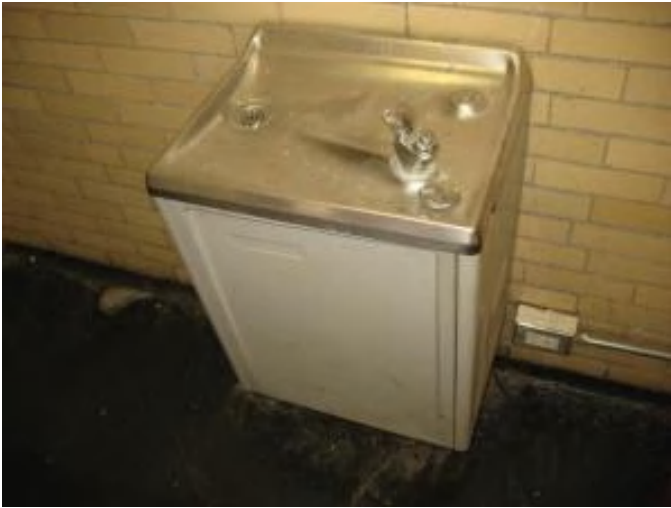
System: D2010 - Plumbing Fixtures

Drinking fountains in the corridors and at the restrooms are wall hung with integral refrigerated coolers. They are well beyond their service life and should be replaced; most are NOT accessible type.

Location: Corridors

Distress: Beyond Service Life

Notes: Replace twelve (12) wall hung drinking fountains and integral refrigerated coolers in the corridors and at the restrooms. These units are well beyond their service life and most are NOT accessible type.

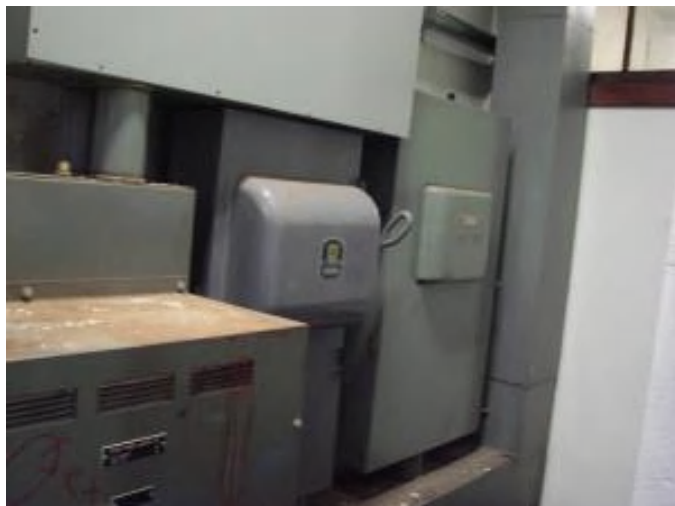
System: D5010 - Electrical Service/Distribution

Site electrical service - The primary power is at 13.2KV from the street power pole which goes underground and feeds a 750KVA pad-mounted outdoor transformer (13.2KV – 120V/208V). The electrical service is old and has reached the end of its useful service. The main switchgear is rated at 2000A, 120V/208V, 3 phase, and is located in main electrical room. The PECO meter is also located inside the electrical room. The service entrance and the main building electrical distribution systems are old, in very poor condition, and do not have ample capacity for future growth.

Location: electrical room

Distress: Beyond Service Life

Notes: Install new Site electrical service 2000KVA, 480V, 3 Phase to feed the existing loads plus new HVAC additional loads.

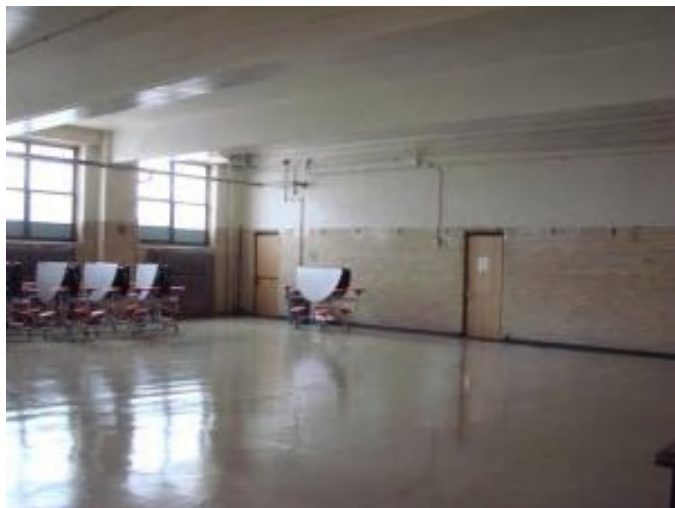
System: D5020 - Lighting and Branch Wiring

Lighting - Interior building is illuminated by various types of fixtures. They include fluorescent lighting (with T-12 & T-8 lamp) in majority of the areas, including; classrooms, corridor, offices and Kitchen. Surface or pendant mounted industrial fluorescent fixtures are used in mechanical and electrical rooms. Gymnasium is illuminated by metal halide enclosed glass fixture. The majorities of interior lighting fixtures is in a poor condition and have reached the end of their useful service.

Location: throughout the building

Distress: Beyond Service Life

Notes: Install new a lighting system for the entire building.

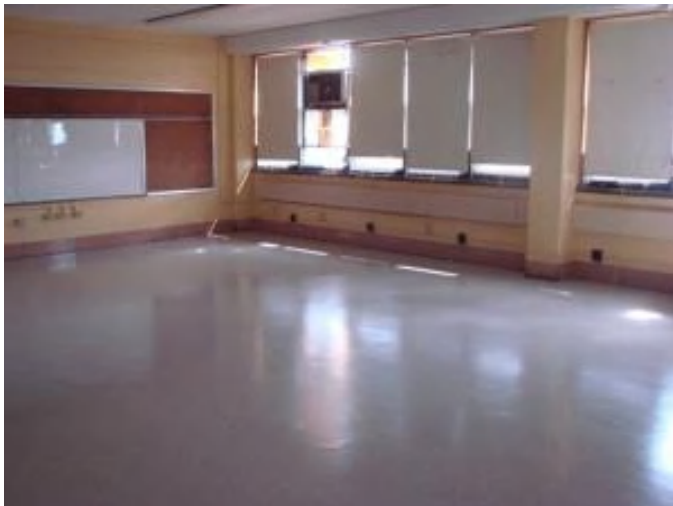
System: D5020 - Lighting and Branch Wiring

Location: throughout the building

Distress: Beyond Service Life

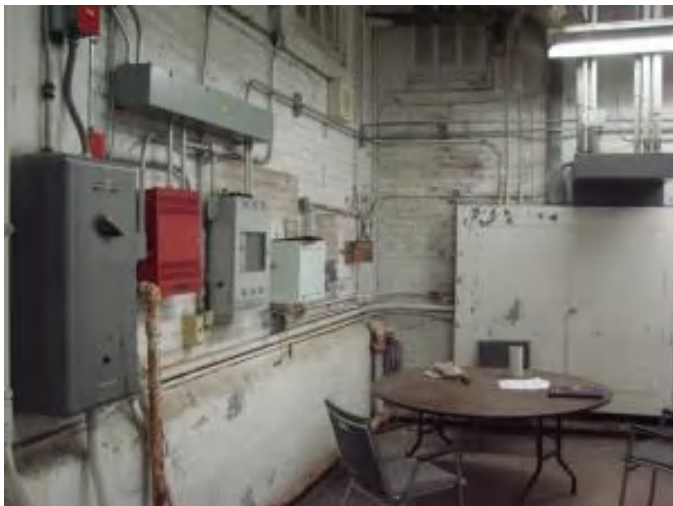
System: D5030 - Communications and Security

Location: throughout the building

Distress: Building / MEP Codes

Notes: Install a new automated/addressable FA system.

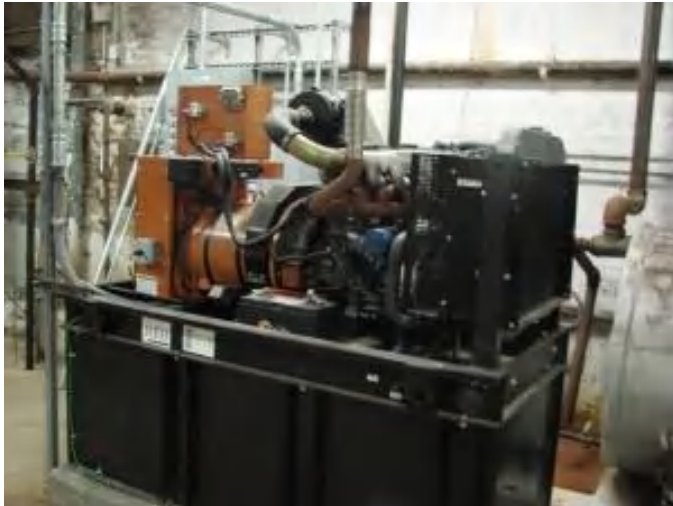
System: D5090 - Other Electrical Systems

Location: electrical room

Distress: Beyond Service Life

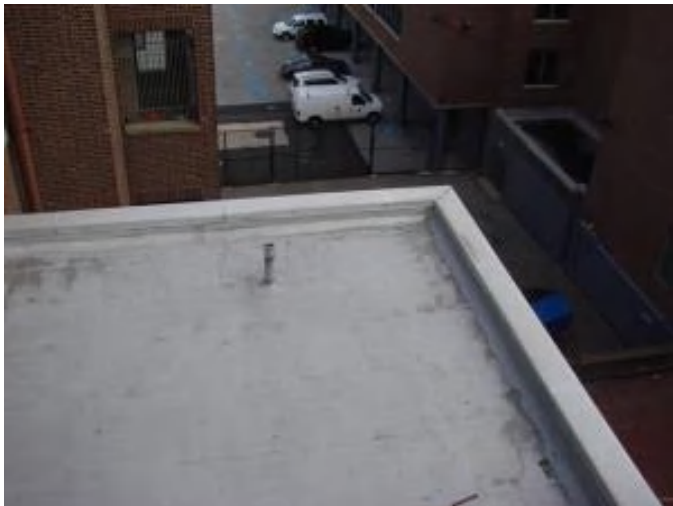
System: B3010105 - Built-Up

Roofing is typically built-up over the original building and modified bitumen over added wing. All roofing and flashing is typically in poor condition with deterioration of the built-up system including water ponding and soft spots; no leaks have been reported.

Location: Exterior

Distress: Beyond Service Life

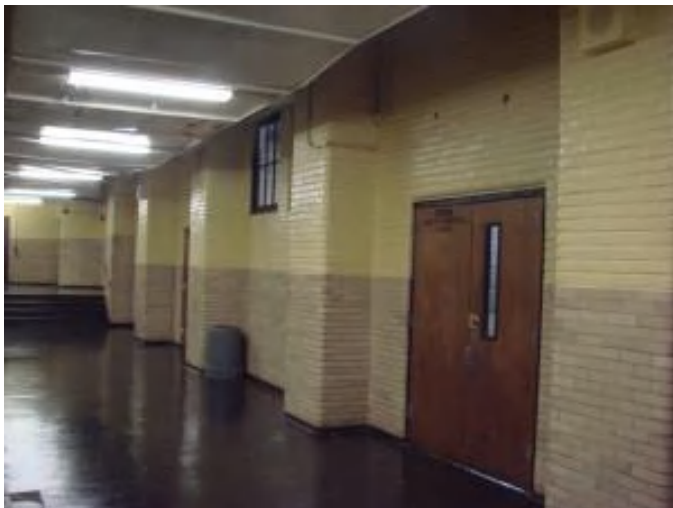
System: C3020413 - Vinyl Flooring

Location: Interior

Distress: Health Hazard / Risk

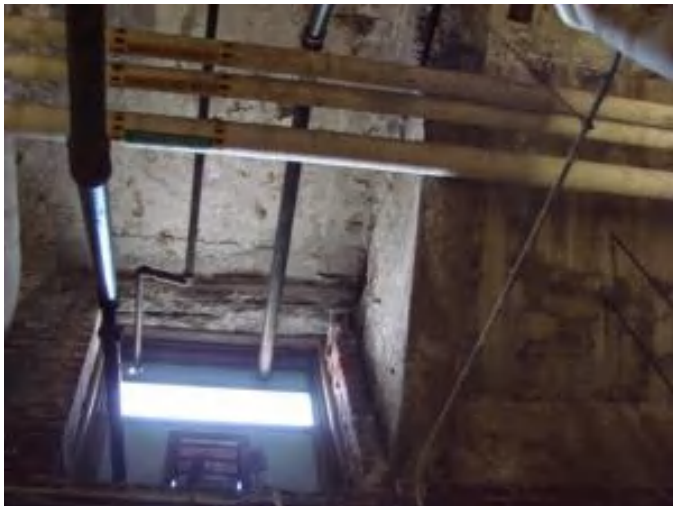
System: C3030 - Ceiling Finishes

Location: Interior

Distress: Appearance

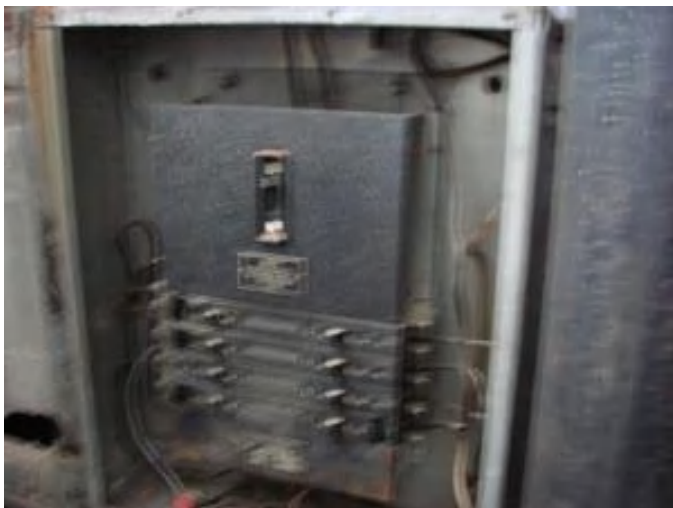
System: D5010 - Electrical Service/Distribution

Location: throughout tghe building

Distress: Beyond Service Life

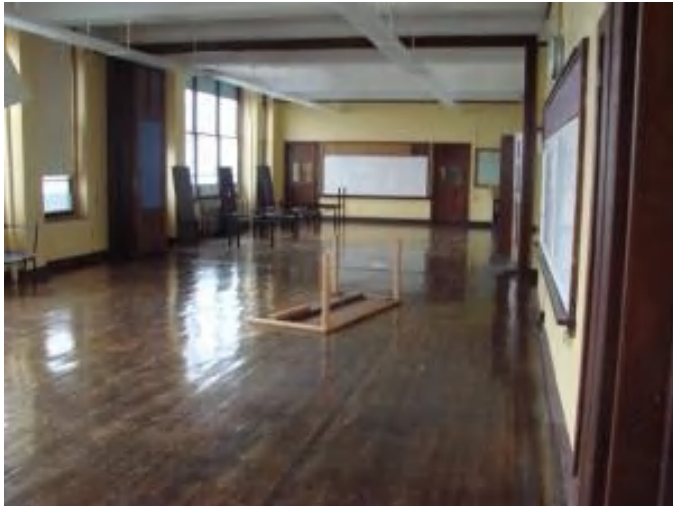
System: D5030 - Communications and Security

Location: throughout the building

Distress: Beyond Service Life

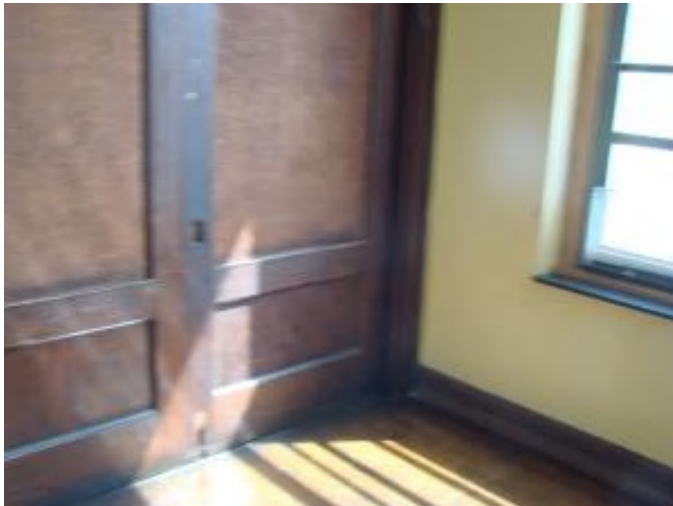
System: C1010 - Partitions

Location: Interior

Distress: Damaged

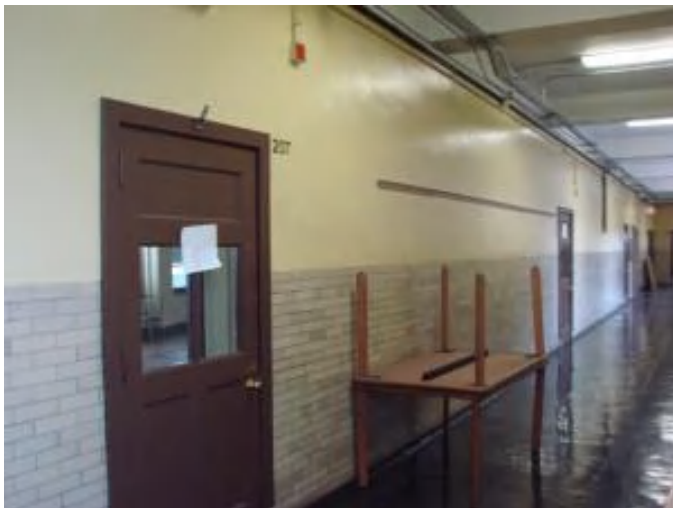
System: C1020 - Interior Doors

Location: Interior

Distress: Beyond Service Life

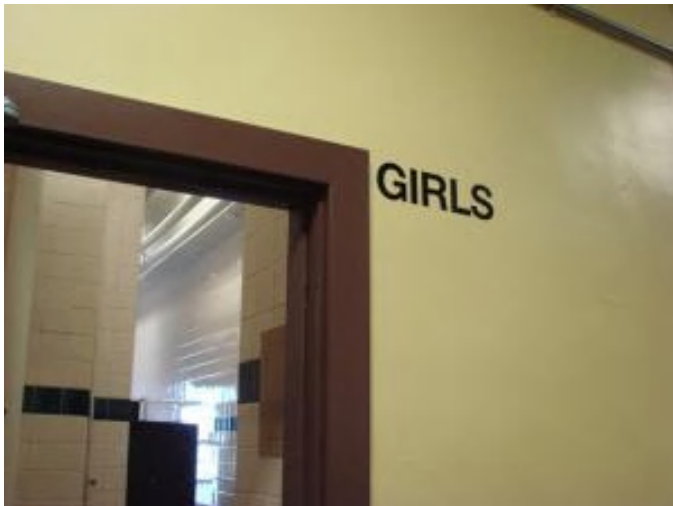
System: C1030 - Fittings

Fittings include original chalk boards, generally in poor condition. Toilet partitions and accessories in are in very good condition, installed in 2007; handrails, generally in good condition. Interior identifying signage is typically directly painted on wall or door surfaces generally in poor condition.

Location: Interior

Distress: Inadequate

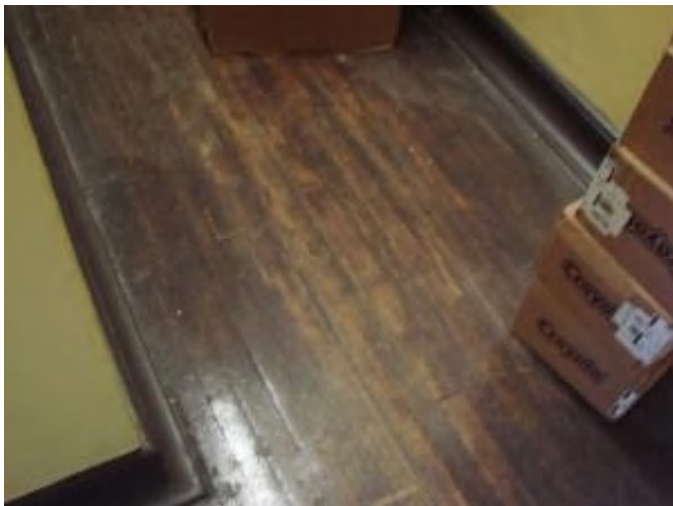
System: C3020414 - Wood Flooring

Location: Interior

Distress: Appearance

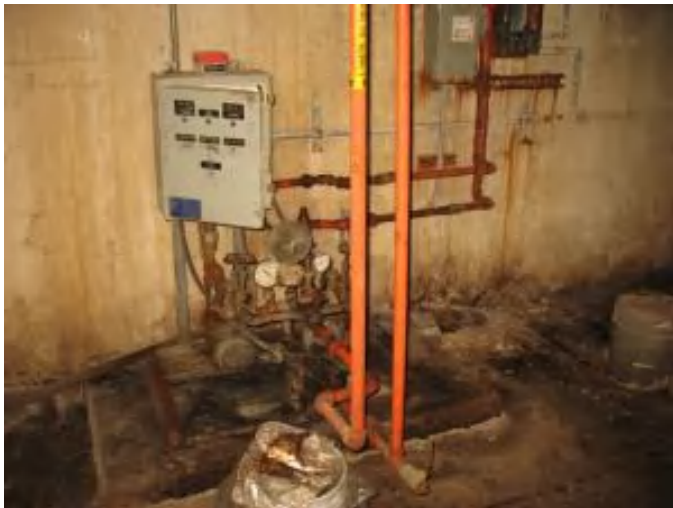
System: D3020 - Heat Generating Systems

The condensate receiver and boiler feed tank are installed in the basement boiler room. The receiver pumps were recently replaced, but are covered in rust. A serious problem was reported with failed steam traps. Live steam passes into the condensate piping system from the failed traps and then vents from the condensate handling equipment. The boiler feed tank piping and pumps show significant rust damage. The District replaced steam traps in 2014 according to the Building Engineer, but the problem persists.

Location: Boiler room

Distress: Damaged

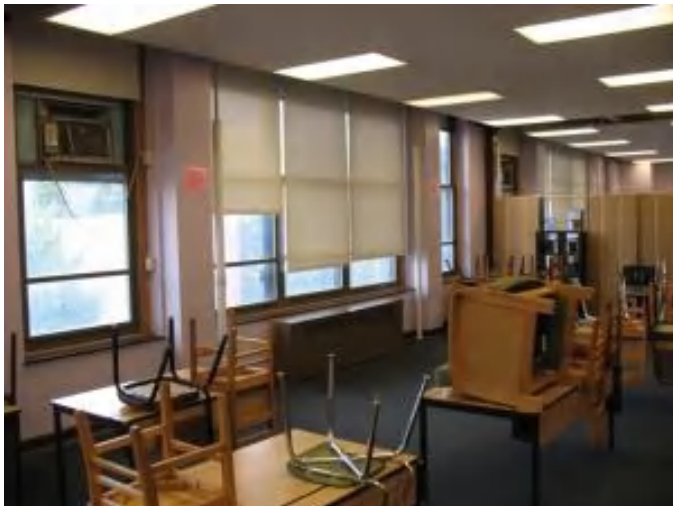
System: D3030 - Cooling Generating Systems

Terminal & Package Units - Several of the classrooms in the school building have window air conditioning units that have an anticipated service life of only 10 years. Installing a 250 ton air-cooled chiller with pumps located in a mechanical room and chilled water distribution piping would supply more reliable air conditioning for the building with a much longer service life.

Location: Throughout building

Distress: Inadequate

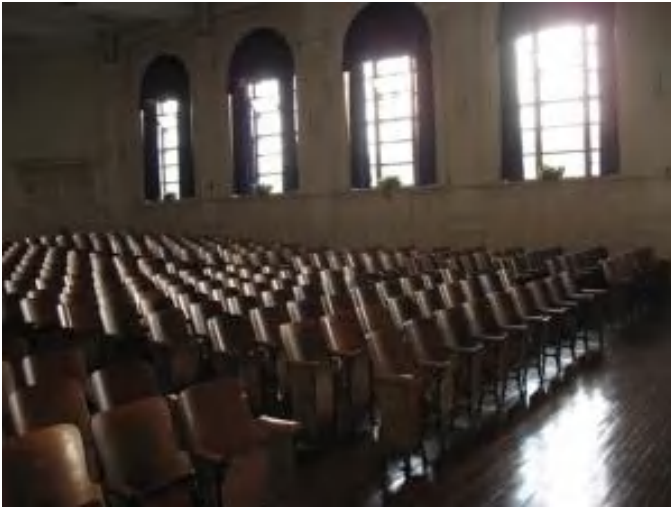
System: D3040 - Distribution Systems

Location: Auditorium

Distress: Building / MEP Codes

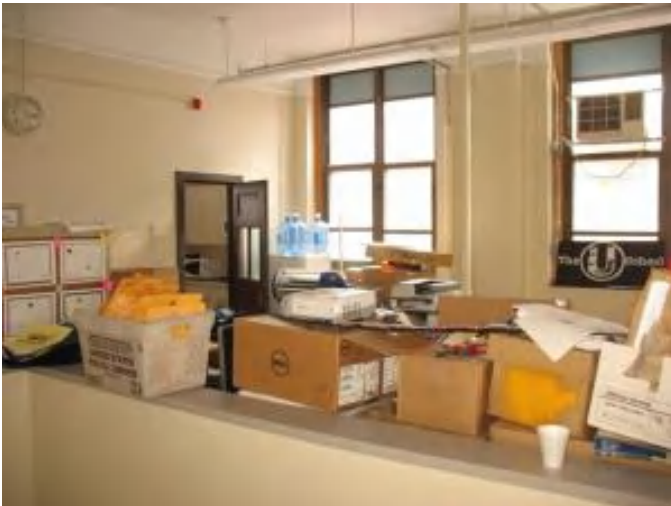
System: D3040 - Distribution Systems

Location: Administration

Distress: Building / MEP Codes

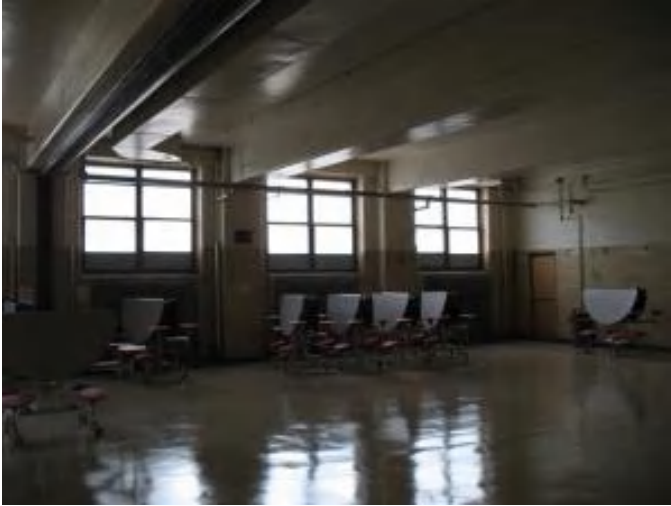
System: D3040 - Distribution Systems

Location: Gymnasium

Distress: Building / MEP Codes

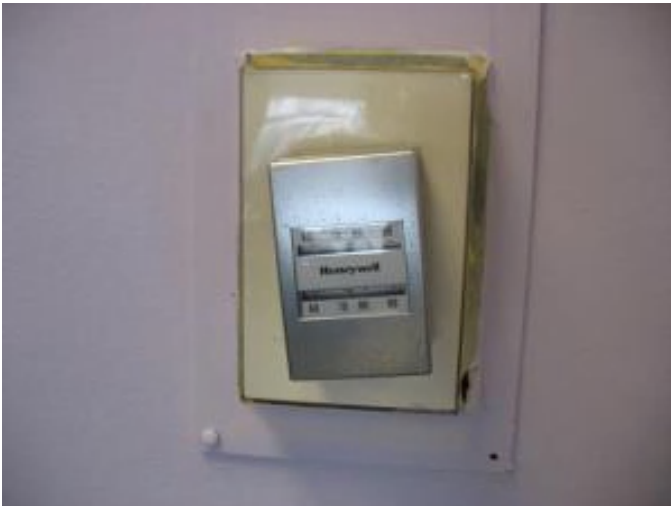
System: D3060 - Controls & Instrumentation

Controls & Instrumentation - The original pneumatic systems no longer provide any control functions. Pneumatic room thermostats are intended to control the steam radiator control valves. In reality the radiator control valves are wide open and heating control is achieved via the boilers. Pneumatic control air is no longer supplied and the compressor has been removed. The pneumatic systems are beyond their service life. The original control valves and pneumatic actuators are beyond their service life and should be rebuilt or replaced. These controls should be converted to DDC.

Location: Throughout building

Distress: Inadequate

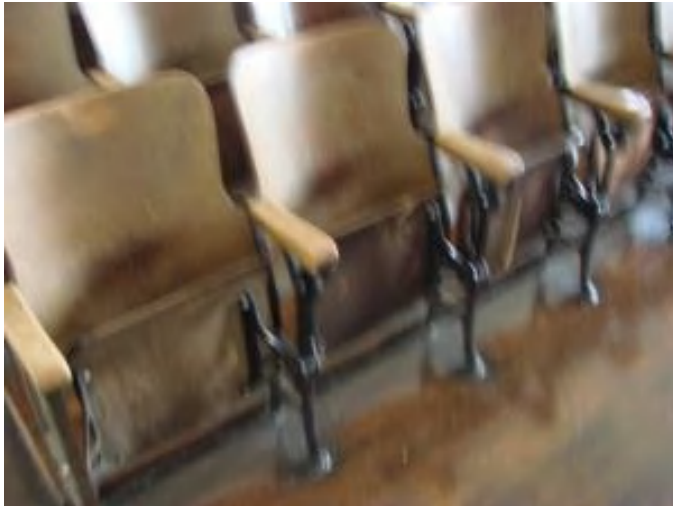
System: E2010 - Fixed Furnishings

Furnishings include fixed casework in classrooms, corridors and library, generally in good condition; window shades/blinds, generally in good condition; fixed auditorium seating is original, generally in fair condition with some damaged and missing seats; it is beyond the service life.

Location: Interior

Distress: Beyond Service Life

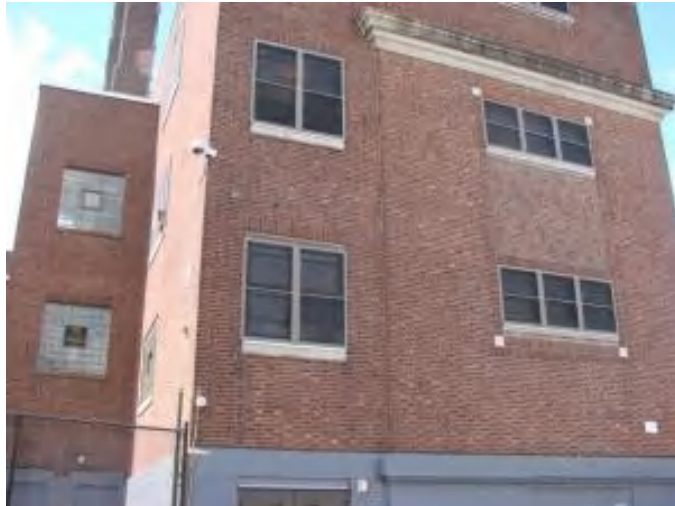
System: G4020 - Site Lighting

Location: Grounds

Distress: Security Issue

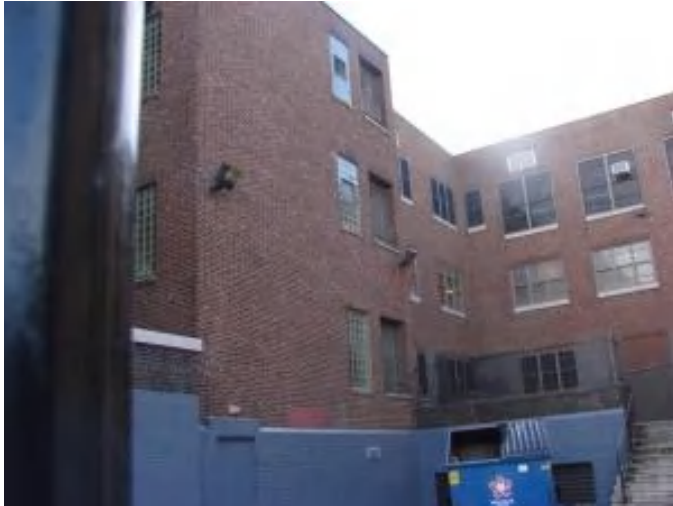
System: G4030 - Site Communications & Security

Location: grounds

Distress: Beyond Service Life

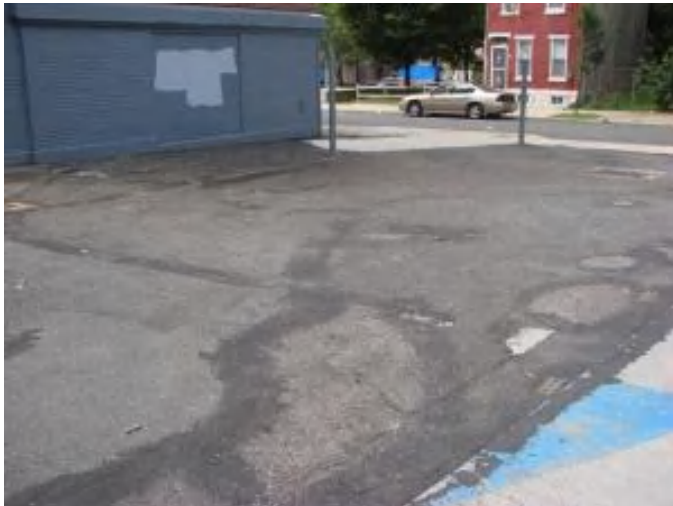
System: G2030 - Pedestrian Paving

Playground adjacent to the building is in poor condition, paving is cracked and deteriorated; playground equipment is new. Original perimeter wrought iron picket fences are generally in poor condition and rusting. There is no landscaping, except two very small patches of grass at southwest and southeast corners of the original building.

Location: Grounds/ site

Distress: Beyond Service Life

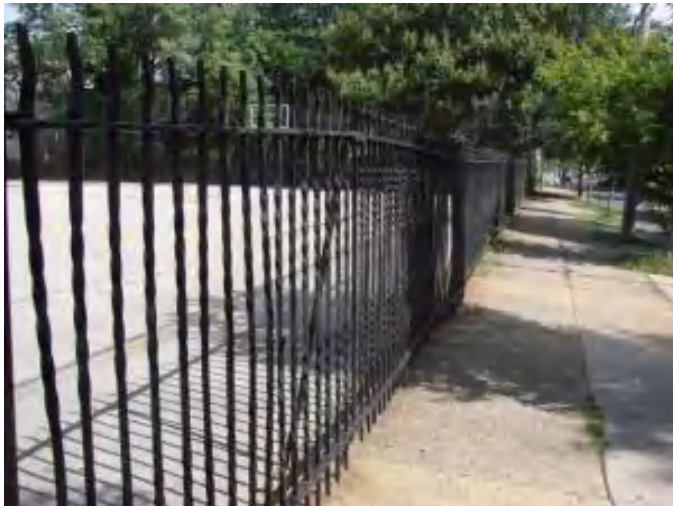
System: G2040 - Site Development

Location: Grounds/ site

Distress: Beyond Service Life
