Facility Condition Assessment Summary Report

CAPA School

S202001;CAPA

Site Assessment Report

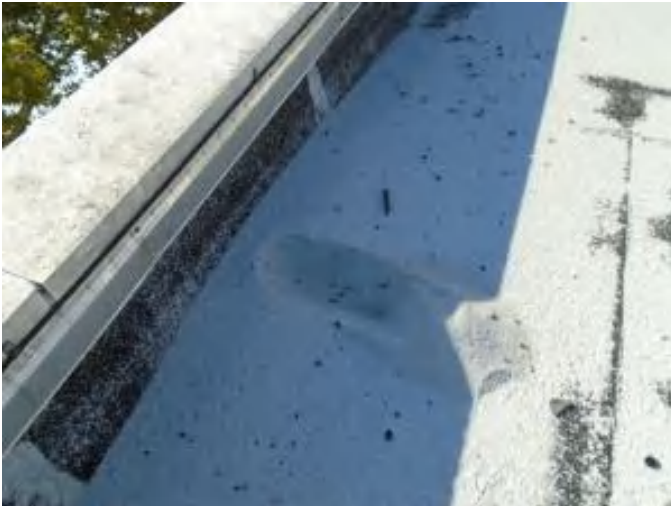
System: B3010105 - Built-Up

Location: Addition roof

Distress: Failing

Notes: Replace built up roofing on addition – beyond service life and failing

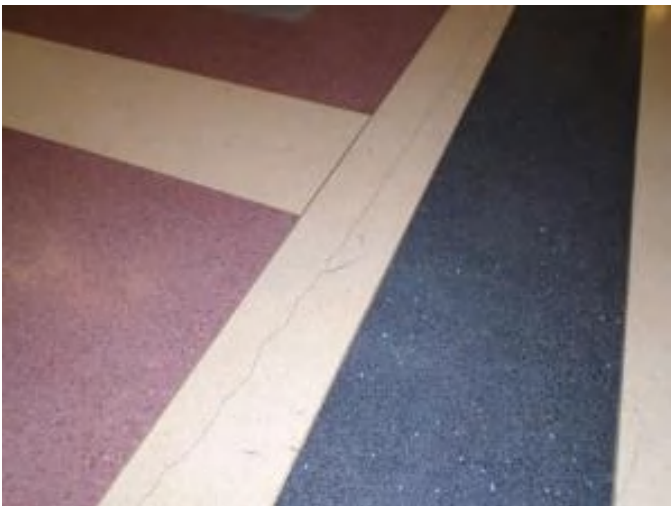
System: C3020412 - Terrazzo & Tile

Location: Grand lobby

Distress: Damaged

Notes: Repair terrazzo tile - cracked

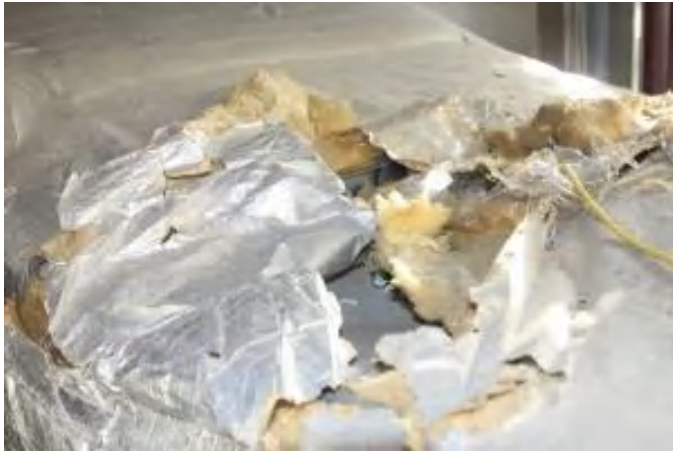
System: D3040 - Distribution Systems

Location: Entire building
Distress: Damaged
Category: 3 - Operations / Maint.
Priority: 2 - Response Time (2-3 yrs)
Correction: Replace hydronic distribution piping insulation - 100 LF of piping
Qty: 200.00
Unit of Measure: L.F.
Estimate: \$6,982.83
Assessor Name: Ben Nixon
Date Created: 09/02/2015

Notes: Replace insulation on chilled water systems with water resistant / vapor barrier insulation to eliminate condensation and prevent water damage to piping, equipment, and building.

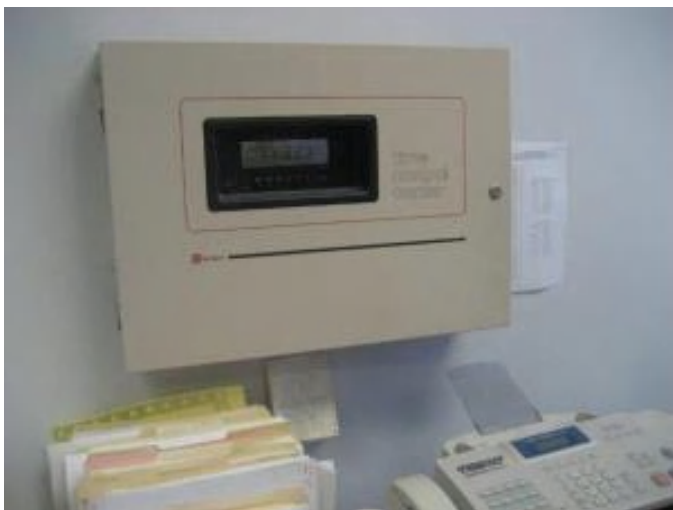
System: D5030 - Communications and Security

The school is provided with a Simplex central clock system. The present clocks are old and difficult to find parts and repair.

Location: Entire Building
Distress: Obsolete
Category: 3 - Operations / Maint.
Priority: 2 - Response Time (2-3 yrs)
Correction: Add/Replace Clock System or Components
Qty: 88.00
Unit of Measure: Ea.
Estimate: \$126,180.60
Assessor Name: Ben Nixon
Date Created: 10/15/2015

Notes: Replace clock and bell system with wireless, battery operated, clock system

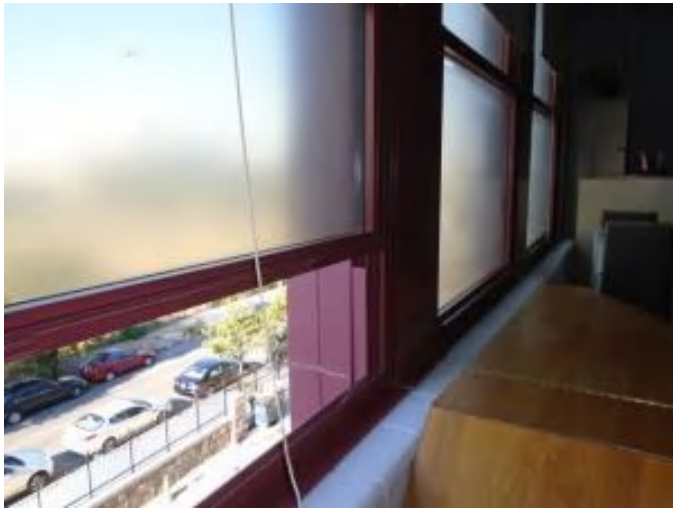
System: B2020 - Exterior Windows

Location: Addition

Distress: Energy Efficiency

Notes: Replace Plexiglas window – hazed and not energy efficient

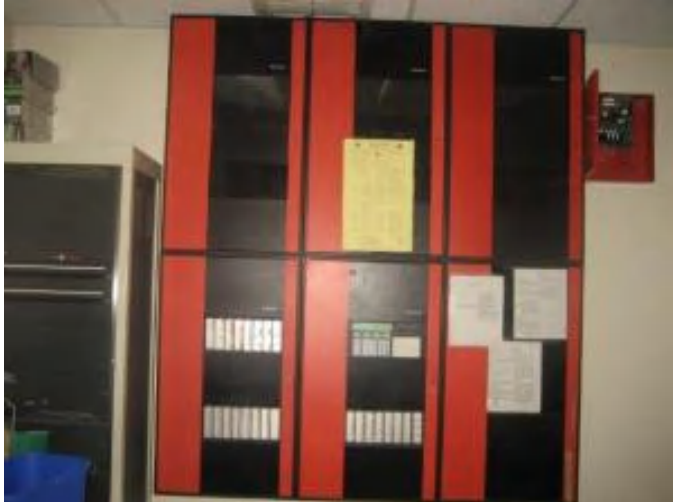
System: D5030 - Communications and Security

Location: Entire Building

Distress: Inadequate

Notes: Provide new fire alarm system.

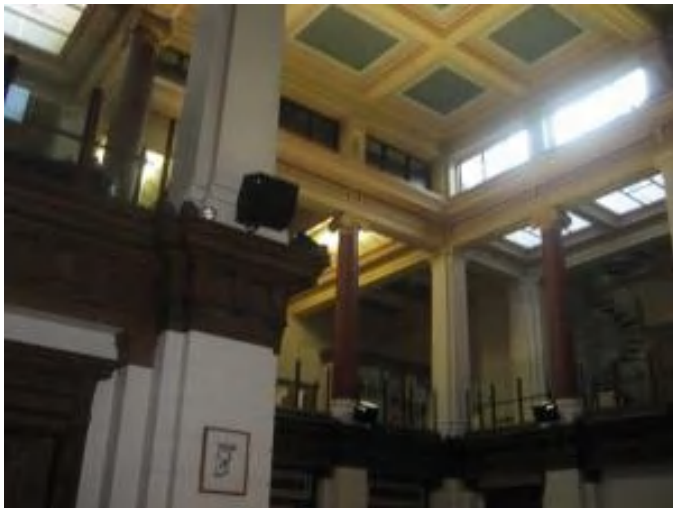
System: D5030 - Communications and Security

Location: Entire Building

Distress: Security Issue

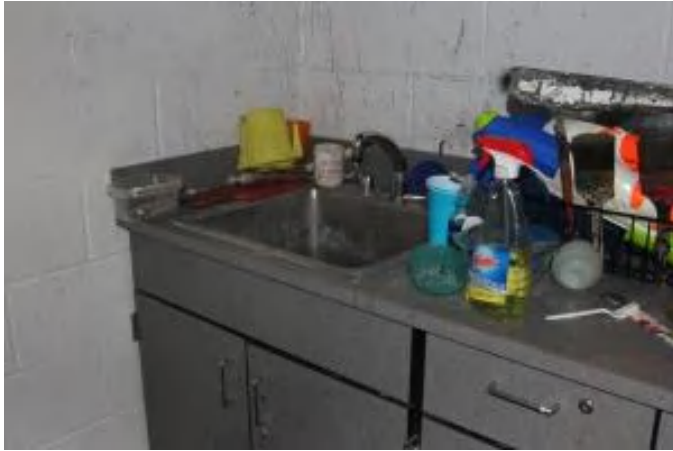
System: D2010 - Plumbing Fixtures

Building plumbing fixtures were installed during the 1996 addition. Restroom fixtures on each floor consist of wall hung water closets, urinals and lavatories. A few fixtures leak, drip, or do not flow at all and need repair. The fixtures should provide reliable service for the next 10 to 20 years.

Location: Bathrooms

Distress: Maintenance Required

Notes: Repair inoperative plumbing fixtures throughout the building.

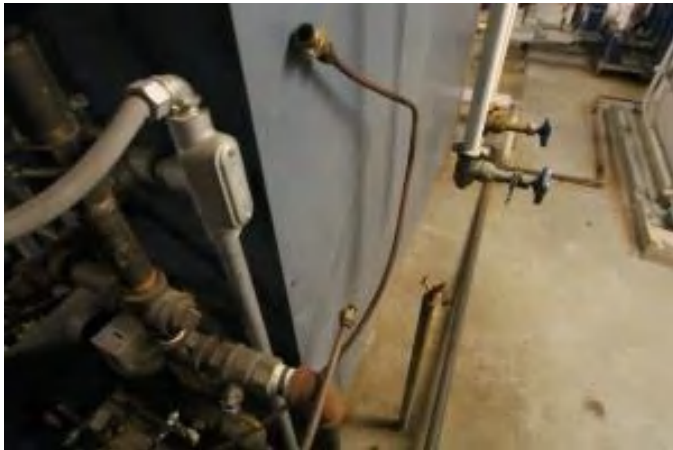
System: D3020 - Heat Generating Systems

Location: Attic mechanical room

Distress: Damaged

Notes: Repair steam boiler to allow humidification control.

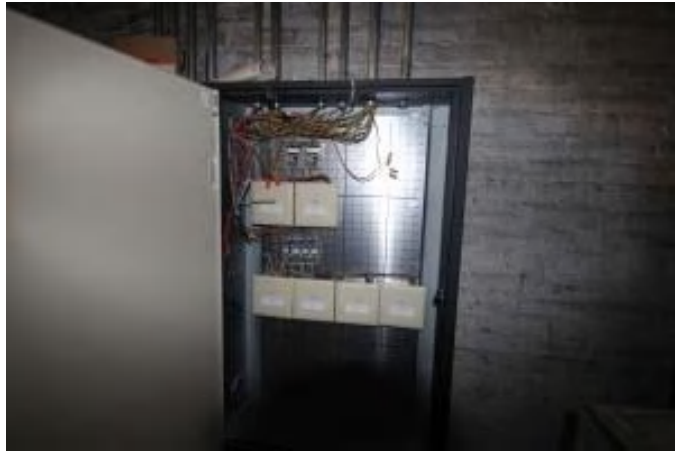
System: D3060 - Controls & Instrumentation

The original electric control system has been inoperable for over 10 years according to the building engineer. Class rooms have wall mounted analog thermostats. The principal stated the chillers do not restart automatically after energy saving shutdowns and also the lack of control system operation causes the building HVAC to run at full capacity and make the building either too hot in the winter or too cold in the summer and waste energy either way. The building control system should be inspected, repaired or upgraded as needed, and recommissioned to allow variable control of systems components for improved comfort and energy savings. Several pressure and temperature instruments throughout the building are damaged and need replacement.

Location: Entire building

Distress: Damaged

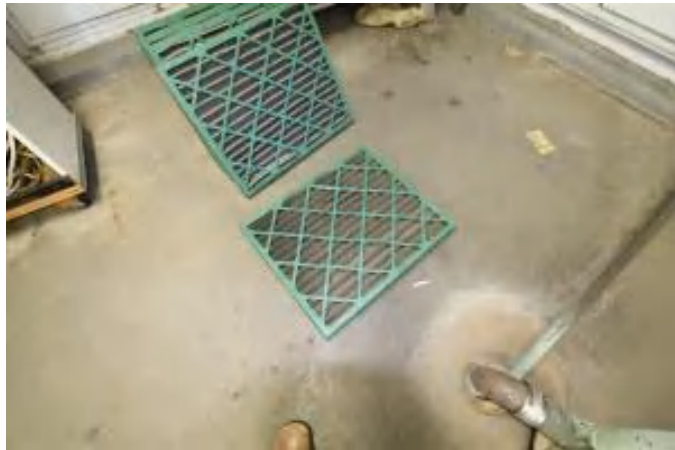
System: D3060 - Controls & Instrumentation

Location: Entire building

Distress: Health Hazard / Risk

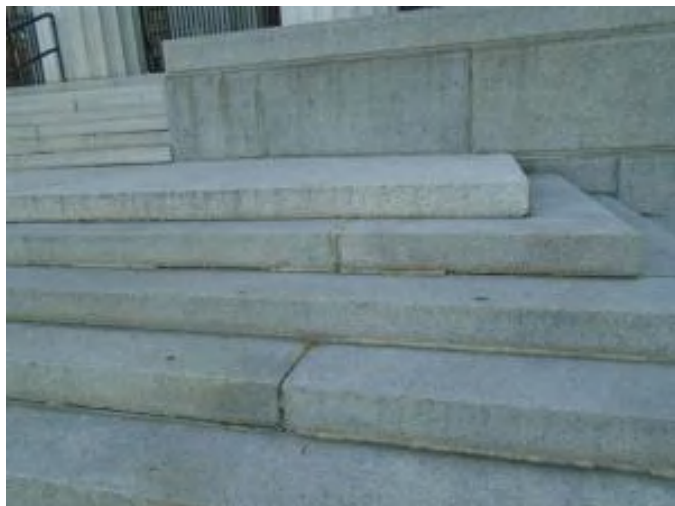
System: G2030 - Pedestrian Paving

Location: G202001;Grounds

Distress: Damaged

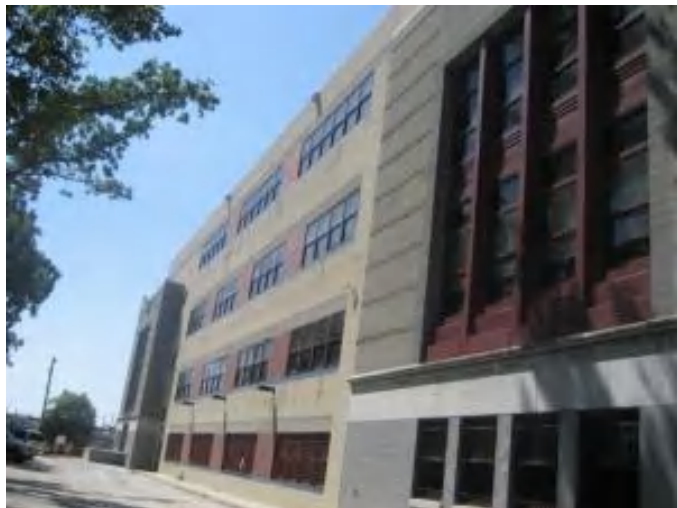
System: G4020 - Site Lighting

The school perimeter is illuminated decorative wall/pole mounted fixtures. Some fixtures do not work and others are difficult to find parts. Replace with equal type inoperative wall/pole mounted lighting fixtures.

Location: Exterior

Distress: Security Issue

- Replace with equal type inoperative wall/pole mounted lighting fixtures.
