## Facility Condition Assessment Summary Report

### Camelot Academy (Boone) School

**S231001;Boone**

**Site Assessment Report**

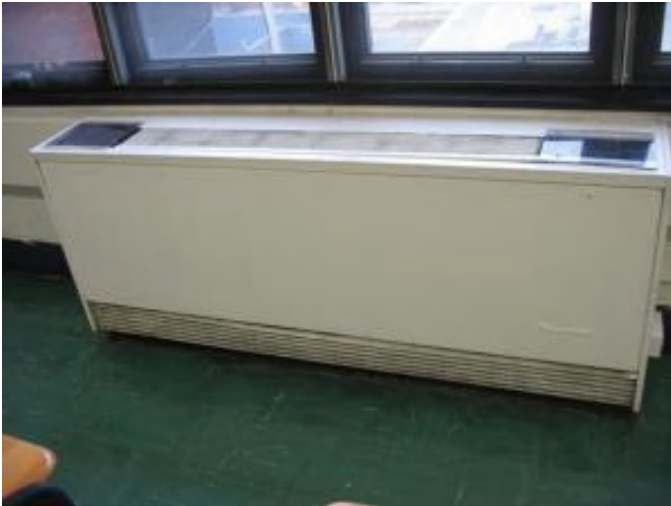
#### System: D3040 - Distribution Systems

**Location:** Throughout building

**Distress:** Failing

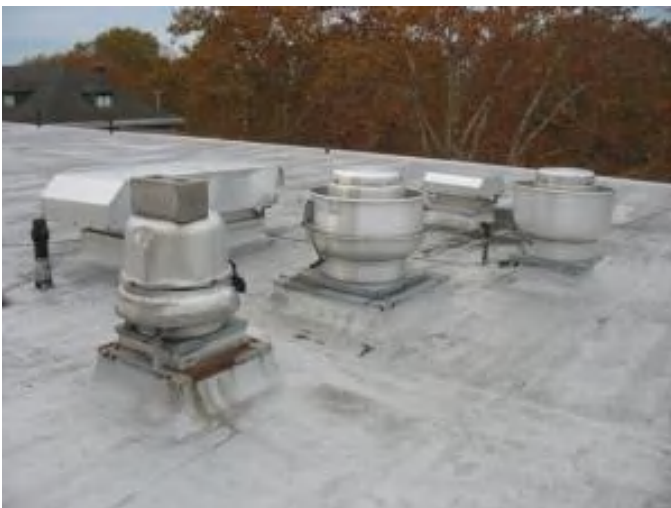
#### System: D3040 - Distribution Systems

**Location:** Roof

**Distress:** Failing

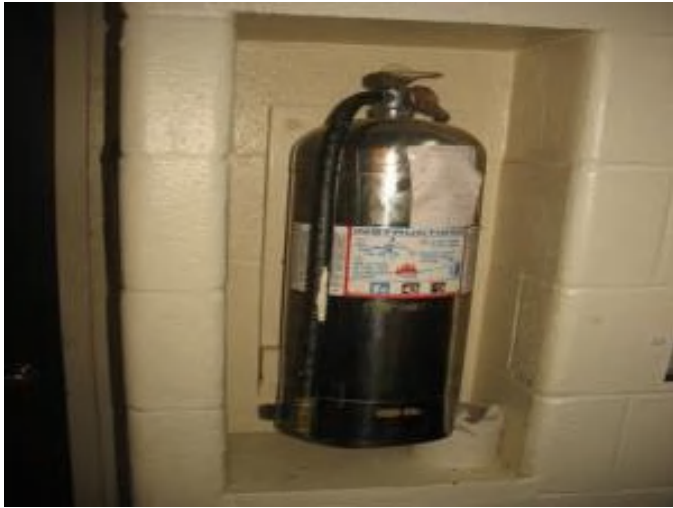
**System: D4010 - Sprinklers**

**Location:** Throughout building

**Distress:** Life Safety / NFPA / PFD

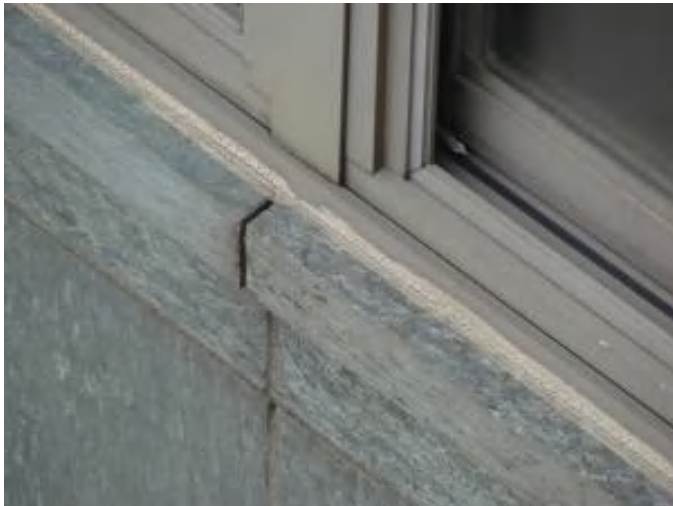
**System: B2010 - Exterior Walls**

**Location:** Rear of building facing gym roof

**Distress:** Building Envelope Integrity

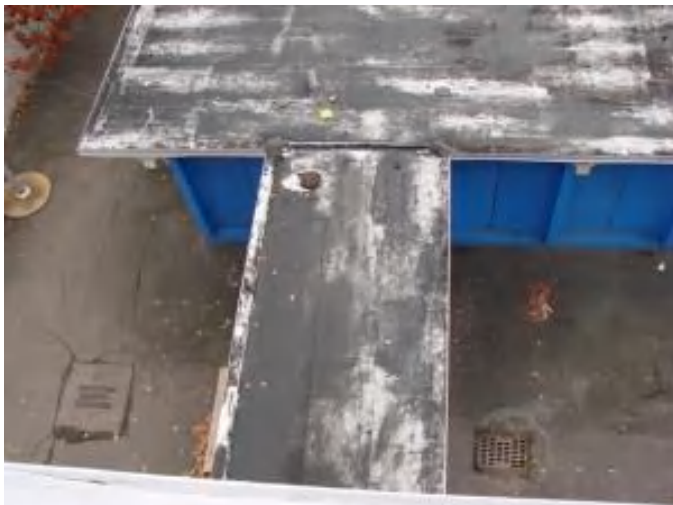
**System: B3010105 - Built-Up**

**Location:** Upper, lower and portable unit roof areas

**Distress:** Building Envelope Integrity

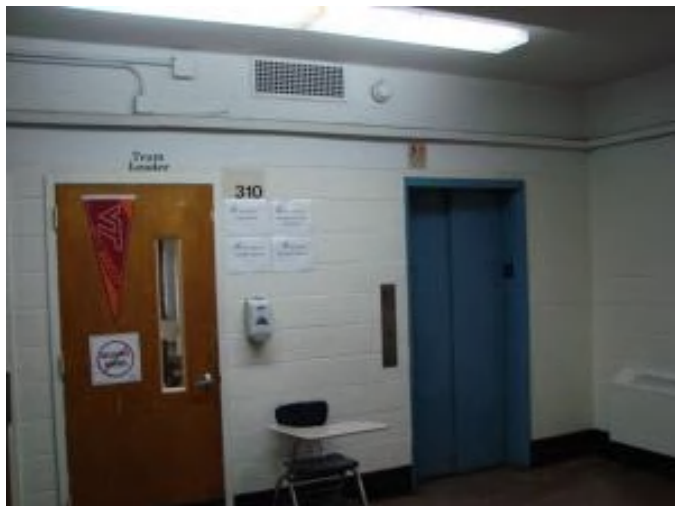
**System: D1010 - Elevators and Lifts**

**Location:** Main lobby area

**Distress:** Beyond Service Life

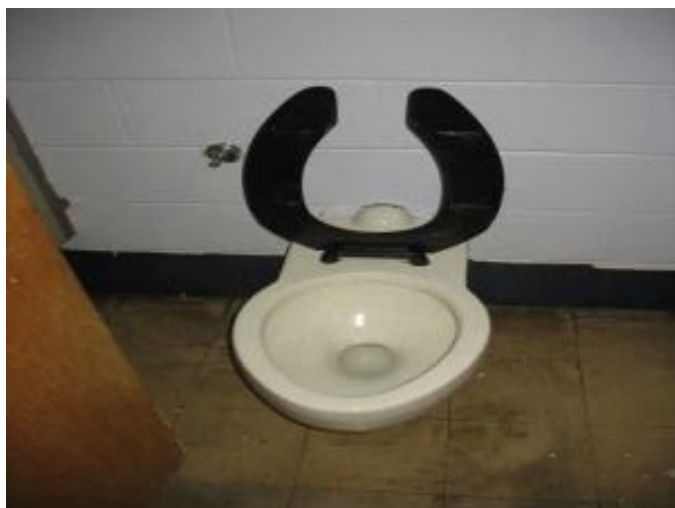
**System: D2010 - Plumbing Fixtures**

**Location:** Restrooms

**Distress:** Beyond Service Life

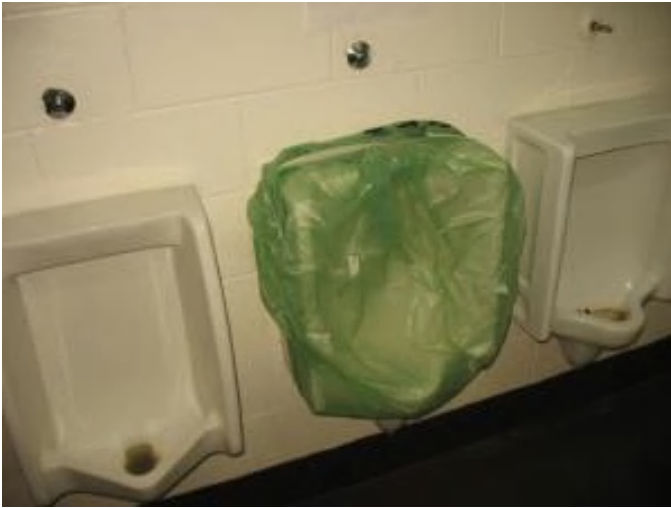
**System: D2010 - Plumbing Fixtures**

**Location:** Restrooms

**Distress:** Beyond Service Life

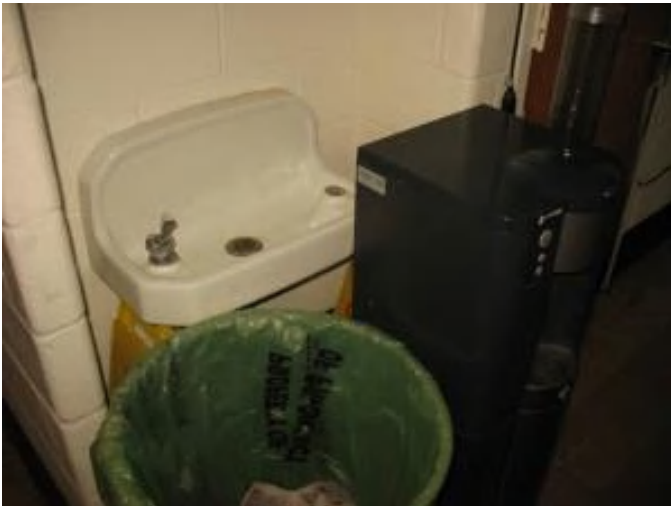
**System: D2010 - Plumbing Fixtures**

**Location:** Corridors

**Distress:** Beyond Service Life

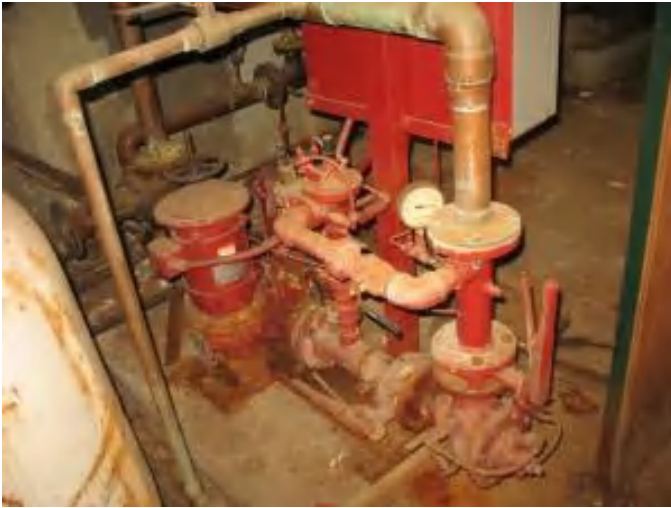
**System: D2020 - Domestic Water Distribution**

**Location:** Boiler room

**Distress:** Damaged

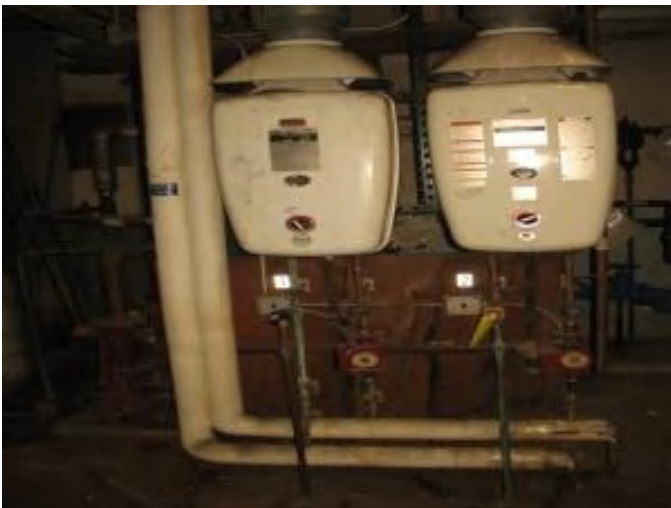
**System: D2020 - Domestic Water Distribution**

**Location:** Boiler room

**Distress:** Beyond Service Life

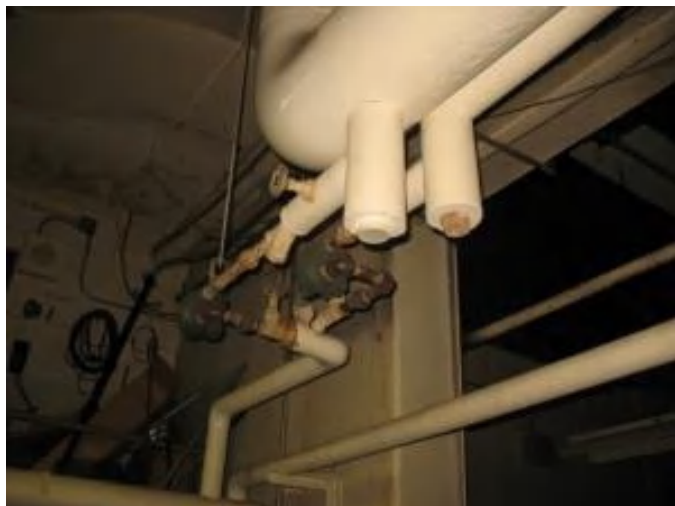
**System: D3040 - Distribution Systems**

**Location:** Throughout building

**Distress:** Beyond Service Life

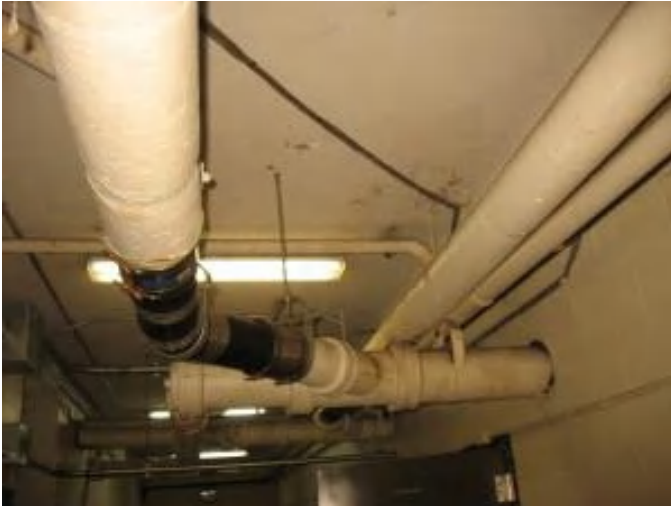
**System: D2030 - Sanitary Waste**

**Location:** Throughout building

**Distress:** Beyond Service Life

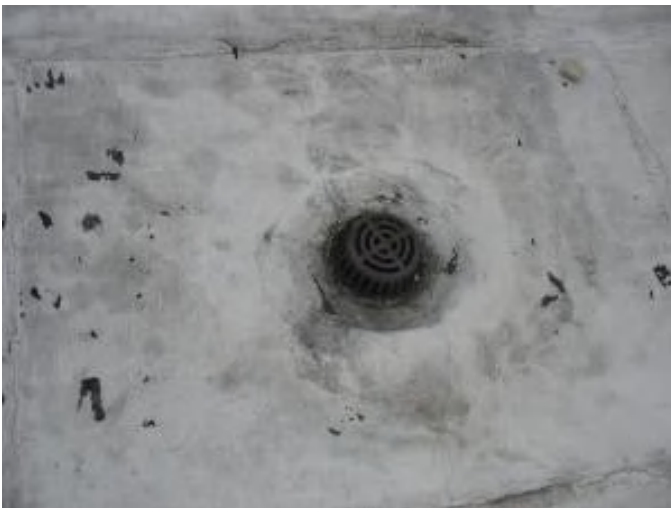
**System: D2040 - Rain Water Drainage**

**Location:** Throughout building

**Distress:** Beyond Service Life

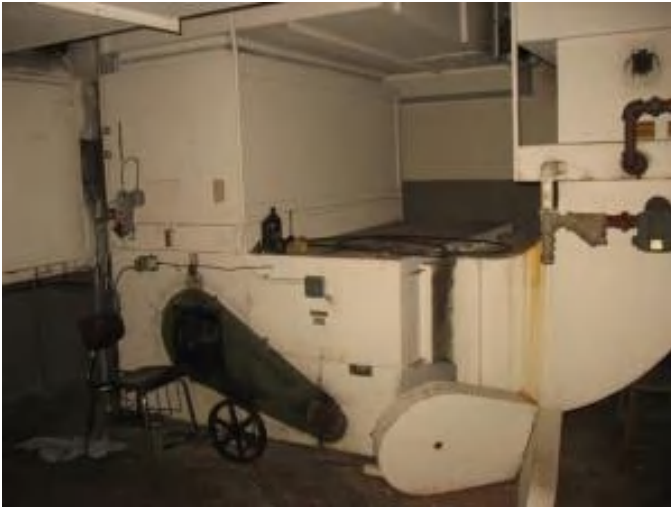
**System: D3040 - Distribution Systems**

**Location:** Auditorium

**Distress:** Building / MEP Codes

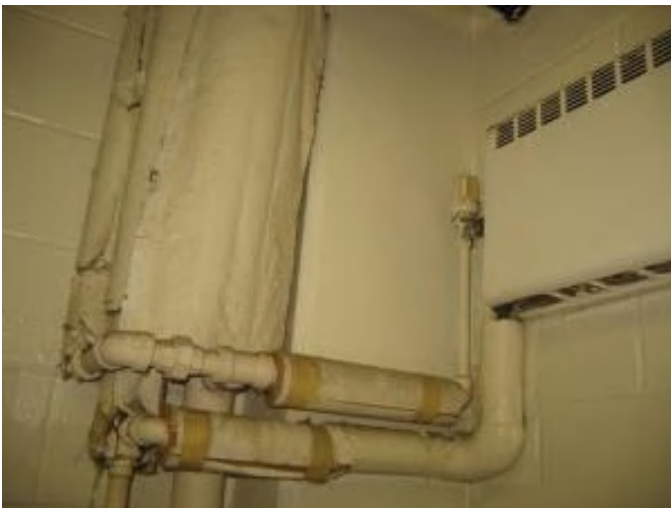
**System: D3040 - Distribution Systems**

**Location:** Throughout building

**Distress:** Beyond Service Life

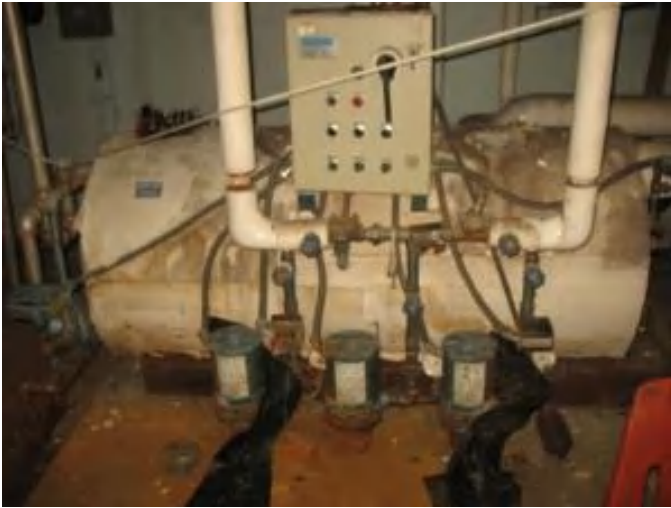
**System: D3040 - Distribution Systems**

**Location:** Boiler room

**Distress:** Damaged

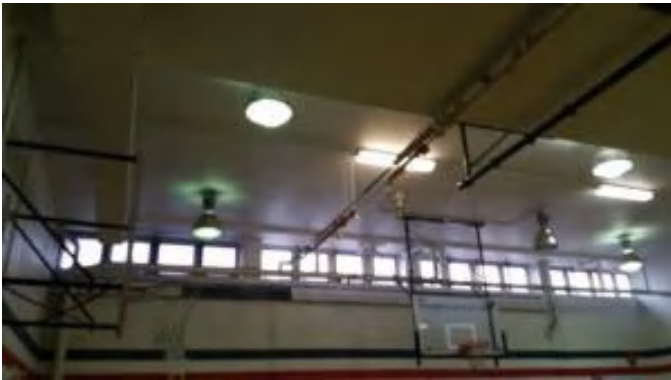
**System: D5020 - Lighting and Branch Wiring**

**Location:** throughout the building

**Distress:** Beyond Service Life

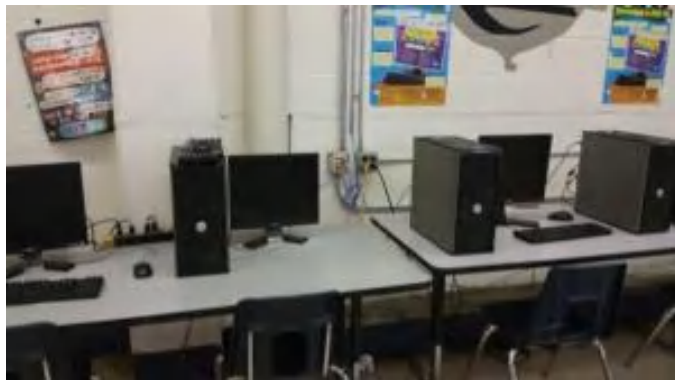
**System: D5020 - Lighting and Branch Wiring**

**Location:** throughout the building

**Distress:** Inadequate

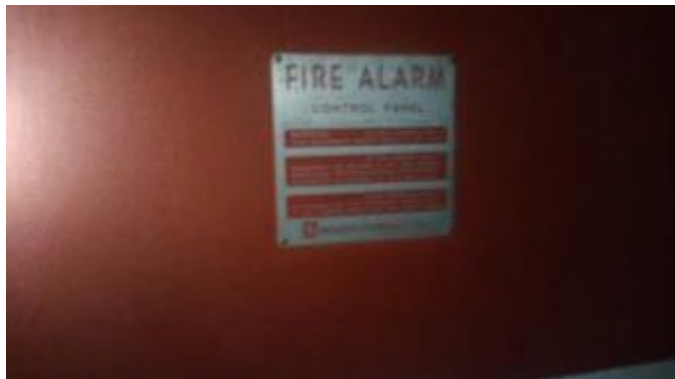
**System: D5030 - Communications and Security**

**Location:** throughout the building

**Distress:** Health Hazard / Risk

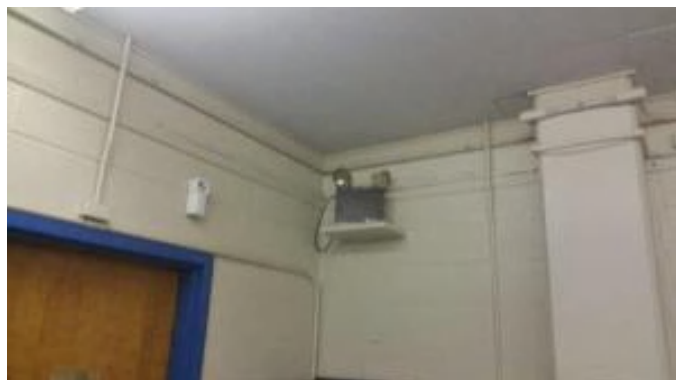
**System: D5090 - Other Electrical Systems**

**Location:** throughout the building

**Distress:** Beyond Service Life

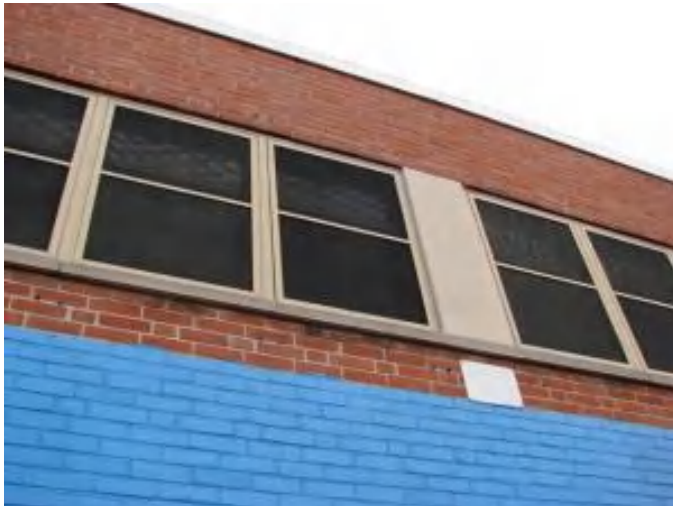
**System: B2020 - Exterior Windows**

**Location:** All exterior elevations

**Distress:** Beyond Service Life

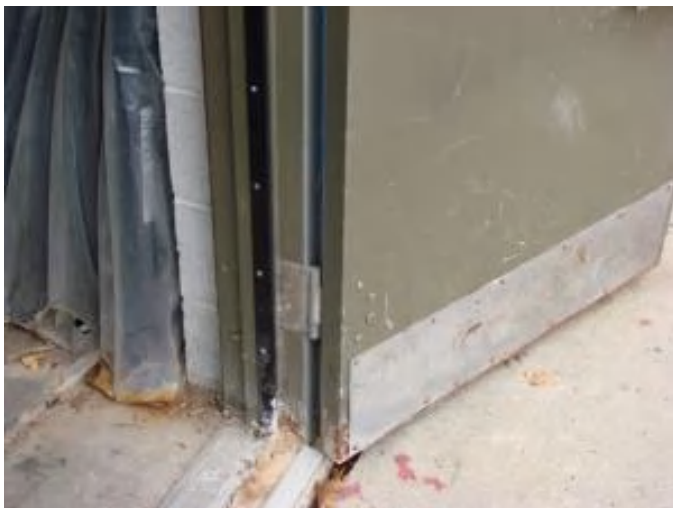
**System: B2030 - Exterior Doors**

**Location:** South elevation egress exit doors

**Distress:** Beyond Service Life

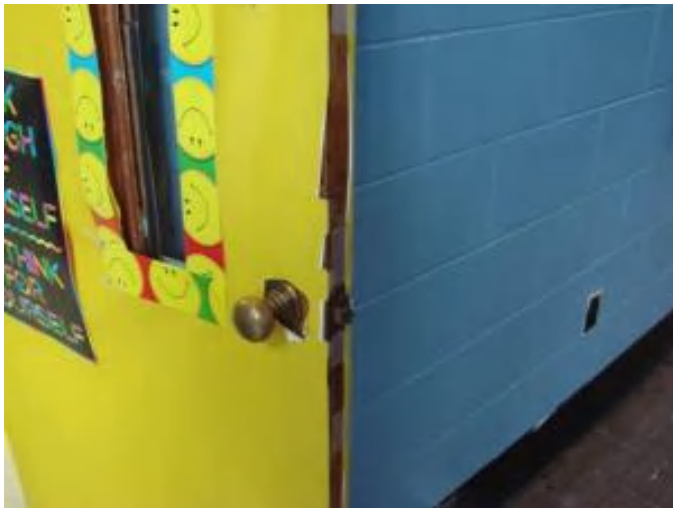
**System: C1020 - Interior Doors**

**Location:** Interior doors; corridors, classrooms, restrooms

**Distress:** Beyond Service Life

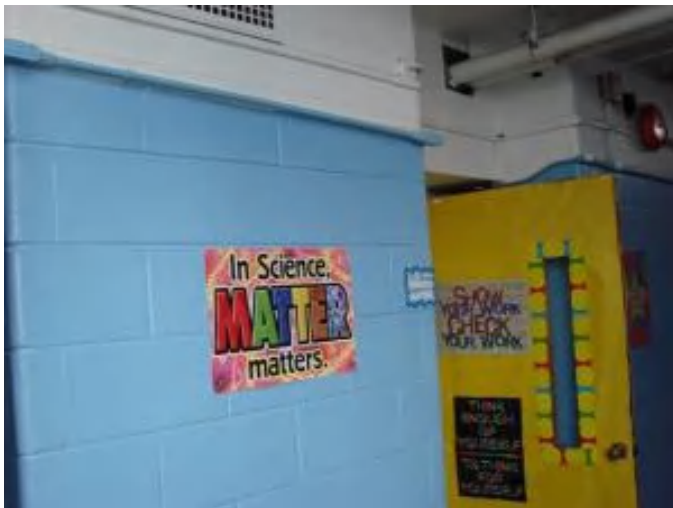
**System: C1030 - Fittings**

**Location:** Offices and classrooms

**Distress:** Appearance

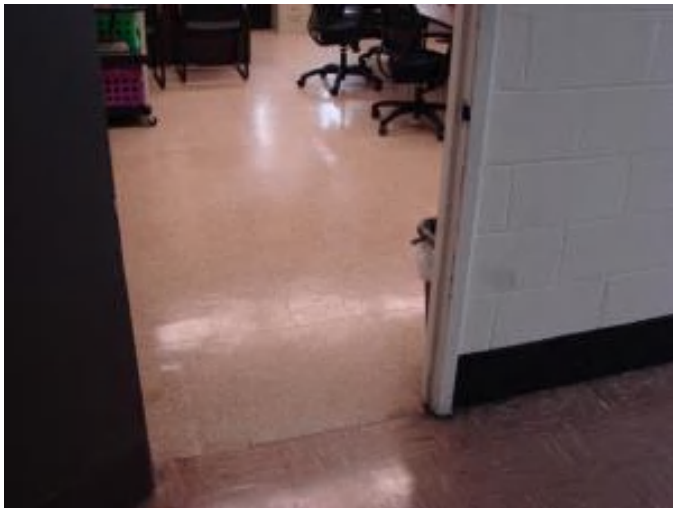
**System: C3020413 - Vinyl Flooring**

**Location:** Corridors, classrooms and storage areas

**Distress:** Beyond Service Life

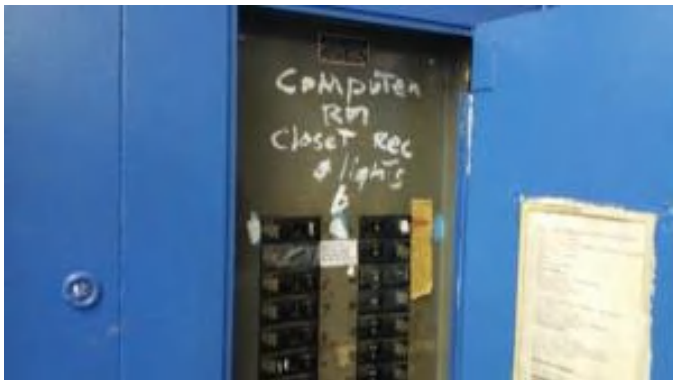
**System: D5010 - Electrical Service/Distribution**

**Location:** throughout the building

**Distress:** Beyond Service Life

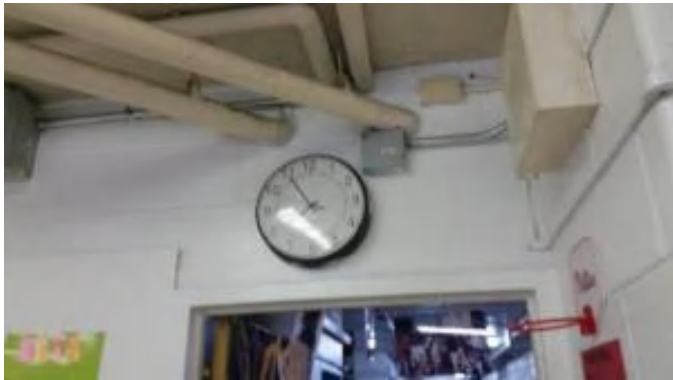
**System: D5030 - Communications and Security**

**Location:** throughout the building

**Distress:** Beyond Service Life

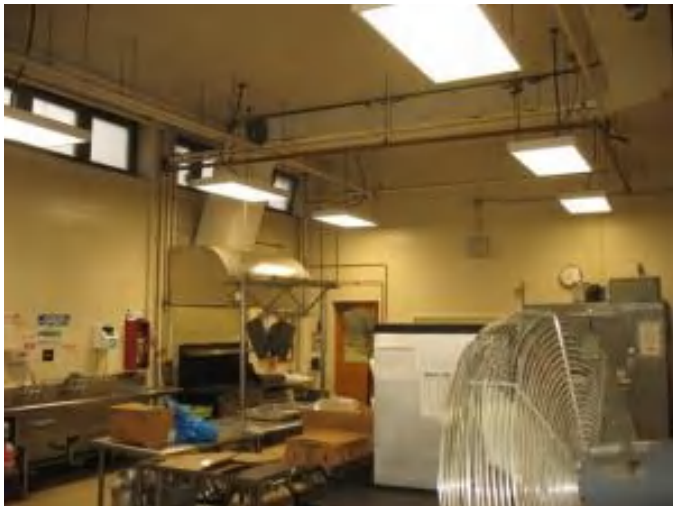
**System: E1090 - Other Equipment**

**Location:** Kitchen

**Distress:** Beyond Service Life

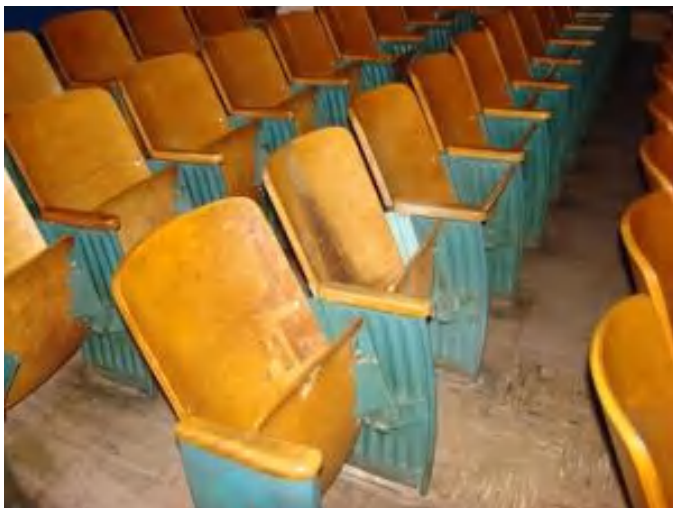
**System: E2010 - Fixed Furnishings**

**Location:** Auditorium

**Distress:** Appearance

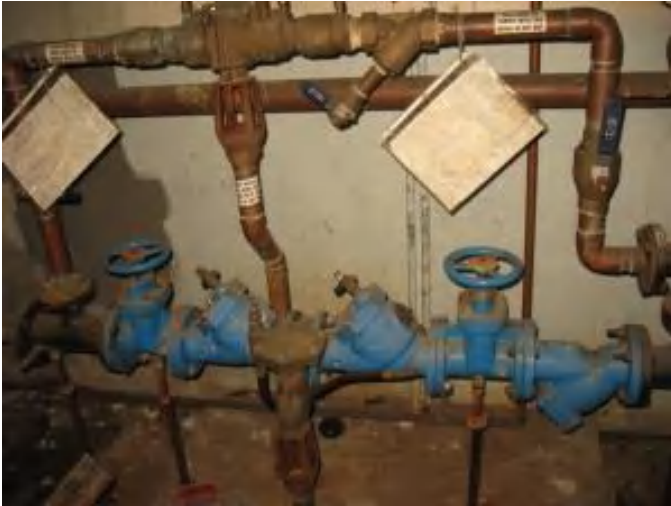
**System: D2020 - Domestic Water Distribution**

**Location:** Throughout building

**Distress:** Beyond Service Life

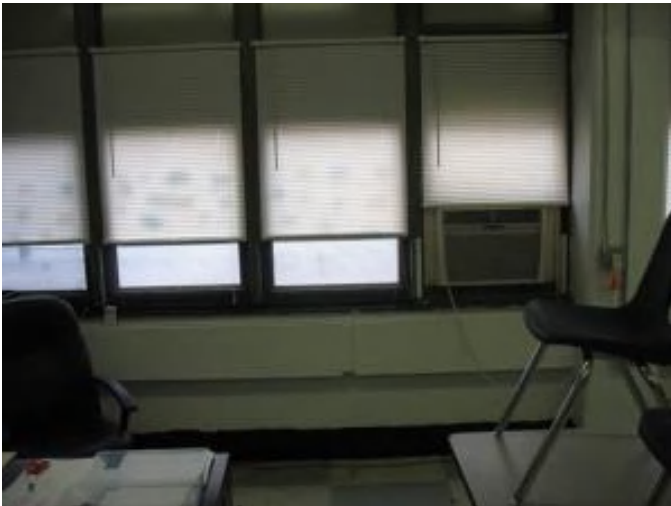
**System: D3030 - Cooling Generating Systems**

**Location:** Throughout building

**Distress:** Inadequate

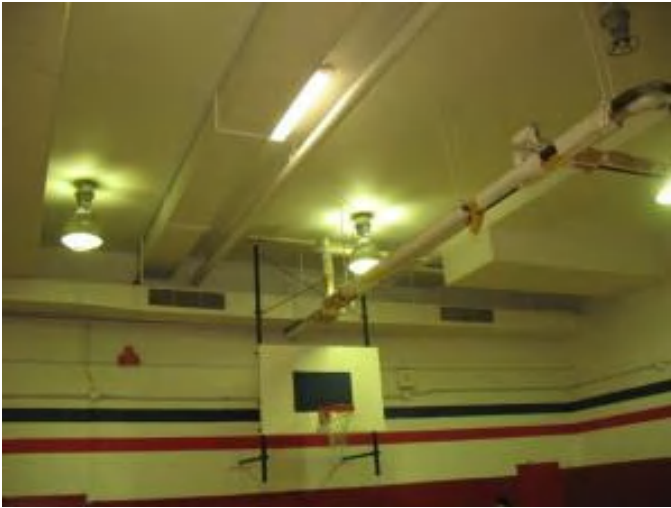
**System: D3040 - Distribution Systems**

**Location:** Gymnasium

**Distress:** Building / MEP Codes

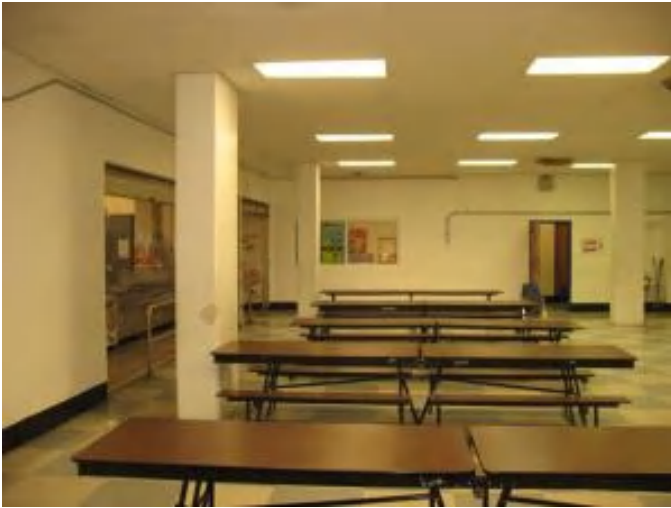
**System: D3040 - Distribution Systems**

**Location:** Cafeteria

**Distress:** Building / MEP Codes

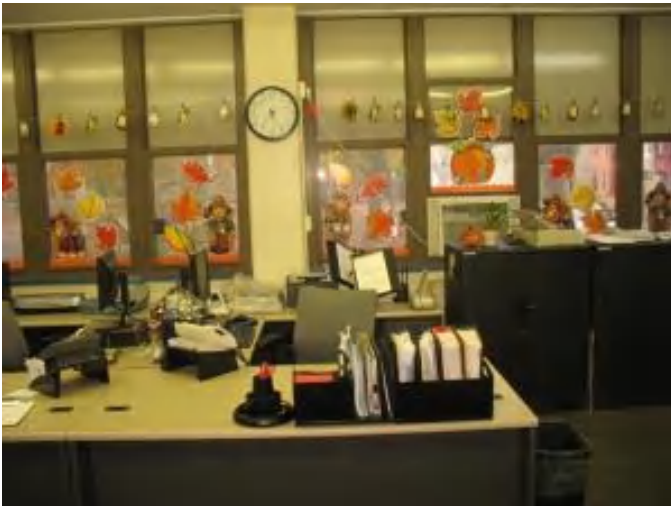
**System: D3040 - Distribution Systems**

**Location:** Administration

**Distress:** Building / MEP Codes

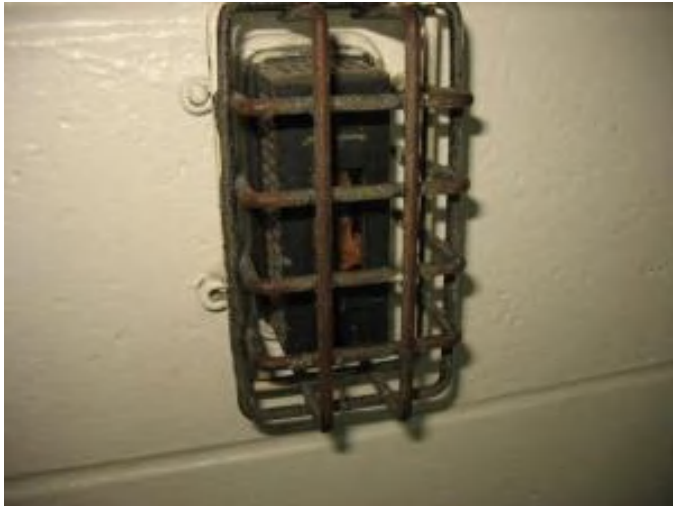
**System: D3060 - Controls & Instrumentation**

**Location:** Throughout building

**Distress:** Failing

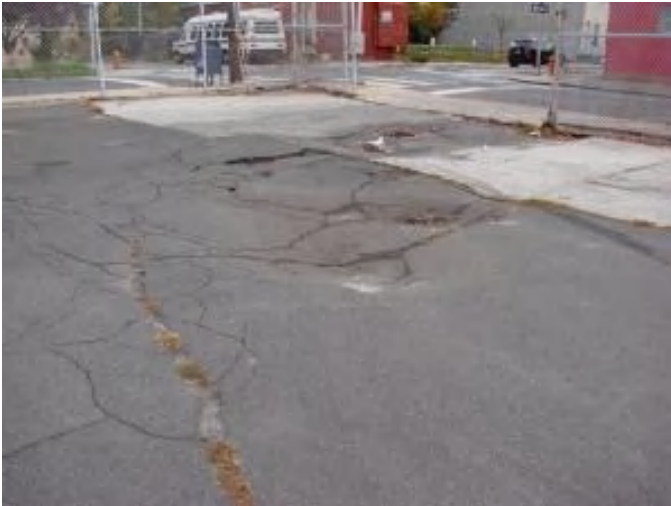
#### System: G2020 - Parking Lots

**Location:** South east corner of onsite parking area

**Distress:** Damaged

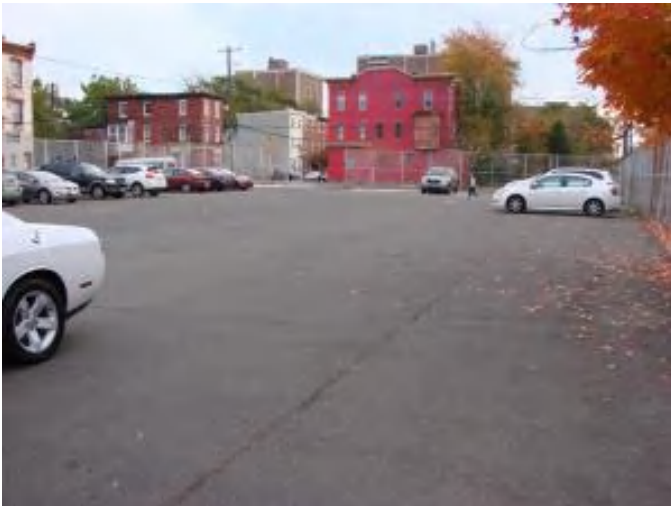
**System: G2020 - Parking Lots**

**Location:** On site parking area

**Distress:** Accessibility

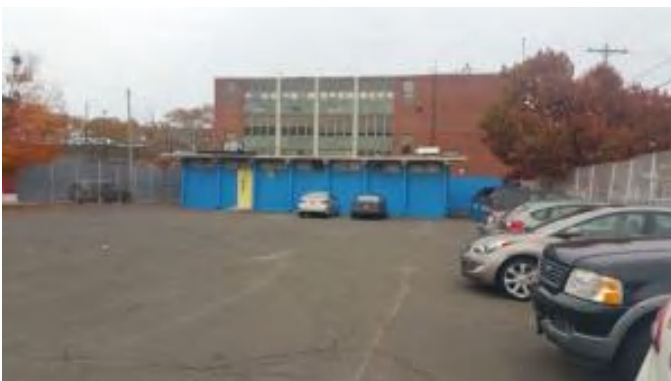
**System: G4020 - Site Lighting**

**Location:** grounds

**Distress:** Inadequate

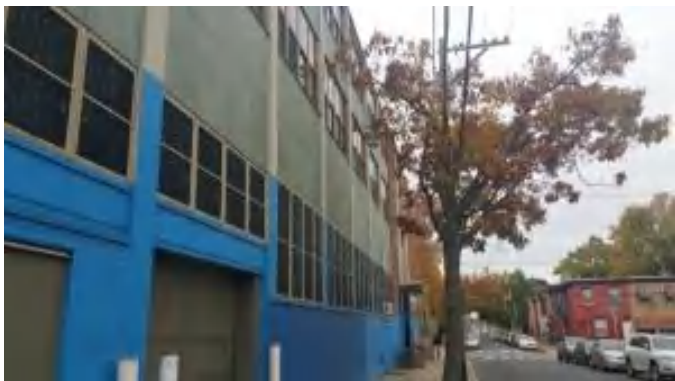
**System: G4030 - Site Communications & Security**

**Location:** grounds

**Distress:** Inadequate
