Facility Condition Assessment Summary Report

Carnell School

January 31, 2017

Facility Condition Assessment
July 2015

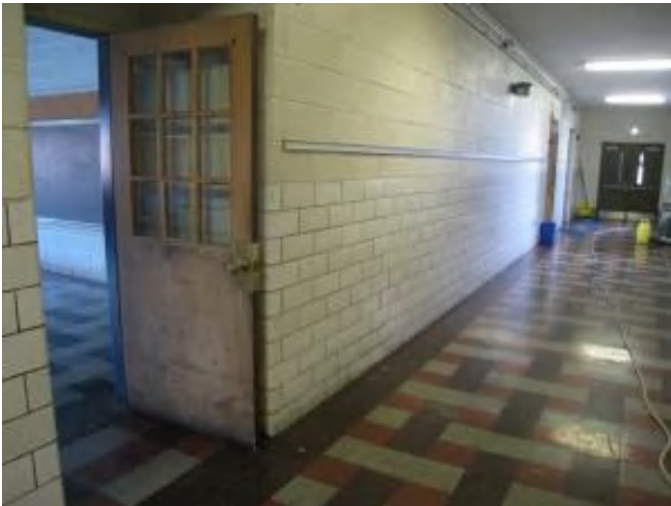
System: C1020 - Interior Doors

Location: main bldg

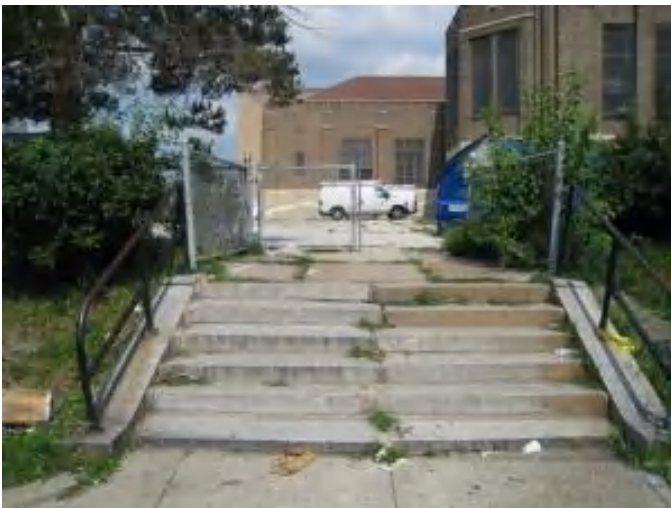
System: C2010 - Stair Construction

Location: main bldg

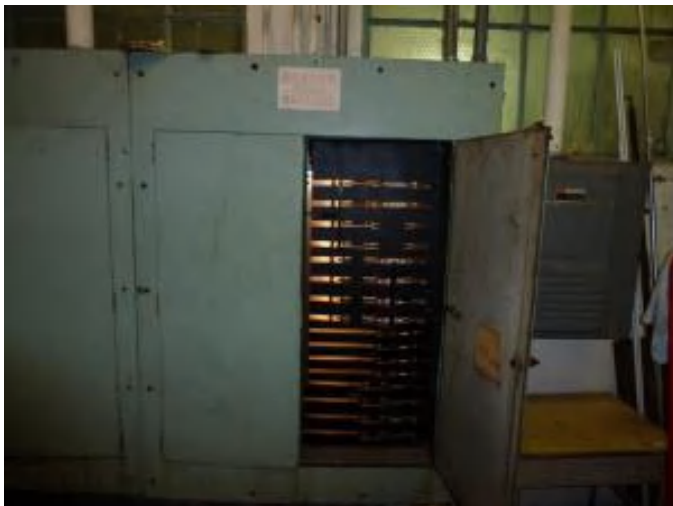
System: D5010 - Electrical Service/Distribution

Location: Entire Building

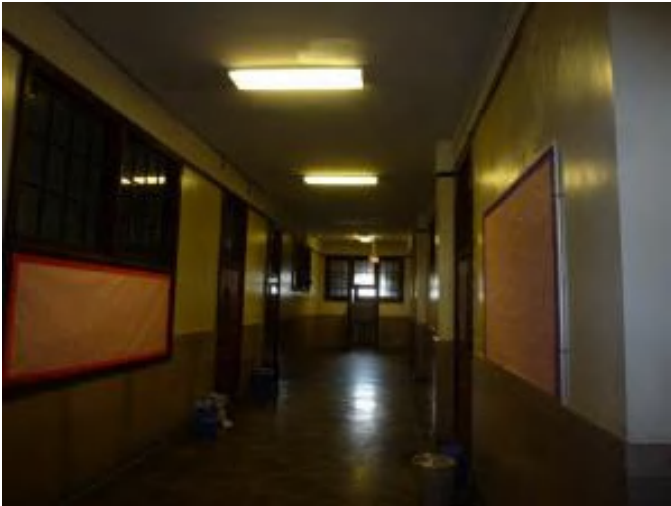
System: D5020 - Lighting and Branch Wiring

Location: Entire building
Distress: Beyond Service Life
Category: 3 - Operations / Maint.
Priority: 1 - Response Time (< 2 yr)
Correction: Replace Lighting Fixtures (SF)
Qty: 1.00
Unit of Measure: S.F.
Estimate: \$1,254,697.08
Assessor Name: System
Date Created: 07/27/2015

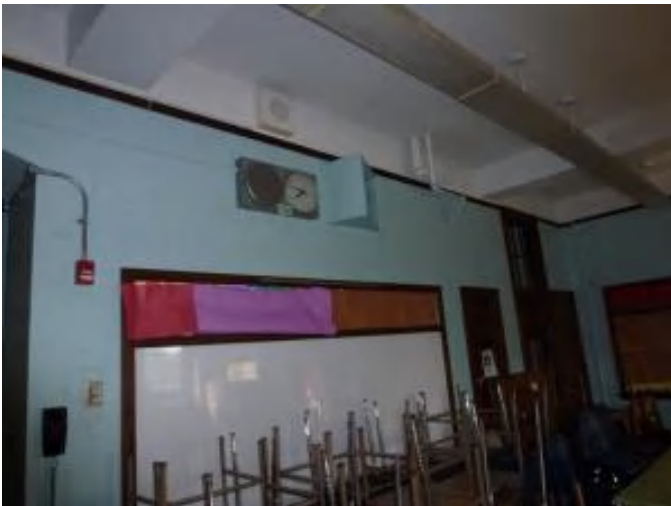
System: D5030 - Communications and Security

Location: Entire Building
Distress: Damaged
Category: 3 - Operations / Maint.
Priority: 1 - Response Time (< 2 yr)
Correction: Add/Replace Clock System or Components
Qty: 1.00
Unit of Measure: Ea.
Estimate: \$164,874.77
Assessor Name: System
Date Created: 07/27/2015

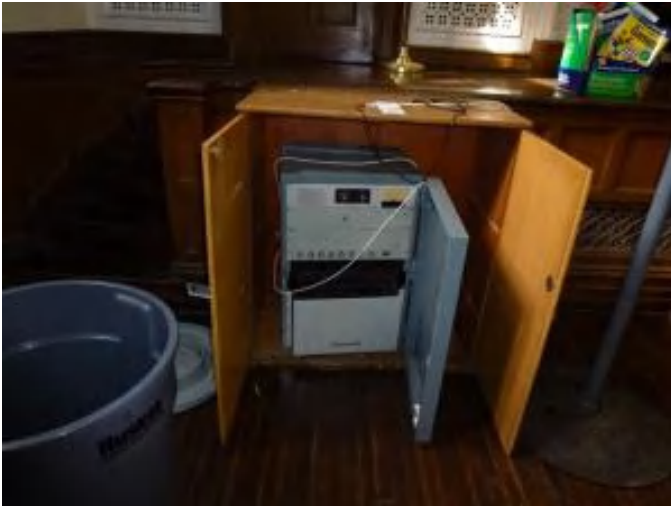
System: D5030 - Communications and Security

Location: Auditorium

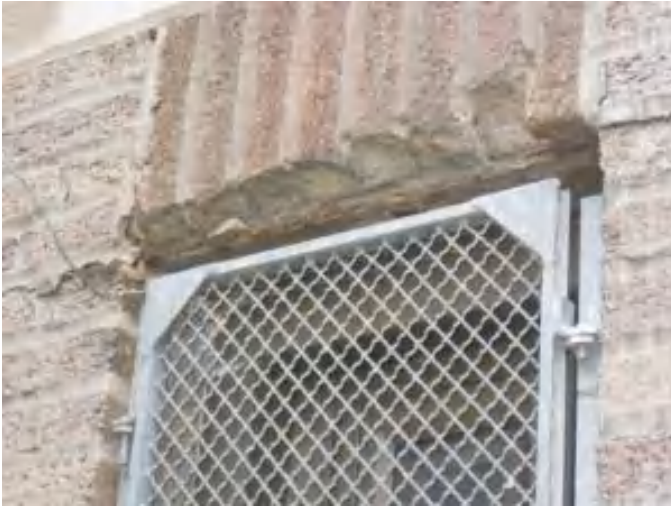
System: B2010 - Exterior Walls

Location: main bldg

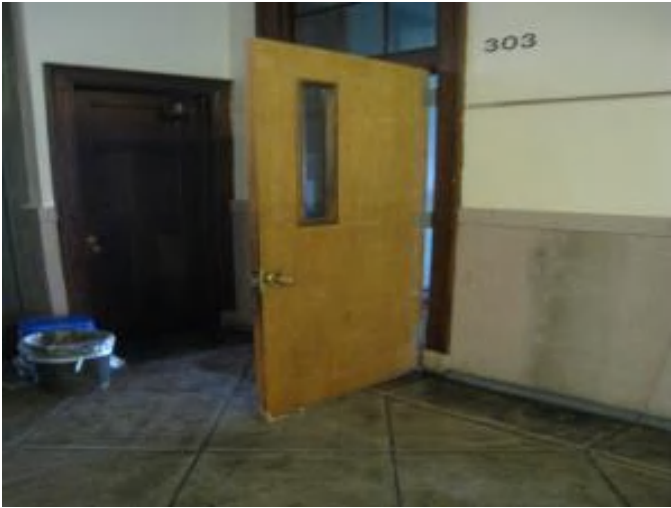
System: C1020 - Interior Doors

Location: main bldg

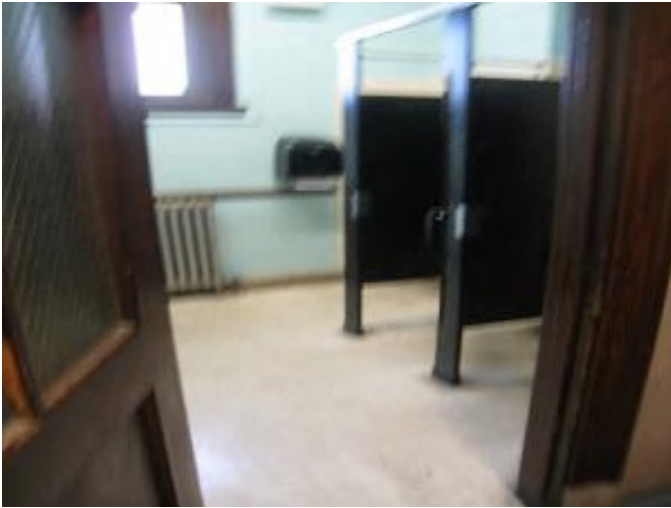
System: C1030 - Fittings

Location: main bldg
Distress: Damaged
Category: 3 - Operations / Maint.
Priority: 2 - Response Time (2-3 yrs)
Correction: Remove and replace toilet partitions
Qty: 20.00
Unit of Measure: Ea.
Estimate: \$51,328.09
Assessor Name: System
Date Created: 07/30/2015

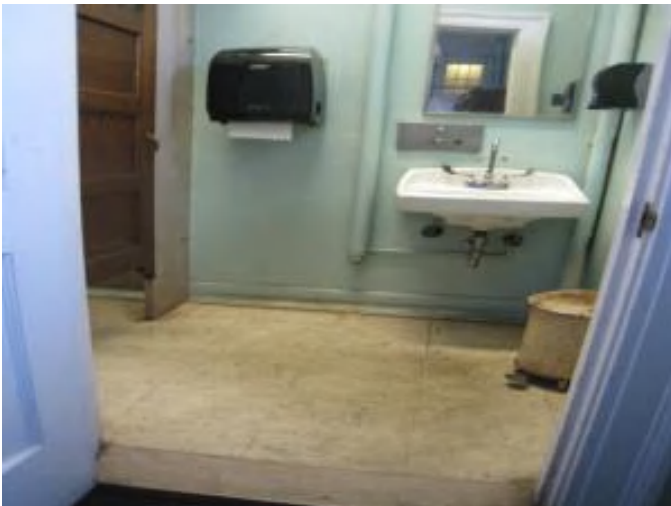
System: C1030 - Fittings

Location: main bldg
Distress: Damaged
Category: 3 - Operations / Maint.
Priority: 2 - Response Time (2-3 yrs)
Correction: Replace toilet accessories - select accessories and quantity
Qty: 10.00
Unit of Measure: Ea.
Estimate: \$5,037.71
Assessor Name: System
Date Created: 07/30/2015

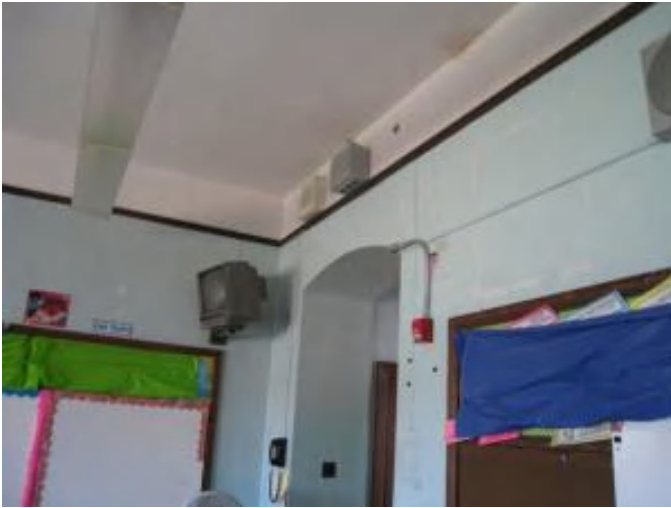
System: C3010230 - Paint & Covering

Location: main bldg

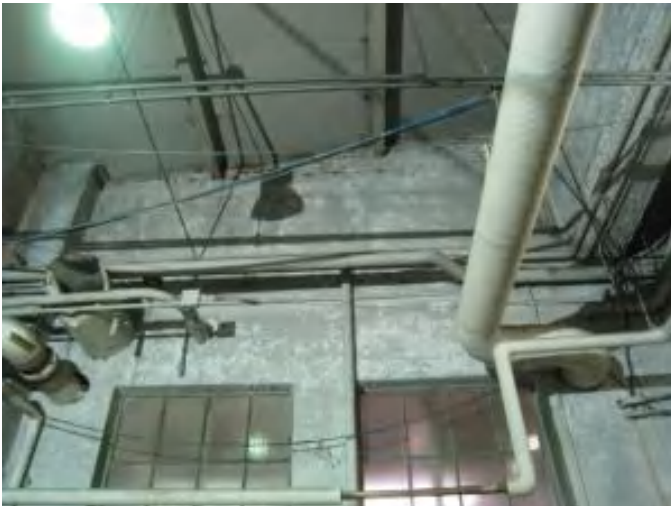
System: C3010230 - Paint & Covering

Location: main bldg

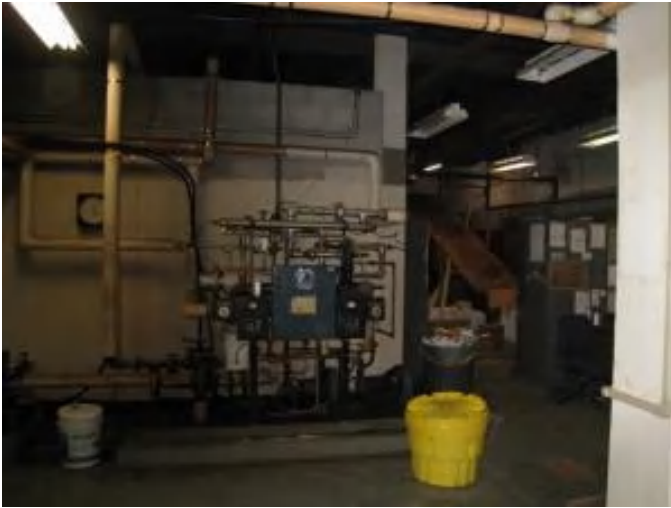
System: C3010230 - Paint & Covering

Location: main bldg
Distress: Appearance
Category: 3 - Operations / Maint.
Priority: 2 - Response Time (2-3 yrs)
Correction: Repair substrate and repaint interior concrete or CMU walls - SF of wall surface
Qty: 6,000.00
Unit of Measure: S.F.
Estimate: \$21,890.20
Assessor Name: System
Date Created: 07/29/2015

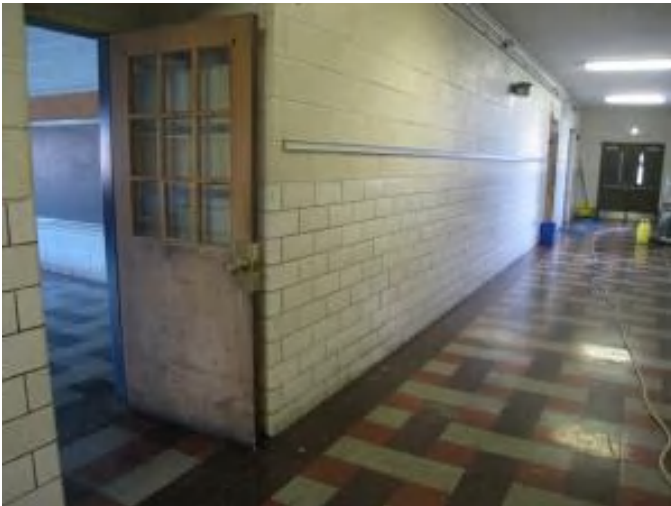
System: C3020413 - Vinyl Flooring

Location: main bldg
Distress: Beyond Service Life
Category: 3 - Operations / Maint.
Priority: 2 - Response Time (2-3 yrs)
Correction: Remove VAT and replace with VCT - SF of area
Qty: 14,200.00
Unit of Measure: S.F.
Estimate: \$215,366.69
Assessor Name: System
Date Created: 07/29/2015

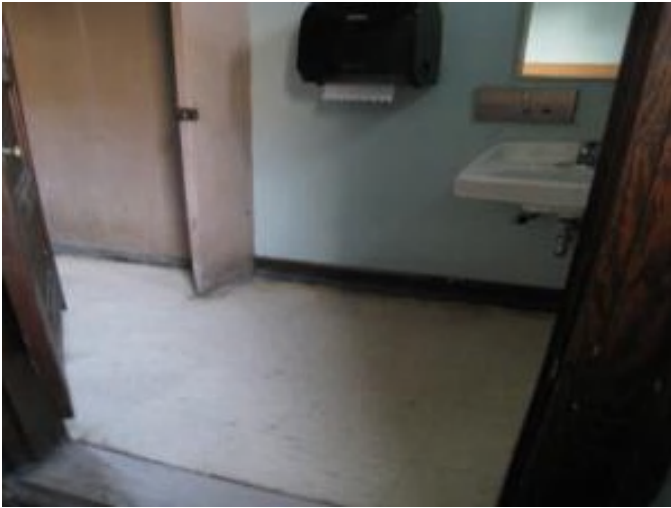
System: C3020413 - Vinyl Flooring

Location: main bldg
Distress: Appearance
Category: 3 - Operations / Maint.
Priority: 2 - Response Time (2-3 yrs)
Correction: Remove and replace VCT

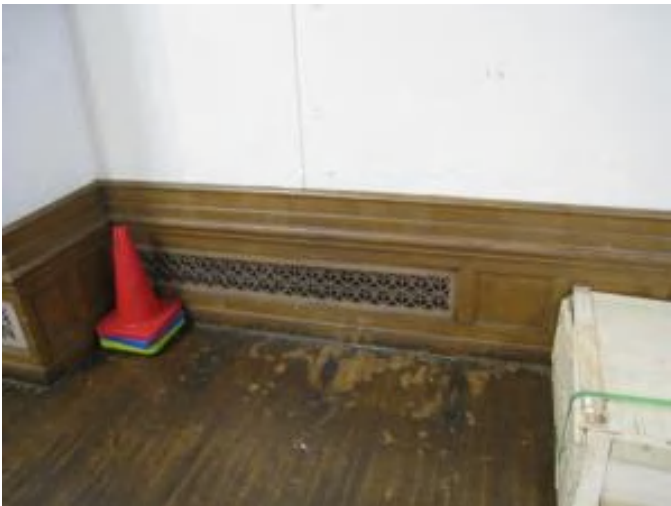
System: C3020414 - Wood Flooring

Location: main bldg
Distress: Damaged
Category: 3 - Operations / Maint.
Priority: 2 - Response Time (2-3 yrs)
Correction: Refinish wood floors

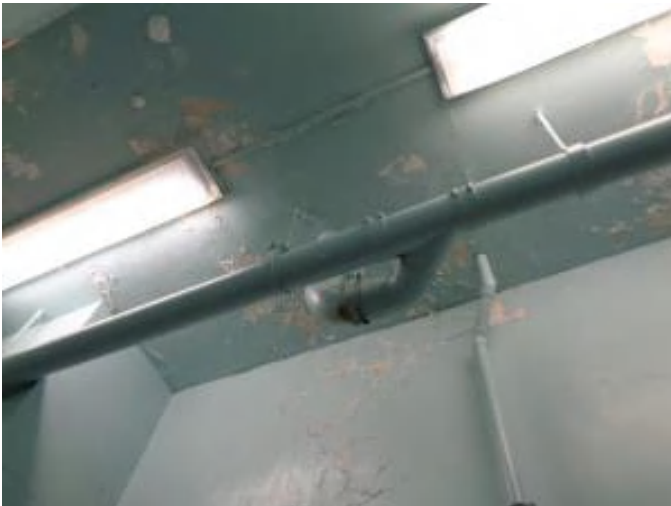
System: D2030 - Sanitary Waste

Location: main building

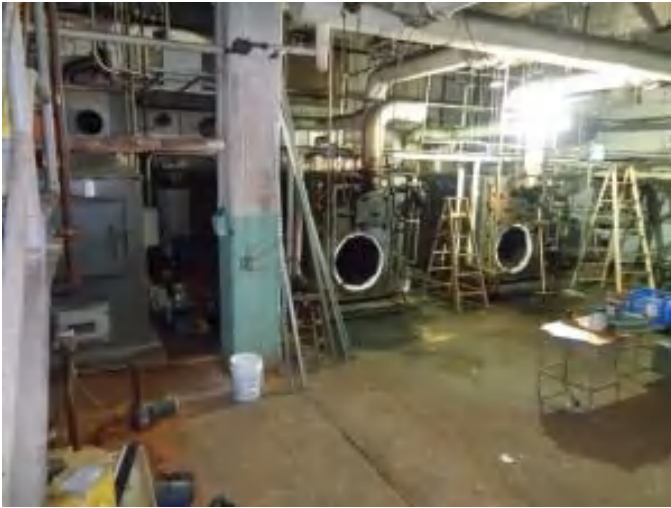
System: D3020 - Heat Generating Systems

Location: main building
Distress: Beyond Service Life
Category: 3 - Operations / Maint.
Priority: 3 - Response Time (3-4 yrs)
Correction: Replace boiler, cast iron sectional (150 HP)
Qty: 2.00
Unit of Measure: Ea.
Estimate: \$1,050,121.66
Assessor Name: System
Date Created: 07/31/2015

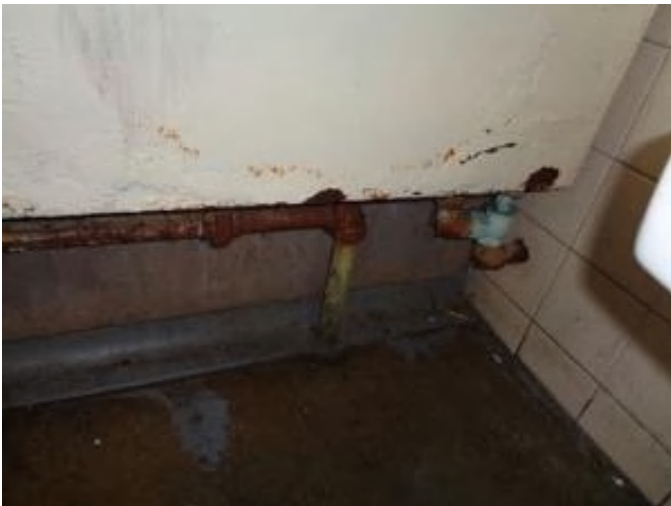
System: D3040 - Distribution Systems

Location: Throughout the building
Distress: Obsolete
Category: 3 - Operations / Maint.
Priority: 3 - Response Time (3-4 yrs)
Correction: Perform testing to identify and replace damaged steam and condensate piping.
Qty: 60,000.00
Unit of Measure: S.F.
Estimate: \$567,622.35
Assessor Name: System
Date Created: 07/31/2015

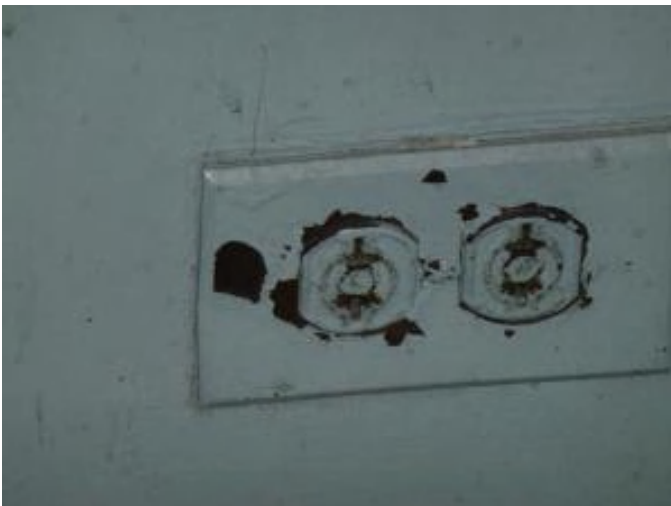
System: D5020 - Lighting and Branch Wiring

Location: Entire Building

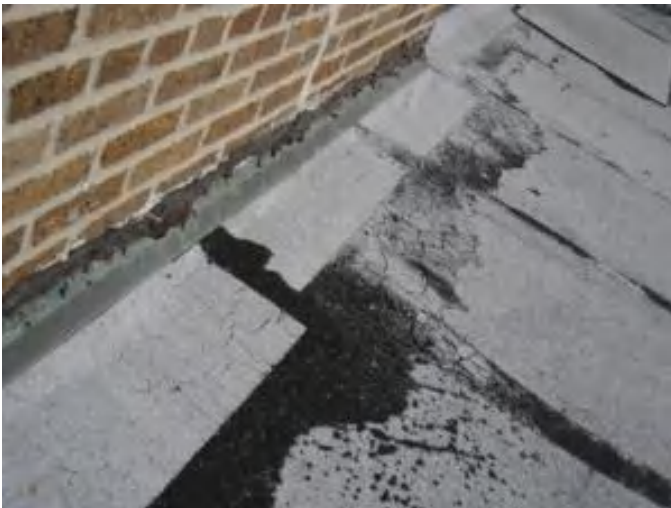
System: B3010105 - Built-Up

Location: main bldg

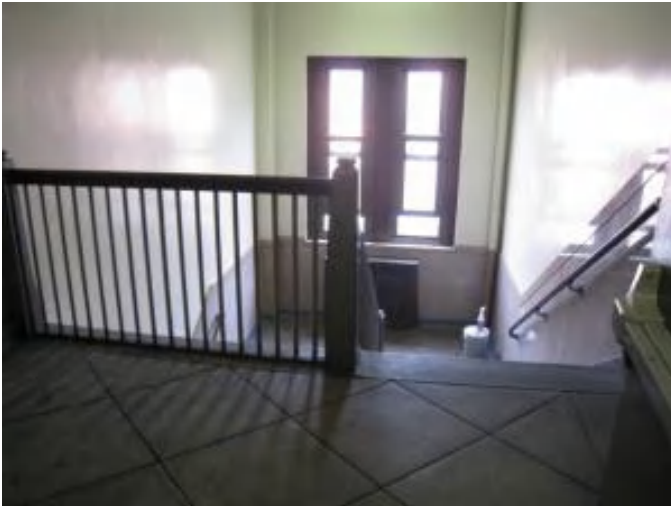
System: C3010230 - Paint & Covering

Location: main bldg

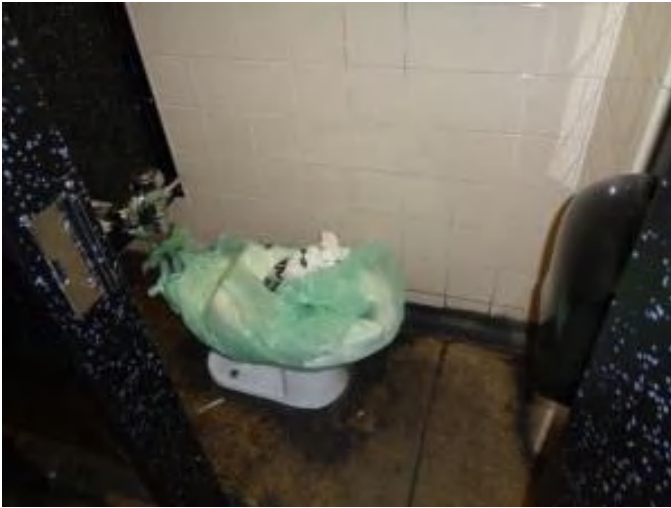
System: D2010 - Plumbing Fixtures

Location: main building
Distress: Obsolete
Category: 3 - Operations / Maint.
Priority: 4 - Response Time (4-5 yrs)
Correction: Remove and replace or replace water closet - quantify additional units
Qty: 20.00
Unit of Measure: Ea.
Estimate: \$152,045.46
Assessor Name: System
Date Created: 07/31/2015

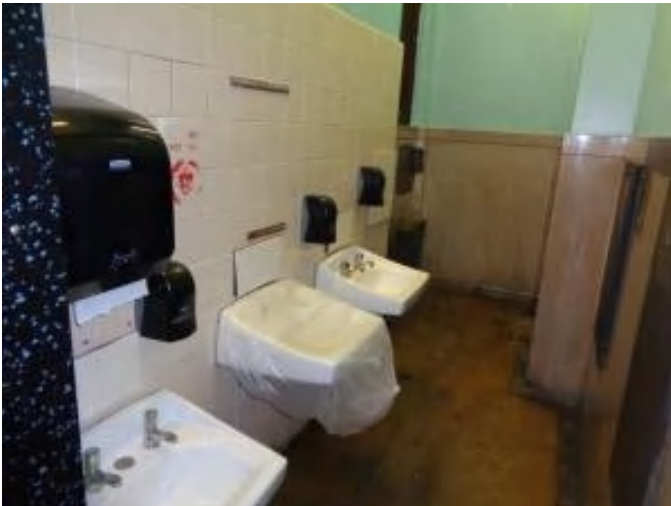
System: D2010 - Plumbing Fixtures

Location: main building
Distress: Obsolete
Category: 3 - Operations / Maint.
Priority: 4 - Response Time (4-5 yrs)
Correction: Remove and replace or replace lavatory - quantify accessible if required
Qty: 20.00
Unit of Measure: Ea.
Estimate: \$87,002.78
Assessor Name: System
Date Created: 07/31/2015

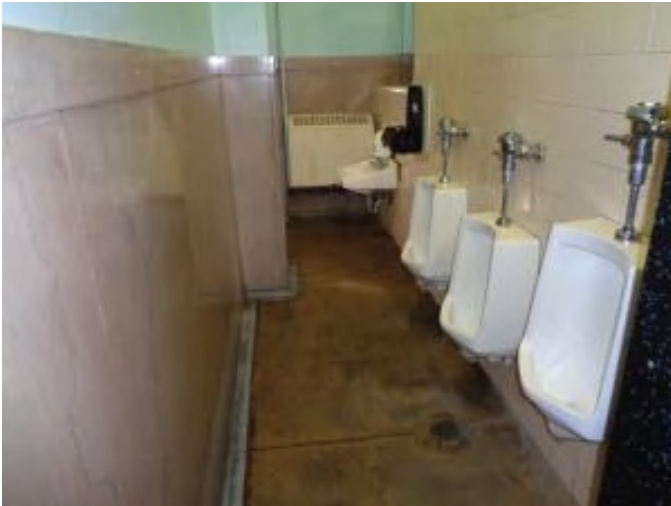
System: D2010 - Plumbing Fixtures

Location: main building
Distress: Obsolete
Category: 3 - Operations / Maint.
Priority: 4 - Response Time (4-5 yrs)
Correction: Remove and replace or replace wall hung urinals
Qty: 20.00
Unit of Measure: Ea.
Estimate: \$69,184.17
Assessor Name: System
Date Created: 07/31/2015

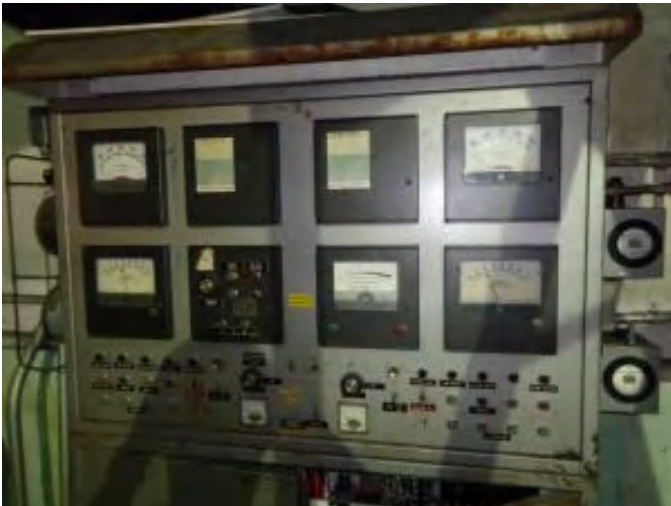
System: D3060 - Controls & Instrumentation

Location: main building
Distress: Failing
Category: 3 - Operations / Maint.
Priority: 4 - Response Time (4-5 yrs)
Correction: Replace pneumatic controls with DDC (150KSF)
Qty: 96,000.00
Unit of Measure: S.F.
Estimate: \$1,719,494.57
Assessor Name: System
Date Created: 07/31/2015

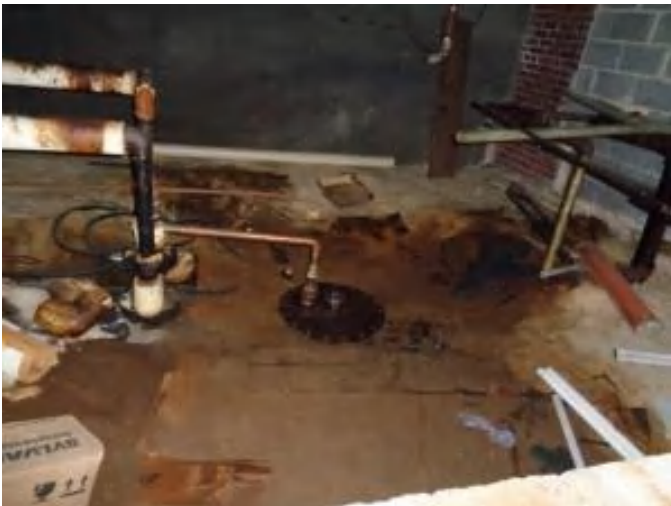
System: D3020 - Heat Generating Systems

Location: main building

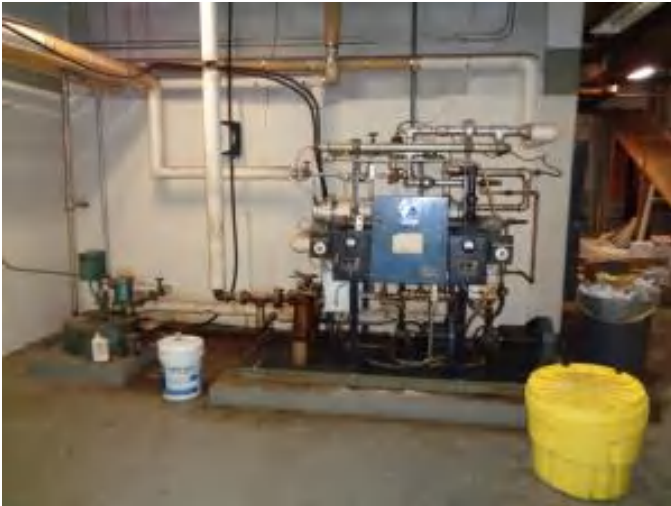
System: D3020 - Heat Generating Systems

Location: main building
Distress: Beyond Service Life
Category: 3 - Operations / Maint.
Priority: 5 - Response Time (> 5 yrs)
Correction: Replace fuel oil pumps
Qty: 1.00
Unit of Measure: Ea.
Estimate: \$26,678.08
Assessor Name: System
Date Created: 07/31/2015

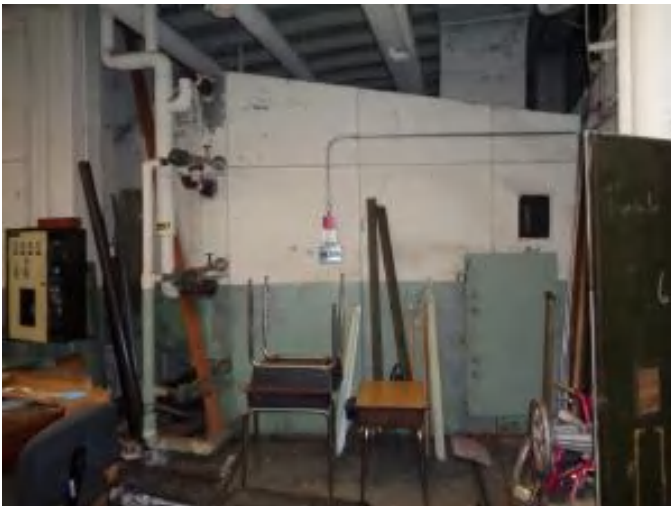
System: D3030 - Cooling Generating Systems

Location: main building
Distress: Inadequate
Category: 4 - Capital Improvement
Priority: 5 - Response Time (> 5 yrs)
Correction: Install chilled water system with distribution piping and pumps. (+75KSF)
Qty: 75,000.00
Unit of Measure: S.F.
Estimate: \$1,204,454.53
Assessor Name: System
Date Created: 08/01/2015

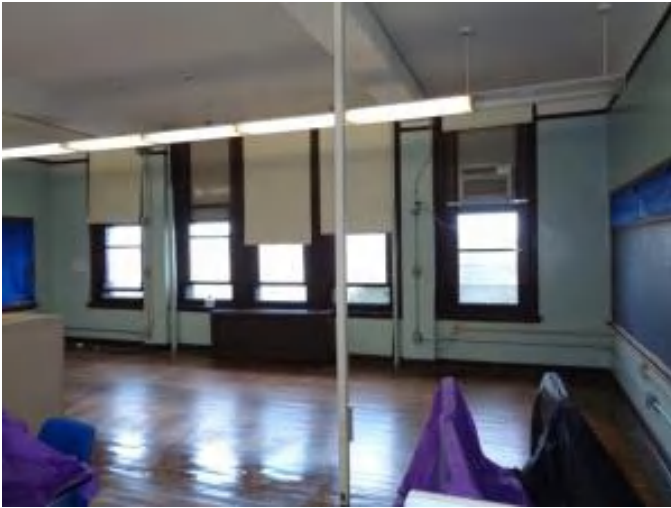
System: D3040 - Distribution Systems

Location: main building

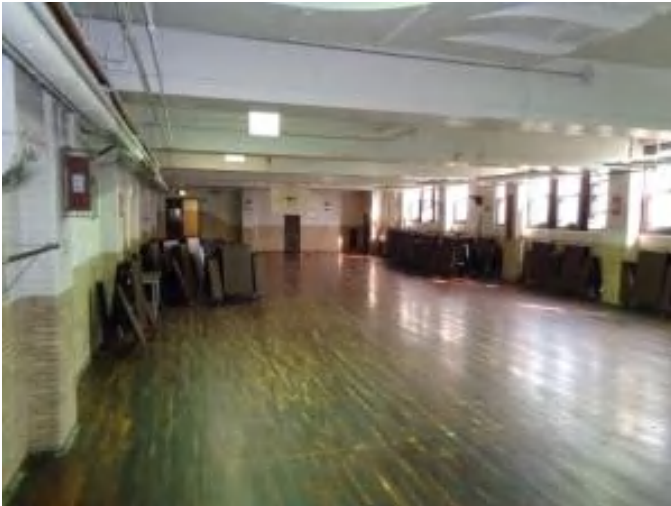
System: D3040 - Distribution Systems

Location: gymnasium
Distress: Beyond Service Life
Category: 3 - Operations / Maint.
Priority: 5 - Response Time (> 5 yrs)
Correction: Install HVAC unit for Gymnasium (single station).
Qty: 5,000.00
Unit of Measure: Ea.
Estimate: \$256,914.56
Assessor Name: System
Date Created: 08/12/2015

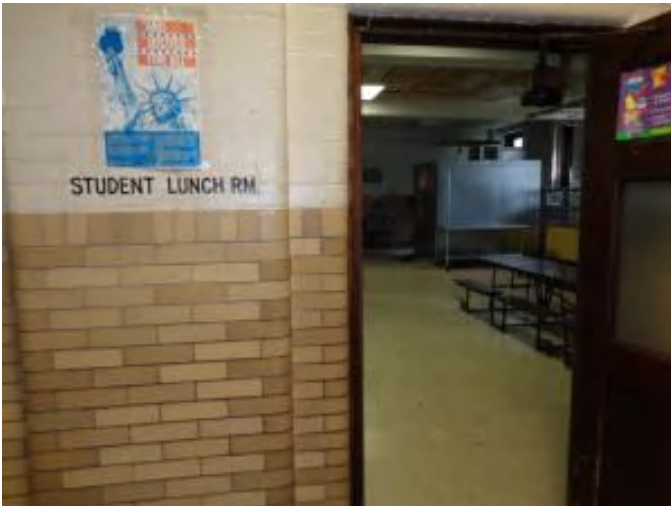
System: D3040 - Distribution Systems

Location: main building
Distress: Inadequate
Category: 4 - Capital Improvement
Priority: 5 - Response Time (> 5 yrs)
Correction: Install HVAC unit for Cafeteria (850 students).
Qty: 150.00
Unit of Measure: Pr.
Estimate: \$70,133.58
Assessor Name: System
Date Created: 08/01/2015

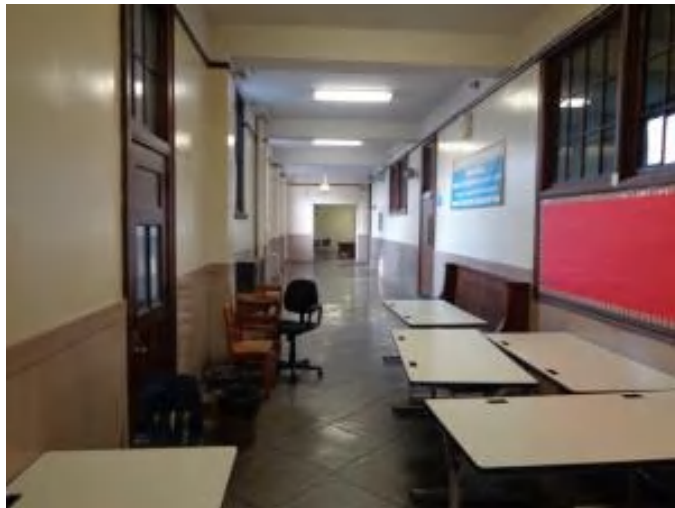
System: D4010 - Sprinklers

Location: main building

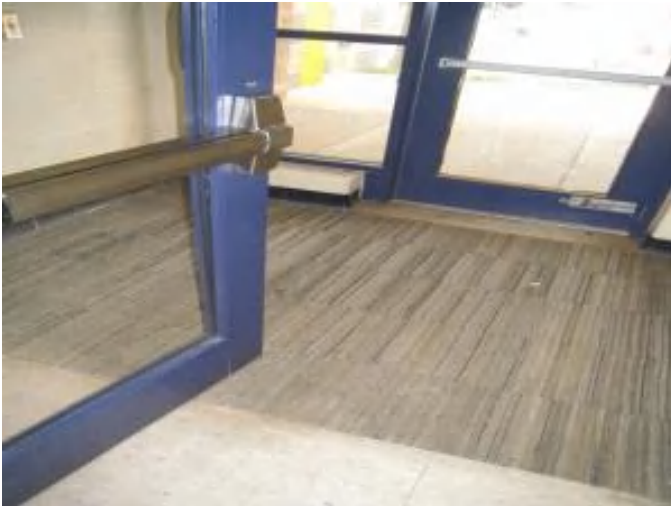
System: B2030 - Exterior Doors

Location: LSH

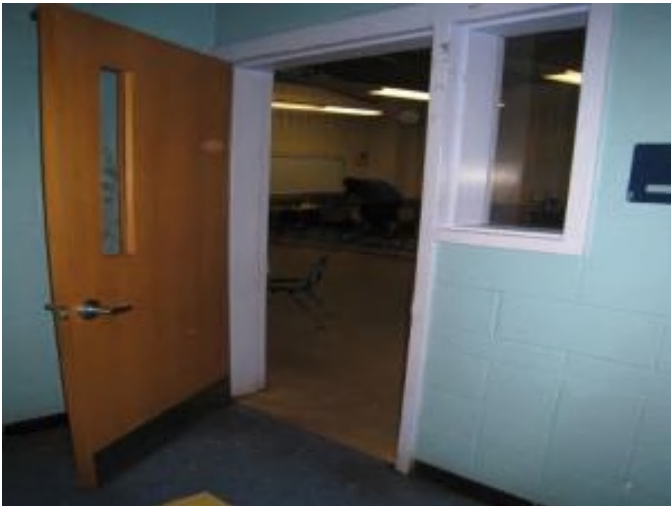
System: C1020 - Interior Doors

Location: LSH

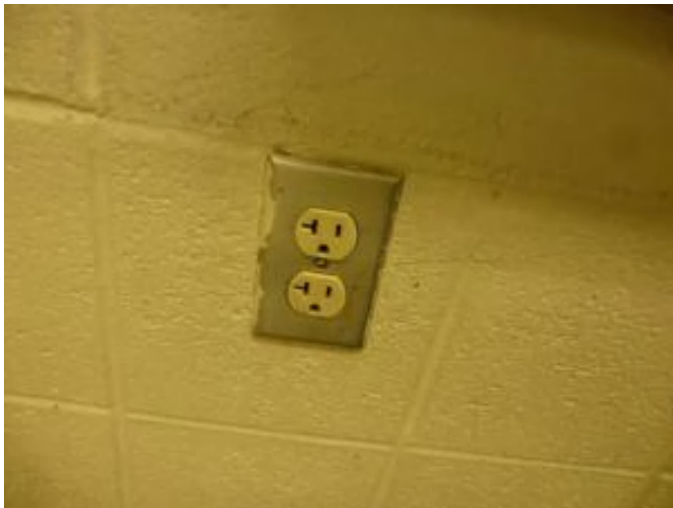
System: D5020 - Lighting and Branch Wiring

Location: LSH
Distress: Beyond Service Life
Category: 3 - Operations / Maint.
Priority: 1 - Response Time (< 2 yr)
Correction: Replace Wiring Device
Qty: 100.00
Unit of Measure: Ea.
Estimate: \$31,553.33
Assessor Name: Craig Anding
Date Created: 07/28/2015

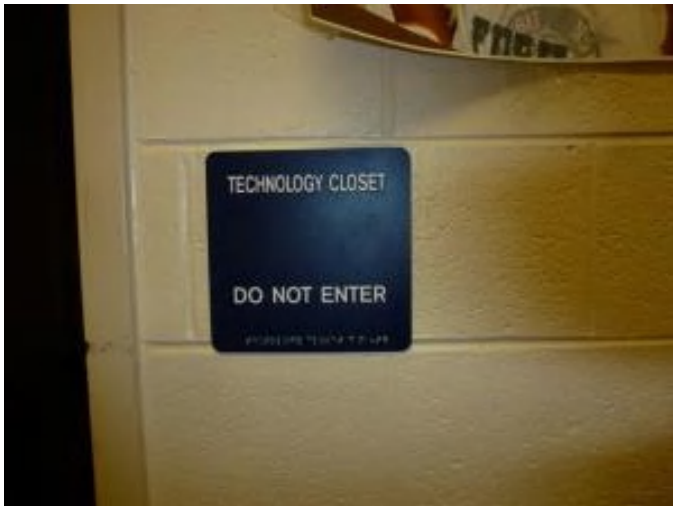
System: D5030 - Communications and Security

Location: LSH
Distress: Damaged
Category: 3 - Operations / Maint.
Priority: 1 - Response Time (< 2 yr)
Correction: Add/Replace Clock System or Components
Qty: 0.00
Unit of Measure: Ea.
Estimate: \$17,340.78
Assessor Name: Craig Anding
Date Created: 07/28/2015

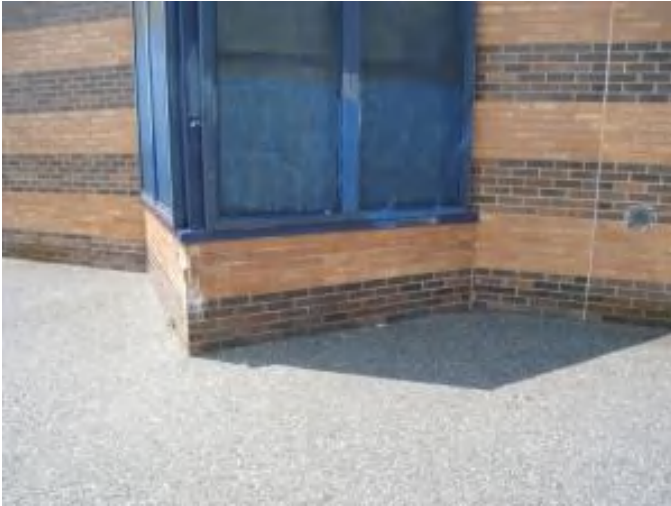
System: B2010 - Exterior Walls

Location: LSH

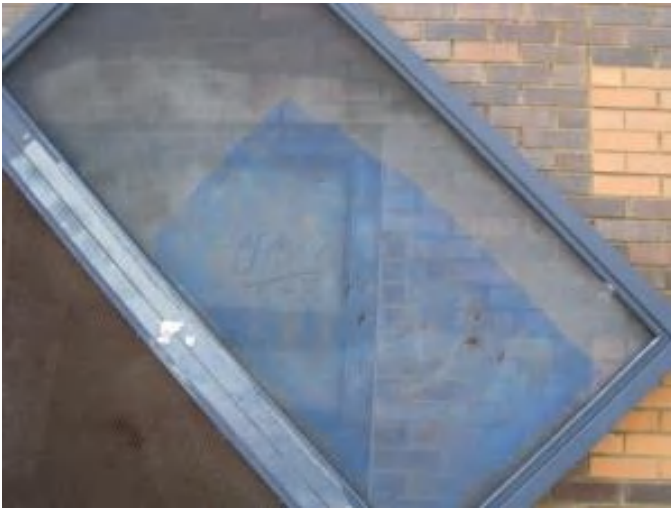
System: B2020 - Exterior Windows

Location: LSH

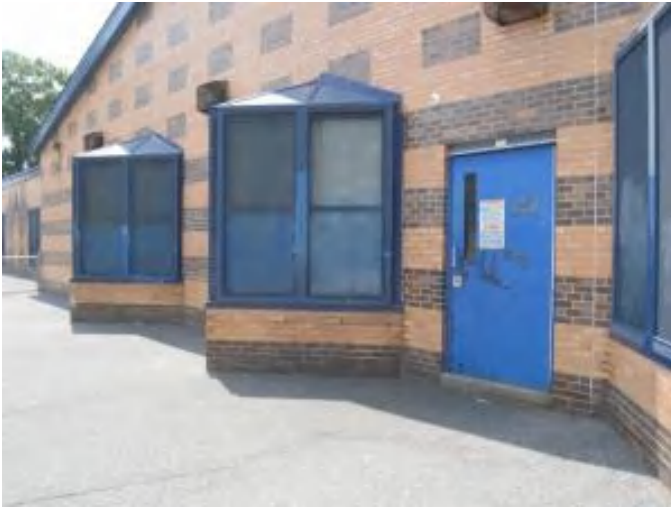
System: B3010130 - Preformed Metal Roofing

Location: LSH

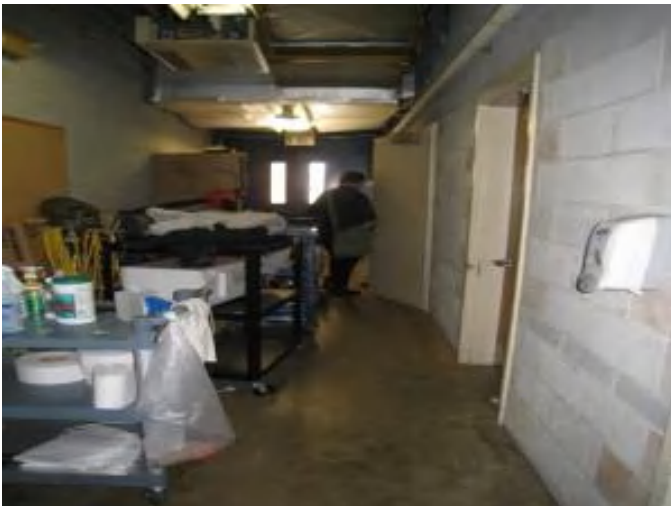
System: C3010230 - Paint & Covering

Location: LSH

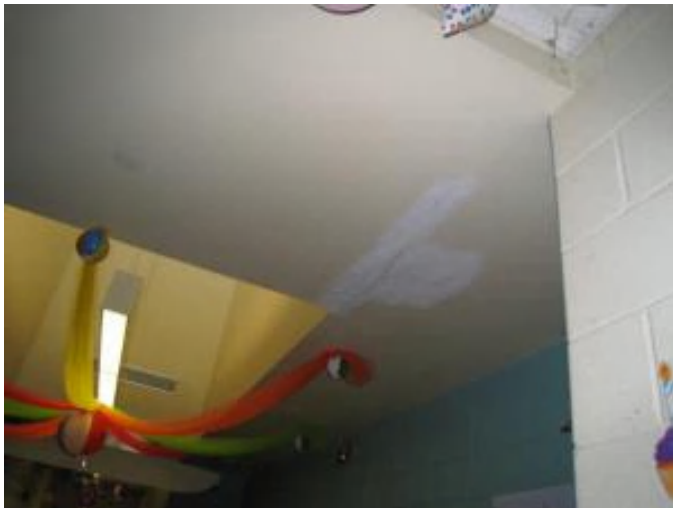
System: C3010230 - Paint & Covering

Location: LSH

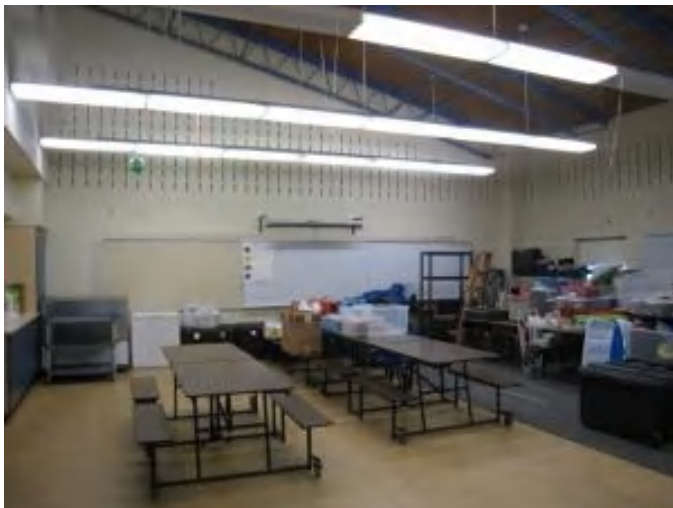
System: C3020411 - Carpet

Location: LSH

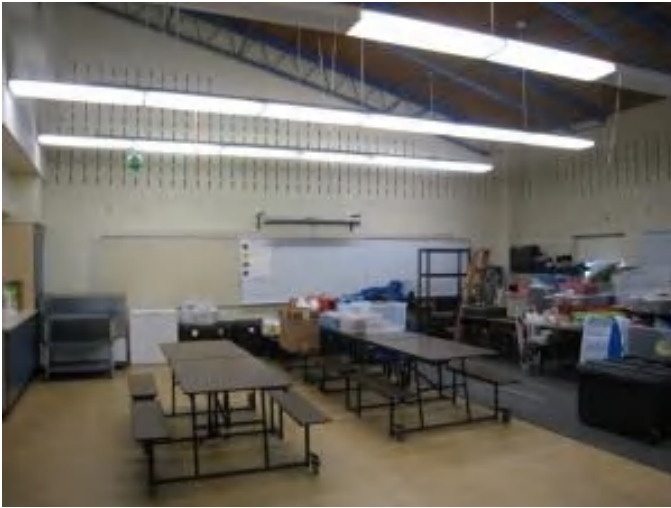
System: C3020413 - Vinyl Flooring

Location: LSH
Distress: Appearance
Category: 3 - Operations / Maint.
Priority: 2 - Response Time (2-3 yrs)
Correction: Remove and replace VCT
Qty: 6,000.00
Unit of Measure: S.F.
Estimate: \$72,105.19
Assessor Name: Craig Anding
Date Created: 07/30/2015

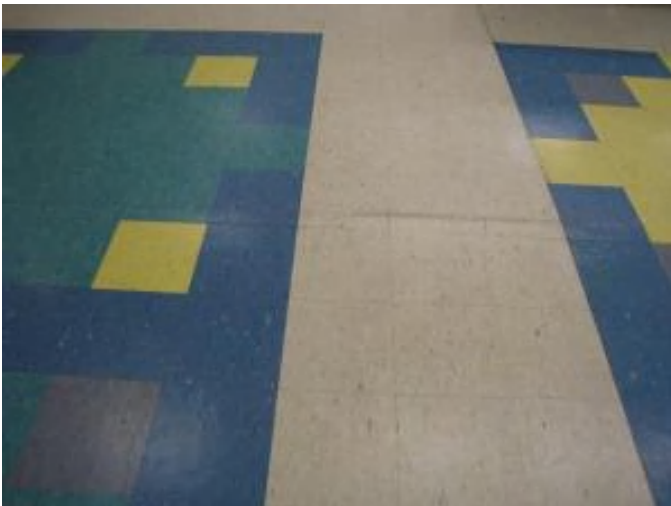
System: C3020413 - Vinyl Flooring

Location: LSH
Distress: Damaged
Category: 3 - Operations / Maint.
Priority: 2 - Response Time (2-3 yrs)
Correction: Remove and replace VCT
Qty: 500.00
Unit of Measure: S.F.
Estimate: \$6,008.77
Assessor Name: Craig Anding
Date Created: 07/30/2015

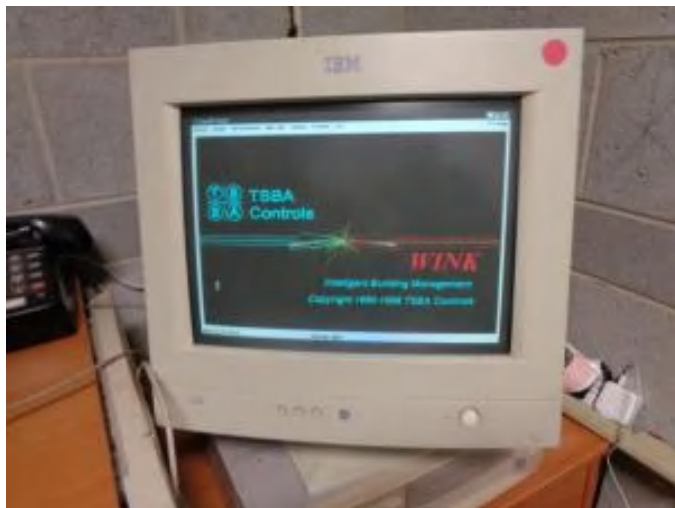
System: D3060 - Controls & Instrumentation

Location: LSH

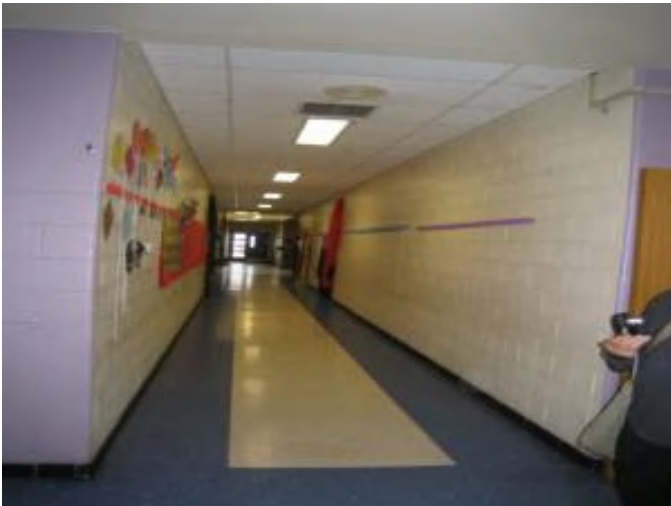
System: C3010230 - Paint & Covering

Location: LSH

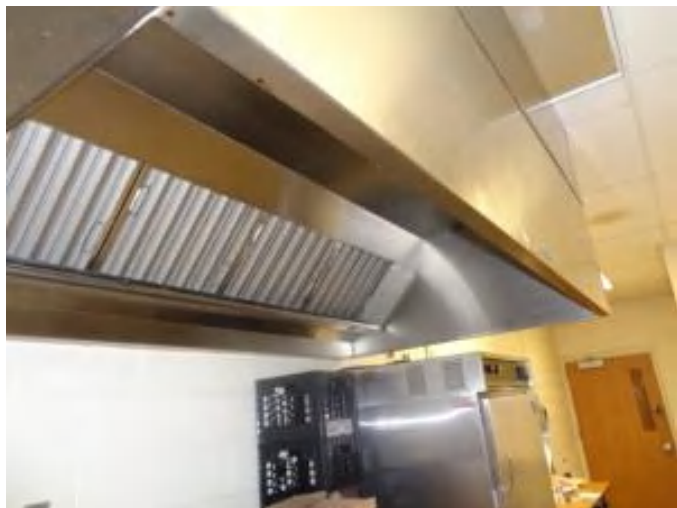
System: D4010 - Sprinklers

Location: LSH

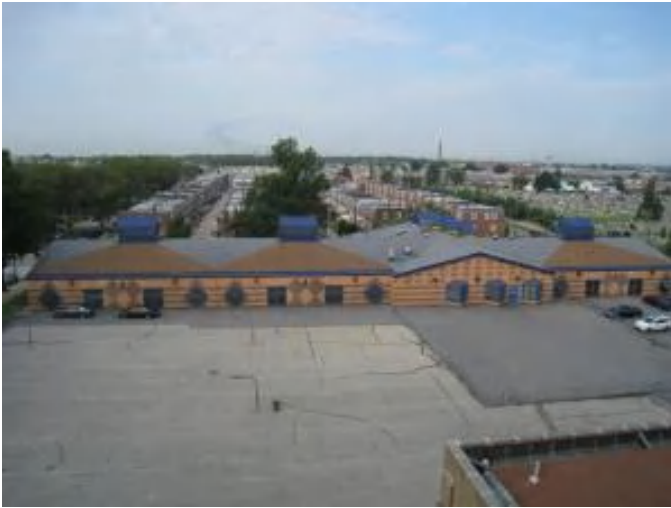
System: G2040 - Site Development

Location: play area fence

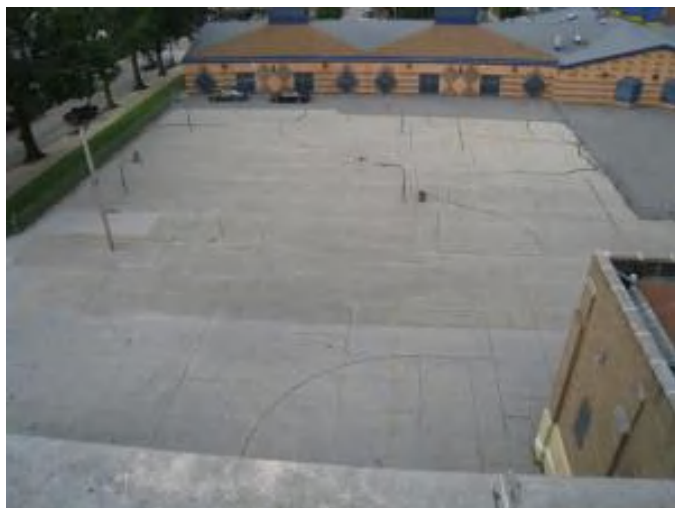
Location: parking lot and play area
