## Facility Condition Assessment Summary Report

### Cassidy School

School District of Philadelphia  
**S424001;Cassidy**  
Final  
**Site Assessment Report**  
January 30, 2017

Facility Assessment  
October 26<sup>th</sup>, 2015

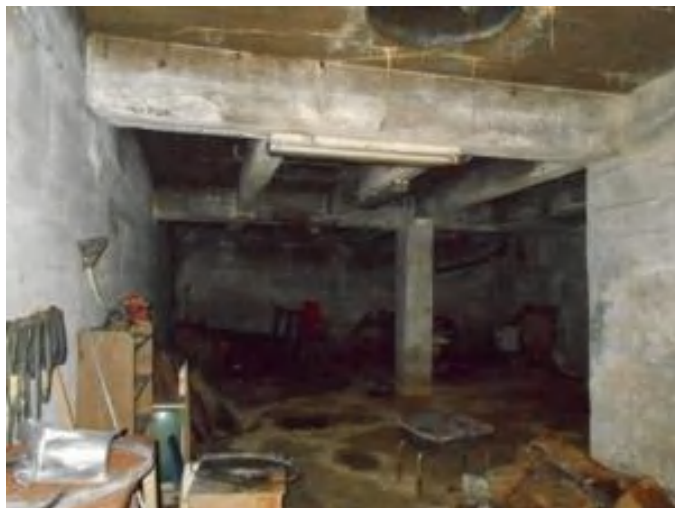
#### System: A2020 - Basement Walls

**Location:** Ash and Coal Rooms

**Distress:** Obsolete

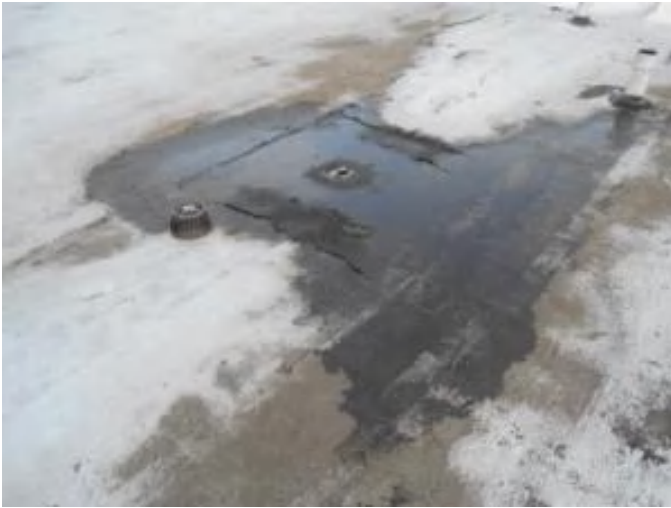
**System: B3010105 - Built-Up**

**Location:** Roofs

**Distress:** Beyond Service Life

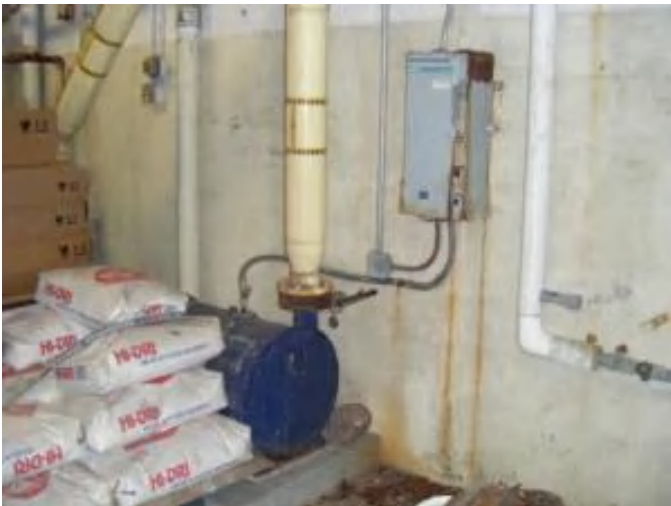
**System: D3020 - Heat Generating Systems**

**Location:** Boiler Room

**Distress:** Energy Efficiency

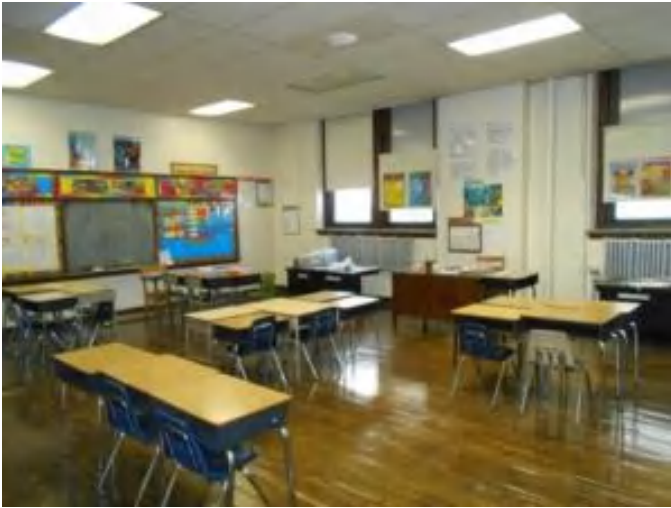
**System: D3040 - Distribution Systems**

**Location:** Classrooms / Labs

**Distress:** Health Hazard / Risk

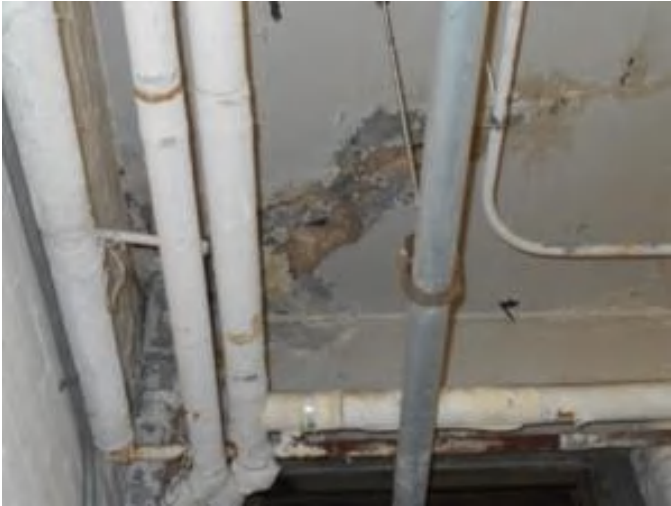
**System: B1010 - Floor Construction**

**Location:** Mech boiler rooms

**Distress:** Damaged

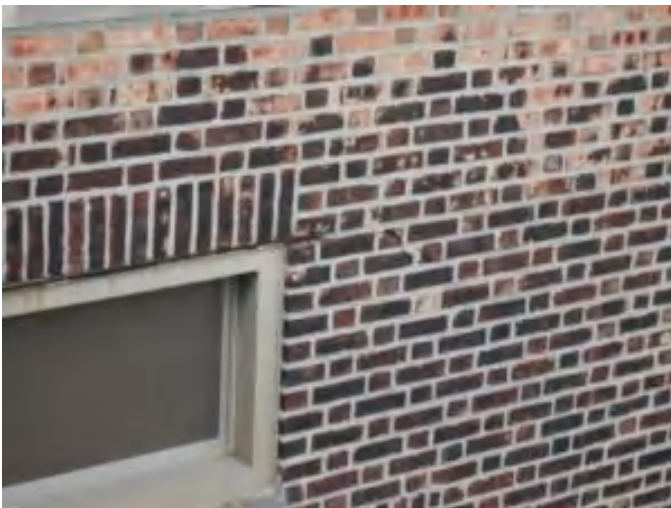
**System: B2010 - Exterior Walls**

**Location:** Exterior walls

**Distress:** Building Envelope Integrity

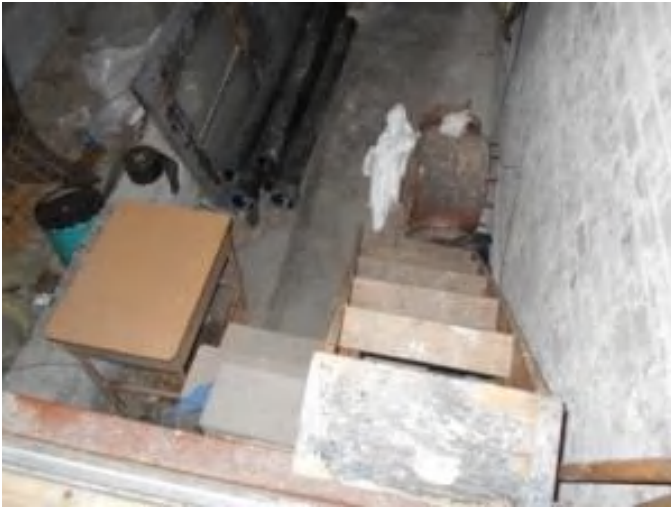
**System: B2010 - Exterior Walls**

**Location:** Roof access

**Distress:** Building / MEP Codes

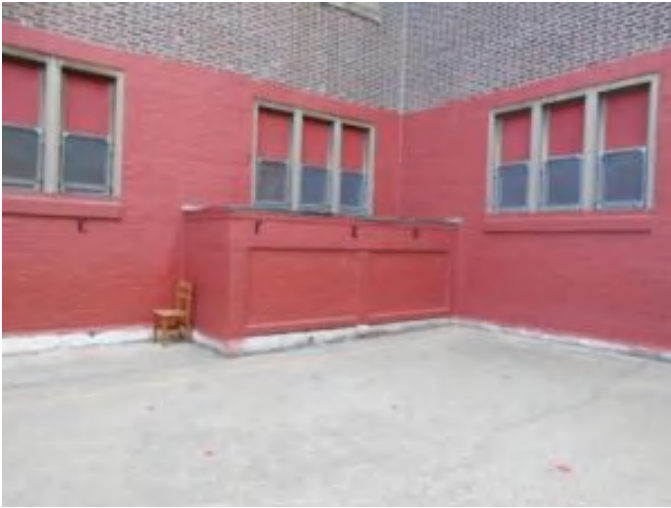
**System: B3010120 - Single Ply Membrane**

**Location:** Exterior deck above boiler room

**Distress:** Failing

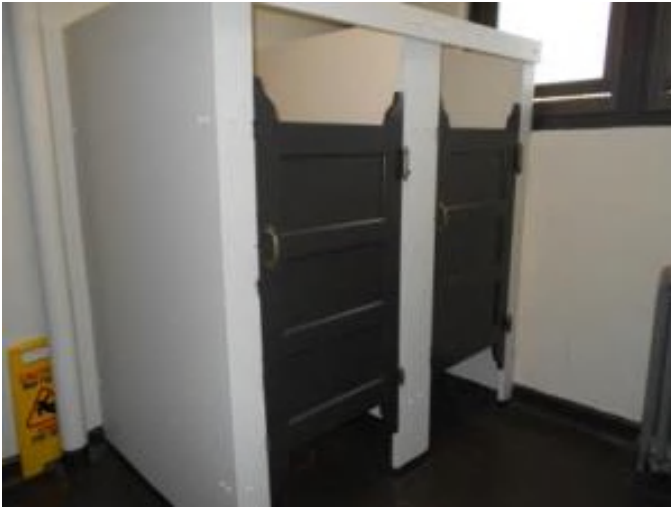
**System: C1010 - Partitions**

**Location:** Each floor

**Distress:** Accessibility

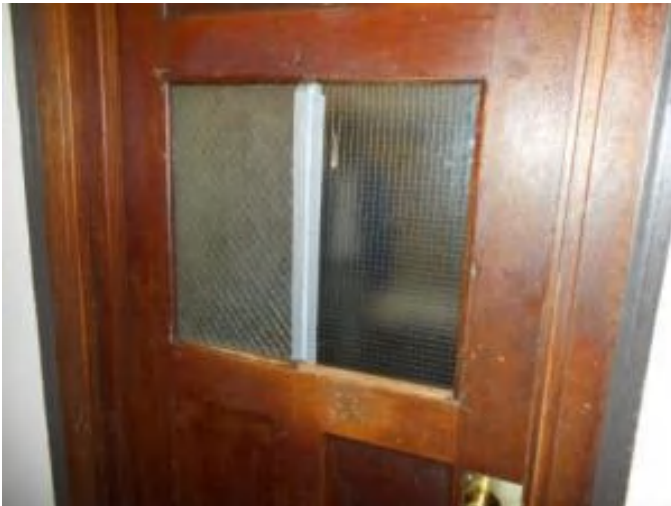
**System: C1020 - Interior Doors**

**Location:** Classrooms

**Distress:** Beyond Service Life

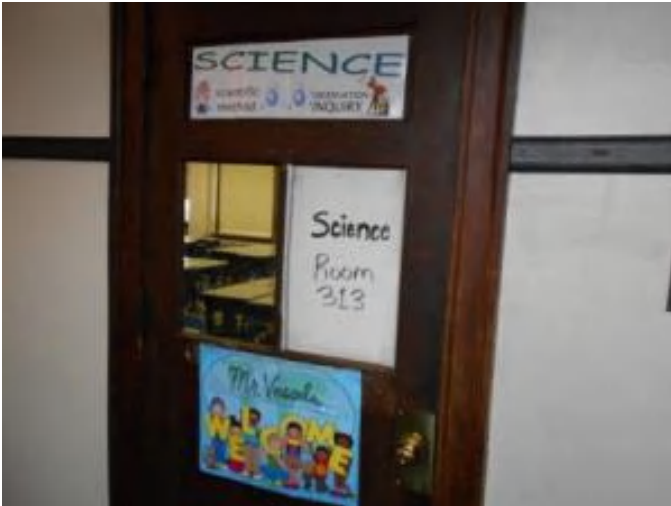
**System: C1030 - Fittings**

**Location:** Throughout the building

**Distress:** Building / MEP Codes

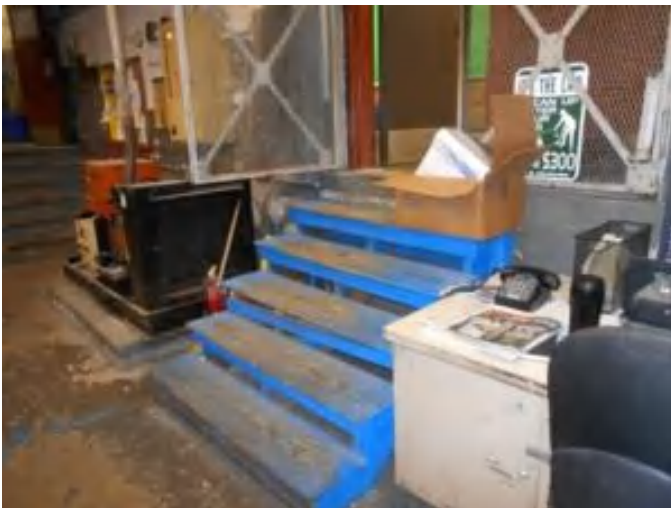
**System: C2010 - Stair Construction**

**Location:** Basement mechanical room

**Distress:** Building / MEP Codes

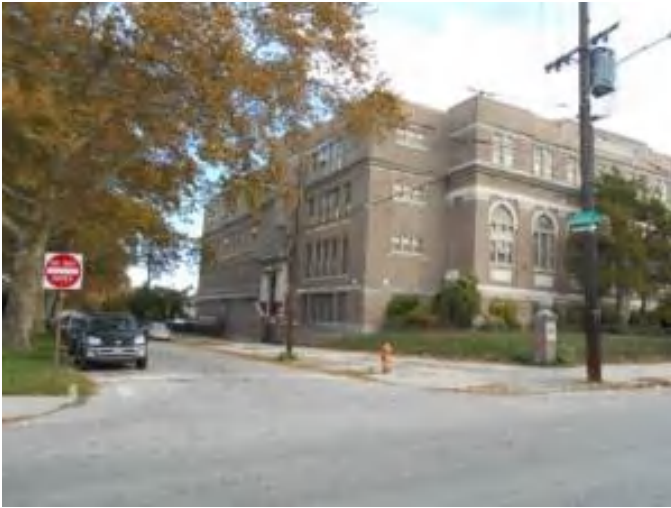
**System: D1010 - Elevators and Lifts**

**Location:** TBD

**Distress:** Accessibility

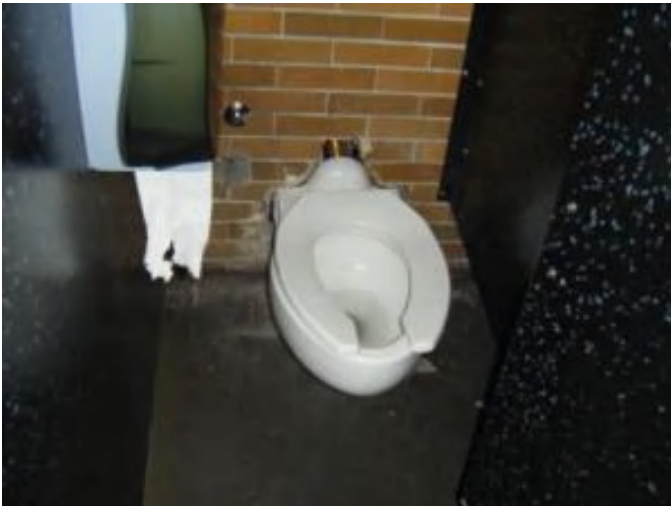
**System: D2010 - Plumbing Fixtures**

**Location:** Restrooms

**Distress:** Beyond Service Life

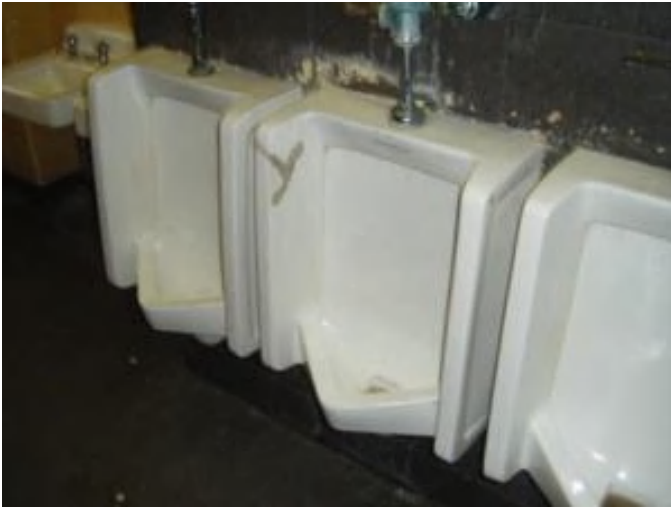
**System: D2010 - Plumbing Fixtures**

**Location:** Restrooms

**Distress:** Beyond Service Life

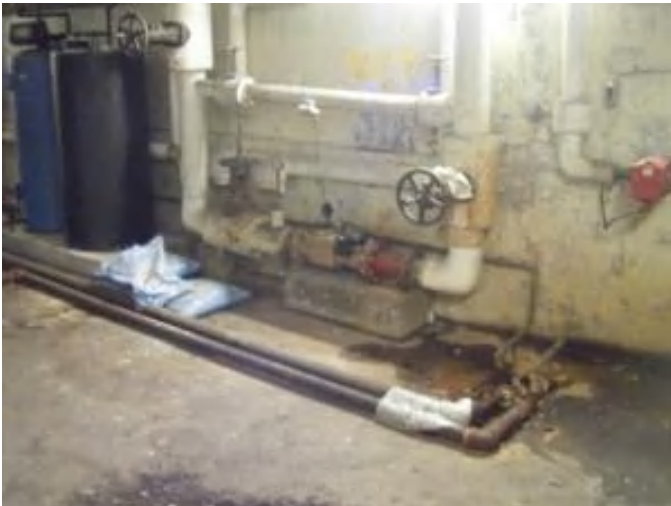
**System: D2020 - Domestic Water Distribution**

**Location:** Boiler Room

**Distress:** Health Hazard / Risk

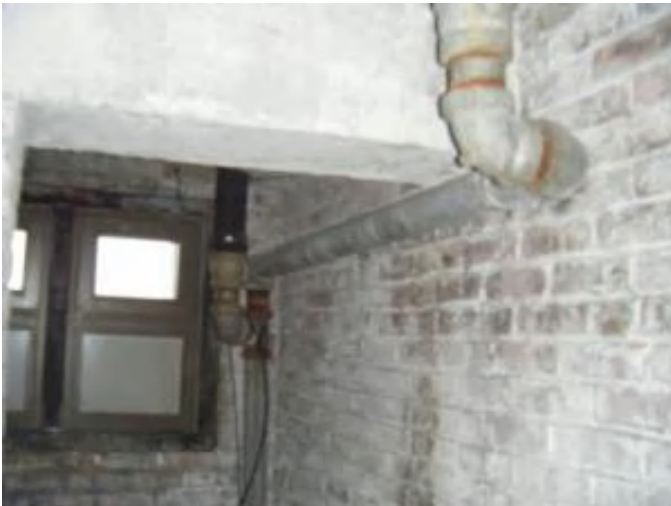
**System: D2040 - Rain Water Drainage**

**Location:** Throughout Building

**Distress:** Beyond Service Life

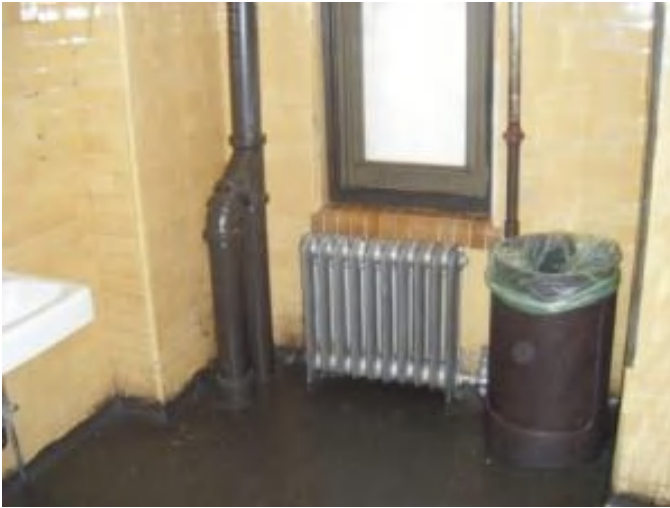
**System: D3040 - Distribution Systems**

**Location:** Restrooms

**Distress:** Health Hazard / Risk

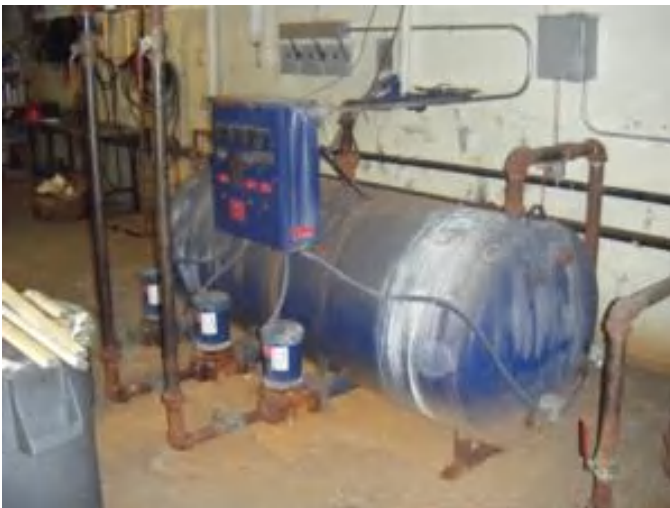
**System: D3040 - Distribution Systems**

**Location:** Boiler Room

**Distress:** Beyond Service Life

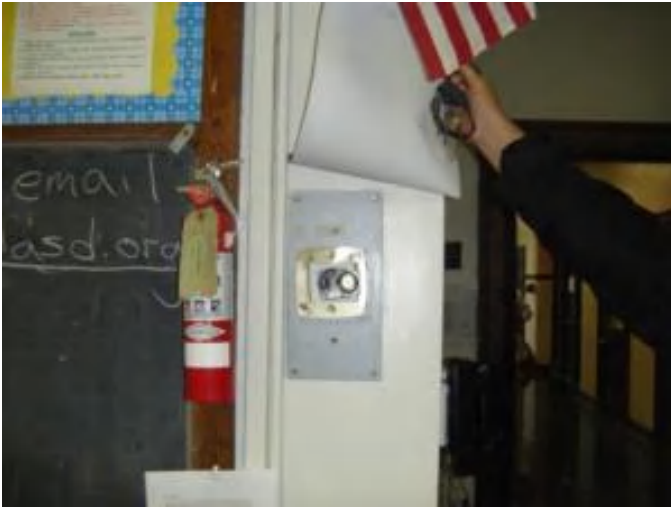
**System: D3060 - Controls & Instrumentation**

**Location:** Throughout Building

**Distress:** Energy Efficiency

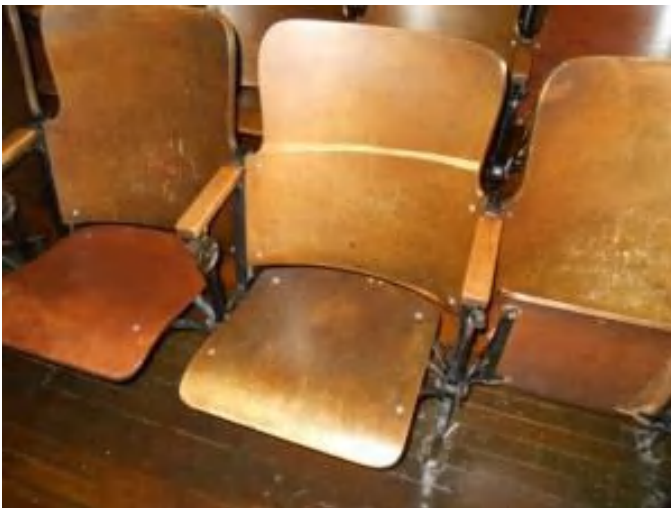
**System: E2010 - Fixed Furnishings**

**Location:** Auditorium

**Distress:** Beyond Service Life

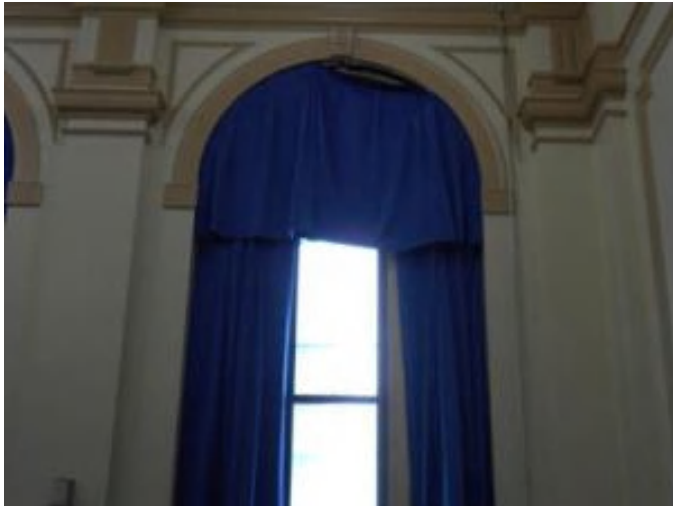
**System: E2010 - Fixed Furnishings**

**Location:** Auditorium window drapes

**Distress:** Failing

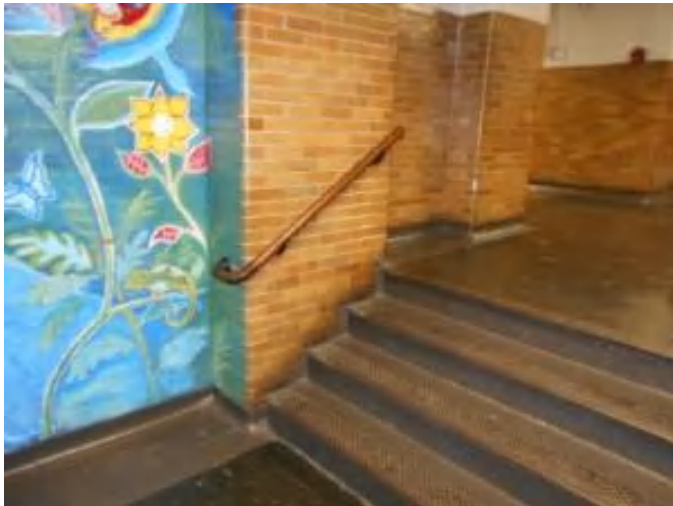
**System: A1030 - Slab on Grade**

**Location:** Basement Corridor

**Distress:** Accessibility

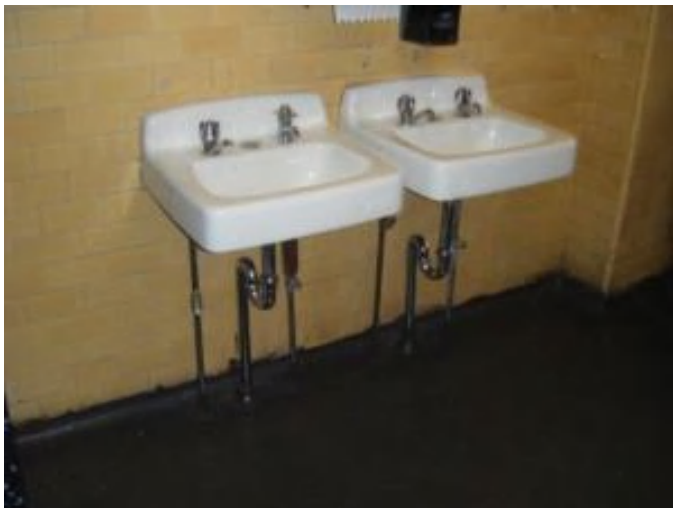
**System: D2010 - Plumbing Fixtures**

**Location:** Restrooms

**Distress:** Accessibility

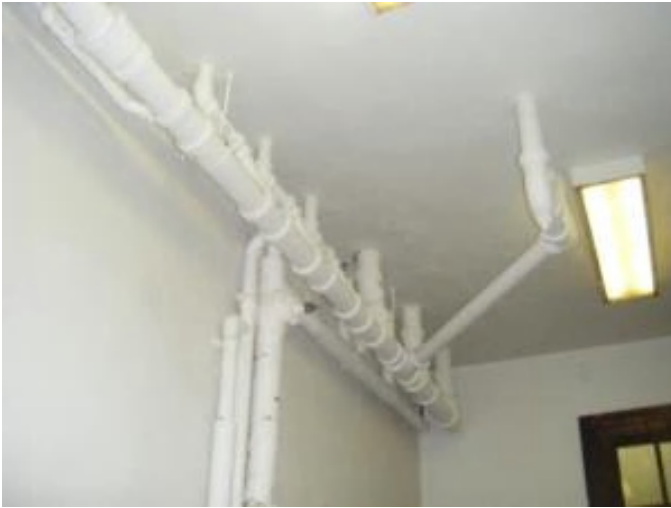
**System: D2030 - Sanitary Waste**

**Location:** Throughout Building

**Distress:** Beyond Service Life

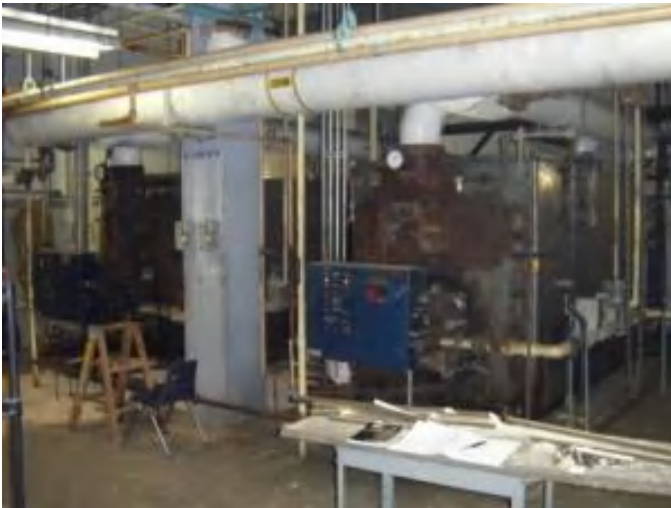
**System: D3020 - Heat Generating Systems**

**Location:** Boiler Room

**Distress:** Beyond Service Life

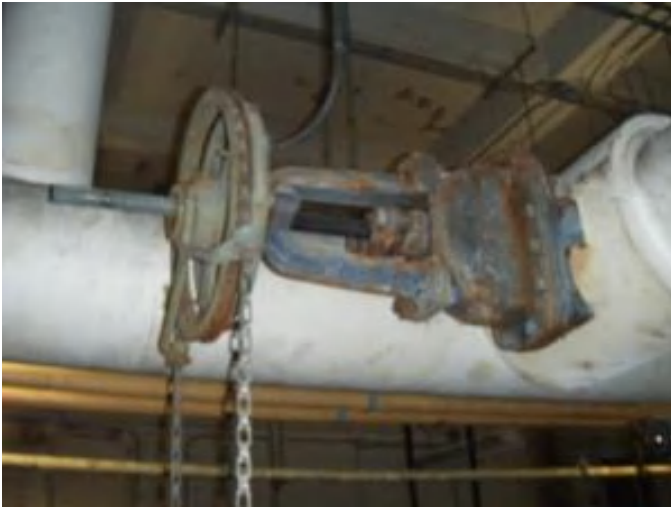
**System: D3020 - Heat Generating Systems**

**Location:** Boiler Room

**Distress:** Beyond Service Life

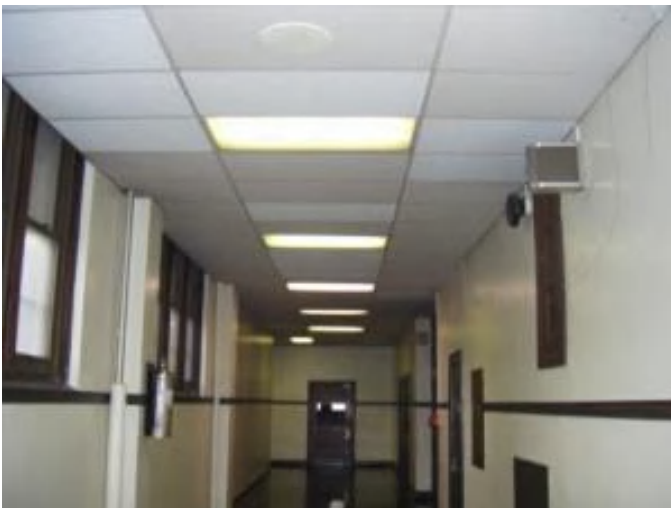
**System: D3040 - Distribution Systems**

**Location:** Corridors

**Distress:** Health Hazard / Risk

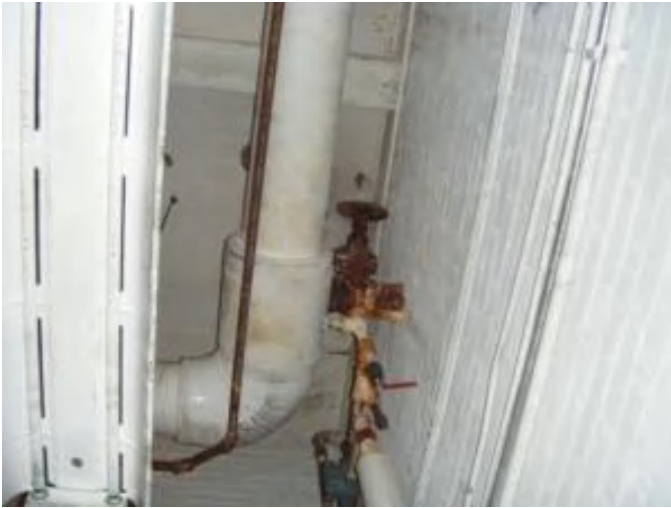
**System: D3040 - Distribution Systems**

**Location:** Throughout Building

**Distress:** Beyond Service Life

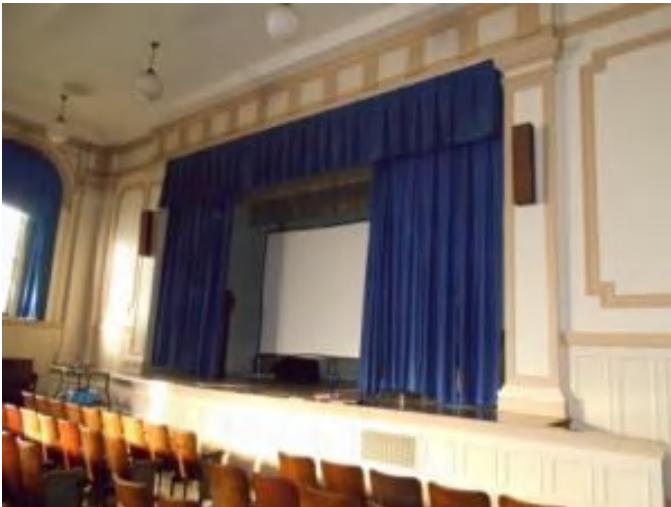
**System: D3040 - Distribution Systems**

**Location:** Auditorium

**Distress:** Health Hazard / Risk

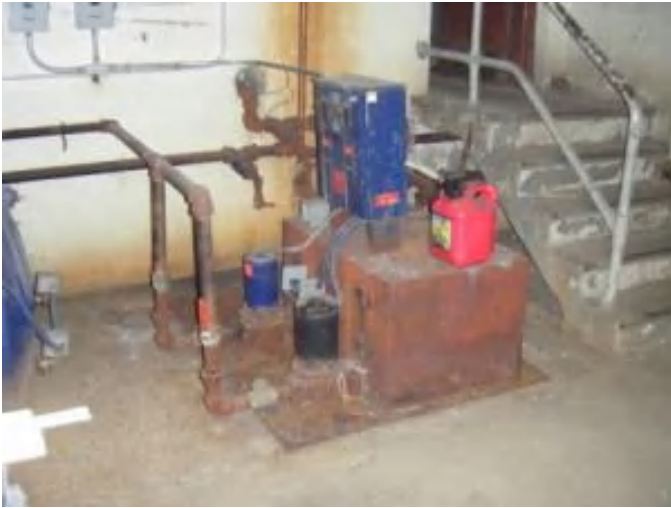
**System: D3040 - Distribution Systems**

**Location:** Boiler Room

**Distress:** Beyond Service Life

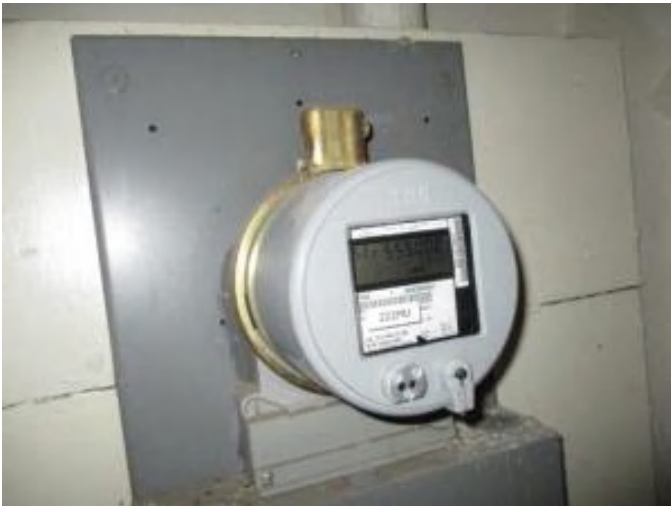
**System: D5010 - Electrical Service/Distribution**

**Location:** Basement

**Distress:** Inadequate

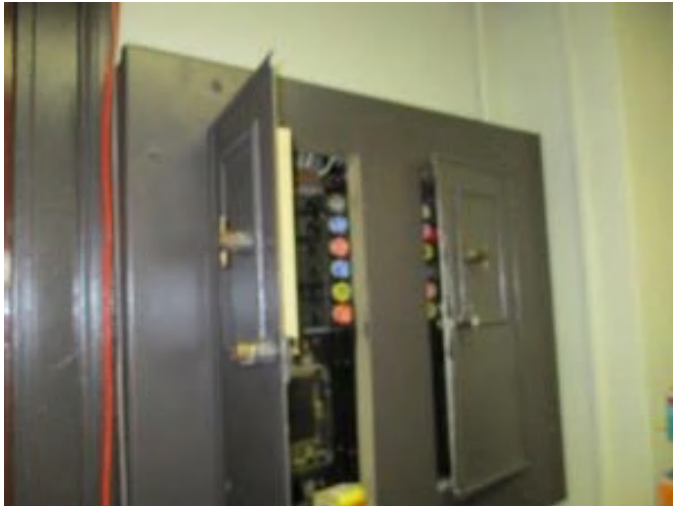
**System: D5010 - Electrical Service/Distribution**

**Location:** Entire Building

**Distress:** Beyond Service Life

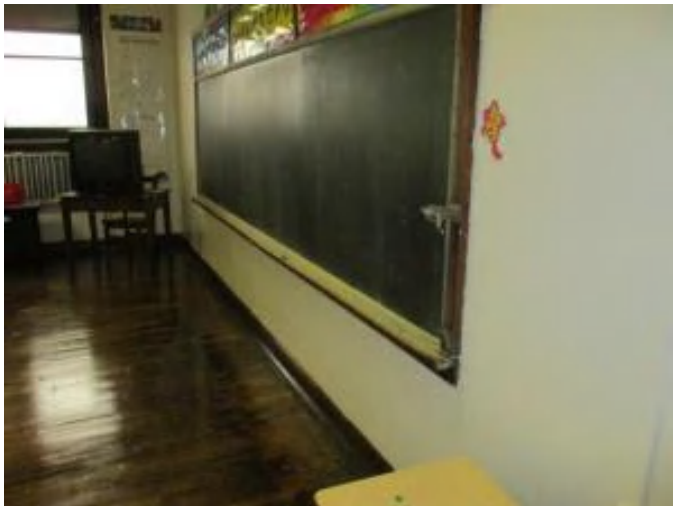
**System: D5020 - Lighting and Branch Wiring**

**Location:** Entire Building

**Distress:** Inadequate

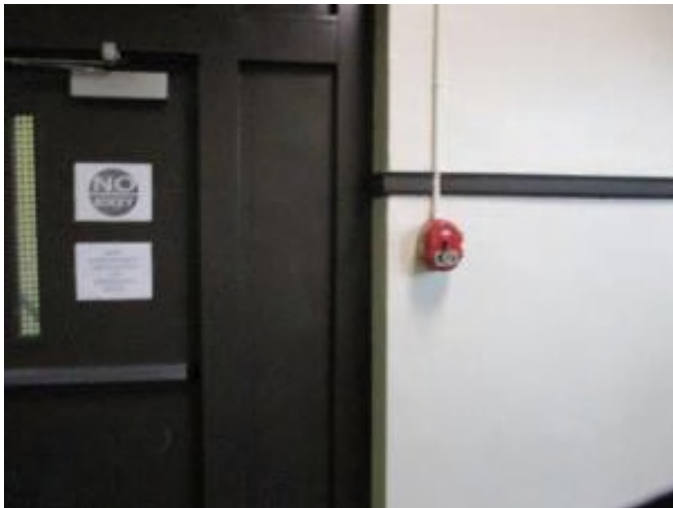
**System: D5030 - Communications and Security**

**Location:** Entire Building

**Distress:** Life Safety / NFPA / PFD

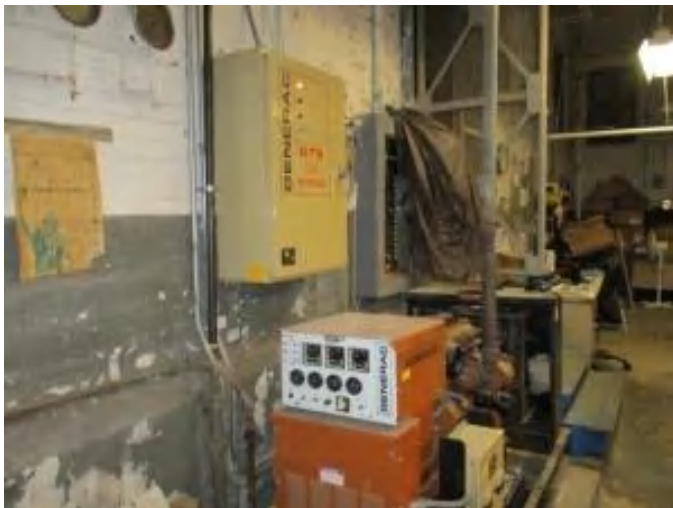
**System: D5090 - Other Electrical Systems**

**Location:** Outdoor

**Distress:** Inadequate

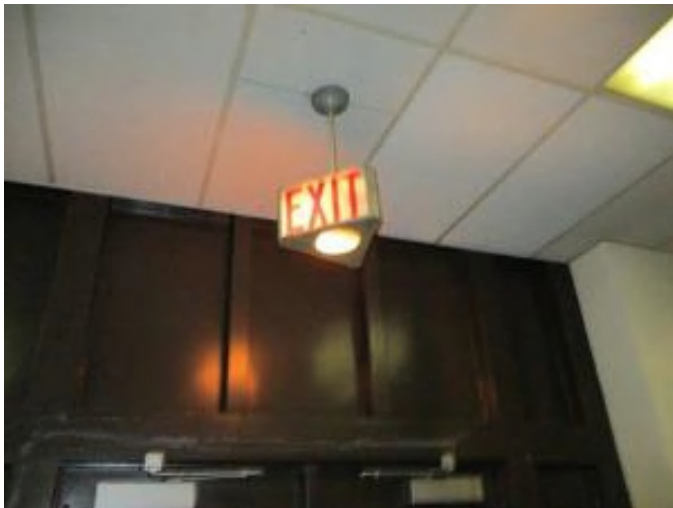
**System: D5090 - Other Electrical Systems**

**Location:** Entire Building

**Distress:** Obsolete

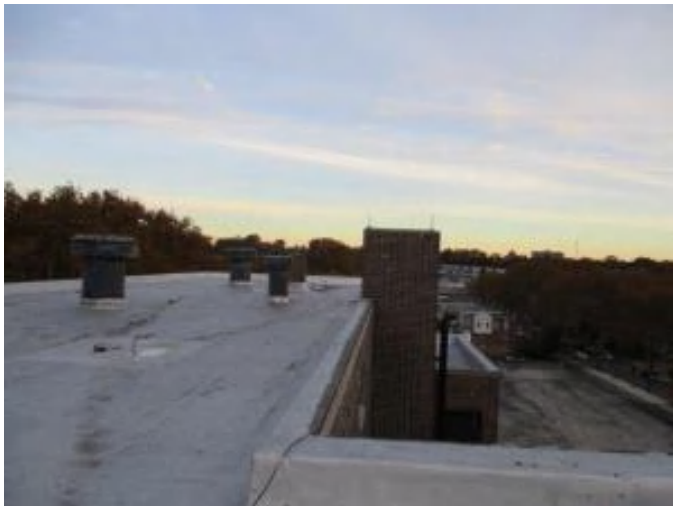
**System: D5090 - Other Electrical Systems**

**Location:** Roof

**Distress:** Building / MEP Codes

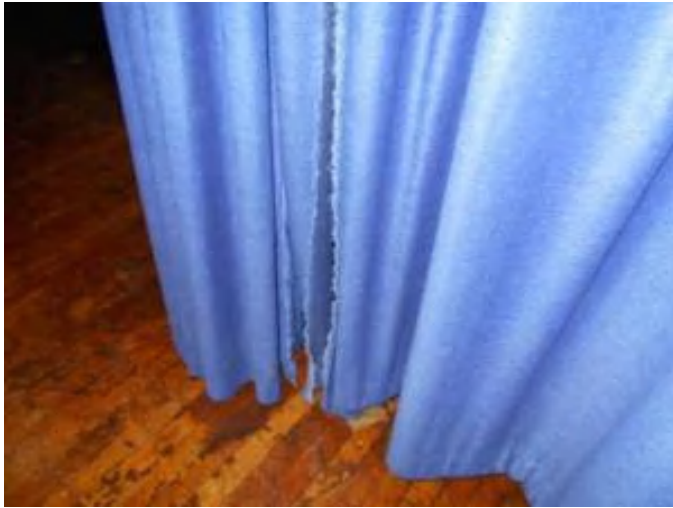
**System: E2010 - Fixed Furnishings**

**Location:** Stage

**Distress:** Damaged

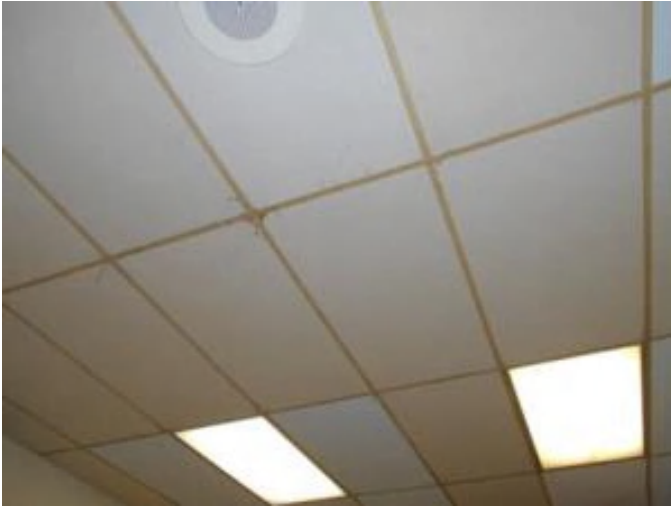
**System: C3030 - Ceiling Finishes**

**Location:** Throughout the building

**Distress:** Appearance

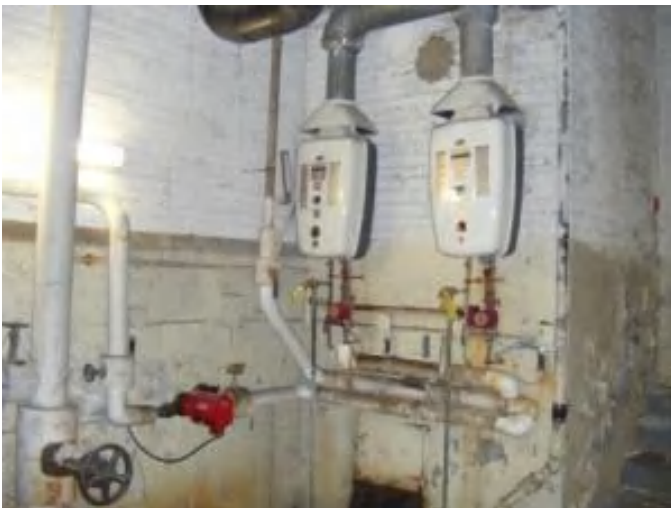
**System: D2020 - Domestic Water Distribution**

**Location:** Boiler Room

**Distress:** Beyond Service Life

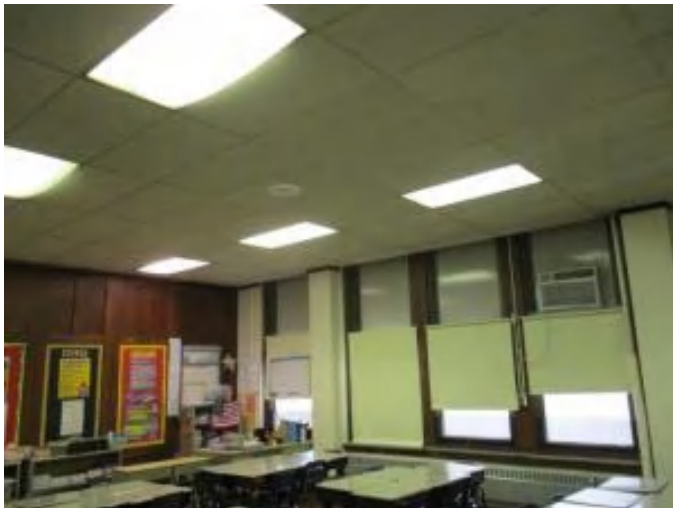
**System: D5020 - Lighting and Branch Wiring**

**Location:** Entire Building

**Distress:** Obsolete

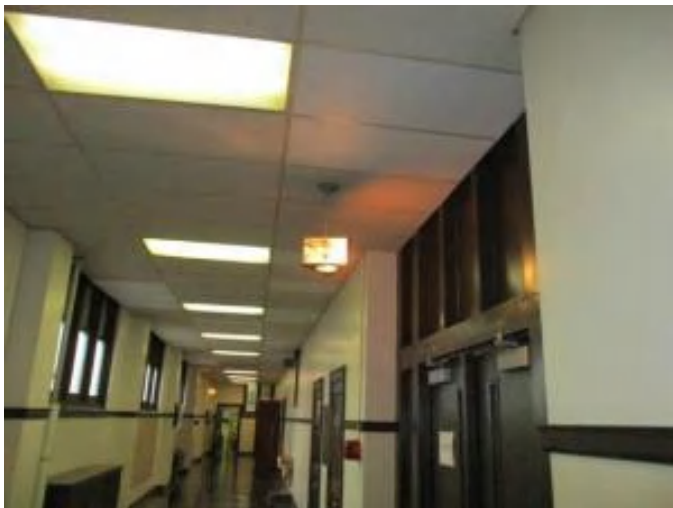
**System: D5030 - Communications and Security**

**Location:** Entire Building

**Distress:** Security Issue

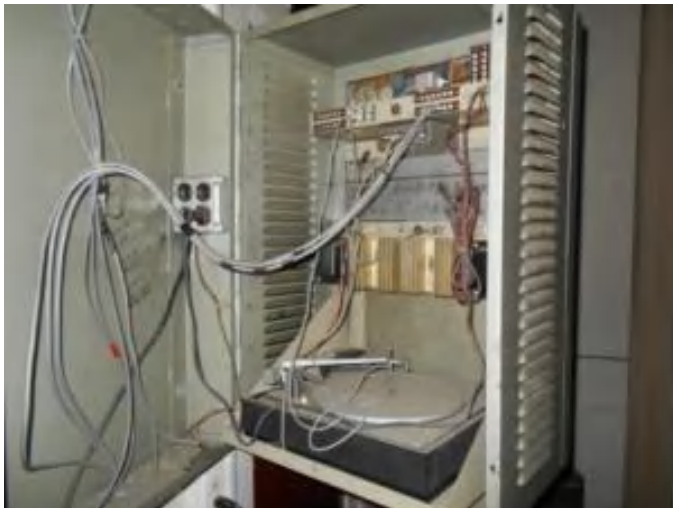
**System: D5030 - Communications and Security**

**Location:** Auditorium

**Distress:** Obsolete

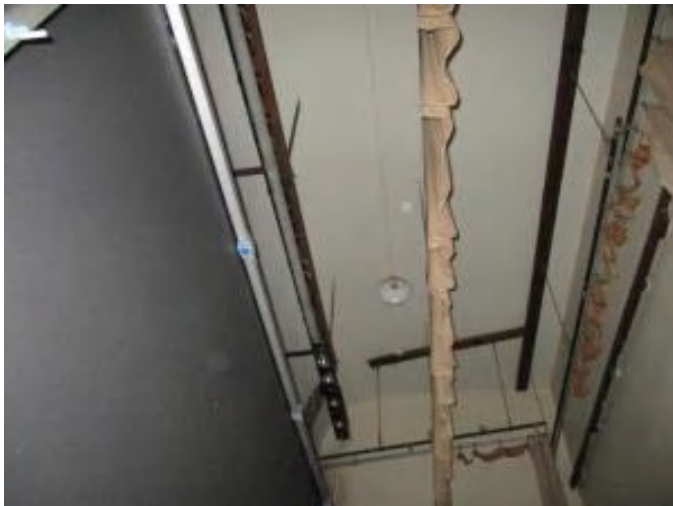
**System: E1020 - Institutional Equipment**

**Location:** Auditorium

**Distress:** Inadequate

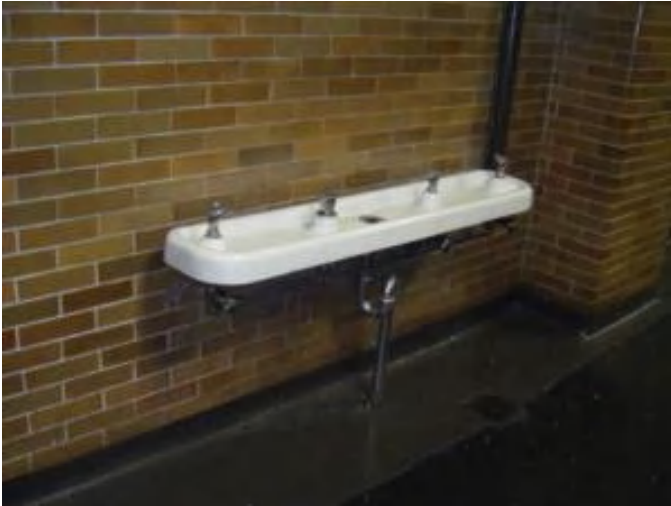
**System: D2010 - Plumbing Fixtures**

**Location:** Corridors

**Distress:** Accessibility

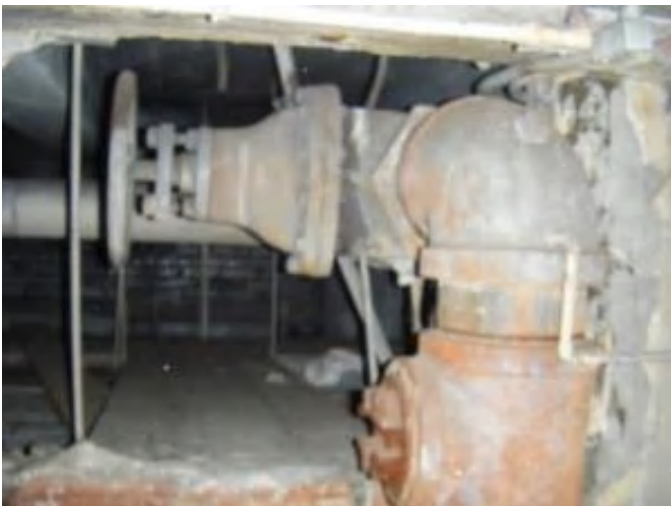
**System: D2020 - Domestic Water Distribution**

**Location:** Throughout Building

**Distress:** Beyond Service Life

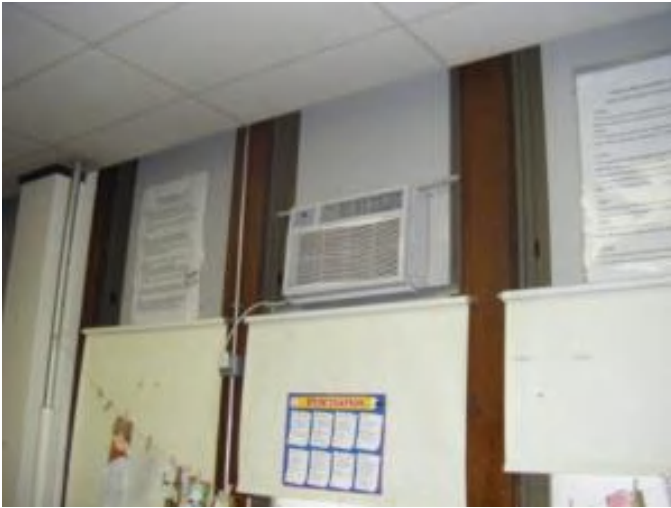
**System: D3030 - Cooling Generating Systems**

**Location:** Throughout Building

**Distress:** Inadequate

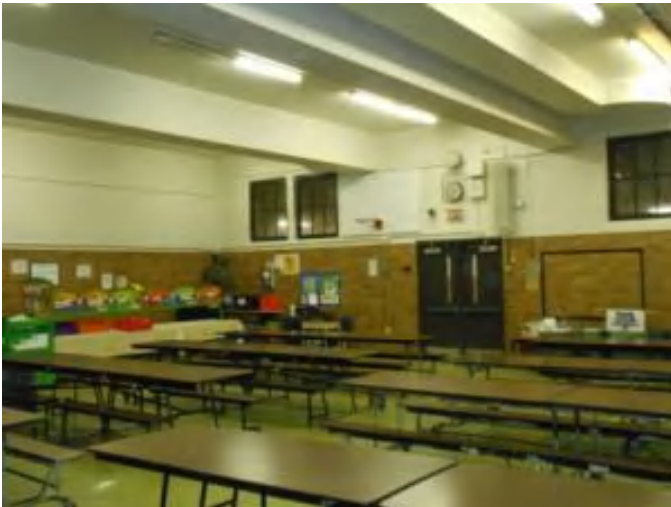
**System: D3040 - Distribution Systems**

**Location:** Gym/Lunchroom

**Distress:** Health Hazard / Risk

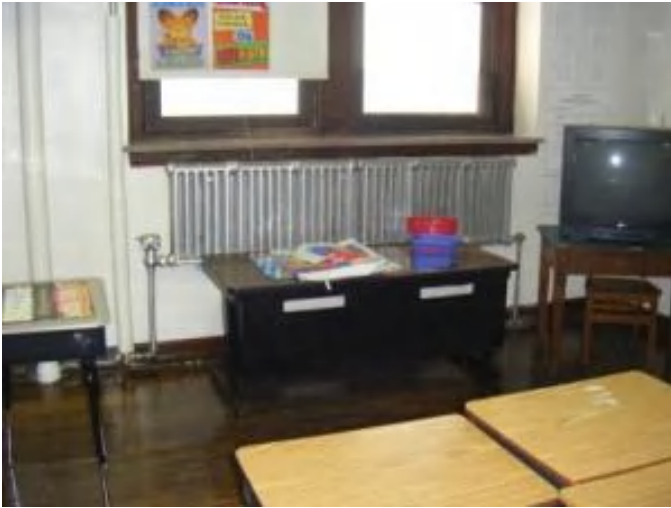
**System: D3040 - Distribution Systems**

**Location:** Throughout Building

**Distress:** Health Hazard / Risk

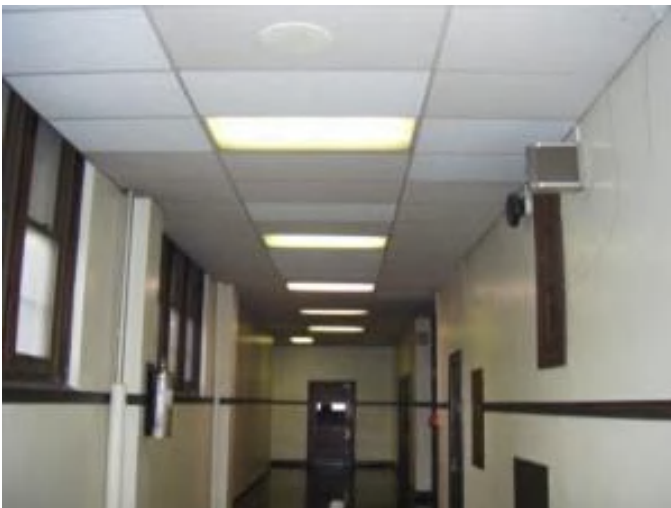
**System: D4010 - Sprinklers**

**Location:** Throughout Building

**Distress:** Life Safety / NFPA / PFD

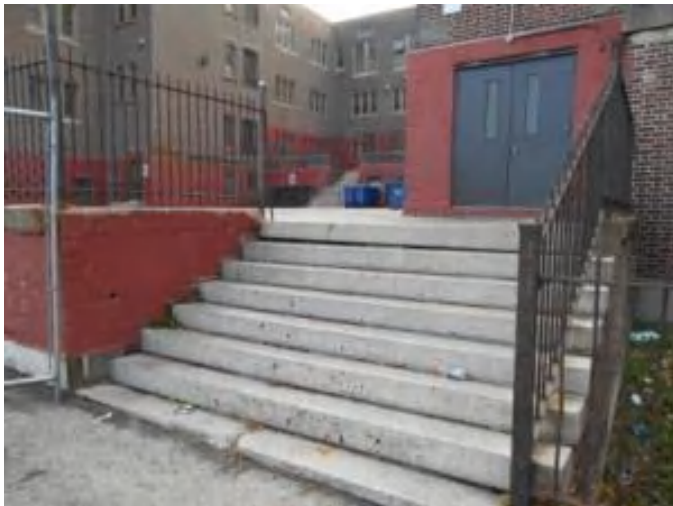
#### **System: G2030 - Pedestrian Paving**

**Location:** Exterior granite steps

**Distress:** Health Hazard / Risk

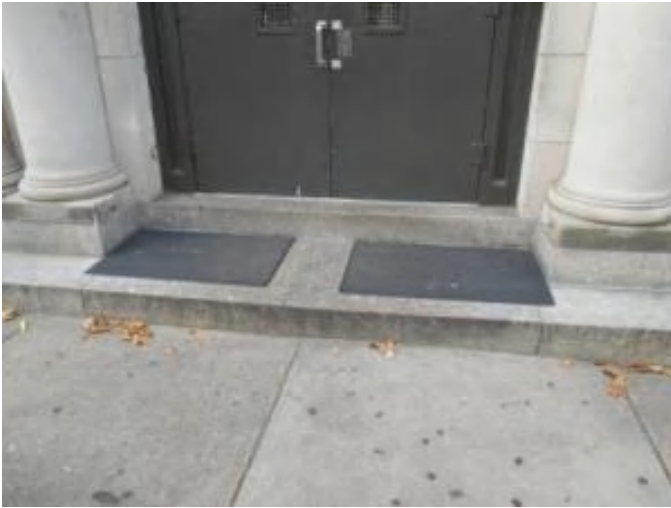
**System: G2030 - Pedestrian Paving**

**Location:** Main entrance on Atwood Ave.

**Distress:** Accessibility

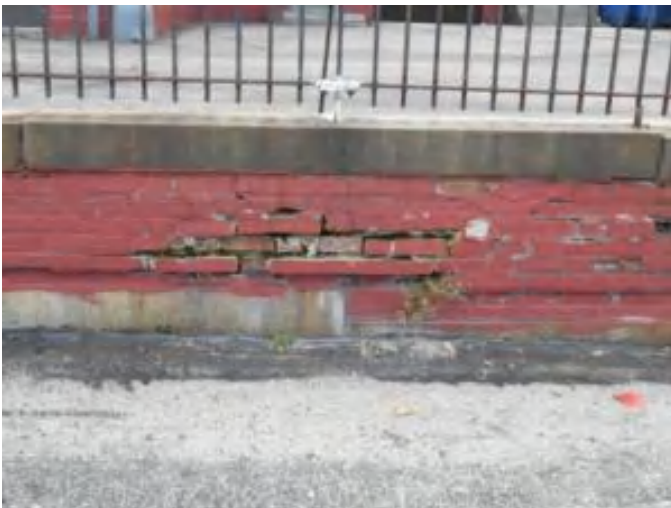
**System: G2040 - Site Development**

**Location:** Exterior, north of building

**Distress:** Failing

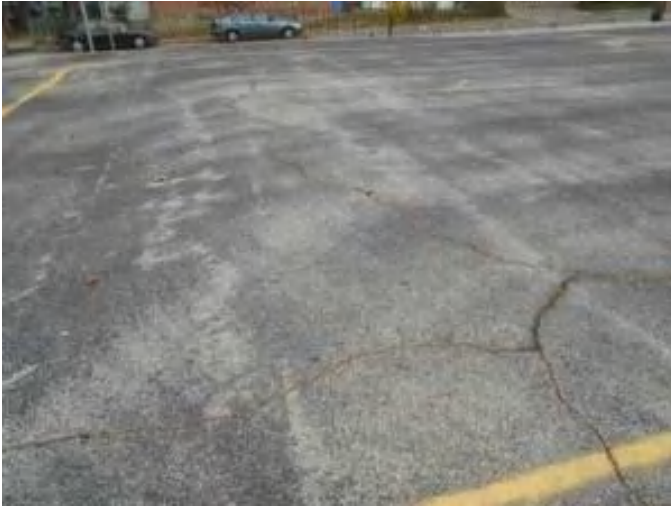
**System: G2020 - Parking Lots**

**Location:** Paved play area

**Distress:** Maintenance Required

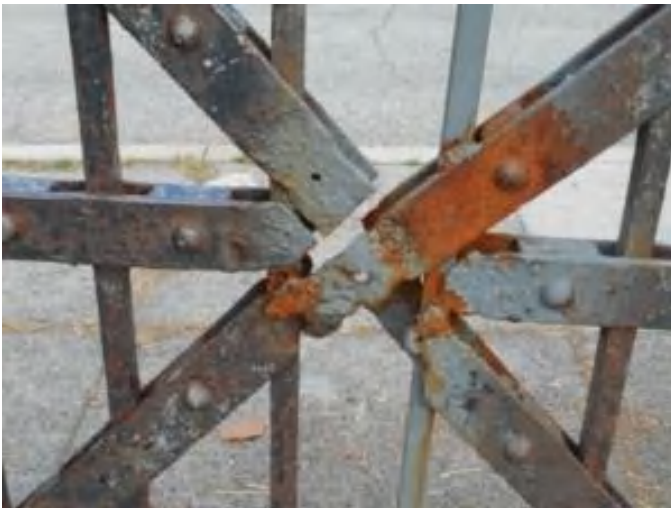
**System: G2040 - Site Development**

**Location:** Site perimeter

**Distress:** Beyond Service Life
