Facility Condition Assessment Summary Report

Catharine School

Catharine Annex (St Vincents) School

January 30, 2017

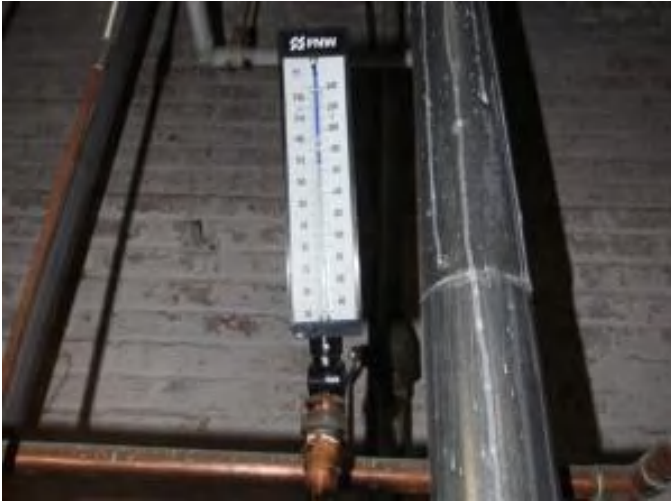
Location: Boiler room

System: D3060 - Controls & Instrumentation

Distress: Damaged

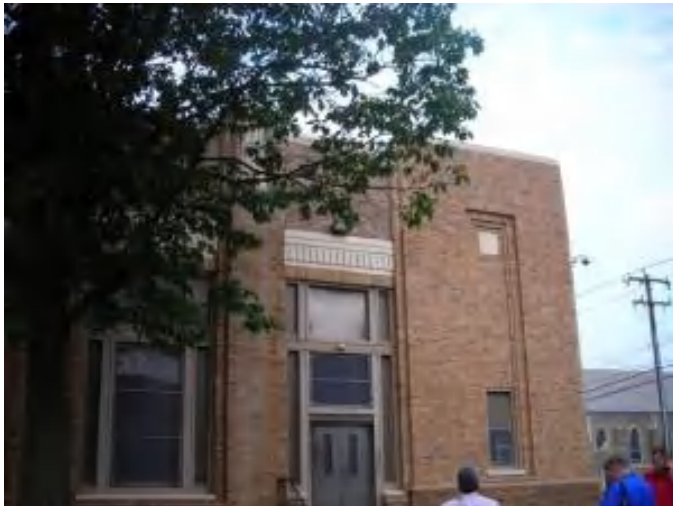
Location: Exterior entrance

System: B2030 - Exterior Doors

Distress: Accessibility

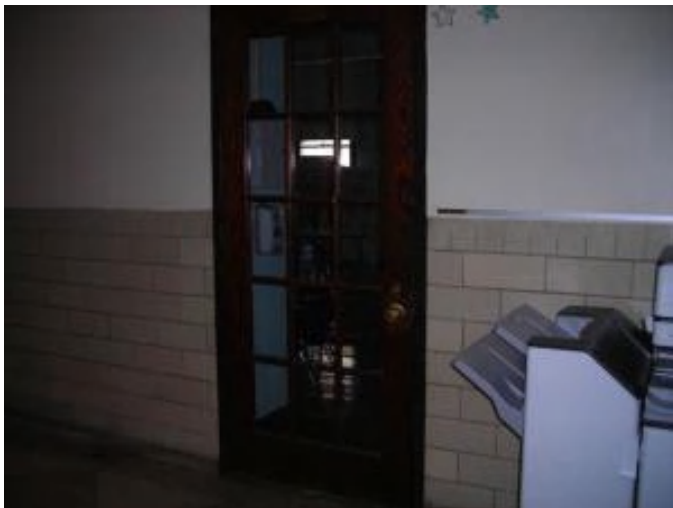
Location: Throughout

System: C1020 - Interior Doors

Distress: Accessibility

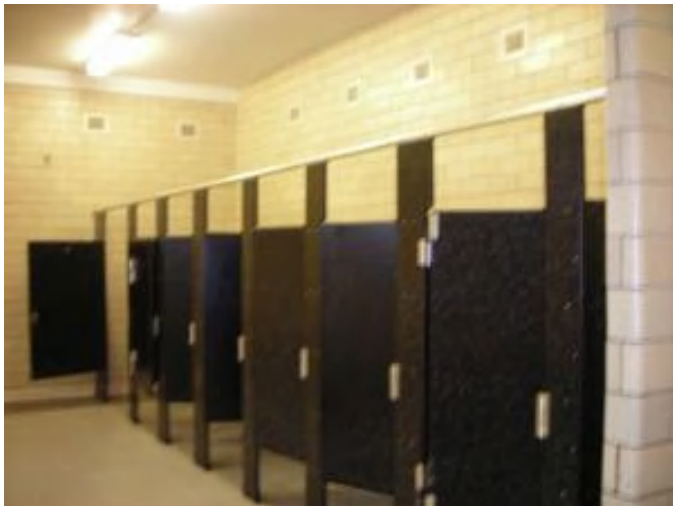
Location: Throughout

System: C1030 - Fittings

Distress: Accessibility

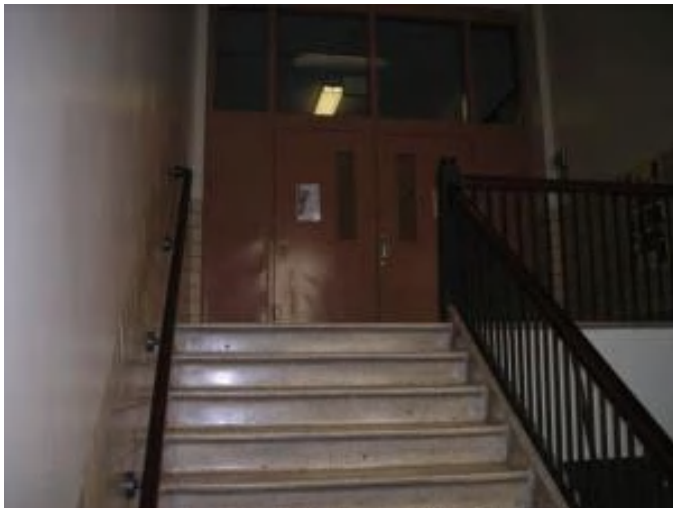
Location: Building

System: D1010 - Elevators and Lifts

Distress: Accessibility

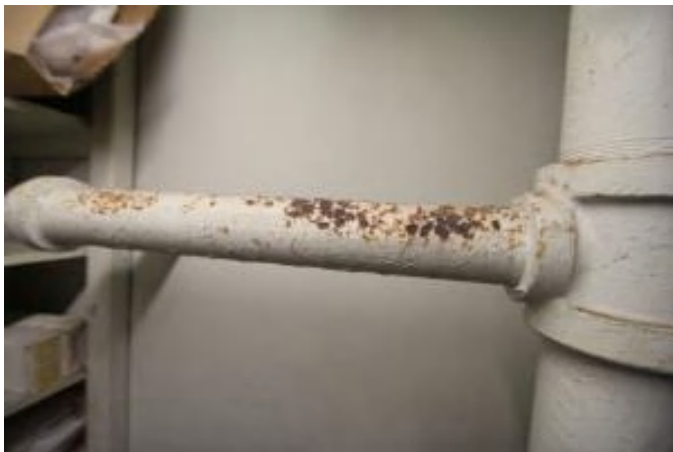
Location: Entire building

Sanitary waste piping is threaded galvanized steel, soldered copper, and cast iron banded coupling pipe. Drain pipes from service sinks in housekeeping closets are leaking and show surface rust. The waste system should be inspected internally and repaired as needed or replaced entirely. There is no sewage ejector pump.

System: D2030 - Sanitary Waste

Distress: Failing

- Provide ADA compliant ramp at one entrance (location TBD)
- Replace sanitary drain piping.
- Replace service sinks beyond service life.
- Replace multiple broken temperature and pressure gauges for HVAC and plumbing

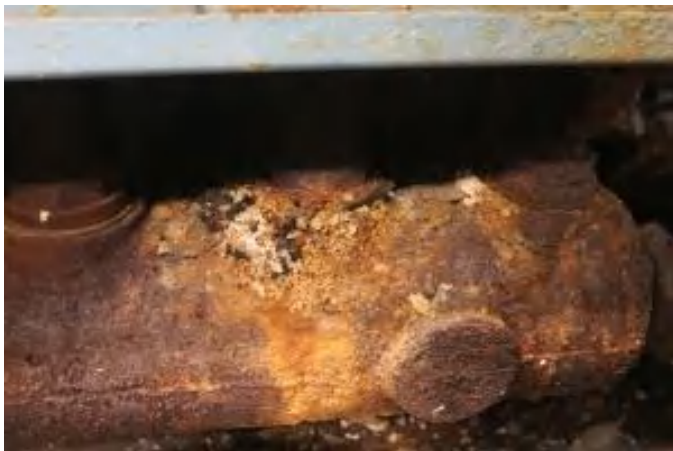
Location: Boiler room

System: D3020 - Heat Generating Systems

Distress: Damaged

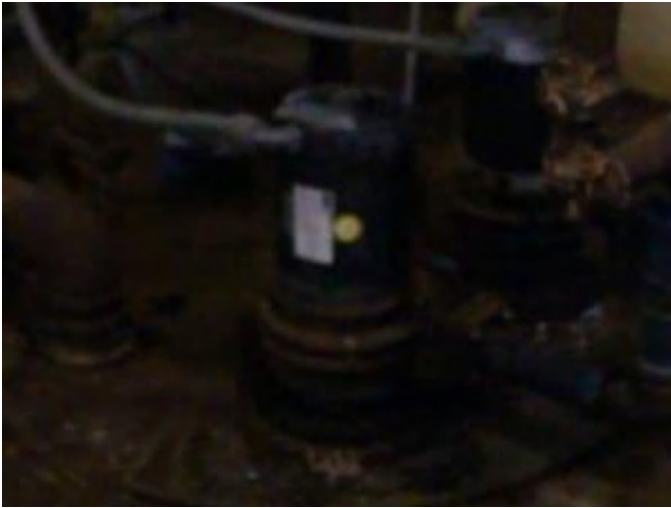
Location: Boiler room

System: D3020 - Heat Generating Systems

Distress: Beyond Service Life

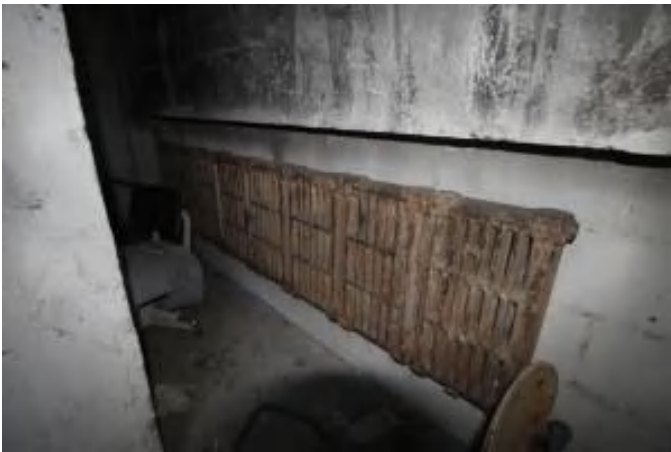
Location: Classrooms

The class rooms in the building are heated by floor mounted unit ventilators. They have dented covers, bent fins, and failing pneumatic damper controls, and they should be replaced due to their age. The hallways and toilet rooms have finned tube terminal units equipped with pneumatic controls and thermostatic steam traps. Many flow control valves are nonfunctional due to damage and age. Terminal units should be replaced due to age also. The incoming gas service is 4" and enters the building from Chester Street and includes a booster.

System: D3040 - Distribution Systems

Distress: Beyond Service Life

- Replace unit ventilators and radiators. Classroom unit ventilators have exceeded useful lifespan.
- Replace rusted and aged boilers.
- Convert steam and condensate pipe to water.

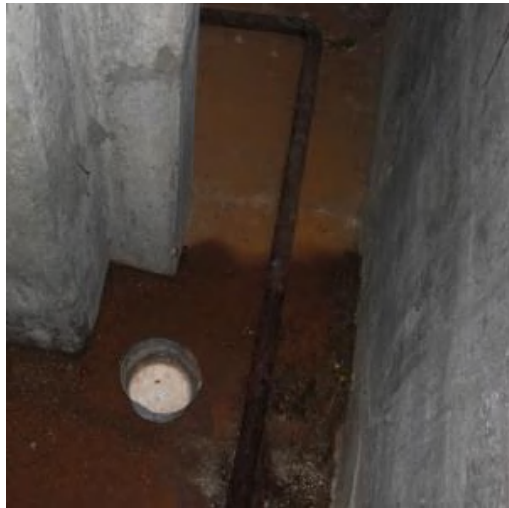
Location: Entire building

System: D3040 - Distribution Systems

Distress: Failing

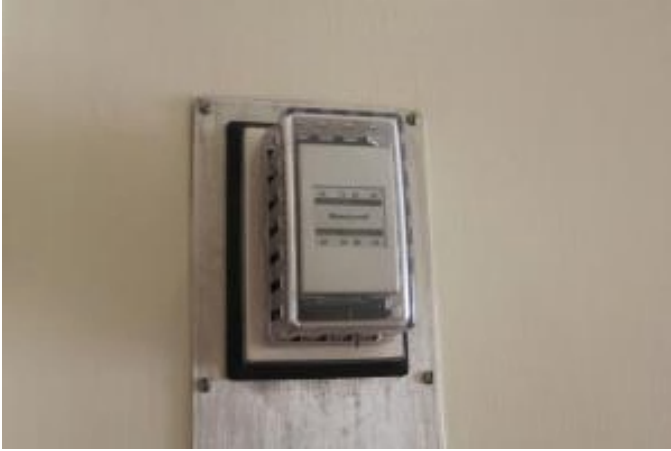
Location: Entire building

System: D3060 - Controls & Instrumentation

Distress: Obsolete

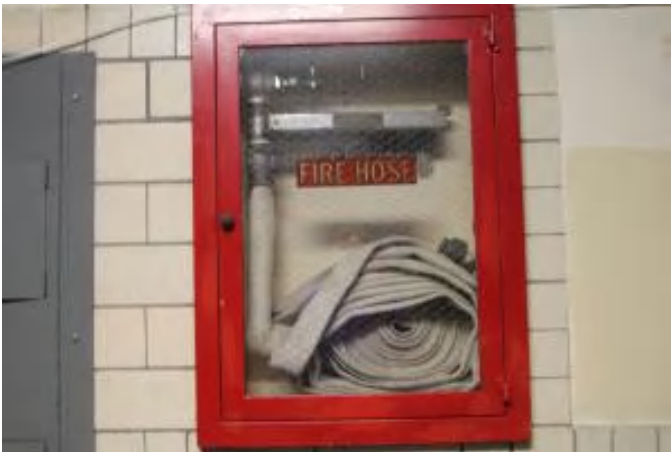
Location: Entire building

System: D4010 - Sprinklers

Distress: Life Safety / NFPA / PFD

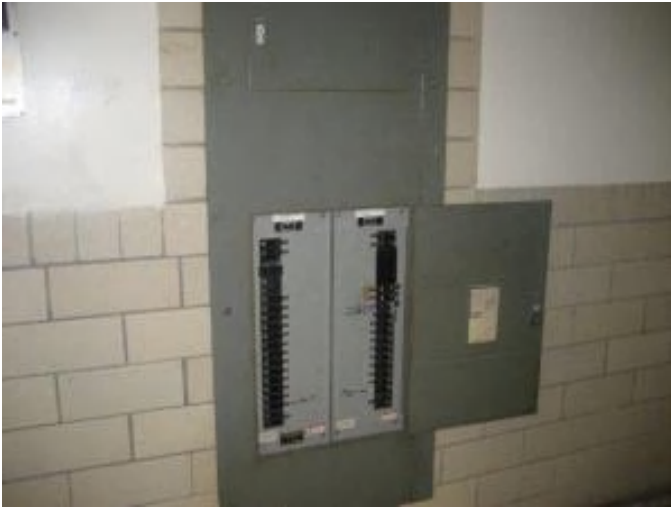
Location: Corridors

System: D5010 - Electrical Service/Distribution

Distress: Building Envelope Integrity

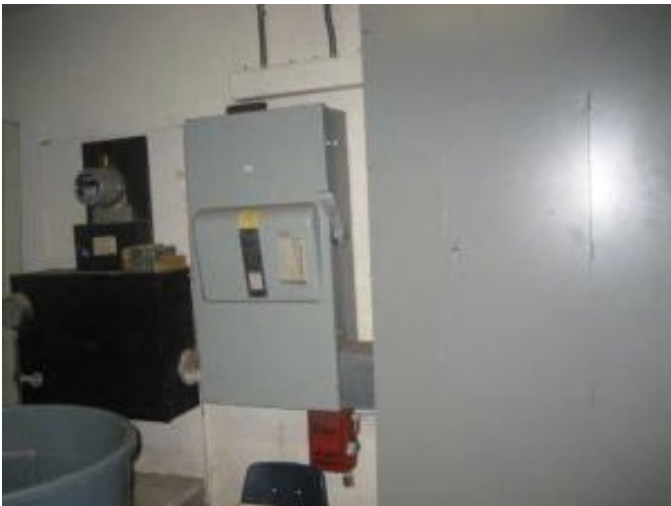
Location: Basement electrical room

System: D5010 - Electrical Service/Distribution

Distress: Building Envelope Integrity

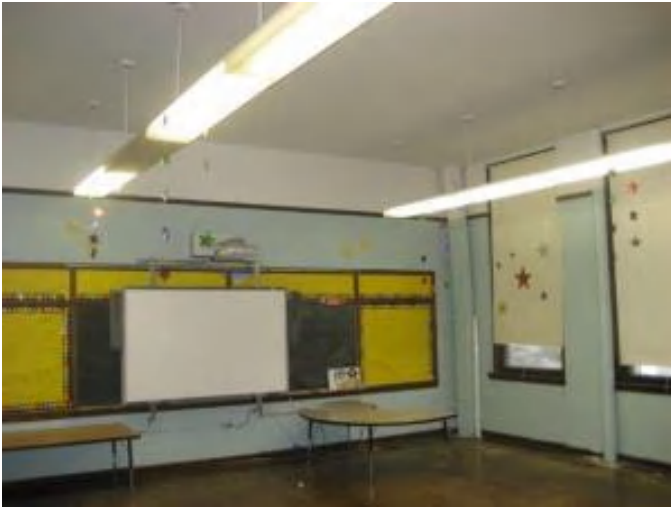
Location: Entire school

System: D5020 - Lighting and Branch Wiring

Distress: Obsolete

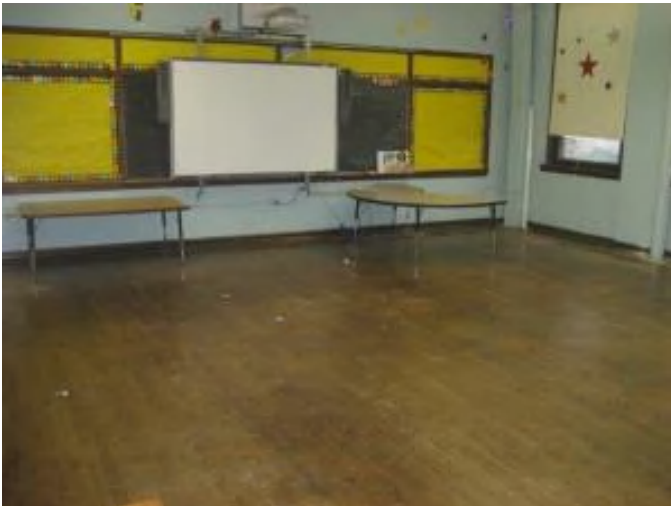
Location: Classrooms

The number of receptacles in classrooms are inadequate. Teachers use extension cords. The teacher's whiteboard and the opposite of it need to be provided with double compartment surface raceways, the other two walls with minimum two duplex outlets each, when feasible.

System: D5020 - Lighting and Branch Wiring

Distress: Inadequate

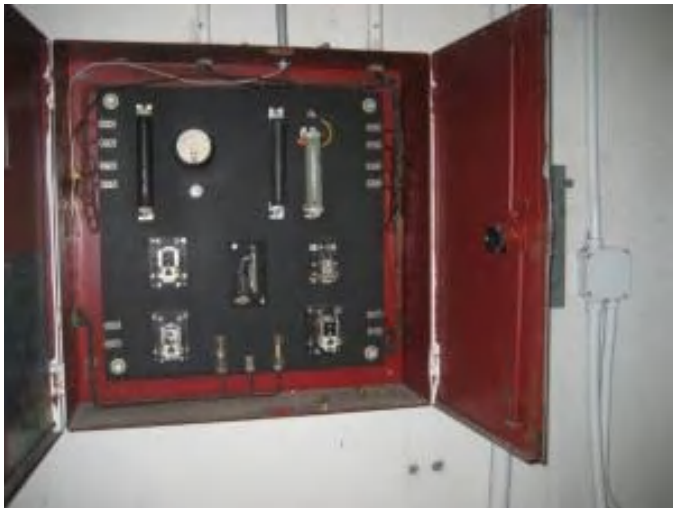
Location: Entire building

System: D5030 - Communications and Security

Distress: Obsolete

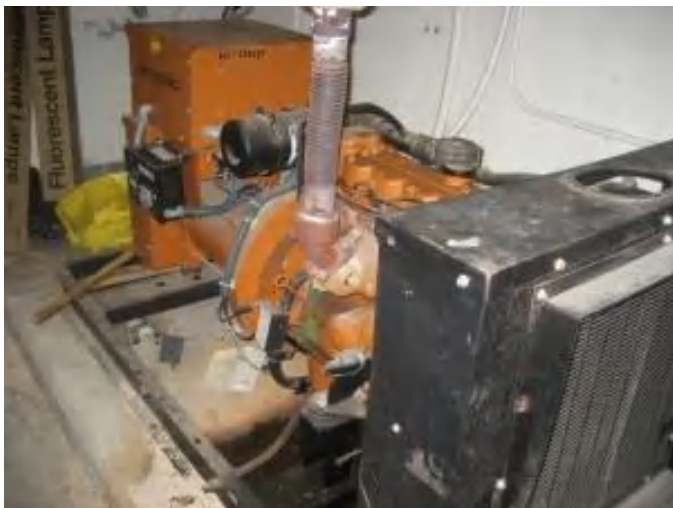
Location: Outdoor

System: D5090 - Other Electrical Systems

Distress: Beyond Service Life

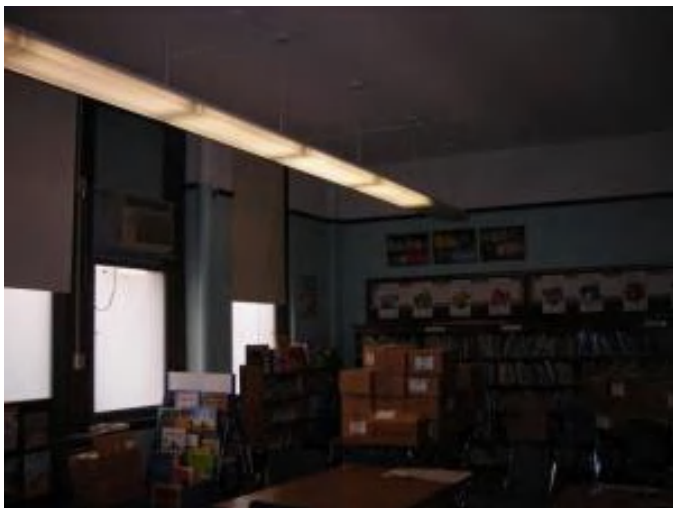
Location: Classrooms

System: E2010 - Fixed Furnishings

Distress: Beyond Service Life

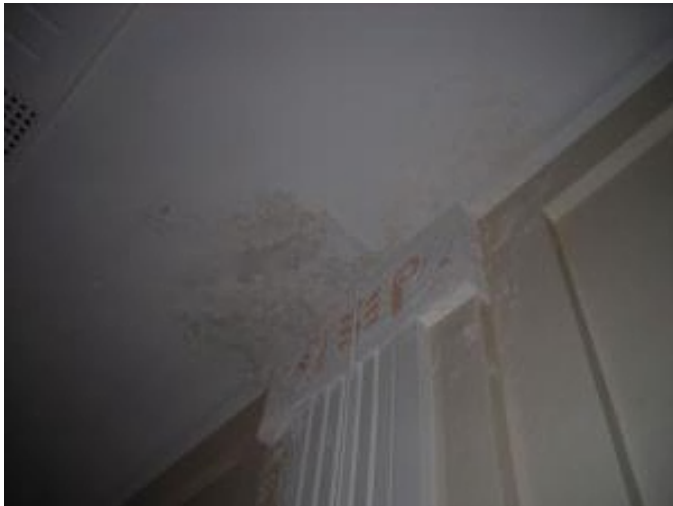
Location: Various

System: C3010230 - Paint & Covering

Distress: Damaged

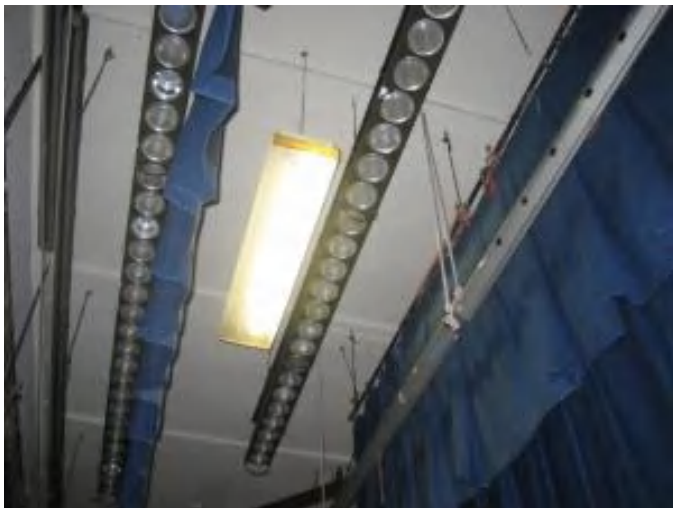
Location: Auditorium

The stage lighting controller is old and has exceeded its service life. Theatrical lighting are ON/OFF from local panel-board. The entire system should be replaced.

System: E1020 - Institutional Equipment

Distress: Obsolete

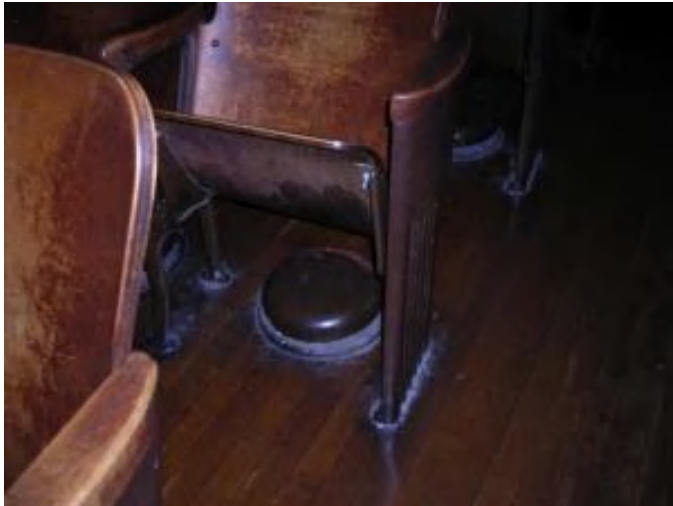
Location: Auditorium

System: E2010 - Fixed Furnishings

Distress: Beyond Service Life

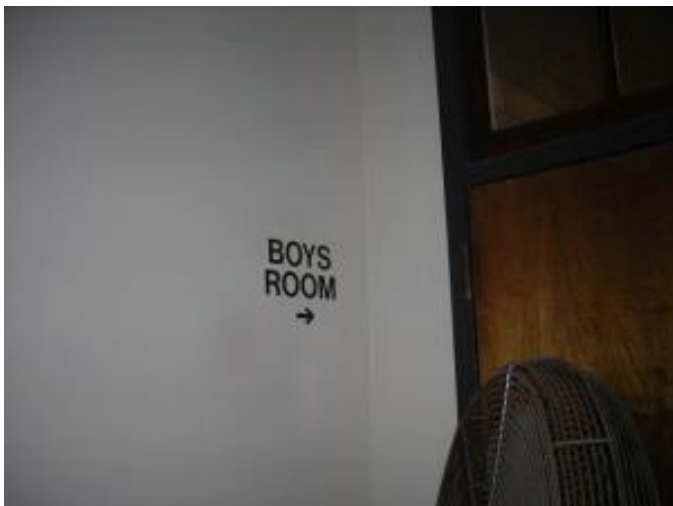
Location: Throughout

System: C1030 - Fittings

Distress: Inadequate

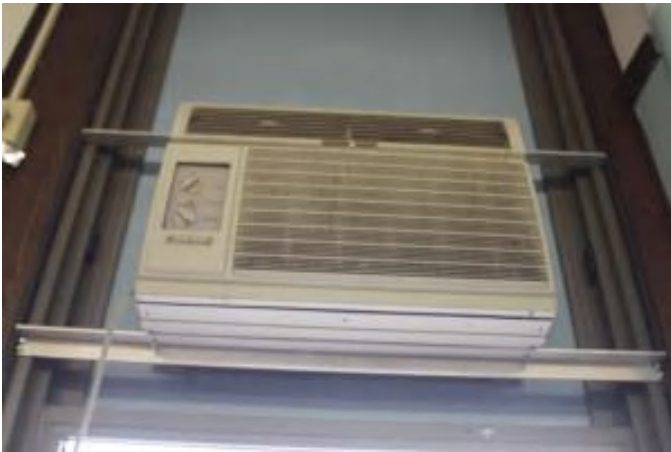
Location: Roof

System: D3030 - Cooling Generating Systems

Distress: Inadequate

- Install hydronic circulation pumps to replace steam feedwater pumps.
- Remove original air handler and replace with modern equipment.
- Install roof mounted, 140 ton capacity, air-cooled chiller, including roof structure upgrade to support 1,200 lbs. over 120 s.f. area.

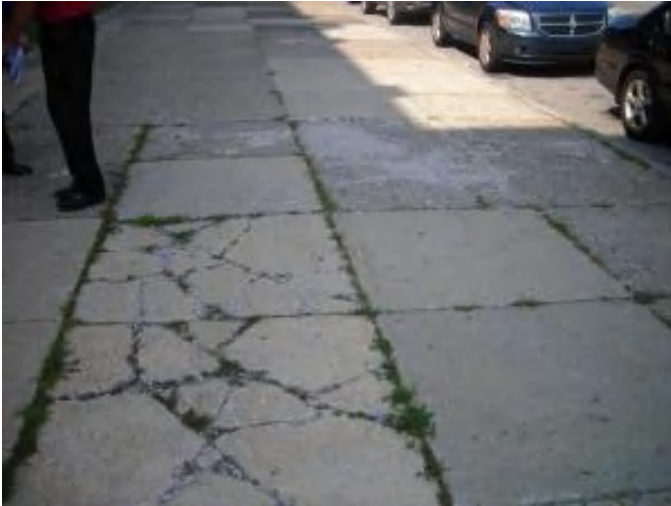
Location: N, E sides

System: G2030 - Pedestrian Paving

Distress: Failing

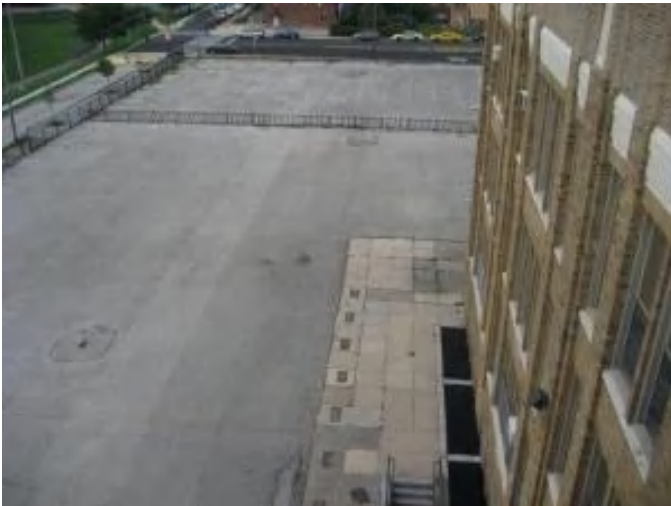
Location: Grounds

System: G4020 - Site Lighting

Distress: Inadequate

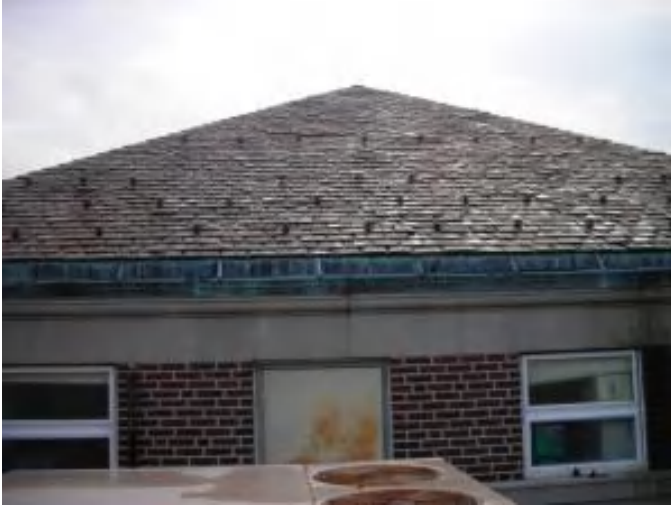
Location: Main roof

System: B3010140 - Shingle & Tile

Distress: Failing

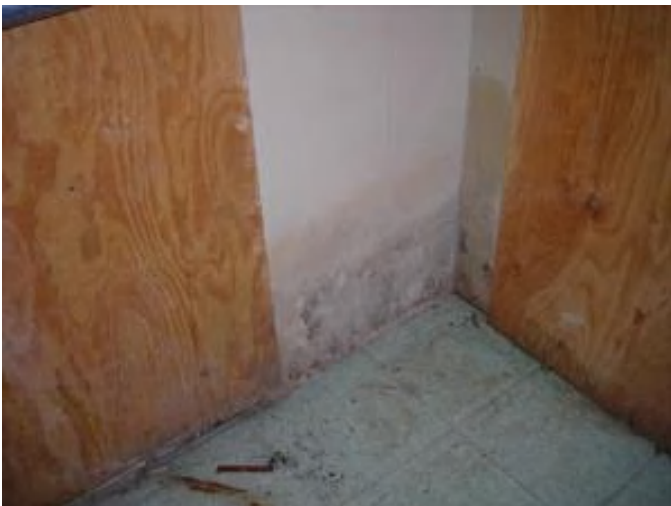
Location: Basement

System: C3010230 - Paint & Covering

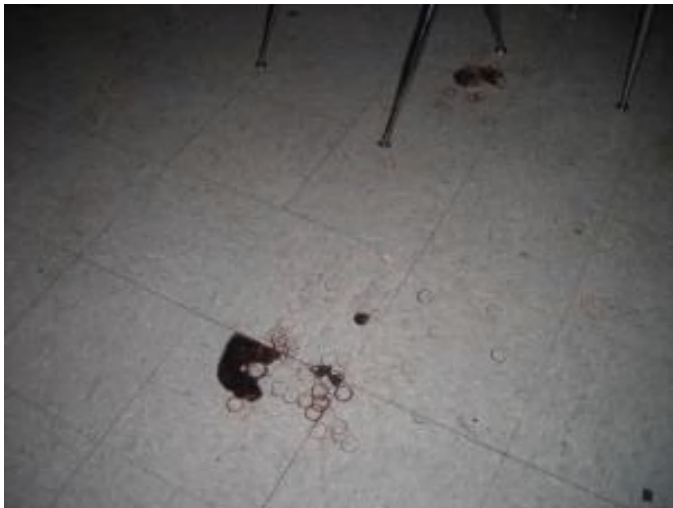
Location: Classroom, cafeteria

System: C3020413 - Vinyl Flooring

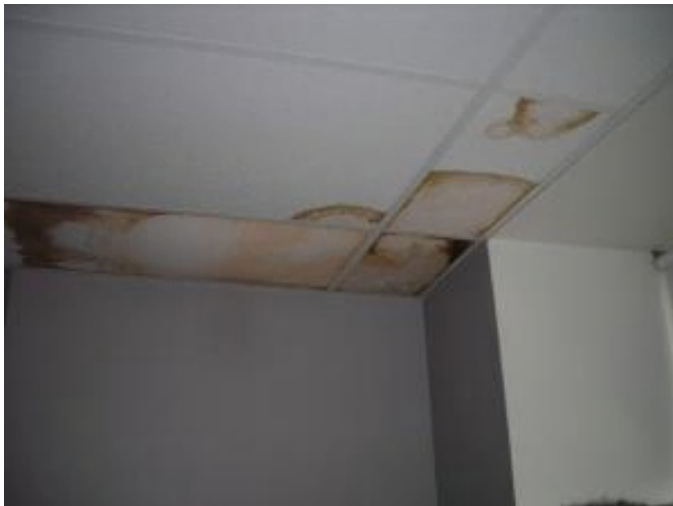
Location: Various

System: C3030 - Ceiling Finishes

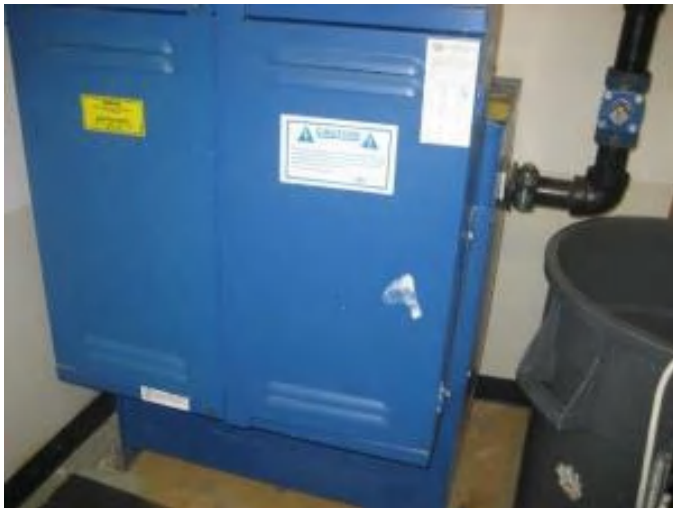
Location: Elevator machine room

System: D1010 - Elevators and Lifts

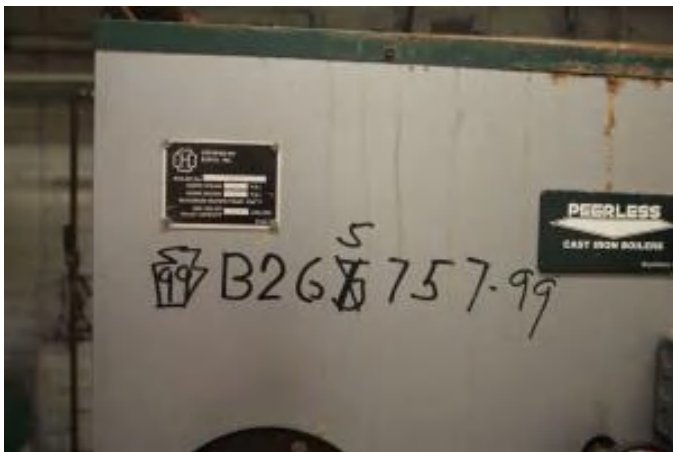
Location: Boiler room

System: D3020 - Heat Generating Systems

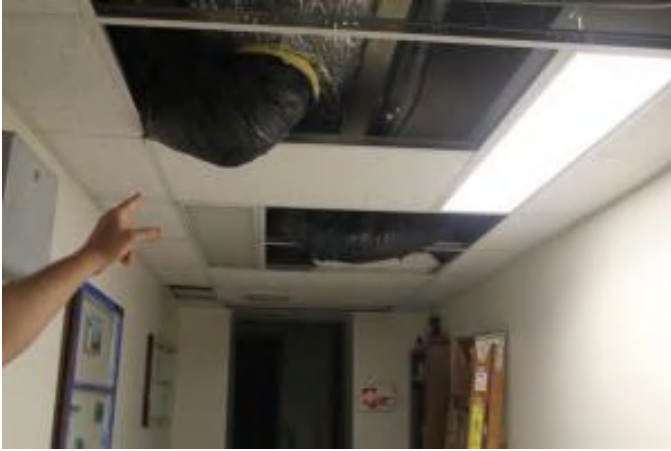
Location: Ceilings

System: D3040 - Distribution Systems

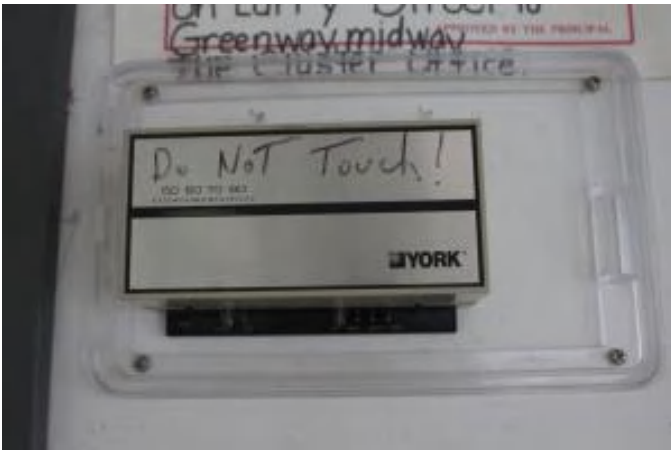
Location: Entire building

System: D3060 - Controls & Instrumentation

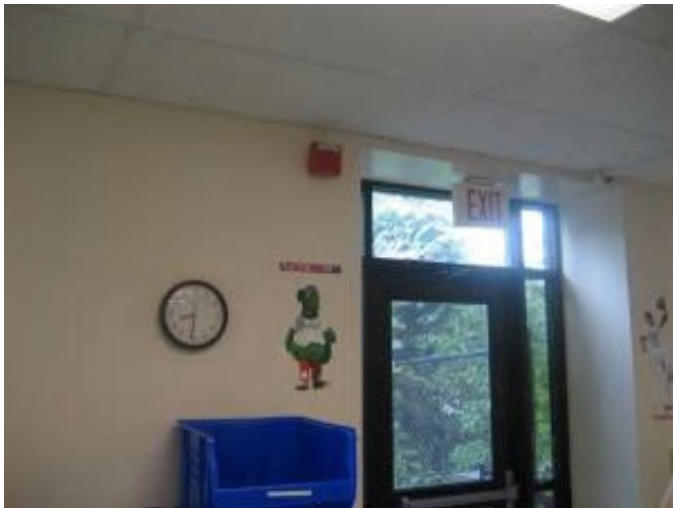
Location: Entire Building

System: D5030 - Communications and Security

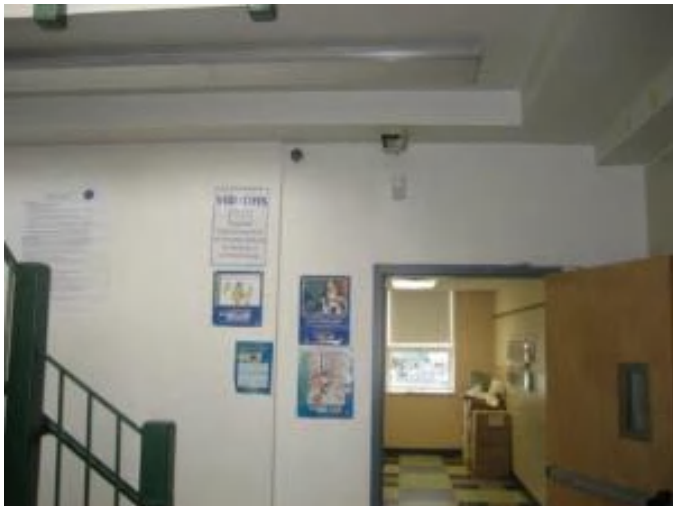
Location: Entire Building

System: D5030 - Communications and Security

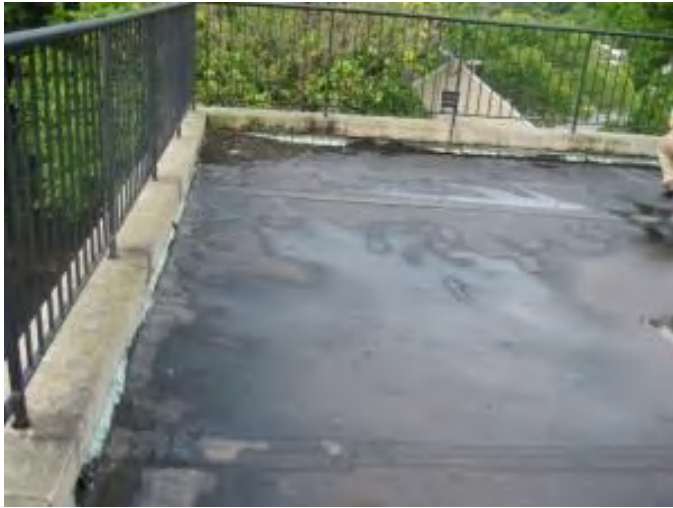
Location: Roof

System: D5090 - Other Electrical Systems

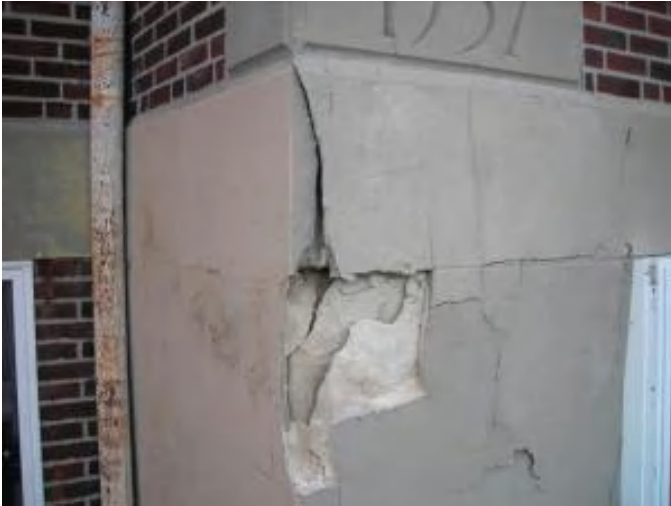
Location: Elevations

System: B2010 - Exterior Walls

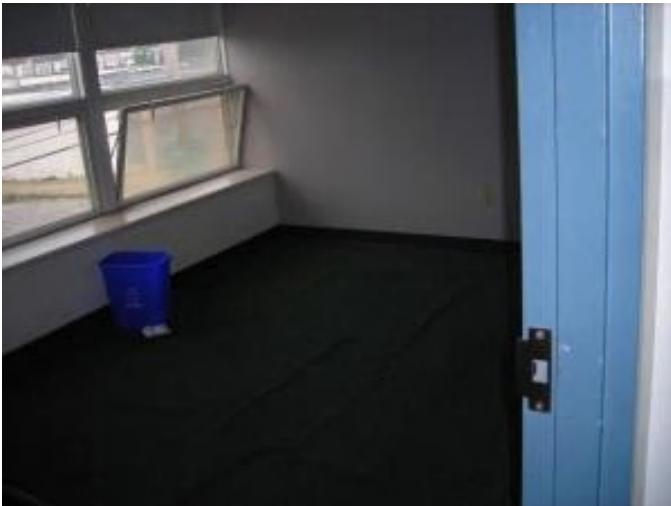
Location: Office

System: C3020411 - Carpet

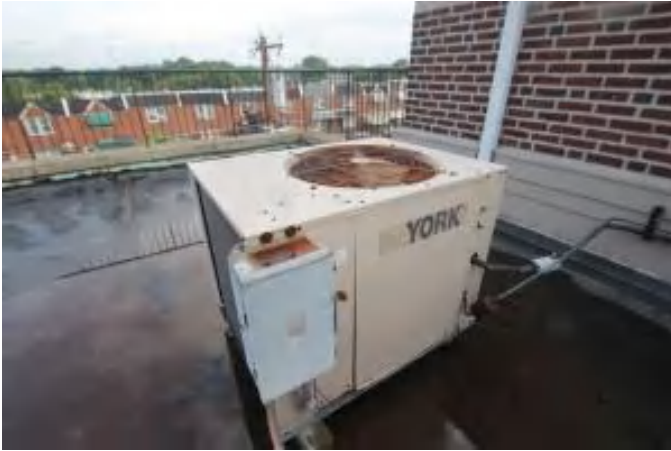
Location: Ground level and roof top

System: D3050 - Terminal & Package Units

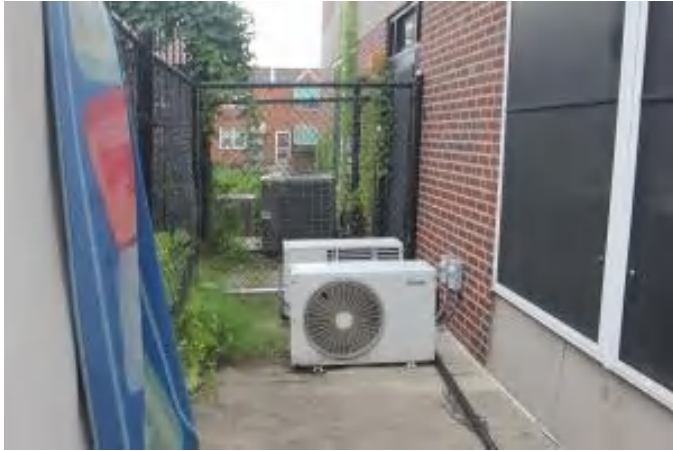
Location: Ground level

System: D3050 - Terminal & Package Units

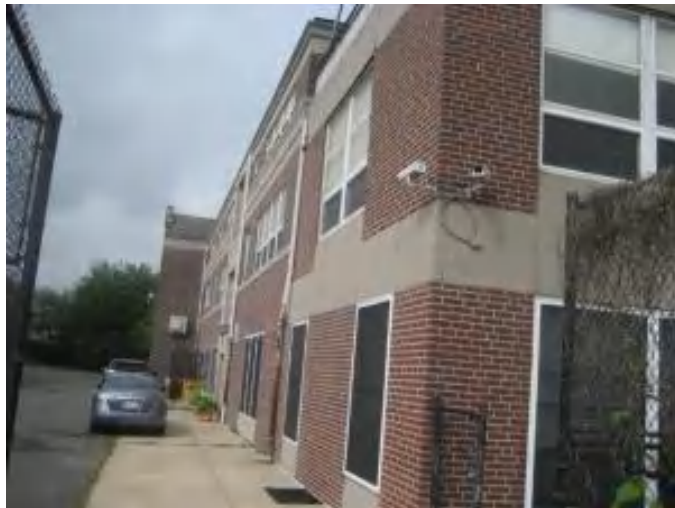
Location: Outdoor

System: G4030 - Site Communications & Security
