Facility Condition Assessment Summary Report

Cayuga School

School District of Philadelphia
S549001;Cayuga
Final
Site Assessment Report

January 30, 2017

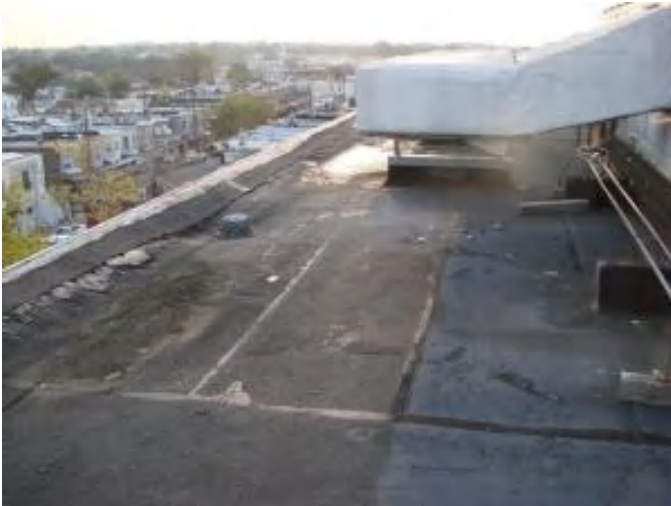
System: B3010105 - Built-Up

Roofing system on the building is built-up, and in poor condition. Flashing is deteriorated and pulling away from mechanical equipment curbs, multiple soft spots have been observed. Multiple leaks have been reported. The transition between original building and added wing has sloping prefinished standing seam roof in good condition.

Location: Exterior

Distress: Beyond Service Life

Notes: Install all new roofing system including insulation within next 3 to 4 years; tear-down existing roofing; install flashing, counter flashing and reglets

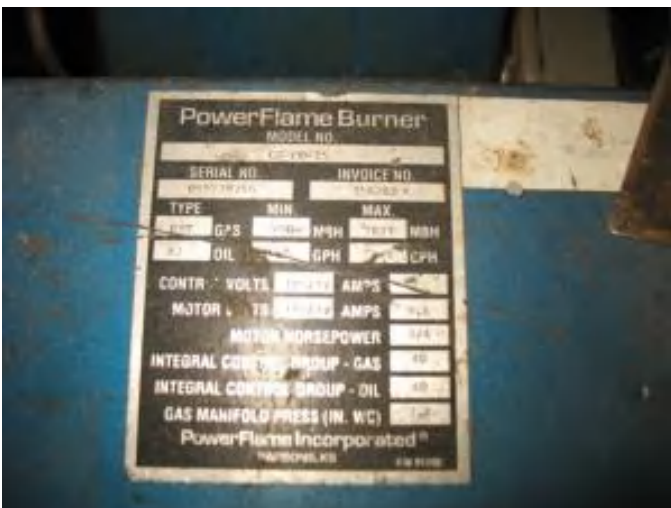
System: D3020 - Heat Generating Systems

Location: Boiler room

Distress: Beyond Service Life

Notes: Replace the two (2) existing 1800MBH dual fuel burners on the boilers, which are at the end of their service life, with more efficient new burners.

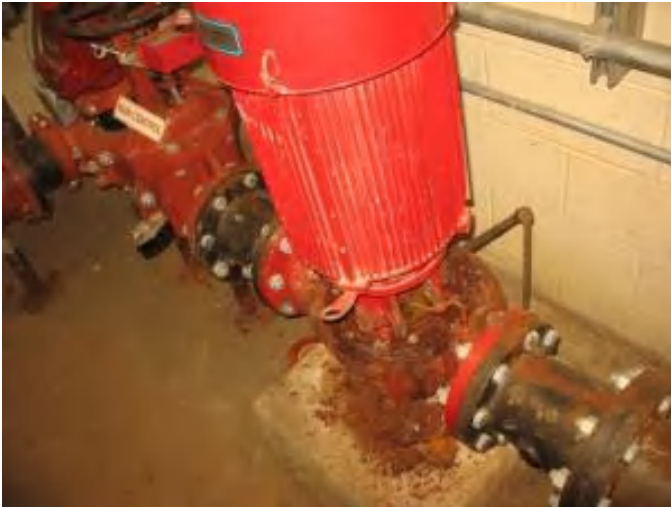
System: D4010 - Sprinklers

Sprinklers - The building is equipped with a wet pipe sprinkler system. An 8" fire water line enters the building in the pump room from 5th Street near the intersection with St. Luke Street. A 25HP inline, vertical mount, electric fire pump is installed in the pump room to ensure adequate pressure to the system. The fire suppression system appears to have been installed in 1997 and the pump is damaged from rust. The 25HP electric fire pump and motor should be replaced.

Location: Pump room

Distress: Damaged

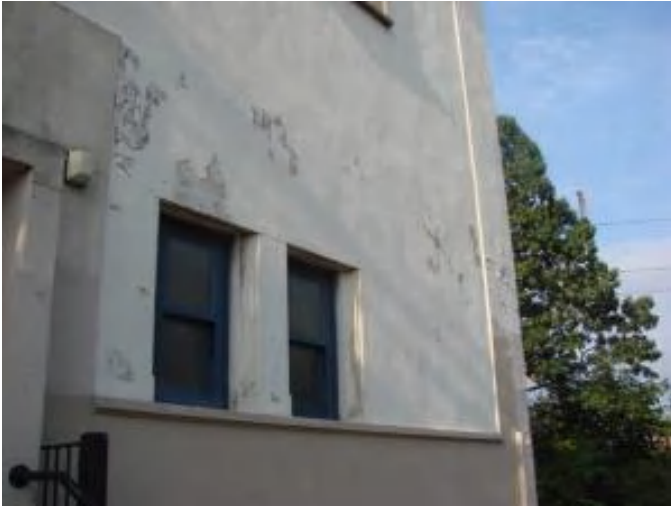
System: B2010 - Exterior Walls

The original building envelope is typically exposed stone basement walls and plastered masonry on first and second floor. The plaster, especially on west wall is severely damaged allowing moisture penetration into the building. The new addition exterior walls are face brick with CMU backup, in good condition; however some cracks were observed in the transition between original building and new wing.

Location: Exterior

Distress: Building Envelope Integrity

Notes: Repair damaged stucco plaster on original building walls

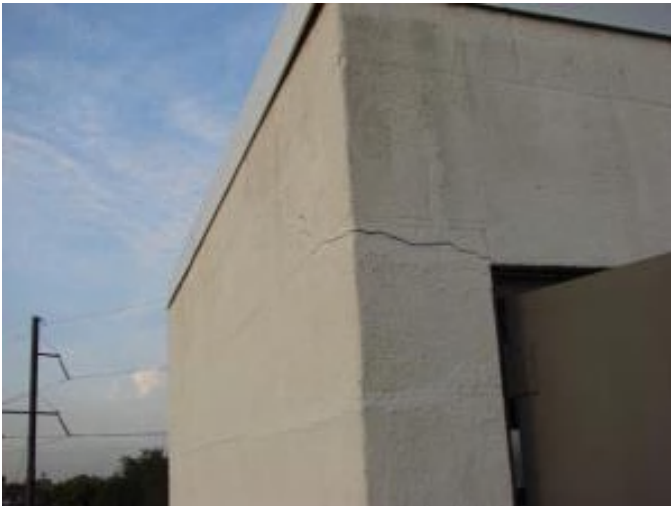
System: B2010 - Exterior Walls

Location: Exterior

Distress: Building Envelope Integrity

Notes: Repair cracks in masonry, replace missing mortar, tuck-point

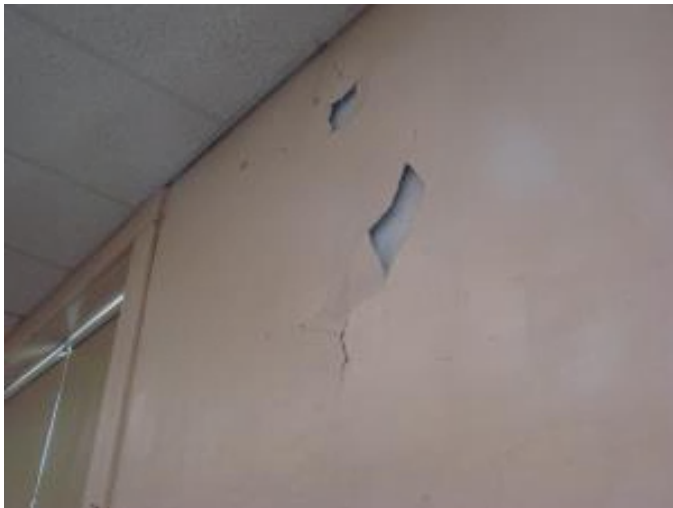
System: C3010230 - Paint & Covering

The interior wall finishes in the original building are generally painted plaster or drywall and glazed block in stairways; toilets. Interior face of the exterior wall in the original building is plaster, severely damaged. Generally, paint is in good condition throughout the building.

Location: Interior
Distress: Damaged
Category: 3 - Operations / Maint.
Priority: 3 - Response Time (3-4 yrs)
Correction: Repair substrate and repaint interior walls - SF of wall surface
Qty: 1,800.00
Unit of Measure: S.F.
Estimate: \$33,267.52
Assessor Name: System
Date Created: 11/18/2015

Notes: Repair and repaint interior face of exterior walls in the original building

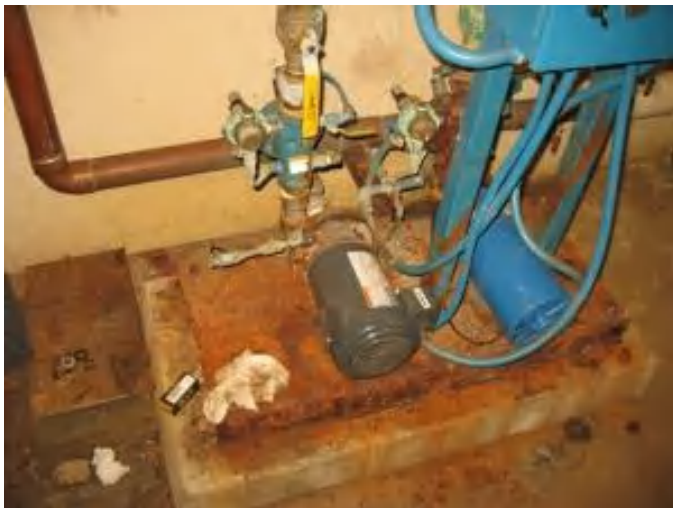
System: D2020 - Domestic Water Distribution

Location: Pump room
Distress: Damaged
Category: 3 - Operations / Maint.
Priority: 3 - Response Time (3-4 yrs)
Correction: Replace duplex domestic booster pump set (5 HP)
Qty: 1.00
Unit of Measure: Ea.
Estimate: \$47,995.11
Assessor Name: System
Date Created: 09/11/2015

Notes: Replace the existing duplex domestic constant pressure pump system in the pump room as it is damaged from rust.

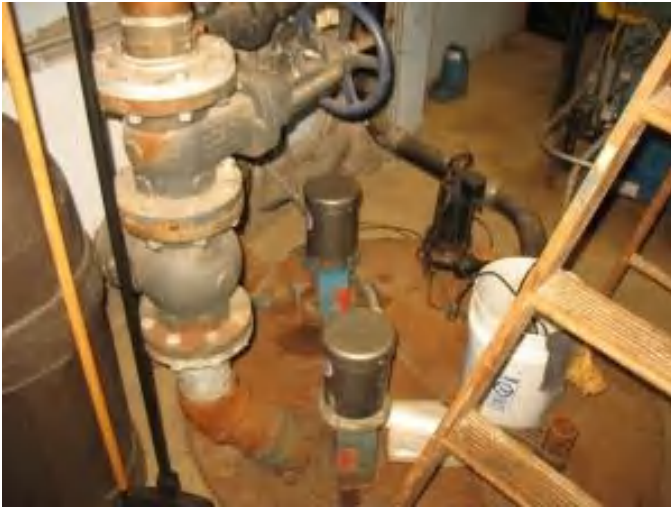
System: D2030 - Sanitary Waste

A sewage ejector pit located in basement boiler room receives water from the basement area. It has two pumps that are beyond their service life. Both pumps and motors should be replaced. The pit is sealed.

Location: Boiler room
Distress: Beyond Service Life
Category: 3 - Operations / Maint.
Priority: 3 - Response Time (3-4 yrs)
Correction: Replace sanitary sewage ejector pit and pumps. (48" dia.)
Qty: 1.00
Unit of Measure: Ea.
Estimate: \$30,685.95
Assessor Name: System
Date Created: 09/11/2015

Notes: Replace existing sewage ejector pump system and piping in the basement as it is beyond its useful service life.

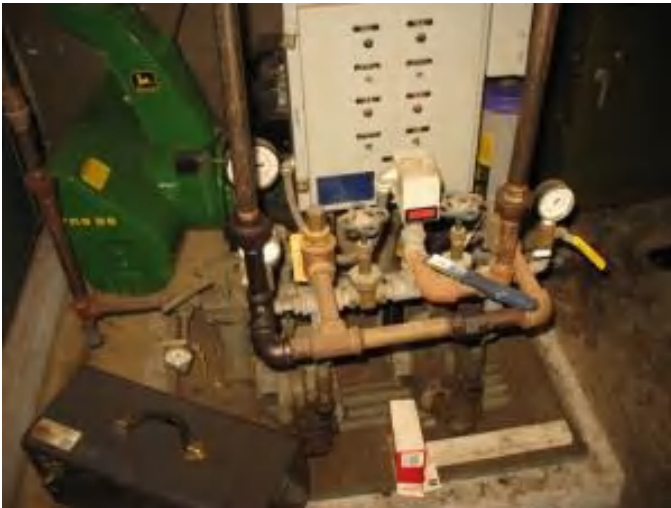
System: D3020 - Heat Generating Systems

The reserve oil supply is stored in a 5,000 gallon underground storage tank (UST), according to the Building Engineer. Duplex pumps located in the boiler room circulate oil through the system. The pumps are estimated to be 20 years old and should be replaced. Oil is used as a backup fuel and the District receives credit from the gas utility as an interruptible service. The current supply has been in storage for some time and should be tested for quality on a regular schedule. USTs have an anticipated service life of 20 years.

Location: Boiler room
Distress: Beyond Service Life
Category: 3 - Operations / Maint.
Priority: 3 - Response Time (3-4 yrs)
Correction: Replace fuel oil pumps
Qty: 1.00
Unit of Measure: Ea.
Estimate: \$23,617.24
Assessor Name: System
Date Created: 09/11/2015

Notes: Replace the existing duplex fuel oil pumping system and associated controls.

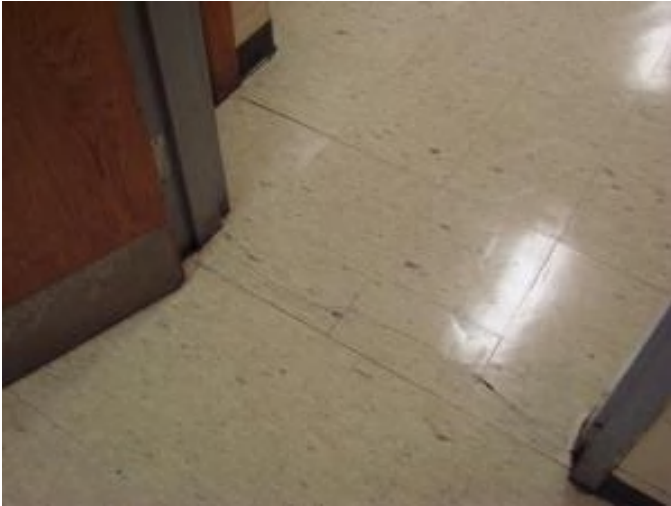
System: C3020413 - Vinyl Flooring

Flooring throughout the building is typically VCT and ceramic tile in toilets. Most flooring is in fair condition; however some VCT tiles are damaged or missing.

Location: Interior

Distress: Damaged

Notes: Replace damaged VCT flooring including cove base (approx10%)

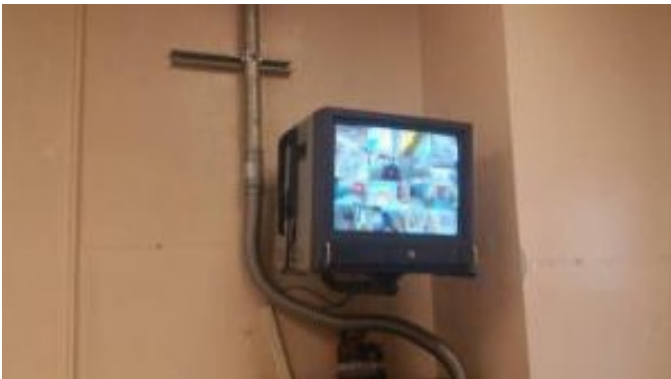
System: D5030 - Communications and Security

Location: throughout the building

Distress: Inadequate

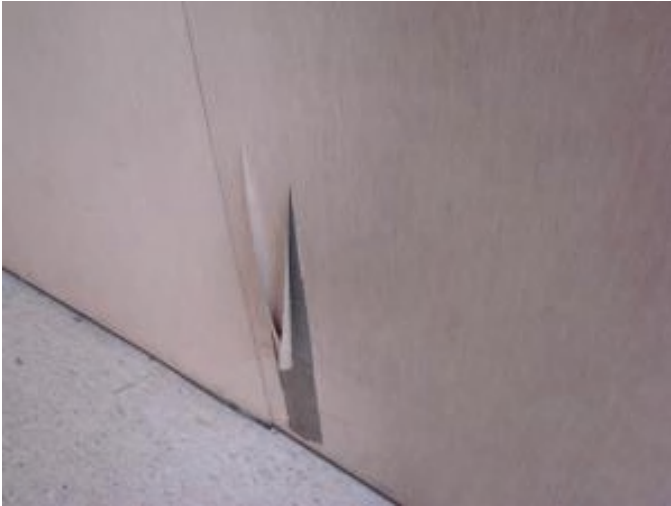
System: C1010 - Partitions

The original building partition wall types include glazed blocks and drywall over metal studs; in the new addition partitions are generally painted CMU. The multipurpose room has a movable partition which is deteriorated.

Location: Interior

Distress: Damaged

Notes: Replace folding partition in multipurpose room

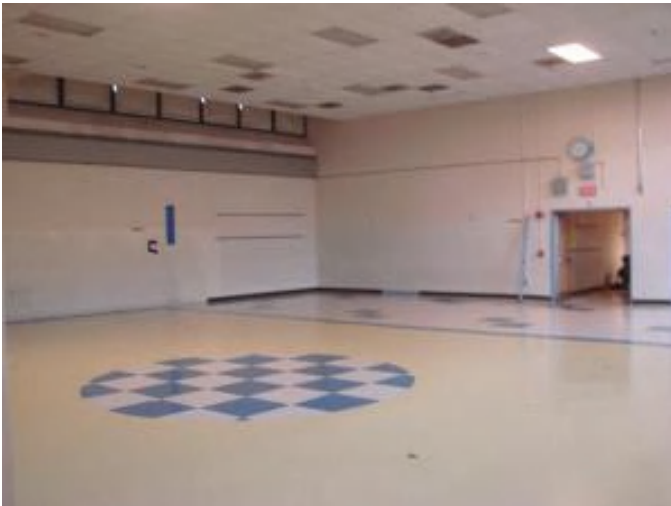
System: C3030 - Ceiling Finishes

Location: Interior

Distress: Beyond Service Life

Notes: Replace all suspended acoustical ceilings in original building

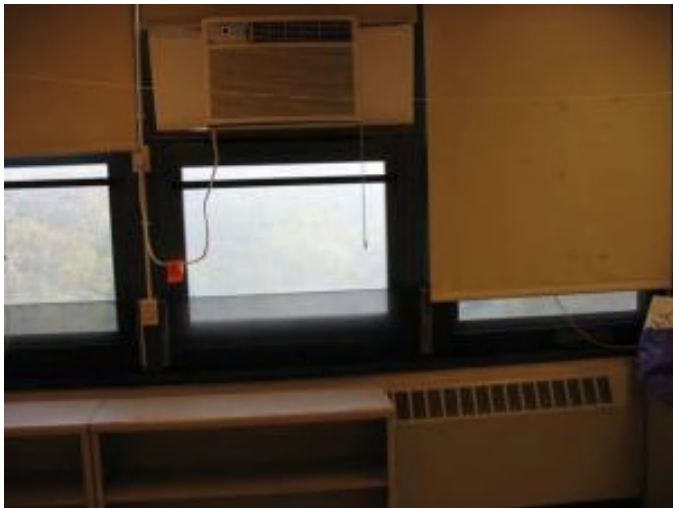
System: D3030 - Cooling Generating Systems

Terminal & Package Units - Several of the classrooms in the school building have window air conditioning units that have an anticipated service life of only 10 years. Installing a 75 ton air-cooled chiller on the roof, with pumps located in the mechanical room, and converting the existing heating water piping to a dual temperature system would supply more reliable air conditioning for the classrooms with a much longer service life.

Location: Throughout building
Distress: Inadequate
Category: 4 - Capital Improvement
Priority: 5 - Response Time (> 5 yrs)
Correction: Install chilled water system with distribution piping and pumps. (+75KSF)
Qty: 49,422.00
Unit of Measure: S.F.
Estimate: \$738,358.07
Assessor Name: System
Date Created: 09/11/2015

Notes: Remove the window air conditioning units and install a 75 ton air-cooled chiller on the roof with chilled water distribution piping and pumps located in the mechanical room to supply more reliable air conditioning for the classrooms with a much longer service life.

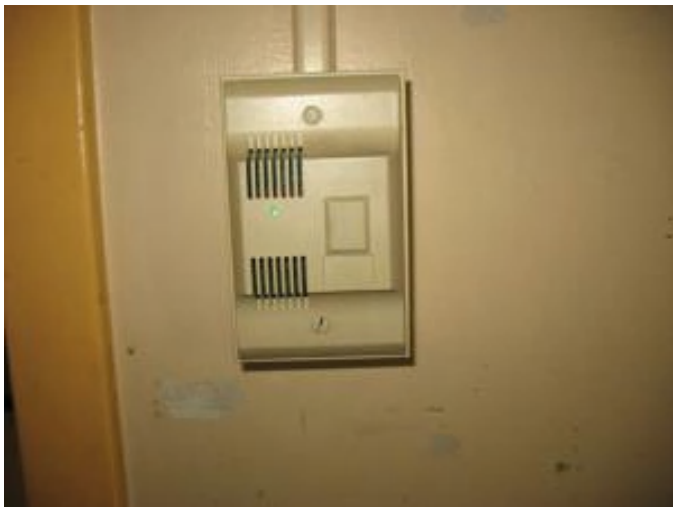
System: D3060 - Controls & Instrumentation

Controls & Instrumentation - A building management system (BMS) was installed during the 1997 renovation. The BMS is no longer operational, according to the Building Engineer, and should be replaced. This system is beyond its service life and is not operational. All of the HVAC equipment is currently operated manually by the Building Engineer.

Location: Throughout building
Distress: Failing
Category: 3 - Operations / Maint.
Priority: 5 - Response Time (> 5 yrs)
Correction: Replace pneumatic controls with DDC (75KSF)
Qty: 49,422.00
Unit of Measure: S.F.
Estimate: \$1,060,207.14
Assessor Name: System
Date Created: 09/11/2015

Notes: Replace the existing, non-functioning, controls for the HVAC systems with modern DDC modules, valves and actuators to improve reliability and energy efficiency. Provide a new building automation system (BAS) with communication interface to the preferred system in use throughout the District.

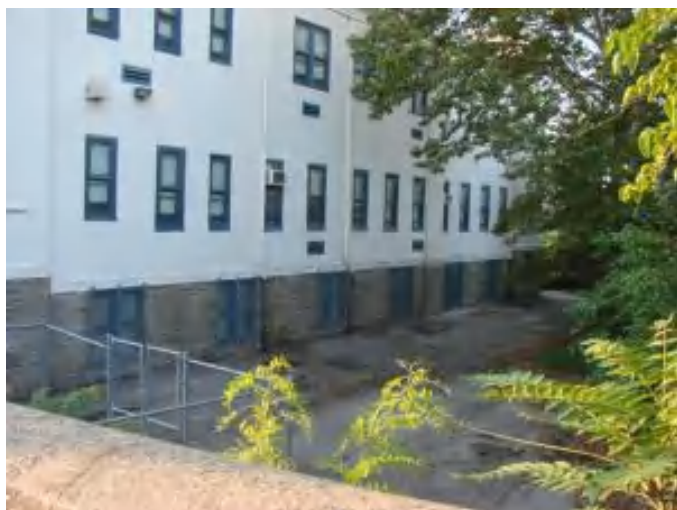
System: G2040 - Site Development

Location: Grounds/ site

Distress: Security Issue

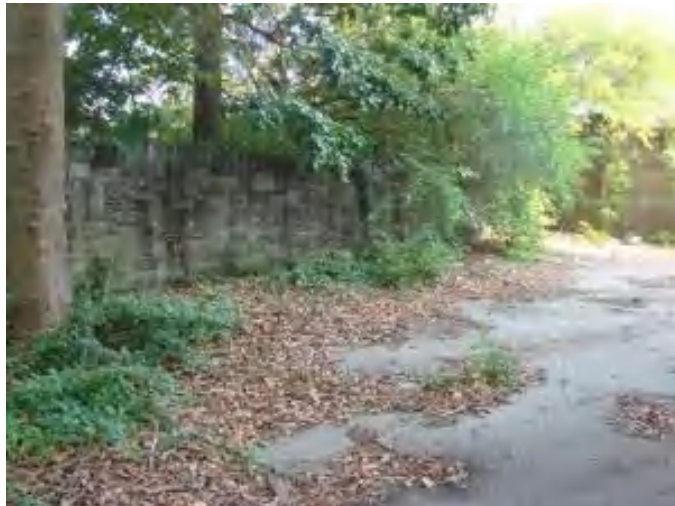
System: G2030 - Pedestrian Paving

Location: Grounds/ site

Distress: Beyond Service Life
