## Facility Condition Assessment Summary Report

### Childs (Barratt) School

School District of Philadelphia  
**S211001;Barratt**  
Final  
**Site Assessment Report**  
January 30, 2017

Facility Assessment  
July 20th, 2015

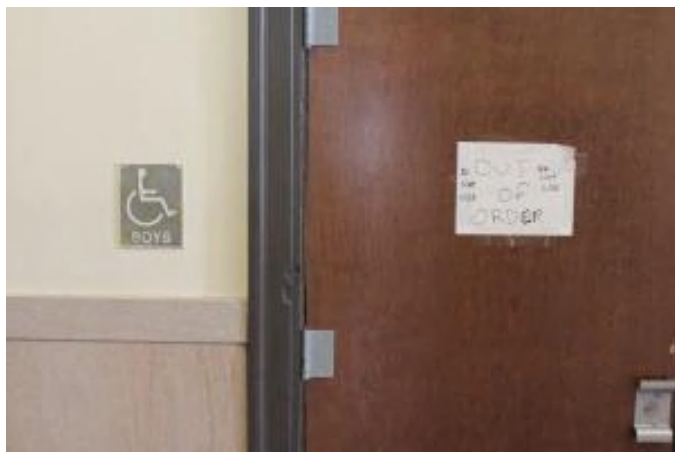
#### System: D2010 - Plumbing Fixtures

**Location:** Toilet rooms

**Distress:** Failing

- Repair out of service toilet room on 3<sup>rd</sup> floor and other inoperative plumbing fixtures throughout the building.
- Replace the aged drinking fountains in the basement with accessible models.

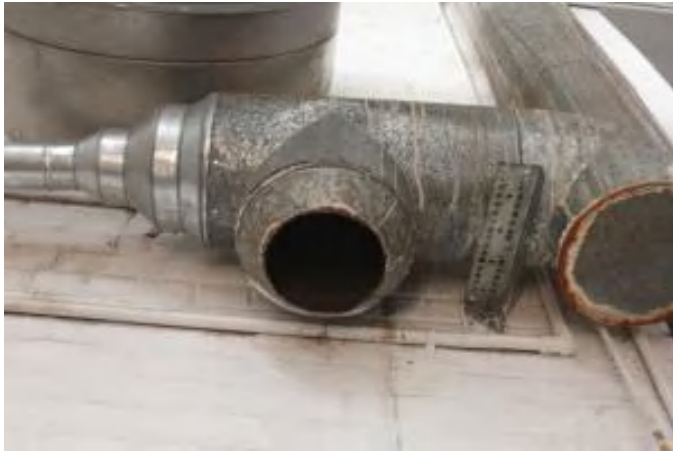
**System: D2020 - Domestic Water Distribution**

**Location:** Boiler room

**Distress:** Damaged

- Install backflow prevention valves on water meter and bypass lines.
- Repair constant draft damper on water heater exhaust duct.
- Replace the original copper domestic water piping to eliminate joints made with lead solder.

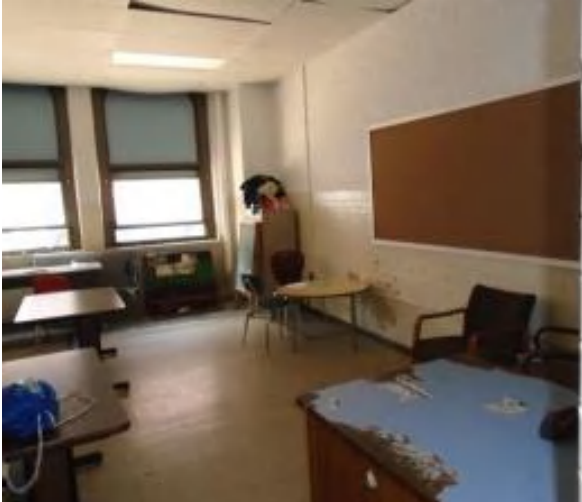
**System: C3030 - Ceiling Finishes**

**Location:** Ceiling

**Distress:** Damaged

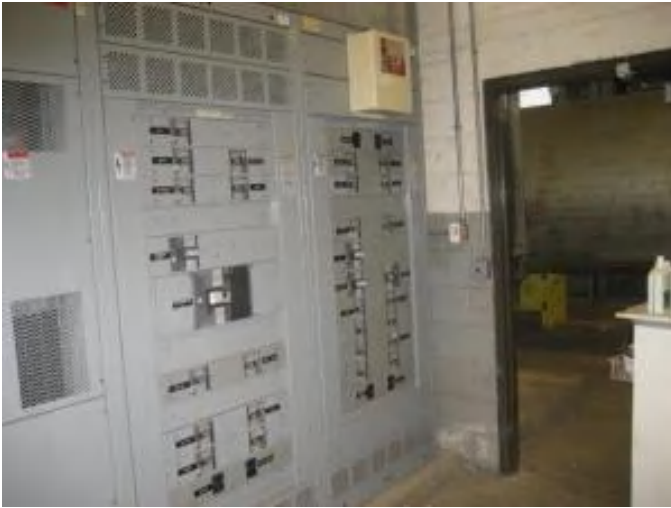
**System: D5010 - Electrical Service/Distribution**

**Location:** Basement- electrical room

**Distress:** Inadequate

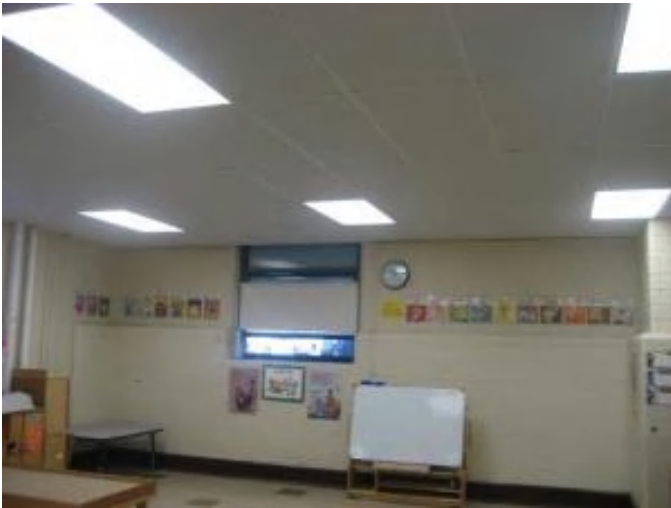
**System: D5020 - Lighting and Branch Wiring**

**Location:** Classrooms

**Distress:** Inadequate

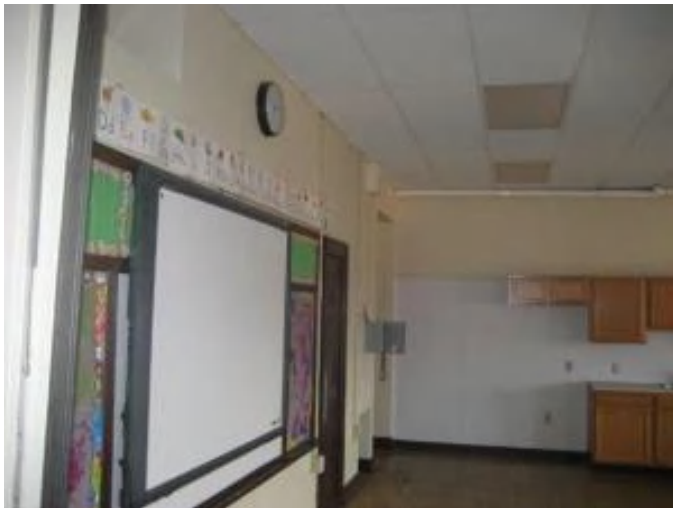
**System: D5030 - Communications and Security**

**Location:** Entire Building

**Distress:** Life Safety / NFPA / PFD

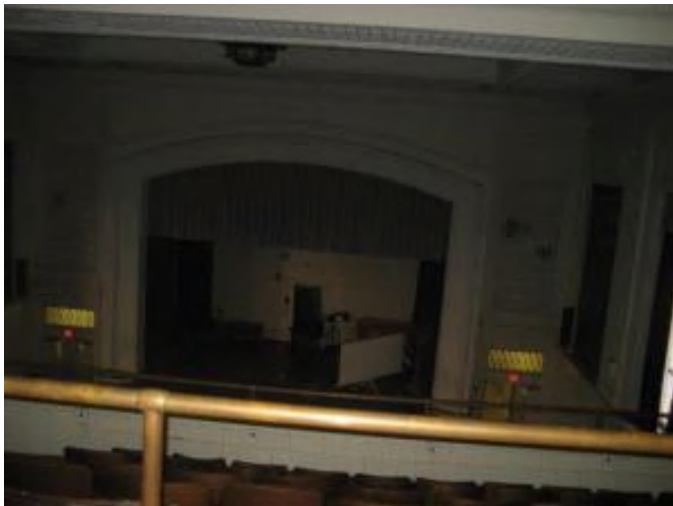
**System: D5030 - Communications and Security**

**Location:** Auditorium

**Distress:** Inadequate

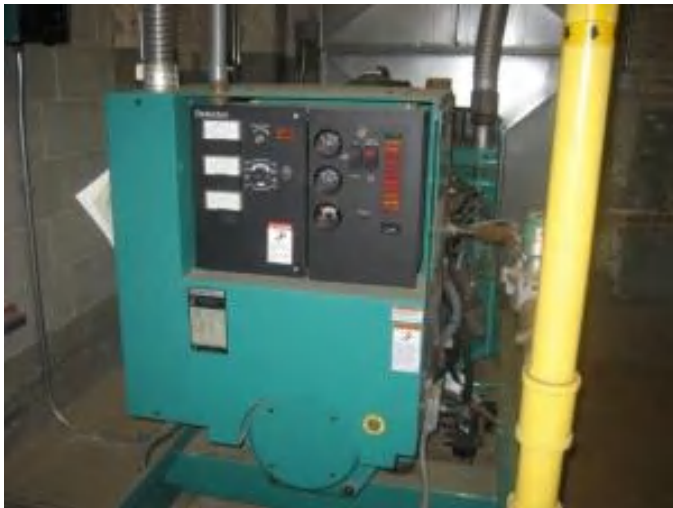
**System: D5090 - Other Electrical Systems**

**Location:** Outdoor

**Distress:** Inadequate

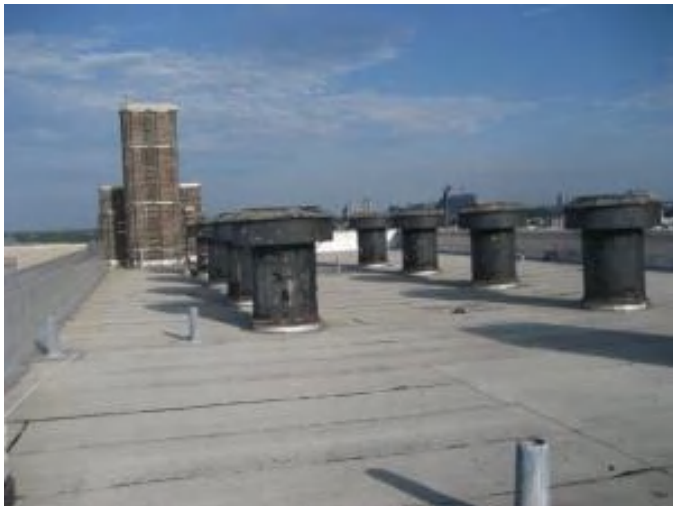
**System: D5090 - Other Electrical Systems**

**Location:** Roof

**Distress:** Building / MEP Codes

At the roof level repair/splice down conductor to maintain the electrical/mechanical continuity of the down conductor. A study should be conducted to determine if the air terminals provide the proper coverage.

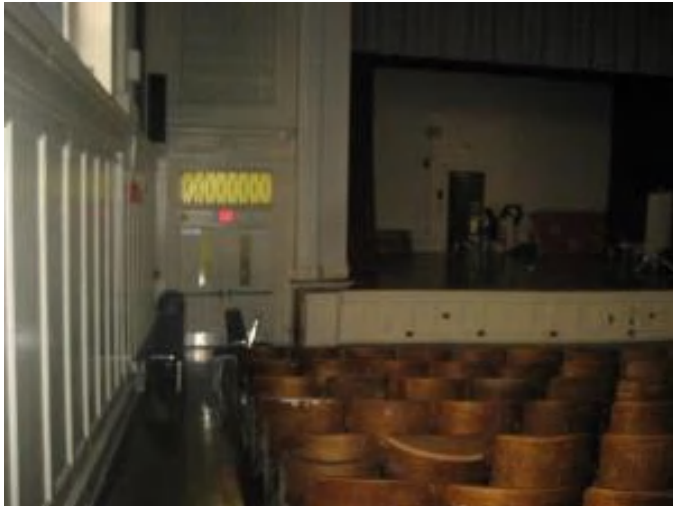
**System: E1020 - Institutional Equipment**

**Location:** Auditorium

**Distress:** Beyond Service Life

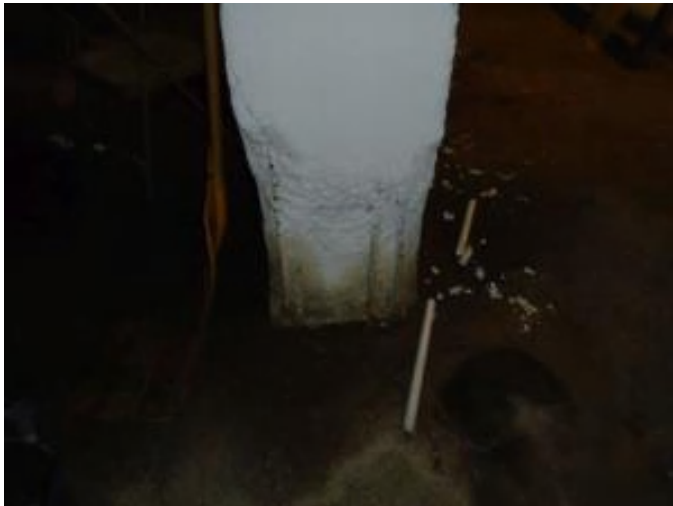
**System: A2020 - Basement Walls**

**Location:** Basement

**Distress:** Damaged

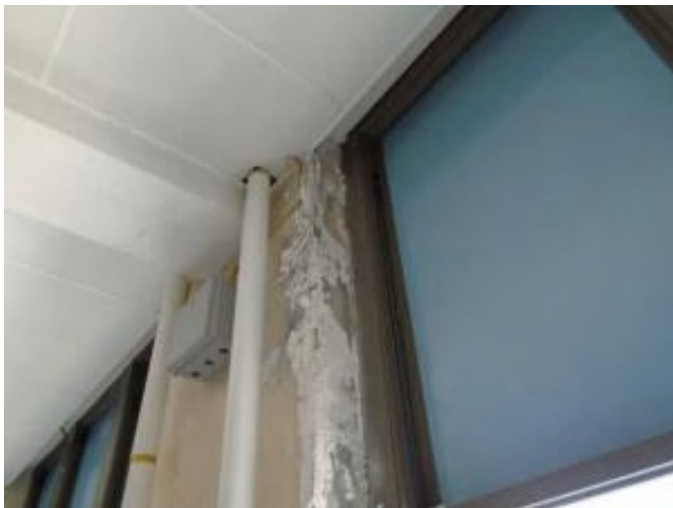
**System: C3010230 - Paint & Covering**

**Location:** North side classrooms

**Distress:** Damaged

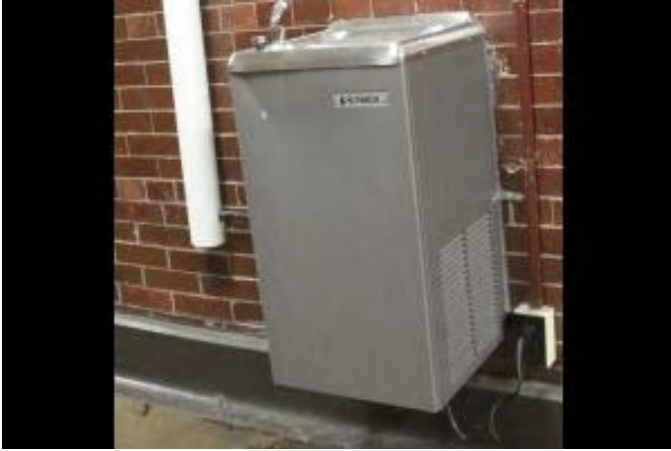
**System: D2010 - Plumbing Fixtures**

**Location:** Basement

**Distress:** Accessibility

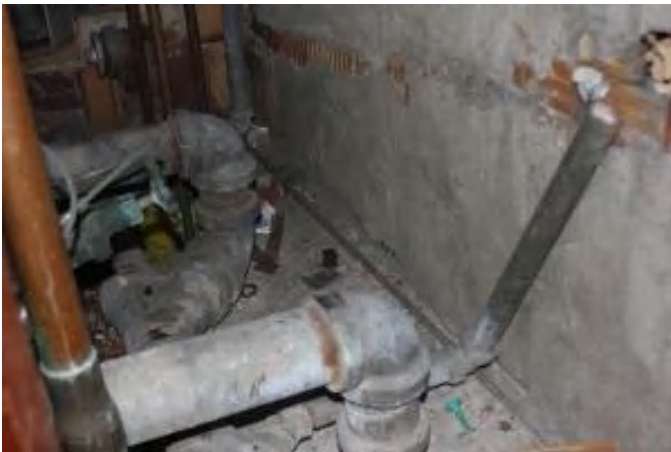
**System: D2030 - Sanitary Waste**

**Location:** Entire building.

**Distress:** Failing

- Hire a qualified contractor to perform a detailed examination of the sanitary waste and rain water drainage piping using visual inspection and video cameras to determine cause of back-ups during heavy rains and replace any damaged or failing piping.

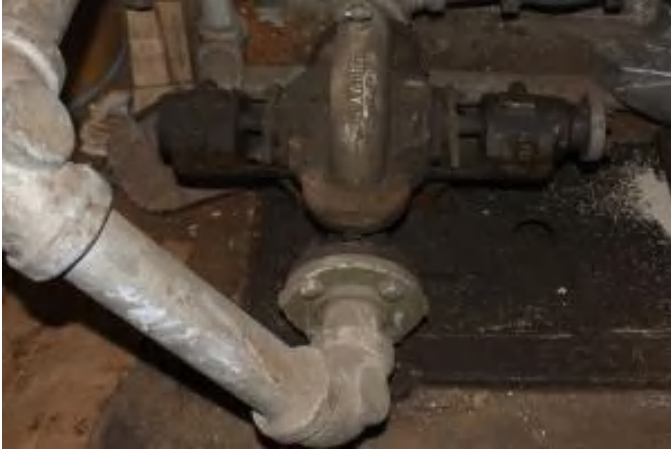
**System: D3040 - Distribution Systems**

**Location:** Fan rooms

**Distress:** Beyond Service Life

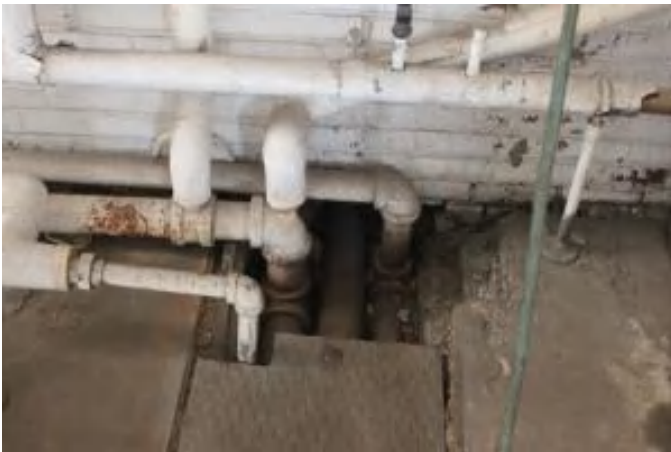
**System: D3040 - Distribution Systems**

**Location:** Entire building

**Distress:** Beyond Service Life

- Replace steam and condensate piping due to age and rust.
- Install 335 ton total capacity cooling system to replace aged and inefficient window unit air conditioners.

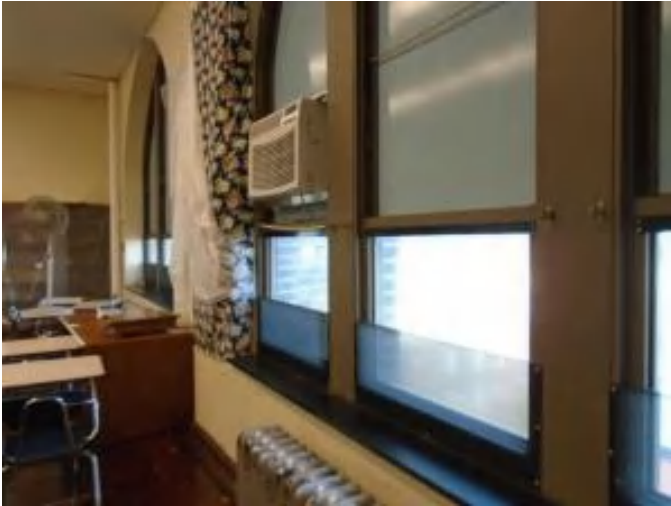
**System: B2020 - Exterior Windows**

**Location:** Gym

**Distress:** Energy Efficiency

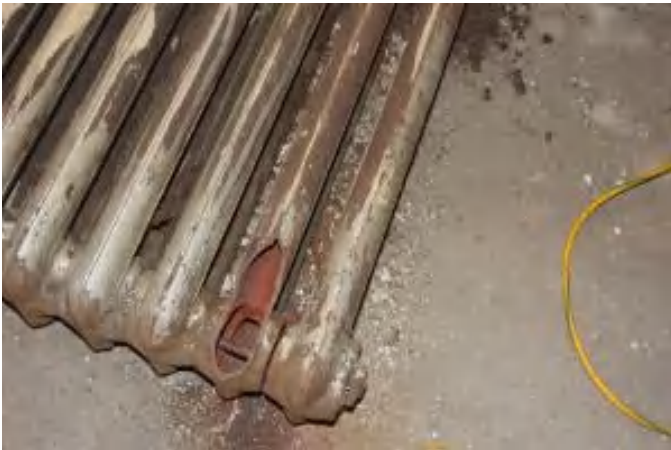
**System: D3040 - Distribution Systems**

Cast iron radiators supply heat for the entire building. They are original to the building and have pneumatic controlled steam valves. The radiators are well beyond their service life and should be replaced with finned tube unit heaters with electronic controls.

**Location:** Entire building

**Distress:** Failing

**Notes:** Replace the existing radiators with finned coil units.

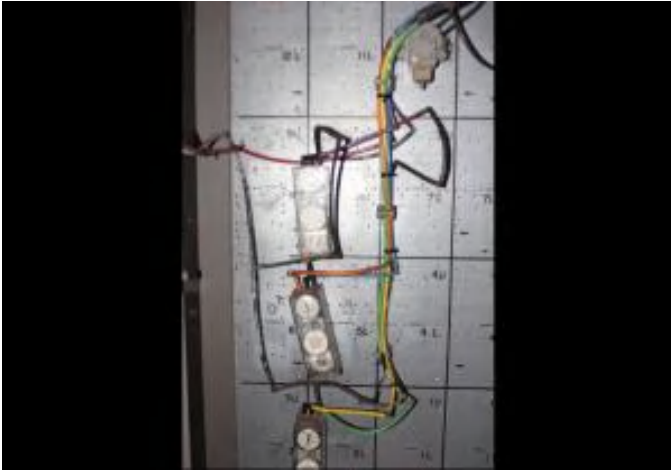
**System: D3060 - Controls & Instrumentation**

The original pneumatic systems have mostly failed according to the building engineer. Pneumatic room thermostats control steam flow valves on the radiators. Central duct dampers are manually adjustable only. The pneumatic systems are beyond their service life. These controls should be converted to DDC and automatically controllable dampers installed when metal ducts are replaced. A new building automation system (BAS) with modern DDC modules and communications network should be installed to serve the HVAC systems in this building to improve reliability and energy efficiency. An interface should be provided with the preferred system in use throughout the District.

**Location:** Entire building

**Distress:** Energy Efficiency

- Replace the pneumatic controls for the HVAC systems with modern DDC modules, valves, and actuators to improve reliability and energy efficiency. Provide a new building automation system (BAS) with communication interface to the preferred system in use throughout the District.

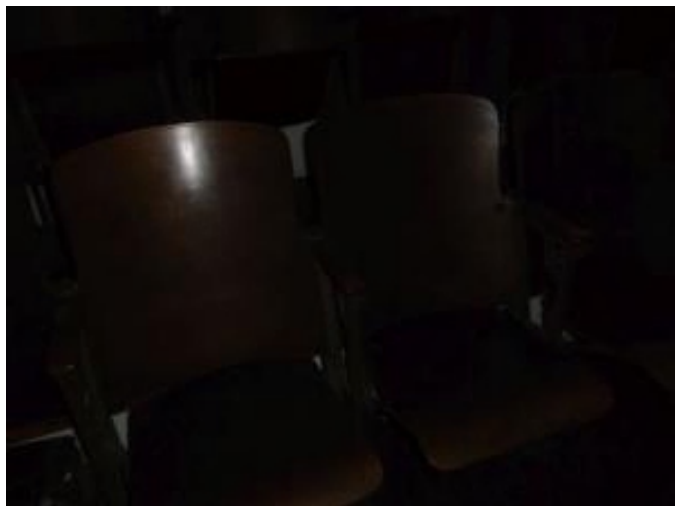
**System: E2010 - Fixed Furnishings**

**Location:** Auditorium

**Distress:** Damaged

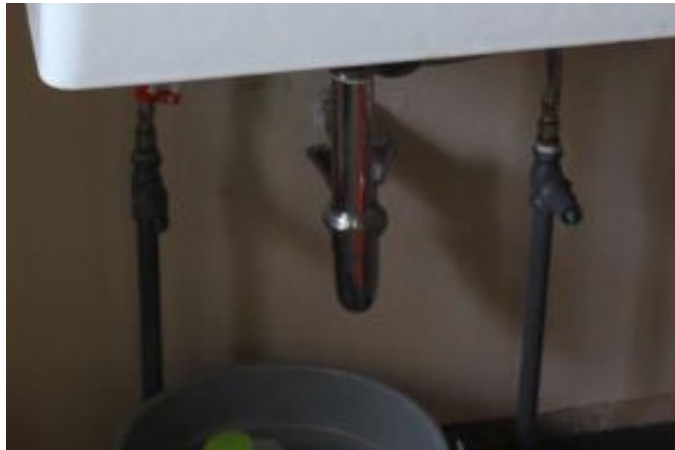
**System: D2020 - Domestic Water Distribution**

**Location:** Entire building

**Distress:** Beyond Service Life

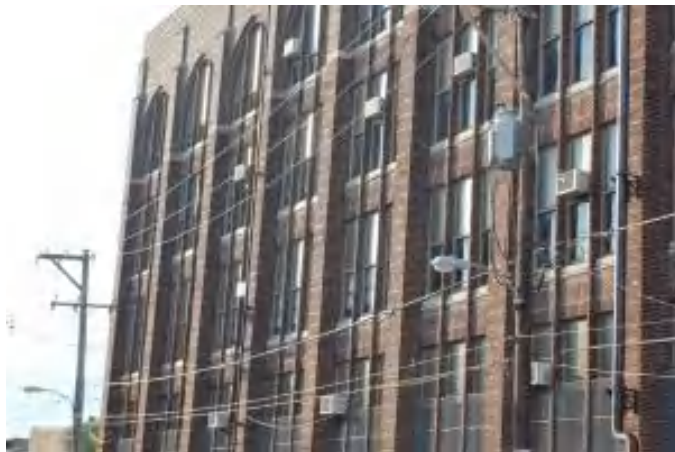
**System: D3030 - Cooling Generating Systems**

The building does not have any central cooling systems. A 335 ton total capacity cooling system should be installed to provide cooling to the entire building and replace approximately 30 aged, inefficient window unit air conditioners.

**Location:** Entire building.

**Distress:** Inadequate

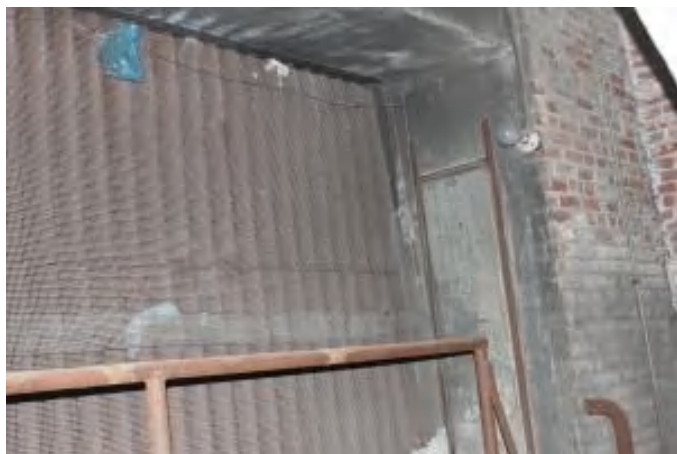
**System: D3040 - Distribution Systems**

**Location:** classrooms

**Distress:** Building / MEP Codes

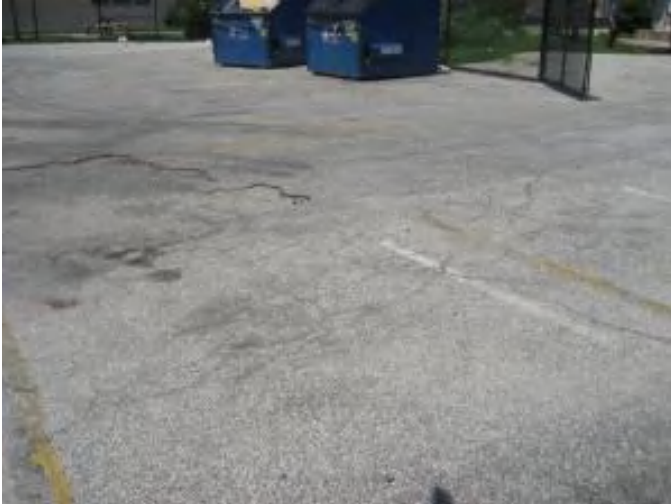
#### **System: G4020 - Site Lighting**

**Location:** Grounds

**Distress:** Security Issue

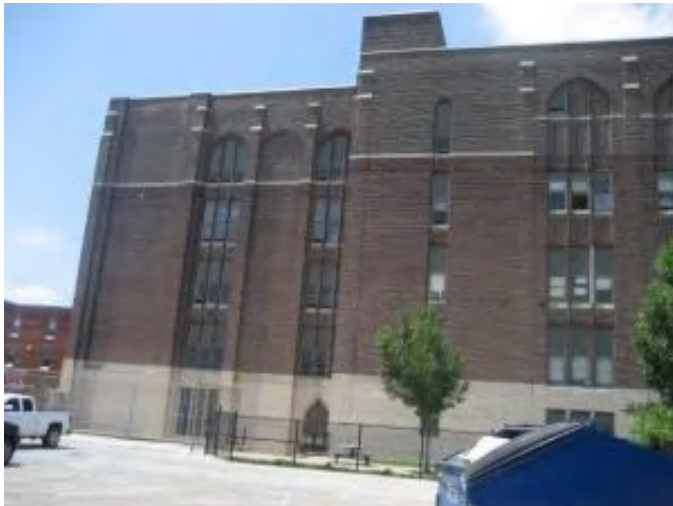
**System: G4030 - Site Communications & Security**

**Location:** Bkuilding Exterior

**Distress:** Security Issue
