## Facility Condition Assessment Summary Report

### Clemente Middle School

School District of Philadelphia  
**S773001;Clemente**  
Final  
**Site Assessment Report**  
February 1, 2017

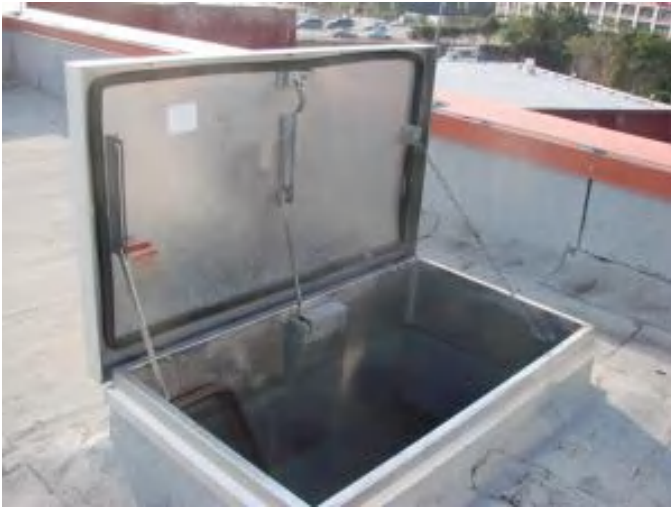
#### System: B3020 - Roof Openings

**Location:** Exterior

**Distress:** OSHA

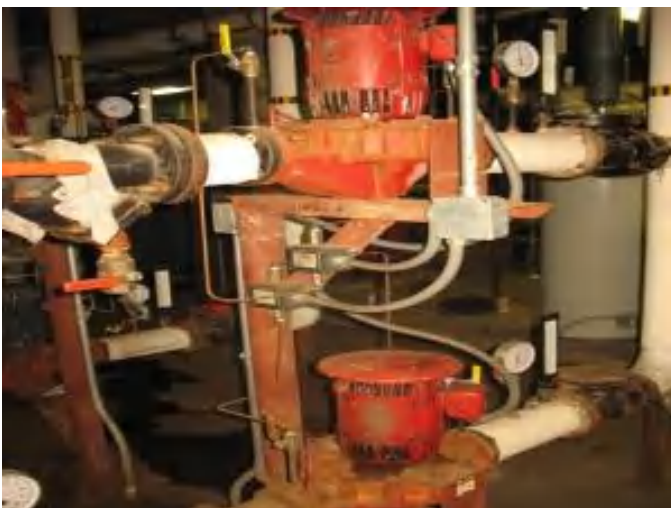
#### System: D3020 - Heat Generating Systems

**Location:** Basement mechanical room

**Distress:** Damaged

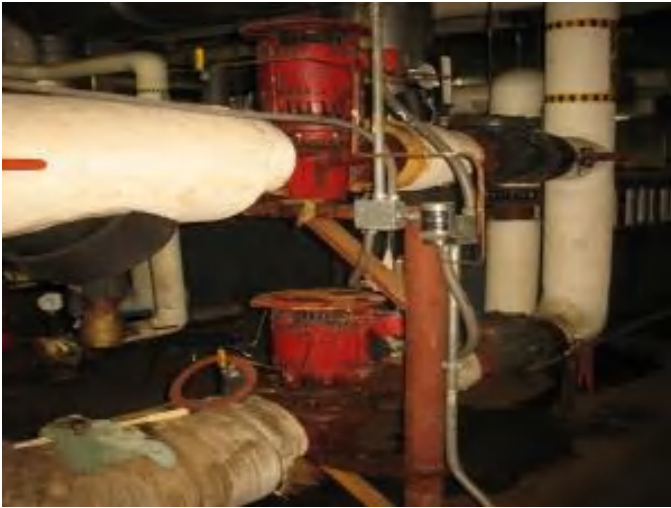
**System: D3030 - Cooling Generating Systems**

**Location:** Basement mechanical room

**Distress:** Damaged

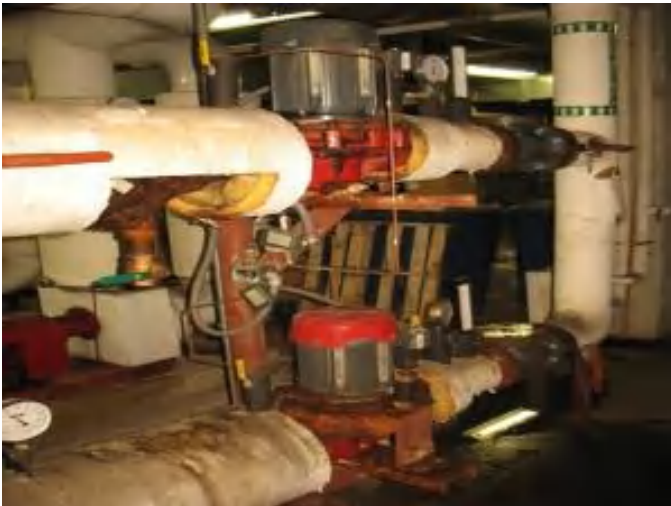
**System: D3030 - Cooling Generating Systems**

**Location:** Basement mechanical room

**Distress:** Damaged

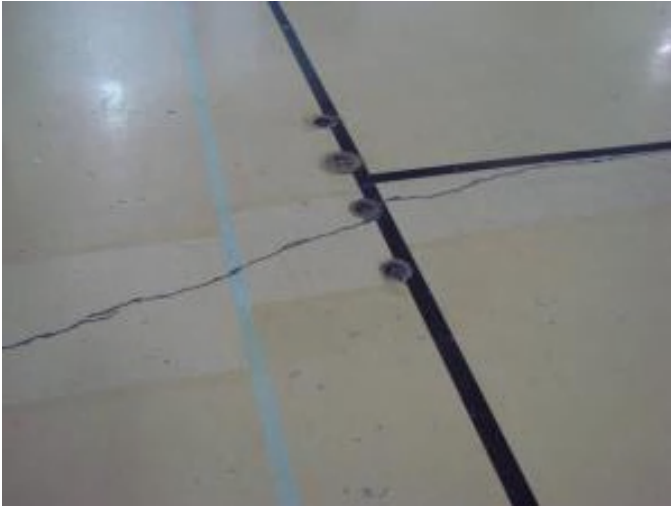
**System: A1030 - Slab on Grade**

**Location:** Interior/ Gym

**Distress:** Damaged

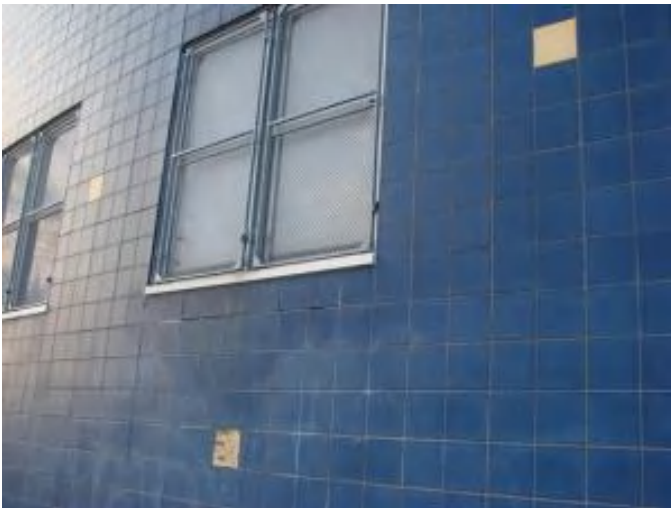
**System: B2010 - Exterior Walls**

**Location:** Exterior

**Distress:** Damaged

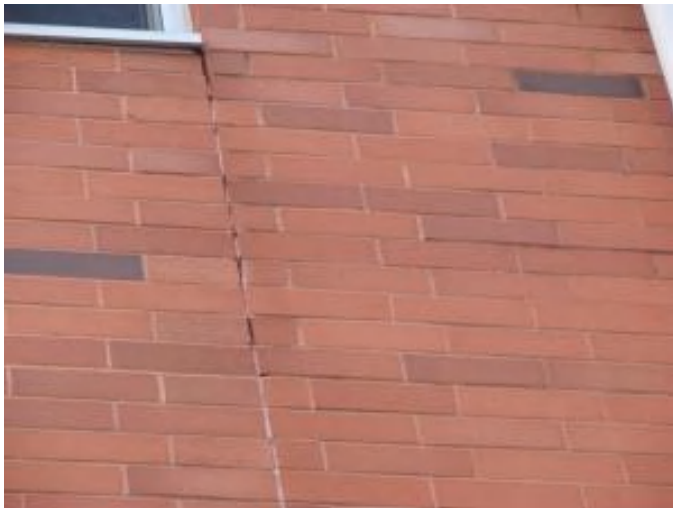
**System: B2010 - Exterior Walls**

**Location:** Exterior

**Distress:** Damaged

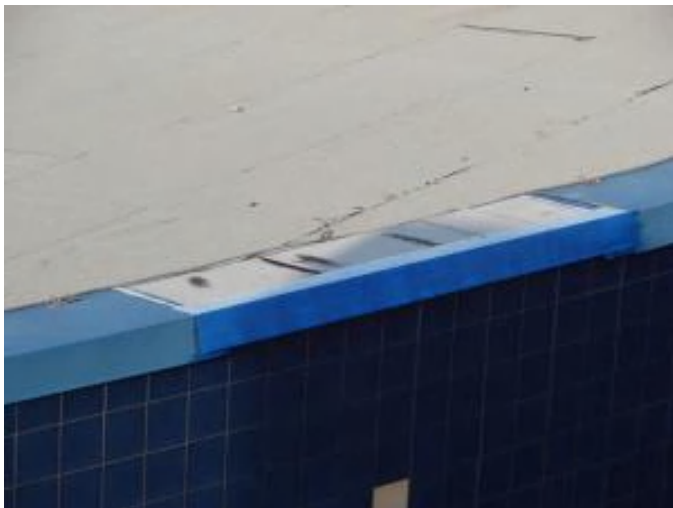
**System: B3010105 - Built-Up**

**Location:** Exterior

**Distress:** Damaged

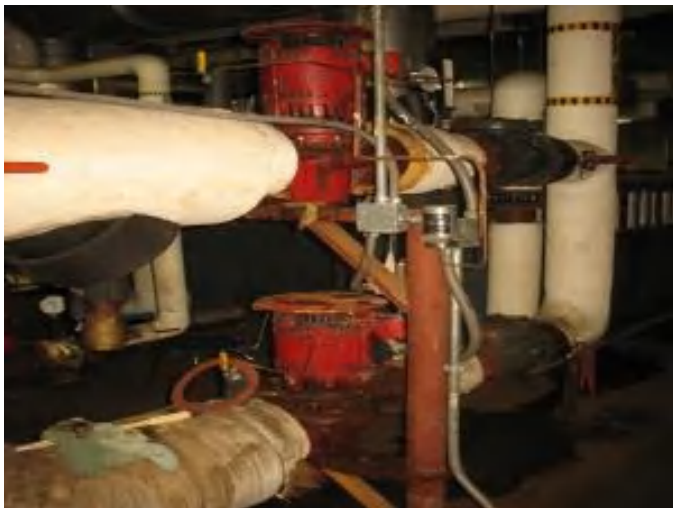
**System: D3020 - Heat Generating Systems**

**Location:** Basement mechanical room

**Distress:** Damaged

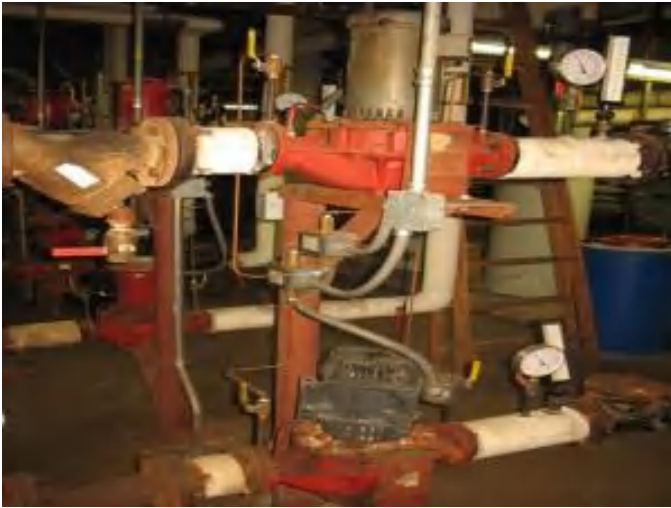
**System: D3020 - Heat Generating Systems**

**Location:** Basement mechanical room

**Distress:** Damaged

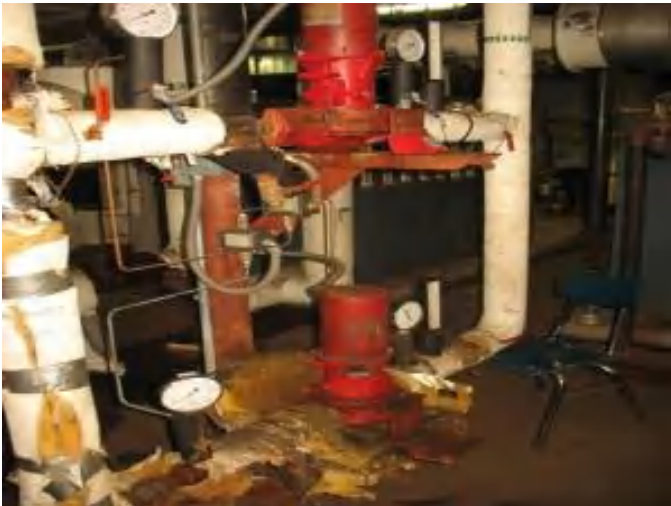
**System: D3030 - Cooling Generating Systems**

**Location:** Basement mechanical room

**Distress:** Damaged

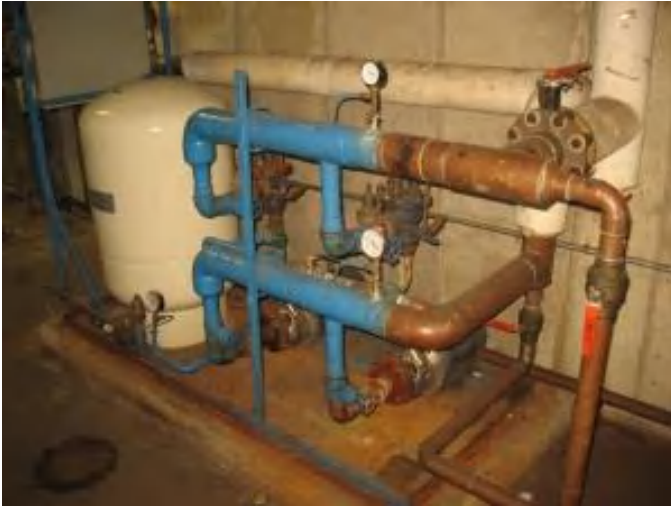
**System: D2020 - Domestic Water Distribution**

**Location:** Basement mechanical room

**Distress:** Beyond Service Life

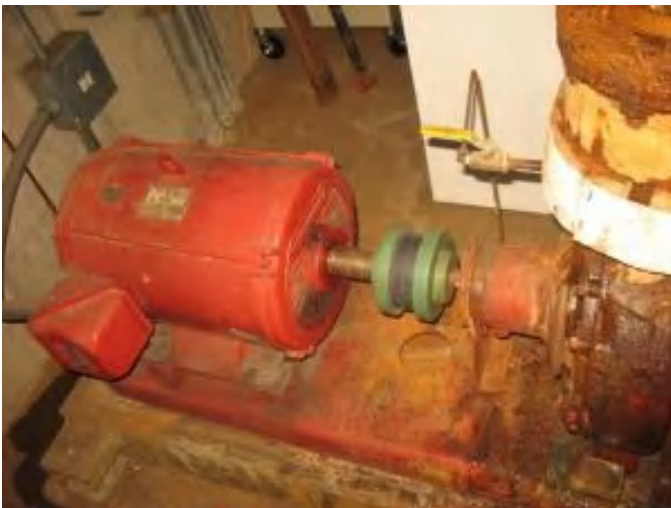
**System: D3030 - Cooling Generating Systems**

**Location:** Basement mechanical room

**Distress:** Beyond Service Life

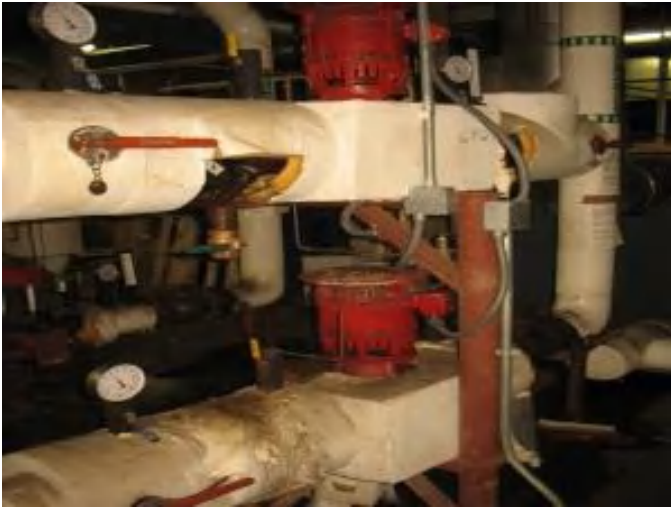
**System: D3030 - Cooling Generating Systems**

**Location:** Basement mechanical room

**Distress:** Damaged

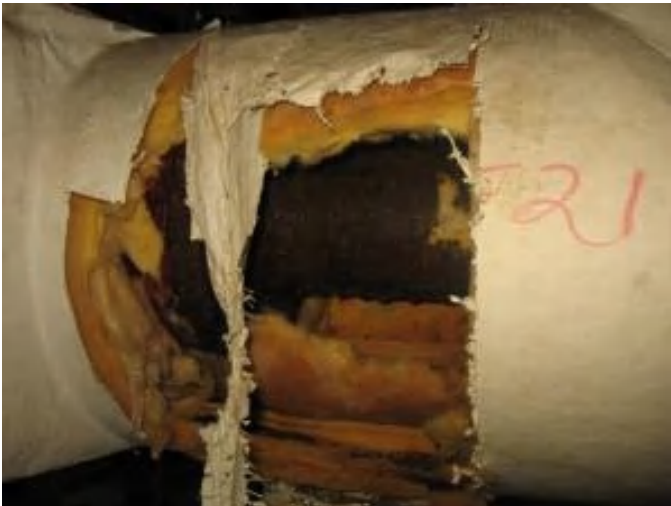
**System: D3040 - Distribution Systems**

**Location:** Throughout building

**Distress:** Maintenance Required

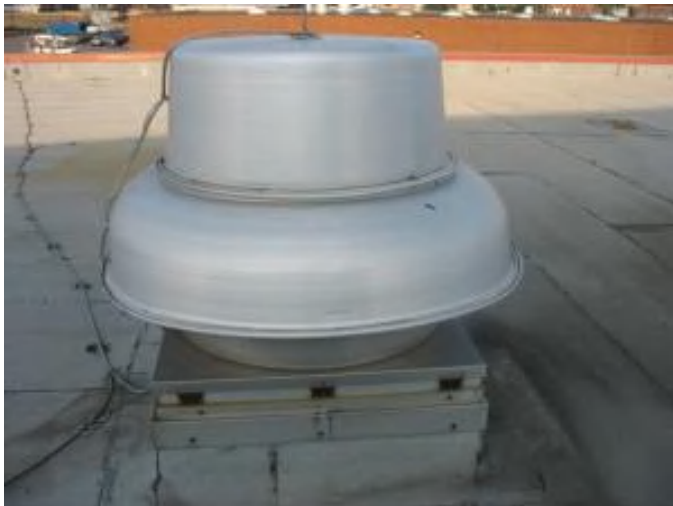
**System: D3040 - Distribution Systems**

**Location:** Roof

**Distress:** Beyond Service Life

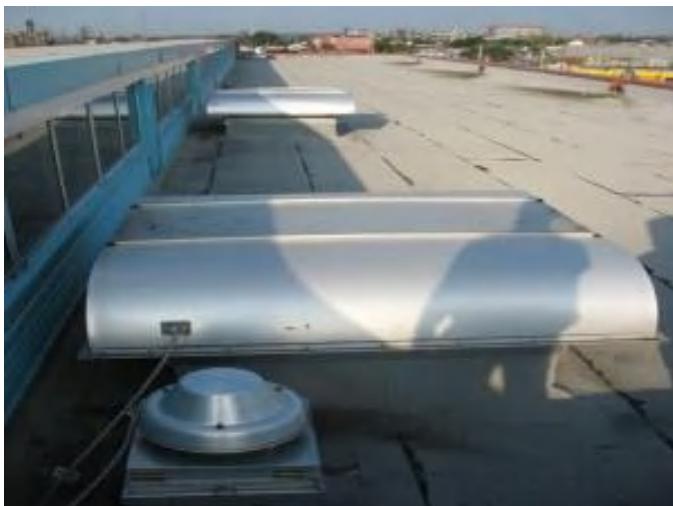
**System: D3040 - Distribution Systems**

**Location:** Roof

**Distress:** Beyond Service Life

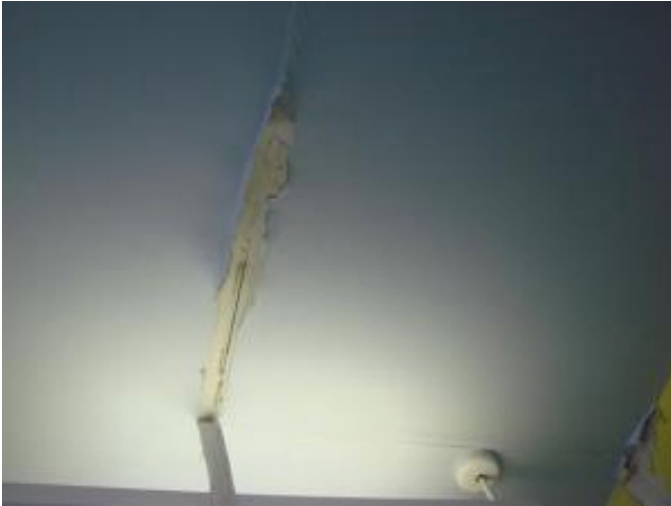
**System: C3030 - Ceiling Finishes**

**Location:** Interior

**Distress:** Damaged

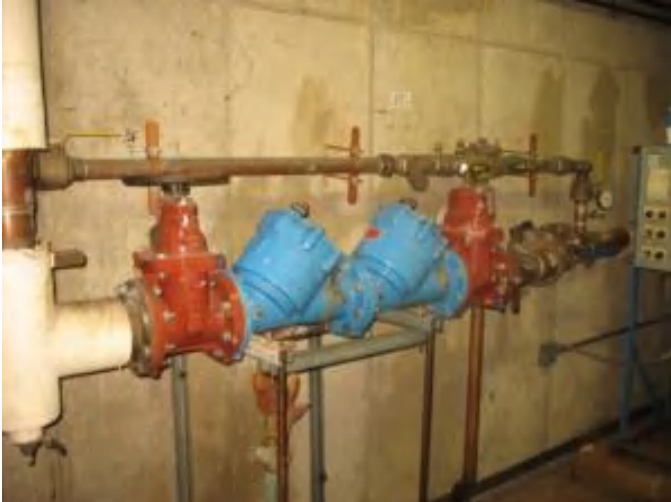
**System: D2020 - Domestic Water Distribution**

**Location:** Throughout building

**Distress:** Damaged

**Notes:** Hire a qualified contractor to perform a detailed inspection of the domestic water piping, in use for over twenty years and with reports of scale build up from the Building Engineer, and replace any damaged piping.

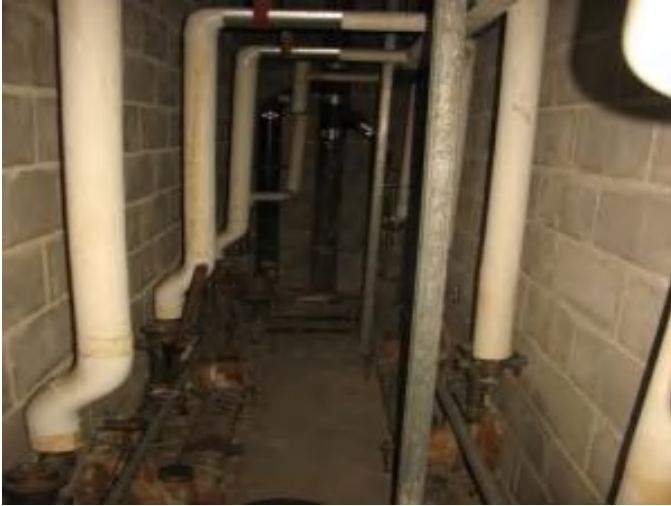
**System: D2030 - Sanitary Waste**

**Location:** Throughout building

**Distress:** Maintenance Required

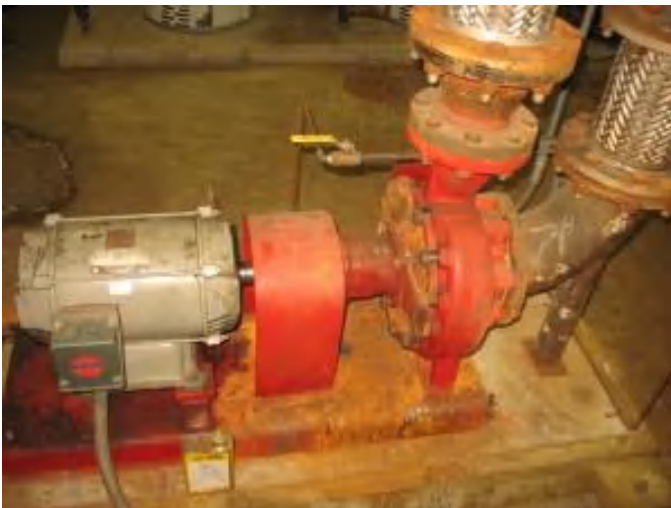
**System: D3020 - Heat Generating Systems**

**Location:** Basement mechanical room

**Distress:** Beyond Service Life

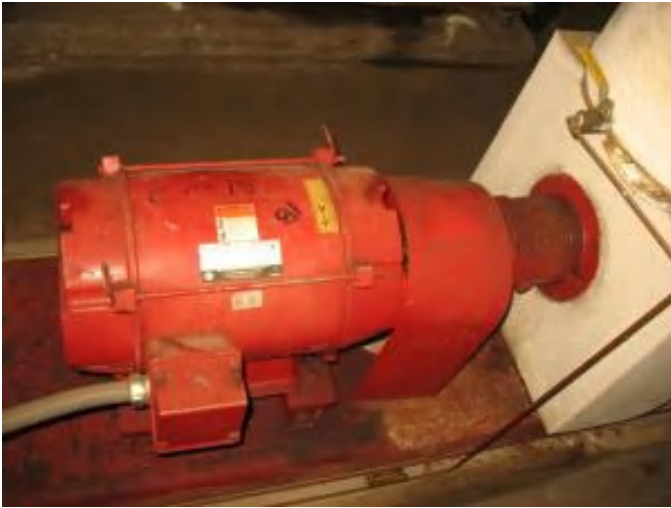
**System: D3030 - Cooling Generating Systems**

**Location:** Basement mechanical room

**Distress:** Beyond Service Life

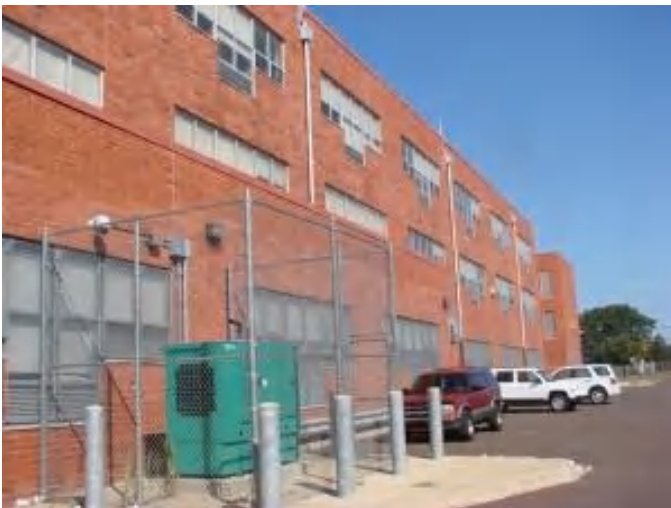
**System: D5030 - Communications and Security**

**Location:** Throughout the building

**Distress:** Security Issue

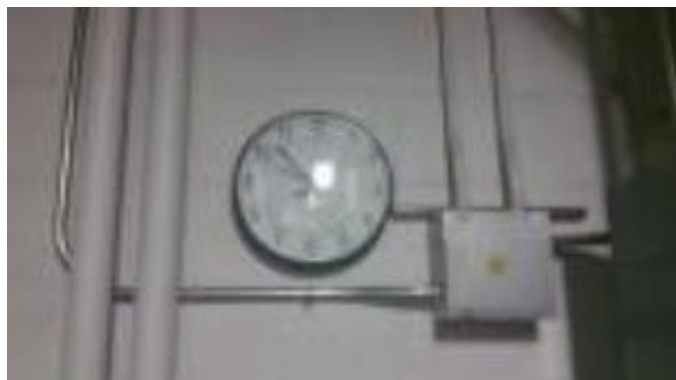
**System: D5030 - Communications and Security**

**Location:** throughout the building

**Distress:** Inadequate

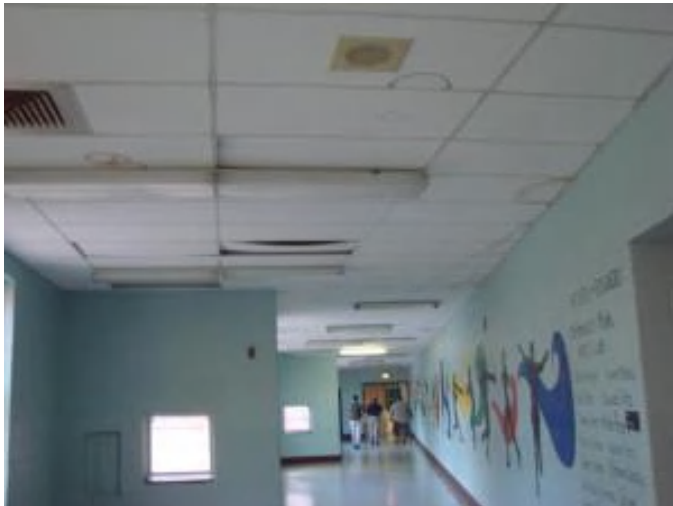
**System: C3030 - Ceiling Finishes**

**Location:** Interior

**Distress:** Damaged

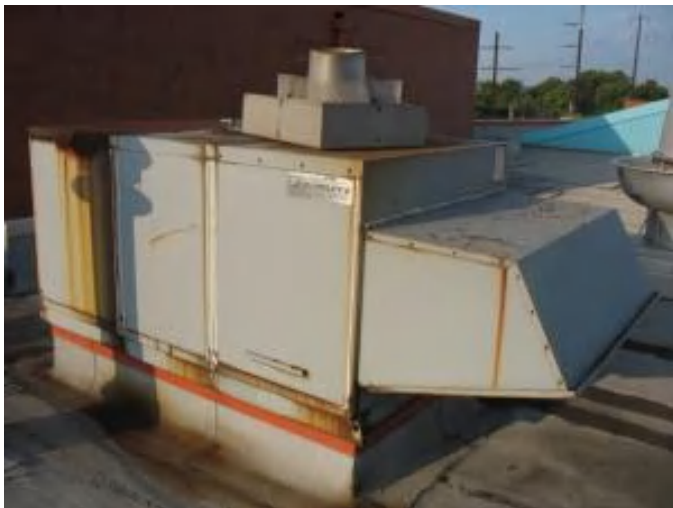
**System: D3040 - Distribution Systems**

**Location:** Roof

**Distress:** Failing

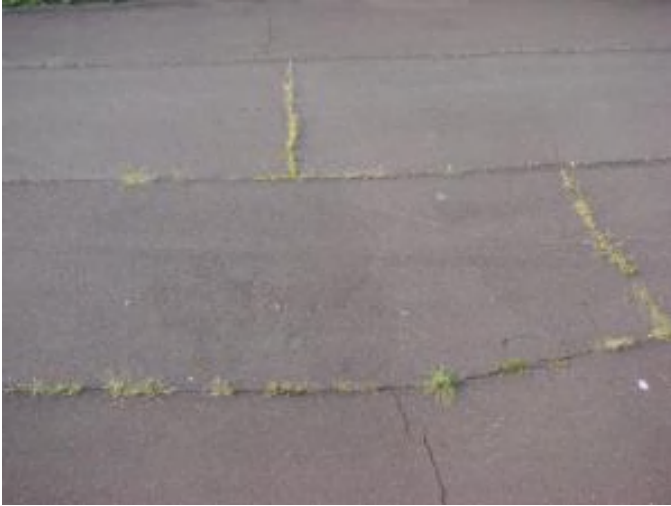
#### System: G2020 - Parking Lots

**Location:** Grounds/ site

**Distress:** Beyond Service Life

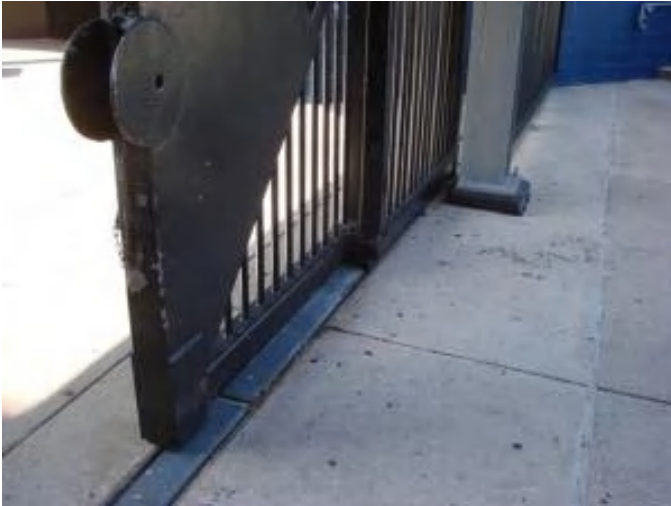
**System: G2040 - Site Development**

**Location:** Grounds/ site

**Distress:** Failing

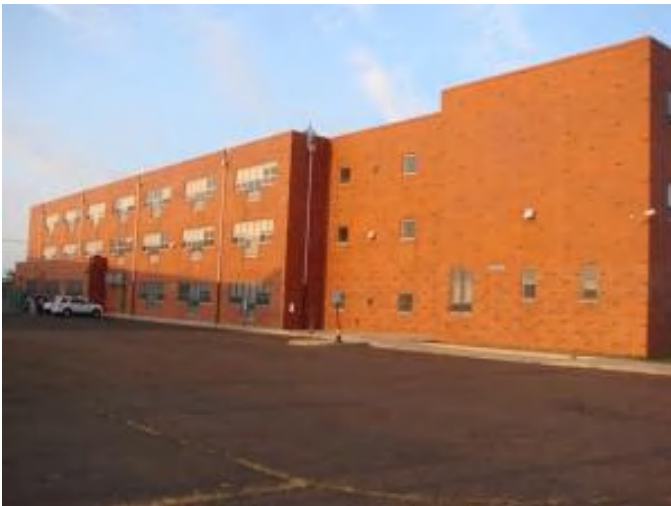
**System: G4020 - Site Lighting**

**Location:** Grounds

**Distress:** Inadequate

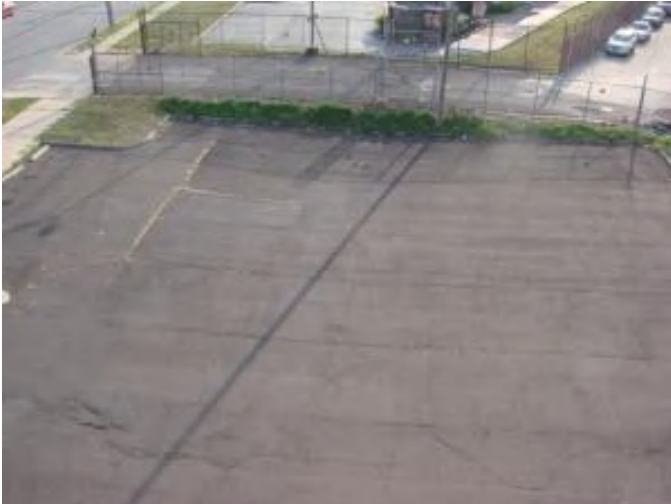
**System: G2020 - Parking Lots**

**Location:** Grounds/ site

**Distress:** Beyond Service Life

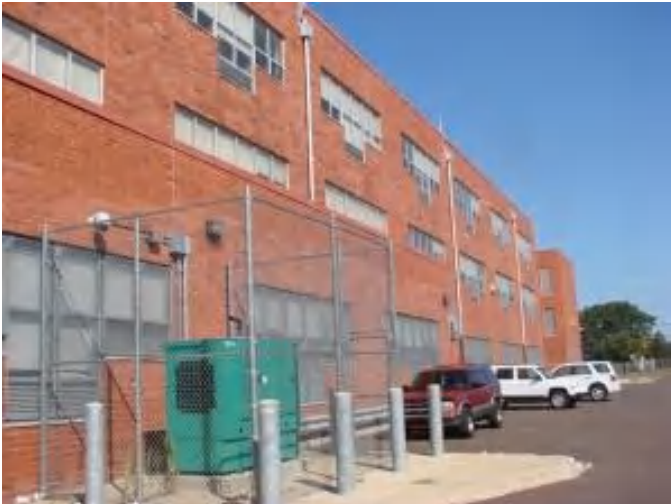
**System: G4030 - Site Communications & Security**

**Location:** Grounds

**Distress:** Inadequate

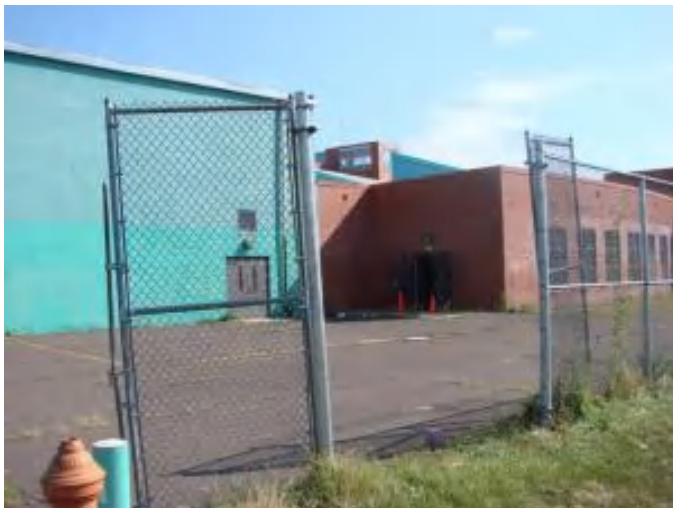
**System: G2040 - Site Development**

**Location:** Grounds/ site

**Distress:** Beyond Service Life

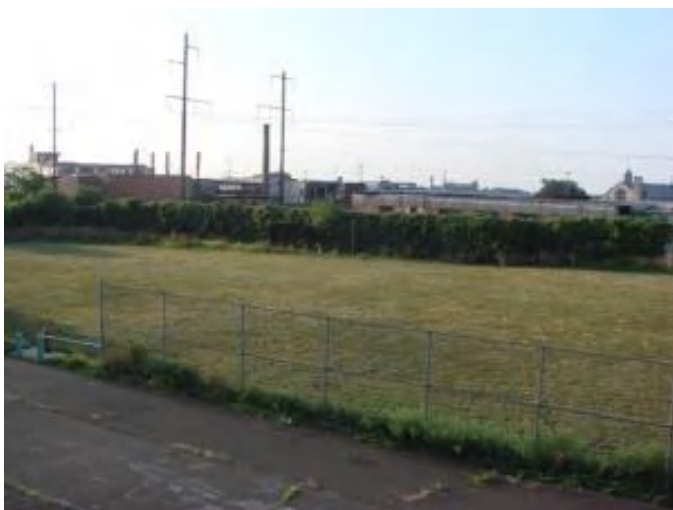
**System: G2050 - Landscaping & Irrigation**

**Location:** Grounds/ site

**Distress:** Beyond Service Life
