Facility Condition Assessment Summary Report

Cleveland School

School District of Philadelphia
S426001;Cleveland
Final
Site Assessment Report
February 1, 2017

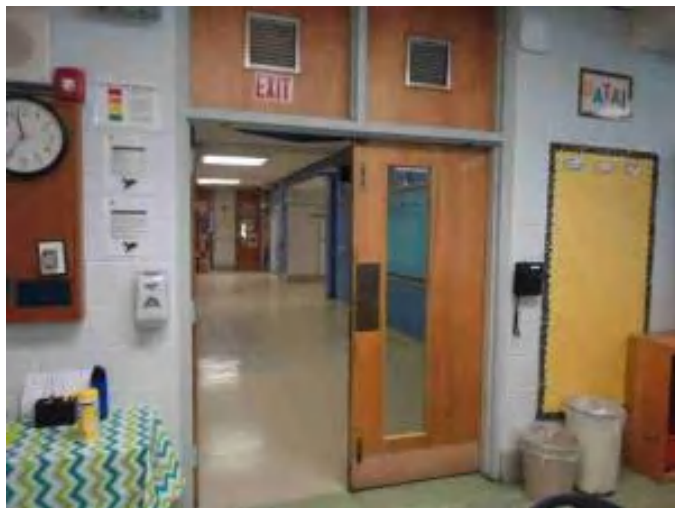
System: C1010 - Partitions

Location: Stairs

Distress: Life Safety / NFPA / PFD

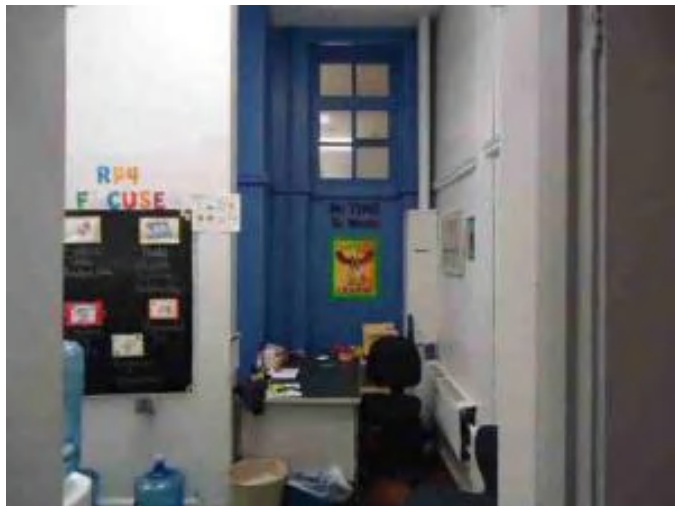
System: C1010 - Partitions

Location: Classrooms

Distress: Life Safety / NFPA / PFD

Notes: There are several transom lites and sidelights constructed into hallway wall systems. It is recommended that the lites and sidelights be removed and replaced with a fire rated wall construction. The deficiency provides a budgetary consideration to correct the hallway, transoms, lites and sidelights.

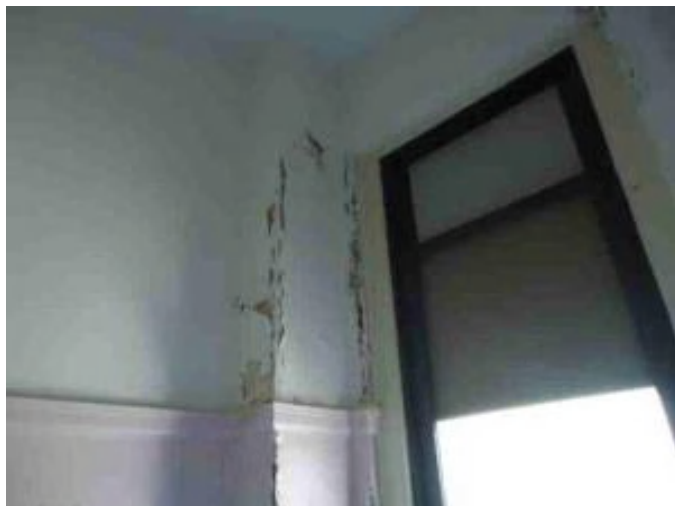
System: C3010230 - Paint & Covering

Location: Building Wide

Distress: Damaged

Notes: There are painted walls, trim, and some painted ceilings in this building. In the older sections of the building, some brick surfaces have been painted. The newer section has a painted CMU finish. The interior finishes in the older sections are in fair to poor condition and will require an almost continuous program of renewal of the applied finishes to maintain an acceptable appearance. The finishes in the new section are in excellent to good condition. Cyclical painting should be considered for a standard approach to maintaining the quality of the interior finishes. It is recommended that all previously painted surfaces be repainted according to established cycles for this occupancy and use type. Minor repairs should be completed before work begins. The leaking section of the building is expected to require major repairs and additional efforts to restore the finishes. This effort is expected to be coordinated with other recommended exterior, mechanical and electrical work in order to prevent overlapping efforts.

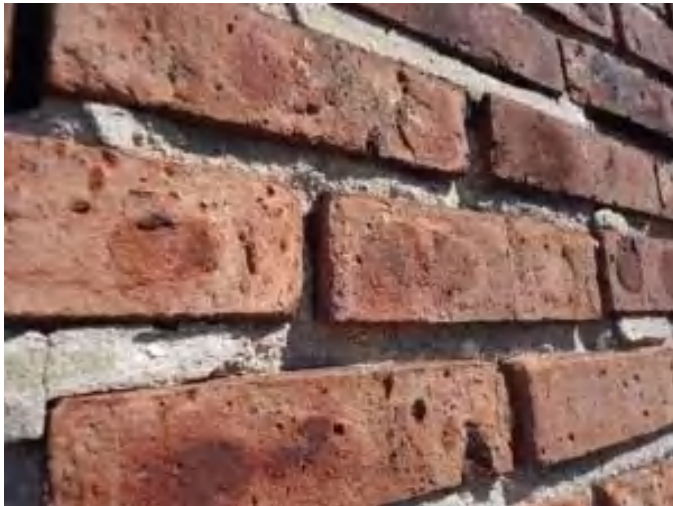
System: B2010 - Exterior Walls

Location: Exterior Elevation

Distress: Damaged

Notes: The exterior brick surfaces are generally in fair to fair to poor condition for their age. In some locations, bricks have cracked or spalled and should be replaced. The repointing of deteriorated mortar joints is recommended, using mortar of a similar color and consistency as the original. Following the detailed examination of the brick and repair of mortar construction joints, the entire building should be pressure washed to remove stains and embedded pollutants. Considering moisture is penetrating the masonry façade the application of sealant is also recommended. This effort is expected to be completed as part of an exterior universal upgrade and should be coordinated with other exterior recommended deficiencies in order not to duplicate work.

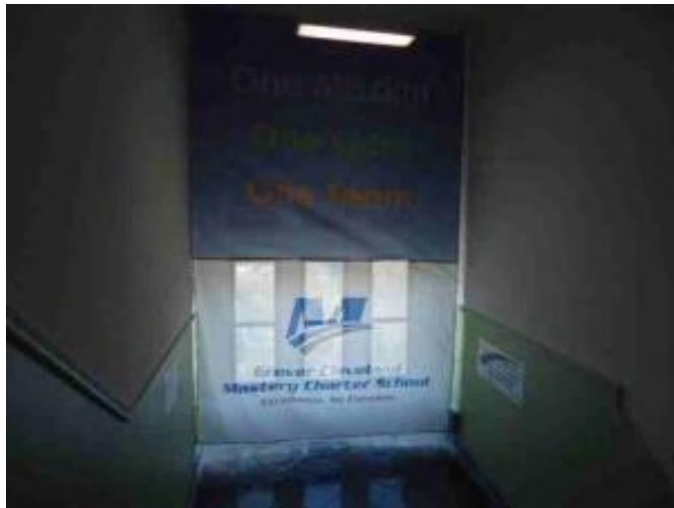
System: B2020 - Exterior Windows

Location: Exterior Elevation

Distress: Damaged

Notes: The exterior windows have been upgraded from the original 1908 applications. A majority of the window system is estimated to have been installed in the 1990's. Several of the windows no longer work and will require attention prior to an overall effort. The windows facing the addition are currently leaking creating interior damage to the wall and floor finishes. Overall, the windows are in fair to poor condition based on the year of installation or last renovation. The entire exterior window system is recommended to be replaced with units that retain their dimensions and profiles, but that incorporate updated energy-efficient features. This effort is expected to be completed as part of an exterior universal upgrade and should be coordinated with other exterior recommended deficiencies in order not to duplicate work.

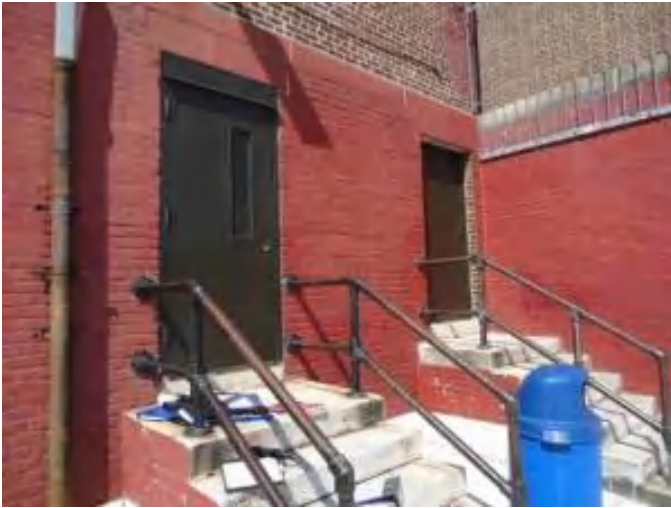
System: B2030 - Exterior Doors

Location: Exterior Elevation

Distress: Damaged

Notes: The exterior doors are metal applications with metal frames. The exterior door system for this school is a very high traffic system. The doors are in fair condition but are aging at a faster rate than expected based on traffic and condition. The exterior door system and service doors are recommended for upgrade. The new doors are expected to retain their dimensions and profiles, but that incorporate updated energy-efficient features. This effort is expected to be completed as part of an exterior universal upgrade and should be coordinated with other exterior recommended deficiencies in order not to duplicate work.

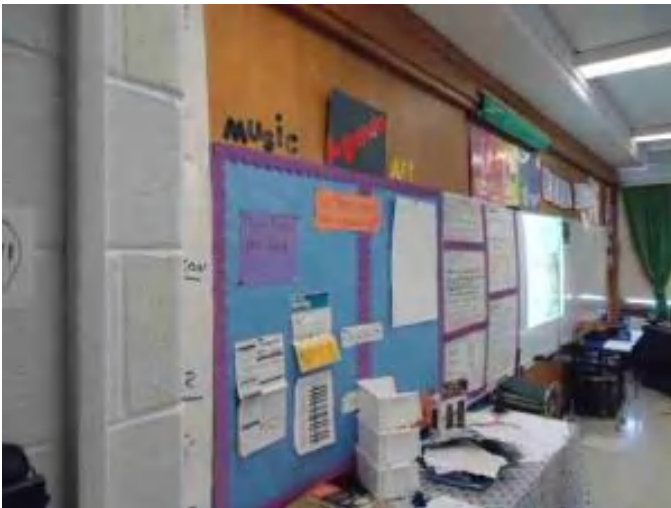
System: C1010 - Partitions

Location: Classroom

Distress: Damaged

Notes: There are several movable partitions that remain in classrooms. These wall systems are no longer used and in most cases cannot be used due to damage or wall modifications to support classroom needs. This deficiency provides a budgetary consideration to remove and replace the wall systems with universal removal of the existing movable partitions and upgrades to a permeate wall systems.

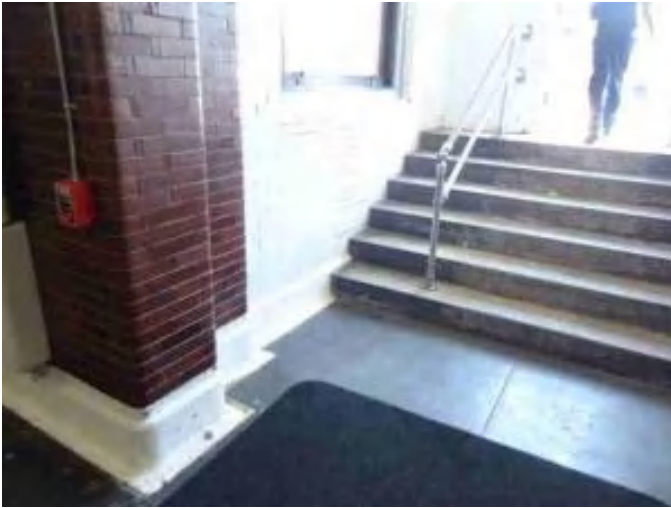
System: C2010 - Stair Construction

Location: Stairs

Distress: Life Safety / NFPA / PFD

Notes: There are two stair systems for this school, the primary or original 1908 and the addition. Current requirements for stairs indicate that they have graspable handrails on both sides, that the rails have a specific end geometry, and that the handrails continue horizontally at the landings. In addition, guardrails must prevent the passage of a 4 inch diameter sphere (6 inches in the triangle formed by the lower rail and tread/riser angle). Although the stairs are compliant with the code enforced at the time of construction until a major renovation occurs, they are deficient in handrail and guardrail design relative to current standards. Future efforts for the original 1908 stair application should include comprehensive stair railing removal and replacement upgrades. The additions railing system will require less comprehensive upgrades. Both systems are budgeted for in this deficiency.

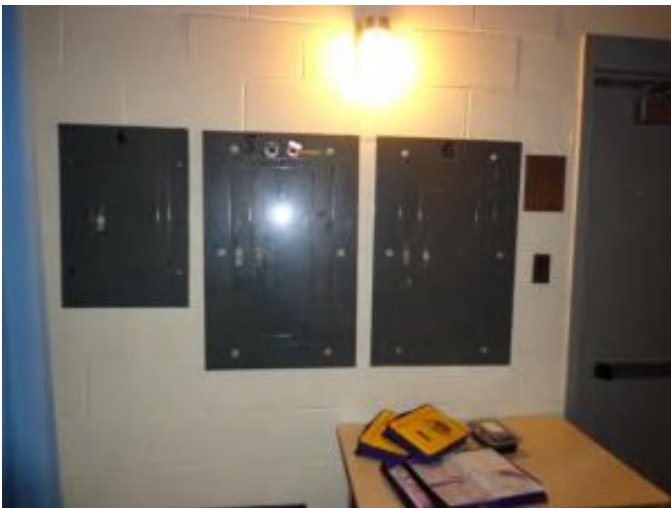
System: D5010 - Electrical Service/Distribution

Location: Building wide

Distress: Beyond Service Life

Notes: Replace 1200A Distribution Panelboard A, 600A Distribution Panelboard DP-I and (8) panelboards in the 1966 building, and (8) panelboards in the 1908 building that have reached the end of their useful life.

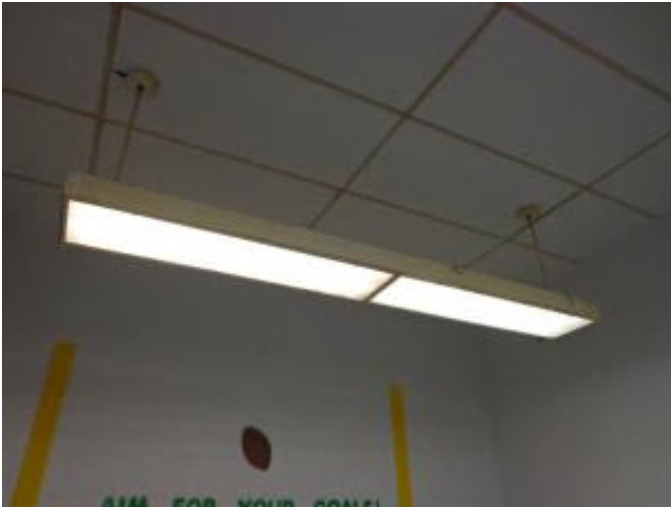
System: D5020 - Lighting and Branch Wiring

Location: Classrooms - 1908 Bldg.

Distress: Beyond Service Life

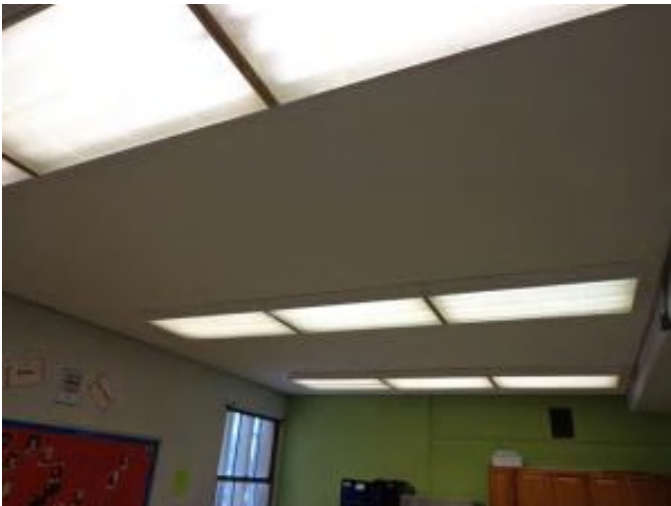
System: D5020 - Lighting and Branch Wiring

Location: Classrooms - 1966 Bldg.

Distress: Beyond Service Life

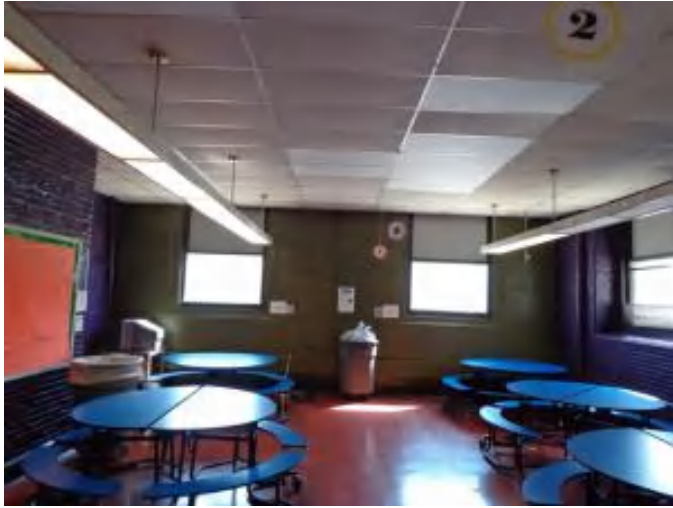
System: D5020 - Lighting and Branch Wiring

Location: Kitchen, cafeteria, restrooms, mechanical rooms - 1908 Bldg.

Distress: Beyond Service Life

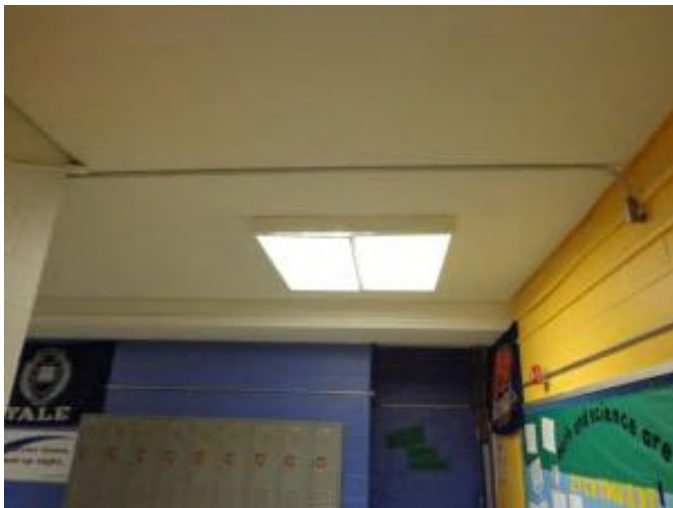
System: D5020 - Lighting and Branch Wiring

Location: Corridors, offices restrooms - 1966 Bldg.

Distress: Beyond Service Life

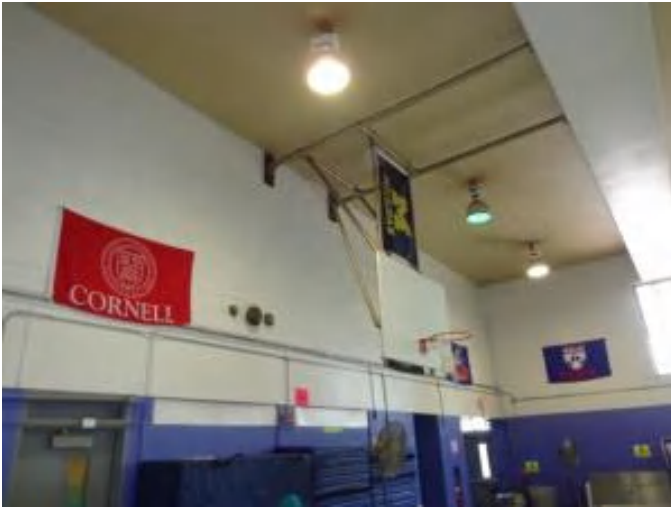
System: D5020 - Lighting and Branch Wiring

Stem mounted industrial style, metal halide fixtures are provided in the gymnasium. Fixtures appear to be nearing end of their useful life and should be replaced within the next three (3) years with LED fixtures.

Location: Gymnasium

Distress: Beyond Service Life

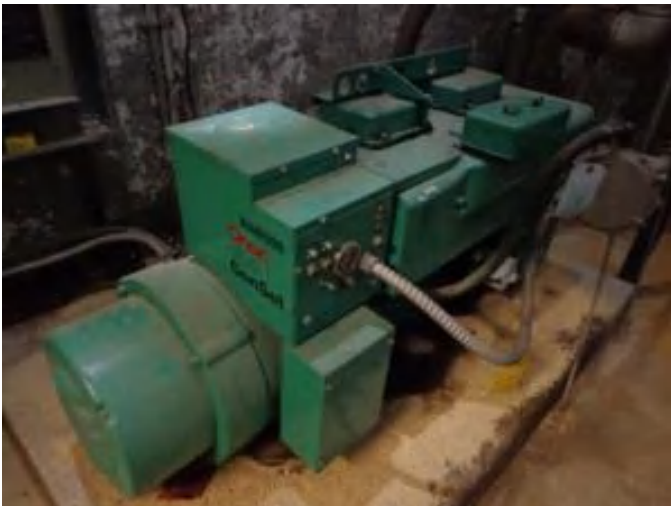
System: D5090 - Other Electrical Systems

Location: Boiler Room 009 - 1908 Bldg.

Distress: Beyond Service Life

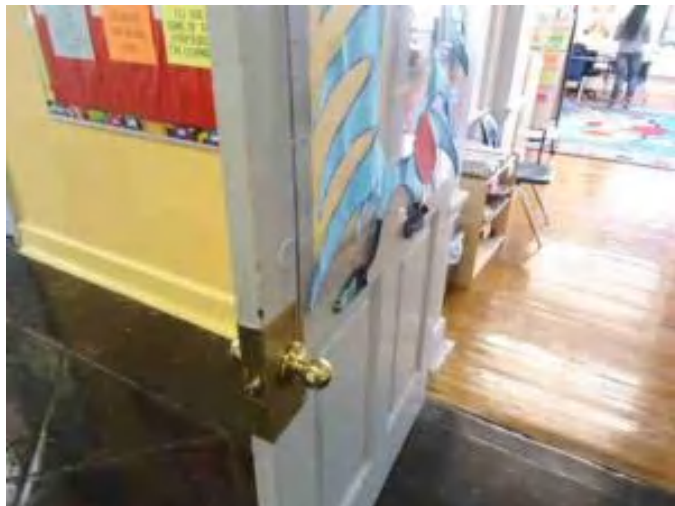
System: C1020 - Interior Doors

Location: Building Wide

Distress: Damaged

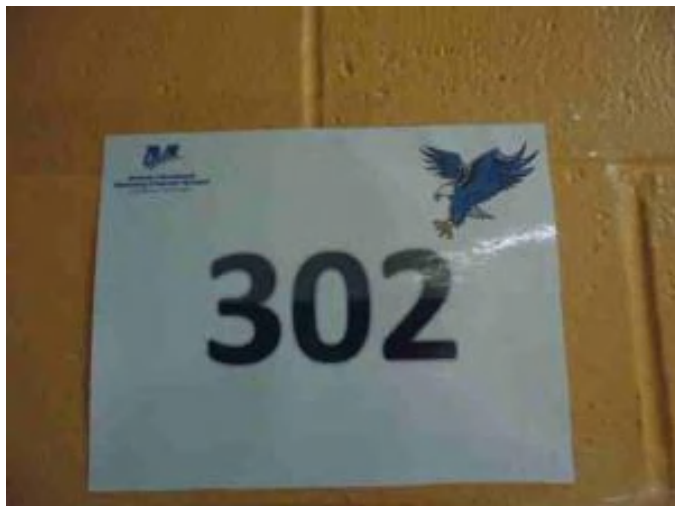
System: C1030 - Fittings

Location: Building Wide

Distress: Damaged

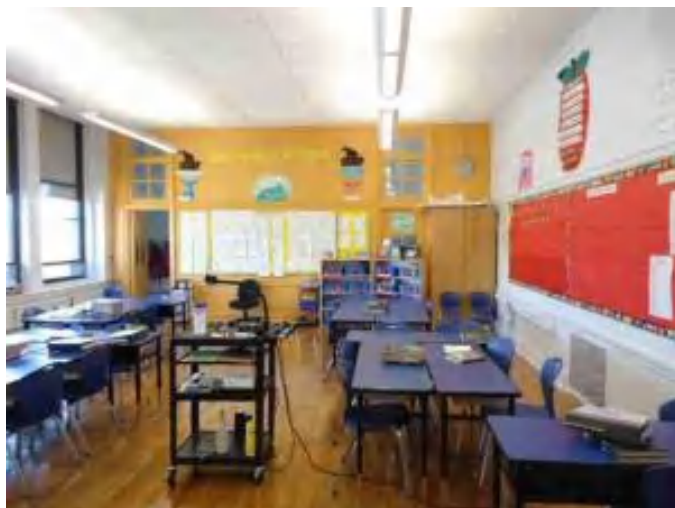
System: C1030 - Fittings

Location: Building Wide

Distress: Damaged

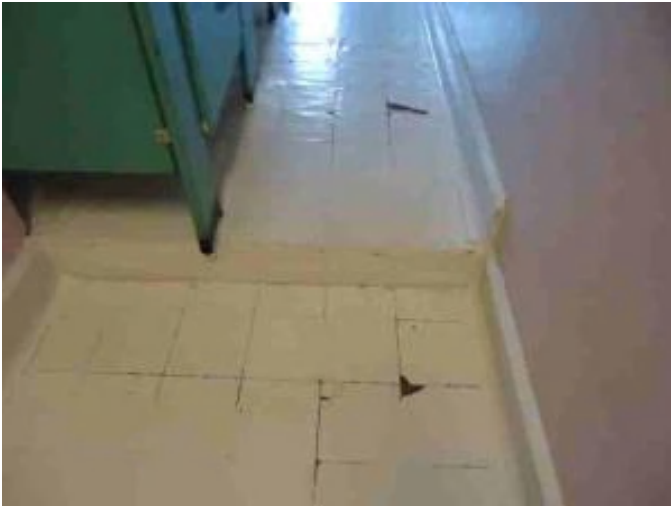
System: C3020413 - Vinyl Flooring

Location: Building Wide

Distress: Health Hazard / Risk

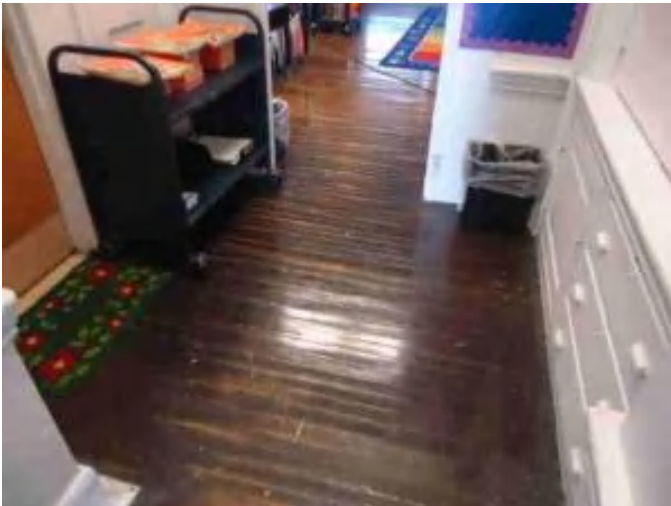
System: C3020414 - Wood Flooring

Location: Classrooms

Distress: Damaged

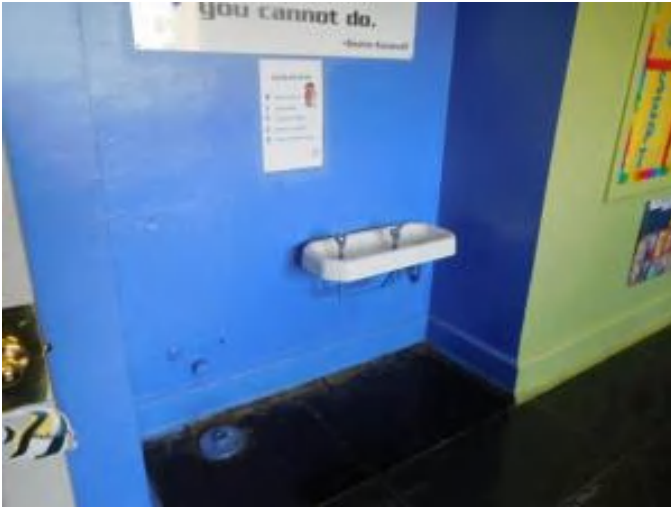
System: D2020 - Domestic Water Distribution

Location: entire building

Distress: Beyond Service Life

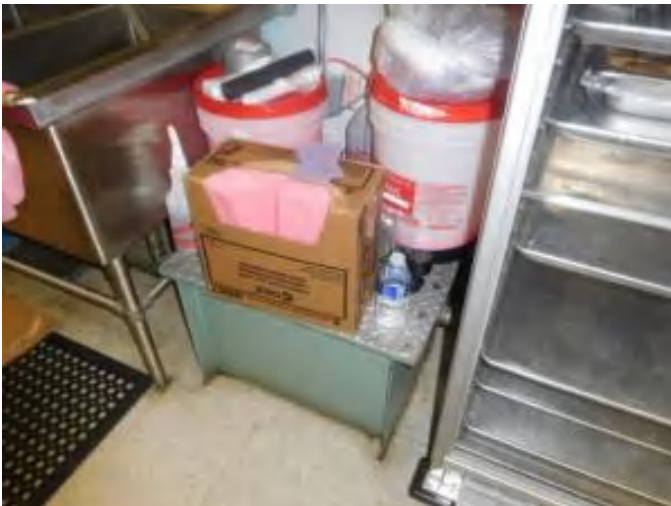
System: D2030 - Sanitary Waste

Location: entire building

Distress: Beyond Service Life

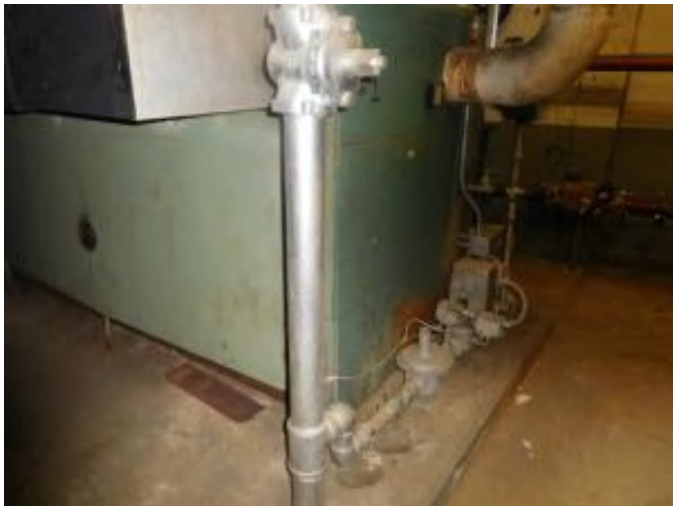
System: D3020 - Heat Generating Systems

Location: mechanical room

Distress: Beyond Service Life

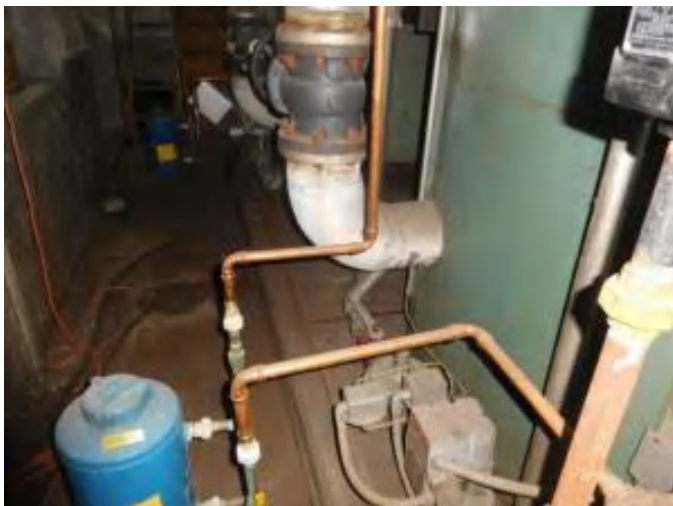
System: D3020 - Heat Generating Systems

Location: mechanical room

Distress: Beyond Service Life

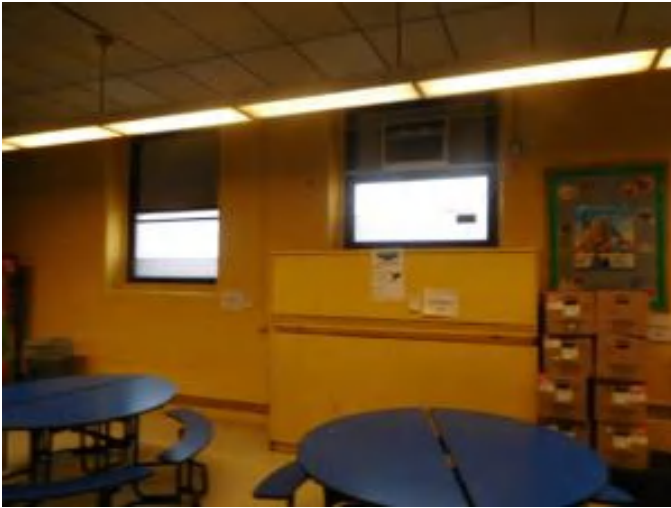
System: D3040 - Distribution Systems

Location: entire building

Distress: Building / MEP Codes

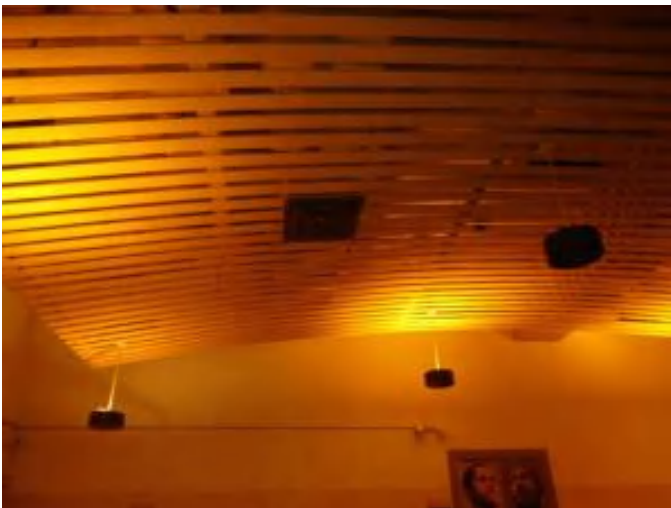
System: D3040 - Distribution Systems

Location: auditorium

Distress: Building / MEP Codes

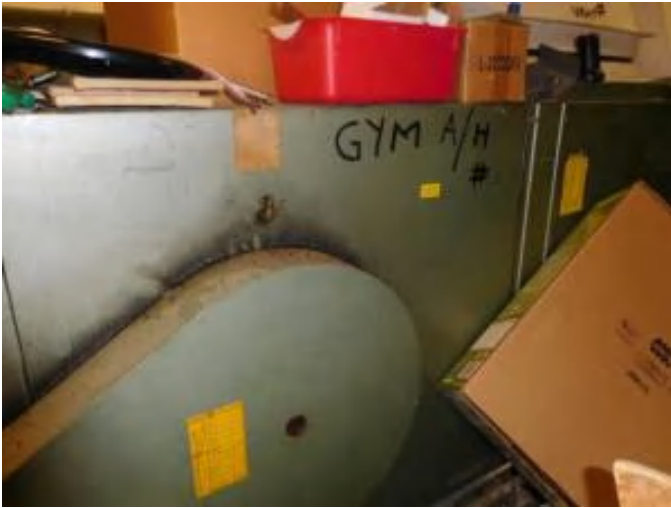
System: D3040 - Distribution Systems

Location: gymnasium

Distress: Building / MEP Codes

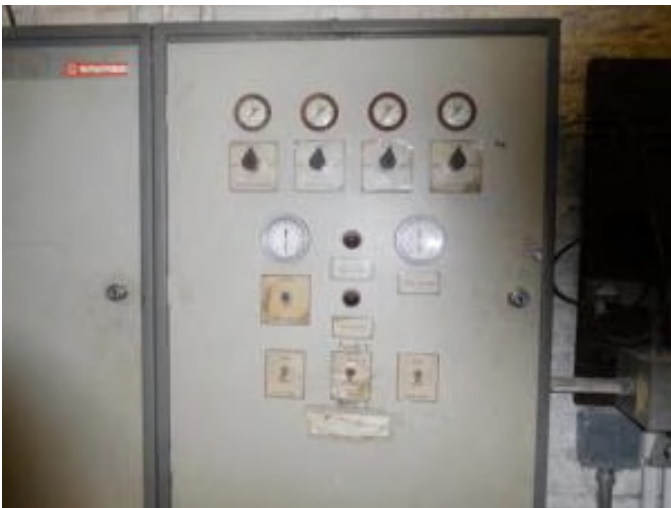
System: D3060 - Controls & Instrumentation

Location: entire building

Distress: Inadequate

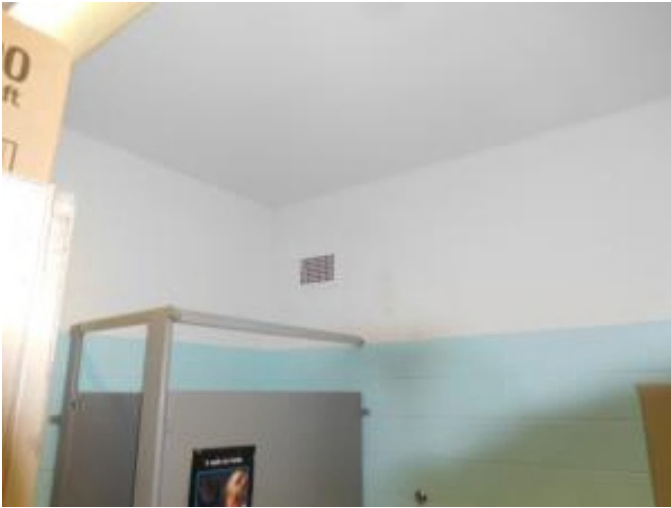
System: D4010 - Sprinklers

Location: entire building

Distress: Life Safety / NFPA / PFD

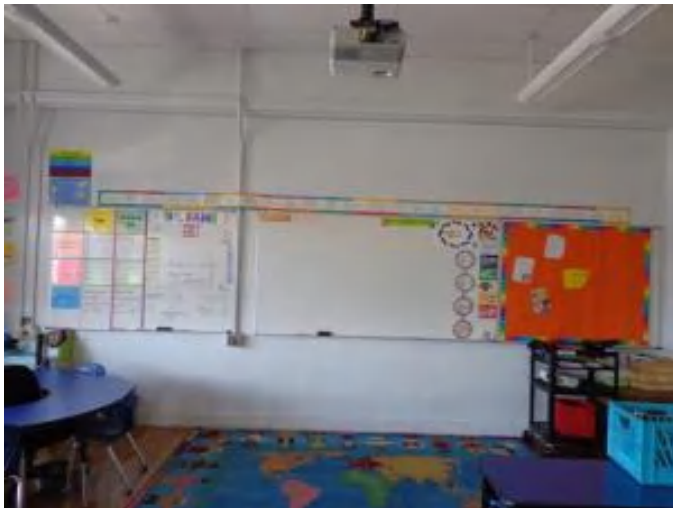
System: D5020 - Lighting and Branch Wiring

Receptacles-- Many of the classrooms do not have an adequate number of receptacles. It is recommended that an additional 5 or 6 duplex receptacles be provided in each classroom using a surface metal raceway system. Ground-fault circuit-interrupting (GFCI) type receptacles were observed in all locations where required by code.

Location: Classrooms

Distress: Inadequate

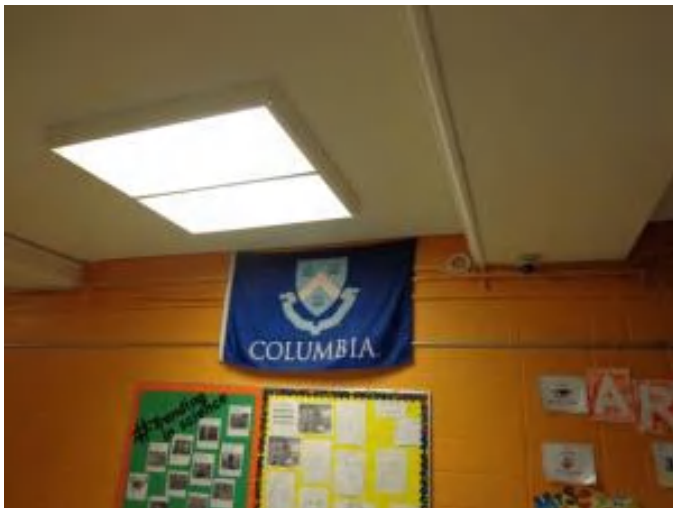
System: D5030 - Communications and Security

Location: Building wide

Distress: Beyond Service Life

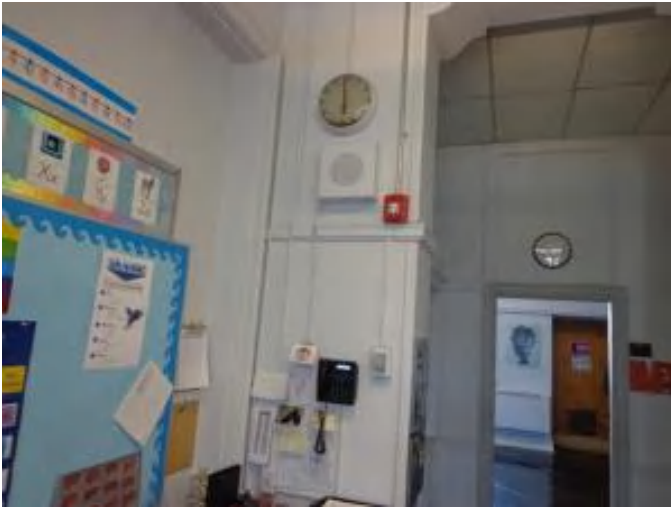
System: D5030 - Communications and Security

Location: Building wide

Distress: Beyond Service Life

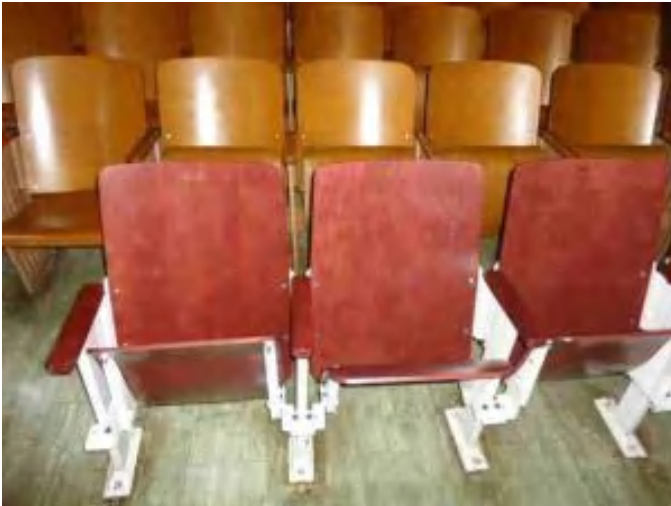
System: E2010 - Fixed Furnishings

Furnishings include: fixed casework; window shades/blinds; and fixed auditorium seating. The fixed seating for this school is from the original construction. The systems are in fair condition considering the age and usage. This project provides a budgetary consideration for universal upgrades for the fixed seating and furnishing of this school. Ensure that ADA requirements are followed with the new seating layout.

Location: Auditorium

Distress: Damaged

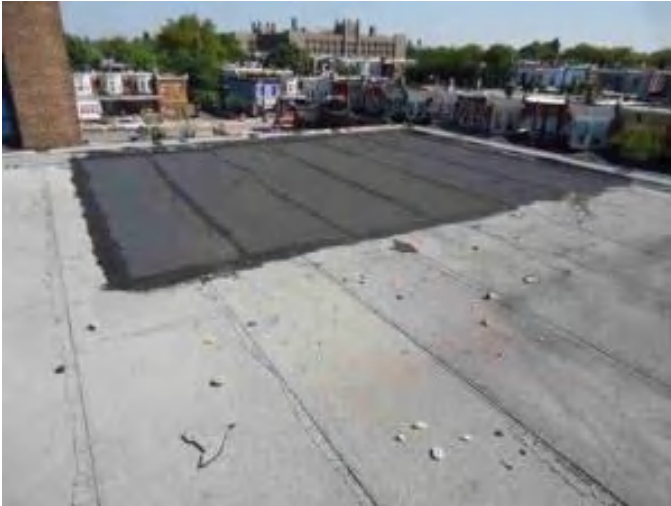
System: B3010105 - Built-Up

The built up roof was installed within the past ten years as reported by the school. The roof is in fair condition with few exceptions. Repairs have been completed on the main section of the roof near the addition however, several areas are reported to have active leaks. This active leak that if not repaired soon will further deteriorate the insulation and the integrity of the classroom finishes. This deficiency provides a budgetary consideration for built up roof system, universal upgrades are recommended.

Location: Roof

Distress: Damaged

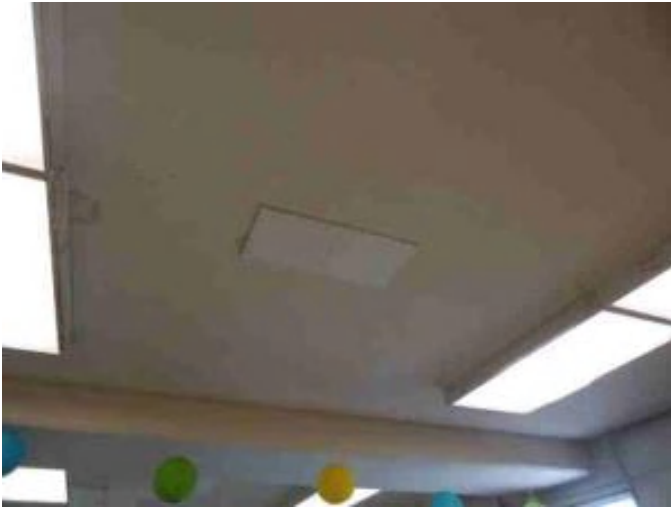
System: C3030 - Ceiling Finishes

The ceiling finish is a mix of 12 x 12 ceiling grid, painted and 2 x 4 Acoustical tile finish. Ceilings have been repaired in several areas and is in fair condition considering the active leaks and the age of the application. The ceiling finish is expected to require upgrades to support the recommended efforts in this report. This deficiency provides a budgetary consideration for removal and replacement of the current ceiling finish to a new acoustical tile finish. Considering the recommended mechanical and electrical upgrades this effort should be completed as part of an overall renewal program for the school. No work should be considered until after the recommended exterior efforts are complete.

Location: Bulding Wide

Distress: Damaged

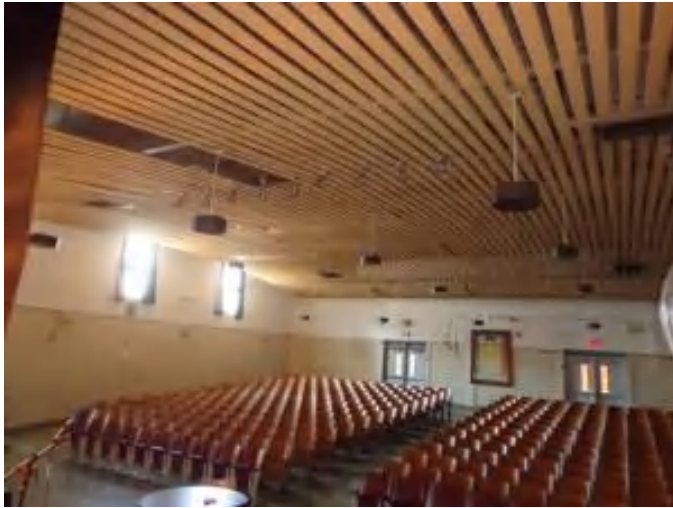
System: D5020 - Lighting and Branch Wiring

Lighting fixtures in the auditorium are stem mounted, indirect "hockey puck" style fixtures with incandescent lamps. These fixtures are outdated, energy inefficient and have reached the end of their useful life. Replacement with pendant mounted, indirect, LED fixtures is recommended. The platform is illuminated with shallow dome fixtures with LED lamps and two rows of electrics for theatrical lighting. There are also (9) ceiling mounted, bullet-style incandescent spotlights that illuminate the platform. The spotlights should be replaced with LED spotlighting fixtures.

Location: Auditorium

Distress: Energy Efficiency

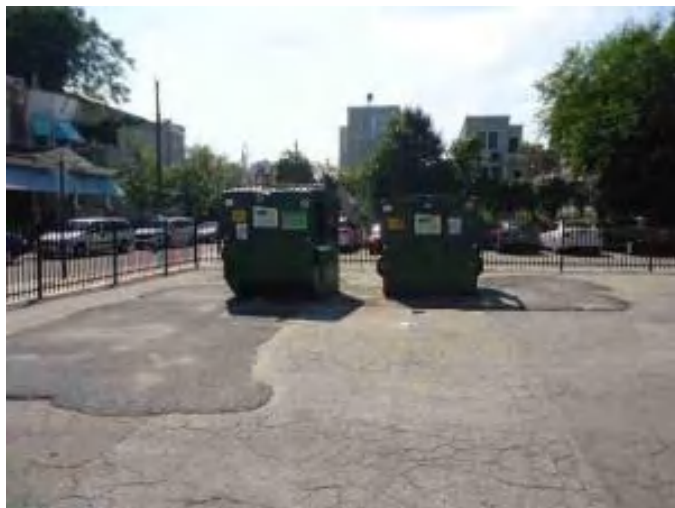
System: G2040 - Site Development

Location: Site

Distress: Health Hazard / Risk

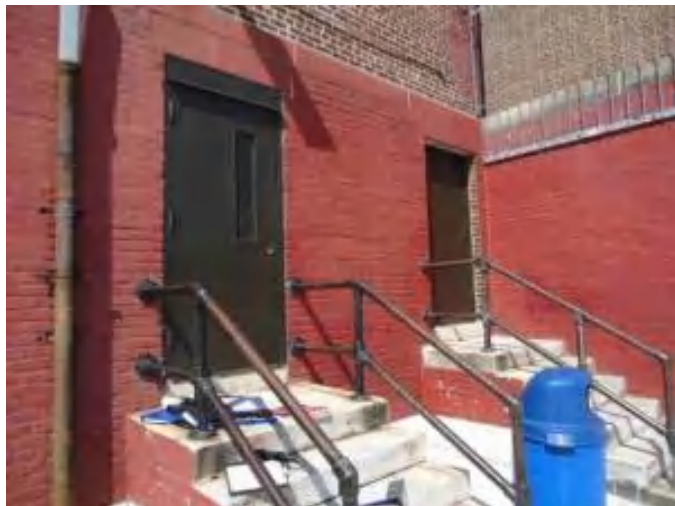
System: G2040 - Site Development

Location: Exterior Stairs

Distress: Damaged

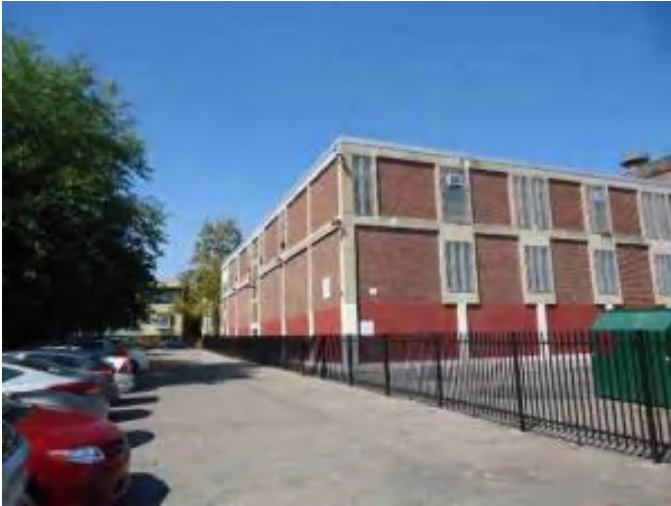
System: G2020 - Parking Lots

Location: Site

Distress: Damaged

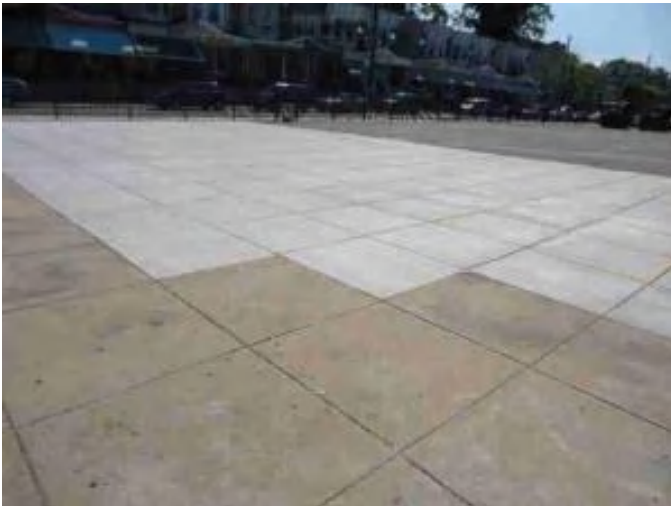
System: G2030 - Pedestrian Paving

Location: Site

Distress: Damaged
