Facility Condition Assessment Summary Report

Clymer School

School District of Philadelphia
S522001;Clymer
Final
Site Assessment Report
February 1, 2017

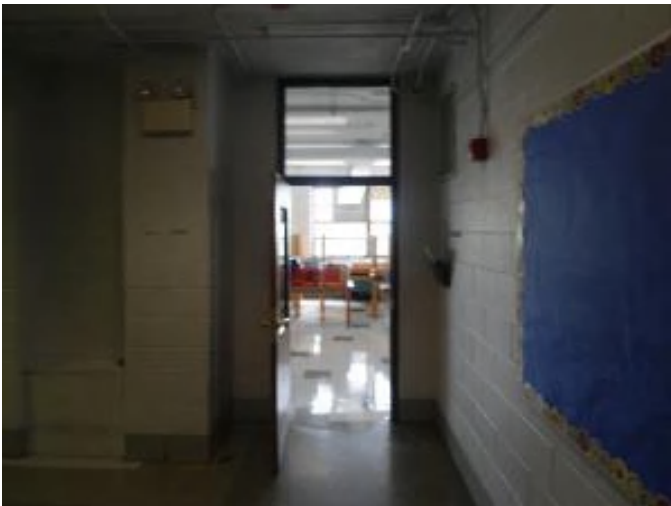
System: C1020 - Interior Doors

Location: Classroom Doors

Distress: Life Safety / NFPA / PFD

Notes: Interior doors are typically wood in metal frames with transom lites, sidelights, wired glass glazing. Other interior doors include wooden glass pane doors with original wooden pane frames, hollow metal in hollow metal frames at stairwells and exit ways, access doors, and closet doors. Doors are generally in good condition and is a mix of ADA compliant and non-complaint doors with both non-rated and fire rated. Doors swing in the direction of exit and do not obstruct hallways. Remove and replace transoms and doors where required.

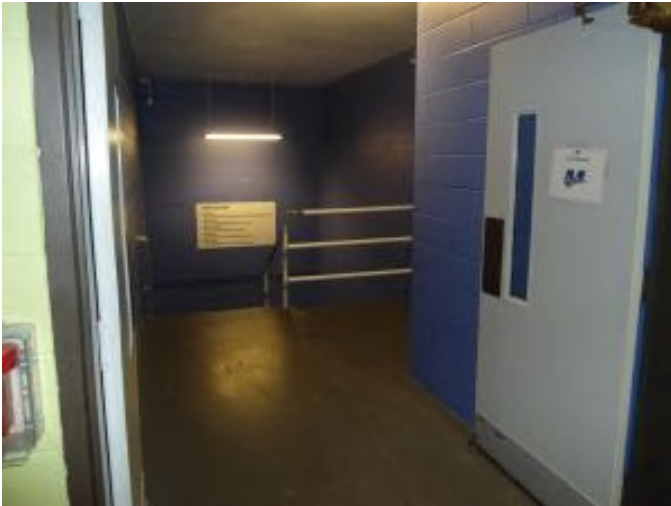
System: C2010 - Stair Construction

Location: Stairs

Distress: Life Safety / NFPA / PFD

Notes: Current requirements for stairs indicate that they have graspable handrails on both sides, that the rails have a specific end geometry, and that the handrails continue horizontally at the landings. In addition, guardrails must prevent the passage of a 4 inch diameter sphere (6 inches in the triangle formed by the lower rail and tread/riser angle). Although the stairs are compliant with the code enforced at the time of construction until a major renovation occurs, they are deficient in handrail and guardrail design relative to current standards. Future efforts should include comprehensive stair railing removal and replacement upgrades.

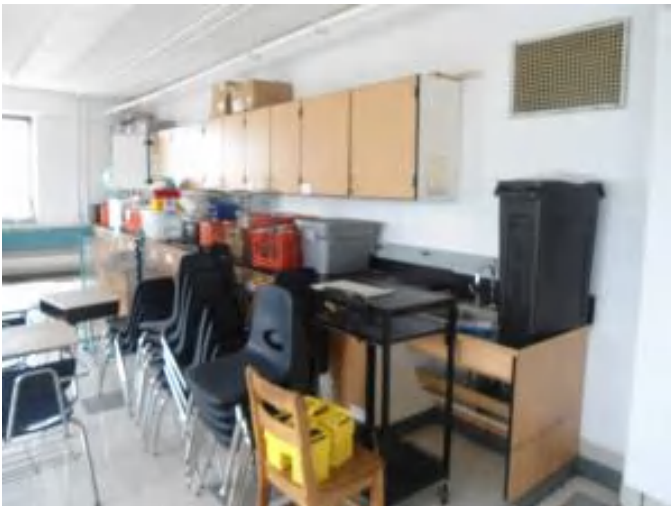
System: E1020 - Institutional Equipment

The lab casework and working desk with countertop have been upgraded from the original construction however the installation date is unknown. The system is in fair condition but showing signs of age and high usage. This deficiency provides a budgetary consideration for new casework and countertops for the lab spaces. Remove and replace casework.

Location: Classroom Labs

Distress: Beyond Service Life

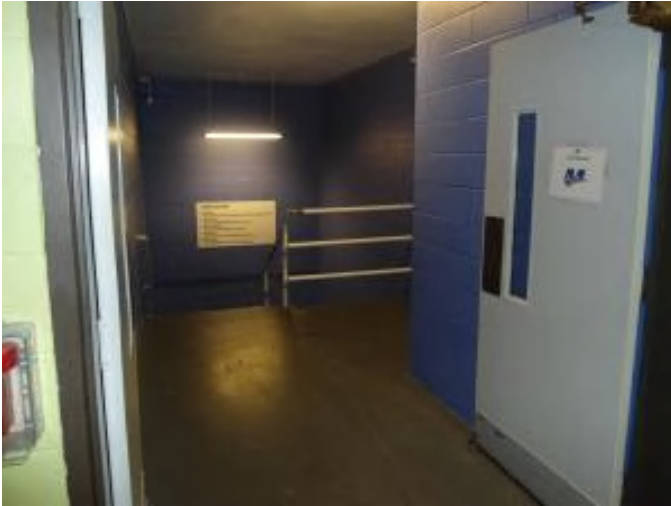
System: C1010 - Partitions

Location: Building Wide

Distress: Life Safety / NFPA / PFD

Notes: Corridor doors are not fire-rated and should be replaced. To prevent doors from being improperly held open, magnetic door holders should be installed and tied to the building fire alarm system to ensure that the door can function as designed in the event of a fire.

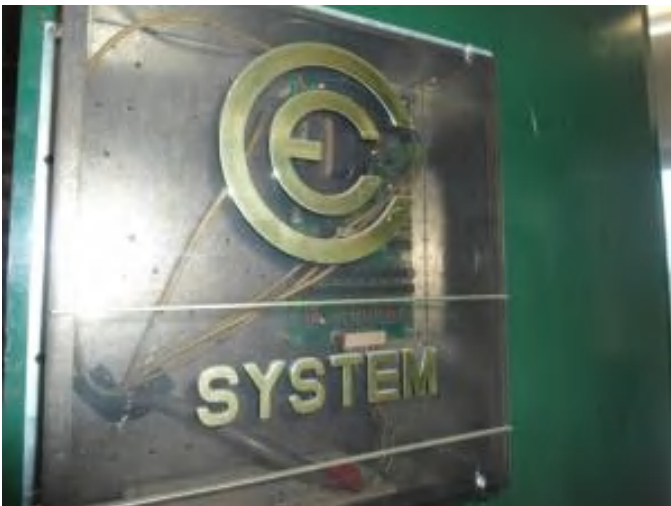
System: D1010 - Elevators and Lifts

Location: Elevator cab, machine room

Distress: Beyond Service Life

Notes: Provide upgrade and modernization of elevator cab, controls and machine room.

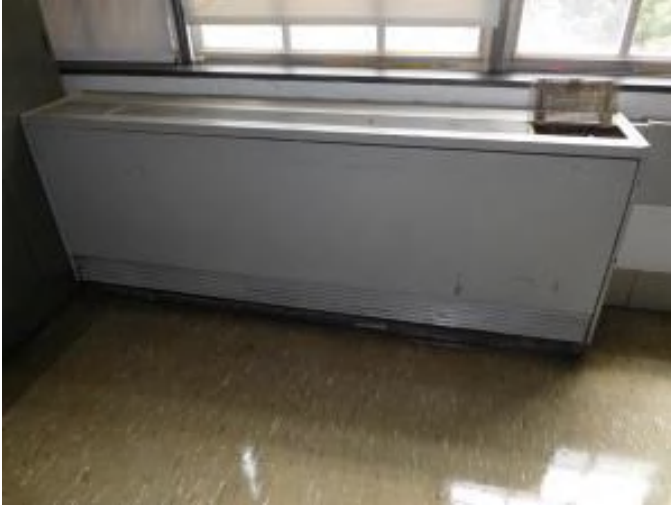
System: D3040 - Distribution Systems

Location: classrooms

Distress: Building / MEP Codes

Notes: Replace the existing unit ventilators with new units designed for quiet operation and equipped with hot water and chilled water coils, hydronic control valves with digital controls and integral heat exchangers to provide code required fresh air quantities. Connect to new chilled and hot water piping systems and building automation control system.

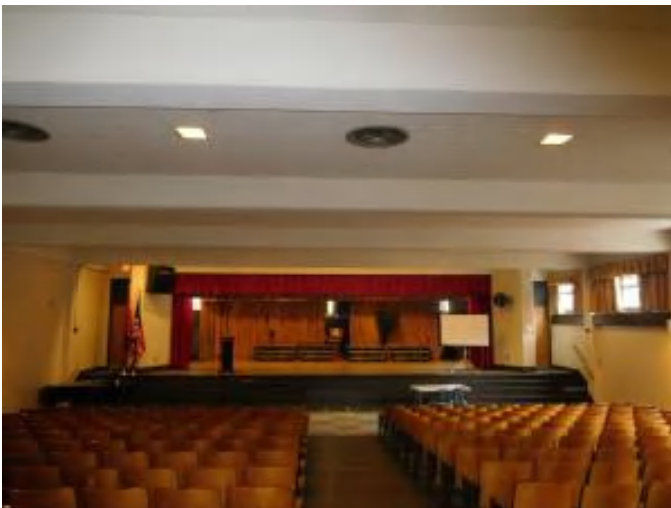
System: D3040 - Distribution Systems

Location: auditorium

Distress: Building / MEP Codes

Notes: Install new single zone horizontal central station air handling unit in auditorium mechanical room to serve auditorium. Connect to existing ductwork. Provide adequate outside air louver and ductwork to furnish code required fresh air. Unit to have hot and chilled water coils, filters, blower and motor. Include hydronic control valves with digital controls. Connect to building automation control system and hot and chilled water piping systems

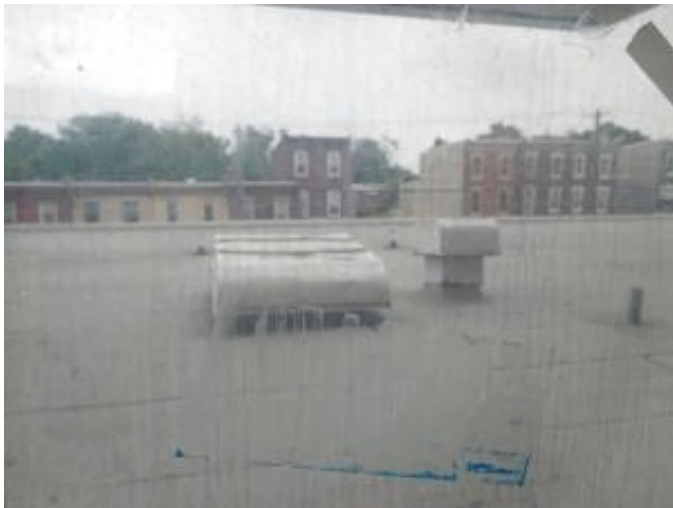
System: D3040 - Distribution Systems

Location: cafeteria roof

Distress: Damaged

Notes: Replace inoperable exhaust fan on roof of cafeteria.

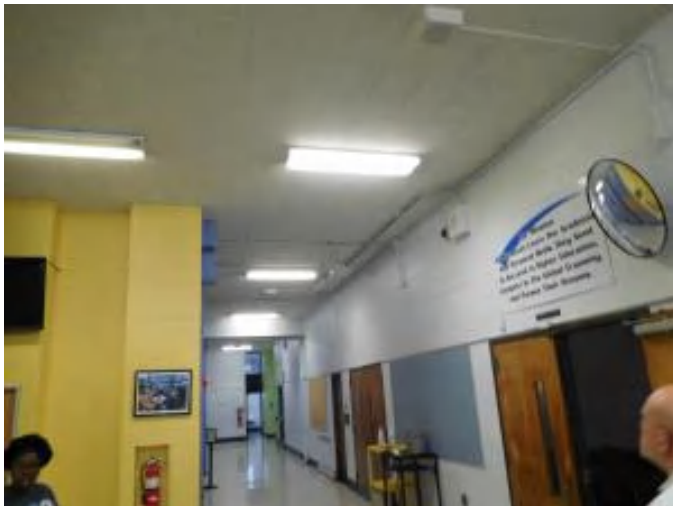
System: D4010 - Sprinklers

Location: entire building

Distress: Life Safety / NFPA / PFD

Notes: Install complete NFPA wet pipe automatic sprinkler system and standpipes. If required provide fire pump and jockey pump with controller.

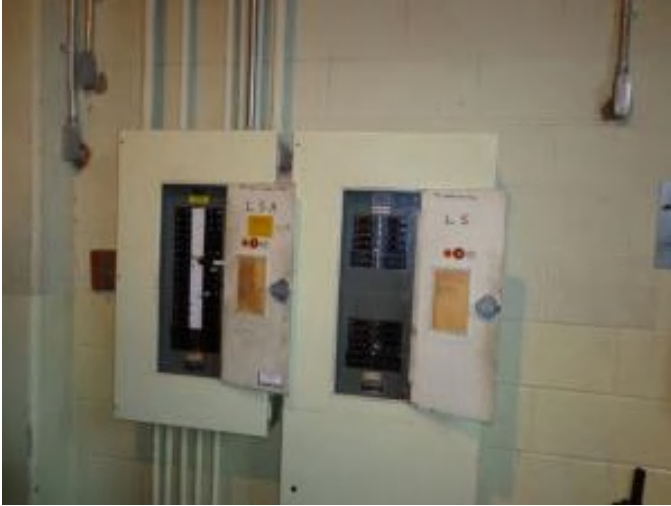
System: D5010 - Electrical Service/Distribution

Panelboards for receptacles and air conditioning units were added in the 2013 upgrade project. Panelboards throughout the remainder of the building have not been replaced. There are eight (8) panelboards throughout the building that have reached the end of their useful life and need to be replaced. There are also five (5) panelboards with exposed bus, with knife blade switches and cartridge type fuses that need are obsolete, have safety concerns, and need to be replaced.

Location: Building wide

Distress: Beyond Service Life

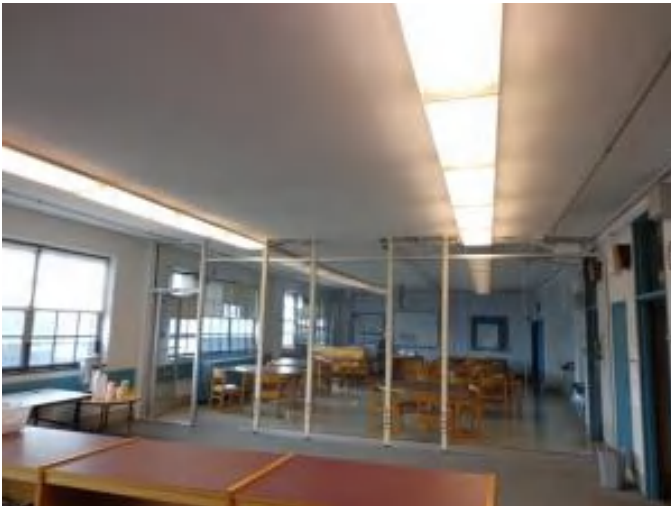
System: D5020 - Lighting and Branch Wiring

Lighting-- The facility has a mixture of fixture types. Corridors and classrooms typically have original surface mounted wraparound fluorescent fixtures with acrylic lenses. Classroom lighting is controlled by two switches; there are no occupancy sensors. Illumination levels in classroom ranged from 25 to 36 footcandles (fc). Fixtures in Art Room 410 and in the corridor on Floor 1 have been upgraded with T8 fluorescent lamps. Fixtures in all other classrooms and other areas have obsolete T12 fluorescent lamps and have reached the end of their useful life. Lighting fixtures need to be replaced in approximately 37,000 SF of the building.

Location: Building wide

Distress: Beyond Service Life

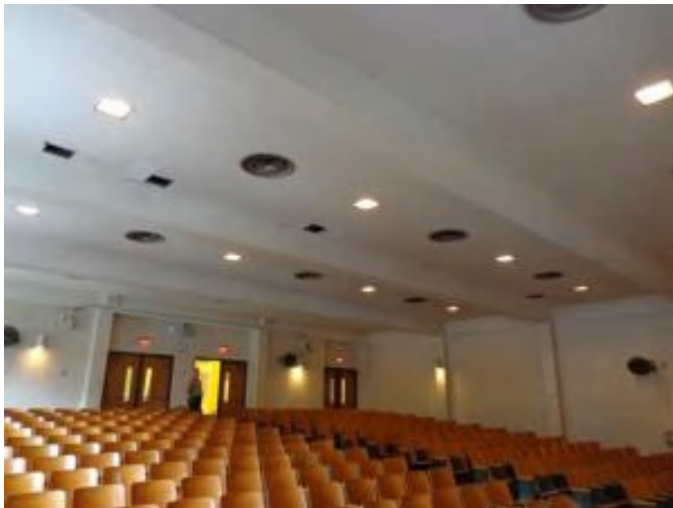
System: D5020 - Lighting and Branch Wiring

Location: Auditorium

Distress: Beyond Service Life

Notes: Replace lighting system and provide dimming system in the auditorium.

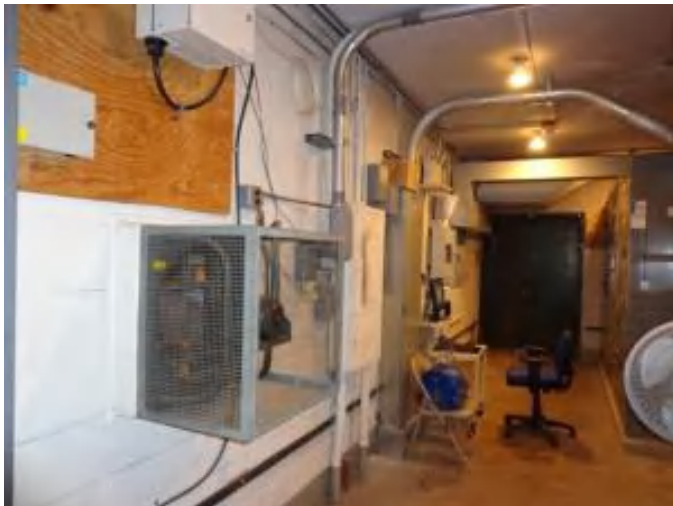
System: D5020 - Lighting and Branch Wiring

Location: Boiler Room, Main Electrical Room

Distress: Beyond Service Life

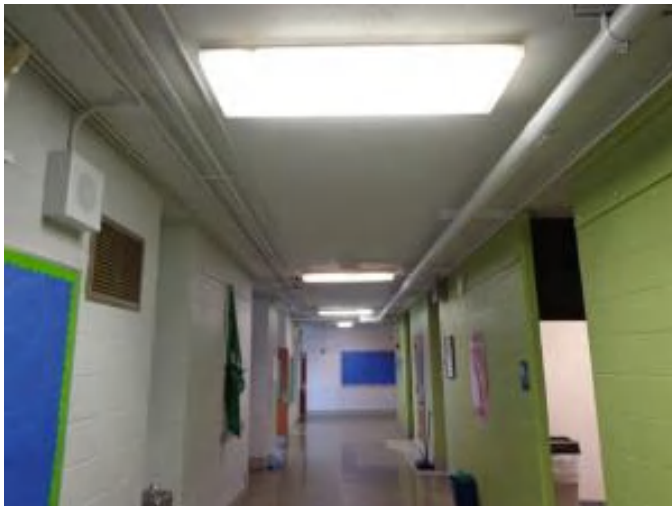
System: D5090 - Other Electrical Systems

Location: Floors 1 -4 Corridors

Distress: Life Safety / NFPA / PFD

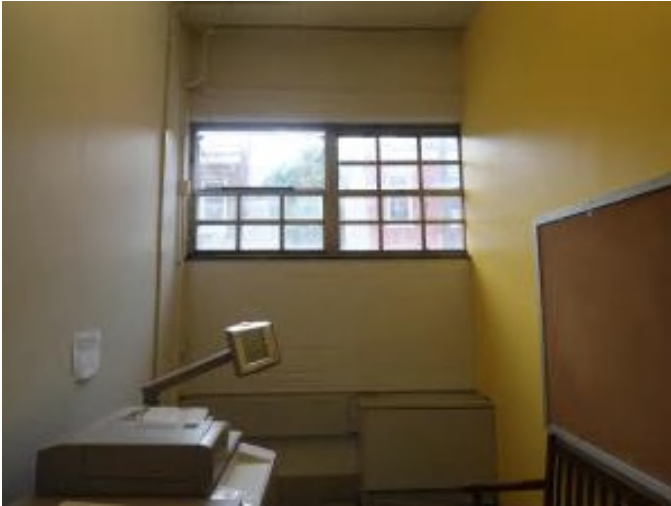
System: B2020 - Exterior Windows

Exterior windows are a mix of single pane industrial grade metal, aluminum framed single pane windows. The single pane and metal-framed windows have been replaced in the last twenty years. Windows are in good condition based on the year of installation or last renovation. The exterior window system is recommended to be replaced with units that retain their dimensions and profiles, but that incorporate updated energy-efficient features.

Location: Building Wide

Distress: Beyond Service Life

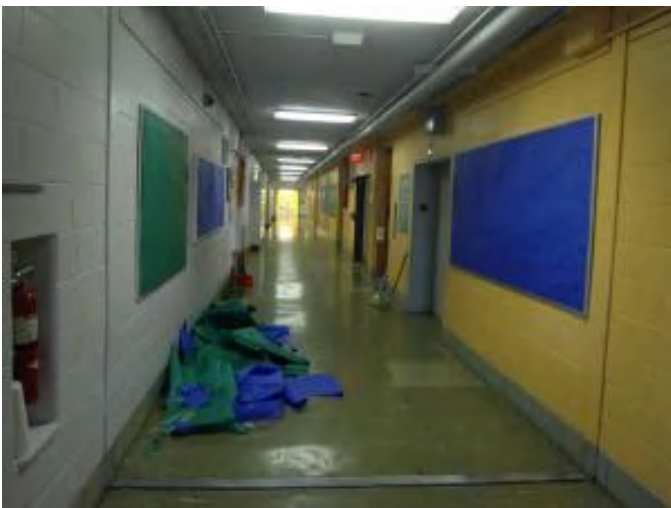
System: C3020413 - Vinyl Flooring

Much of the vinyl floor tile finishes in this building have been removed and replaced with a 12x12 vinyl floor finish. There a few remaining areas such as the hallway and select classrooms still have older 9x9 vinyl flooring. It is recommended that all of the remaining vinyl flooring be removed and upgraded to a 12x12 floor tile finish.

Location: Building Wide

Distress: Health Hazard / Risk

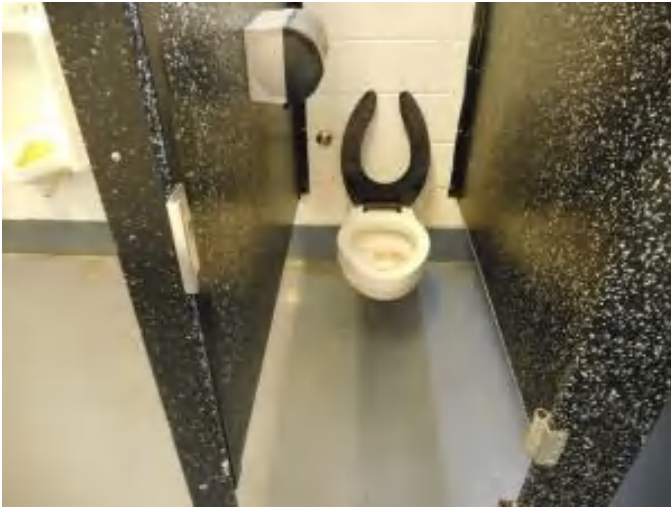
System: D2010 - Plumbing Fixtures

The plumbing fixtures are well beyond anticipated service life and are recommended to be replaced, including water closets, urinals, lavatories and drinking fountains. Fittings and trim should be replaced as well. The domestic water piping is from 1964, has exceeded normal life, may contain lead solder and should be replaced. The cast iron rainwater and sanitary and vent piping are also original. The cast iron sanitary piping should be inspected with cameras and damaged sections replaced. Rainwater and vent piping should be serviceable for ten to fifteen more years. The gas water heater should be serviceable for ten to fifteen more years.

Location: entire building

Distress: Beyond Service Life

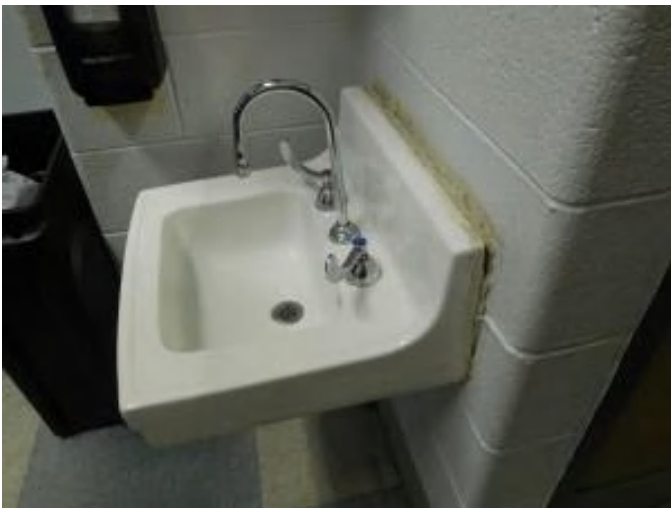
System: D2010 - Plumbing Fixtures

Location: entire building

Distress: Beyond Service Life

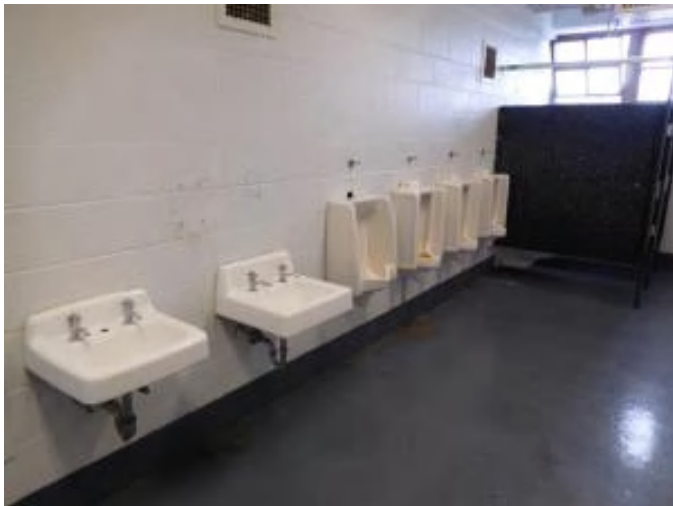
System: D2010 - Plumbing Fixtures

Location: entire building

Distress: Beyond Service Life

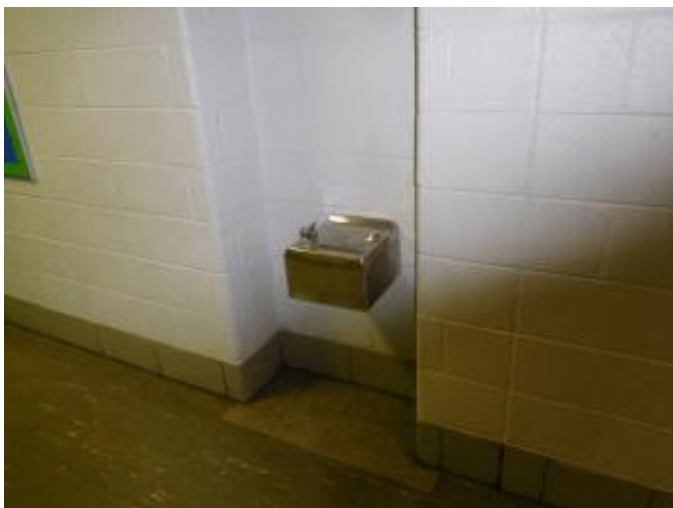
System: D2010 - Plumbing Fixtures

Location: entire building

Distress: Beyond Service Life

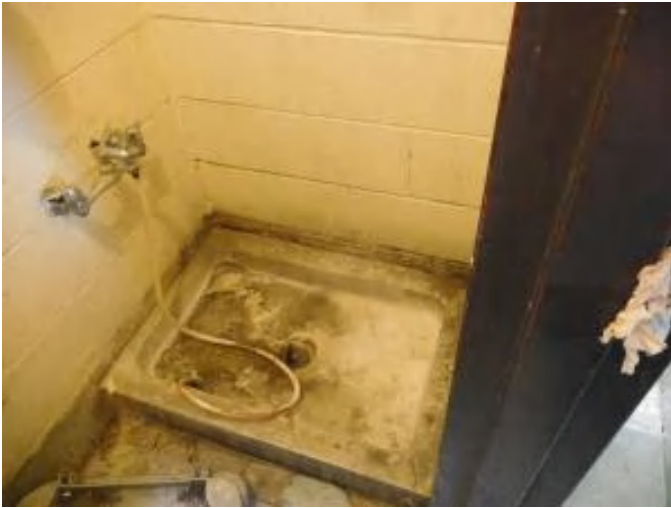
System: D2030 - Sanitary Waste

Location: entire building

Distress: Beyond Service Life

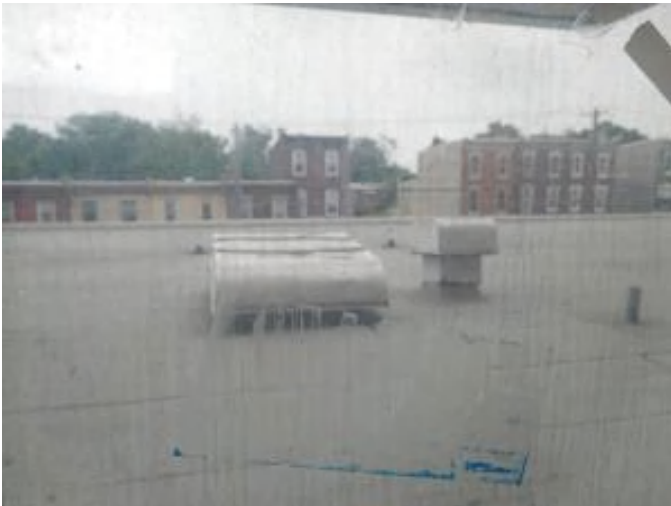
System: D3030 - Cooling Generating Systems

There is no central air conditioning. There are approximately fifty window air conditioners for cooling and the classroom unit ventilators and two air handling units for ventilation. There are transfer air grills from classrooms to corridors to relieve ventilation air from the unit ventilators to roof mounted relief hoods. There are no fire dampers in the grills. Two centrifugal roof ventilators provide ducted exhaust from toilet rooms and custodial closets. A roof mounted general exhaust fan over the cafeteria is not operable.

Location: roof, mechanical room

Distress: Inadequate

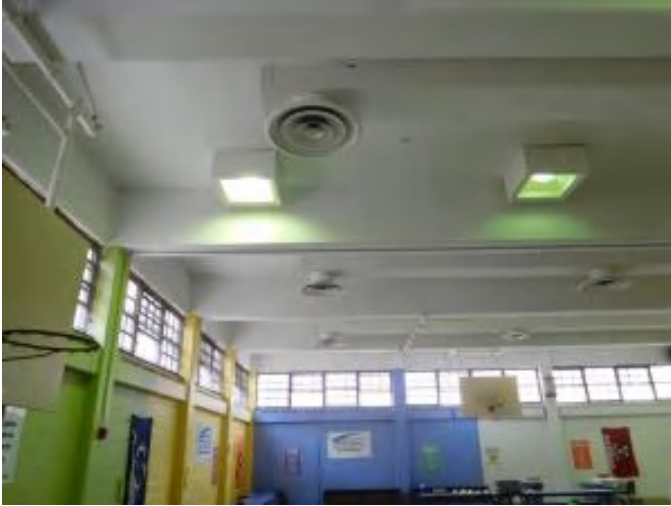
System: D3040 - Distribution Systems

Location: cafeteria

Distress: Building / MEP Codes

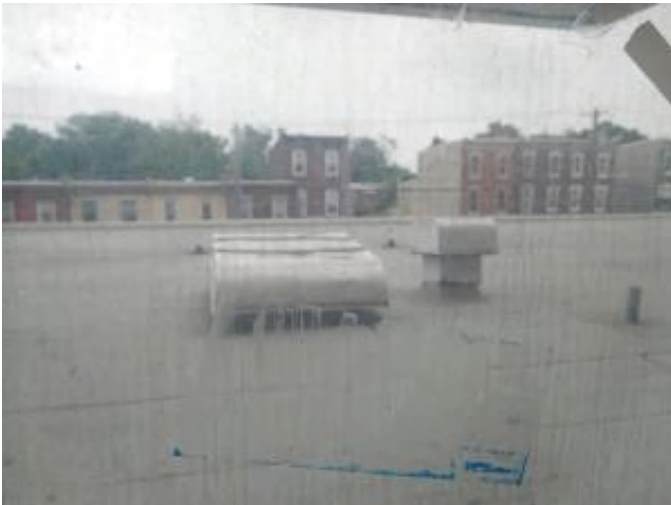
System: D3040 - Distribution Systems

Location: cafeteria roof

Distress: Damaged

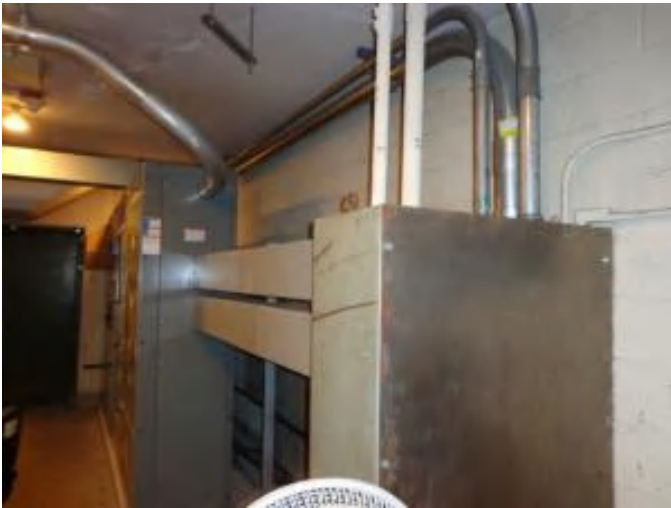
System: D5010 - Electrical Service/Distribution

Electrical Service-- Electrical service to the building is provided by PECO Energy Company. An underground service is routed to a 1600A, 208/120V, 3 phase, 4 wire Square D Main Switchboard located in the electrical room in the Basement. The main electrical service equipment was replaced in a 2013 upgrade project. The switchboard has a 1600A MCB, surge protective device, power circuit monitor and one distribution section with feeder circuit breakers. There is a wall mounted, main grounding bus located adjacent to the switchboard. Another distribution section with a 1200A main disconnecting means, and associated circuit breakers and feeders, would be needed when a central air conditioning system and fire pump is added for this school.

Location: Main Electrical Room

Distress: Inadequate

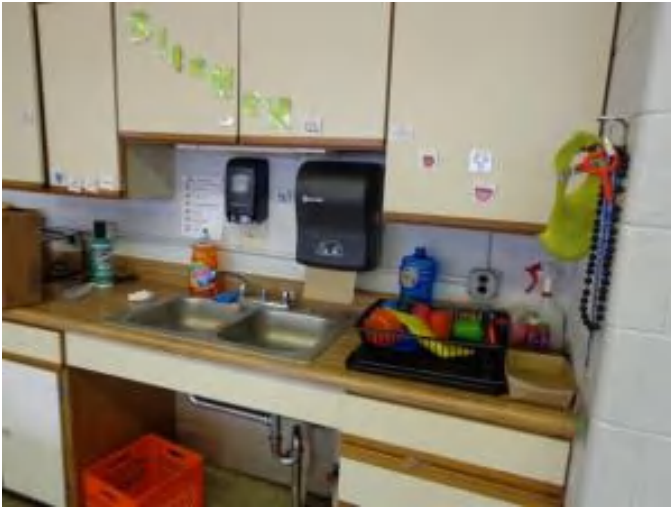
System: D5020 - Lighting and Branch Wiring

Receptacles-- Classrooms are typically supplied with 3 or 4 duplex receptacles. Additional receptacles were added as needed in classrooms using surface mounted conduit. Receptacles within 6 feet of the sinks in Classroom 110 and Art Room 405 need to be replaced with ground-fault circuit-interrupting type receptacles for protection of personnel, as required by National Electrical Code (NEC) Article 210.8.

Location: Classroom 110, Art Room 405

Distress: Life Safety / NFPA / PFD

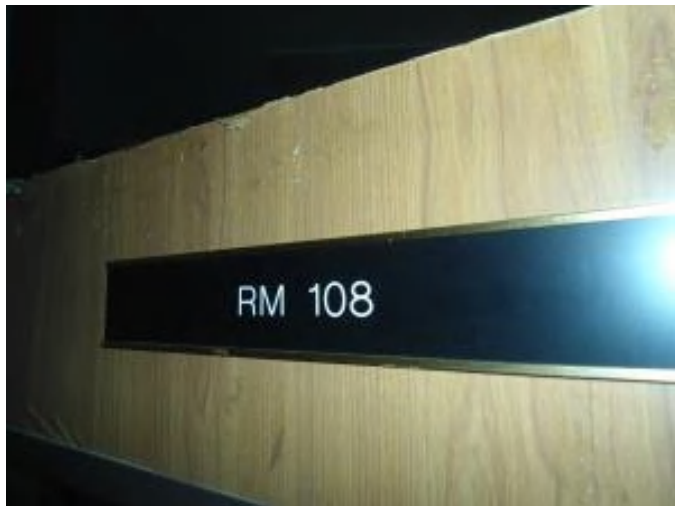
System: C1030 - Fittings

Location: Building Wide Signage

Distress: Damaged

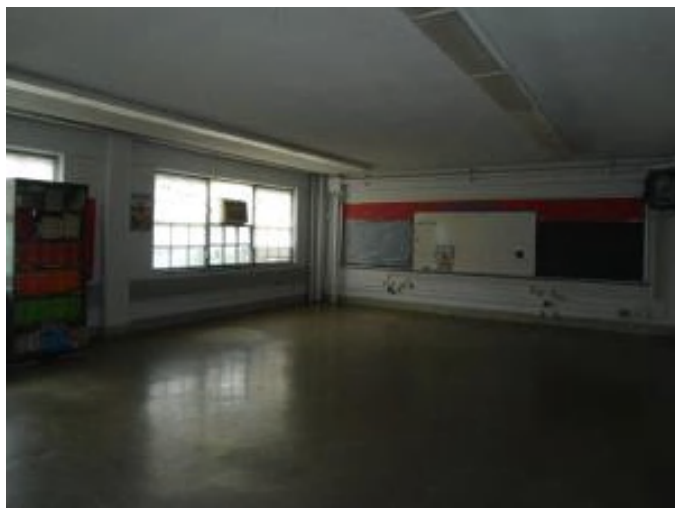
System: C1030 - Fittings

Location: Building Wide

Distress: Inadequate

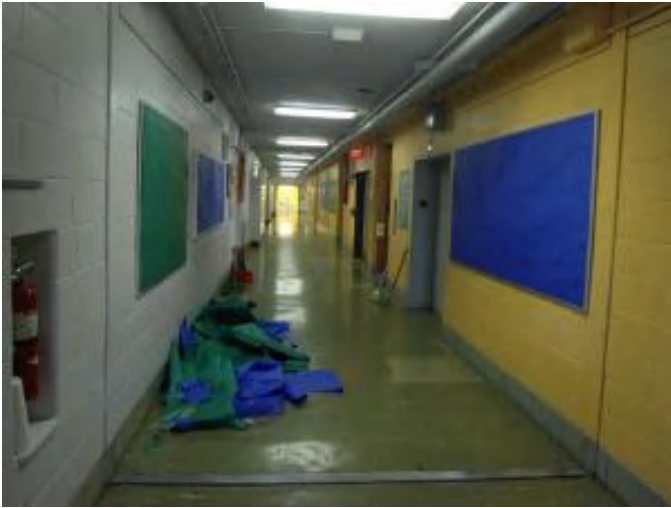
System: C1030 - Fittings

There are several tack boards in the hallways for student displays. The systems are beyond the expected service life for this application. Remove and replace tack boards is recommended.

Location: Building Wide

Distress: Beyond Service Life

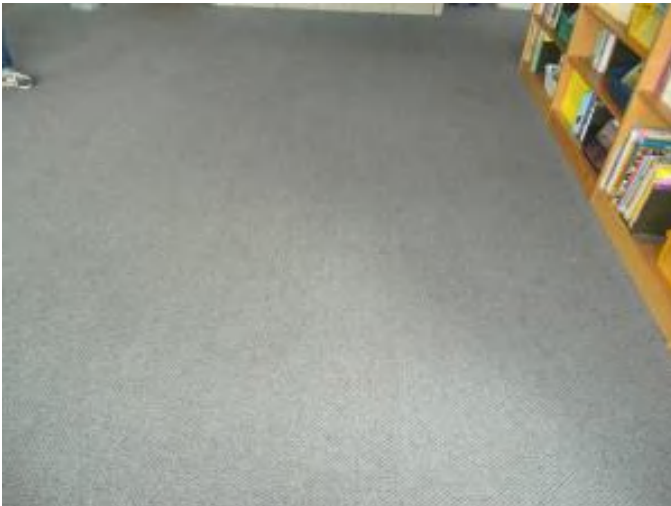
System: C3020411 - Carpet

The interior carpet finish was installed in 2000 and is in fair condition considering the age and high traffic conditions. This finish will exceed its expected life within the next five years and is recommended for upgrade.

Location: Library and Administration

Distress: Beyond Service Life

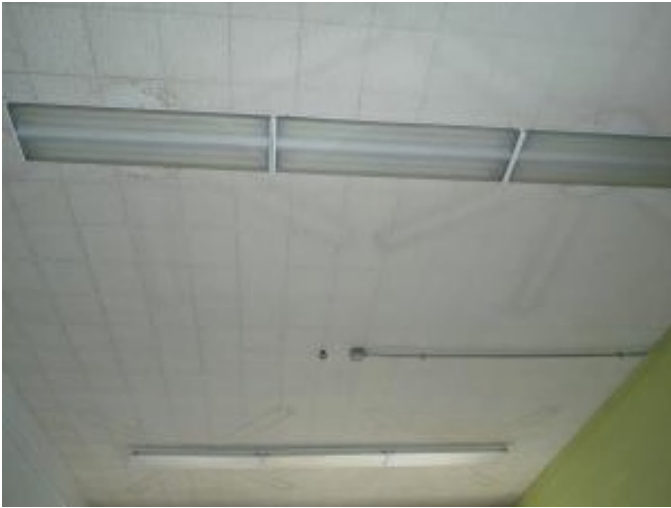
System: C3030 - Ceiling Finishes

The ceiling finish is a mix of 12 x 12 ceiling grid, painted and exposed concrete decking. The ceiling finish has been repaired in several areas and is in good condition considering the age of the application. The ceiling finish is expected to required upgrades within the next five to ten years. This deficiency provides a budgetary consideration for removal and replacement of the current ceiling finish to a new acoustical tile finish. Considering the recommended mechanical and electrical upgrades this effort should be completed as part of an overall renewal program for the school.

Location: Building Wide

Distress: Beyond Service Life

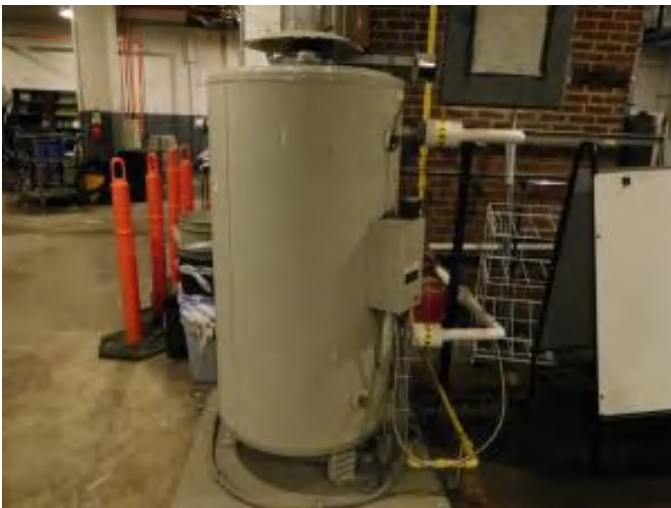
System: D2020 - Domestic Water Distribution

Location: entire building

Distress: Beyond Service Life

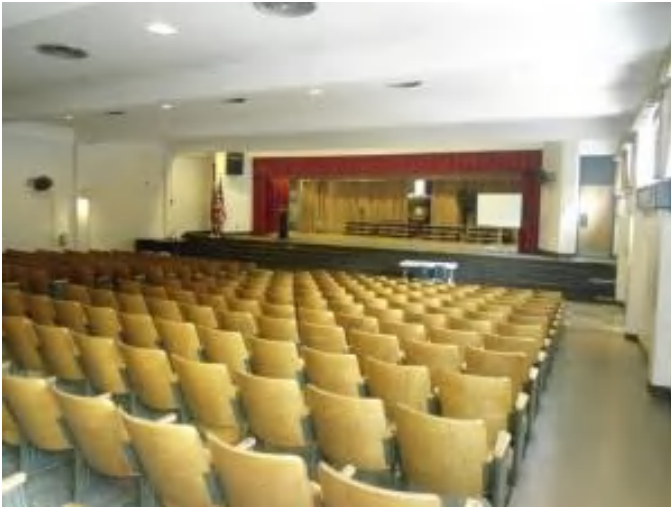
System: E2010 - Fixed Furnishings

Furnishings include: fixed casework; window shades and original fixed auditorium seating. In each case the finishes are in good condition.

Location: Building Wide

Distress: Beyond Service Life

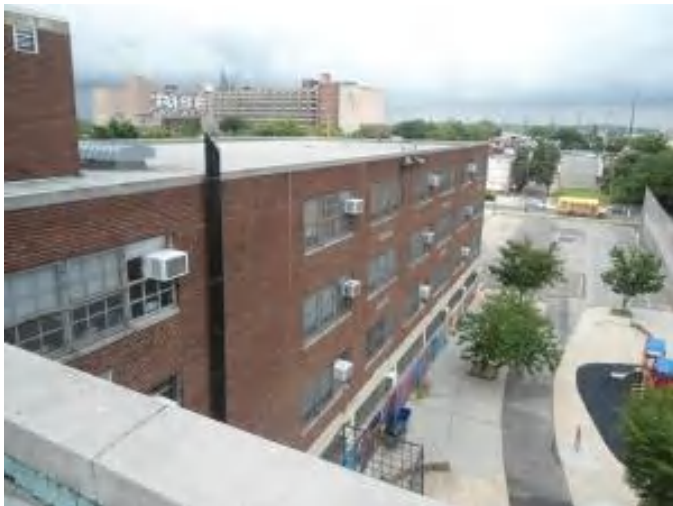
System: G2050 - Landscaping & Irrigation

Location: Play Ground

Distress: Appearance

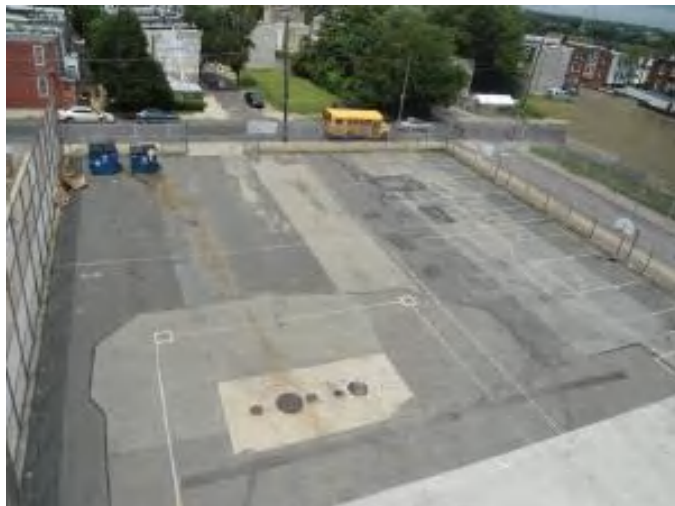
System: G2040 - Site Development

Location: Site

Distress: Health Hazard / Risk

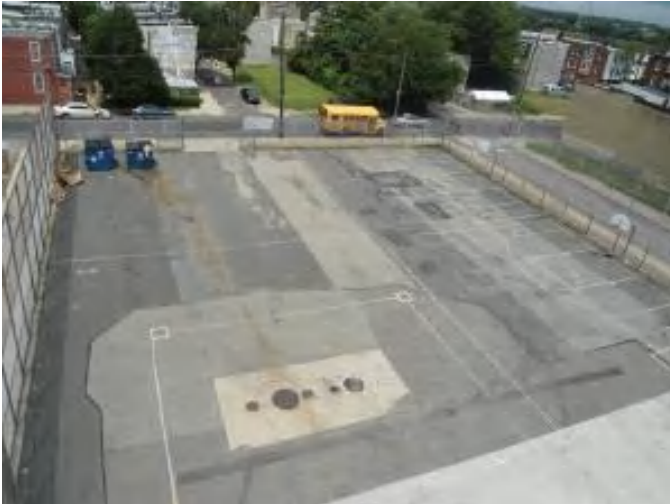
System: G2020 - Parking Lots

Location: Parking Play Area

Distress: Beyond Service Life

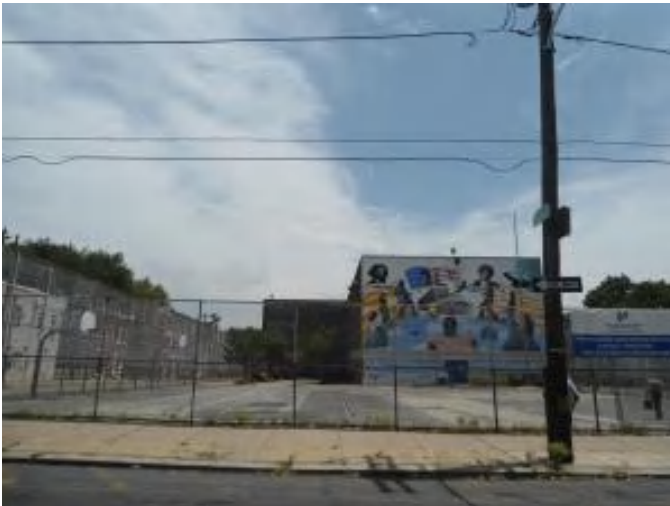
System: G2030 - Pedestrian Paving

Location: Site

Distress: Beyond Service Life

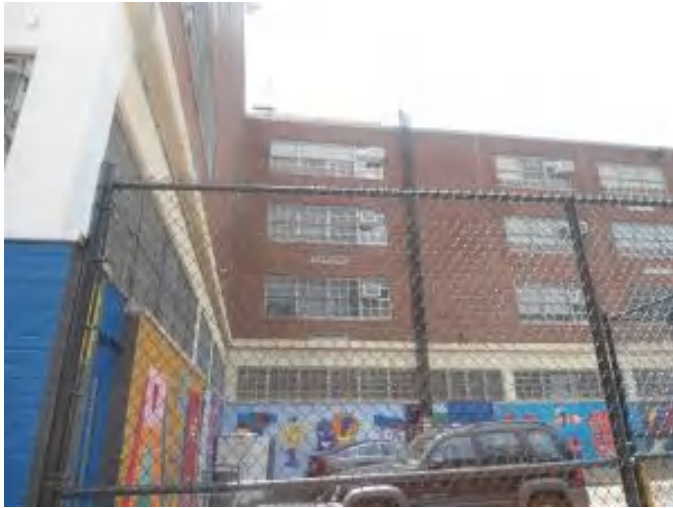
System: G2040 - Site Development

Location: Site

Distress: Beyond Service Life
