Facility Condition Assessment Summary Report

Conwell School

Conwell Annex School

School District of Philadelphia
S523001;Conwell
Final
Site Assessment Report
February 2, 2017

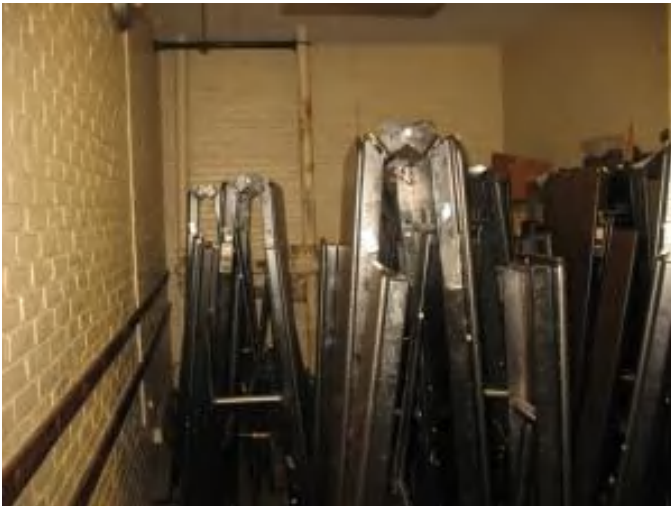
Location: Boiler Room

System: D2030 - Sanitary Waste

Distress: Health Hazard / Risk

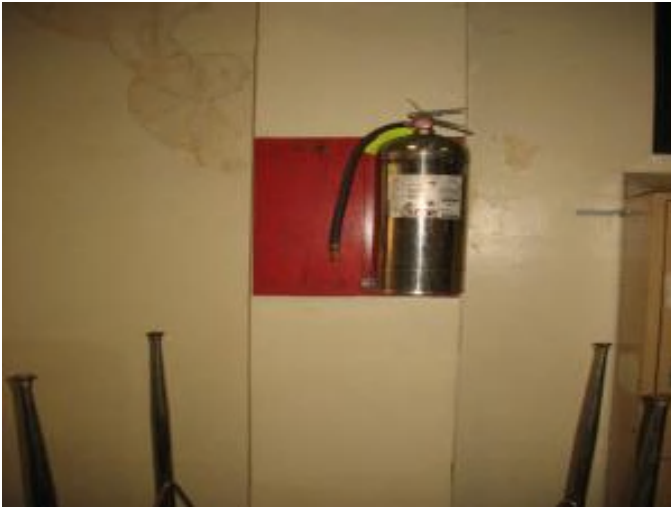
Location: Throughout Building

System: D4010 - Sprinklers

Distress: Life Safety / NFPA / PFD

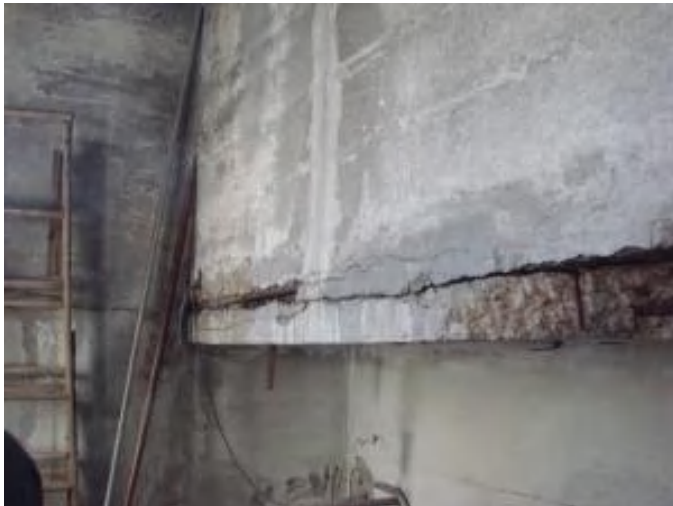
Location: Roof slab

System: B1010 - Floor Construction

Distress: Damaged

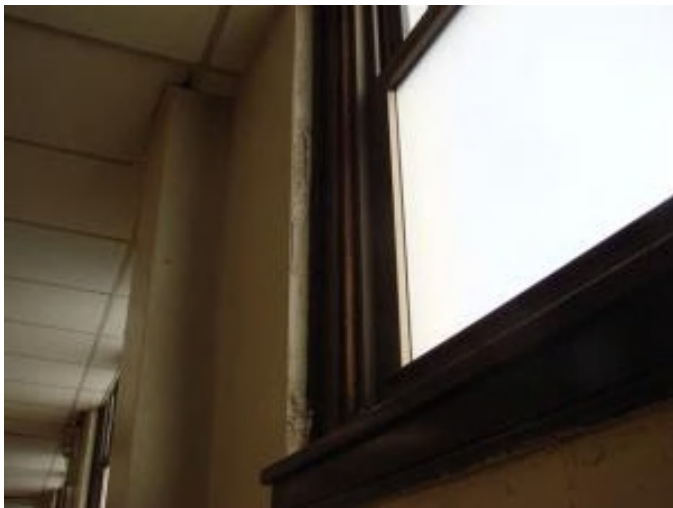
Location: Exterior

System: B2020 - Exterior Windows

Distress: Beyond Service Life

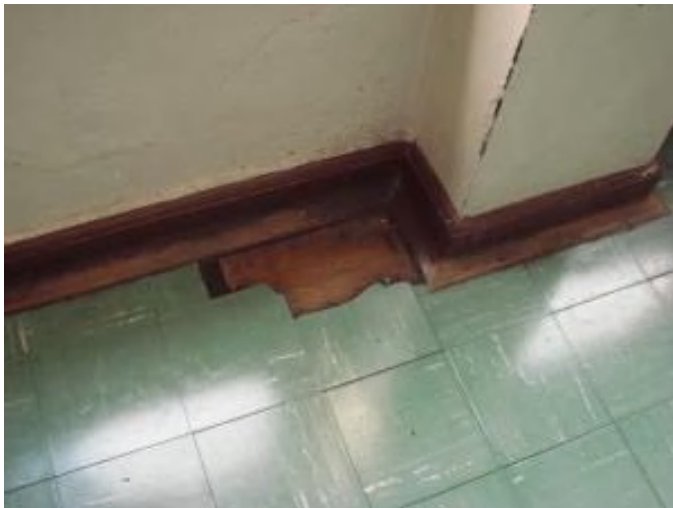
Location: Interior

System: C3020413 - Vinyl Flooring

Distress: Beyond Service Life

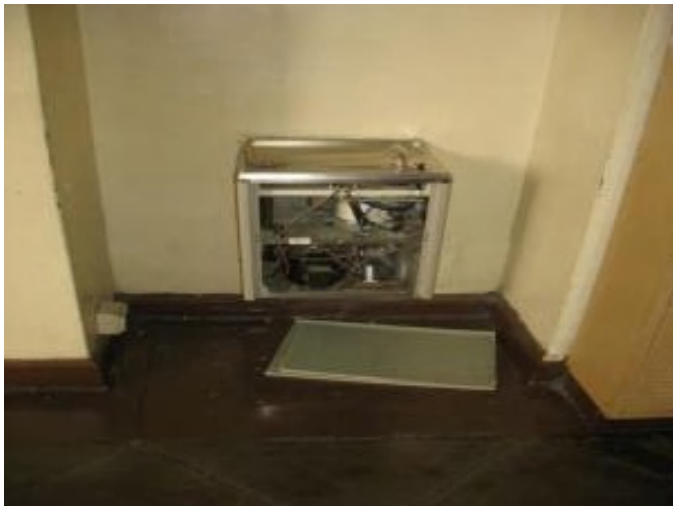
Location: Corridors

System: D2010 - Plumbing Fixtures

Distress: Beyond Service Life

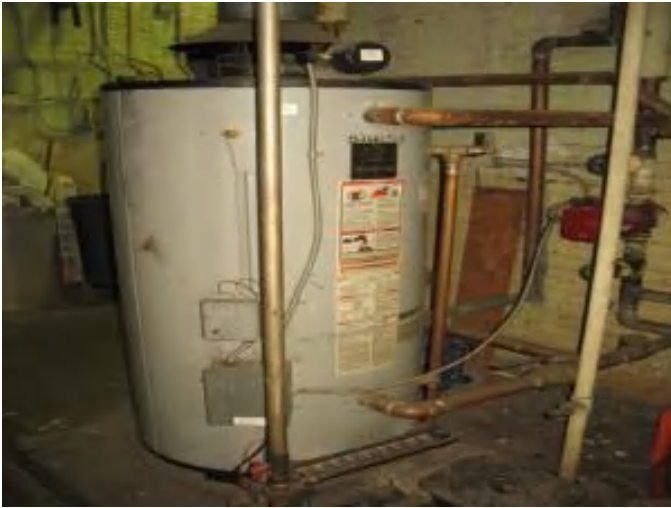
Location: Boiler Room

System: D2020 - Domestic Water Distribution

Distress: Beyond Service Life

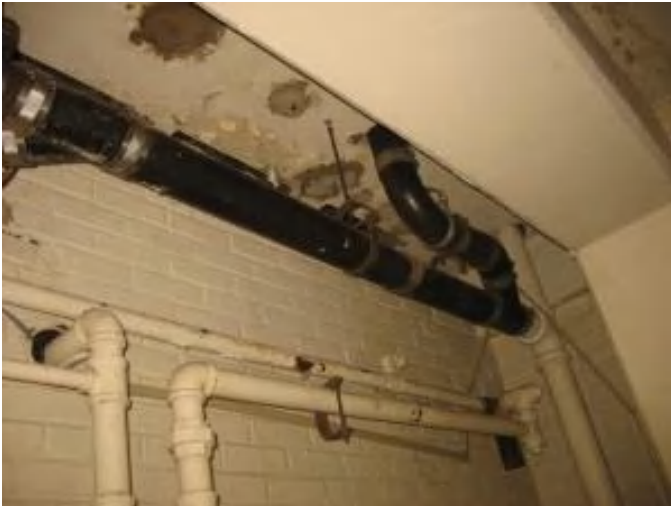
Location: Throughout Building

System: D2030 - Sanitary Waste

Distress: Beyond Service Life

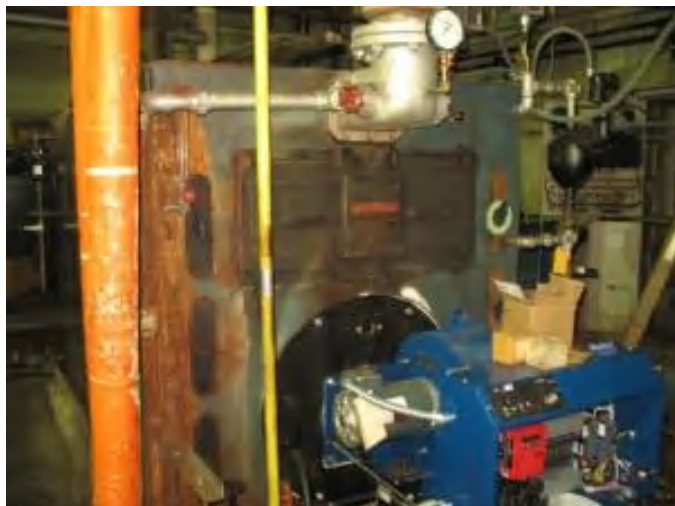
Location: Boiler Room

System: D3020 - Heat Generating Systems

Distress: Beyond Service Life

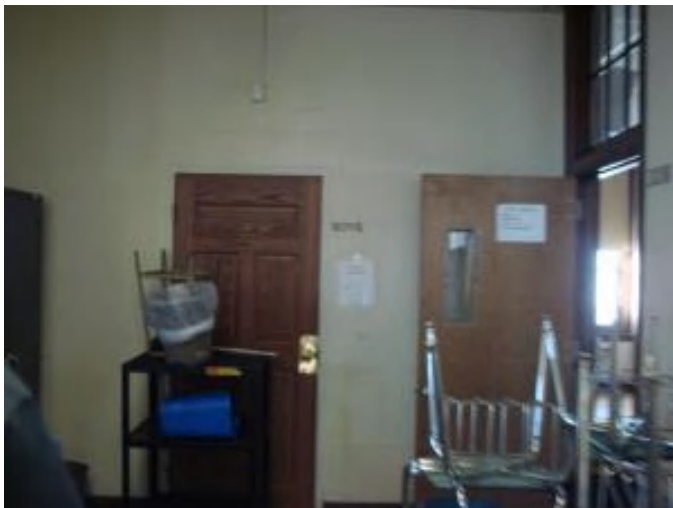
Location: Interior

System: C1020 - Interior Doors

Distress: Accessibility

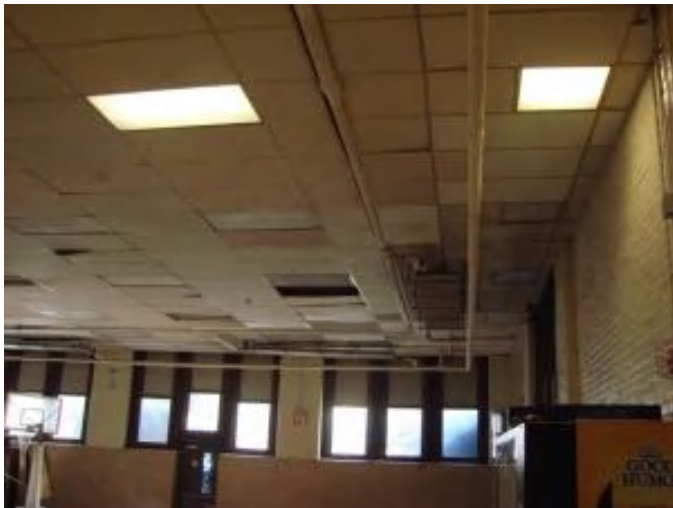
Location: Interior

System: C3030 - Ceiling Finishes

Distress: Beyond Service Life

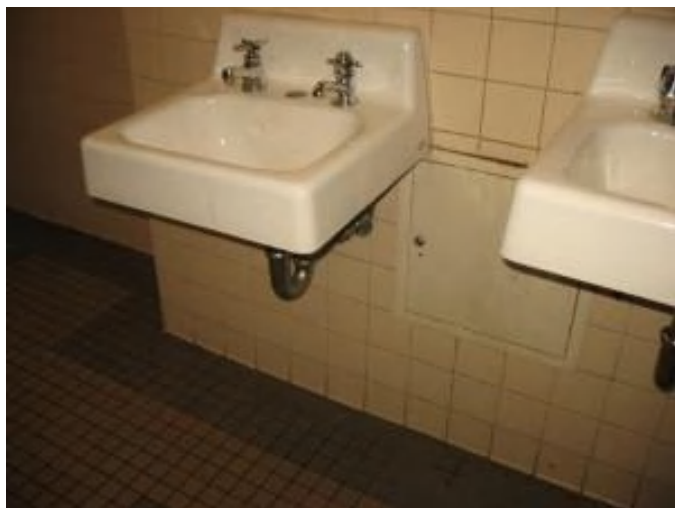
Location: Restrooms

System: D2010 - Plumbing Fixtures

Distress: Accessibility

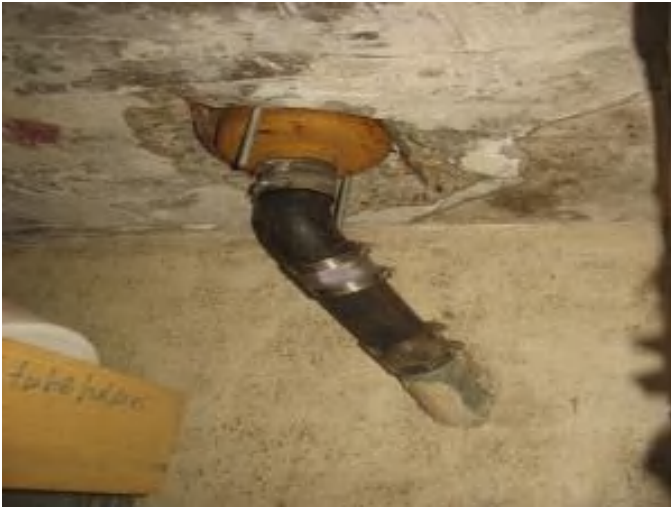
Location: Throughout Building

System: D2040 - Rain Water Drainage

Distress: Beyond Service Life

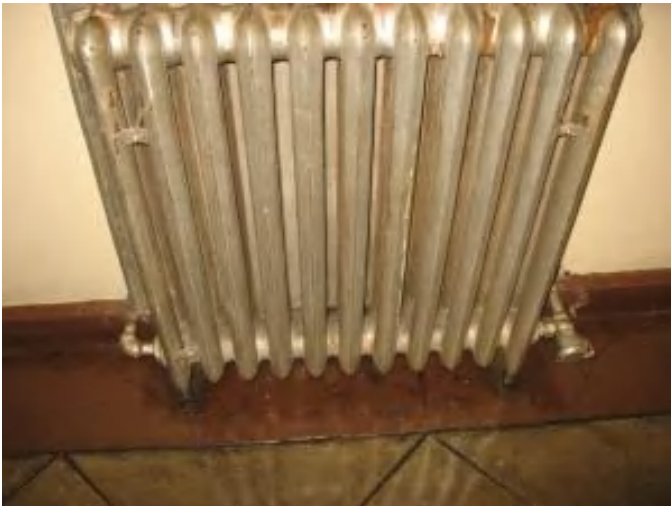
Location: Throuout Building

System: D3040 - Distribution Systems

Distress: Building / MEP Codes

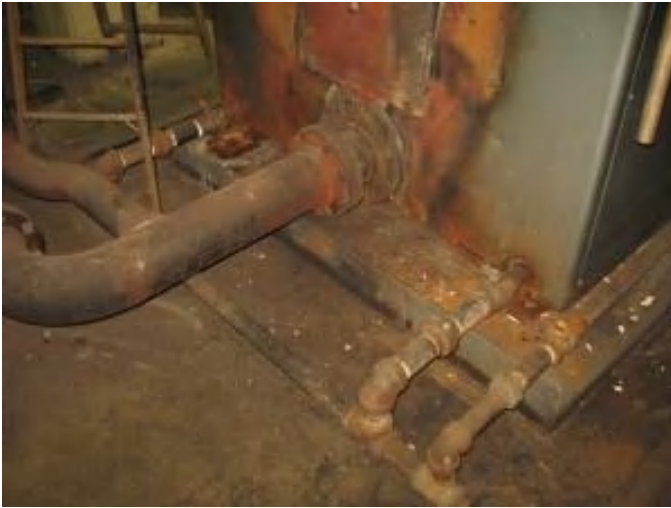
Location: Throughout Building

System: D3040 - Distribution Systems

Distress: Beyond Service Life

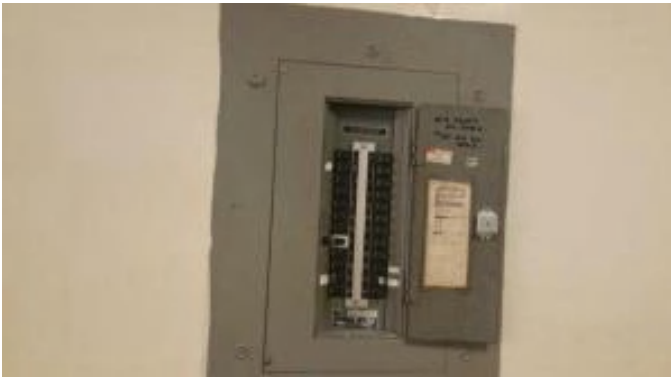
Location: Throughout the building

System: D5010 - Electrical Service/Distribution

Distress: Beyond Service Life

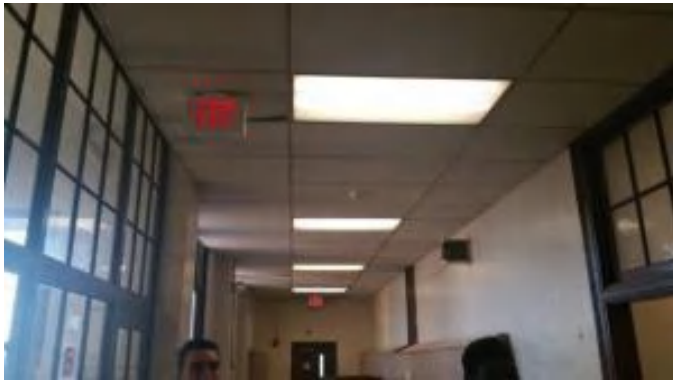
Location: Throughout the building

System: D5020 - Lighting and Branch Wiring

Distress: Beyond Service Life

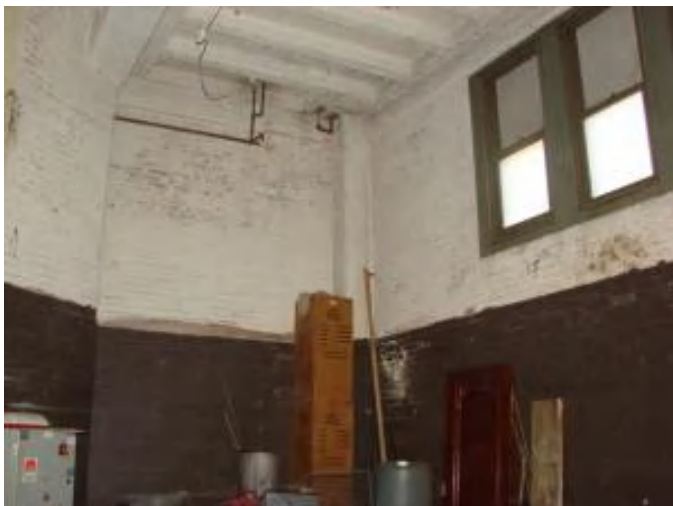
Location: Interior

System: C3010230 - Paint & Covering

Distress: Beyond Service Life

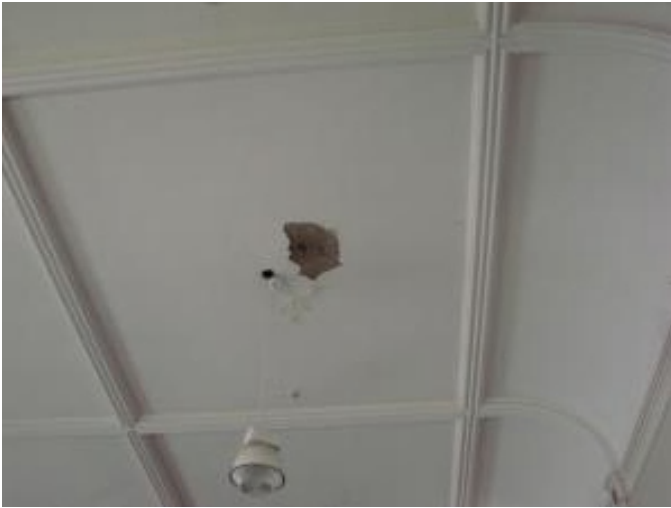
Location: Interior

System: C3030 - Ceiling Finishes

Distress: Damaged

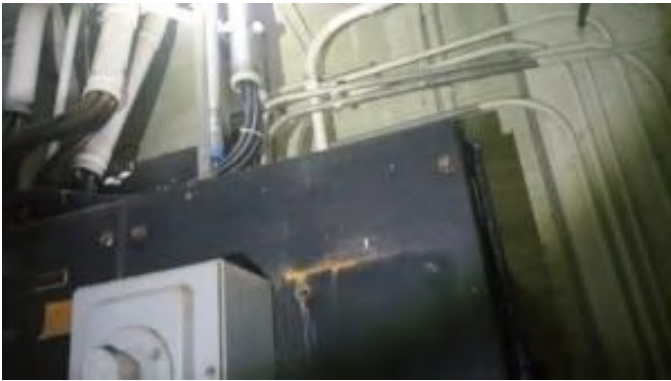
Location: Electrical room inside the basement

System: D5010 - Electrical Service/Distribution

Distress: Beyond Service Life

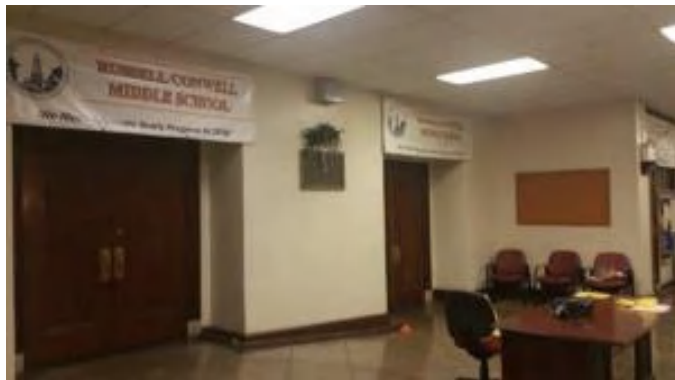
Location: In the Auditorium

System: D5020 - Lighting and Branch Wiring

Distress: Inadequate

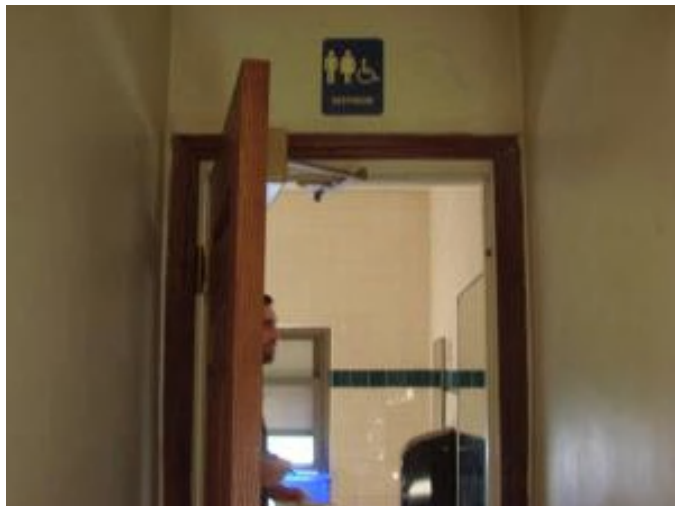
Location: Interior

System: C1030 - Fittings

Distress: Building / MEP Codes

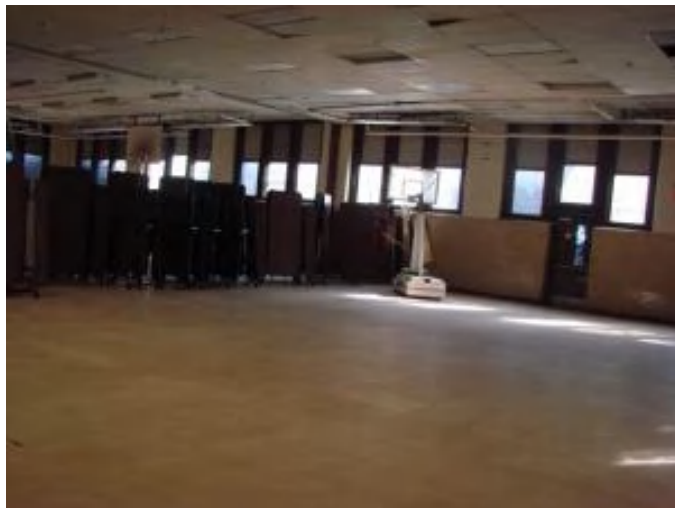
Location: Interior

System: C3020413 - Vinyl Flooring

Distress: Beyond Service Life

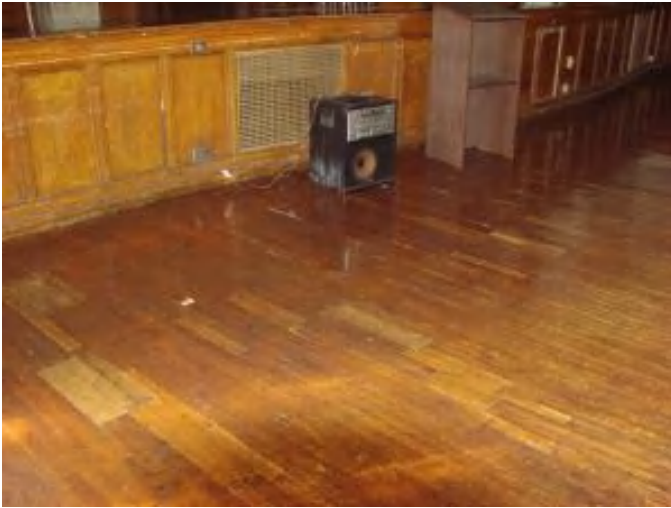
Location: Interior

System: C3020414 - Wood Flooring

Distress: Beyond Service Life

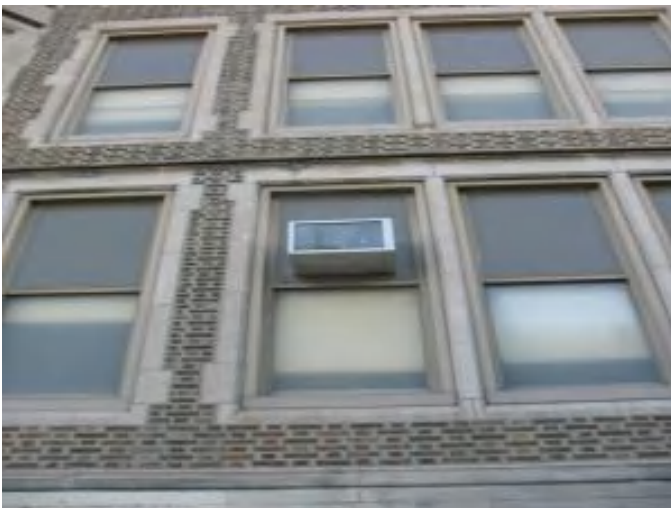
Location: Throughout Buildin

System: D3030 - Cooling Generating Systems

Distress: Inadequate

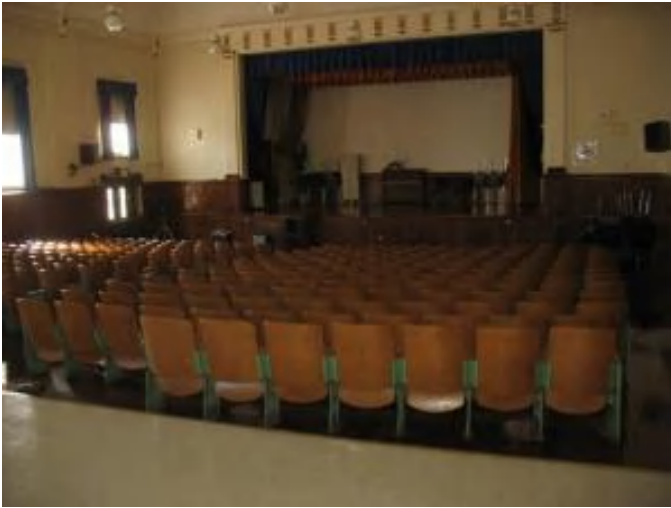
Location: Auditorium

System: D3040 - Distribution Systems

Distress: Building / MEP Codes

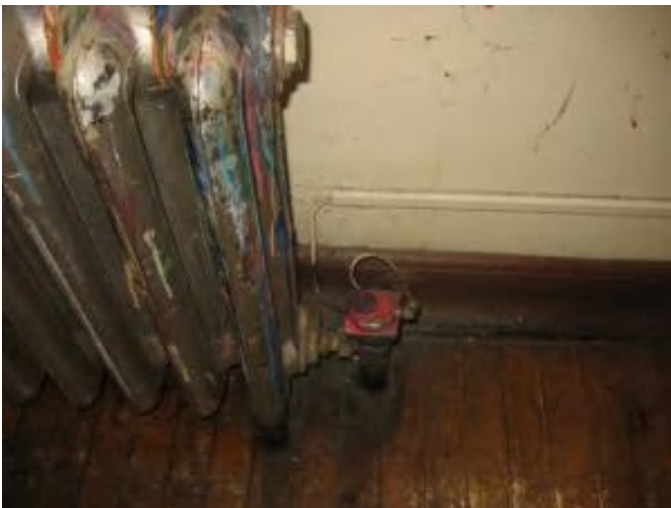
Location: Throughout Building

System: D3060 - Controls & Instrumentation

Distress: Inadequate

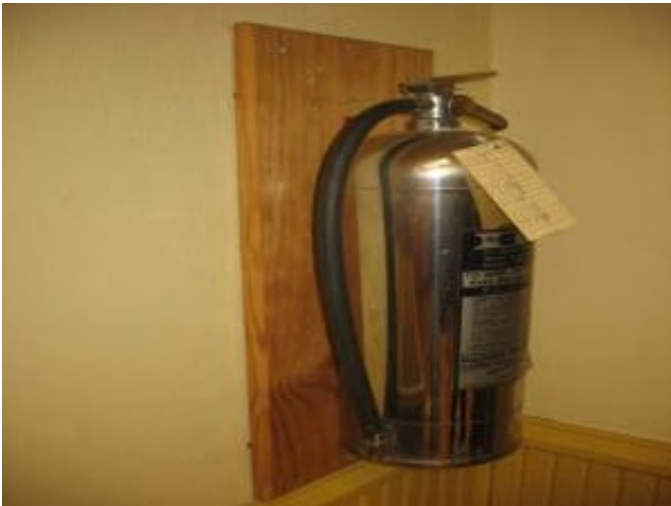
Location: Throughout building

System: D4010 - Sprinklers

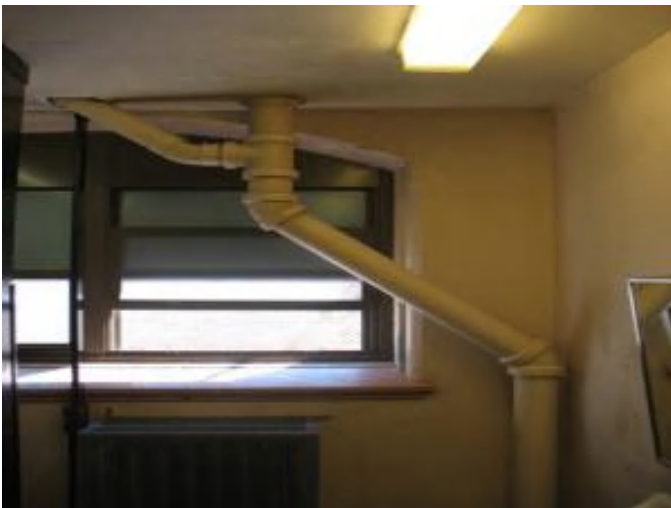
Location: Throughout building

System: D2030 - Sanitary Waste

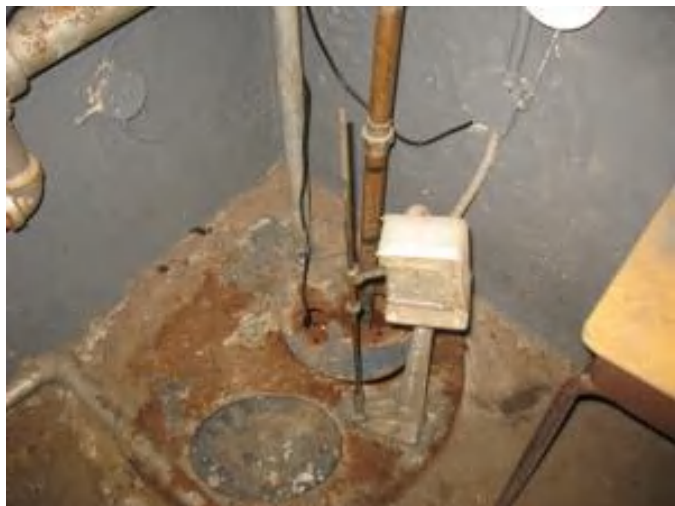
Location: Boiler room

System: D2030 - Sanitary Waste

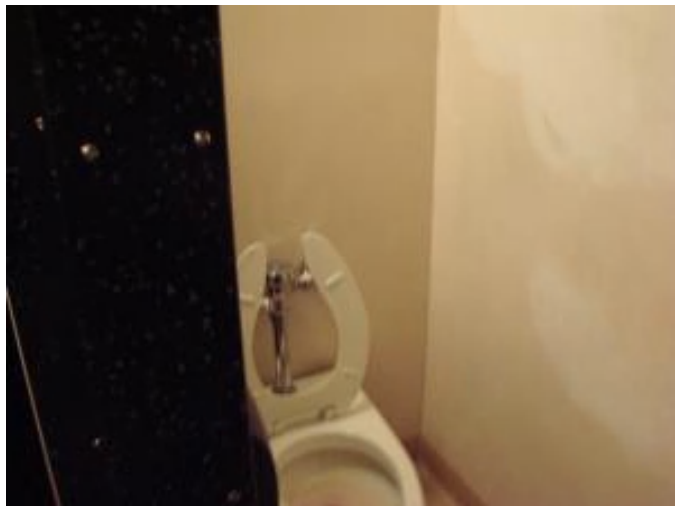
Location: Interior

System: C3010230 - Paint & Covering

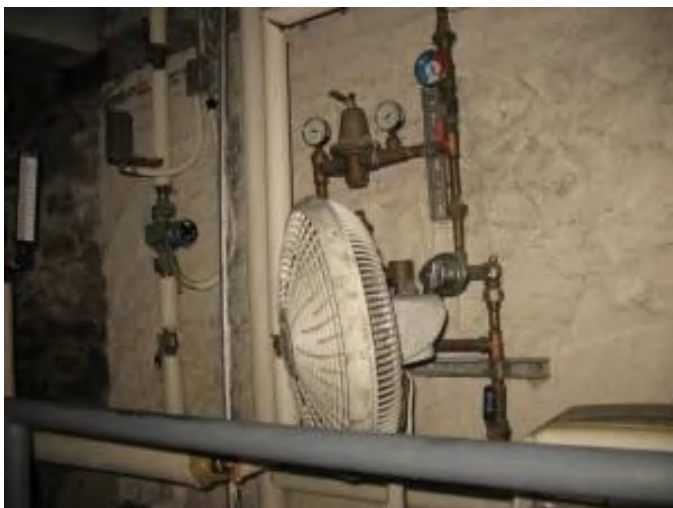
Location: Throughout building

System: D2020 - Domestic Water Distribution

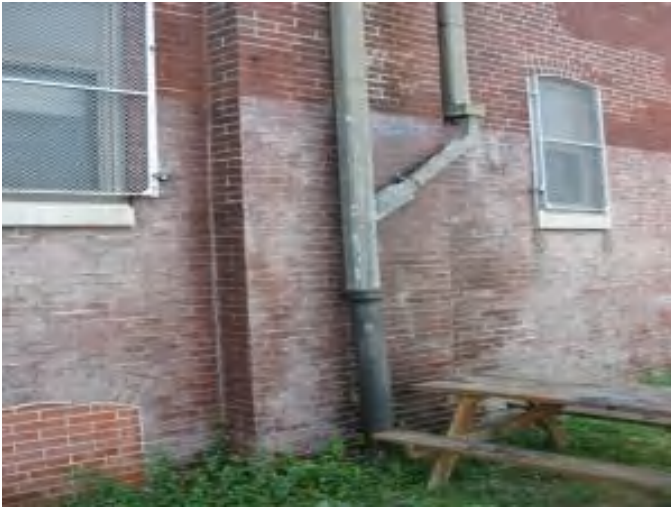
Location: Throughout building

System: D2040 - Rain Water Drainage

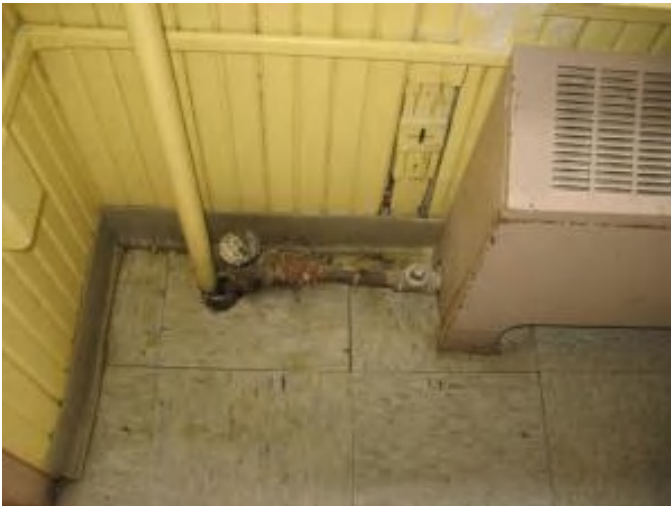
Location: Throughout building

System: D3040 - Distribution Systems

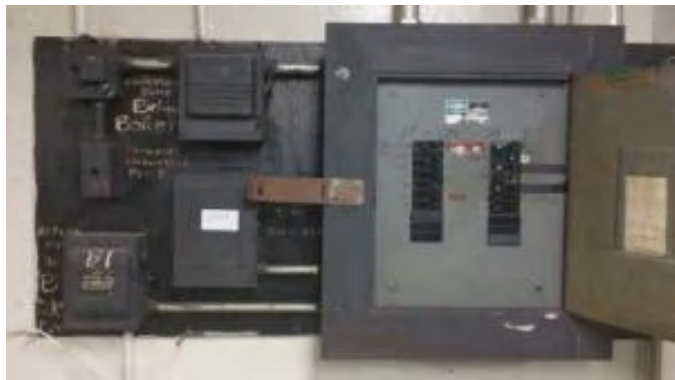
Location: throughout the building

System: D5010 - Electrical Service/Distribution

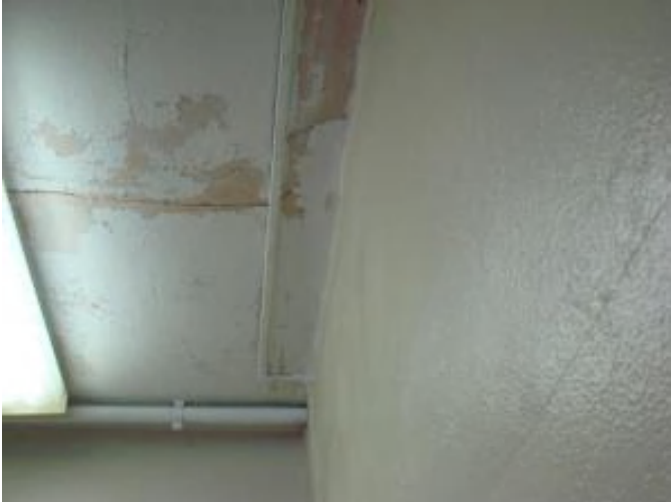
Location: Interior

System: C3030 - Ceiling Finishes

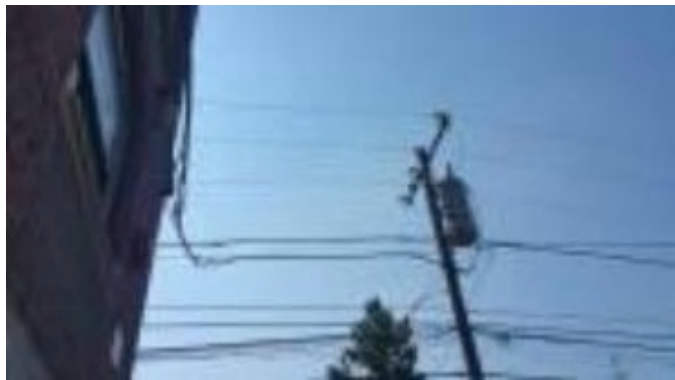
Location: Electrical Room

System: D5010 - Electrical Service/Distribution

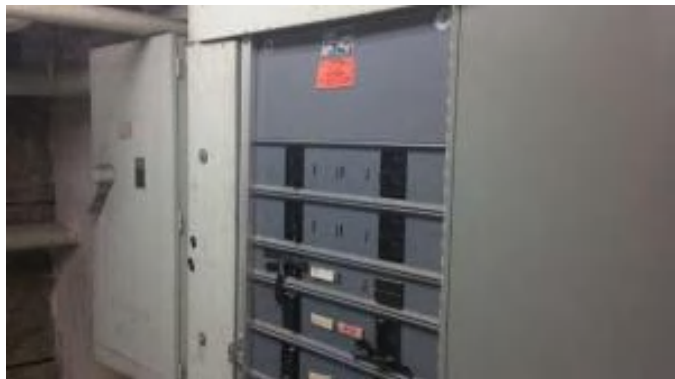
Location: Throughout the building

System: D5010 - Electrical Service/Distribution

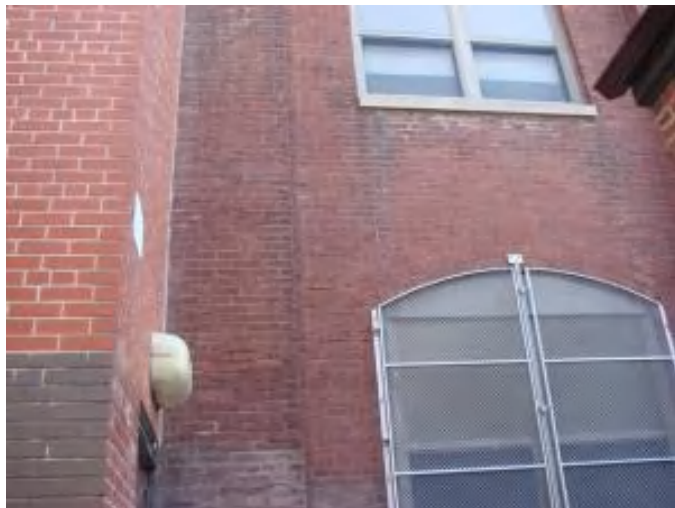
Location: throughout the building

System: D5030 - Communications and Security

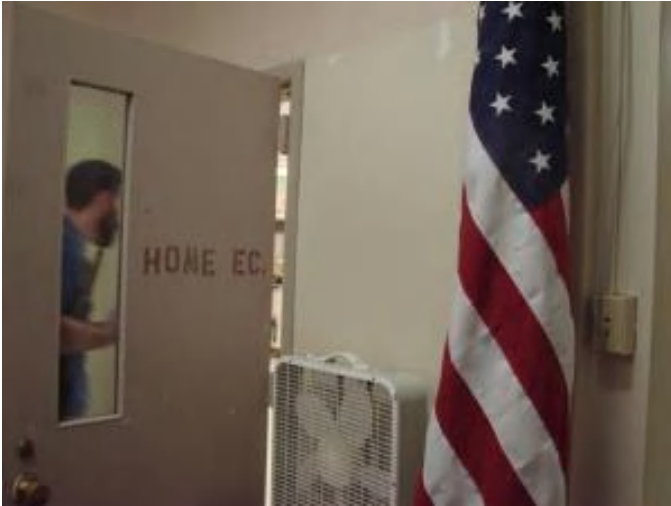
Location: Interior

System: C1030 - Fittings

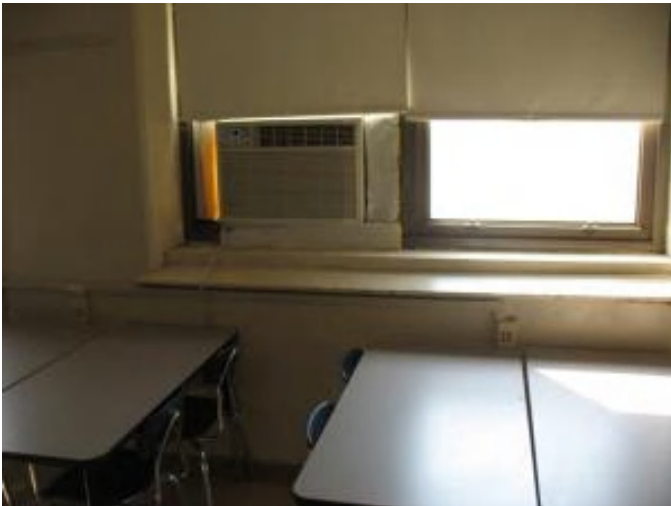
Location: Throughout building

System: D3030 - Cooling Generating Systems

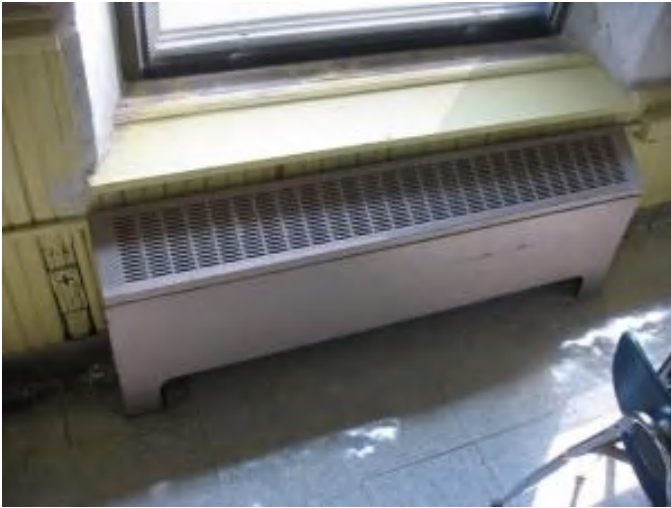
Location: Throughout building

System: D3040 - Distribution Systems

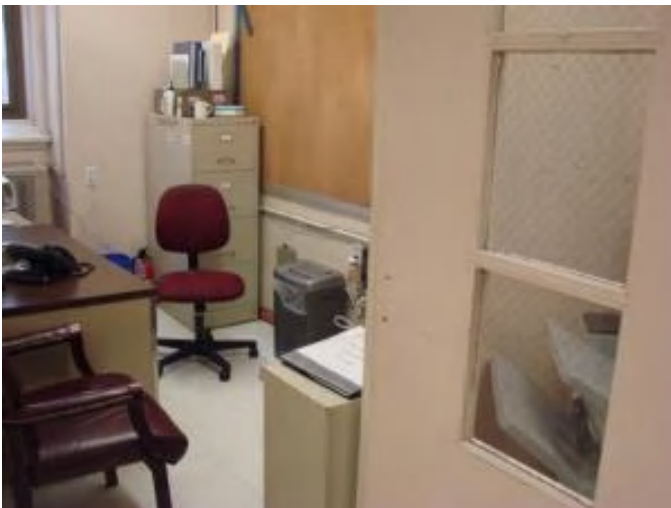
Location: Throughout building

System: D3040 - Distribution Systems

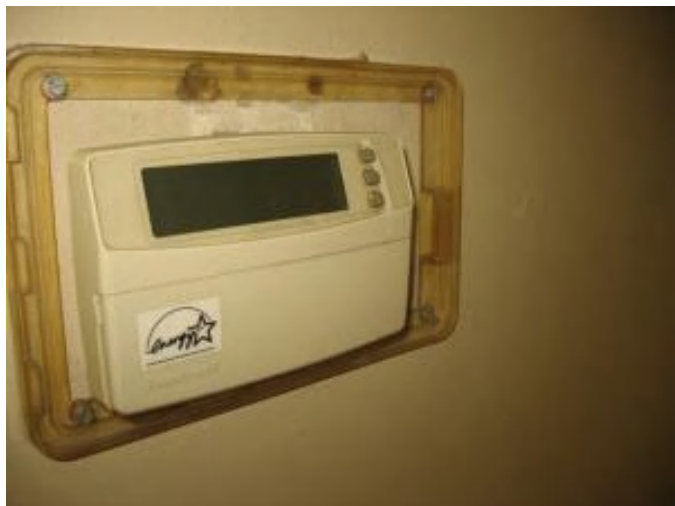
Location: Throughout building

System: D3060 - Controls & Instrumentation
