### Cooke School

**S710001;Cooke**

**Site Assessment Report**

February 1, 2017

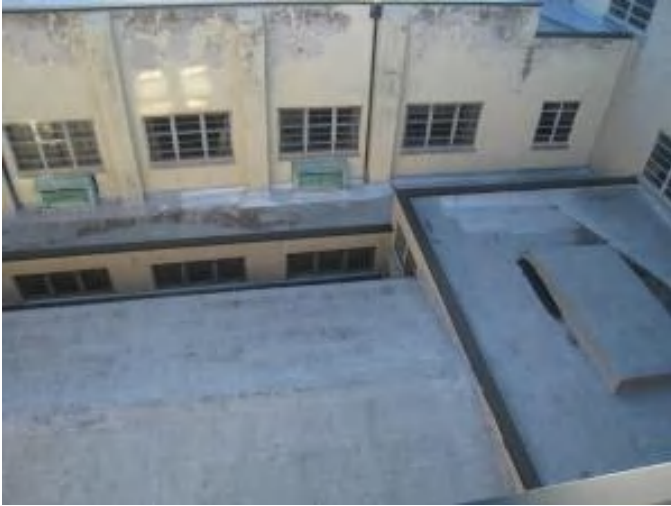
#### System: B2010 - Exterior Walls

**Location:** exterior walls, inside of "O"

**Distress:** Damaged

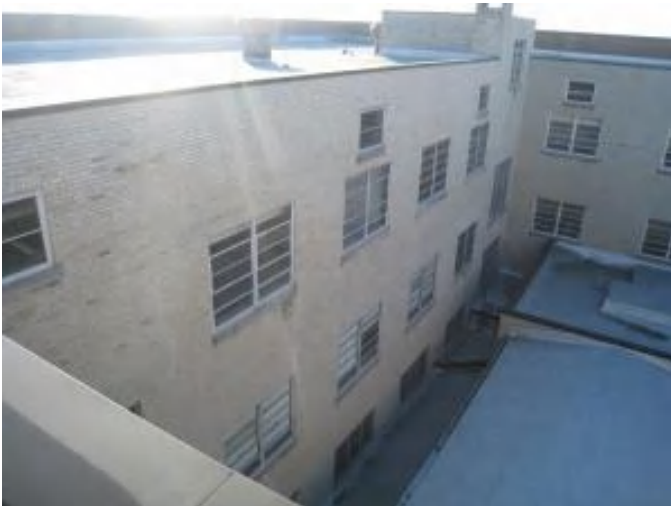
#### System: B3010105 - Built-Up

**Location:** roof

**Distress:** Building Envelope Integrity

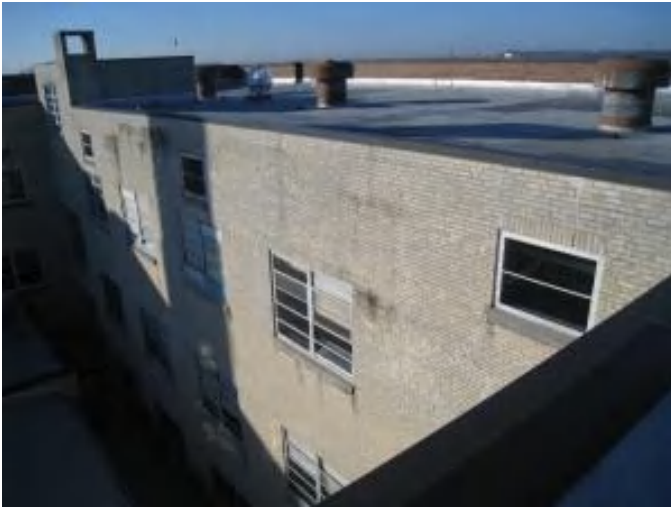
**System: B3010105 - Built-Up**

**Location:** roof

**Distress:** Building Envelope Integrity

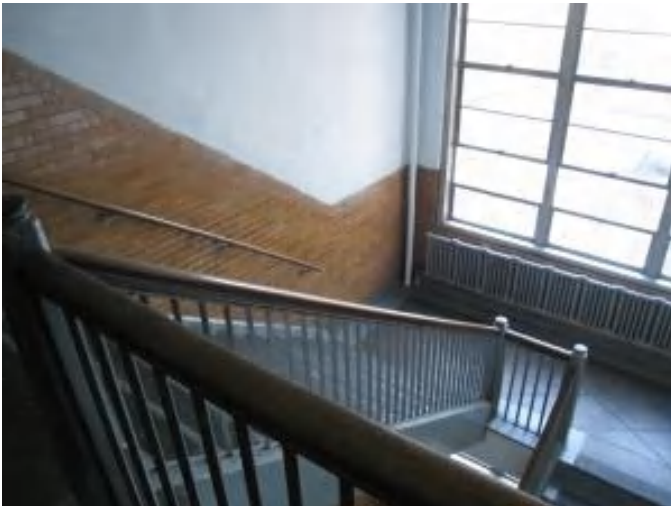
**System: C2010 - Stair Construction**

**Location:** stairways

**Distress:** Building / MEP Codes

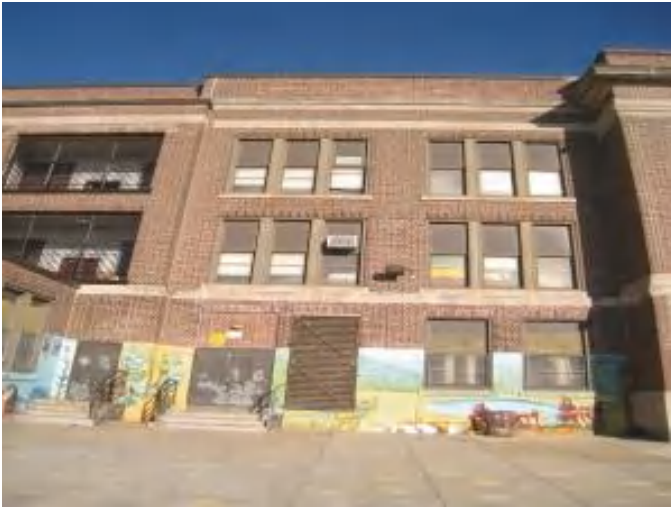
**System: C2010 - Stair Construction**

**Location:** exterior stairways

**Distress:** Building / MEP Codes

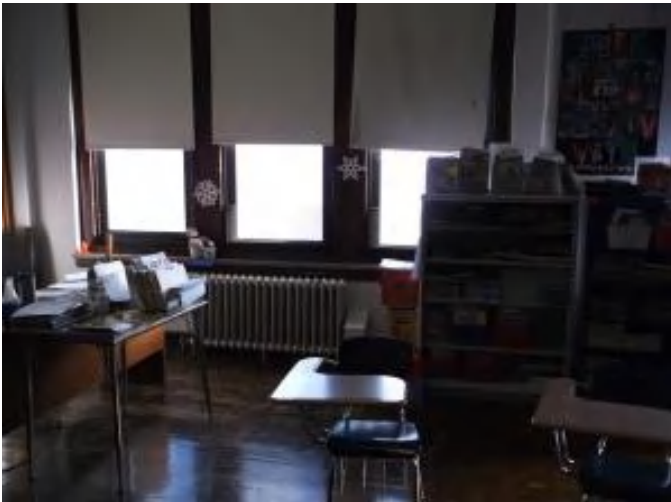
**System: D3040 - Distribution Systems**

**Location:** Throughout the building

**Distress:** Beyond Service Life

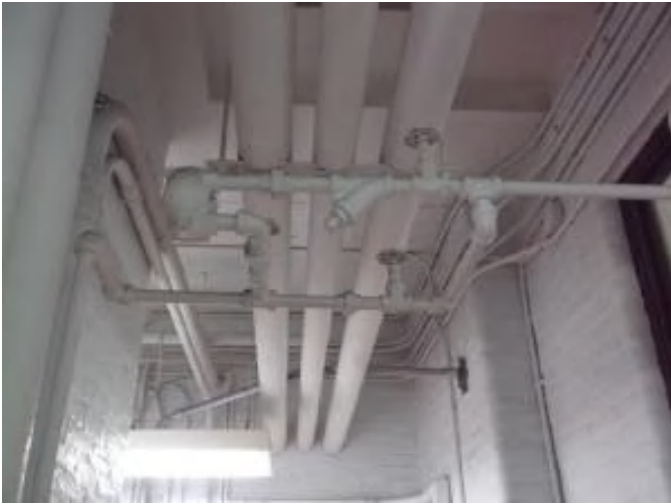
**System: D3040 - Distribution Systems**

**Location:** Throughout the building

**Distress:** Beyond Service Life

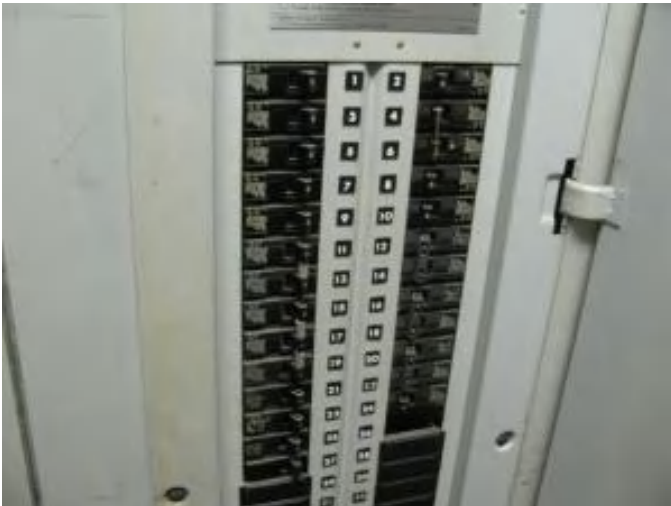
**System: D5010 - Electrical Service/Distribution**

**Location:** Entire Building

**Distress:** Beyond Service Life

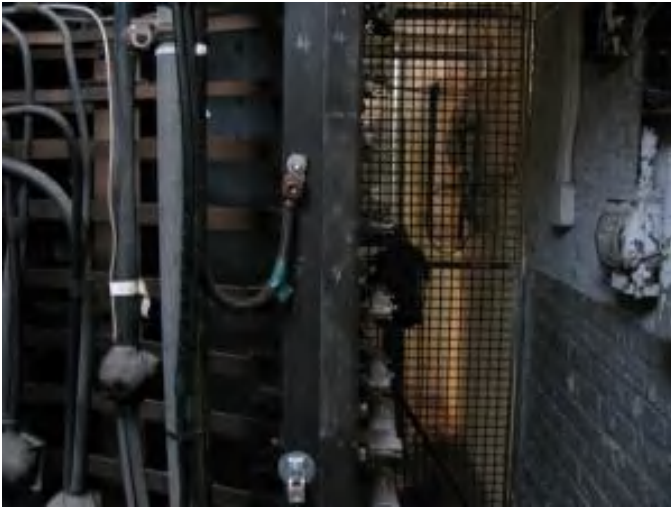
**System: D5010 - Electrical Service/Distribution**

**Location:** Elctrical Room

**Distress:** Beyond Service Life

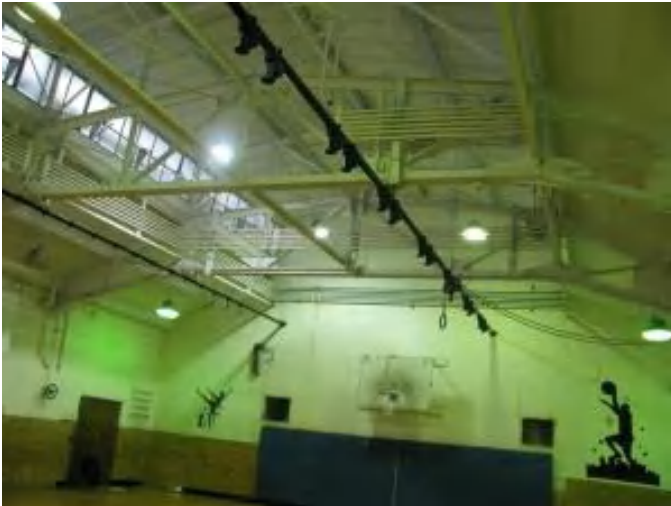
**System: D5020 - Lighting and Branch Wiring**

**Location:** Entire Building

**Distress:** Beyond Service Life

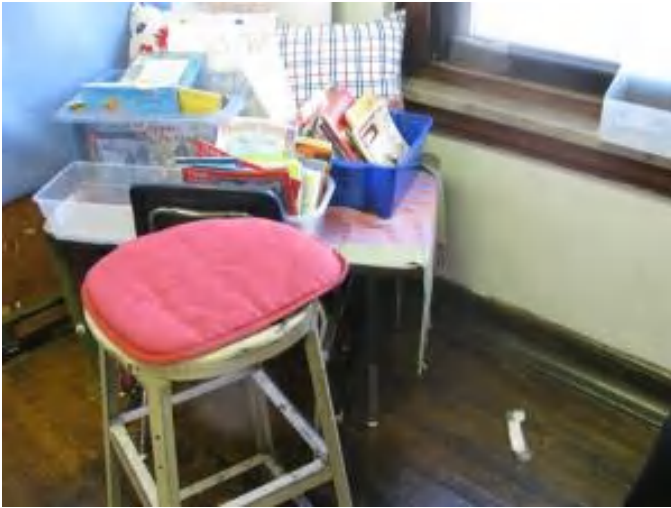
**System: D5020 - Lighting and Branch Wiring**

**Location:** Classroom

**Distress:** Inadequate

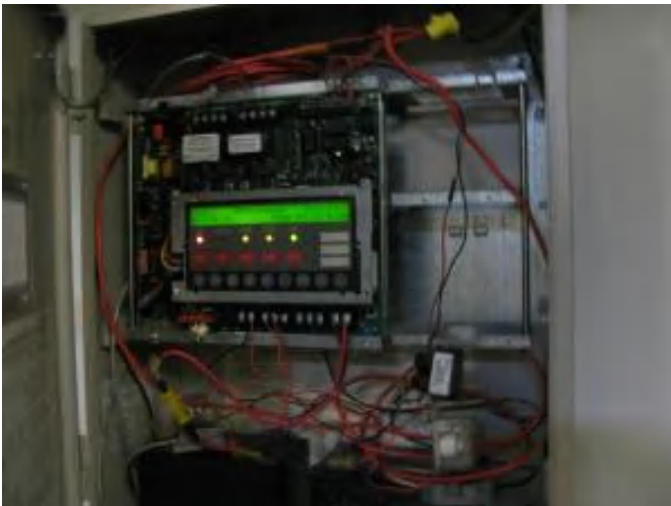
**System: D5030 - Communications and Security**

**Location:** Entier Building

**Distress:** Life Safety / NFPA / PFD

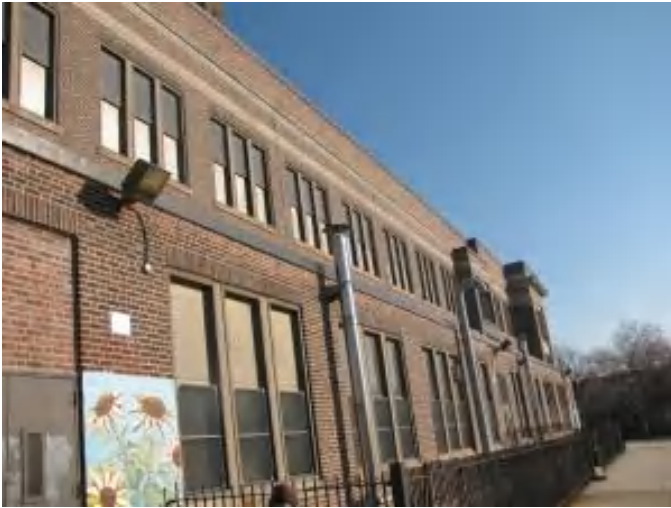
**System: D5030 - Communications and Security**

**Location:** Entire Building

**Distress:** Security Issue

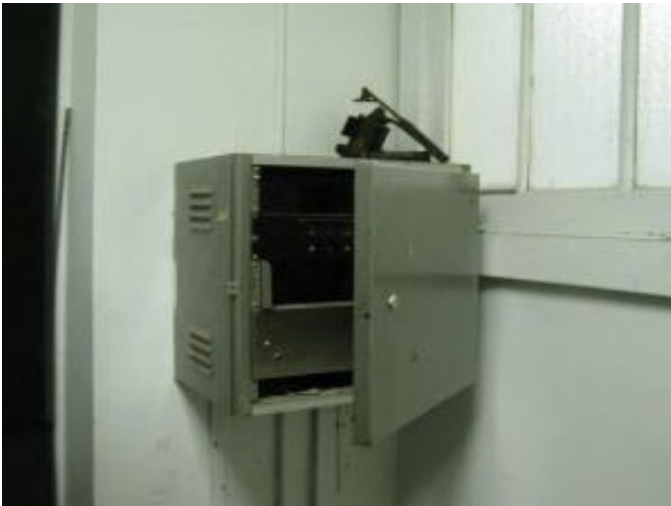
**System: D5030 - Communications and Security**

**Location:** Auditorium

**Distress:** Beyond Service Life

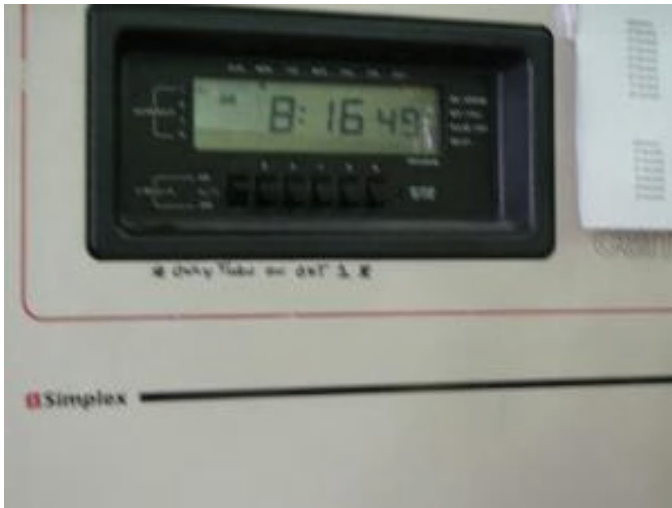
**System: D5030 - Communications and Security**

**Location:** Entier Building

**Distress:** Inadequate

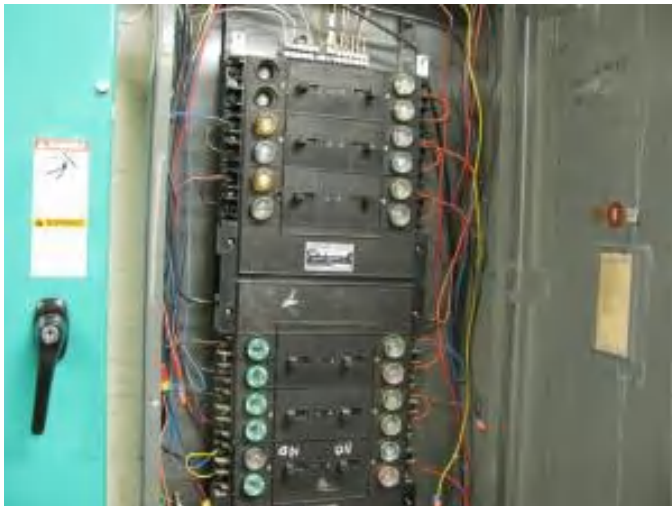
**System: D5090 - Other Electrical Systems**

**Location:** Boiler Room

**Distress:** Life Safety / NFPA / PFD

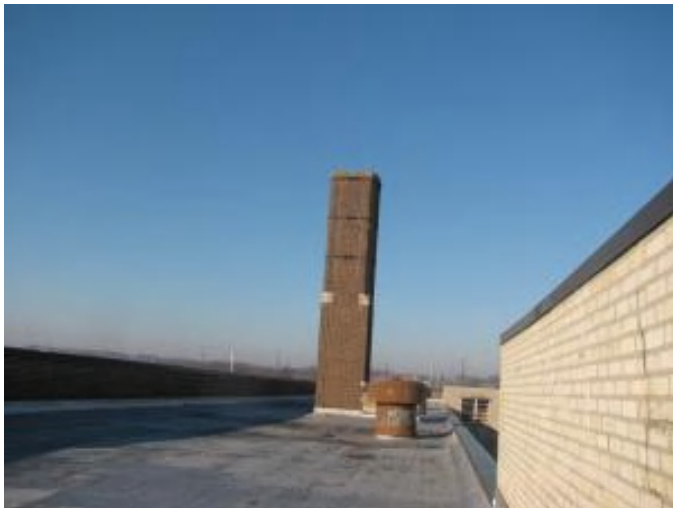
**System: D5090 - Other Electrical Systems**

**Location:** Roof

**Distress:** Life Safety / NFPA / PFD

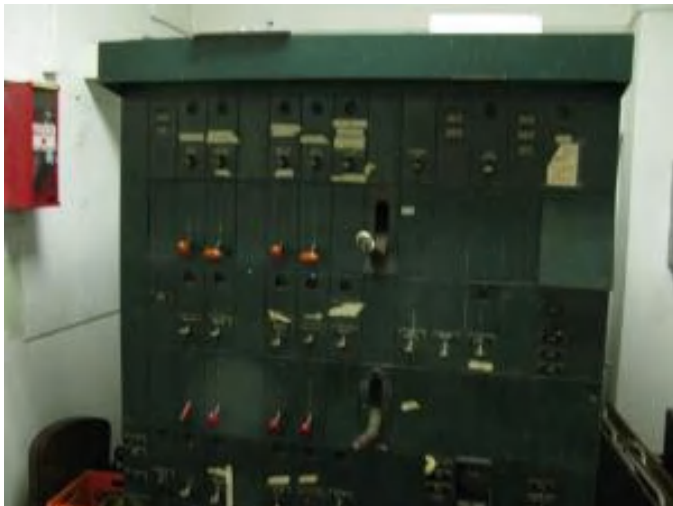
**System: E1020 - Institutional Equipment**

**Location:** Auditorium

**Distress:** Inadequate

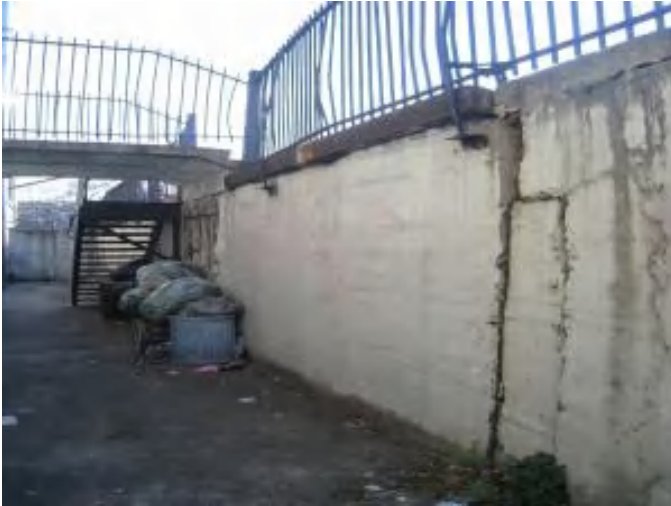
**System: A2020 - Basement Walls**

The exterior element of most serious concern is the concrete wall that forms the window well along the West Mentor Street side of the building. This concrete wall has a substantial amount of spalling and cracking. A raised concrete walkway with brick walls serving as guards (instead of aluminum handrails and guards) spans the recessed area way allowing access to the kitchen from W. Mentor St. This concrete "bridge" has lost a great deal of concrete material underneath, exposing reinforcing rods and appearing to be to the

**Location:** areaway walls

**Distress:** Failing

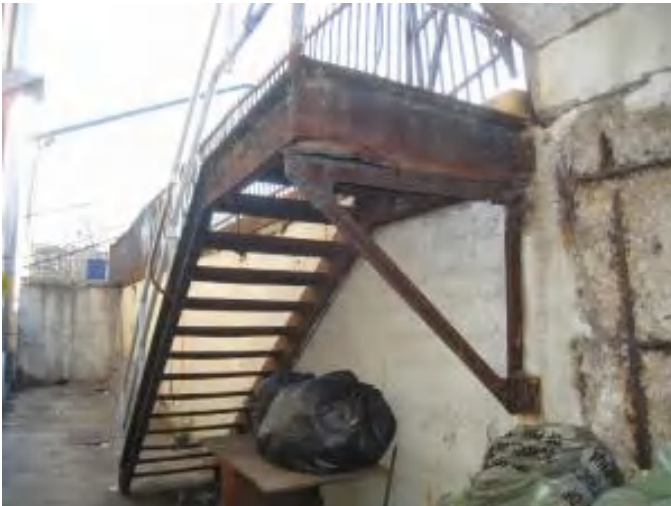
**System: A2020 - Basement Walls**

point of failure at any time. The brick walls on the sides of the access bridge from the street to the kitchen are also cracking and leaning. The building wall on the opposite side of the area way is also cracking, spalling, crumbling and failing, exposing all vertical and horizontal reinforcing rods underneath the raised walkway bridge. The lintels supporting the brick wall over the louvers and windows into the boiler room are rusting. The steel stair up from the base of the area way to the street is heavily rusted and might not be safe to utilize. The area drains at the bottom of the area way might be clogged as evident from debris in and around the drains. Since the bridge is the only from the street into the building, the bridge, concrete retaining wall and building wall systems need to be repaired immediately before collapsing into the window well.

**Location:** areaway foundation basement wall

**Distress:** Failing

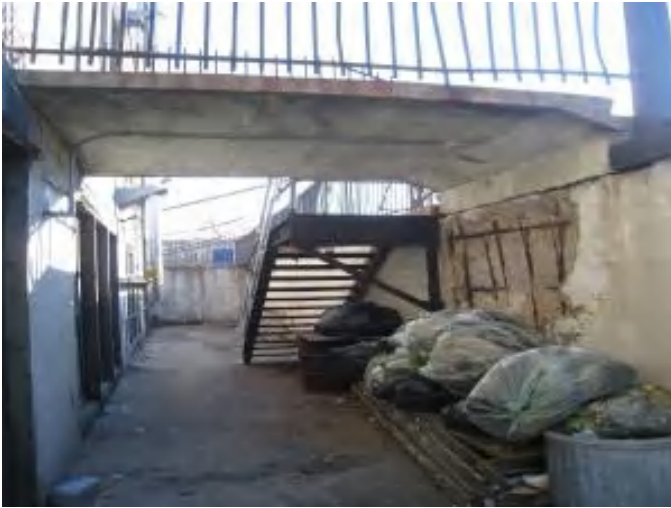
**System: B1010 - Floor Construction**

**Location:** rear access to kitchen over areaway

**Distress:** Failing

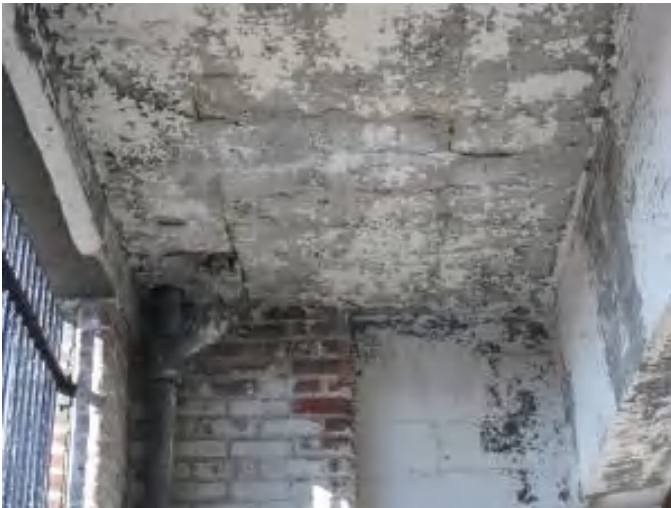
**System: B1010 - Floor Construction**

**Location:** fire exit stairways

**Distress:** Failing

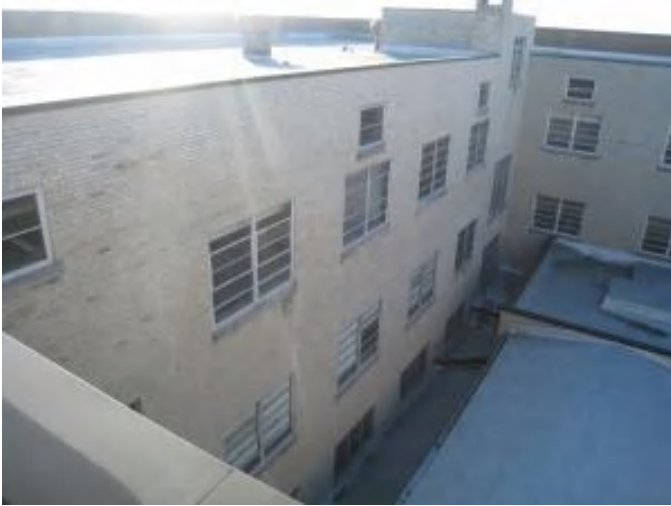
**System: B2010 - Exterior Walls**

**Location:** exterior brick, inside of "O"

**Distress:** Damaged

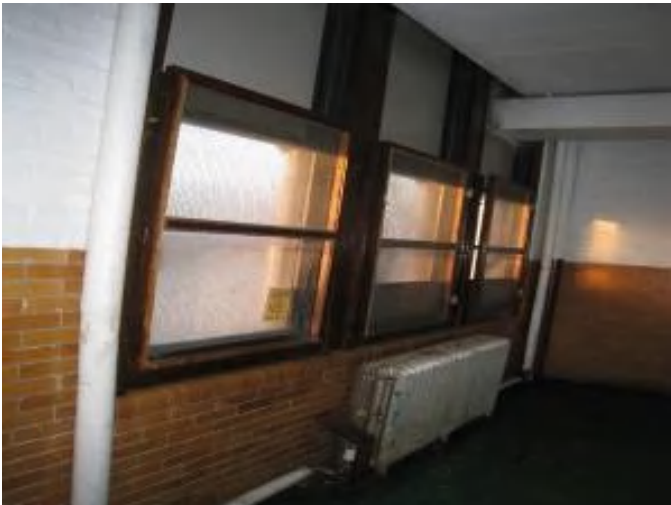
**System: B2020 - Exterior Windows**

Exterior windows were replaced in the 1990's (approximately) with dark bronze anodized aluminum frame operable single hung units with double pane insulated glazing. Windows are in poor condition are difficult to operate, do not stay open slamming closed, and leak cold air in the winter. Clerestory windows in the gym have electric motor operators that are not functioning. Plexi glass vision panels in these windows is getting so cloudy that it is difficult to see out of some windows. All windows should be replaced with new insulated glass units.

**Location:** exterior windows

**Distress:** Beyond Service Life

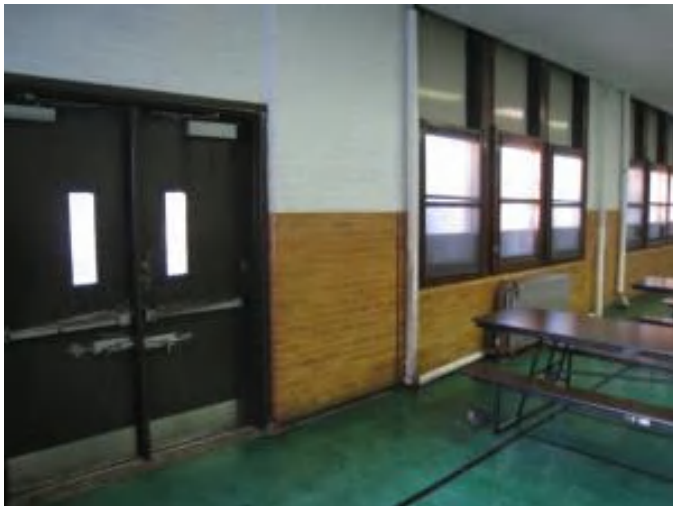
**System: B2030 - Exterior Doors**

**Location:** exterior doors

**Distress:** Damaged

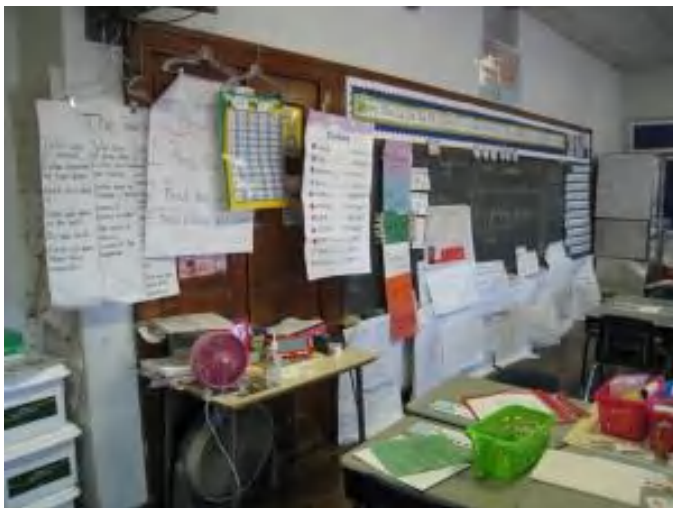
**System: C1010 - Partitions**

**Location:** folding partitions between classrooms

**Distress:** Failing

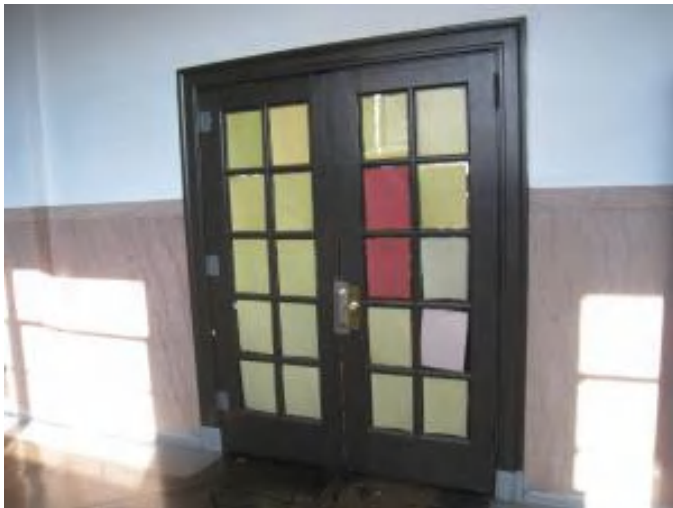
**System: C1020 - Interior Doors**

**Location:** corridor doors

**Distress:** Building / MEP Codes

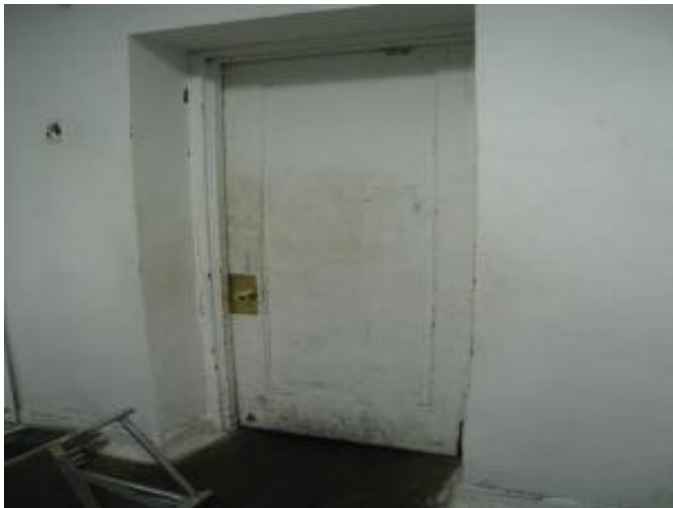
**System: C1020 - Interior Doors**

**Location:** interior doors inside rooms

**Distress:** Appearance

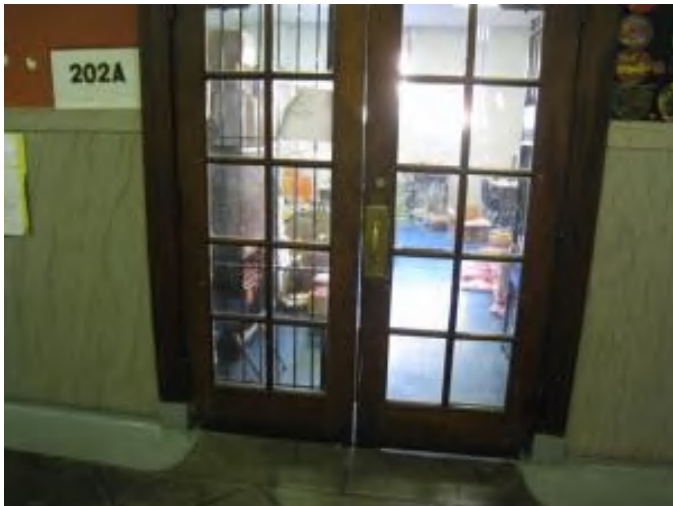
**System: C1020 - Interior Doors**

**Location:** corridor doors

**Distress:** Building / MEP Codes

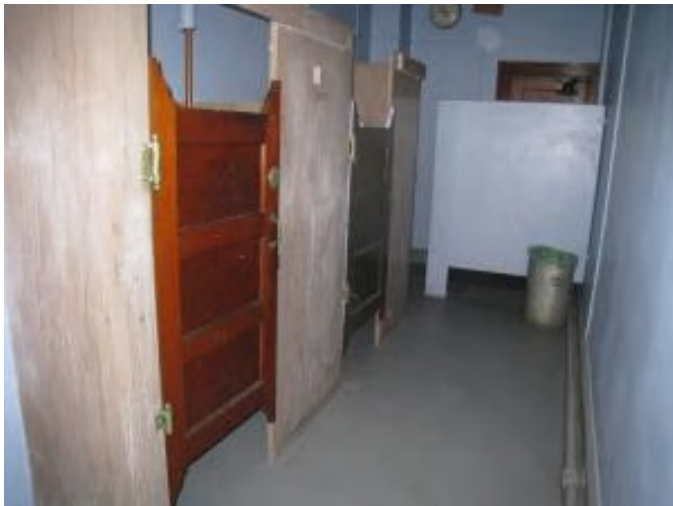
**System: C1030 - Fittings**

**Location:** toilet rooms

**Distress:** Beyond Service Life

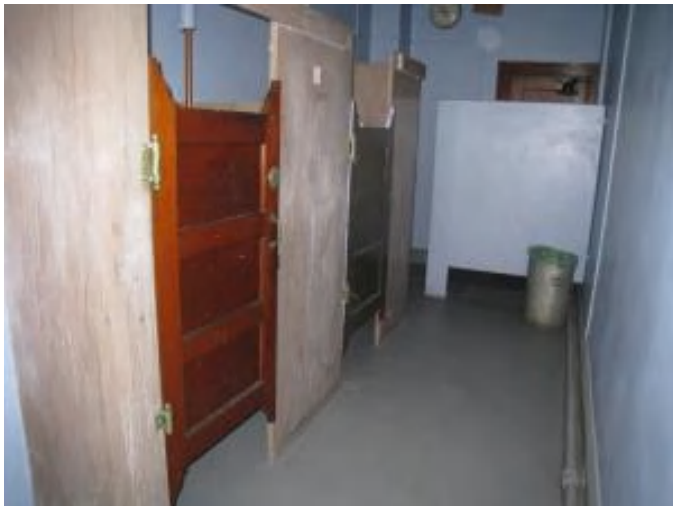
**System: C1030 - Fittings**

**Location:** toilet rooms

**Distress:** Damaged

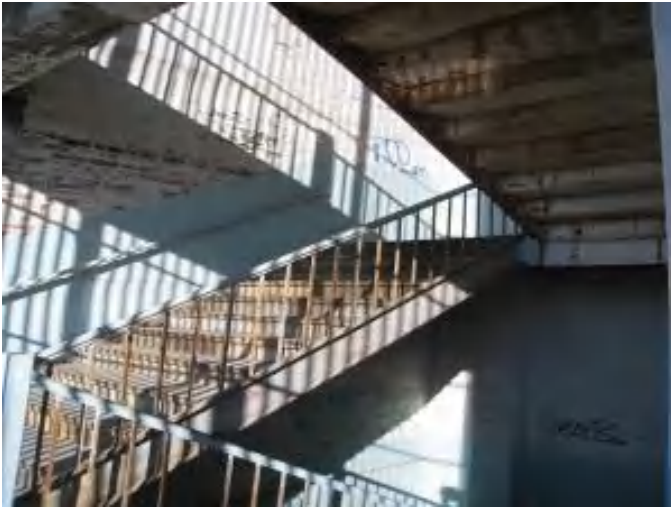
**System: C2010 - Stair Construction**

**Location:** fire exit stairways

**Distress:** Failing

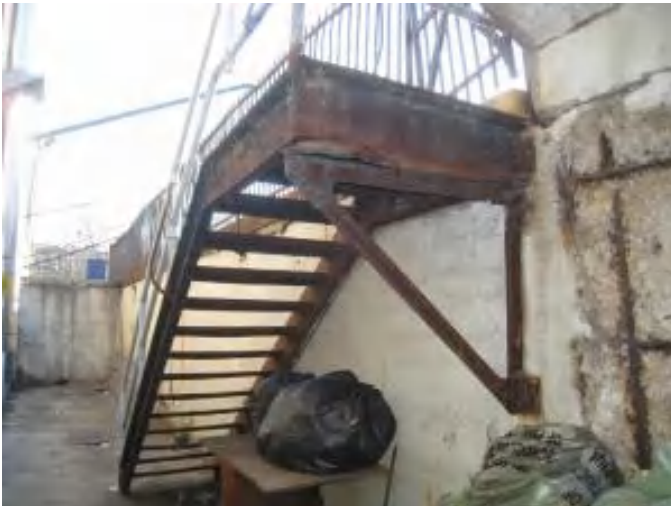
**System: C2010 - Stair Construction**

**Location:** areaway

**Distress:** Failing

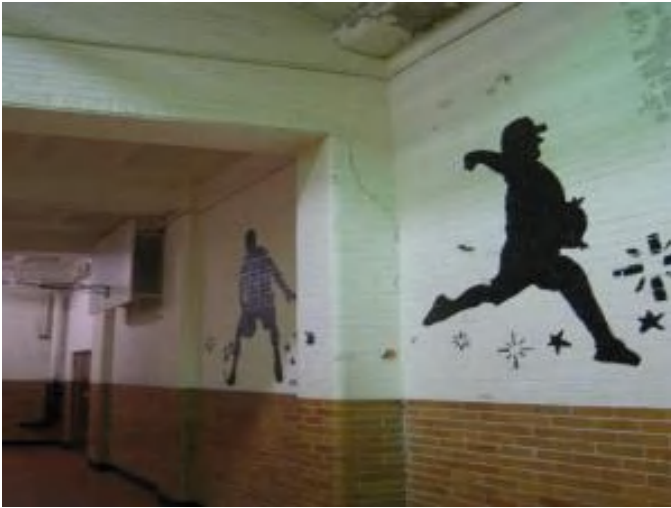
**System: C3010230 - Paint & Covering**

**Location:** interior walls

**Distress:** Damaged

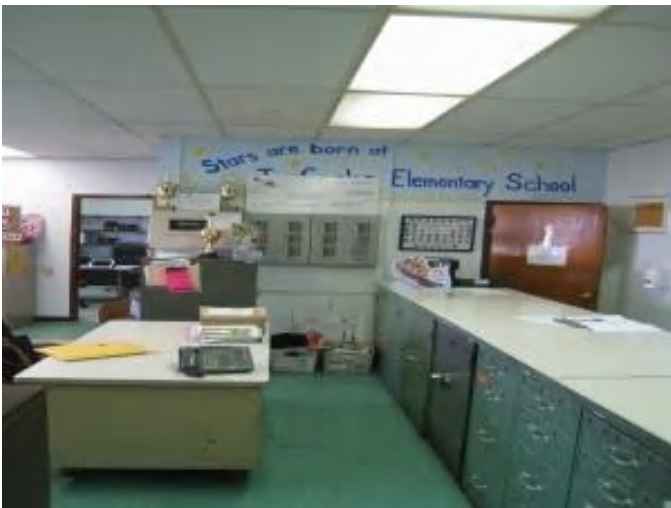
**System: C3020413 - Vinyl Flooring**

**Location:** cafeterias, kitchen, and other rooms

**Distress:** Failing

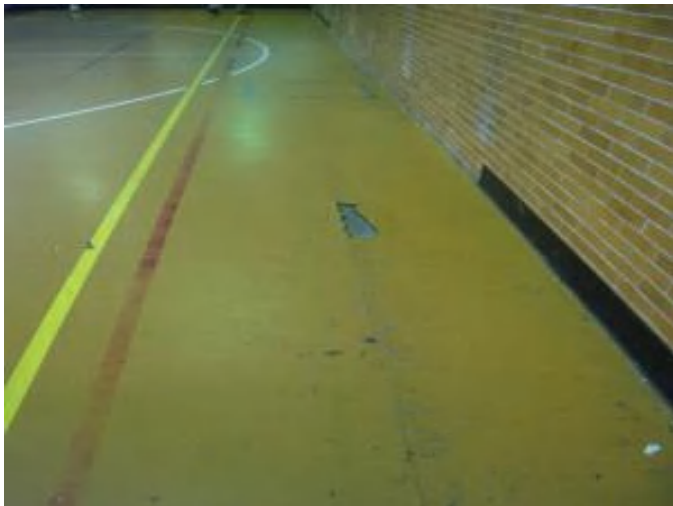
**System: C3020413 - Vinyl Flooring**

**Location:** gymnasium

**Distress:** Damaged

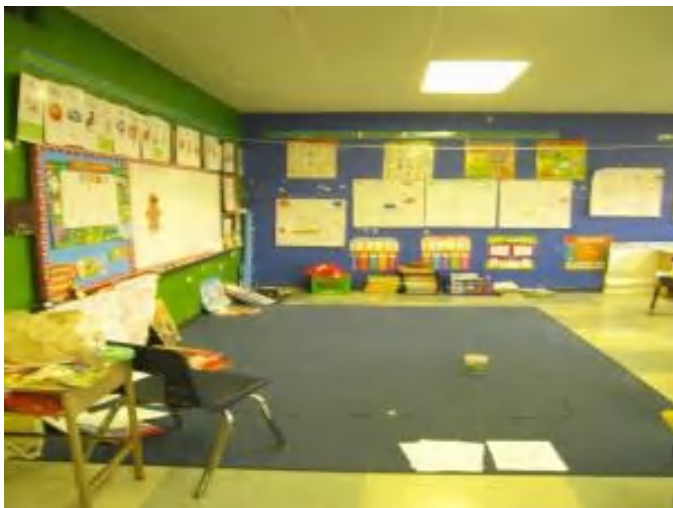
**System: C3020413 - Vinyl Flooring**

**Location:** offices and other rooms

**Distress:** Appearance

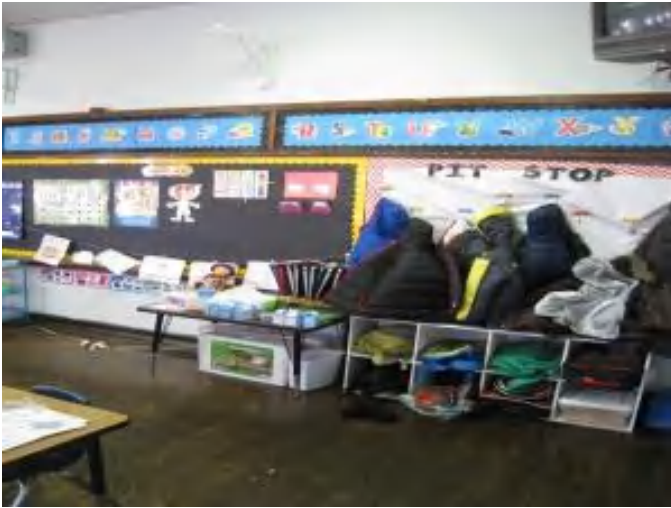
**System: C3020414 - Wood Flooring**

**Location:** wood floors

**Distress:** Appearance

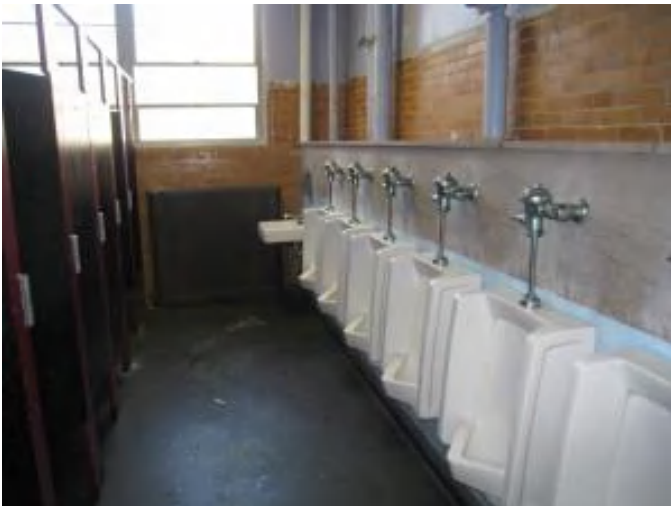
**System: C3020415 - Concrete Floor Finishes**

**Location:** concrete floors

**Distress:** Appearance

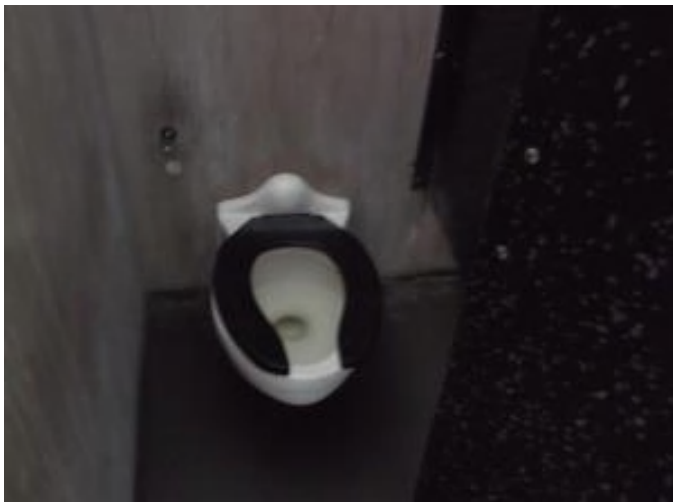
**System: D2010 - Plumbing Fixtures**

**Location:** Throughout the building

**Distress:** Beyond Service Life

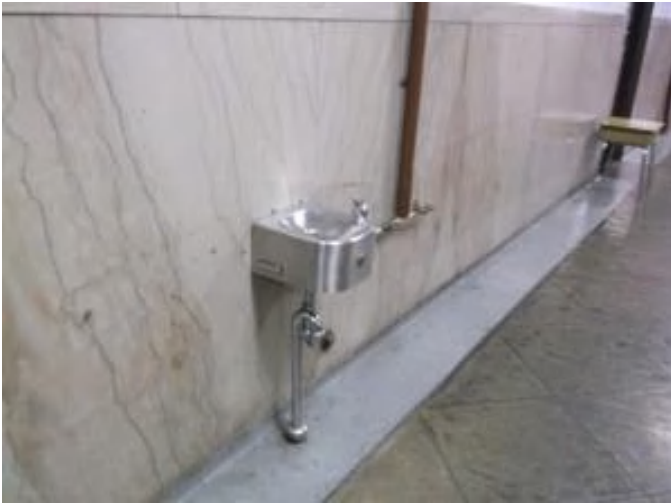
**System: D2010 - Plumbing Fixtures**

**Location:** Throughout the building

**Distress:** Beyond Service Life

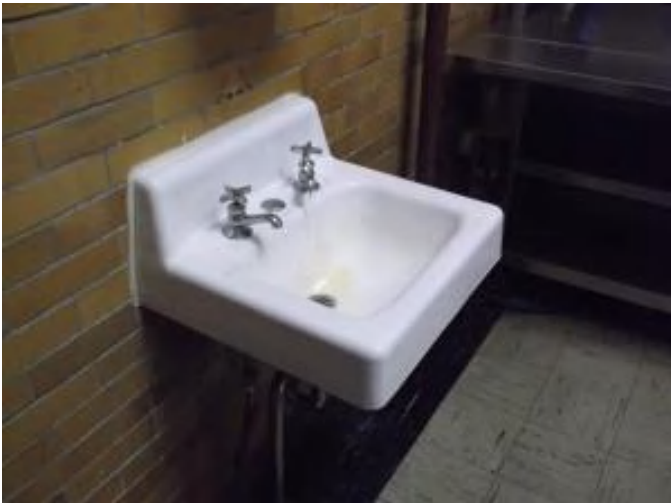
**System: D2010 - Plumbing Fixtures**

**Location:** Throughout the building

**Distress:** Beyond Service Life

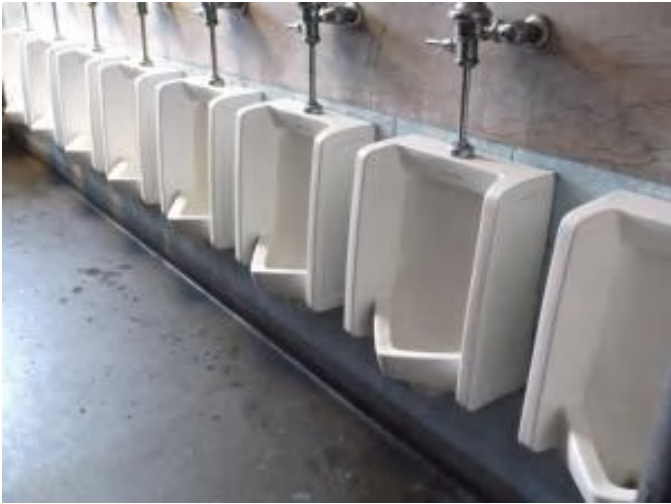
**System: D2010 - Plumbing Fixtures**

**Location:** Throughout the building

**Distress:** Beyond Service Life

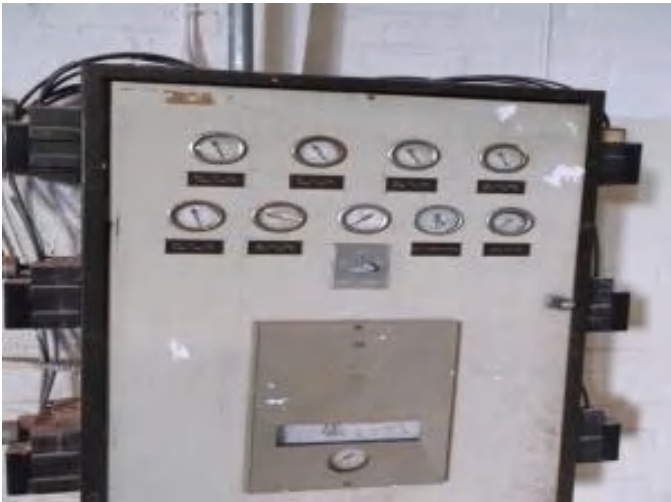
**System: D3060 - Controls & Instrumentation**

**Location:** Throughout the building

**Distress:** Beyond Service Life

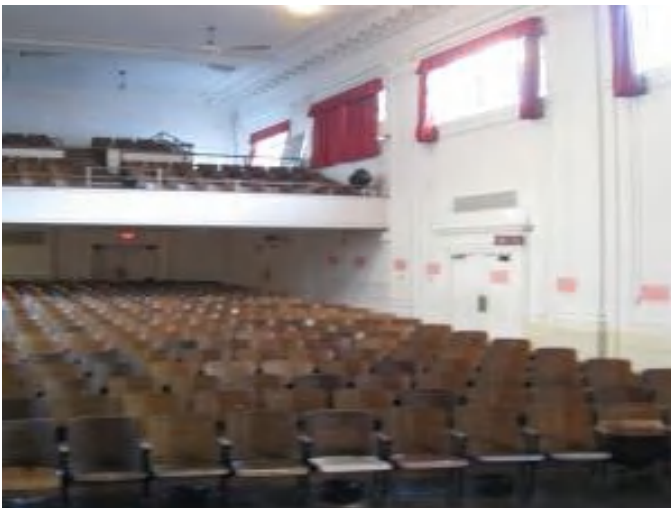
**System: E2010 - Fixed Furnishings**

**Location:** auditorium

**Distress:** Damaged

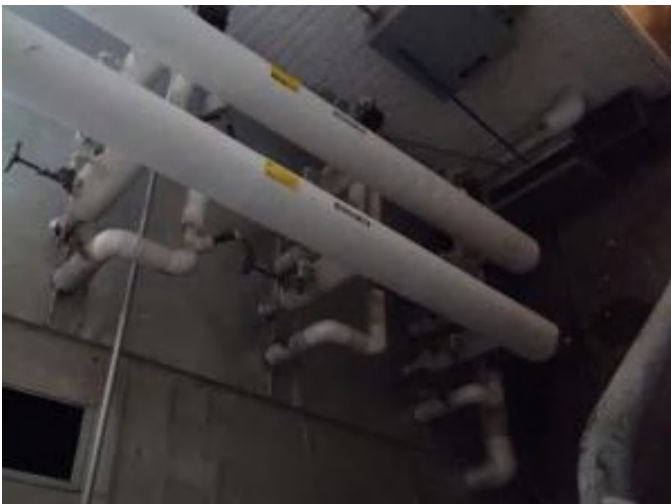
**System: D3040 - Distribution Systems**

**Location:** Throughout the building

**Distress:** Beyond Service Life

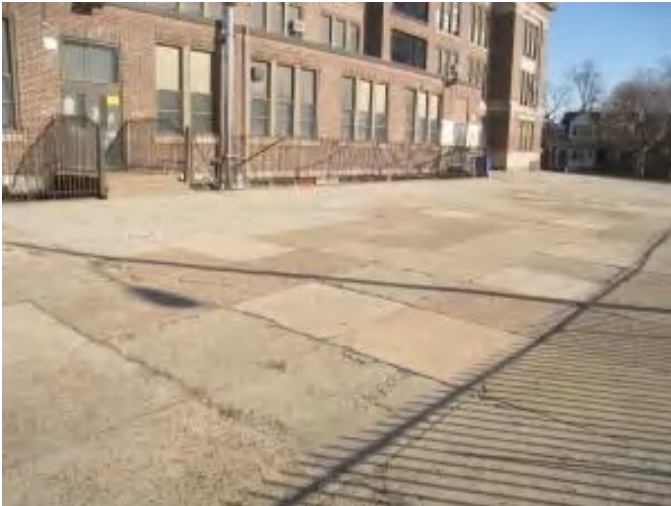
#### System: G2030 - Pedestrian Paving

**Location:** concrete playground

**Distress:** Failing

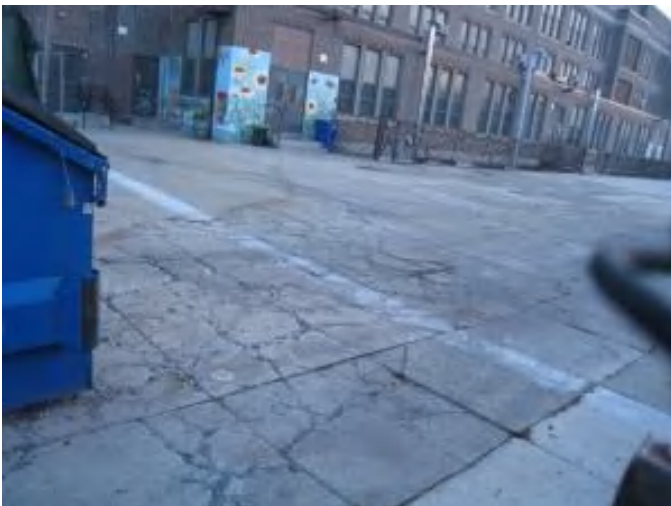
#### System: G2030 - Pedestrian Paving

**Location:** dumpster pad

**Distress:** Failing

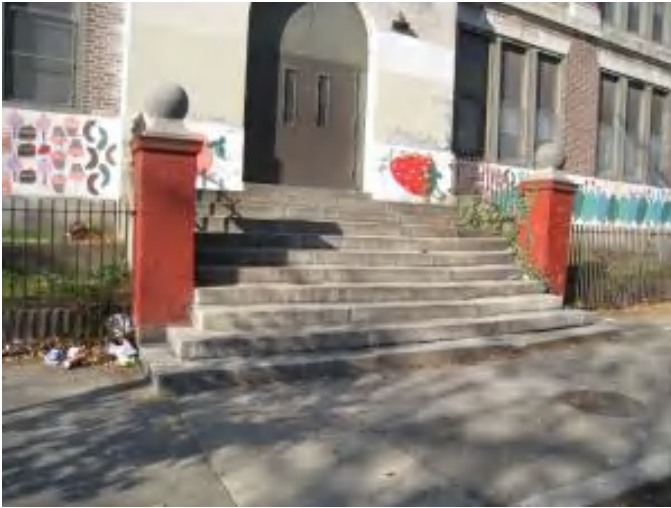
**System: G2030 - Pedestrian Paving**

**Location:** exterior stairs

**Distress:** Failing

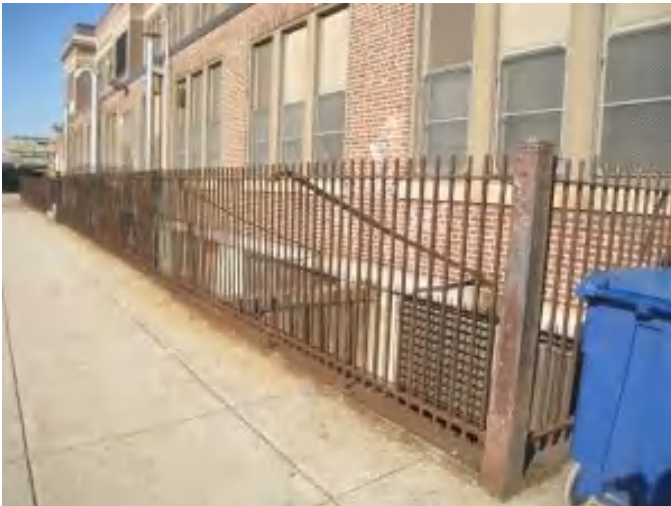
**System: G2040 - Site Development**

**Location:** perimeter site fence

**Distress:** Failing

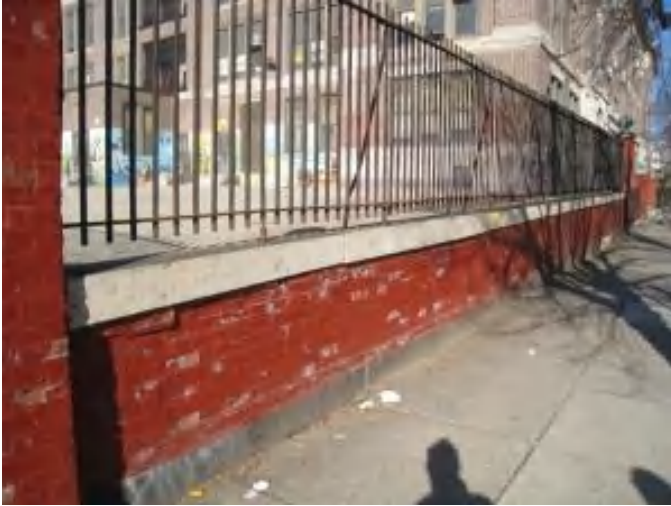
**System: G2040 - Site Development**

**Location:** all along W. Mentor St. sidewalk

**Distress:** Failing
