## Facility Condition Assessment Summary Report

### Cramp School

School District of Philadelphia  
**S547001;Cramp**  
Final  
**Site Assessment Report**

January 30, 2017

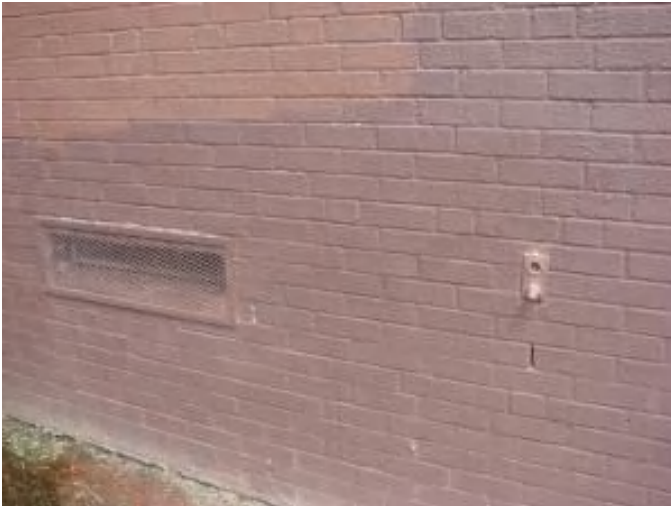
#### System: B2010 - Exterior Walls

**Location:** Exterior

**Distress:** Appearance

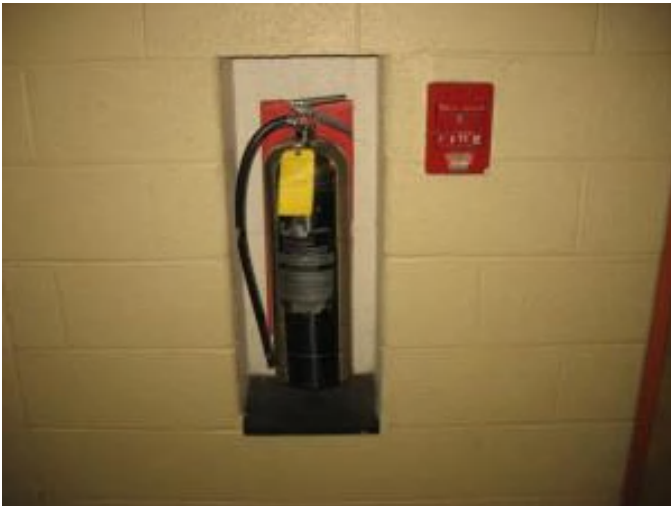
#### System: D4010 - Sprinklers

**Location:** Throughout building

**Distress:** Life Safety / NFPA / PFD

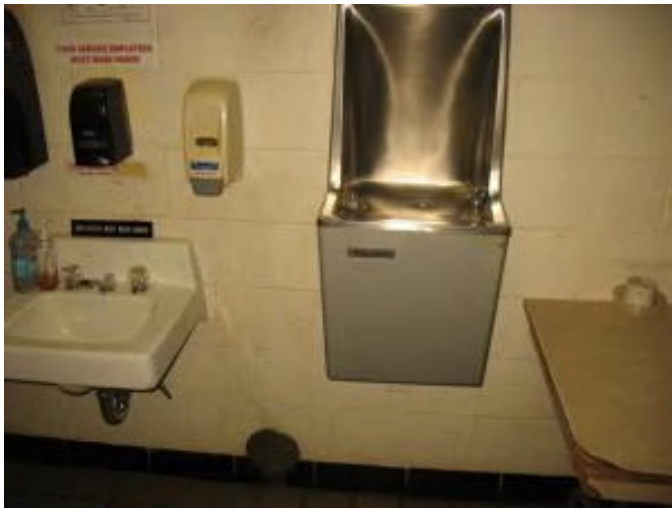
**System: D2010 - Plumbing Fixtures**

Drinking fountains, located only in the Cafeteria and Gymnasium, consist of wall hung fixtures with integral refrigerated coolers. They are beyond their service life, several are damaged, and should be replaced; most are NOT accessible type.

**Location:** Cafeteria and Gymnasium

**Distress:** Beyond Service Life

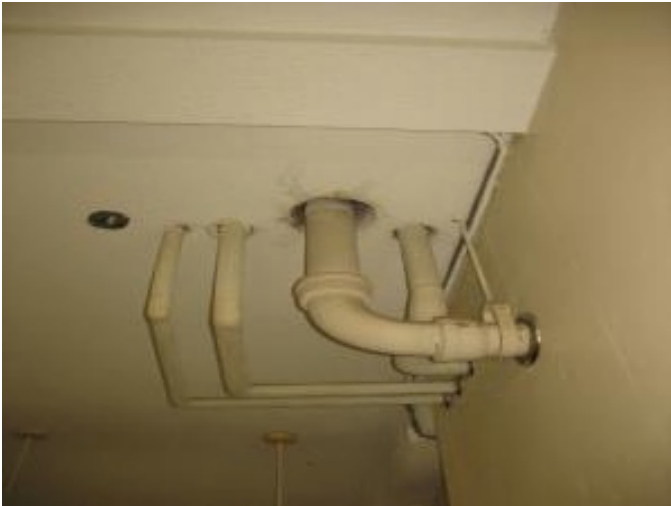
**System: D2030 - Sanitary Waste**

Sanitary Waste - The original sanitary sewer piping is a mixture of galvanized piping with threaded fittings and heavy weight cast iron piping with hub and spigot fittings. The maintenance staff reported mostly minor problems with the sanitary waste piping systems. However, the sewer piping has been in service over 45 years and will require more frequent attention from the maintenance staff as time passes. The District should hire a qualified contractor to examine the sanitary waste piping using video cameras to locate and replace any damaged piping and to further quantify the extent of potential failures.

**Location:** Throughout building

**Distress:** Beyond Service Life

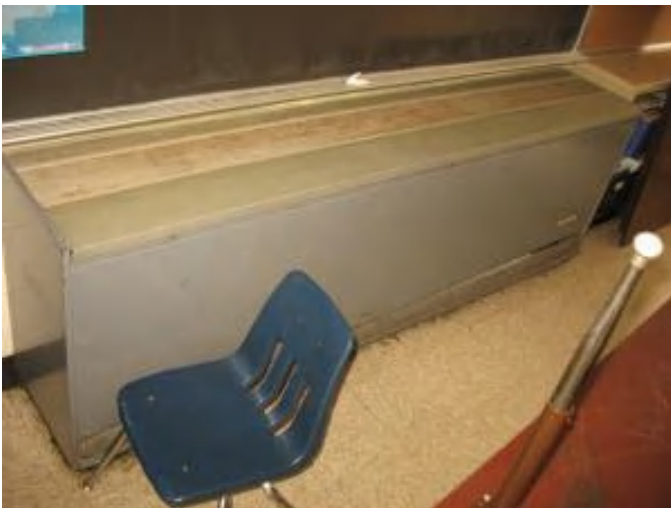
**System: D3040 - Distribution Systems**

**Location:** Throughout building

**Distress:** Beyond Service Life

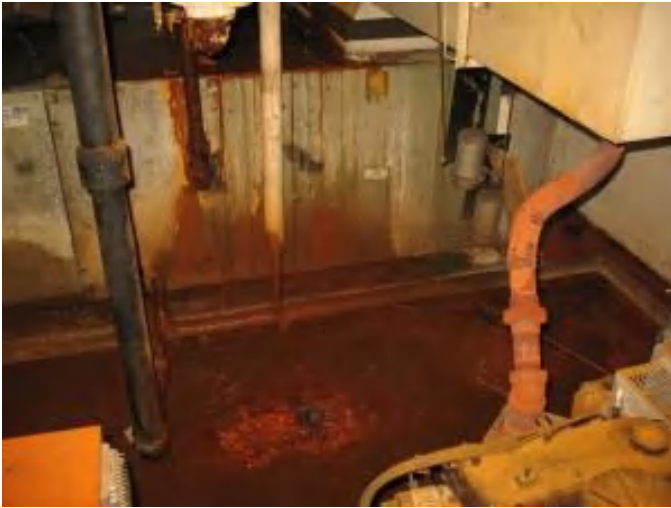
**System: D3040 - Distribution Systems**

Distribution Systems - Building water distribution piping is black steel with threaded fittings. The distribution piping in the basement has been damaged by condensation and has significant rust damage. The piping has been in use beyond its service life and will require more frequent attention from the maintenance staff to address pipe/valve failures as time passes. The District should hire a qualified contractor to examine the distribution piping and perform additional testing to locate and replace any damaged piping and to

**Location:** Basement

**Distress:** Damaged

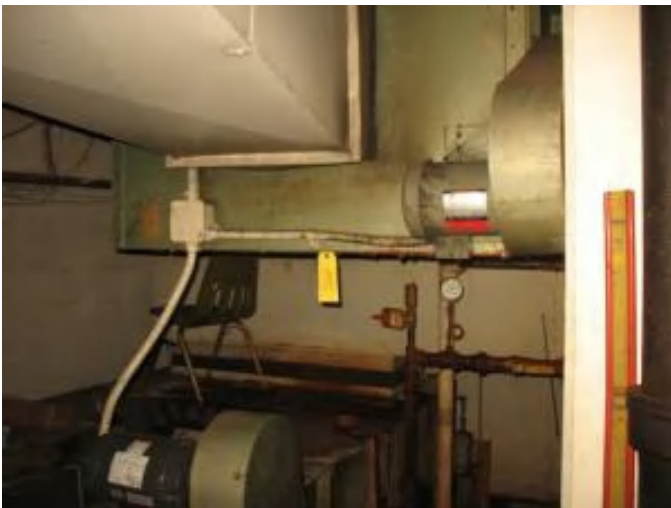
**System: D3040 - Distribution Systems**

**Location:** Basement

**Distress:** Damaged

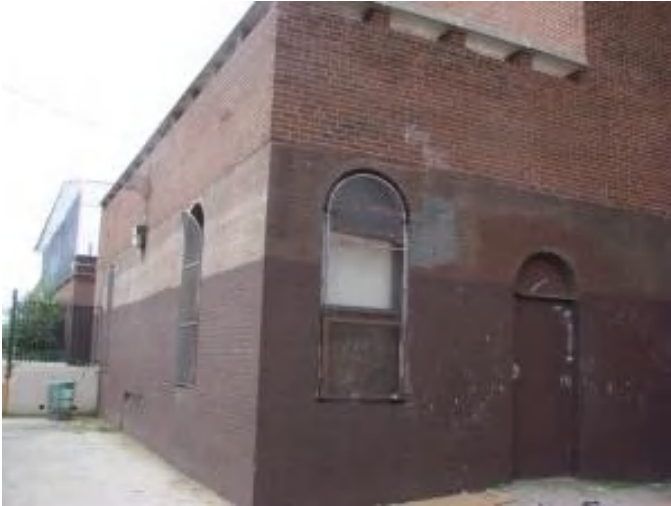
**System: B2020 - Exterior Windows**

**Location:** Exterior

**Distress:** Security Issue

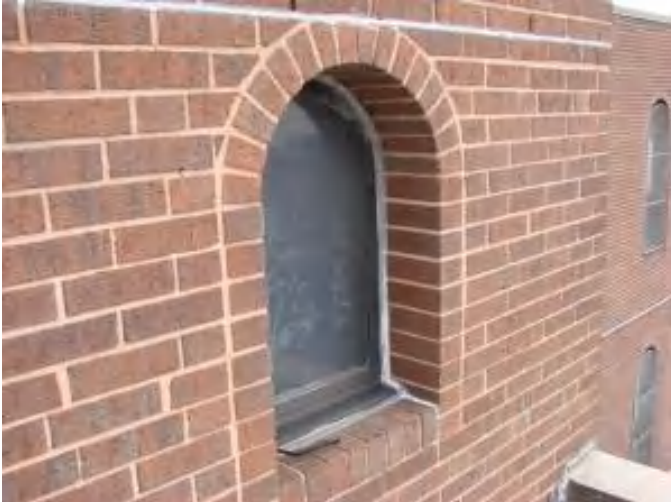
**System: B2020 - Exterior Windows**

**Location:** Exterior

**Distress:** Beyond Service Life

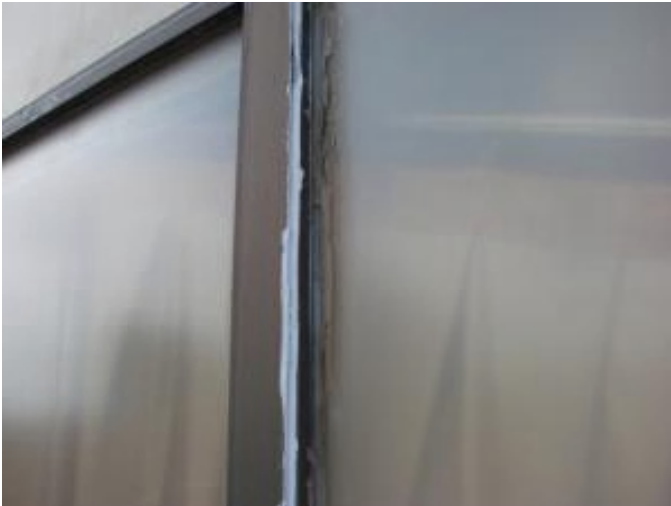
**System: B2020 - Exterior Windows**

**Location:** Exterior

**Distress:** Beyond Service Life

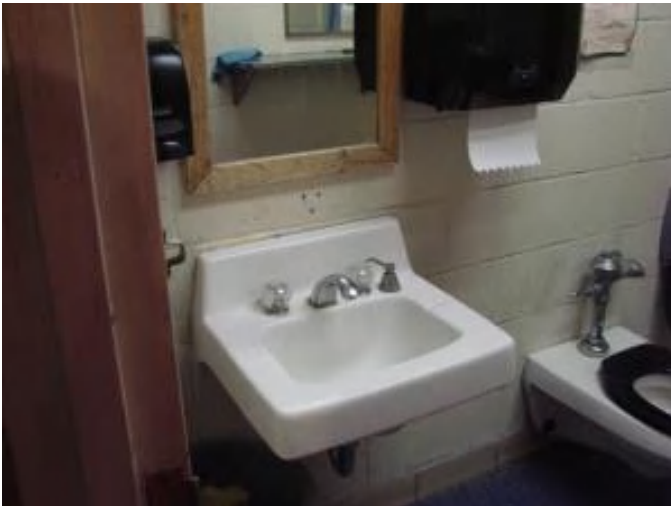
**System: C1030 - Fittings**

**Location:** Interior

**Distress:** Accessibility

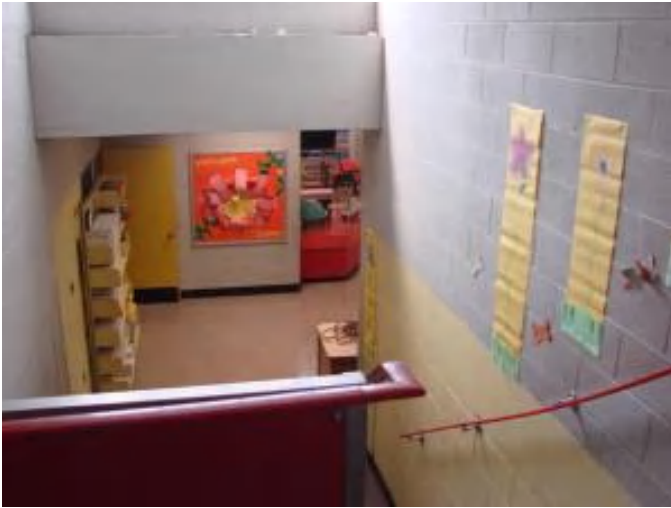
**System: C3010230 - Paint & Covering**

**Location:** Interior

**Distress:** Beyond Service Life

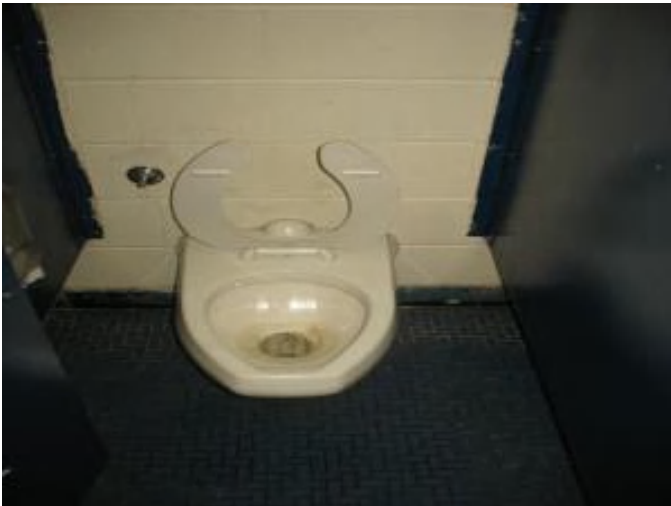
**System: D2010 - Plumbing Fixtures**

**Location:** Restrooms

**Distress:** Building / MEP Codes

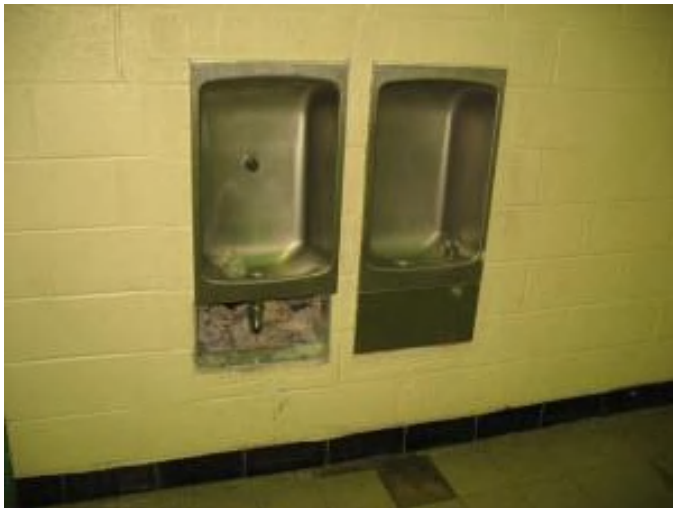
**System: D2020 - Domestic Water Distribution**

**Location:** Throughout building

**Distress:** Beyond Service Life

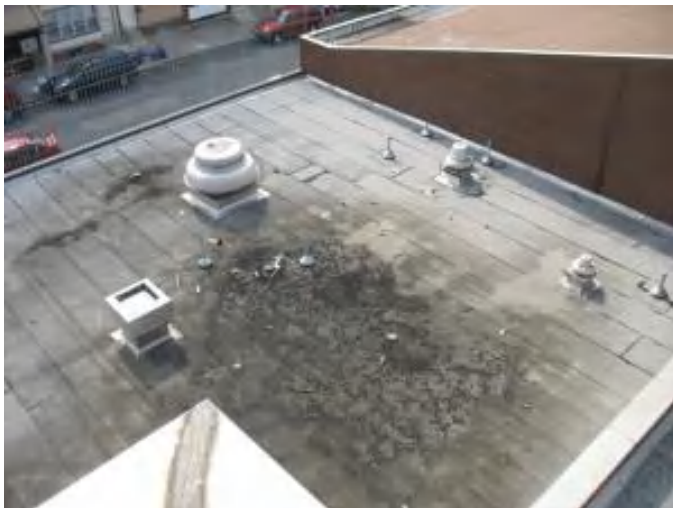
**System: D2040 - Rain Water Drainage**

Rain Water Drainage - The rain water drains from the roof are routed through mechanical chases in the building and appear to be original. The drain piping should be inspected by a qualified contractor and repaired as necessary.

**Location:** Throughout building

**Distress:** Beyond Service Life

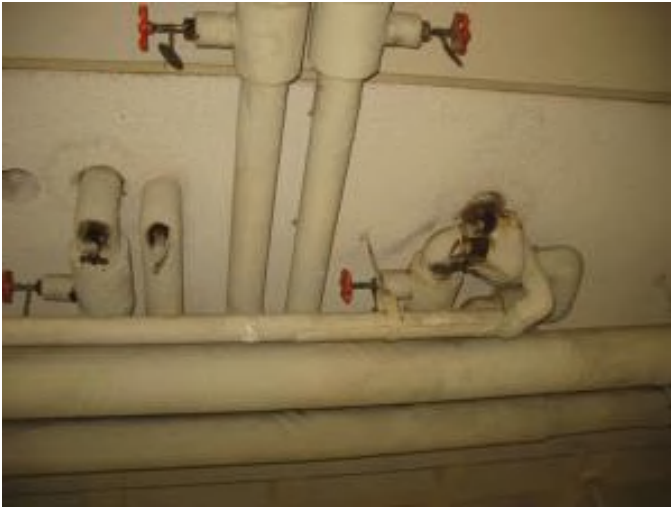
**System: D3040 - Distribution Systems**

**Location:** Throughout building

**Distress:** Beyond Service Life

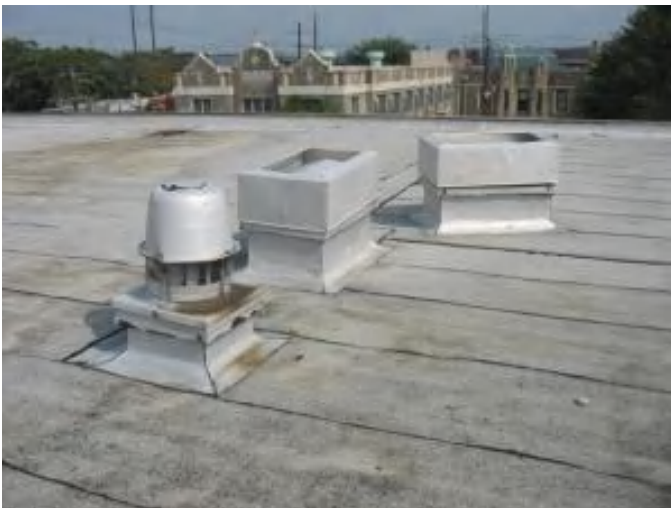
**System: D3040 - Distribution Systems**

**Location:** Roof

**Distress:** Beyond Service Life

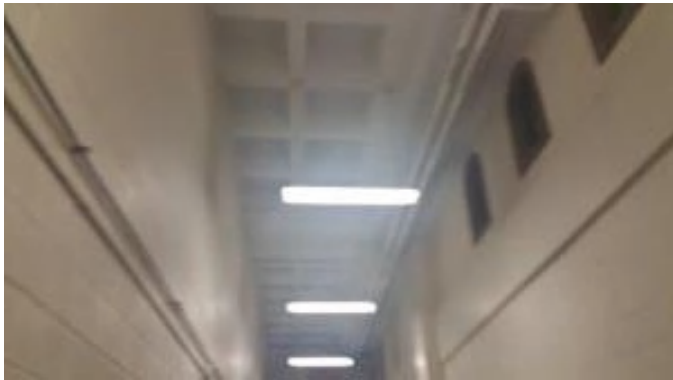
**System: D5020 - Lighting and Branch Wiring**

**Location:** throughout the building

**Distress:** Beyond Service Life

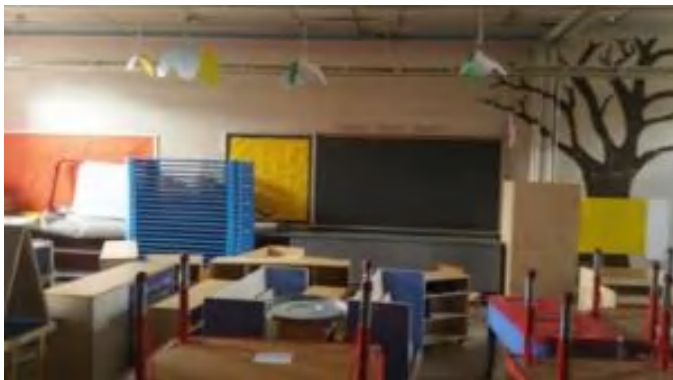
**System: D5020 - Lighting and Branch Wiring**

**Location:** throughout the building

**Distress:** Beyond Service Life

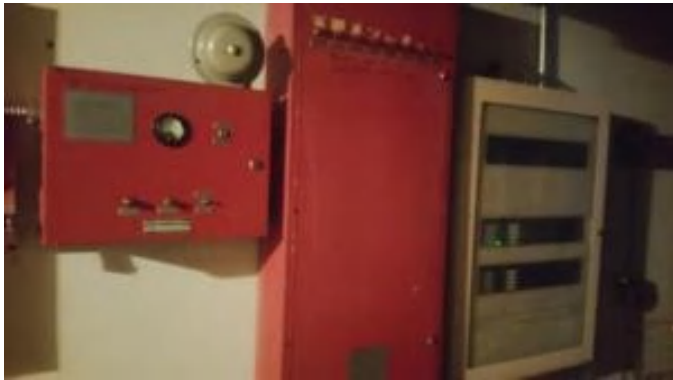
**System: D5030 - Communications and Security**

**Location:** throughout the building

**Distress:** Beyond Service Life

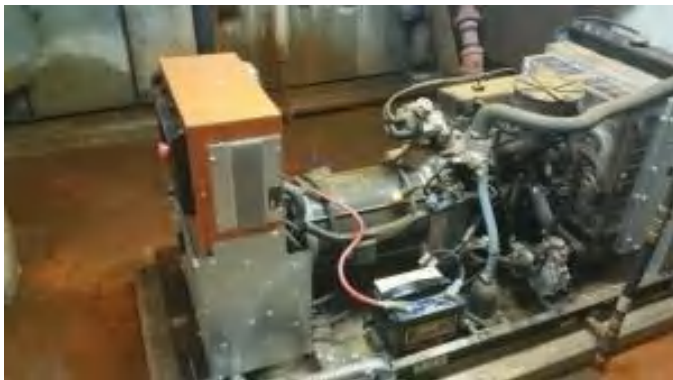
**System: D5090 - Other Electrical Systems**

**Location:** Electrical room

**Distress:** Inadequate

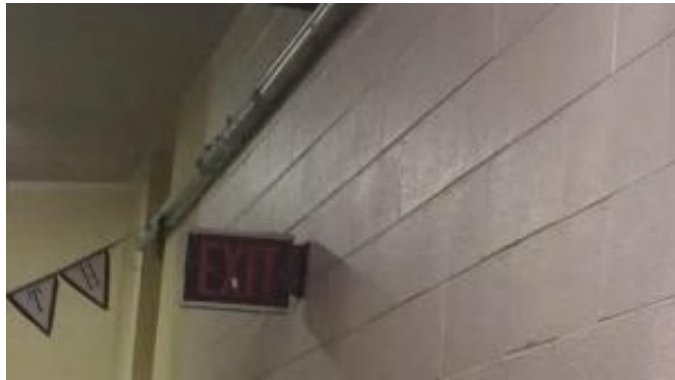
**System: D5090 - Other Electrical Systems**

**Location:** throughout the building

**Distress:** Life Safety / NFPA / PFD

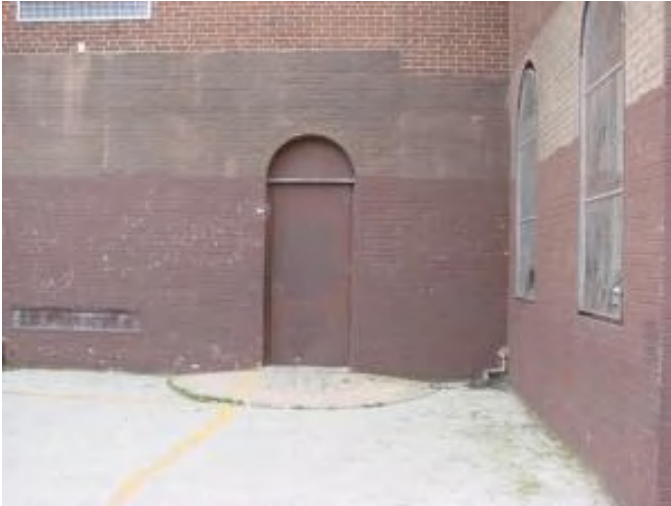
**System: B2030 - Exterior Doors**

**Location:** Exterior

**Distress:** Beyond Service Life

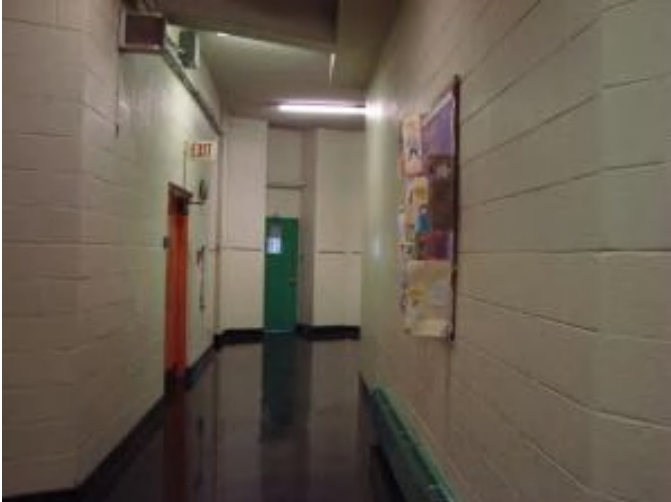
**System: C3020413 - Vinyl Flooring**

**Location:** Interior

**Distress:** Health Hazard / Risk

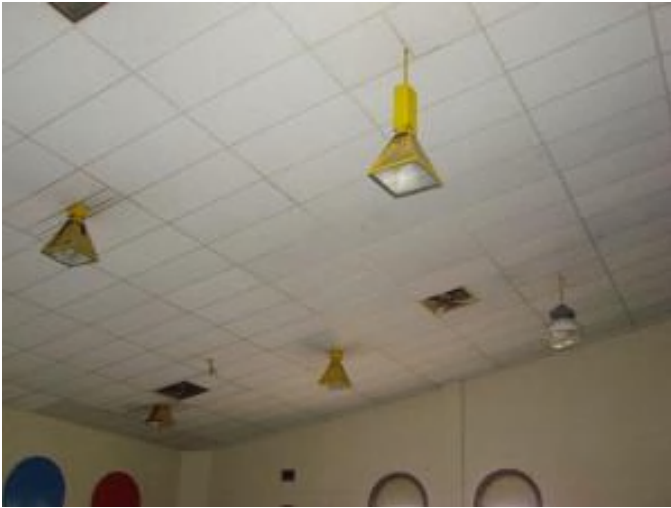
**System: C3030 - Ceiling Finishes**

**Location:** Interior

**Distress:** Beyond Service Life

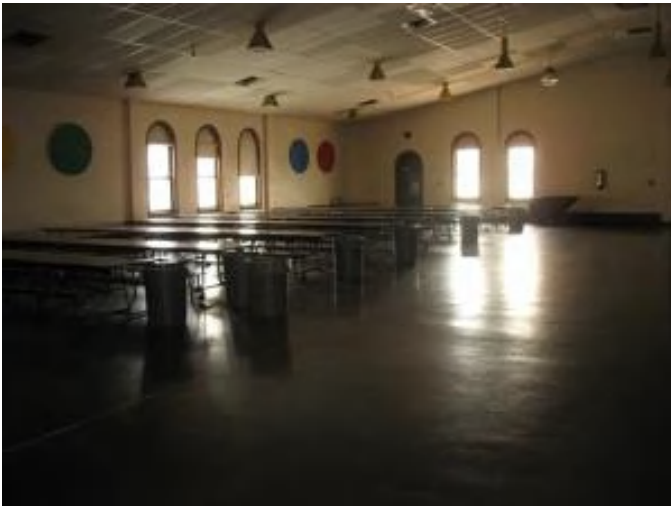
**System: D3040 - Distribution Systems**

**Location:** Cafetorium

**Distress:** Beyond Service Life

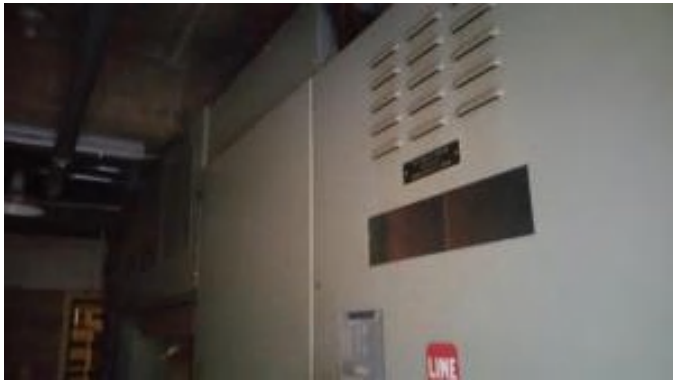
**System: D5010 - Electrical Service/Distribution**

**Location:** electrical room

**Distress:** Beyond Service Life

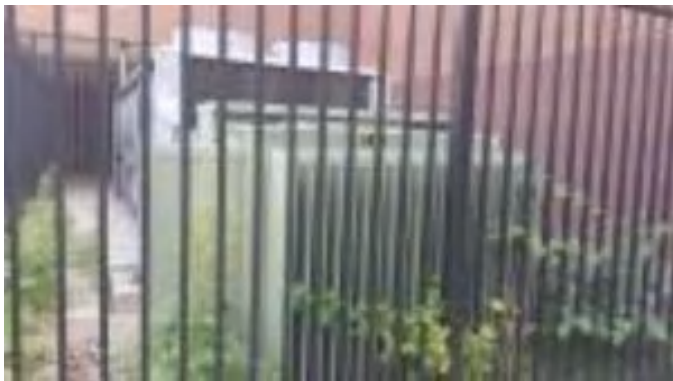
**System: D5010 - Electrical Service/Distribution**

**Location:** Electrical room

**Distress:** Beyond Service Life

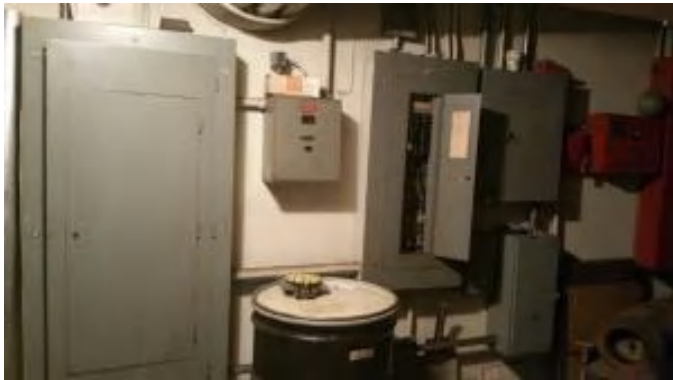
**System: D5010 - Electrical Service/Distribution**

**Location:** throughout the building

**Distress:** Beyond Service Life

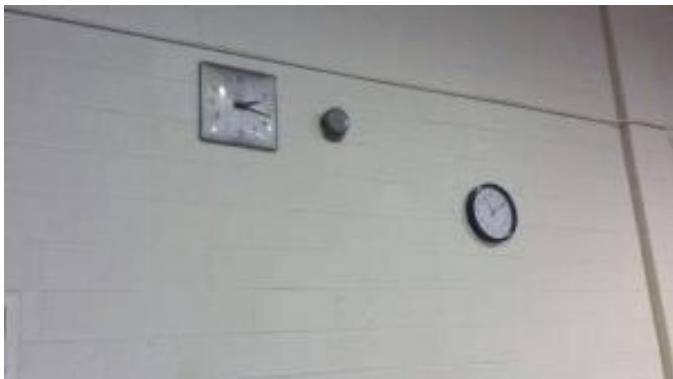
**System: D5030 - Communications and Security**

**Location:** throughout the building

**Distress:** Beyond Service Life

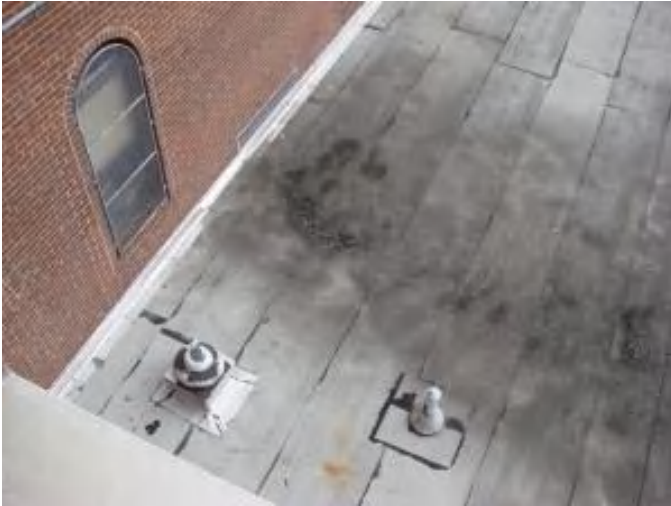
**System: B3010105 - Built-Up**

**Location:** Exterior

**Distress:** Building Envelope Integrity

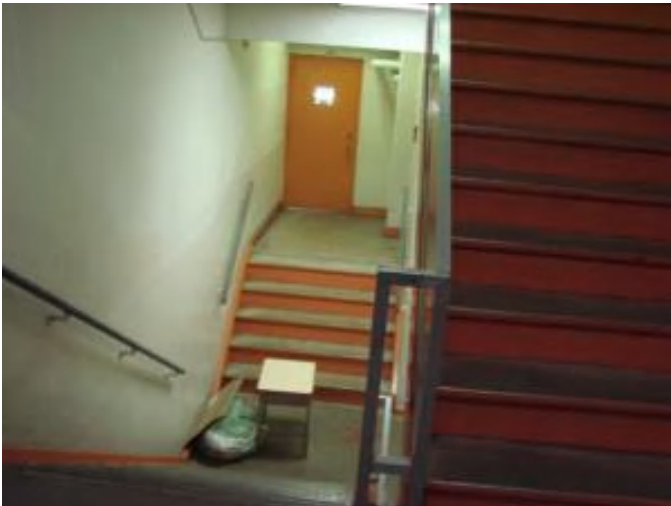
**System: C1020 - Interior Doors**

**Location:** Interior

**Distress:** Accessibility

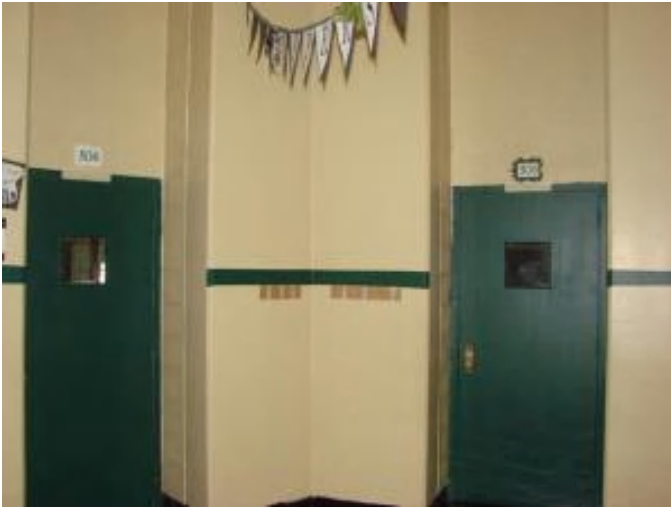
**System: C1030 - Fittings**

**Location:** Interior

**Distress:** Inadequate

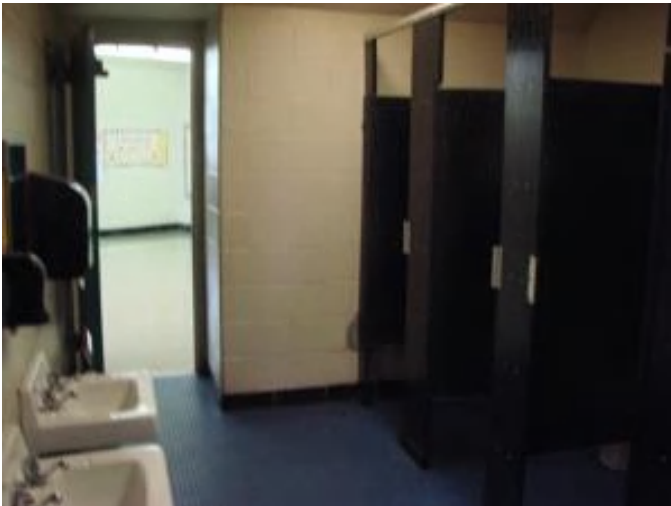
**System: C3020412 - Terrazzo & Tile**

**Location:** Interior

**Distress:** Damaged

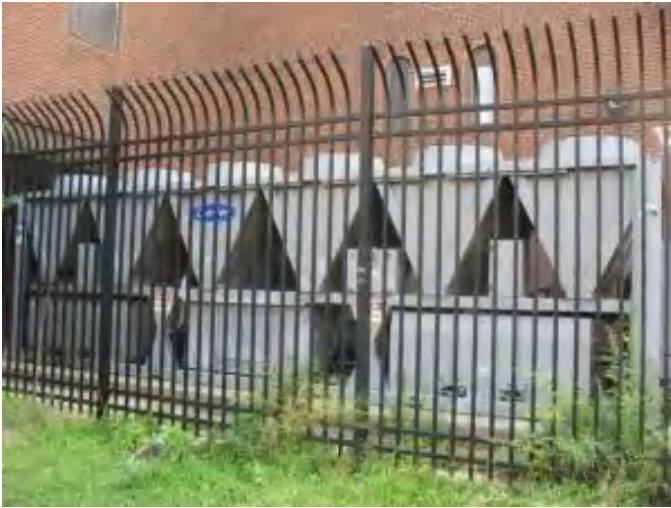
**System: D3030 - Cooling Generating Systems**

**Location:** Roof  
**Distress:** Inadequate  
**Category:** 4 - Capital Improvement  
**Priority:** 5 - Response Time (> 5 yrs)  
**Correction:** Install chilled water system with distribution piping and pumps. (+75KSF)  
**Qty:** 80,088.00  
**Unit of Measure:** S.F.  
**Estimate:** \$1,214,157.63  
**Assessor Name:** System  
**Date Created:** 09/09/2015

**Notes:** Replace the existing screw chiller with a new 200 ton packaged air cooled chiller fitted with modern controls. All associated piping and pumping systems should also be replaced.

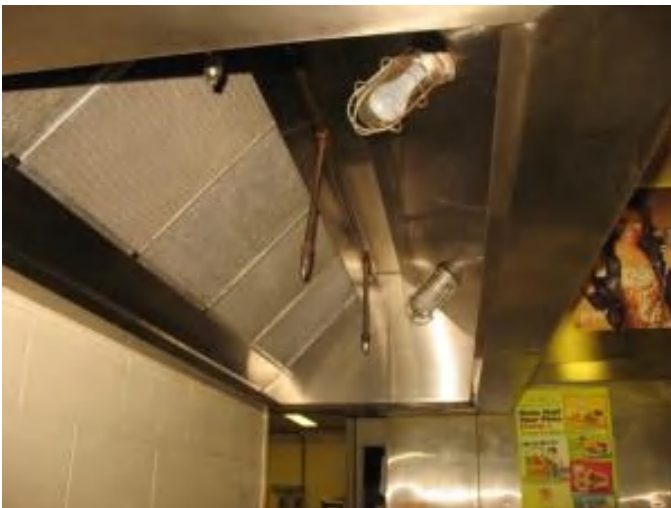
**System: D3040 - Distribution Systems**

**Location:** Kitchen  
**Distress:** Inadequate  
**Category:** 4 - Capital Improvement  
**Priority:** 5 - Response Time (> 5 yrs)  
**Correction:** Install GF makeup air unit for kitchen exhaust hood (single 10 ft hood).  
**Qty:** 1.00  
**Unit of Measure:** Ea.  
**Estimate:** \$309,401.34  
**Assessor Name:** System  
**Date Created:** 09/09/2015

**Notes:** Install a gas fired make-up air unit serving the Kitchen for when the exhaust hood is in operation.

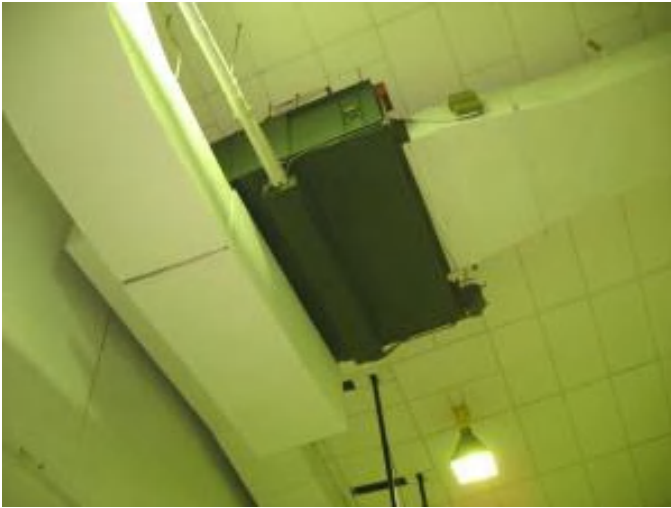
**System: D3040 - Distribution Systems**

**Location:** Gymnasium

**Distress:** Beyond Service Life

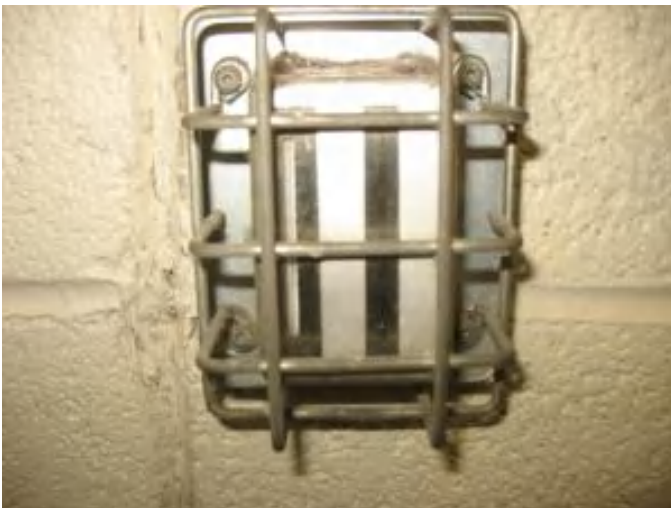
**System: D3060 - Controls & Instrumentation**

**Location:** Throughout building

**Distress:** Inadequate

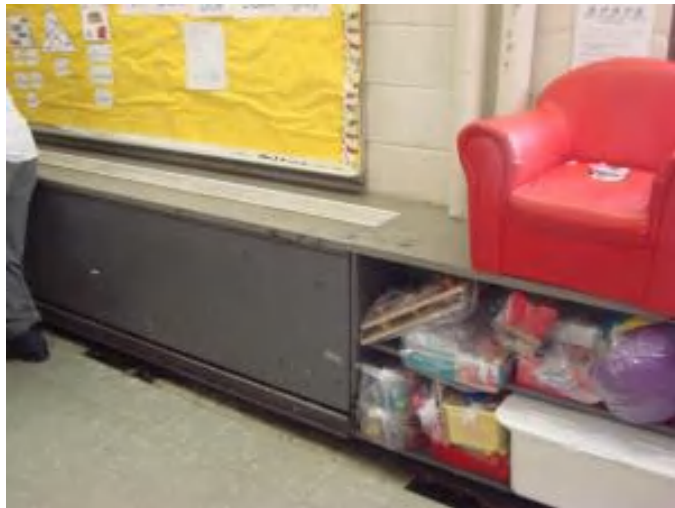
**System: E2010 - Fixed Furnishings**

**Location:** Interior

**Distress:** Beyond Service Life

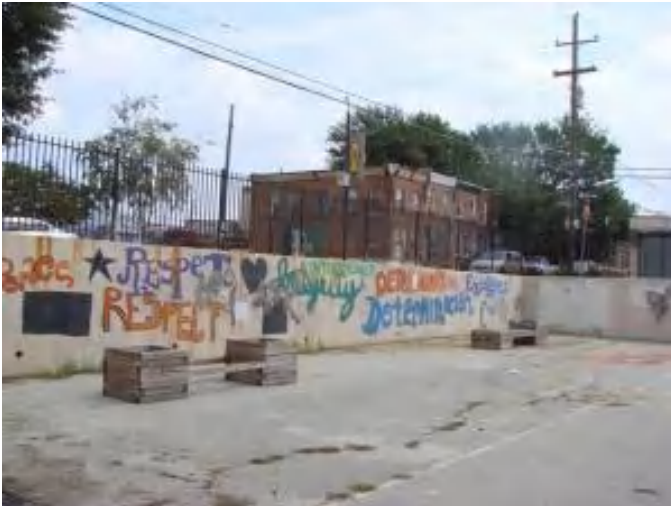
#### System: G2030 - Pedestrian Paving

**Location:** Grounds/ site

**Distress:** Beyond Service Life

**Notes:** Provide ADA compliant ramp at the main entrance

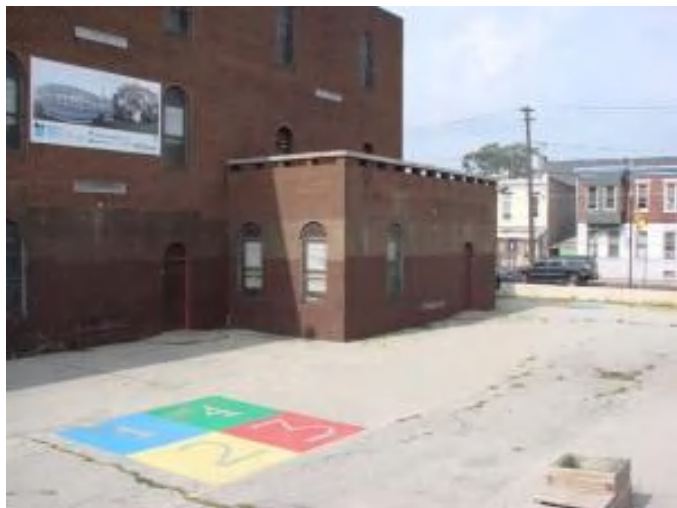
**System: G4020 - Site Lighting**

**Location:** outdoor grounds

**Distress:** Security Issue

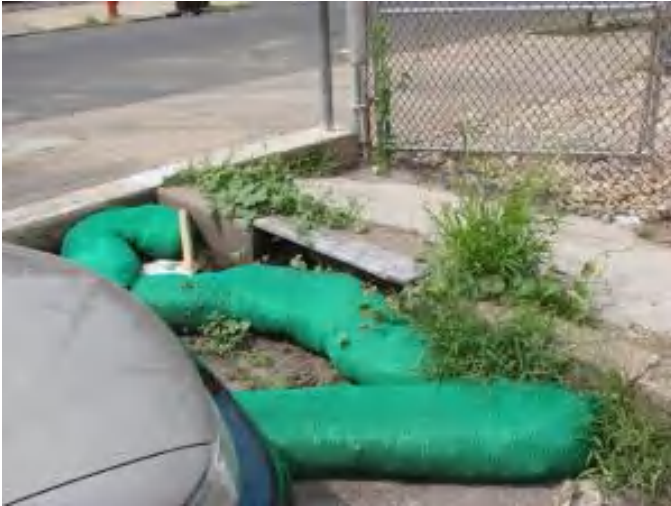
**System: G2020 - Parking Lots**

**Location:** Grounds/ site

**Distress:** Beyond Service Life

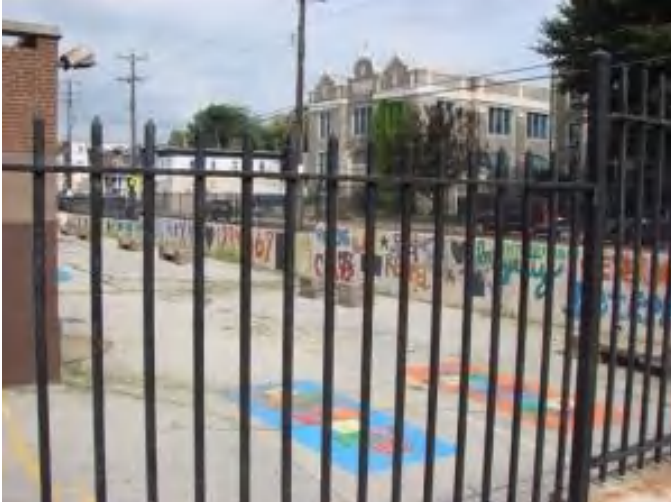
**System: G2040 - Site Development**

**Location:** Grounds/ site

**Distress:** Beyond Service Life

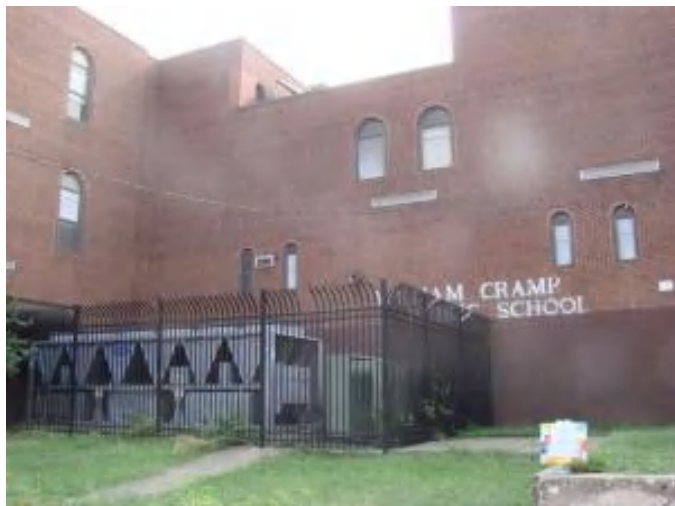
**System: G4030 - Site Communications & Security**

**Location:** outdoor grounds

**Distress:** Security Issue
