## Facility Condition Assessment Summary Report

### Creighton School

### Creighton LSH School

February 1, 2017

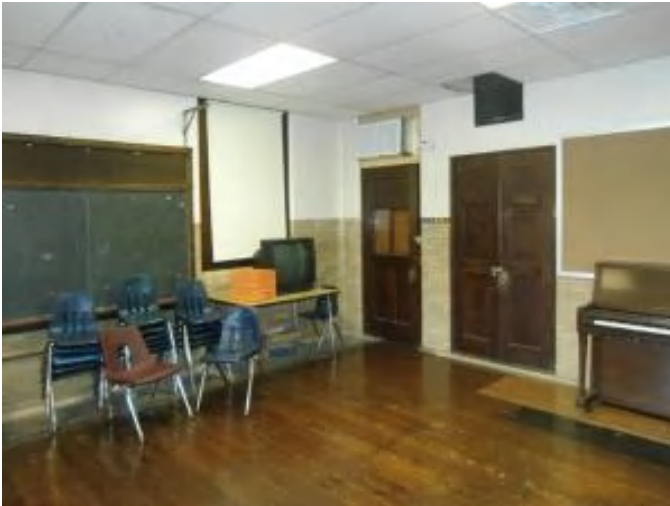
#### System: C3020414 - Wood Flooring

**Location:** Building Wide

**Distress:** Beyond Service Life

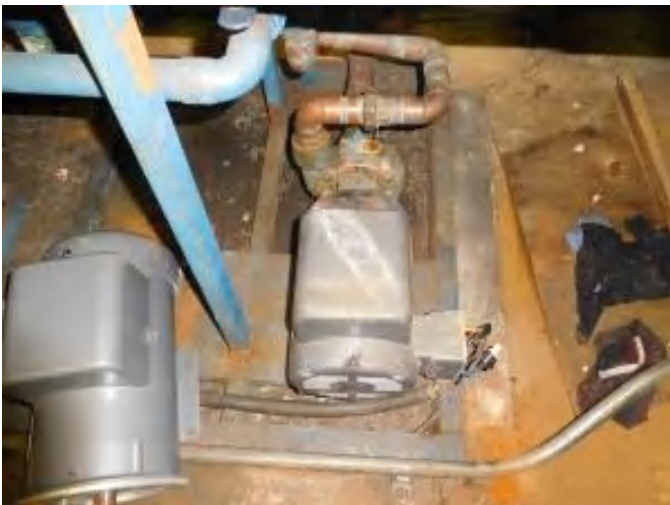
#### System: D2020 - Domestic Water Distribution

**Location:** mechanical room

**Distress:** Inadequate

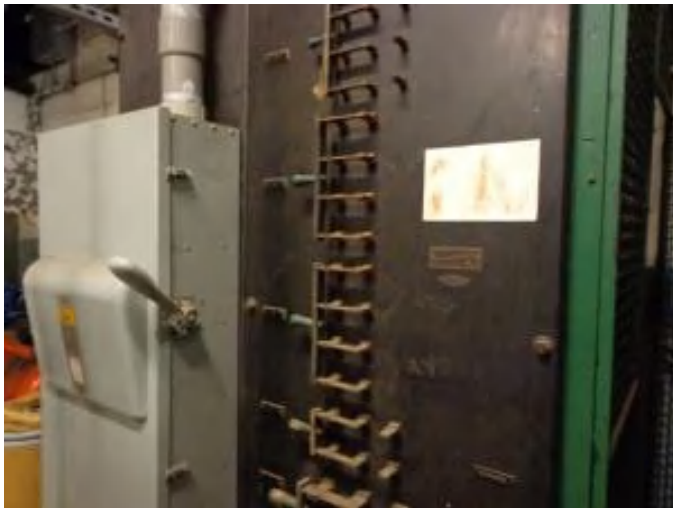
**System: D5010 - Electrical Service/Distribution**

**Location:** Main Electrical Room

**Distress:** Beyond Service Life

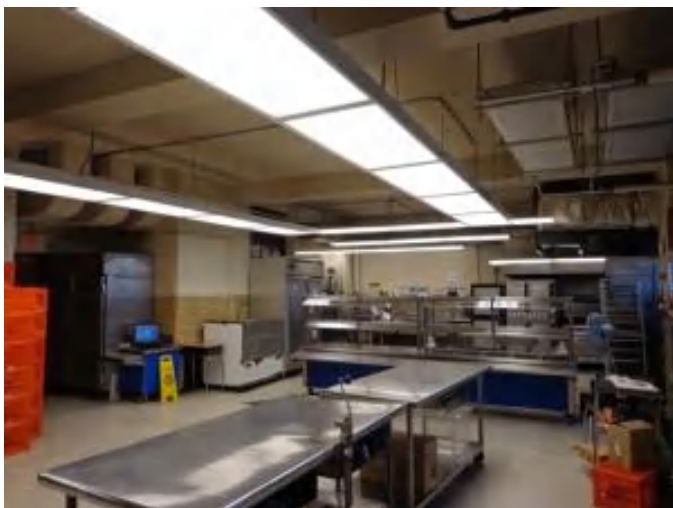
**System: D5020 - Lighting and Branch Wiring**

**Location:** Kitchen

**Distress:** Life Safety / NFPA / PFD

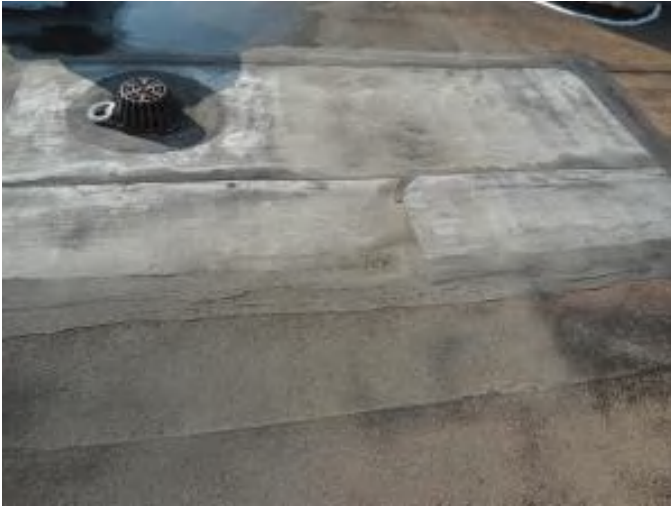
**System: B3010105 - Built-Up**

**Location:** Roof

**Distress:** Damaged

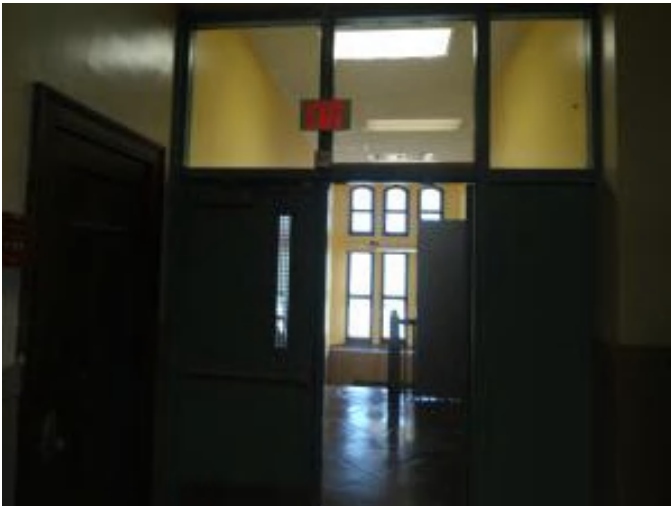
**System: C1010 - Partitions**

**Location:** Building Wide

**Distress:** Building / MEP Codes

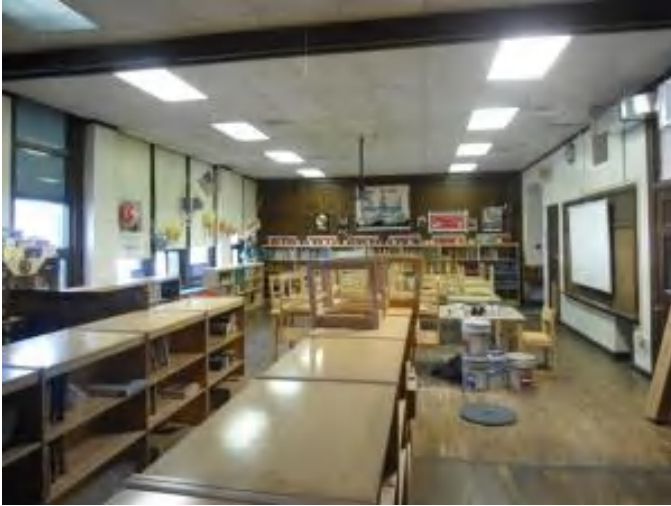
**System: C1010 - Partitions**

**Location:** Library

**Distress:** Building / MEP Codes

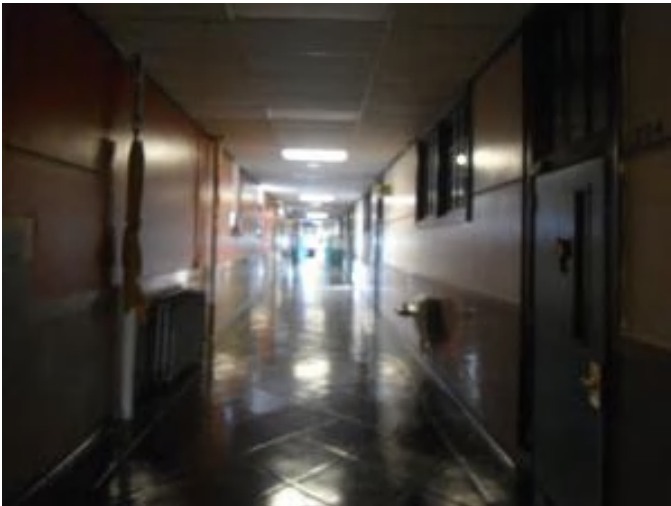
**System: C1010 - Partitions**

**Location:** Hallways

**Distress:** Life Safety / NFPA / PFD

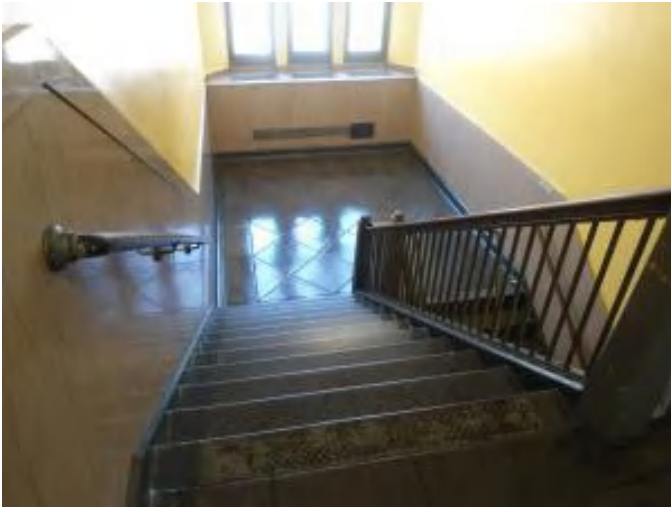
**System: C2010 - Stair Construction**

**Location:** Stairs

**Distress:** Building / MEP Codes

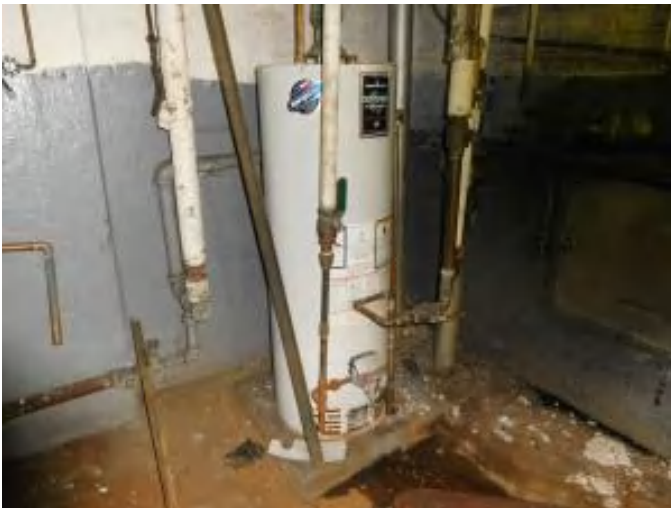
**System: D2020 - Domestic Water Distribution**

**Location:** entire building

**Distress:** Beyond Service Life

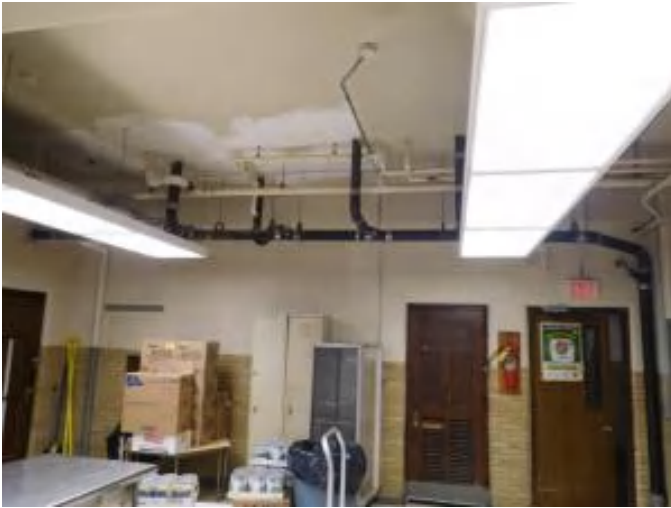
**System: D2030 - Sanitary Waste**

**Location:** entire building

**Distress:** Beyond Service Life

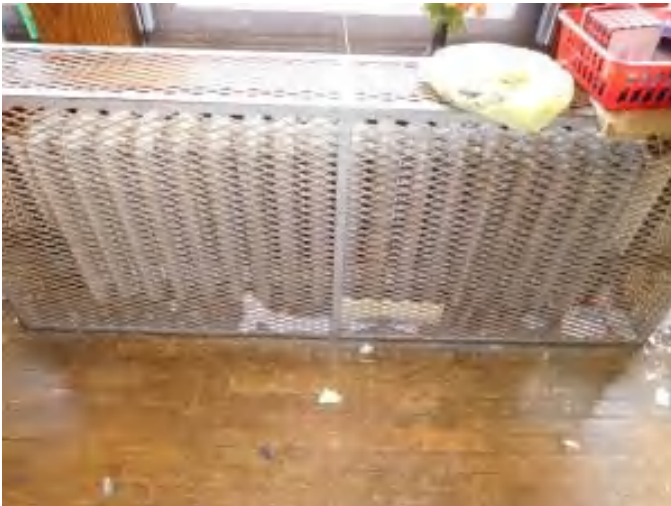
**System: D3040 - Distribution Systems**

**Location:** entire building

**Distress:** Building / MEP Codes

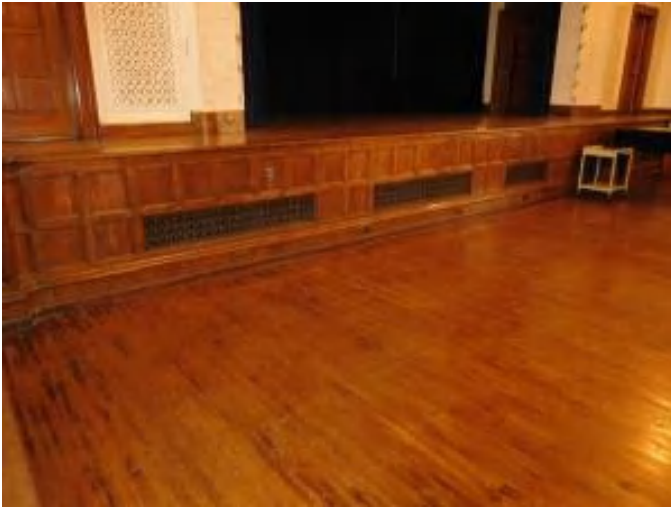
**System: D3040 - Distribution Systems**

**Location:** auditorium

**Distress:** Building / MEP Codes

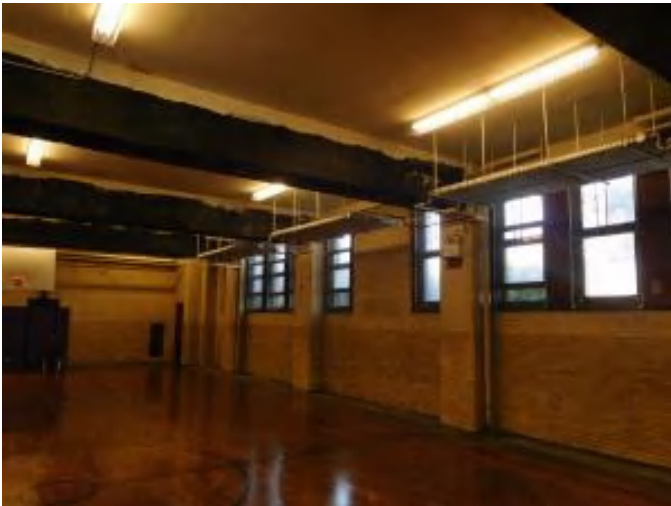
**System: D3040 - Distribution Systems**

**Location:** gymnasium

**Distress:** Inadequate

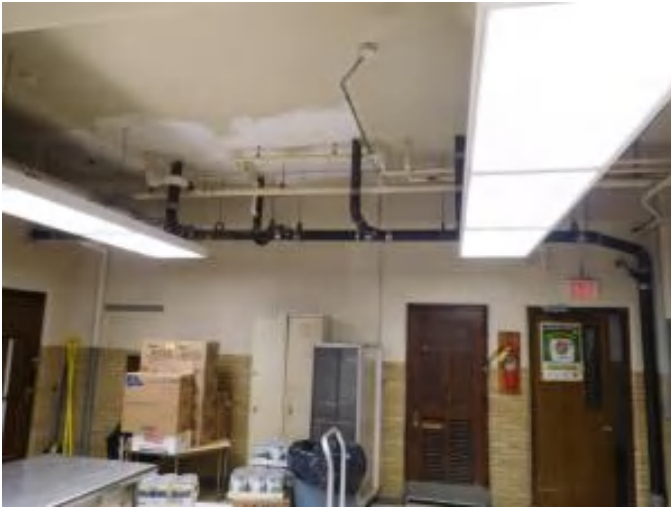
**System: D3040 - Distribution Systems**

**Location:** cafeteria

**Distress:** Building / MEP Codes

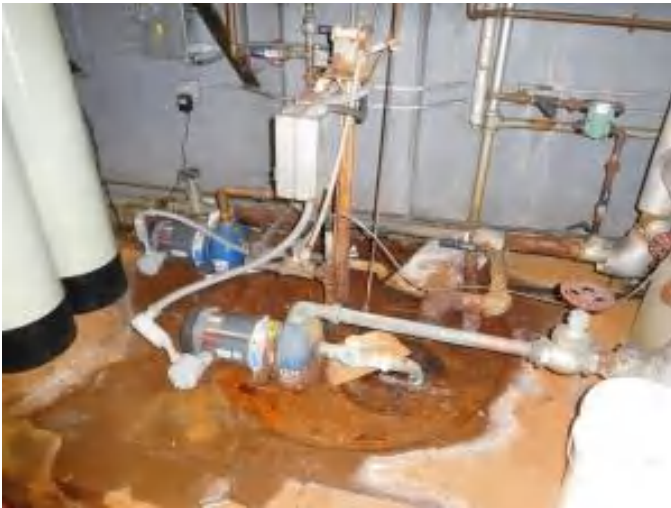
**System: D3040 - Distribution Systems**

**Location:** mechanical room

**Distress:** Beyond Service Life

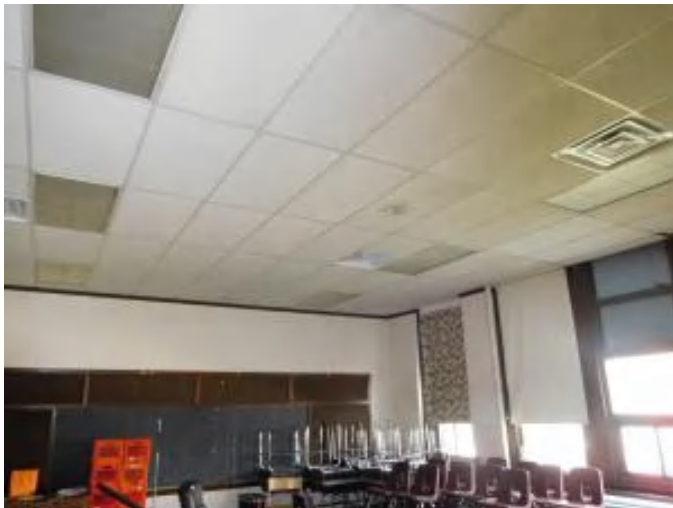
**System: D4010 - Sprinklers**

**Location:** entire building

**Distress:** Life Safety / NFPA / PFD

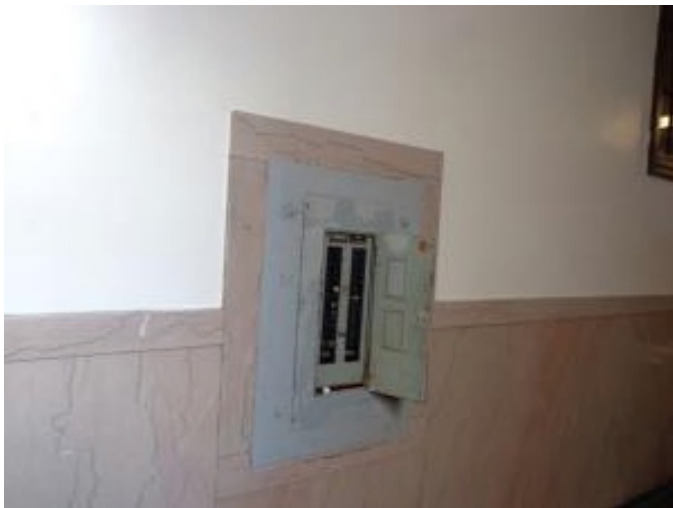
**System: D5010 - Electrical Service/Distribution**

**Location:** Corridors - Floor 1-3

**Distress:** Beyond Service Life

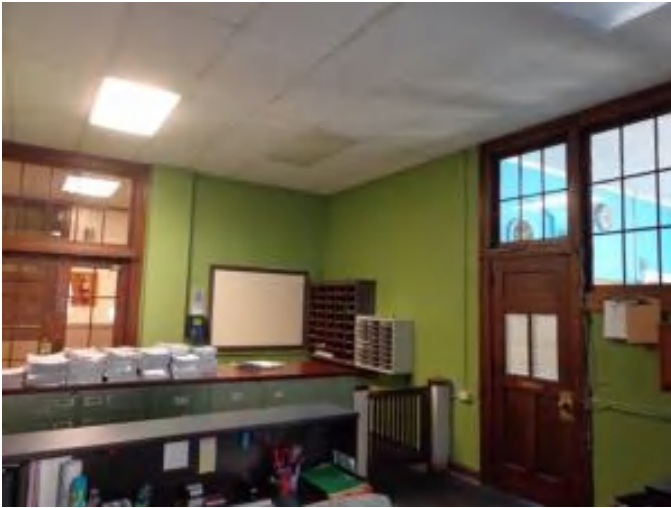
**System: D5020 - Lighting and Branch Wiring**

**Location:** Classrooms, Toilet Rooms, Stairwells

**Distress:** Beyond Service Life

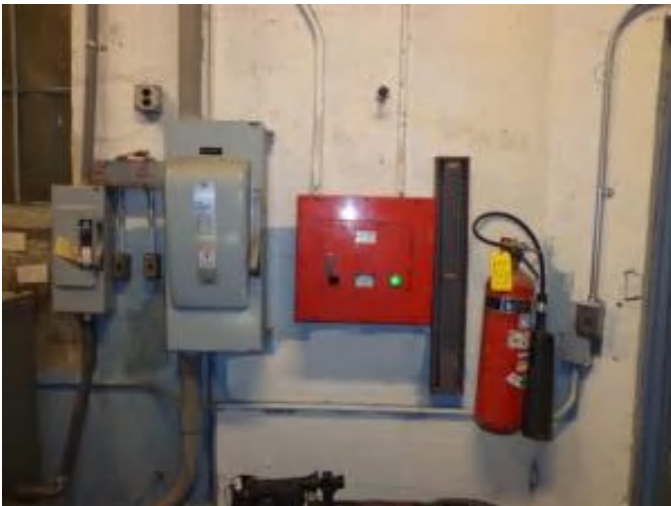
**System: D5030 - Communications and Security**

**Location:** Entire Building

**Distress:** Building / MEP Codes

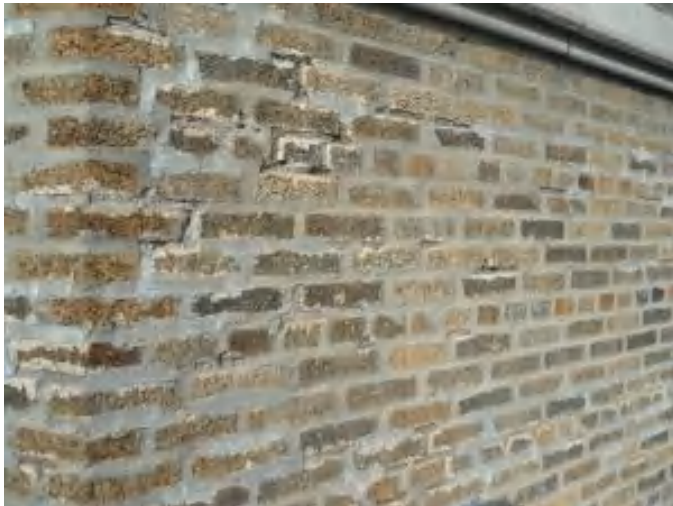
**System: B2010 - Exterior Walls**

**Location:** Exterior Brick Surface

**Distress:** Damaged

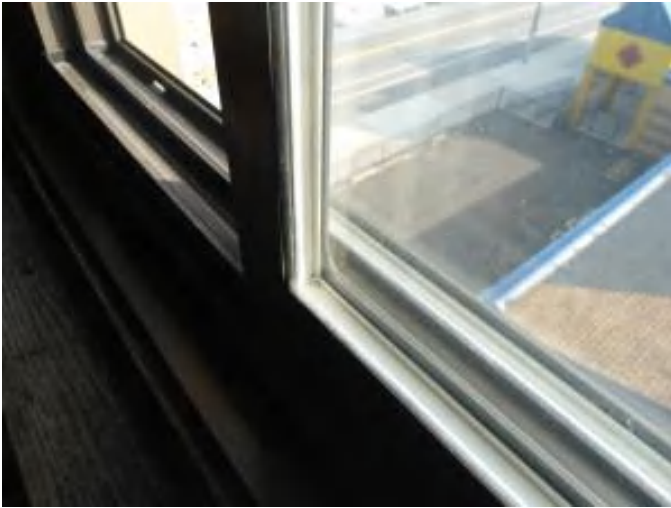
**System: B2020 - Exterior Windows**

**Location:** Exterior Windows

**Distress:** Damaged

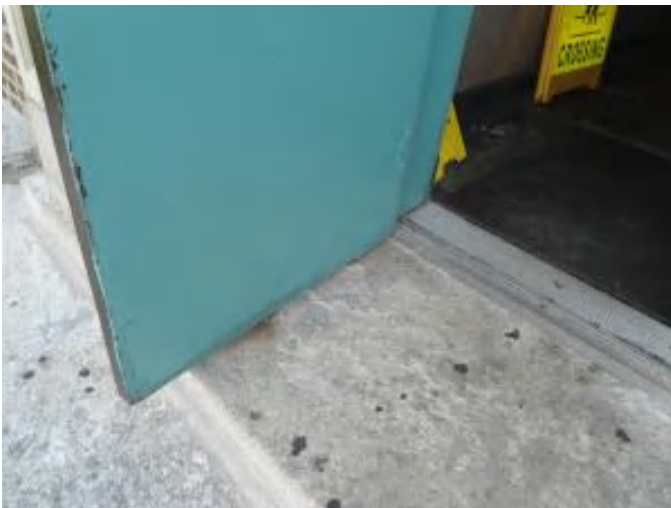
**System: B2030 - Exterior Doors**

**Location:** Exterior Doors

**Distress:** Damaged

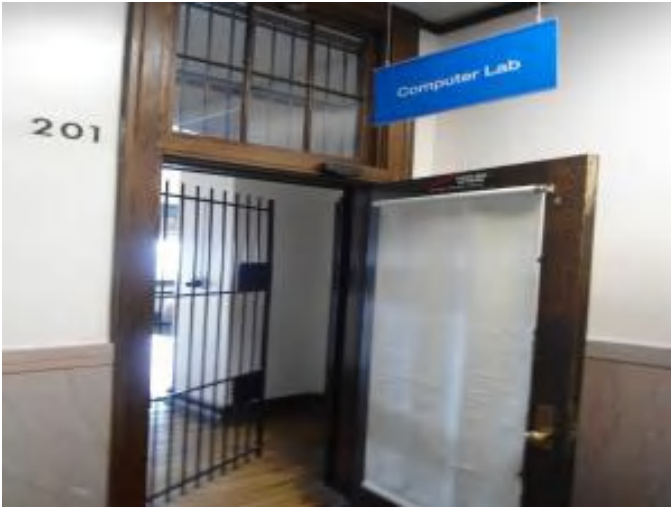
**System: C1020 - Interior Doors**

**Location:** Building Wide

**Distress:** Beyond Service Life

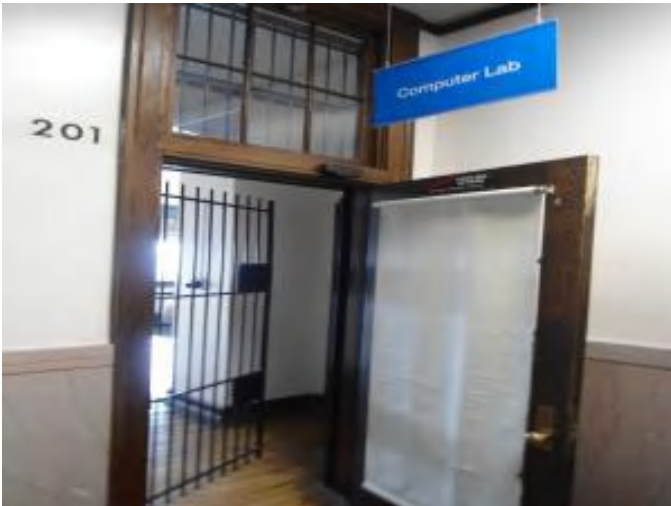
**System: C1030 - Fittings**

**Location:** Building Wide Signage

**Distress:** Damaged

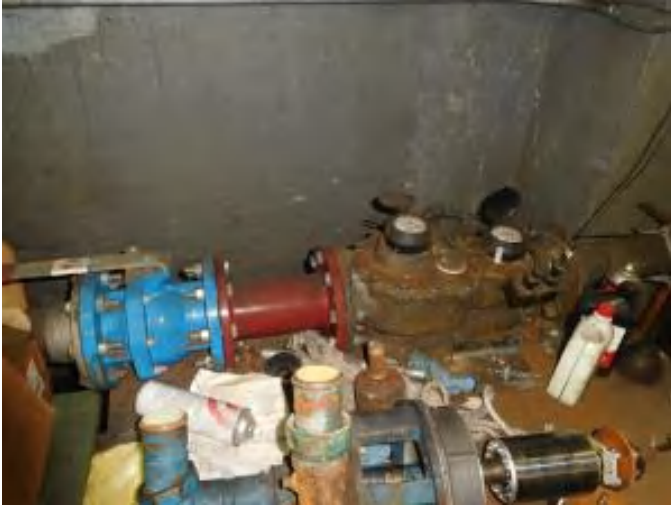
**System: D2020 - Domestic Water Distribution**

**Location:** mechanical room

**Distress:** Building / MEP Codes

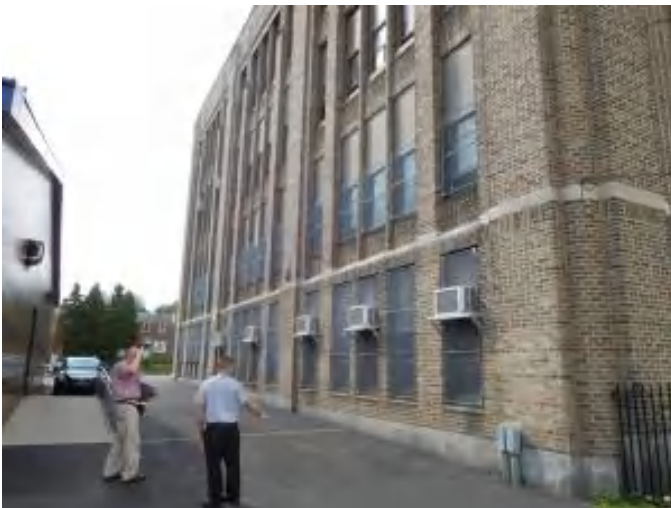
**System: D3030 - Cooling Generating Systems**

**Location:** roof, mechanical room

**Distress:** Inadequate

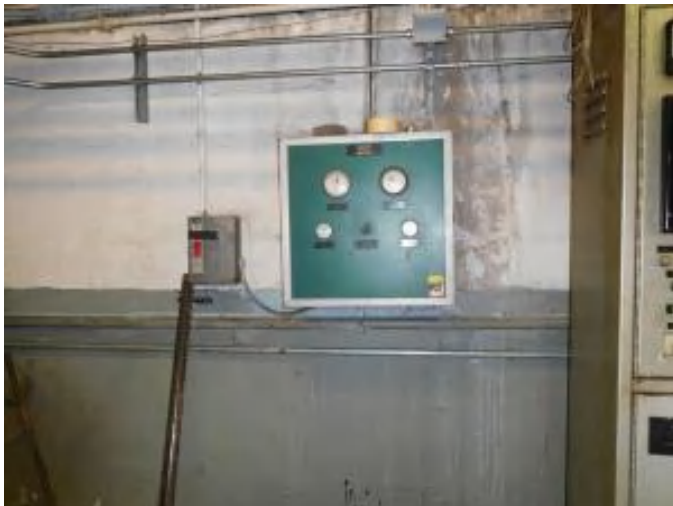
**System: D3060 - Controls & Instrumentation**

**Location:** entire building

**Distress:** Inadequate

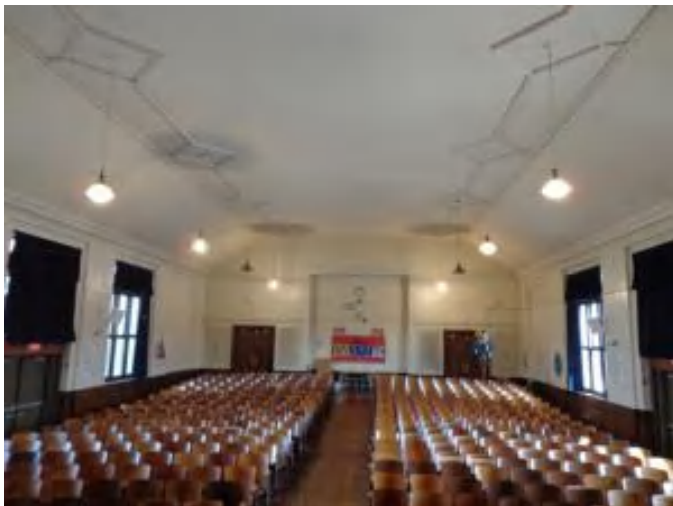
**System: D5020 - Lighting and Branch Wiring**

**Location:** Auditorium

**Distress:** Beyond Service Life

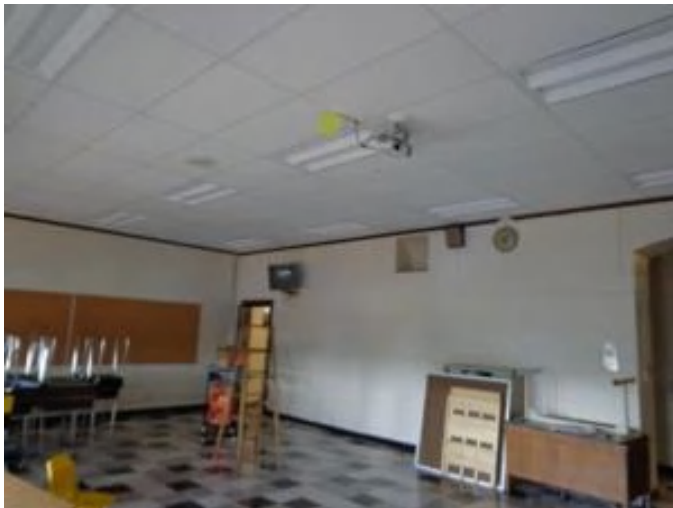
**System: D5030 - Communications and Security**

**Location:** Entire Building

**Distress:** Beyond Service Life

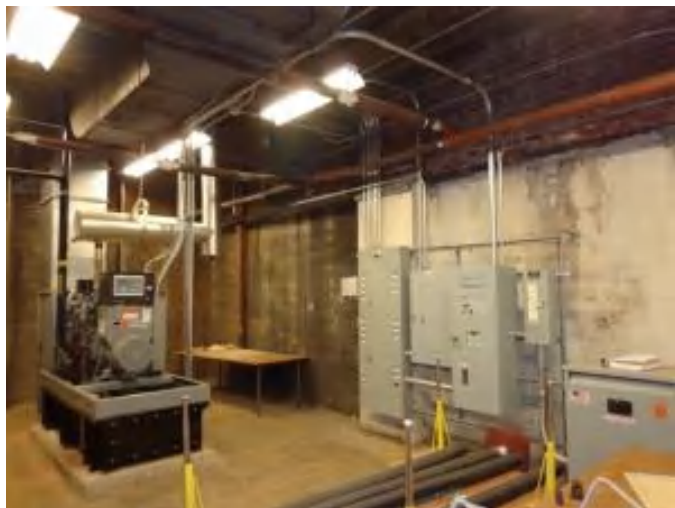
**System: D5090 - Other Electrical Systems**

**Location:** Main Electrical Room

**Distress:** Inadequate

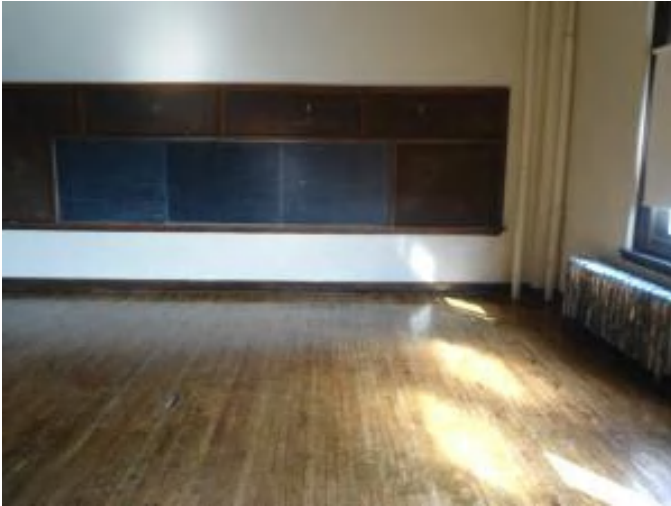
**System: C1030 - Fittings**

**Location:** Building Wide

**Distress:** Beyond Service Life

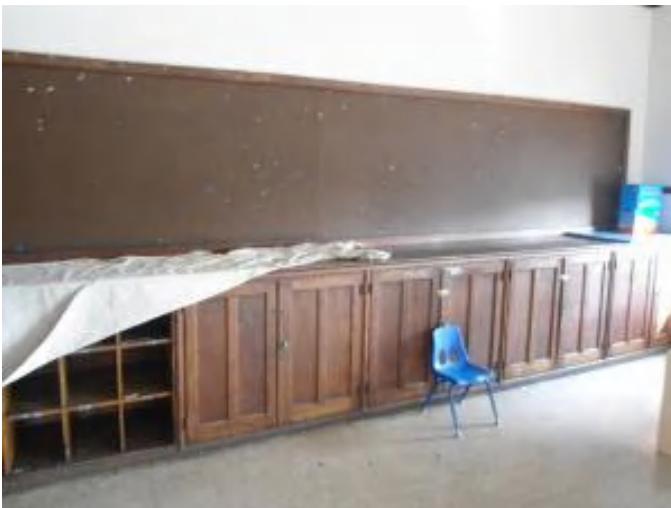
**System: C1030 - Fittings**

**Location:** Building Wide

**Distress:** Beyond Service Life

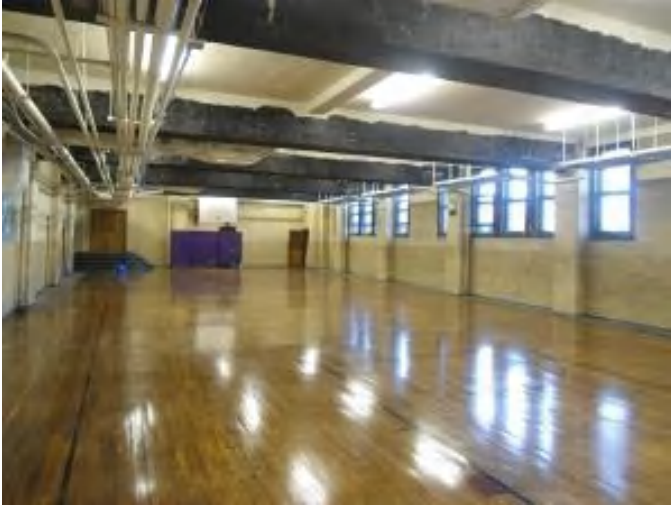
**System: C3020414 - Wood Flooring**

**Location:** Gym

**Distress:** Damaged

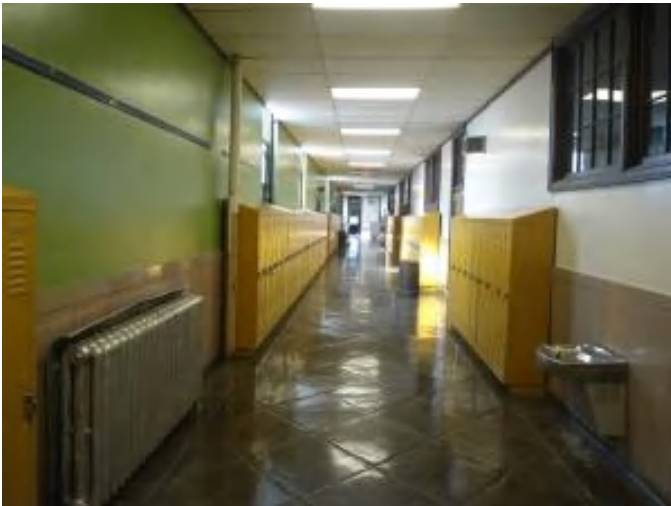
**System: D1010 - Elevators and Lifts**

**Location:** Building Wide

**Distress:** Accessibility

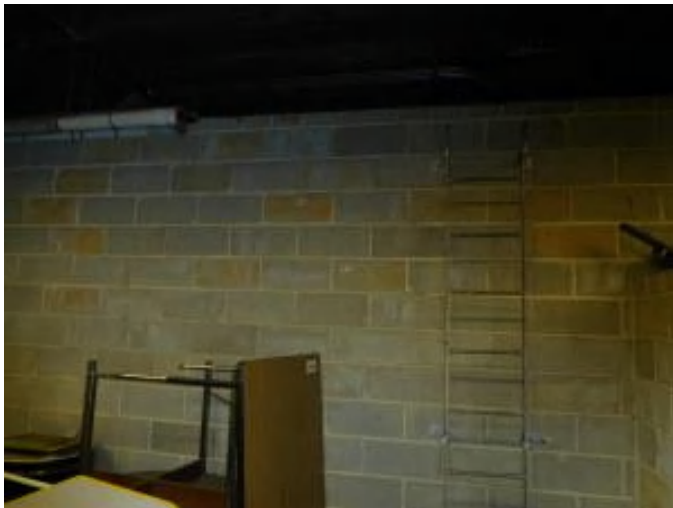
**System: D3020 - Heat Generating Systems**

**Location:** exterior, mechanical room

**Distress:** Health Hazard / Risk

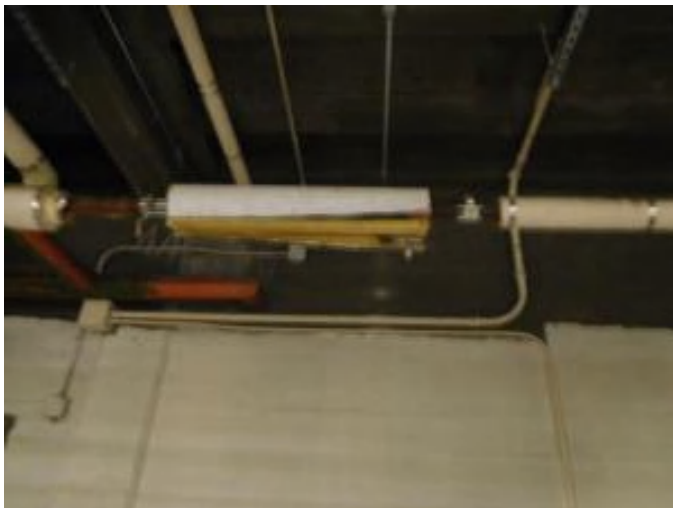
**System: D3020 - Heat Generating Systems**

**Location:** mechanical room

**Distress:** Beyond Service Life

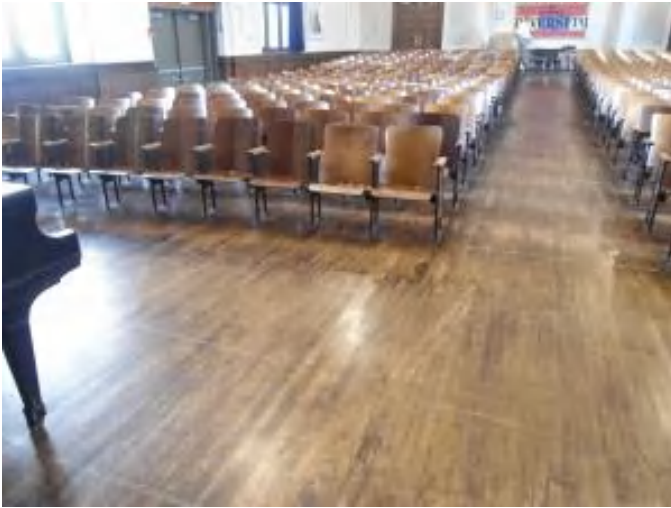
**System: E2010 - Fixed Furnishings**

**Location:** Auditorium

**Distress:** Beyond Service Life

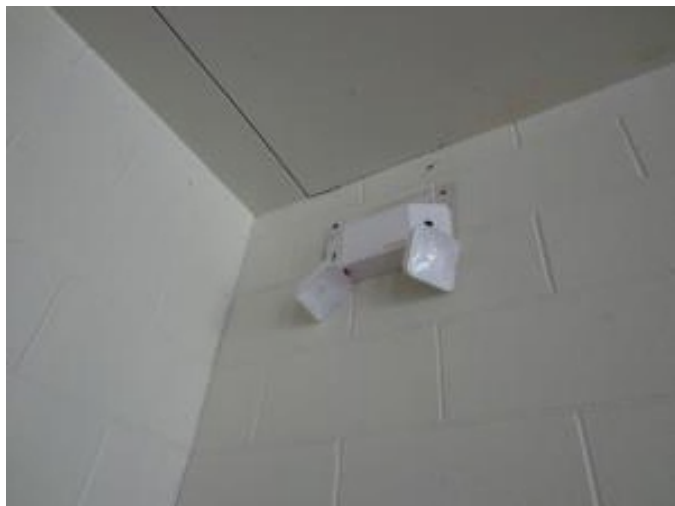
#### System: D5090 - Other Electrical Systems

**Location:** Multi-Purpose Room

**Distress:** Damaged

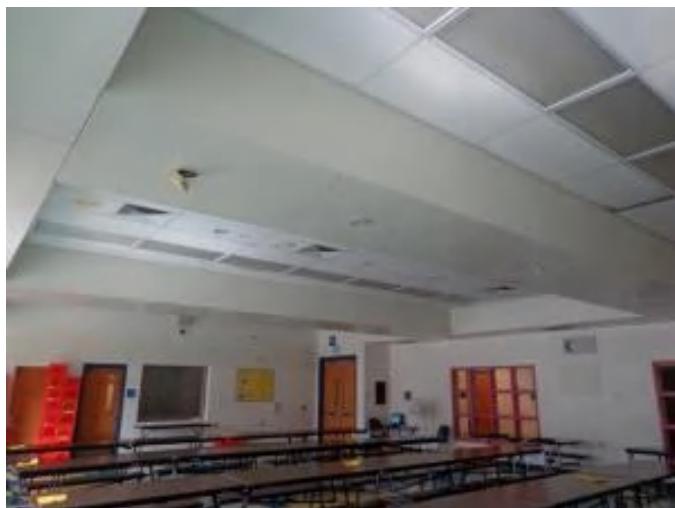
**System: D5030 - Communications and Security**

**Location:** Multi-Purpose Room

**Distress:** Appearance

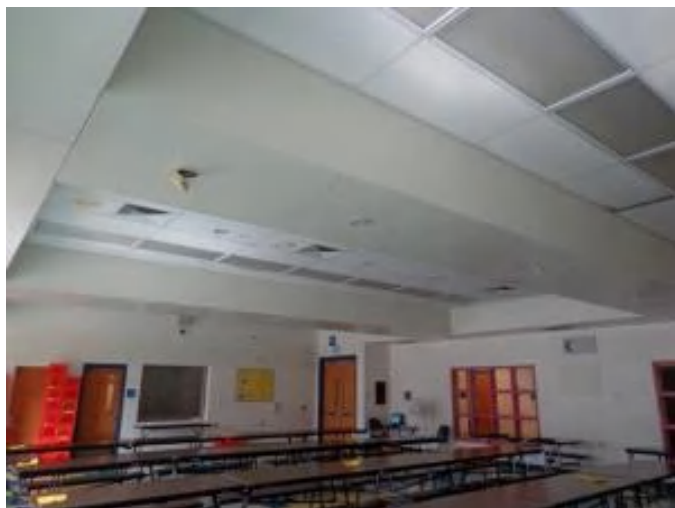
**System: D5020 - Lighting and Branch Wiring**

**Location:** Multi-Purpose Room

**Distress:** Maintenance Required

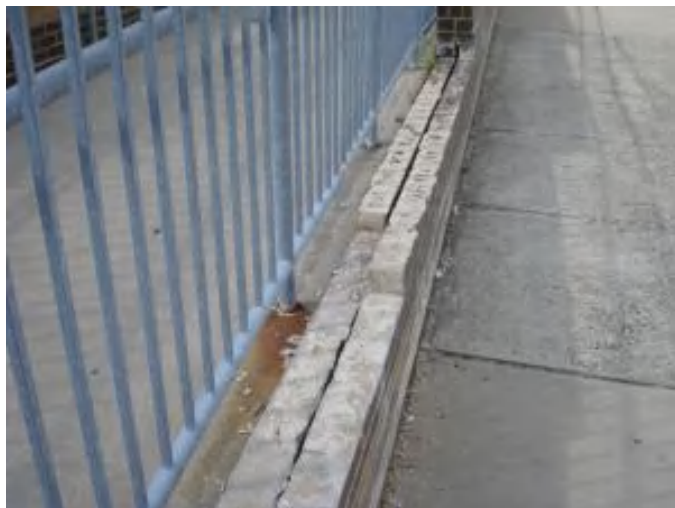
#### System: G2040 - Site Development

**Location:** LSH Site

**Distress:** Health Hazard / Risk

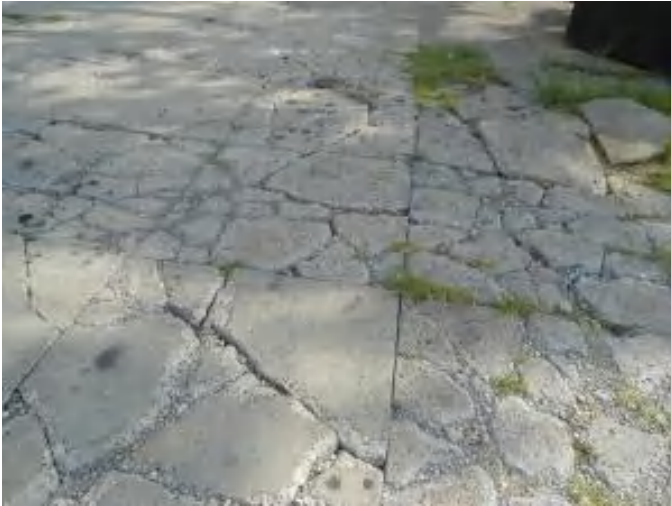
**System: G2030 - Pedestrian Paving**

**Location:** Sidewalks

**Distress:** Damaged

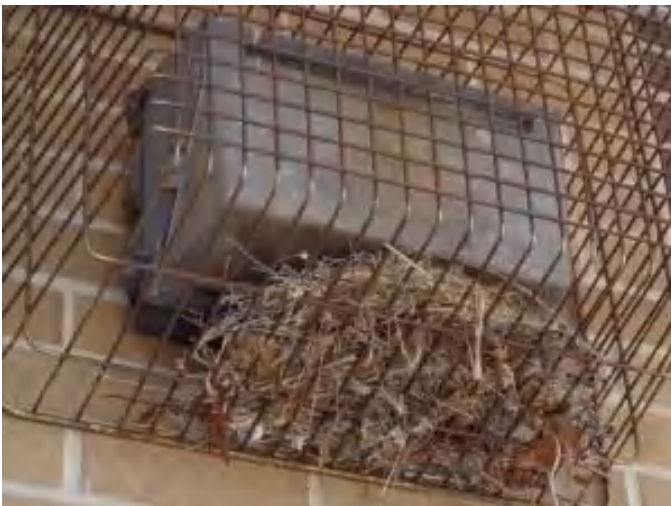
**System: G4020 - Site Lighting**

**Location:** Building Exterior

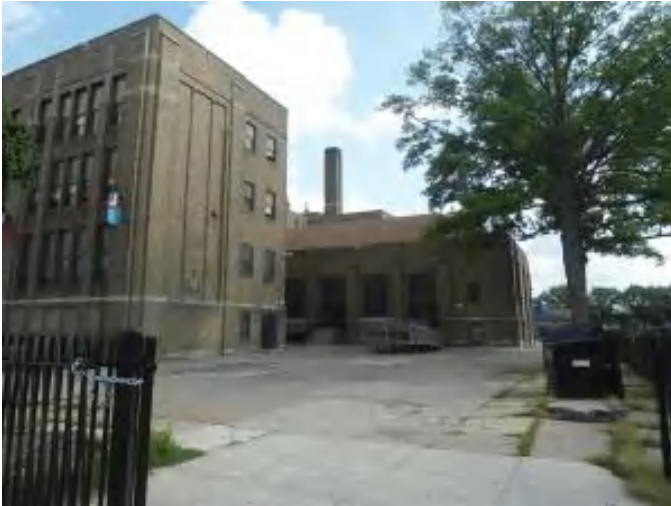
**System: G2040 - Site Development**

**Location:** Site

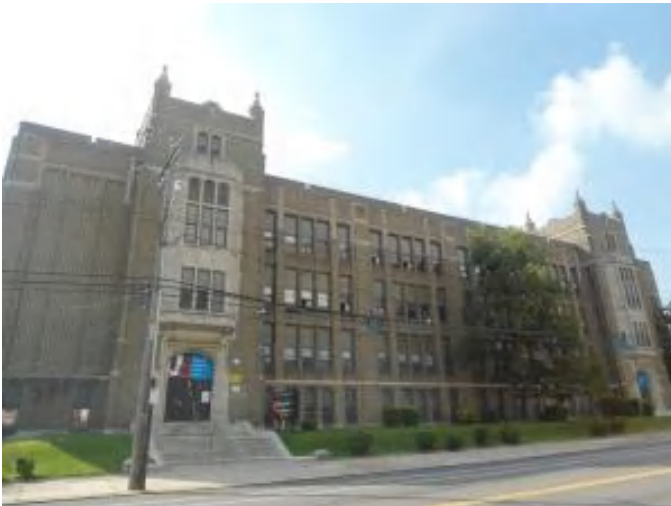
**System: G2050 - Landscaping & Irrigation**

**Location:** G724001;Grounds
