## Facility Condition Assessment Summary Report

### Crossan School

School District of Philadelphia  
**S823001; Crossan**  
Final  
**Site Assessment Report**

January 31, 2017

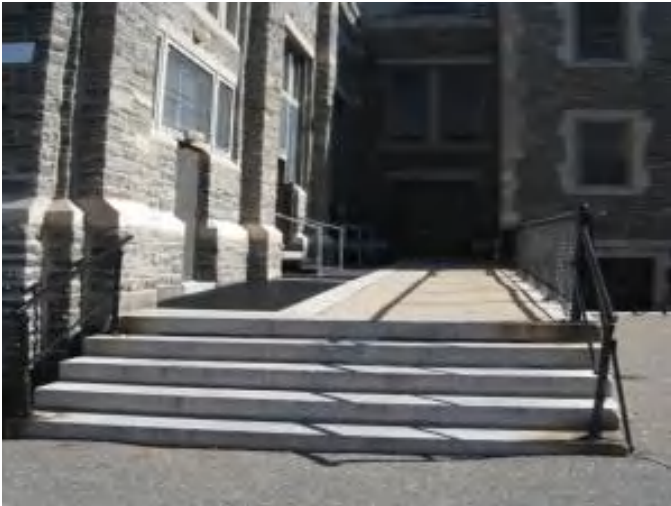
#### System: B2010 - Exterior Walls

**Location:** exterior walkway along auditorium

**Distress:** Failing

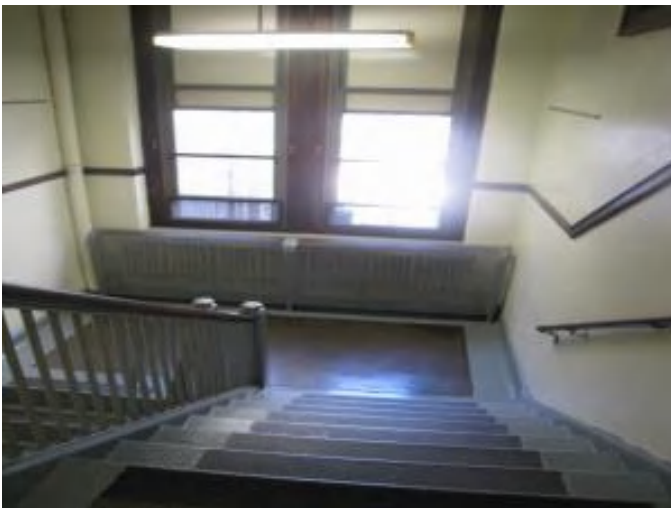
#### System: C2010 - Stair Construction

**Location:** stairways

**Distress:** Building / MEP Codes

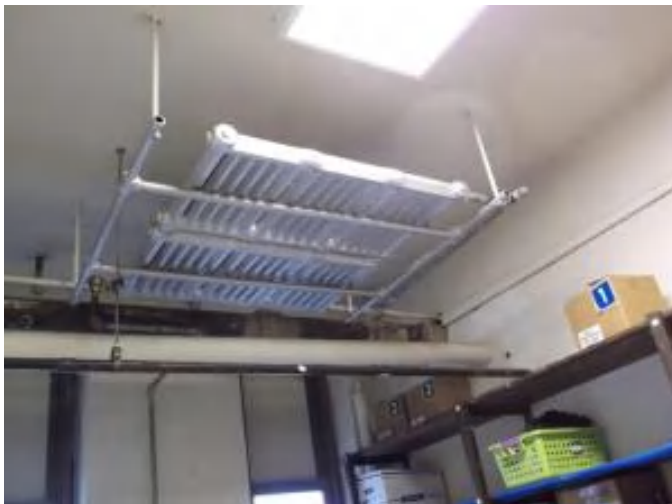
**System: D3040 - Distribution Systems**

**Location:** Throughout the building

**Distress:** Beyond Service Life

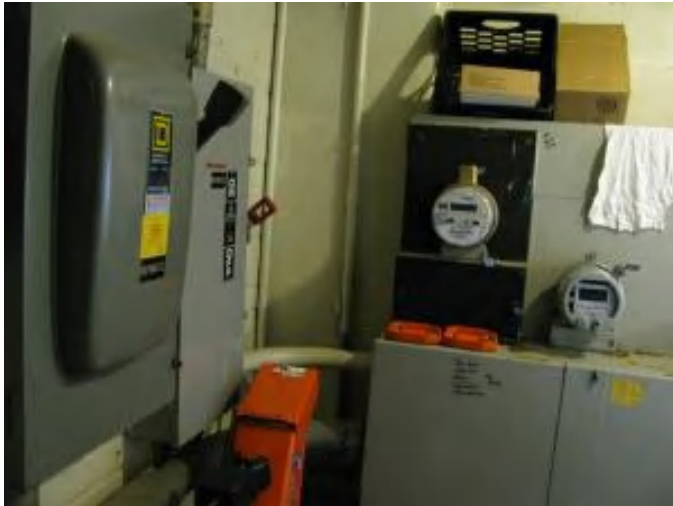
**System: D5010 - Electrical Service/Distribution**

**Location:** Electrical Room  
**Distress:** Inadequate  
**Category:** 4 - Capital Improvement  
**Priority:** 1 - Response Time (< 2 yr)  
**Correction:** Replace Switchboard  
**Qty:** 1.00

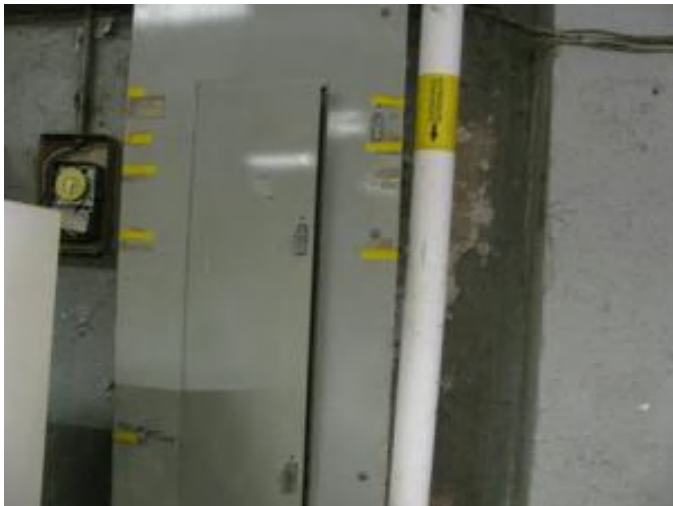
**System: D5010 - Electrical Service/Distribution**

**Location:** Entire Building  
**Distress:** Beyond Service Life  
**Category:** 3 - Operations / Maint.  
**Priority:** 1 - Response Time (< 2 yr)  
**Correction:** Replace Electrical Distribution System (U)  
**Qty:** 1.00

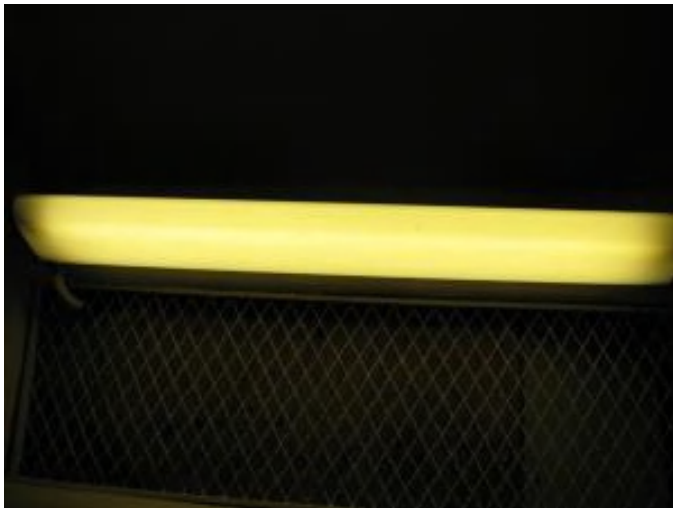
**System: D5020 - Lighting and Branch Wiring**

**Location:** Entire Building  
**Distress:** Beyond Service Life  
**Category:** 3 - Operations / Maint.  
**Priority:** 1 - Response Time (< 2 yr)  
**Correction:** Replace lighting fixtures  
**Qty:** 1.00  
**Unit of Measure:** Ea.  
**Estimate:** \$62,852.11  
**Assessor Name:** System  
**Date Created:** 10/19/2015

**Notes:** Replace existing lighting fixtures with new fluorescent fixtures where needed. Estimated 40 each. Replace existing incandescent fixtures in basement and other area with fluorescent lighting fixtures. Estimated 25 each. Replace gymnasium illuminates with LED high bay . Estimated 15 each.

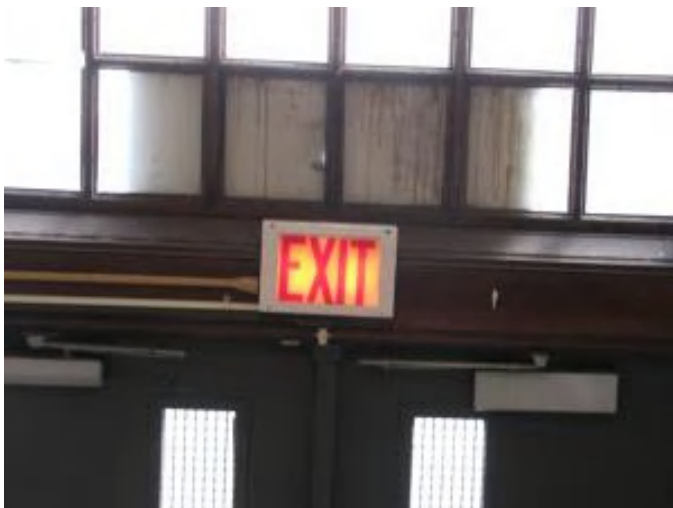
**System: D5020 - Lighting and Branch Wiring**

**Location:** Entire Building  
**Distress:** Inadequate  
**Category:** 4 - Capital Improvement  
**Priority:** 1 - Response Time (< 2 yr)  
**Correction:** Replace lighting fixtures  
**Qty:** 1.00  
**Unit of Measure:** Ea.  
**Estimate:** \$19,541.71  
**Assessor Name:** System  
**Date Created:** 10/19/2015

**Notes:** Replace existing exit signs with battery pack types. Estimated 25 each

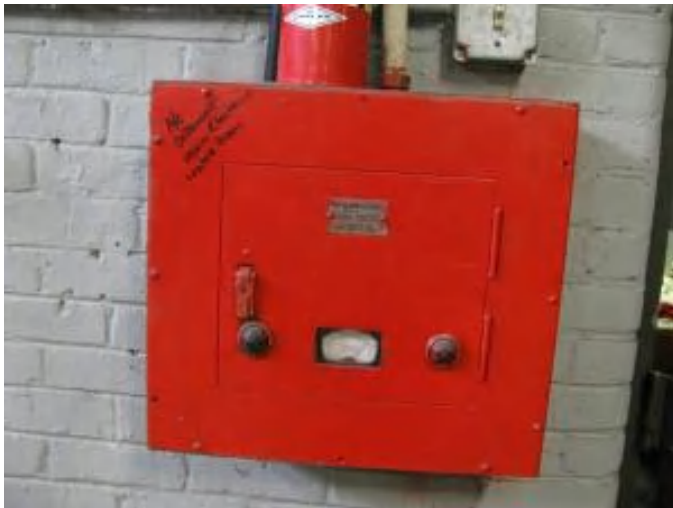
**System: D5030 - Communications and Security**

**Location:** Entire Building  
**Distress:** Beyond Service Life  
**Category:** 3 - Operations / Maint.  
**Priority:** 1 - Response Time (< 2 yr)  
**Correction:** Replace fire alarm system  
**Qty:** 1.00  
**Unit of Measure:** S.F.  
**Estimate:** \$170,192.75  
**Assessor Name:** System  
**Date Created:** 10/19/2015

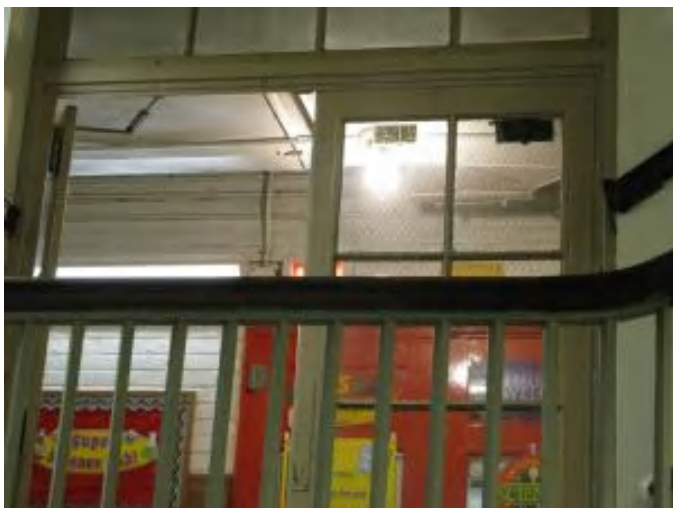
**System: D5030 - Communications and Security**

**Location:** Entire Building  
**Distress:** Security Issue  
**Category:** 1 - Health & Safety  
**Priority:** 1 - Response Time (< 2 yr)  
**Correction:** Add/Replace Video Surveillance System  
**Qty:** 1.00  
**Unit of Measure:** Ea.  
**Estimate:** \$97,759.65  
**Assessor Name:** System  
**Date Created:** 10/19/2015

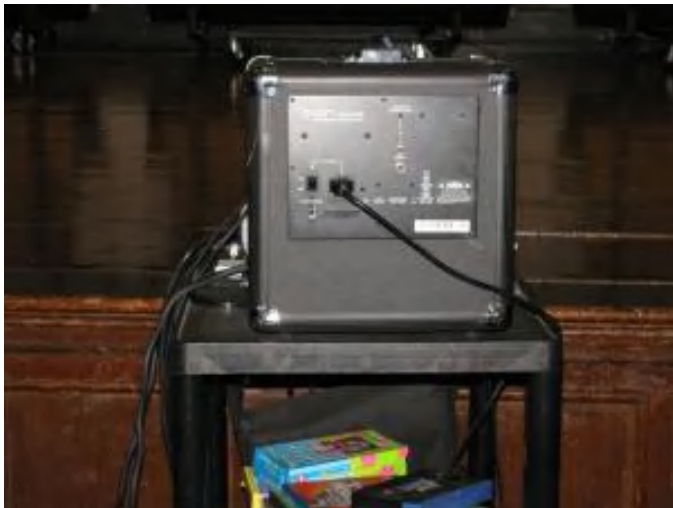
**System: D5030 - Communications and Security**

**Location:** Auditorium  
**Distress:** Beyond Service Life  
**Category:** 3 - Operations / Maint.  
**Priority:** 1 - Response Time (< 2 yr)  
**Correction:** Add/Replace Sound System  
**Qty:** 1.00  
**Unit of Measure:** LS  
**Estimate:** \$38,400.80  
**Assessor Name:** System  
**Date Created:** 10/19/2015

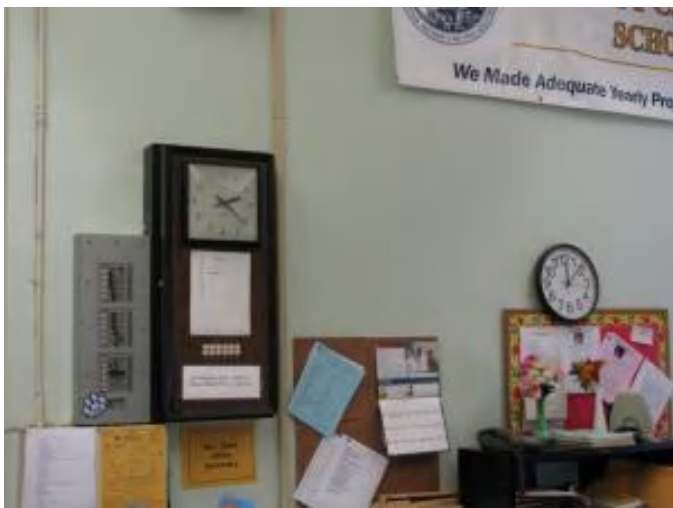
**System: D5030 - Communications and Security**

**Location:** Entire Building  
**Distress:** Inadequate  
**Category:** 4 - Capital Improvement  
**Priority:** 1 - Response Time (< 2 yr)  
**Correction:** Add/Replace Clock System or Components  
**Qty:** 1.00  
**Unit of Measure:** Ea.  
**Estimate:** \$22,679.90  
**Assessor Name:** System  
**Date Created:** 10/19/2015

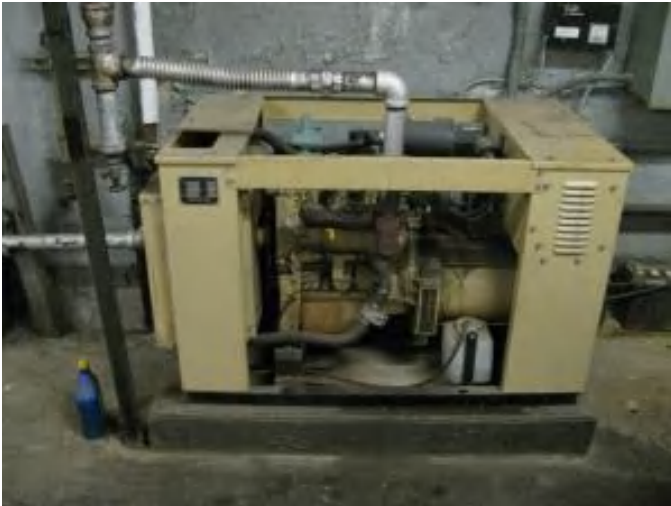
**System: D5090 - Other Electrical Systems**

**Location:** Boiler Room  
**Distress:** Beyond Service Life  
**Category:** 3 - Operations / Maint.  
**Priority:** 1 - Response Time (< 2 yr)  
**Correction:** Replace standby generator system  
**Qty:** 1.00  
**Unit of Measure:** Ea.  
**Estimate:** \$77,696.29  
**Assessor Name:** System  
**Date Created:** 10/19/2015

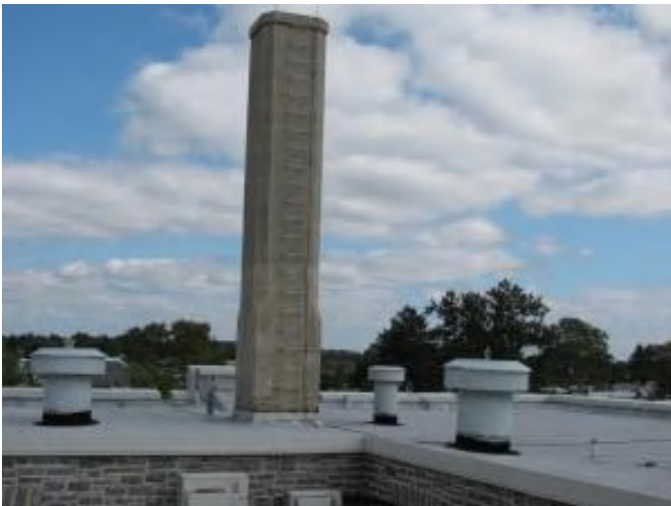
**System: D5090 - Other Electrical Systems**

**Location:** Roof  
**Distress:** Life Safety / NFPA / PFD  
**Category:** 1 - Health & Safety  
**Priority:** 1 - Response Time (< 2 yr)  
**Correction:** Provide Lightning Protection System  
**Qty:** 1.00  
**Unit of Measure:** LS  
**Estimate:** \$27,722.35  
**Assessor Name:** System  
**Date Created:** 10/19/2015

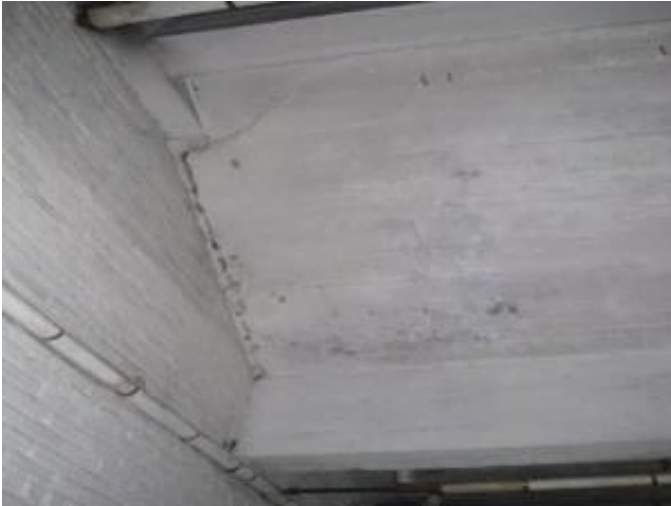
**System: A2020 - Basement Walls**

**Location:** basement walls

**Distress:** Failing

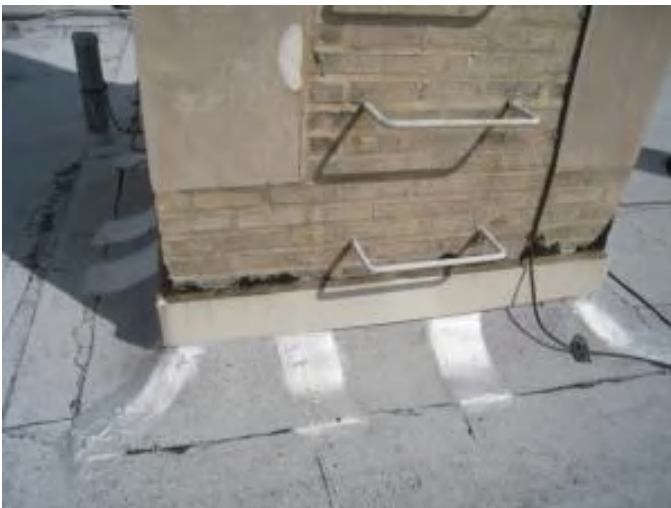
**System: B2010 - Exterior Walls**

**Location:** chimney

**Distress:** Failing

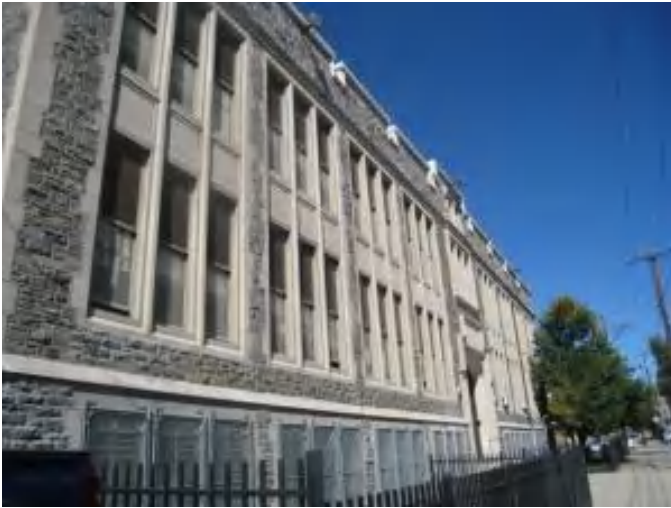
**System: B2020 - Exterior Windows**

**Location:** exterior windows

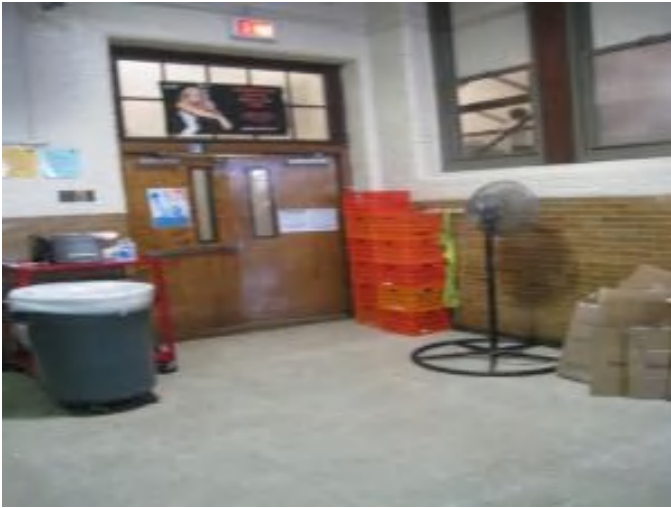
**System: C3020413 - Vinyl Flooring**

**Location:** gymateria  
**Distress:** Failing  
**Category:** 3 - Operations / Maint.  
**Priority:** 2 - Response Time (2-3 yrs)  
**Correction:** Remove and replace VCT  
**Qty:** 3,150.00  
**Unit of Measure:** S.F.  
**Estimate:** \$37,855.22  
**Assessor Name:** System  
**Date Created:** 01/04/2016

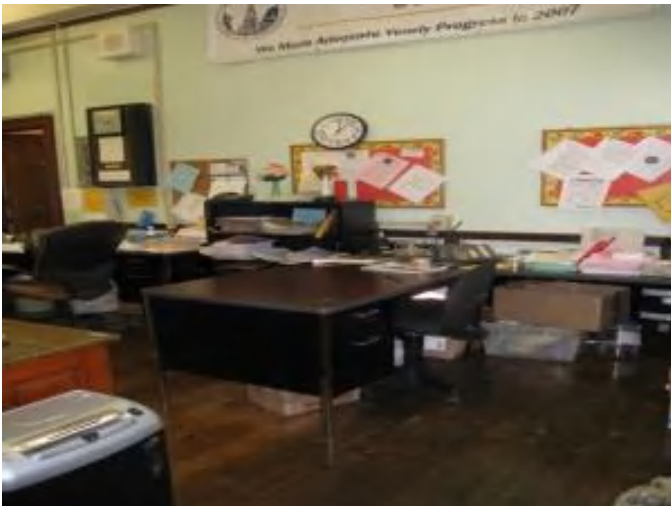
**System: C3020414 - Wood Flooring**

**Location:** classrooms  
**Distress:** Appearance  
**Category:** 3 - Operations / Maint.  
**Priority:** 2 - Response Time (2-3 yrs)  
**Correction:** Refinish wood floors  
**Qty:** 14,150.00  
**Unit of Measure:** S.F.  
**Estimate:** \$152,352.20  
**Assessor Name:** System  
**Date Created:** 01/04/2016
