### Daroff School

**S421001;Daroff**

**Site Assessment Report**

**February 1, 2017**

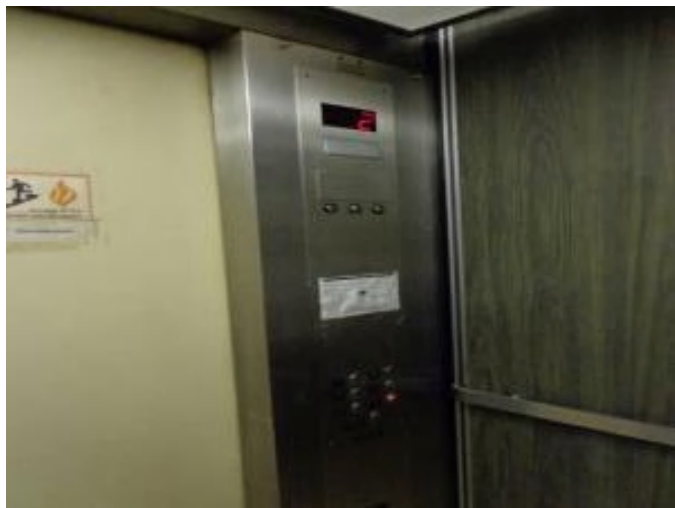
**Location:** Elevator Pit off Main Office

**Distress:** Beyond Service Life

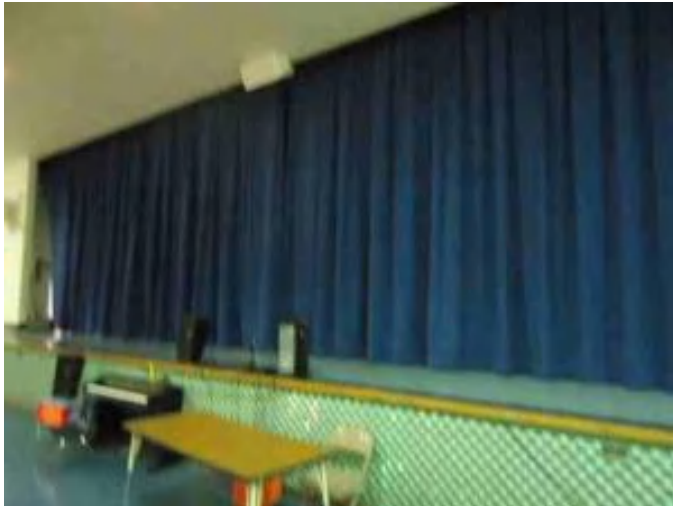
**Location:** Stage

**Distress:** Life Safety / NFPA / PFD

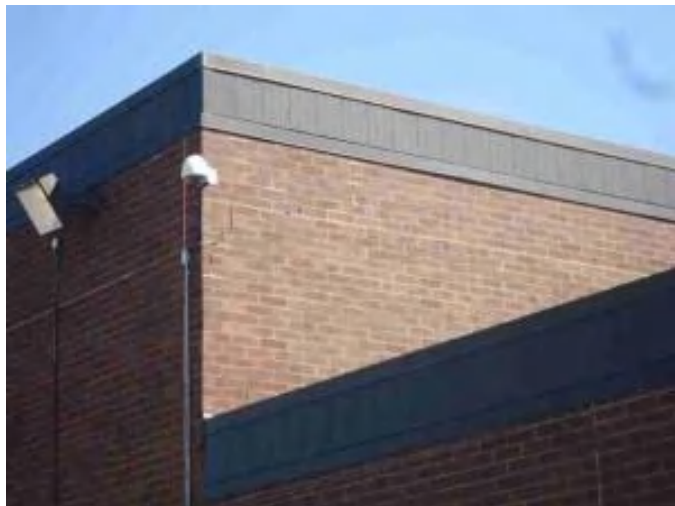
**Location:** Exterior Elevation

The exterior brick surfaces are generally in fair to very good condition for their age. The exterior brick finish facing Race Street and from the corner of North Fifty-Sixth Street to the main entrance is damaged. In some locations, bricks have cracked and should be replaced. The repointing of deteriorated mortar joints is also recommended, using mortar of a similar color and consistency as the original. Following the detailed examination of the brick and repair of mortar construction joints, the entire building should be pressure washed to remove stains and embedded pollutants. If moisture is found to be penetrating the masonry facade, the application of a spray sealant to the suspected exterior masonry surface is recommended.

**Distress:** Damaged

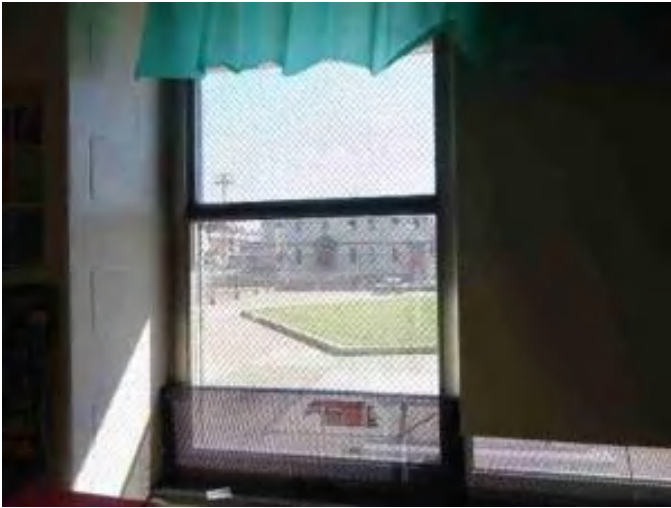
**Location:** Exterior Elevation

The windows appear to be original to the buildings construction several of the windows no longer work and will require attention prior to an overall effort. The windows are in poor condition. The entire exterior window system is recommended to be replaced with units that retain their dimensions and profiles, but that incorporate updated energy-efficient features.

**Distress:** Damaged

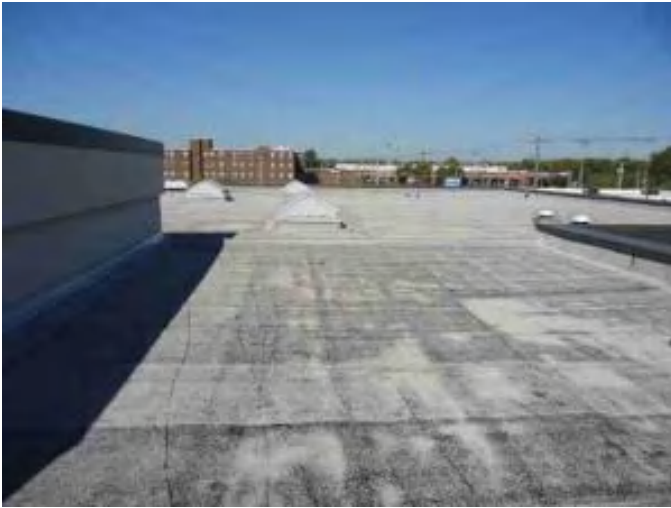
**Location:** Roof

There are a number of roof sections and different roof elevations ranging from the main roof to the mechanical roof. The built up application was reported to have been installed in the early 1990'S. Considering the age and condition of the roofing systems, universal upgrades are recommended.

**Distress:** Damaged

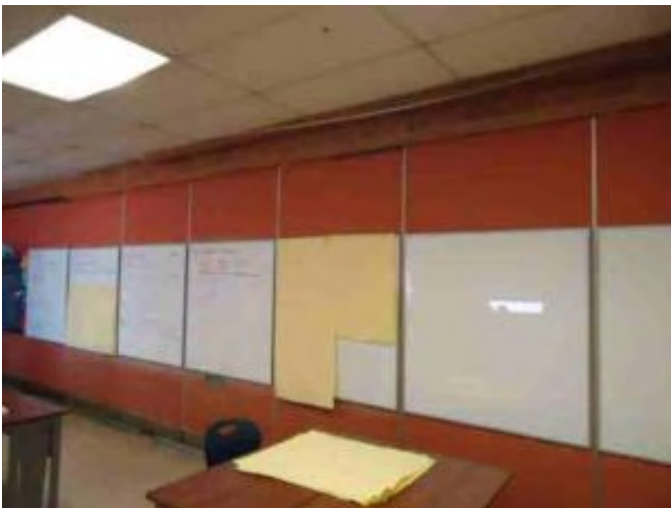
**Location:** Classroom

Interior partitions include painted CMU, glazed block and moveable partitions. There are several movable partitions that remain in classrooms. These wall systems are no longer used and in most cases cannot be used due to damage or wall modifications to support classroom needs. This deficiency provides a budgetary consideration to remove and replace the wall systems with universal removal of the existing movable partitions and upgrades to a permeate wall systems.

**Distress:** Damaged

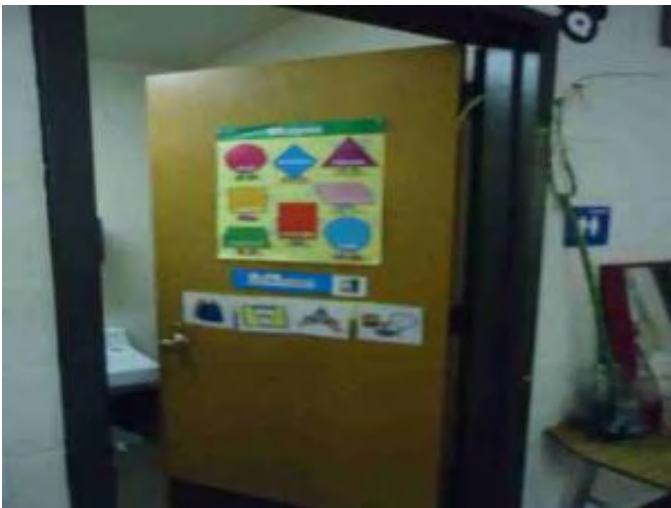
**Location:** Classrooms

**Distress:** Damaged

**Notes:** Interior doors are typically wood in wood frames with wooden transom and wired glass glazing. Other interior doors include hollow metal in hollow metal frames at some of the stairwells and exit ways, access doors. Doors are generally in fair condition and is a mix of ADA compliant and non-complaint doors with both non-rated and fire rated. Several of the classroom doors are aging at a faster than normal rate for this application. Numerous repairs to locksets and door hardware have advanced the deterioration of the doors. This deficiency provides a budgetary consideration to replace a portion of the interior doors and frames with consideration for the physically challenged.

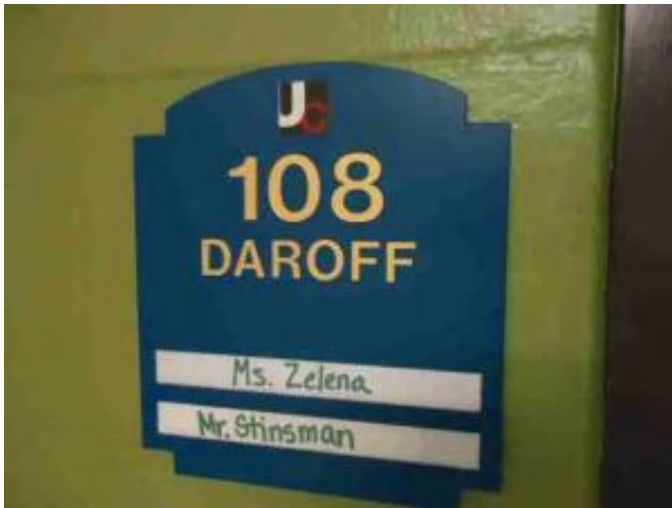
**Location:** Building Wide

**Distress:** Damaged

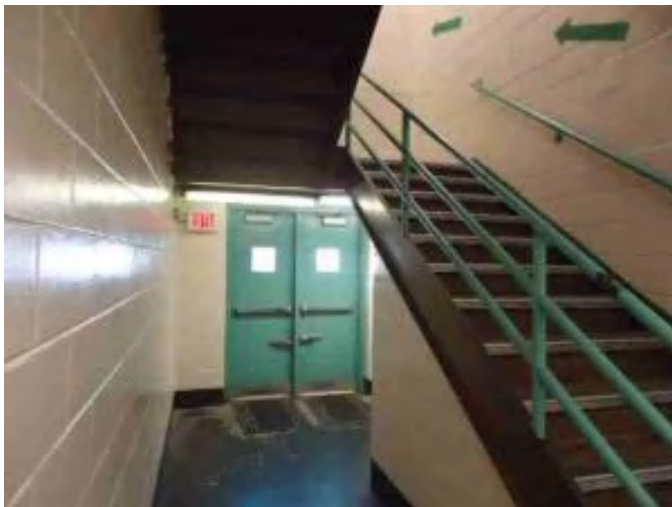
**Location:** Stairs

Current requirements for stairs indicate that they have graspable handrails on both sides, that the rails have a specific end geometry, and that the handrails continue horizontally at the landings. In addition, guardrails must prevent the passage of a 4 inch diameter sphere (6 inches in the triangle formed by the lower rail and tread/riser angle). Although the stairs are compliant with the code enforced at the time of construction until a major renovation occurs, they are deficient in handrail and guardrail design relative to current standards. Future efforts should include comprehensive stair railing removal and replacement upgrades.

**Distress:** Life Safety / NFPA / PFD

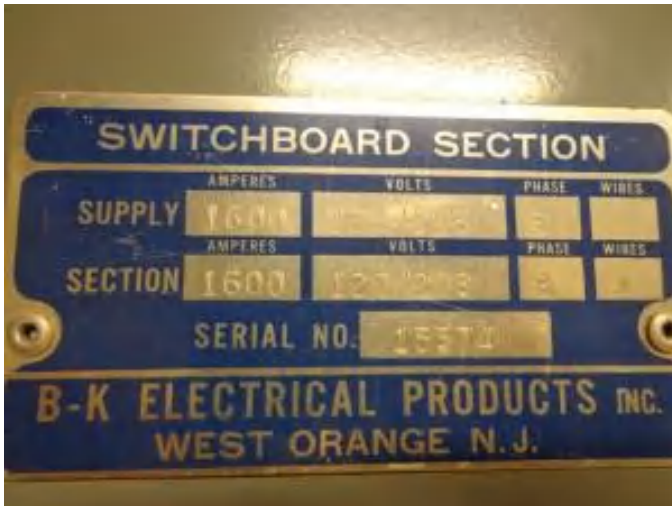
**Location:** Main Electrical Room 001

**Distress:** Beyond Service Life

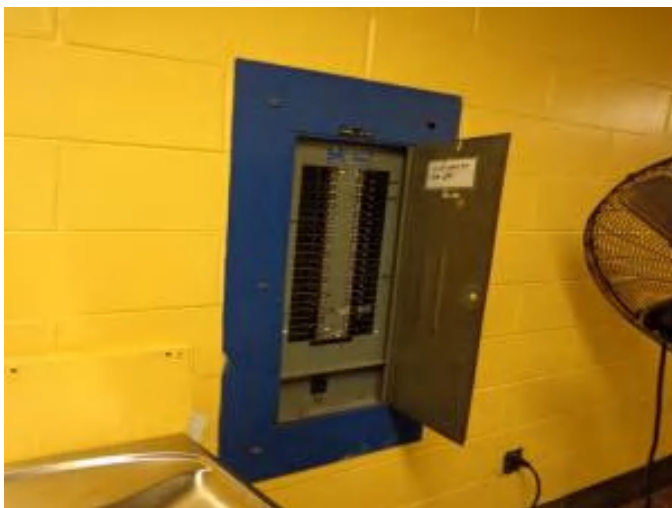
**Location:** Floors 1 and 2

**Distress:** Beyond Service Life

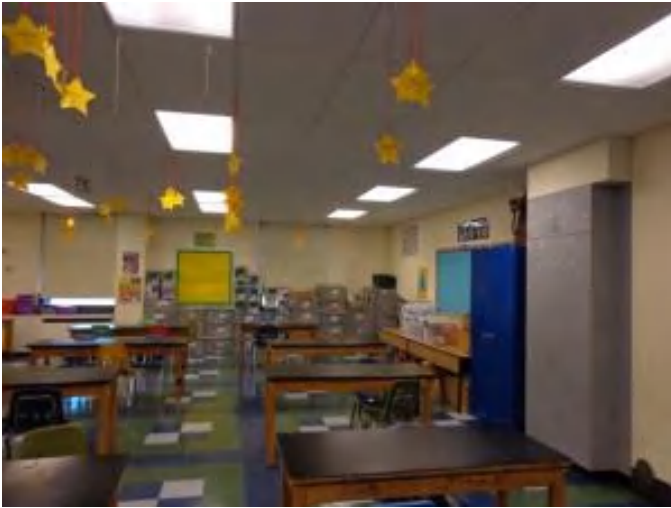
**Location:** Classrooms

**Distress:** Beyond Service Life

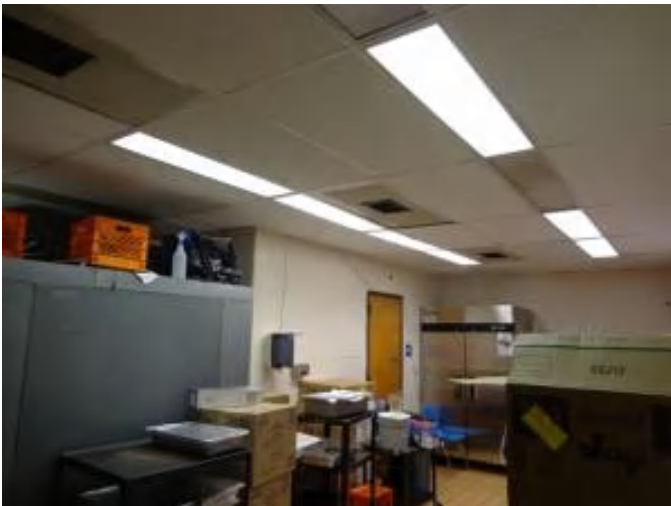
**Location:** Various locations

**Distress:** Beyond Service Life

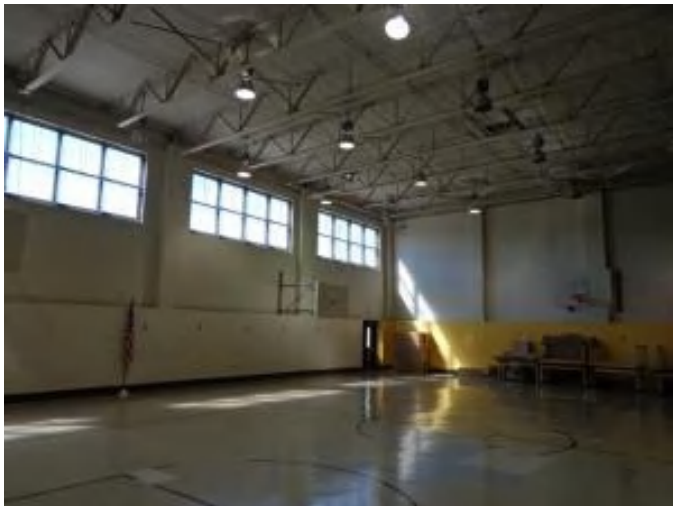
**Location:** Gymnasium

**Distress:** Beyond Service Life

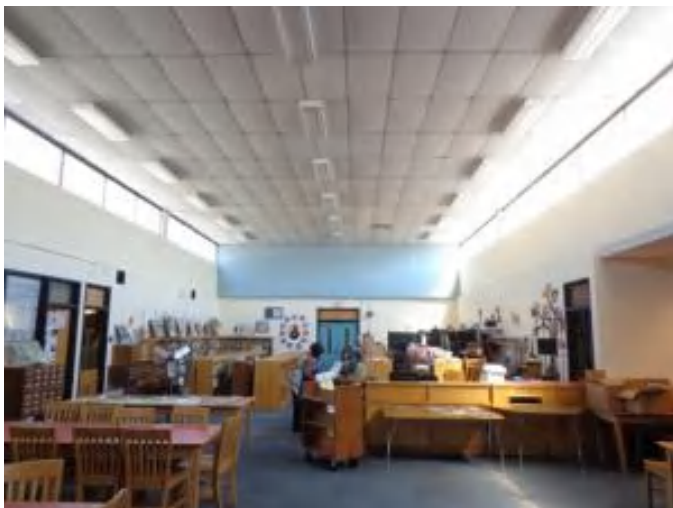
**Location:** IMC

**Distress:** Beyond Service Life

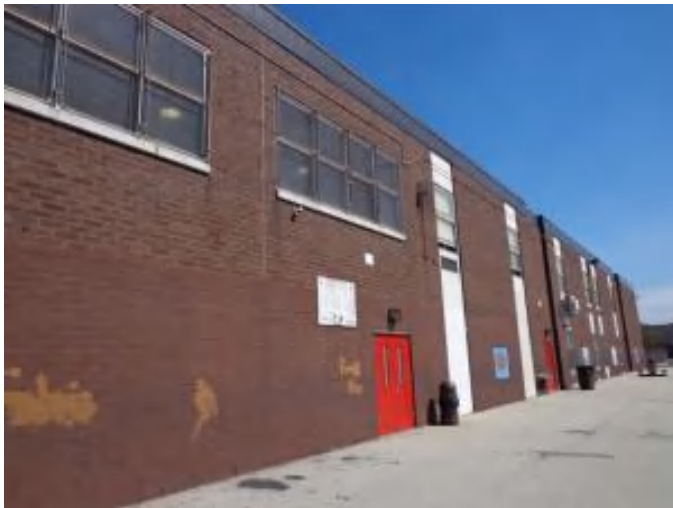
**Location:** Exit discharges

Incandescent wall mounted fixtures are provided above exterior egress doors. It is recommended fixtures be replaced with LED wall packs. There are also HID floodlight fixtures on the west and south sides of the building.

**Distress:** Energy Efficiency

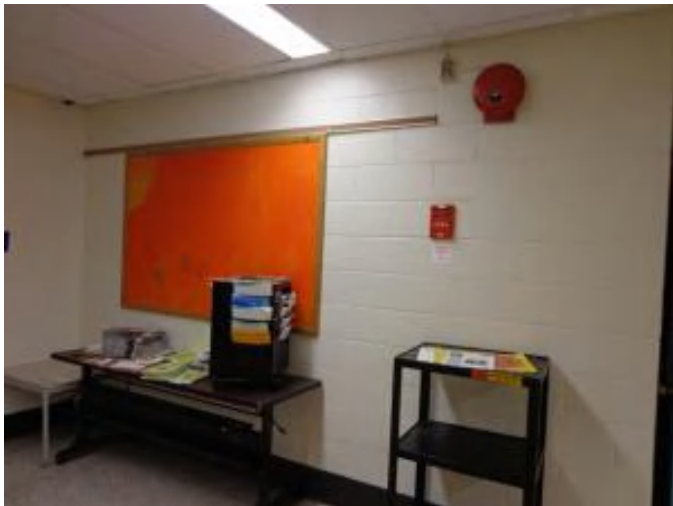
**Location:** Building wide

**Distress:** Life Safety / NFPA / PFD

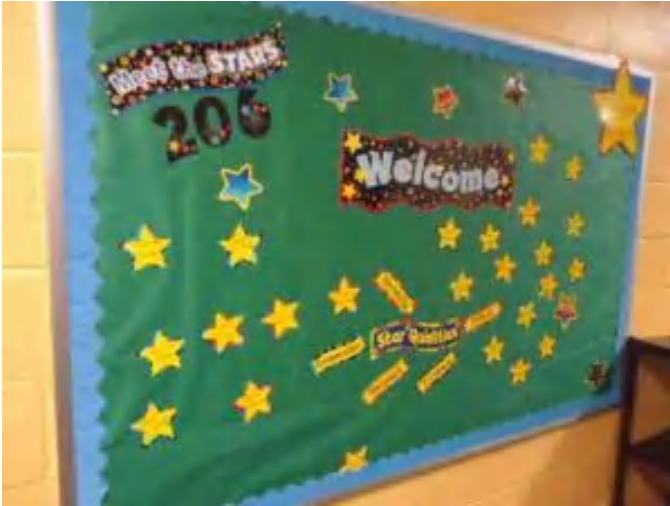
**Location:** Classroom

**Distress:** Damaged

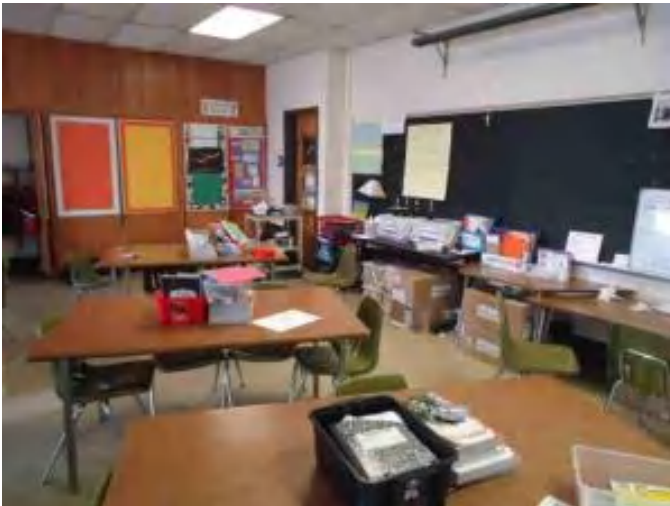
**Location:** Classroom

**Distress:** Damaged

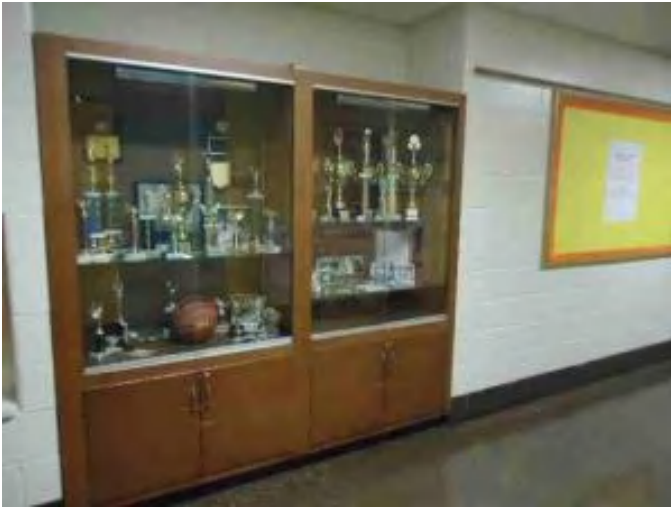
**Location:** Building Wide

There are painted walls, trim, and some painted ceilings in this building. The interior finishes are in fair condition and will require an almost continuous program of renewal of the applied finishes to maintain an acceptable appearance. Cyclical painting should be considered for a standard approach to maintaining the quality of the interior finishes. It is recommended that all previously painted surfaces be repainted according to established cycles for this occupancy and use type. Minor repairs should be completed before work begins.

**Distress:** Damaged

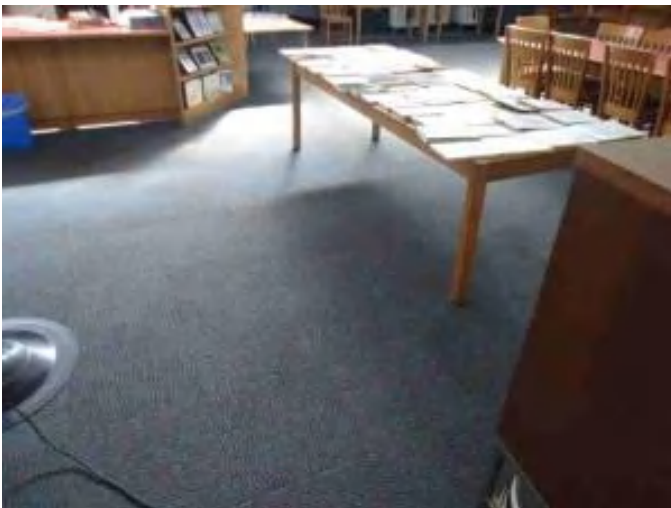
**Location:** IMC

**Distress:** Damaged

**Notes:** The interior carpet finish was installed approximately in 2010 and is in fair condition considering the age and high traffic conditions. This finish will exceed its expected life within the next five years and is recommended for removal and replacement.

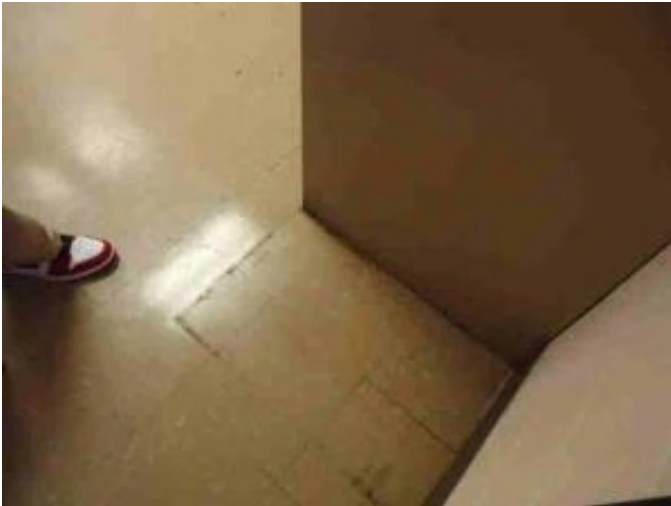
**Location:** Building Wide

The floor finish for this school is a combination of carpet in the administrative and IMC area, tile in the kitchen and service line areas, 12x12 classrooms, hallways and concrete stairs finishes. Some of the vinyl tile finish is a 9 x 9 application and is suspect to contain asbestos. This finish is recommended for upgrade to a new 12 x 12 vinyl tile application.

**Distress:** Health Hazard / Risk

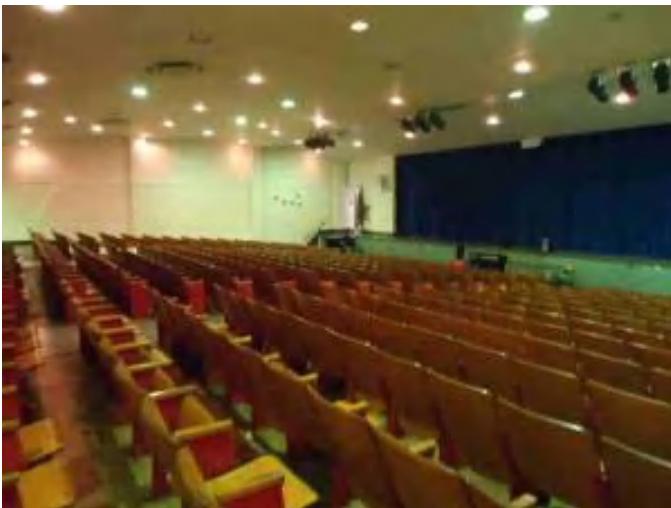
**Location:** Building Wide

The ceiling finish is a mix of 12 x 12 ceiling grid, painted and 2 x 4 Acoustical tile finish. Ceilings have been repaired in several areas and are in good condition considering the age of the application and the current condition of the school. The ceiling finish is expected to require upgrades to support the recommended efforts in this report prior to re-opening. This deficiency provides a budgetary consideration for removal and replacement of the current ceiling finish to a new acoustical tile finish. Considering the recommended mechanical and electrical upgrades this effort should be completed as part of an overall renewal program for the school.

**Distress:** Damaged

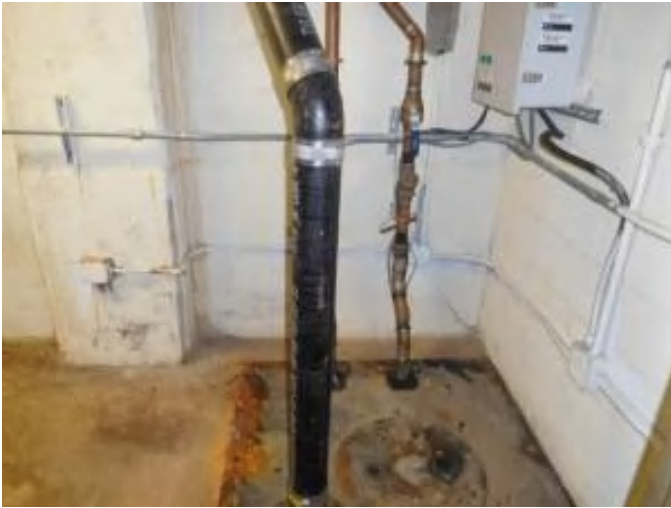
**Location:** entire building

**Distress:** Beyond Service Life

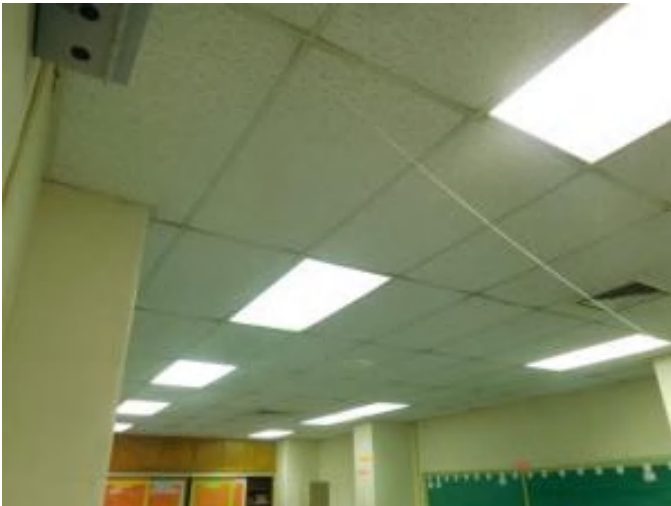
**Location:** interior classrooms

**Distress:** Building / MEP Codes

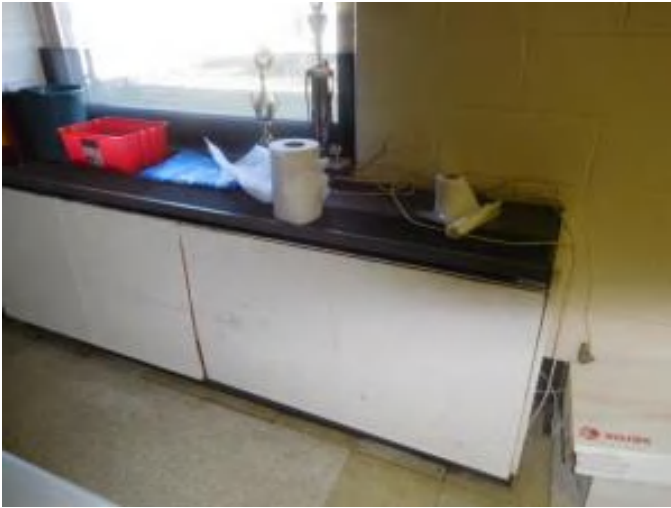
**Location:** exterior classrooms

**Distress:** Building / MEP Codes

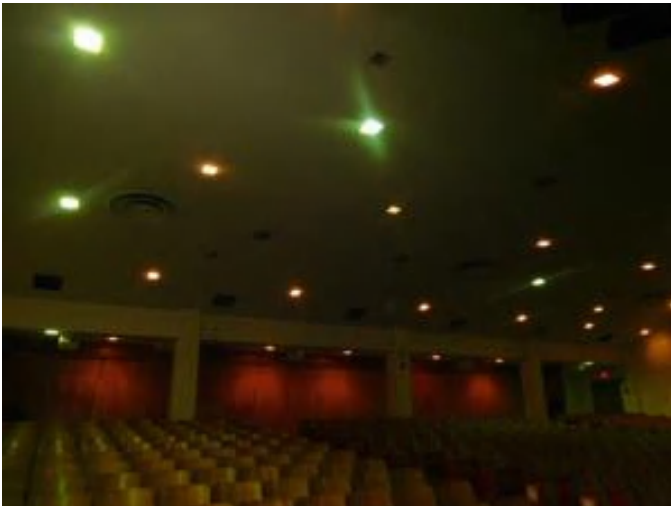
**Location:** auditorium

**Distress:** Building / MEP Codes

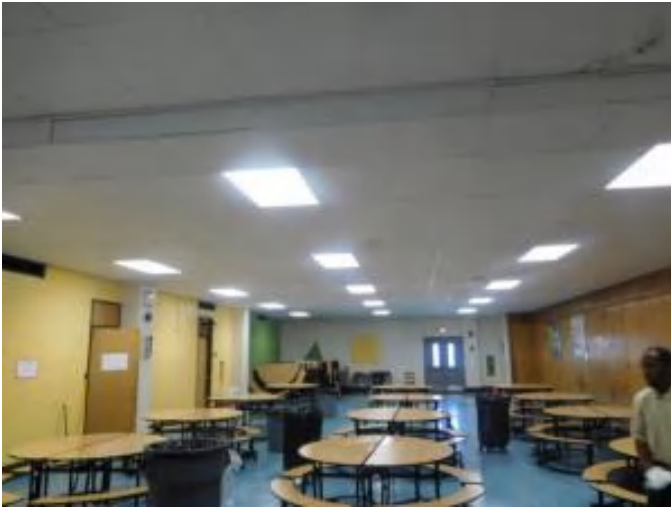
**Location:** cafeteria

**Distress:** Building / MEP Codes

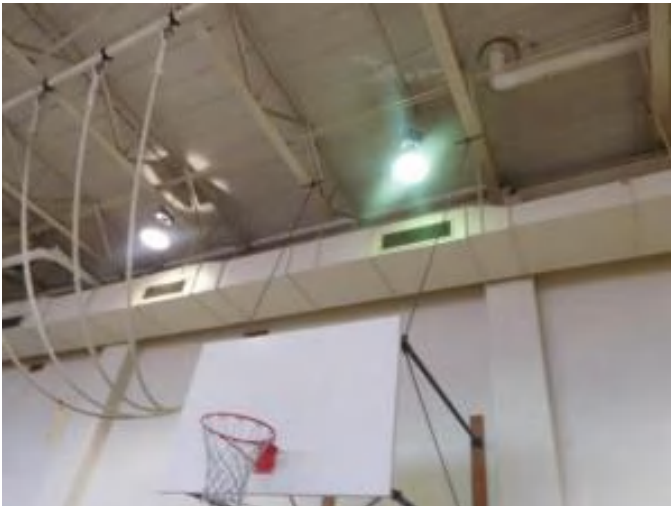
**Location:** gymnasium

**Distress:** Building / MEP Codes

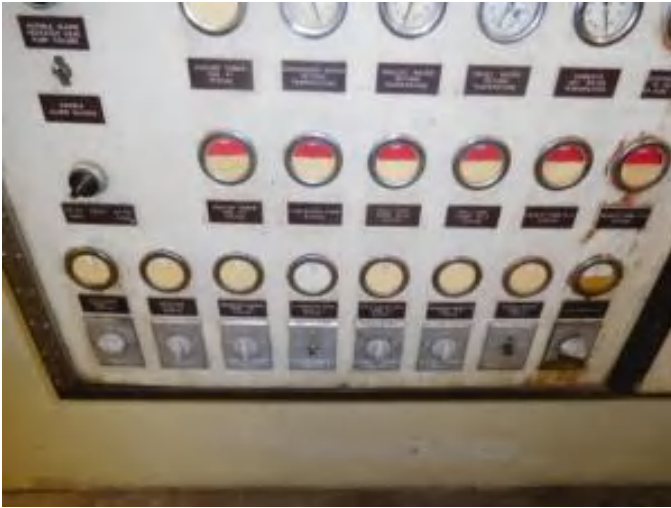
**Location:** entire building

**Distress:** Inadequate

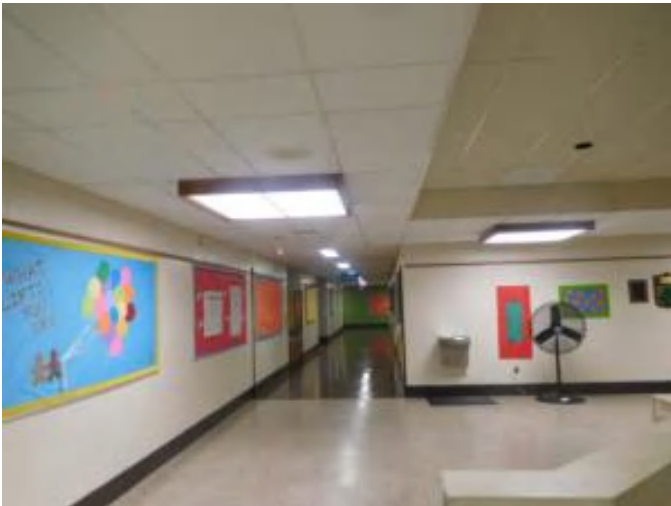
**Location:** entire building

**Distress:** Life Safety / NFPA / PFD

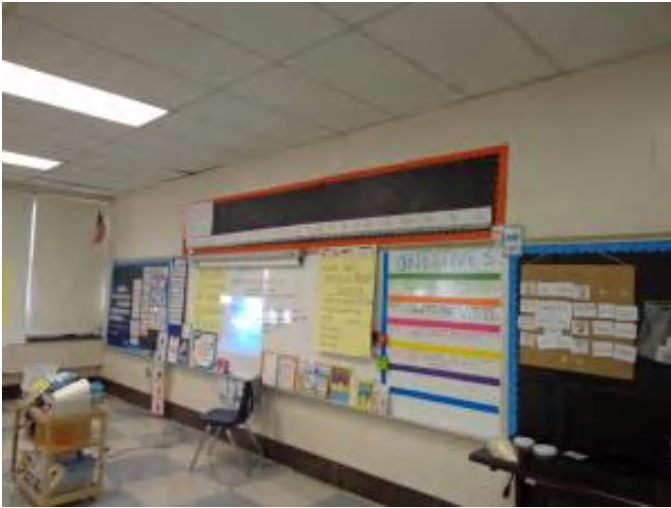
**Location:** Classrooms

Receptacles-- Classrooms are typically supplied with only 2 to 4 duplex receptacles, which is inadequate for today's classrooms. It is recommended 6 to 8 additional duplex receptacles be provided in each classroom using a surface metal raceway system.

**Distress:** Inadequate

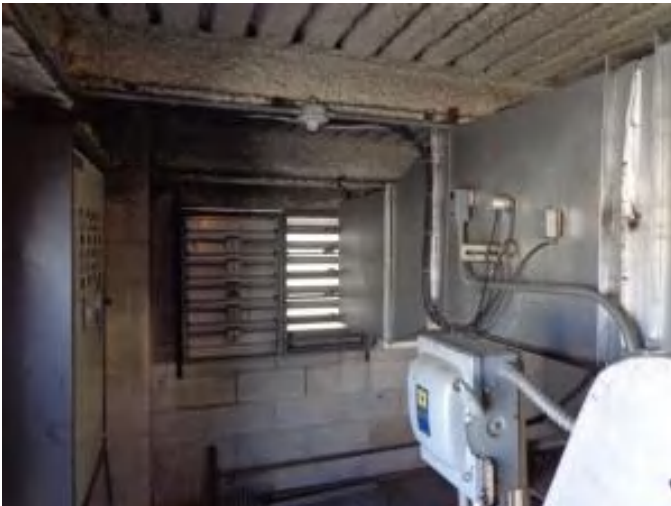
**Location:** Roof

**Distress:** Inadequate

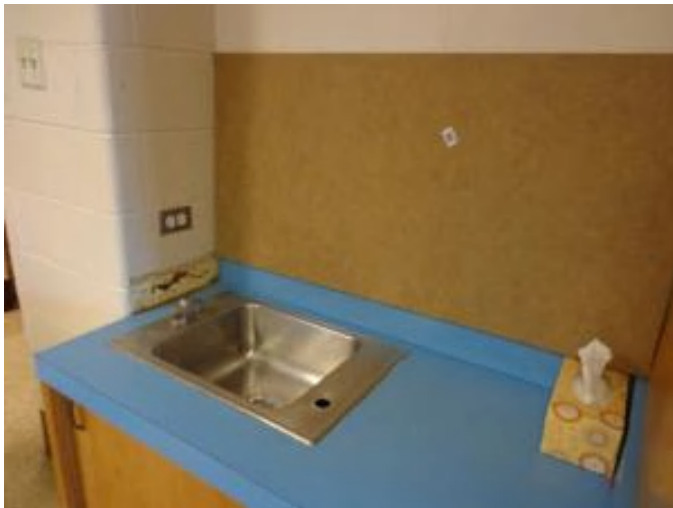
**Location:** Receptacles at sinks

There are some classrooms that have sinks. It was observed that receptacles located within 6 feet of the sinks need to be replaced with ground-fault circuit-interrupting (GFCI) type receptacles to comply with NFPA 70, NEC Article 210.8 (B). An allowance for replacement of eight (8) duplex receptacles with GFCI type is included in this report.

**Distress:** Life Safety / NFPA / PFD

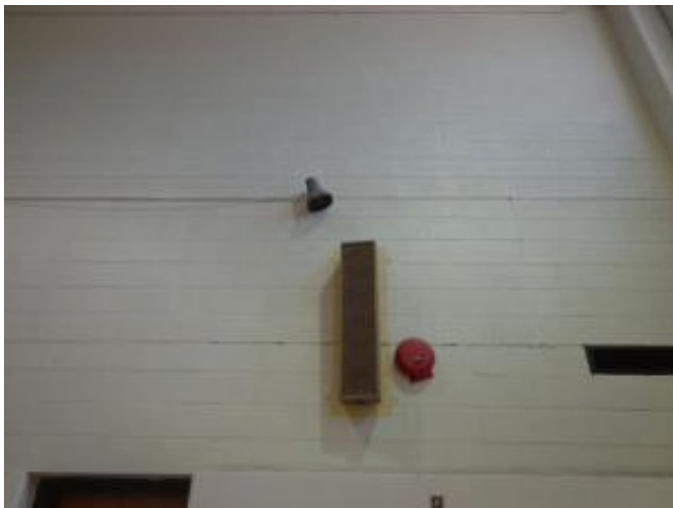
**Location:** Building wide

**Distress:** Beyond Service Life

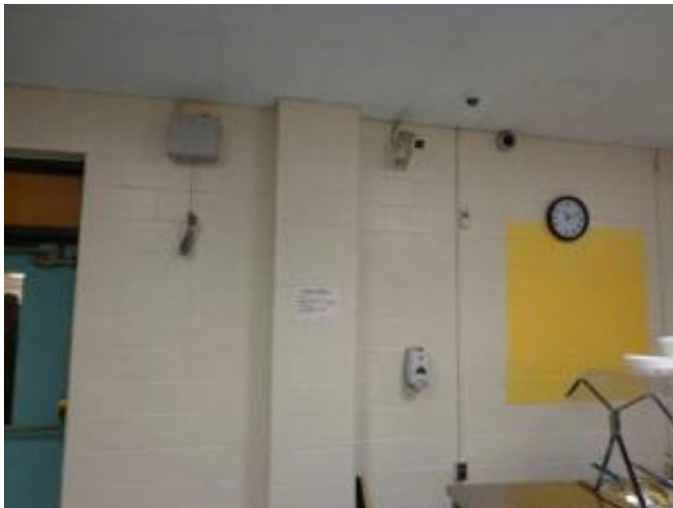
**Location:** Building wide

**Distress:** Beyond Service Life

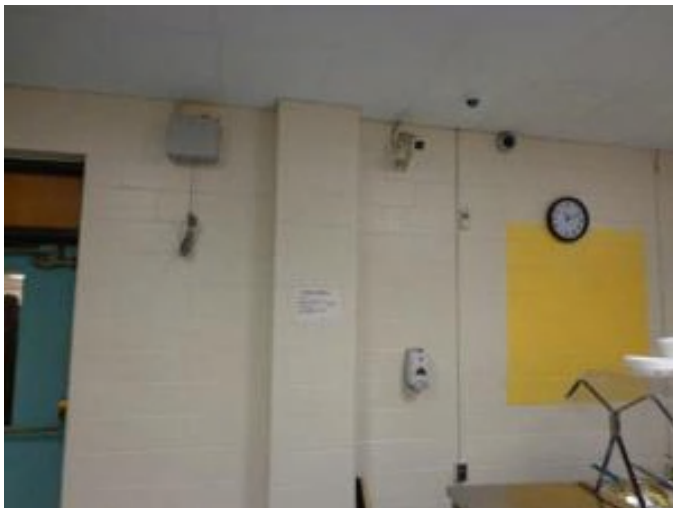
**Location:** Building wide

**Distress:** Beyond Service Life

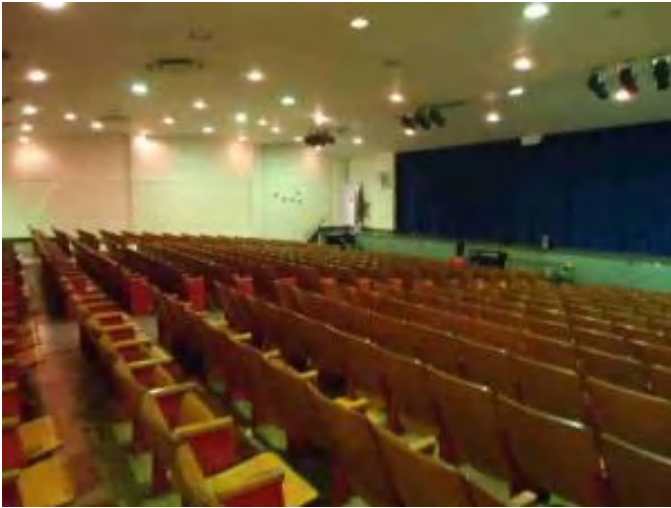
**Location:** Auditorium

Furnishings include: fixed casework; window shades/blinds; and fixed auditorium seating. The fixed seating for this school is from the original construction. The systems are in fair condition considering the age and usage. This project provides a budgetary consideration for universal upgrades for the fixed seating and furnishing of this school. Ensure that ADA requirements are followed with the new seating layout.

**Distress:** Damaged

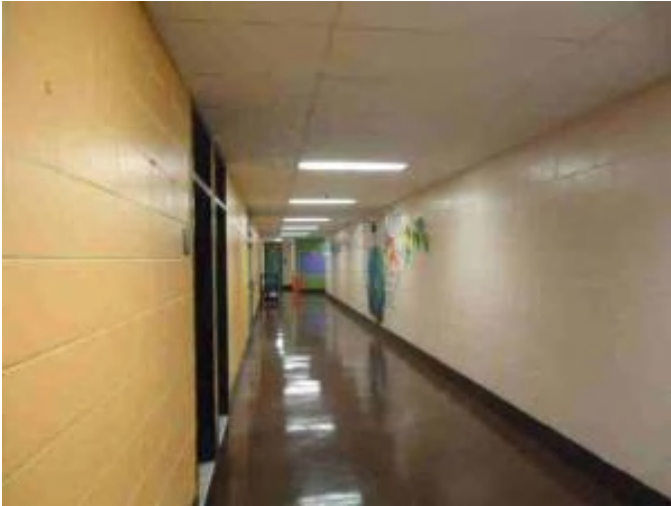
**Location:** Building Wide

There is no elevator that services this school. Goods, services, and amenities offered in public buildings are generally required to be available to all persons. To assist those that may be physically challenged and to meet current accessibility legislation to provide wheelchair access to the upper floors of this facility, the installation of a new hydraulic elevator has been recommended on the exterior elevation of the building or at another suitable location. The new installation should blend as much as possible with the overall appearance of this historic structure and include all required ADA features, such as audible jewels and gongs, an accessible control panel, etc.

**Distress:** Inadequate

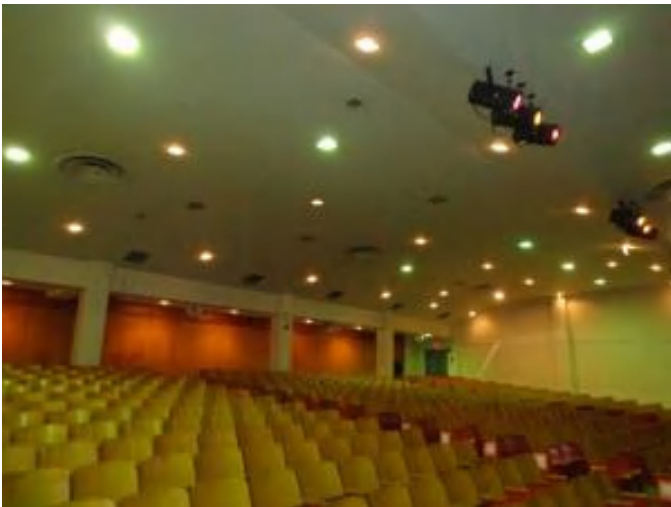
**Location:** Auditorium

The auditorium is illuminated with recessed incandescent lighting fixtures. These fixtures should be replaced with energy efficient, dimmable LED downlights that would also reduce maintenance costs. There are three (3) ceiling mounted theatrical lighting positions in front of the stage, each with three (3) spotlighting fixtures. There are also two rows of electrics and seven (7) 8-foot fluorescent worklights with T8 lamps above the stage. There is no dimmer panel for the auditorium. Lighting fixtures are switched by circuit breakers in the lighting panelboard.

**Distress:** Energy Efficiency

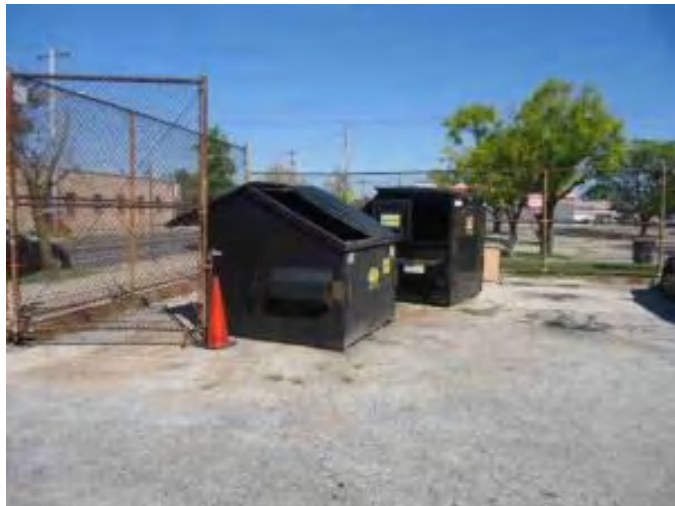
**Location:** Site

**Distress:** Health Hazard / Risk

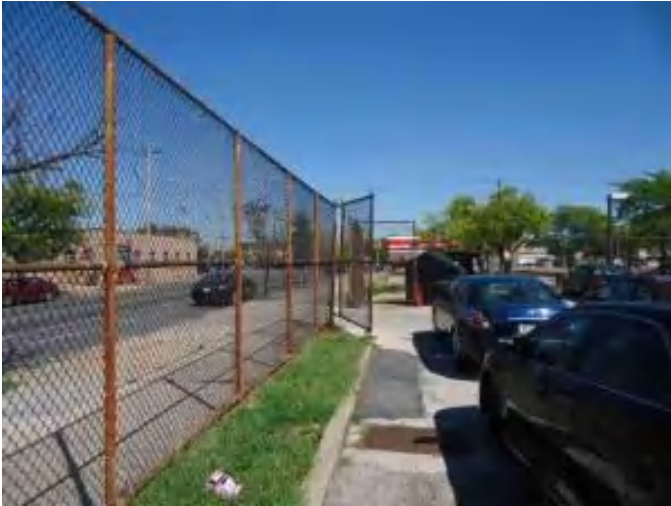
**Location:** Site

**Distress:** Damaged

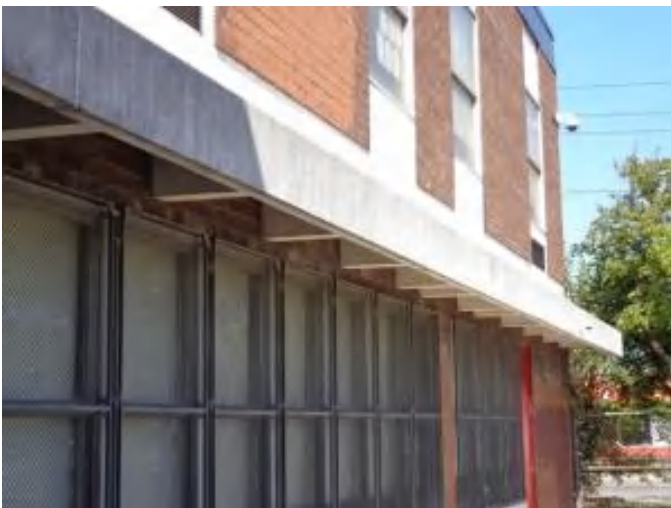
**Location:** Exterior

**Distress:** Beyond Service Life

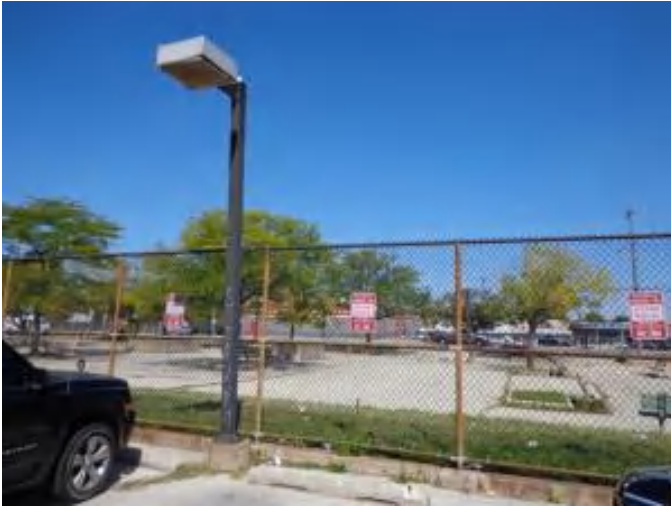
**Location:** Parking lot on west side

**Distress:** Damaged
