Facility Condition Assessment Summary Report

Day School

School District of Philadelphia
S620001;Day
Final
Site Assessment Report
January 31, 2017

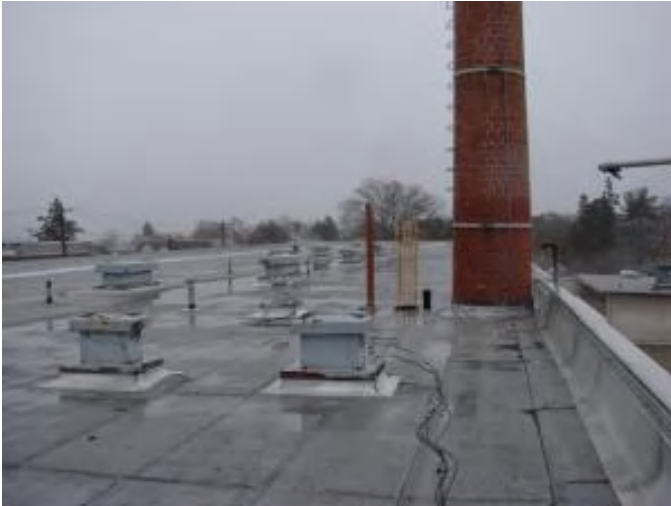
System: B3010105 - Built-Up

Roofing is typically built-up system installed before 1990. All roofing is beyond service life. No leaks have been reported.

Location: Roof
Distress: Beyond Service Life
Category: 3 - Operations / Maint.
Priority: 2 - Response Time (2-3 yrs)
Correction: Remove and Replace Built Up Roof
Qty: 27,344.00
Unit of Measure: S.F.
Estimate: \$926,469.68
Assessor Name: System
Date Created: 02/17/2016

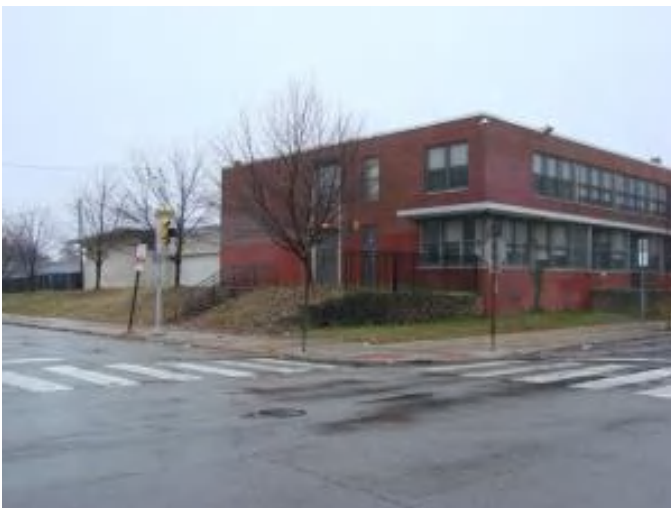
System: D1010 - Elevators and Lifts

Location: TBD
Distress: Accessibility
Category: 2 - Code Compliance
Priority: 2 - Response Time (2-3 yrs)
Correction: Add interior hydraulic elevator - 2 floors - adjust the electrical run lengths to hook up the elevator
Qty: 1.00
Unit of Measure: Ea.
Estimate: \$387,153.48
Assessor Name: System
Date Created: 02/17/2016

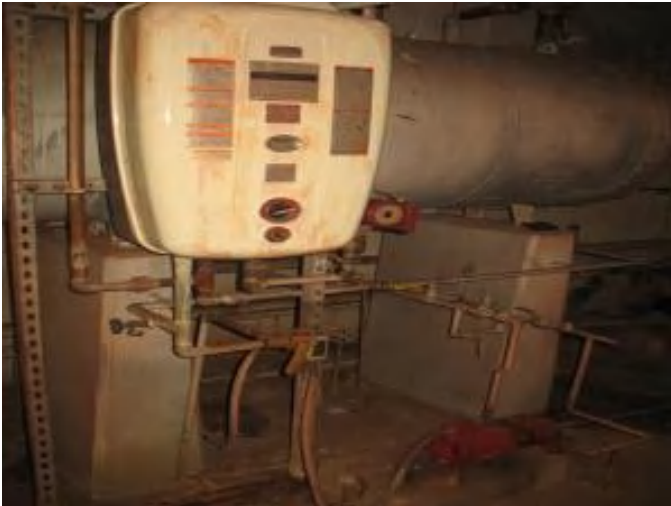
System: D2020 - Domestic Water Distribution

One (1) Paloma instant hot water heater with associated circulating pump, installation date unknown, supplies hot water for domestic use. The hot water heater serves a domestic water storage tank located in the boiler room with a single circulating pump is connected to the storage tank. The heater and tank are located in the boiler room. The heater was operable during the site visit and the Building Engineer reported no serious issues; however it is most likely beyond its service life and should be replaced in the next 1-3 years.

Location: Boiler room
Distress: Beyond Service Life
Category: 3 - Operations / Maint.
Priority: 2 - Response Time (2-3 yrs)
Correction: Replace instantaneous water heater
Qty: 1.00
Unit of Measure: Ea.
Estimate: \$24,473.55
Assessor Name: System
Date Created: 02/01/2016

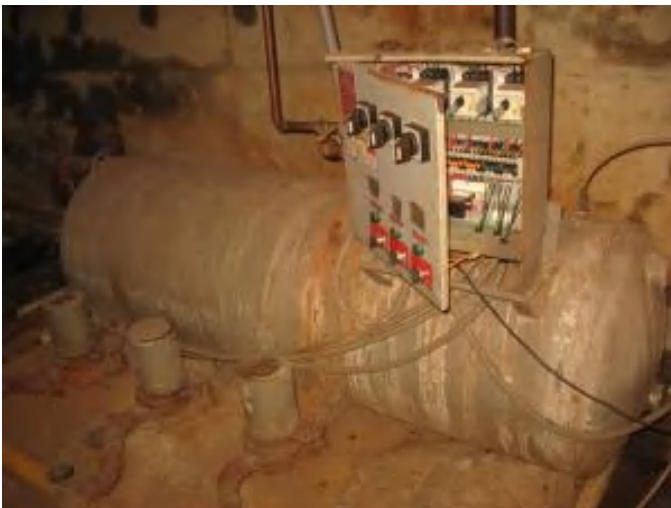
System: D3020 - Heat Generating Systems

The boiler feed tank assembly with three (3) pumps headered together is installed in the boiler room. A serious problem was reported with steam leaking into the system from failed steam traps. Steam was observed leaking from the condensate return pit. The boiler feed tank and pumps should be replaced. A water chemical treatment system is connected to the feed tank.

Location: Boiler room
Distress: Beyond Service Life
Category: 3 - Operations / Maint.
Priority: 2 - Response Time (2-3 yrs)
Correction: Replace boiler feed pump (duplex) and surge tank
Qty: 1.00
Unit of Measure: Ea.
Estimate: \$113,045.40
Assessor Name: System
Date Created: 02/01/2016

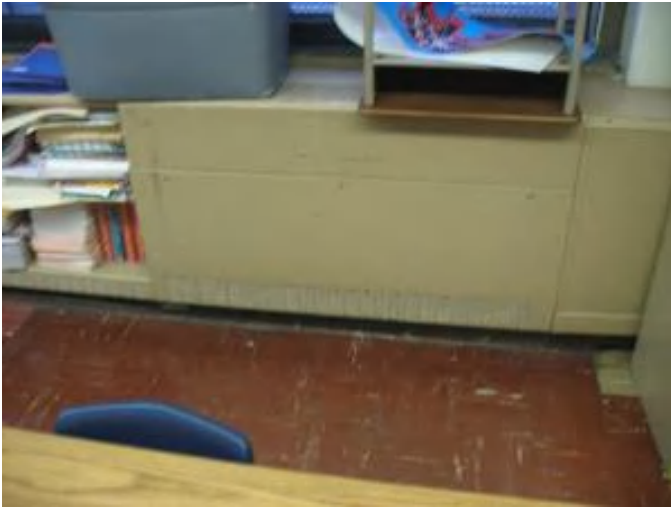
System: D3040 - Distribution Systems

Location: Classrooms
Distress: Beyond Service Life
Category: 3 - Operations / Maint.
Priority: 2 - Response Time (2-3 yrs)
Correction: Replace classroom unit ventilator (htg/clg coils, 5 tons, 2,000 CFM)
Qty: 18.00
Unit of Measure: Ea.
Estimate: \$897,816.11
Assessor Name: System
Date Created: 02/01/2016

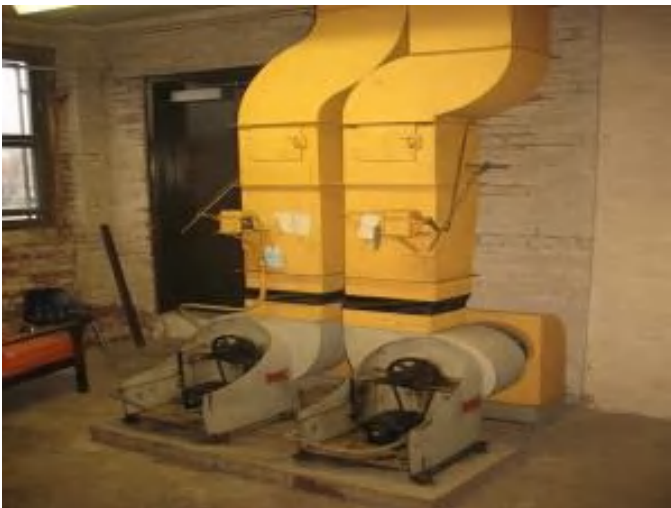
System: D3040 - Distribution Systems

Location: Mechanical rooms
Distress: Beyond Service Life
Category: 3 - Operations / Maint.
Priority: 2 - Response Time (2-3 yrs)
Correction: Replace utility set exhaust fan (5 HP)
Qty: 4.00
Unit of Measure: Ea.
Estimate: \$152,349.03
Assessor Name: System
Date Created: 02/01/2016

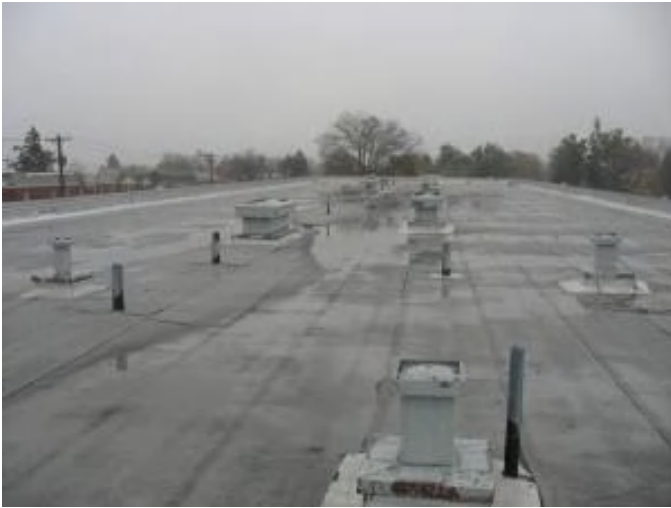
System: D3040 - Distribution Systems

Location: Roof
Distress: Beyond Service Life
Category: 3 - Operations / Maint.
Priority: 2 - Response Time (2-3 yrs)
Correction: Replace rooftop gravity ventilator units - select the proper type and size
Qty: 12.00
Unit of Measure: Ea.
Estimate: \$26,324.03
Assessor Name: System
Date Created: 02/01/2016

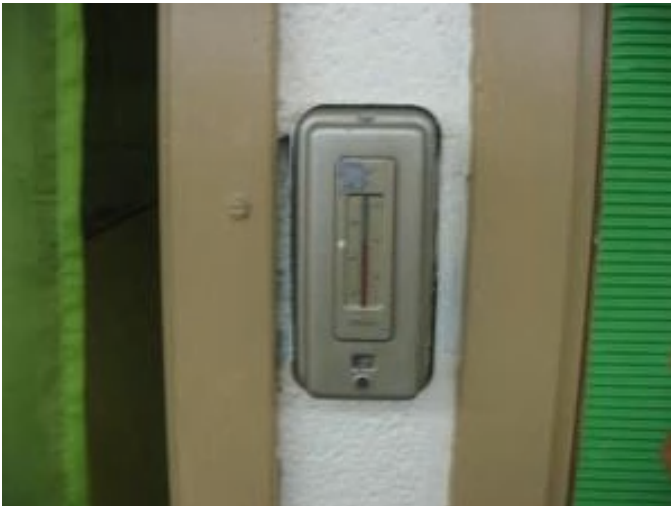
System: D3060 - Controls & Instrumentation

Location: Throughout building
Distress: Failing
Category: 3 - Operations / Maint.
Priority: 2 - Response Time (2-3 yrs)
Correction: Replace pneumatic controls with DDC (75KSF)
Qty: 42,000.00
Unit of Measure: S.F.
Estimate: \$900,987.82
Assessor Name: System
Date Created: 02/01/2016

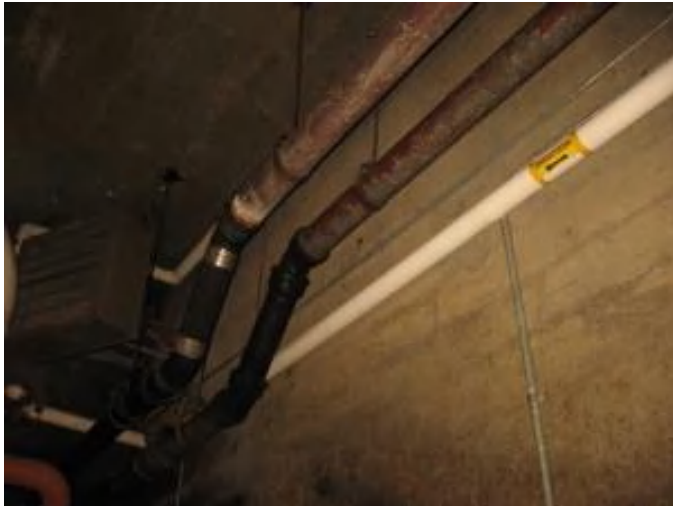
System: D2030 - Sanitary Waste

The maintenance staff reported mostly minor problems with the sanitary waste piping systems. However, the sewer piping has been in service for almost 65 years and will require more frequent attention from the maintenance staff as time passes. The District should hire a qualified contractor to examine the sanitary waste piping using video cameras to locate and replace any damaged piping and to further quantify the extent of potential failures.

Location: Throughout building
Distress: Beyond Service Life
Category: 3 - Operations / Maint.
Priority: 3 - Response Time (3-4 yrs)
Correction: Inspect sanitary waste piping and replace damaged sections. (+50KSF)
Qty: 42,000.00
Unit of Measure: S.F.
Estimate: \$206,041.55
Assessor Name: System
Date Created: 02/01/2016

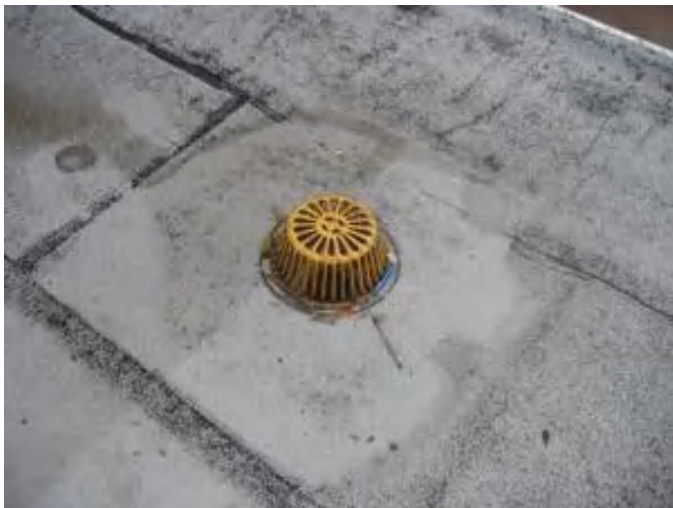
System: D2040 - Rain Water Drainage

Rain water drains from the roof are routed through mechanical chases in the building and appear to be original. The piping is threaded galvanized and has been in use well beyond its service life. The District should hire a qualified contractor to examine the rain water drainage piping using video cameras to locate and replace any damaged piping and to further quantify the extent of potential failures.

Location: Throughout building
Distress: Beyond Service Life
Category: 3 - Operations / Maint.
Priority: 3 - Response Time (3-4 yrs)
Correction: Inspect internal rain water drainage piping and replace pipe - based on SF of multi-story building - insert SF of building
Qty: 42,000.00
Unit of Measure: S.F.
Estimate: \$186,246.06
Assessor Name: System
Date Created: 02/01/2016

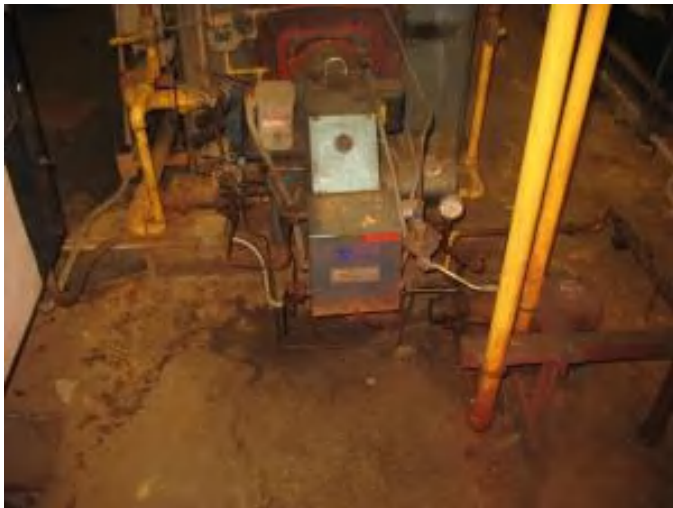
System: D3020 - Heat Generating Systems

Location: Boiler room
Distress: Beyond Service Life
Category: 3 - Operations / Maint.
Priority: 3 - Response Time (3-4 yrs)
Correction: Replace power burner, gas/oil (100 HP)
Qty: 3.00
Unit of Measure: Ea.
Estimate: \$233,719.44
Assessor Name: System
Date Created: 02/01/2016

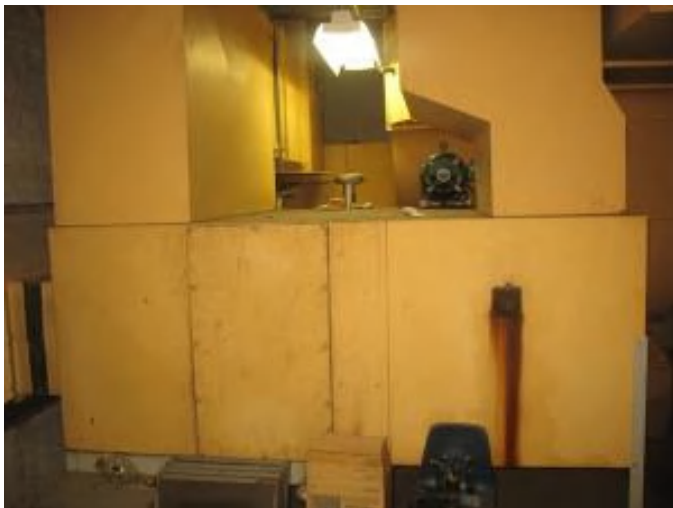
System: D3040 - Distribution Systems

Location: Auditorium
Distress: Beyond Service Life
Category: 3 - Operations / Maint.
Priority: 3 - Response Time (3-4 yrs)
Correction: Install HVAC unit for Auditorium (200 seat).
Qty: 358.00
Unit of Measure: Seat
Estimate: \$533,034.21
Assessor Name: System
Date Created: 02/01/2016

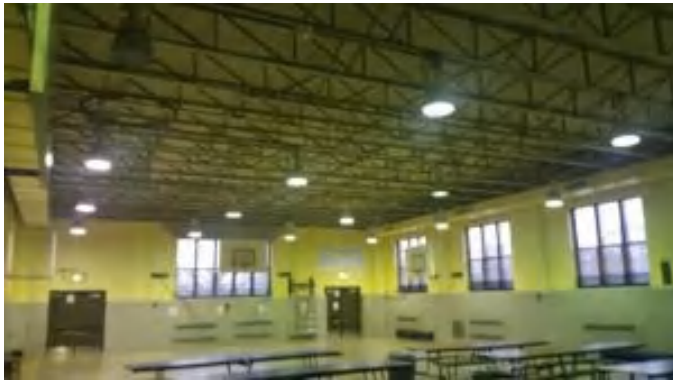
System: D5020 - Lighting and Branch Wiring

Location: throughout the building
Distress: Beyond Service Life
Category: 3 - Operations / Maint.
Priority: 3 - Response Time (3-4 yrs)
Correction: Replace Lighting Fixtures (SF)
Qty: 0.00
Unit of Measure: S.F.
Estimate: \$326,606.22
Assessor Name: System
Date Created: 02/11/2016

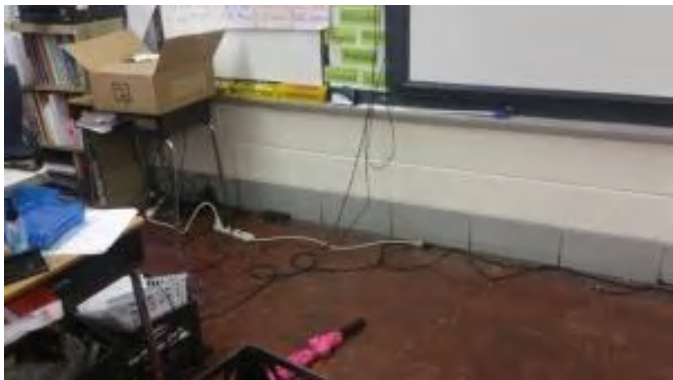
System: D5020 - Lighting and Branch Wiring

Location: throughout the building
Distress: Inadequate
Category: 4 - Capital Improvement
Priority: 3 - Response Time (3-4 yrs)
Correction: Replace Wiring Devices (SF) - surface mounted conduit and boxes
Qty: 0.00
Unit of Measure: S.F.
Estimate: \$164,106.76
Assessor Name: System
Date Created: 02/11/2016

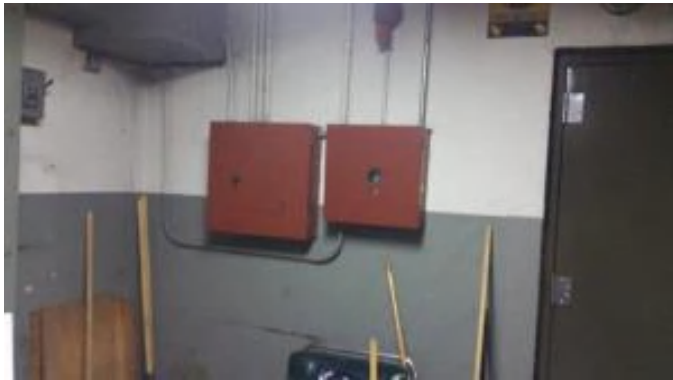
System: D5030 - Communications and Security

Location: throughout the building
Distress: Health Hazard / Risk
Category: 1 - Health & Safety
Priority: 3 - Response Time (3-4 yrs)
Correction: Replace fire alarm system
Qty: 1.00
Unit of Measure: S.F.
Estimate: \$221,088.85
Assessor Name: System
Date Created: 02/11/2016

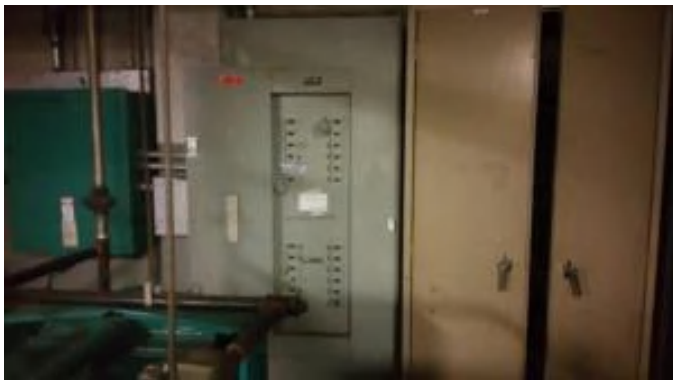
System: D5090 - Other Electrical Systems

Location: electrical room
Distress: Beyond Service Life
Category: 3 - Operations / Maint.
Priority: 3 - Response Time (3-4 yrs)
Correction: Replace standby generator system
Qty: 1.00
Unit of Measure: Ea.
Estimate: \$174,591.39
Assessor Name: System
Date Created: 02/11/2016

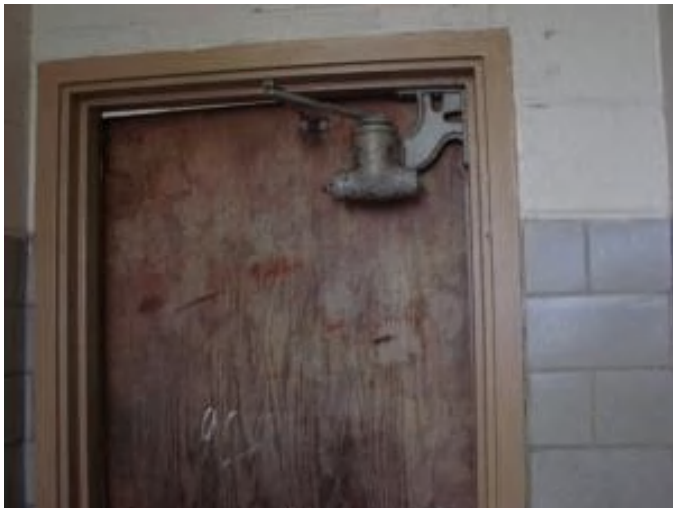
System: C1020 - Interior Doors

Location: Throughout
Distress: Beyond Service Life
Category: 3 - Operations / Maint.
Priority: 4 - Response Time (4-5 yrs)
Correction: Remove and replace interior doors - wood doors with hollow metal frames - per leaf
Qty: 60.00
Unit of Measure: Ea.
Estimate: \$286,235.23
Assessor Name: System
Date Created: 02/17/2016

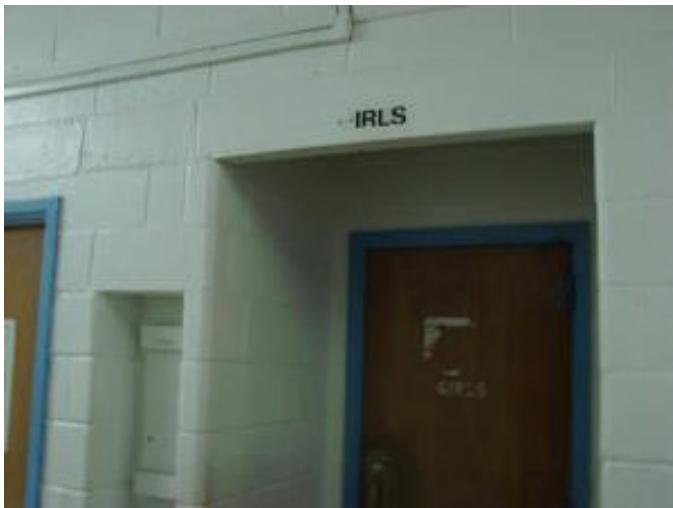
System: C1030 - Fittings

Location: Throughout
Distress: Inadequate
Category: 4 - Capital Improvement
Priority: 4 - Response Time (4-5 yrs)
Correction: Replace missing or damaged signage - insert the number of rooms
Qty: 80.00
Unit of Measure: Ea.
Estimate: \$21,673.00
Assessor Name: System
Date Created: 02/17/2016
