## Facility Condition Assessment Summary Report

### De Burgos School

School District of Philadelphia  
**S517001;deBurgos**  
Final  
**Site Assessment Report**  
January 30, 2017

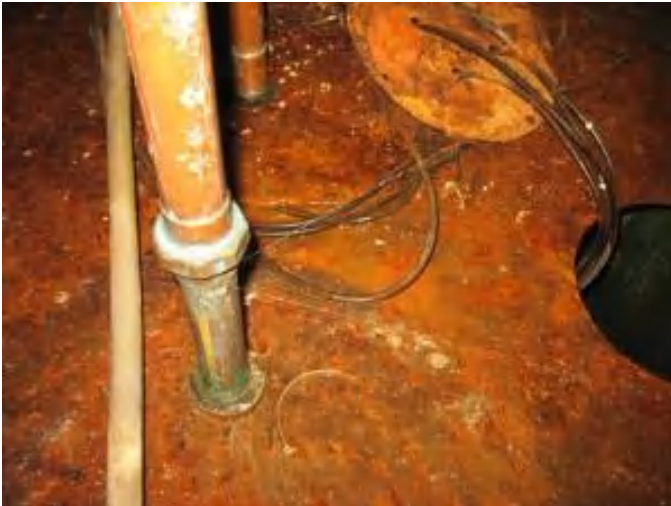
#### System: D2030 - Sanitary Waste

Two (2) sewage ejector pits located in the basement mechanical room receive water from the basement area; one is in the upper mechanical room area and the other in the depressed chiller pit. The upper ejector has dual 2HP submerged pumps that are original to the building. The system appeared to be in good condition and the pit is sealed. The lower sewage ejector pit has submerged pumps, which were not visible during the site visit. A pin hole leak was observed in the copper piping on this pump system and the cover is covered in rust. The leak should be repaired and the cover replaced.

**Location:** Basement Mechanical Room

**Distress:** Health Hazard / Risk

**Correction:** Replace defective or leaking piping - select the appropriate size and insert length and number of fittings in the estimate

**Notes:** Replace the piping section with the pin hole leak in the sewage ejector piping in the chiller pit and replace the rusted cover of the pit.

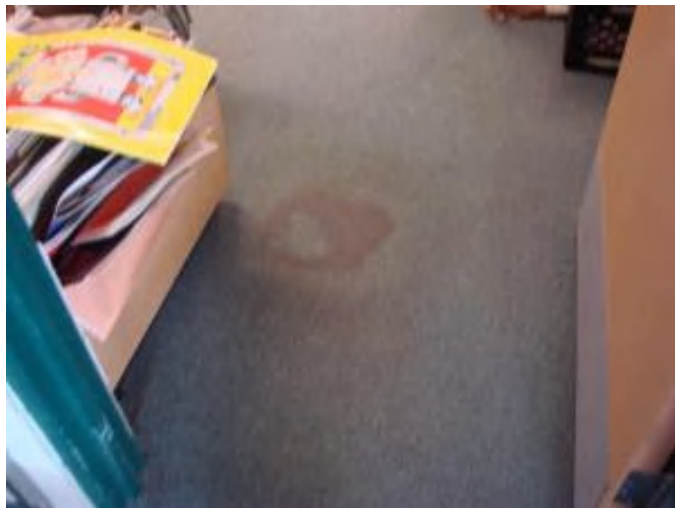
**System: C3020411 - Carpet**

Flooring in most areas is generally vinyl composition tile, in very good condition. Flooring in library and principal's office is carpet in very poor condition. Gym has resilient sheet flooring in very good condition. Flooring in toilets and kitchen area is typically ceramic tiles and quarry tiles, respectively; in good condition.

**Location:** Interior

**Distress:** Beyond Service Life

**Correction:** Remove and replace carpet

**Notes:** Replace carpet in library and office spaces

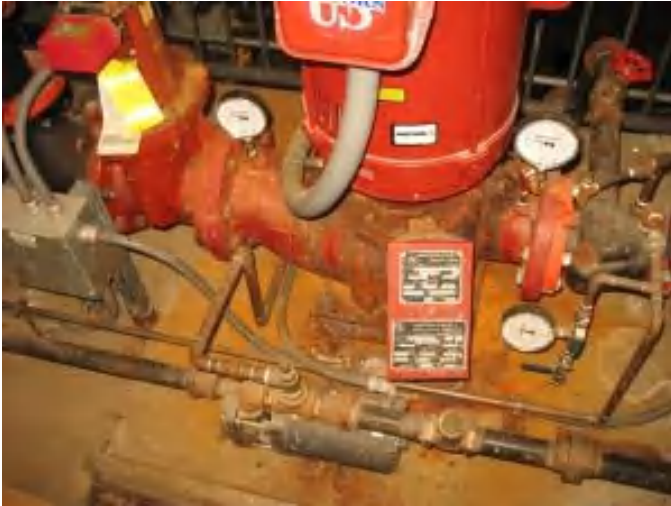
**System: D4010 - Sprinklers**

Sprinklers - The building is equipped with a wet type sprinkler system. An 8" fire water line enters the building in the basement mechanical room along the same wall as the domestic water and gas line. An inline vertical mount 40-HP, 500 gpm Armstrong pump ensures adequate pressure throughout the system during a sprinkler discharge. The fire suppression system is the originally installed equipment and should not need replacement within the next 10 years, but the fire pump is damaged from rust and should be inspected by a qualified contractor.

**Location:** Basement Mechanical Room

**Distress:** Damaged

**Correction:** Replace fire pump, electric, 1000 GPM

**Notes:** Hire a qualified contractor to inspect the fire pump and repair or replace it as necessary.

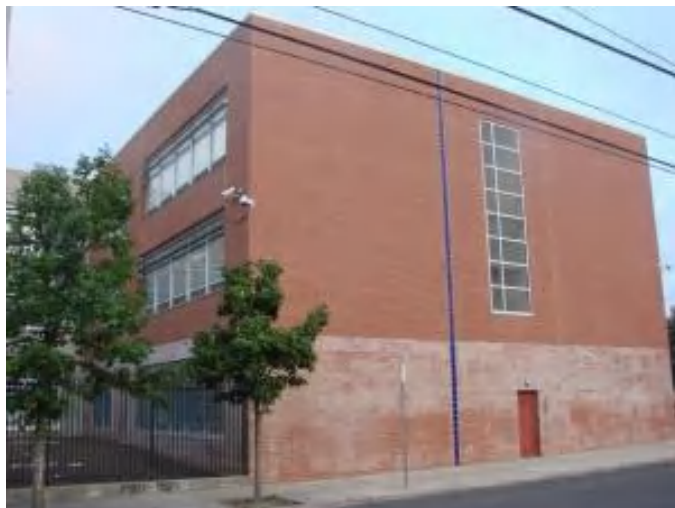
#### System: G4030 - Site Communications & Security

**Location:** Grounds

**Distress:** Security Issue
