Decatur School

Decatur Annex School

School District of Philadelphia
S833001; Shallcross and Decatur
Final
Site Assessment Report
January 31, 2017

Facility Condition Assessment
September 2015

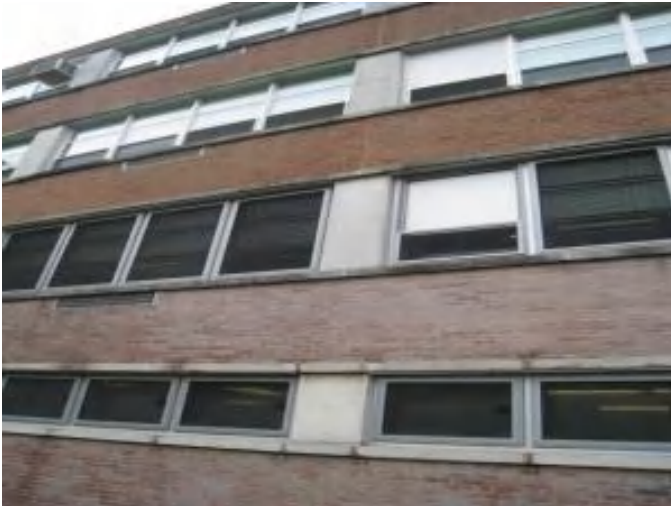
System: B2010 - Exterior Walls

Location: Decatur Main Building - exterior window sills

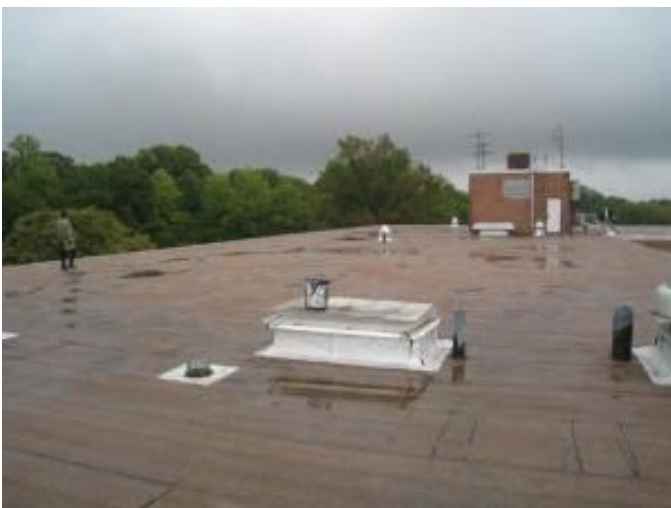
System: B3010105 - Built-Up

Location: Decatur Main Building - roof

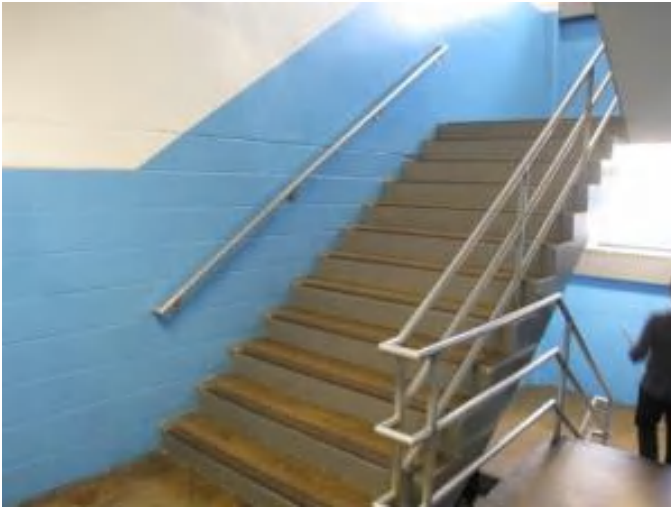
System: C2010 - Stair Construction

Location: Decatur Main Building - stairs

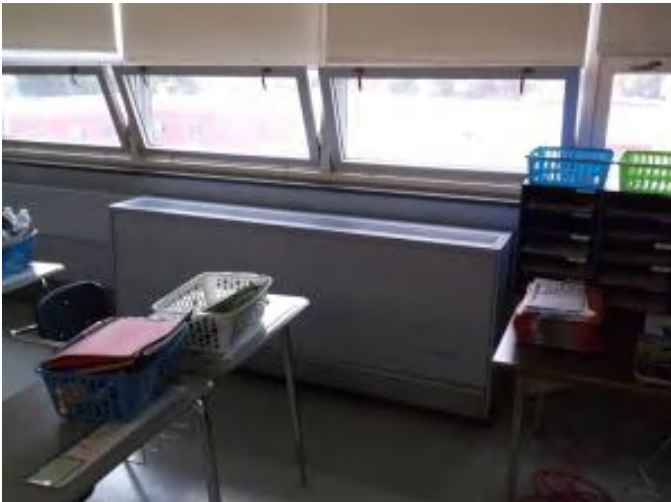
System: D3040 - Distribution Systems

Location: Decatur Main Building - throughout the building

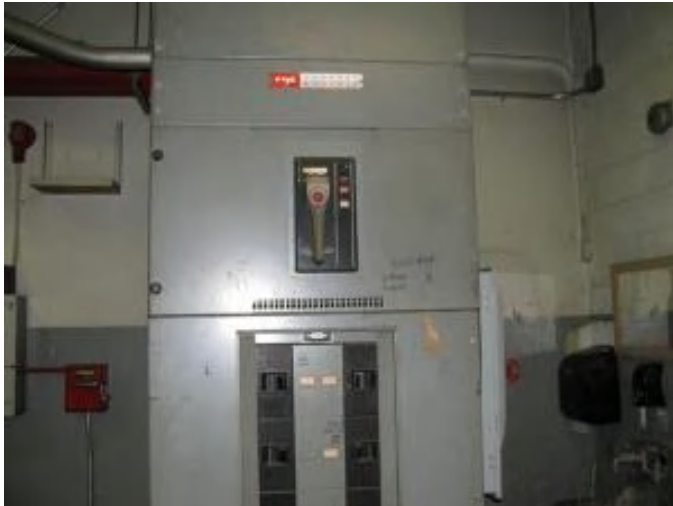
System: D5010 - Electrical Service/Distribution

Location: Electrical Building
Distress: Beyond Service Life
Category: 3 - Operations / Maint.
Priority: 1 - Response Time (< 2 yr)
Correction: Replace Switchboard
Qty: 1.00
Unit of Measure: Ea.
Estimate: \$520,610.38
Assessor Name: System
Date Created: 10/20/2015

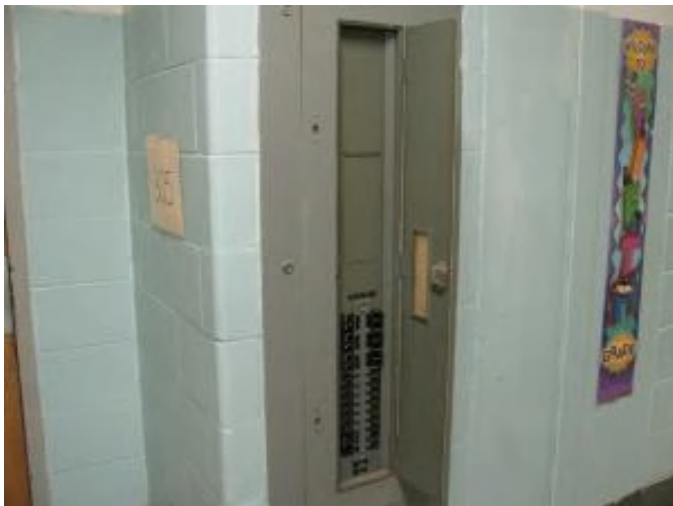
System: D5010 - Electrical Service/Distribution

Location: Entire Building
Distress: Beyond Service Life
Category: 3 - Operations / Maint.
Priority: 1 - Response Time (< 2 yr)
Correction: Replace Electrical Distribution System (U)
Qty: 1.00
Unit of Measure: Ea.
Estimate: \$405,399.54
Assessor Name: System
Date Created: 10/21/2015

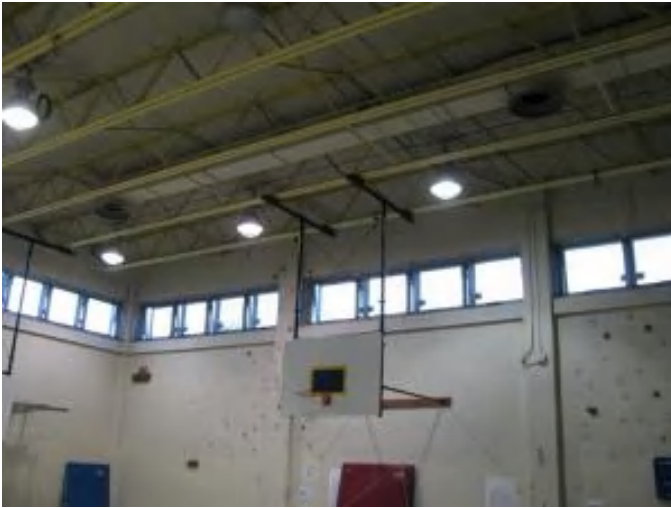
System: D5020 - Lighting and Branch Wiring

Location: Entire Building
Distress: Beyond Service Life
Category: 3 - Operations / Maint.
Priority: 1 - Response Time (< 2 yr)
Correction: Replace Lighting Fixtures (SF)
Qty: 1.00
Unit of Measure: S.F.
Estimate: \$1,347,006.94
Assessor Name: System
Date Created: 10/21/2015

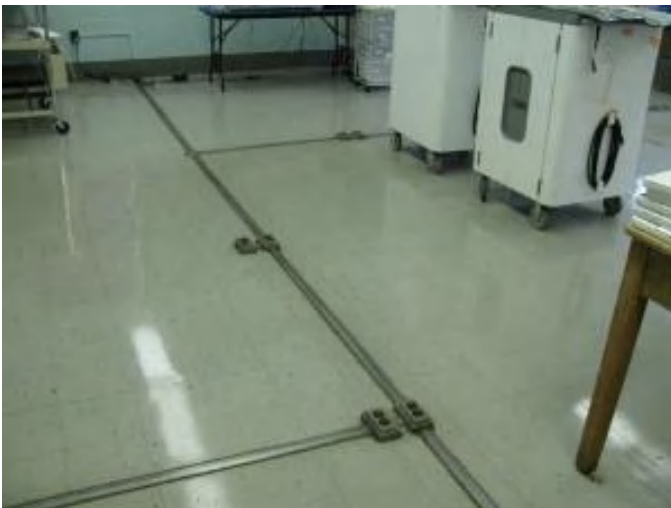
System: D5020 - Lighting and Branch Wiring

Location: Entire Building
Distress: Beyond Service Life
Category: 3 - Operations / Maint.
Priority: 1 - Response Time (< 2 yr)
Correction: Replace Wiring Devices (SF) - surface mounted conduit and boxes
Qty: 1.00
Unit of Measure: S.F.
Estimate: \$592,878.84
Assessor Name: System
Date Created: 10/21/2015

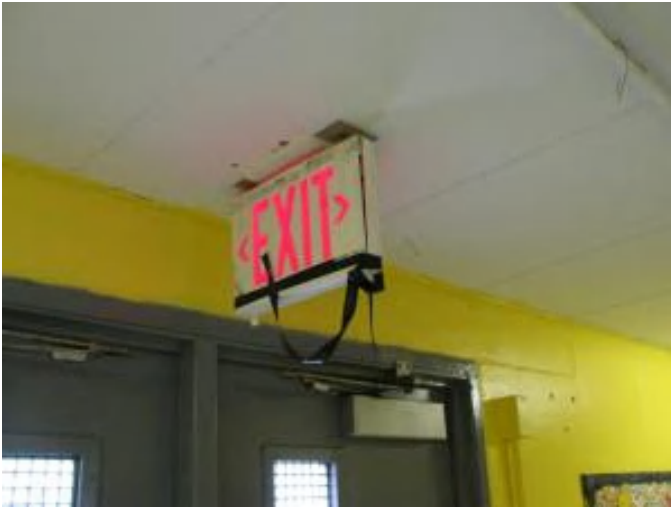
System: D5020 - Lighting and Branch Wiring

Location: Entire Building
Distress: Inadequate
Category: 4 - Capital Improvement
Priority: 1 - Response Time (< 2 yr)
Correction: Replace lighting fixtures
Qty: 1.00
Unit of Measure: Ea.
Estimate: \$30,304.68
Assessor Name: System
Date Created: 10/21/2015

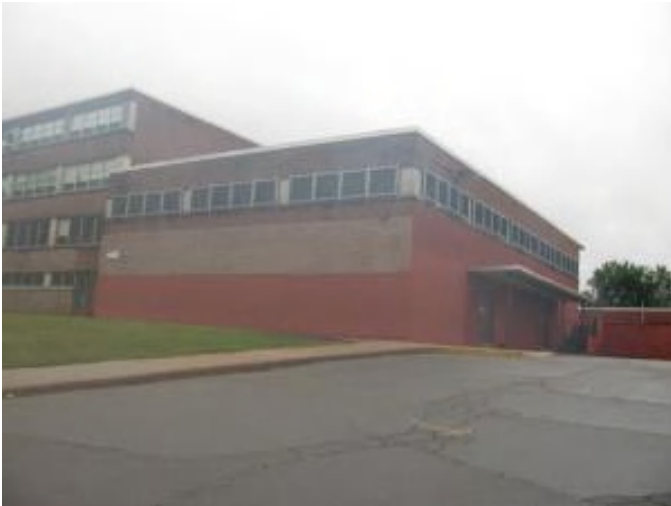
System: D5020 - Lighting and Branch Wiring

Location: Exterior Building (Decatur)
Distress: Inadequate
Category: 4 - Capital Improvement
Priority: 1 - Response Time (< 2 yr)
Correction: Add Lighting Fixtures
Qty: 1.00
Unit of Measure: Ea.
Estimate: \$21,778.65
Assessor Name: System
Date Created: 10/21/2015

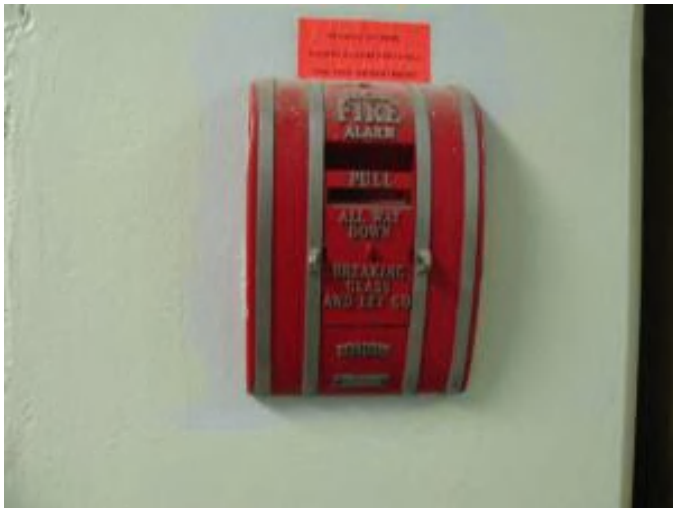
System: D5030 - Communications and Security

Location: Entire building (Decatur)
Distress: Beyond Service Life
Category: 3 - Operations / Maint.
Priority: 1 - Response Time (< 2 yr)
Correction: Replace fire alarm system
Qty: 1.00
Unit of Measure: S.F.
Estimate: \$506,992.63
Assessor Name: System
Date Created: 10/21/2015

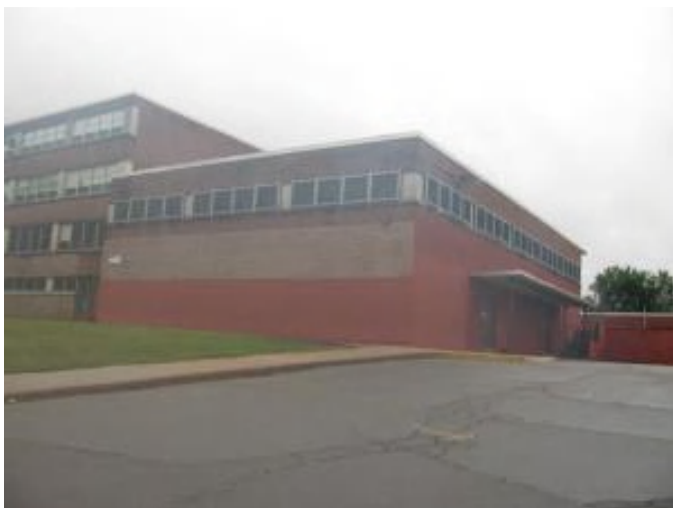
System: D5030 - Communications and Security

Location: Entire Building (Decatur)
Distress: Security Issue
Category: 1 - Health & Safety
Priority: 1 - Response Time (< 2 yr)
Correction: Add/Replace Video Surveillance System
Qty: 1.00
Unit of Measure: Ea.
Estimate: \$249,498.95
Assessor Name: System
Date Created: 10/21/2015

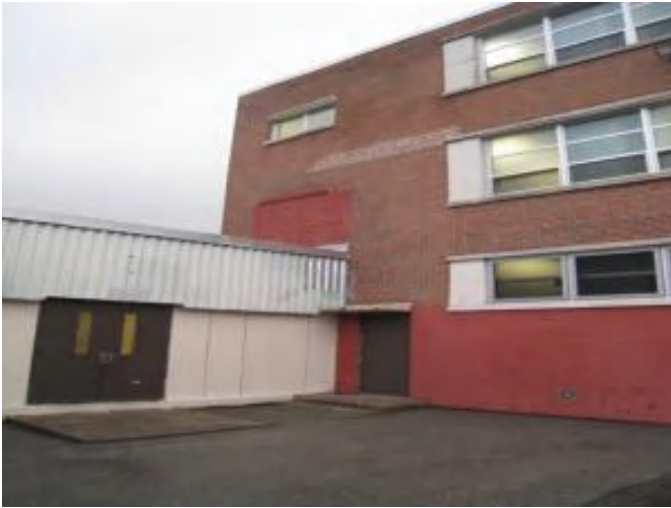
System: B2030 - Exterior Doors

Location: Decatur Main Building - exterior doors
Distress: Failing
Category: 3 - Operations / Maint.
Priority: 2 - Response Time (2-3 yrs)
Correction: Refinish and repaint exterior doors - per leaf
Qty: 24.00
Unit of Measure: Ea.
Estimate: \$14,334.13
Assessor Name: System
Date Created: 11/20/2015

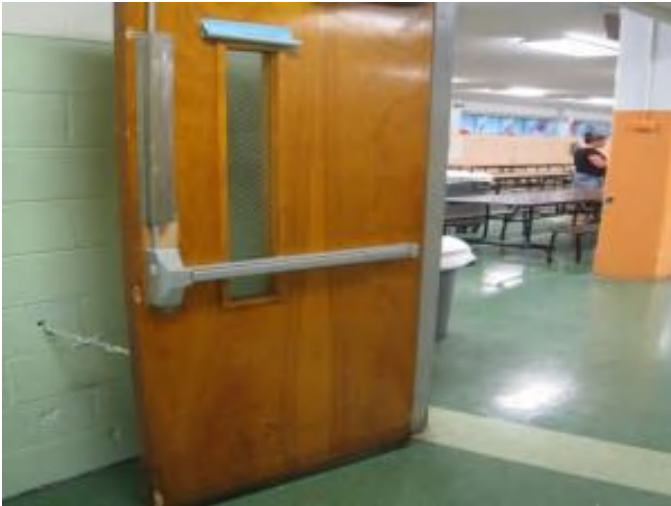
System: C1020 - Interior Doors

Location: Decatur Main Building - corridors
Distress: Damaged
Category: 3 - Operations / Maint.
Priority: 2 - Response Time (2-3 yrs)
Correction: Remove and replace interior doors - wood doors with hollow metal frames - per leaf
Qty: 40.00
Unit of Measure: Ea.
Estimate: \$190,823.48
Assessor Name: System
Date Created: 11/20/2015
