Facility Condition Assessment Summary Report

Dick School

S427001;Dick

Site Assessment Report

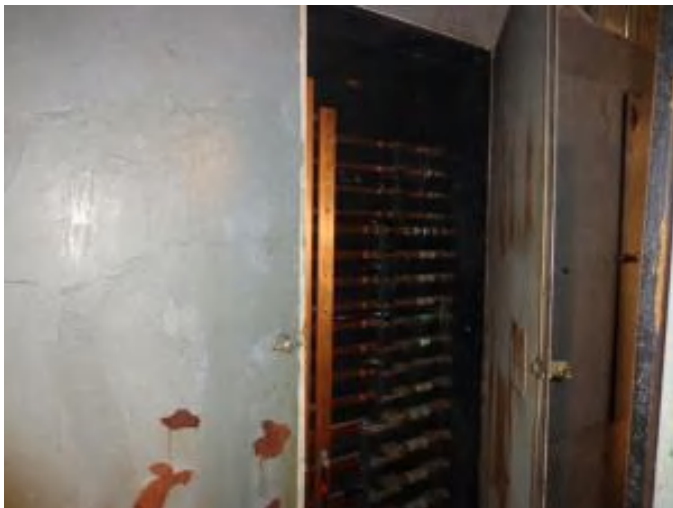
System: D5010 - Electrical Service/Distribution

Location: Electrical Supply Room, Mech. Rm. 005 and Boiler Rm. 004

Distress: Beyond Service Life

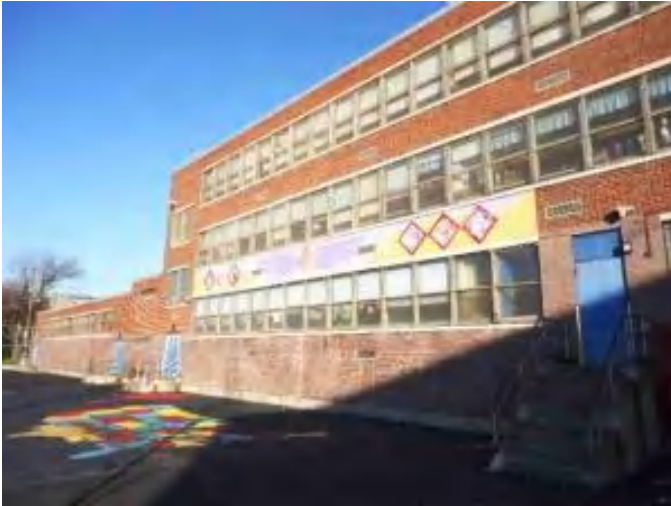
System: B2010 - Exterior Walls

Location: Exterior Elevation

Distress: Damaged

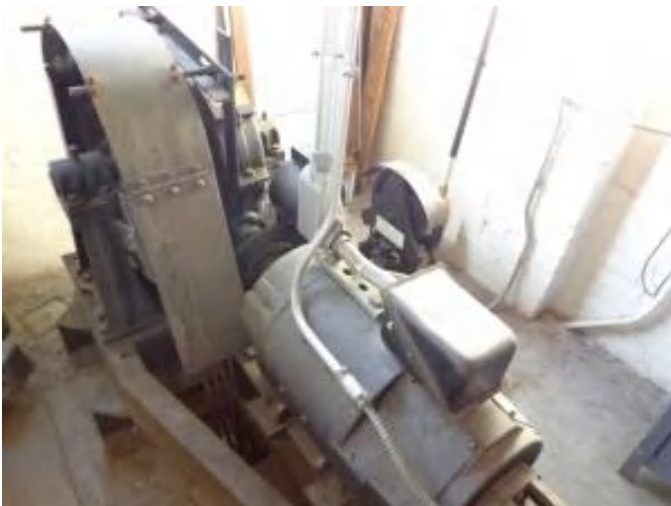
System: D1010 - Elevators and Lifts

Location: Elevator Machine Room

Distress: Beyond Service Life

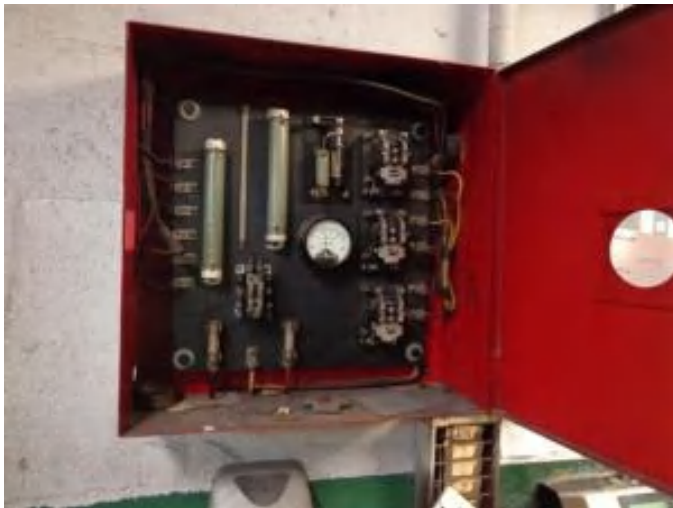
System: D5030 - Communications and Security

Location: Building wide
Distress: Life Safety / NFPA / PFD
Category: 1 - Health & Safety
Priority: 2 - Response Time (2-3 yrs)
Correction: Replace fire alarm system
Qty: 71,000.00
Unit of Measure: S.F.
Estimate: \$484,360.17
Assessor Name: System
Date Created: 01/26/2016

Notes: Replace fire alarm system with an addressable type system meeting current NFPA Codes and ADA requirements.

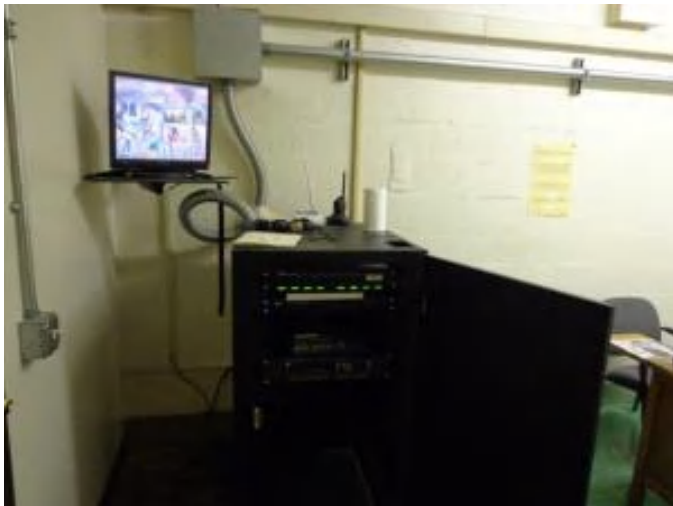
System: D5030 - Communications and Security

Location: Building wide
Distress: Security Issue
Category: 1 - Health & Safety
Priority: 2 - Response Time (2-3 yrs)
Correction: Add/Replace Video Surveillance System
Qty: 11.00
Unit of Measure: Ea.
Estimate: \$72,457.15
Assessor Name: System
Date Created: 01/26/2016

Notes: Provide allowance for replacement of 11 interior video surveillance cameras and addition of 8 cameras, one monitor and one DVR.

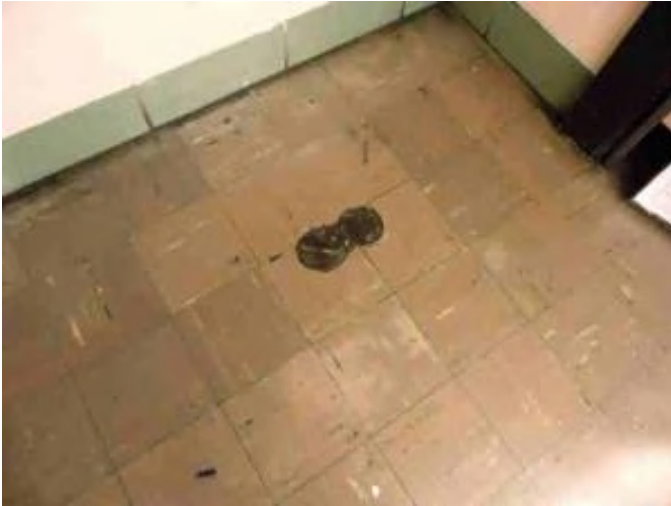
System: C3020413 - Vinyl Flooring

Location: Building Wide

Distress: Health Hazard / Risk

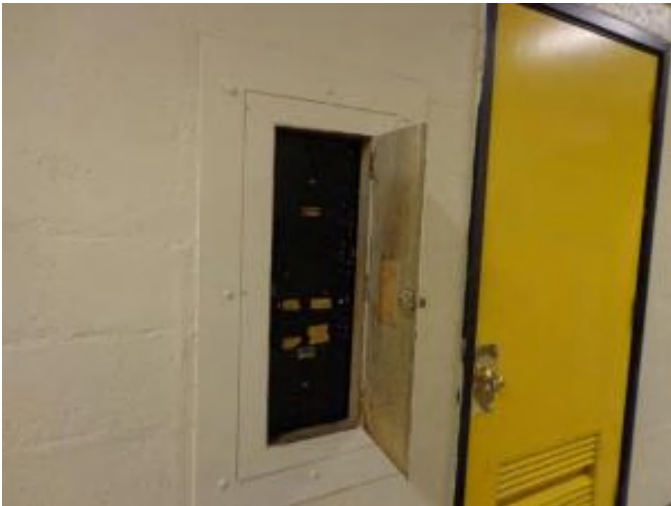
System: D5010 - Electrical Service/Distribution

Location: Building wide

Distress: Beyond Service Life

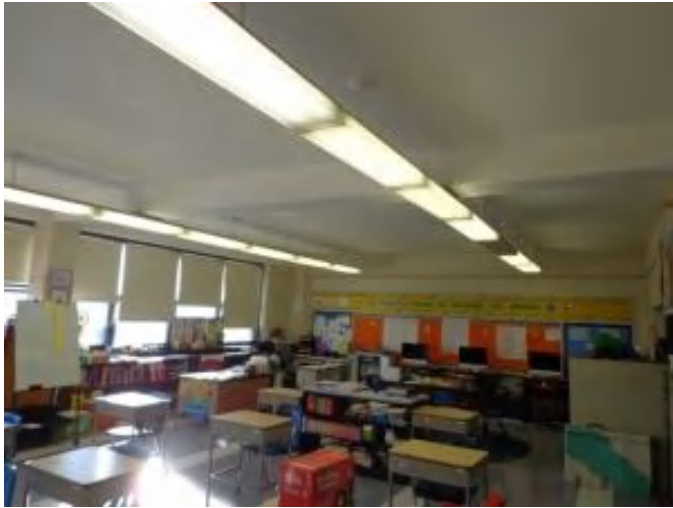
System: D5020 - Lighting and Branch Wiring

Location: Building wide

Distress: Beyond Service Life

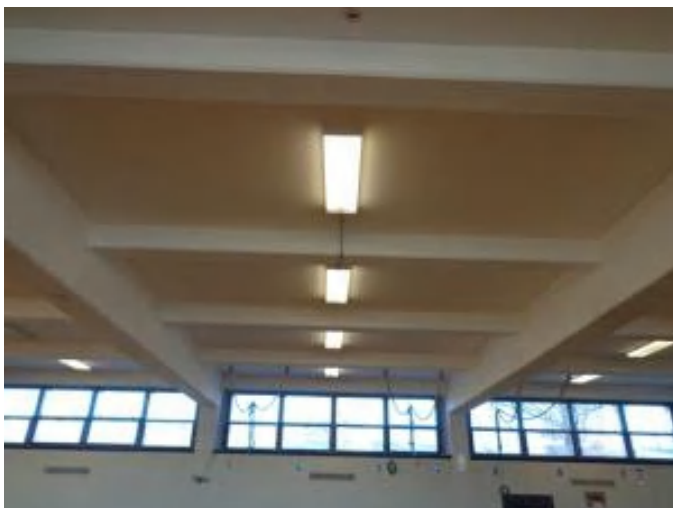
System: D5020 - Lighting and Branch Wiring

The gymnasium is illuminated with (24) 4 lamp, surface mounted fluorescent wraparound fixtures. Fixtures are nearing end of their useful life and should be replaced within 3 to 4 years.

Location: Gymnasium

Distress: Beyond Service Life

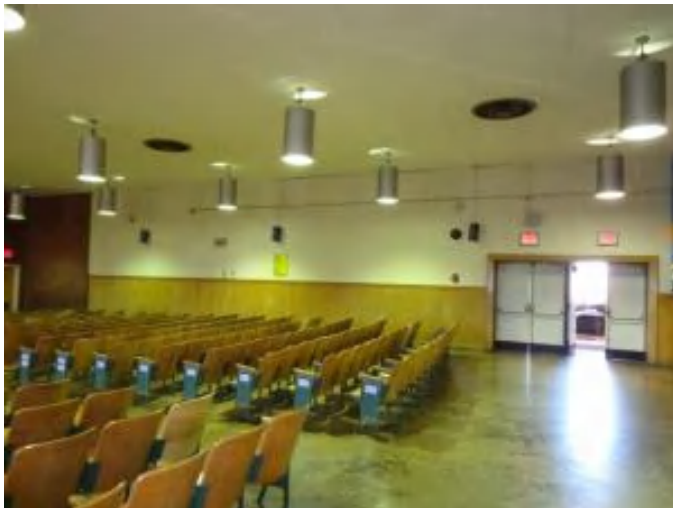
System: D5020 - Lighting and Branch Wiring

The auditorium has 20 pendant mounted metal halide cylinder fixtures and nine (9) wall mounted cylinders with up/down lighting. Lighting in the auditorium has served its useful life. Replacement with LED lighting fixtures is included in this report. The platform has (9) 4 foot industrial fluorescent worklights and two rows of theatrical batten lighting.

Location: Auditorium
Distress: Beyond Service Life
Category: 3 - Operations / Maint.
Priority: 3 - Response Time (3-4 yrs)
Correction: Replace lighting fixtures
Qty: 29.00
Unit of Measure: Ea.
Estimate: \$49,762.09
Assessor Name: System
Date Created: 01/26/2016

Notes: Replace (20) metal halide cylinder style downlights and (9) wall mounted cylinder up/down fixtures in the auditorium with LED downlight fixtures.

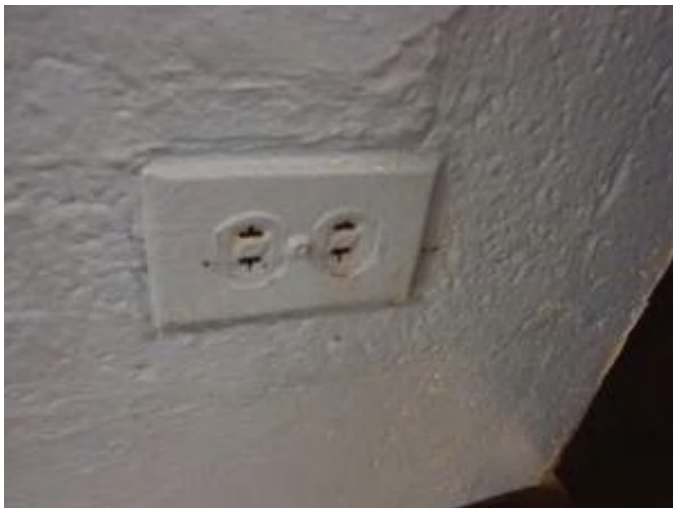
System: D5020 - Lighting and Branch Wiring

Location: Building wide
Distress: Beyond Service Life
Category: 3 - Operations / Maint.
Priority: 3 - Response Time (3-4 yrs)
Correction: Replace Wiring Device
Qty: 80.00
Unit of Measure: Ea.
Estimate: \$40,308.94
Assessor Name: System
Date Created: 01/26/2016

Notes: Replace all existing duplex receptacles in the building with new devices due to their age and condition. Several receptacles are not 3 wire grounding type (estimate 80 duplex receptacles to be replaced).

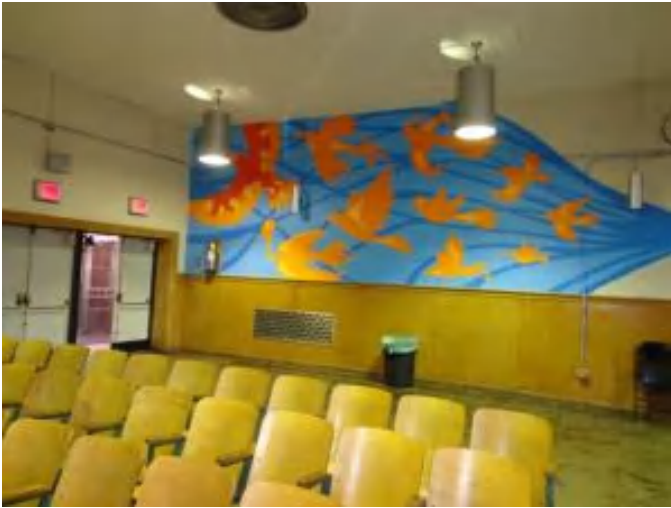
System: D5090 - Other Electrical Systems

Location: Building wide

Distress: Beyond Service Life

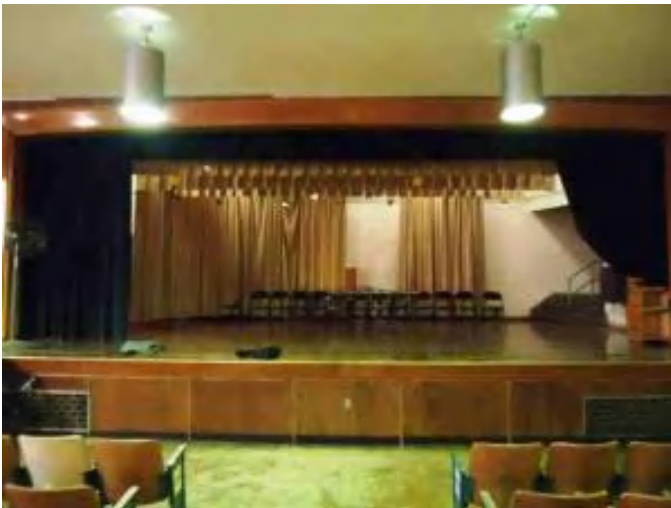
System: E2010 - Fixed Furnishings

The school stage has a stage curtain assembly that appears to be from the original construction. Modern applications are typically fire-proof applications with adjustable tracks and electric support for operation. The curtains are torn in a few section and the track is not functioning properly, overall the system is in poor condition. It is recommended that the curtain and track system be upgraded to a new system. Special care should be considered in regards to modern fire proofing for the new installation.

Location: Stage

Distress: Life Safety / NFPA / PFD

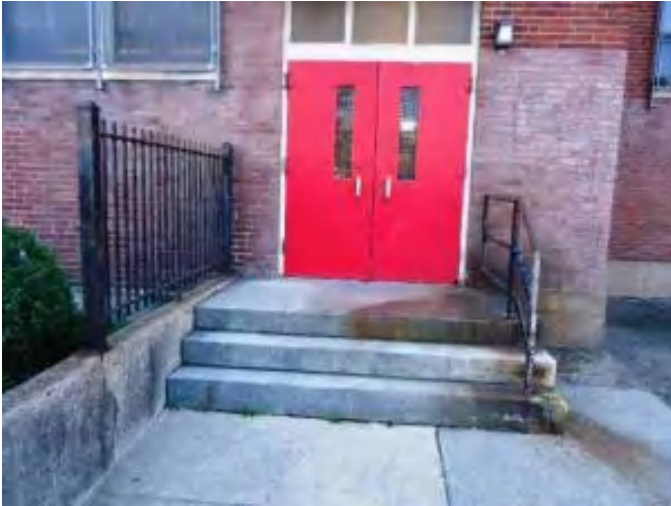
System: B2030 - Exterior Doors

The exterior doors are metal applications with metal frames. The exterior door system for this school is a very high traffic system. The doors are in fair condition but are aging at a faster rate than expected based on traffic and condition. The exterior door system and service doors are recommended for upgrade. The new doors are expected to retain their dimensions and profiles, but that incorporate updated energy-efficient features.

Location: Exterior Elevation

Distress: Damaged

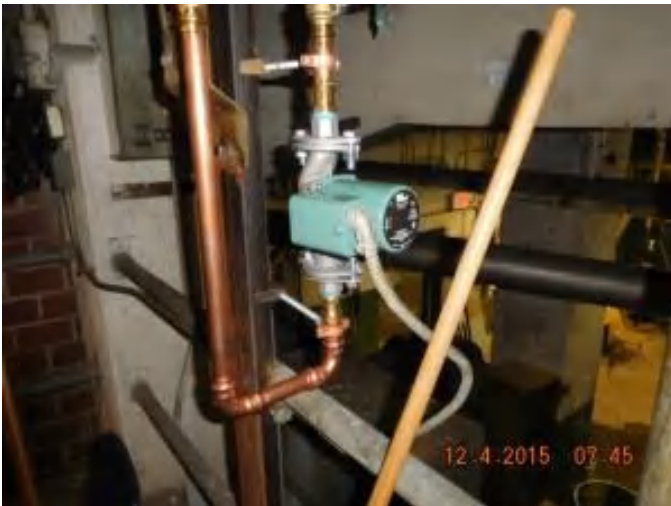
System: D2020 - Domestic Water Distribution

Location: entire building

Distress: Beyond Service Life

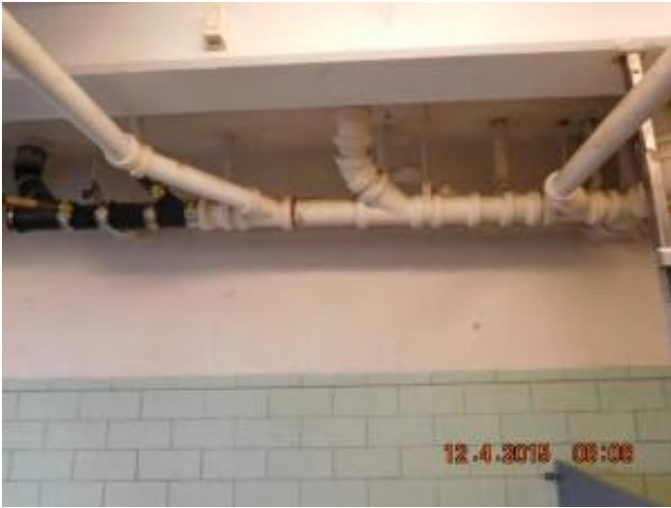
System: D2030 - Sanitary Waste

Location: entire building
Distress: Beyond Service Life
Category: 3 - Operations / Maint.
Priority: 4 - Response Time (4-5 yrs)
Correction: Inspect sanitary waste piping and replace damaged sections. (+50KSF)
Qty: 71,000.00
Unit of Measure: S.F.
Estimate: \$348,308.26
Assessor Name: System
Date Created: 02/07/2016

Notes: Inspect old cast iron sanitary piping including camera observation and replace damaged sections.

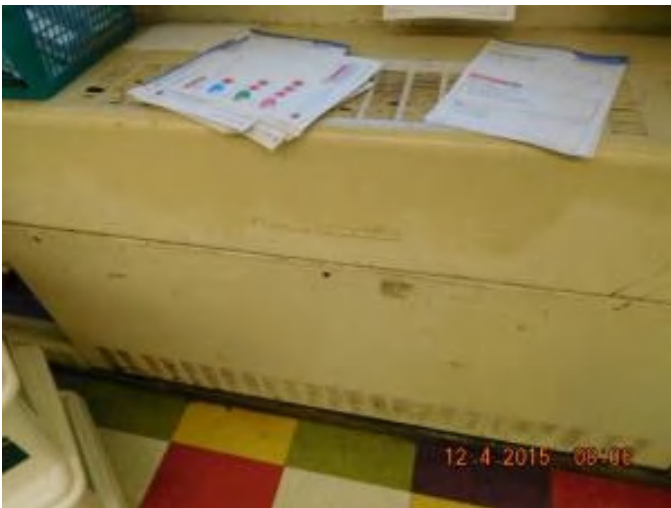
System: D3040 - Distribution Systems

Location: classrooms
Distress: Building / MEP Codes
Category: 2 - Code Compliance
Priority: 4 - Response Time (4-5 yrs)
Correction: Replace the existing unit ventilators with new units designed to provide adequate ventilation per ASHRAE Std 62 - insert the SF of bldg. in the qty.
Qty: 71,000.00
Unit of Measure: S.F.
Estimate: \$3,424,986.12
Assessor Name: System
Date Created: 02/07/2016

Notes: Replace the existing unit ventilators with new units designed for quiet operation and equipped with hot water and chilled water coils, hydronic control valves with digital controls and integral heat exchangers to provide code required fresh air quantities. Connect to new chilled and hot water piping systems and building automation control system

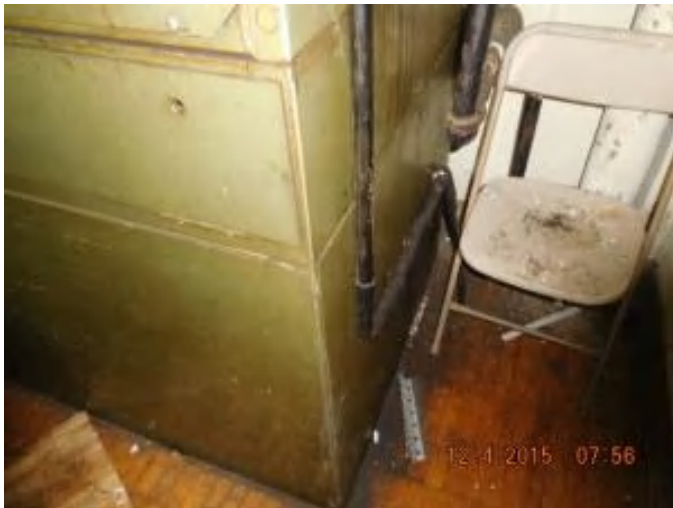
System: D3040 - Distribution Systems

Location: auditorium

Distress: Building / MEP Codes

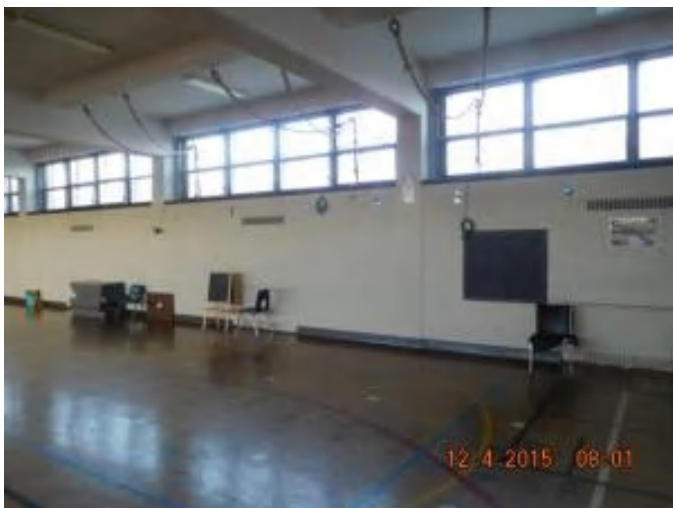
System: D3040 - Distribution Systems

Location: gymnasium

Distress: Building / MEP Codes

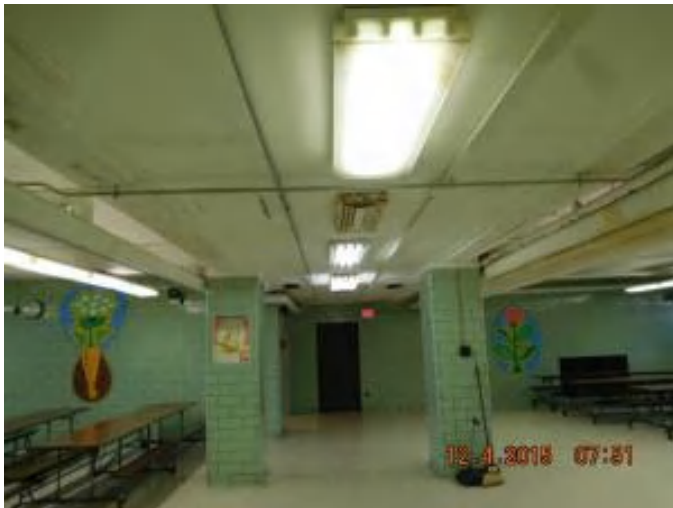
System: D3040 - Distribution Systems

Location: cafeteria
Distress: Building / MEP Codes
Category: 2 - Code Compliance
Priority: 4 - Response Time (4-5 yrs)
Correction: Install HVAC unit for Cafeteria (850 students).
Qty: 596.00
Unit of Measure: Student
Estimate: \$304,985.18
Assessor Name: System
Date Created: 02/07/2016

Notes: Provide a new central station air handling unit for the cafeteria with hot and chilled water coils, filters, outside and return air dampers, hydronic valves and controls, blower and motor. Connect to hot and chilled water systems and control system.

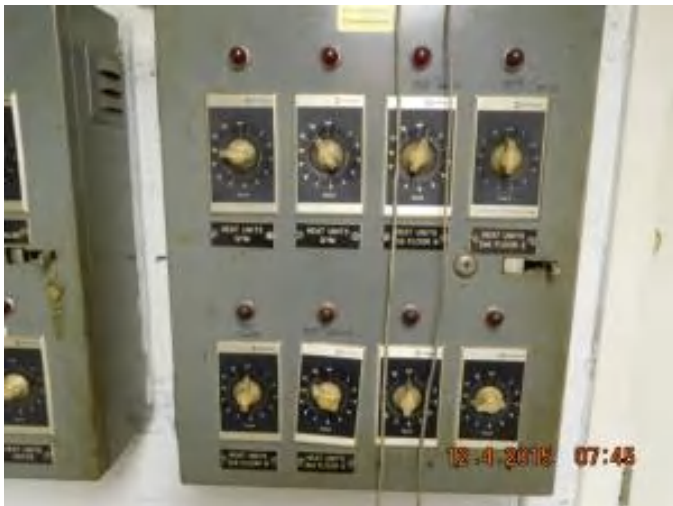
System: D3060 - Controls & Instrumentation

Location: entire building
Distress: Inadequate
Category: 4 - Capital Improvement
Priority: 4 - Response Time (4-5 yrs)
Correction: Replace pneumatic controls with DDC (75KSF)
Qty: 71,000.00
Unit of Measure: S.F.
Estimate: \$1,523,100.98
Assessor Name: System
Date Created: 02/07/2016

Notes: Install new direct digital control system and building automation system with remote computer control capability and graphics package

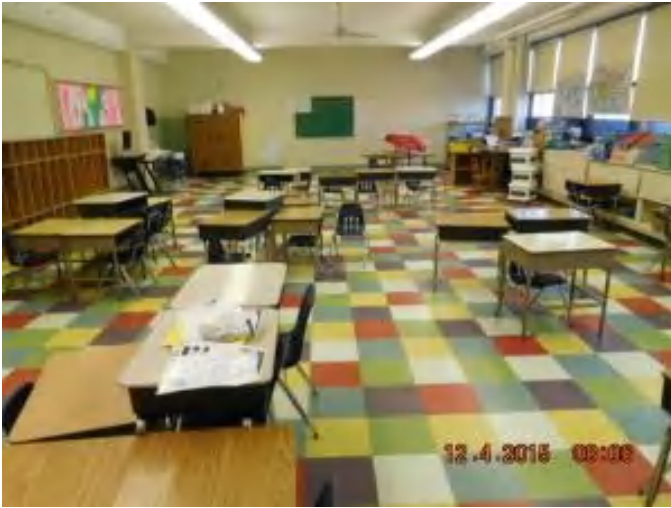
System: D4010 - Sprinklers

Location: entire building

Distress: Life Safety / NFPA / PFD

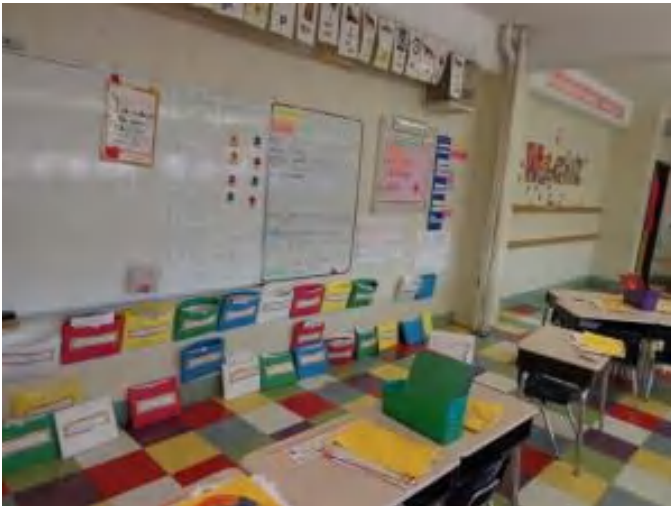
System: D5020 - Lighting and Branch Wiring

Receptacles—Most of the classrooms are provided with only 2 or 3 duplex receptacles, which is not adequate for today's classroom environment. An additional 6 to 8 duplex receptacles should be provided in each of the 30 classrooms using a surface metal raceway system. Some of the receptacles were observed to be 2 wire, non-grounding type receptacles and need to be replaced with 3 wire grounding type receptacles to comply with code. Replacement of all duplex receptacles in the building is included in this report due to their age and condition.

Location: Classrooms

Distress: Inadequate

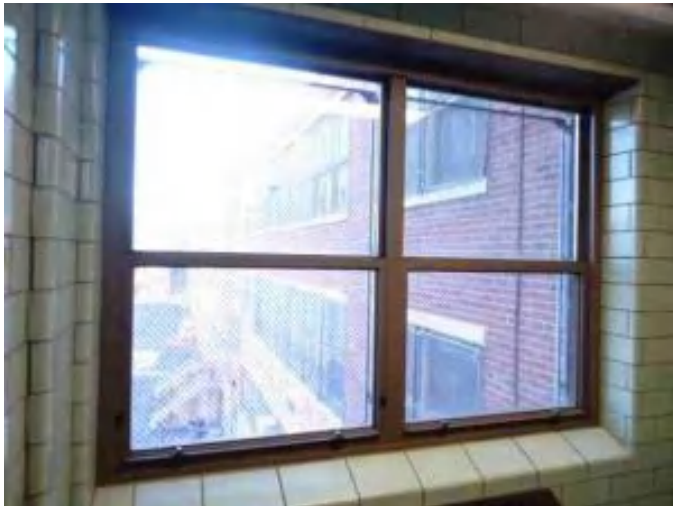
System: B2020 - Exterior Windows

Exterior windows are a single pane industrial grade aluminum framed single pane windows. Windows are in good condition with few exceptions. The exterior window system is recommended to be replaced with units that retain their dimensions and profiles, but that incorporate updated energy-efficient features. This universal upgrade is expected to be completed as part of an overall renovation effort to eliminate dual efforts.

Location: Exterior Elevation

Distress: Damaged

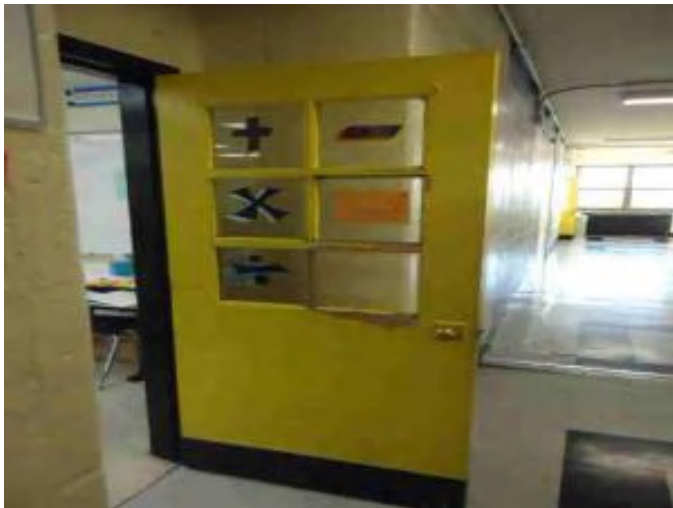
System: C1020 - Interior Doors

Location: Classroom
Distress: Damaged
Category: 3 - Operations / Maint.
Priority: 5 - Response Time (> 5 yrs)
Correction: Remove and replace interior doors - wood doors with hollow metal frames - per leaf
Qty: 30.00
Unit of Measure: Ea.
Estimate: \$143,117.61
Assessor Name: System
Date Created: 02/08/2016

Notes: Interior doors are typically wood in wood frames with wooden transom and wired glass glazing. Other interior doors include hollow metal in hollow metal frames at the stairwells and exit ways and access doors. Doors are generally in fair condition and is a mix of ADA compliant and non-complaint doors with both non-rated and fire rated. Several of the classroom doors are aging at a faster than normal rate for this application. Numerous repairs to locksets and door hardware have advanced the deterioration of the doors. This deficiency provides a budgetary consideration to replace a portion of the interior doors and frames with consideration for the physically challenged.

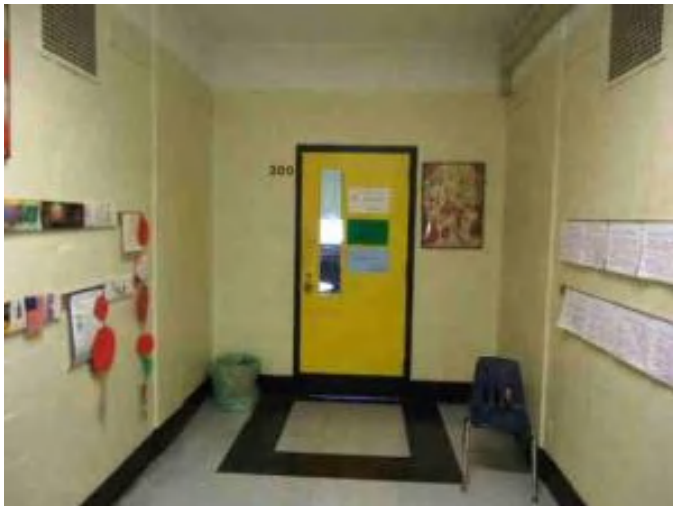
System: C1030 - Fittings

Location: Building Wide
Distress: Damaged
Category: 3 - Operations / Maint.
Priority: 5 - Response Time (> 5 yrs)
Correction: Replace missing or damaged signage - insert the number of rooms
Qty: 200.00
Unit of Measure: Ea.
Estimate: \$54,182.50
Assessor Name: System
Date Created: 02/08/2016

Notes: There is no directional signage and room signage is a custom design in places and scarce or painted with no consistency in others. Accessibility signage criteria have been established for the physically challenged. These include mounting heights, contrast and finish, raised and Braille characters and pictograms, and character proportions and heights. It is recommended that compliant signage be installed throughout the building.

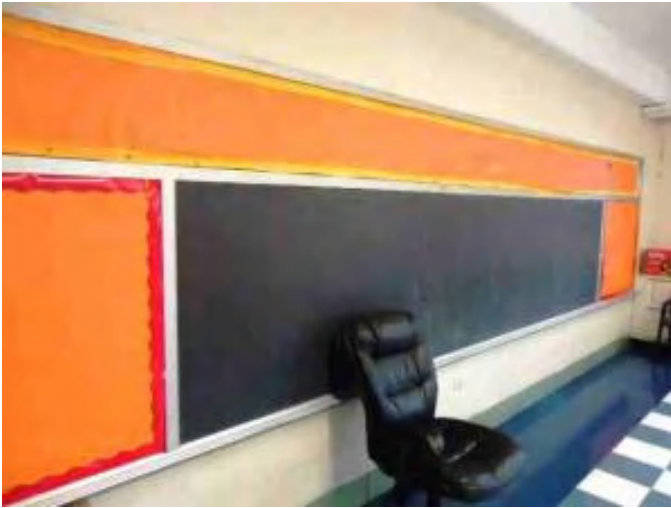
System: C1030 - Fittings

Some of the classroom chalk boards are original to the buildings construction. This system is damaged and beyond its expected life, universal upgrades are warranted. Remove and upgrade damaged chalk boards to new marker board systems.

Location: Classroom

Distress: Damaged

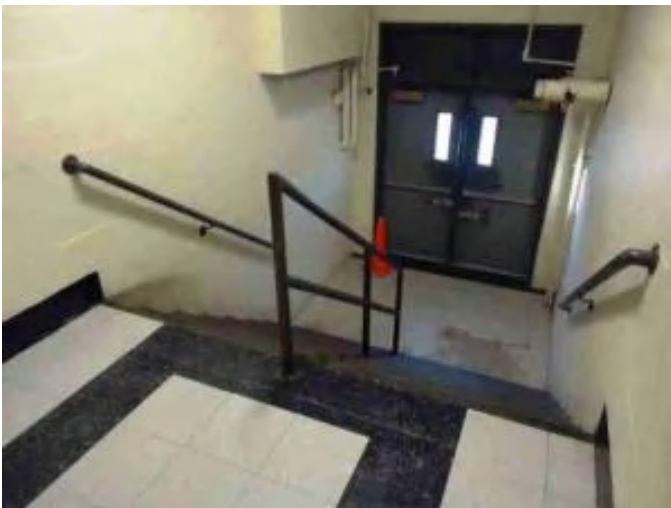
System: C2010 - Stair Construction

Location: Stairs

Distress: Damaged

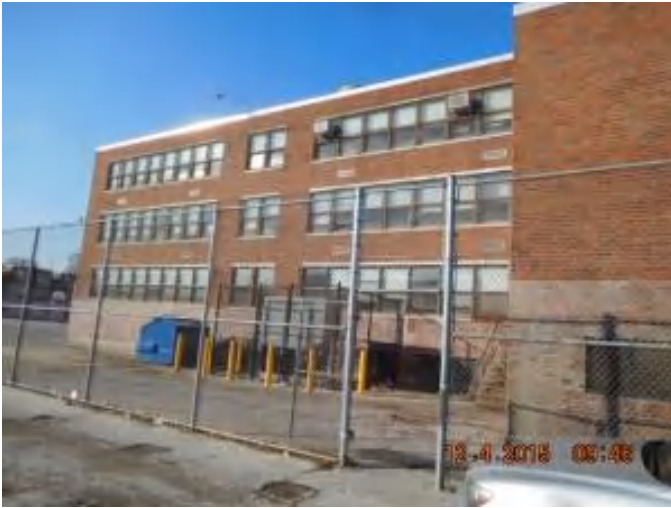
System: D3030 - Cooling Generating Systems

Location: roof, mechanical room
Distress: Inadequate
Category: 4 - Capital Improvement
Priority: 5 - Response Time (> 5 yrs)
Correction: Install chilled water system with distribution piping and pumps. (+75KSF)
Qty: 71,000.00
Unit of Measure: S.F.
Estimate: \$1,140,230.64
Assessor Name: System
Date Created: 02/07/2016

Notes: Provide a two hundred ton chilled water system with air cooled package chiller on the roof with pumps, piping and controls. Connect to new air handling units and unit ventilators.

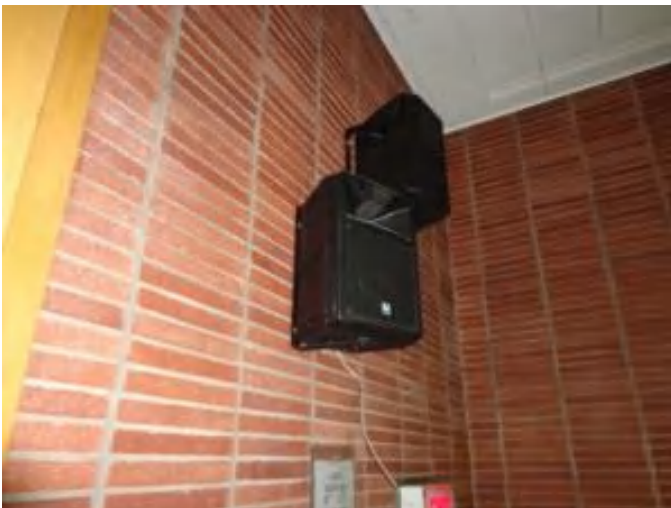
System: E1020 - Institutional Equipment

Location: Auditorium
Distress: Beyond Service Life
Category: 3 - Operations / Maint.
Priority: 5 - Response Time (> 5 yrs)
Correction: Replace sound system
Qty: 1.00
Unit of Measure: LS
Estimate: \$16,769.59
Assessor Name: System
Date Created: 01/26/2016

Notes: Replace sound system cabinet and speakers in the auditorium.

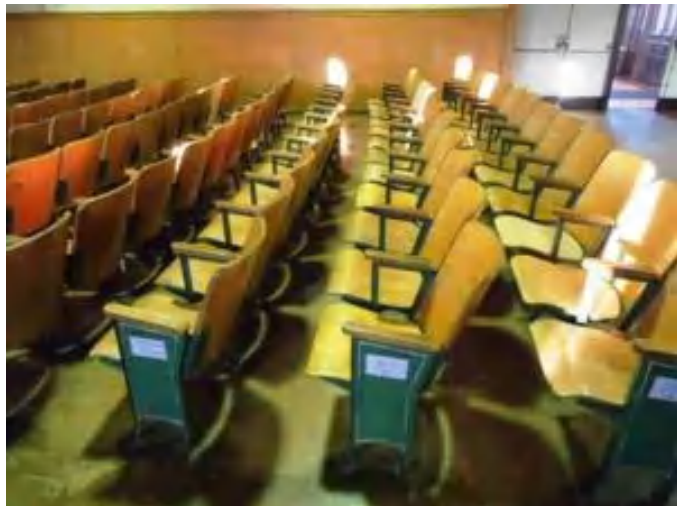
System: E2010 - Fixed Furnishings

Furnishings include: fixed casework; window shades and fixed auditorium seating. The fixed seating for this school is from the original construction. The systems are in fair condition considering the age and usage. This project provides a budgetary consideration for universal upgrades for the fixed seating and furnishing of this school. Ensure that ADA requirements are followed with the new seating layout.

Location: Auditorium

Distress: Damaged

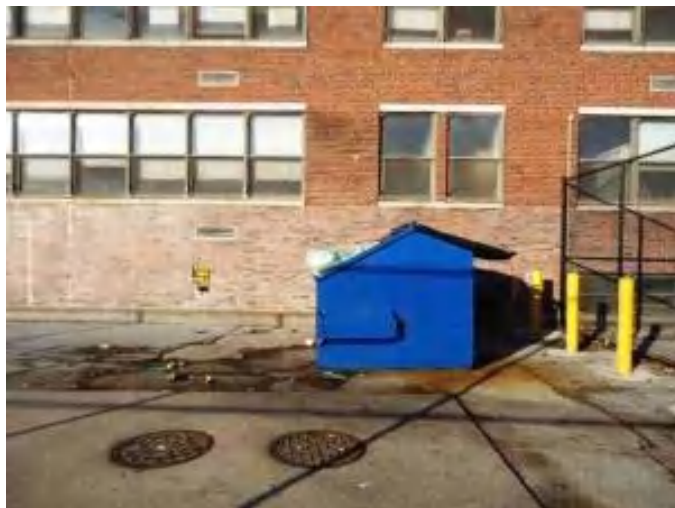
System: G2040 - Site Development

Location: Site

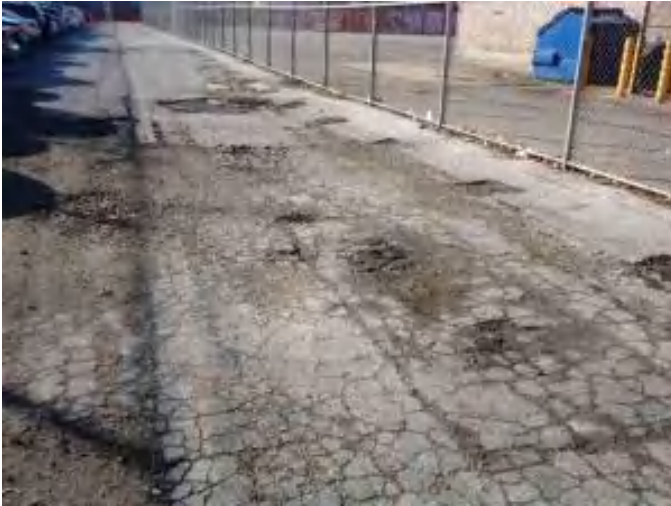
System: G2020 - Parking Lots

Location: Parking Lot

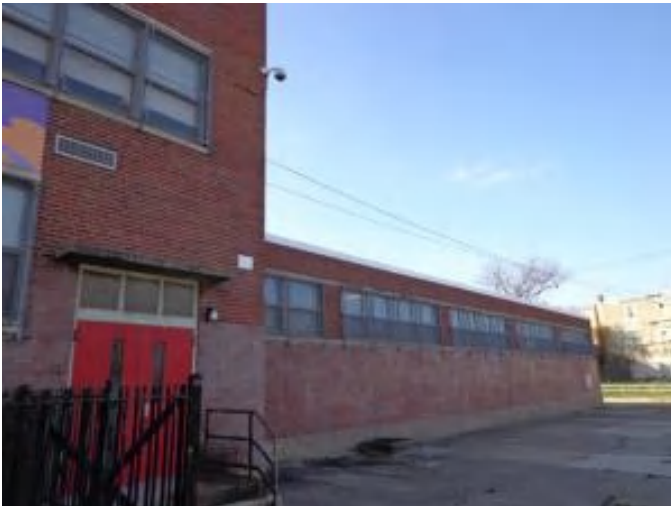
System: G4030 - Site Communications & Security

Location: Site

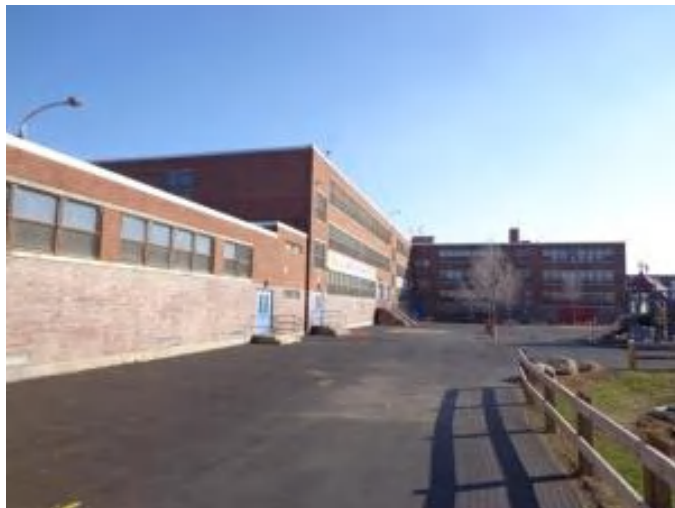
System: G4020 - Site Lighting

Location: Site
