## Facility Condition Assessment Summary Report

### Disston School

School District of Philadelphia  
**S824001;Disston**  
Final  
**Site Assessment Report**

January 31, 2017

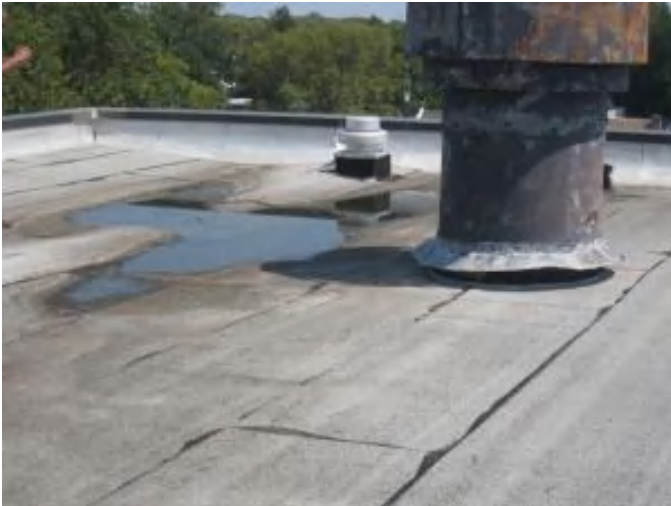
#### System: B3010105 - Built-Up

**Location:** roof

**Distress:** Beyond Service Life

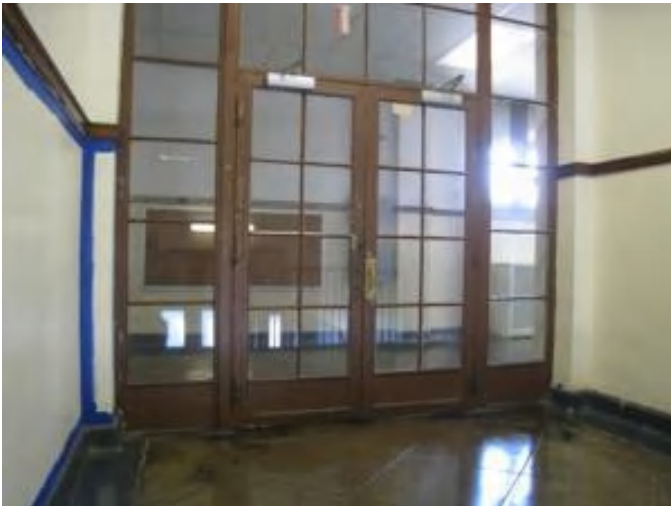
#### System: C1010 - Partitions

**Location:** stairway walls

**Distress:** Life Safety / NFPA / PFD

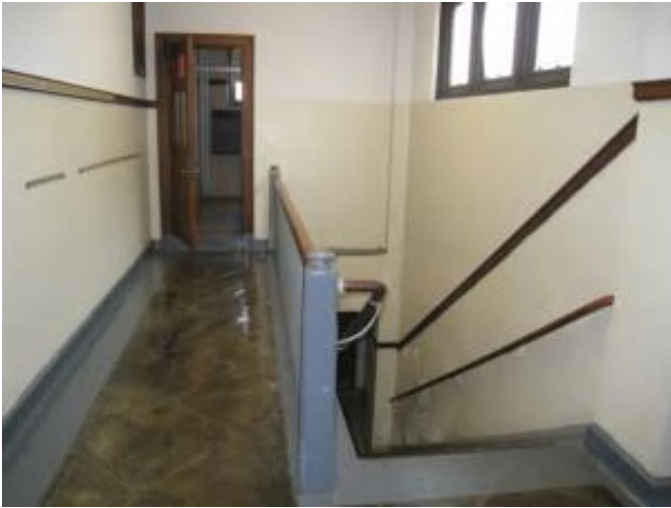
**System: C1010 - Partitions**

**Location:** open stairways

**Distress:** Life Safety / NFPA / PFD

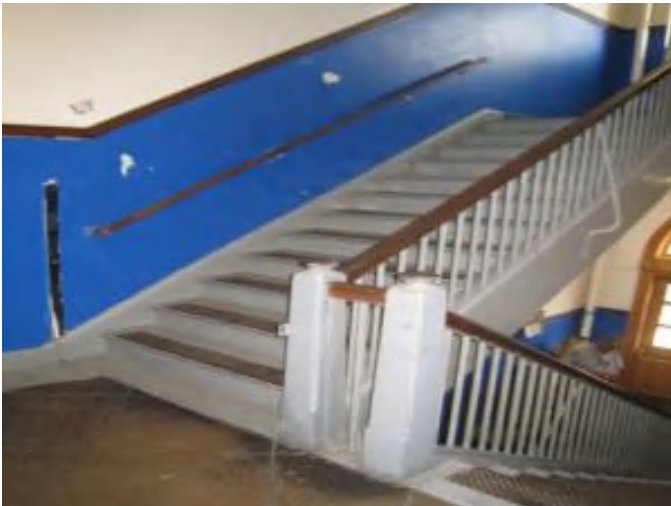
**System: C2010 - Stair Construction**

**Location:** stairways

**Distress:** Building / MEP Codes

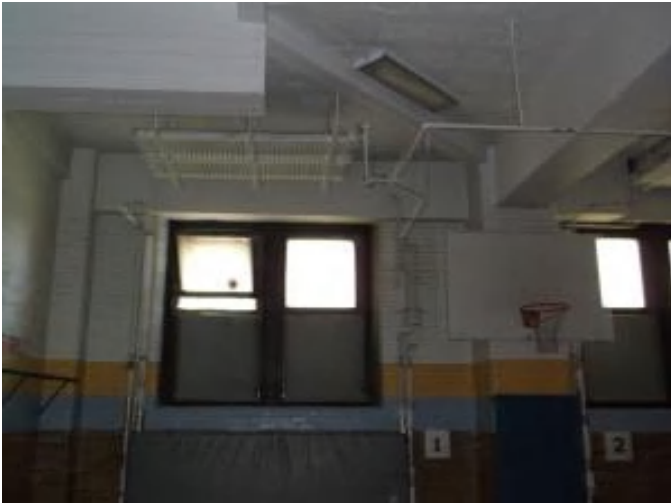
**System: D3040 - Distribution Systems**

**Location:** Throughout the building

**Distress:** Beyond Service Life

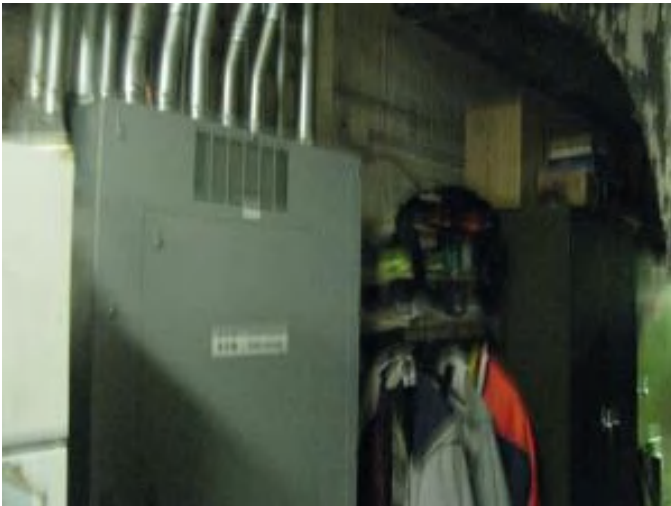
**System: D5010 - Electrical Service/Distribution**

**Location:** Boiler Room

**Distress:** Beyond Service Life

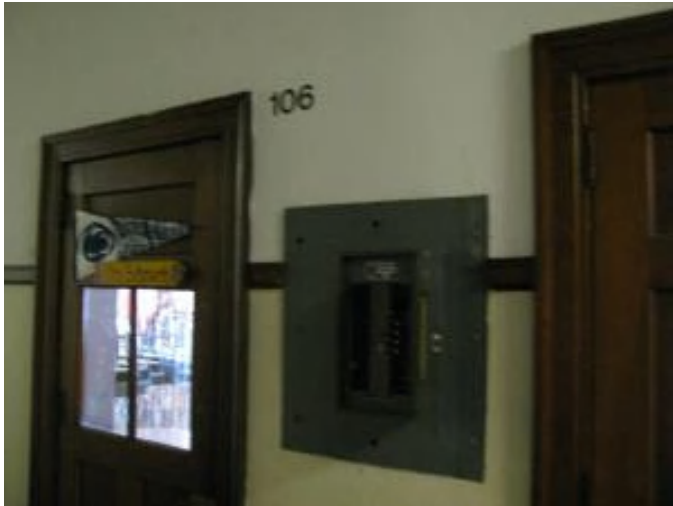
**System: D5010 - Electrical Service/Distribution**

**Location:** Entire Building  
**Distress:** Beyond Service Life  
**Category:** 3 - Operations / Maint.  
**Priority:** 1 - Response Time (< 2 yr)  
**Correction:** Replace Electrical Distribution System (U)  
**Qty:** 1.00  
**Unit of Measure:** Ea.  
**Estimate:** \$405,399.54  
**Assessor Name:** System  
**Date Created:** 09/10/2015

**Notes:** Replace the entire distribution system with new panels and new wiring/conduits. Provide arc flash label on the electrical equipment. Estimated 16 panel boards.

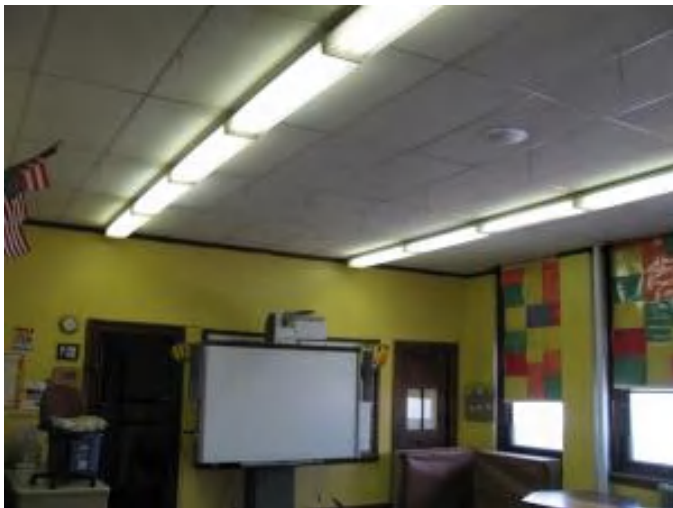
**System: D5020 - Lighting and Branch Wiring**

**Location:** Entire Building  
**Distress:** Beyond Service Life  
**Category:** 3 - Operations / Maint.  
**Priority:** 1 - Response Time (< 2 yr)  
**Correction:** Replace Lighting Fixtures (SF)  
**Qty:** 1.00  
**Unit of Measure:** S.F.  
**Estimate:** \$1,083,155.02  
**Assessor Name:** System  
**Date Created:** 09/10/2015

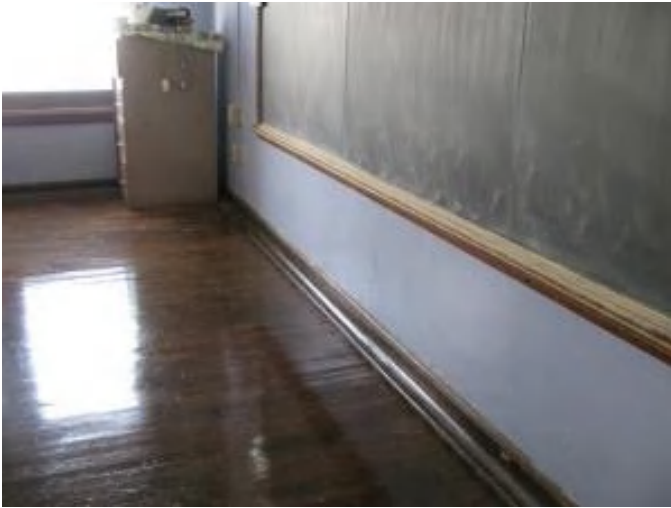
**System: D5020 - Lighting and Branch Wiring**

**Location:** Entier Building

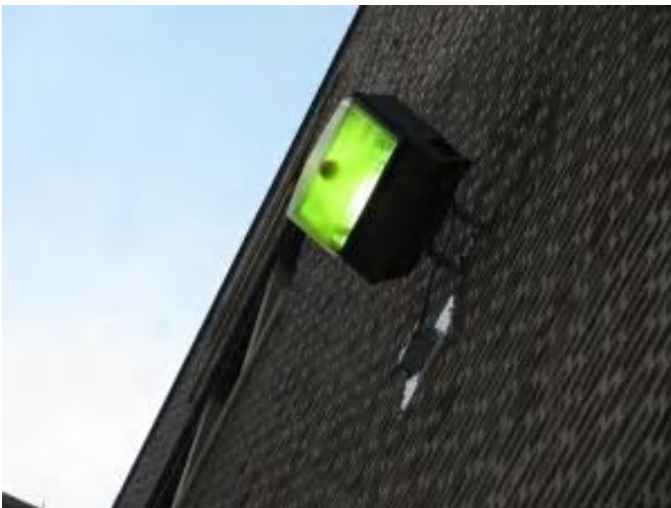
**System: D5020 - Lighting and Branch Wiring**

**Location:** Exterior walls

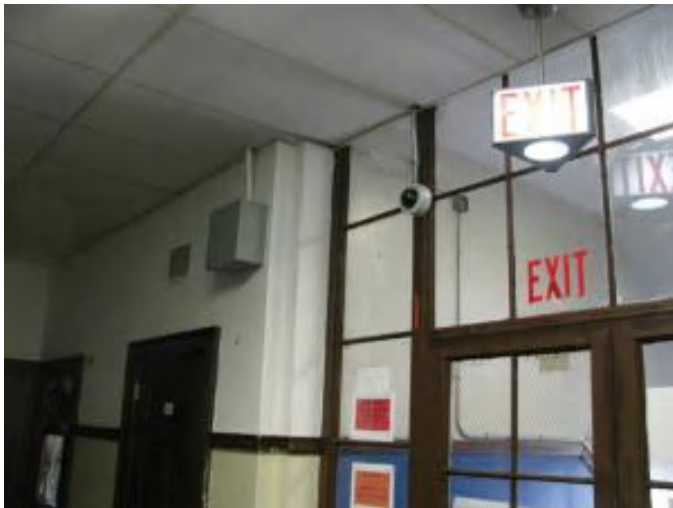
**System: D5020 - Lighting and Branch Wiring**

**Location:** B824001;Disston  
**Distress:** Health Hazard / Risk  
**Category:** 1 - Health & Safety  
**Priority:** 1 - Response Time (< 2 yr)  
**Correction:** Add Lighting Fixtures  
**Qty:** 25.00  
**Unit of Measure:** Ea.  
**Estimate:** \$25,253.90  
**Assessor Name:** System  
**Date Created:** 09/10/2015

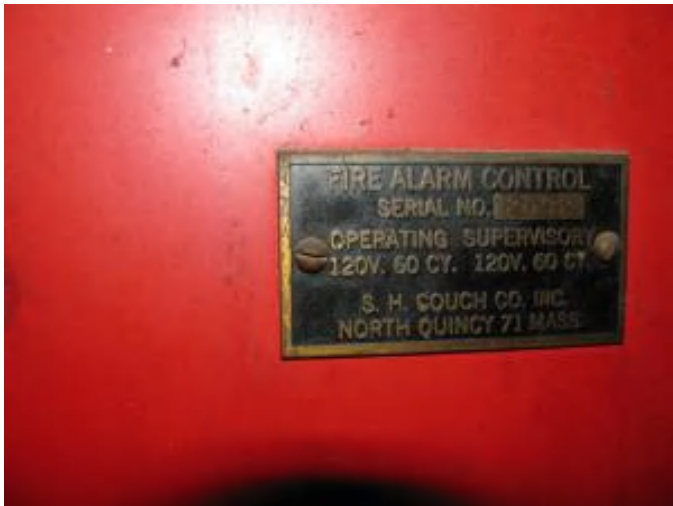
**System: D5030 - Communications and Security**

**Location:** Entier Building  
**Distress:** Beyond Service Life  
**Category:** 3 - Operations / Maint.  
**Priority:** 1 - Response Time (< 2 yr)  
**Correction:** Replace fire alarm system  
**Qty:** 1.00  
**Unit of Measure:** S.F.  
**Estimate:** \$314,330.20  
**Assessor Name:** System  
**Date Created:** 09/10/2015

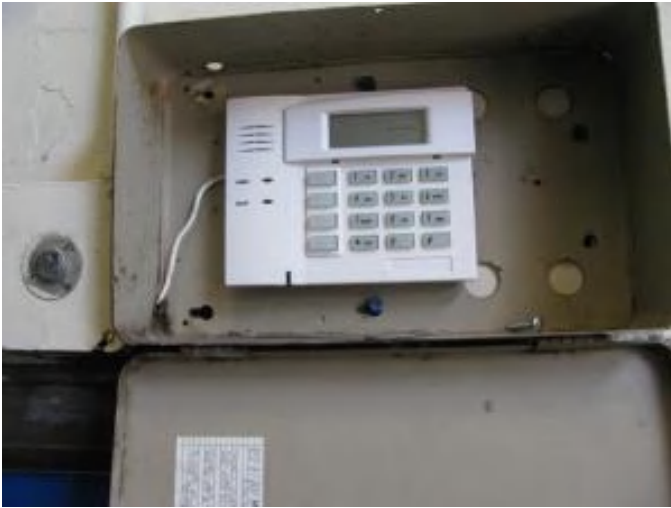
**System: D5030 - Communications and Security**

**Location:** Entire Building

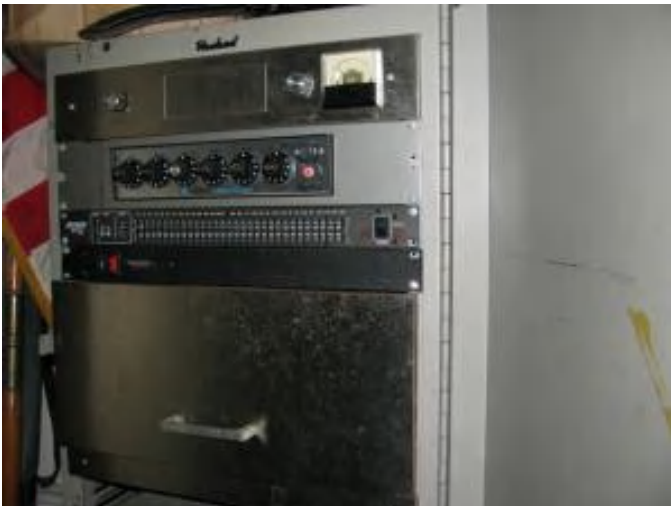
**System: D5030 - Communications and Security**

**Location:** Auditorium

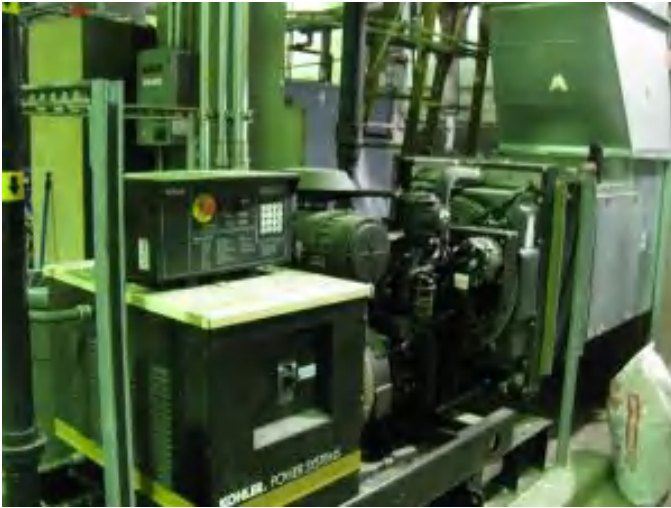
**System: D5090 - Other Electrical Systems**

**Location:** Basement

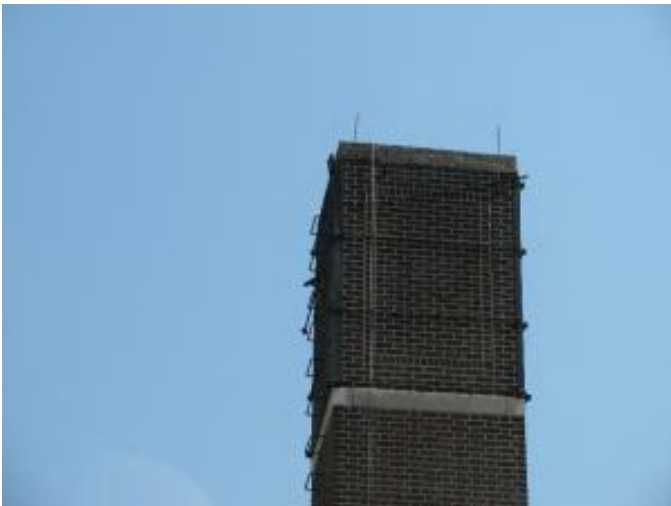
**System: D5090 - Other Electrical Systems**

**Location:** Roof

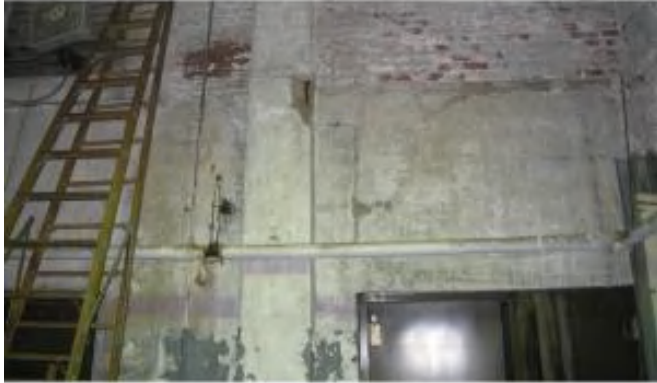
**System: A2020 - Basement Walls**

**Location:** mechanical room

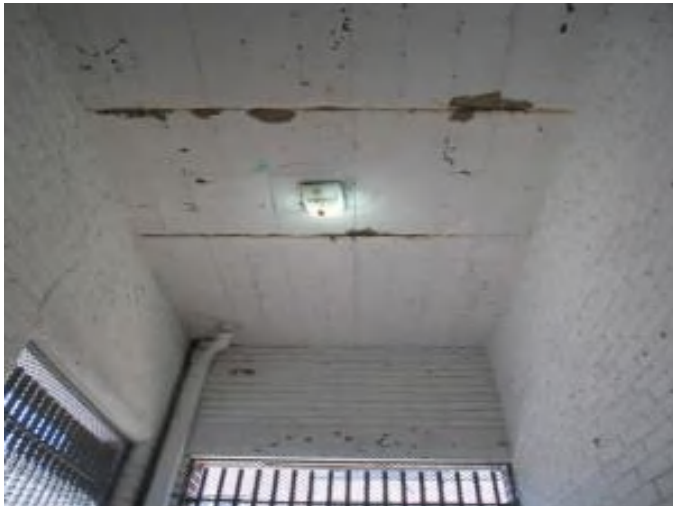
**System: B1010 - Floor Construction**

**Location:** fire stair towers

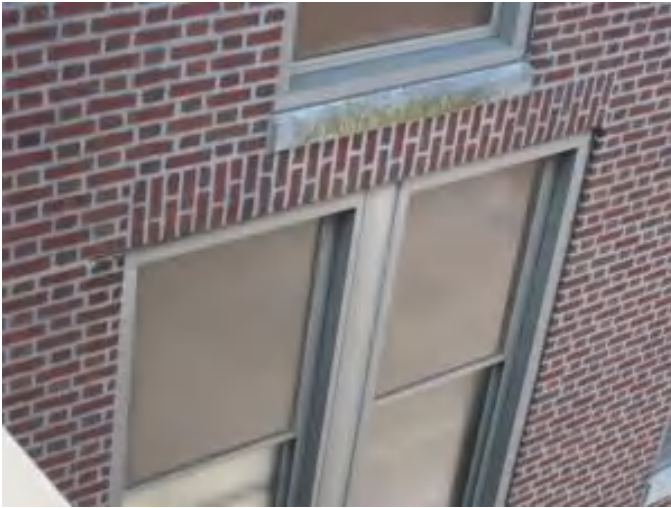
**System: B2010 - Exterior Walls**

**Location:** rear walls / lintels

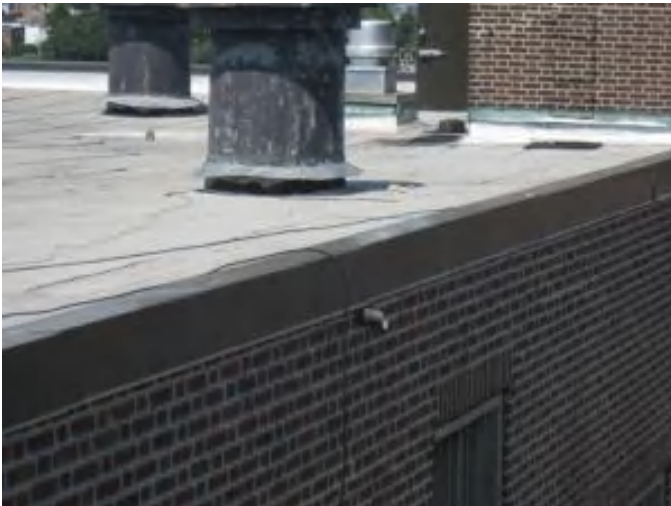
**System: B2010 - Exterior Walls**

**Location:** exterior walls (rear)

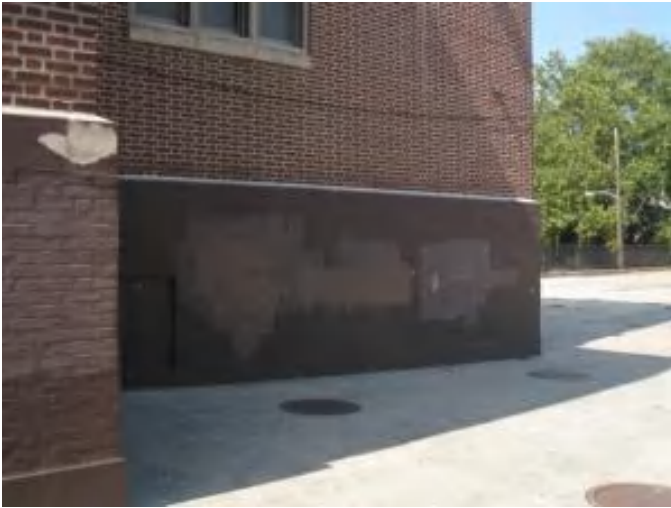
**System: B2010 - Exterior Walls**

**Location:** painted lower part of exterior walls  
**Distress:** Appearance  
**Category:** 3 - Operations / Maint.  
**Priority:** 2 - Response Time (2-3 yrs)  
**Correction:** Repaint exterior walls - CMU  
**Qty:** 5,000.00  
**Unit of Measure:** S.F.  
**Estimate:** \$36,309.38  
**Assessor Name:** System  
**Date Created:** 10/15/2015

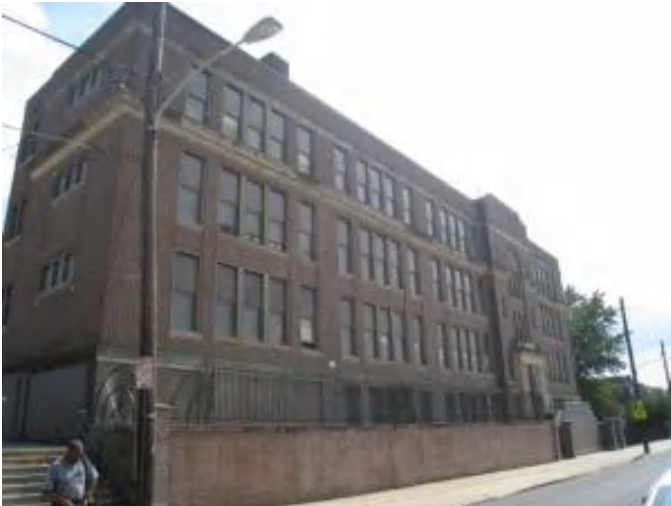
**System: B2010 - Exterior Walls**

**Location:** limestone band exterior walls  
**Distress:** Appearance  
**Category:** 3 - Operations / Maint.  
**Priority:** 2 - Response Time (2-3 yrs)  
**Correction:** Sooty and dirty walls - powerwash  
**Qty:** 10,000.00  
**Unit of Measure:** S.F.  
**Estimate:** \$10,937.35  
**Assessor Name:** System  
**Date Created:** 10/15/2015

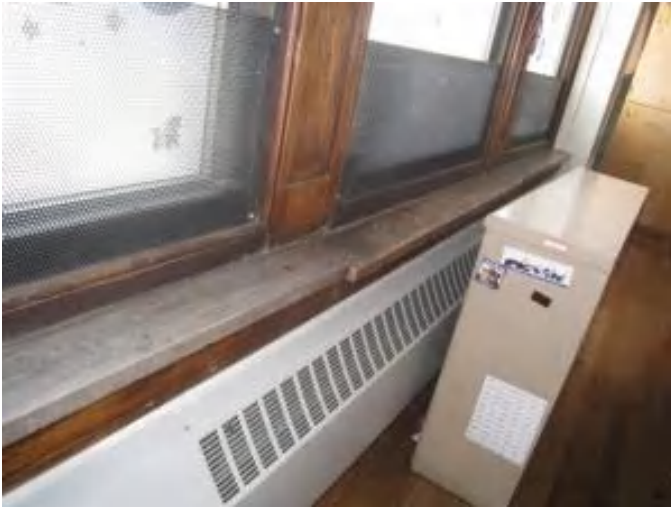
**System: B2020 - Exterior Windows**

**Location:** exterior windows

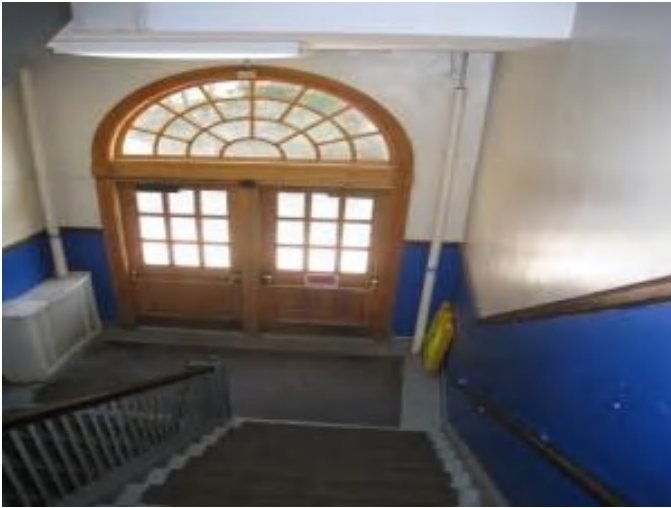
**System: B2030 - Exterior Doors**

**Location:** front doors  
**Distress:** Failing  
**Category:** 3 - Operations / Maint.  
**Priority:** 2 - Response Time (2-3 yrs)  
**Correction:** Refinish and repaint exterior doors - per leaf  
**Qty:** 4.00  
**Unit of Measure:** Ea.  
**Estimate:** \$2,389.02  
**Assessor Name:** System  
**Date Created:** 10/15/2015

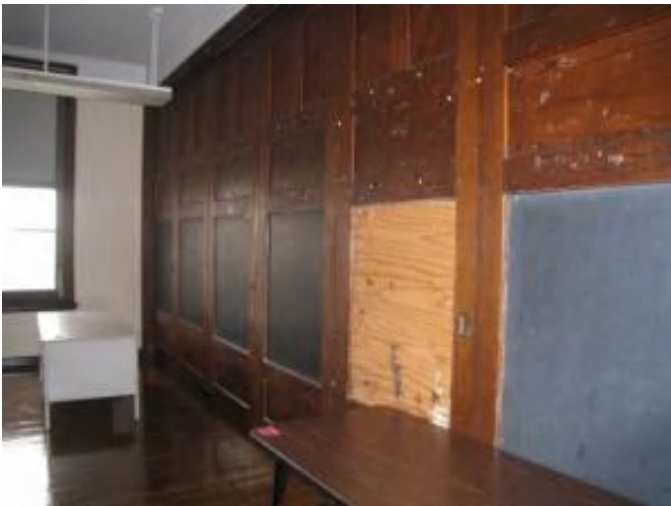
**System: C1010 - Partitions**

**Location:** classrooms  
**Distress:** Damaged  
**Category:** 3 - Operations / Maint.  
**Priority:** 2 - Response Time (2-3 yrs)  
**Correction:** Remove folding wood partitions; replace with metal studs and gypsum board painted  
**Qty:** 2,400.00  
**Unit of Measure:** S.F.  
**Estimate:** \$53,470.79  
**Assessor Name:** System  
**Date Created:** 10/15/2015

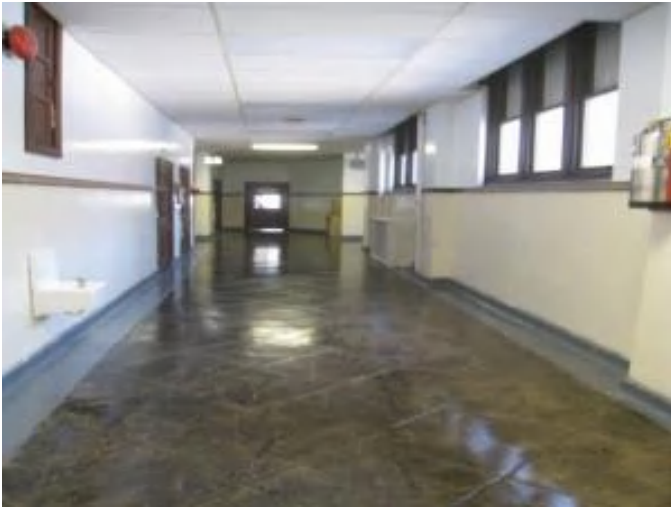
**System: C1010 - Partitions**

**Location:** corridors

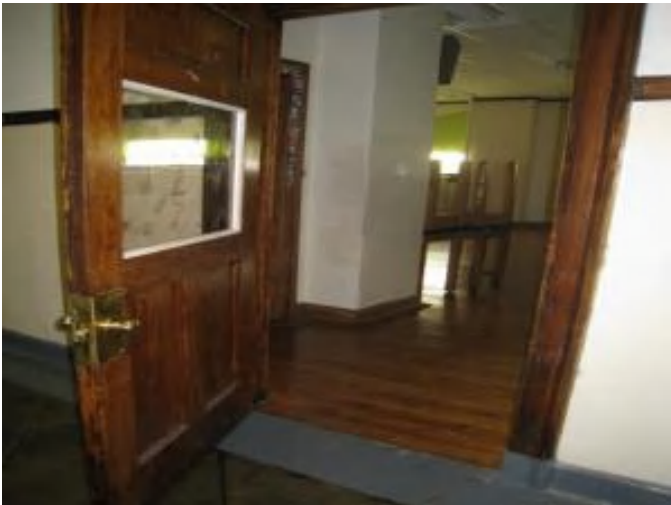
**System: C1020 - Interior Doors**

**Location:** classroom and office doors

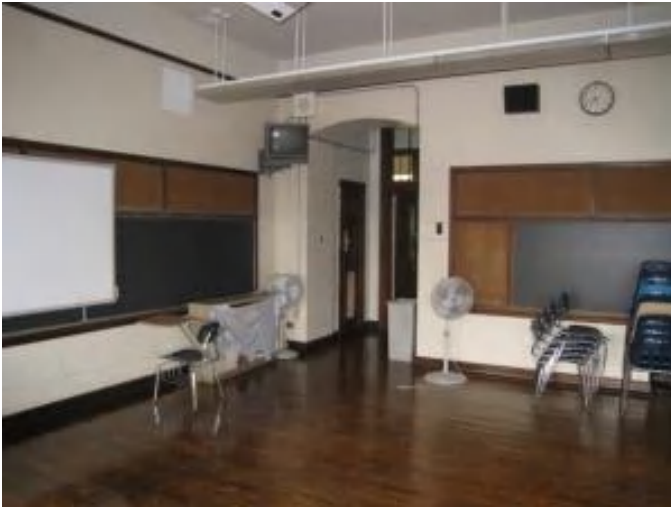
**System: C1020 - Interior Doors**

**Location:** classrooms  
**Distress:** Appearance  
**Category:** 3 - Operations / Maint.  
**Priority:** 2 - Response Time (2-3 yrs)  
**Correction:** Refinish interior doors  
**Qty:** 70.00  
**Unit of Measure:** Ea.  
**Estimate:** \$57,972.81  
**Assessor Name:** System  
**Date Created:** 10/15/2015

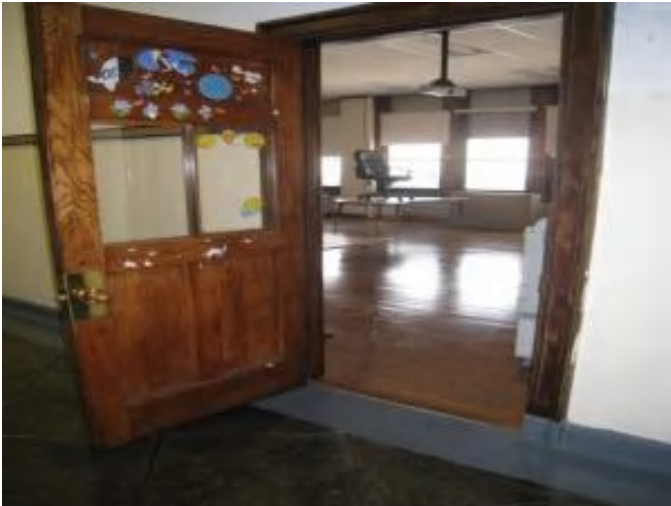
**System: C1020 - Interior Doors**

**Location:** classrooms and offices  
**Distress:** Security Issue  
**Category:** 1 - Health & Safety  
**Priority:** 2 - Response Time (2-3 yrs)  
**Correction:** Provide security hardware for classroom and office doors  
**Qty:** 70.00  
**Unit of Measure:** Ea.  
**Estimate:** \$16,060.56  
**Assessor Name:** System  
**Date Created:** 10/15/2015

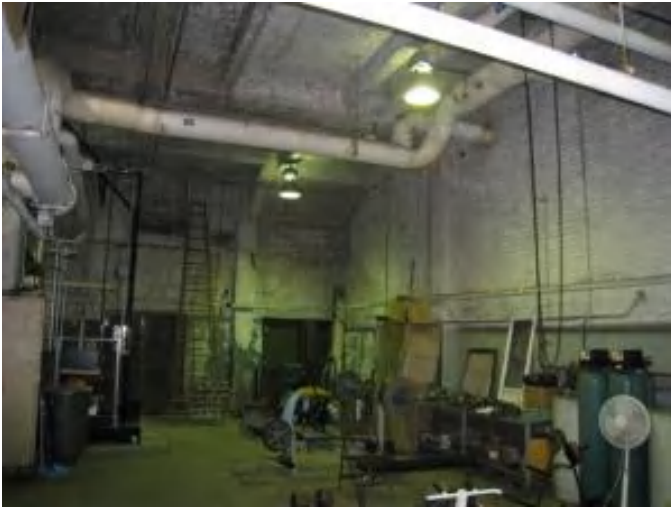
**System: C1020 - Interior Doors**

**Location:** basement

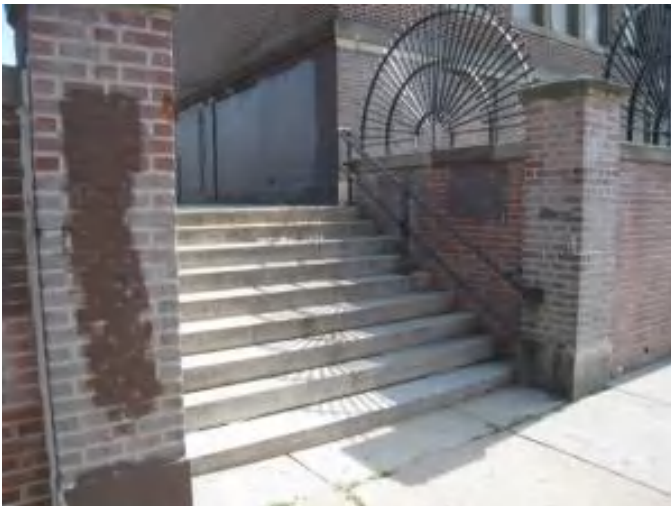
**System: C2010 - Stair Construction**

**Location:** exterior stairs

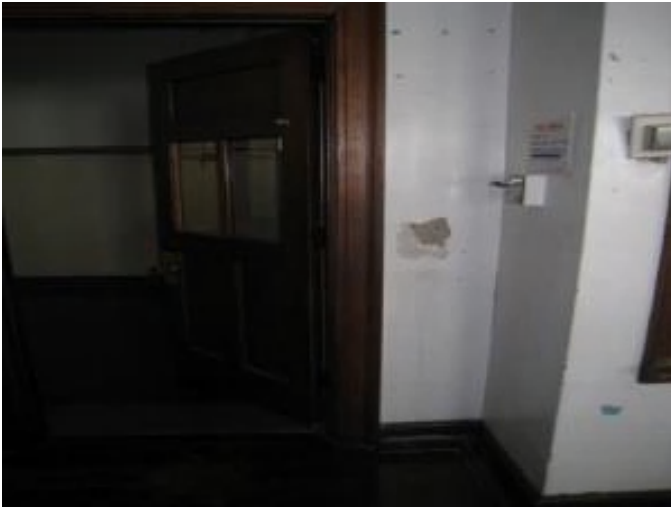
**System: C3010230 - Paint & Covering**

**Location:** interior walls

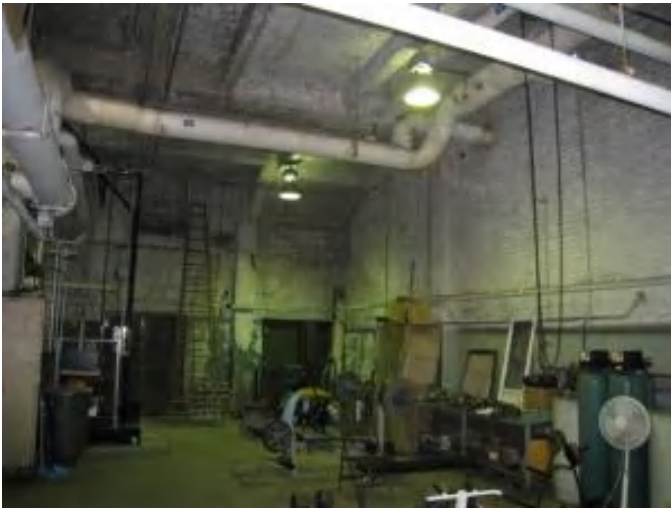
**System: C3010230 - Paint & Covering**

**Location:** mechanical room

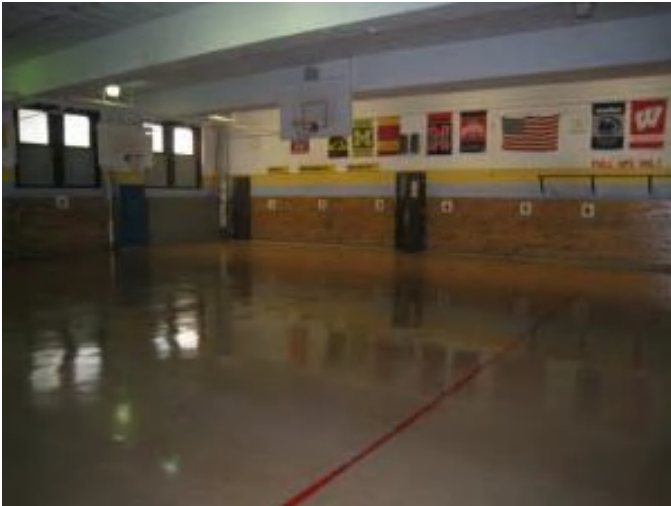
**System: C3020413 - Vinyl Flooring**

**Location:** gym and other rooms

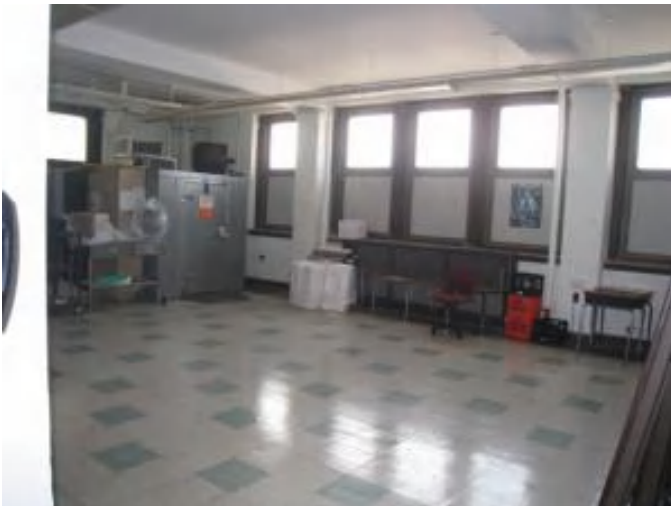
**System: C3020413 - Vinyl Flooring**

**Location:** classrooms

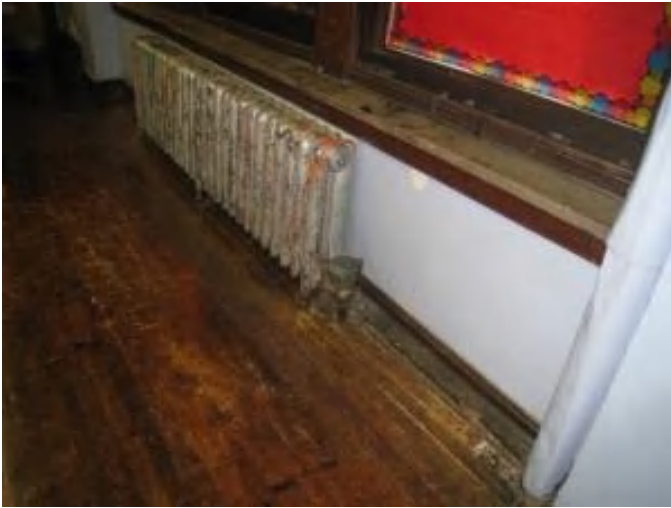
**System: C3020414 - Wood Flooring**

**Location:** classrooms

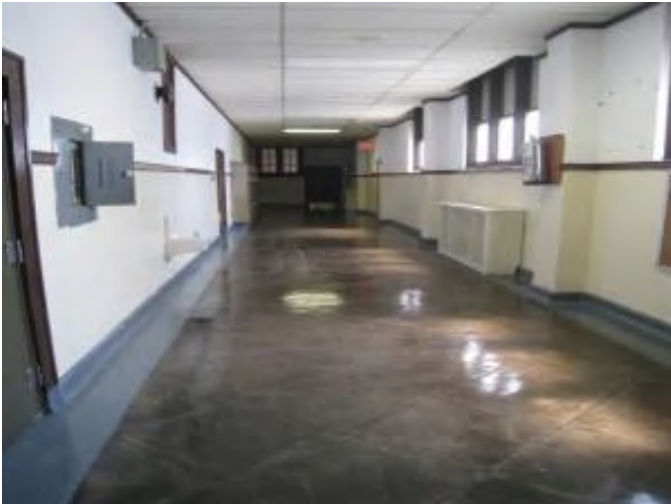
**System: C3020415 - Concrete Floor Finishes**

**Location:** basement, corridors, stairs

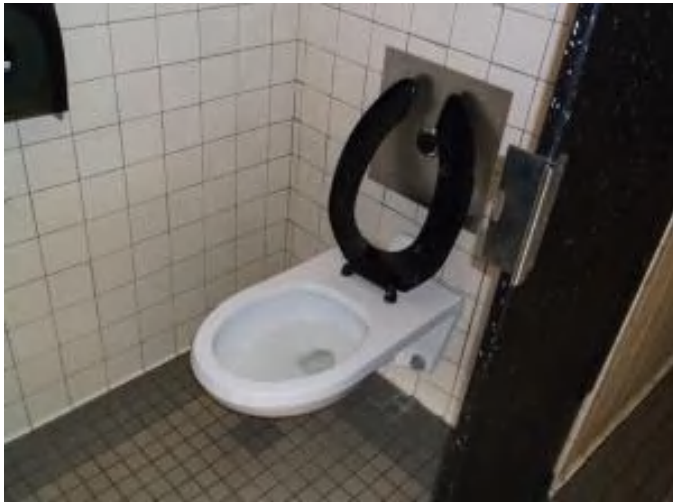
**System: D2010 - Plumbing Fixtures**

**Location:** Throughout the building

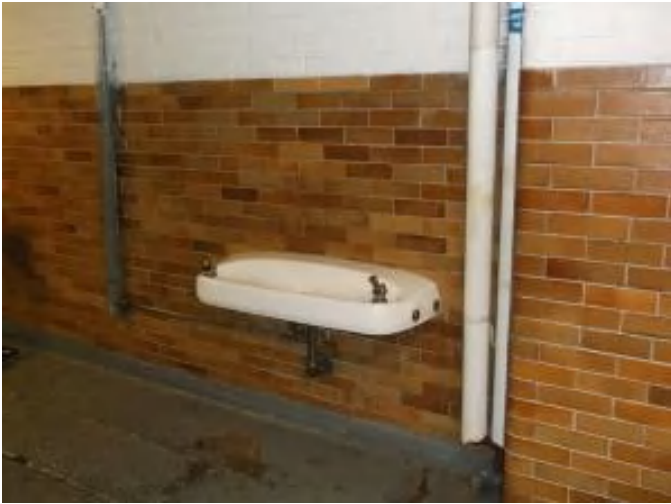
**System: D2010 - Plumbing Fixtures**

**Location:** Throughout the building

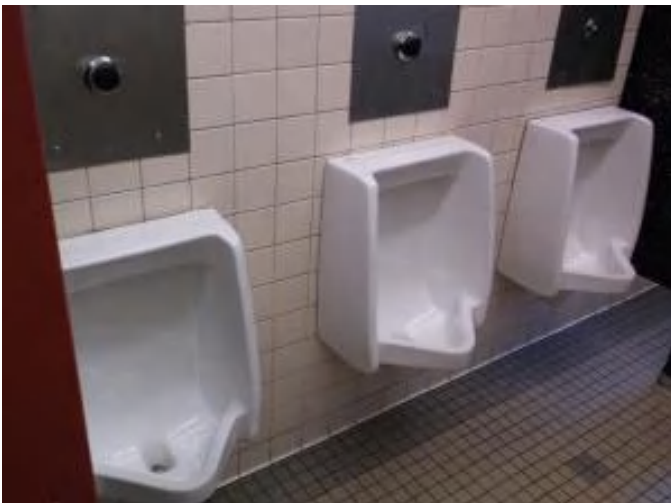
**System: D2010 - Plumbing Fixtures**

**Location:** Throughout the building

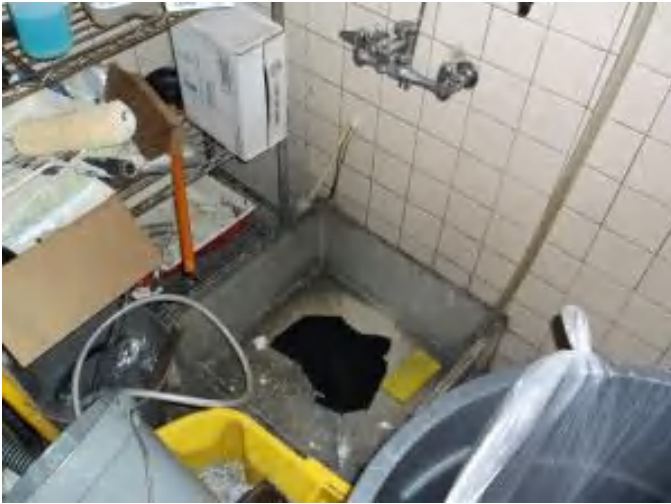
**System: D2010 - Plumbing Fixtures**

**Location:** Throughout the building

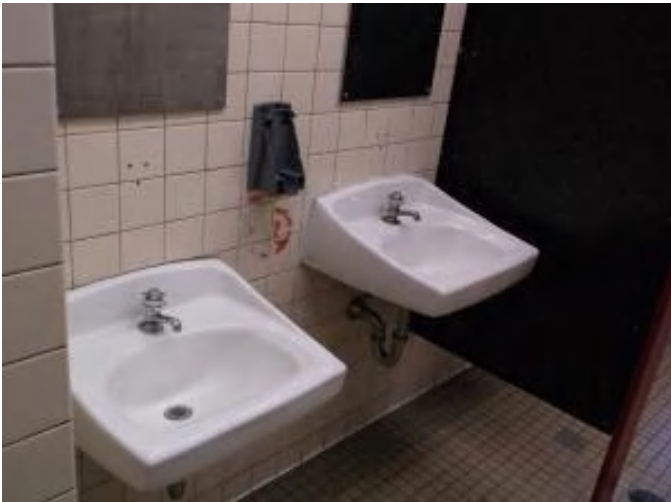
**System: D2010 - Plumbing Fixtures**

**Location:** Throughout the building

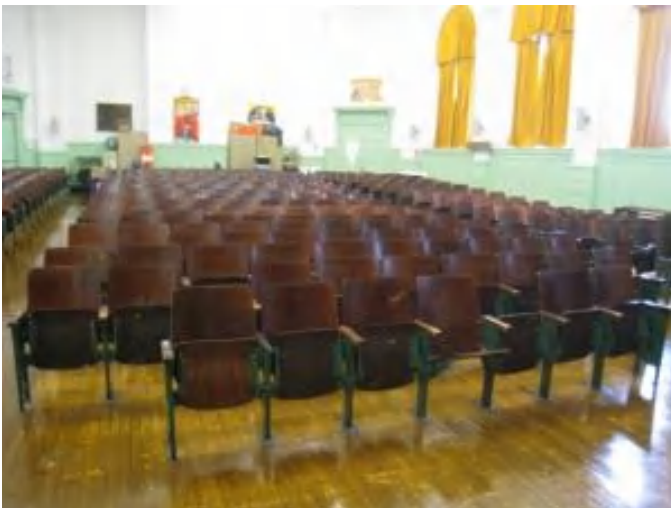
**System: E2010 - Fixed Furnishings**

**Location:** auditorium

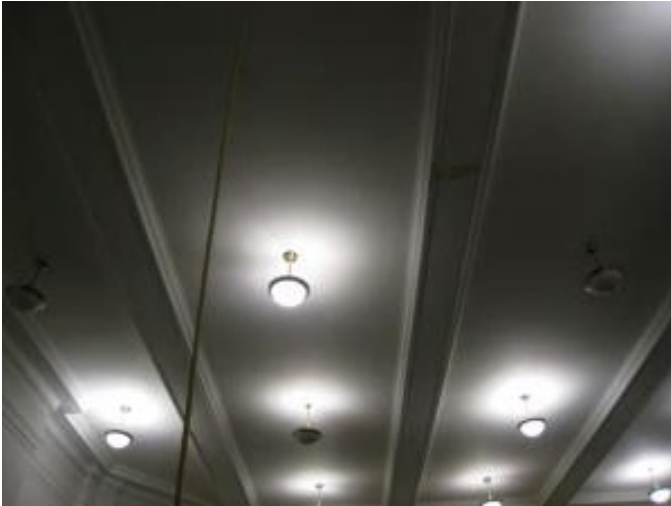
**System: C3030 - Ceiling Finishes**

**Location:** ceilings

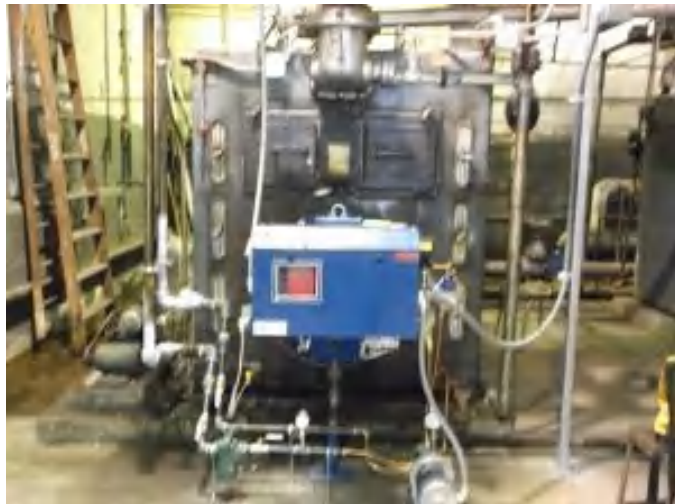
**System: D3020 - Heat Generating Systems**

**Location:** Boiler Mechanical Equipment Room

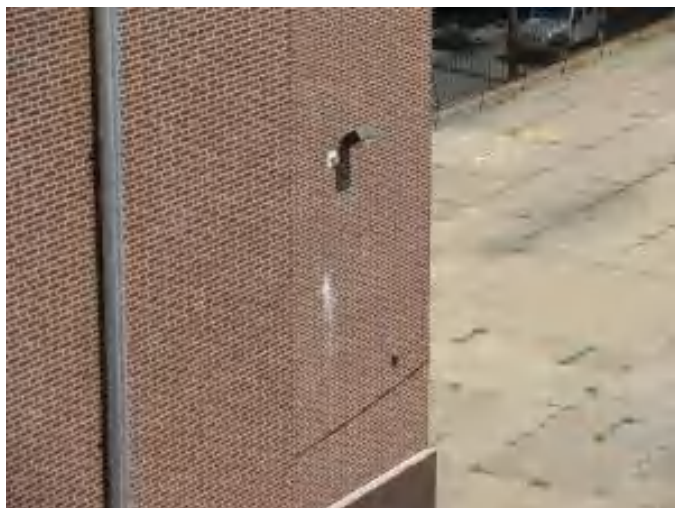
**System: D5030 - Communications and Security**

**Location:** Exterior Walls

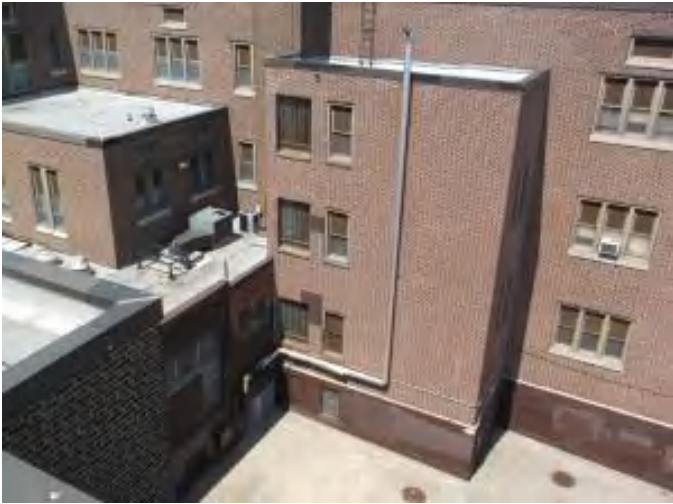
**System: D3030 - Cooling Generating Systems**

**Location:** Adjacent to building  
**Distress:** Inadequate  
**Category:** 4 - Capital Improvement  
**Priority:** 5 - Response Time (> 5 yrs)  
**Correction:** Install chilled water system with distribution piping and pumps. (+75KSF)  
**Qty:** 75,000.00  
**Unit of Measure:** S.F.  
**Estimate:** \$1,204,454.53  
**Assessor Name:** System  
**Date Created:** 11/17/2015

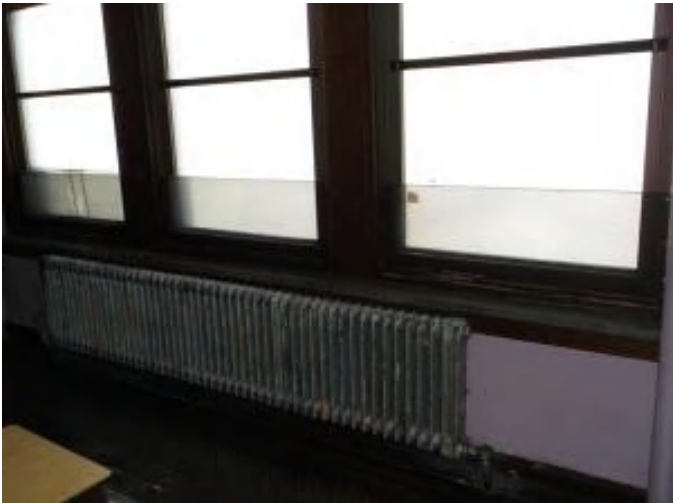
**System: D3040 - Distribution Systems**

**Location:** Throughout the building  
**Distress:** Beyond Service Life  
**Category:** 3 - Operations / Maint.  
**Priority:** 5 - Response Time (> 5 yrs)  
**Correction:** Provide classroom FC units and dedicated OA ventilation system. (20 clsrms)  
**Qty:** 20.00  
**Unit of Measure:** C  
**Estimate:** \$1,661,219.77  
**Assessor Name:** System  
**Date Created:** 11/17/2015

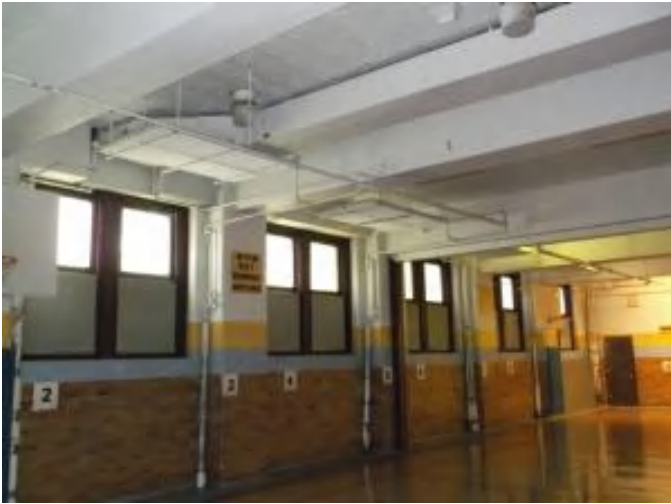
**System: D3040 - Distribution Systems**

**Location:** Gym

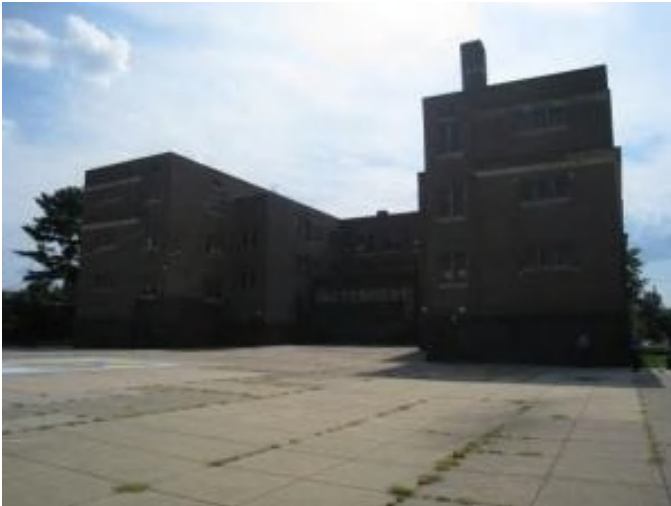
#### System: G2030 - Pedestrian Paving

**Location:** rear play area

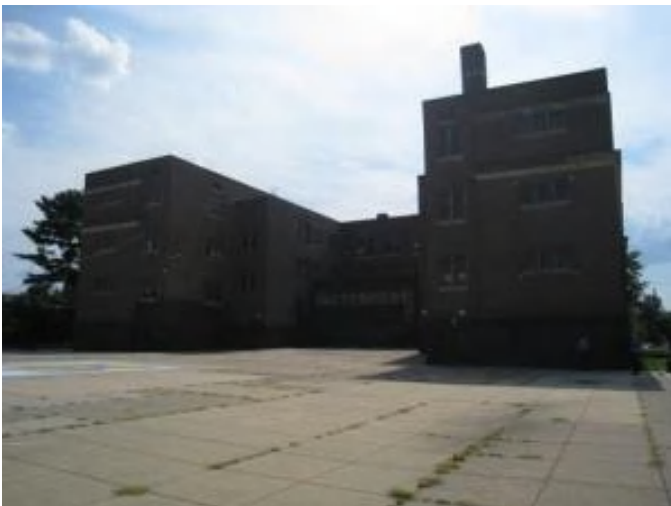
#### System: G2030 - Pedestrian Paving

**Location:** rear/side of building

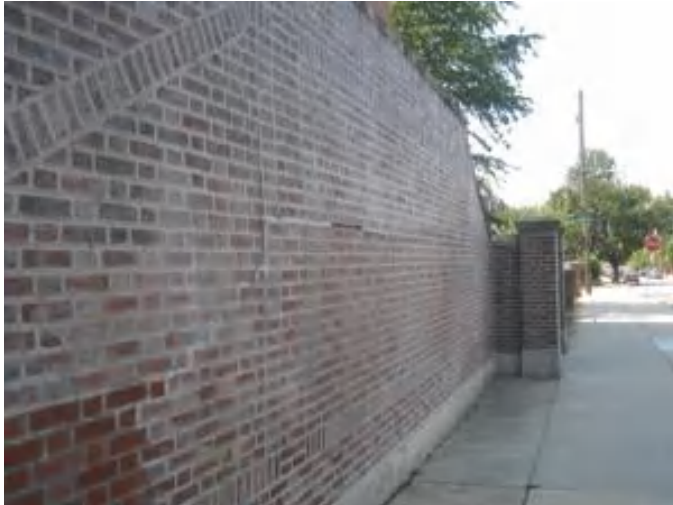
**System: G2040 - Site Development**

**Location:** brick retaining wall along Cottage St and Gillespie St

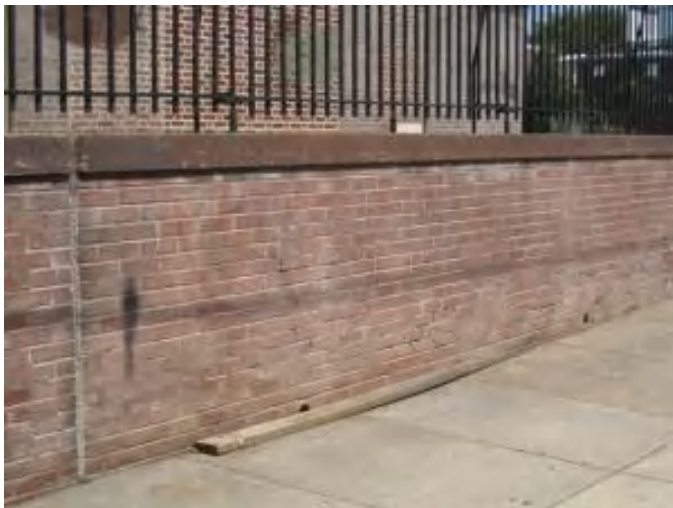
**System: G2040 - Site Development**

**Location:** site fence

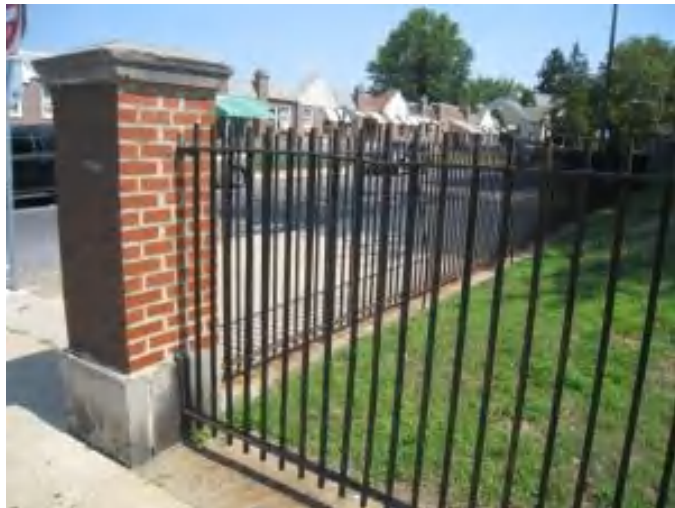
**System: G2040 - Site Development**

**Location:** site fence
