Facility Condition Assessment Summary Report

Dobbins High School

School District of Philadelphia
S406001;Dobbins
Final
Site Assessment Report
January 30, 2017

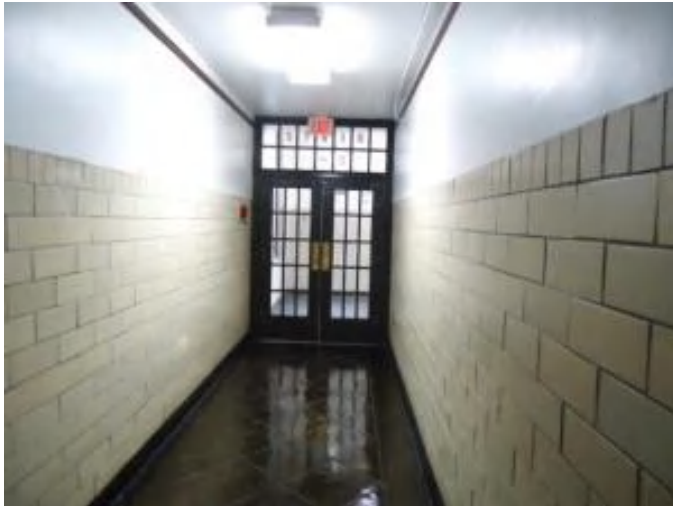
System: C1010 - Partitions

Location: Stairs

Distress: Damaged

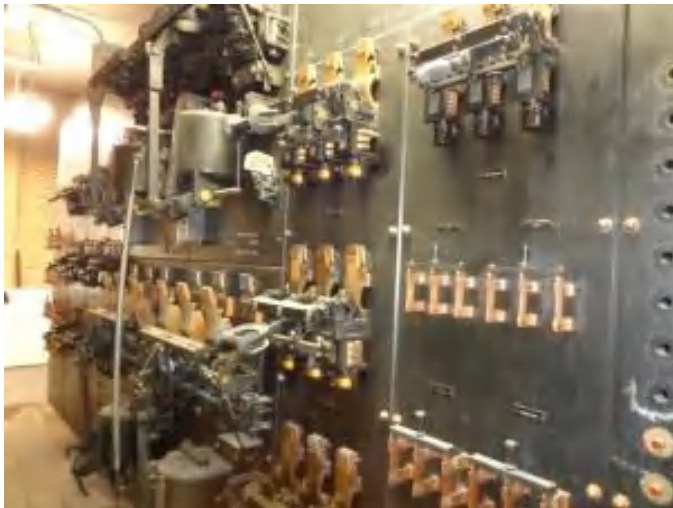
System: D5010 - Electrical Service/Distribution

Location: Mechanical Room 029
Distress: Health Hazard / Risk
Category: 1 - Health & Safety
Priority: 1 - Response Time (< 2 yr)
Correction: Replace Switchboard
Qty: 1.00
Unit of Measure: Ea.
Estimate: \$1,650,243.20
Assessor Name: System
Date Created: 01/18/2016

Notes: Replace existing obsolete main switchboard with knife blade switches in the Main Electrical Room with two (2) substations fed from load interrupter switches in the transformer vault. Estimated size is 1000 kVA, 3000A 208/120V, 3 phase, 4 wire.

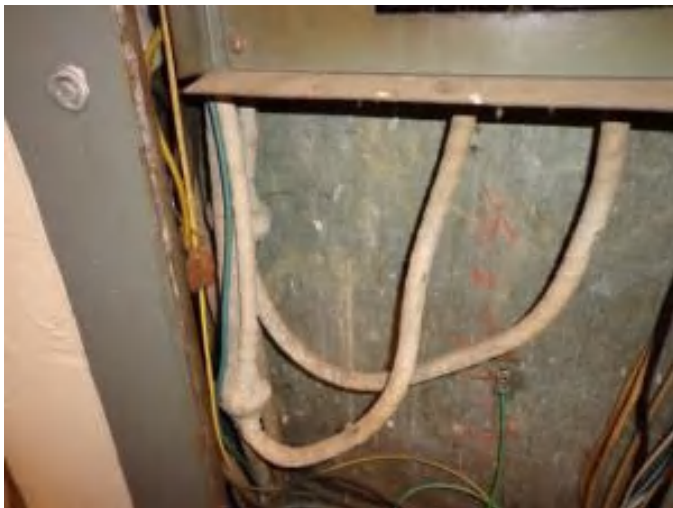
System: D5010 - Electrical Service/Distribution

Location: Building wide
Distress: Health Hazard / Risk
Category: 1 - Health & Safety
Priority: 1 - Response Time (< 2 yr)
Correction: Remove asbestos from electrical panel - based on approximately 20 SF
Qty: 46.00
Unit of Measure: Ea.
Estimate: \$88,571.25
Assessor Name: System
Date Created: 01/22/2016

Notes: Abate asbestos wrapped cables within panelboard enclosures for 46 panelboards.

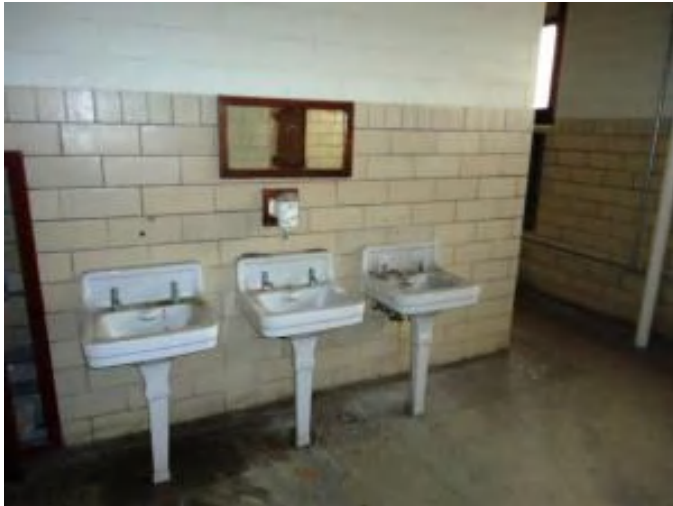
System: C1010 - Partitions

Location: Restrooms

Distress: Damaged

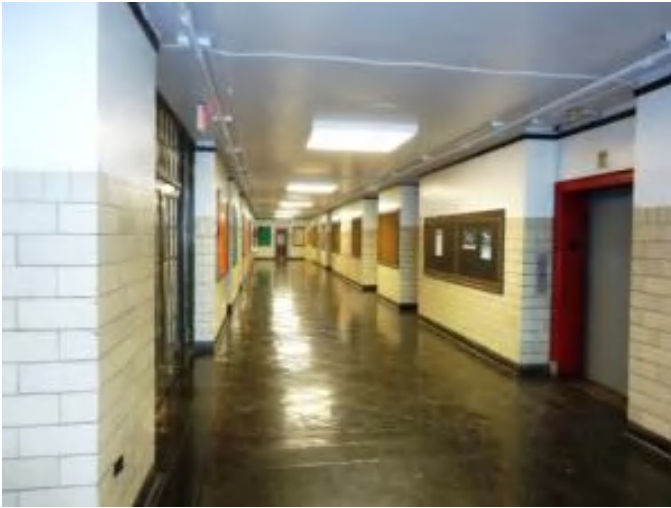
System: C1010 - Partitions

Location: Elevator
Distress: Building / MEP Codes
Category: 2 - Code Compliance
Priority: 2 - Response Time (2-3 yrs)
Correction: Build fire resistant elevator lobby to comply with fire separation requirements - each floor
Qty: 24.00
Unit of Measure: Ea.
Estimate: \$852,249.00
Assessor Name: System
Date Created: 10/27/2015

Notes: The present floor plan arrangement has the elevator lobbies opening up into the existing hall corridors. IBC 2000 states that elevators opening into a fire resistant corridor shall be provided with an elevator lobby at each floor containing such a corridor. The lobby should completely separate the elevators from the corridor with rated partitions. Elevator lobbies need to have at least one means of egress and contain smoke detectors. This deficiency recommends the construction of fire resistant barrier with automatically closing fire doors to be installed between the elevator lobbies and the corridors to provide the required separation and protection.

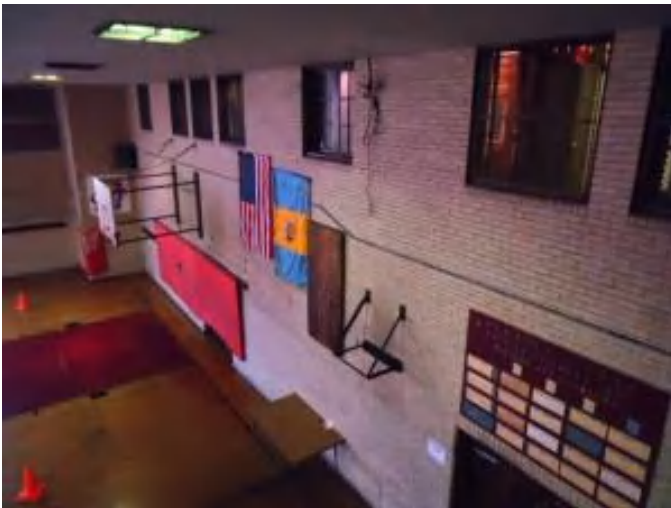
System: C1010 - Partitions

Location: Building Wide
Distress: Life Safety / NFPA / PFD
Category: 1 - Health & Safety
Priority: 2 - Response Time (2-3 yrs)
Correction: Remove non-rated interior glass panels and replace with studs, gypsum board, paint (E) wall
Qty: 5,000.00
Unit of Measure: S.F.
Estimate: \$133,746.62
Assessor Name: System
Date Created: 10/27/2015

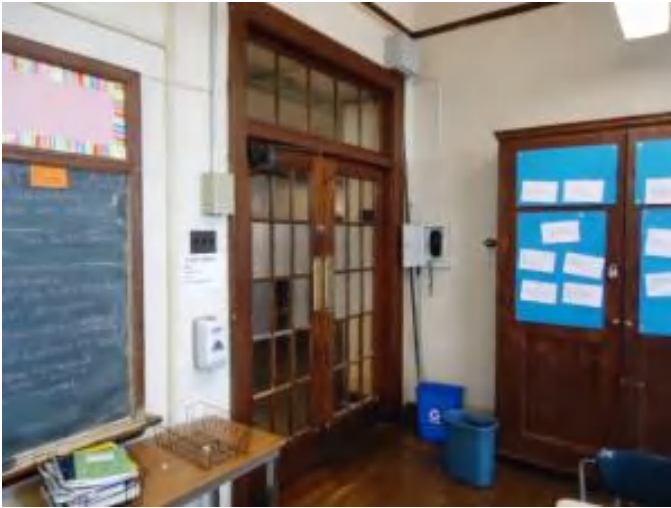
System: C1020 - Interior Doors

Location: Classroom Door System
Distress: Damaged
Category: 3 - Operations / Maint.
Priority: 2 - Response Time (2-3 yrs)
Correction: Remove and replace interior doors - wood doors with hollow metal frames - per leaf
Qty: 600.00
Unit of Measure: Ea.
Estimate: \$2,862,352.27
Assessor Name: System
Date Created: 10/27/2015

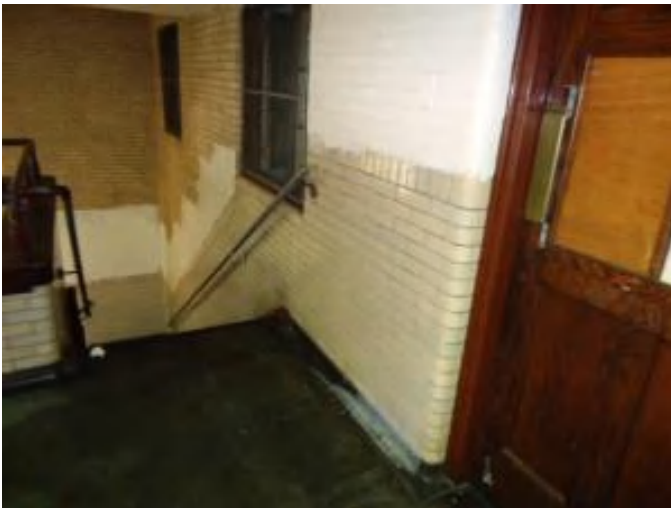
System: C2010 - Stair Construction

Location: Stairs
Distress: Life Safety / NFPA / PFD
Category: 1 - Health & Safety
Priority: 2 - Response Time (2-3 yrs)
Correction: Replace inadequate or install proper stair railing - select appropriate material
Qty: 5,000.00
Unit of Measure: L.F.
Estimate: \$844,314.00
Assessor Name: System
Date Created: 10/27/2015

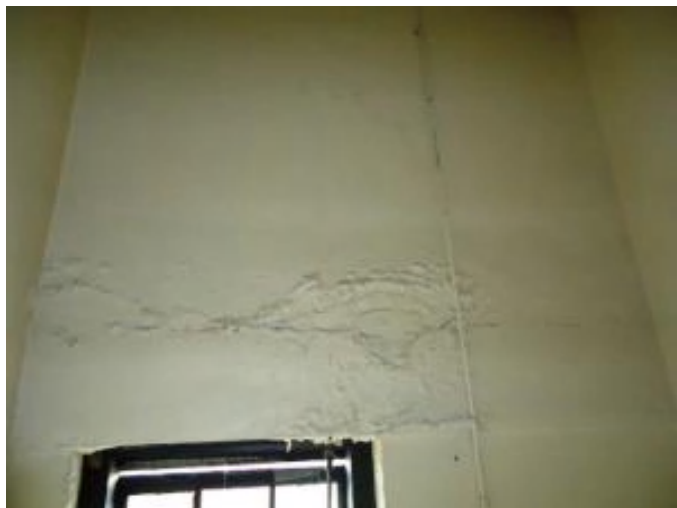
System: C3010230 - Paint & Covering

Location: Building Wide

Distress: Damaged

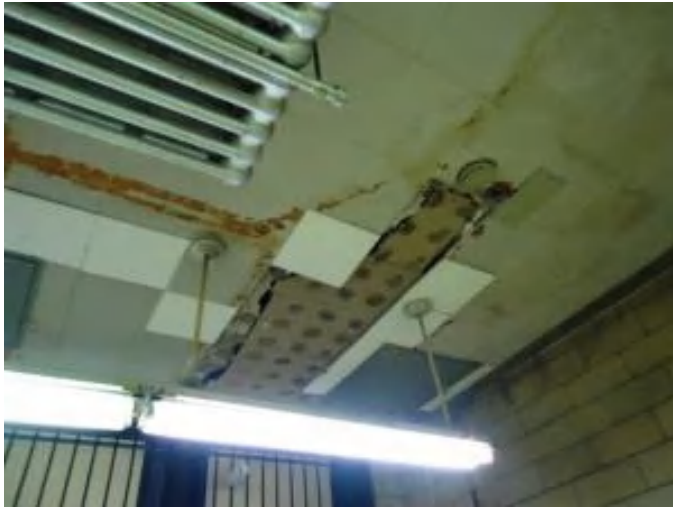
System: C3030 - Ceiling Finishes

Location: Building Wide

Distress: Damaged

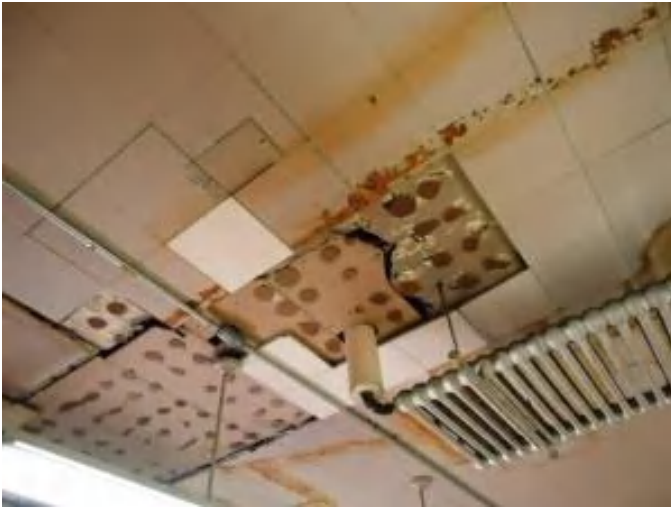
System: C3030 - Ceiling Finishes

Location: Building Wide

Distress: Damaged

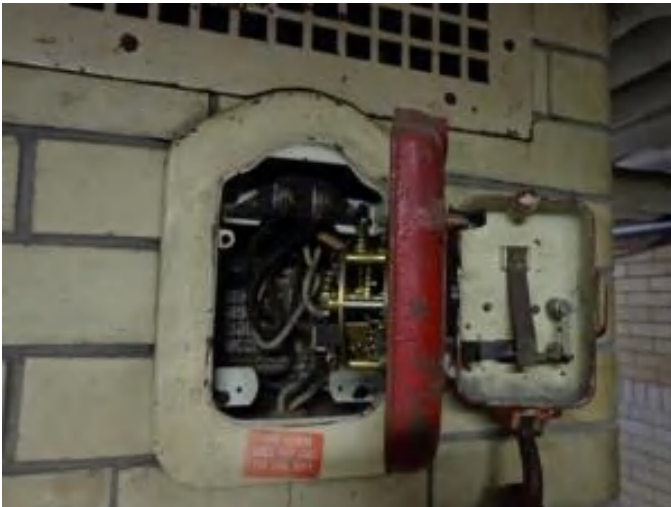
System: D5030 - Communications and Security

Location: Building wide

Distress: Beyond Service Life

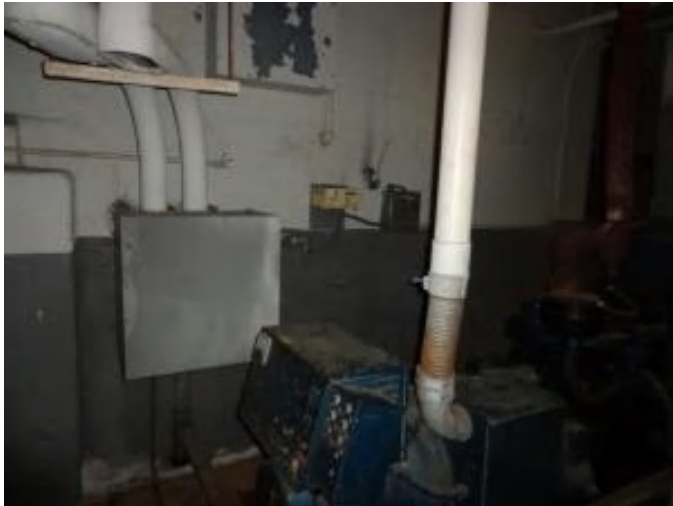
System: D5090 - Other Electrical Systems

Location: Mechanical Room 209
Distress: Beyond Service Life
Category: 3 - Operations / Maint.
Priority: 2 - Response Time (2-3 yrs)
Correction: Replace standby generator system
Qty: 1.00
Unit of Measure: Ea.
Estimate: \$375,048.44
Assessor Name: System
Date Created: 01/18/2016

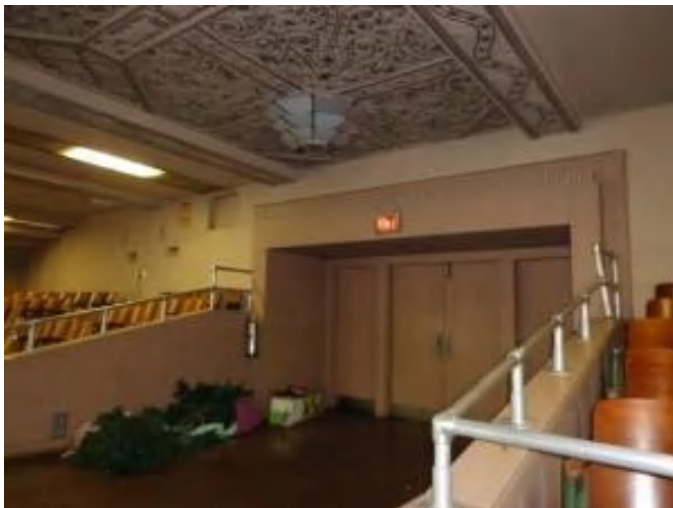
System: D5090 - Other Electrical Systems

Location: Building wide
Distress: Beyond Service Life
Category: 3 - Operations / Maint.
Priority: 2 - Response Time (2-3 yrs)
Correction: Replace Emergency/Exit Lighting
Qty: 135.00
Unit of Measure: Ea.
Estimate: \$114,455.57
Assessor Name: System
Date Created: 01/18/2016

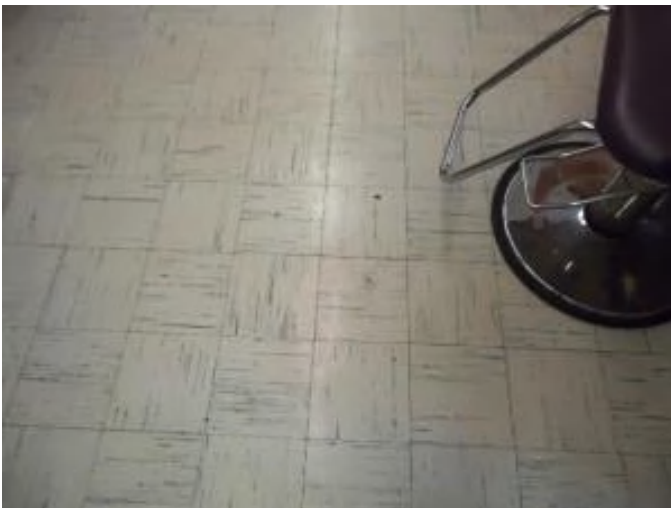
System: C3020413 - Vinyl Flooring

Location: Building Wide

Distress: Damaged

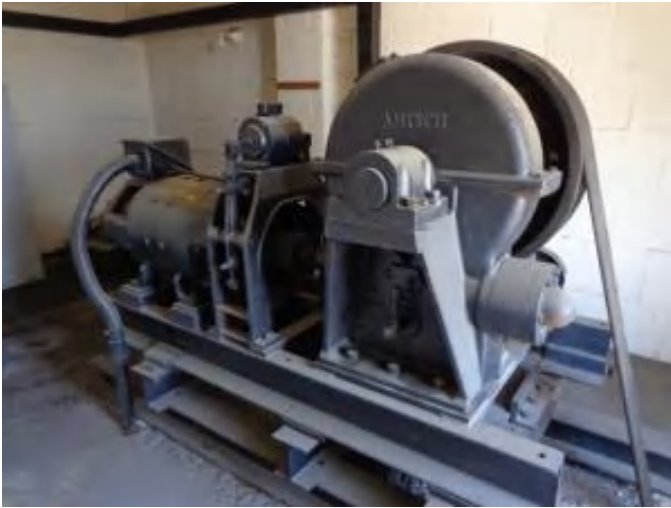
System: D1010 - Elevators and Lifts

Location: Elevator Machine Rooms

Distress: Beyond Service Life

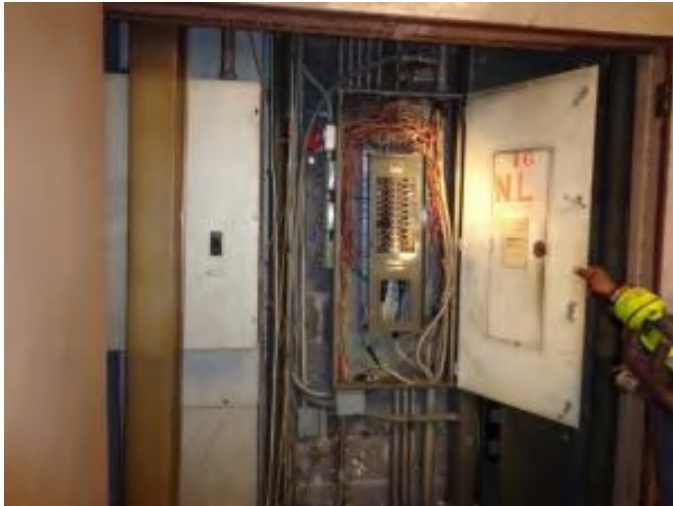
System: D5010 - Electrical Service/Distribution

Location: Building wide
Distress: Beyond Service Life
Category: 3 - Operations / Maint.
Priority: 3 - Response Time (3-4 yrs)
Correction: Replace Panelboard
Qty: 49.00
Unit of Measure: Ea.
Estimate: \$1,901,960.92
Assessor Name: System
Date Created: 01/18/2016

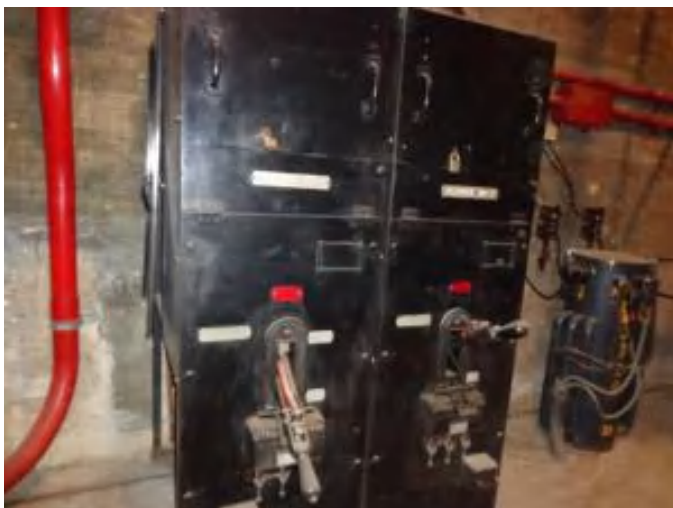
System: D5010 - Electrical Service/Distribution

Location: Basement Transformer Vault
Distress: Beyond Service Life
Category: 3 - Operations / Maint.
Priority: 3 - Response Time (3-4 yrs)
Correction: Replace Service Transformer, Add Switchboard
Qty: 1.00
Unit of Measure: Ea.
Estimate: \$1,573,211.69
Assessor Name: System
Date Created: 01/18/2016

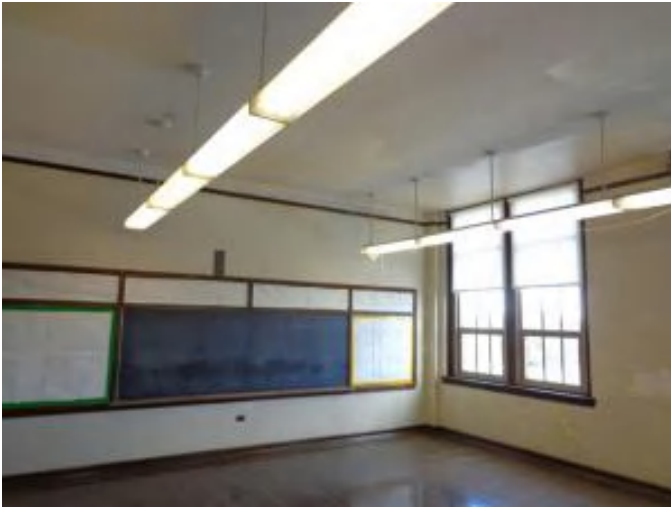
System: D5020 - Lighting and Branch Wiring

Location: Building wide

Distress: Beyond Service Life

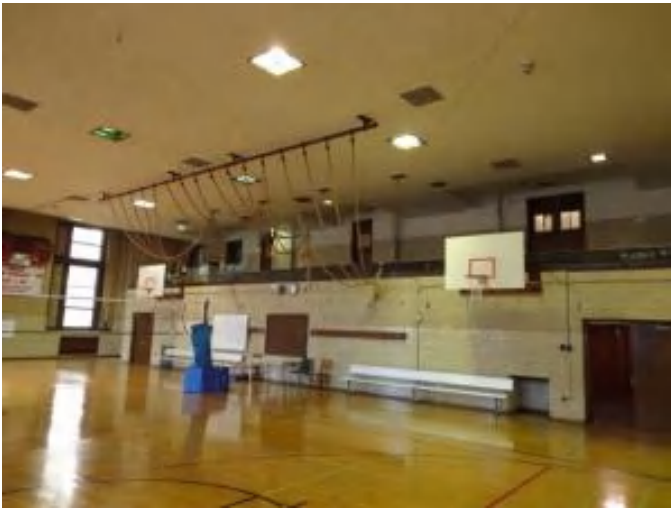
System: D5020 - Lighting and Branch Wiring

Location: Gymnasiums

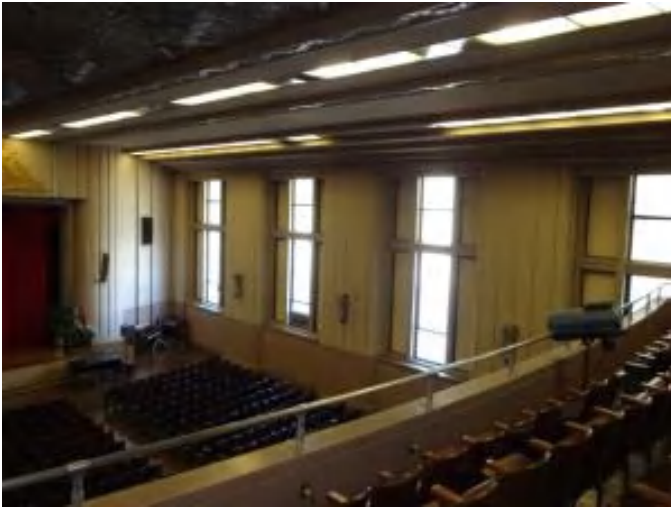
System: D5020 - Lighting and Branch Wiring

Location: Auditorium
Distress: Beyond Service Life
Category: 3 - Operations / Maint.
Priority: 3 - Response Time (3-4 yrs)
Correction: Replace lighting fixtures
Qty: 155.00
Unit of Measure: Ea.
Estimate: \$136,322.82
Assessor Name: System
Date Created: 01/18/2016

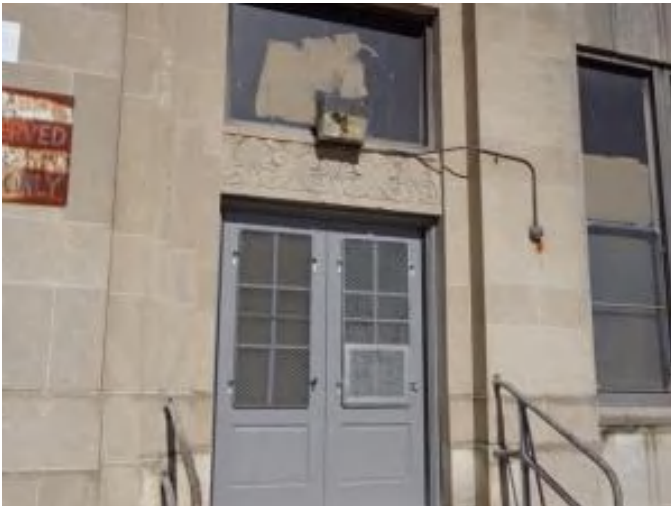
System: D5020 - Lighting and Branch Wiring

Location: Exterior Building
Distress: Beyond Service Life
Category: 3 - Operations / Maint.
Priority: 3 - Response Time (3-4 yrs)
Correction: Replace lighting fixtures
Qty: 6.00
Unit of Measure: Ea.
Estimate: \$9,562.79
Assessor Name: System
Date Created: 01/18/2016

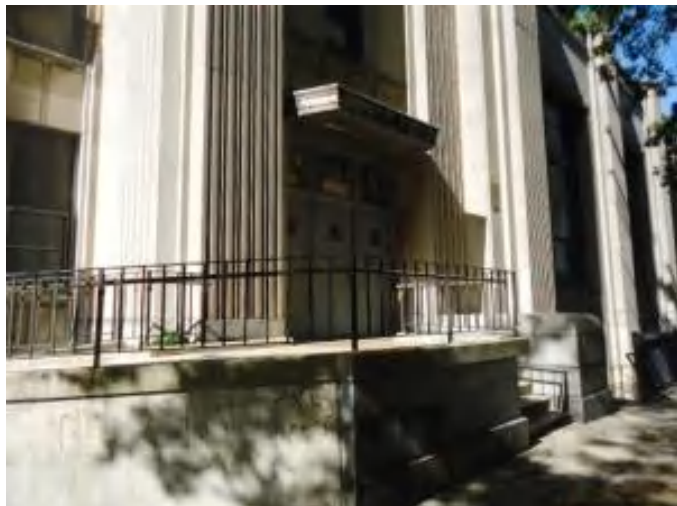
System: B2030 - Exterior Doors

Location: Exterior Elevation

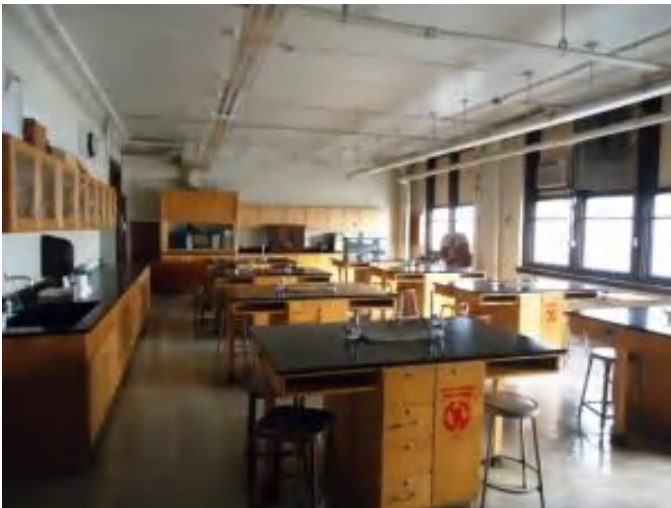
System: C1010 - Partitions

Location: Science Labs
Distress: Damaged
Category: 3 - Operations / Maint.
Priority: 4 - Response Time (4-5 yrs)
Correction: Remodel existing classroom for lab use - approx 900 GSF - with chemical storage room, 15 tables + instructors table
Qty: 5.00
Unit of Measure: Ea.
Estimate: \$1,763,745.42
Assessor Name: System
Date Created: 10/27/2015

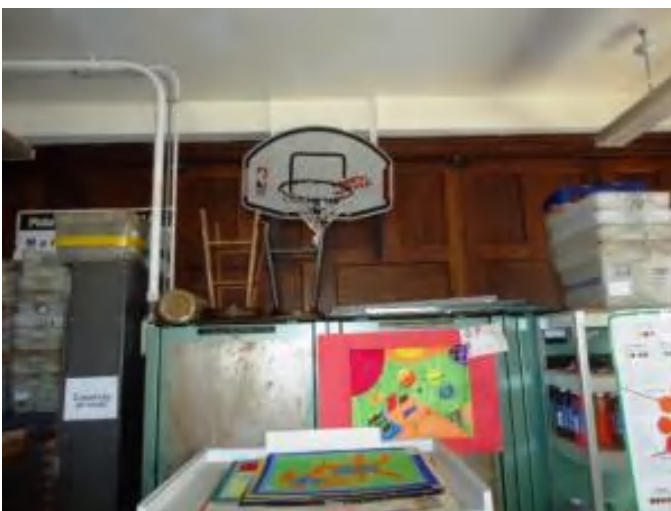
System: C1010 - Partitions

Location: Building Wide
Distress: Damaged
Category: 3 - Operations / Maint.
Priority: 4 - Response Time (4-5 yrs)
Correction: Remove folding wood partitions; replace with metal studs and gypsum board painted
Qty: 5,000.00
Unit of Measure: S.F.
Estimate: \$111,397.49
Assessor Name: System
Date Created: 10/27/2015

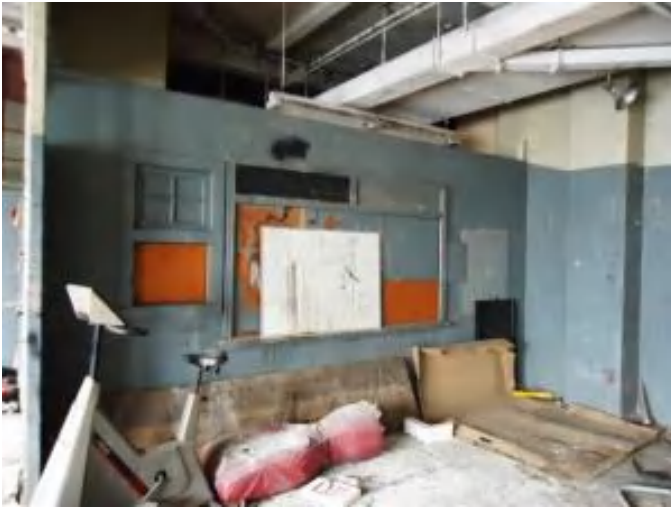
System: C1030 - Fittings

Location: Building Wide

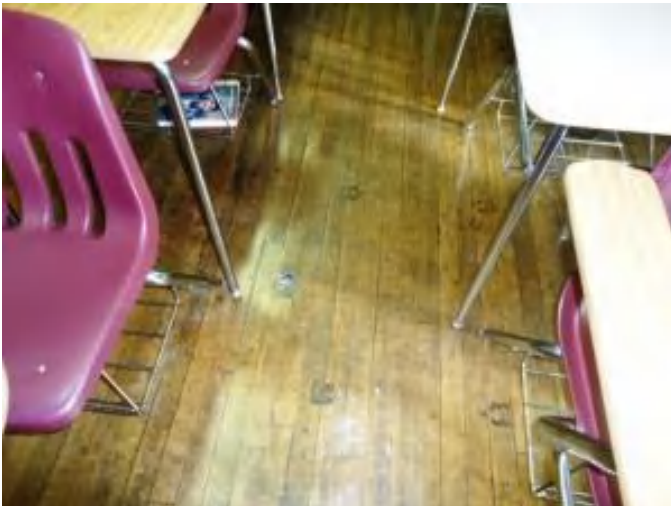
System: C3020414 - Wood Flooring

Location: Building Wide

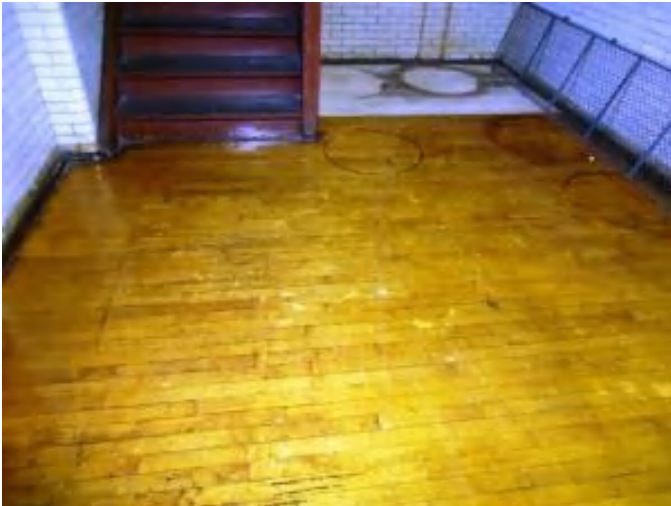
System: C3020414 - Wood Flooring

Location: Gyms

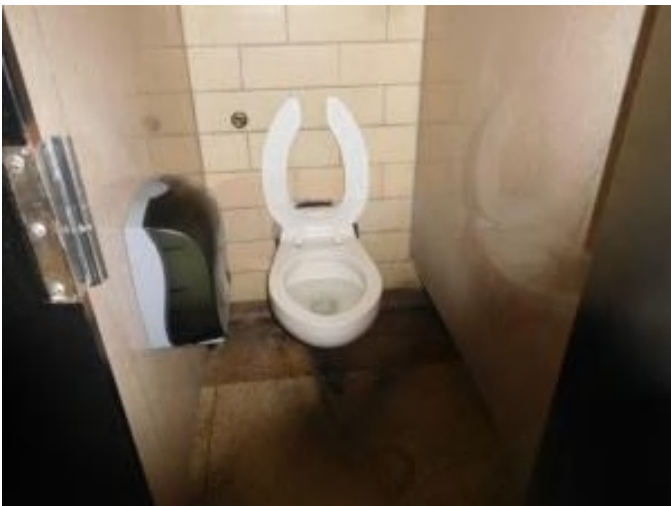
System: D2010 - Plumbing Fixtures

Location: toilet rooms

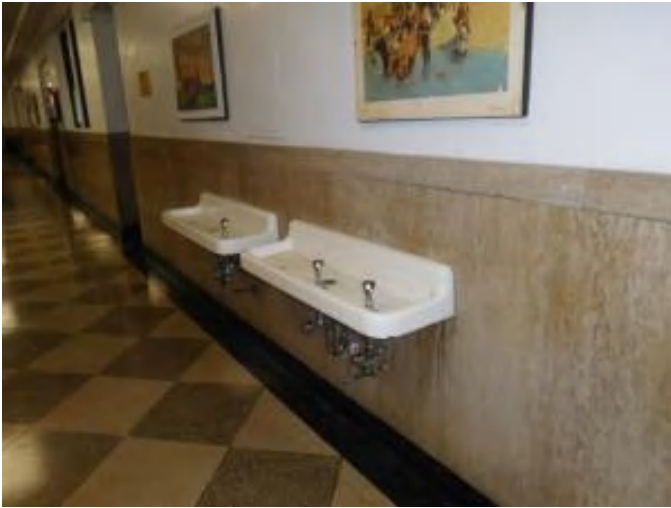
System: D2010 - Plumbing Fixtures

Location: corridors

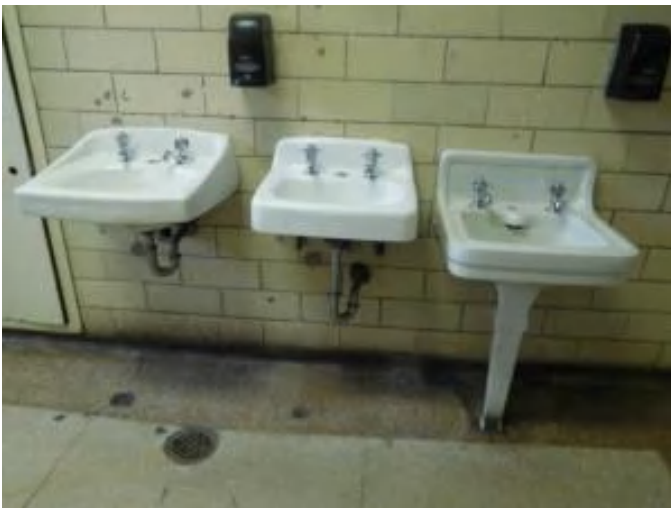
System: D2010 - Plumbing Fixtures

Location: toilet rooms

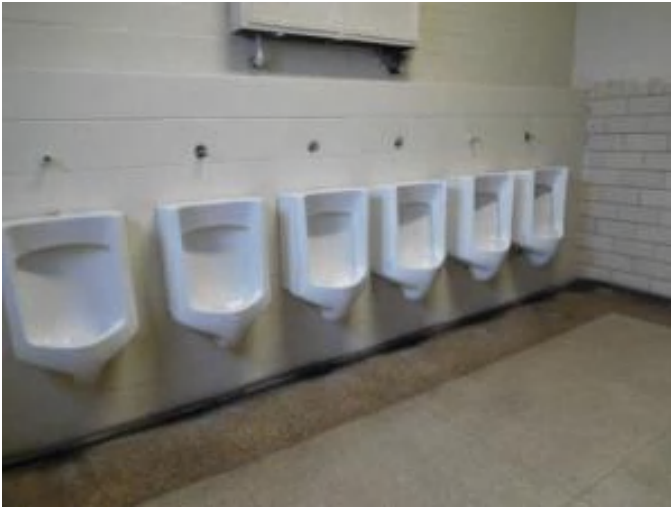
System: D2010 - Plumbing Fixtures

Location: toilet rooms

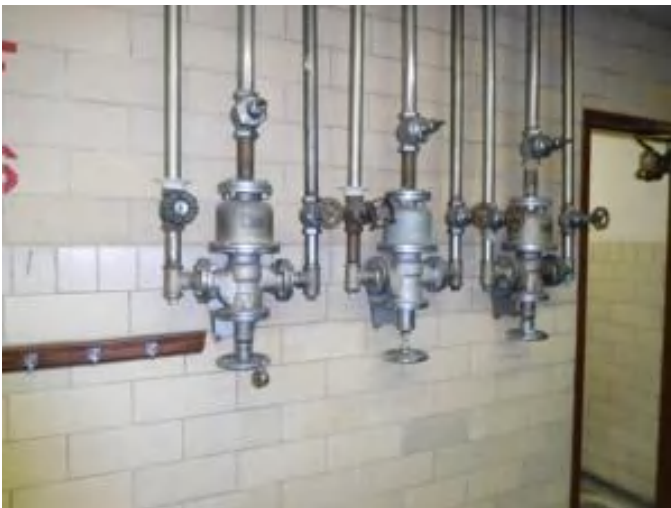
System: D2010 - Plumbing Fixtures

Location: toilet rooms

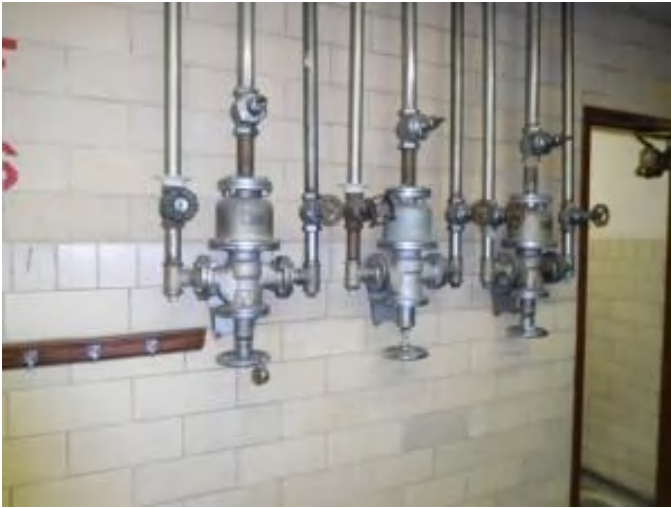
System: D2020 - Domestic Water Distribution

Location: entire building

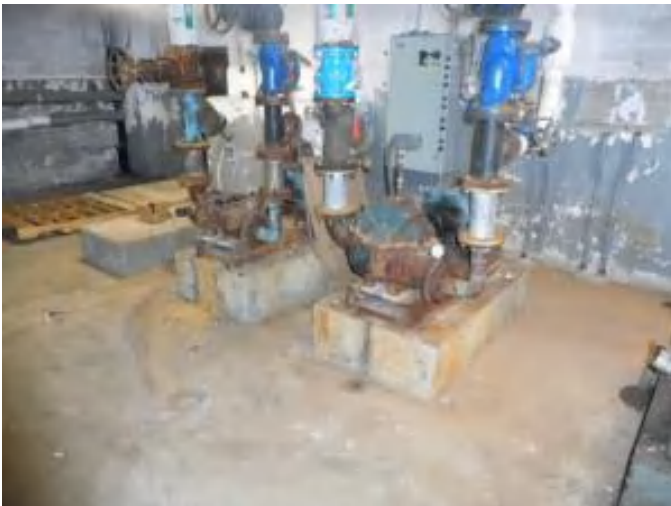
System: D2020 - Domestic Water Distribution

Location: mechanical room

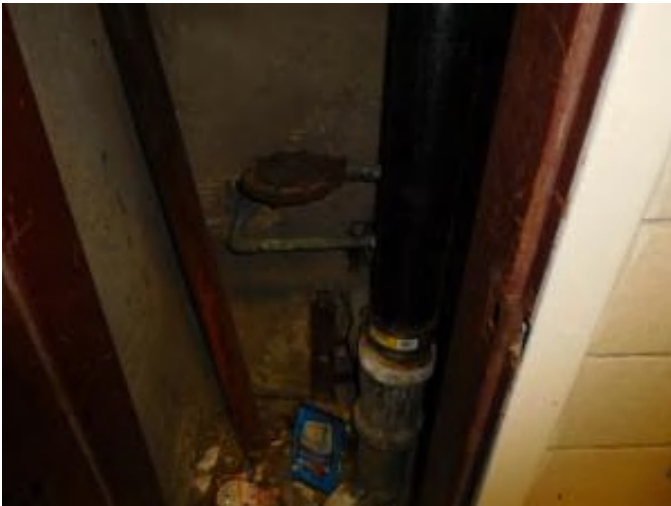
System: D2030 - Sanitary Waste

Location: entire building

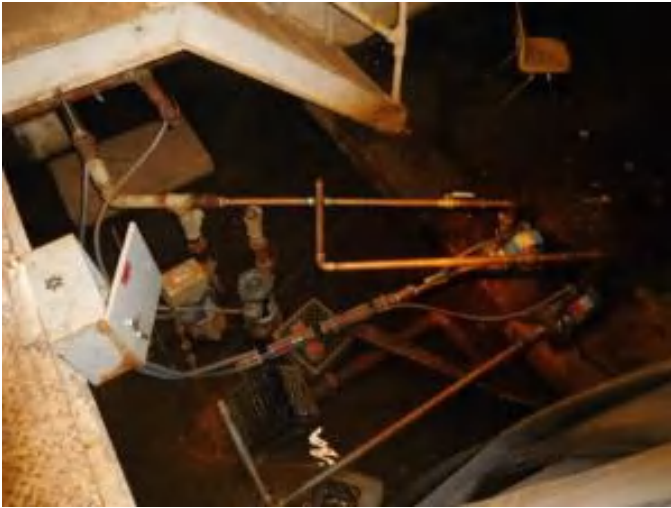
System: D2030 - Sanitary Waste

Location: mechanical room

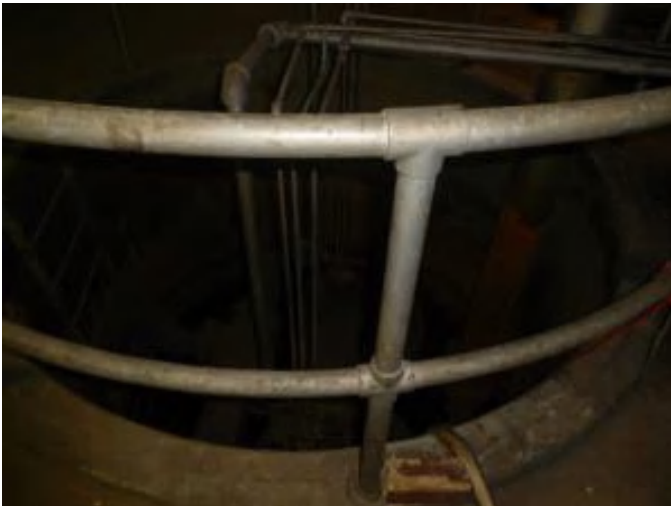
System: D2030 - Sanitary Waste

Location: mechanical room

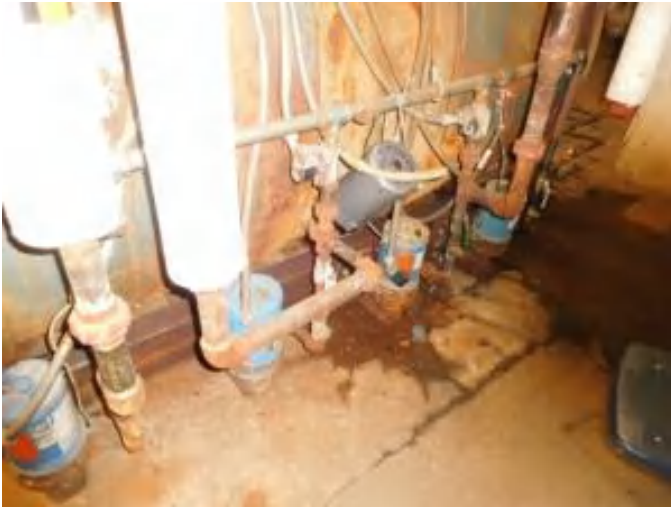
System: D3020 - Heat Generating Systems

Location: mechanical room

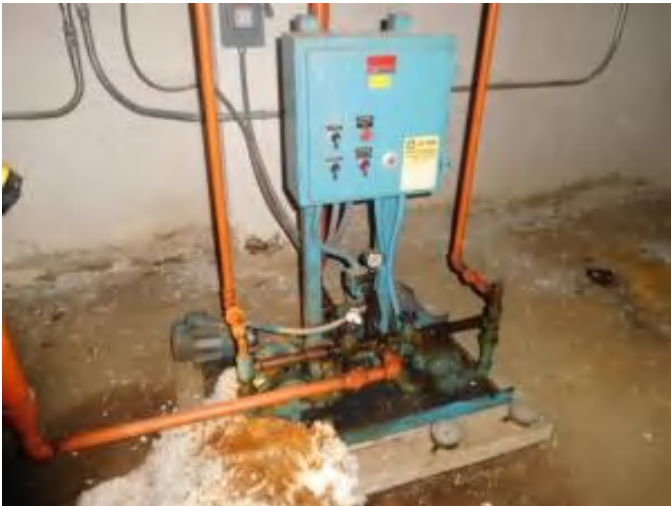
System: D3020 - Heat Generating Systems

Location: mechanical room

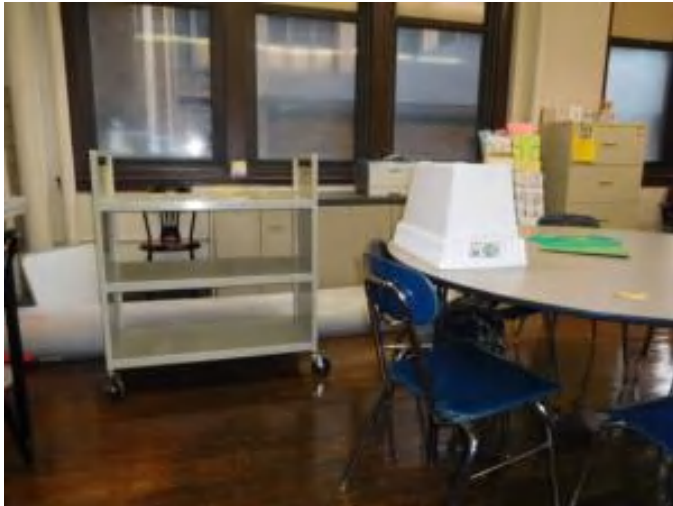
System: D3040 - Distribution Systems

Location: entire building

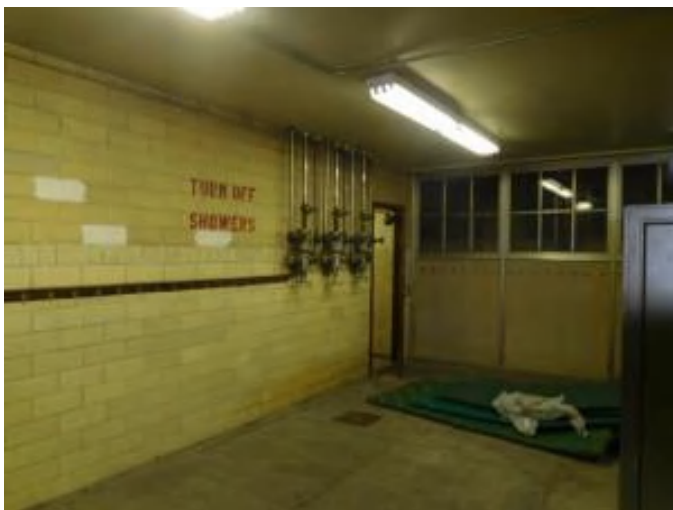
System: D3040 - Distribution Systems

Location: toilet and locker rooms

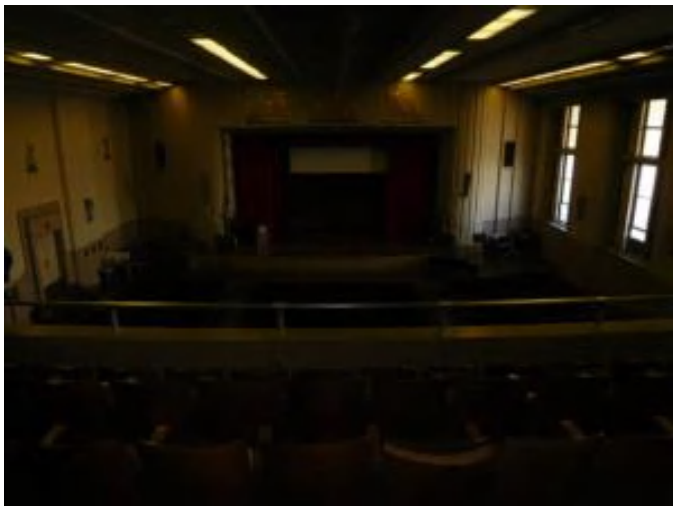
System: D3040 - Distribution Systems

Location: auditorium

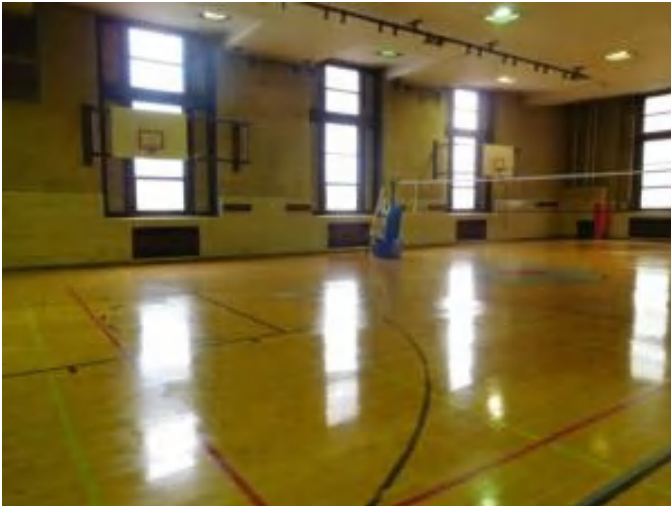
System: D3040 - Distribution Systems

Location: gymnasiums

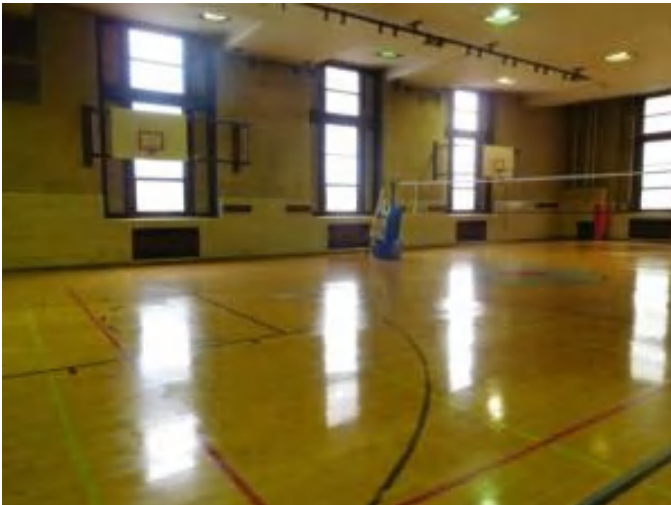
System: D3040 - Distribution Systems

Location: gymnasiums

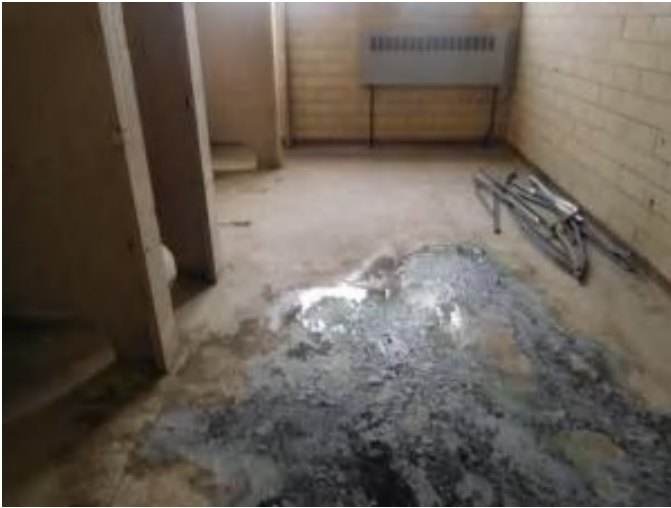
System: D3040 - Distribution Systems

Location: toilet and locker rooms
Distress: Building / MEP Codes
Category: 2 - Code Compliance
Priority: 4 - Response Time (4-5 yrs)
Correction: Provide inline centrifugal fan and wall outlet louver for restroom exhaust (4 plbg fixtures)
Qty: 4.00
Unit of Measure: Ea.
Estimate: \$68,828.17
Assessor Name: System
Date Created: 01/20/2016

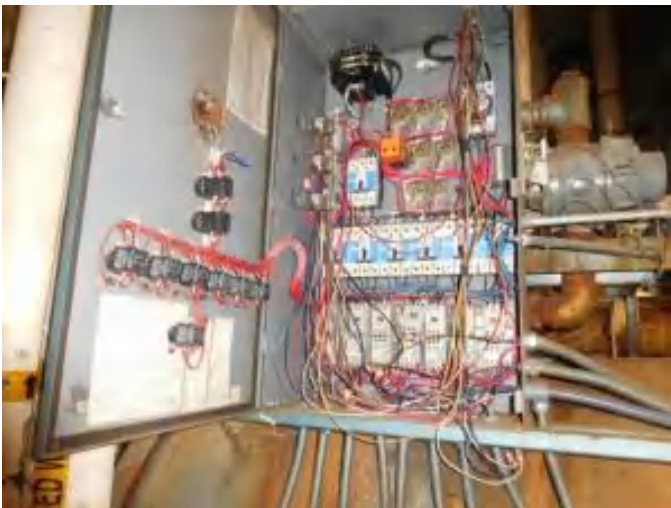
System: D3060 - Controls & Instrumentation

Location: entire building
Distress: Inadequate
Category: 4 - Capital Improvement
Priority: 4 - Response Time (4-5 yrs)
Correction: Replace pneumatic controls with DDC (350KSF)
Qty: 312,395.00
Unit of Measure: S.F.
Estimate: \$5,755,392.35
Assessor Name: System
Date Created: 01/19/2016

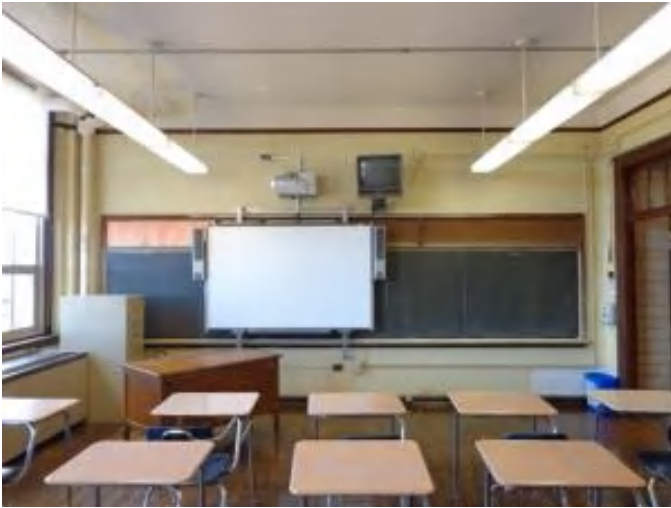
System: D5020 - Lighting and Branch Wiring

Location: Classrooms

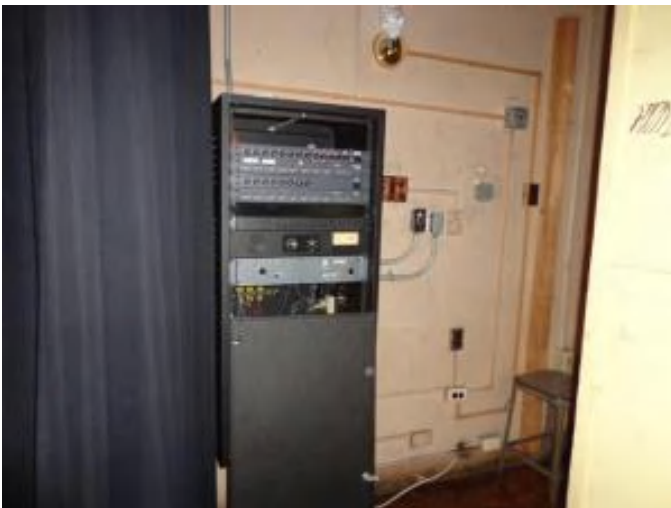
System: D5030 - Communications and Security

Location: Auditorium stage

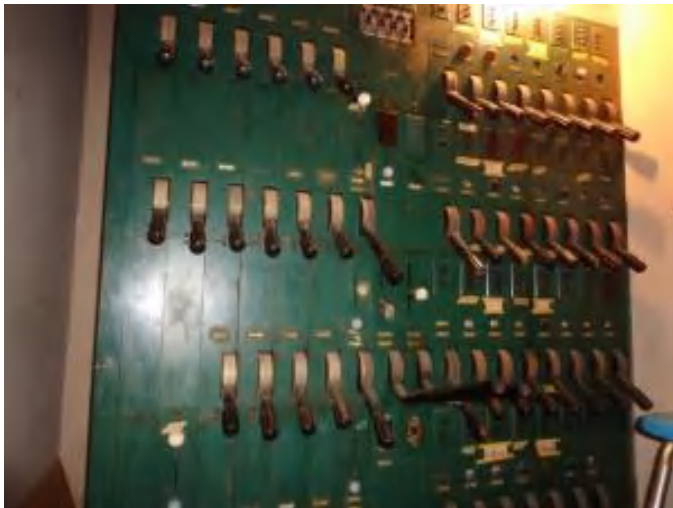
System: E1020310 - Theater and Stage Equipment, EACH

Location: Stage

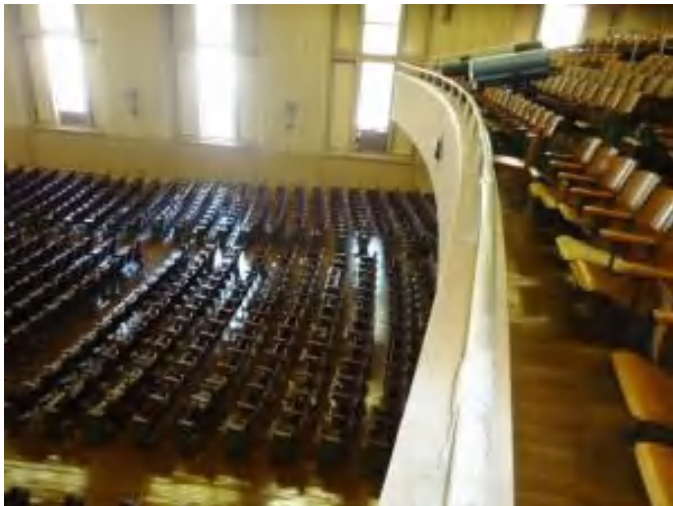
System: E2010 - Fixed Furnishings

Location: Auditorium

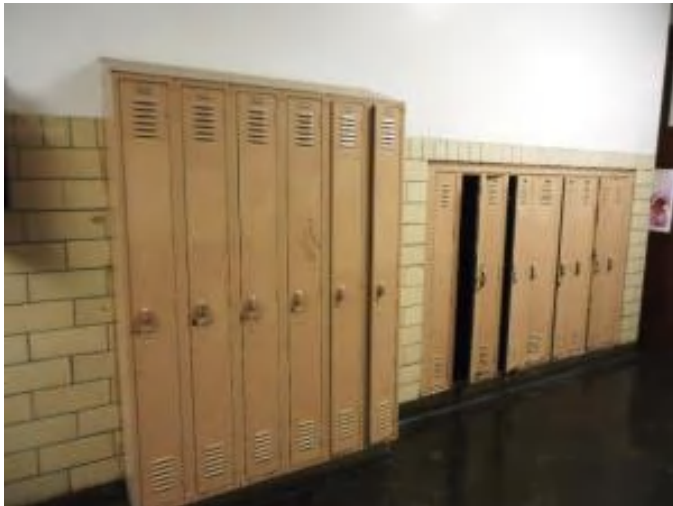
System: C1030 - Fittings

Location: Building Wide

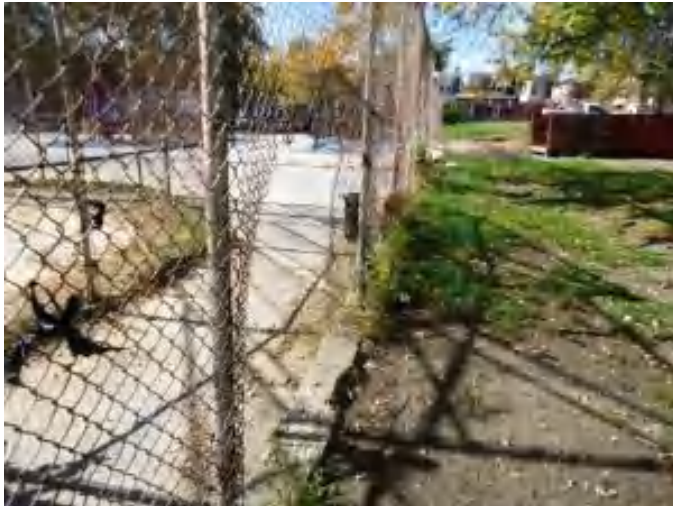
System: G2040 - Site Development

Location: Site

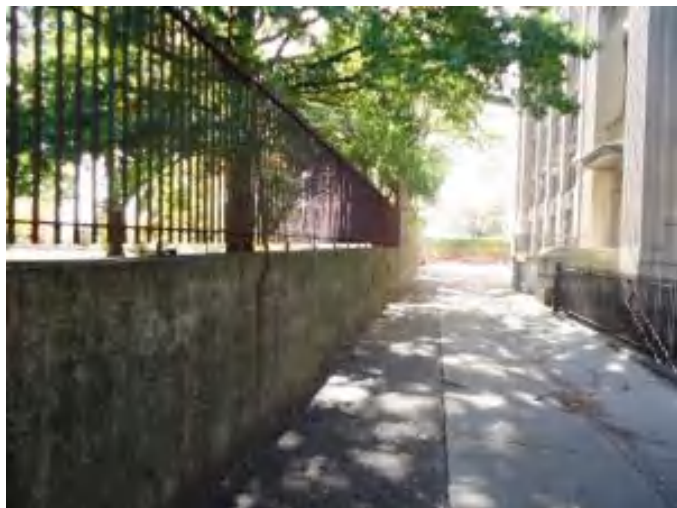
System: G2040 - Site Development

Location: Site

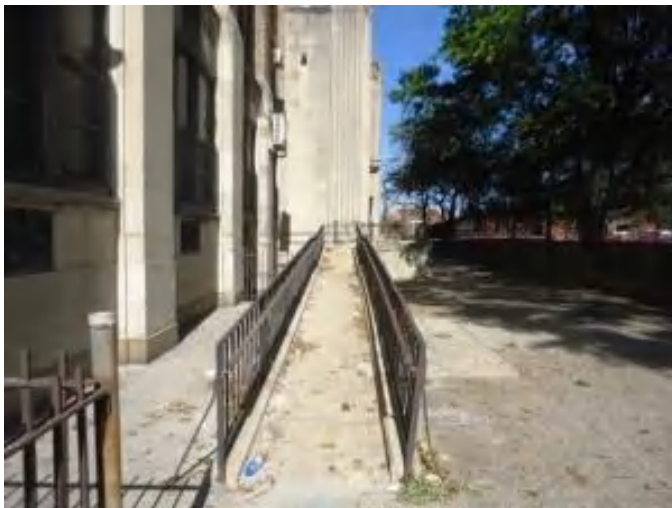
System: G2030 - Pedestrian Paving

Location: Site

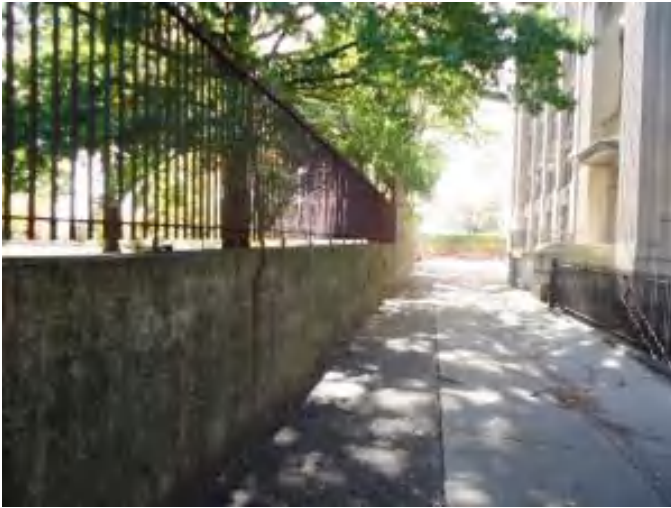
System: G2040 - Site Development

Location: Site

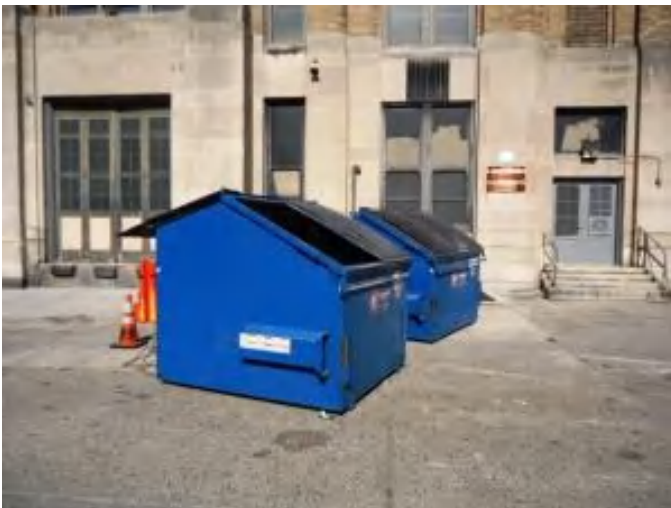
System: G2040 - Site Development

Location: Site
