Facility Condition Assessment Summary Report

Douglass, F School

School District of Philadelphia
S451001; Douglass, F
Final
Site Assessment Report
February 1, 2017

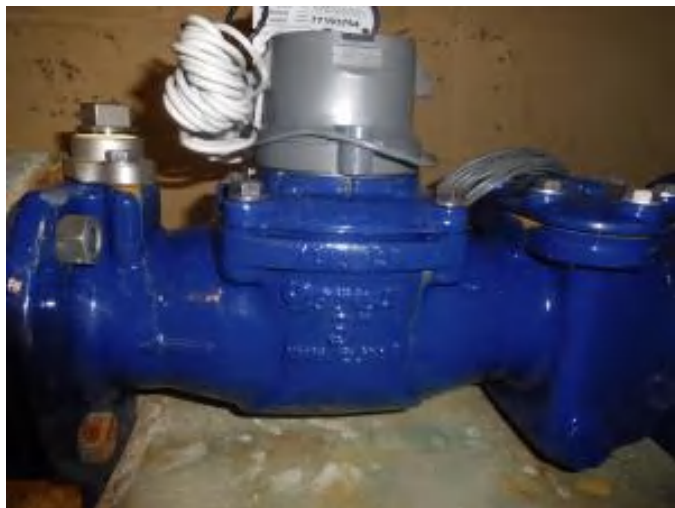
System: D2020 - Domestic Water Distribution

Location: mechanical room

Distress: Building / MEP Codes

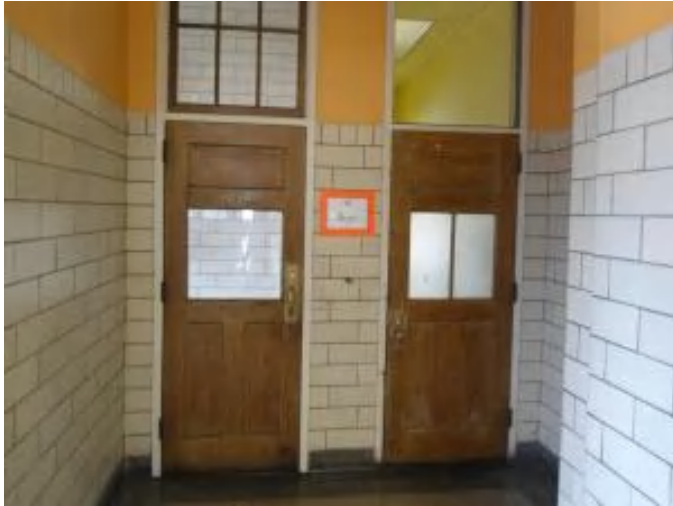
System: C1010 - Partitions

Location: Building Wide

Distress: Life Safety / NFPA / PFD

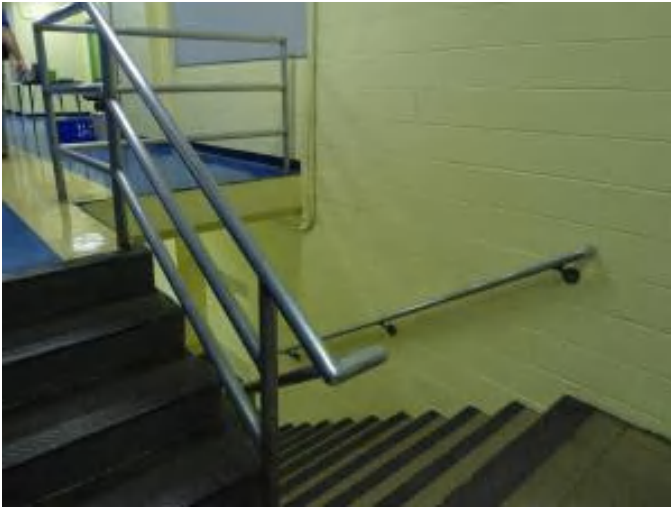
System: C2010 - Stair Construction

Current requirements for stairs indicate that they have graspable handrails on both sides, that the rails have a specific end geometry, and that the handrails continue horizontally at the landings. In addition, guardrails must prevent the passage of a 4 inch diameter sphere (6 inches in the triangle formed by the lower rail and tread/riser angle). Although the stairs are compliant with the code enforced at the time of construction until a major renovation occurs, they are deficient in handrail and guardrail design relative to current standards. Future efforts should include comprehensive stair railing removal and replacement upgrades.

Location: Stairs

Distress: Building / MEP Codes

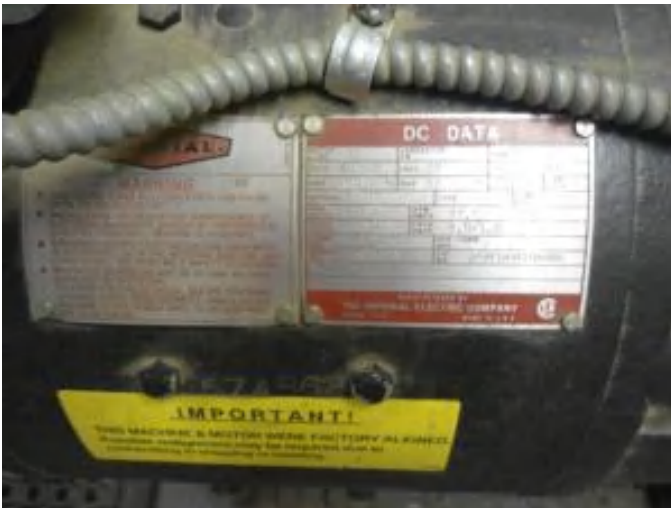
System: D1010 - Elevators and Lifts

Location: 1963 Building Addition

Distress: Beyond Service Life

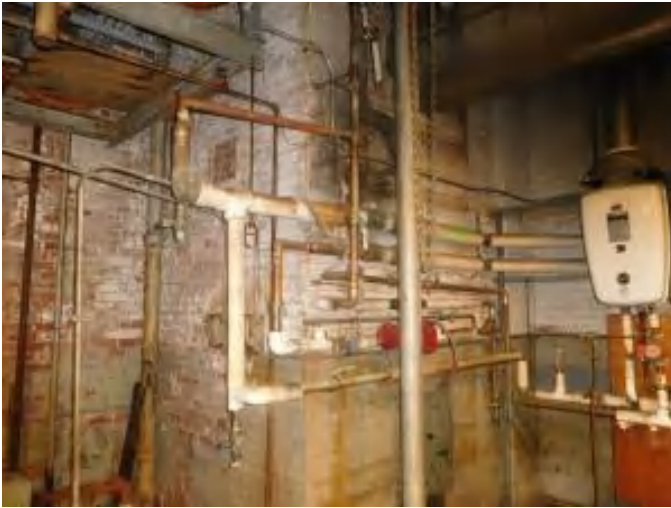
System: D2020 - Domestic Water Distribution

Location: entire building
Distress: Beyond Service Life
Category: 3 - Operations / Maint.
Priority: 3 - Response Time (3-4 yrs)
Correction: Replace domestic water piping (150 KSF)
Qty: 109,651.00
Unit of Measure: S.F.
Estimate: \$454,730.05
Assessor Name: System
Date Created: 09/02/2015

Notes: Replace domestic hot and cold water piping including valves, fittings, hangars and insulation

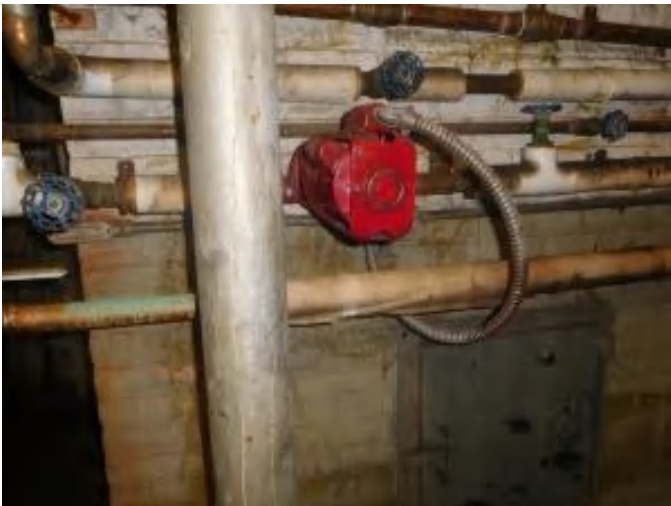
System: D2020 - Domestic Water Distribution

Location: mechanical room
Distress: Inadequate
Category: 4 - Capital Improvement
Priority: 3 - Response Time (3-4 yrs)
Correction: Replace duplex domestic booster pump set (5 HP)
Qty: 1.00
Unit of Measure: Ea.
Estimate: \$50,533.86
Assessor Name: System
Date Created: 09/02/2015

Notes: Provide new domestic water booster pump system with two pumps, pressure tank, and controls. Connect to main domestic water line.

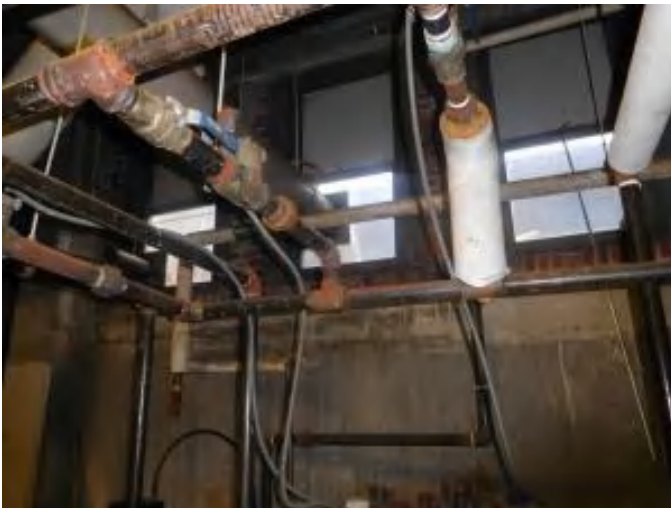
System: D2030 - Sanitary Waste

Location: entire building

Distress: Beyond Service Life

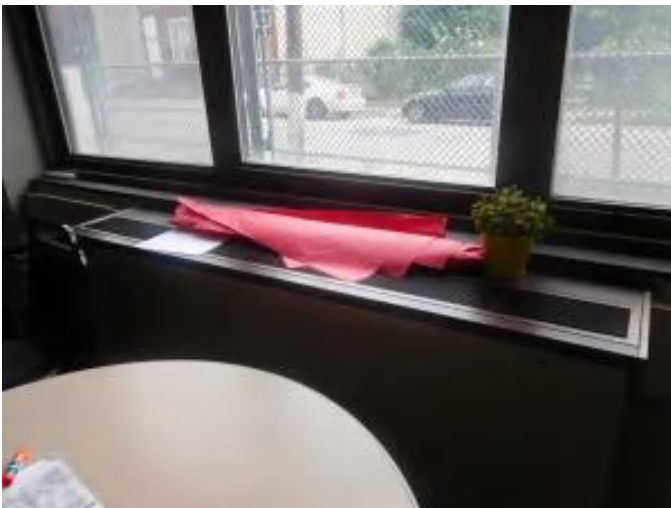
System: D3040 - Distribution Systems

Location: entire building

Distress: Inadequate

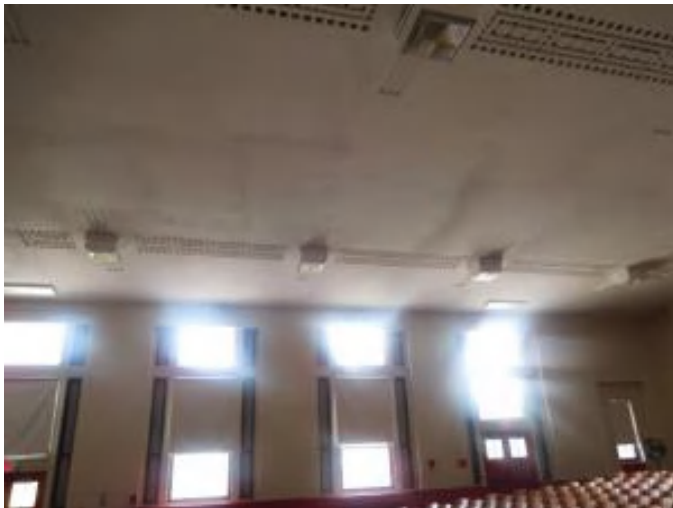
System: D3040 - Distribution Systems

Location: auditorium

Distress: Building / MEP Codes

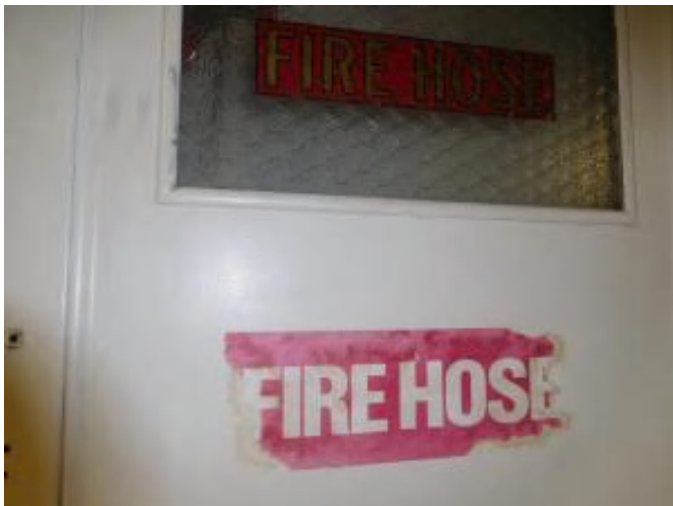
System: D4010 - Sprinklers

Location: entire building

Distress: Life Safety / NFPA / PFD

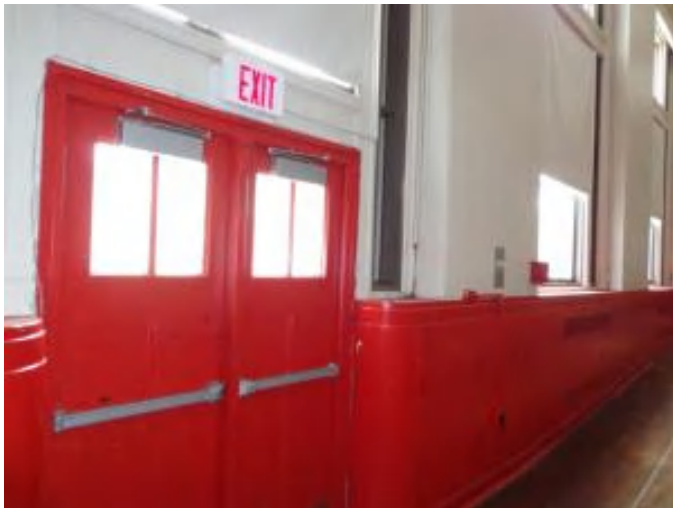
System: D5030 - Communications and Security

Location: Entire Building
Distress: Life Safety / NFPA / PFD
Category: 1 - Health & Safety
Priority: 3 - Response Time (3-4 yrs)
Correction: Replace fire alarm system
Qty: 109,651.00
Unit of Measure: S.F.
Estimate: \$462,758.34
Assessor Name: System
Date Created: 08/14/2015

Notes: Replace obsolete fire alarm system with addressable fire alarm system that meets current NFPA codes and ADA requirements.

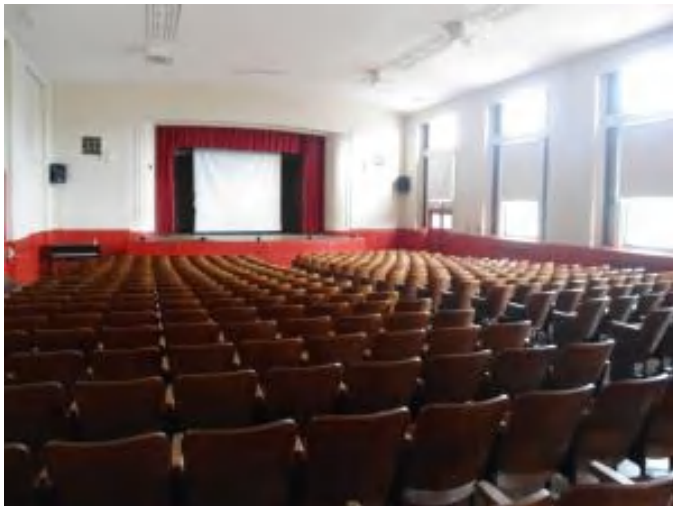
System: E2010 - Fixed Furnishings

The school stage has a stage curtain assembly that appears to be from the original construction. Modern applications are typically fire-proof applications with adjustable tracks and electric support for operation. The curtains are torn in a few sections and the track is not functioning properly, overall the system is in poor condition. It is recommended that the curtain and track system be upgraded to a new system. Special care should be considered in regards to modern fire proofing for the new installation.

Location: Stage
Distress: Damaged
Category: 3 - Operations / Maint.
Priority: 3 - Response Time (3-4 yrs)
Correction: Remove and replace stage curtain - insert the LF of track and SF of curtain
Qty: 1.00
Unit of Measure: Ea.
Estimate: \$30,206.59
Assessor Name: System
Date Created: 09/11/2015

Notes: The school stage has a stage curtain assembly that appears to be from the original construction. Modern applications are typically fire-proof applications with adjustable tracks and electric support for operation. The curtains are torn in a few section and the track is not functioning properly, overall the system is in poor condition. It is recommended that the curtain and track system be upgraded to a new system. Special care should be considered in regards to modern fire proofing for the new installation.

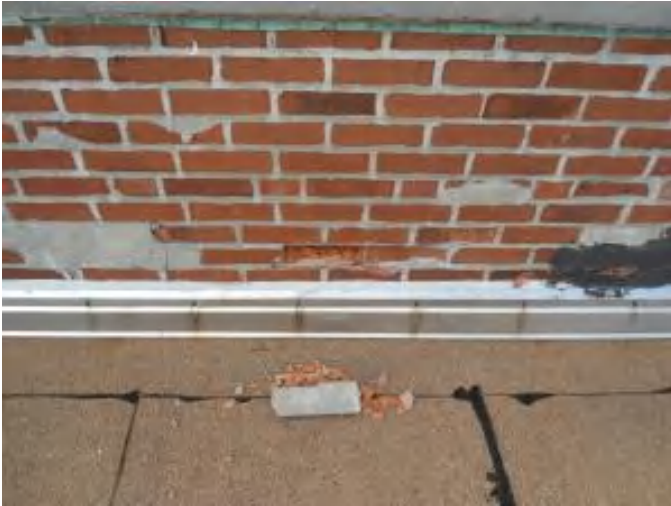
System: B2010 - Exterior Walls

The exterior brick surfaces are generally in fair to good condition for their age. In some locations, bricks have cracked or spalled and should be replaced. The repointing of deteriorated mortar joints is also recommended, using mortar of a similar color and consistency as the original. Following the detailed examination of the brick and repair of mortar construction joints, the entire building should be pressure washed to remove stains and embedded pollutants. If moisture is found to be penetrating the masonry facade, the application of a spray sealant to the suspected exterior masonry surface is recommended.

Location: Exterior Elevation

Distress: Damaged

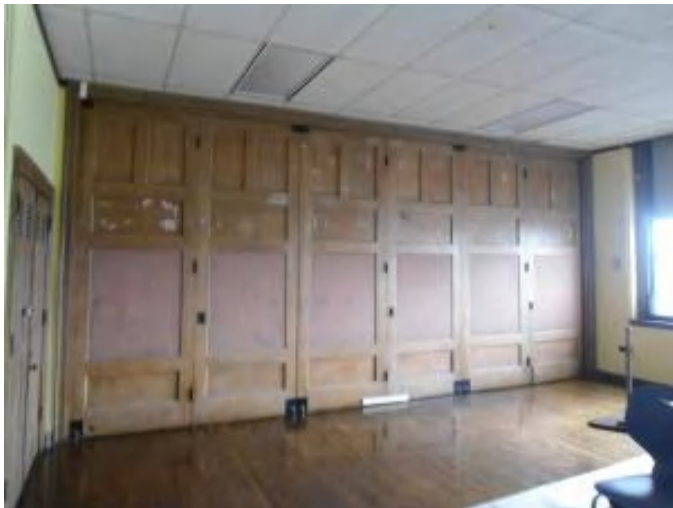
System: C1010 - Partitions

There are several movable partitions that remain in classrooms. These wall systems are no longer used and in most cases cannot be used due to damage or wall modifications to support classroom needs. This deficiency provides a budgetary consideration to remove and replace the wall systems with universal removal of the existing movable partitions and upgrades to a permeate wall systems.

Location: Classrooms

Distress: Life Safety / NFPA / PFD

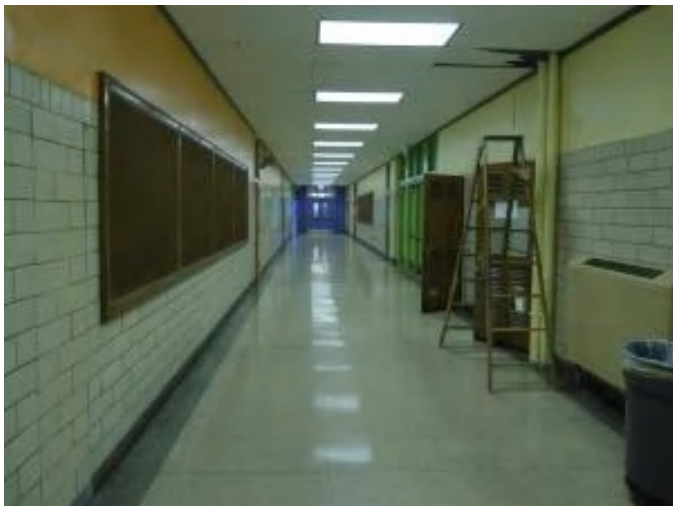
System: C1030 - Fittings

There is a mix of tack boards in this school that range from the age and condition. There are several tack boards in the classrooms and hallways for student displays. The classroom tack boards are newer and in better shape; however, the hallway board appears to be original. The systems are beyond the expected service life for this application. Remove and replace the hallway tack boards is recommended.

Location: Hallways

Distress: Damaged

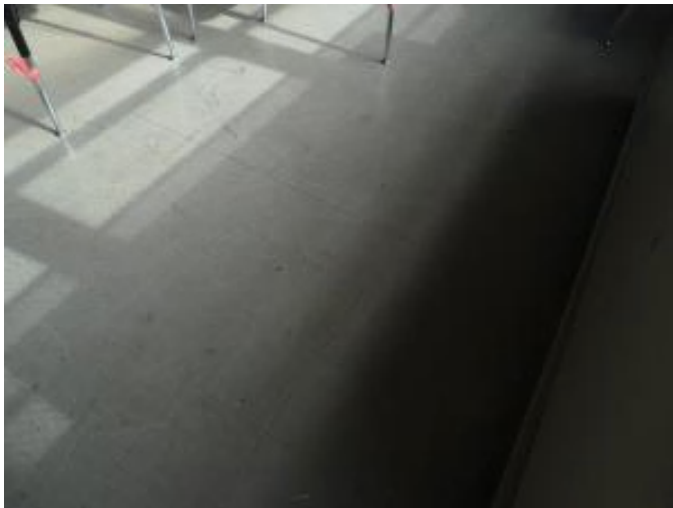
System: C3020413 - Vinyl Flooring

The vinyl floor finish in most of this school is in very good condition and appears to have part of an isolated upgrade. Some of the original flooring that was not a part of that effort consists of a 9x9 finish. This finish is suspect to contain asbestos and is recommended for upgrade. Remove and replace with a 12x12 vinyl tile application.

Location: Building Wide

Distress: Health Hazard / Risk

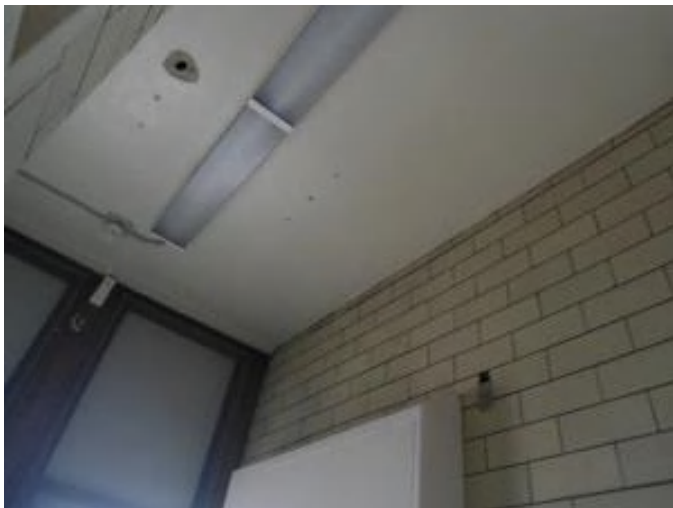
System: C3030 - Ceiling Finishes

The ceiling finish is a mix of 12 x 12 ceiling grid, painted and 2 x 4 Acoustical tile finish. Ceilings have been repaired in several areas and are in good condition considering the age of the application and the current condition of the school. However there are sections that are stained and damaged that will require upgrades. The ceiling finish is expected to require upgrades to support the recommended efforts in this report. This deficiency provides a budgetary consideration for removal and replacement of the current ceiling finish to a new acoustical tile finish. Considering the recommended mechanical and electrical upgrades this effort should be completed as part of an overall renewal program for the school.

Location: Building Wide

Distress: Damaged

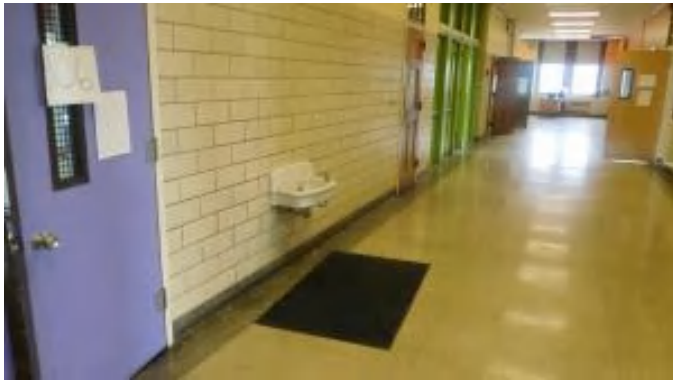
System: D2010 - Plumbing Fixtures

Location: basement corridors

Distress: Beyond Service Life

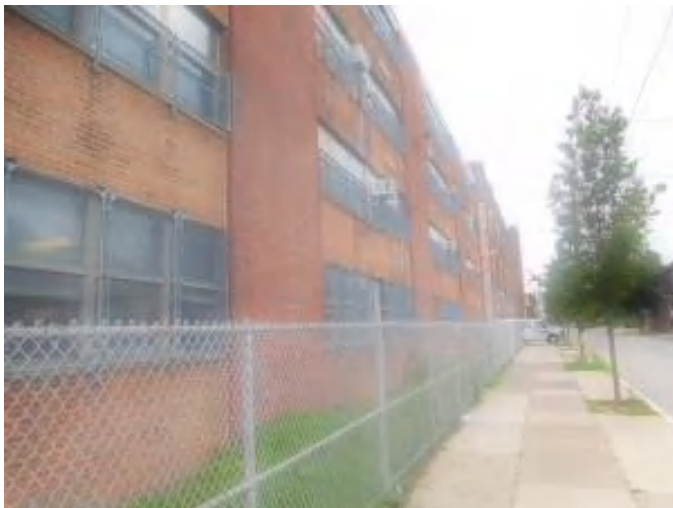
System: D3030 - Cooling Generating Systems

Location: roof, mechanical room

Distress: Inadequate

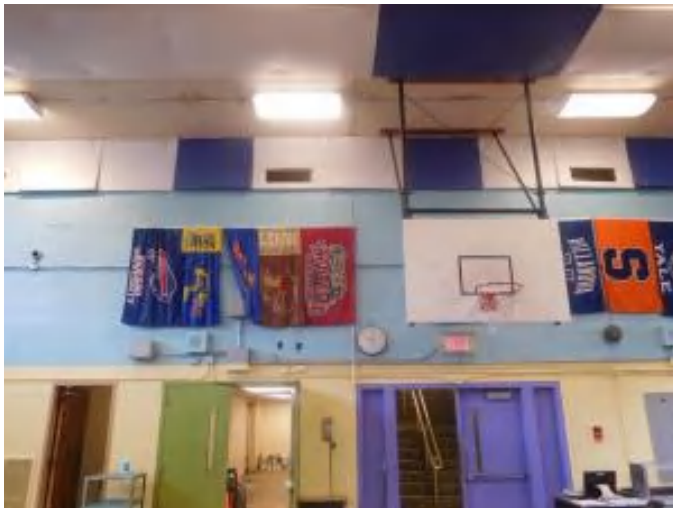
System: D3040 - Distribution Systems

Location: cafeteria

Distress: Building / MEP Codes

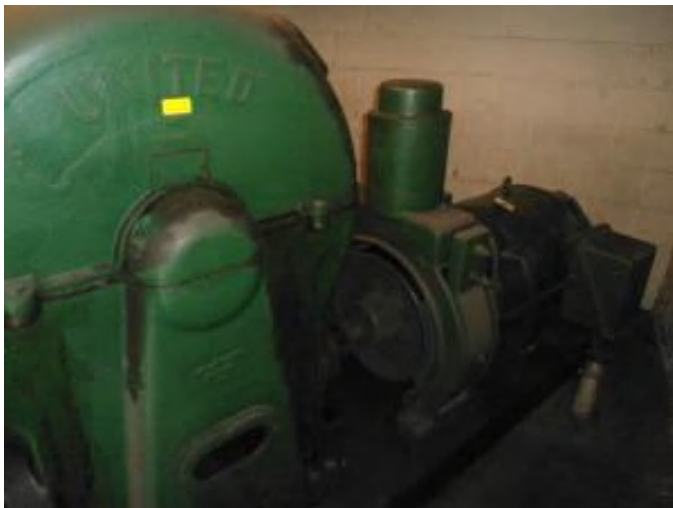
System: D3050 - Terminal & Package Units

Location: roof

Distress: Inadequate

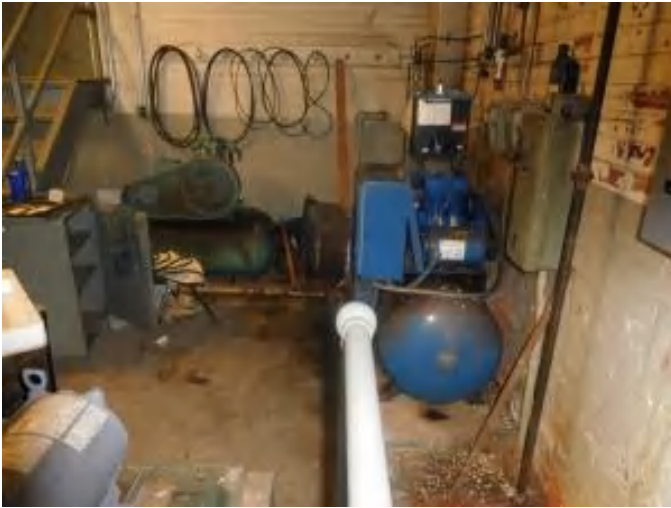
System: D3060 - Controls & Instrumentation

Location: entire building
Distress: Inadequate
Category: 4 - Capital Improvement
Priority: 4 - Response Time (4-5 yrs)
Correction: Replace pneumatic controls with DDC (150KSF)
Qty: 109,651.00
Unit of Measure: S.F.
Estimate: \$1,964,003.39
Assessor Name: System
Date Created: 09/02/2015

Notes: Install new direct digital control system and building automation system with remote computer control capability and graphics package.

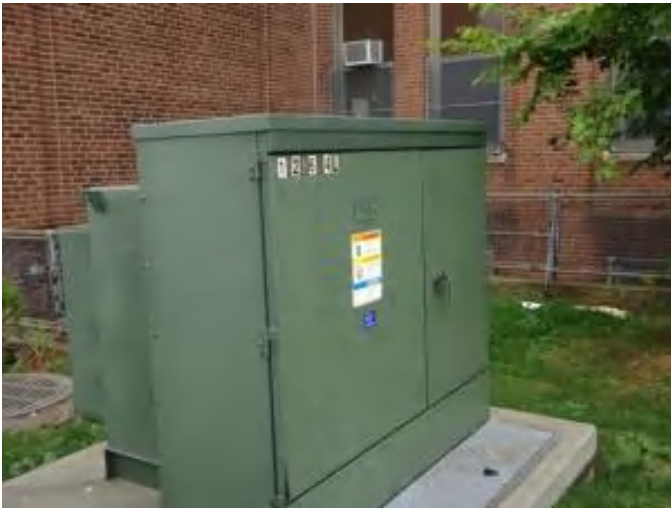
System: D5010 - Electrical Service/Distribution

Location: Boiler Room
Distress: Inadequate
Category: 4 - Capital Improvement
Priority: 4 - Response Time (4-5 yrs)
Correction: Add Electrical Switchgear and Distribution System
Qty: 0.00
Unit of Measure: Ea.
Estimate: \$267,846.47
Assessor Name: System
Date Created: 08/14/2015

Notes: Provide a separate underground service from the pad mount transformer to a second main service disconnecting means and distribution section with feeder circuit breakers to supply HVAC equipment for the addition of a central air conditioning system for the building.

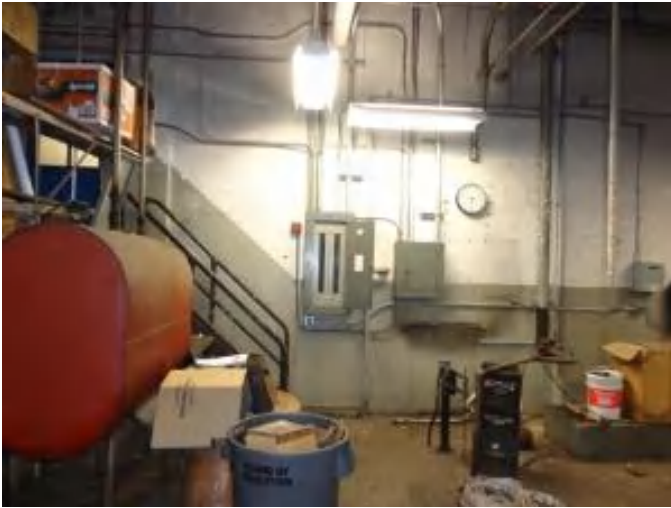
System: D5010 - Electrical Service/Distribution

Location: Boiler Room

Distress: Beyond Service Life

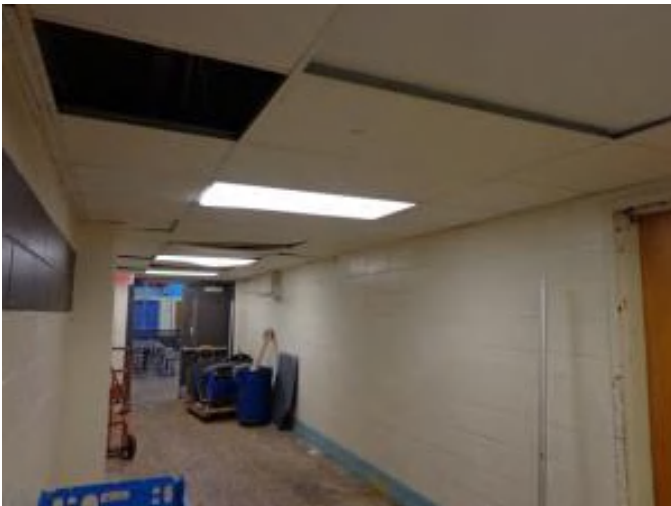
System: D5020 - Lighting and Branch Wiring

Location: Basement Corridor, Prep kitchen

Distress: Damaged

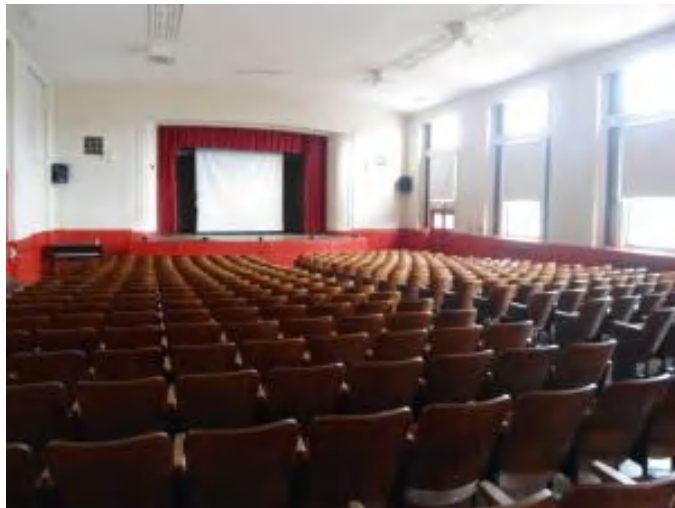
System: E2010 - Fixed Furnishings

Location: Auditorium

Distress: Beyond Service Life

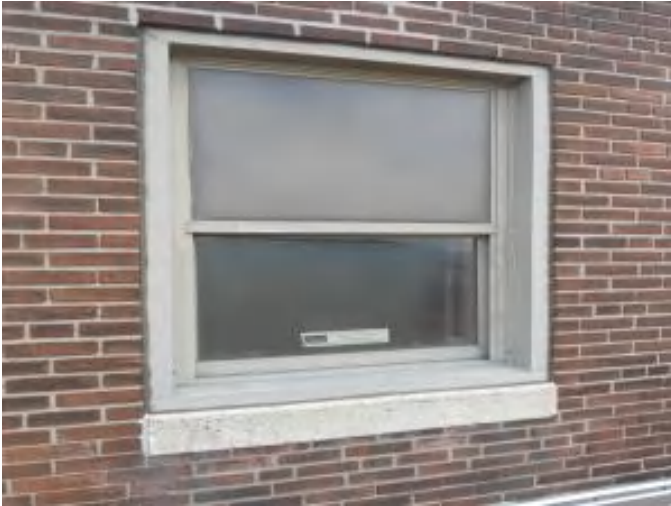
System: B2020 - Exterior Windows

Exterior windows have been upgraded from the original applications. The current system is estimated to have been installed in the 1990's. Several windows no longer work and will require attention prior to an overall effort. Windows are in fair condition based on the year of installation or last renovation. The exterior window system is recommended to be replaced with units that retain their dimensions and profiles, but that incorporate updated energy-efficient features.

Location: Exterior Elevation
Distress: Damaged
Category: 3 - Operations / Maint.
Priority: 5 - Response Time (> 5 yrs)
Correction: Remove and replace aluminum windows - pick the appropriate size and style and insert the number of units
Qty: 250.00
Unit of Measure: Ea.
Estimate: \$1,720,055.46
Assessor Name: System
Date Created: 09/10/2015

Notes: Exterior windows have been upgraded from the original applications. The current system is estimated to have been installed in the 1990's. Several windows no longer work and will require attention prior to an overall effort. Windows are in fair condition based on the year of installation or last renovation. The exterior window system is recommended to be replaced with units that retain their dimensions and profiles, but that incorporate updated energy-efficient features.

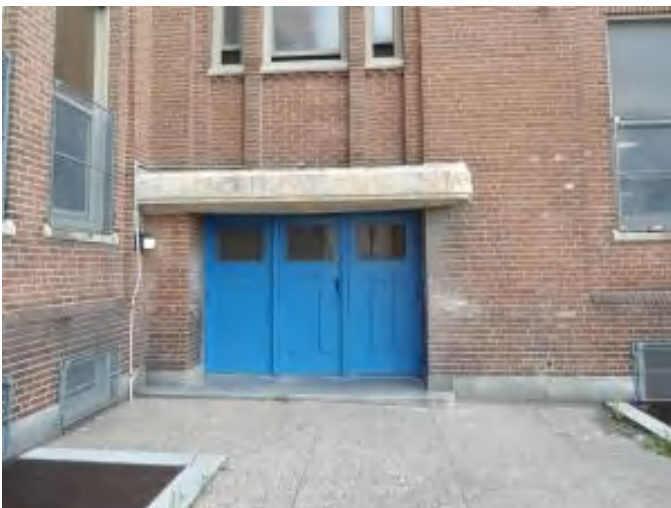
System: B2030 - Exterior Doors

The exterior doors are metal applications with metal frames. The exterior door system for this school is a very high traffic system. The doors are in fair condition but are aging at a faster rate than expected based on traffic and condition. The exterior door system, store front and service doors are recommended for upgrade.

Location: Exterior Elevation
Distress: Damaged
Category: 3 - Operations / Maint.
Priority: 5 - Response Time (> 5 yrs)
Correction: Remove and replace exterior doors - per leaf
Qty: 14.00
Unit of Measure: Ea.
Estimate: \$127,502.49
Assessor Name: System
Date Created: 09/10/2015

Notes: The exterior doors are metal applications with metal frames. The exterior door system for this school is a very high traffic system. The doors are in fair condition but are aging at a faster rate than expected based on traffic and condition. The exterior door system, store front and service doors are recommended for upgrade.

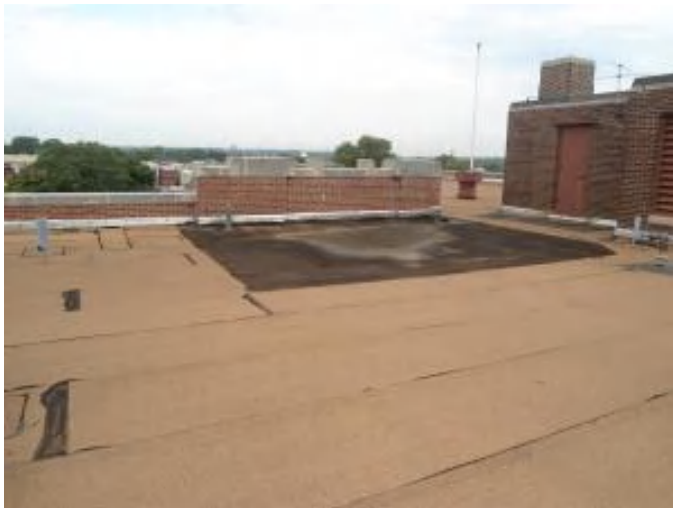
System: B3010105 - Built-Up

There are a four roof sections and different roof elevations ranging from the main roof to the mechanical roof. Parapet heights, coping materials, and the height of the flashing also varies in different sections. The main roof is a built up application that was reported to have been installed in the early 1990'S. As indicated in the photos sections of the roof is showing conditions that lead to failure such as ponding. Also note the recent roof repairs that have been completed near the access point and on the main level. Considering the age and condition of the roofing systems, universal upgrades are recommended. Remove and replace all roof sections.

Location: Roof
Distress: Beyond Service Life
Category: 3 - Operations / Maint.
Priority: 5 - Response Time (> 5 yrs)
Correction: Remove and Replace Built Up Roof
Qty: 20,000.00
Unit of Measure: S.F.
Estimate: \$677,640.22
Assessor Name: System
Date Created: 09/10/2015

Notes: There are a number of roof sections and different roof elevations ranging from the main roof to the mechanical roof. Parapet heights, coping materials, and the height of the flashing also varies in different sections. The main roof is a built up application that was reported to have been installed in the early 1990'S. As indicated in the photos sections of the roof is showing conditions that lead to failure such as ponding. Also note the recent roof repairs that have been completed near the access point and on the main level. Considering the age and condition of the roofing systems, universal upgrades are recommended. Remove and replace all roof sections.

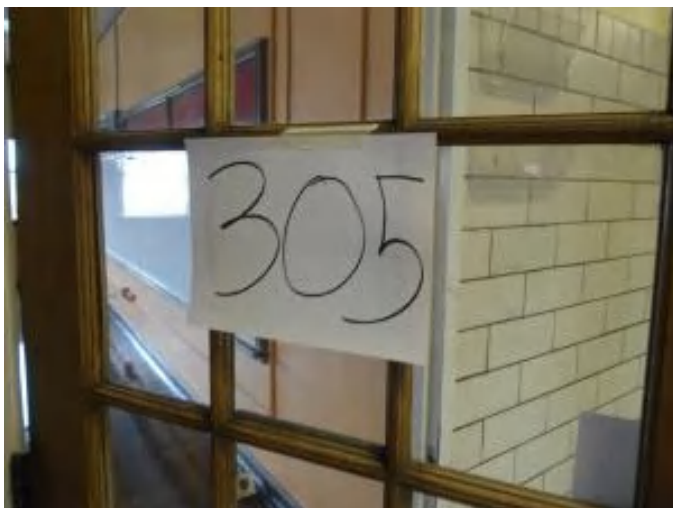
System: C1020 - Interior Doors

A large portion of the interior doors are code compliant with both ADA and are fire rated. However, several interior doors are typically wood in wood frames with transom lites or sidelights, glass glazing. The older doors are generally in good condition considering the age of the application. To restore the door finishes, universal upgrades are required for the older door applications. Remove and replace original door systems.

Location: Building Wide
Distress: Beyond Service Life
Category: 3 - Operations / Maint.
Priority: 5 - Response Time (> 5 yrs)
Correction: Remove and replace interior doors - wood doors with wood frame - per leaf
Qty: 30.00
Unit of Measure: Ea.
Estimate: \$139,630.17
Assessor Name: System
Date Created: 09/10/2015

Notes: A large portion of the interior doors are code compliant with both ADA and are fire rated. However, several interior doors are typically wood in wood frames with transom lites or sidelights, glass glazing. The older doors are generally in good condition considering the age of the application. To restore the door finishes, universal upgrades are required for the older door applications. Remove and replace original door systems.

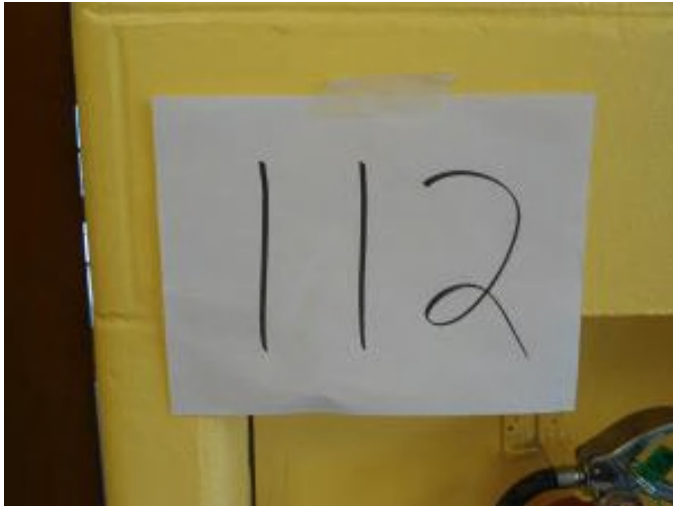
System: C1030 - Fittings

There is no directional signage and room signage is a custom design in places and scarce or painted with no consistency in others. Accessibility signage criteria have been established for the physically challenged. These include mounting heights, contrast and finish, raised and Braille characters and pictograms, and character proportions and heights. It is recommended that compliant signage be installed throughout the building.

Location: Building Wide Signage
Distress: Beyond Service Life
Category: 3 - Operations / Maint.
Priority: 5 - Response Time (> 5 yrs)
Correction: Replace missing or damaged signage - insert the number of rooms
Qty: 250.00
Unit of Measure: Ea.
Estimate: \$65,058.17
Assessor Name: System
Date Created: 09/10/2015

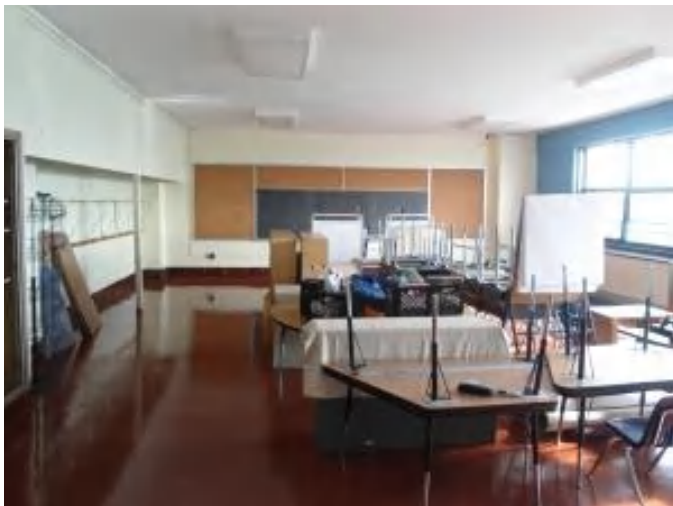
System: C1030 - Fittings

Location: Classrooms
Distress: Beyond Service Life
Category: 3 - Operations / Maint.
Priority: 5 - Response Time (> 5 yrs)
Correction: Replace blackboards with marker boards - pick the appropriate size and insert the quantities
Qty: 20.00
Unit of Measure: Ea.
Estimate: \$13,764.64
Assessor Name: System
Date Created: 09/10/2015

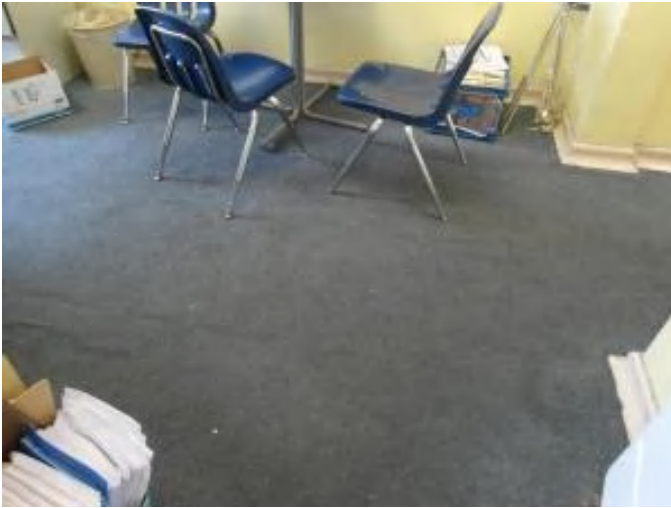
System: C3020411 - Carpet

The interior carpet finish was installed approximately in 2000 and is in fair condition considering the age and high traffic conditions. This finish will exceed its expected life within the next five years and is recommended for removal and replacement.

Location: Administration Areas

Distress: Damaged

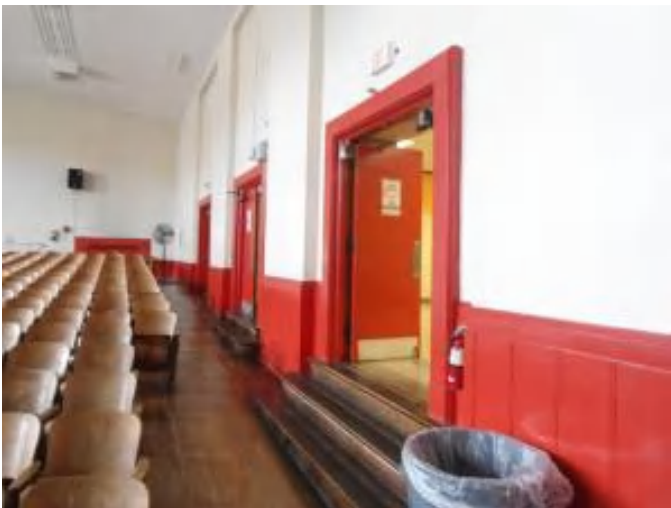
System: C3020414 - Wood Flooring

The classrooms and auditorium in this school have a wooden floor finish that appears to be from original construction. The system is showing signs of age such as the effects of sanding and refinishing with yearly cleaning and waxing with some repairs. The floor finish is in fair condition however, the finish is beyond its expected life cycle. It is recommended that the wooden floor finish be removed and replaced with an in kind finish.

Location: Building Wide

Distress: Beyond Service Life

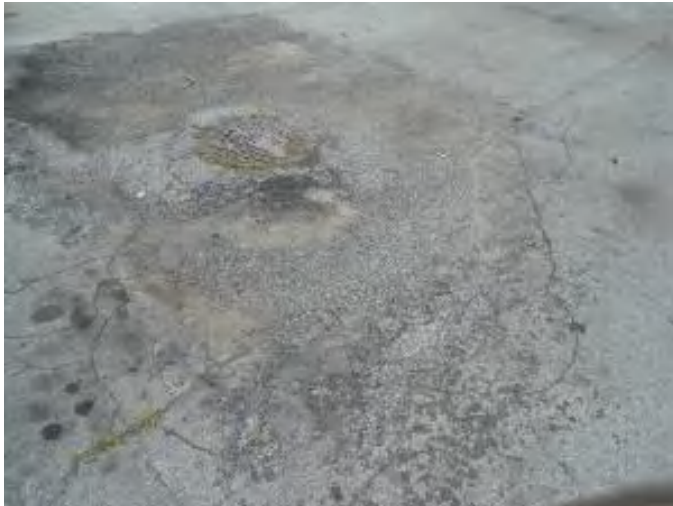
System: G2020 - Parking Lots

Location: Site

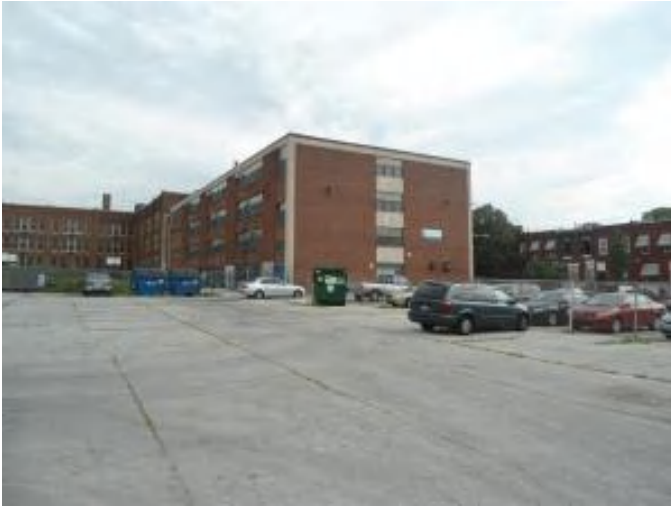
System: G2040 - Site Development

Location: Site

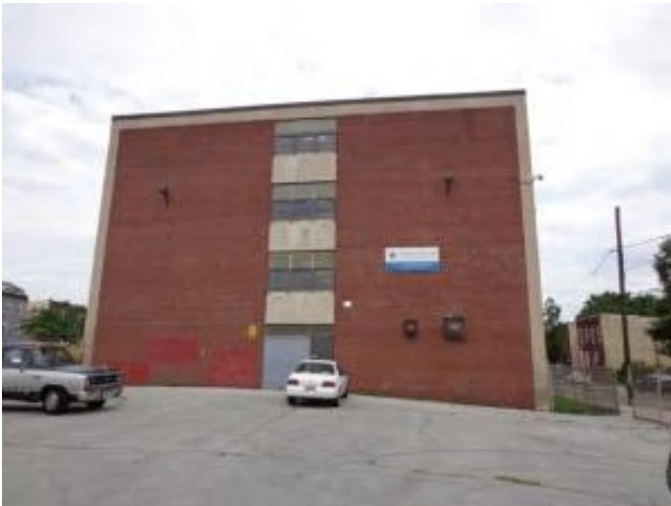
System: G4030 - Site Communications & Security

Location: Exterior - west side

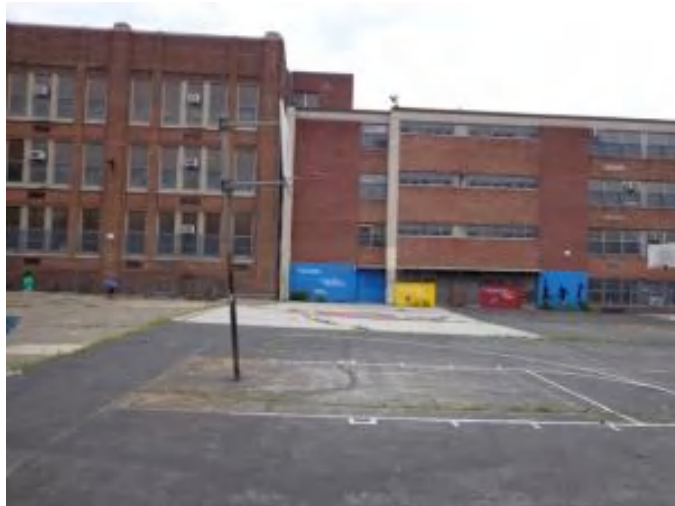
System: G4030 - Site Communications & Security

Location: Exterior - west side
